UNDERWATER BRIDGE INSPECTION REPORT

Bridge #: CUY-6-1499
Detroit-Superior
Waterway: Cuyahoga River
City: Cleveland, Ohio

Diver: Youri Bardyguine
Tender: Pat Murphy - Mark Maquire
Date: 2 October 2002

Name: HNTB
Address: 55 Erieview Plaza Suite 500
Cleveland, Ohio 44114-1816
Field Representative: Bill Vermes
Telephone #: (216) 522-1140

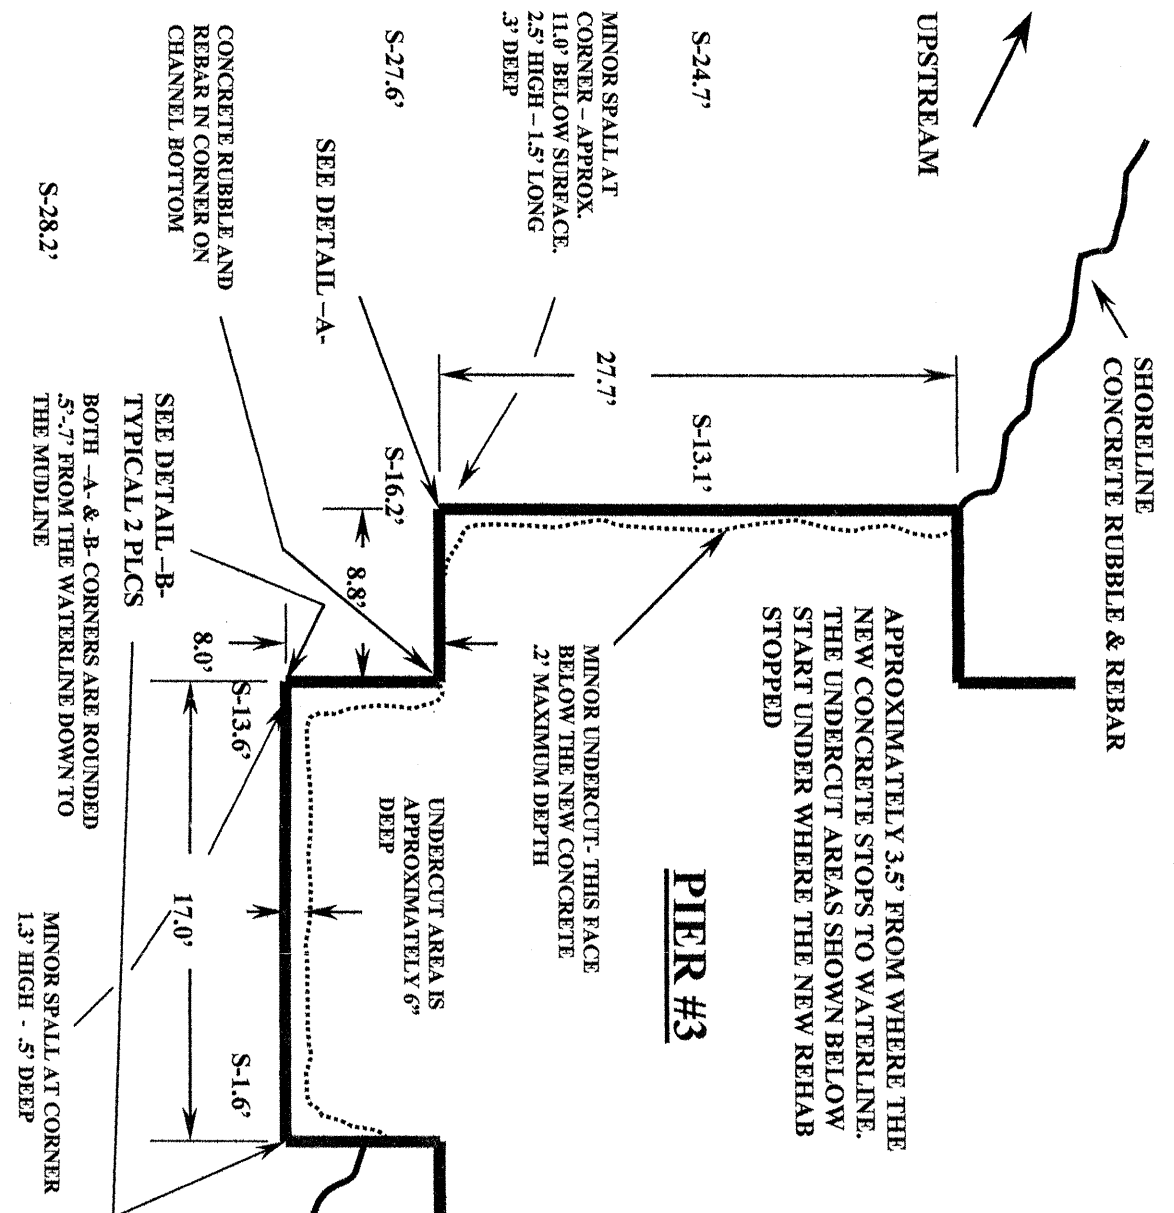
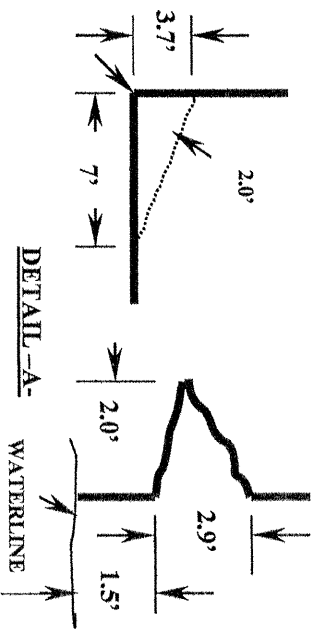
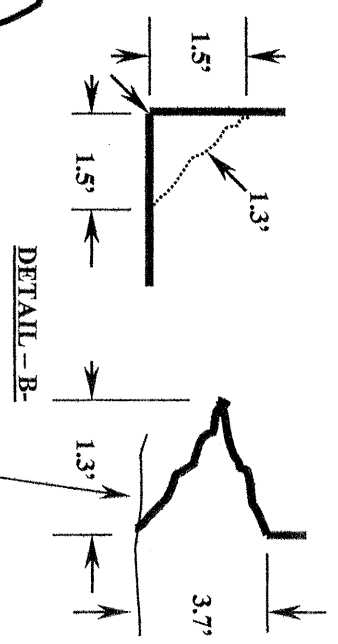
DETROIT SUPERIOR PIER #3 WEST BANK

Impact Damage: Pier corners are spalled above the waterline – see detail. Corners are rounded and spalled below the waterline.

Unusual Conditions: New concrete placed during rehab stopped 3.5' above waterline. Existing concrete below the new has spalling on the face with the corners rounded below the waterline.

THE CONCRETE FACE OF THE PIER IS SMOOTH BELOW THE WATERLINE. THE SPALLING AND EXPOSED AGGREGATE IS PRESENT FROM THE WATERLINE UP.

EXISTING STEEL SHEET PILING POOR CONDITION APPROX. 25' DOWNSTREAM
