**BRIDGE INSPECTION REPORT  
BRIDGE NO. CUY-06-14.56  
VETERAN'S MEMORIAL BRIDGE  
OVER CUYAHOGA RIVER VALLEY  
CUYAHOGA COUNTY, OHIO**

Prepared by

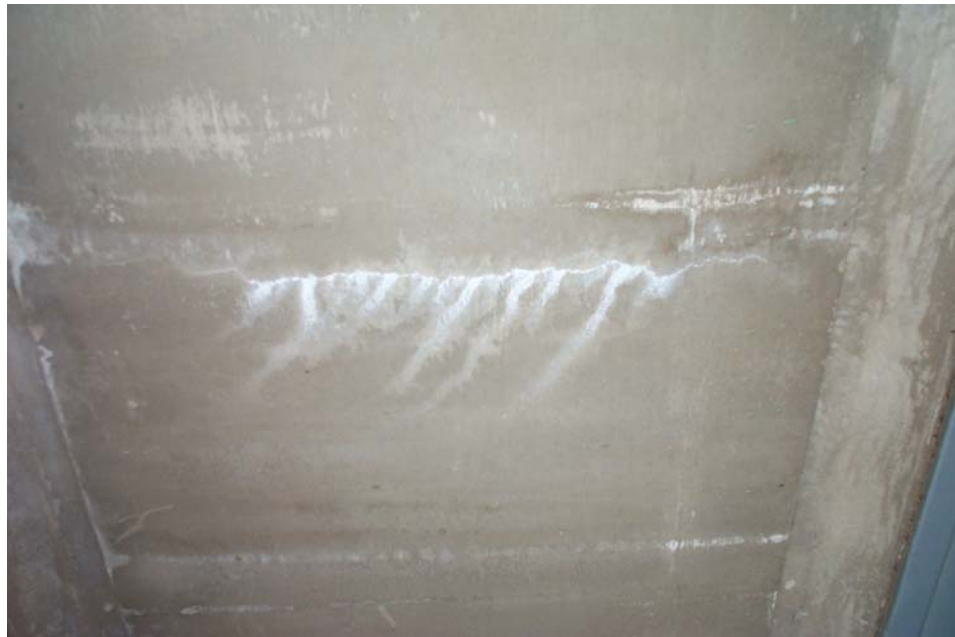
Photo 2. View showing a 0.002 to 0.003-inch wide transverse crack in the bottom side of the upper deck of Span 4 at a location between Panel Points 1' and 2' and Stringers H and J.

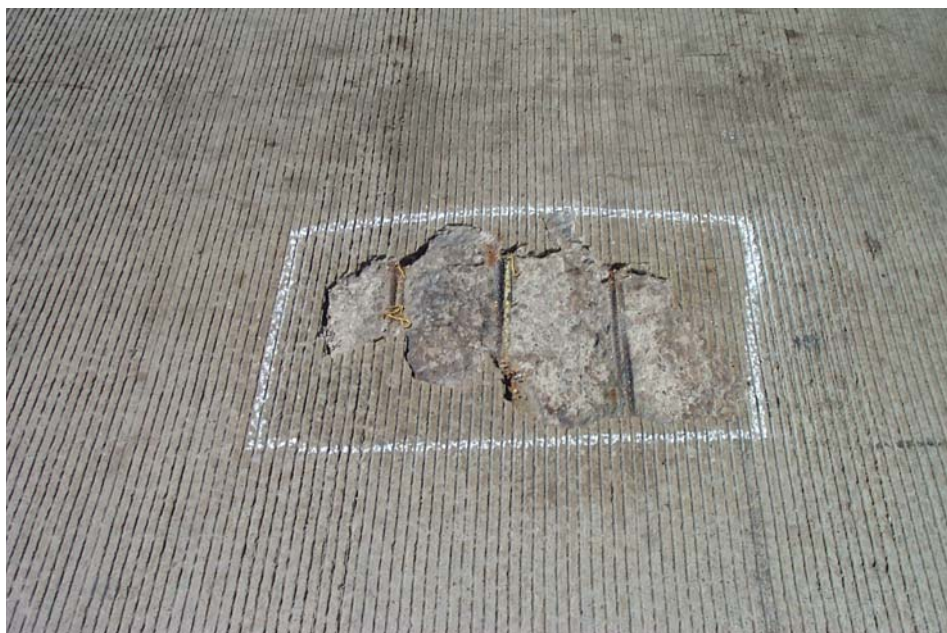
Photo 3. View showing a 20- by 30-inch spalled and delaminated area on the wearing surface in the north eastbound lane of the upper deck above East Station, at a location approximately 75 feet west of the end of the concrete wearing surface at the east end of the station.

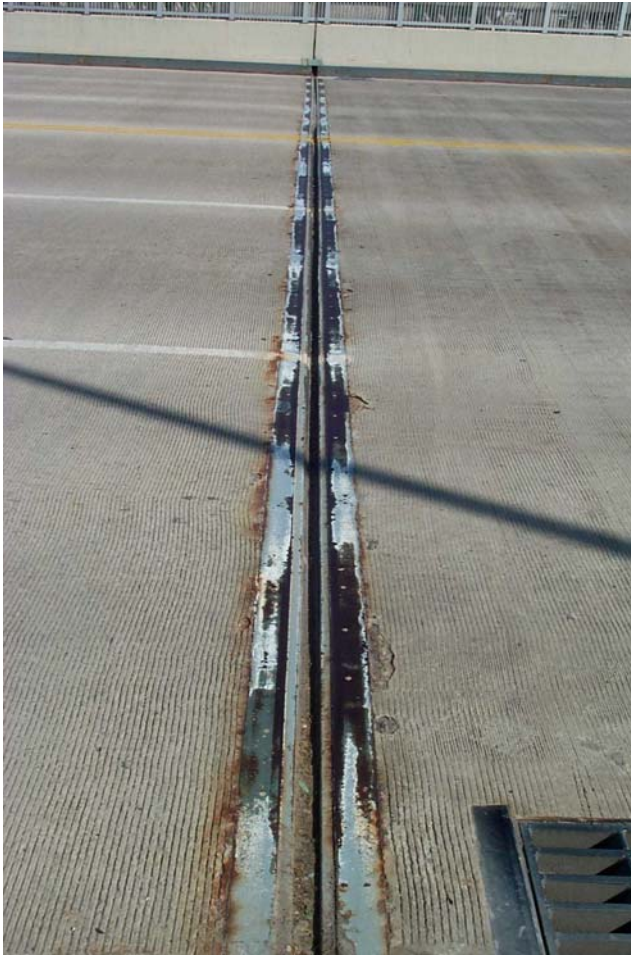
Photo 4. View looking south over the joint in the upper deck at Pier 7 showing scaled/spalled areas along the joint armor.  
DCP\_2277.JPG

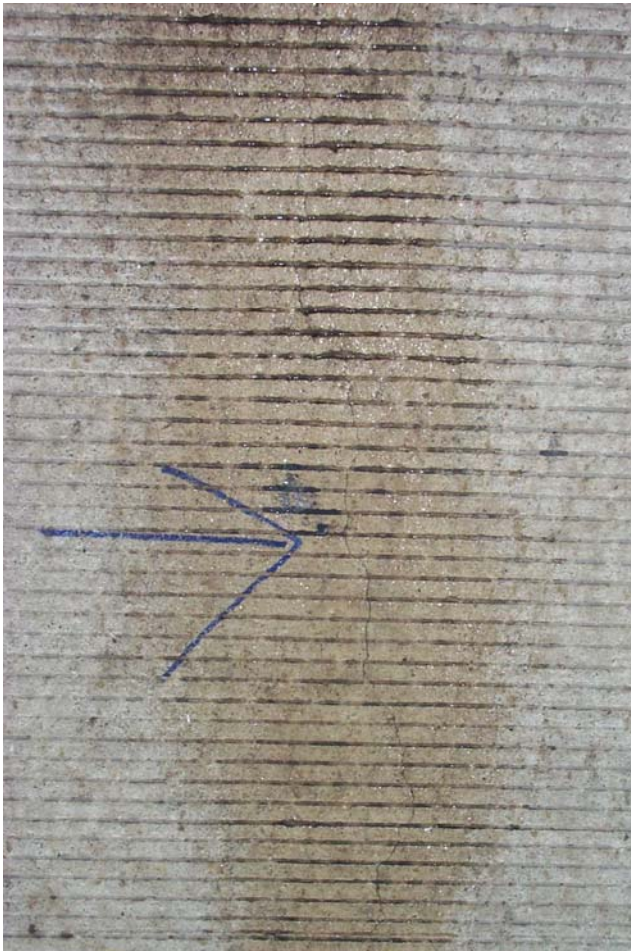
Photo 5. Close-up view showing a typical longitudinal crack in the wearing surface of the upper deck in the south westbound lane in Span 7. The crack measures between 0.003 and 0.005 inch in width.  
DCP\_2343.JPG

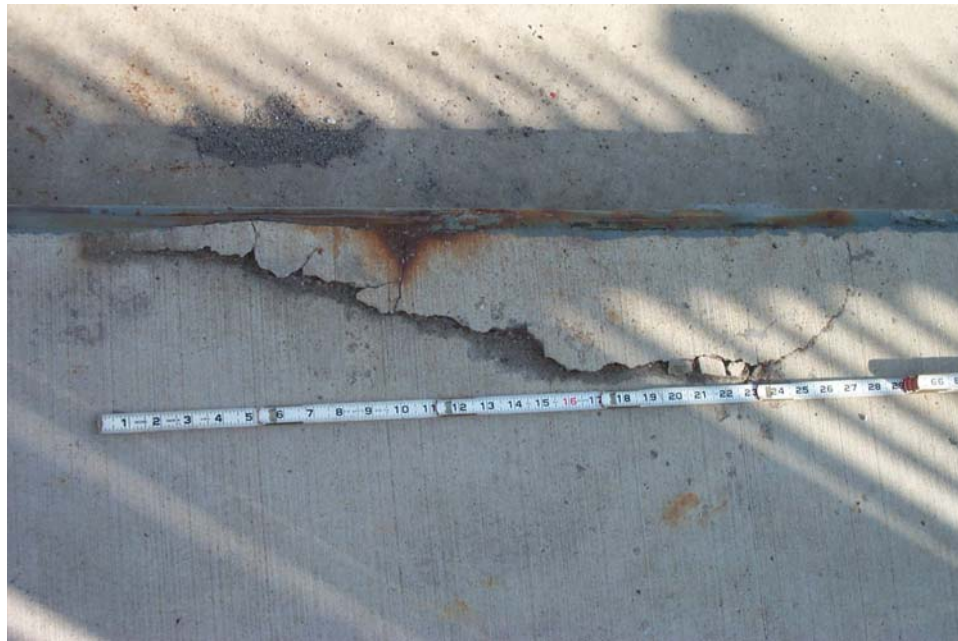
Photo 6. View showing a 28-inch long by up to 6-inch wide delaminated and spalled area on the north sidewalk along the curb plate in Span 13.

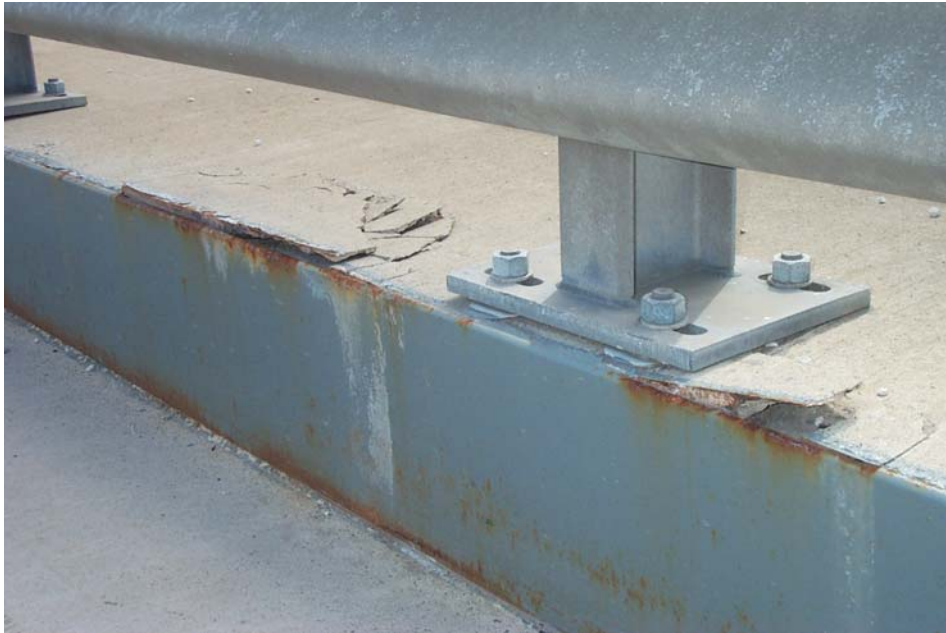
Photo 7. View showing 9½-inch wide by 30-inch long and 4-inch wide by 10½-inch long spalled and delaminated areas along the north curb plate of the north arch-truss island between PP7 and PP8. Also in view are areas of rust along the top and bottom of the curb plate.  
DCP\_2282.JPG

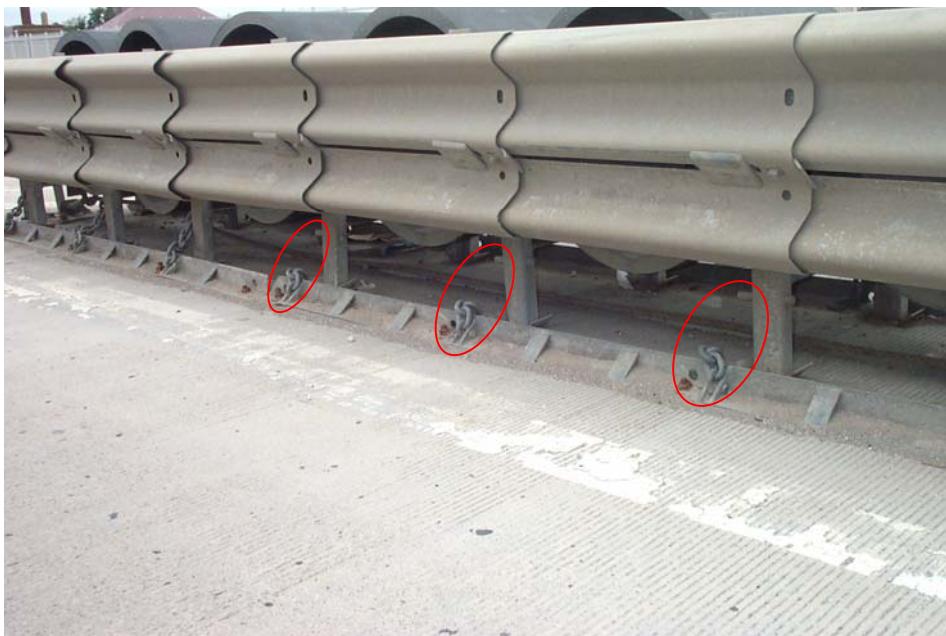
Photo 8. View from the south side of the LMA device located at the west end of the south arch truss. The ovals show locations where the anchor chain is disconnected from the horizontal pin on the leg of the LMA device.  
DCP\_2642.JPG

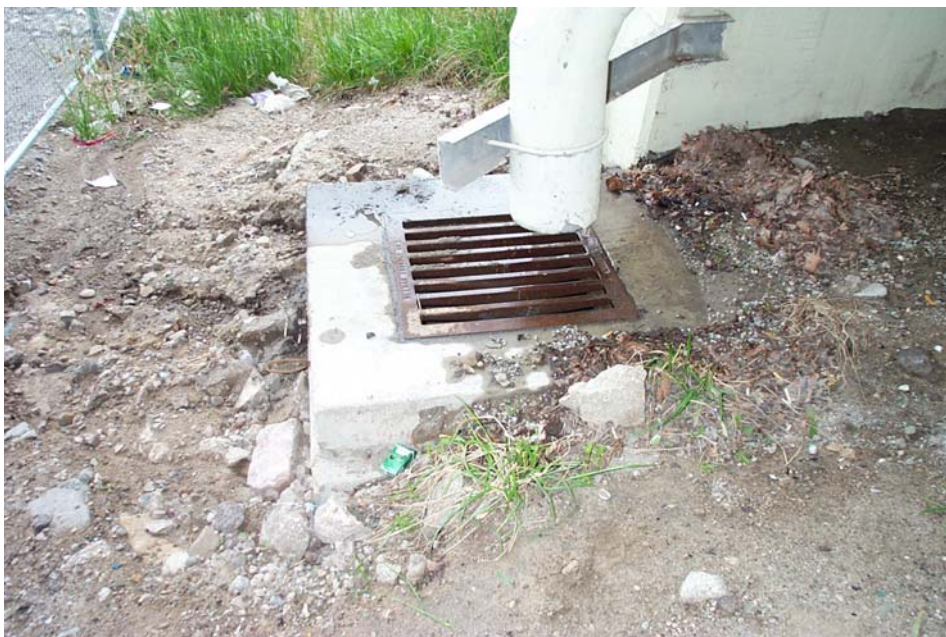
Photo 9. View looking south showing the end of the downspout and the lid of the catch basin at Pier 1 South. Note that the lid could be moved up to 5 inches to the north, which would better align the spout with the grate.

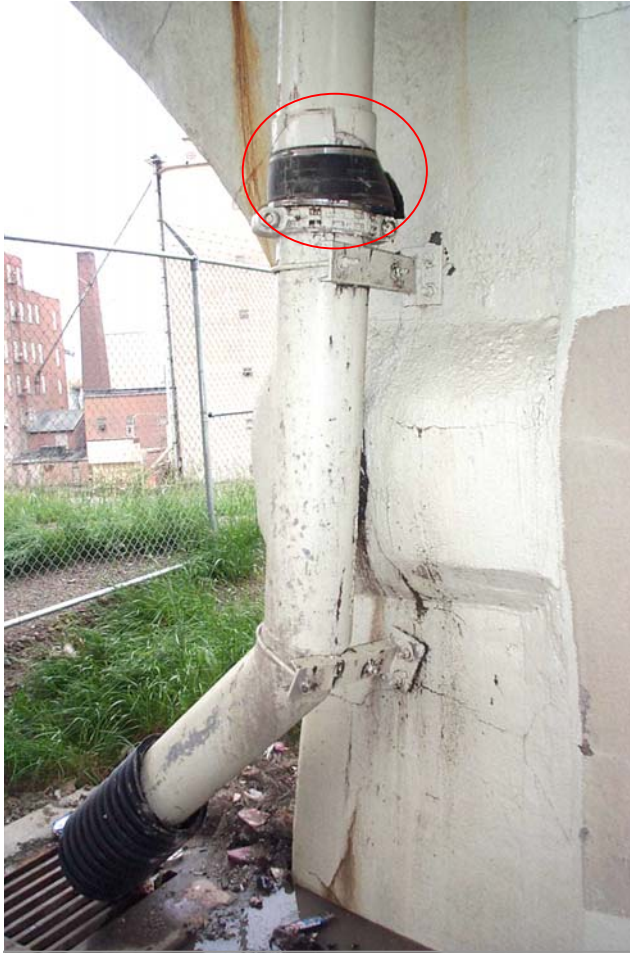
Photo 10. View looking southeastward showing the broken connection collar and rubber repair strip (oval) and the CPP extension at the bottom of the downspout at Pier 2 South. Note the water pooled alongside the pier that leaked out of the collar.

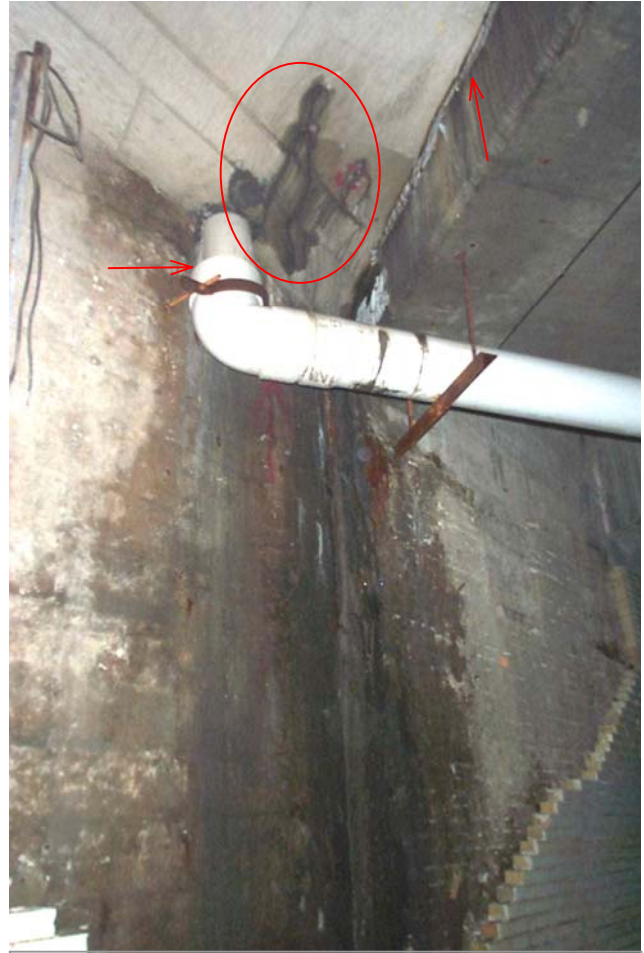
Photo 11. View looking southeastward showing the PVC downspout below the deck scupper in the south gutter at the east end of East Station. The horizontal arrow points to the junction where water escapes through the gap between the vertical spout and the elbow. The oval highlights the area where water is leaking through holes drilled into the deck floor. Also note the water leaking through the adjacent deck joint (vertical arrow).

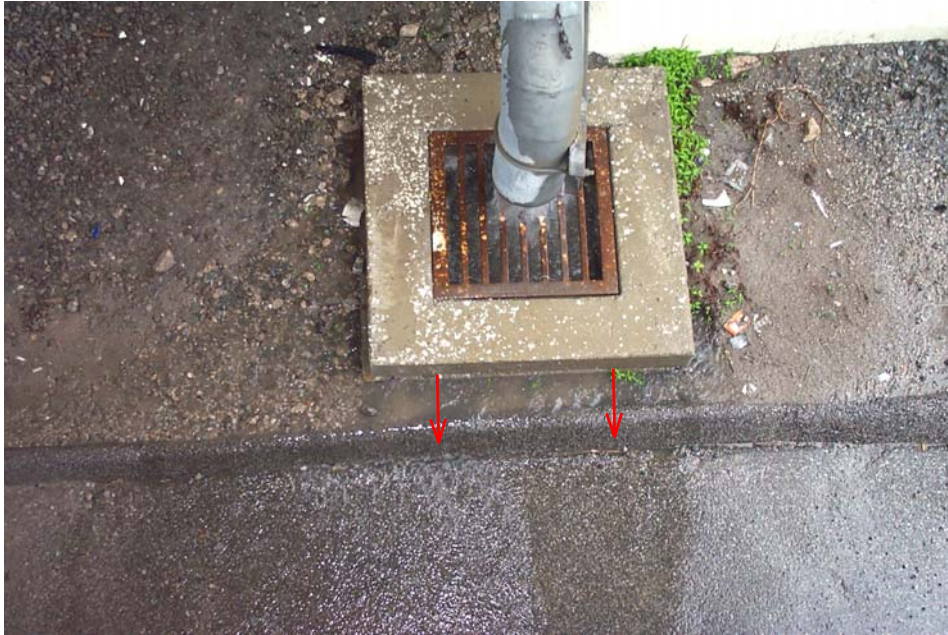
Photo 12. View looking down at the downspout and catch basin at Pier 9 South showing water leaking under the lid of the basin (arrows) and flowing into the adjacent parking lot. DCP\_2375.JPG

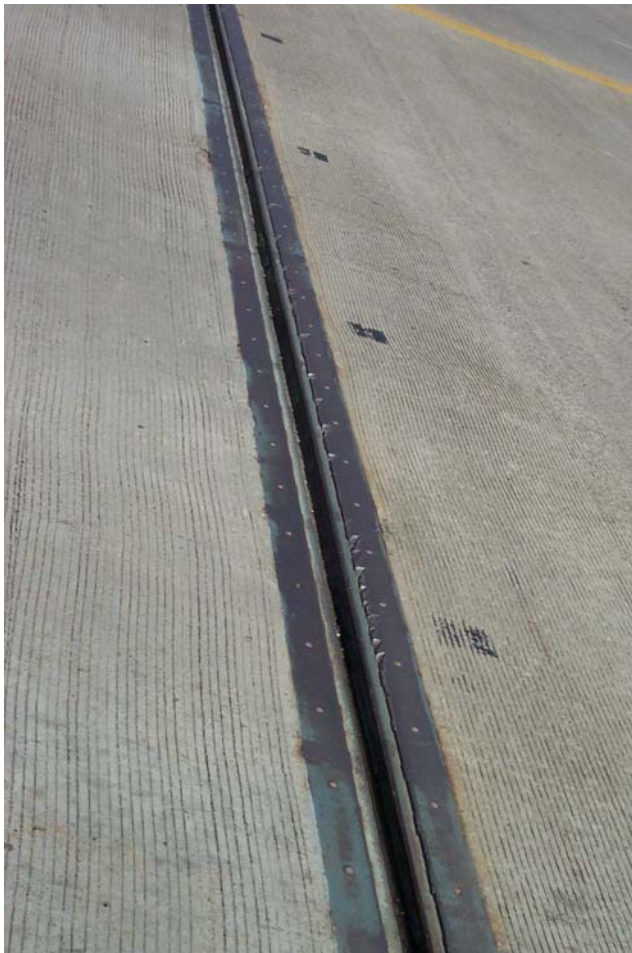
Photo 13. View looking south showing gouges in the joint armor along the west side of the deck joint at Tower B. Also note the absence of paint and light rust on the armor. DCP\_2276.JPG

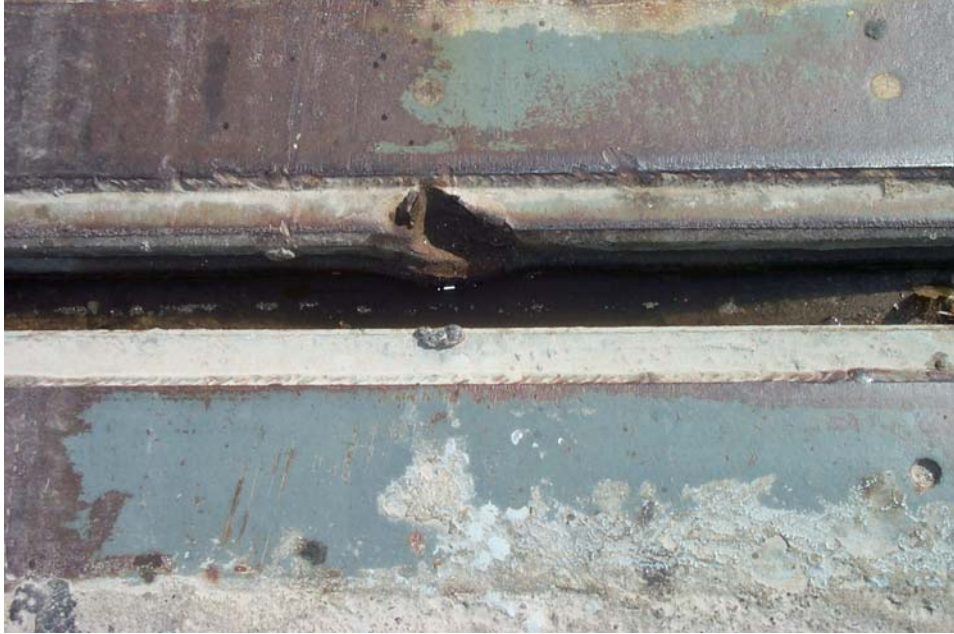
Photo 14. View showing a 2-inch long tear in the joint armor on the east side of the east joint at Pier 3, near the center of the south eastbound lane.

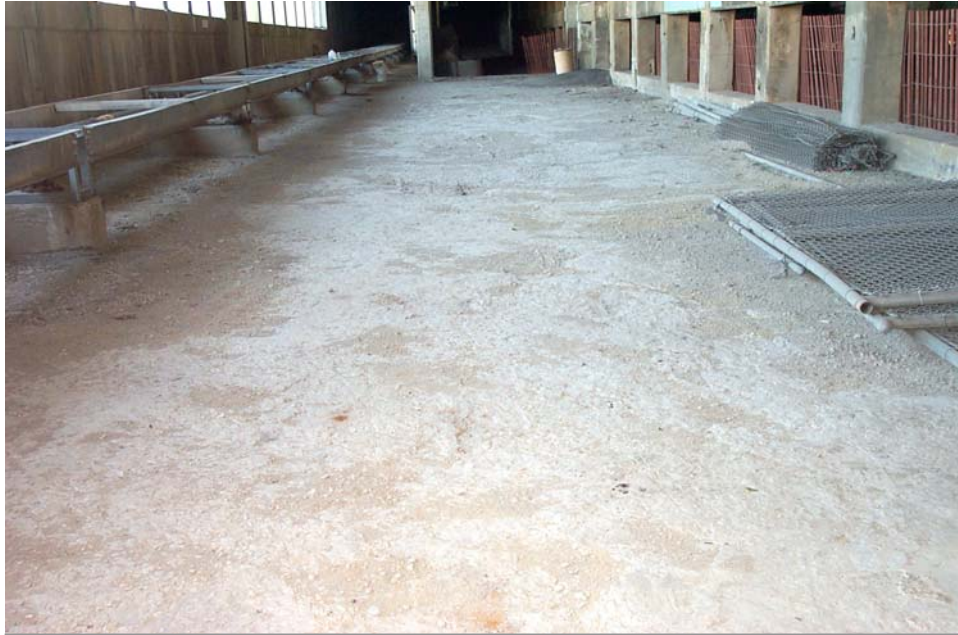
Photo 17. View looking west through the south bay of Span 1B showing the poor condition of the surface of the original lower level concrete deck.

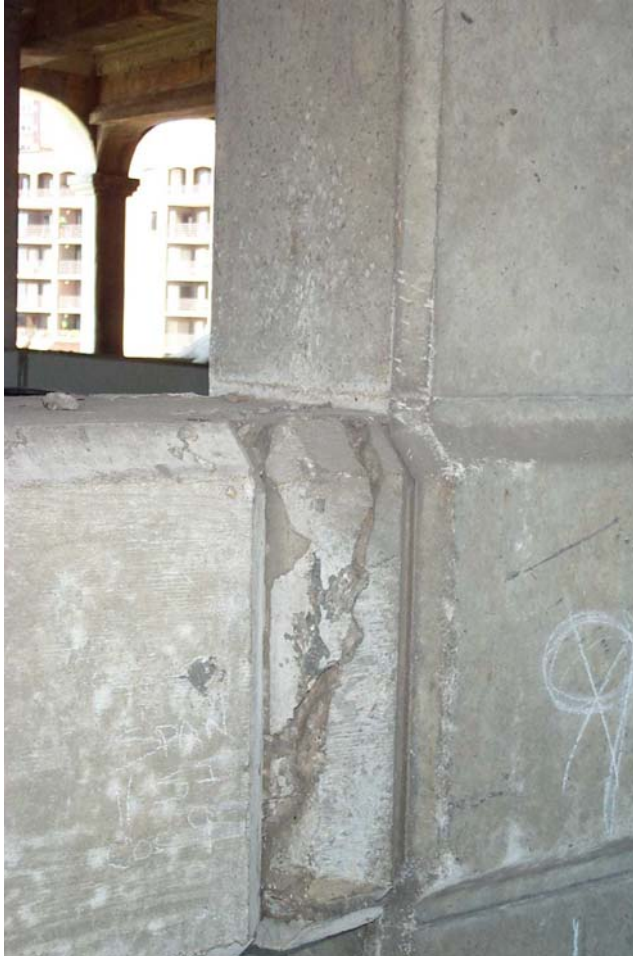
Photo 18. View of a crack through the south face of the railing adjacent to Column 1 in the south interior column row in Span 12. Note that the railing has a keyed joint at this location that coincides with the expansion joint in the deck. Insufficient opening in the key may have caused the concrete to crack from pressure encountered during movement.

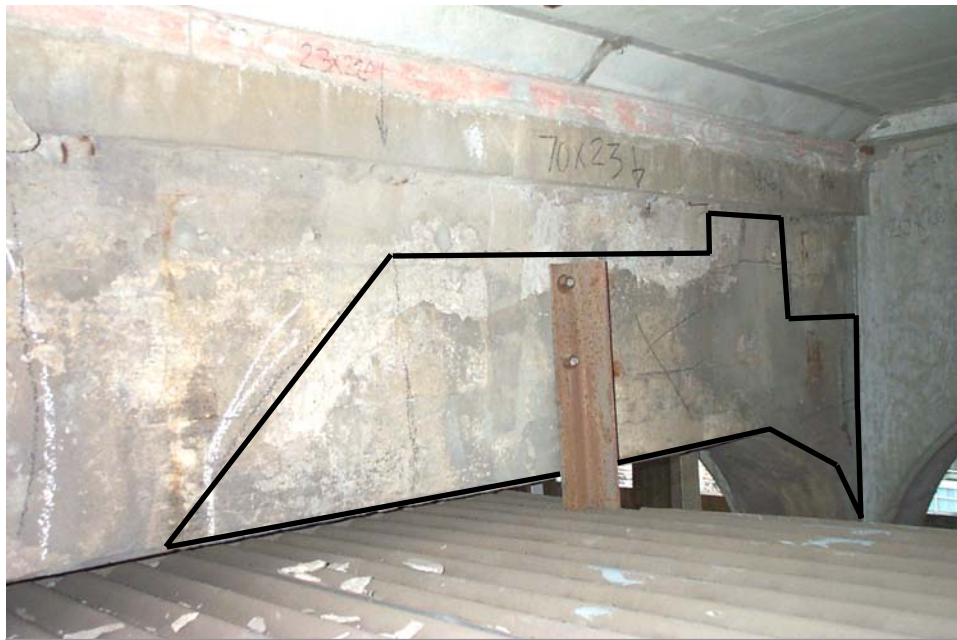
Photo 19. View of the east face of Floor Beam 15 in the south bay of Span 3. The black lines outline an area of delaminated concrete located within the north half of the beam.

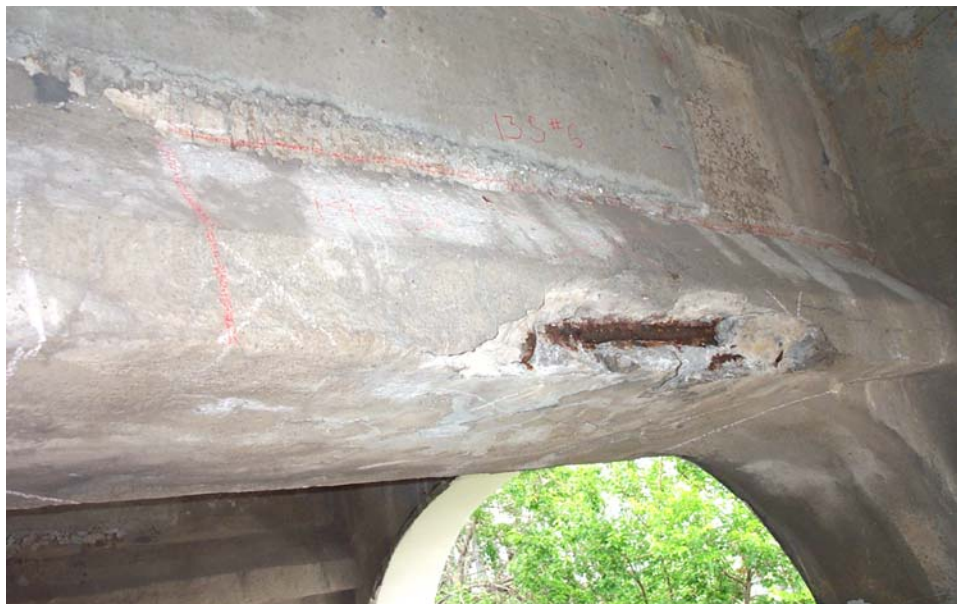
Photo 20. View of the lower portion of the west face and the bottom of Floor Beam 6 in the south bay of Span 13 showing a spall with exposed reinforcement. The widened section at the bottom of the beam encapsulates extra reinforcement added at the end portions of the original beams during the 1967 rehabilitation as a strengthening measure. The red lines outline delaminated concrete that was part of the strengthening repair. Areas of delamination are fairly typical at the strengthened beam ends.

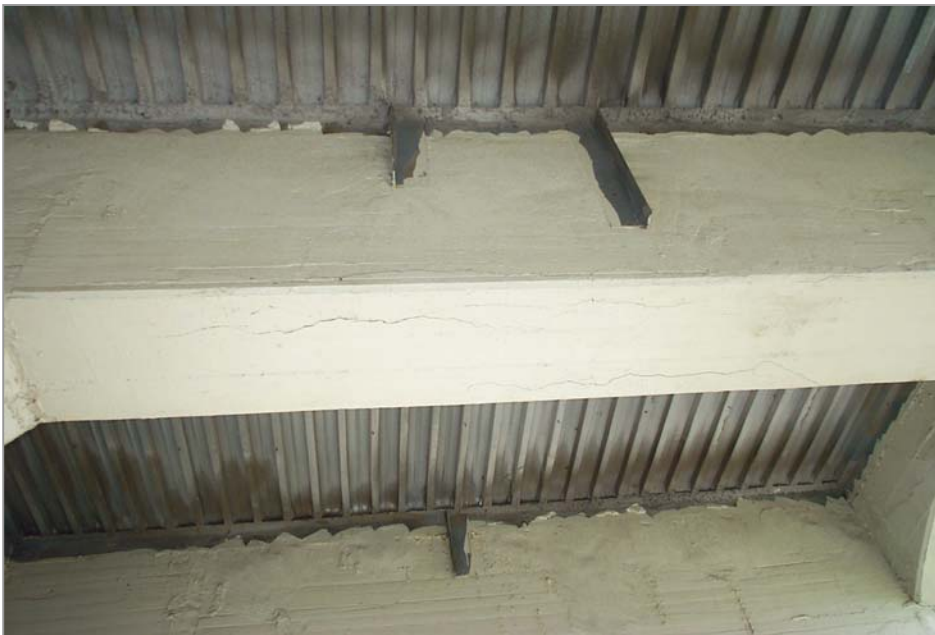
Photo 21. View looking upward showing longitudinal cracks on the bottom face and within the lower 4 inches of the west face of Floor Beam 6 in the south bay of Span 3. A similar crack is present within the lower 4 inches of the east face also. The concrete below the cracks in the vertical faces and on the entire bottom face is delaminated.

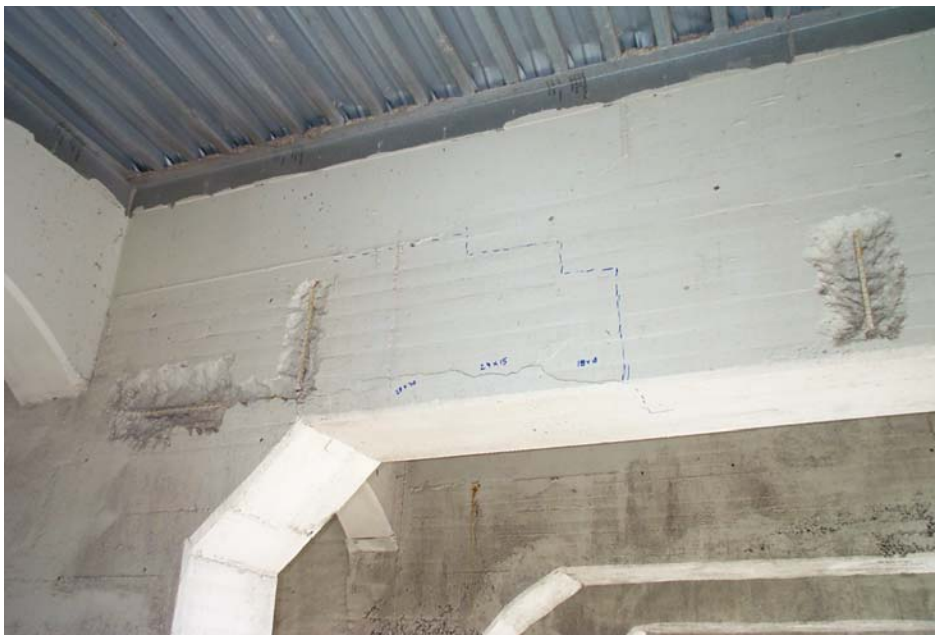
Photo 22. View of the bottom and west faces of Floor Beam 2 in the south bay of Span 5. The blue dashed lines show the edges of an area of delaminated concrete that extends to the right of the spalls above the spandrel column. Note that the concrete on the bottom face of the floor beam below the marked area is also delaminated.

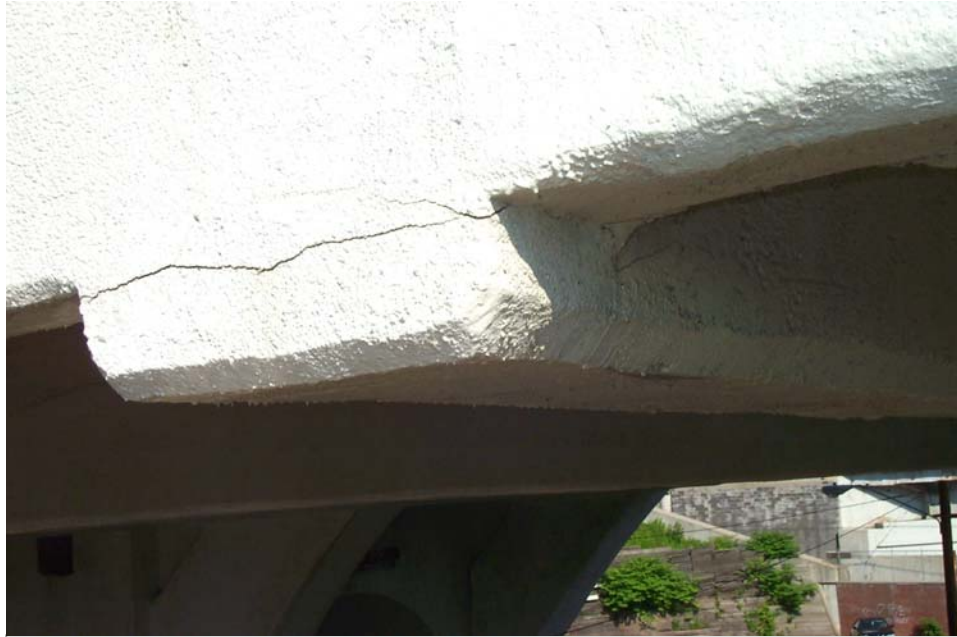
Photo 23. View showing a horizontal crack in the north end face of Floor Beam 5 in Span 12, approximately 5 inches above the bottom of the beam. The crack separates an area of delaminated concrete that extends 9 inches inward (south) along both vertical faces of the floor beam and 19 inches on the bottom face. A similar crack and area of delamination was noted at the ends of several other beams in Span 12.

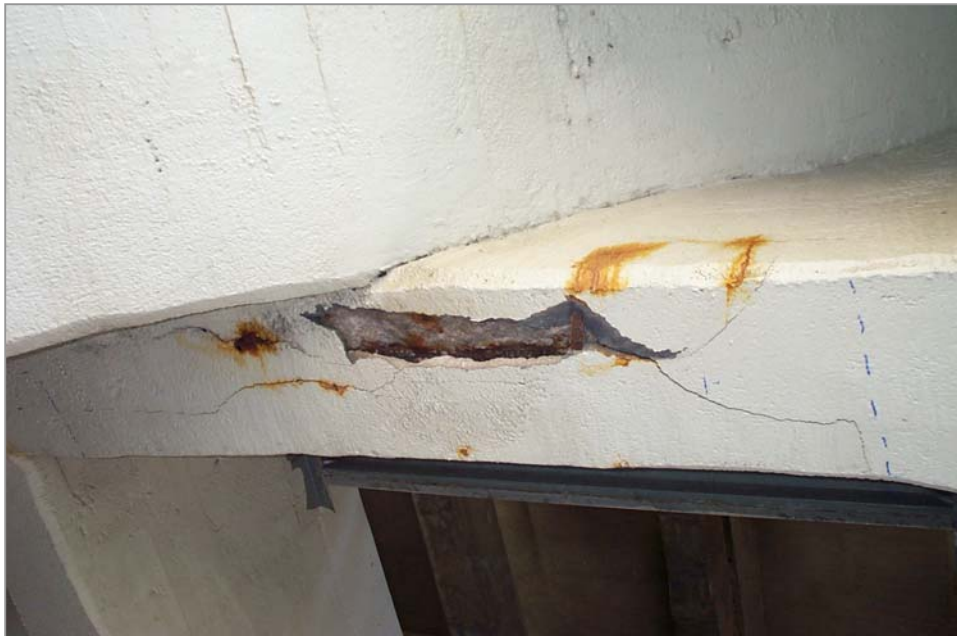
Photo 24. View showing a delaminated and spalled area on the bottom face of the longitudinal beam adjacent to the north exterior arch ring that connects the ends of Floor Beams 10, 11, and 12 in Span 12. Note that this area lies directly above a parking lot and that the concrete is separated and loose.

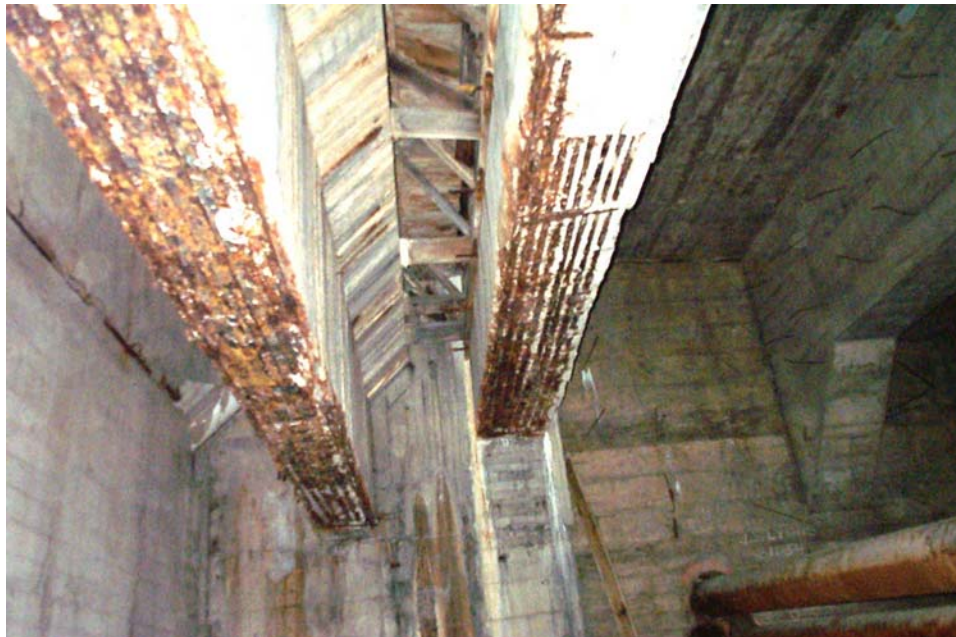
Photo 25. View looking north beneath Floor Beams 1 and 2 in the north bay inside the cellular East Abutment showing heavy spalls and corroded reinforcement along the bottom of the floor beams. The lower layer of longitudinal bars is exposed over the full length of Floor Beam 1 and the north two-thirds of Floor Beam 2 in this bay. Similar spalls expose large areas of reinforcement on these two beams in the center and south bays also.

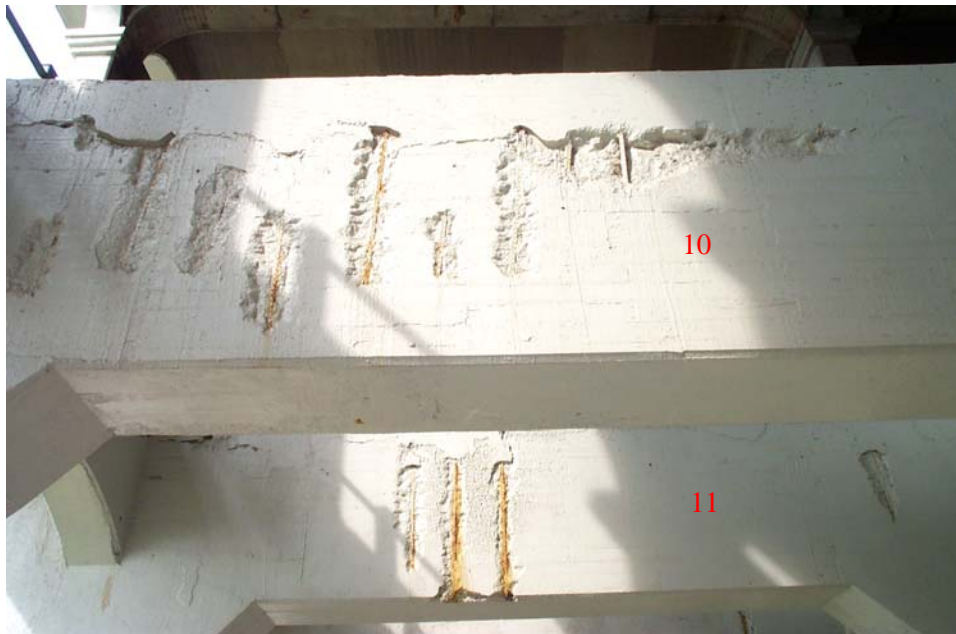
Photo 26. View looking east showing shallow spalls on the west face of Floor Beams 10 and 11 in the north bay of Span 10. Note that this condition is typical of many floor beams in Span 10 but is most pronounced at Floor Beam 10.

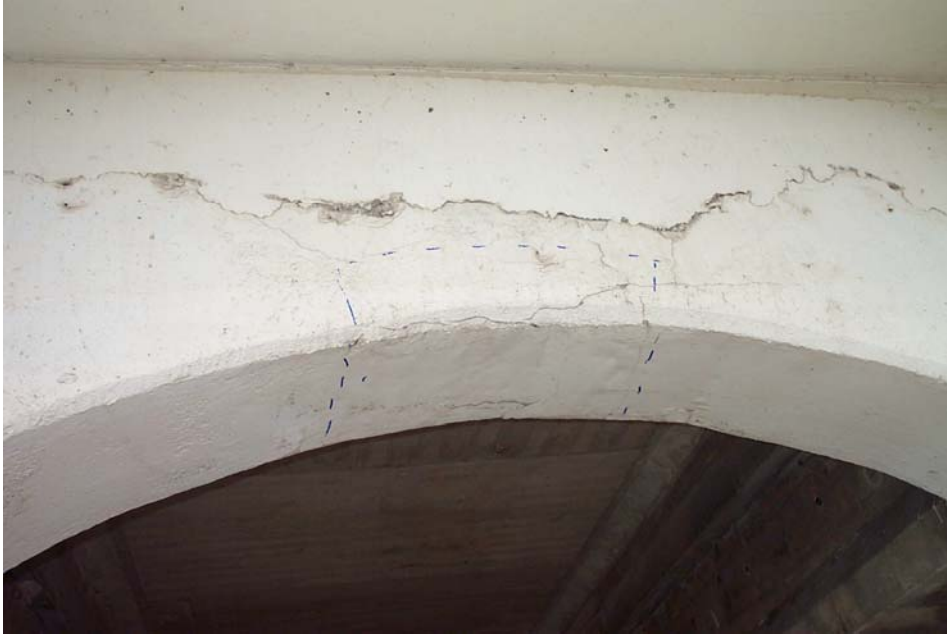
Photo 27. View looking north showing the jack arch between Columns 9 and 10 in the south exterior column row of Span 5. The dashed blue lines highlight the edges of an area of delaminated concrete on the south and bottom faces.

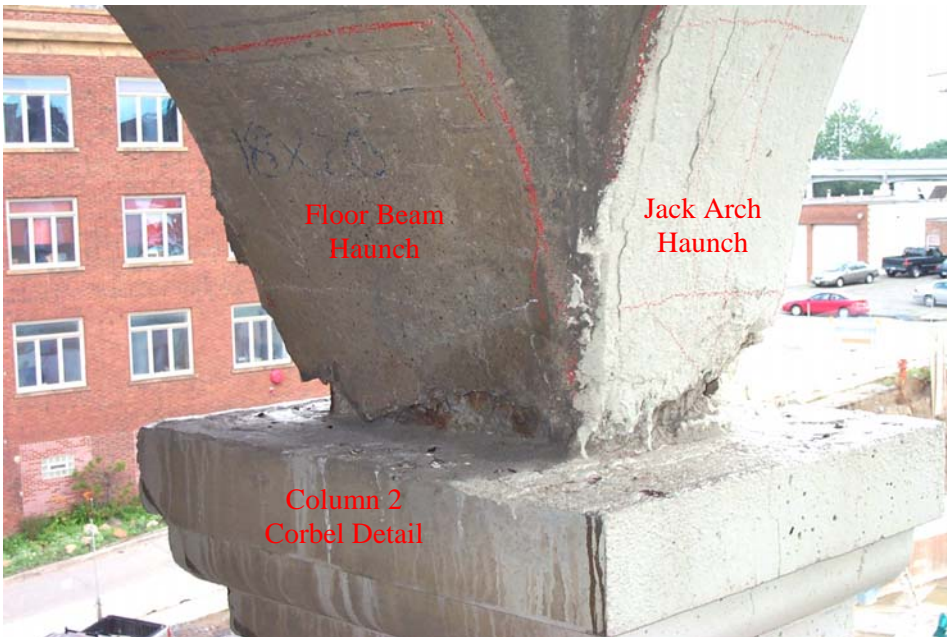
Photo 28. View of the corbel detail at the top of Column 2 in the north exterior column row in Span 2. The red lines outline areas of delaminated concrete on the bottom face at the base of the floor beam haunch and the jack arch haunch. Also in view are spalled or void areas along the haunch interface with the top of the corbel detail.

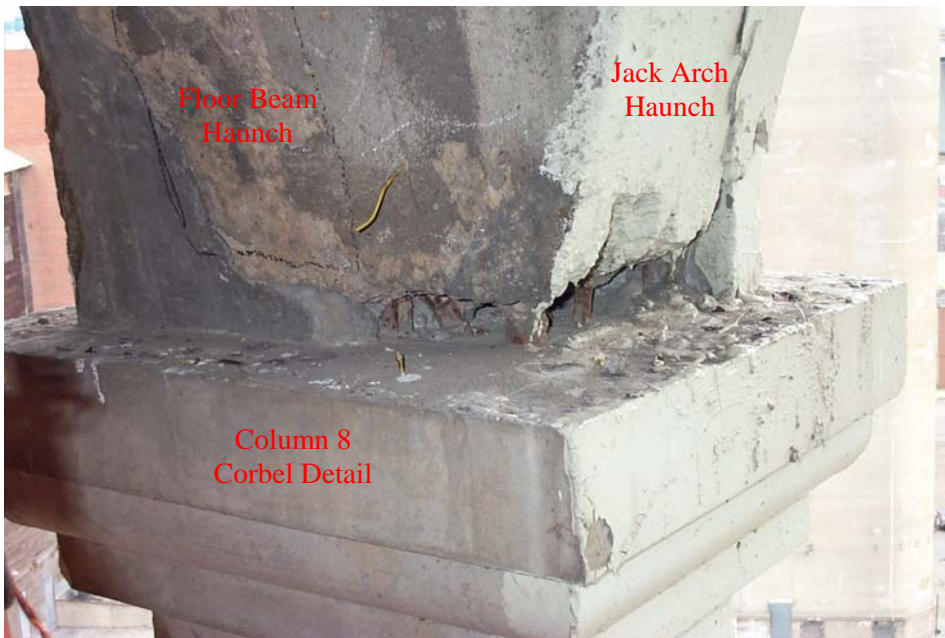
Photo 29. View at the corbel detail on top of Column 8 in the south exterior column row in Span 3 showing reinforcement exposed in the spalled/void areas along the interface of the floor beam and jack arch haunch with the corbel detail.

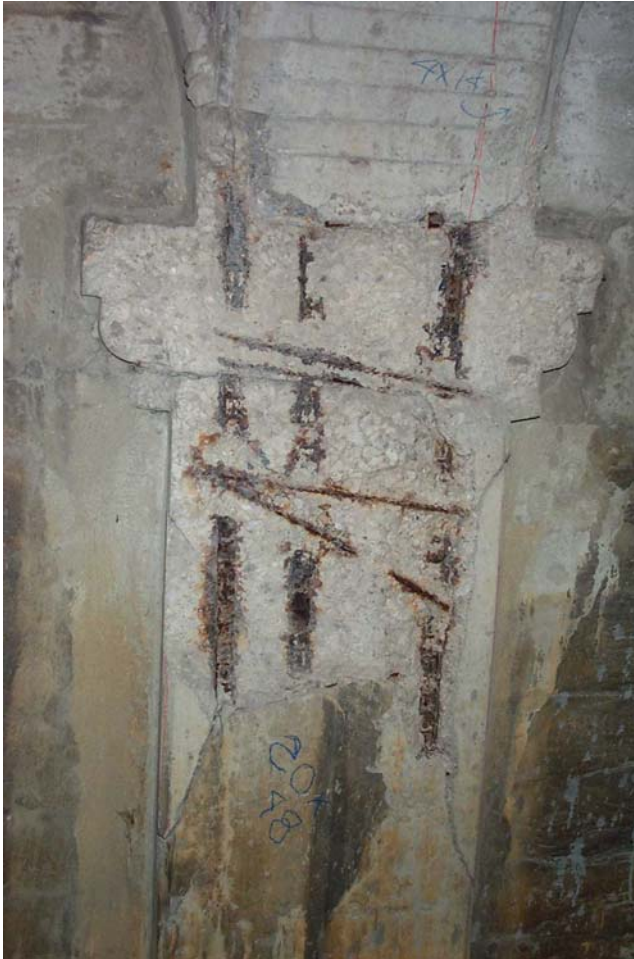
Photo 30. View showing a spalled area on the south face at the top of Column 6 in the north central column row in Span 1A. Note that the south protrusion of the corbel detail has fallen away and the spalled area extends the full width of the column and up to 48 inches down from the top.

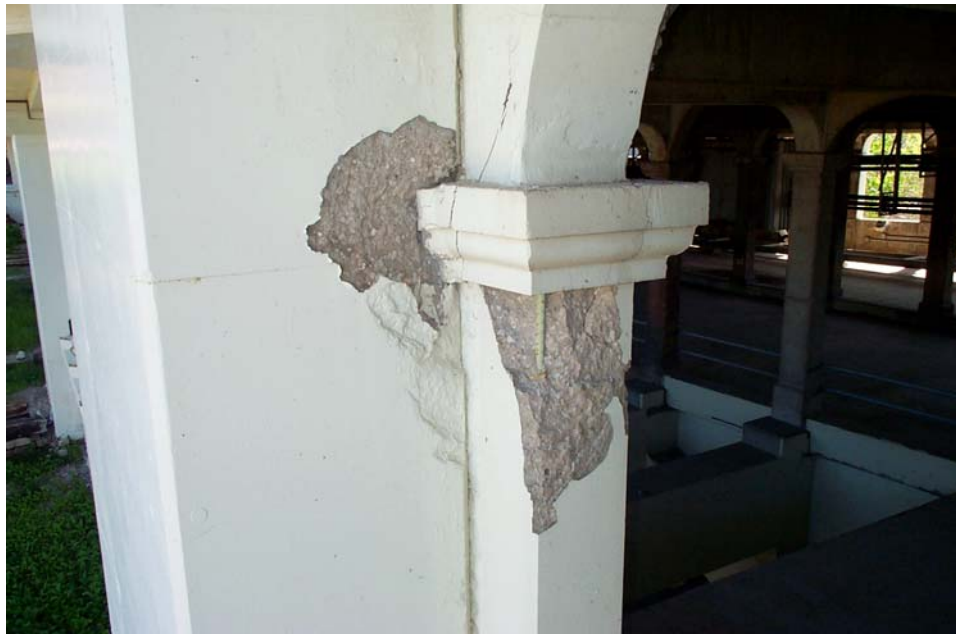
Photo 31. View showing a spalled area on the west and north faces at the top of Column 12 in the north exterior column row in Span 12. Note that portions of the corbel detail and the jack arch are cracked and delaminated in this area. The epoxy coating on the exposed reinforcement bar indicates that the column was replaced in the 1995 rehabilitation and thus the concrete deterioration developed in a short period of time. Also in view is a spall on the west face of the pier shaft. The east sidewalk along Robert Lockwood, Jr. Blvd. passes directly below this location.

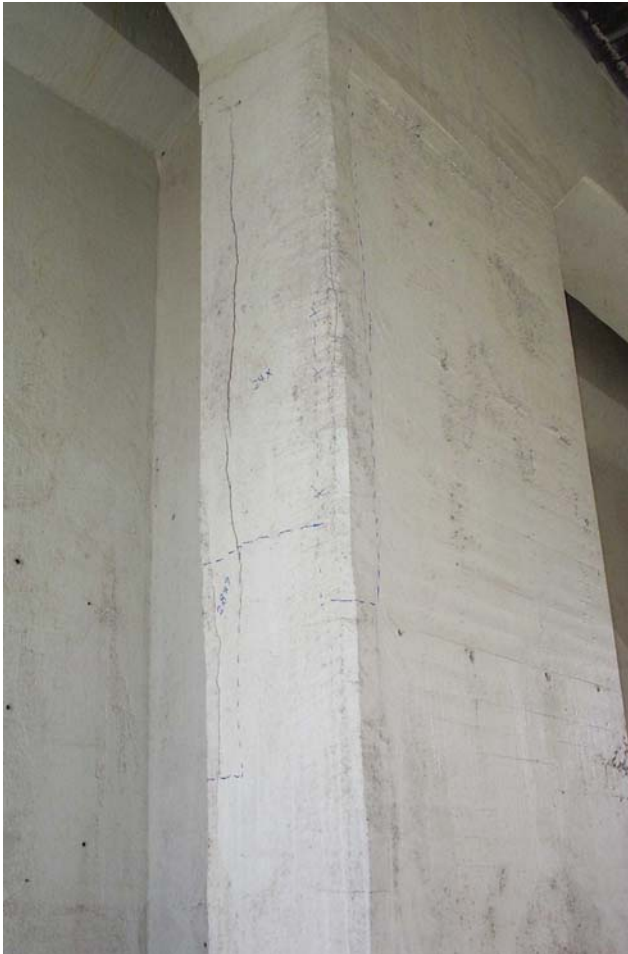
Photo 32. View showing areas of delamination outlined by blue lines on the south and east faces and a longitudinal crack along the west edge of the south face of Column 1 in the south interior row in Span 8. A total of 31.9 square feet of delaminated concrete was recorded for this column.

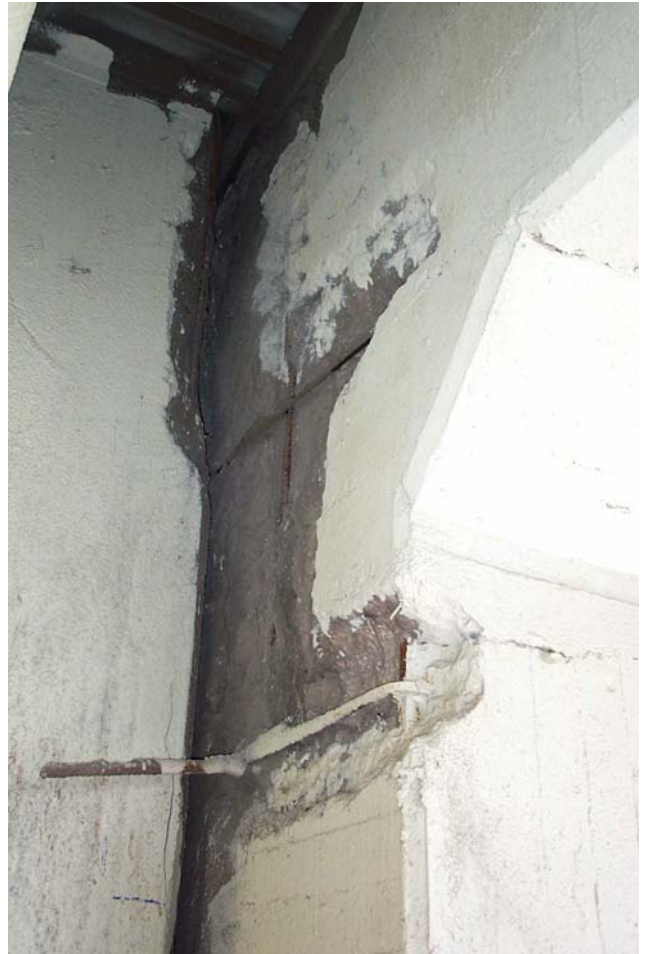
Photo 33. View showing 36- x 42-inch and 36- x 36-inch spalls on the west face and a 6- x 8-inch spall on the south face of Column 1 in the south interior row in Span 6.

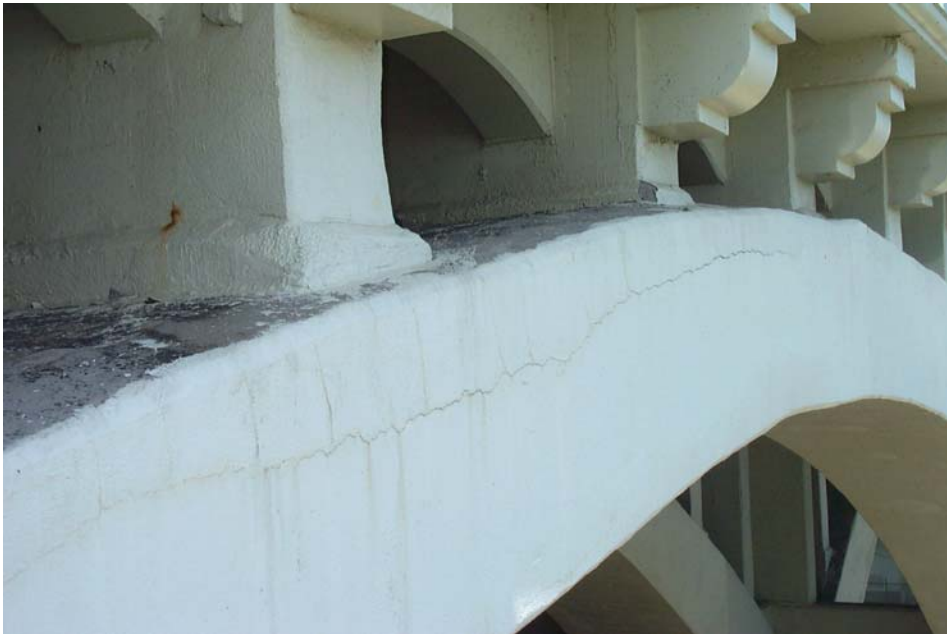
Photo 34. View showing a concentric crack located approximately 12 to 16 inches below the top of the south face of the south exterior arch rib, that extends from the 3<sup>rd</sup> to the 6<sup>th</sup> spandrel column bay in Span 1. Note that the concrete within the area above the crack is patch concrete and is delaminated. Also, a similar size area of delaminated patch concrete is present along the adjacent edge of the top face of the rib.

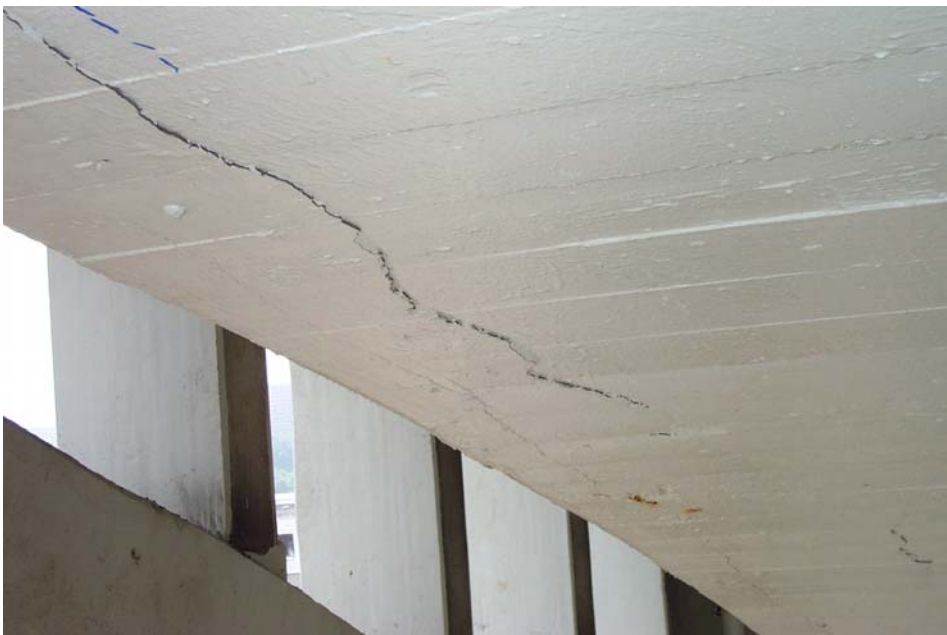
Photo 35. View showing a 13 to 20-inch wide delaminated area of original concrete along the south edge of the bottom face of the south interior arch rib below the 6<sup>th</sup> spandrel column bay in Span 7. This band of delaminated concrete extends below the next two spandrel column bays to the west and is positioned above West Avenue.

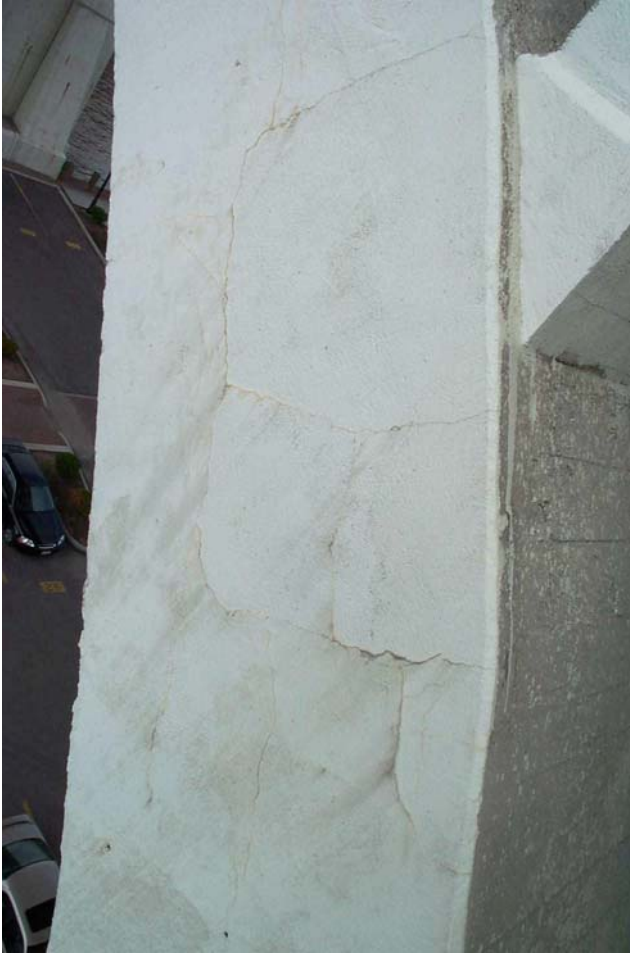
Photo 36. View showing map cracks on the south face of the south arch rib near the 14<sup>th</sup> spandrel column in Span 5. No delaminations were detected by sounding in this area.
