**BRIDGE INSPECTION REPORT  
BRIDGE NO. CUY-06-14.56  
VETERAN'S MEMORIAL BRIDGE  
OVER CUYAHOGA RIVER VALLEY  
CUYAHOGA COUNTY, OHIO**

Prepared by

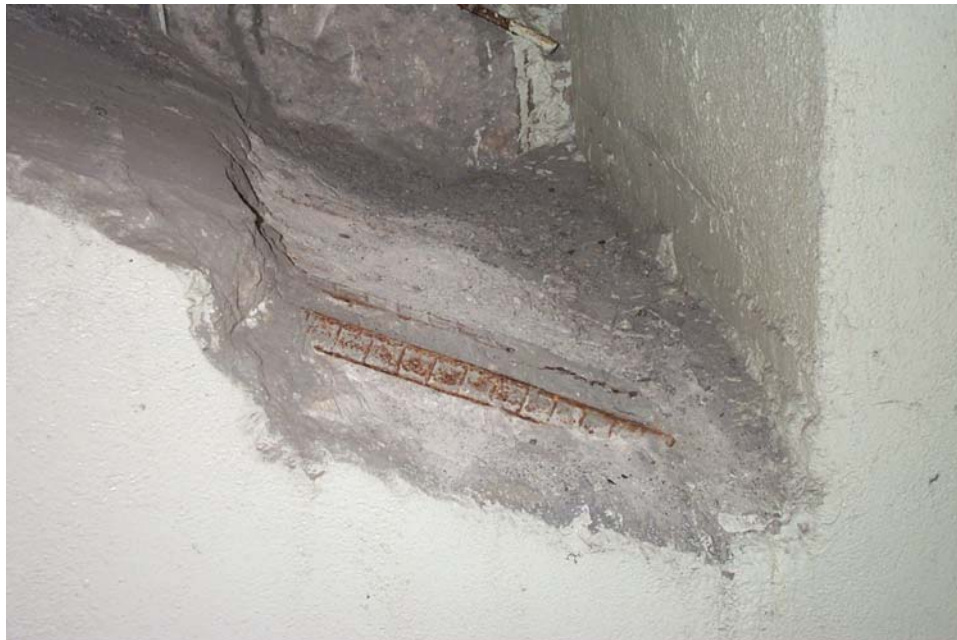
Photo 37. View showing reinforcement exposed in a 22- x 36-inch area on the top surface of the north interior arch rib in Span 13, adjacent to East Abutment. This area appears to be what remains of a larger area that was prepared for patching, which was not completed.

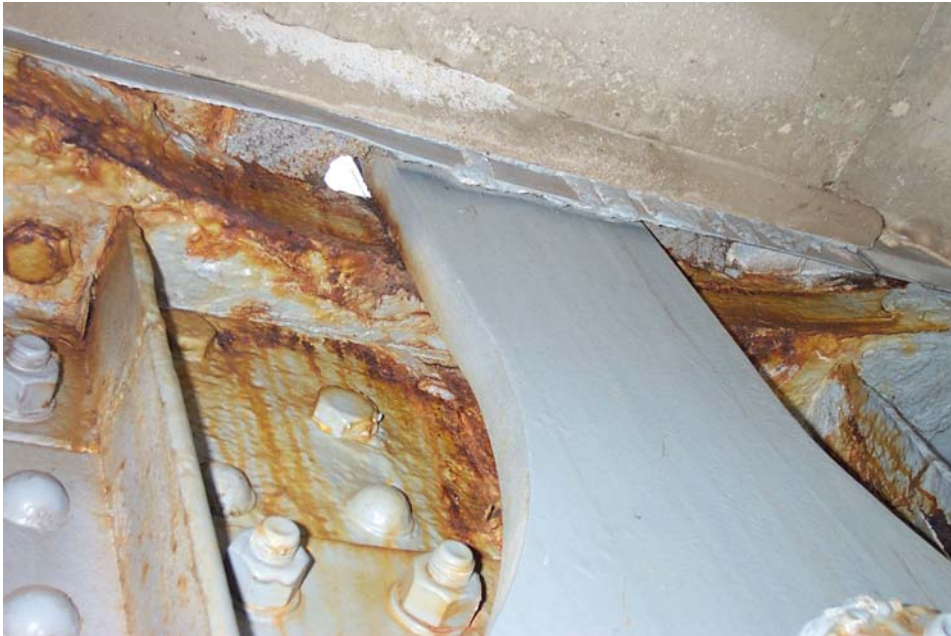
Photo 39. View of the opening through the deck around the west eyebar hanger for the upper deck floor beam at Panel Point 8 of the north truss. Note the active corrosion on the web and top flange of the floor beam. The corrosion on the opposite face of the hanger is hidden from view.

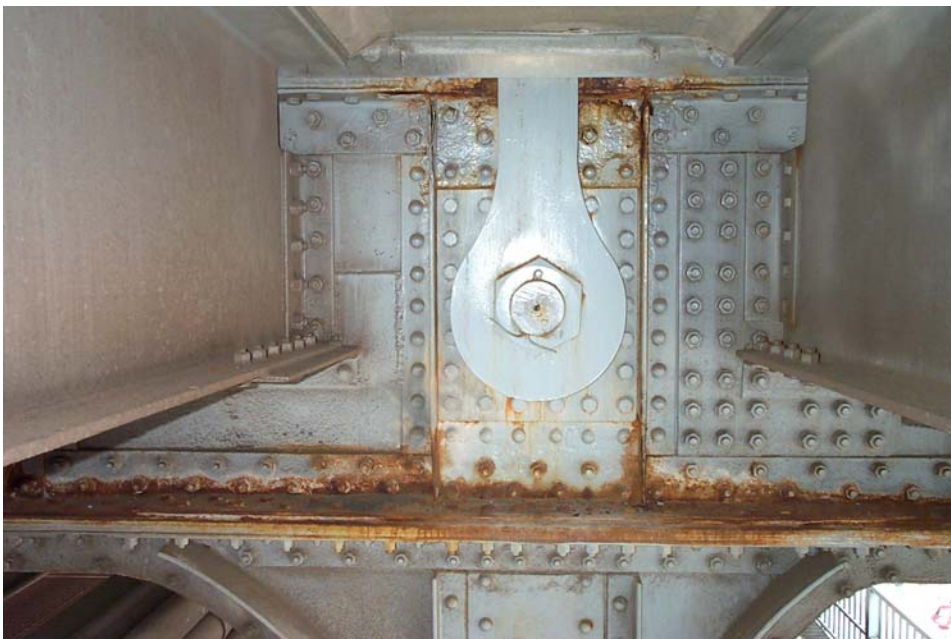
Photo 40. View from the west side of the upper deck floor beam at Panel Point 7' of the south truss. Note the corrosion that has developed on the top and bottom flange and portions of the web of the floor beam as a result of exposure to water and roadway chemicals that passed through the opening in the deck around the hanger.

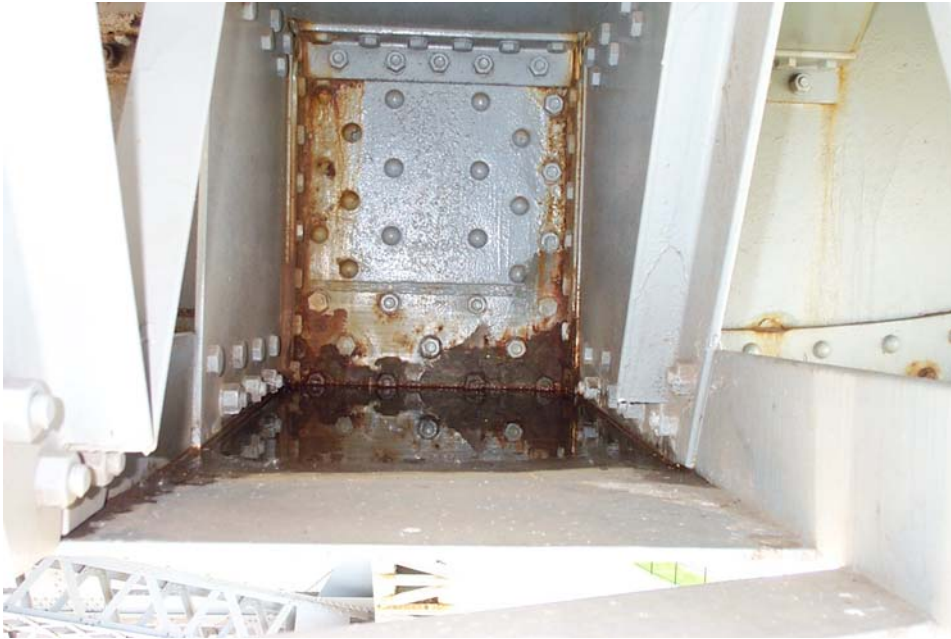
Photo 41. View looking west through the horizontal strut at the connection to the lower deck floor beam at Panel Point 4 of the north truss showing corrosion on the web of the floor beam and water collected inside the strut. The water, which originates from above the upper deck, flows down the vertical and accumulates in the connection area.  
DCP\_2347.JPG

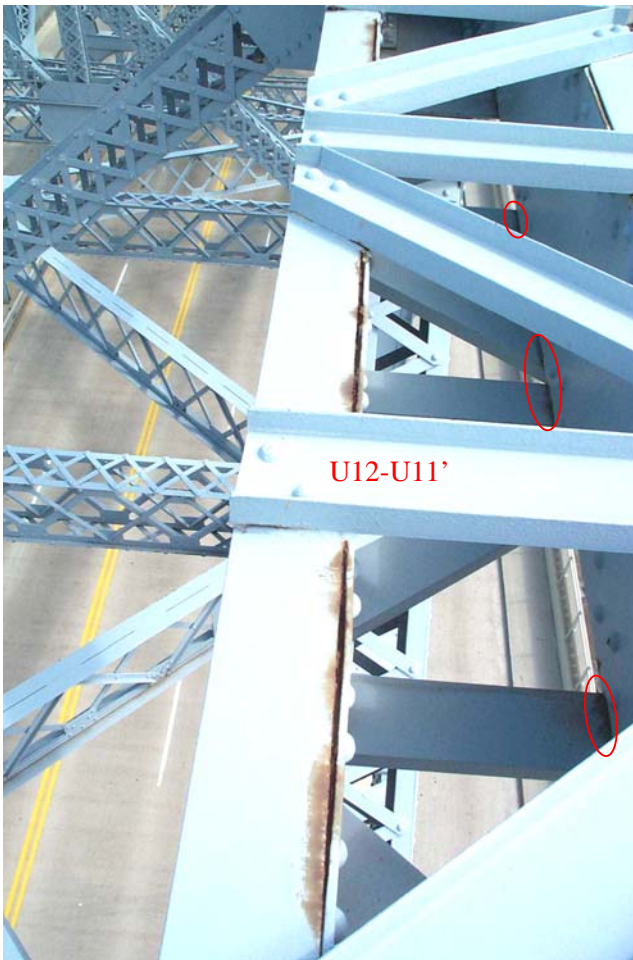
Photo 42. View looking east along Top Chord U12-U11' of the south truss showing areas of initial pack rust and active corrosion between the top edge of the north web plate and the vertical leg of the angle. The ovals highlight areas where the corrosion has reactivated on the web of the lower lacing channels.  
DCP\_2512.JPG

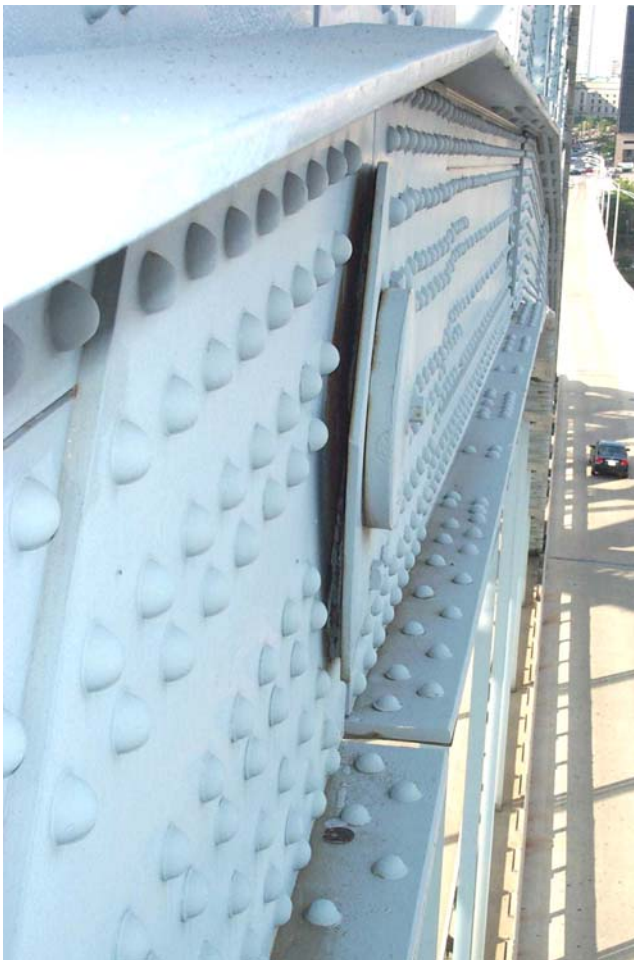
Photo 43. View looking east along the south side of the lower chord at Panel Point L12 of the south truss showing a gap between the web of the chord and the edge of the cover plate caused by the expansion of pack rust behind the plate.

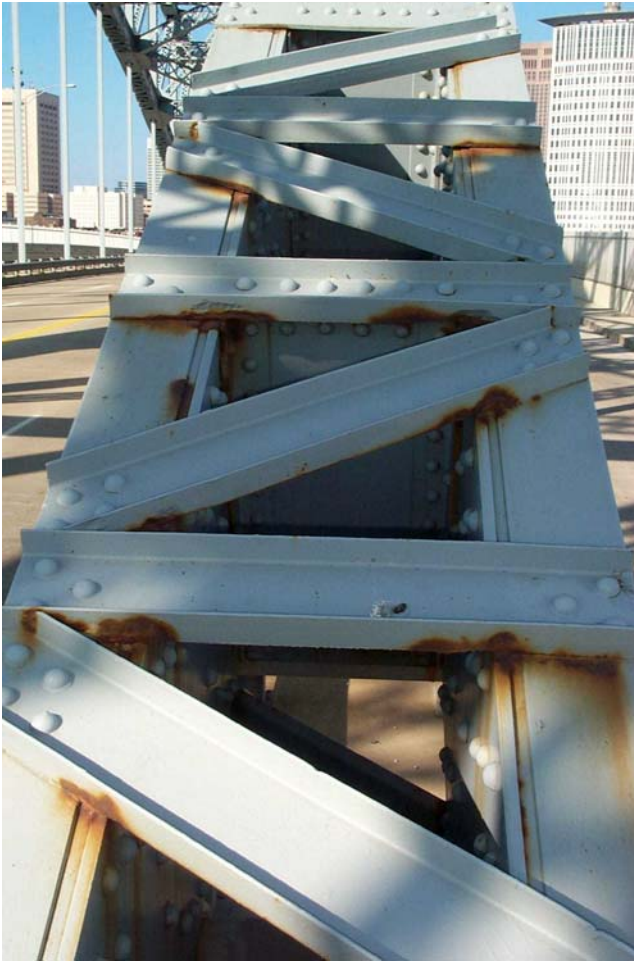
Photo 44. View looking east at areas of pitting and active corrosion on the top lacing channels of Lower Chord L5-L6 in the south truss.

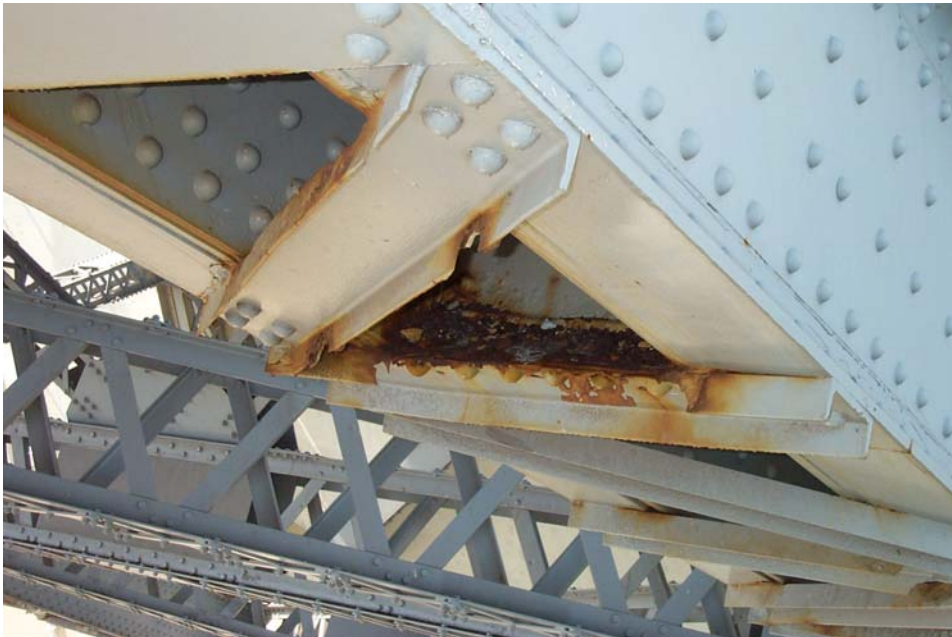
Photo 45. View of corrosion holes through the flanges of the lower lacing channels and active corrosion on the web diaphragm of the lower chord of the north truss, below Panel Point L2.

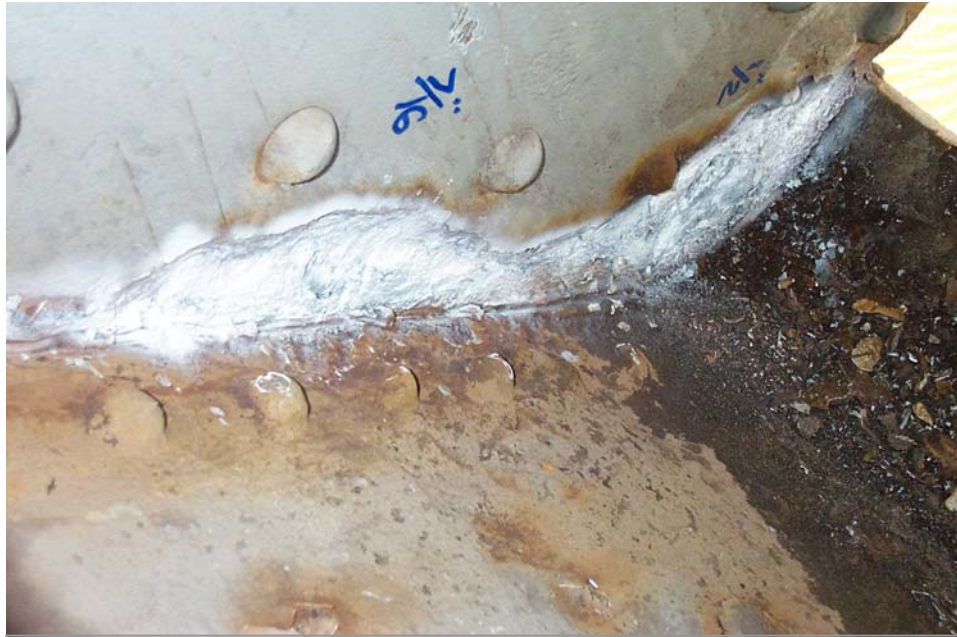
Photo 46. View inside Lower Chord L2-L3 of the south truss at the first diaphragm east of Panel Point L2. The white paint highlights an area of scale on the inside face of the north inside web plate, along the web diaphragm. The measurements show the depth of section loss where the scale was removed. Note that the scale was not removed from the entire area.

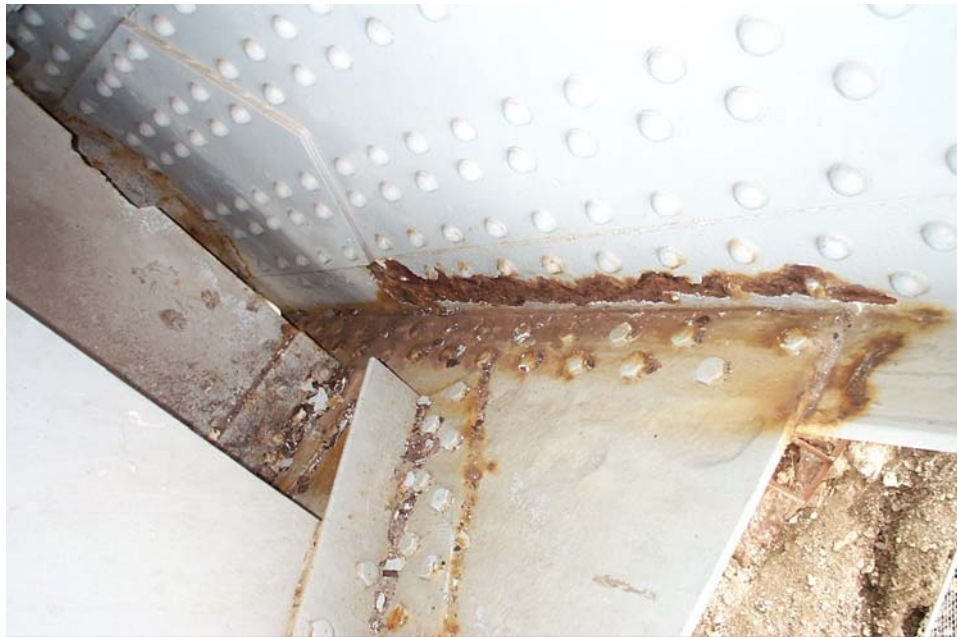
Photo 47. View showing section loss and active corrosion on the vertical leg of the lower interior angle of Lower Chord L0-L1 of the north truss adjacent to the lateral brace connection plate at Panel Point L0.

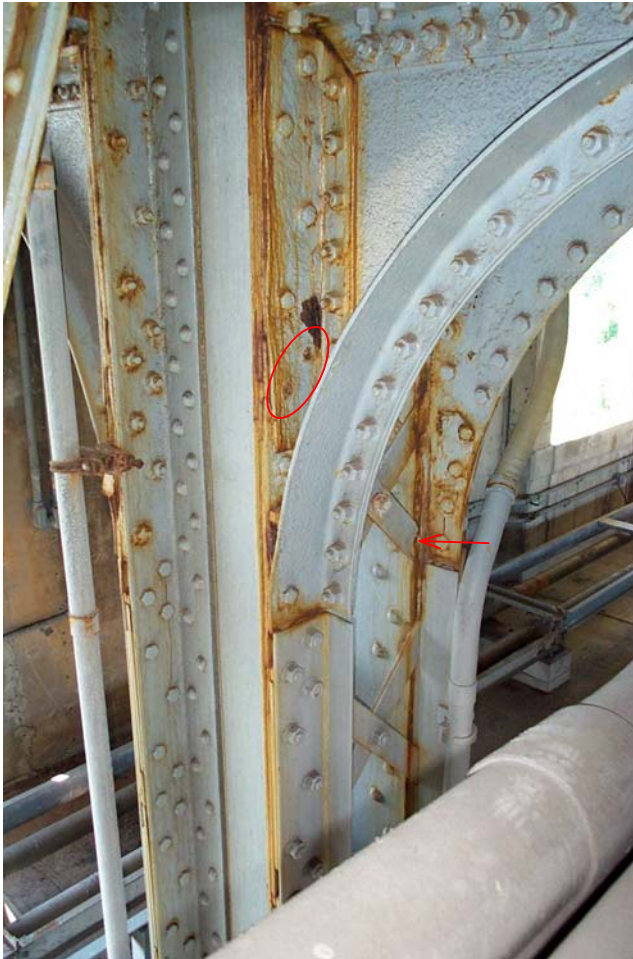
Photo 48. View of Vertical Post L0-U0 of the south truss, looking southwestward. The oval highlights 2 of 3 bolts missing from the north flange and the arrow points to 1 of 3 lacing bars corroded through along the west web. Also note the pack rust between the flange angles and the rust stains. Not in view are corrosion holes through the west stiffener plate on the north side of the member and through both west curved stiffener angles.

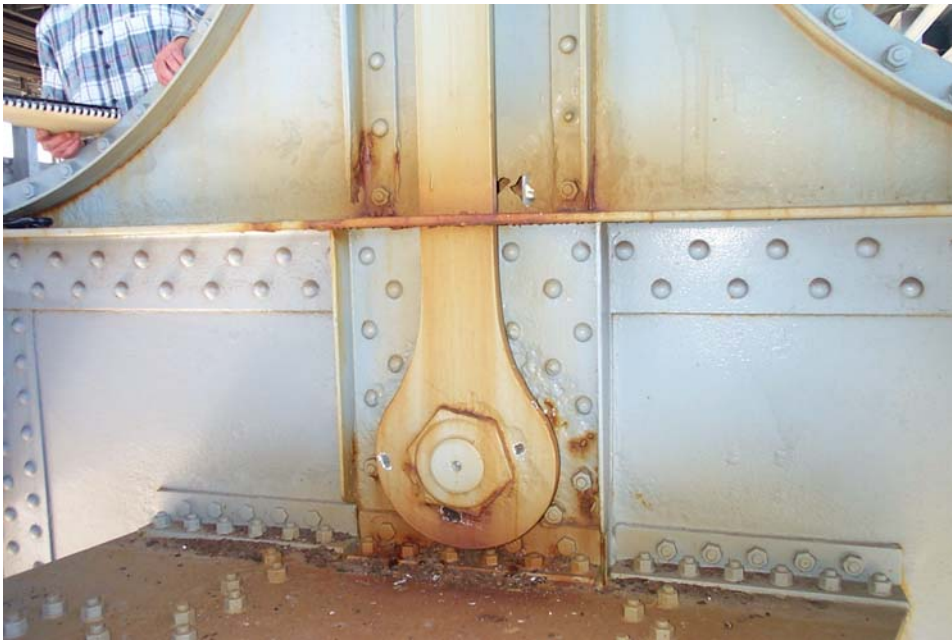
Photo 49. View from the east side of the connection bracket above the lower deck floor beam at Panel Point L4 of the north truss showing pitted areas and holes in the vertical plate of the bracket. Also note the deep pits and holes corroded through the web stiffener plate of the floor beam, adjacent to the pin.

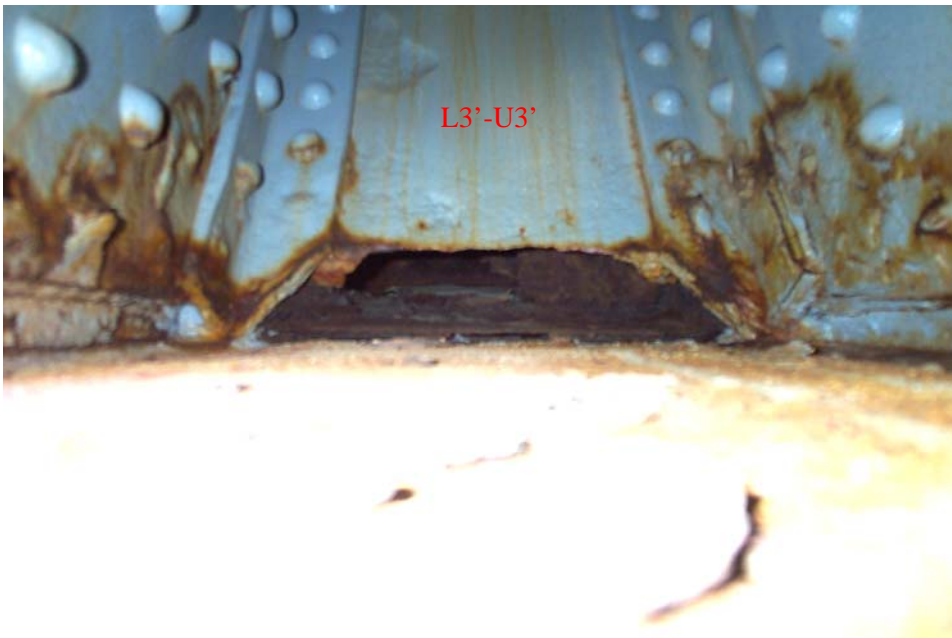
Photo 50. View looking west inside Lower Chord L3'-L2' of the south truss, into the opening at the bottom of the east web plate of Vertical Post L3'-U3'. Note the rust showing through the areas of scale that were painted over on the inside web plates of the lower chord. Also note the large chunks of flake rust lying on top of the lower chord. The chunks separated and fell from the surfaces inside the vertical post that were not cleaned during the painting operation.

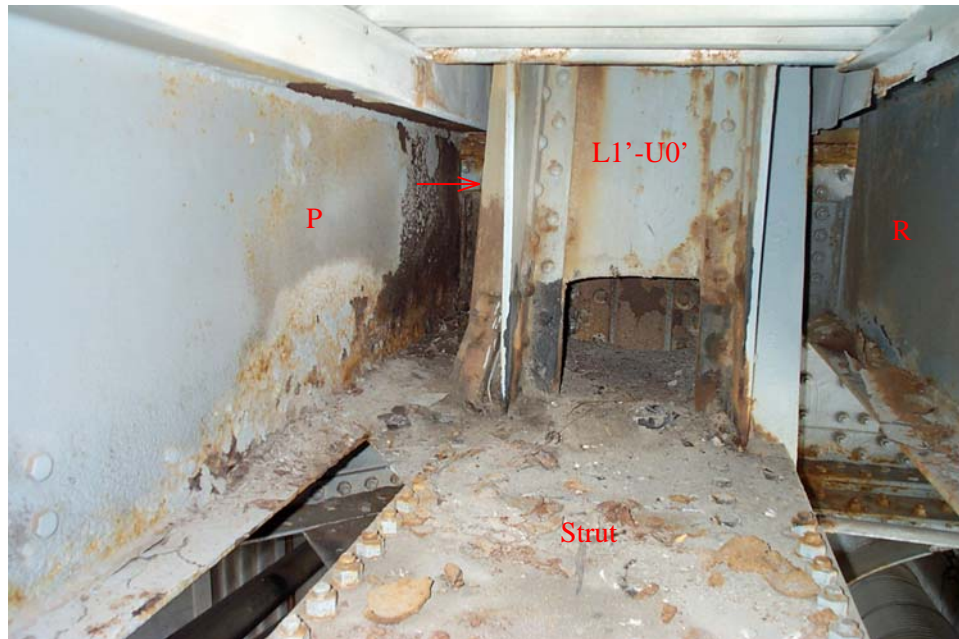
Photo 51. View looking east between Stringers P and R towards the intersection of the horizontal strut with Diagonal L1'-U0' of the south truss, showing accumulations of blasting material and areas of rust that were either painted over or missed. Not visible in the photo are the rust and scale that remain on the surfaces inside and on the north side of (arrow) the diagonal, extending from the horizontal strut up to the connection to Vertical Post L0'-U0'.

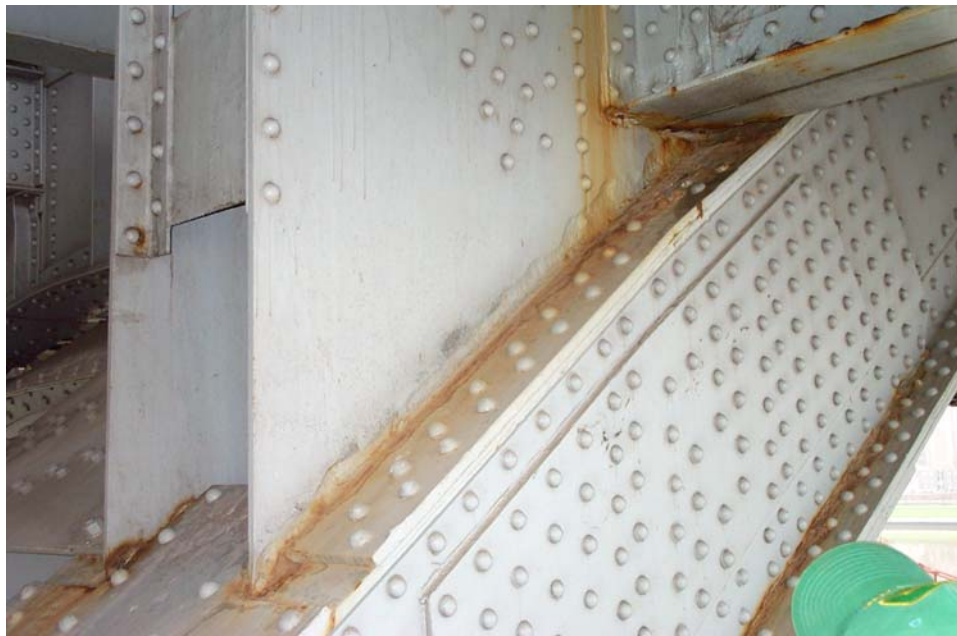
Photo 52. View of the outside face of the south gusset plate at Panel Point L3 of the south truss showing a typical band of pitting along the top plate of the lower chord.

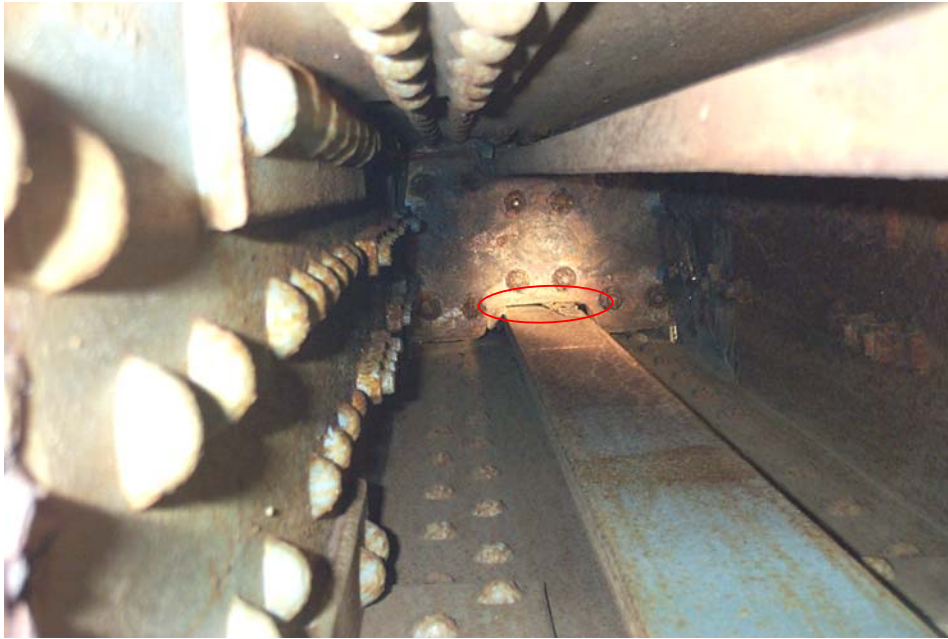
Photo 55. View looking up inside Vertical Post L4-U4 of the north truss showing the absence of paint and the band of pitting on the inside face of the west hanger (oval), adjacent to the lower flange of the upper deck floor beam.

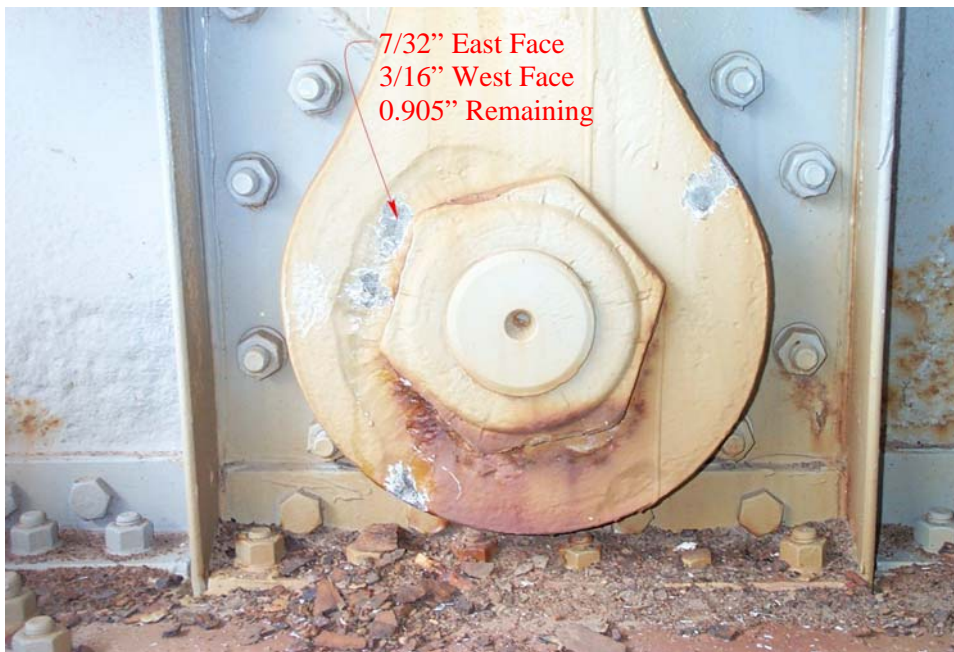
Photo 56. View of a circular band of pitting on the outside face of the east hanger, at the connection to the lower floor beam at Panel Point 4 of the south truss. The pitted area is approx. 1 1/2 to 2 inches wide and extends between the positions of 7 and 11 o'clock (moving clockwise). A similar area of pitting is present on the opposite (inside) face of the hanger and extends between the positions of 3 and 2 o'clock (moving clockwise). The measurements show the depth of pitting and remaining bar thickness at the location measured. Also note the pieces of heavy rust scale lying on the beam flange that were removed from the inside face of the hanger to determine the depth of section loss.

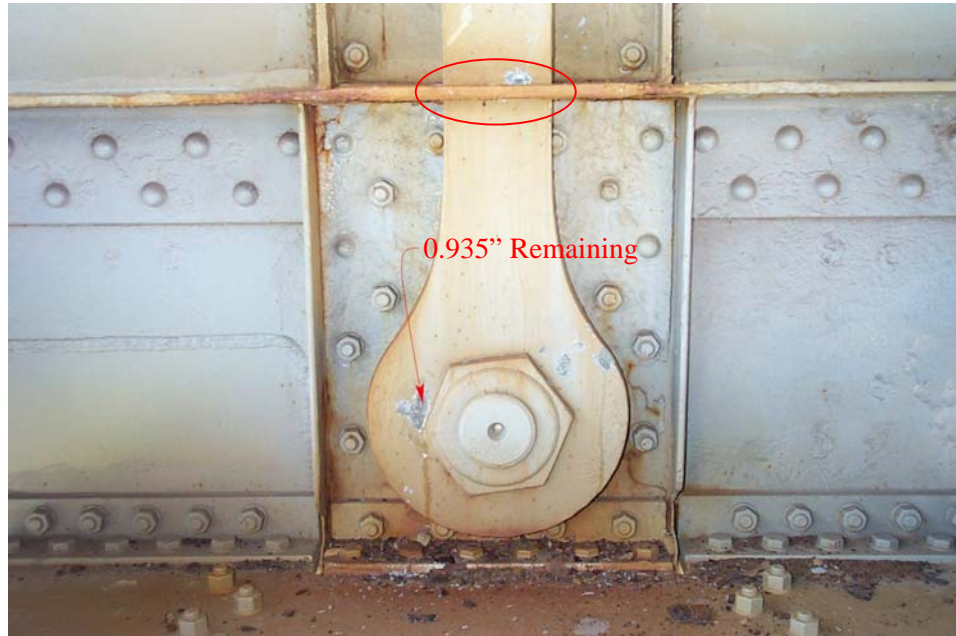
Photo 57. View showing a circular band of pitting on the outside face of the west hanger at the connection to the lower floor beam at Panel Point 4' of the north truss. The pitted area is up to 2 inches wide and extends between the positions of 8 and 10:30 o'clock (moving clockwise). A similar area of pitting on the opposite face extends between the positions of 8 and 4 o'clock (moving clockwise). The measurement shows the remaining bar thickness at the location measured. Again, note the rust scale lying on the beam flange that was removed from the inside face of the hanger. The oval shows the location of a transverse band of pitting on the inside face of the bar where the metal thickness measures 1.061 inches, which represents a net section loss of approximately 13%.

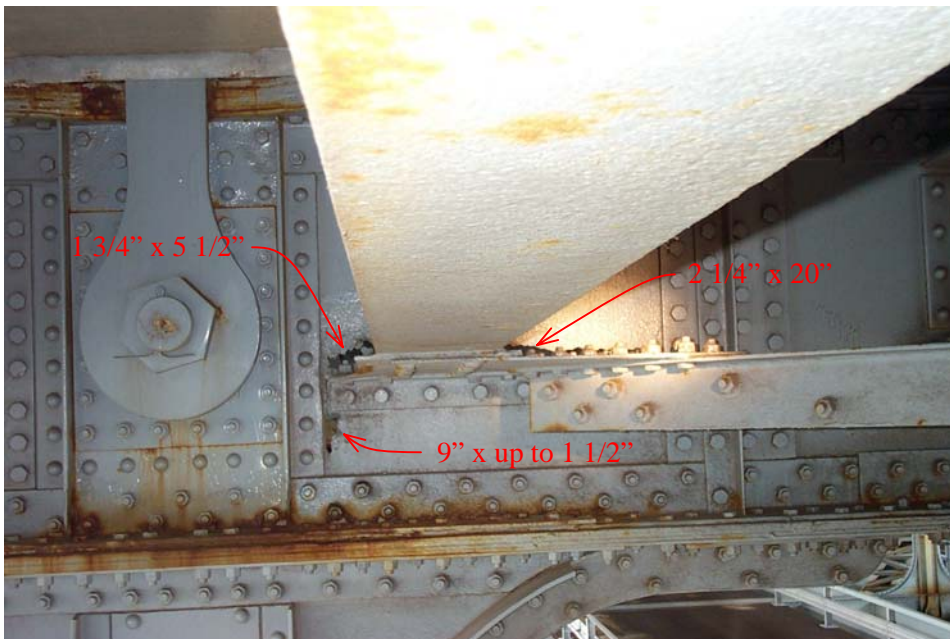
Photo 58. View from the west side of the upper deck floor beam at Panel Point 8' showing corrosion holes in the beam web adjacent to the seat angle for Stringer E. The holes at this location were the largest observed on the upper deck floor beams. Also, note the rust on the top and bottom flange of the floor beam.

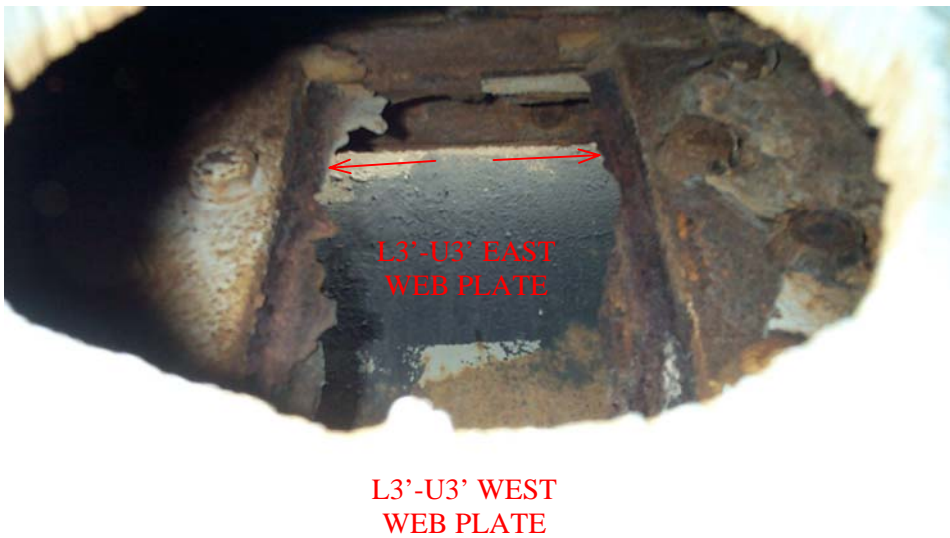
Photo 59. View looking through a 7-inch wide hole cut in the west web plate of Vertical Post L3'-U3' of the south truss, showing a portion of the web of the upper deck floor beam enclosed within the vertical post. The arrows point to the vertical edges of an 8-inch wide hole corroded through the web plate of the floor beam (between vertical stiffener angles). The hole extends vertically through the top half of the web, and the lower half is heavily scaled and thin in this area.

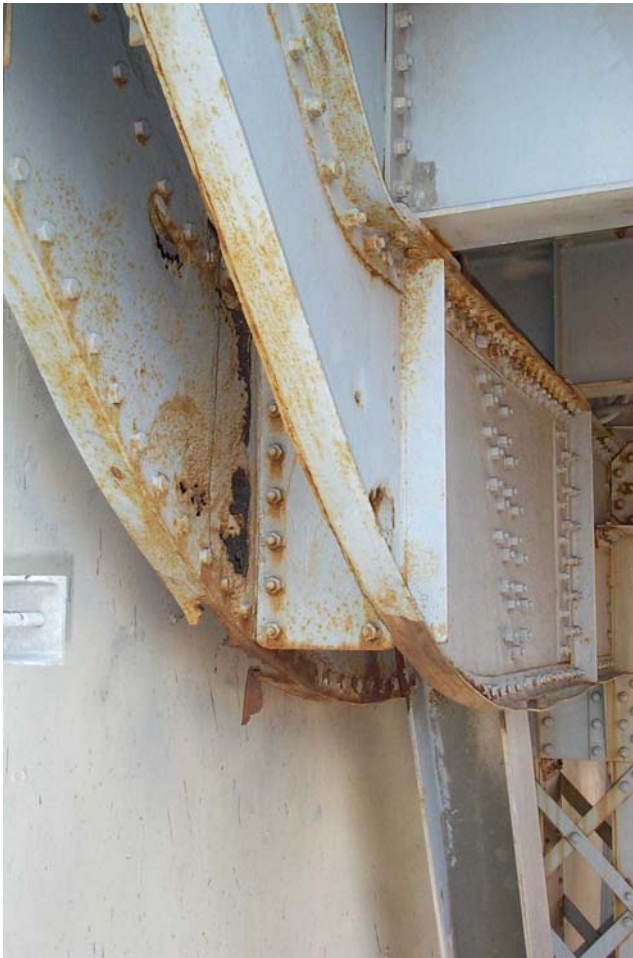
Photo 60. View showing corrosion holes in the web plates and lower flange angles at the north cantilevered end of the lower deck floor beam at Panel Point 0'.

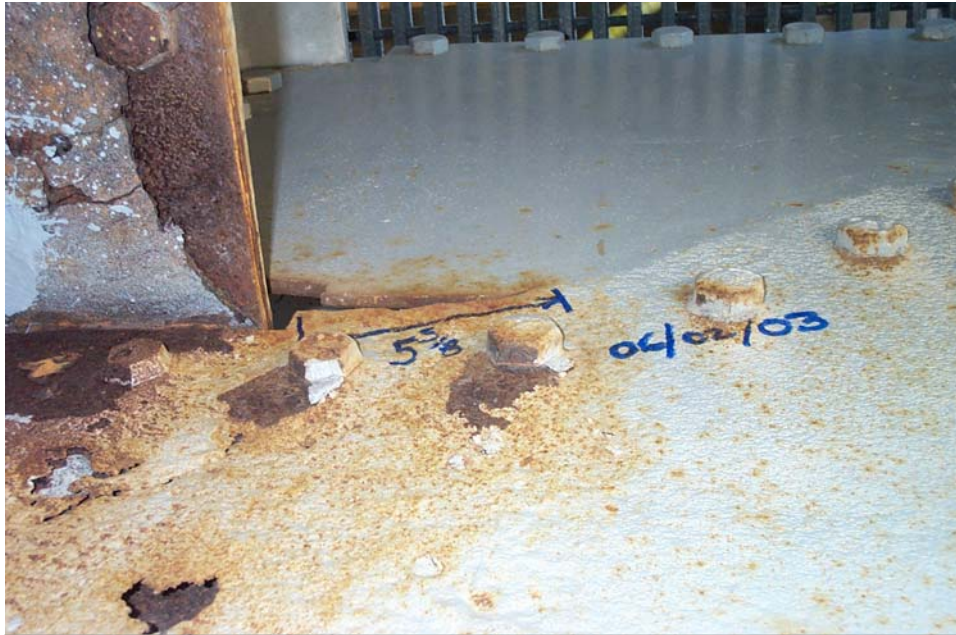
Photo 61. View showing a 5 5/8-inch long crack in the west web plate of the lower deck floor beam at Panel Point 0, adjacent to the north edge of the lower flange of Stringer 12. Not in view are large corrosion holes in the floor beam web below the stringer.

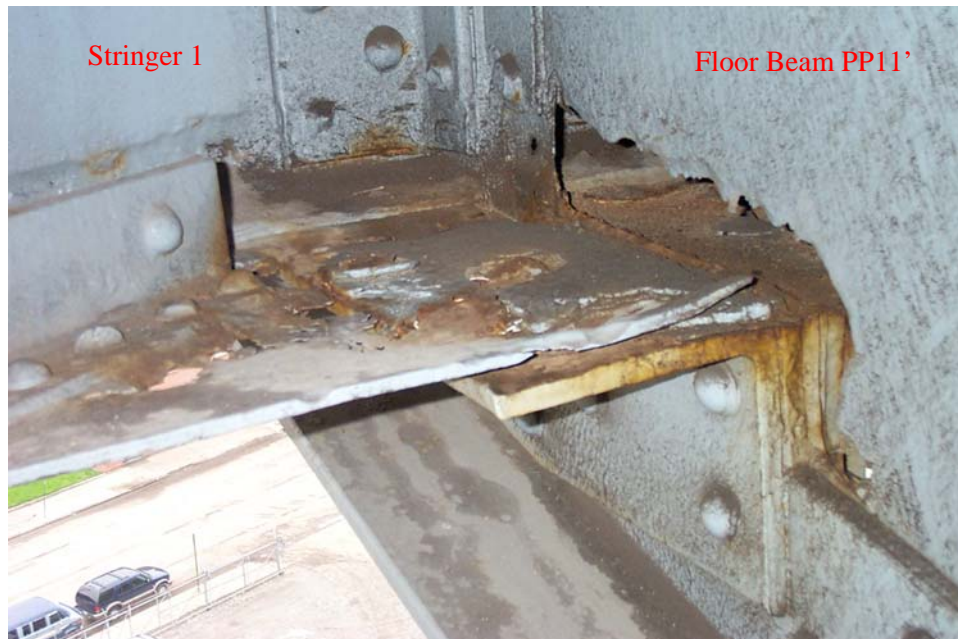
Photo 62. View from the east side of the lower deck floor beam at Panel Point 11' showing a typical corrosion hole through the web, above the north half of the seat angle at Stringer 1. Also in view are perforations through the connection plate, and groove pitting and a 1-inch diameter hole in the lower web of the stringer.

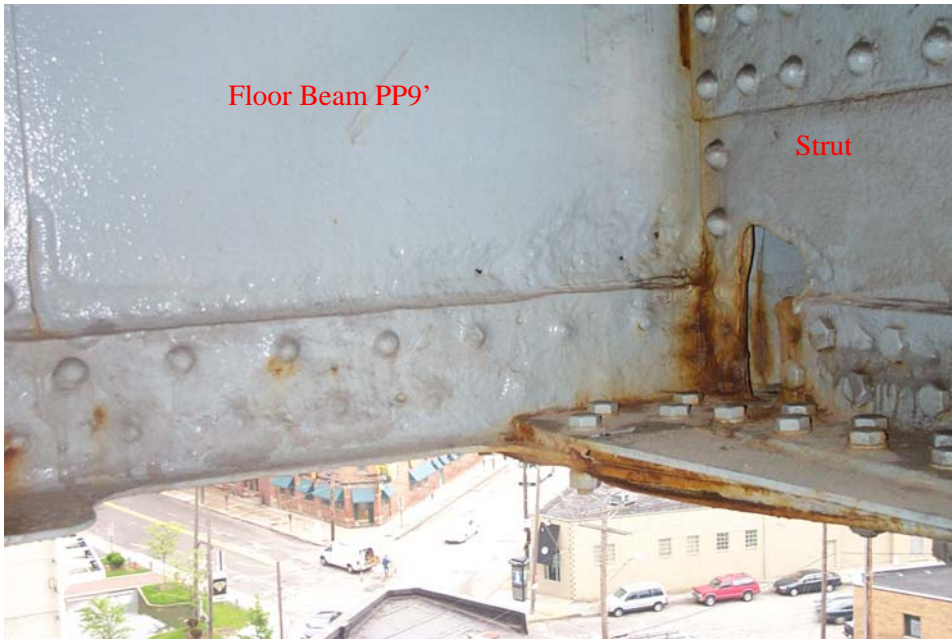
Photo 63. View from the west side of the lower deck floor beam at Panel Point 9', on the north side of the connection to the strut located between Stringer Lines 2 and 3. Note the band of deep pitting and perforations in the floor beam web along the lower flange angle, the section loss to the angle, and the portion of the lower flange that has been coped. Also note the coped hole in the web of the strut and the reactivated corrosion.

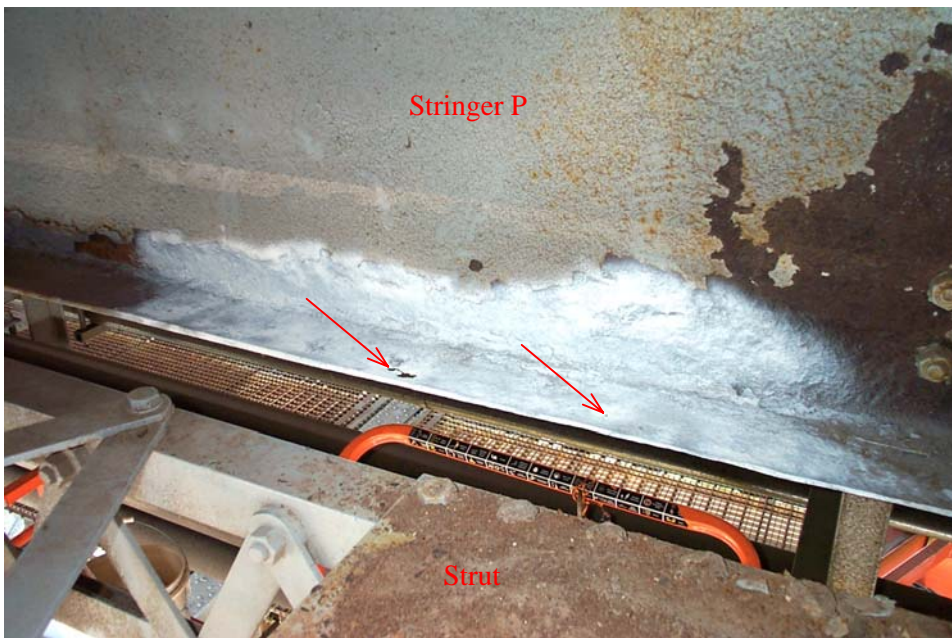
Photo 64. View from the south side of Stringer P showing a 3-foot-6-inch long area on the lower web and bottom flange where the scale was removed and white paint applied to highlight the section loss. The arrows point to a 1 x 2 1/2-inch and a 1/4-inch diameter hole in the bottom flange. The depth of pitting in the web is up to 3/8-inch. Note the close proximity of the strut member.

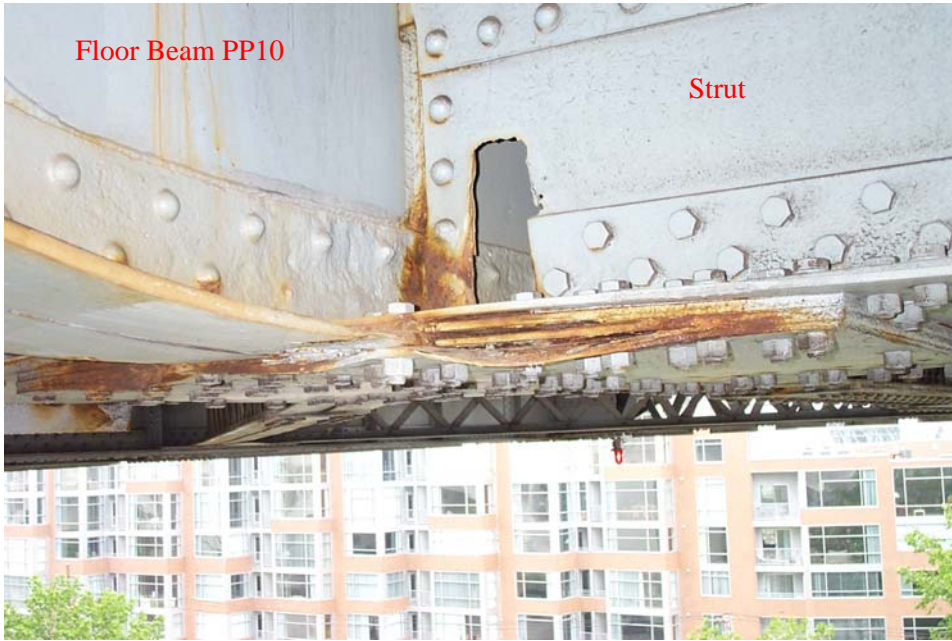
Photo 66. View from the east side of the lower deck floor beam at Panel Point 10 showing the connection to the horizontal strut located between Stringers 2 and 3. Note the pack rust between the edges of the gusset plate, fill plate, and the lower flange angles of the strut and the floor beam. Also in view is a hole coped in the web of the strut and section loss to the rivets and vertical leg of the lower flange angle of the floor beam.

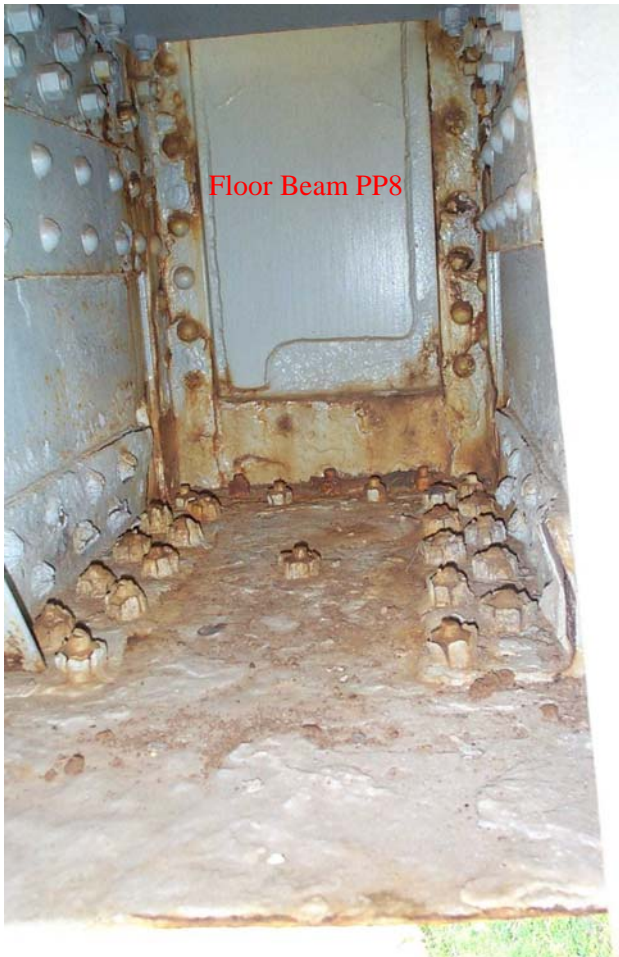
Photo 67. View inside the horizontal strut between Stringers 10 and 11, looking towards the connection on the east side of the lower deck floor beam at Panel Point 8, showing areas of flake rust that were painted over at the time of the last rehabilitation.

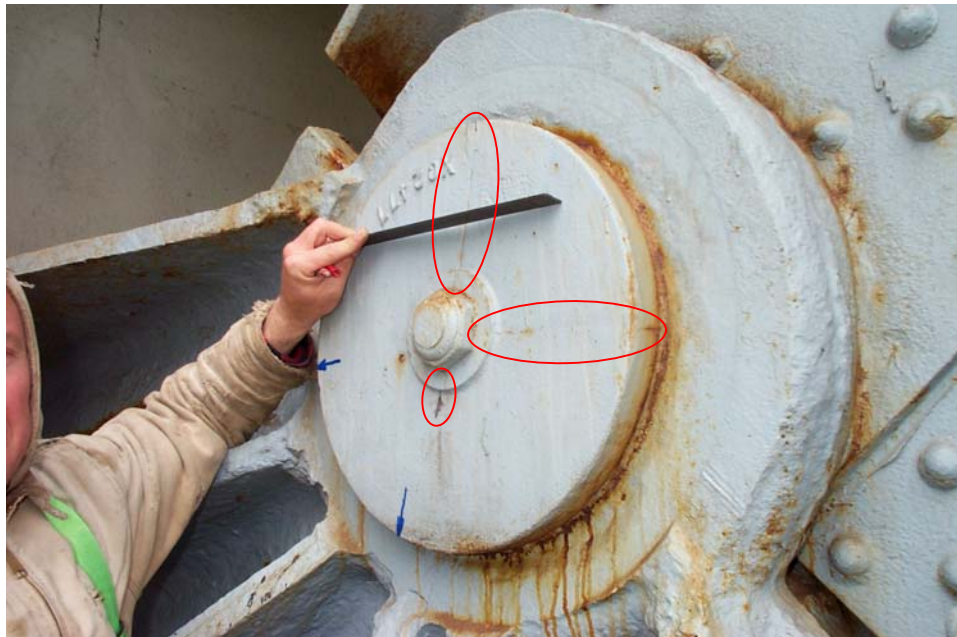
Photo 68. View showing radial and edge cracks (ovals) in the face of the retaining washer on the south side of the bearing at the west end of the south arch rib. The straight edge shows cupping in the face of the washer at the upper crack. The arrows point to the locations of transverse cracks at the edge of the washer. Note the active rust that shows at the interface of the washer and the flange of the shoe.

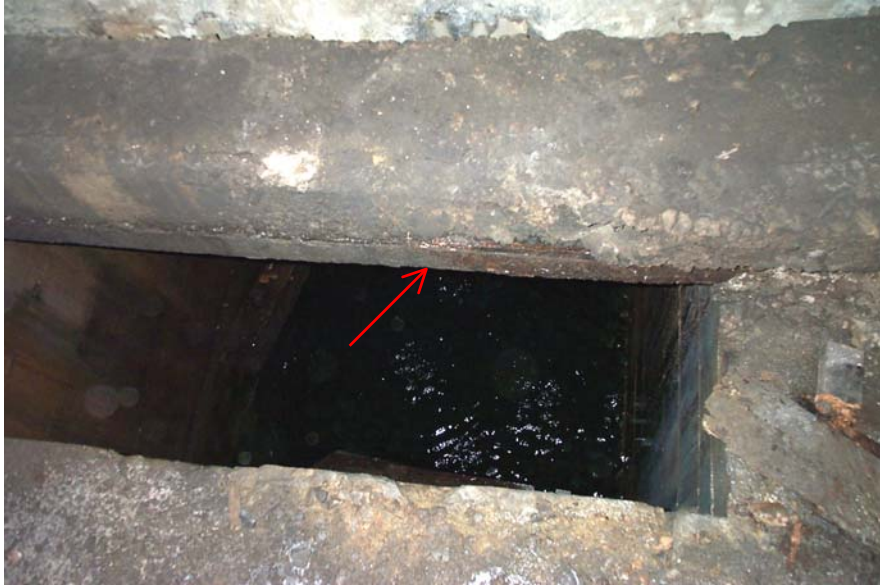
Photo 69. View inside the cellular East Abutment showing a 12- x 18-inch concrete conduit above a cell opening on the north side of the north column wall. The arrow points to the location where water is leaking from the bottom of the conduit. The type of pipe or utility that is encapsulated within the concrete is undetermined. Also in view is approximately 6 feet of water inside the cell.

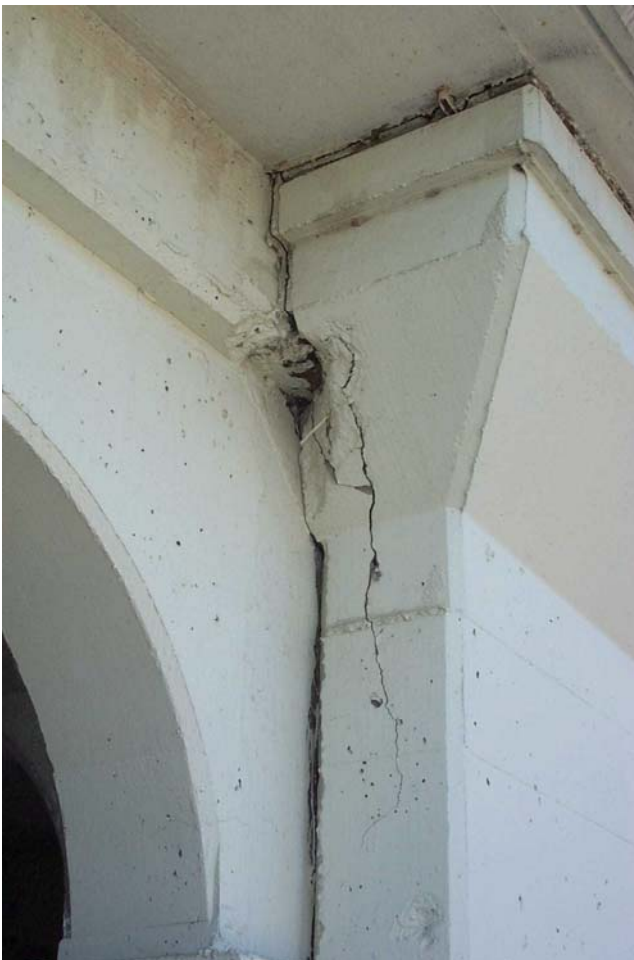
Photo 70. View of a 10- x 50-inch spall/delamination on the east face of the north exterior pier shaft at Pier 1, just below the sidewalk at the upper level deck.

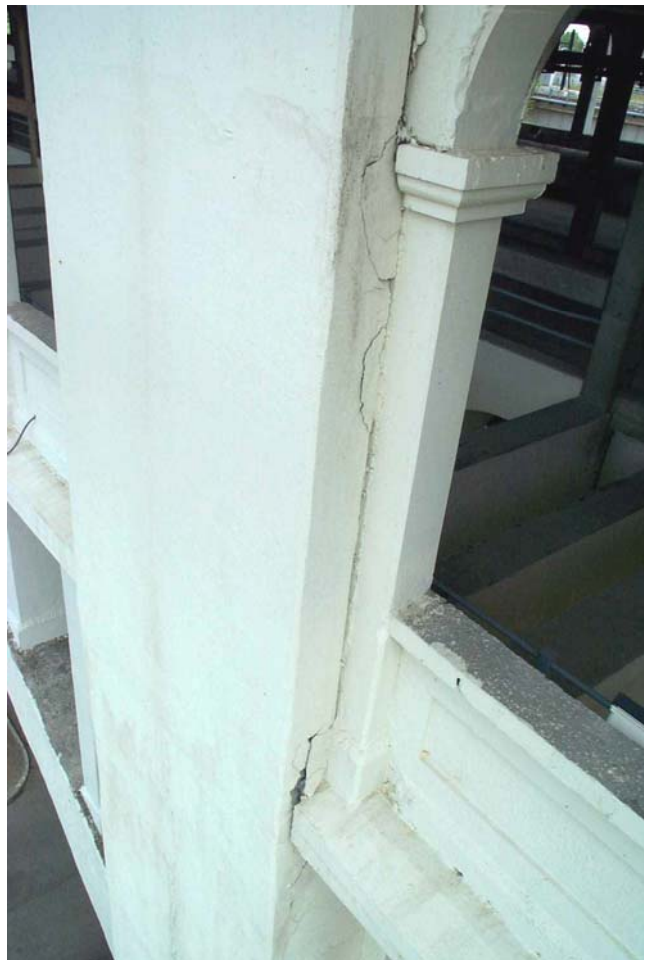
Photo 71. View of three delaminated areas on the west face of the north exterior pier shaft at Pier 8, along the interface with the upper deck column.

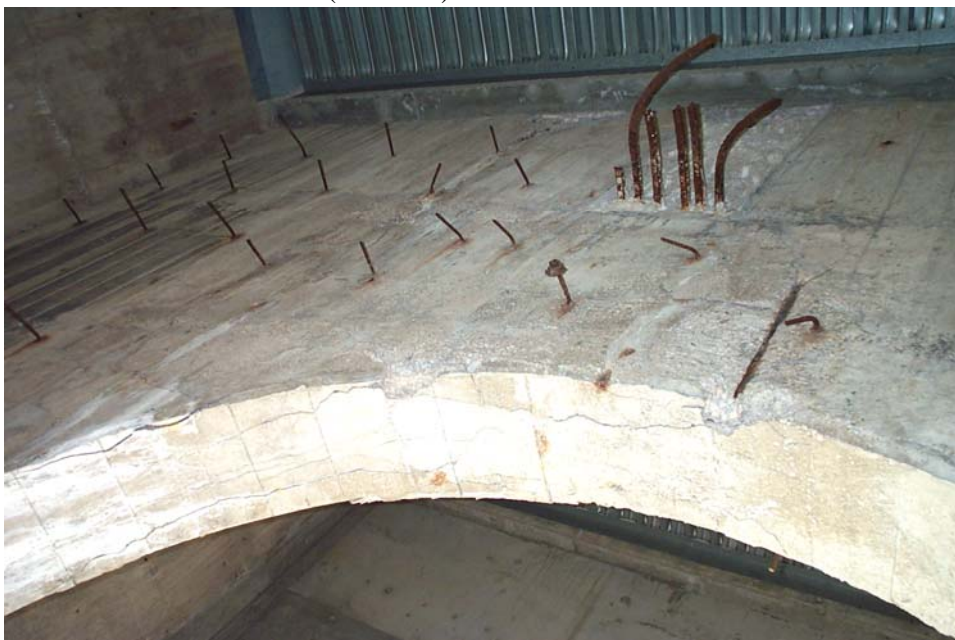
Photo 74. View inside the north bay of the tower at Pier 4 showing cracks, delaminations and spalls on the bottom and west faces of the jack-arch beam.

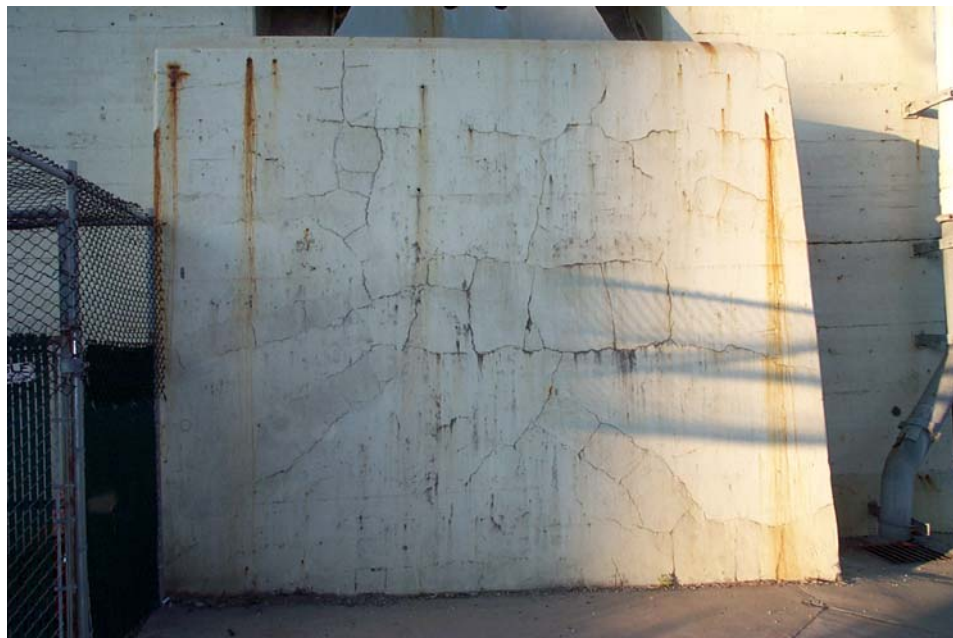
Photo 75. View of the west face of the pedestal for the south truss at Pier 4 showing map cracks and rust stains.
