**BRIDGE INSPECTION REPORT  
BRIDGE NO. CUY-06-14.56  
VETERAN'S MEMORIAL BRIDGE  
OVER CUYAHOGA RIVER VALLEY  
CUYAHOGA COUNTY, OHIO**

Prepared by

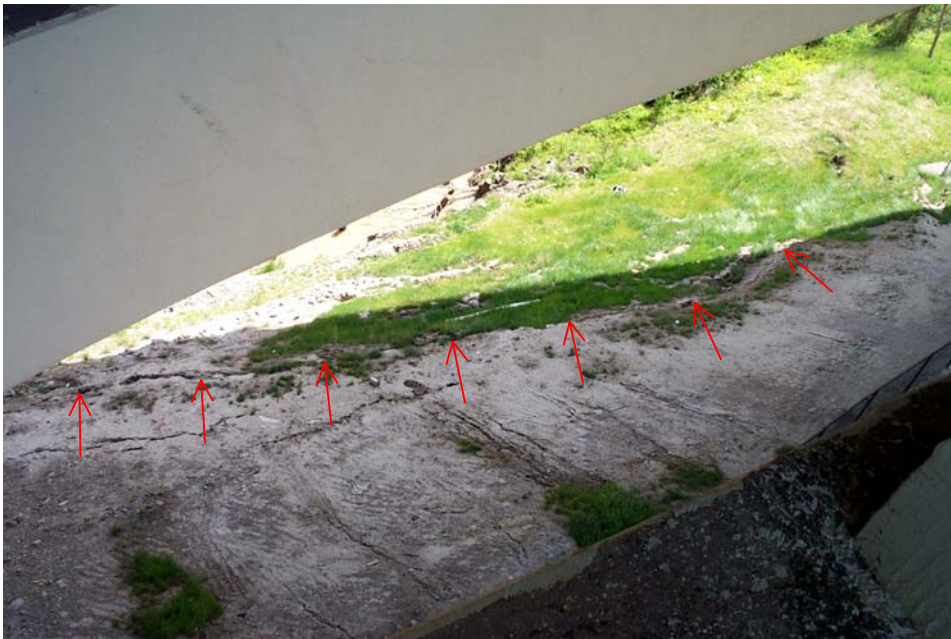
Photo 76. View looking south showing the area of slope failure in the embankment west of Pier 3. The arrows point to the cracks formed where the embankment has separated. Note that the cracks are partially obscured by the grass.

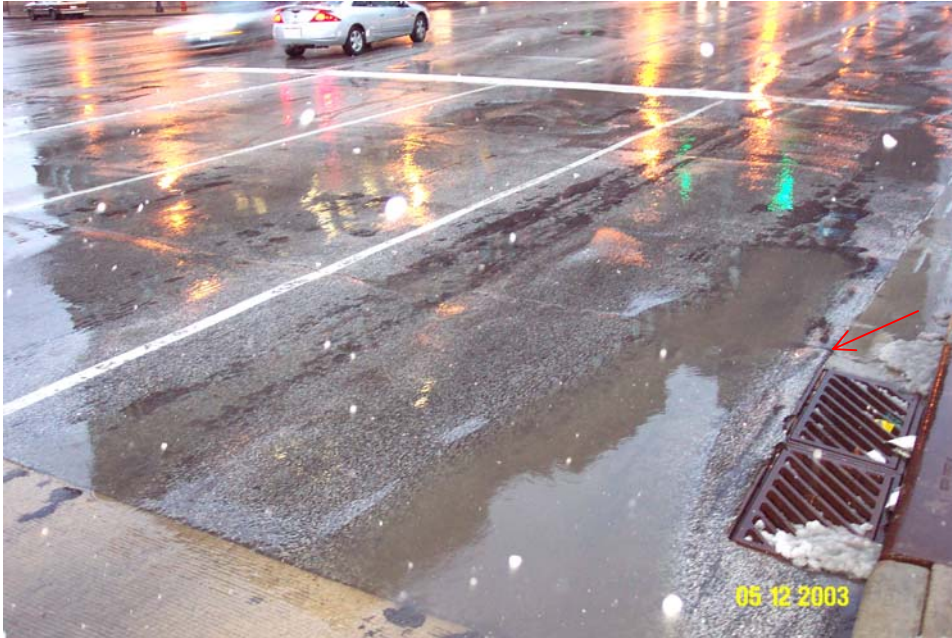
Photo 77. View looking northeastward from the end of the concrete wearing surface, showing the condition of the asphalt pavement in the eastbound lanes of the east approach. Note the wheel line grooves in the south and center lanes and the wide transverse crack (arrow) that extends across the entire roadway.

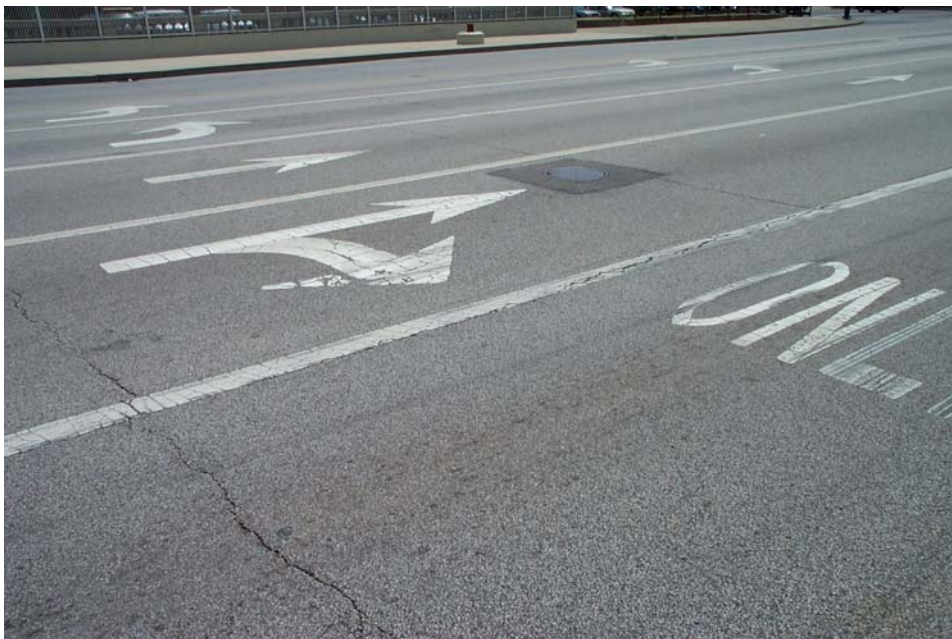
Photo 78. View looking southwestward from the west end of Span 1A showing typical transverse and longitudinal cracks in the west approach pavement.

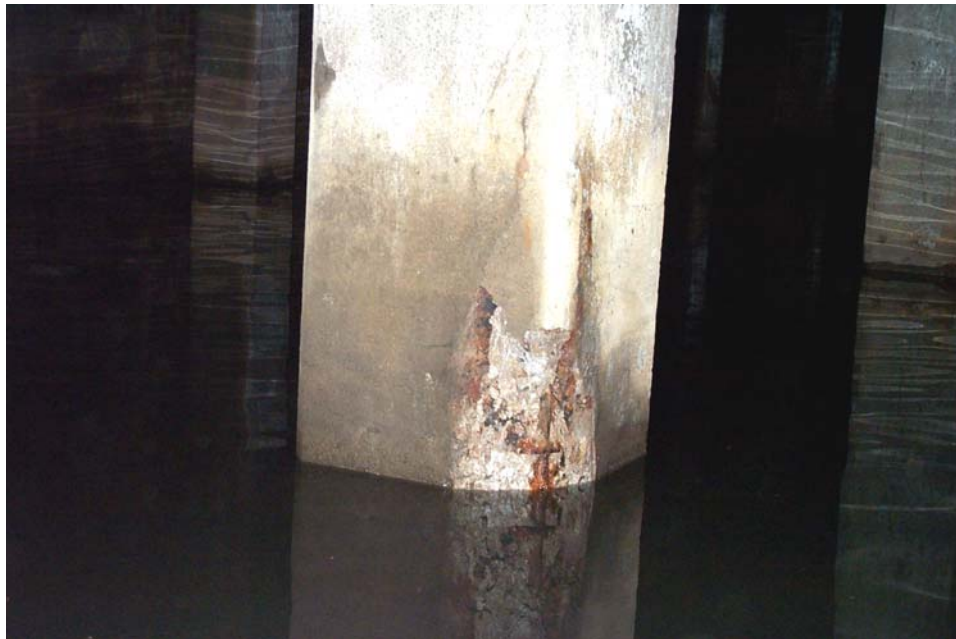
Photo 79. View showing a spalled and delaminated area at the corner of the south and west faces at the bottom of Column 22 in Column Row N in East Subway Tunnel. The spalled area extends to the floor of the tunnel that was covered by a pool of water 8 inches deep at this location at the time of the inspection.

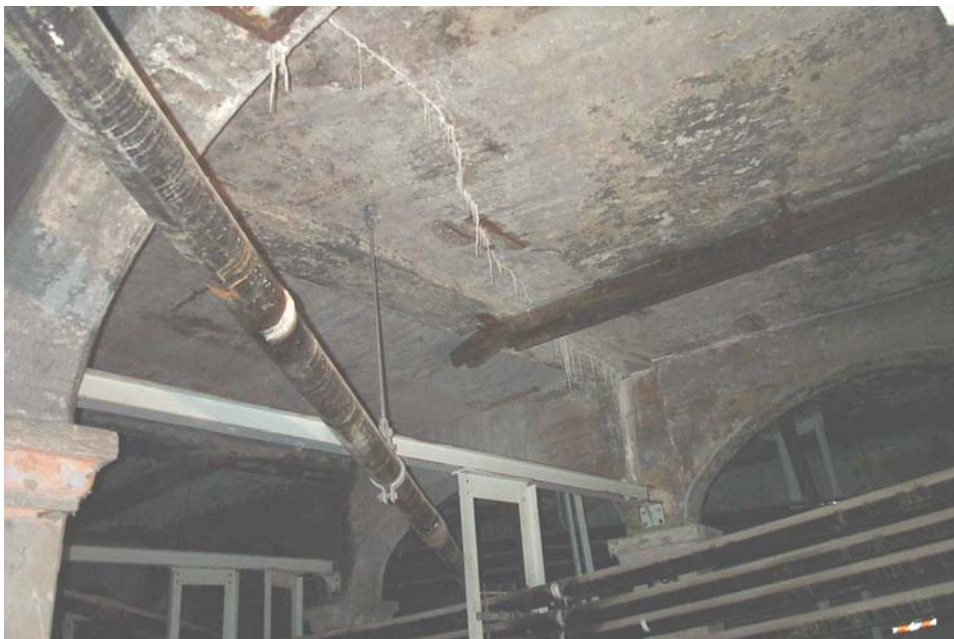
Photo 80. View looking southeastward showing a transverse crack with efflorescence and stalactites on the roof slab of West Station, between Column Rows C and D and Column Lines 7 and 8. The crack extends from the north wall to Column Row E.

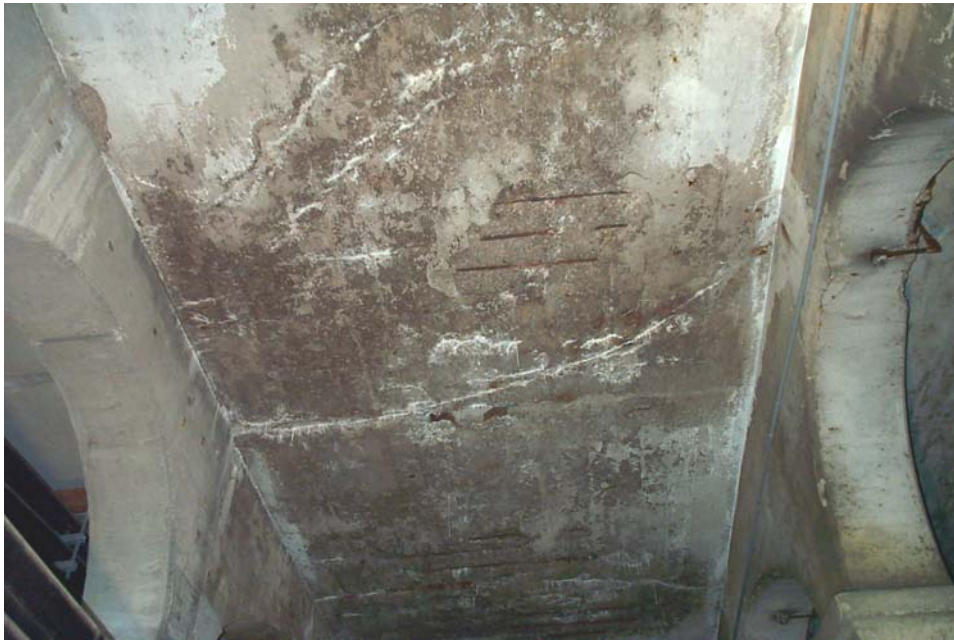
Photo 81. View looking west showing spalls and transverse cracks with efflorescence on the roof slab of West Station, between Column Rows C and D and Column Lines 29 through 31.

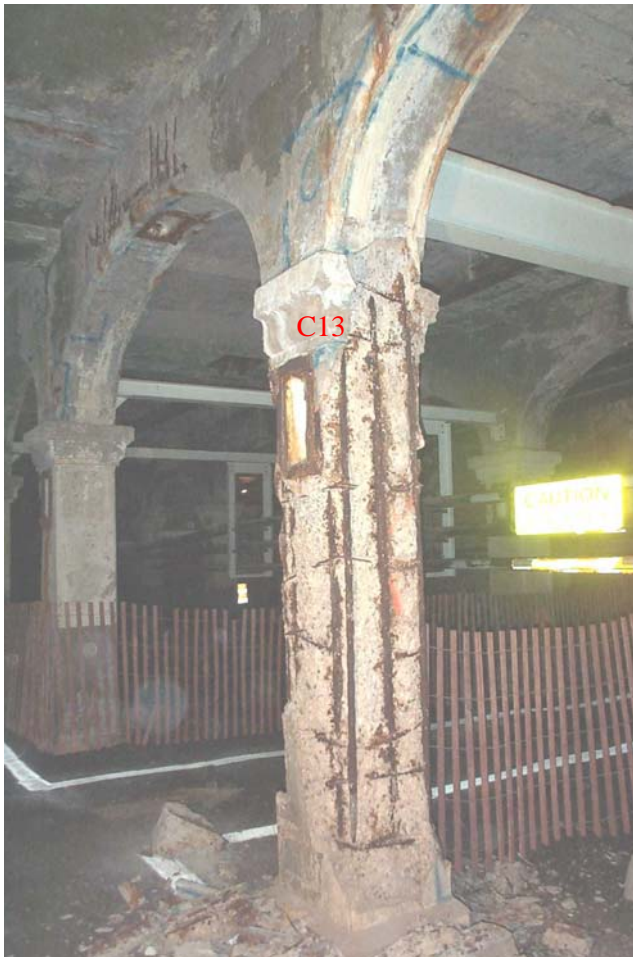
Photo 82. View looking southeastward showing deep spalls with exposed and disbonded reinforcement on the north and west faces of Column C13 in West Station. Similar spalls are present on half of the south face and portions of the east face of the column. Also in view are spalls with exposed reinforcement and surrounding delaminations on the north and bottom faces of the adjacent jack-arch beam.

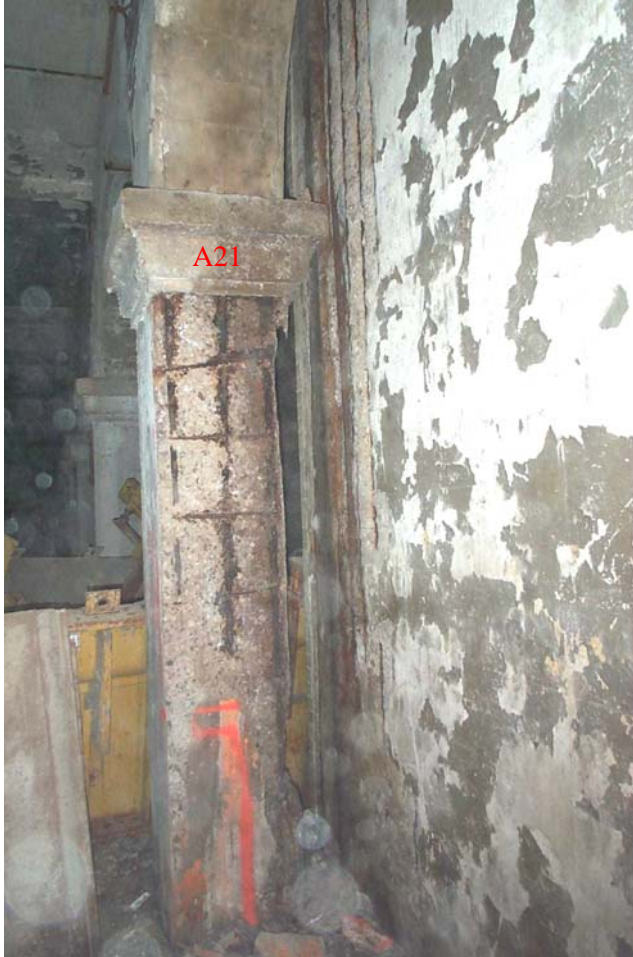
Photo 83. View looking west showing deep spalls with exposed reinforcement on the east face of Column A21 in West Station. Similar deterioration was noted on the west face and a portion of the north face of the column. Also in view is a spalled area several feet wide that extends over the full height of the north wall.

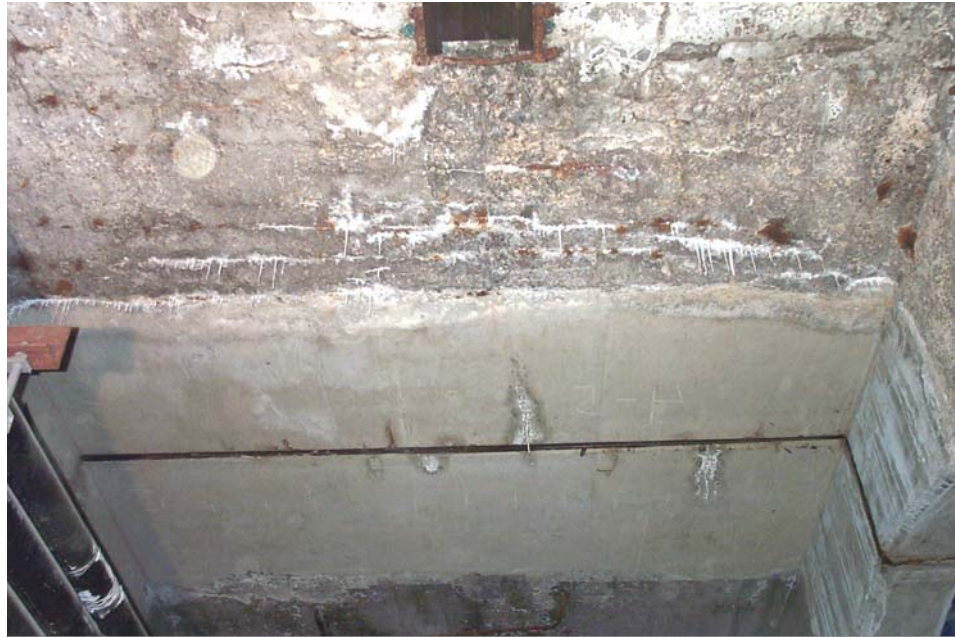
Photo 84. View looking west at the expansion joint in the roof slab between Panels 4 and 5 in the south bay of Detroit Avenue Subway Tunnel. Note the short cracks with efflorescence in the replacement concrete and the cracks, efflorescence and rust stains in the original concrete along the interface with the replacement concrete.

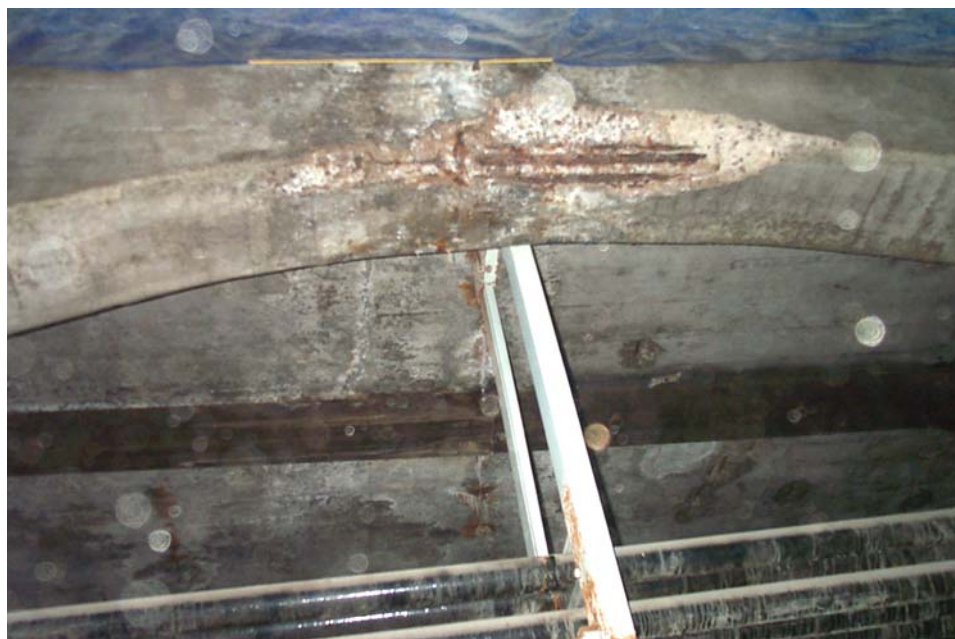
Photo 85. View looking south showing spalls with exposed reinforcement on the north and bottom faces of the jack-arch beam located between Columns 7 and 8 in Detroit Avenue Subway Tunnel. Also in view is a typical transverse crack with efflorescence on the roof slab in the south bay.

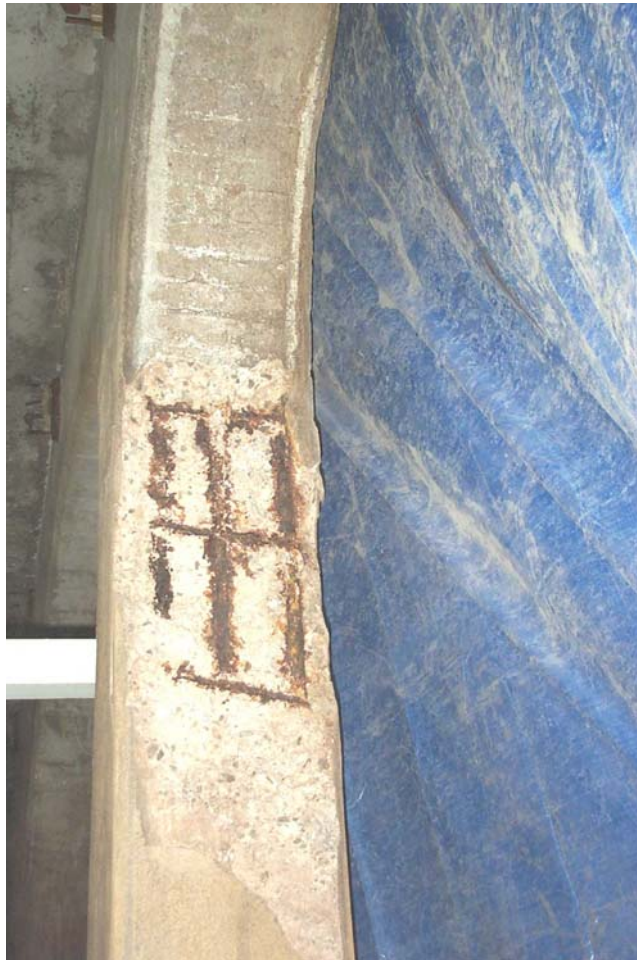
Photo 86. View looking west showing a large spall with exposed reinforcement on the east face within the upper half of Column 44 in Detroit Avenue Subway Tunnel. County maintenance workers performing repairs to the north wall erected the blue tarp along the column line.

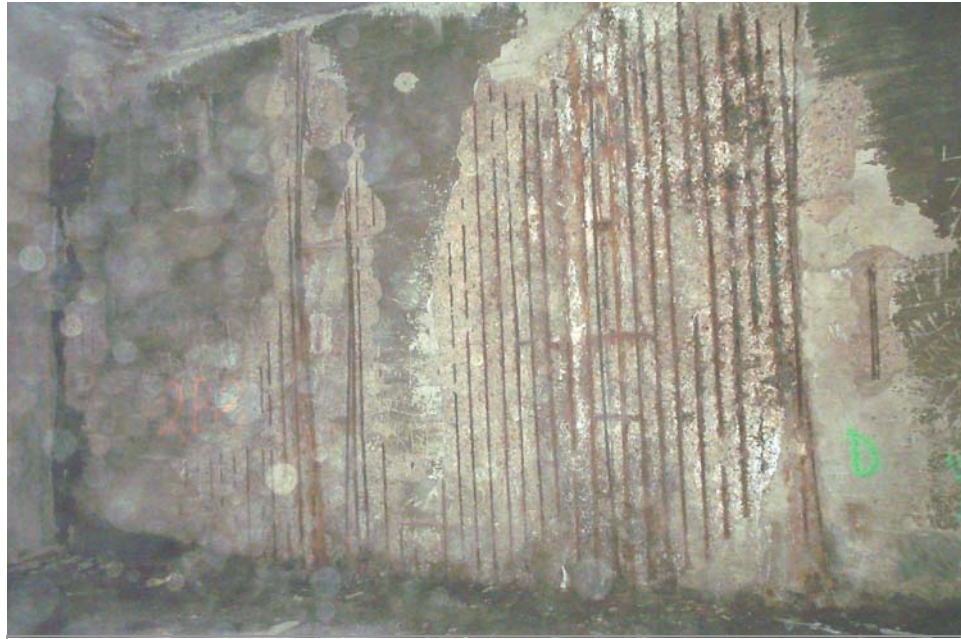
Photo 87. View of the north wall of Detroit Avenue Subway Tunnel in an area adjacent to Columns 1, 2 and 3 showing large full-height spalls with exposed and disbonded reinforcement. The tunnel closure wall is visible at the left of the photo.

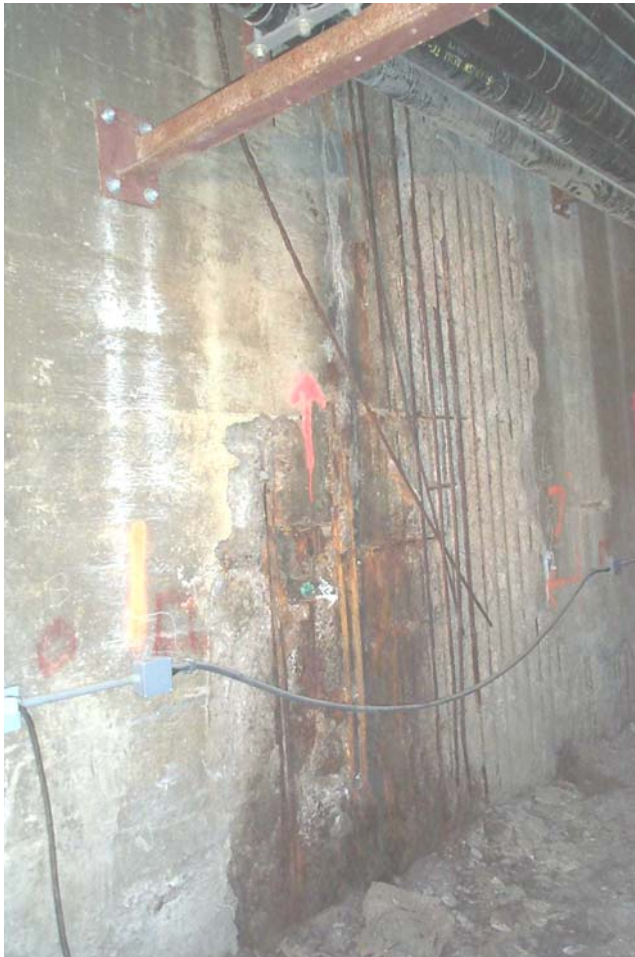
Photo 88. View of a full-height spall approximately 8 feet wide, with exposed and disbonded reinforcement. The area is located on the south wall of Detroit Avenue Subway Tunnel, below the roof slab expansion joint at the east end of the tunnel. This condition is typical at many of the expansion joints.

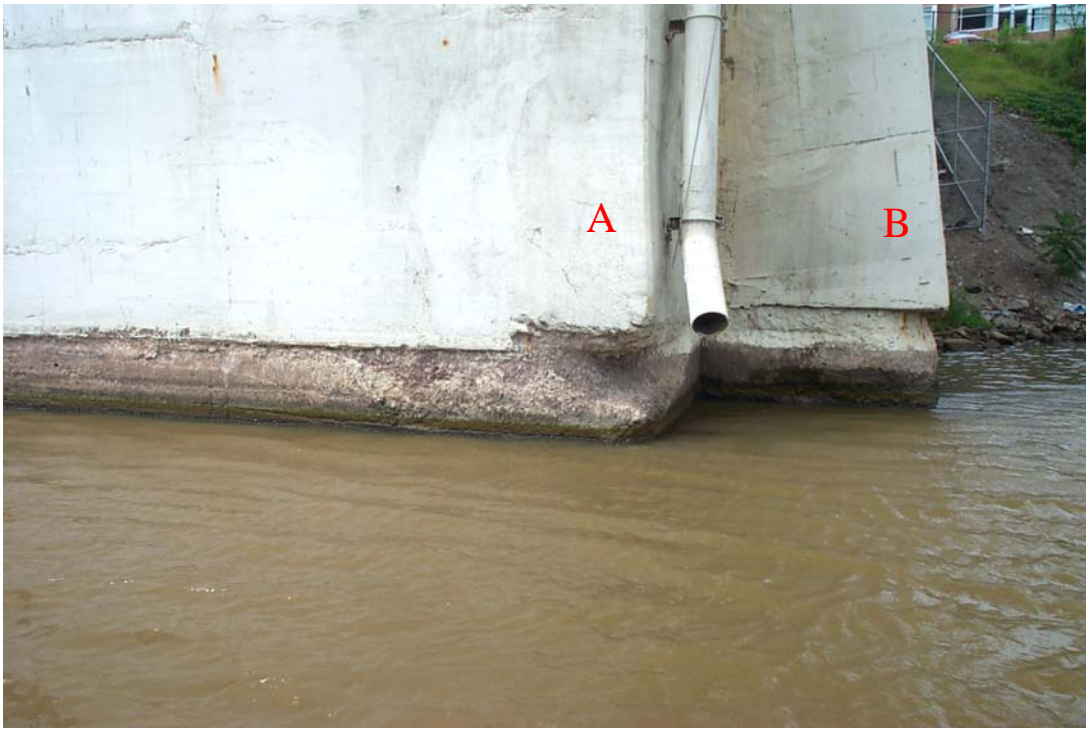
Photo 1. View looking northwestward showing deterioration of the concrete of Pier 3 in the splash zone between the water line and a horizontal construction joint or lower limit line of former concrete repair. Note the rounding at the corners marked “A” and “B” where the concrete loss ranges from 16 to 24 inches in depth. Loss of section in other areas within the splash zone varies up to 6 inches in depth. Not visible in the photo are spalled or dished-out areas at corners A and B below the water line with concrete loss extending 3 to 6 inches into the pier, and rounding at the corners with concrete loss of up to 9 inches (see Pier No. 3 Plan View, Page 9 and Pier No. 3 Detail A and B, Page 10).

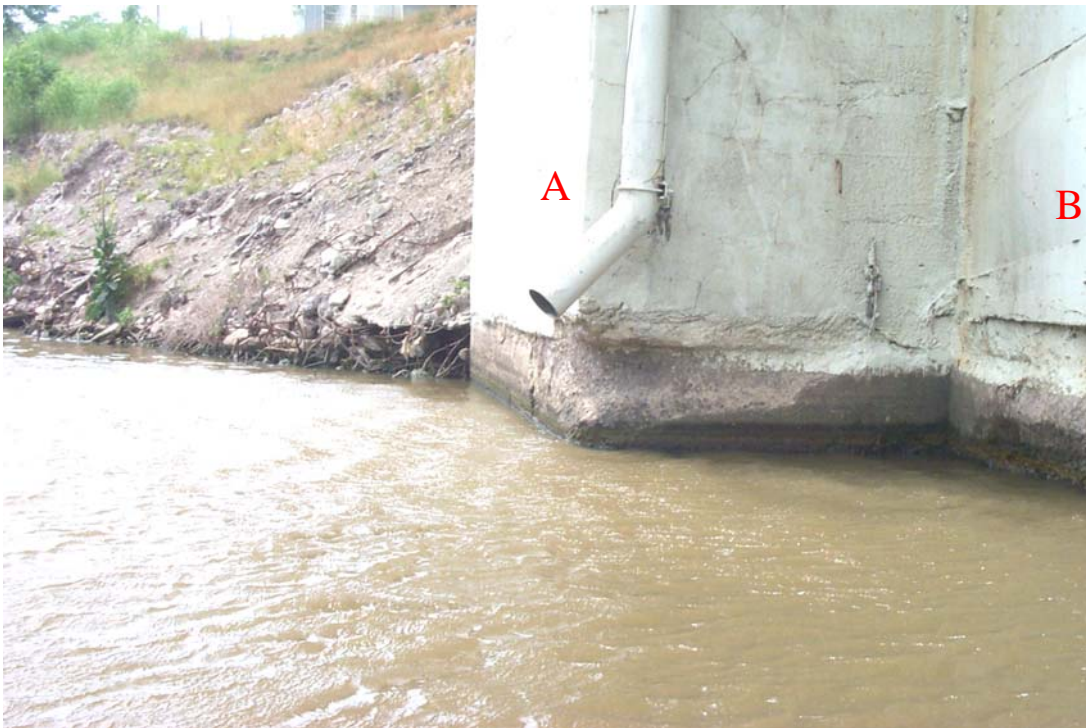
Photo 2. Additional view looking west showing the spalled and missing concrete within the splash zone at corners A and B of Pier 3. This condition does not appear to have changed significantly from what was reported in the previous inspection.

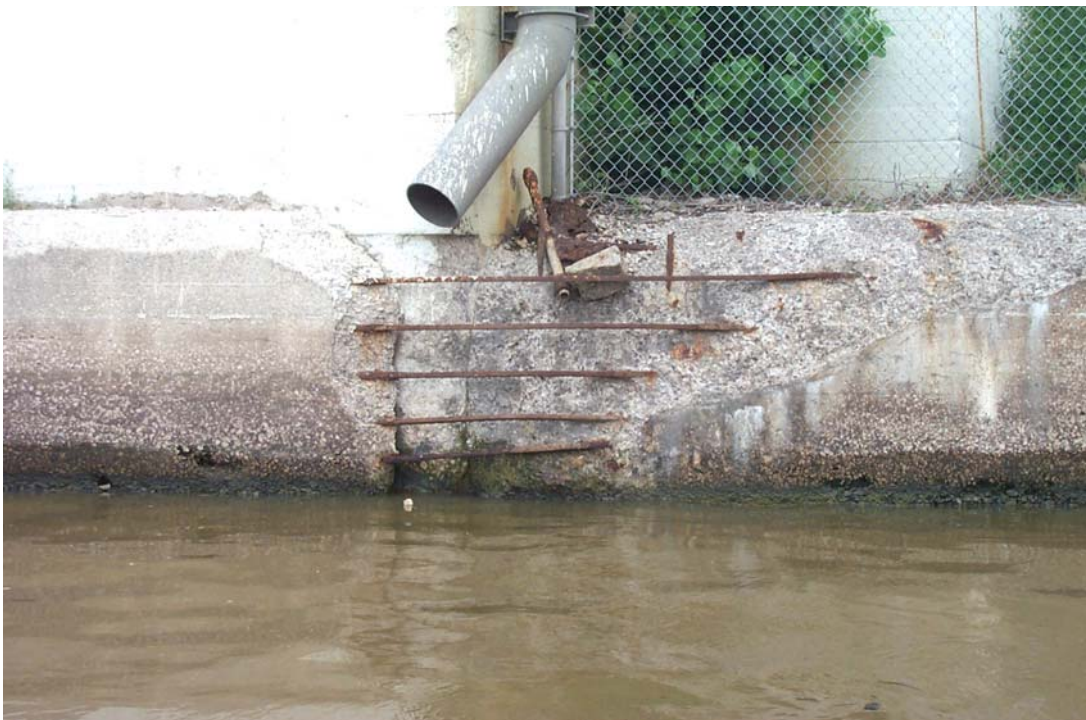
Photo 4. View looking northeastward showing the large spalled area on the concrete cap of the protection wall along Pier 4. The area is approximately 12 feet wide at the top of the cap and tapers to a width of approximately 2 to 3 feet below the water surface and exposes a total of 8 horizontal reinforcement bars (see Pier No. 4 Plan View, Sheet 11).

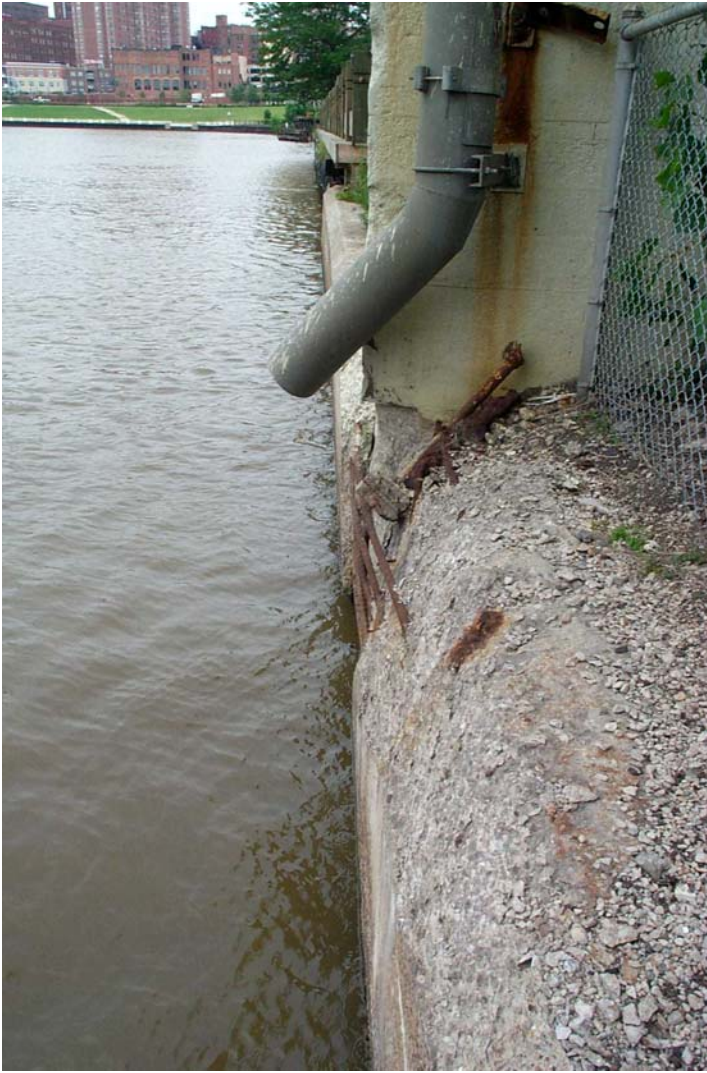
Photo 5. Additional view looking downstream along the concrete cap of the protection wall showing the spalled area on the cap adjacent to the corner of Pier 4.

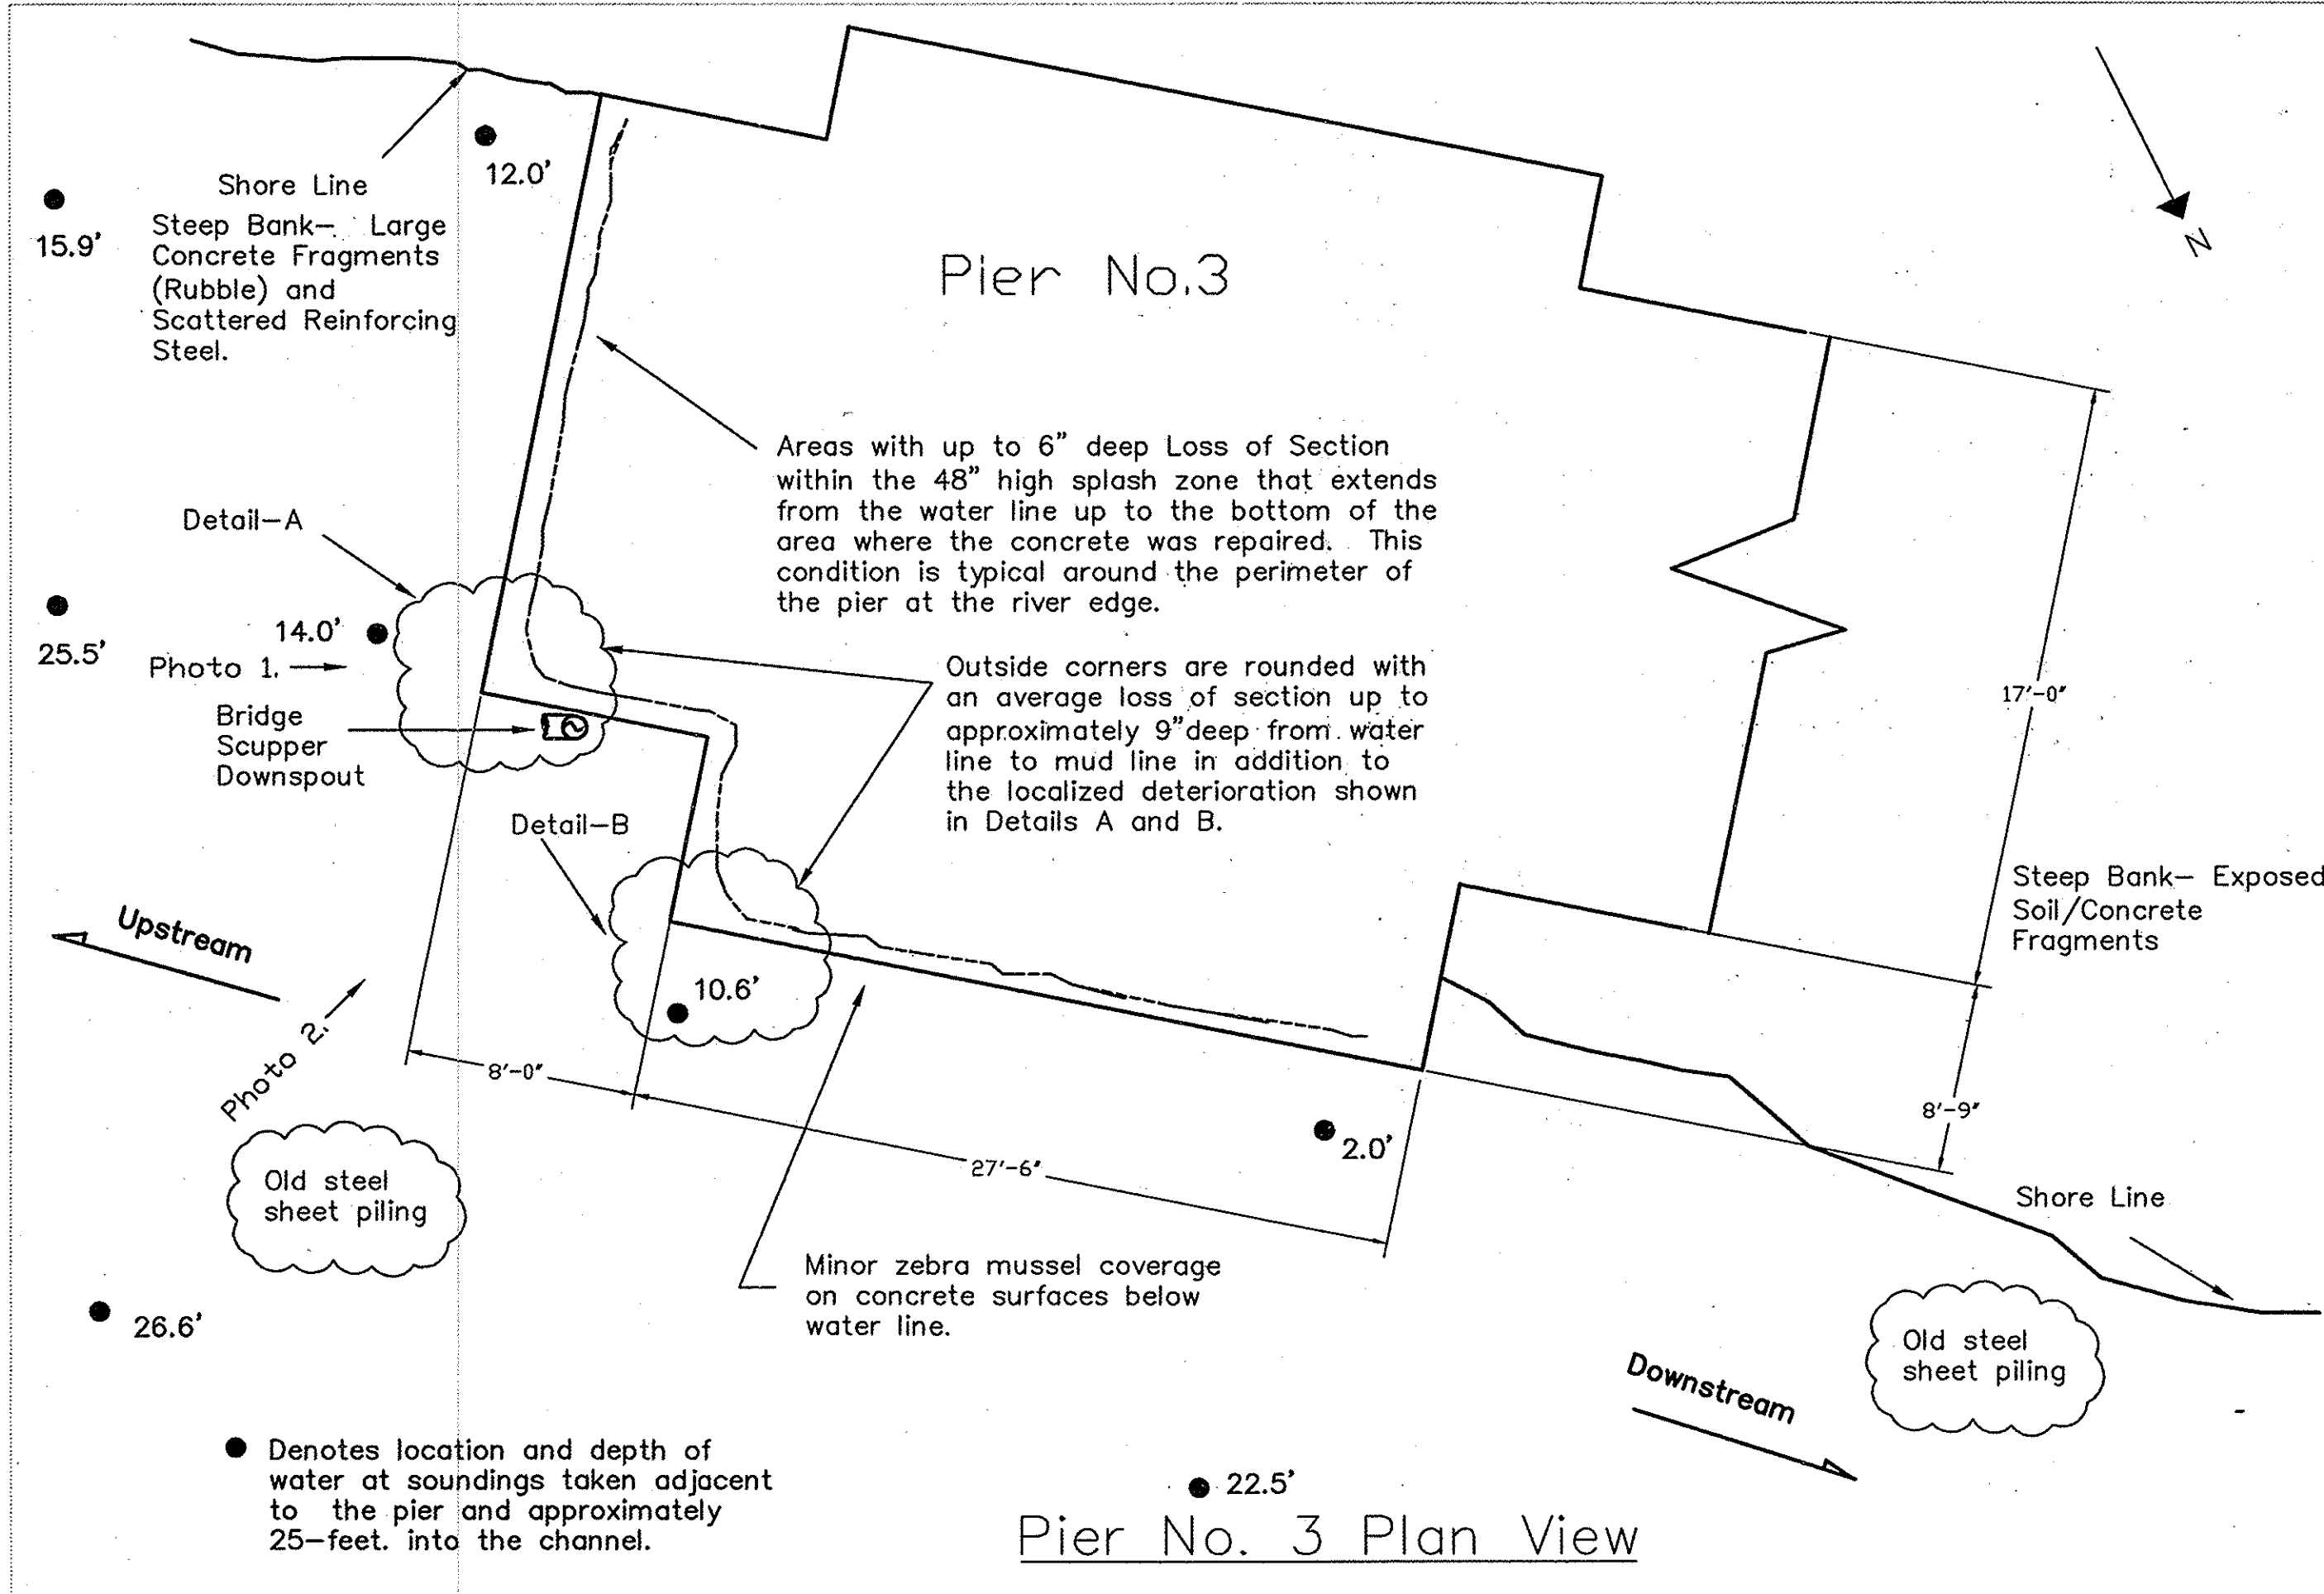
Areas with up to 6" deep Loss of Section within the 48" high splash zone that extends from the water line up to the bottom of the area where the concrete was repaired. This condition is typical around the perimeter of the pier at the river edge.

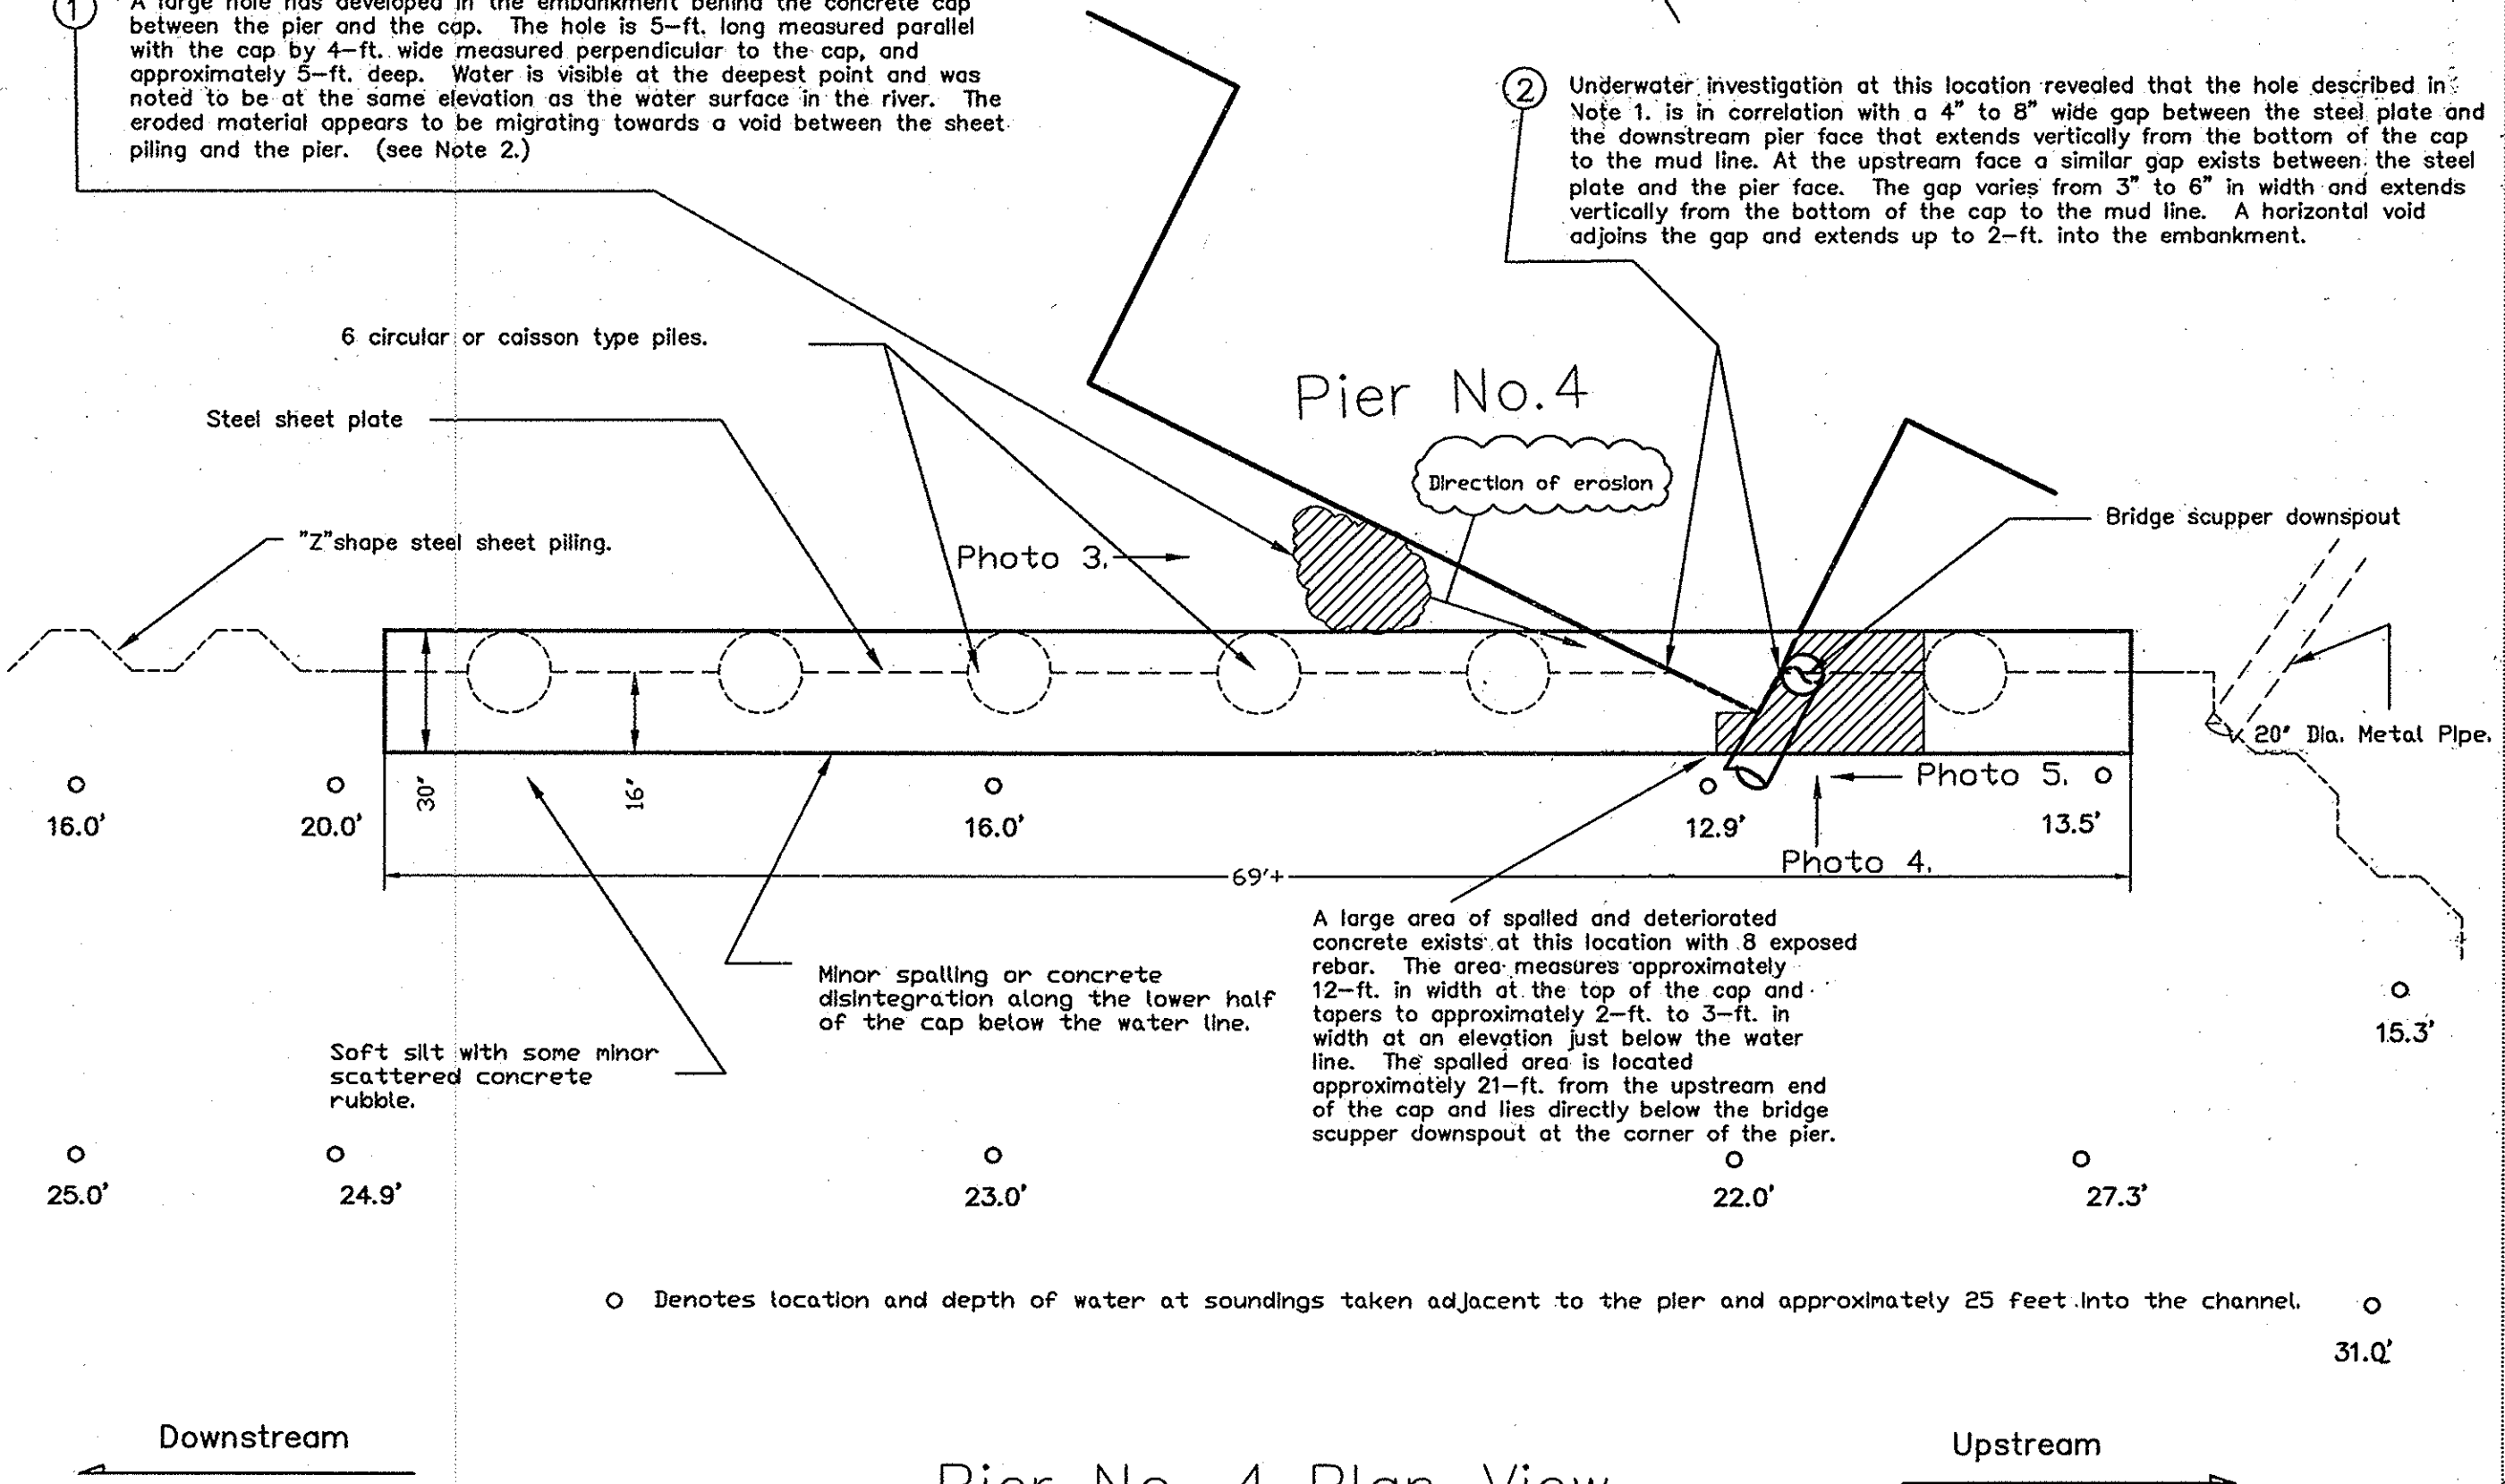
Minor spalling or concrete disintegration along the lower half of the cap below the water line.
