2009 Annual Inspection of the Detroit-Superior Bridge CUY-6-1456 SFN 1800930

Supplemental Report of 2009 Inspection Results

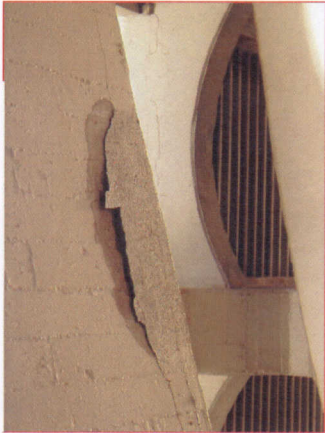
Cracking in north exterior arch..

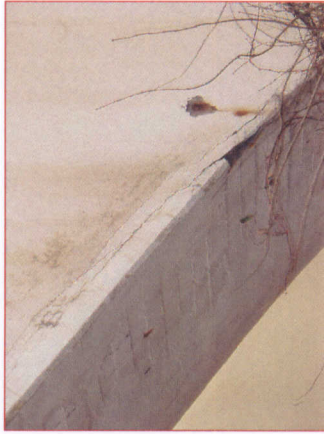
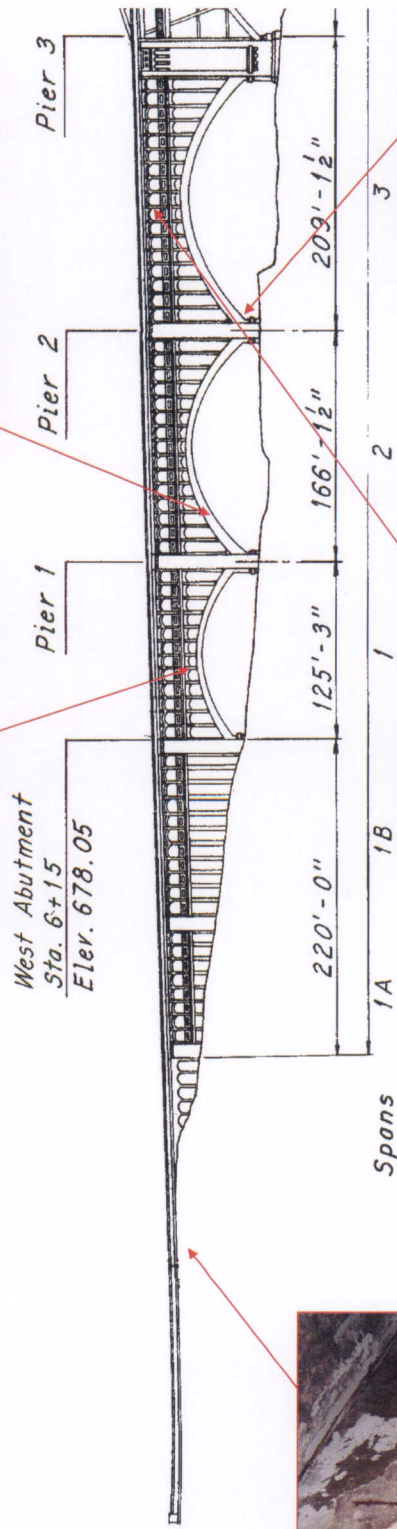
Typical condition of columns in far back of the vaults on the west side of the bridge. This part of the vaults is past the restored area that is used for tours...

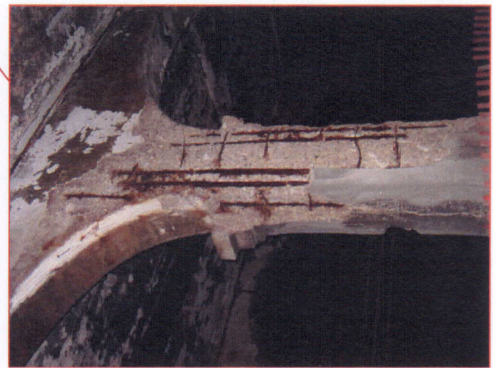
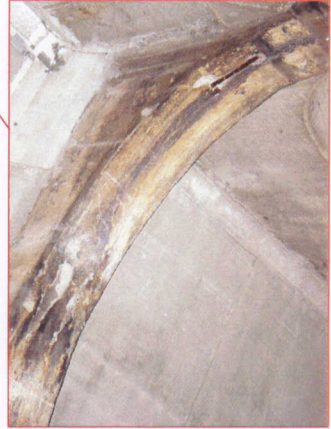
Spall with exposed rebar on underside of arch between 3-NI-10 and 3-NI-11..

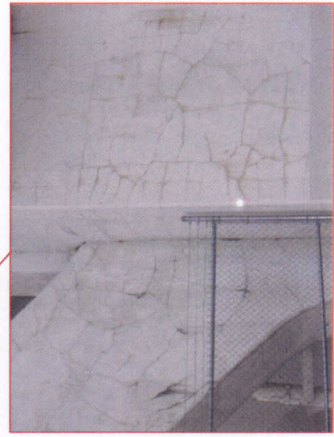
Map cracking in north exterior arch..

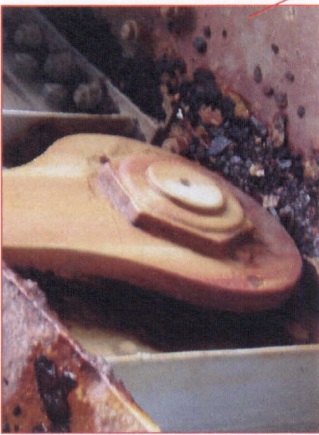
Rust staining over top coat of eyebolt, pack rust behind eyebolt (typical).

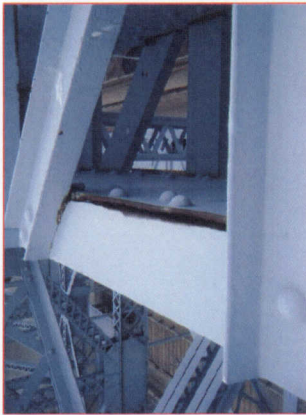
Pack rust beginning to reactivate in some locations between truss member components.

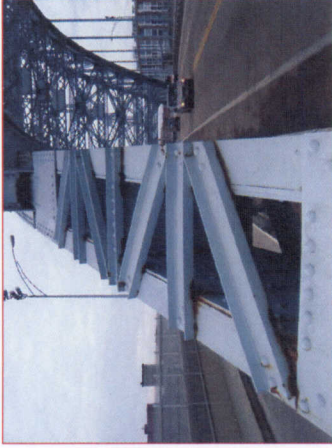
Pack rust beginning to reactivate in some locations between truss member components.

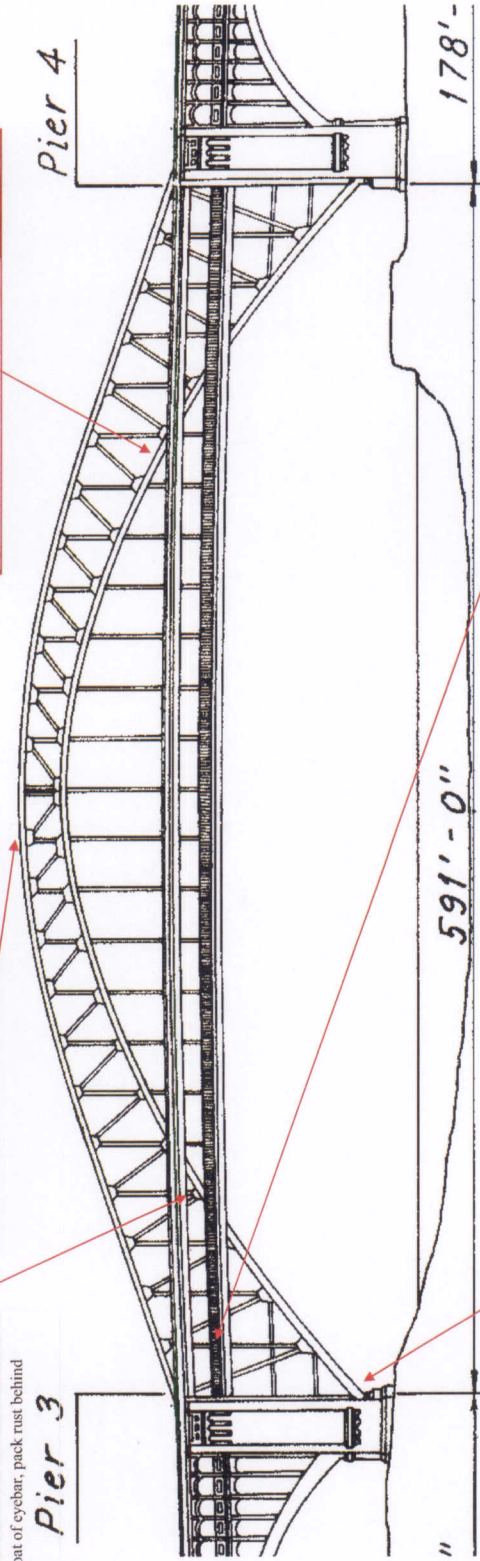
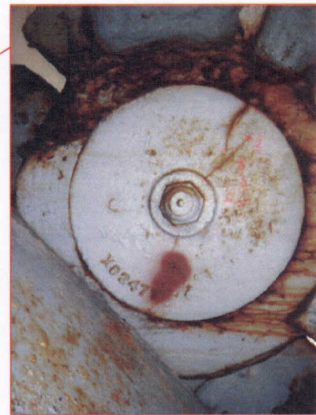
Cracked pin cap at skewback – no measurable change in the cracks from previous inspections (SW skewback).

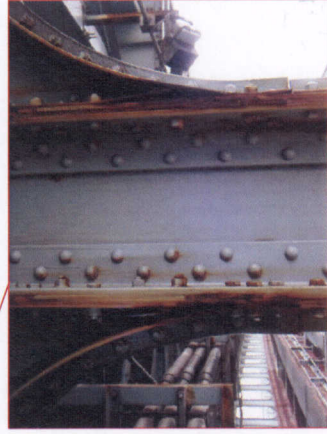
Typical reactivation of pack rust between plates of vertical (U1-L1 south truss shown here).

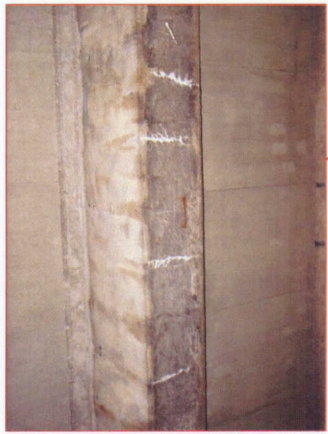
Cracks with efflorescence on bottom face of floorbeam, extending up the sides.

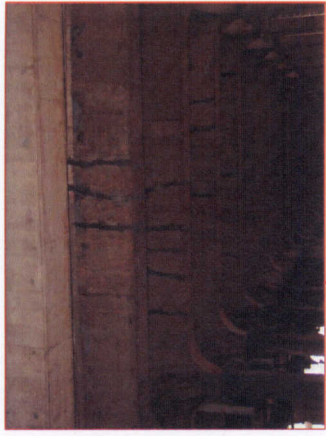
Most floorbeams in this span have been epoxy-injected at the flexure cracks. Repairs are performing well.

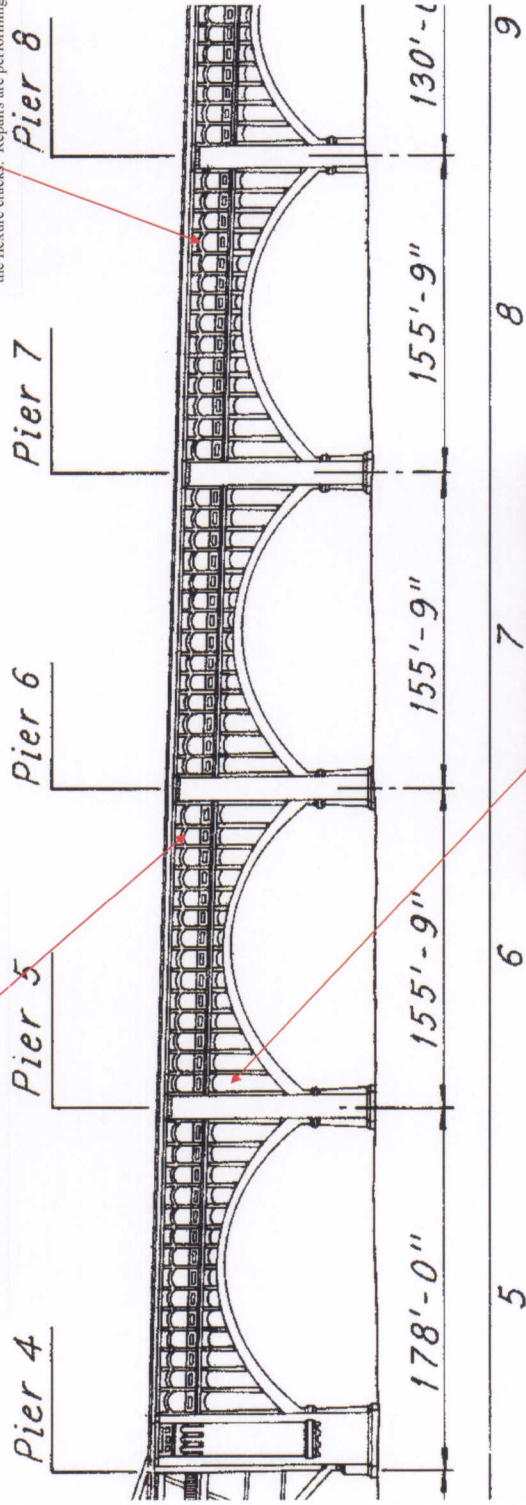
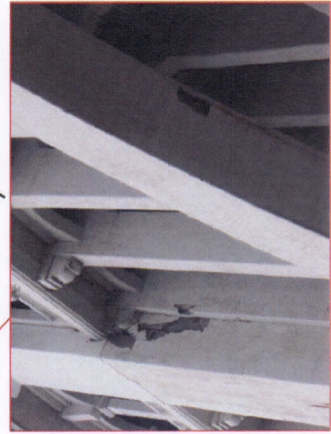
Spall due to crushing on north face, pier 5.

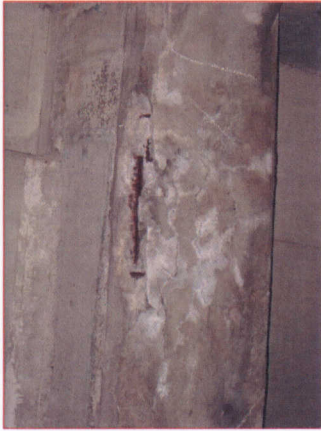
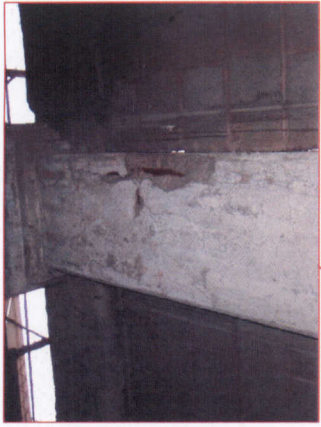
Spall with exposed rebar on column ES-5, SE

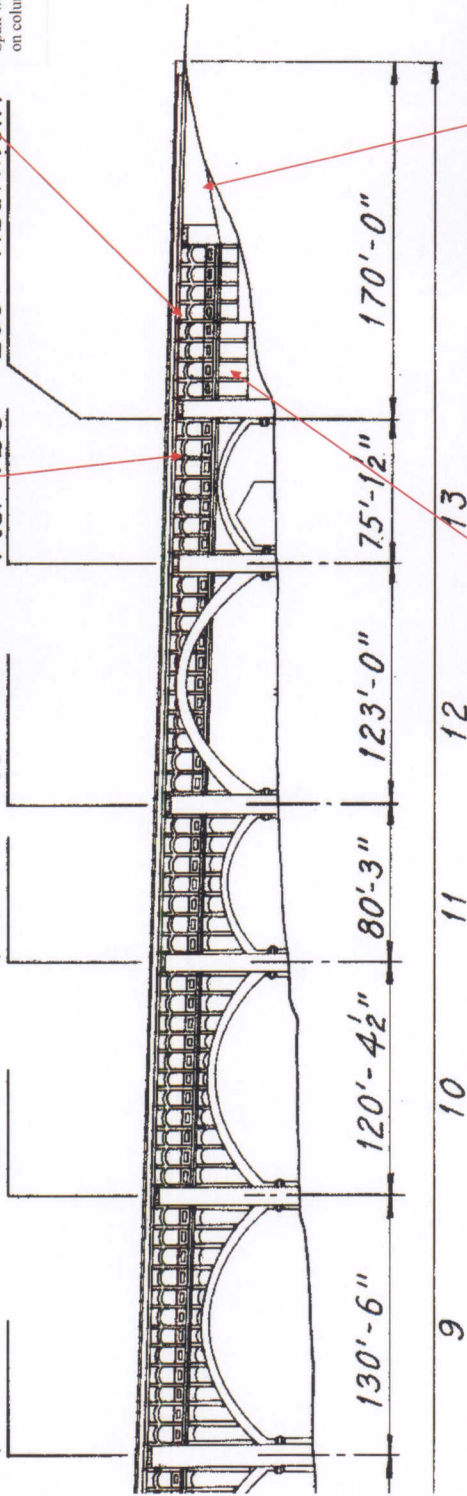
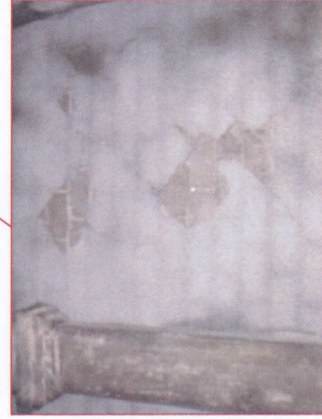
Block wall between arches has developed some cracks and mortar finish coat is spalling/peeling off.

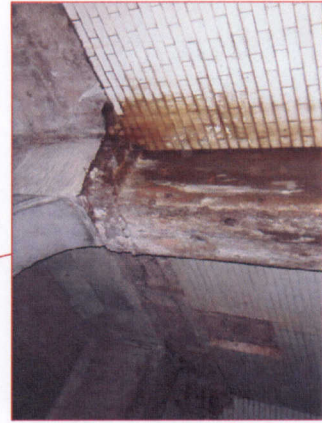
Heavy scaling, cracking and efflorescence, column ES-18, SE
