# 2010 PHYSICAL CONDITION REPORT

## CUY - 00006 - 1456 DETROIT-SUPERIOR BRIDGE OVER THE CUYAHOGA RIVER

**SFN 1800930**

**INSPECTED: AUGUST 30, 2010 THROUGH OCTOBER 3, 2010**

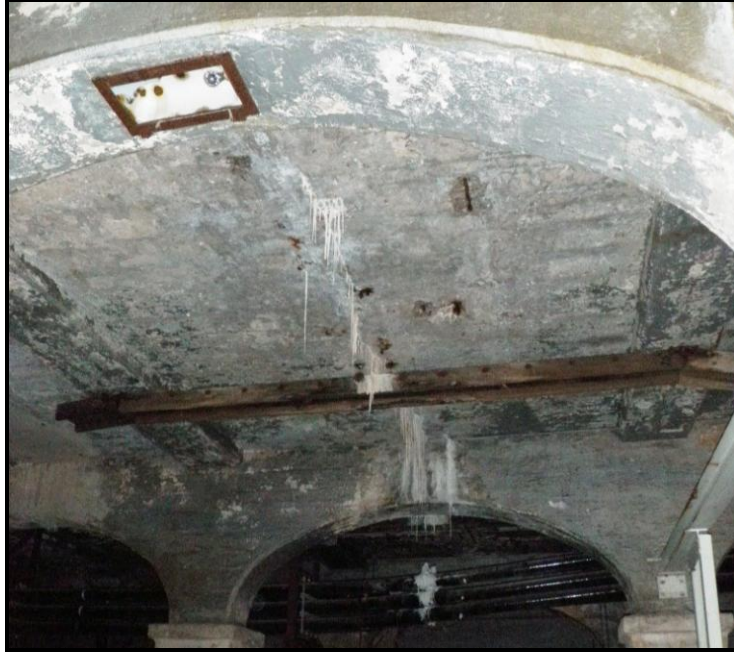
Significant amounts of spalled areas with exposed reinforcing steel, numerous delaminations, large mottled areas, large transverse cracks with efflorescence and failing patches cover approximately 1/3 of the area of the west tunnel floor slab. This section of the slab is by far in the worst shape and should be considered for future replacement based on the area of spalls with exposed reinforcing (See Photos 1 & 2).

*Photo 1: Large Crack with Efflorescence in the West Approach Tunnel*

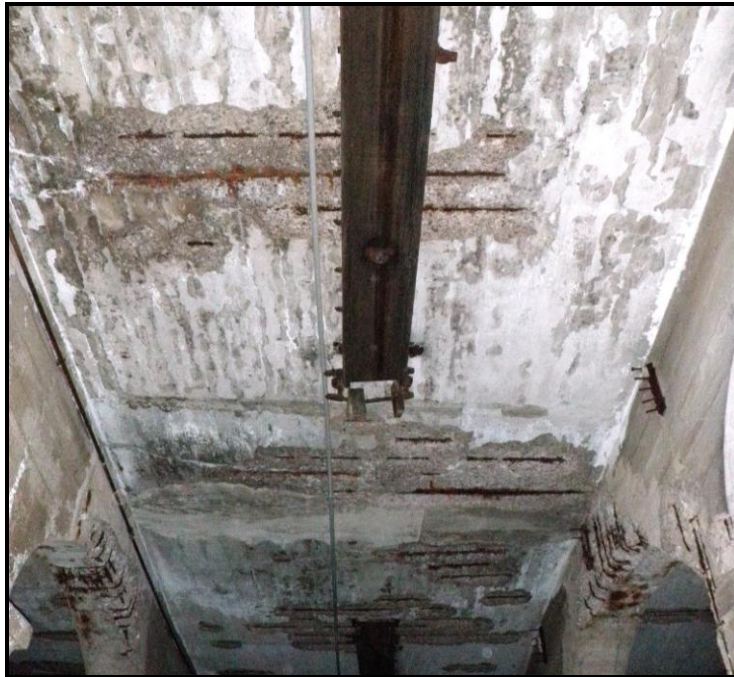
*Photo 2: Typical Large Spalled Areas with Exposed Reinforcing Steel in the West Approach Tunnel*

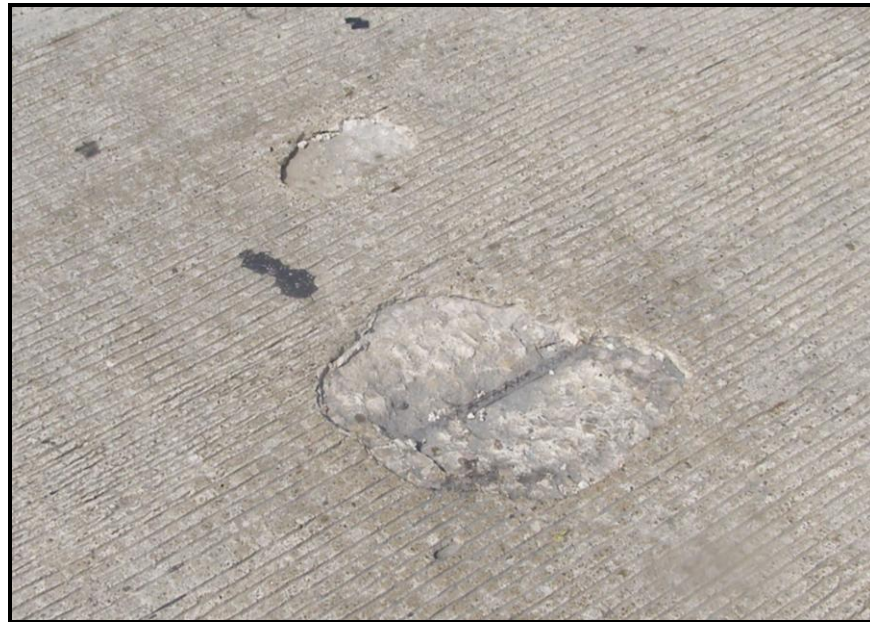
*Photo 3: Wearing Surface Popout with Exposed Reinforcing Steel*

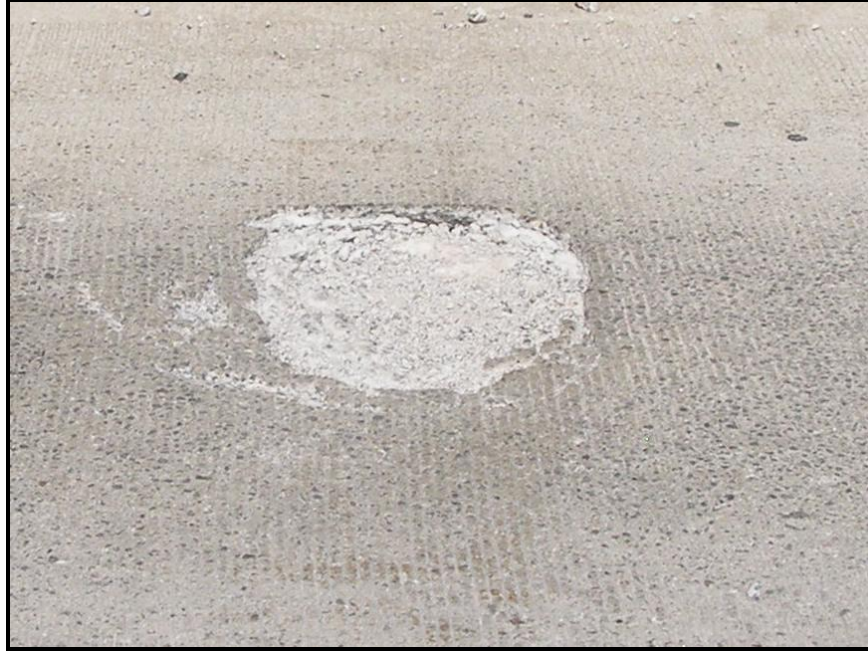
*Photo 4: Large Spall at Panel Point 7*

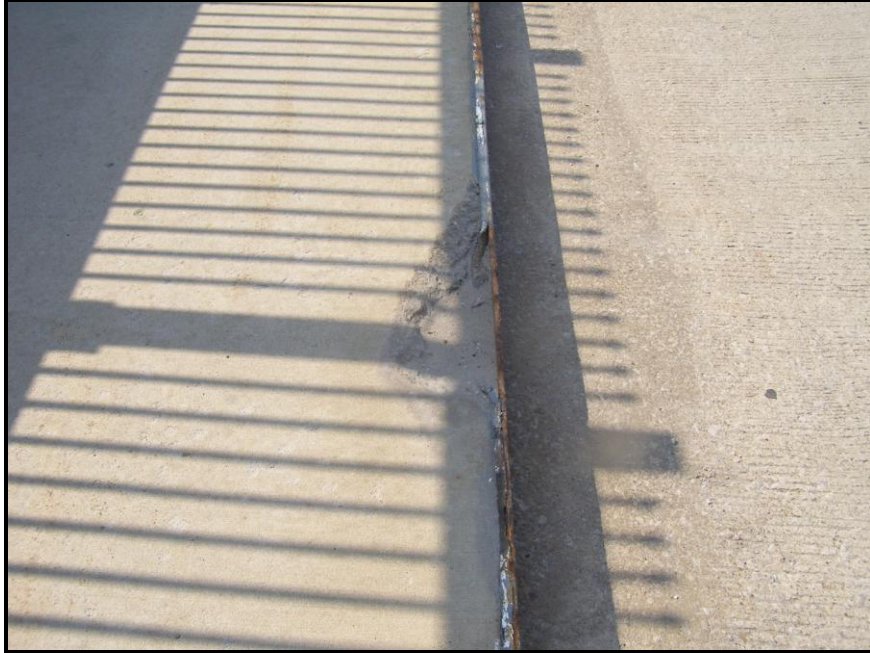
*Photo 5: Typical Sidewalk Spall*

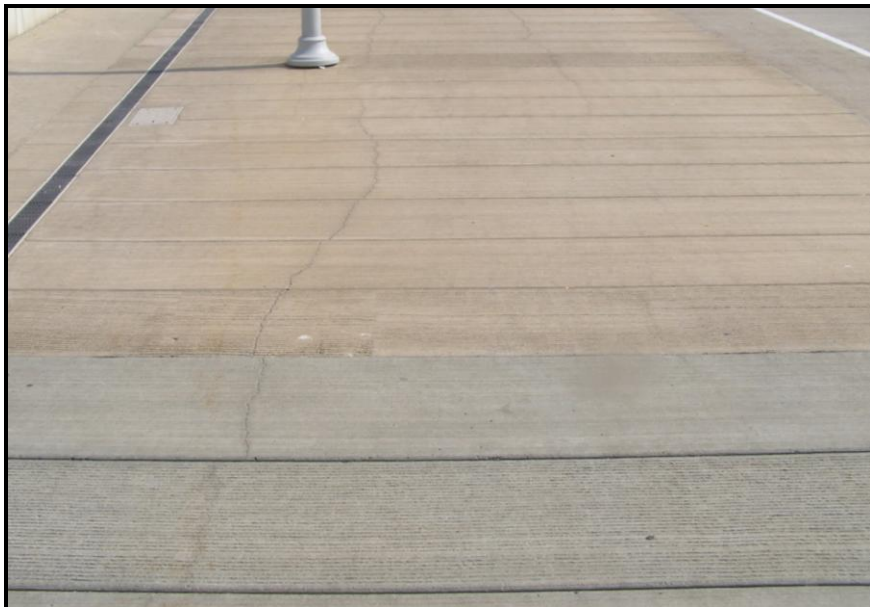
*Photo 6: Typical Longitudinal Cracks in the Sidewalk*

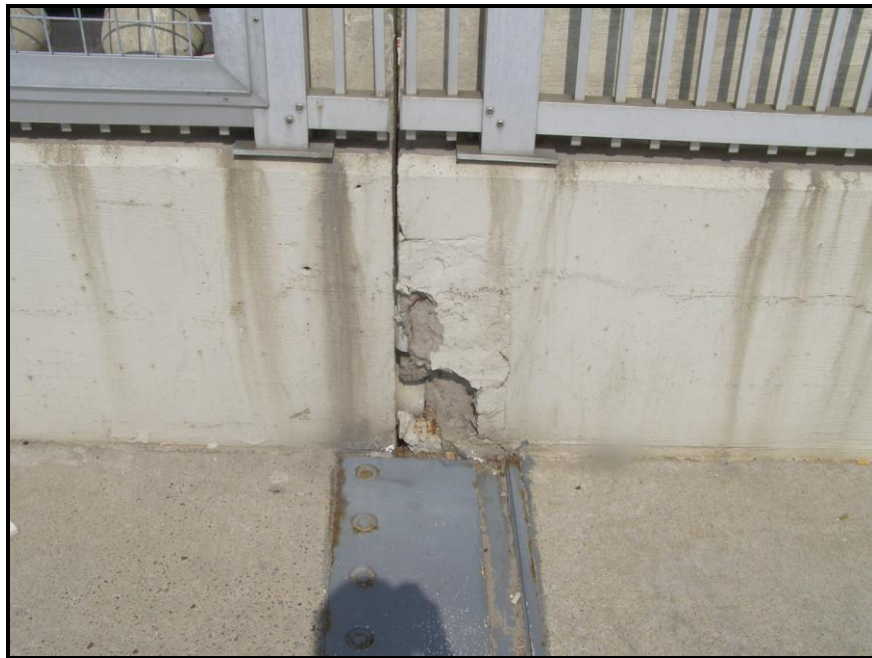
*Photo 7: Fractured Concrete Parapet at Joint 9*

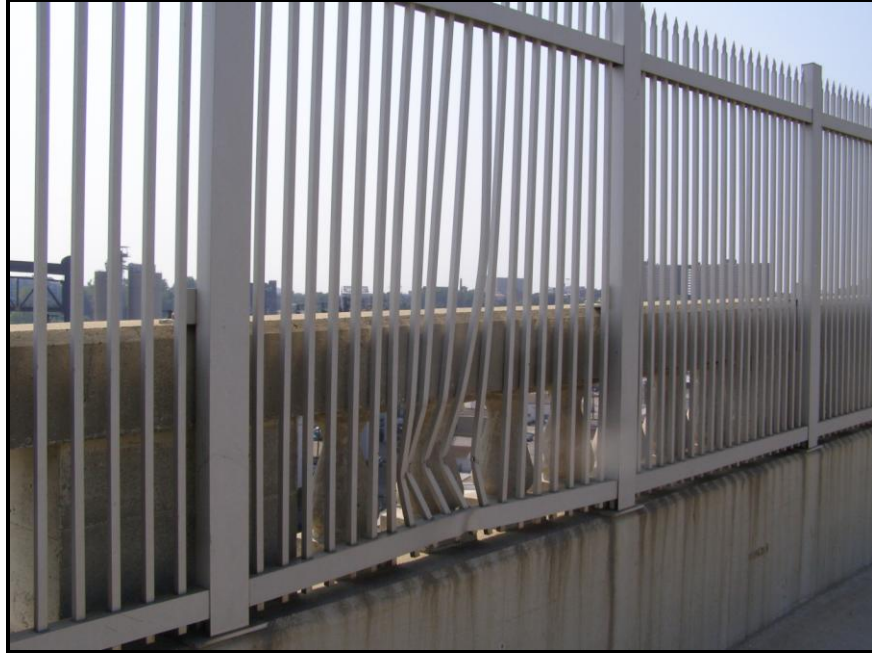
*Photo 8: Damaged Vandal Protection Fence*

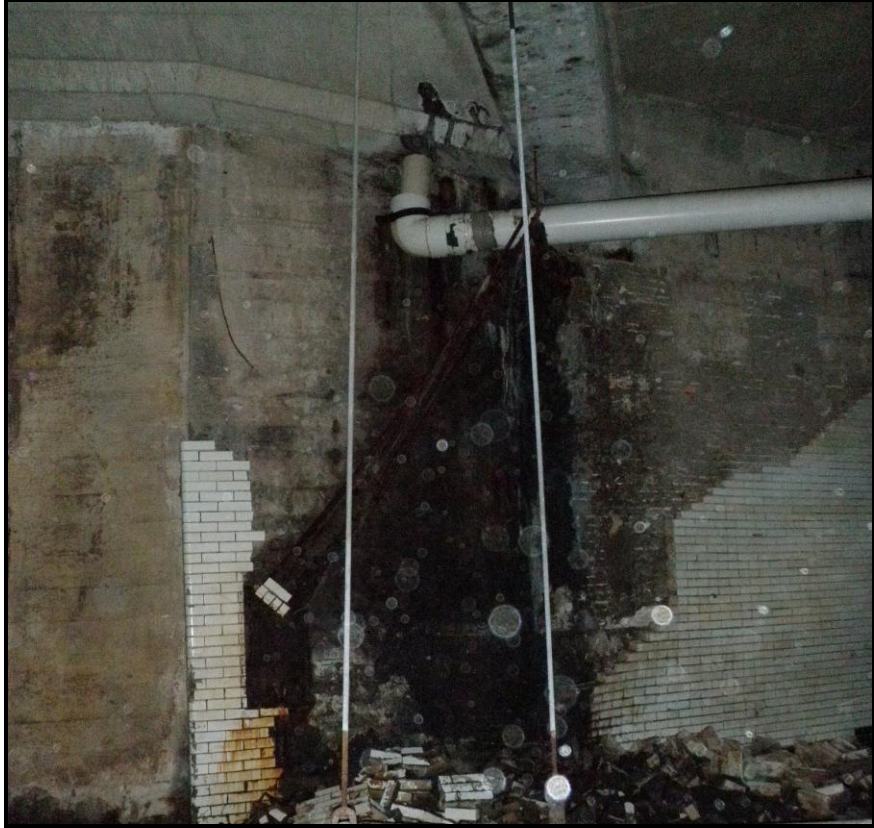
*Photo 9: Broken and Leaking Drainpipe near the East Abutment*

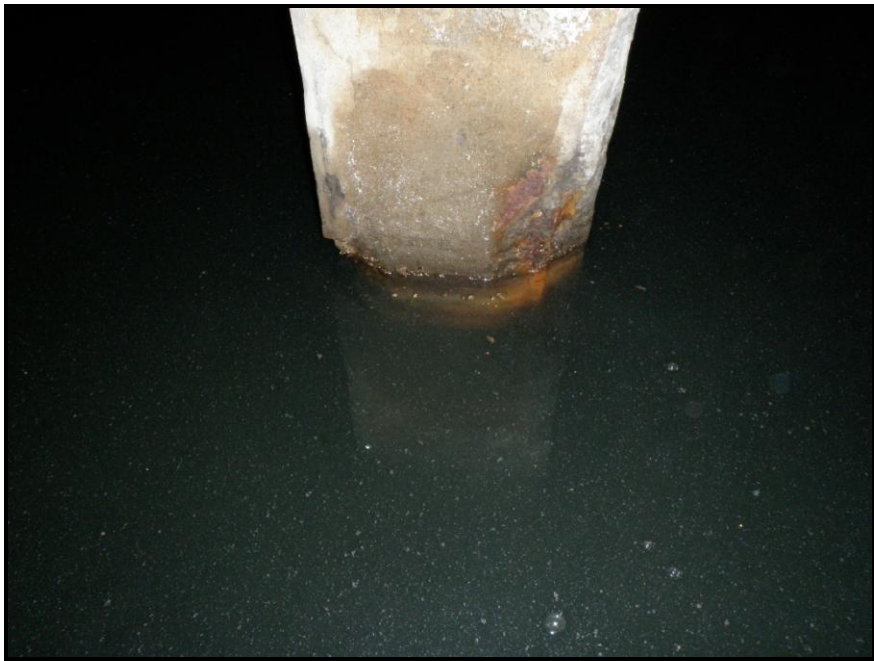
*Photo 10: Standing Water in the East Tunnel*

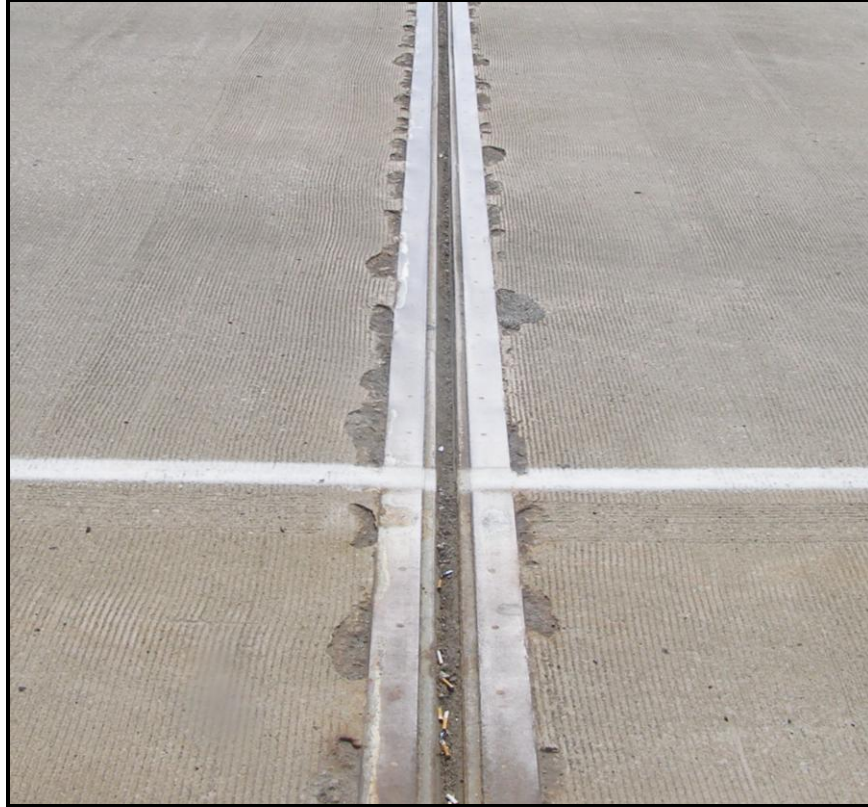
*Photo 11: Typical Spalls on Both Sides of the Joint Armor*

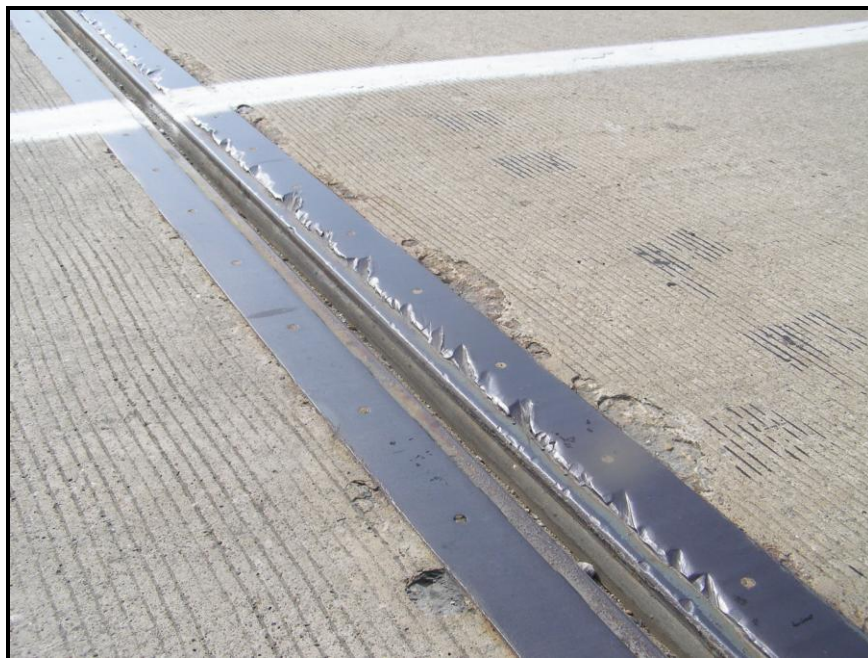
*Photo 12: Typical Plow Damage to Joint Armor*

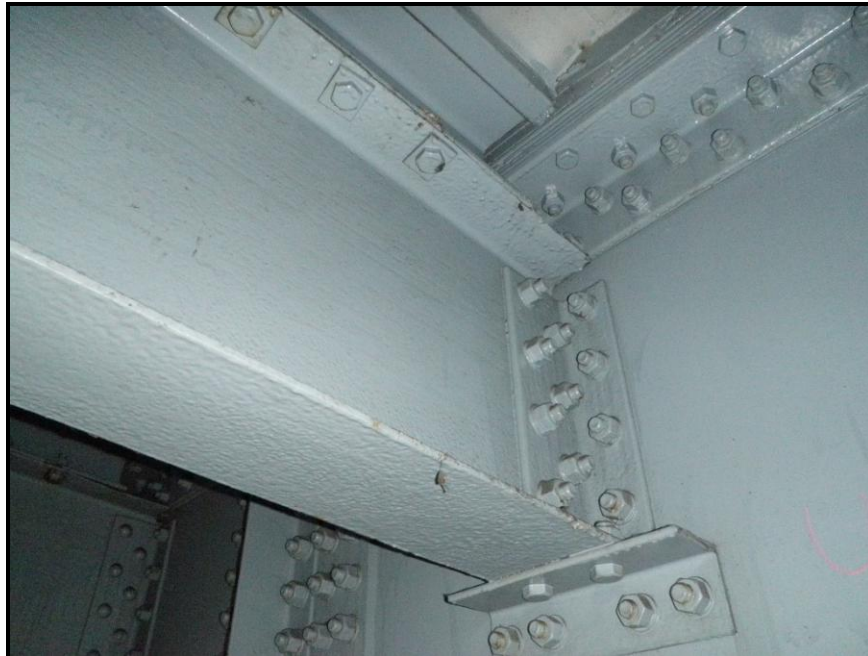
*Photo 13: Old Pitting in Upper Deck Stringers*

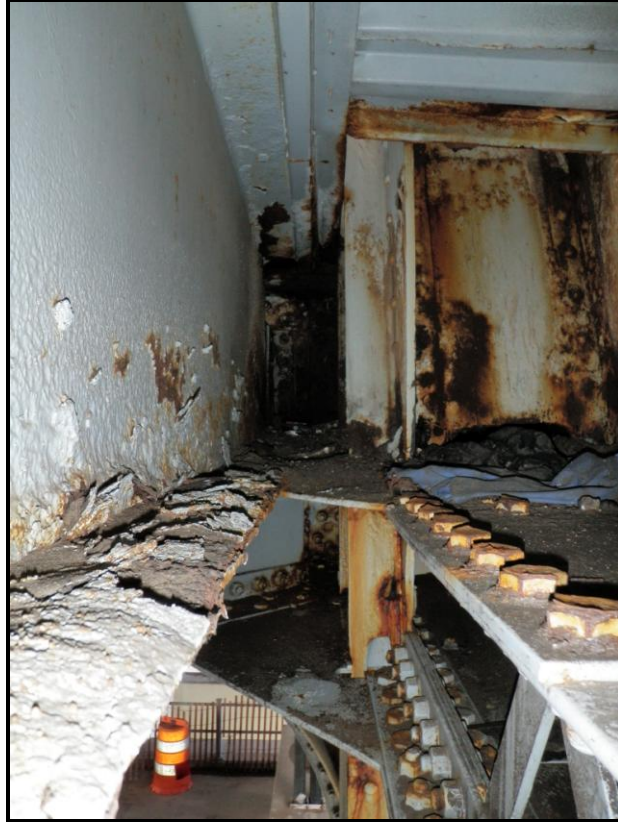
*Photo 14: Typical Corroded Bottom Flange of Upper Deck Stringer*

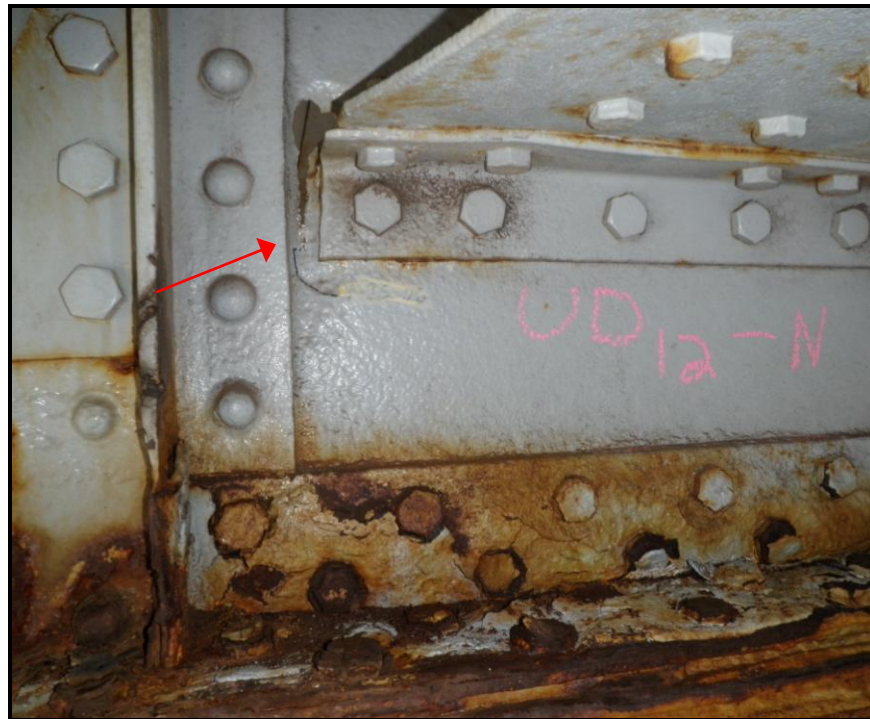
*Photo 15: Hole in FB-U12-N Showing No Change from Previous Inspection*

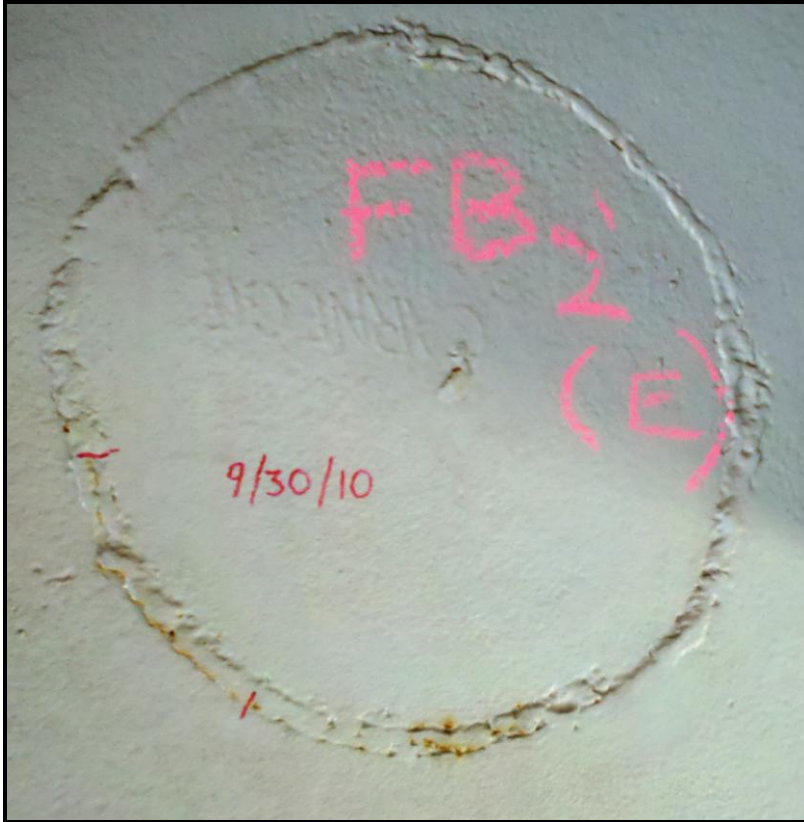
*Photo 20: Showing the New Cracked Weld in the Southern Circular Weld in FB-U2'*

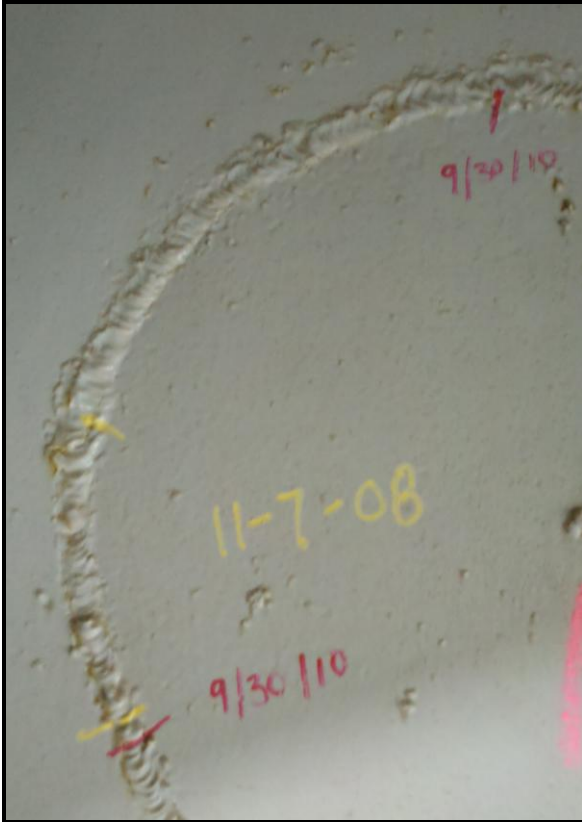
*Photo 21: Showing the Extent of the Growth of the Crack in the Southern Circular Weld in FB-U2'*

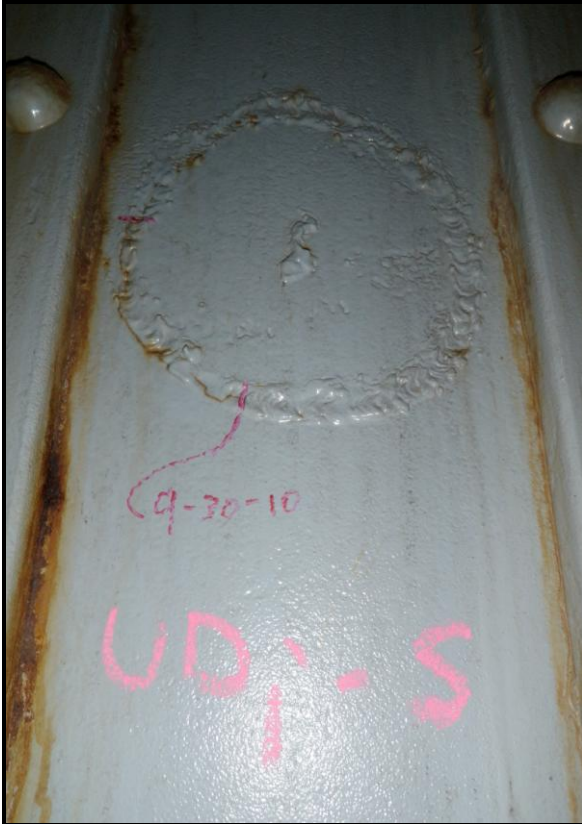
*Photo 22: Showing the New Cracked Weld in the Southern Circular Weld in FB-U1'*

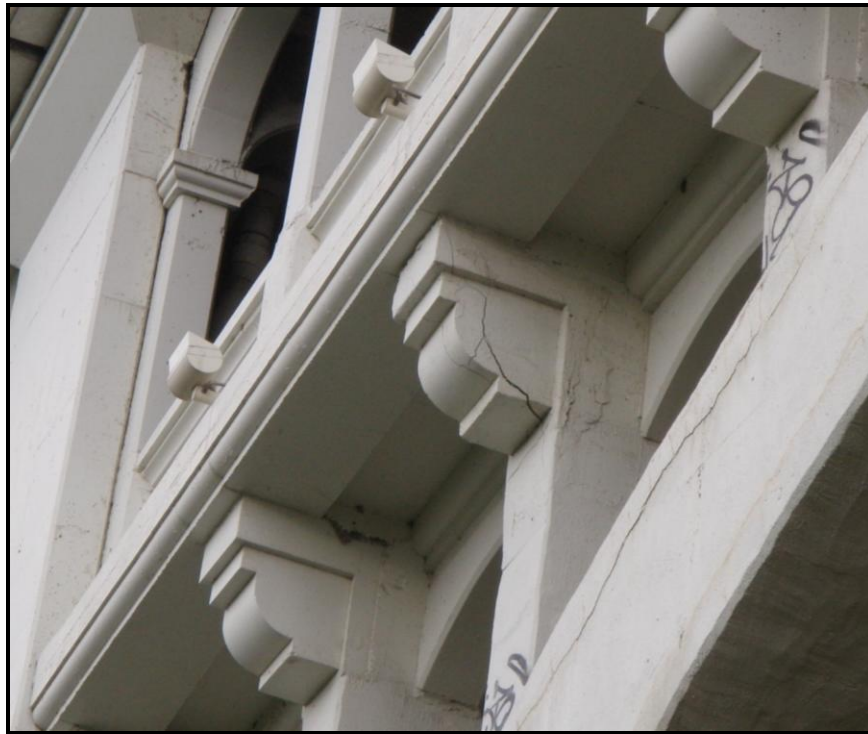
*Photo 24: Corbel 4, Span 2 Cracked and Loose*

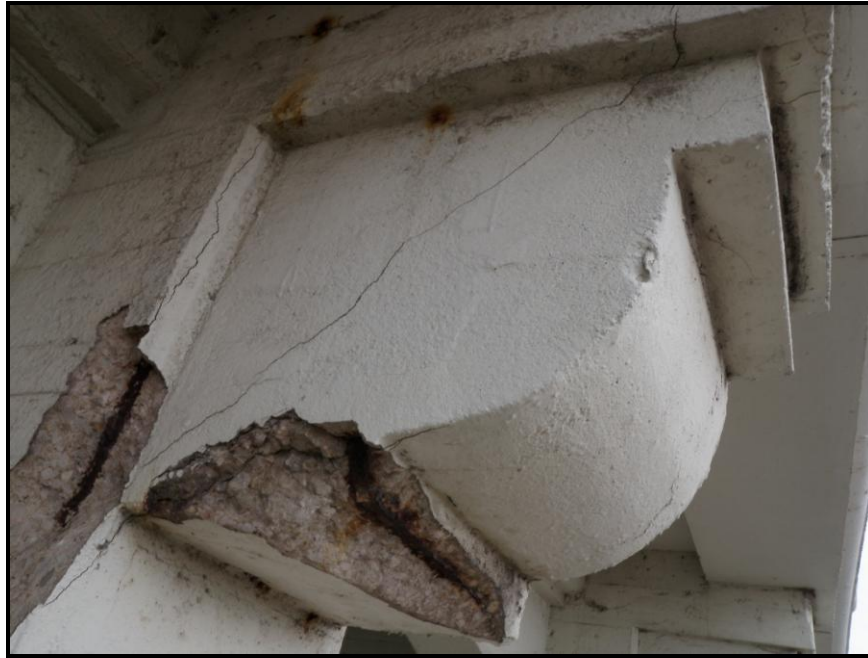
*Photo 25: Corbel 12, Span 6 Completely Delaminated and Loose*

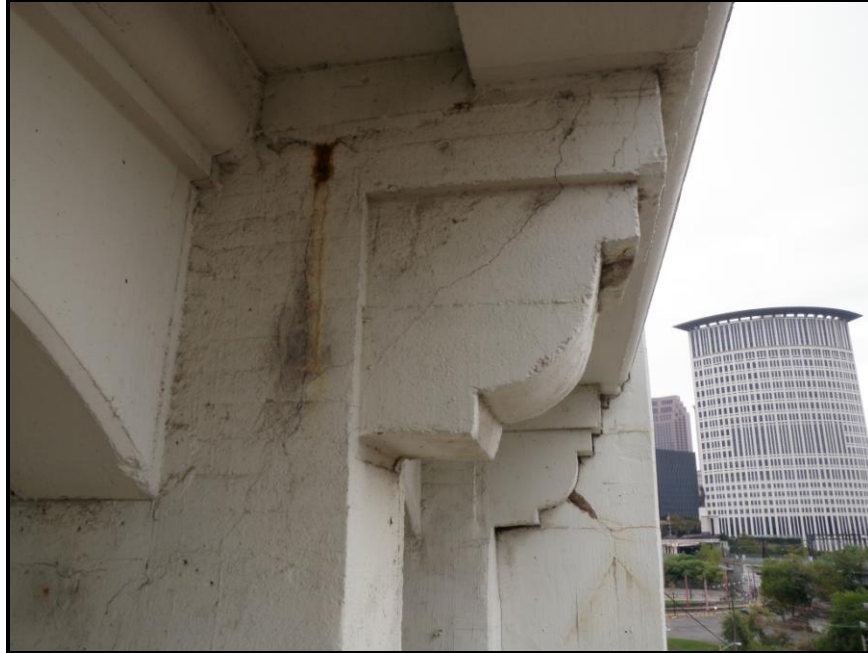
Corbel 14 - Completely delaminated and loose, corbel should be removed (See Photo 26)

*Photo 26: Corbel 14, Span 6 Completely Delaminated and Loose*

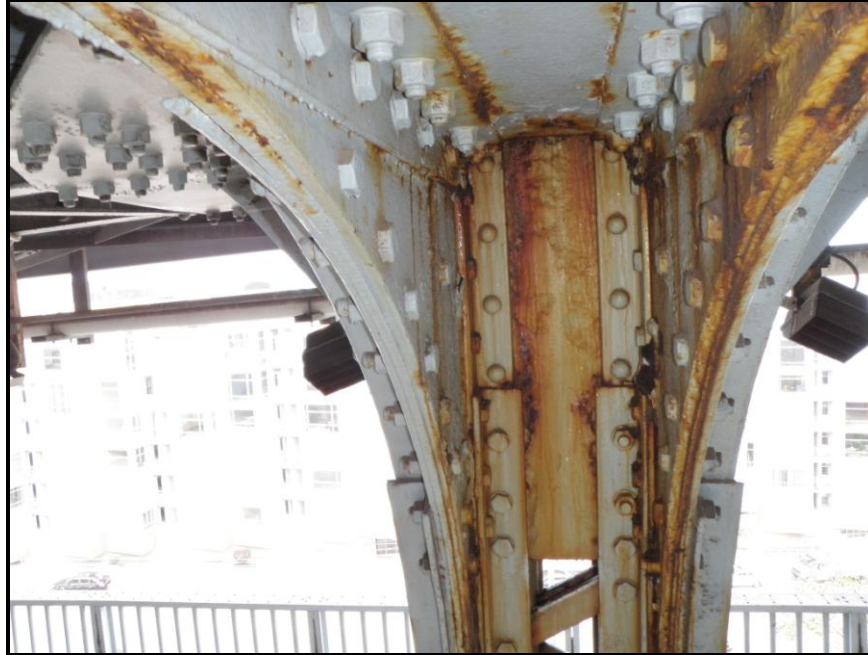
*Photo 27: Typical Corrosion on Vertical Member Immediately Below the Upper Deck Pass-Through*

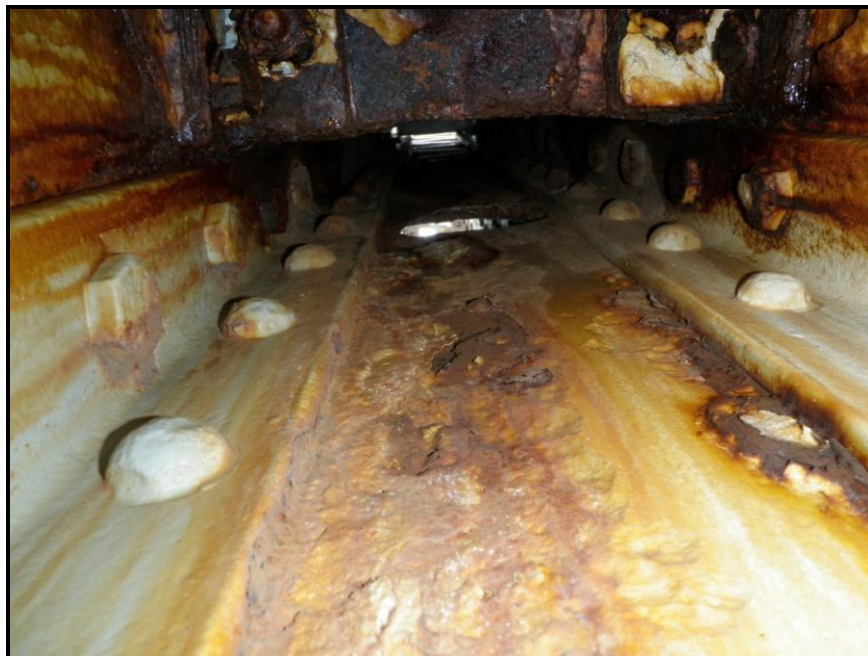
*Photo 28: Through Holes in Cover Plate of L0-S Vertical*

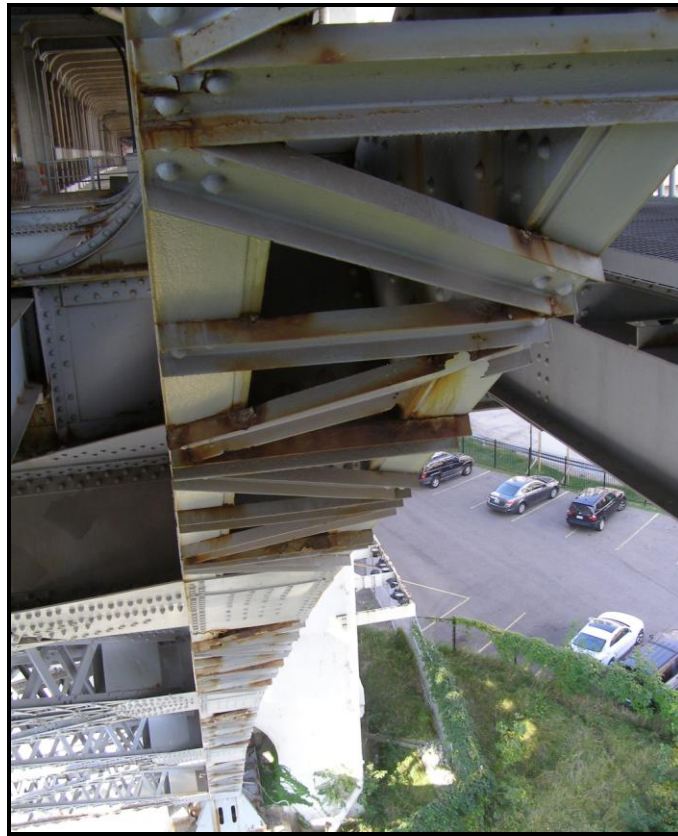
*Photo 31: Corrosion and Holes to the Bottom of the Lower Chord from Panel Point L<sub>0</sub>-L<sub>4</sub>*

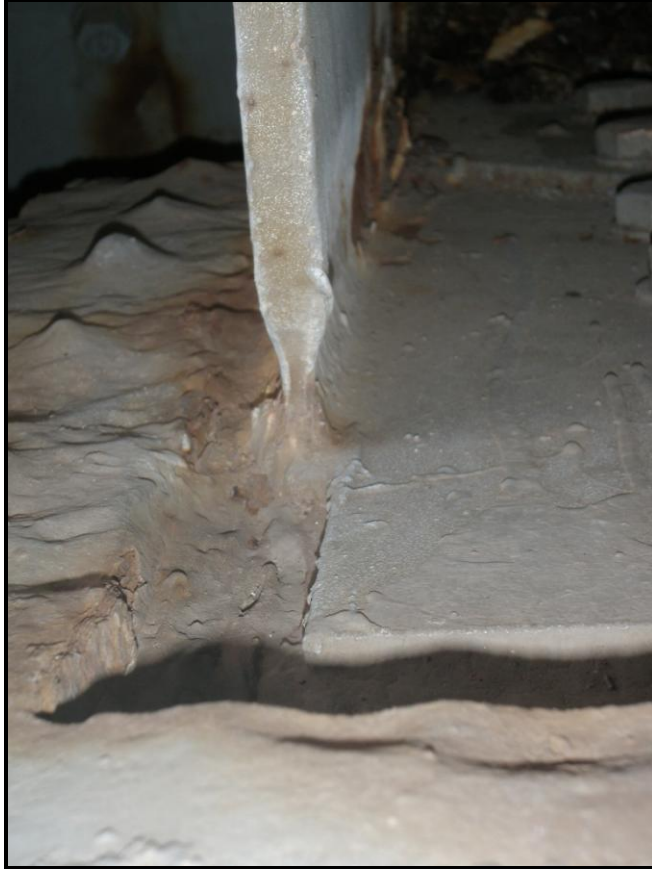
Additionally, the gusset plates at the connections with the vertical and diagonal members are groove pitted along the top of the lower chord (See Photo 32).

*Photo 32: Typical Groove Pitting along the Gusset Plates at the Top of the Lower Chord*

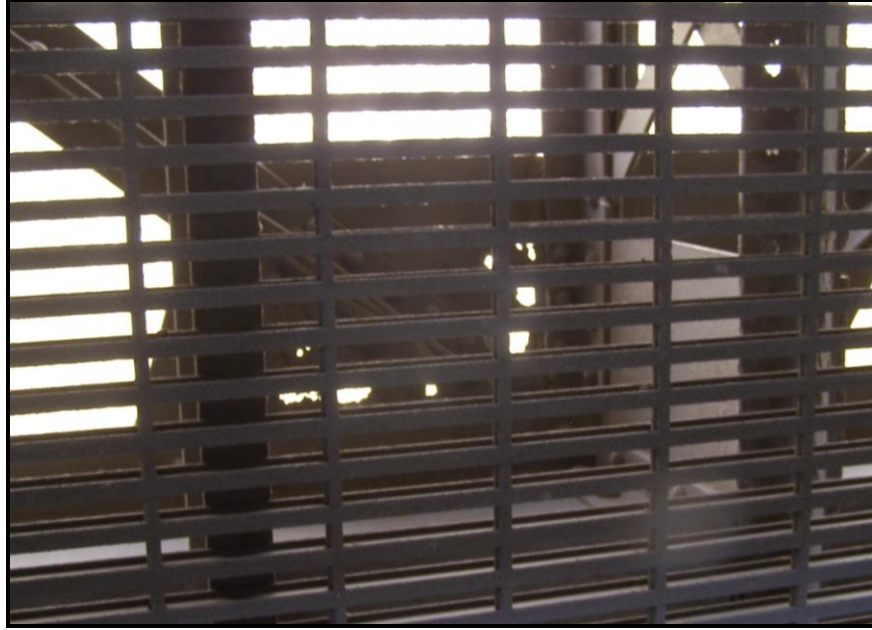
The Lower Lateral Bracing was rated a 2, meaning that it is in Fair Condition. The lower lateral bracing is only found in Span 4. There is old pitting in the members with some light corrosion at the connections. The gussets connecting the lower lateral bracing with the exterior stringers are heavily pitted with through-holes (See Photo 33).

*Photo 33: Through Holes in the Gusset Connecting the Lower Lateral Bracing with the Northern Most Exterior Stringer as seen through the Fiberglass Deck Panel*

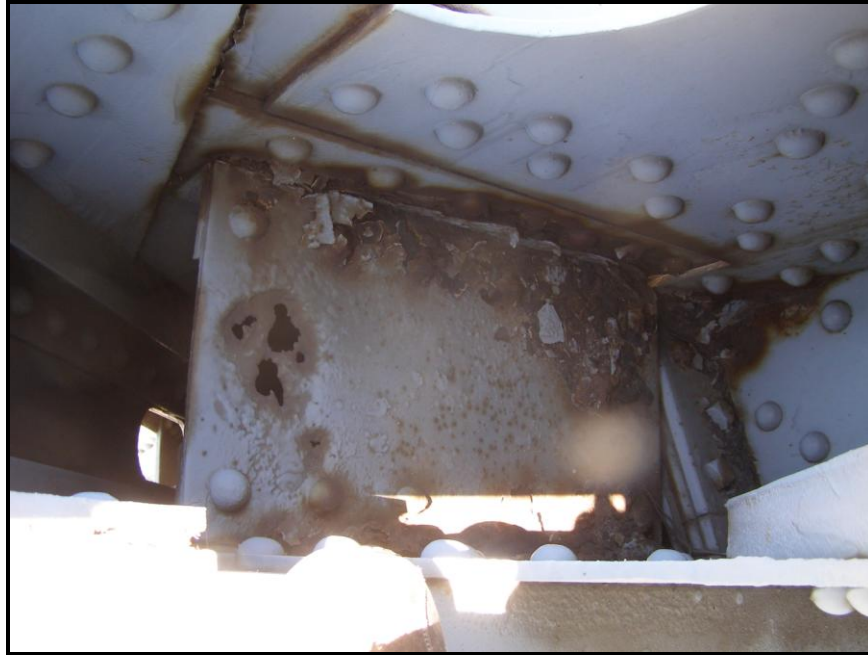
The Portals were rated a 2 meaning that they are in Fair Condition. The portals are only found in Span 4. The portals have minor pitting and light corrosion with isolated through holes in the batten plates inside of the lower portion of the portals (See Photo 34).

*Photo 34: Typical Corrosion and Through-Hole in a Batten Plate inside of the Portals*

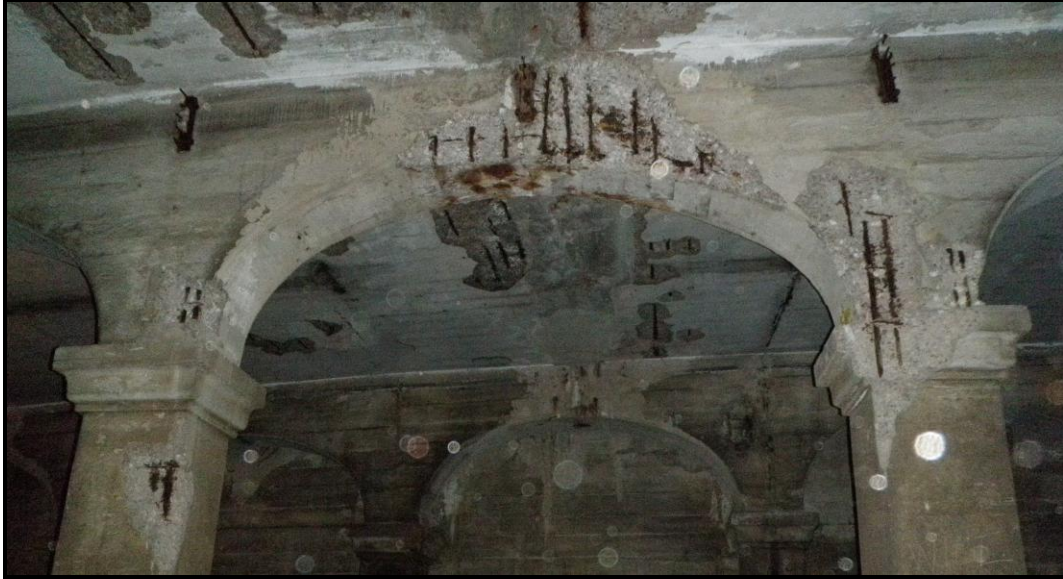
30% of the jack arches are spalled with exposed reinforcing. (See Photo 35 for a typical spall)

*Photo 35: Typical Spalled Jack Arch in the West Tunnel*

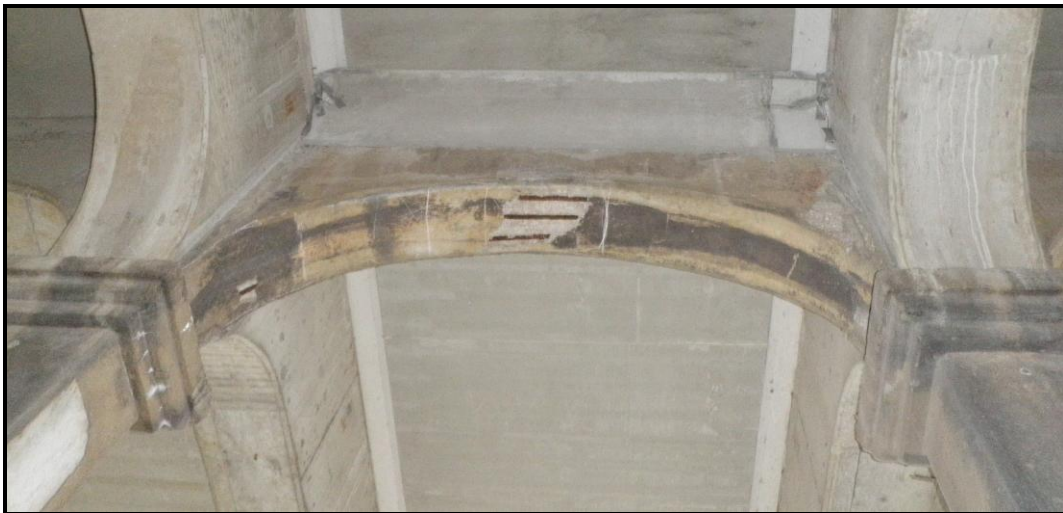
*Photo 36: Typical jack arch spall in Spans 1A, 1B, 1-3 and 4-13*

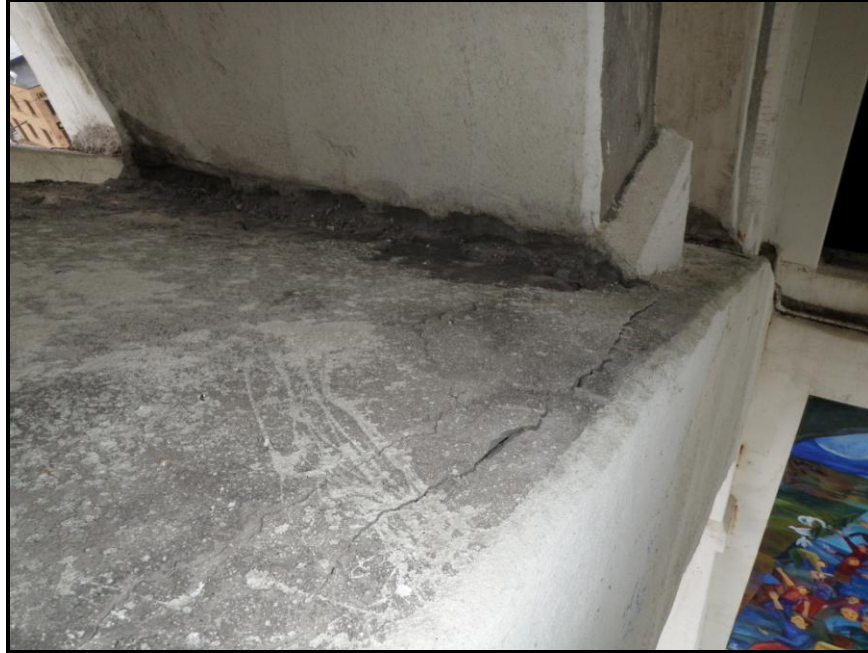
*Photo 37: Typical Corner Crack in Spandrel Arch Rib*

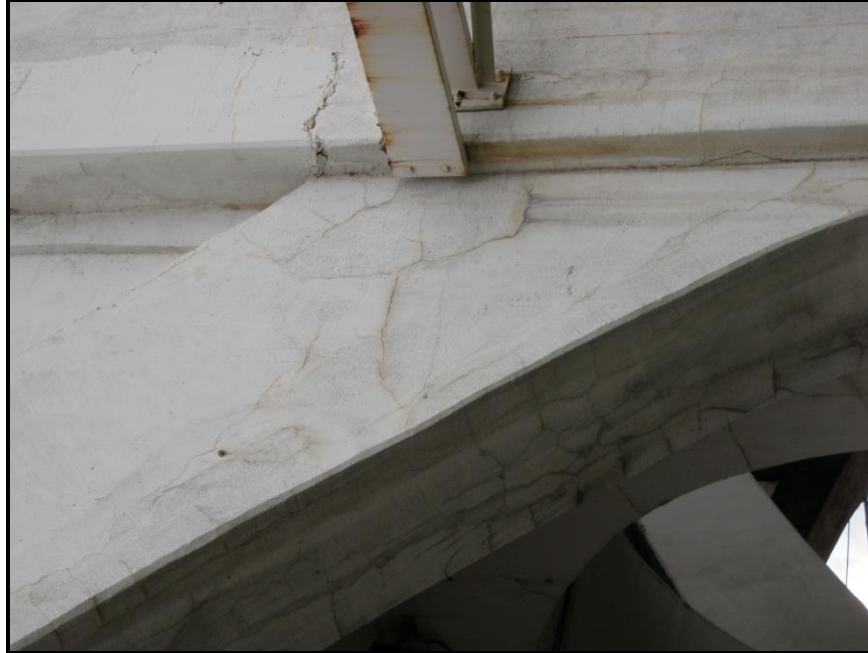
The whole arch rib has been patched from columns 1-5, the patch concrete is map cracked, but tight (See Photo 38). The interior face has been patched from columns 12-16, the patch concrete is cracked but tight. The top exterior corner is cracked between columns 3-6.

*Photo 38: Typical Map Cracking in the Spandrel Arch Rib Concrete*

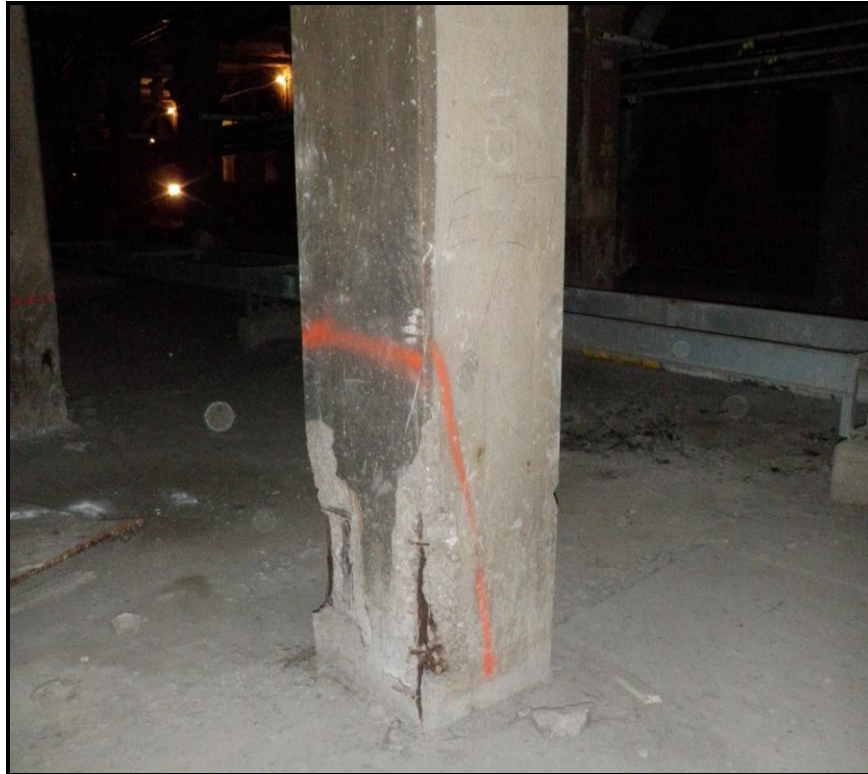
*Photo 40: Typical Spalled Column Base*

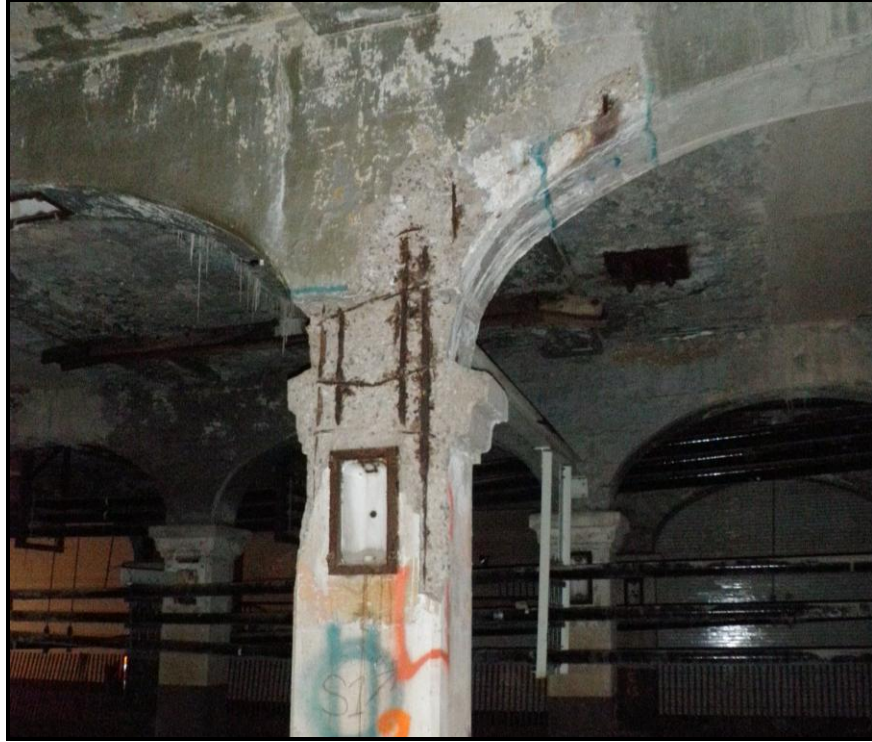
*Photo 41: Typical Spalled Column Capital*

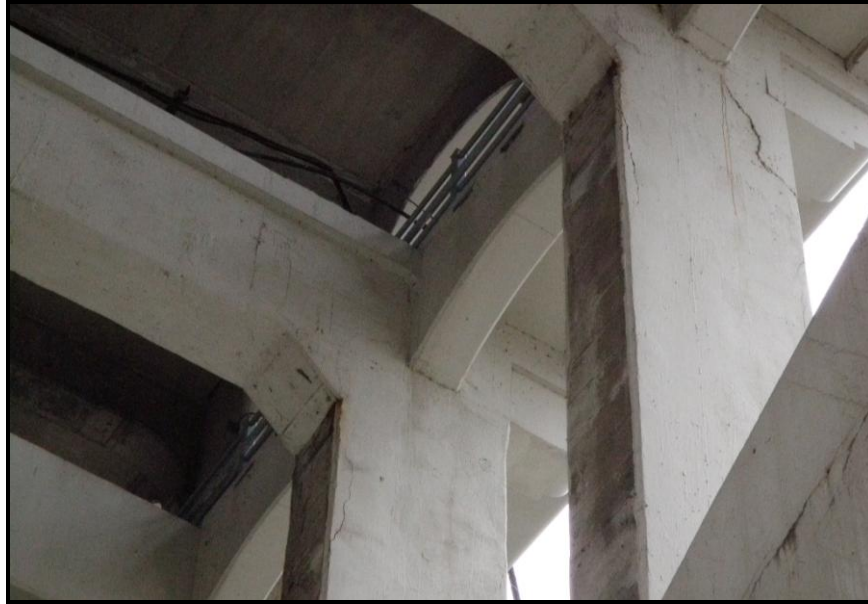
*Photo 42: Typical Arch Column Cracks*

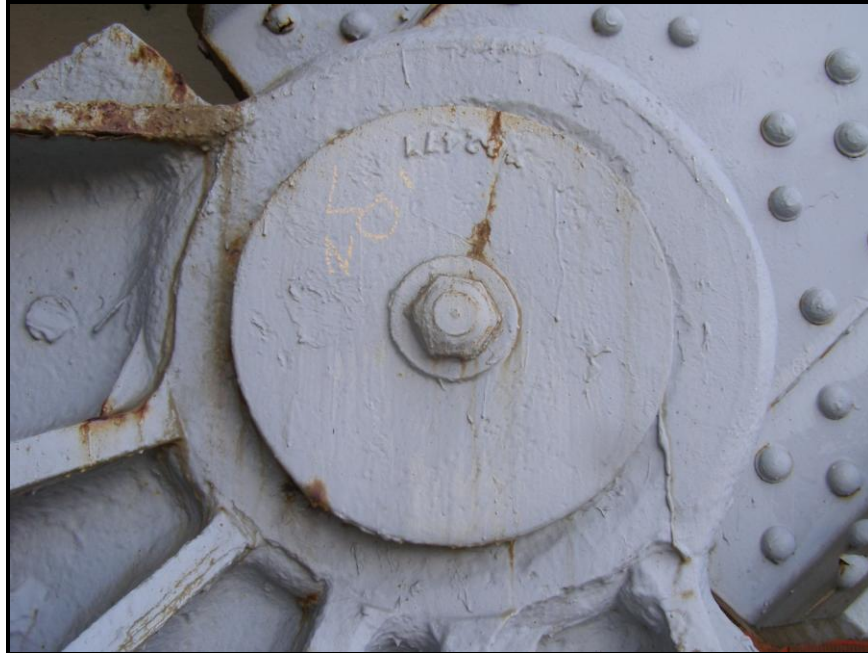
*Photo 44: Cracked South Retaining Washer at L<sub>0</sub> - N*

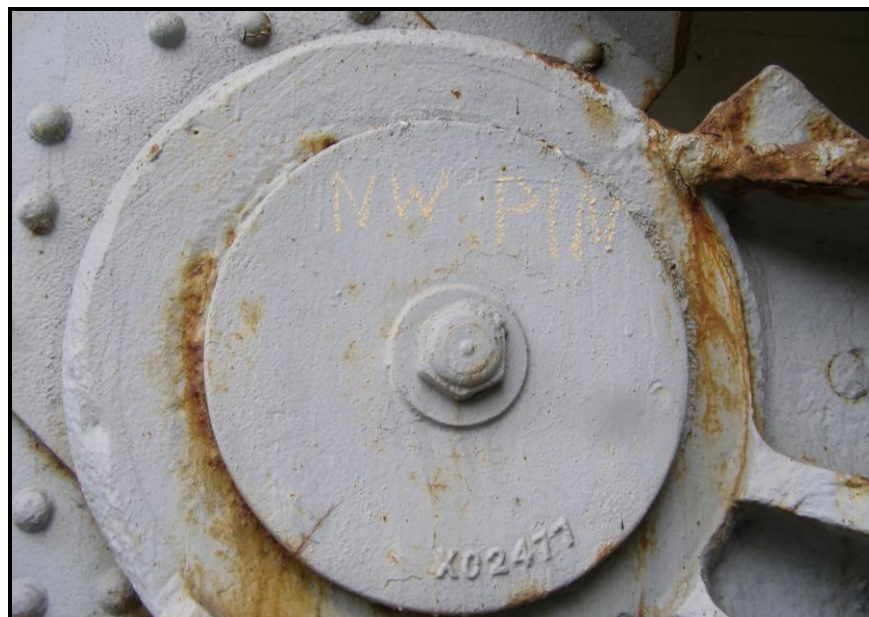
*Photo 45: Cracked South Retaining Washer at L<sub>0</sub> - N*

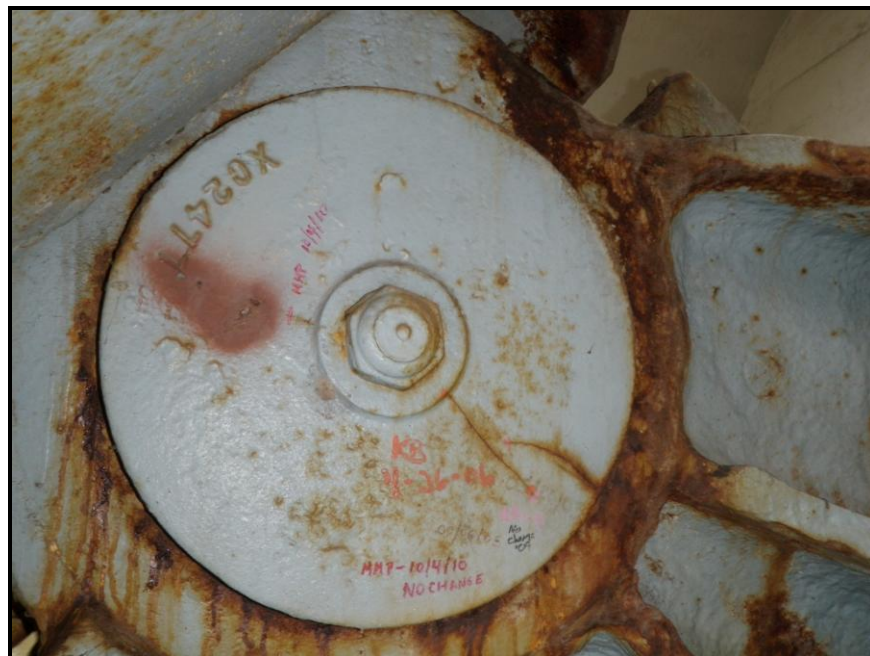
*Photo 47: Cracked North Retaining Washer at L<sub>0</sub>- S. Note the New Crack on the Other Side of the Center Bolt.*

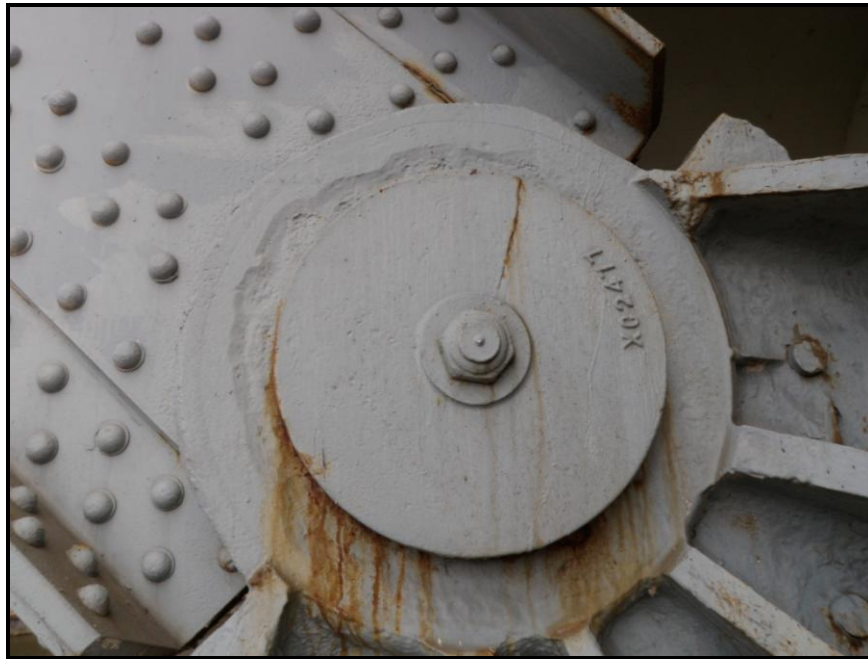
*Photo 48: Cracked South Washer at L<sub>0</sub>- S*
