# 2010 PHYSICAL CONDITION REPORT

## CUY - 00006 - 1456 DETROIT-SUPERIOR BRIDGE OVER THE CUYAHOGA RIVER

**SFN 1800930**

**INSPECTED: AUGUST 30, 2010 THROUGH OCTOBER 3, 2010**

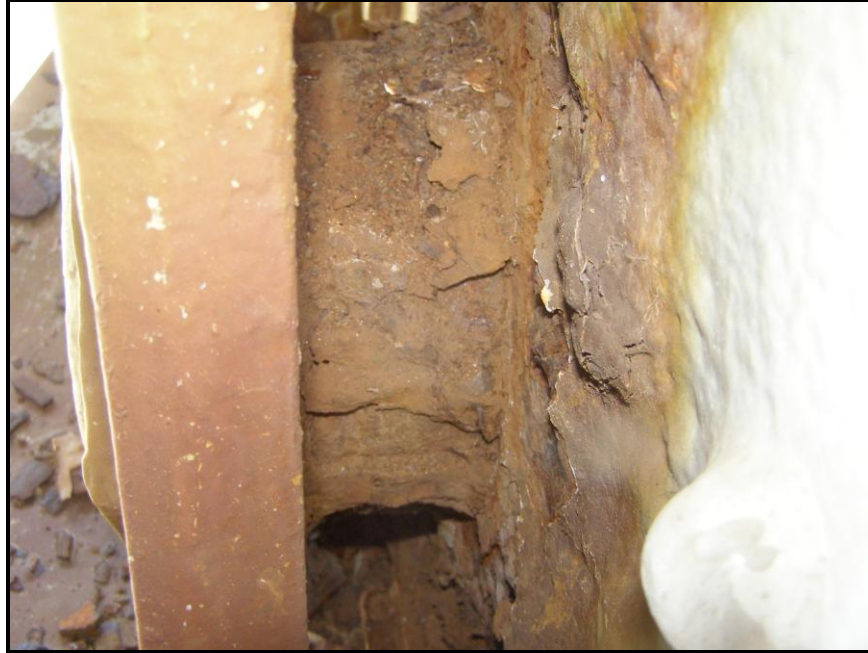
*Photo 49: Corroded Pin Sleeve at L<sub>4</sub> North*

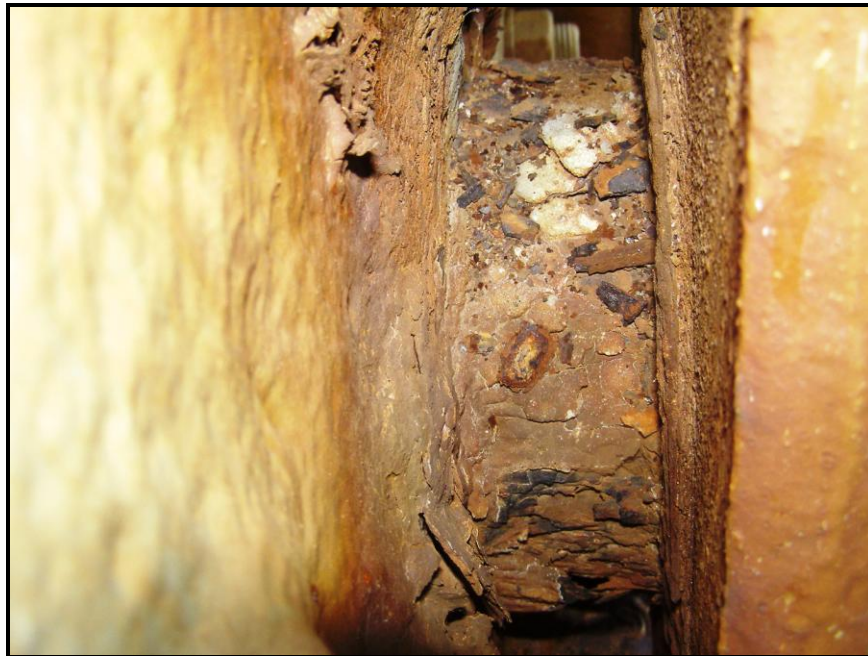
*Photo 50: Corroded Pin Sleeve at L<sub>4</sub> North*

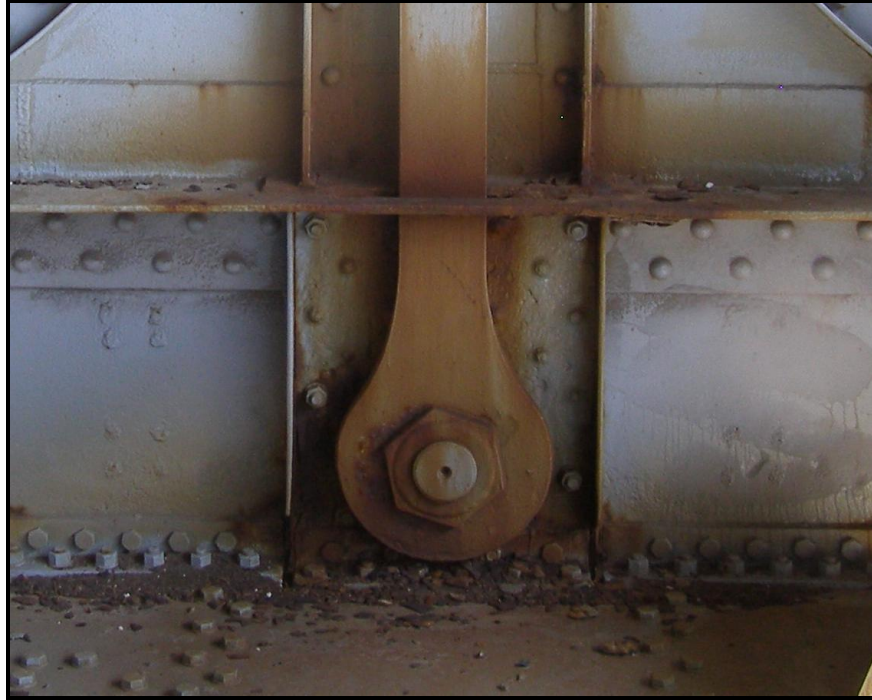
The only Fatigue Prone Connection found on the bridge is the vertical eye-bars located in Span 4 (See Photo 51). These were rated a 2, meaning that they are in Fair Condition. The pins and eye-bars at panel points  $L_4$  and  $L_4'$  are corroded, but there are no signs of fatigue-induced cracking.

*Photo 51: Corroded Eye-Bar at  $L_4$ -S. No Cracks Visible.*

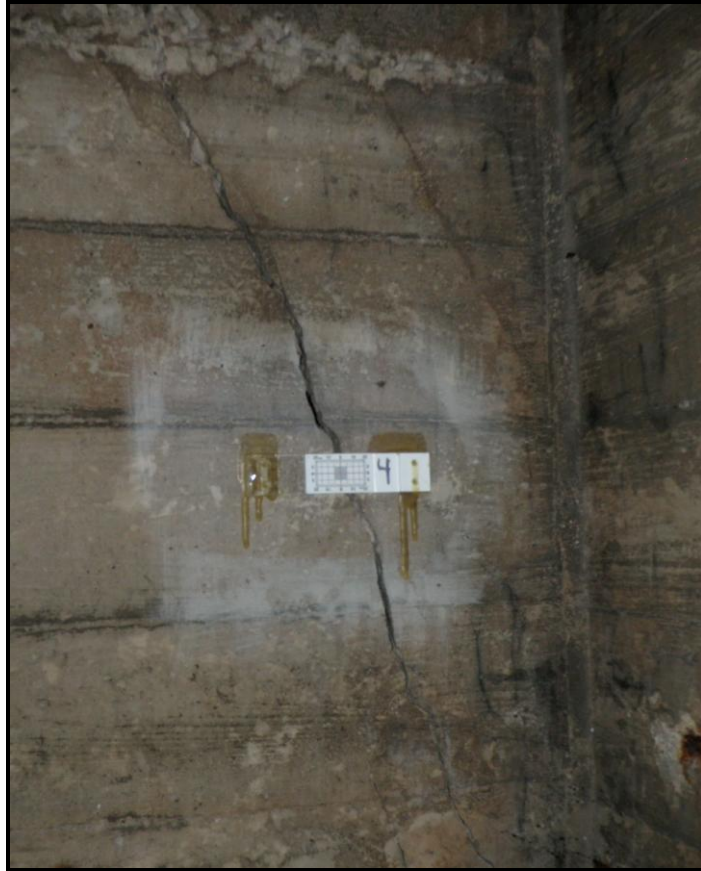
Cellular Construction: There is cracking in the concrete of the cells. Crack monitors have been installed and are monitored by ODOT District 12 (See Photo 52). The bottom of the lower deck slab is heavily spalled with exposed reinforcing throughout.

*Photo 52: Typical Crack Monitor Installed on a Crack in the Cellular Construction*

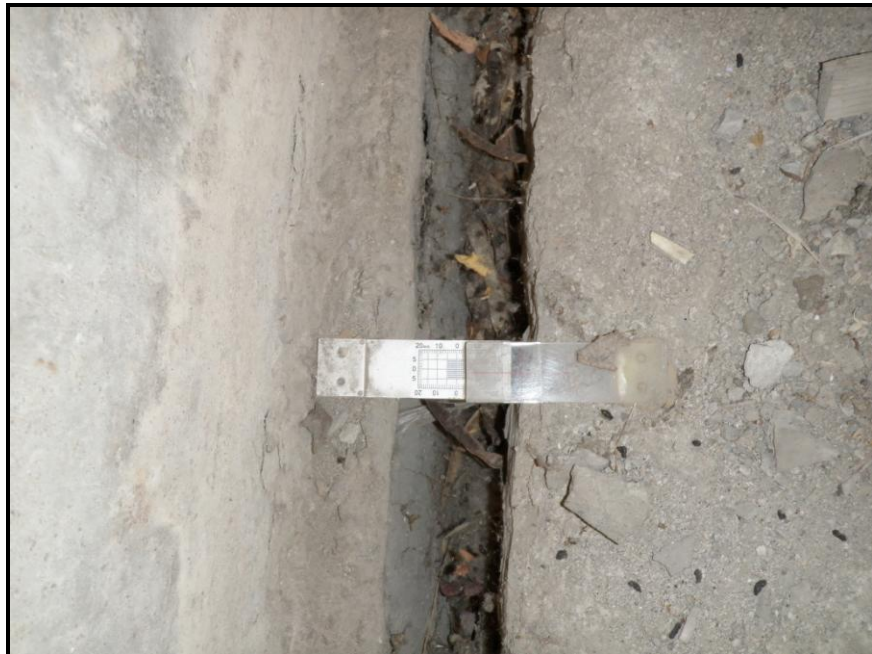
*Photo 54: Crack Monitor Installed at the Interface between the Top of the Lower Deck and Tower B*

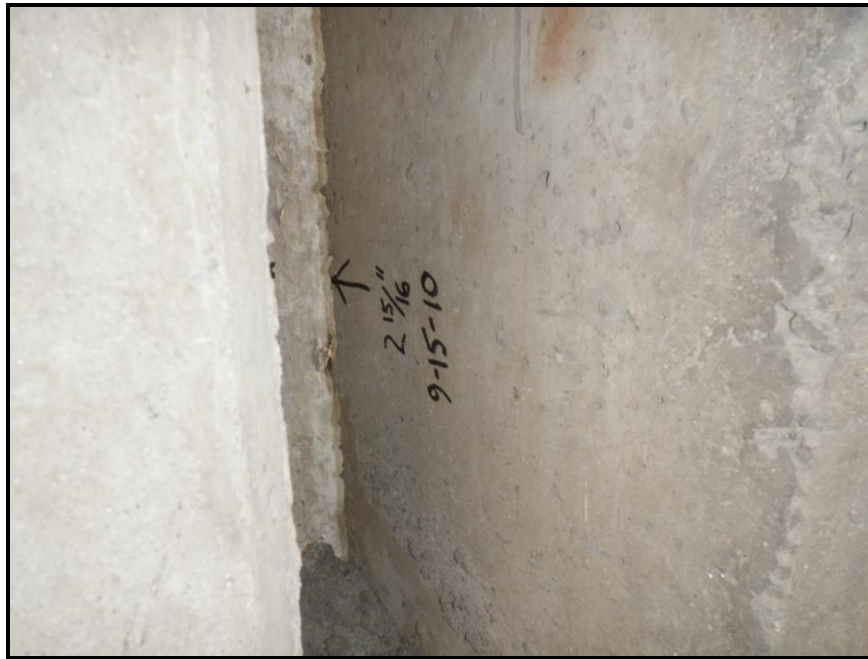
*Photo 55: Gap Measurement between the West Edge of Tower B Showing the Amount of Rotation Away from the Surrounding Structure*

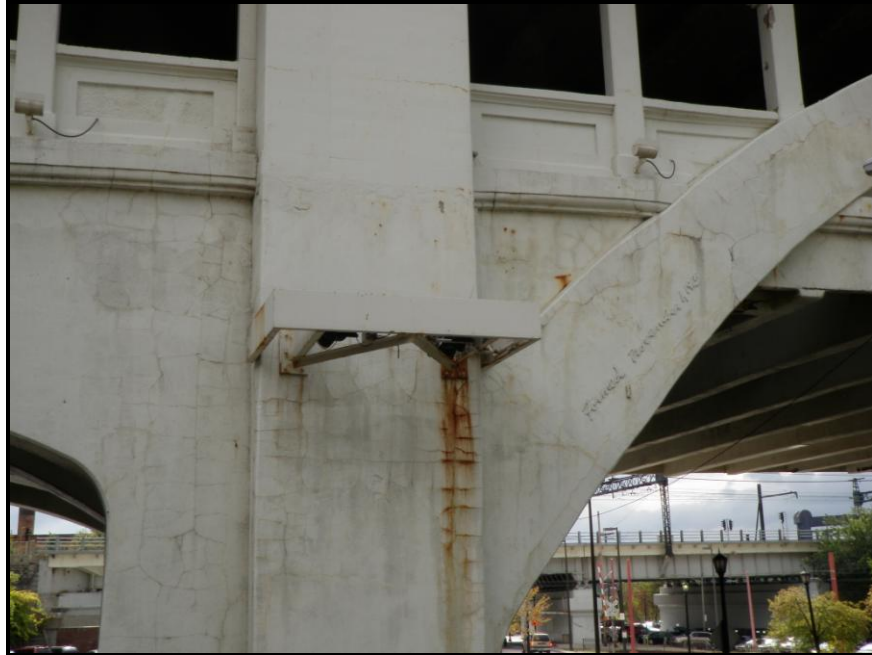
*Photo 57: Typical Map Cracked Concrete at the Base of the Towers*

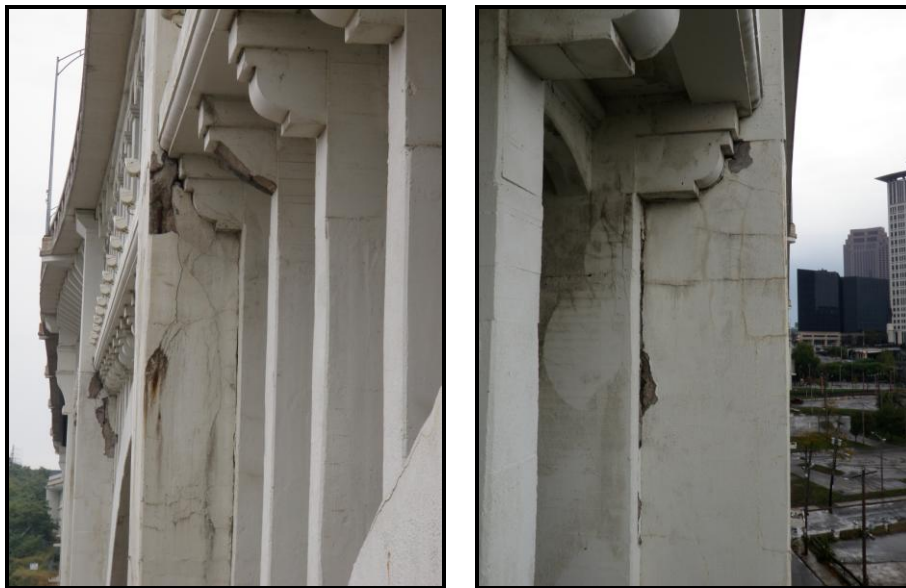
*Photo 58 & 59: Typical Spalled and Map Cracked Concrete at the Tops of the Towers*

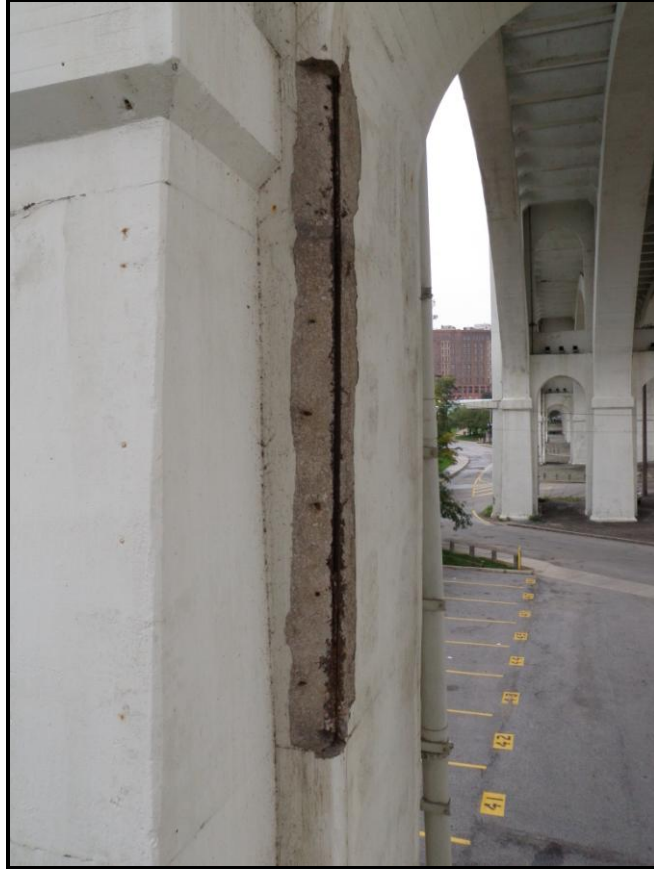
*Photo 60: Typical Large Corner Spall on Tower 5*

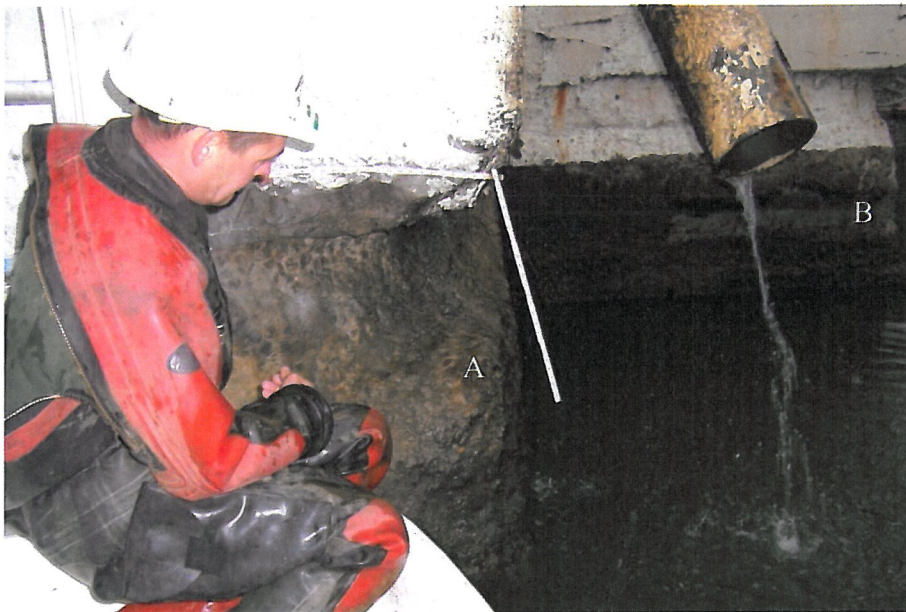
*Photo 6 – Facing North. Southeast corner of Pier 3.  
Note the Scaling and Spalling of the concrete at the construction joint.*

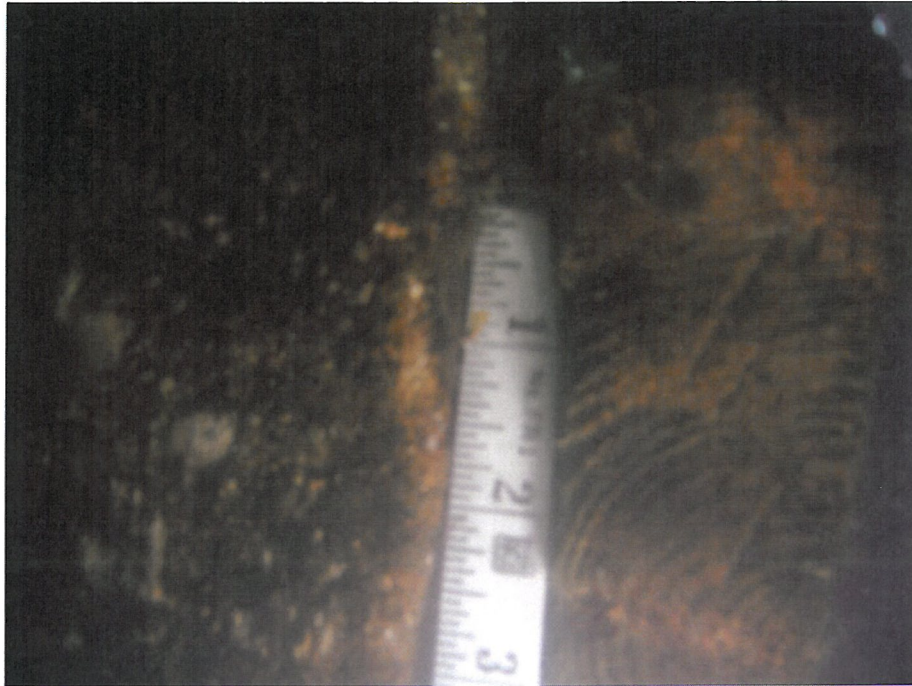
*Photo 8 – Facing East. Southwest corner of Pier 4  
shown behind the deteriorated concrete cap and exposed rebar .*
