2010 PHYSICAL CONDITION REPORT

CUY - 00006 - 1456 DETROIT-SUPERIOR BRIDGE OVER THE CUYAHOGA RIVER

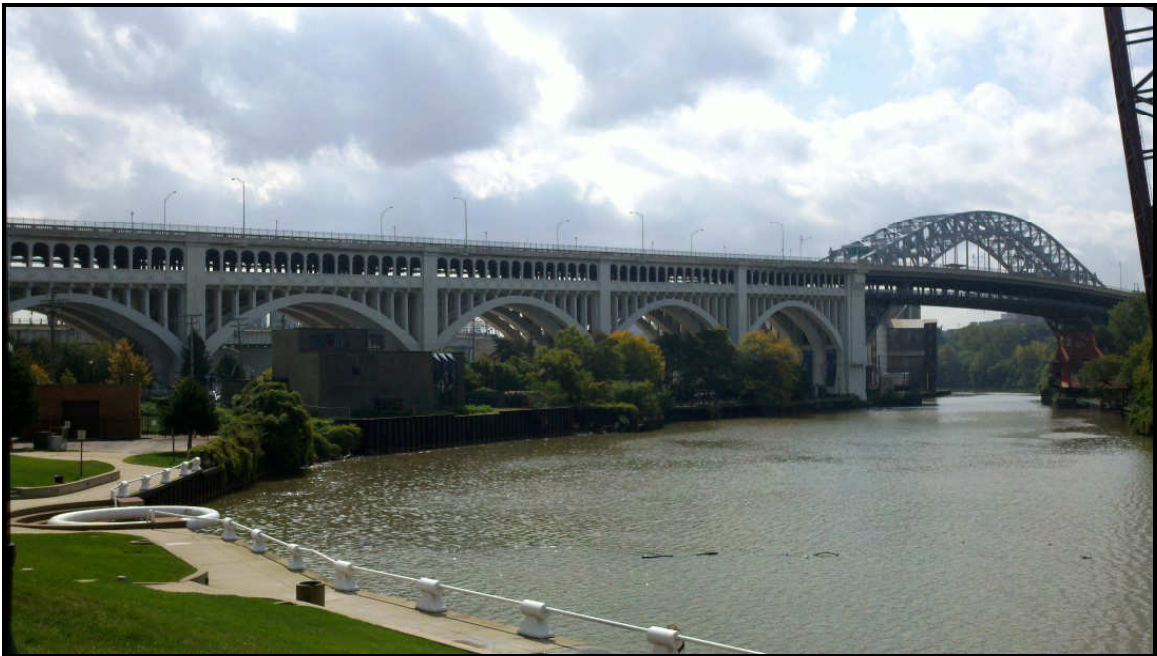
CUYAHOGA COUNTY, OHIO

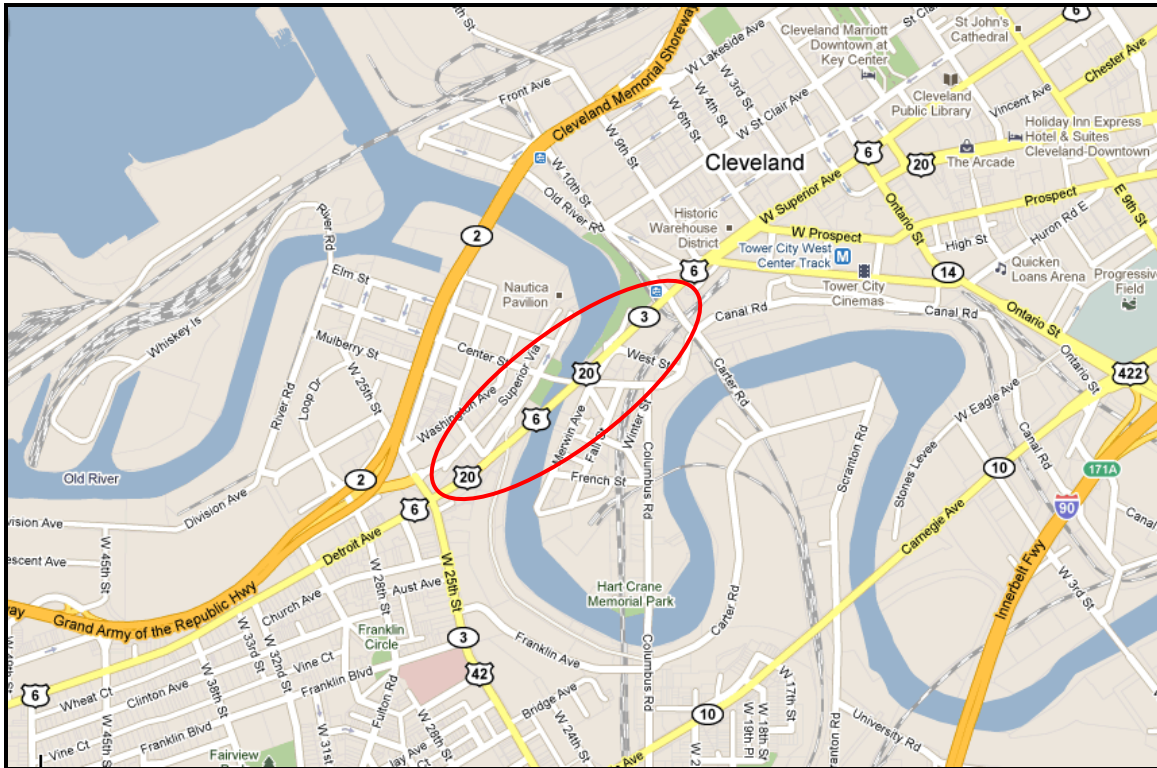
Map of the Location of the Detroit-Superior Bridge over the Cuyahoga River

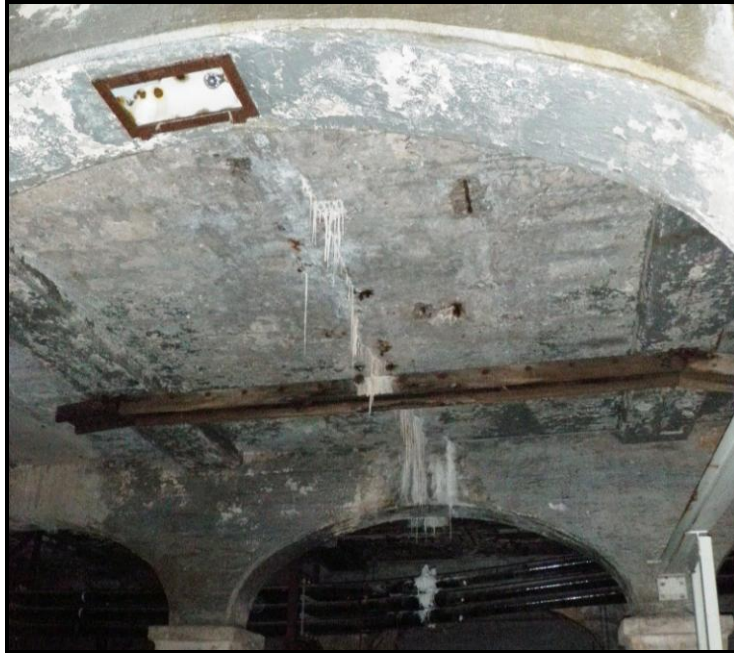
Photo 1: Large Crack with Efflorescence in the West Approach Tunnel

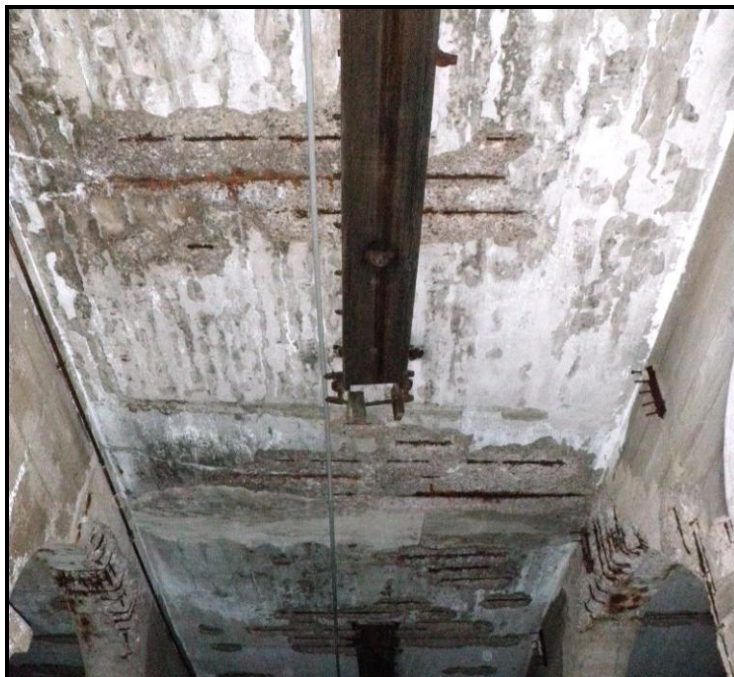
Photo 2: Typical Large Spalled Areas with Exposed Reinforcing Steel in the West Approach Tunnel

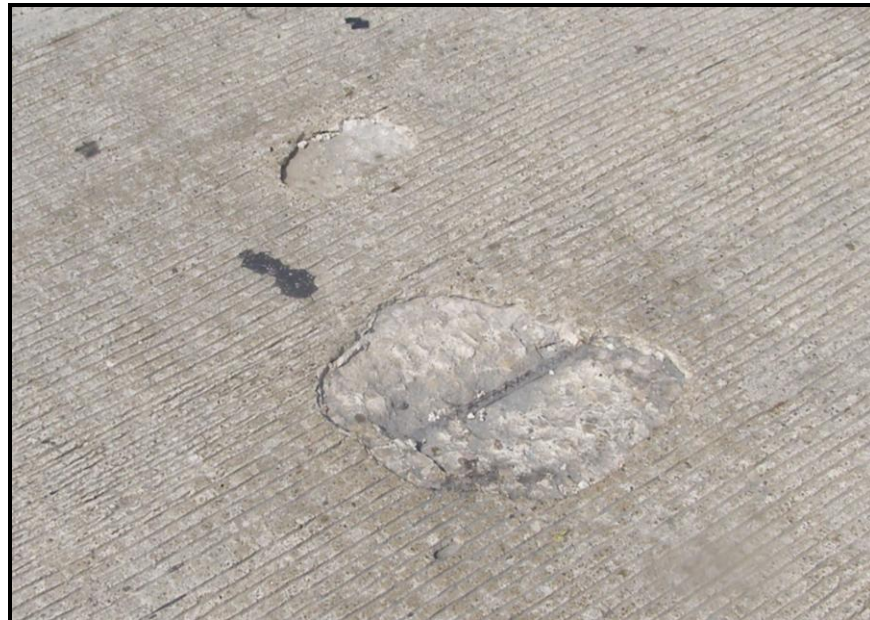
Photo 3: Wearing Surface Popout with Exposed Reinforcing Steel

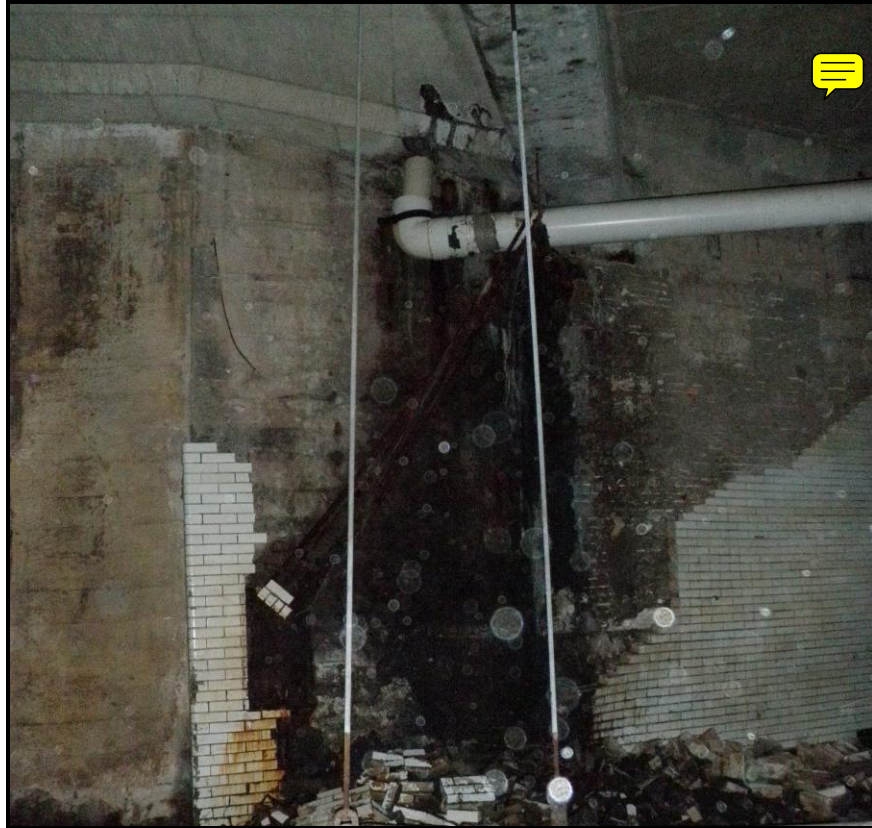
Photo 9: Broken and Leaking Drainpipe near the East Abutment

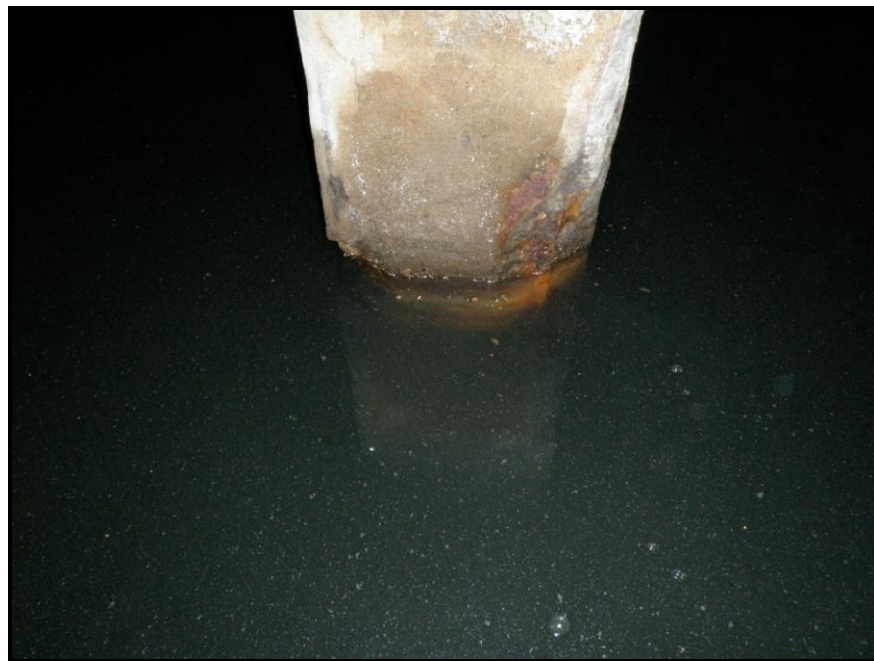
Photo 10: Standing Water in the East Tunnel

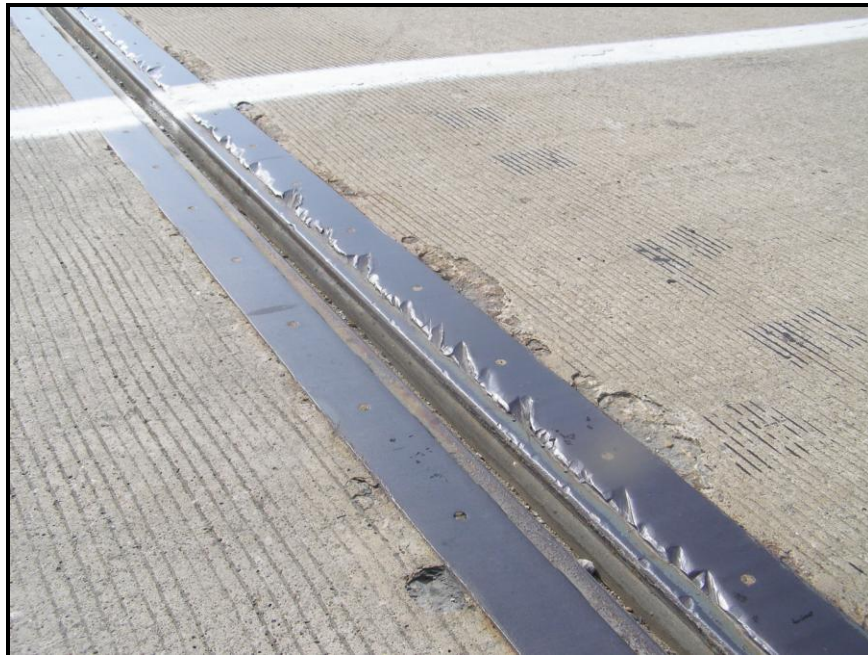
Photo 12: Typical Plow Damage to Joint Armor

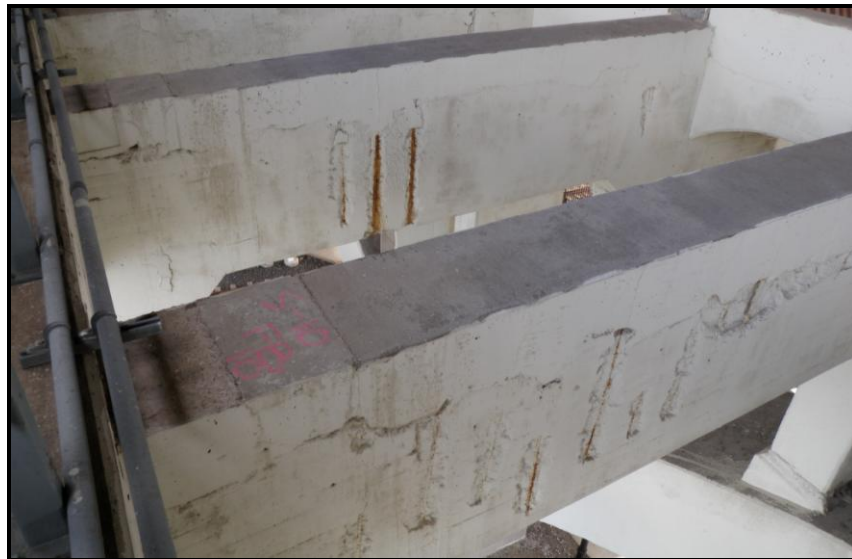
Photo 23: Typical Shallow Spalls over the Vertical Legs of the Stirrups in the Face of the Floor Beam

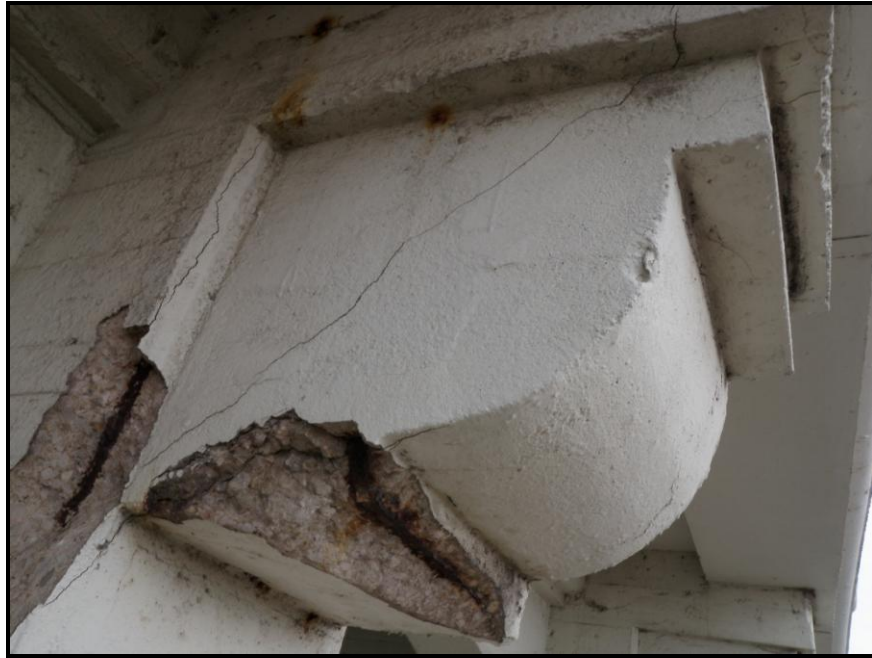
Photo 25: Corbel 12, Span 6 Completely Delaminated and Loose

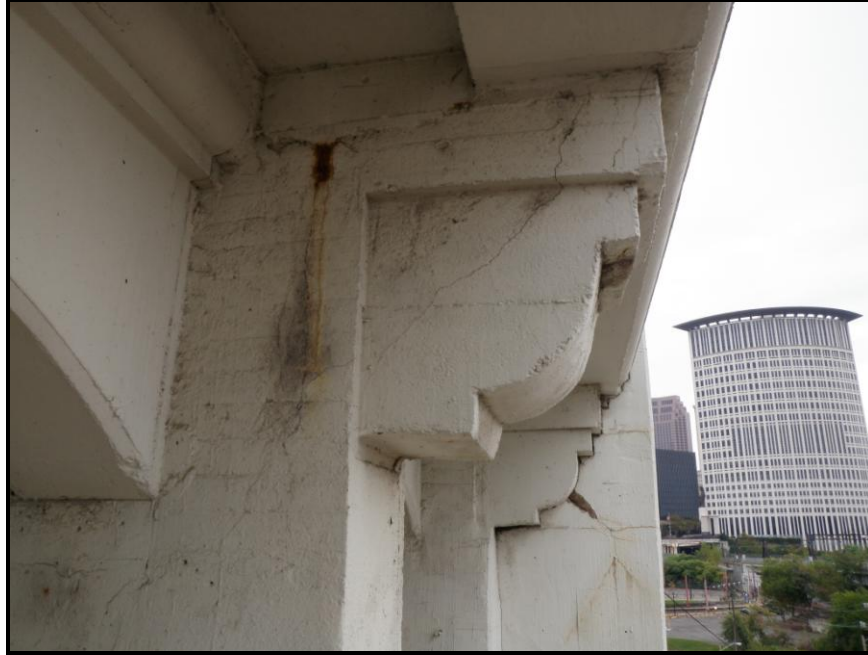
Photo 26: Corbel 14, Span 6 Completely Delaminated and Loose

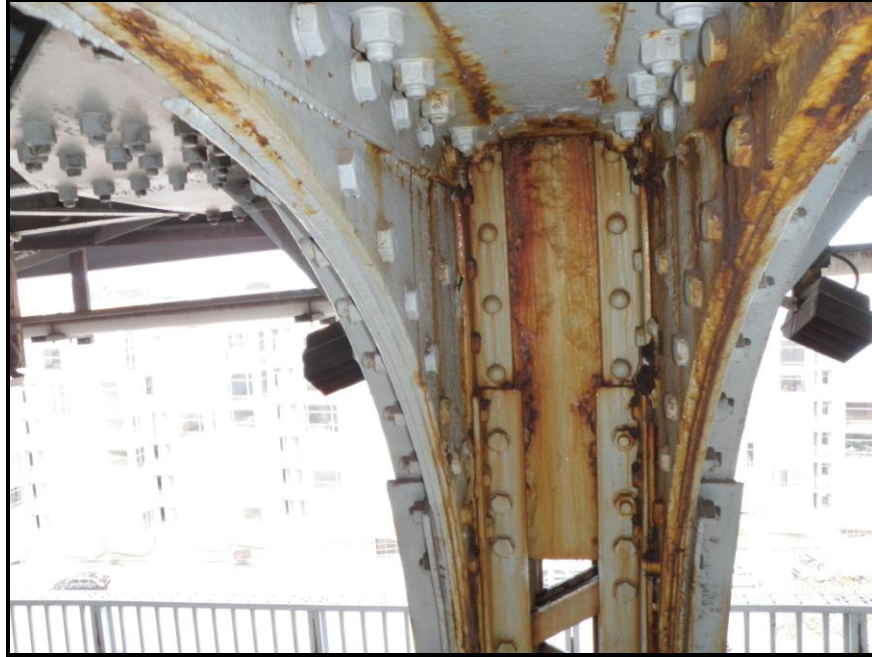
Photo 27: Typical Corrosion on Vertical Member Immediately Below the Upper Deck Pass-Through

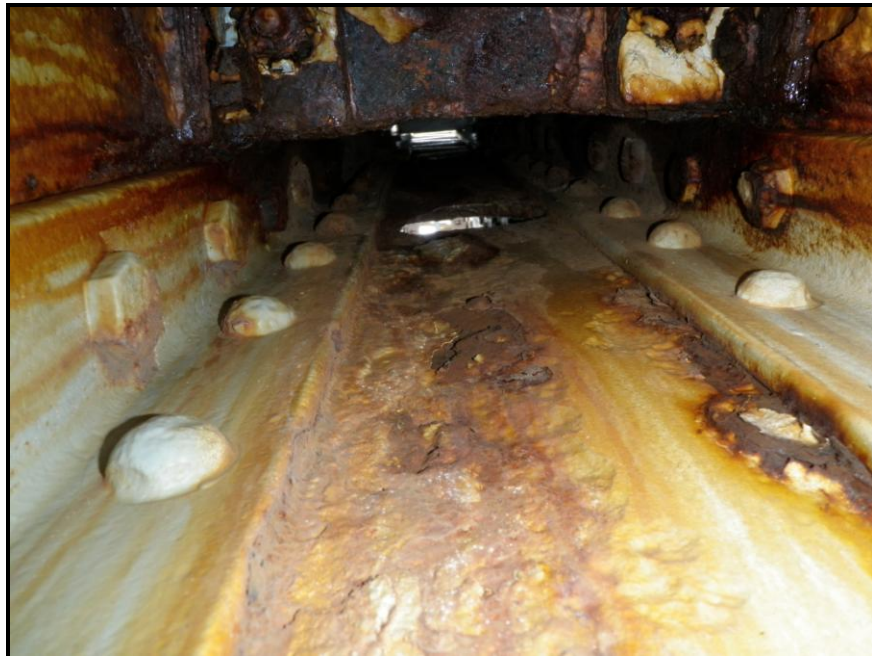
Photo 28: Through Holes in Cover Plate of L0-S Vertical

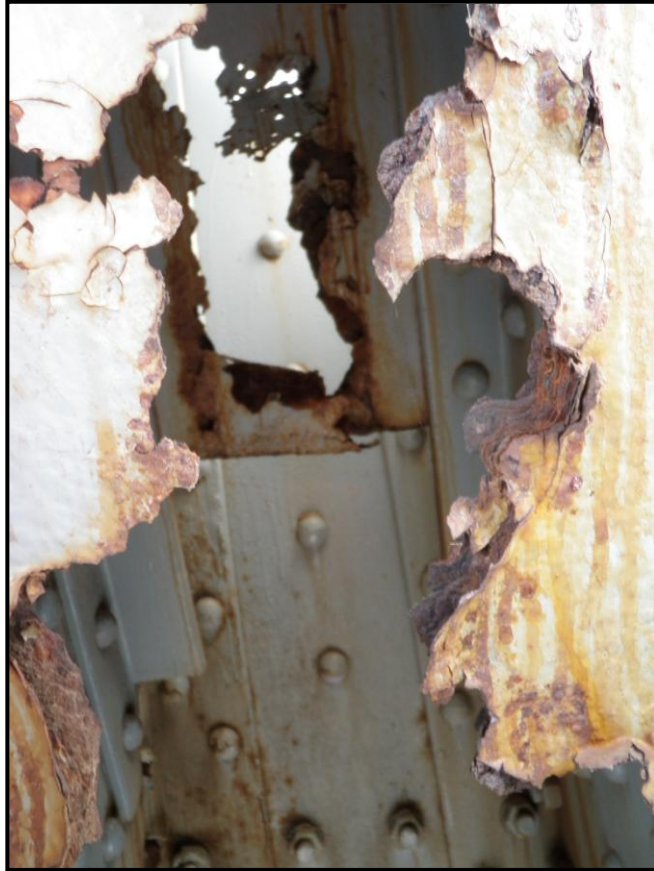
Photo 30: Holes through the Ends of the Vertical and Diagonal Members at the L₂ Panel Point in the South Arch

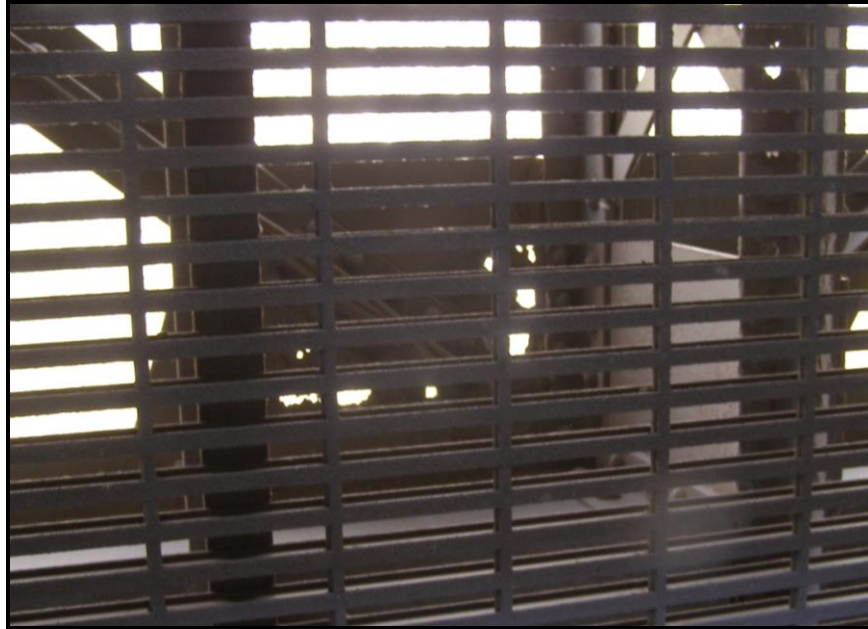
Photo 33: Through Holes in the Gusset Connecting the Lower Lateral Bracing with the Northern Most Exterior Stringer as seen through the Fiberglass Deck Panel

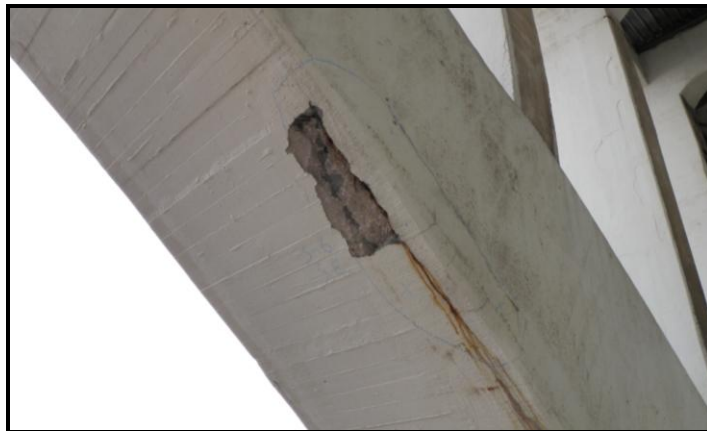
Photo 39: Spalled and Delaminated Area in the South Exterior Arch Rib of Span 6

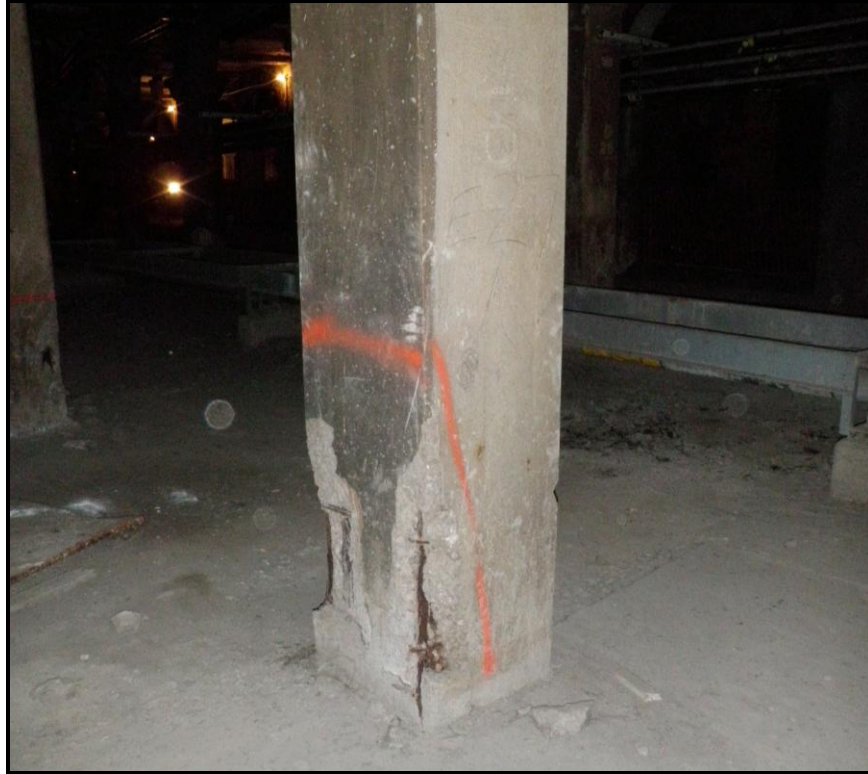
Photo 40: Typical Spalled Column Base

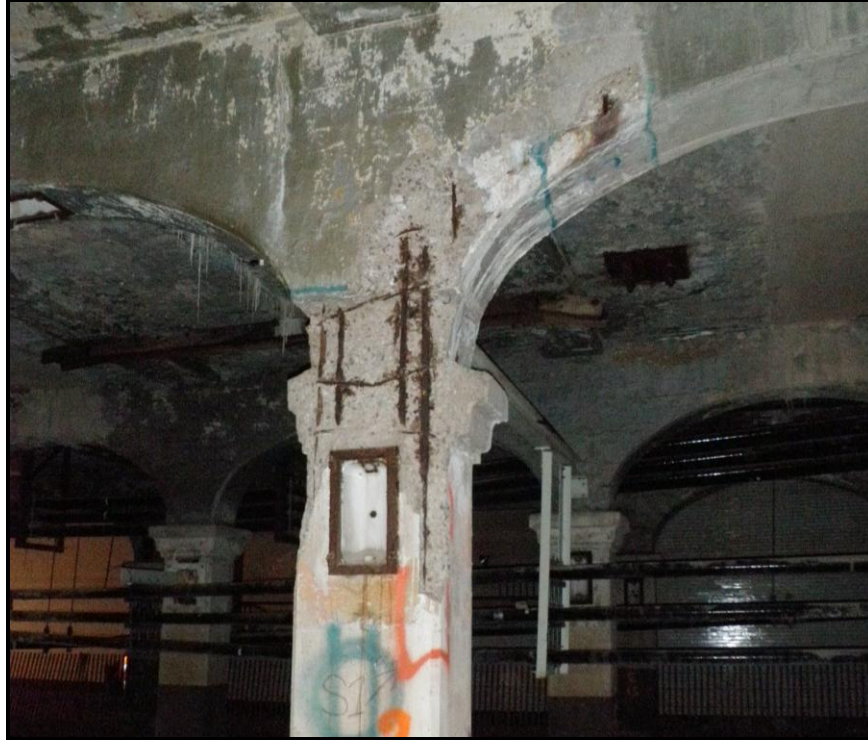
Photo 41: Typical Spalled Column Capital

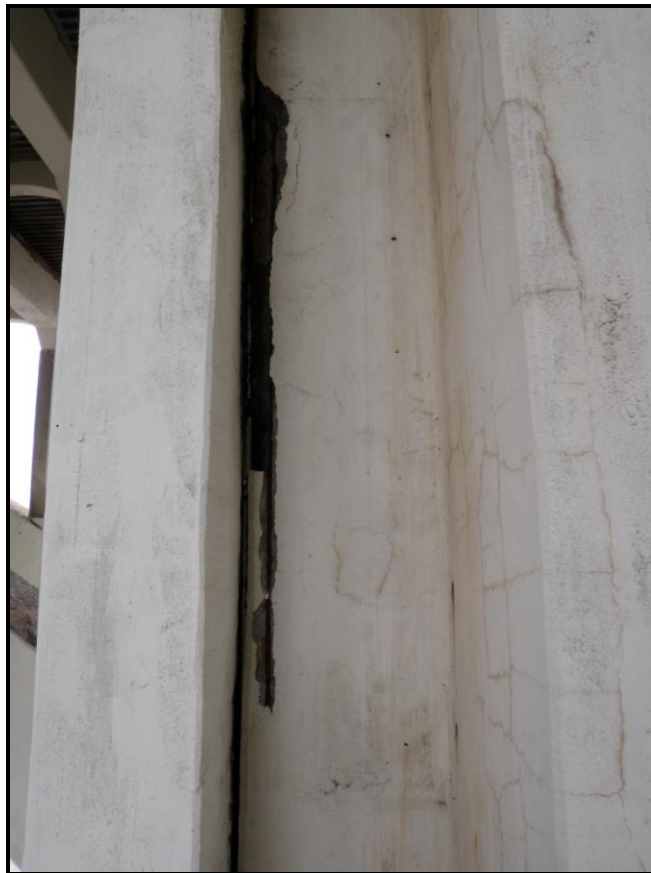
*Photo 43: Large Corner Spall Removed along Column 1 on the North Exterior Arch Rib of Span 6.
The Spall along Column 1 on the North Interior Rib is Similar.*

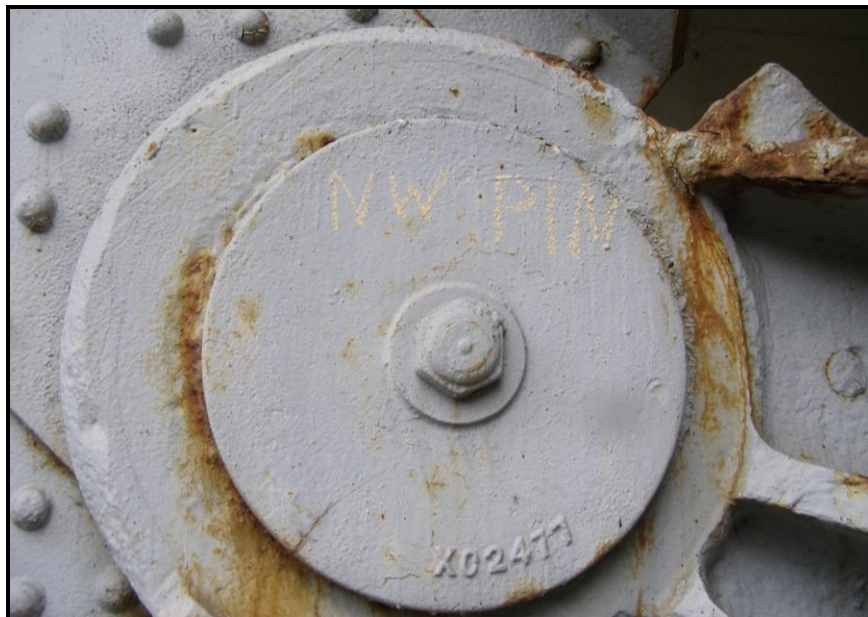
Photo 45: Cracked South Retaining Washer at L₀ - N

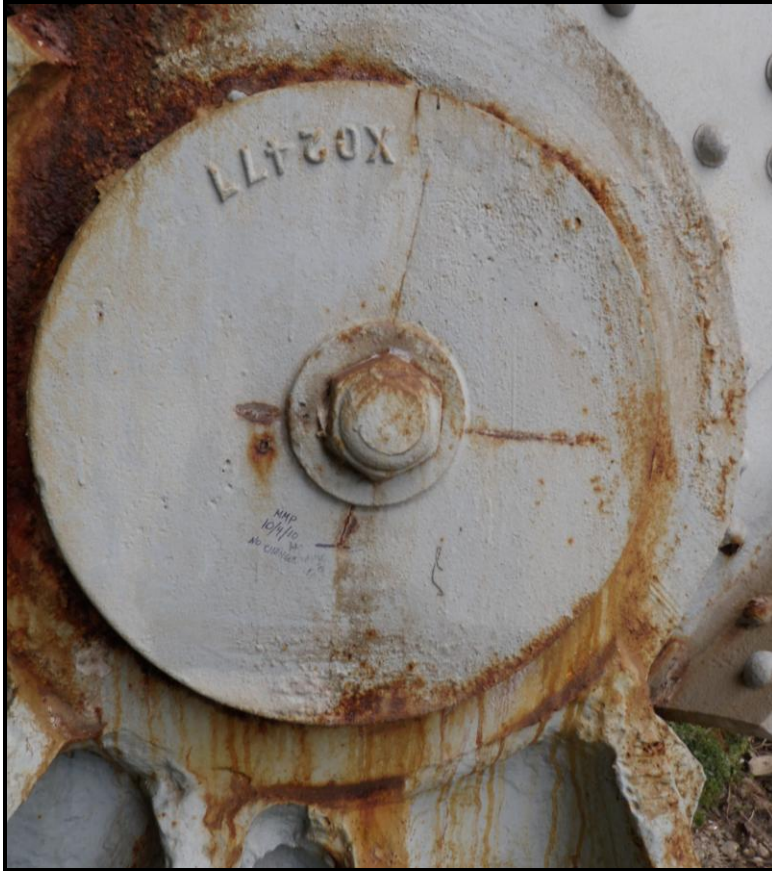
Photo 46: Cracked South Retaining Washer at L₀- S. No Change to Previously Noted Cracks.

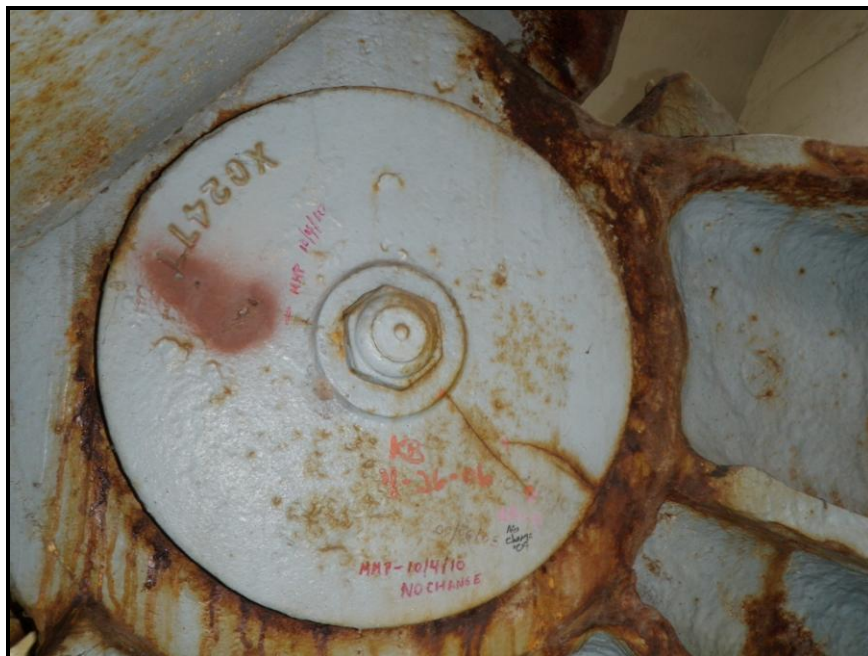
Photo 47: Cracked North Retaining Washer at L₀- S. Note the New Crack on the Other Side of the Center Bolt.

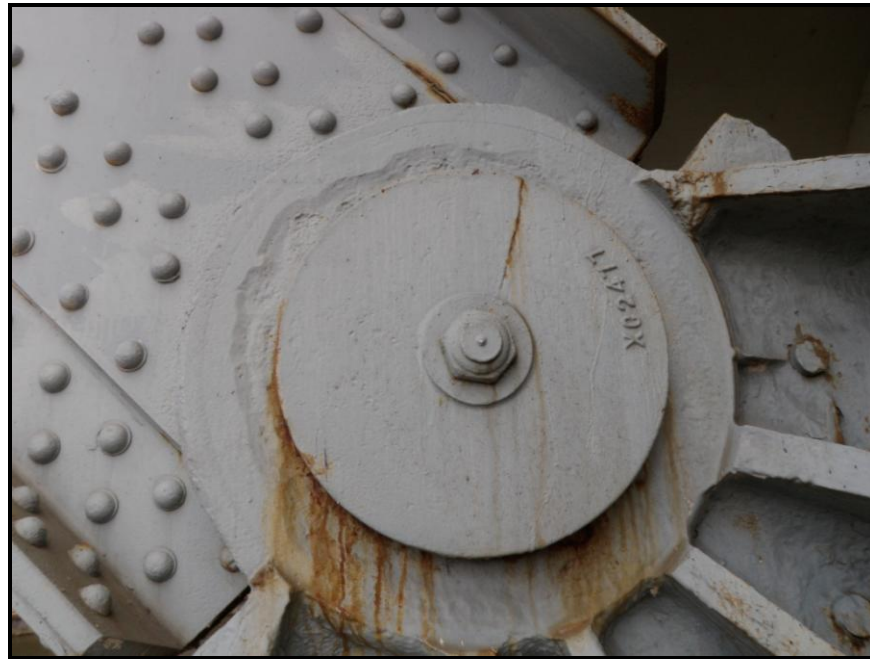
Photo 48: Cracked South Washer at L₀- S

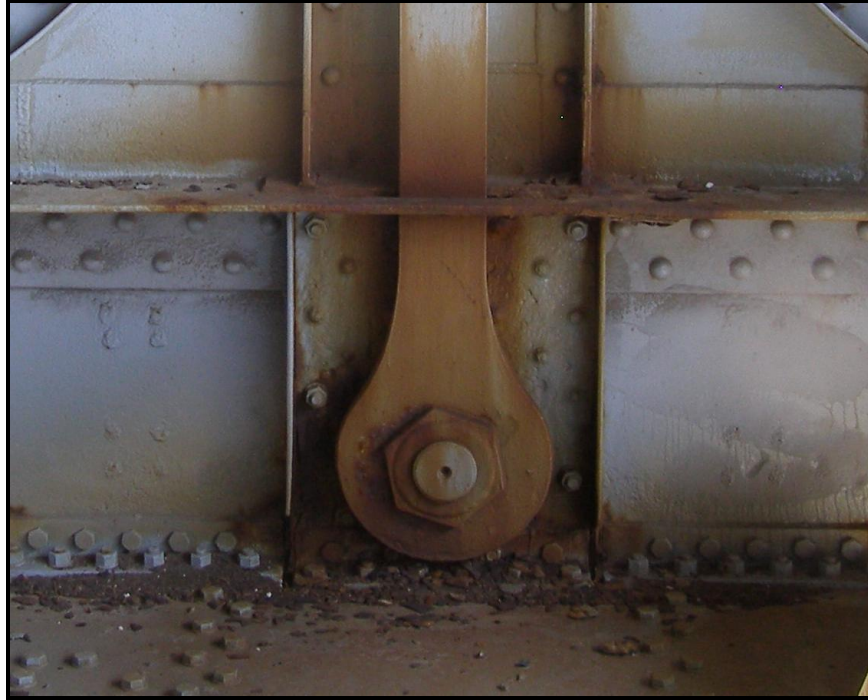
Photo 51: Corroded Eye-Bar at L₄-S. No Cracks Visible.

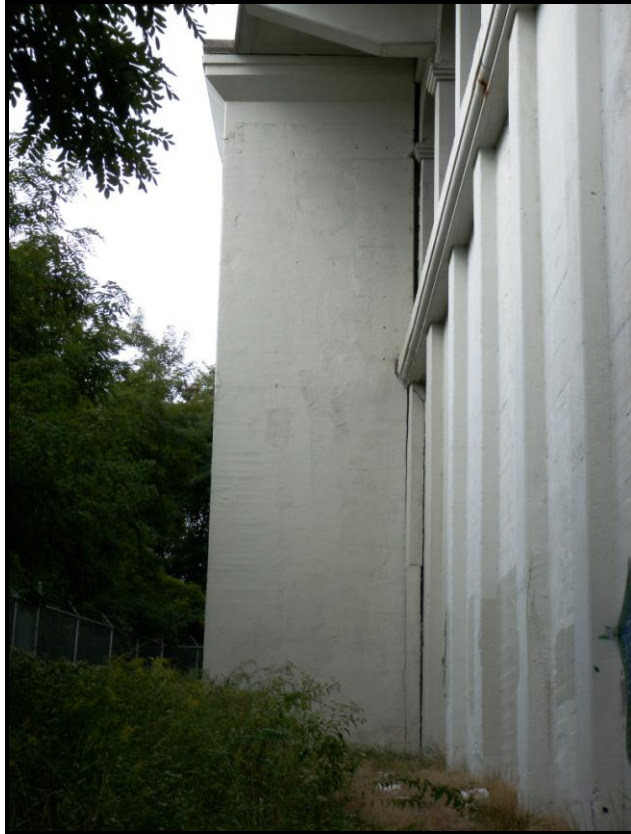
Photo 53: Tower B Rotating South Away from the Bridge. Note the Large Gap between the Top of the Tower and the Adjacent Jack Arch Column.

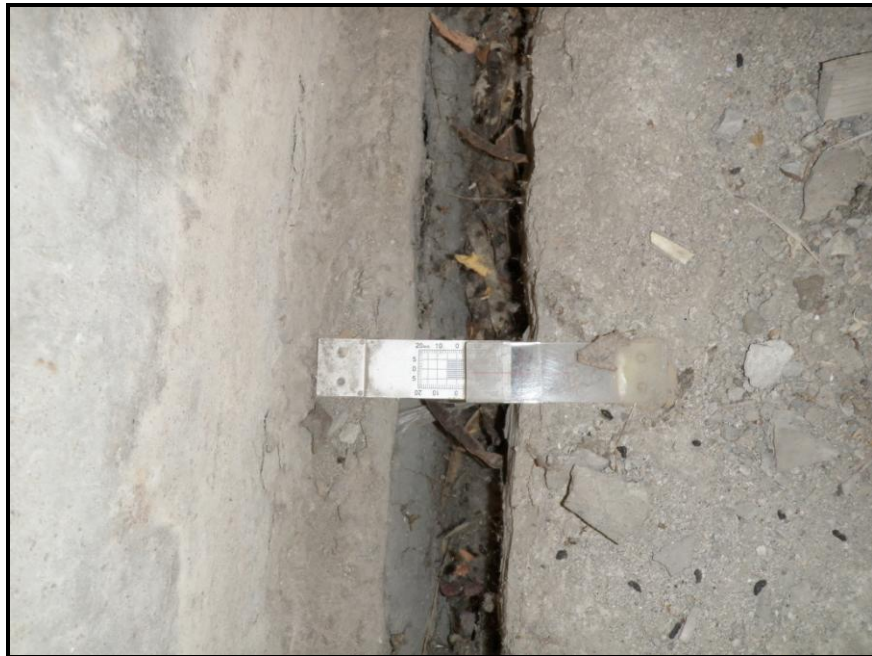
Photo 54: Crack Monitor Installed at the Interface between the Top of the Lower Deck and Tower B

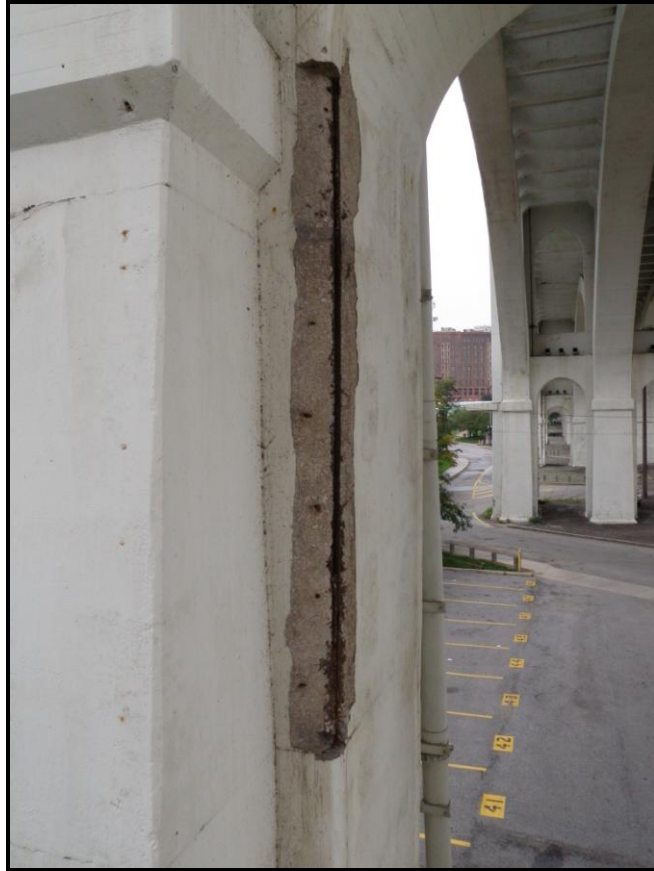
Photo 60: Typical Large Corner Spall on Tower 5

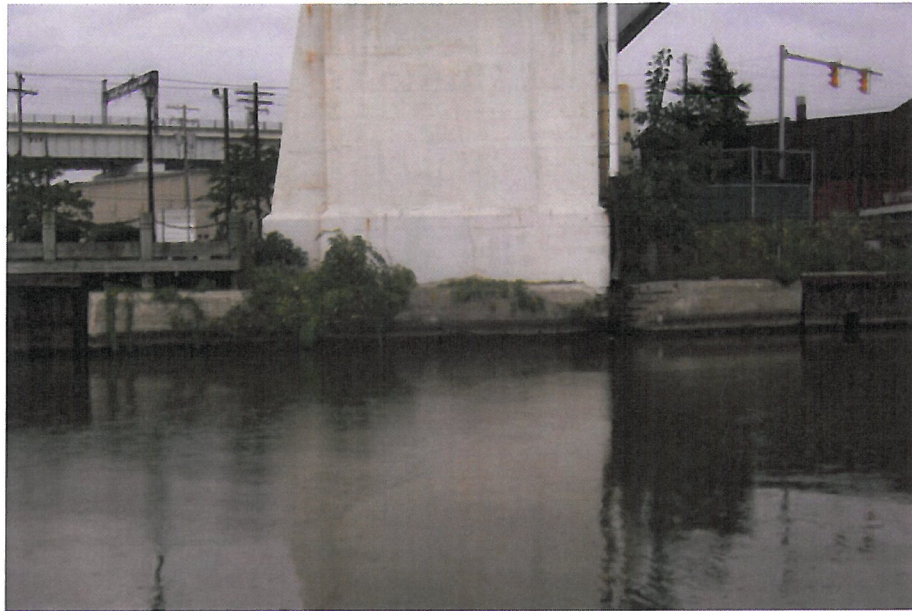
Photo by T. Clower, 10/2/10

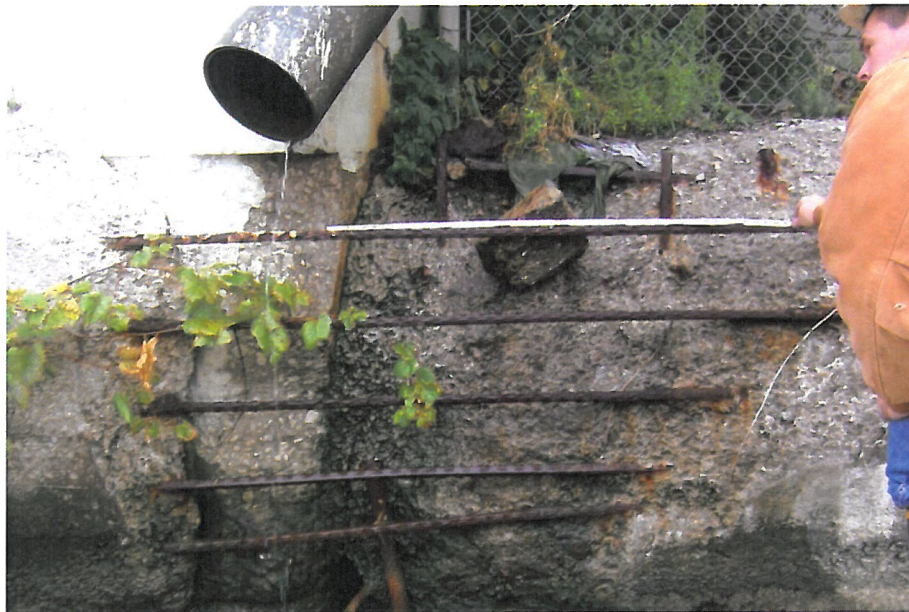
Photo by M. Suchan, 10/2/10
