CUV-06-1458  
Project Number

Veteran's Memorial Bridge (Detroit Superior Bridge)  
over the Cuyahoga River in Cleveland, Ohio  
Bridge Name

Oct 2, 2010  
Inspection Date

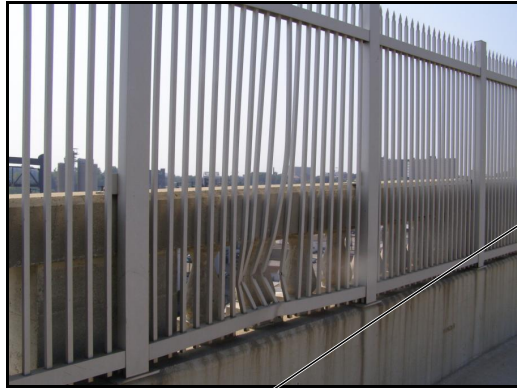
*Photo 8: Damaged Vandal Protection Fence*

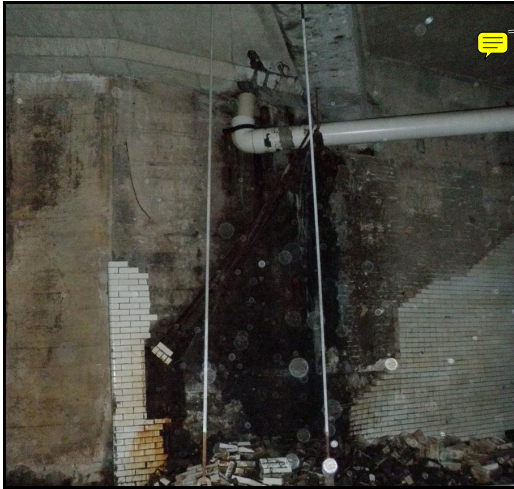
The drainage was rated a 2 which means that it is in Fair Condition. The drainage system effectively moves water out of the travel way and off of the bridge deck. The drain pipes below the upper deck have some breaks and misalignment (See Photo 9). Additionally water pools on the lower deck. It has completely filled the east and west stations and the east tunnel has a large lake of water spanning the entire width of the bridge, approximately 200 feet long and up to 4' deep (See Photo 10).

*Photo 9: Broken and Leaking Drainpipe near the East Abutment*

Author: ahaupt Subject: Highlight Date: 9/21/2011 1:07:33 PM  
Routine Maintenance: City of Cleveland; Drainage Repair: Review all drainage pipes for positive connection.  
Major Maintenance: ODOT; review and program project to eliminate standing water at east and west approach.

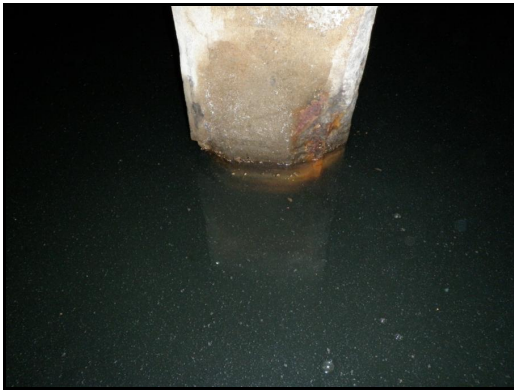
*Photo 10: Standing Water in the East Tunnel*

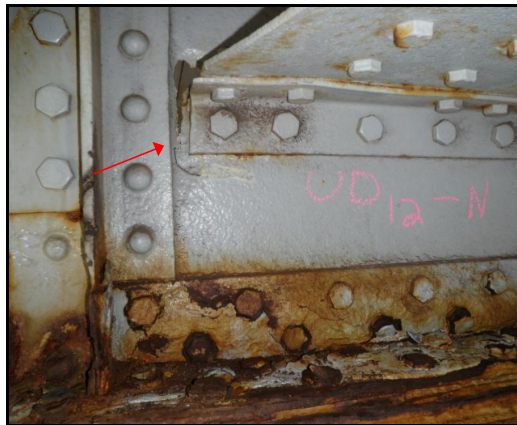
All of the steel floor beams in span 4 have active corrosion and pitting below the openings in the deck where the hangers connect to the trusses. In addition, some of the floor beams have small through holes. The through holes in the north sides of FB-U12, FB-U11', FB-U8' and FB-U6' have not changed since last inspection (See Photos 15 - 18). There are circular welds in the south sides of the webs of FB-U2' and FB-U1' near the connections with the south truss. **These welds are cracked. The northern cracked weld in FB-U2' was previously noted, but the crack has grown. The southern cracked weld in FB-U2' and the cracked weld in FB-U1' are new (See Photos 19-22).**

*Photo 15: Hole in FB-U12-N Showing No Change from Previous Inspection*

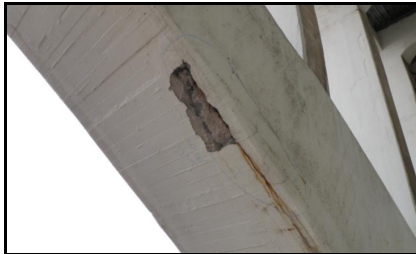
The exterior face from columns 2-3 is cracked and delaminated. The bottom face from columns 3-4 is spalled with exposed reinforcing. Spall is 4' long, 2' wide, 6" deep, with a large delaminated area around the spall (See Photo 39).

Photo 39: Spalled and Delaminated Area in the South Exterior Arch Rib of Span 6

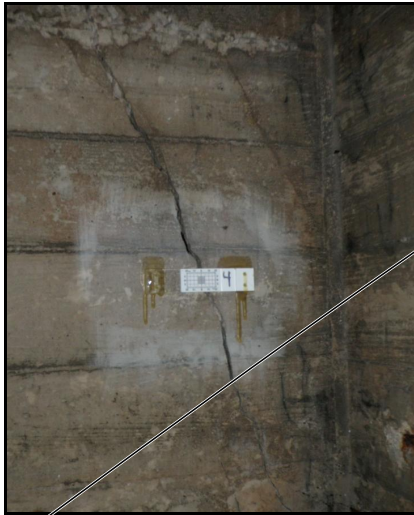
Photo 52: Typical Crack Monitor Installed on a Crack in the Cellular Construction

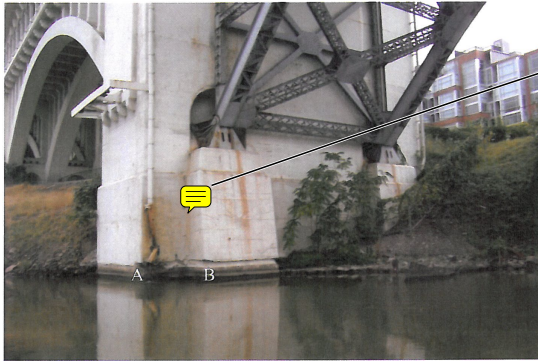
- The concrete surfaces had up to 1 ½-inch deep scaling typical with exposed aggregate. The conditions in the splash zone and at the corners were much worse. Photos 5, 6 and Figure 2 show heavy scaling and large corner spalls. The corner spall in the splash zone at corner A is 2 feet deep and 2.9 feet tall. It continues in both directions, eventually diminishing to the typical scaling discussed above. Likewise the corner spall in the splash zone at corner B is 1.3 feet deep and 3.7 feet tall. Both corners are rounded from the splash zone to the bottom. No exposed reinforcing steel was detected in these spalls.

- The scupper drain pipe above corner A is not properly connected; hence the water leaks by the pipe and runs down the pier face directly over the already damaged corner.

Photo 5 – Facing West. East face of Pier 3.  
Note Scupper Pipe disconnected allowing water to run down the east face of the Pier 3.

Author: ahaupt Subject: Cuy-480-0957; SFN 1812513 Date: 9/21/2011 1:43:34 PM  
Routine Maintenance: City of Cleveland; Drainage: disconnect scupper.

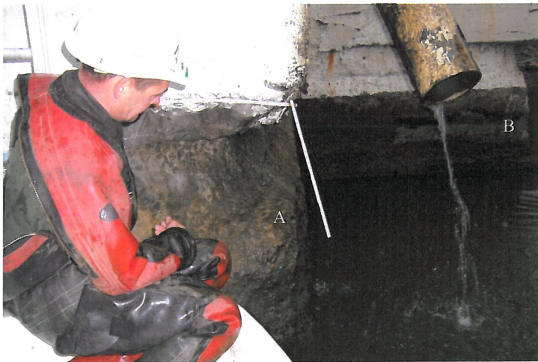
Photo 6 – Facing North. Southeast corner of Pier 3.  
Note the Scaling and Spalling of the concrete at the construction joint.
