**PHYSICAL CONDITION REPORT  
FOR THE 2011 ROUTINE INSPECTION**

**VETERAN'S MEMORIAL (DETROIT-SUPERIOR) BRIDGE**

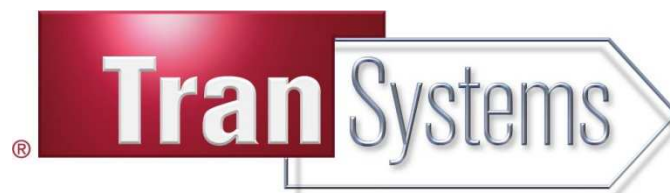
**Routine  
PHYSICAL CONDITION REPORT  
of**

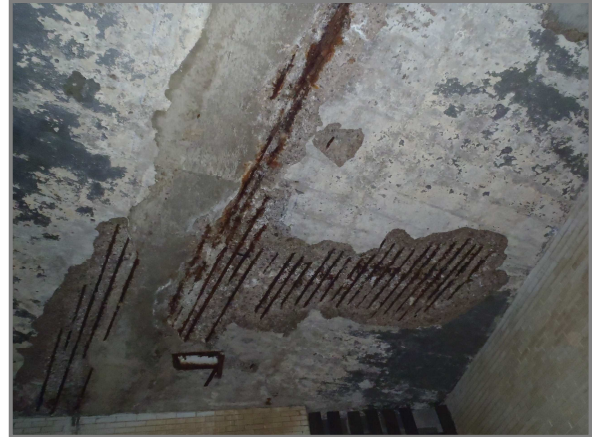
Photo 1 – Deck spall near the junction of the West 25th Street tunnel and the West Approach Spans.

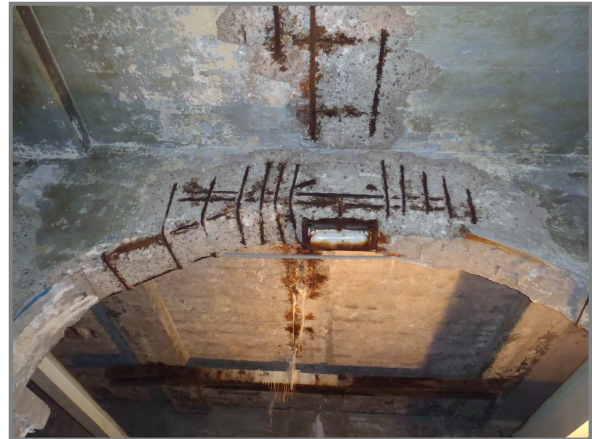
Photo 2 – Deck spall with exposed reinforcement and crack with heavy efflorescence in the West Approach.

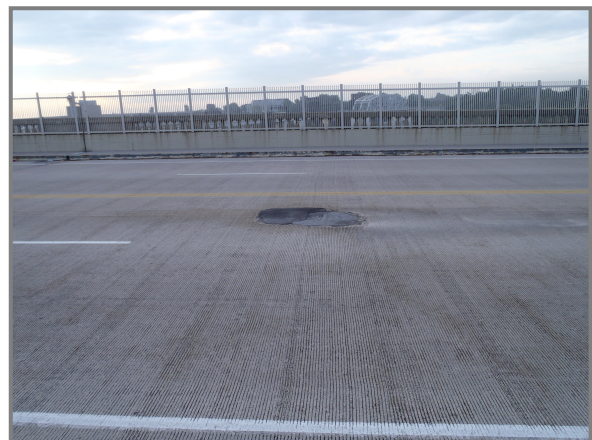
Photo 3 – Isolated spall with asphaltic patch in the deck surface (westbound lanes shown).

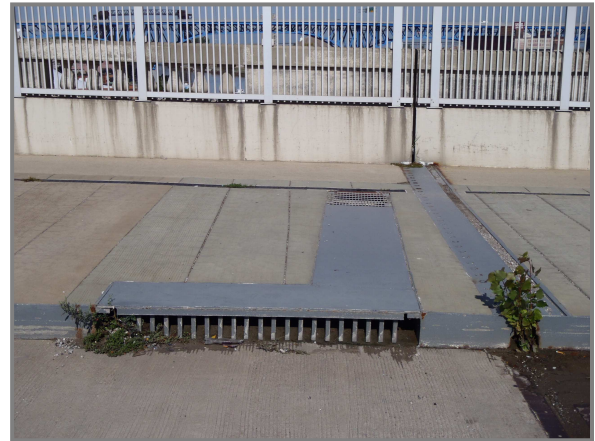
Photo 4 – Typical curb drain and heavy granular debris in the joint membrane at the curb.

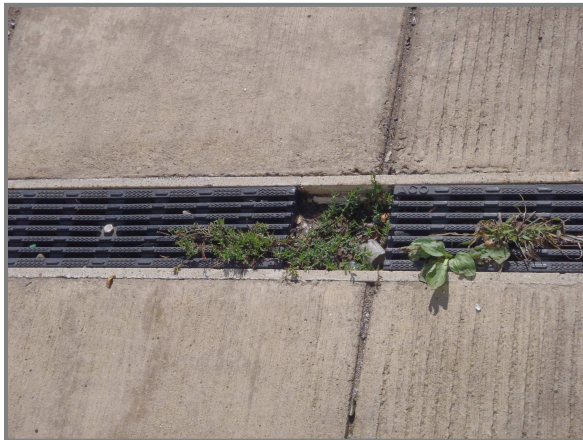
Photo 5 – Missing grate at longitudinal north sidewalk trench drain and vegetation becoming established.

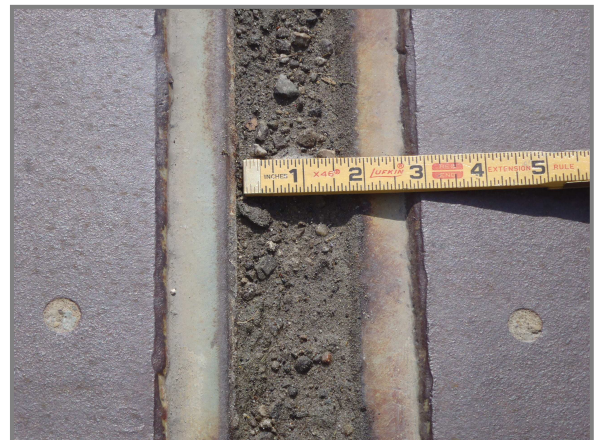
Photo 6 – Typical joint membrane with heavy granular debris.

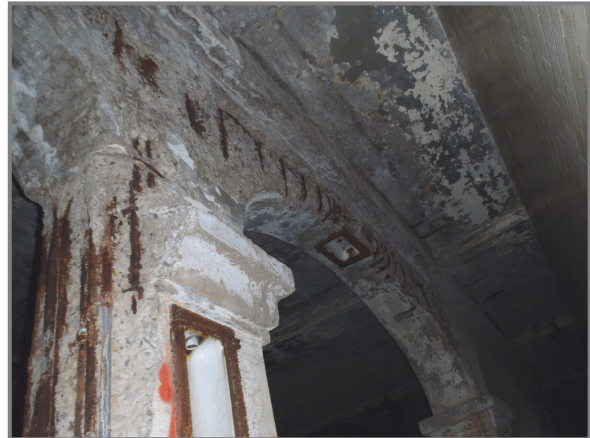
Photo 7 – Jack arch spalling in the West Approach. Jack arch 12-13 in Line C shown.

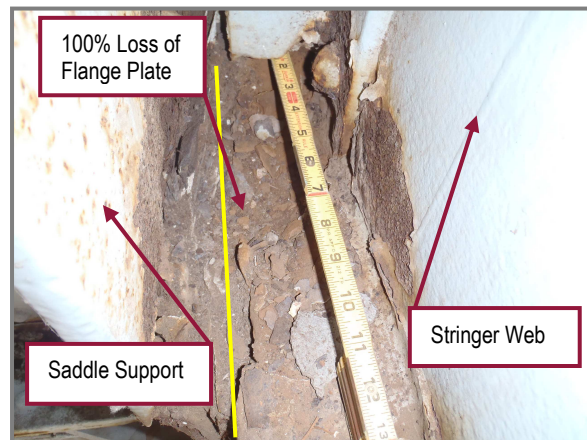
Photo 8 – Lower deck, Stringer 3 at the saddle bearing, east face of Floorbeam 3, 100% loss of bottom flange.

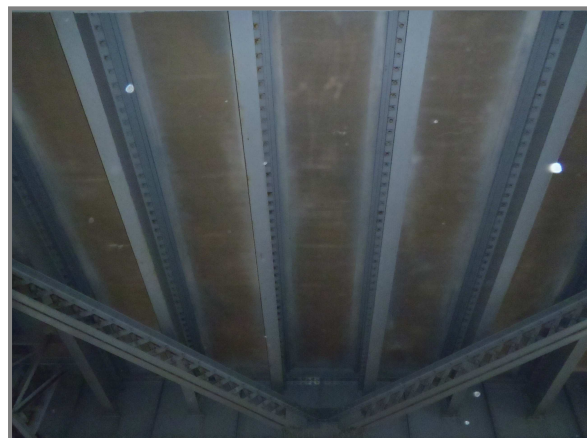
Photo 9 – Upper deck typical stringer condition, Bay 1-2 shown.

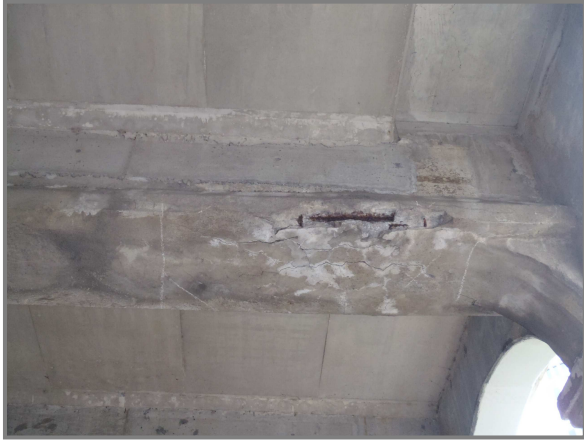
Photo 10 – Isolated spall with exposed reinforcement on the bottom face of upper Floorbeam 6 in Span 13. Note the retrofitted bottom flange.

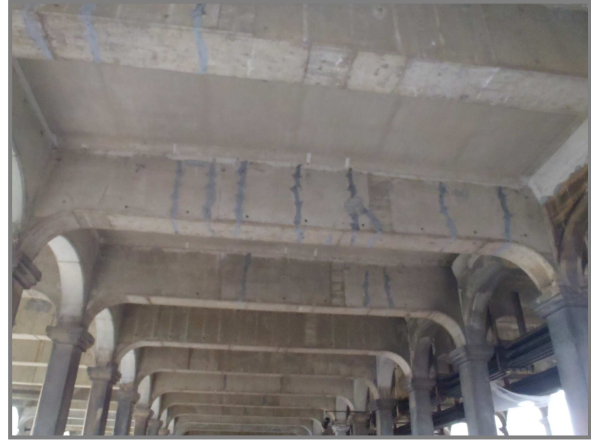
Photo 11 – Floorbeam 9 in Span 6, Bay B-C with epoxy injection repairs at transverse floorbeam cracking.

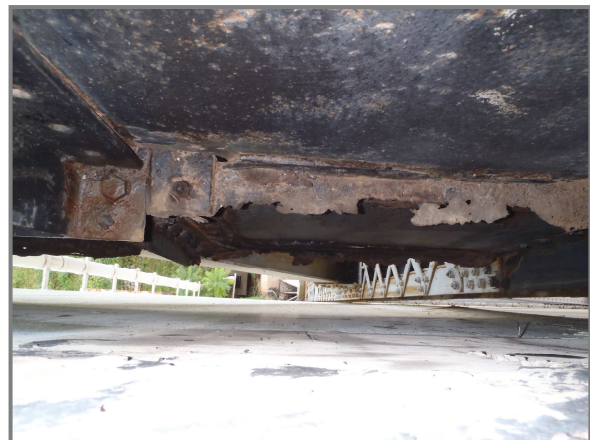
Photo 12 – West face, Floorbeam 0 north cantilever with heavy losses to both west flanges.

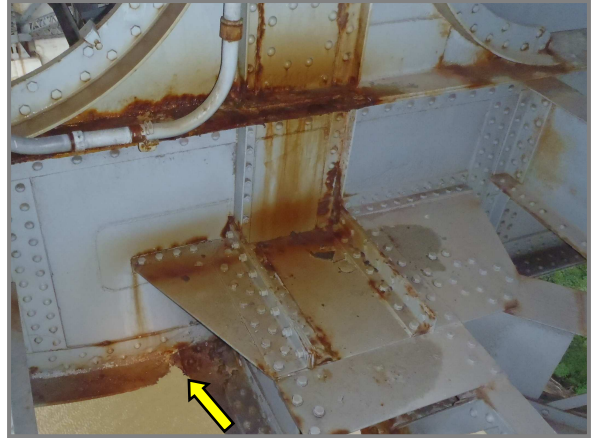
Photo 14 – Typical path of water running down built up hanger onto lower deck framing components. Note bottom flange losses and welded web retrofit plates on floorbeam. Floorbeam 8 at the south vertical post connection.

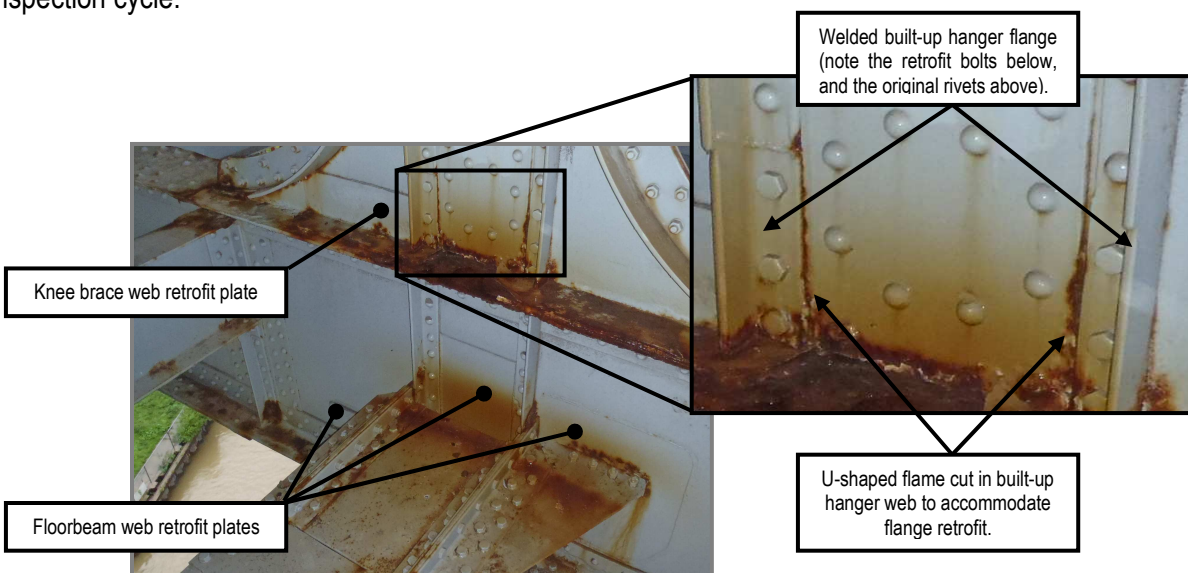
Photo 15 – Typical lower floorbeam retrofits.

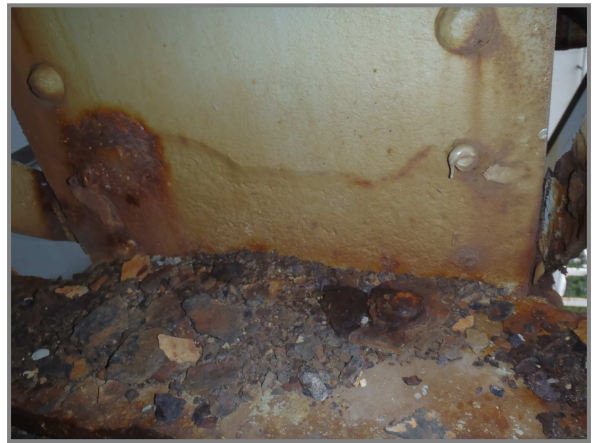
Photo 16 – Interior face of U4' L4' web with 1/16" deep pitting along the lower floorbeam top flange interface.

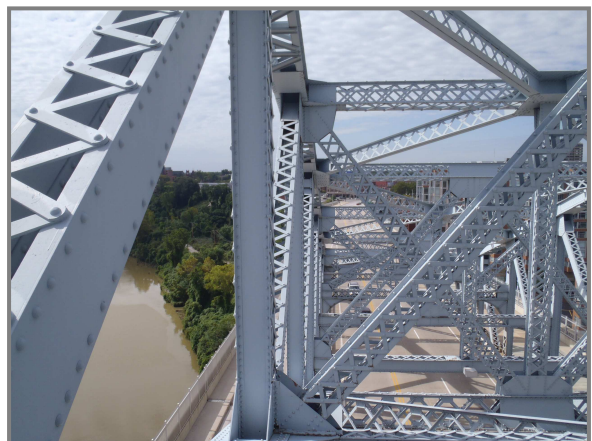
Photo 17 – Typical vertical member above the upper deck level with no significant deficiencies. Member U8L8 South shown.

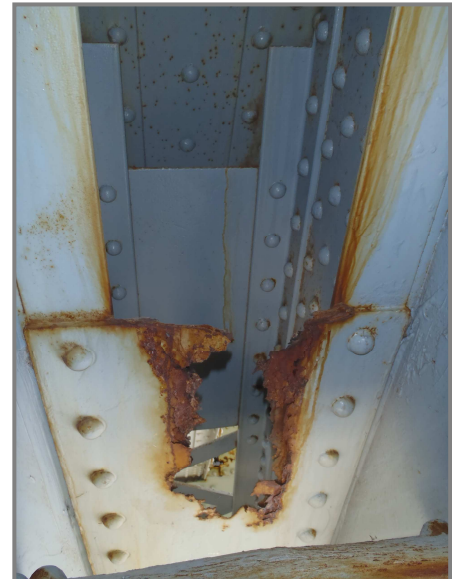
Photo 18 – Holed through portion of the underside stay plate at the lower panel connection of U1L2.

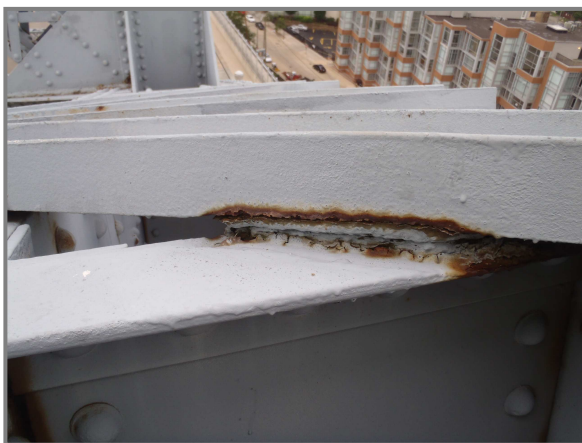
Photo 20 – Member L8L9 on the North Truss with 3/4" impacted rust between the middle intermediate diaphragm flange and the upper lacing channel.

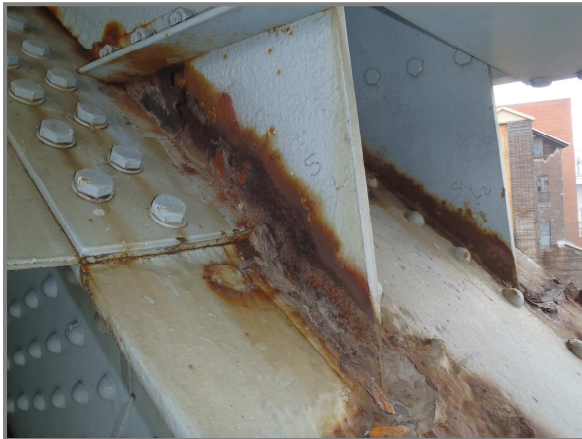
Photo 21: – West free edges of the south truss L2 gusset plates with pitting from 1/16" to 3/16" deep along the lower chord interface.

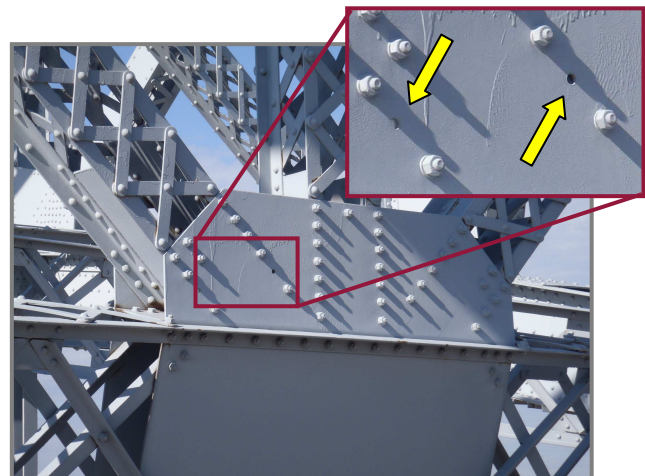
Photo 23: – East face of the lower mid-panel gusset at panel point 15 (ML15) showing two blank bolt holes (retrofit) for the ML15-U15 South diagonal connection.

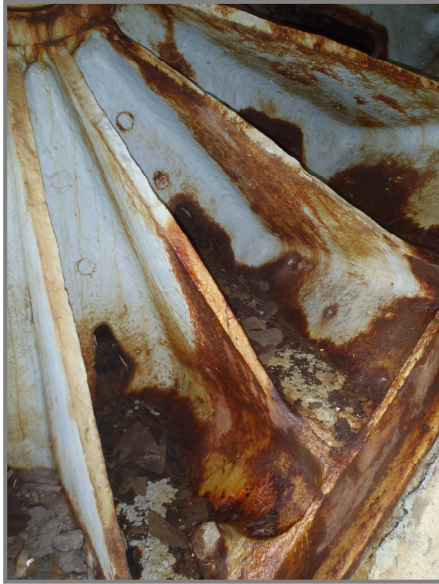
Photo 24 – Southwest truss bolster with significant section loss to the bearing stiffeners and rust reactivation.

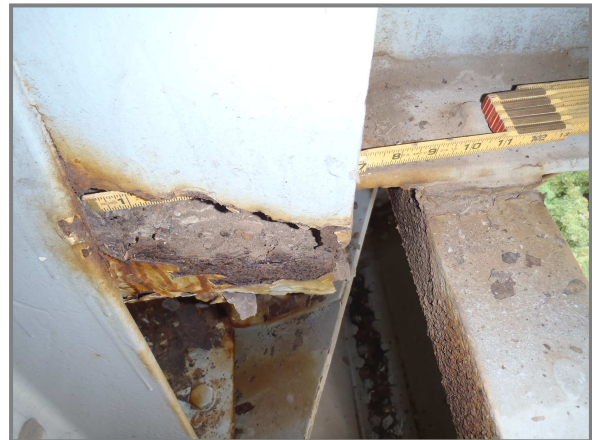
Photo 25 – Saddle bearing with 100% section loss.

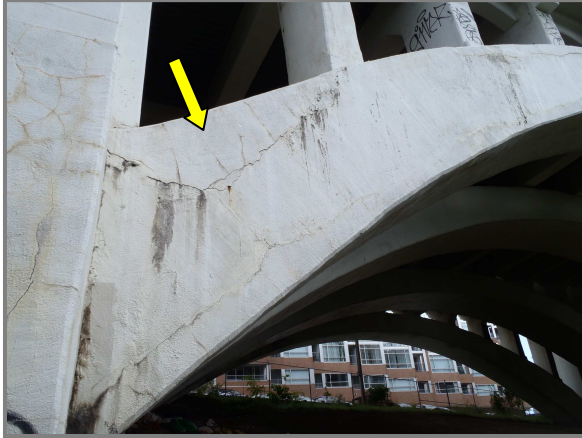
Photo 26 – Arch D in Span 1, South Elevation showing 1/16" wide cracking in the arch near the tower base. Note the large (~30sqft) delamination between the tower and column 1 (arrow).

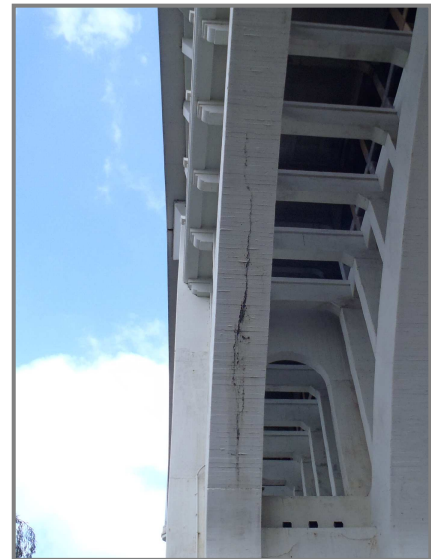
Photo 27 – Arch A in Span 5 with an approximately 1/4" wide x 40' long longitudinal crack.

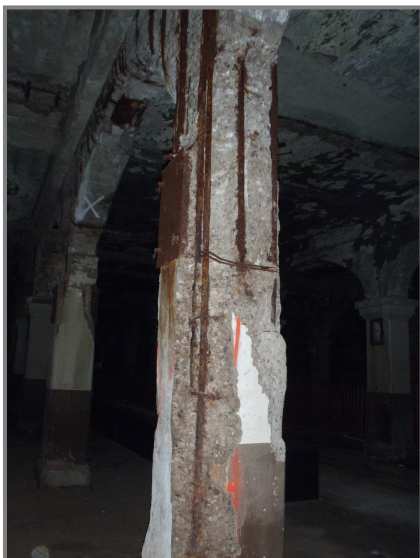
Photo 28 – Jack arch line B, Column 16 in the West Approach span with nearly 100% loss of cover.

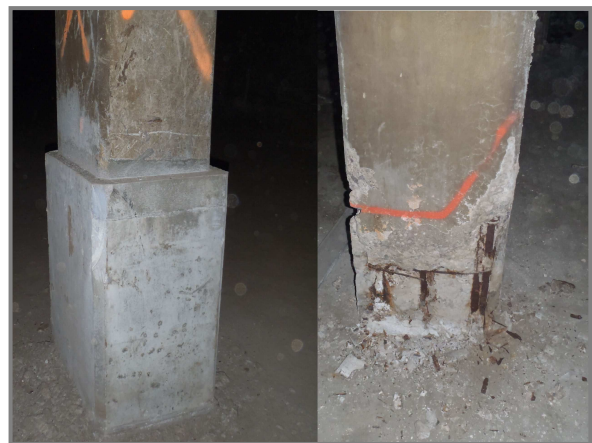
Photo 29 – Typical column base repaired (left) and unrepaired conditions (right).

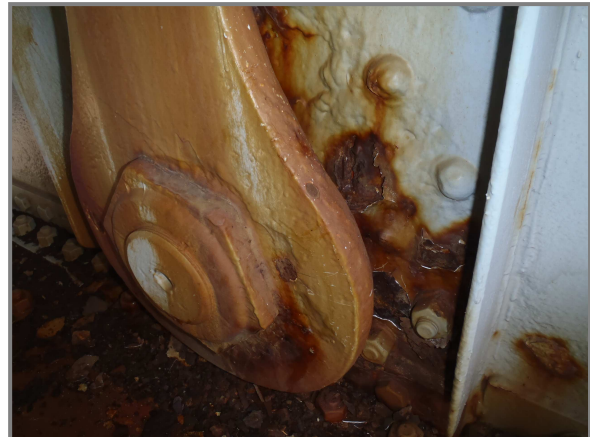
Photo 30 – East hanger, lower deck Floorbeam 4 of the North Truss with 3/16" - 1/4" deep pitting to the exterior face of the eyebar at the net section. Note the reactivation of rust and the advanced losses to the adjacent web-reinforcing pin plate.

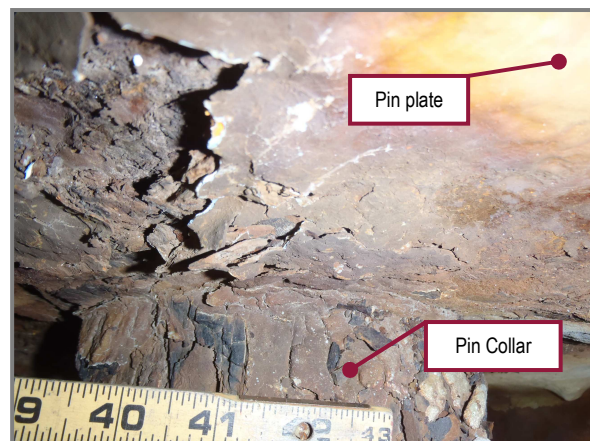
Photo 31 – Heavy laminate rusting at the lower hanger pin collar at the South Truss Floorbeam 4' connection.

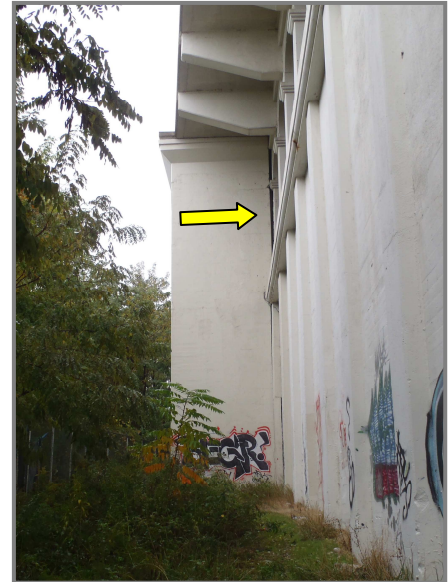
Photo 32 – Leaning South Tower B. Note the gap between the upper portion of the tower and the lower deck fascia members.

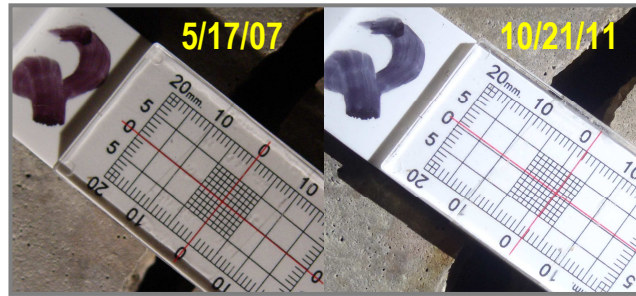
Photo 35 – Crack Gauge 2 showing approximately 2mm of movement since the installation in 2007.

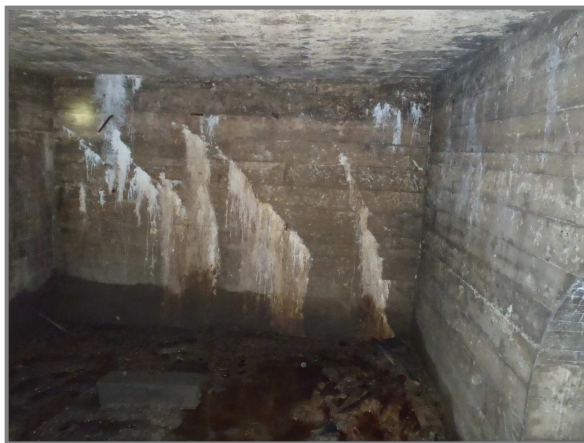
Photo 36 – Diagonal cracking and heavy efflorescence, north wall of North Cell 1.

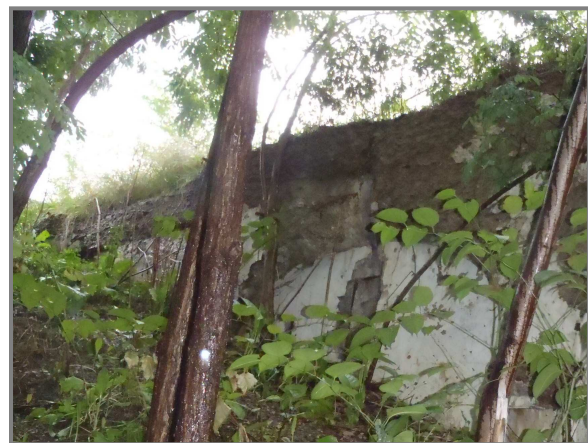
Photo 37 – Heavy deterioration of concrete at the southwest wing.

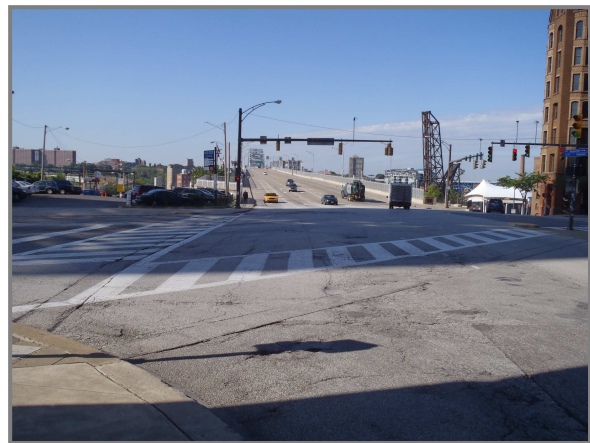
Photo 38 – View looking west from the East Approach

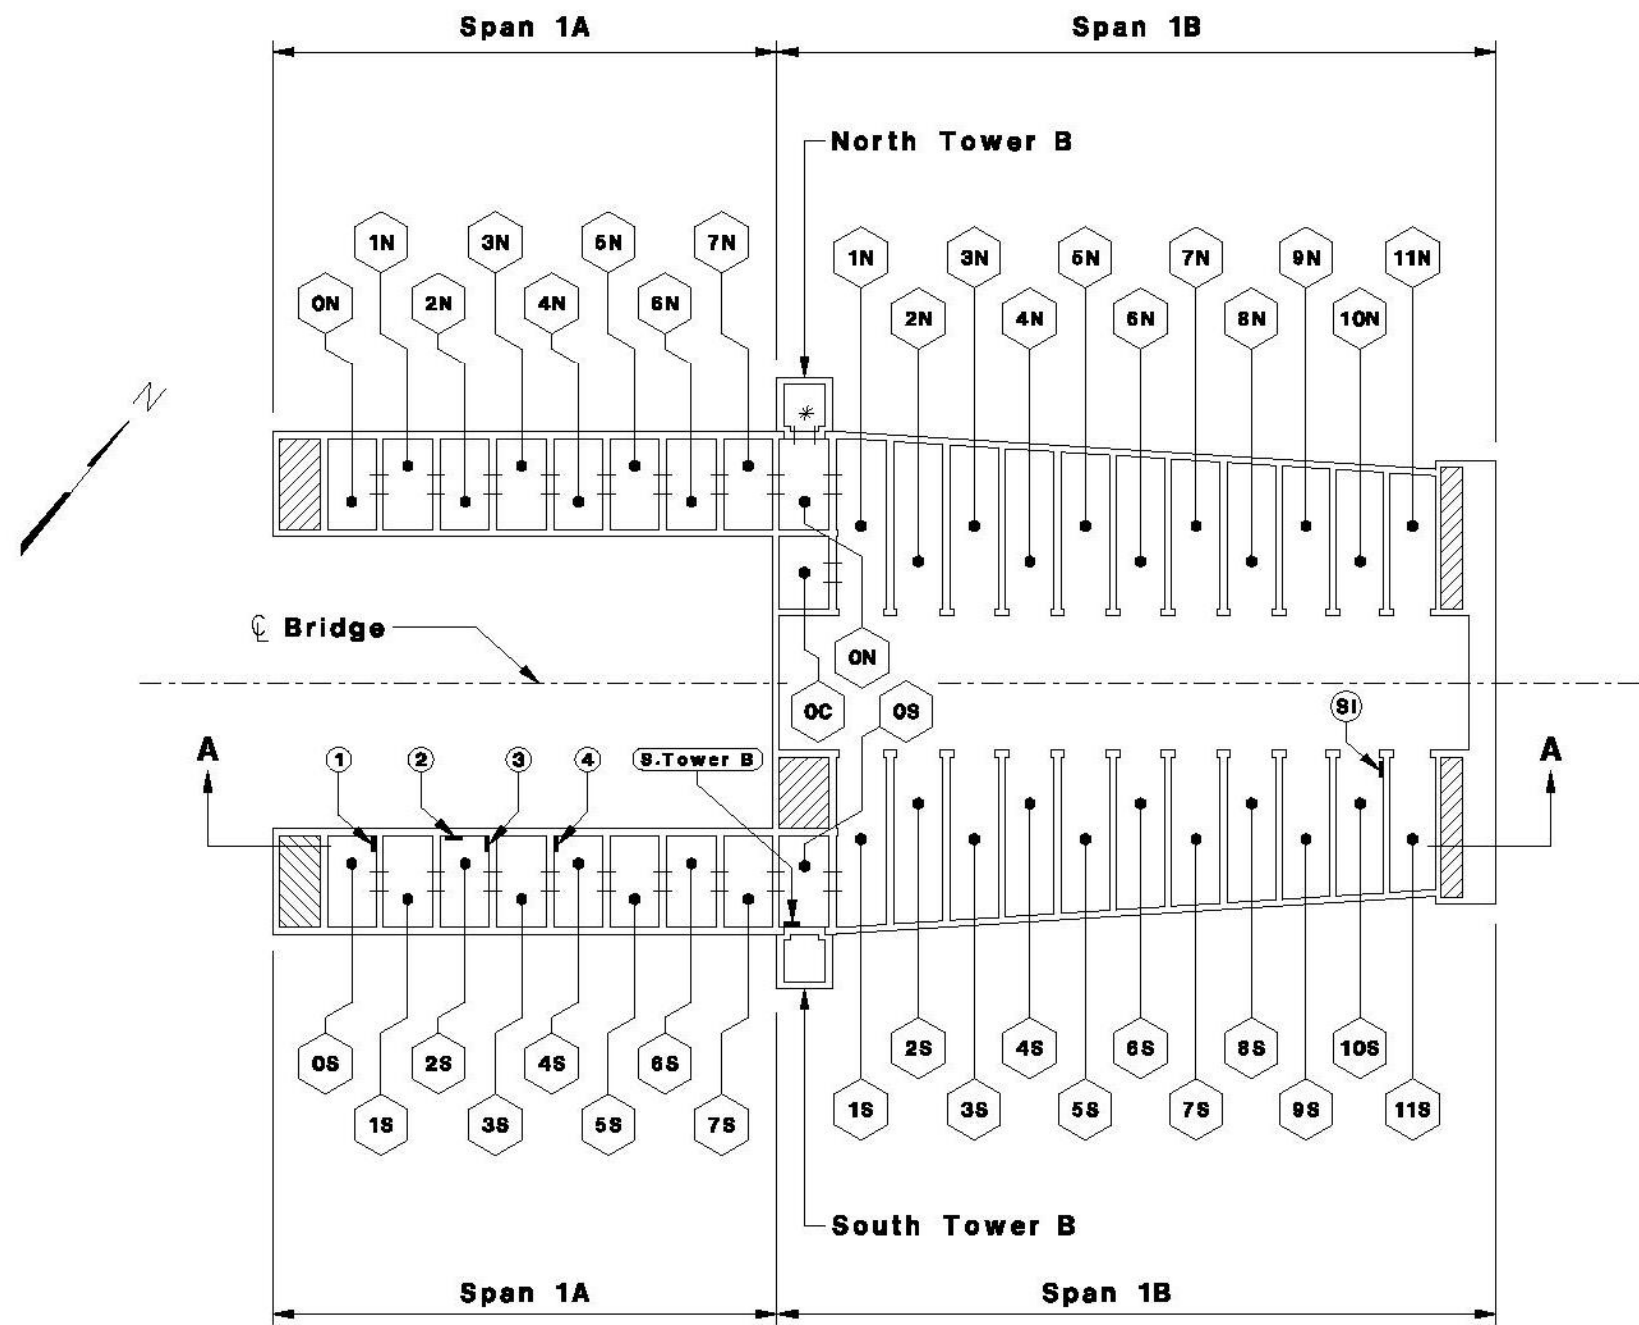
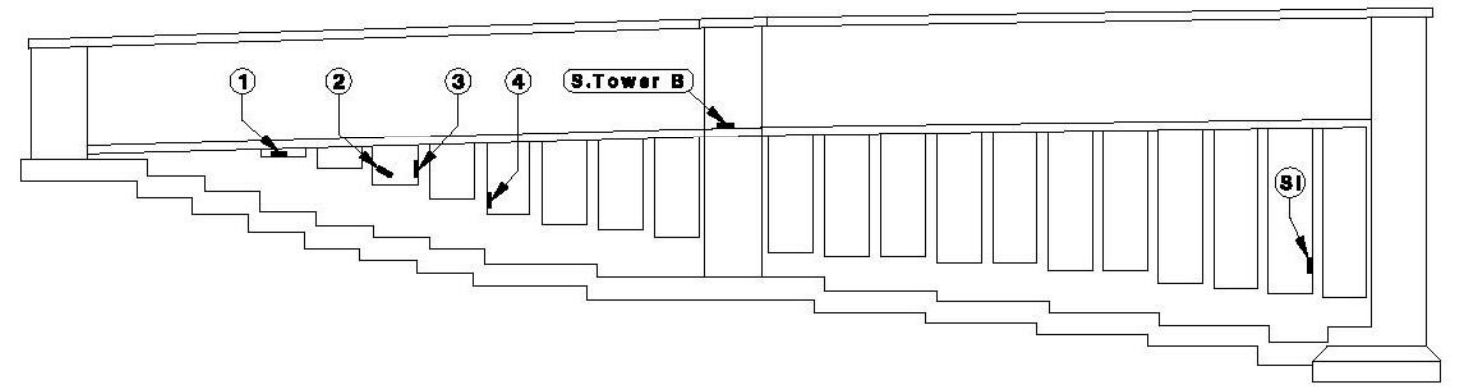
**Appendix A**  
Cellular Construction Layout,  
Unified Nomenclature and Crack Gauge Locations

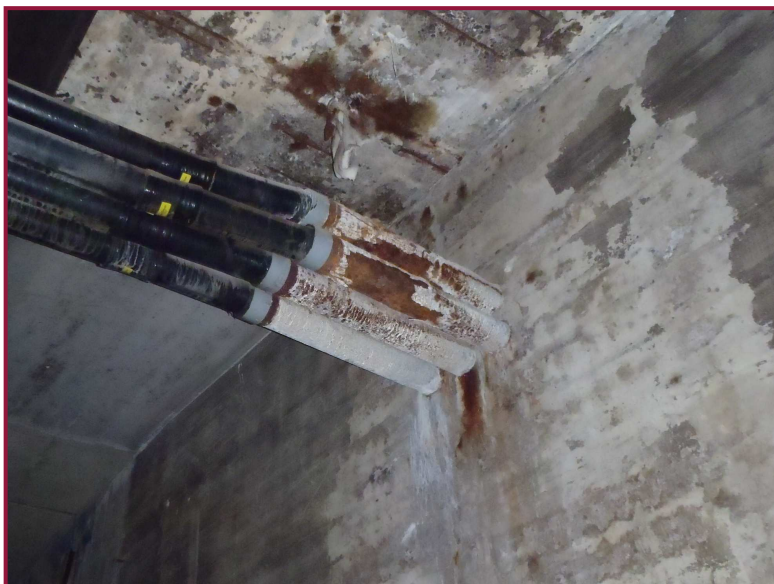
The utility conduit in Bay 31 (transverse to the tunnel) exhibits moderate corrosion of the projecting pipes at both walls (west wall shown). Note that the deck slab is leaking above this location, contributing to the corrosion.

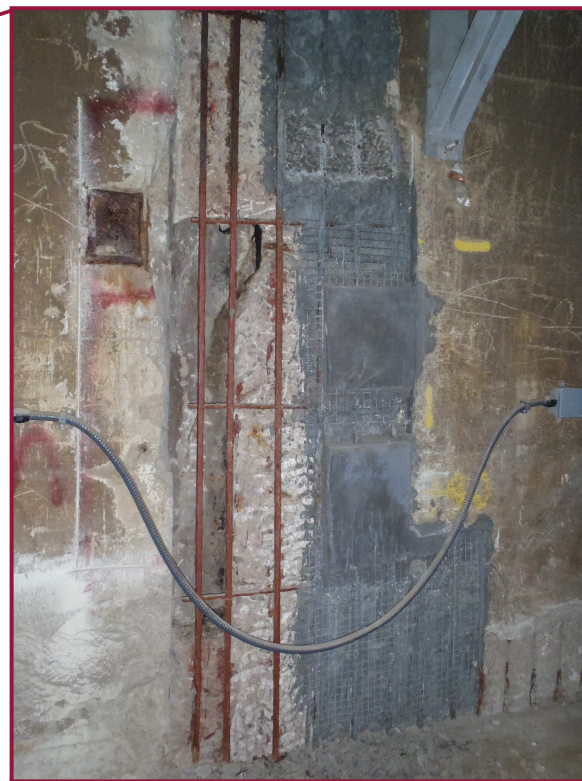
East wall in Bay 30 (joint location) with deteriorated concrete and partial concrete repair.

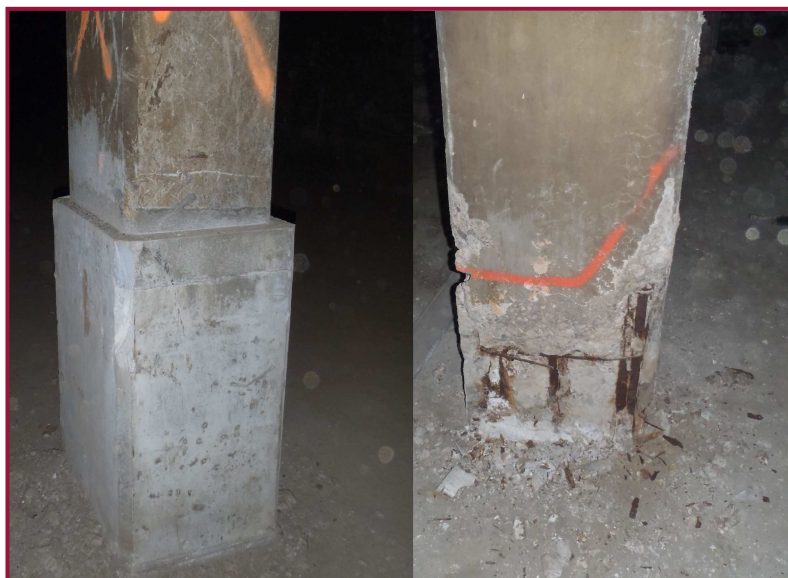
Columns in the West 25<sup>th</sup> Street tunnel with typical base repair (left; column 6) and base deterioration (right; column 12).

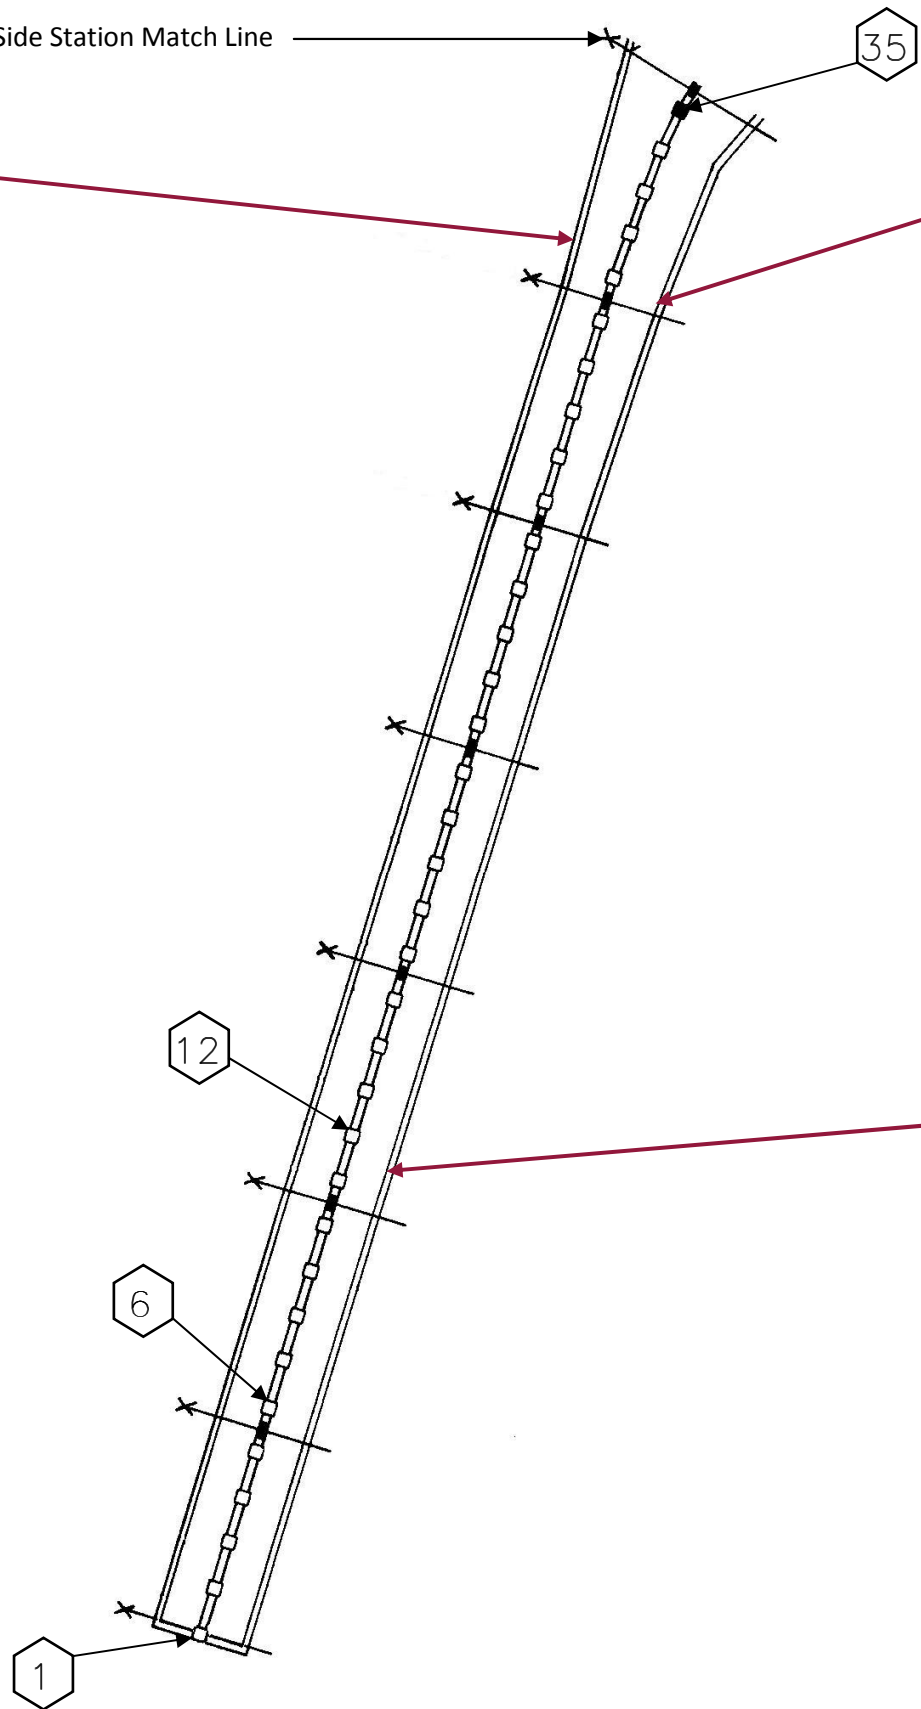
**West 25<sup>th</sup> Street Tunnel Plan**

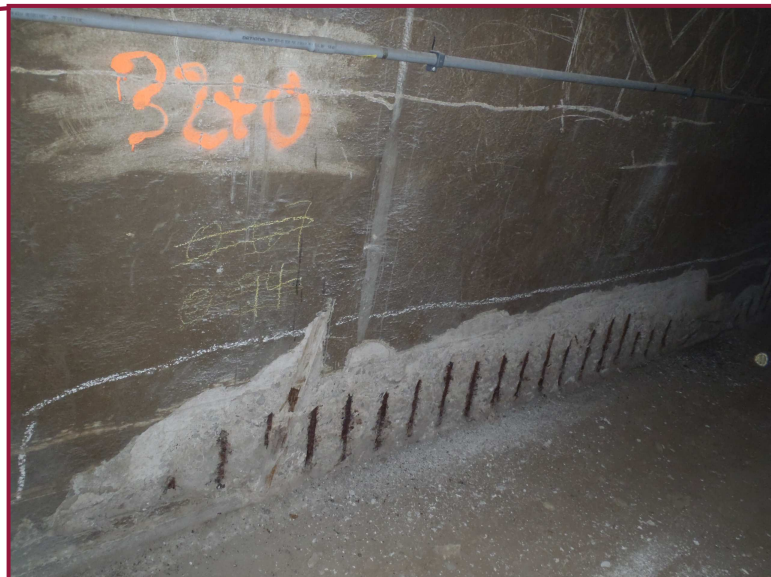
Approximately 8' long section of localized spalling of the bottom 2'-3' of the east wall in Bay 11. Exposed reinforcement exhibits negligible loss.

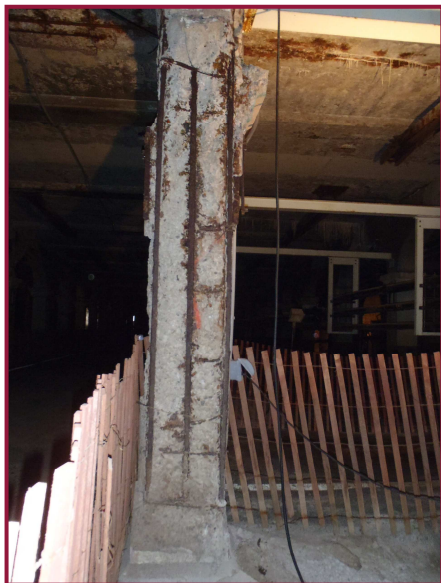
Column 14 in Line C exhibits significant loss of cover and exposed reinforcement with minor section loss. While column spalls are common throughout the west jack arches, the magnitude of deterioration shown here is isolated to only a few locations.

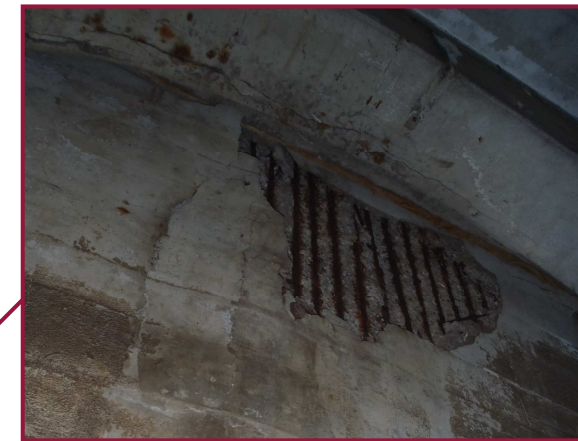
The south face of the north wall exhibits widespread spalled and delaminated areas from approximately Column 23 to Column 31. Between Columns 26 and 28 the full height of the wall exhibits spalls/eminent spalls.

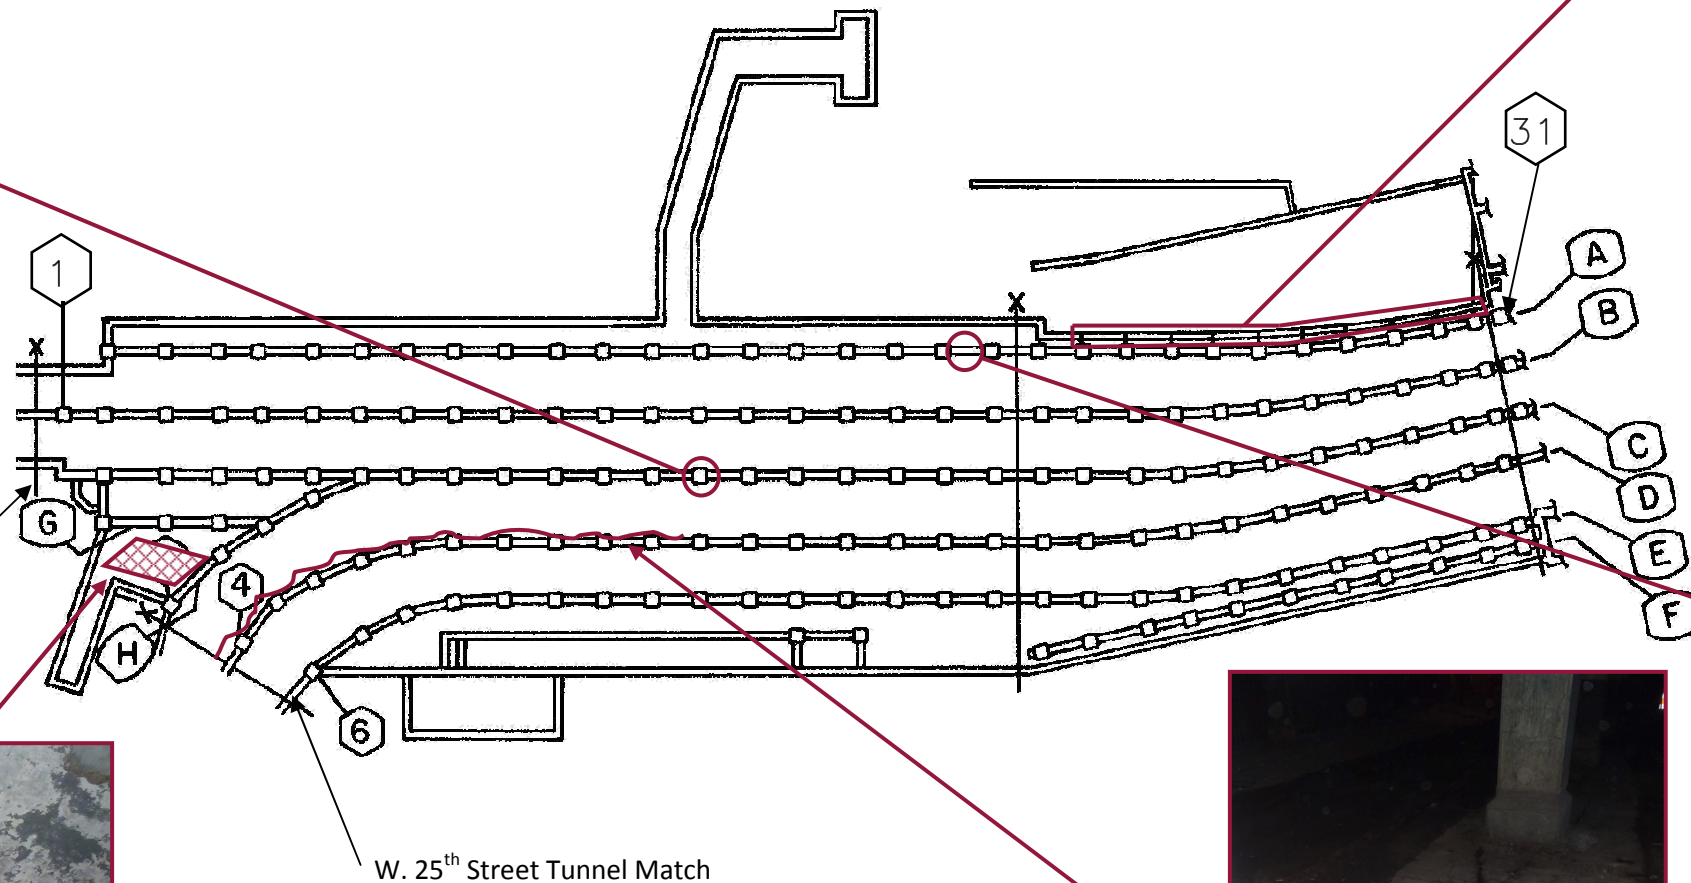
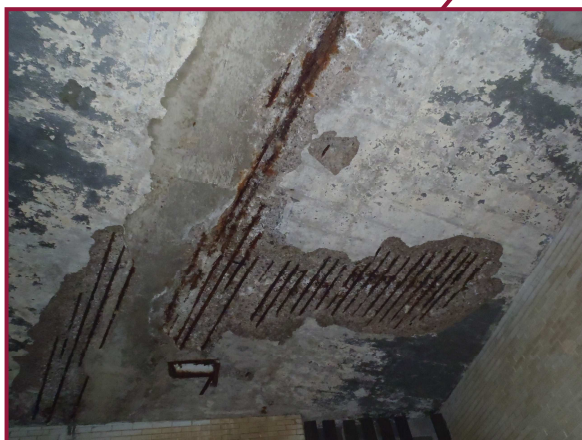
Large spall (~30 ft<sup>2</sup>) between jack arch Lines G and H. Spalls are common throughout the underside of the upper deck in the West Side Station, typically ranging from 2 ft<sup>2</sup>-10 ft<sup>2</sup>.

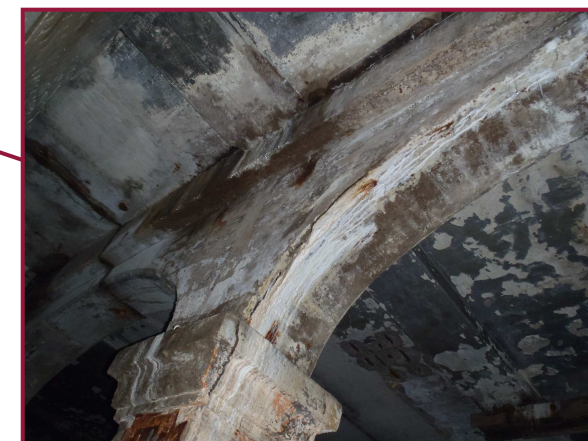
Line A jack arch above Column 20 with large delamination of cover concrete at the north face of the haunch. Upper deck is actively dripping onto jack arch at this location and concrete condition.

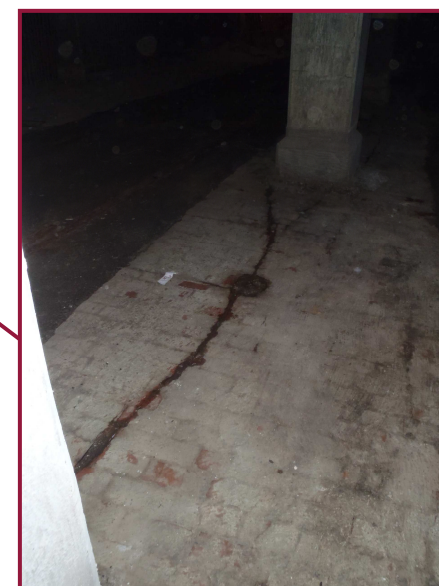
Crack in lower deck up to 1" wide following Line D from approximately Column 3 to Column 14.

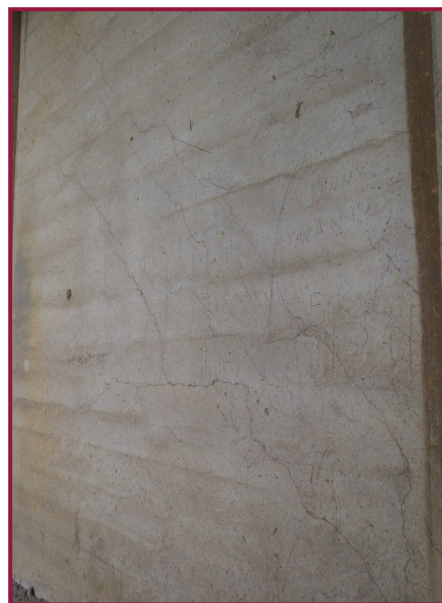
The south face of the South Center curtain wall in Span 1A exhibits diagonal cracking up to 1/16" wide.

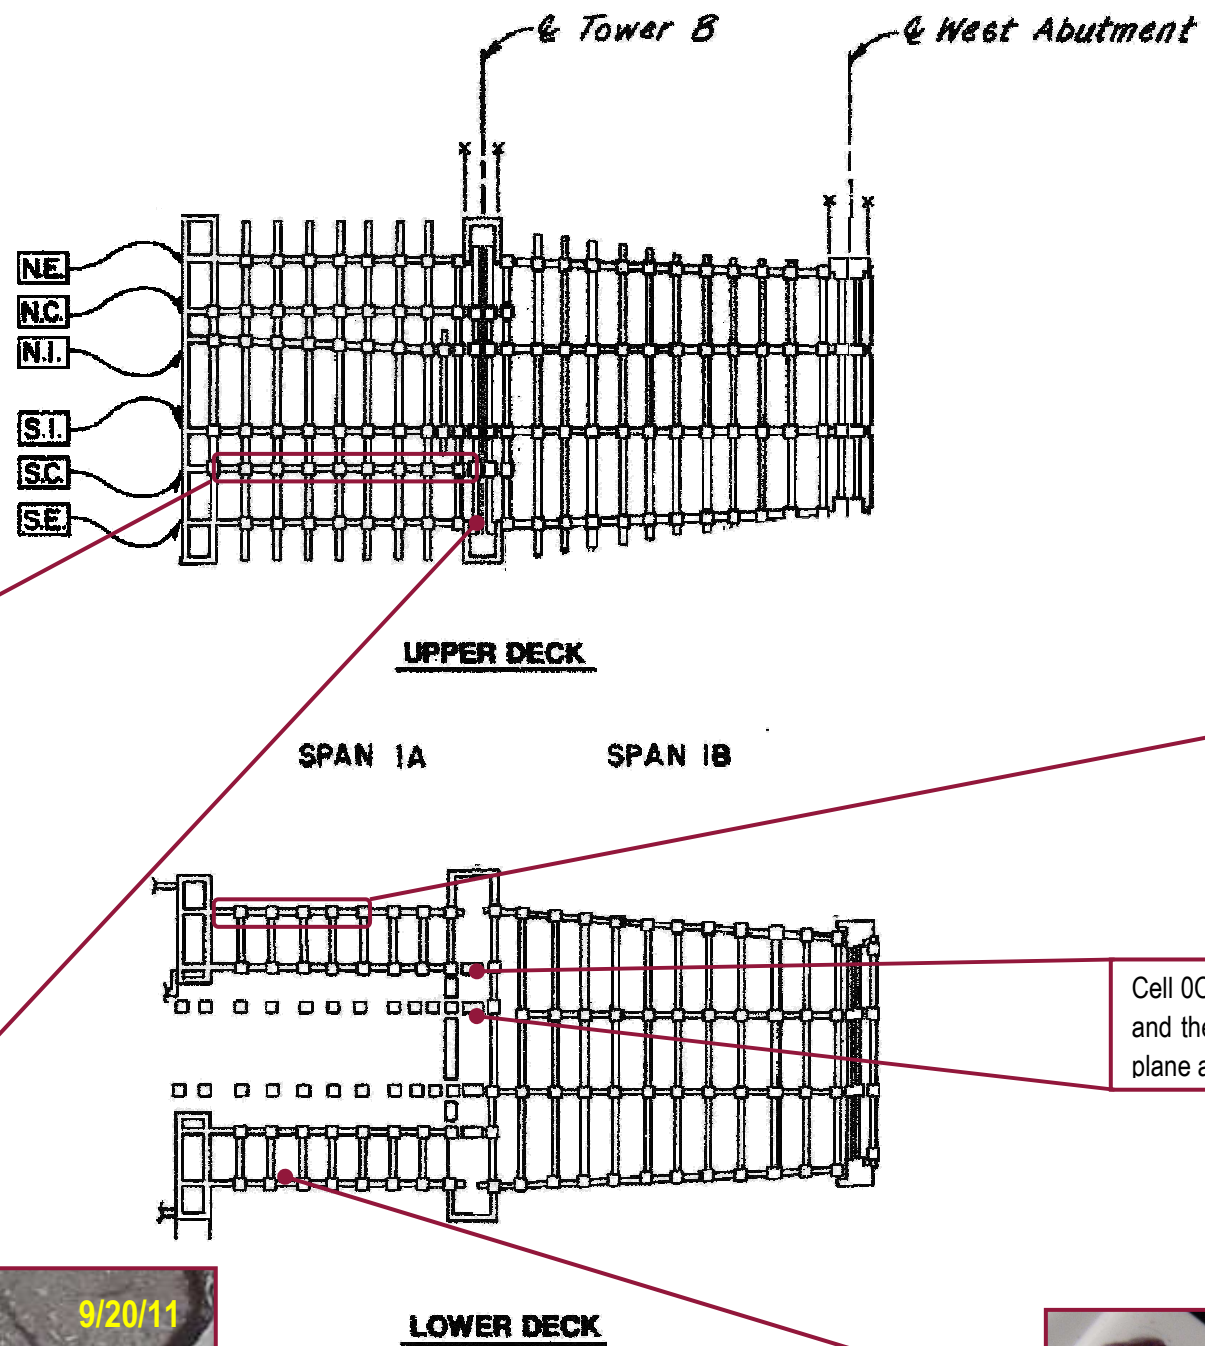
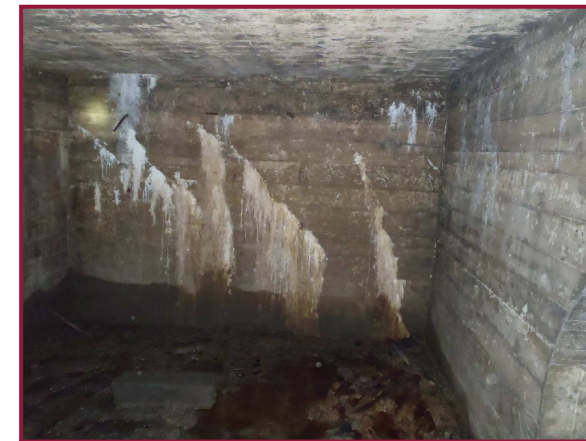
The north walls of the Vaults 0N to 4N exhibit diagonal hairline cracking with heavy efflorescence in Span 1A (Cell 0N shown). The direction of the cracking is consistent between adjacent cells and magnitude of the deterioration increases from east to west starting at Cell 4N.

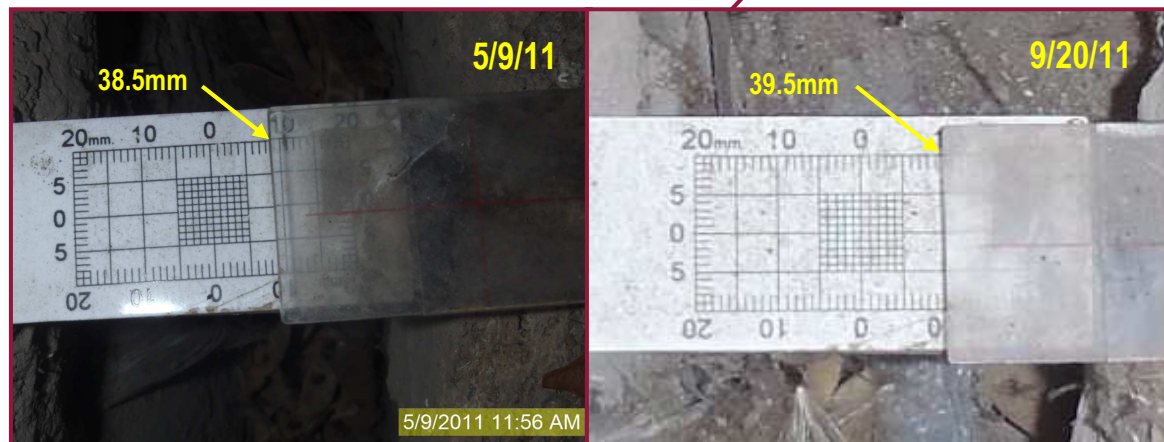
South Tower B crack gauge at the upper deck level showing 1mm of movement over a 4-month period. This gauge was originally installed in 2006 and indicates approximately 48.5mm (1.91") of movement since.

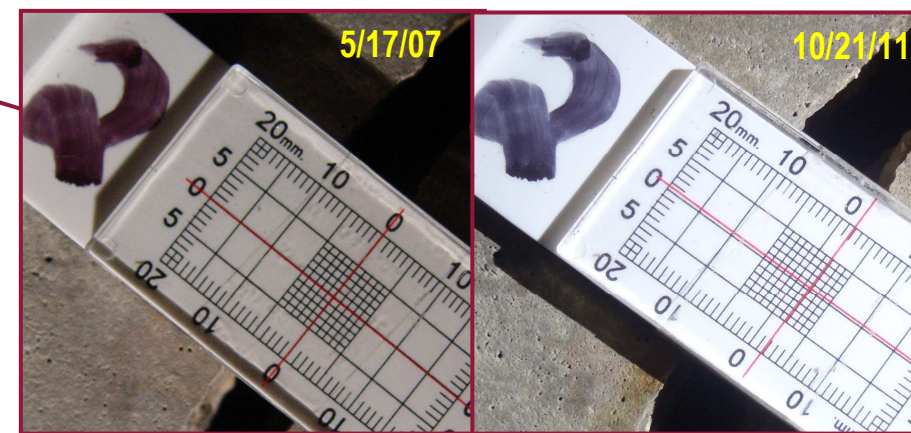
Crack Gauge 2 in Cell 2S of Span 1A exhibits approximately 2mm of movement since the gauge was installed in 2007.

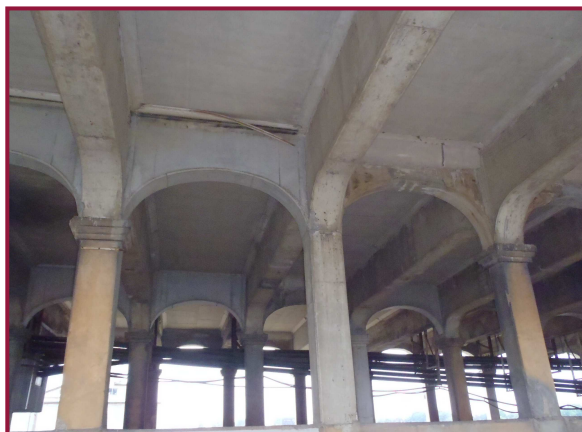
Jack arch Line B in Span 3, typical for Spans 1-3. Note that portions of the arches, columns and floorbeams have been repaired (light in color), while other portions were not (discolored).

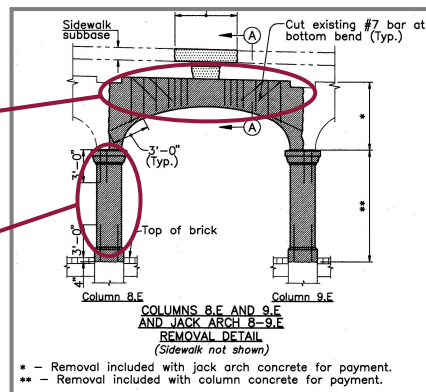
Typical jack arch removal/repair detail per the 1994 rehabilitation plans.
