**PHYSICAL CONDITION REPORT  
FOR THE 2011 ROUTINE INSPECTION**

**VETERAN'S MEMORIAL (DETROIT-SUPERIOR) BRIDGE**

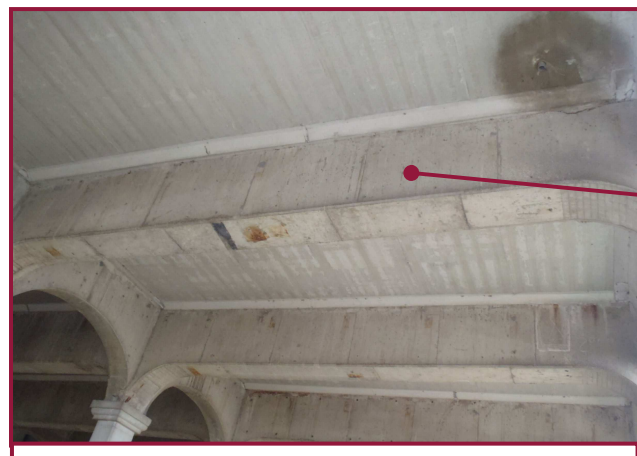
Typical repaired floorbeam condition, Span 2, Floorbeam 5 between Lines A and B shown.

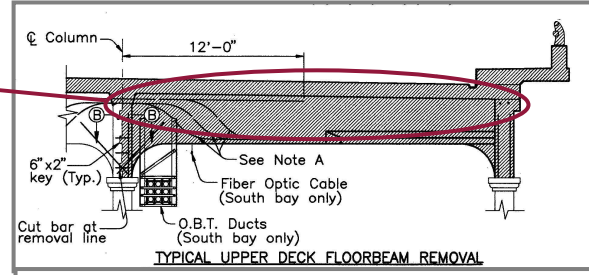
Typical concrete floorbeam removal/repair detail per the 1994 rehabilitation plans.

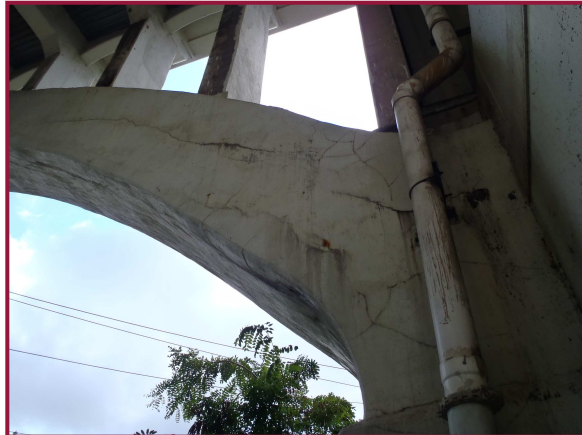
North face of Arch D in Span 2 with widespread cracking in the western 25' of the arch. Arch cracking is typical in Spans 1-3; however, the condition shown is worse than typical due to the adjacent drainage elements at this location.

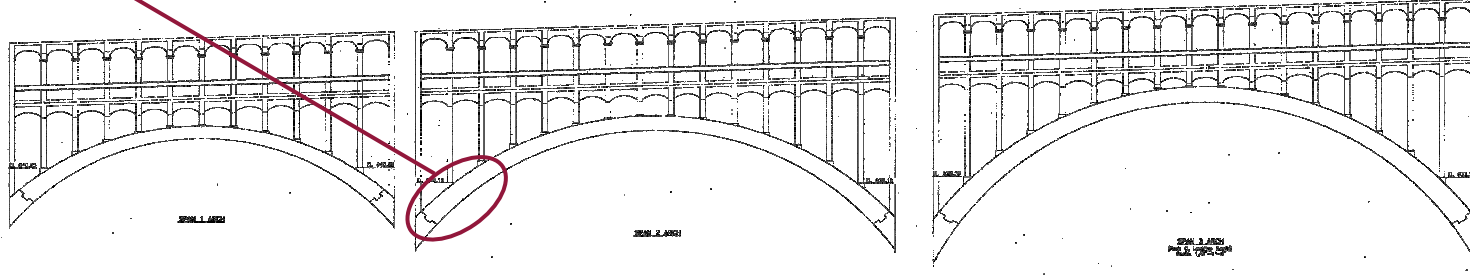
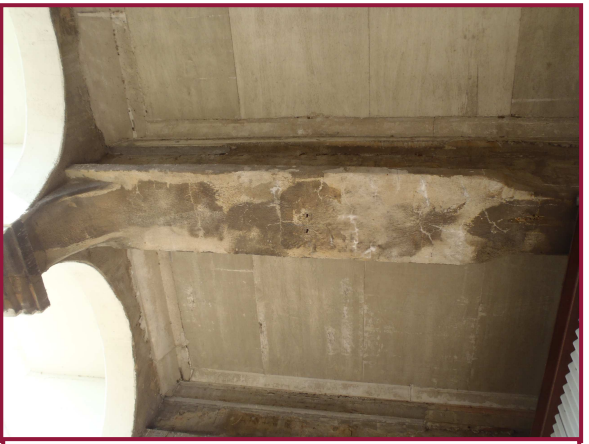
Floorbeam 16 between jack arch Lines C & D with transverse hairline cracking and light efflorescence throughout the bottom face. This condition is isolated throughout Spans 1-3, especially at floorbeams that have not been rehabilitated, as shown.

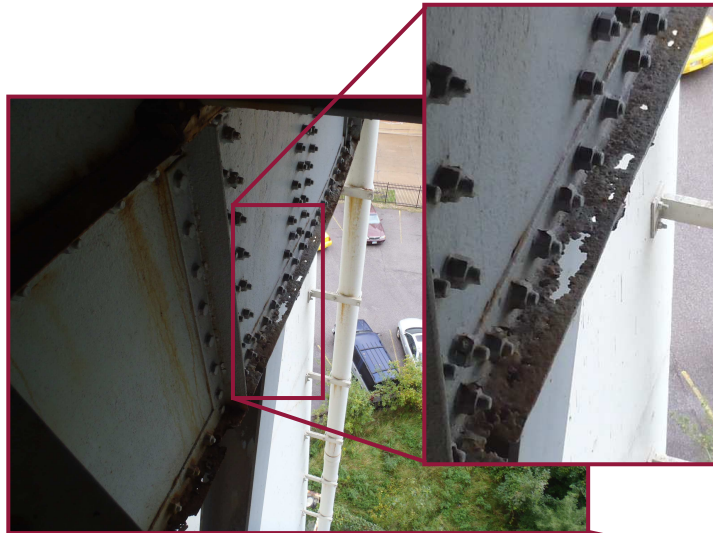
The Floorbeam 0 north cantilever bracket exhibits advanced section loss of the bottom flange with holed through sections. This condition is locally common at the end floorbeams and isolated throughout the truss where the members are exposed.

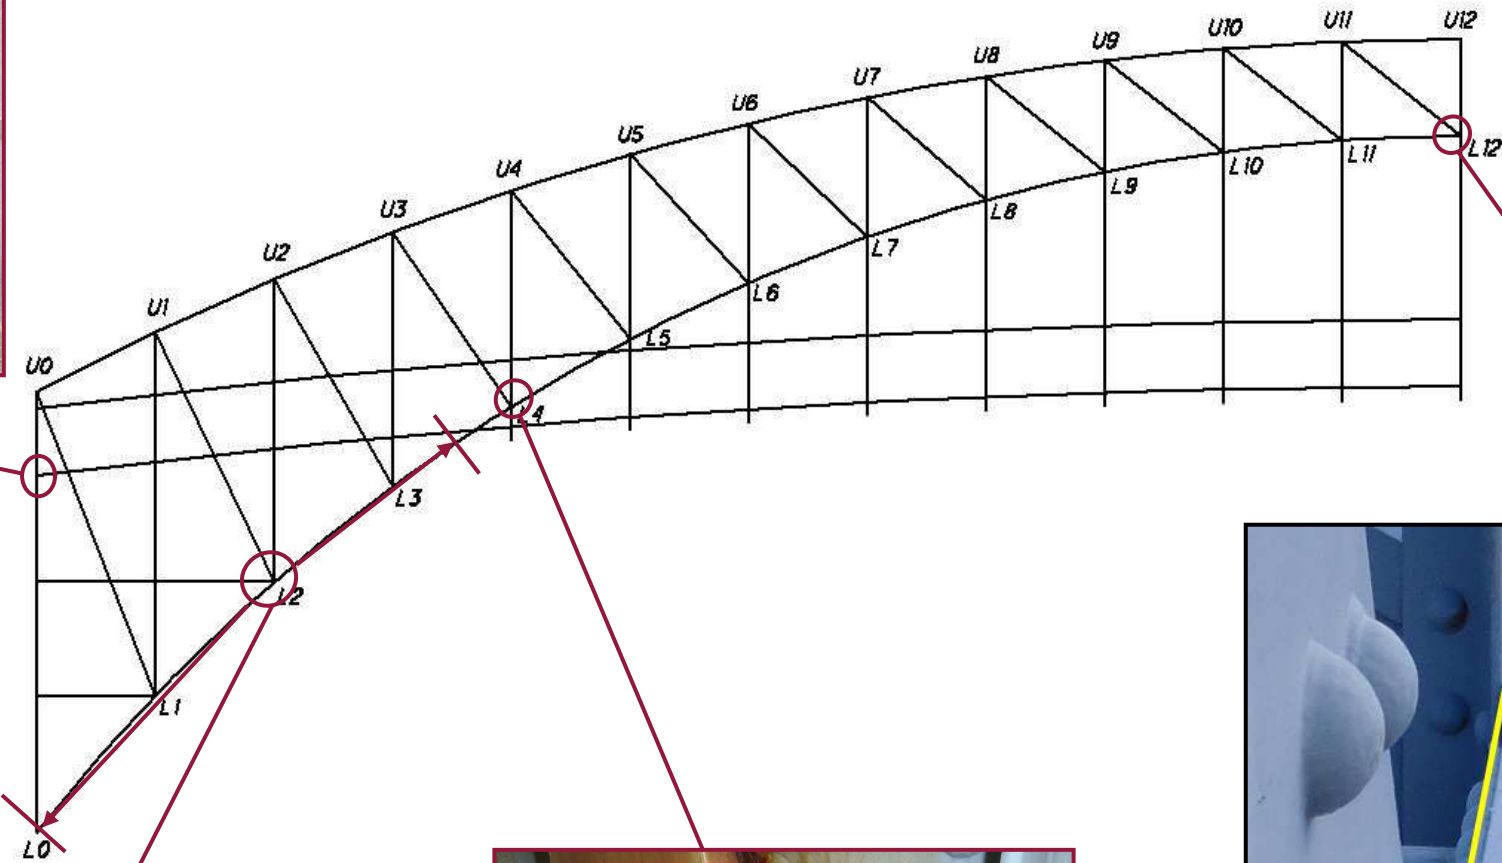
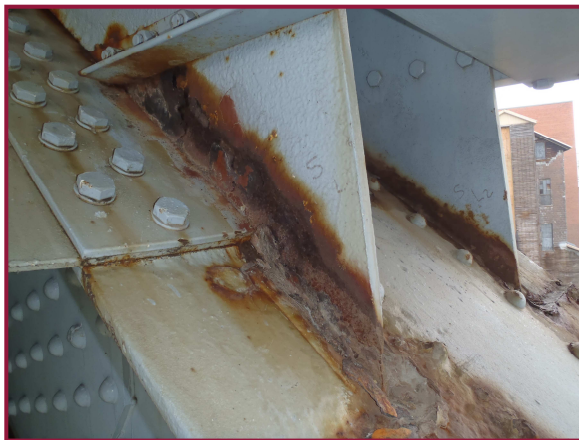
South Truss L2 gusset plate with heavy pitting along the lower chord interface. Similar advanced losses were noted at several lower chord panels below the lower deck level.

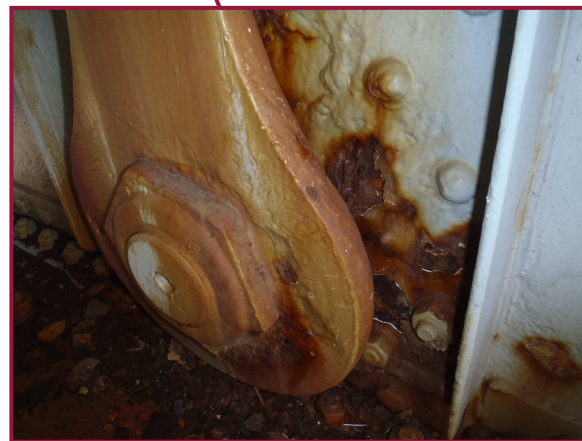
Moderate to heavy pitting is common at lower pin connections below the upper deck. North Truss lower Panel 4 shown.

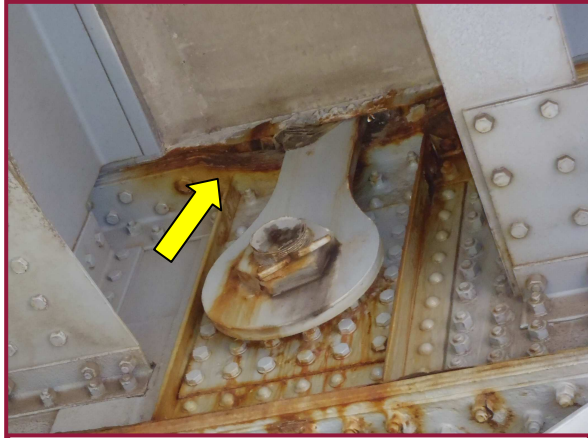
Pin connections at the upper floorbeams (Panels 5 to 5') typically exhibit rust activation and staining throughout the adjacent floorbeam components. Additionally, moderate to heavy pack rust between the top flange and deck is typical at these locations (south hanger at Floorbeam 6' shown).

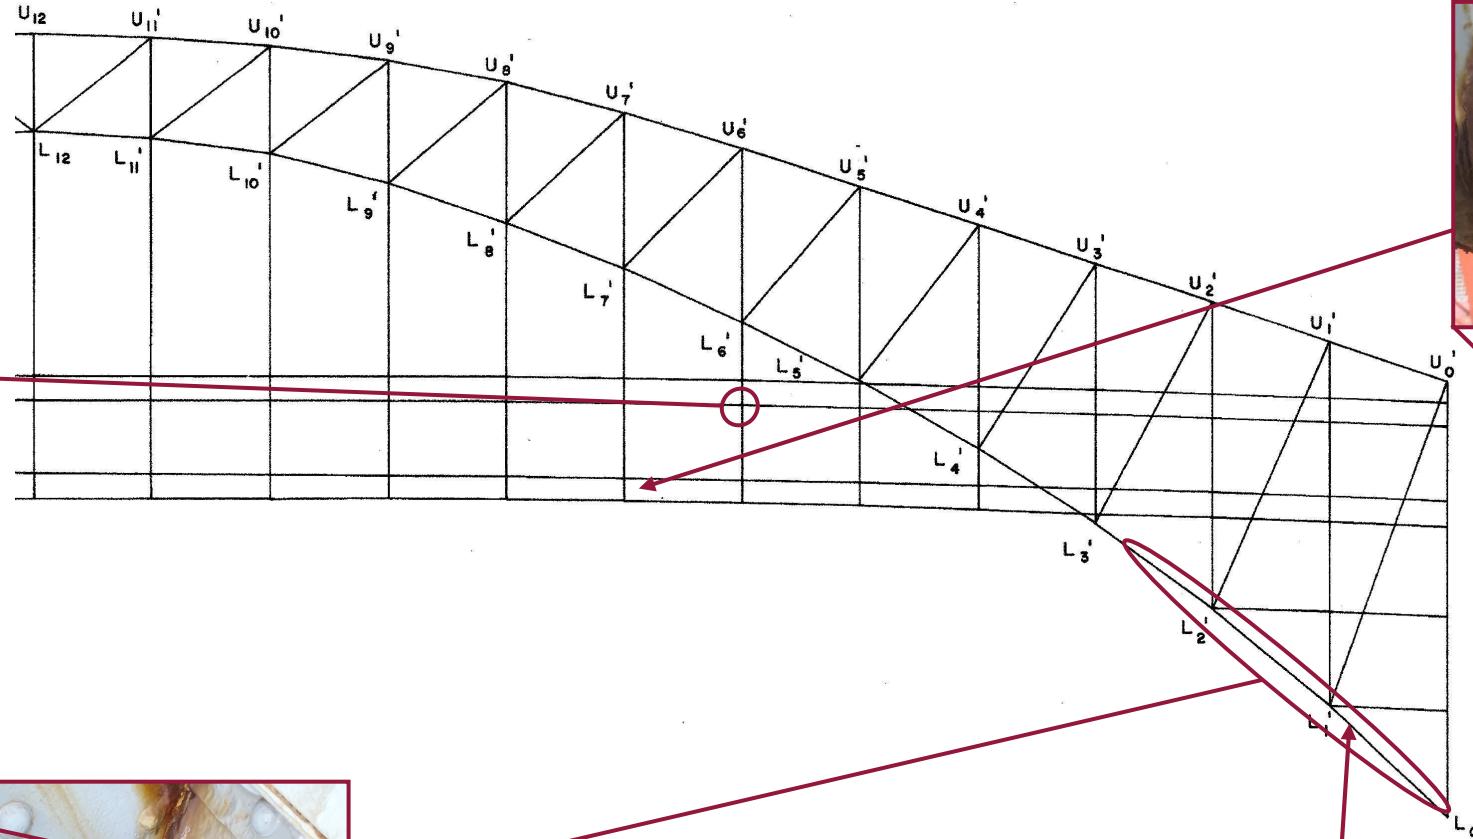
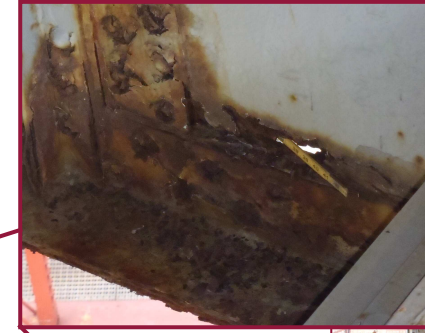
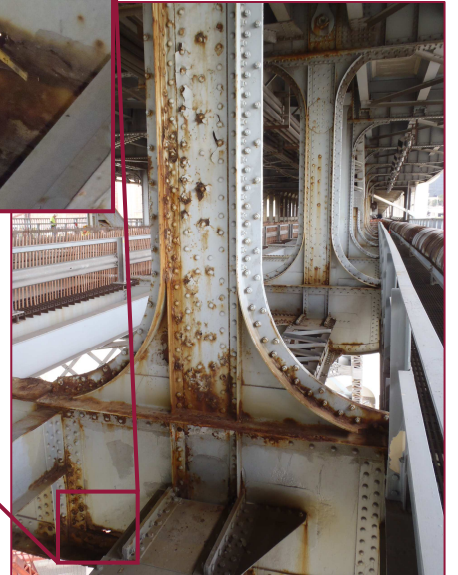
Typical lower hanger and floorbeam condition with rust activating throughout. Many floorbeams throughout the truss have been retrofitted with bolted and/or welded plates; however, the web of Floorbeam 7' remains holed through to the interior of the south hanger (shown).

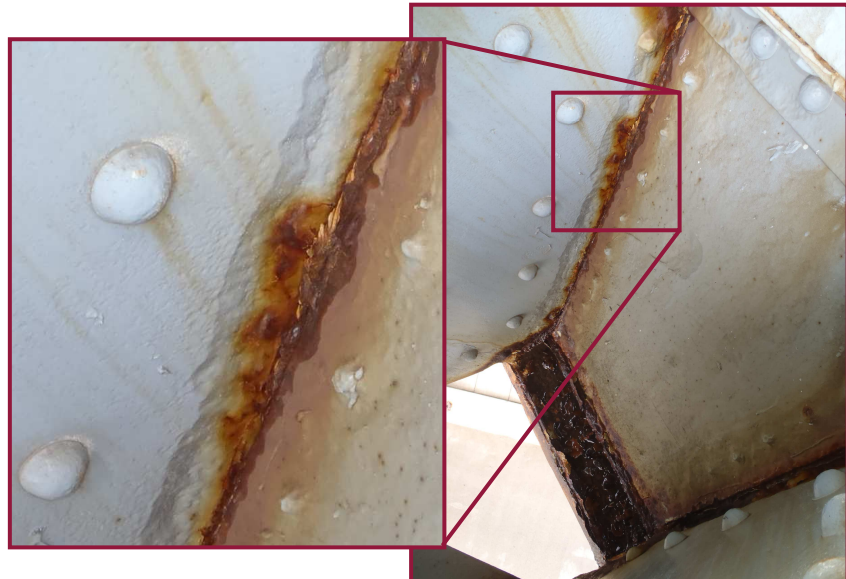
Advanced section loss (up to 1/2" deep) was noted on the interior faces of the lower chord web members below the lower deck (Panels 3'-0'). The losses occur immediately adjacent to the intermediate diaphragms and have been cleaned and painted; however, rust is reactivating at most locations. South Truss, L0'L1' shown.

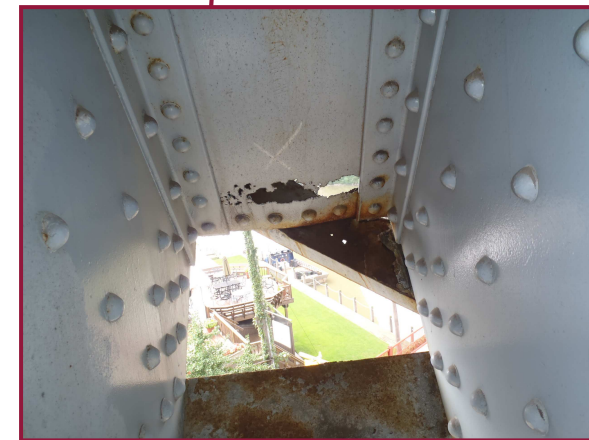
Several intermediate lower chord diaphragms below the lower deck level (Panels 3'-0') exhibit advanced section losses, including holed through sections. Adjacent bottom lacing channels exhibit similar conditions, as shown here at L0'L1' near L1'.

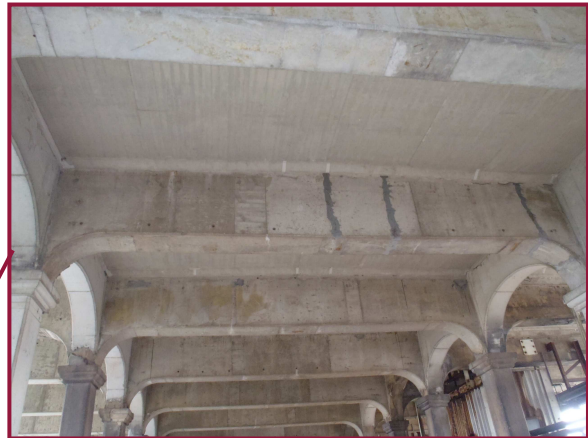
Floorbeam 2 in Span 6 with vertical cracks in the south face (north face similar). Note that the cracks have been repaired with epoxy injection, which is an isolated repair condition in Spans 5-7.

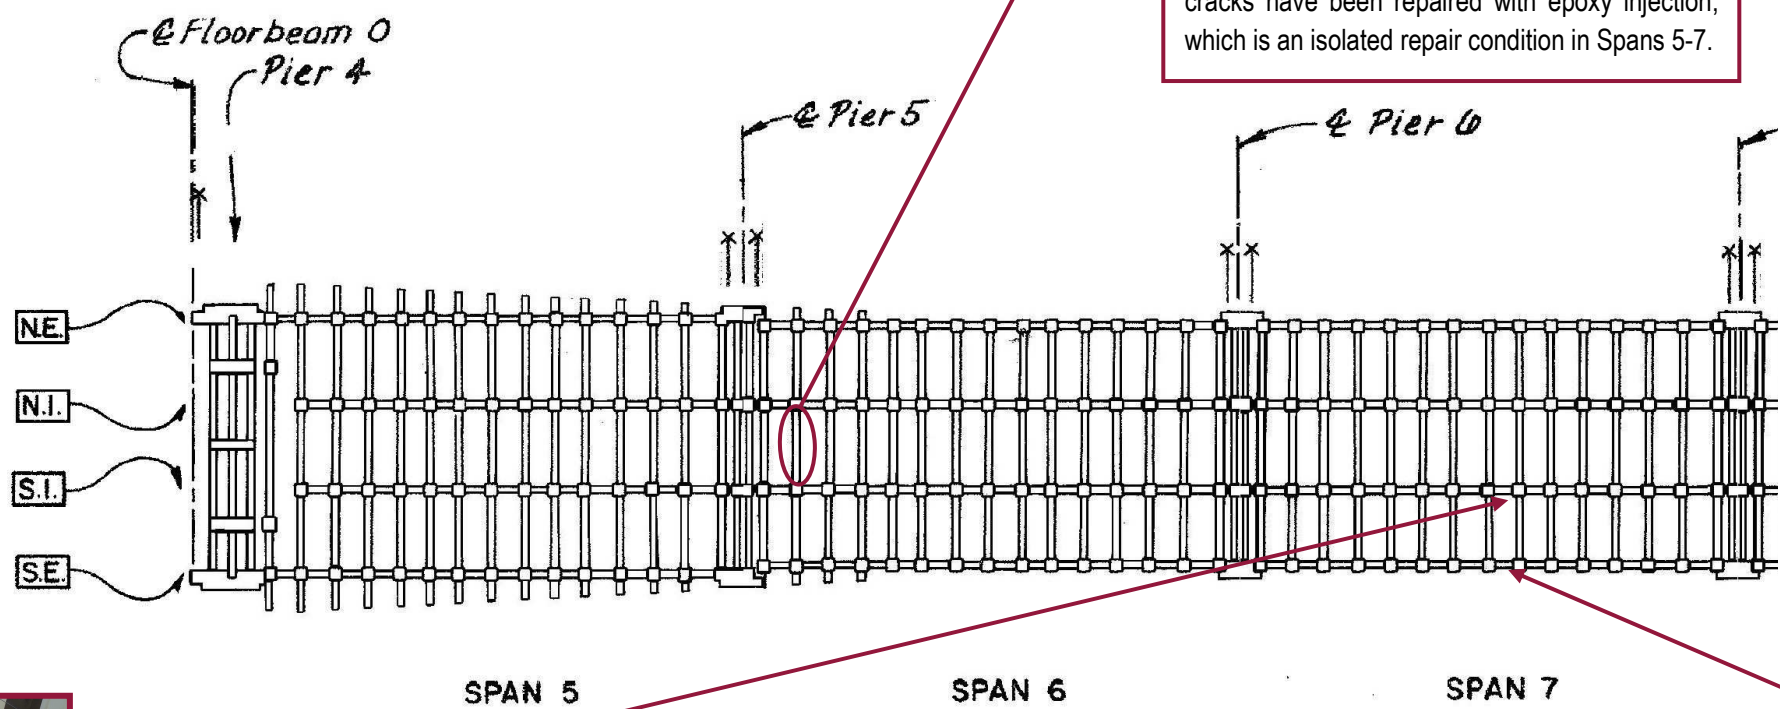
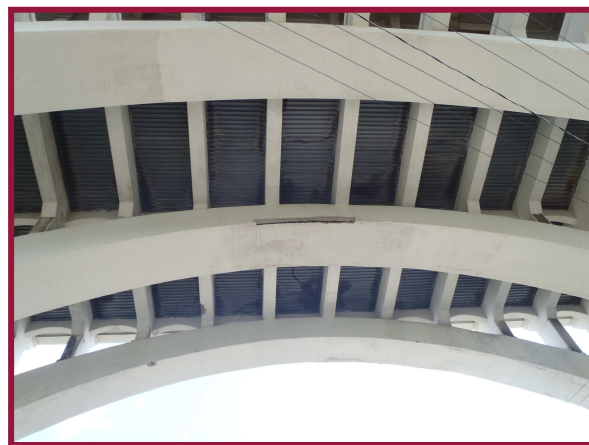
Arch C in Span 7 exhibits a 12' long x 6" wide spall on the south bottom corner of the rib. This minor spalling exemplifies the most advanced concrete deterioration in Spans 5-7.

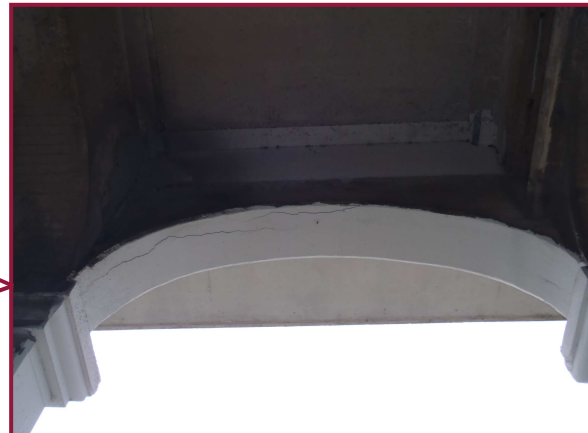
Isolated 1/4" longitudinal cracking in the bottom face of the arch between Columns 8 and 9, Line D in Span 7.

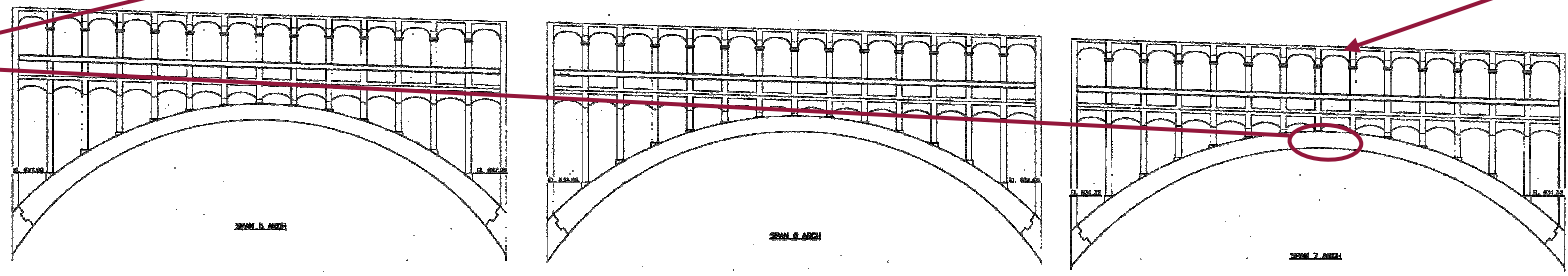
### West Approach Plan Spans 5-7

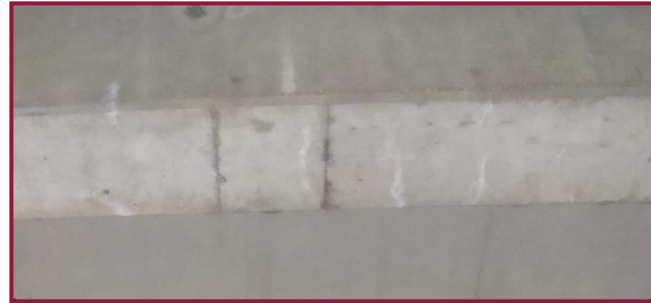
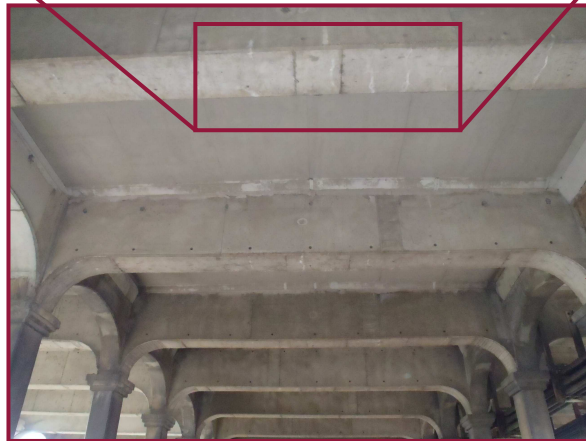
Interior bay of Floorbeam 9 in Span 8 with transverse hairline cracking along the bottom face of the beam. Between Lines A and B, the cracking is on the bottom face of the beam at Floorbeams 2-6. Between Lines B and C, the cracks exhibit light efflorescence and typically extend the full height of the web on both faces from Floorbeams 2-14.

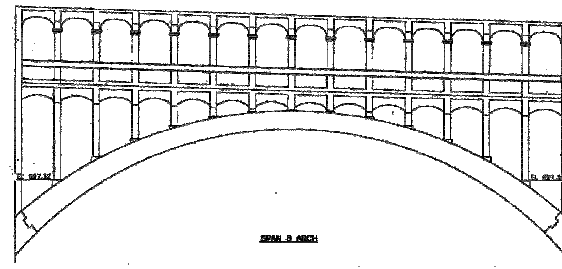
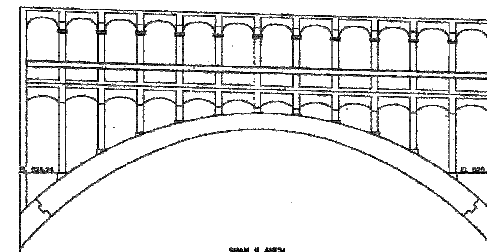
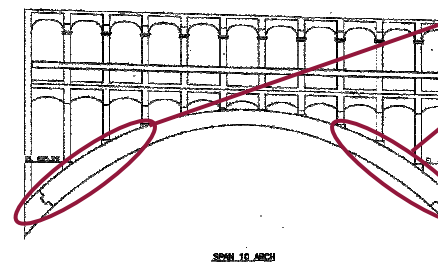
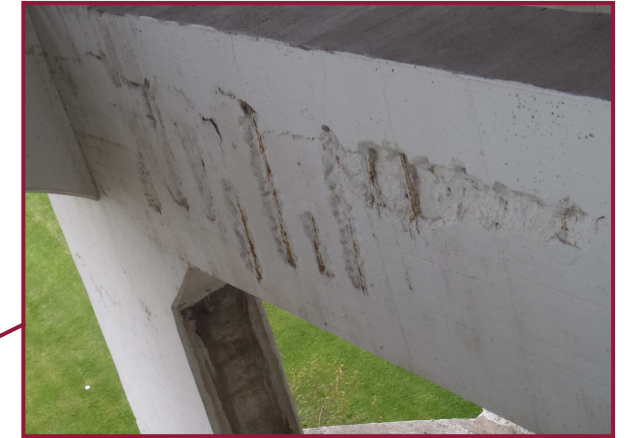
Floorbeam 10 in Span 10 exhibits intermittent spalling across the west face in the north bay, corresponding to locations of reinforcement. This condition is typical for the north bay in Span 10.

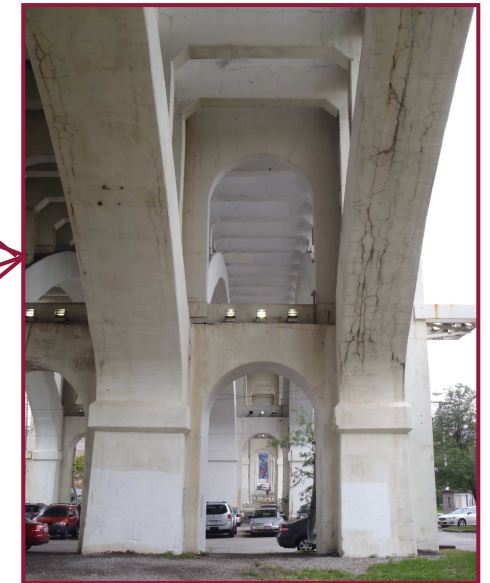
Arch A in Span 10 exhibits widespread map cracking throughout the bottom face of the rib, especially in the end 30' to 40' adjacent to the piers.

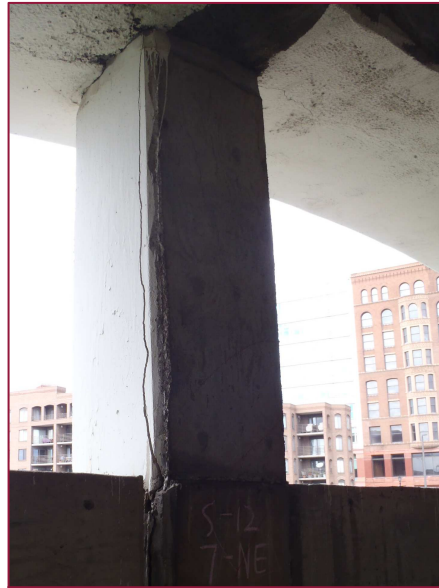
Vertical cracking of the arch Line D concrete hangers is typical in Span 12 (Hanger 7 shown above). Additionally, the arch rib exhibits moderate cracking as it passes through the lower deck (below).

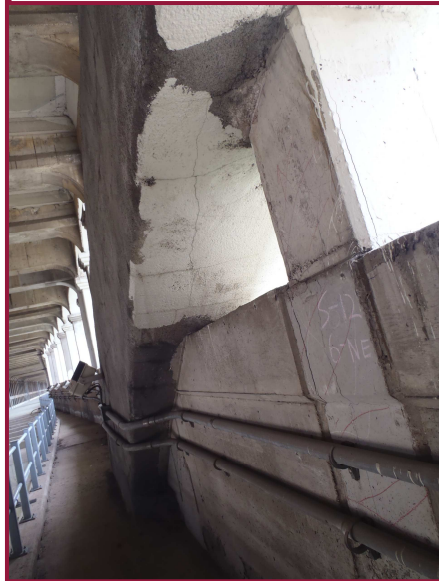
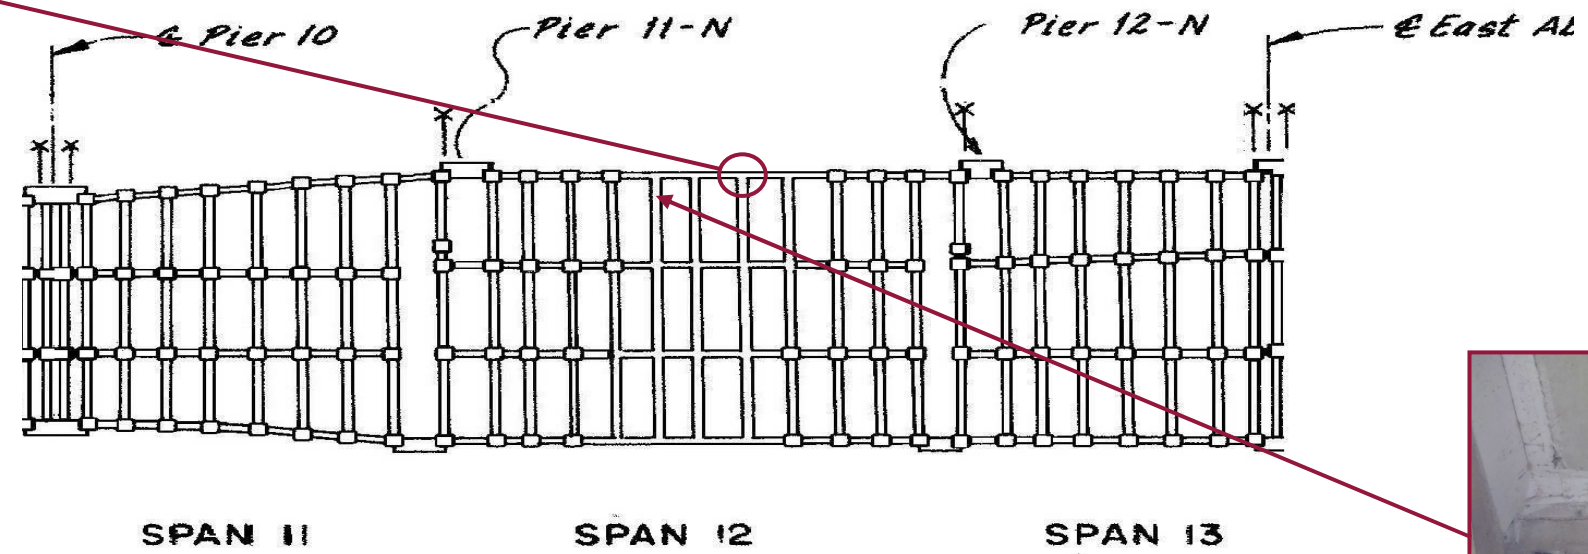
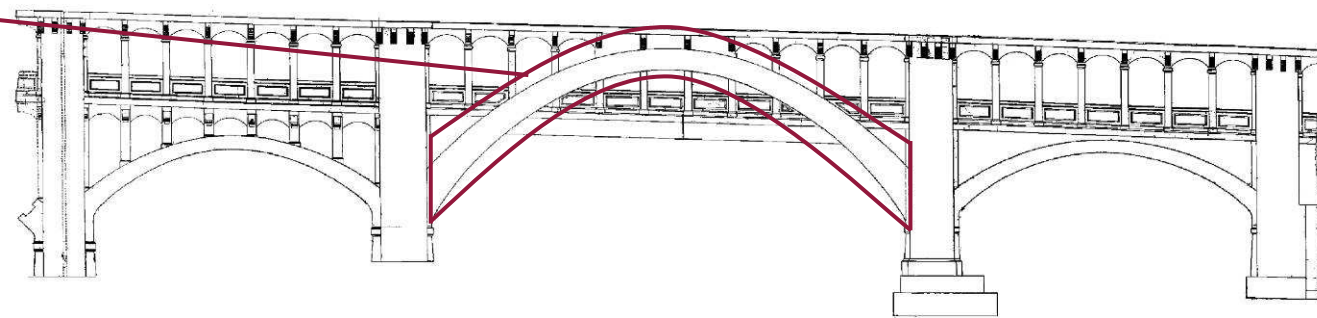
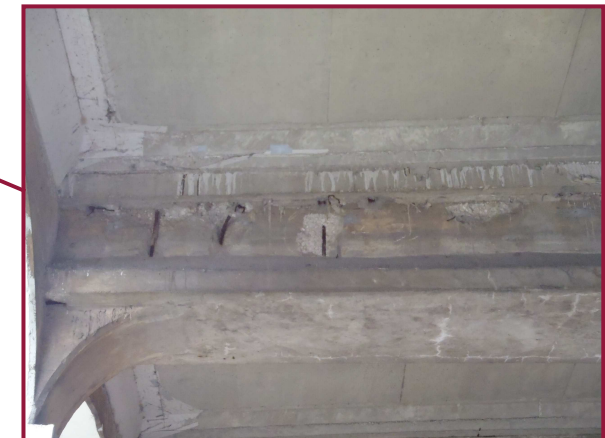
Floorbeam 5 north bay in Span 12 exhibits isolated web spalling at vertical reinforcement near the north floorbeam connection.
