**PHYSICAL CONDITION REPORT
FOR THE 2012 IN-DEPTH INSPECTION**

VETERAN'S MEMORIAL (DETROIT-SUPERIOR) BRIDGE

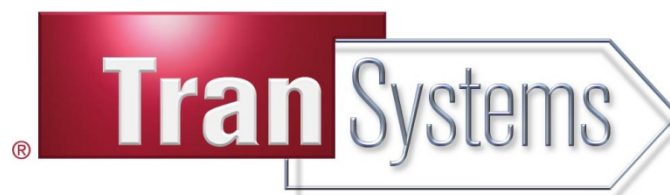
**In-Depth
PHYSICAL CONDITION REPORT
of
DETROIT-SUPERIOR BRIDGE
BRIDGE NO. CUY-6-1456
SFN: 1800930
CUYAHOGA COUNTY, OHIO**

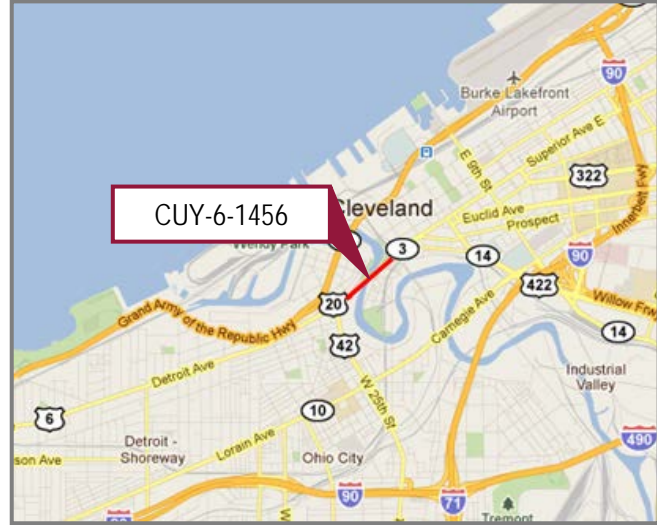
The CUY-6-1456 (Detroit-Superior) Bridge carries four lanes of US Route 6 approximately 2,880 feet over numerous local streets including the Center Street Swing Bridge, surface parking lots, RTA railroad tracks, and the Cuyahoga River. The bridge was designed as a double-deck structure, carrying vehicular and pedestrian traffic on the upper deck and street railway traffic on the lower deck. Use of the lower deck for streetcars was abandoned in 1955, but now serves as a multi-functional space for the City of Cleveland.

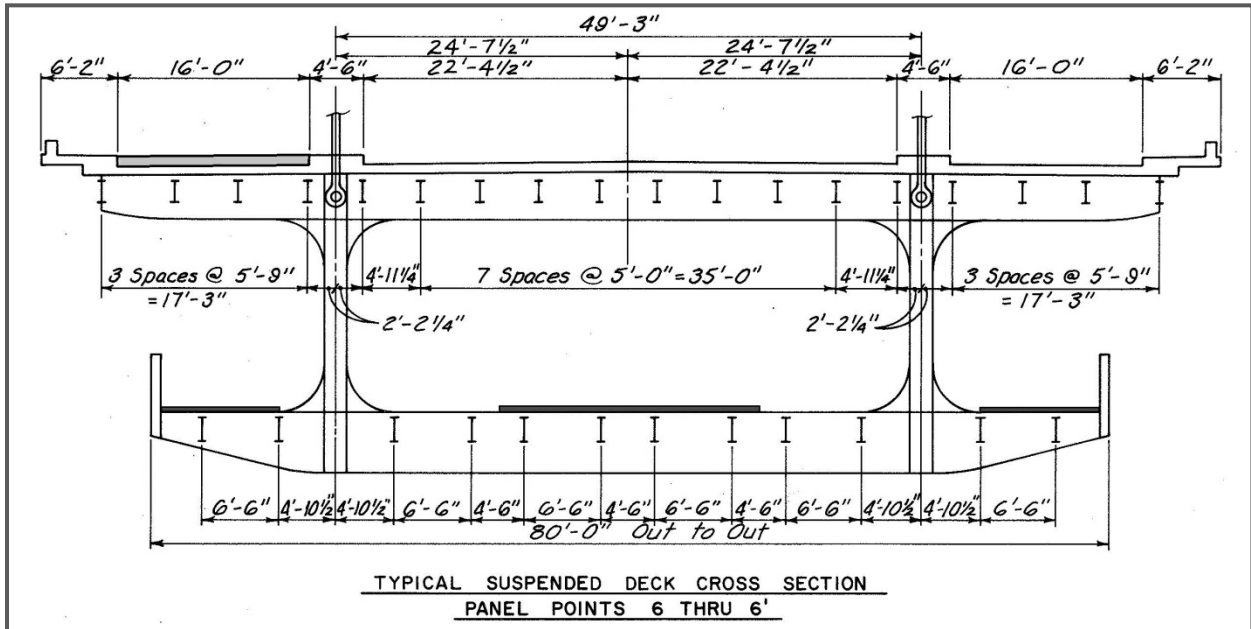
Figure 2 – Typical cross section in steel main span, looking east. Note additional top deck sidewalk added in 2003 (gray) and pedestrian walkway locations on lower deck (black).

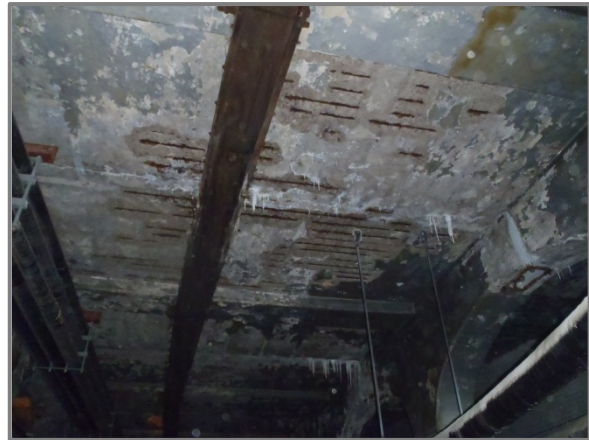
Photo 1 – Deck underside spall and heavy efflorescence in West Side Station between column lines D and E.

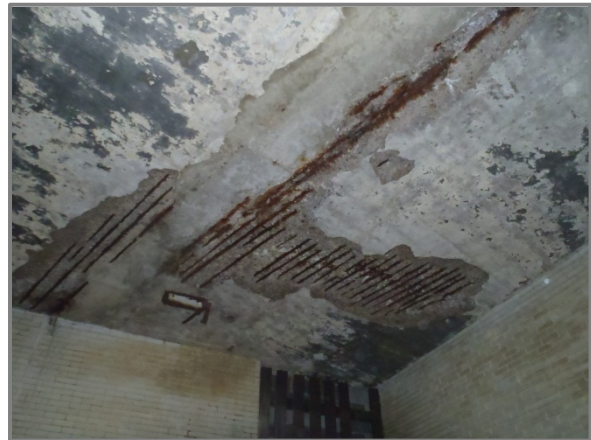
Photo 2 – Spall with exposed reinforcing in West Side Station deck underside adjacent to West 25th Street Tunnel.

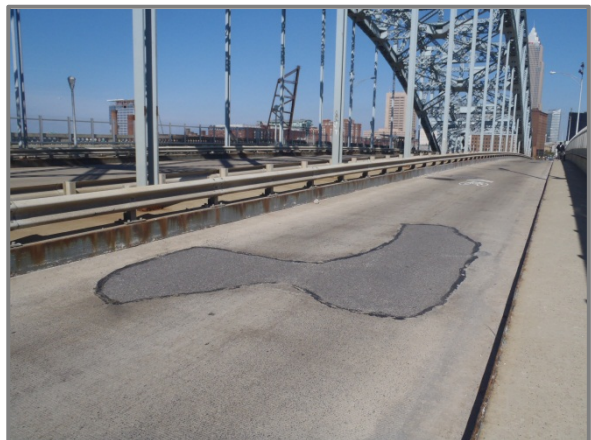
Photo 3 – Large spall with asphaltic patch in Span 4 right eastbound traffic lane.

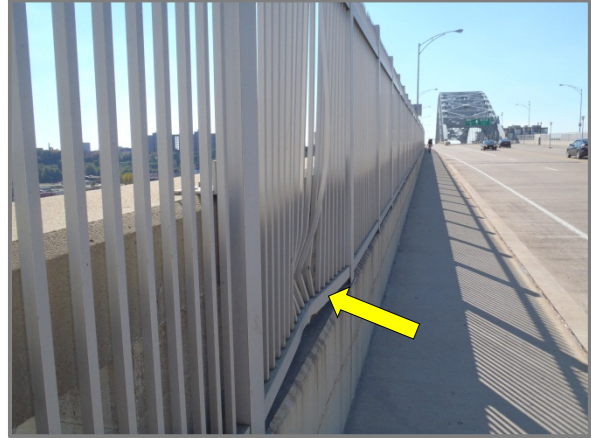
Photo 4 – Pedestrian protection fence with impact damage in Span 7.

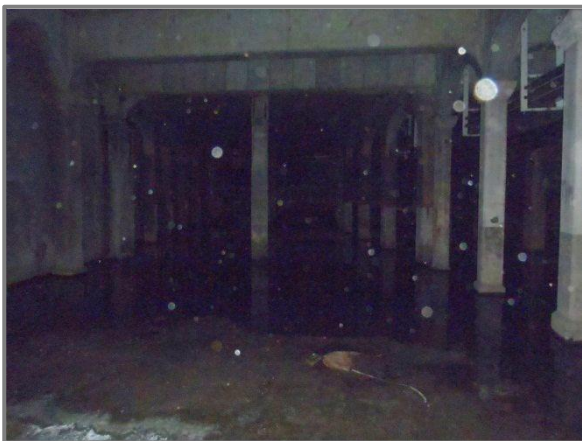
Photo 5 – East approach cellular construction with standing water.

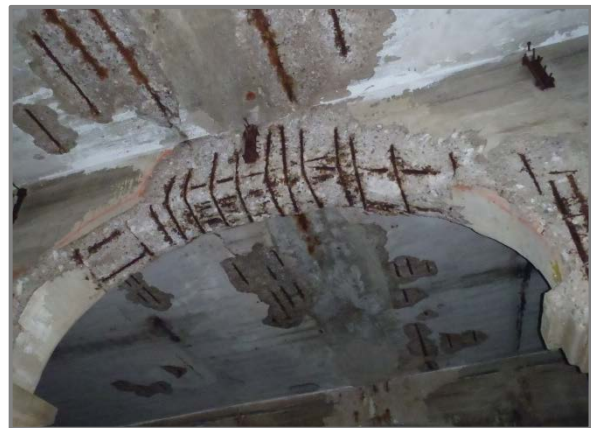
Photo 8 – Spall with exposed reinforcing in West Side Station jack arch between Columns B26 and B27.

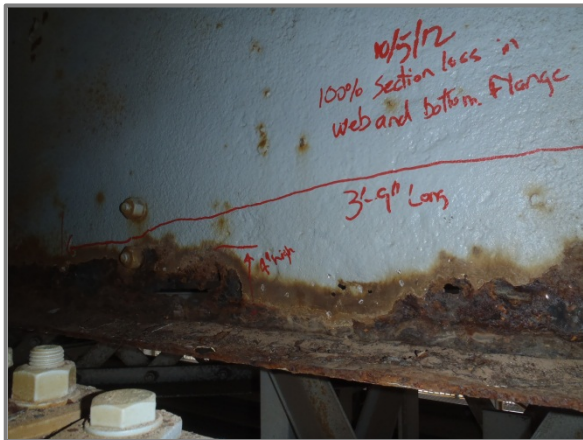
Photo 9 – Stringer P between Floorbeams 20 and 21 with 100% section loss in web and bottom flange.

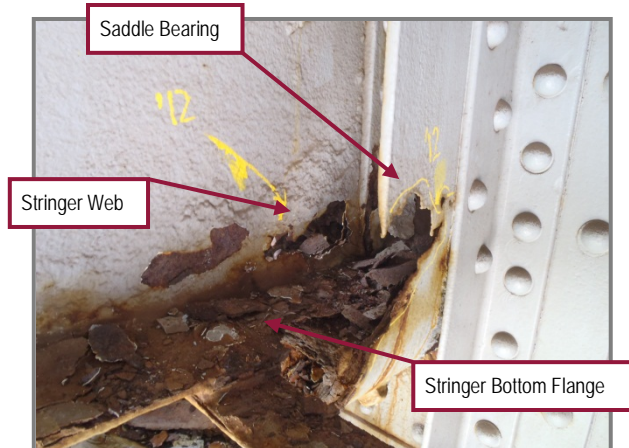
Photo 10 – Lower deck Stringer 10 at west face Floorbeam 21 saddle bearing. Note 100% section loss on the stringer web and bottom flange, as well as the saddle bearing.

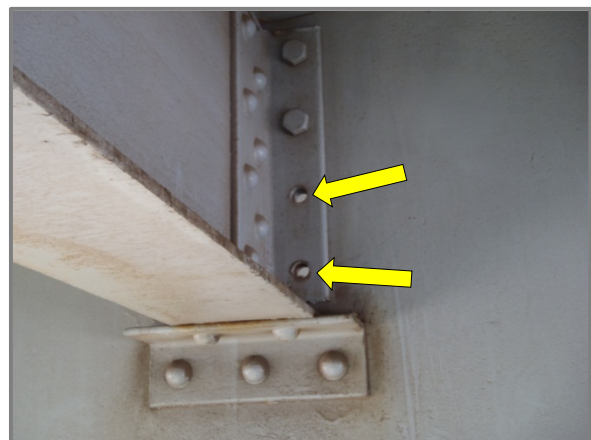
Photo 11 – Stringer F connection angle to west face of Floorbeam 18 with 2 of 4 bolts missing.

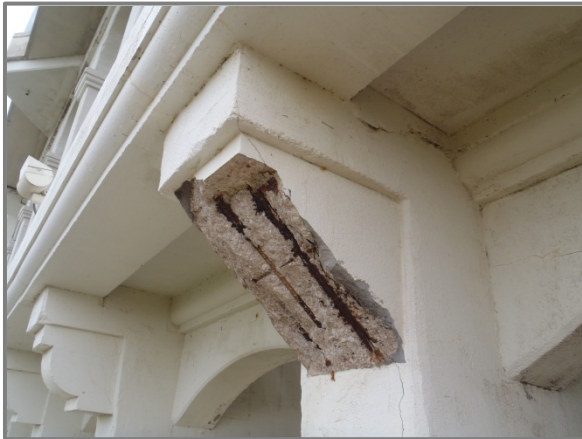
Photo 12 – Span 7 Column 10 corbel outside northernmost concrete arch with front face spall and exposed reinforcing.

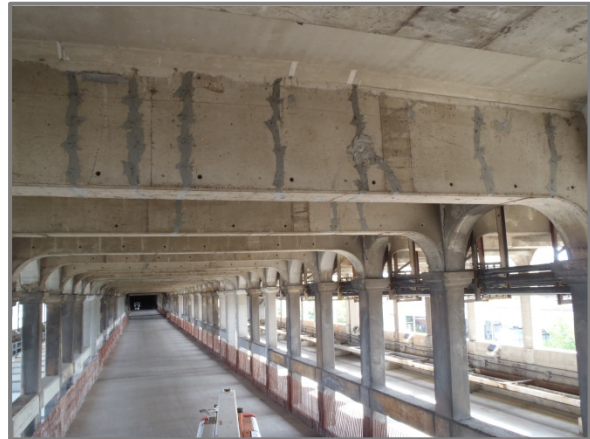
Photo 13 – Span 9 Floorbeam 6 west face with epoxy injection crack repairs between interior column lines.

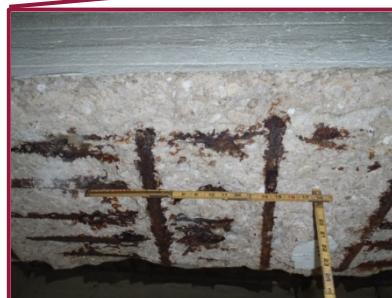
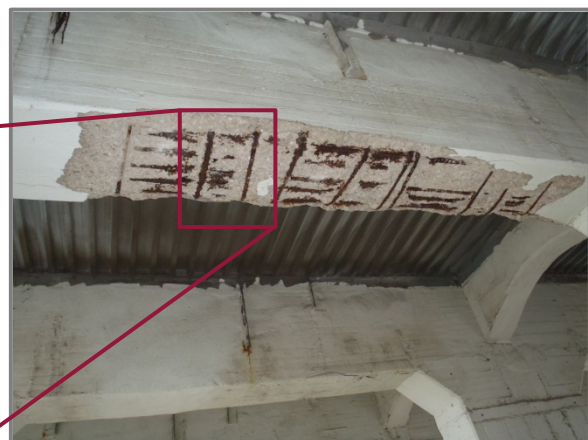
Photo 14 – Span 3 Lower Floorbeam 6 with large underside spall and exposed reinforcement with minor section loss.

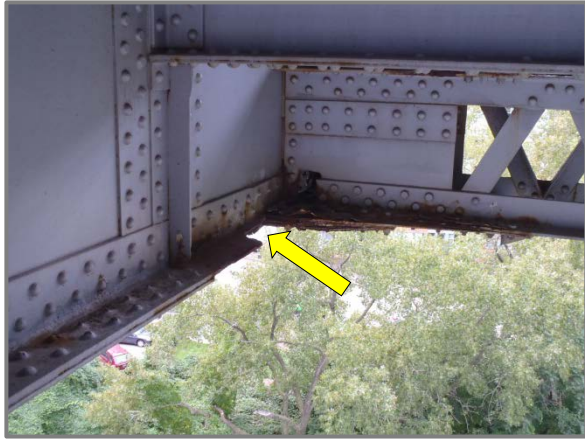
Photo 15 – Floorbeam 9 east face at North Truss with 100% section loss on bottom flange outstanding leg (west face similar).

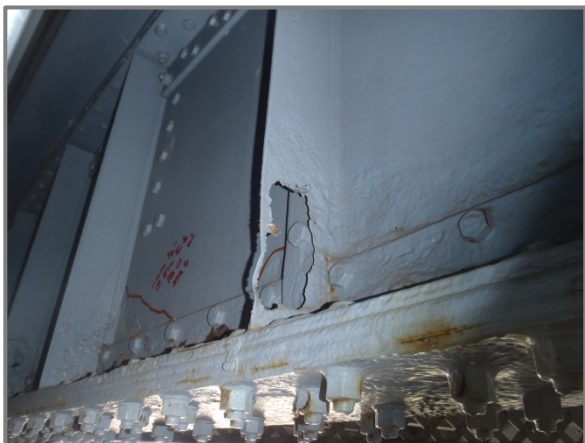
Photo 17 – West face of Floorbeam 0 with heavy losses to the web plate, web stiffeners and bottom cover plates.

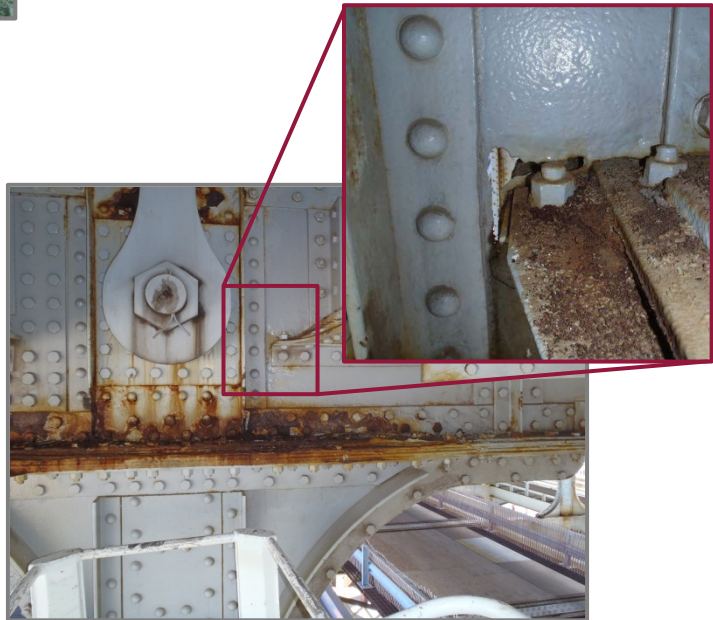
Photo 16 – Floorbeam 12 west face with perforation in web along lateral brace connection plate.

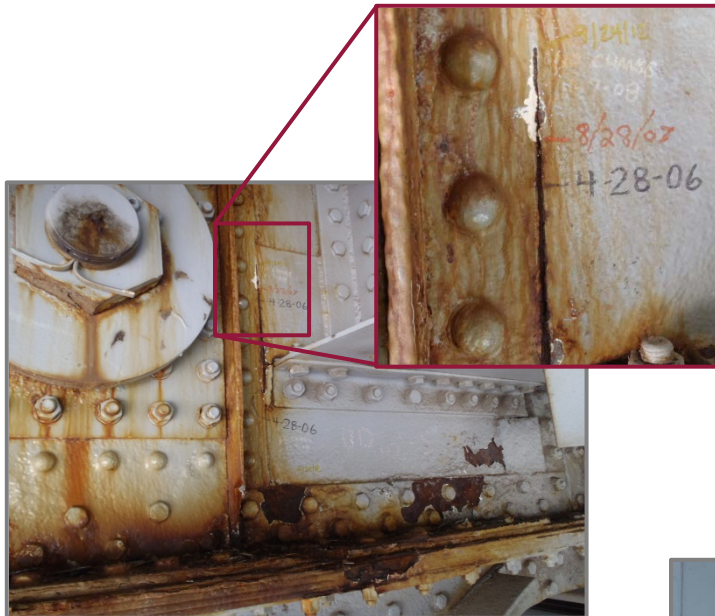
Photo 18 – Floorbeam 14 east face adjacent to South Truss hanger with crack in web retrofit plate weld.

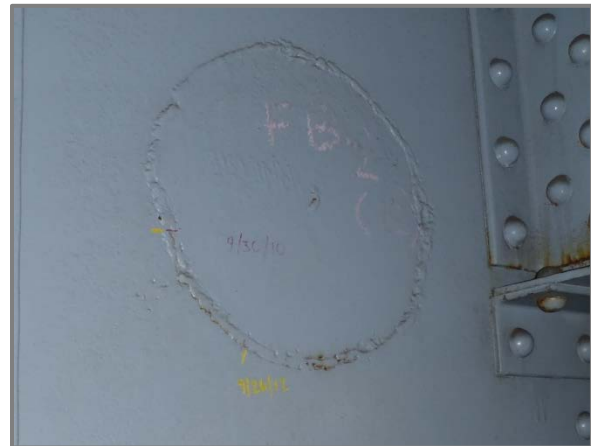
Photo 19 – Floorbeam 23 east face near North Truss with circular retrofit exhibiting a broken weld which has propagated a total of 3/8" since the 2010 inspection.

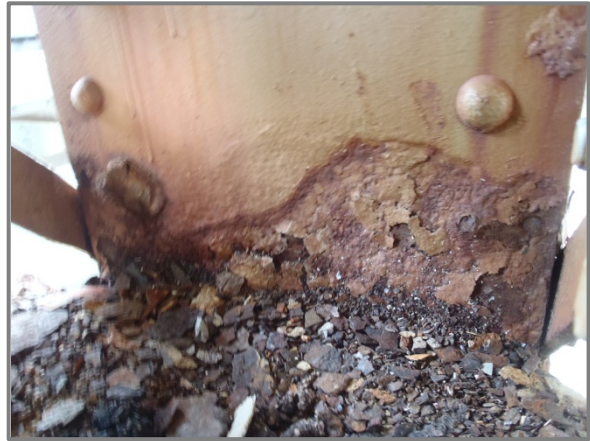
Photo 20 – South Truss vertical member U3-L3 with heavy active corrosion and section loss to interior faces of box section (west web plate shown).

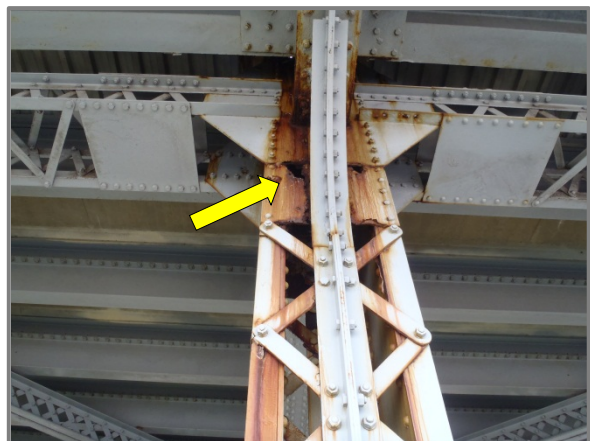
Photo 21 – North Truss U3-L3 north face with 100% section loss in batten plate at longitudinal strut connection.

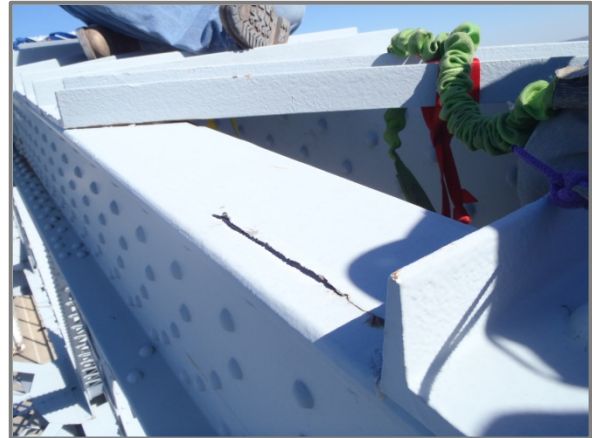
Photo 23 – South Truss U7-U8 with 8" long by 1/2" wide by 1/16" thick laminar tear in north top flange angle.

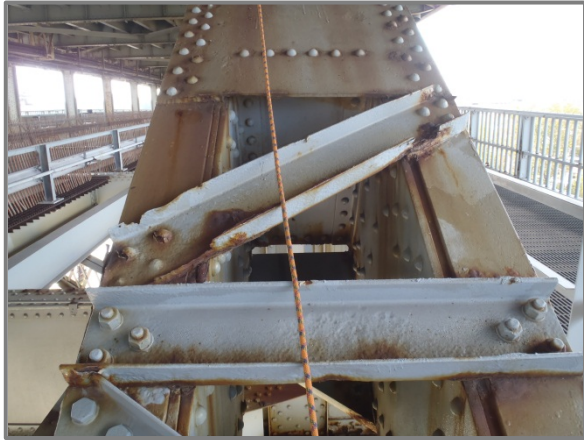
Photo 25 – North Truss member L20-L21 with heavy section loss on top lacing channels east of L20.

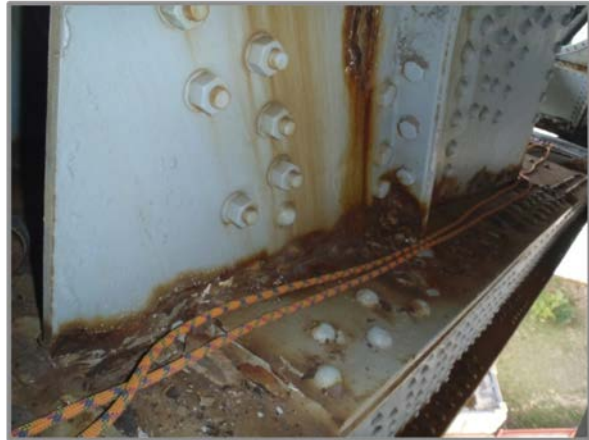
Photo 26 – North truss interior L20 gusset plate with heavy pitting and active corrosion on south face along west lower chord connection.

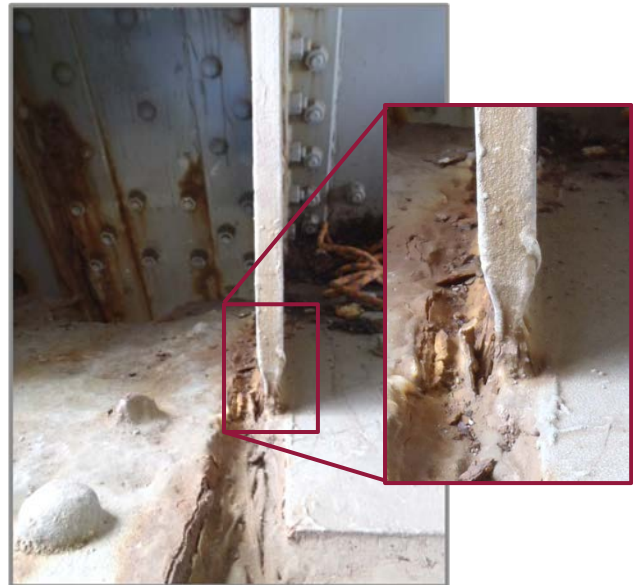
Photo 27 – South Truss L2 interior gusset plate with 1/4" effective thickness remaining for 24" along connection to member L2-L3.

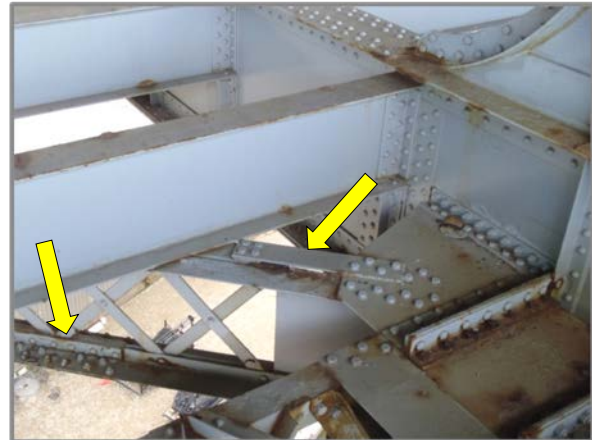
Photo 29 – Lower framing lateral bracing member with multiple bolted retrofits near connection to east face of Floorbeam 16.

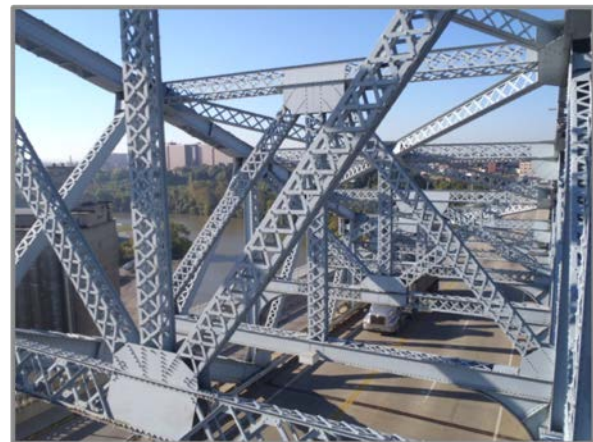
Photo 30 – General view of main truss sway bracing, looking west from Panel Point 8.

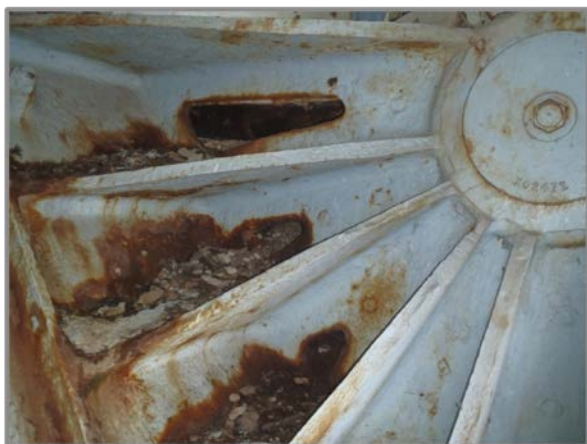
Photo 32 – Northwest truss bolster with substantial section loss to bearing stiffeners and rust reactivation.

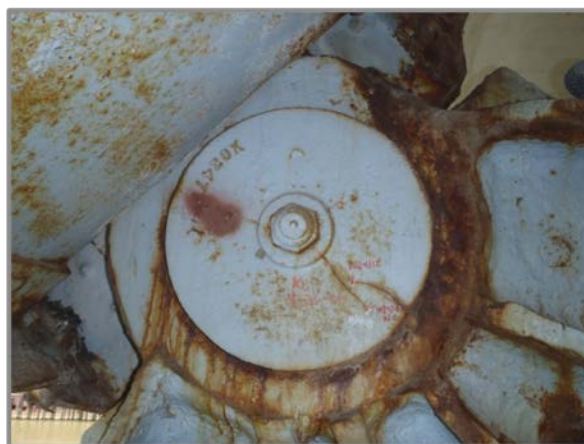
Photo 33 – North pin retaining washer at L0 South Truss with 2 radial cracks.

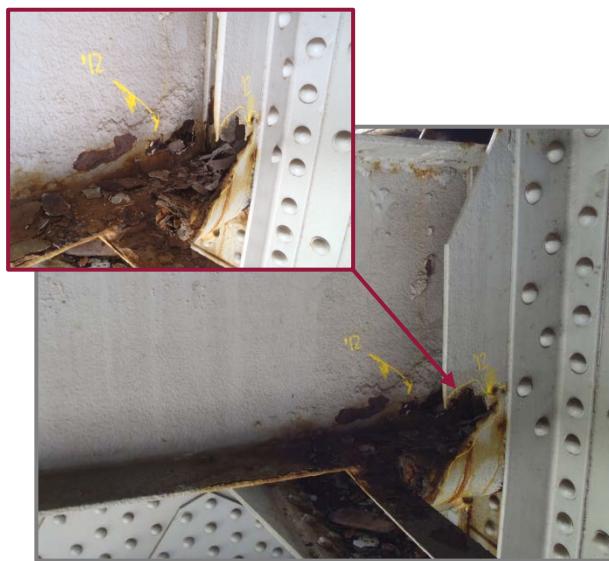
Photo 34 – Lower deck Stringer 10 south face saddle bearing at Floorbeam 21. Note 100% section loss on the stringer web, bottom flange, and saddle bearing.

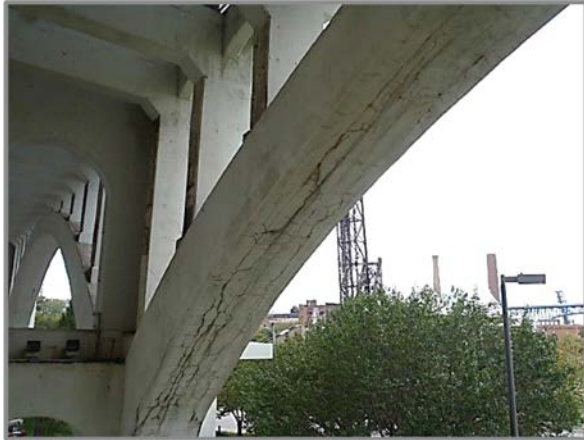
Photo 35 – Map cracking throughout underside of Arch A in Span 10, looking west toward Pier 9.

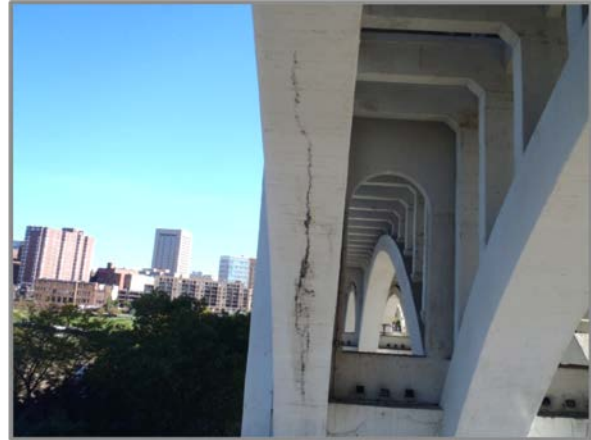
Photo 36 – Span 5 Arch A exhibiting longitudinal crack approximately 1/4" wide by 40' long on underside of arch rib.

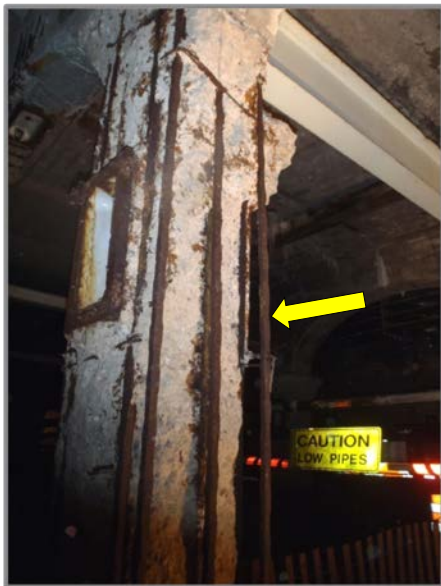
Photo 37 – Column C13 in West Side Station with advanced spalling and fully exposed reinforcement exhibiting moderate loss of section. Condition has worsened since previously noted during the 2011 inspection.

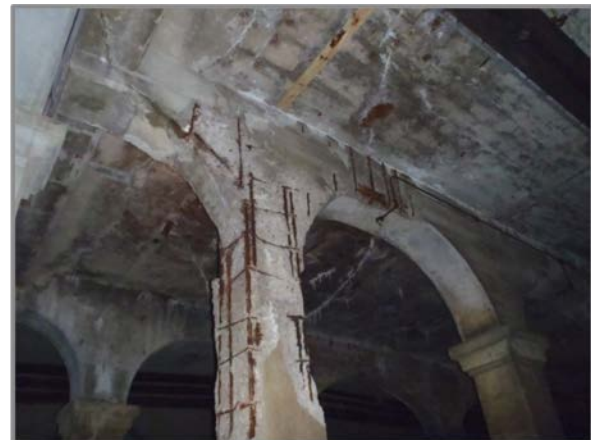
Photo 38 – Easternmost column in West Side Station jack arch Line C with heavy spalling and exposed rebar on all faces.

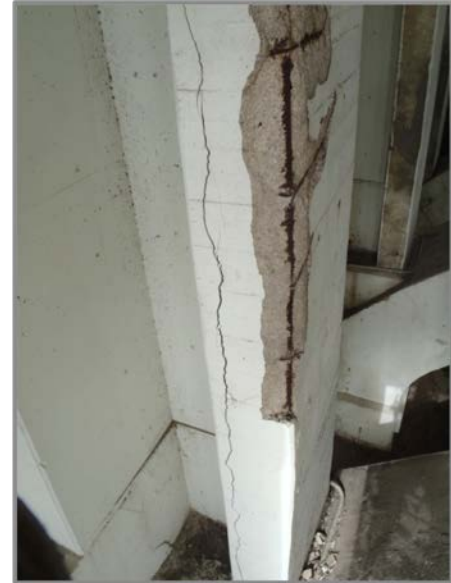
Photo 39 – Span 2 Column 1C with southeast corner spall and exposed reinforcement with section loss.

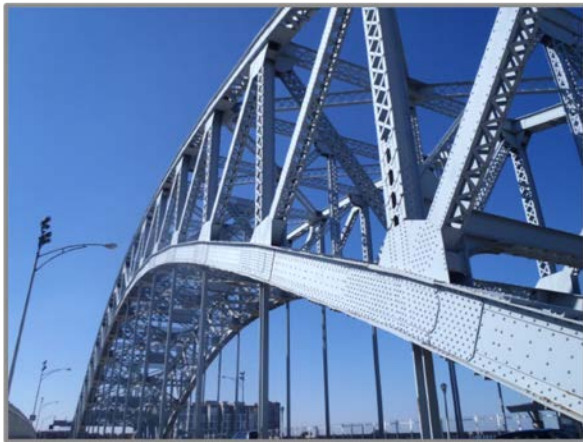
Photo 40 – General view of South Arch, looking west, showing overall paint condition of members above deck.

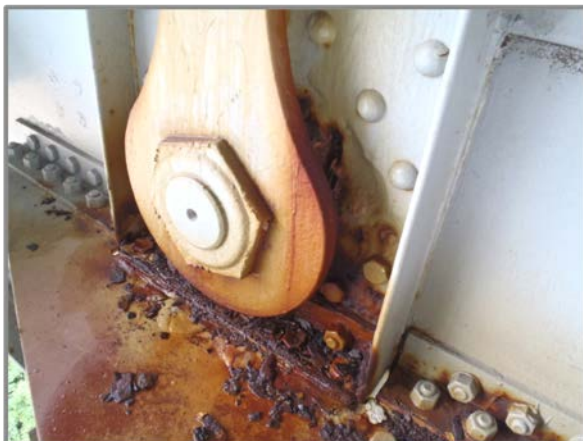
Photo 41 – East lower eyebar connection at L4 North. Note active corrosion in area and up to 3/8" pitting on pin plate.

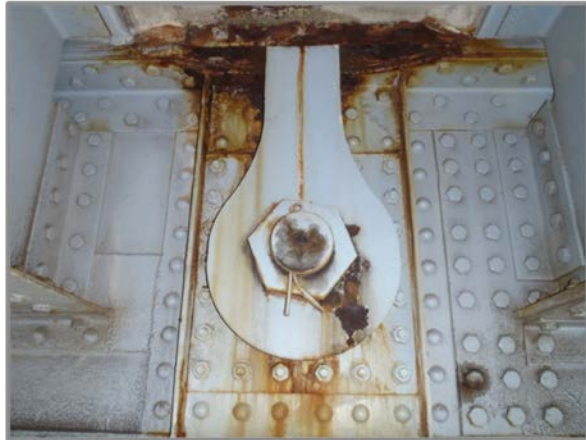
Photo 42 – West face of eyebar at connection to south lower pin at Panel Point 11. Note moderate corrosion throughout area but section loss on eyebar.

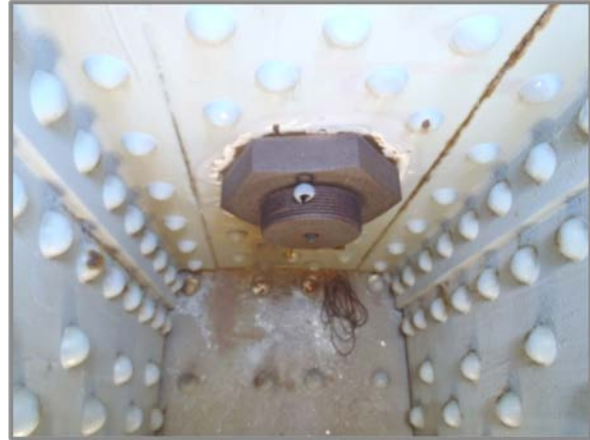
Photo 43 – Unpainted west pin nut on upper eyebar connection at L13 North. Active rust present with no measureable section loss.

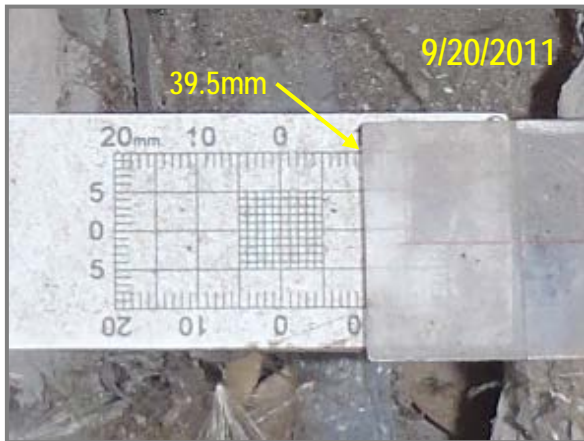
Photo 45 – September 20, 2011 South Tower B crack gauge reading (during 2011 routine inspection by TranSystems).

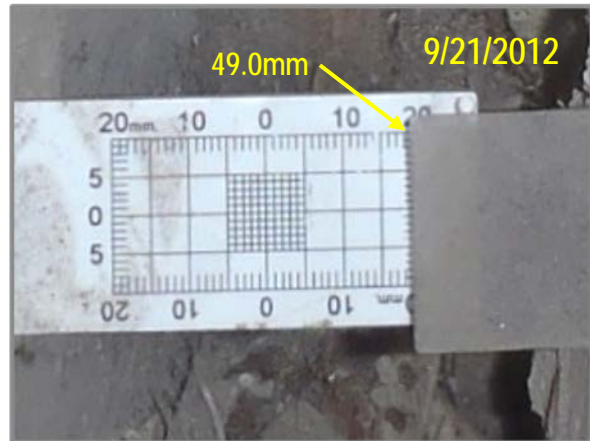
Photo 46 – September 21, 2012 South Tower B crack gauge reading (during 2012 in-inspection by TranSystems).

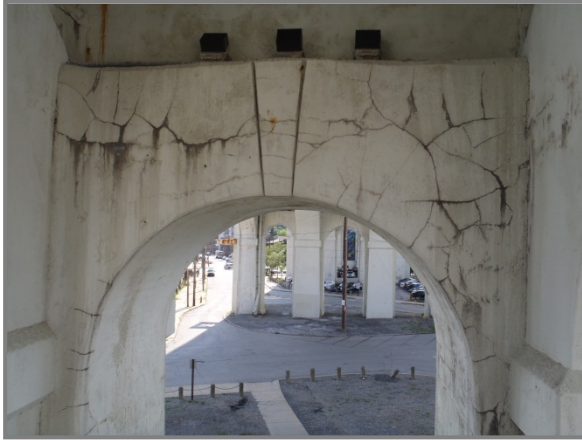
Photo 47 – Pier 7 lateral strut between Arch lines B and C with map cracking throughout.

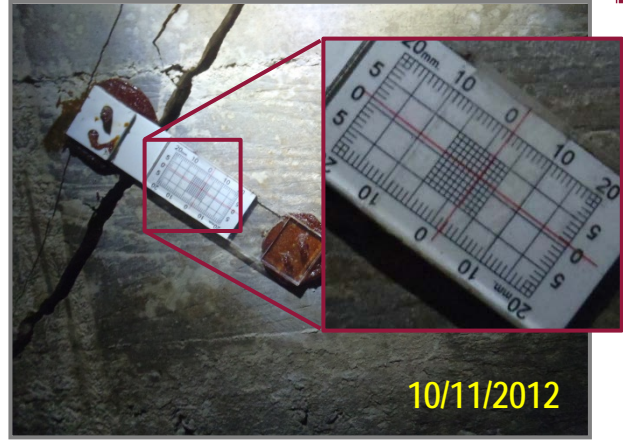
Photo 48 – Crack Gauge 1 showing approximately 2mm of movement since installation in 2007.

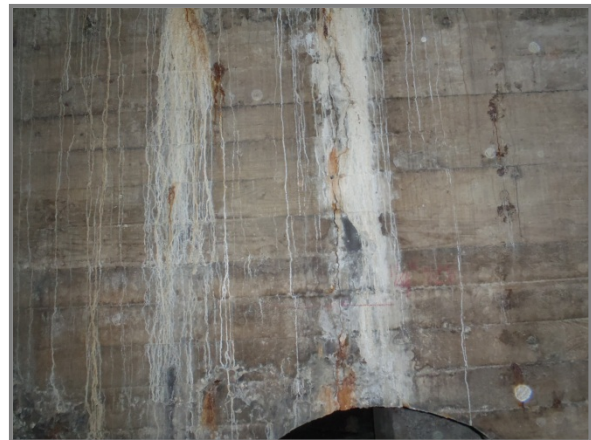
Photo 49 – Cell 0N in Span 1B with 1/2" crack with spalls and heavy efflorescence on east face.

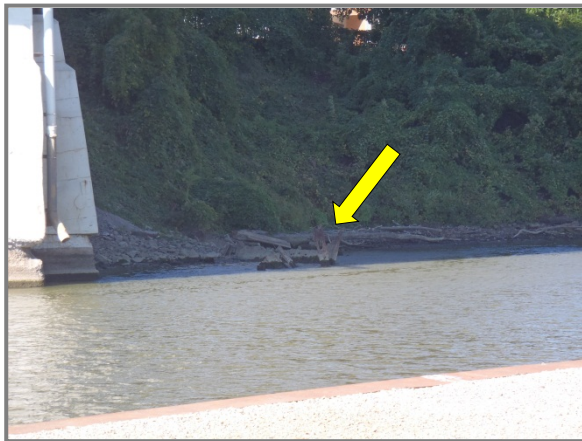
Photo 50 – Failed sheet pile protection downstream of Pier 3.

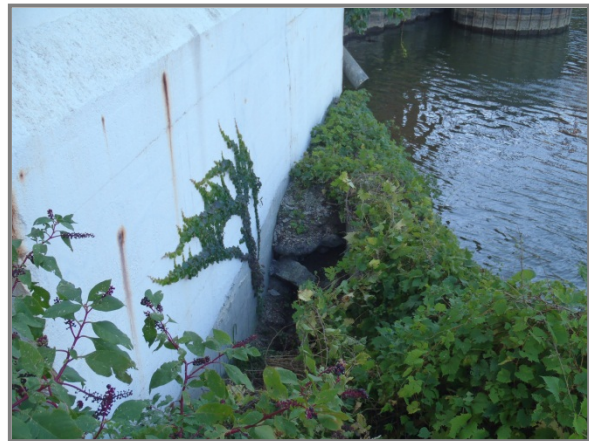
Photo 51 – Sinkhole along north face of Pier 4 which has increased in size since last inspected.

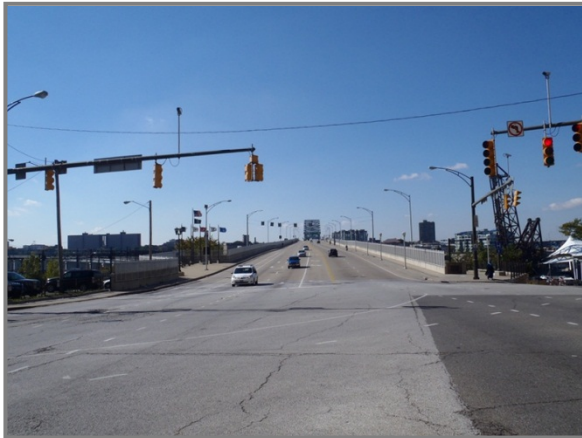
Photo 52 – General view looking toward the structure from the East Approach.

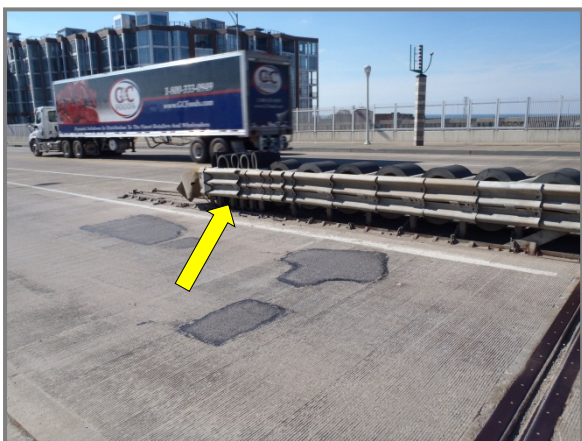
Photo 53 – Eastbound impact attenuator exhibiting damage from vehicular impact at the west end of the South Truss.

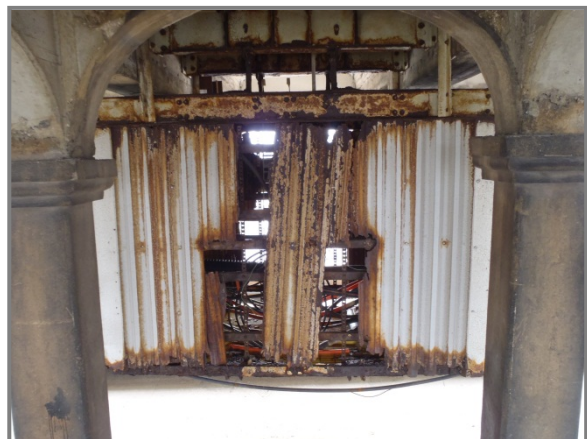
Photo 54 – Utility junction box in Span 6 with advanced corrosion throughout and failed outer containment. Deterioration is due to water infiltration through access manhole above.

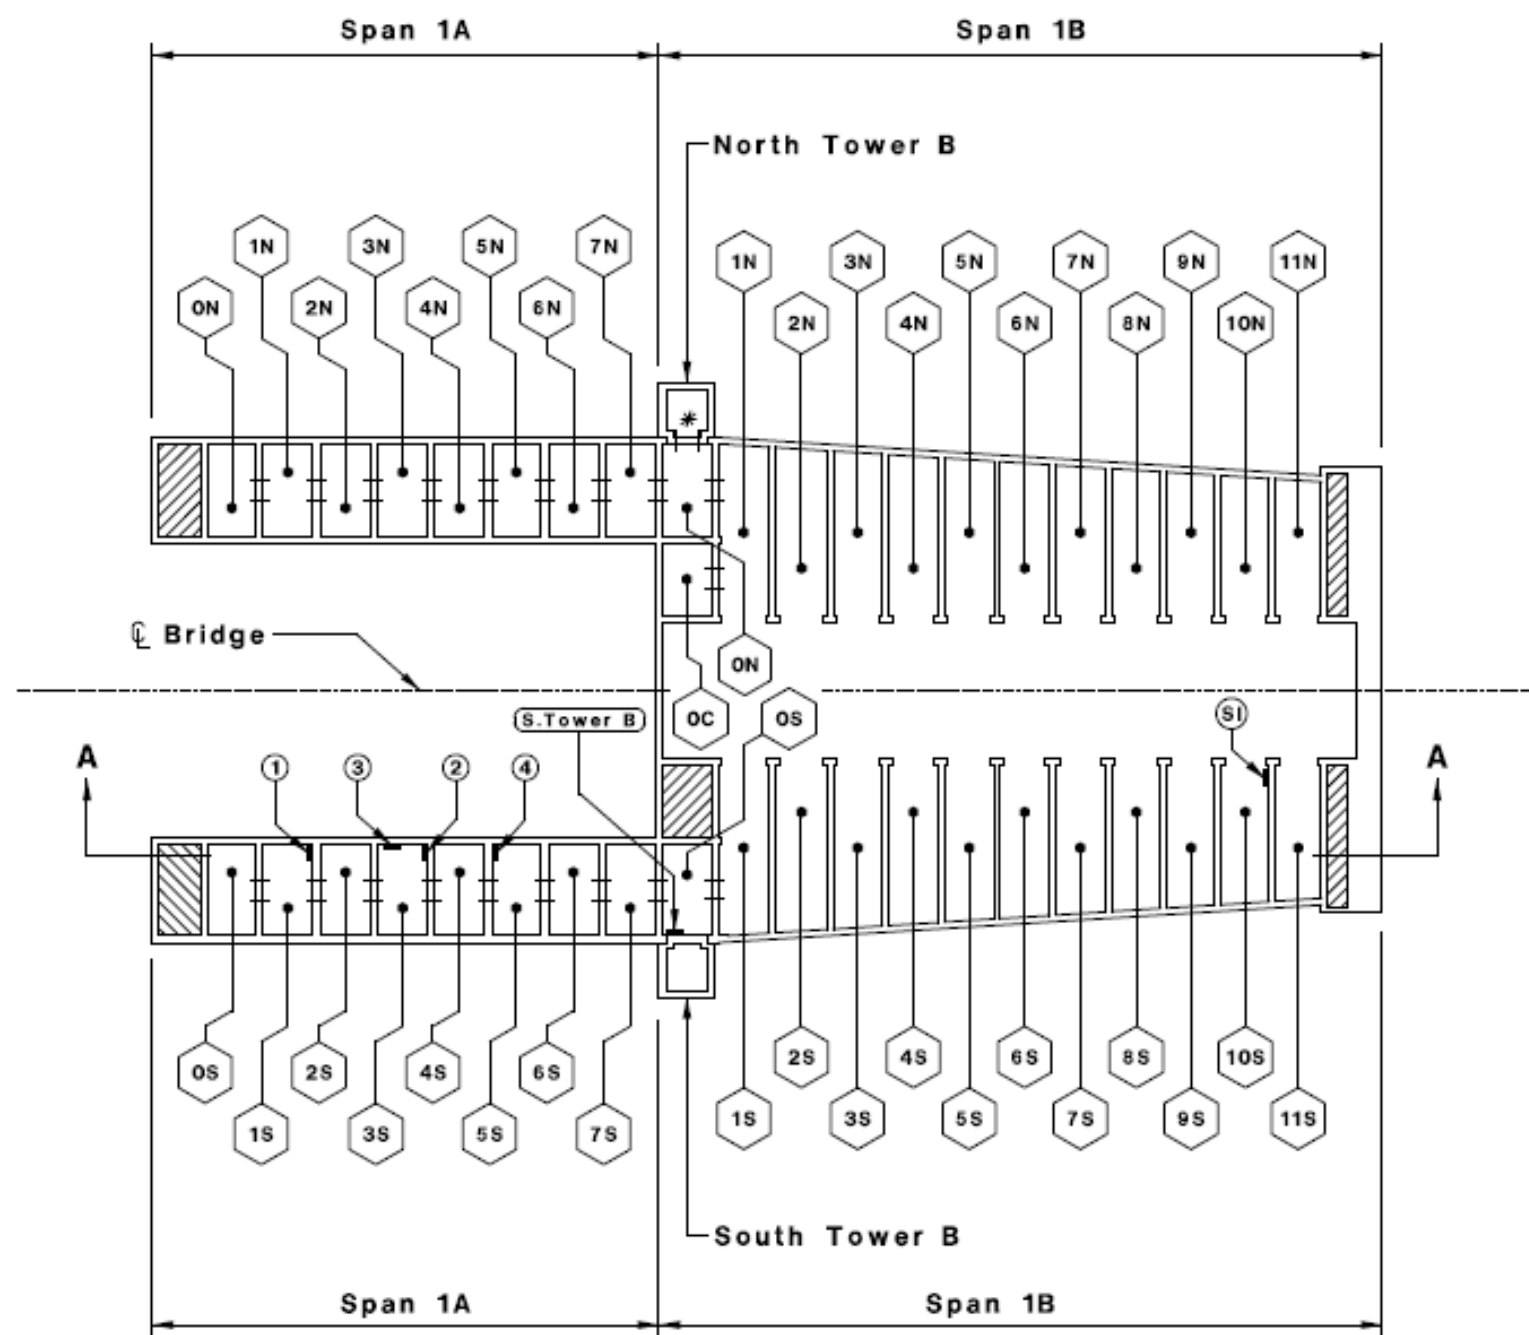
Cellular Construction Layout, Unified Nomenclature and Crack Gauge Locations

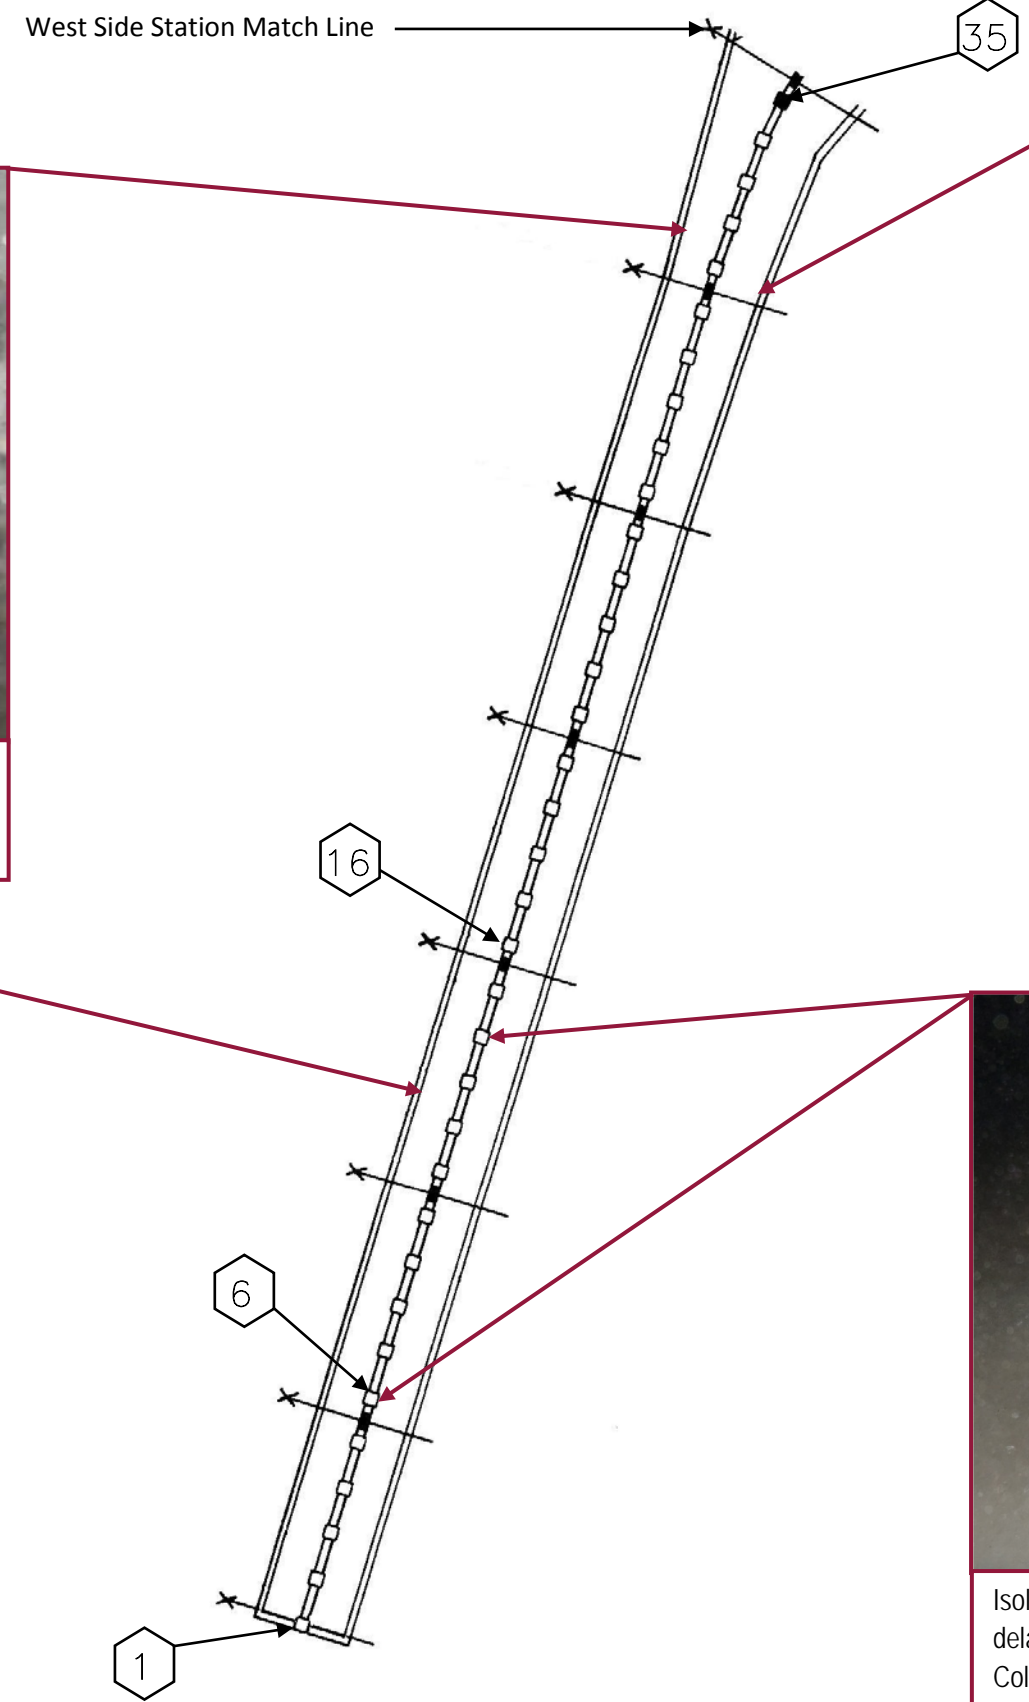
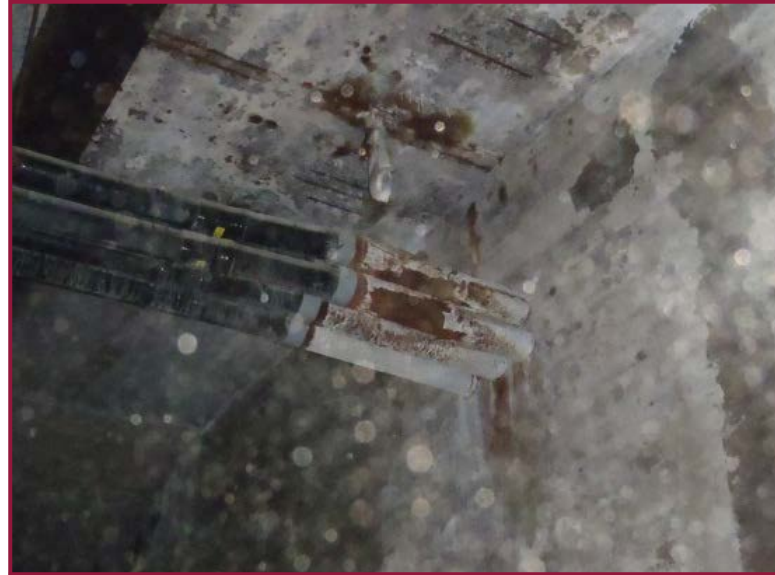
The transverse utility conduit in Bay 31 exhibits moderate corrosion of the projecting pipes at both walls (west wall shown). The deck slab is leaking above this location, contributing to the corrosion.

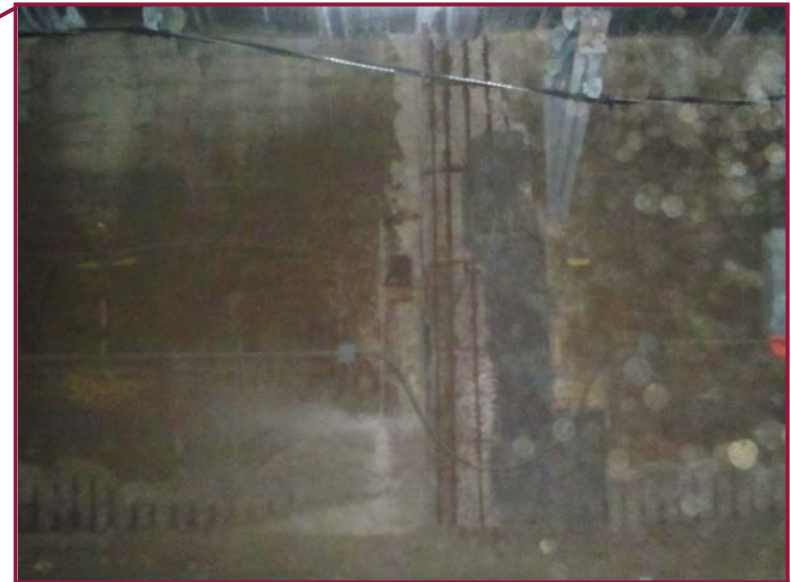
The east wall in Bay 30 (joint location) exhibits a full height spall and partial concrete repair. This condition is common at joint locations throughout the West 25th Street Tunnel.

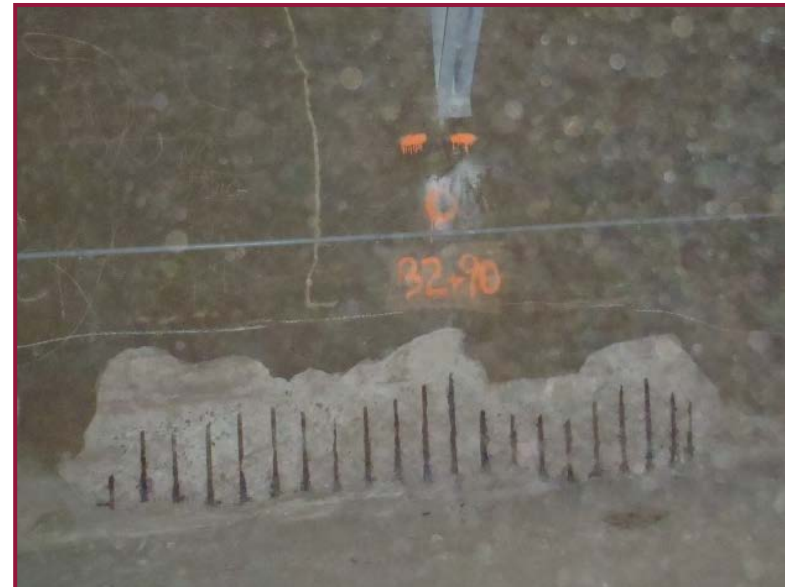
Approximately 8' long section of localized spalling along the bottom of the west wall in Bay 12. Exposed reinforcement typically exhibits negligible loss.

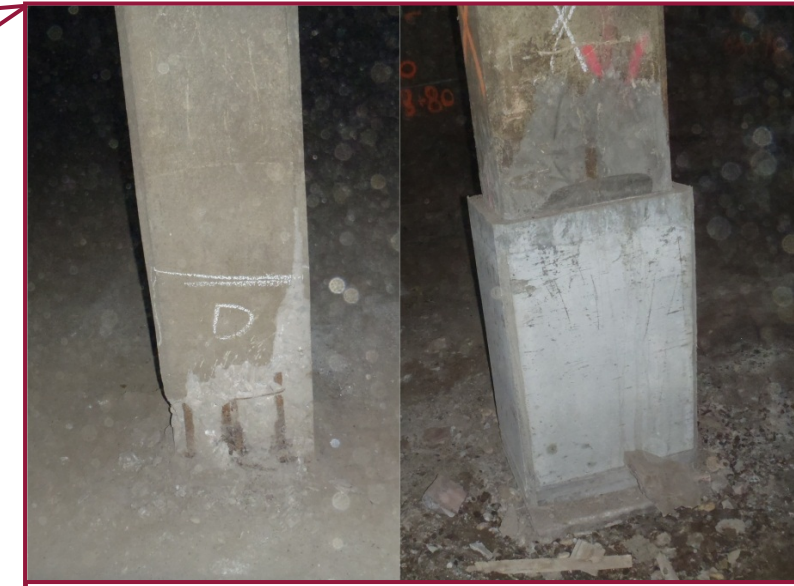
Isolated columns throughout the West 25th Street Tunnel exhibit delaminations or spalls with exposed reinforcement at the base (left; Column 14). Numerous column bases have received repairs at this location (right; Column 6).

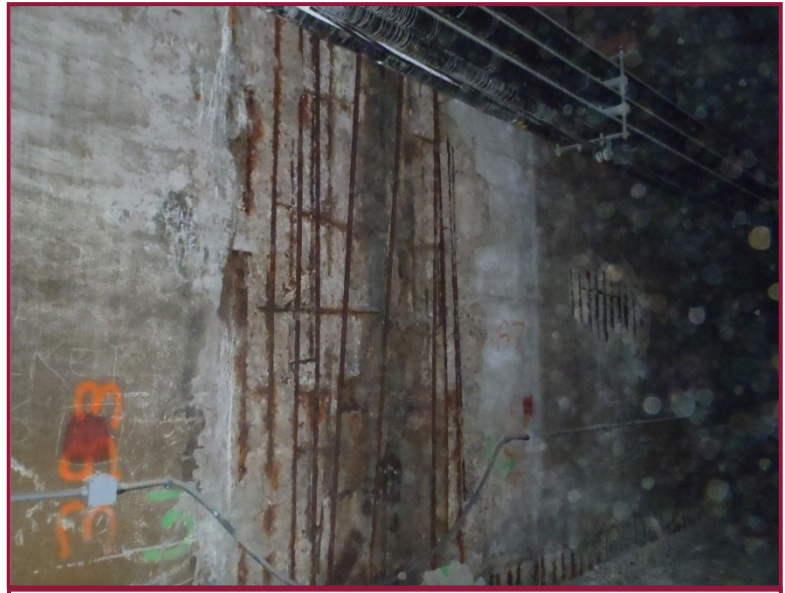
Full height by 8' wide spall with exposed reinforcement in south wall between Columns 19 and 20 (joint location). Several reinforcing bars have 100% section loss. This condition is common at joint locations throughout the Detroit Avenue Tunnel.

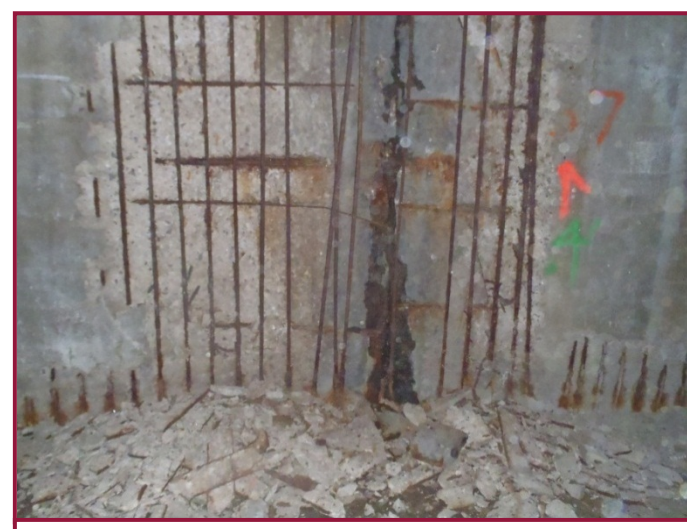
Up to 3" deep spall with exposed reinforcement in north wall at joint location between Columns 29 and 30. Spalled area is 8' wide by up to full height with numerous rebar exhibiting 100% section loss. Note the accumulation of spalled concrete at the base of the wall.

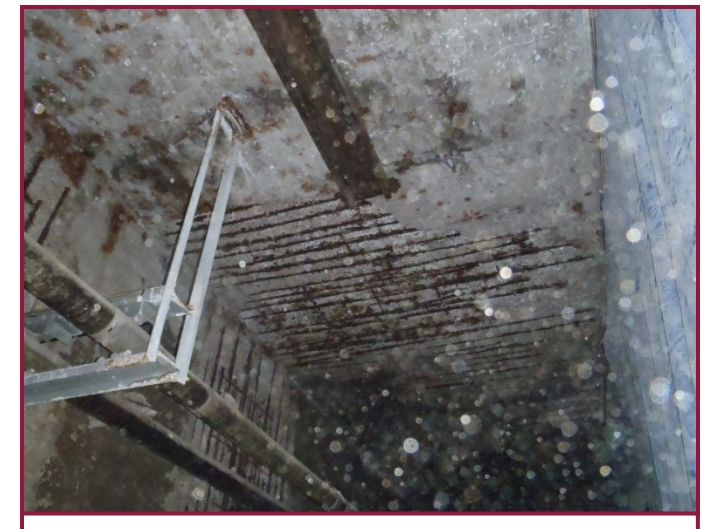
Large spall (~200 ft²) in deck underside adjacent to the north wall between Columns 46 and 47. All transverse reinforcing bars are exposed within spalled area.
