**PHYSICAL CONDITION REPORT
FOR THE 2012 IN-DEPTH INSPECTION**

VETERAN'S MEMORIAL (DETROIT-SUPERIOR) BRIDGE

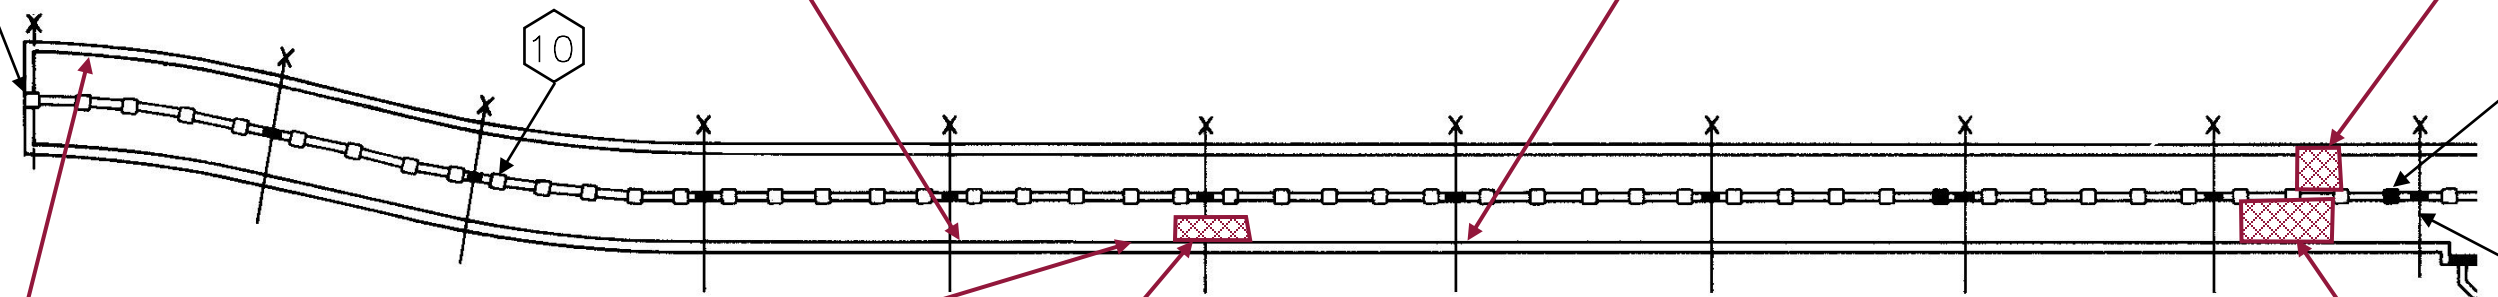
West Side Station Match Line

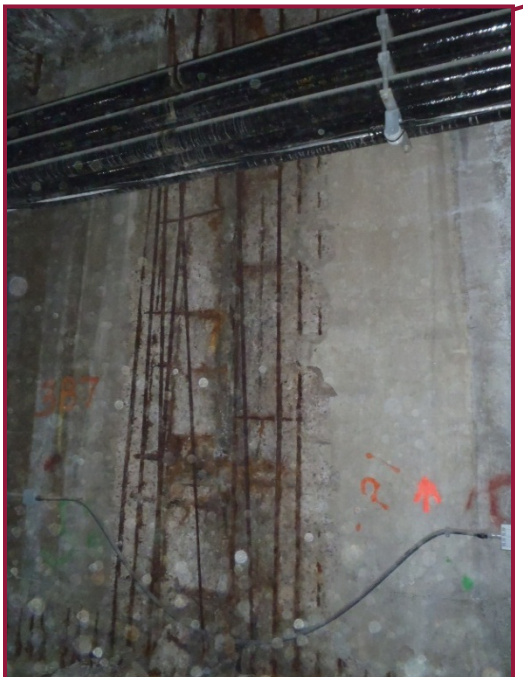
South wall exhibits a 6' wide by full height spall with exposed reinforcement adjacent to Column 23. Several vertical bars exhibit 100% section loss

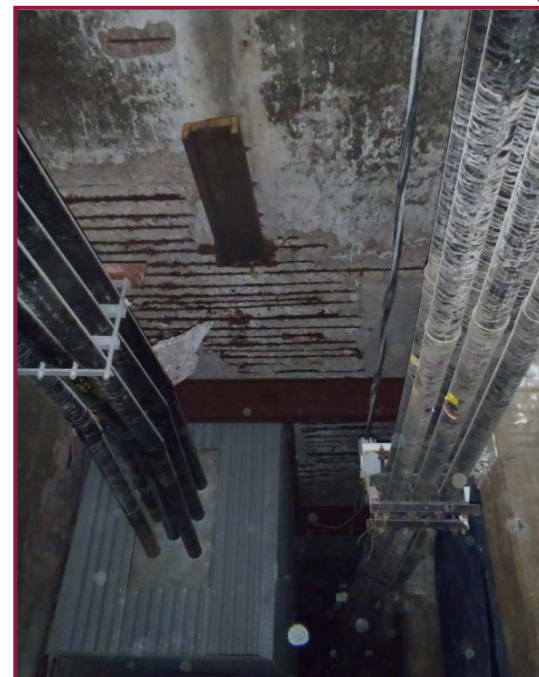
Large spall in deck underside (approximately 20' long by 8' wide) with all transverse bars exposed at east end of the Detroit Avenue Tunnel.

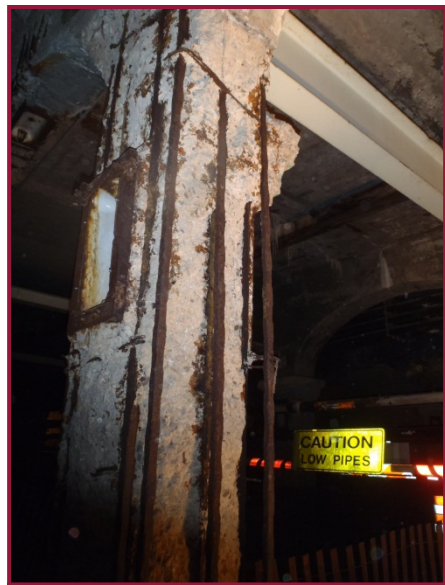
Column 14 in Line C exhibits up to 5" deep spalling, significant loss of concrete cover and exposed rebar with minor section loss. While large spalls are common throughout the concrete columns, the magnitude of deterioration shown here is isolated to only a few locations.

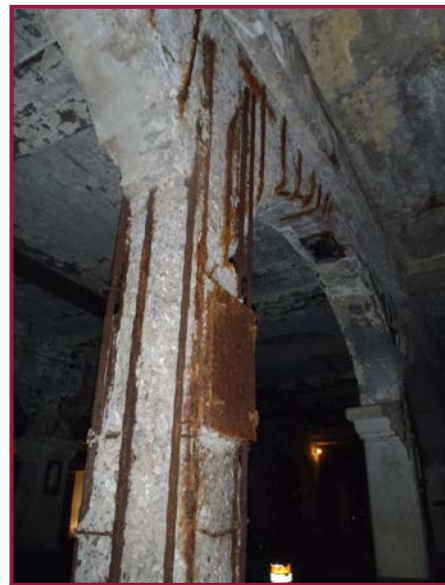
Column 16 in jack arch Line A with advanced spalling and fully exposed reinforcement with section loss.

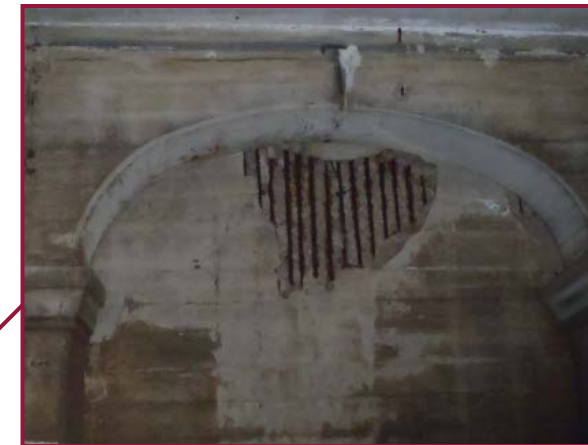
The south face of the north wall exhibits widespread spalled and delaminated areas from approximately Column 23 to Column 31. The full height of the wall exhibits spalls/imminent spalls between Columns 26 and 28.

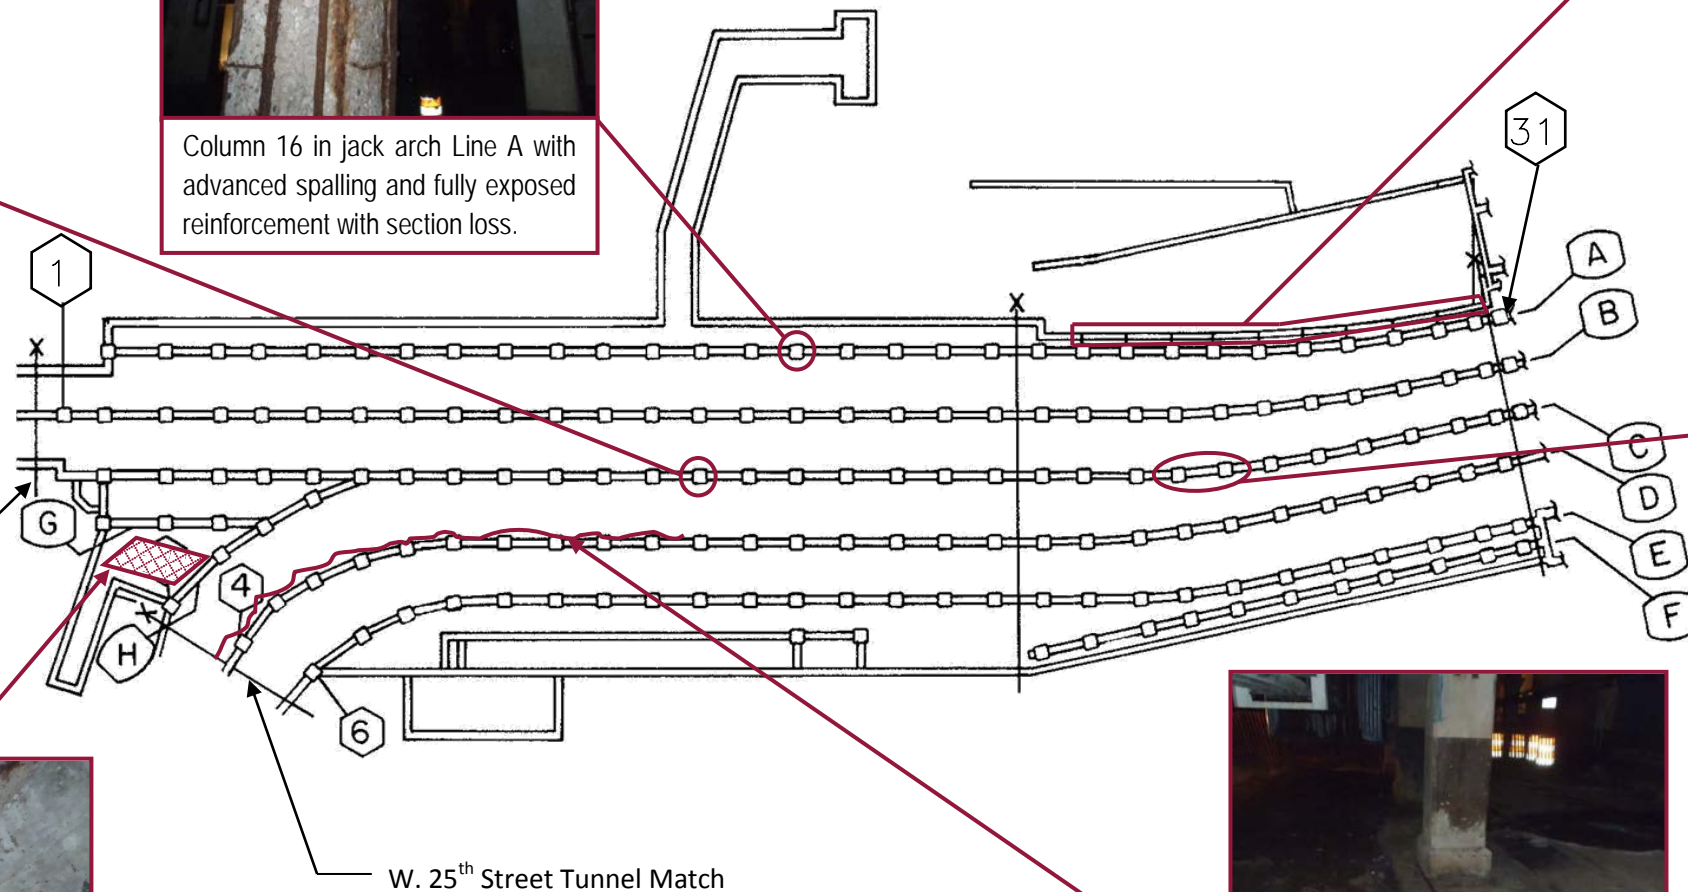
Detroit Avenue Tunnel Match Line

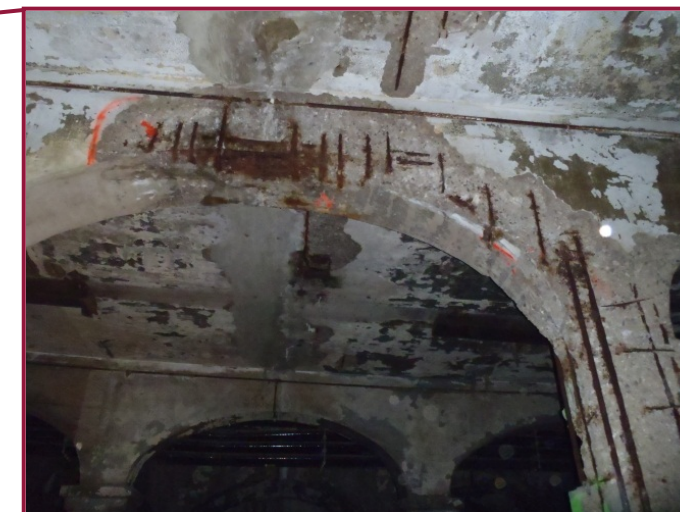
The Line C jack arch between Columns 24 and 25 exhibits advanced spalling with exposed reinforcement throughout the north face. This spalled area extends into Column 25.

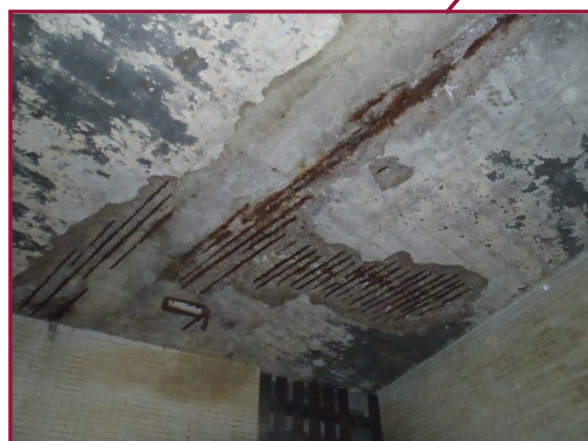
Large spall (~30 ft²) in the deck underside between jack arch Lines G and H. Spalls are common throughout the upper deck floor in the West Approach, typically ranging from 2 ft²-10 ft².

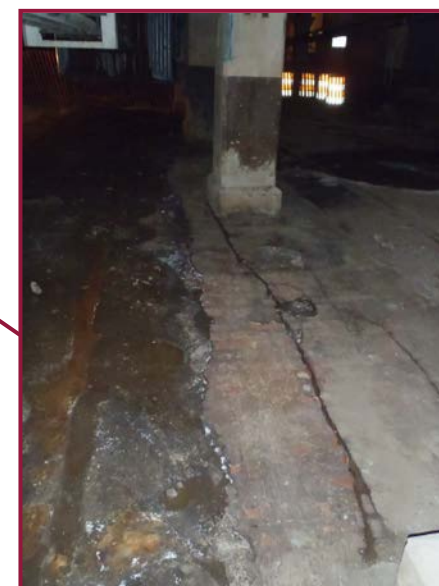
Crack in lower deck up to 1" wide extends from approximately Column 3 to Column 14 along Line D.

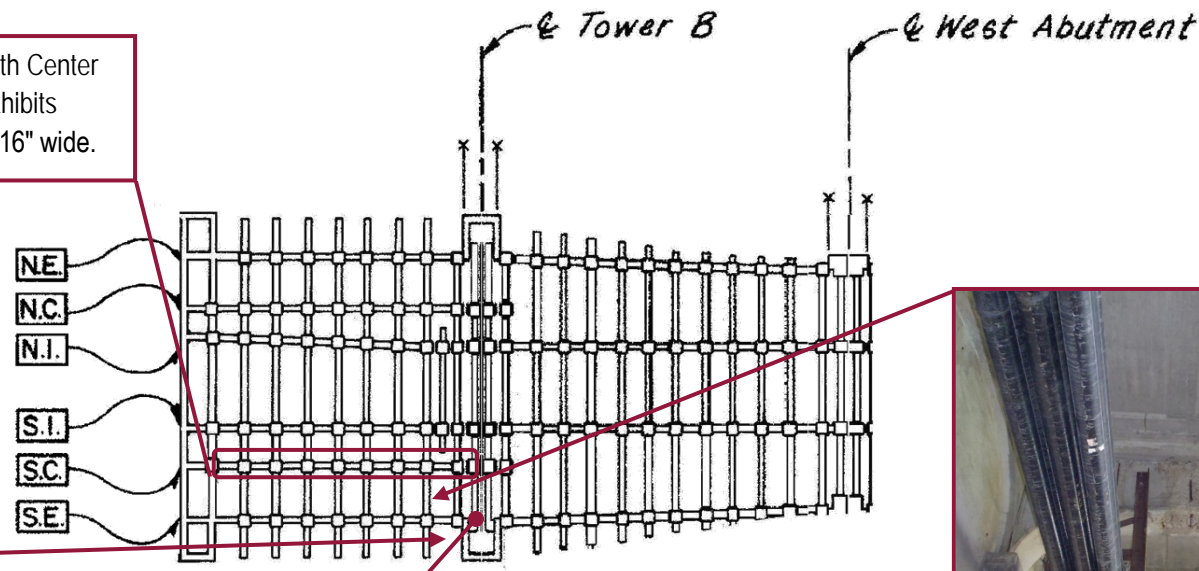
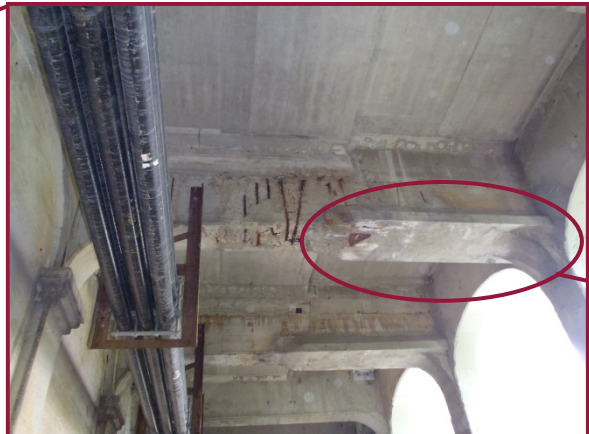
South exterior portion of Floorbeam 8 in Span 1A with isolated exposed reinforcing bars due to insufficient cover. Note bottom flange widening retrofit extending from exterior column.

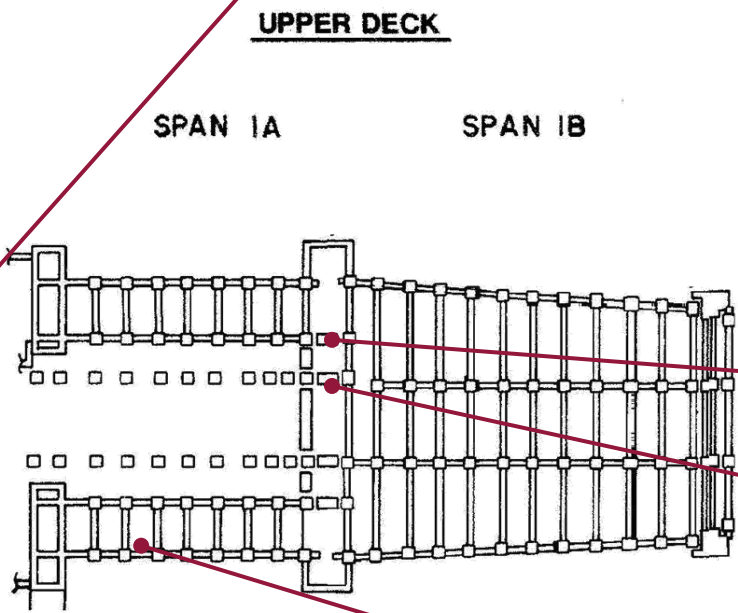
Cell 0C exhibits large cracks up to 1" wide between the lower deck slab and the north and south walls. This location is aligned laterally with South Tower B.

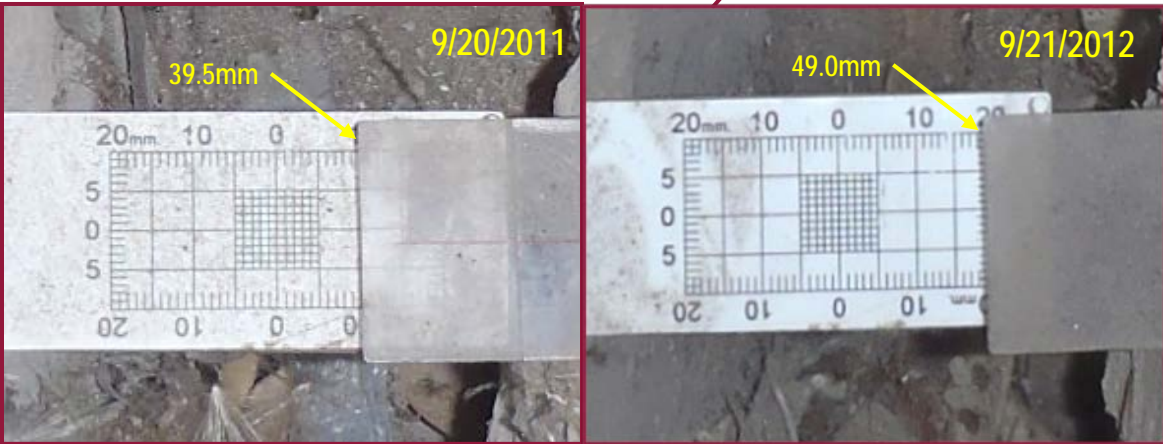
South Tower B crack gauge at the upper deck level showing nearly 10mm of movement over the past year. This gauge was originally installed in 2006 and indicates approximately 59.0mm (2.32") of movement since at an average rate of 9.83mm (0.39") per year.

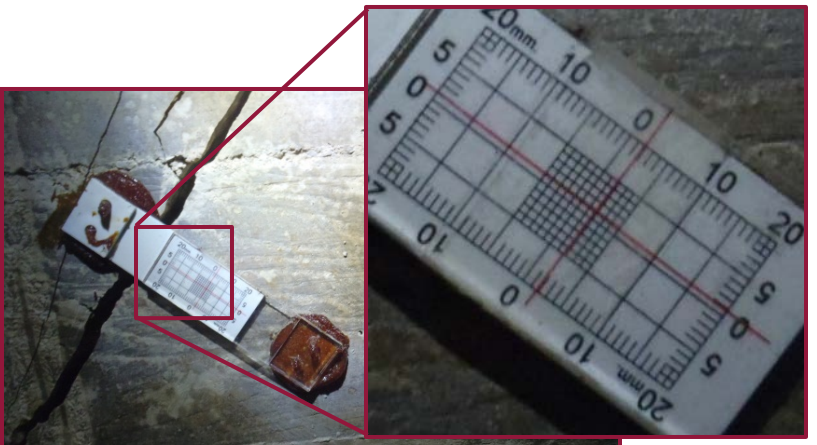
10/11/2012
Crack Gauge 1 within the lower cellular units showing approximately 2mm of movement since installation in 2007.

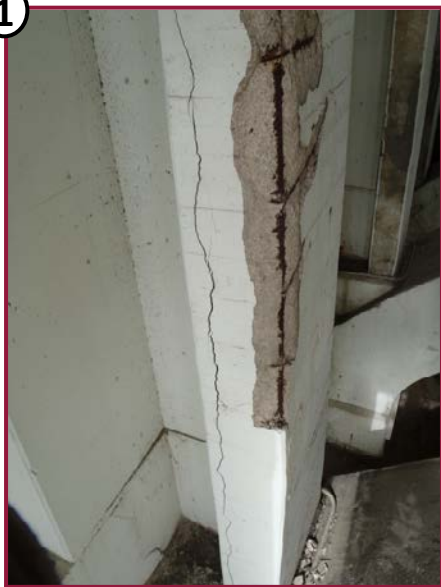
Arch C westernmost open spandrel column with southeast corner spall with exposed reinforcement and 1/4" wide vertical crack in south face. West face of column is delaminated at this location.

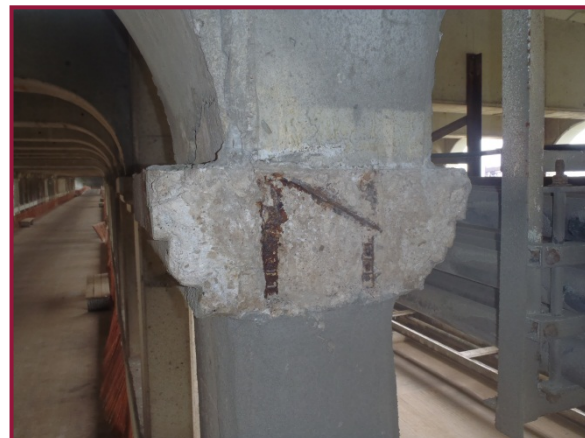
Spalls with exposed reinforcement are common in decorative column capitals throughout all concrete approach spans (west face of Column C2 in Span 1 shown).

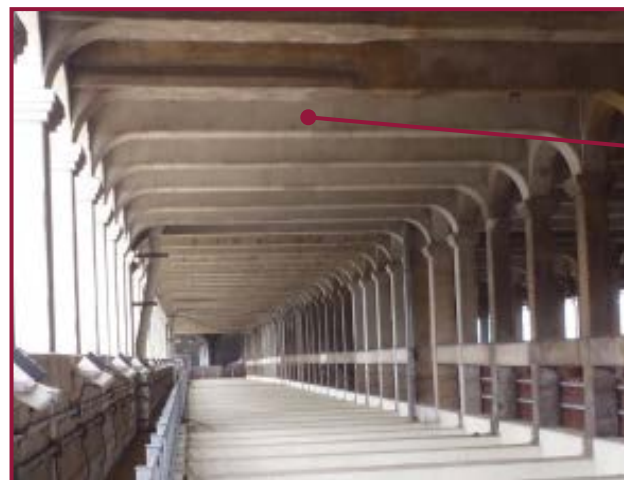
General view looking east from Span 1 between Lines A and B. Isolated floorbeams, columns and jack arches have been repaired (light in color), while many elements are from original construction (discolored).

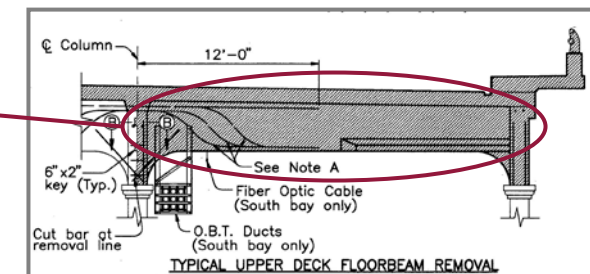
Typical concrete floorbeam removal/repair detail per the 1994 rehabilitation plans.

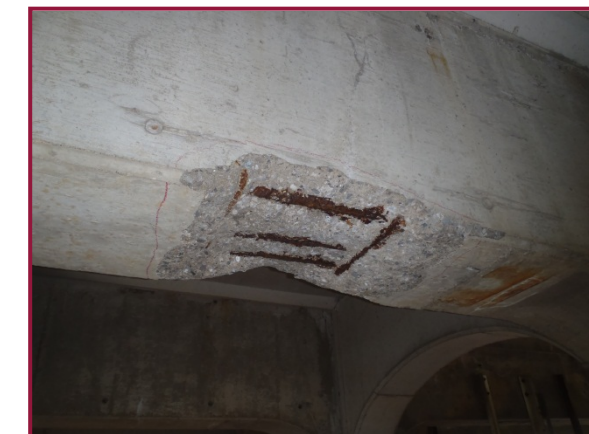
Span 3 Floorbeam 9 with 33" long x 20" wide x 3" deep underside spall with exposed reinforcement between Lines B and C. Isolated spalling is common throughout Spans 1-3.

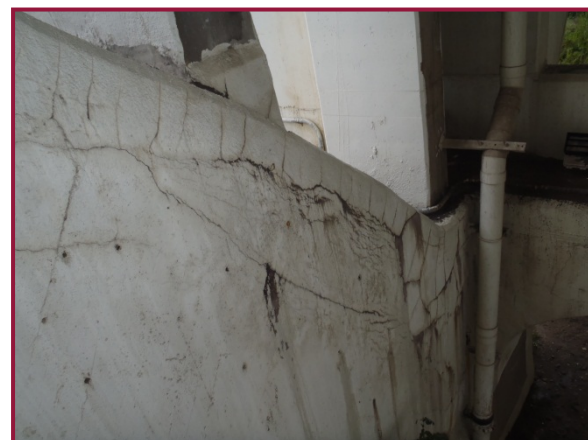
North face of Arch D in Span 3 with widespread map cracking for the western 25' of the arch. Arch cracking is typical in Spans 1-3, with the condition most pronounced adjacent to drainage elements at the piers.

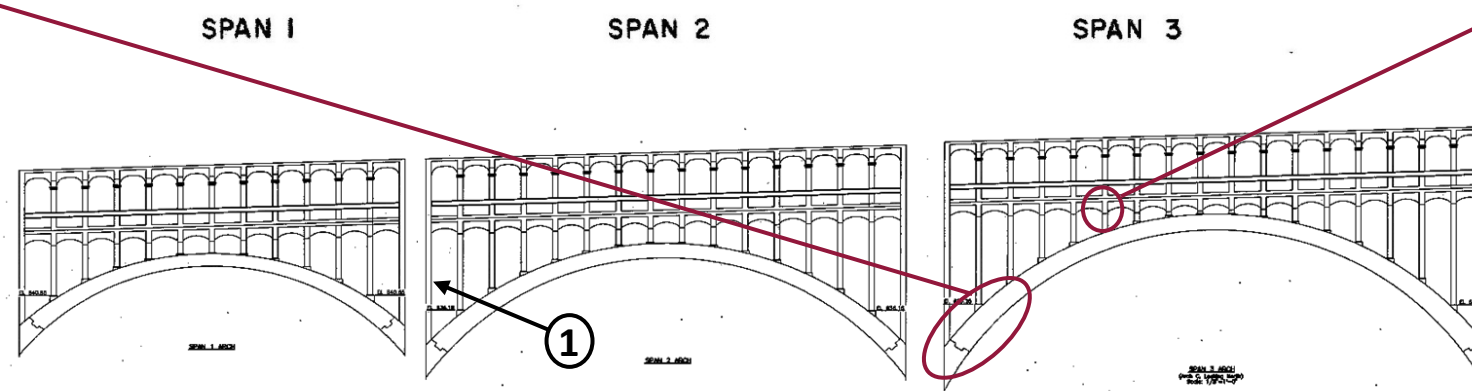
West Approach Plan
Spans 1-3

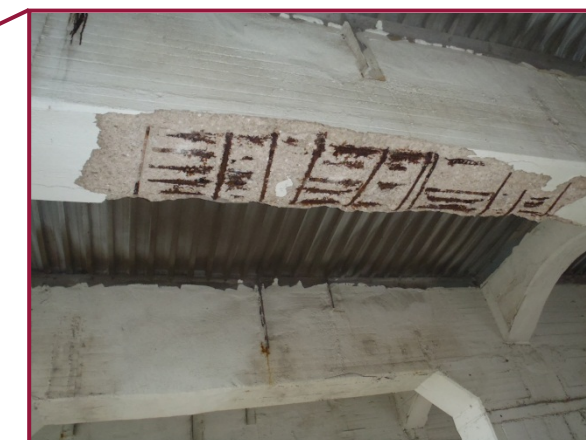
Span 3 Lower Floorbeam 6 with large underside spall and exposed reinforcement with minor section loss.

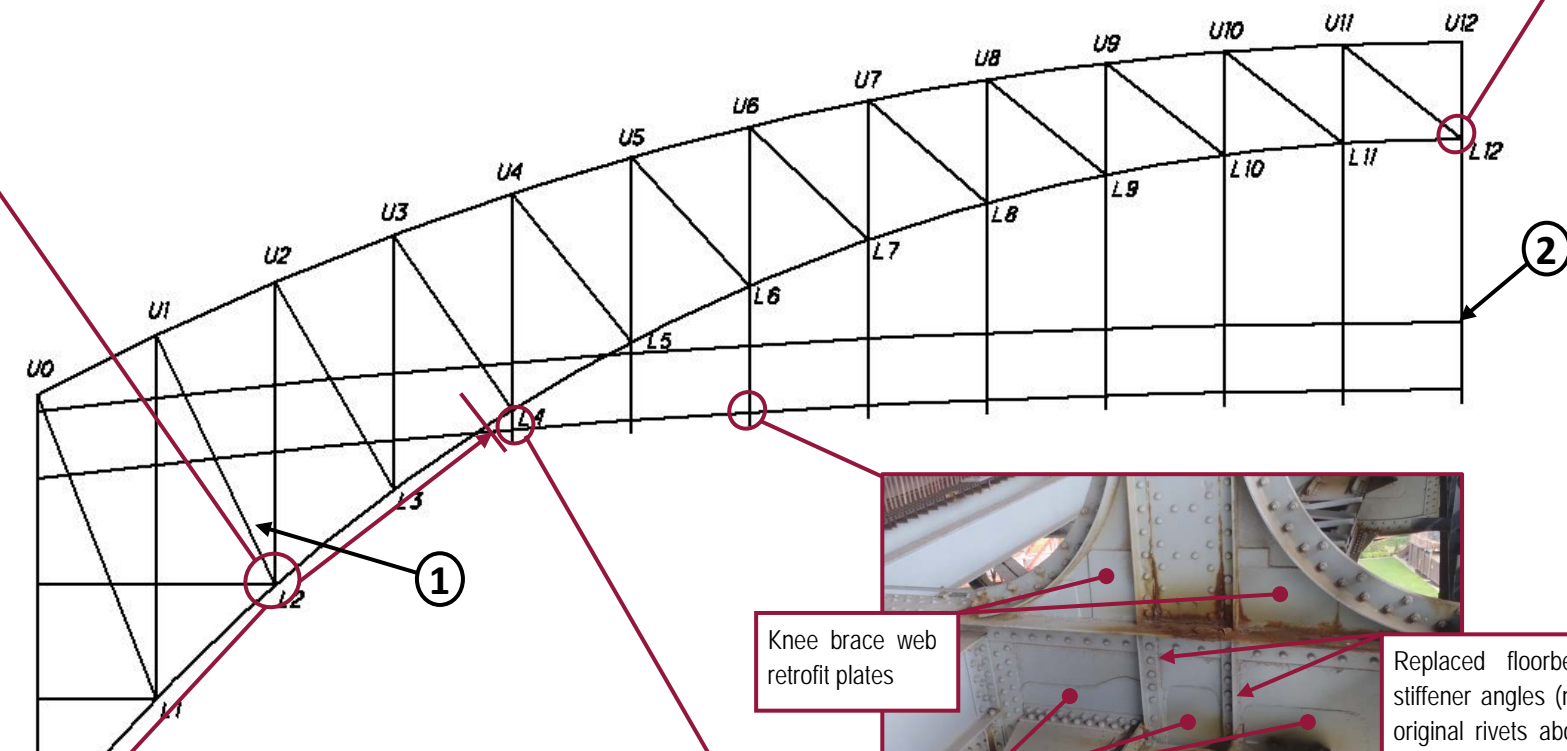
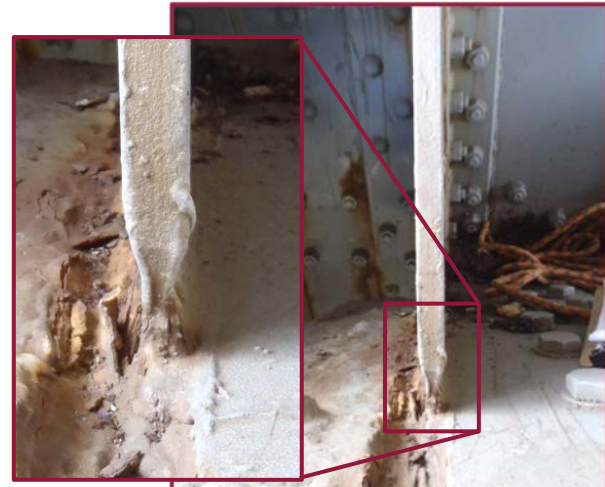
South Truss L2 interior gusset plate with 1/4" (of 3/4" original) effective thickness remaining for 24" along connection to L2-L3. Section loss along the shear plane of lower chord connections is common in gusset plates below the upper deck level (Panel Points 0 to 4).

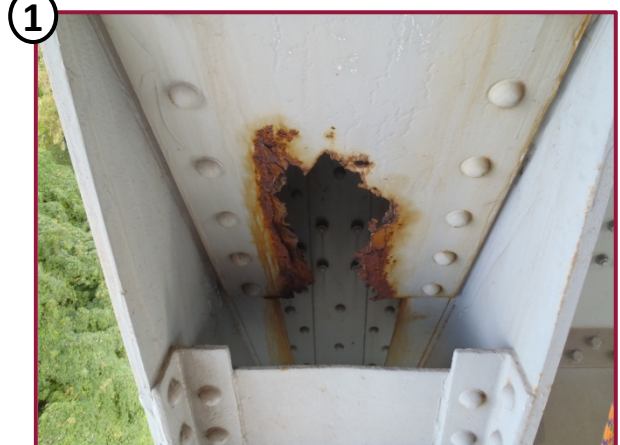
North Truss U1-L2 underside batten plate within connection to gusset plate U1 with a portion holed through. Isolated diagonal and vertical member batten plates below the upper deck level exhibit this condition.

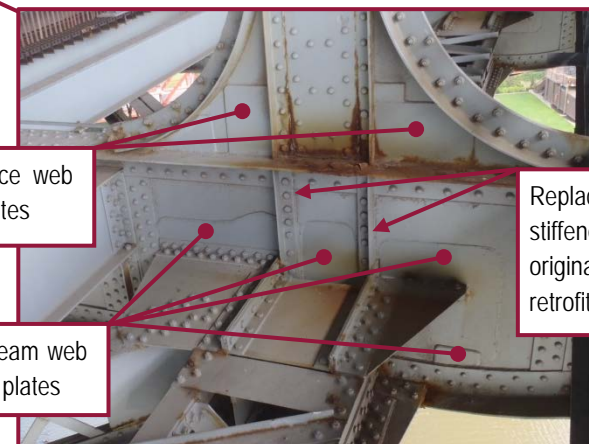
Knee brace web retrofit plates

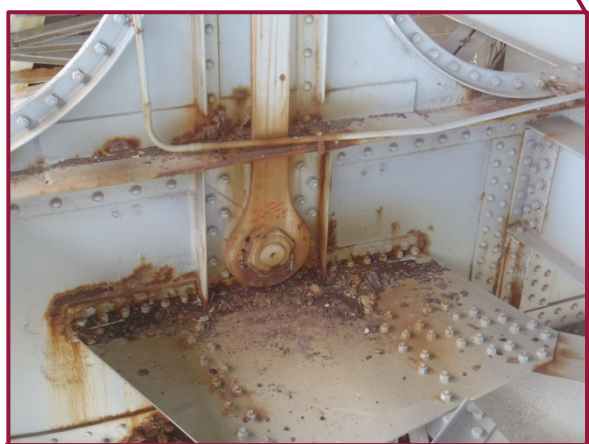
Moderate to heavy pitting is common at the lower pin connections below the upper deck. East face of Lower Floorbeam 4 shown at south connection, with 3/16" section loss to the eyebar head. Note active corrosion throughout this location.

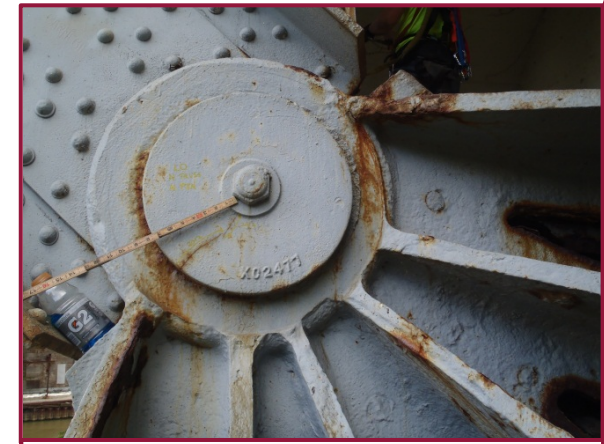
The north pin retaining washer at L0 on the North Truss exhibits a radial crack from the center bolt to the edge. A history of cracking has been reported in several of the bearing pin retaining washers at truss bolster bearings throughout the main span.

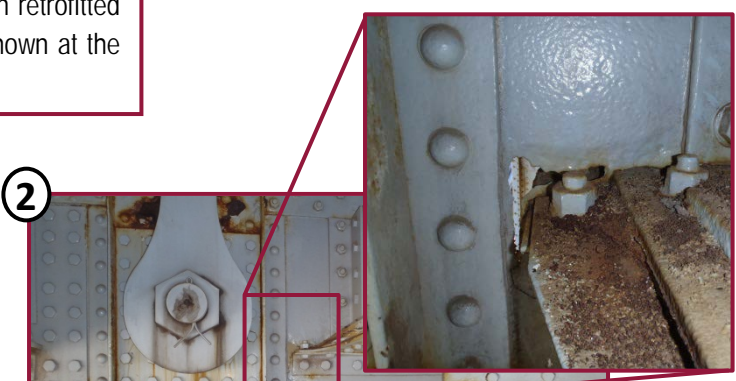
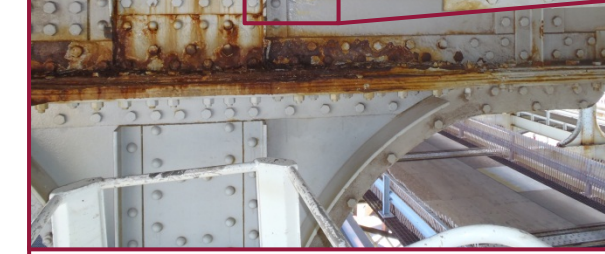
Floorbeam 12 west face with perforation in web along lateral brace connection plate. Isolated upper floorbeams throughout Span 4 exhibit similar conditions at this location.

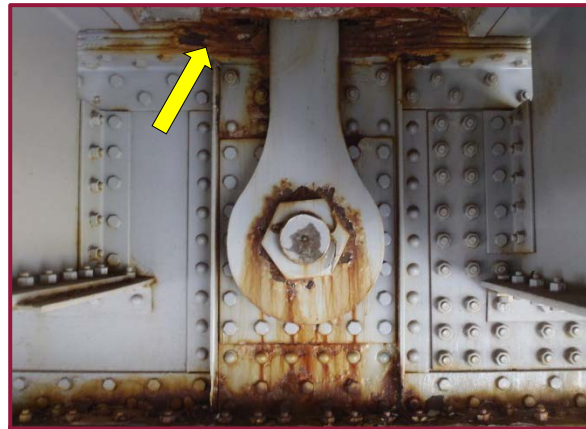
Pin connections at the upper floorbeams (from Panels 5 to 19) typically exhibit rust activation and staining throughout the adjacent floorbeam components. Additionally, moderate to heavy pack rust between the top flange and deck is typical at these locations (north hanger at Floorbeam 17 shown).

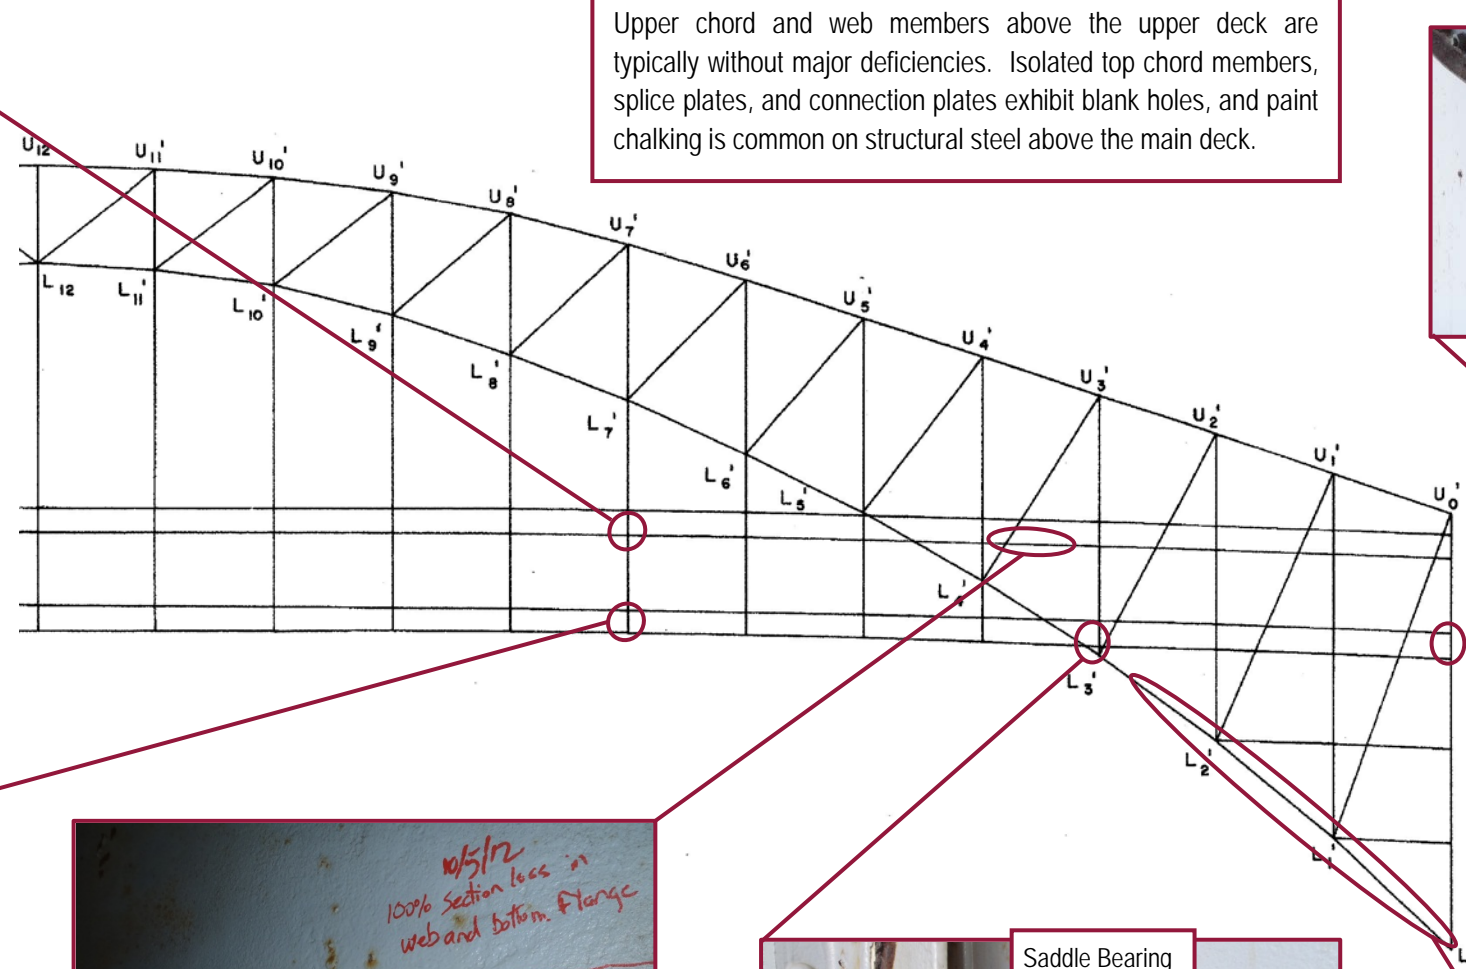
Upper chord and web members above the upper deck are typically without major deficiencies. Isolated top chord members, splice plates, and connection plates exhibit blank holes, and paint chalking is common on structural steel above the main deck.

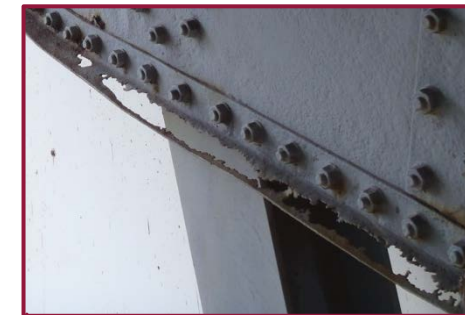
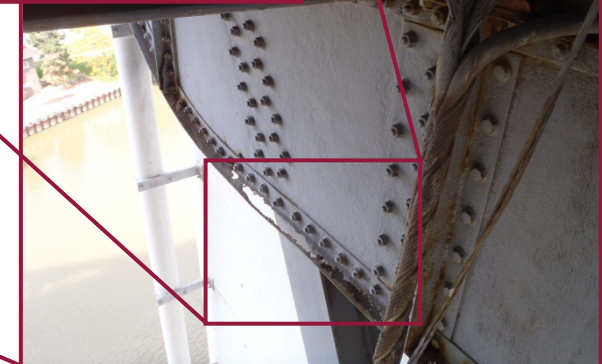
The north cantilever bracket at Floorbeam 24 exhibits advanced section loss of the bottom flange with holed through sections. This condition is locally common at the end floorbeams and isolated throughout the truss where the members are exposed.

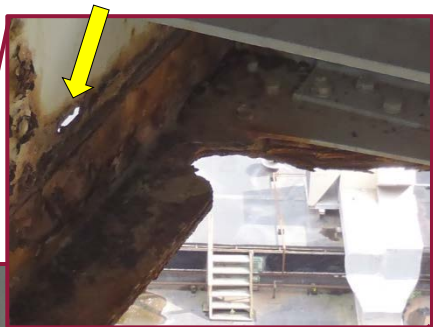
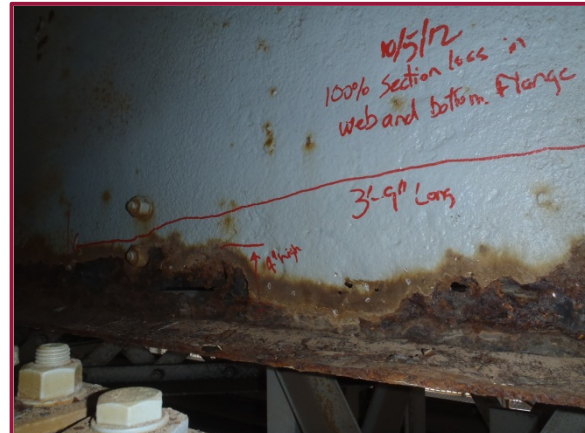
Stringer P between Floorbeams 20 and 21 with 100% section loss in web and bottom flange. Isolated stringers exhibit heavy section losses throughout the span, typically localized to the areas adjacent to the truss lines and hanger connections.

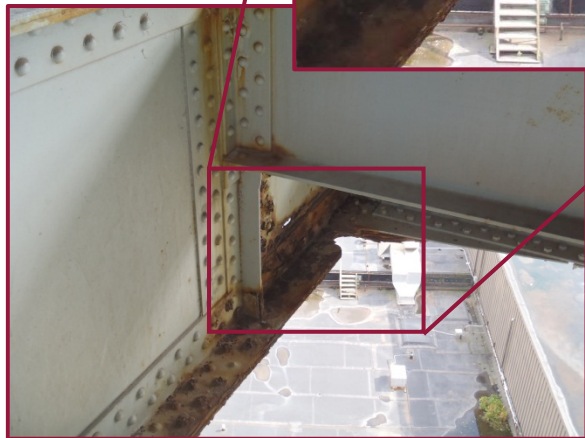
West face of Lower Floorbeam 17 adjacent to south hanger connection with advanced section loss and active corrosion. The west bottom flange exhibits an 8" wide by full width area of 100% section loss, and a 4" long by 1" high perforation is present in the web along the bottom flange vertical leg.

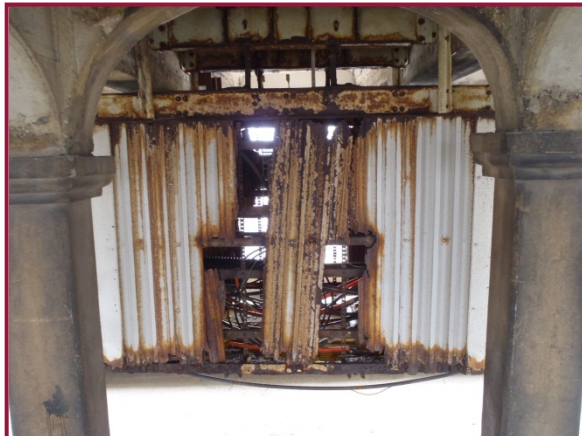
Utility junction box in Span 6 with advanced corrosion throughout and failed corrugated metal outer containment. Deterioration is due to water infiltration through access manhole above.

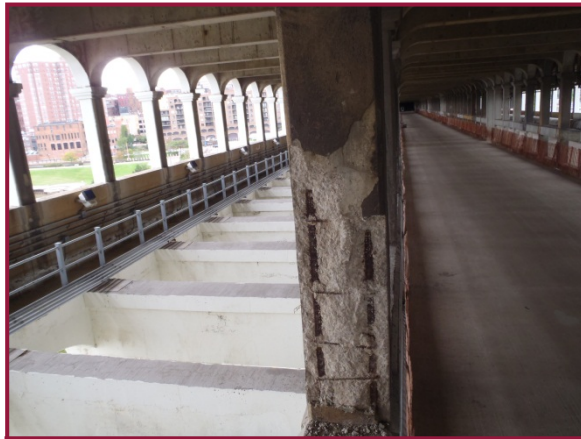
Spall with exposed reinforcement in the west face of Column 3B in Span 7 between the upper and lower decks.

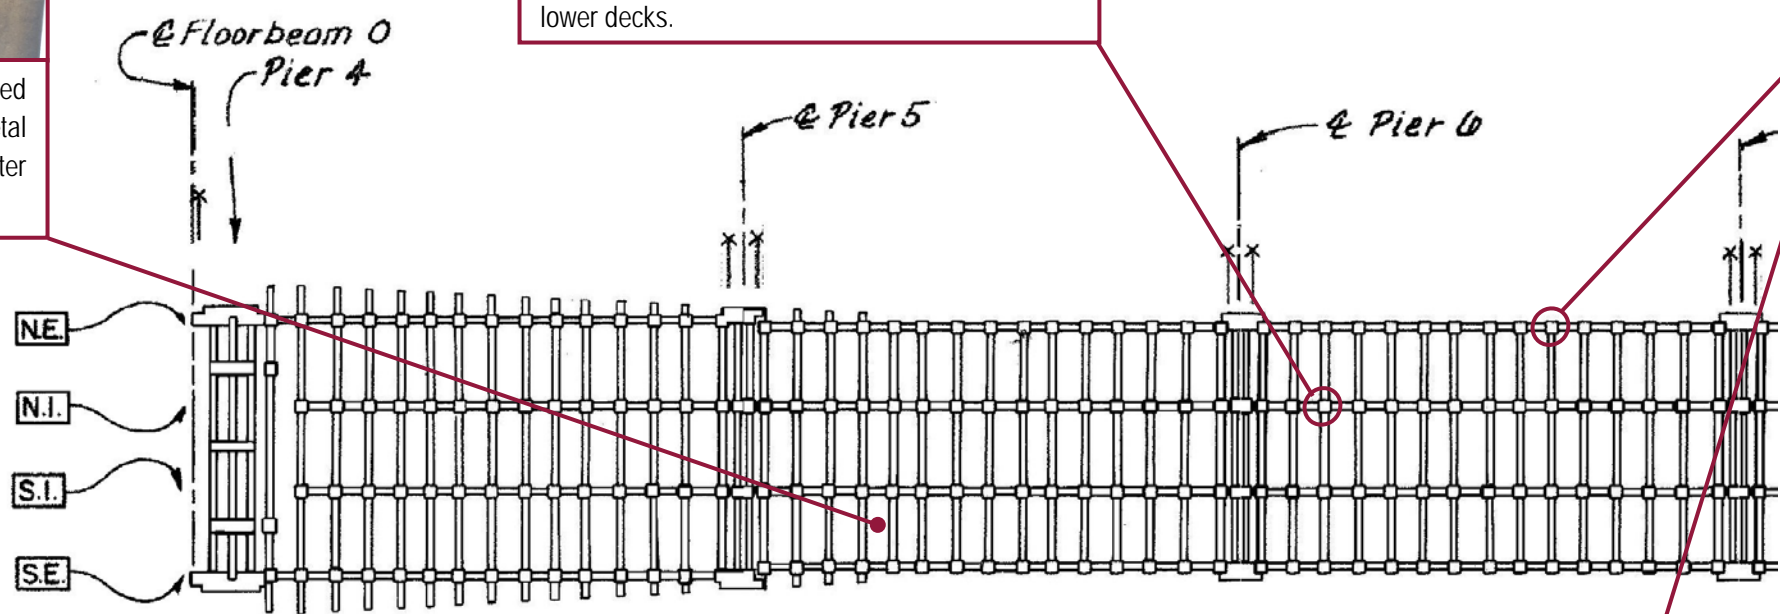
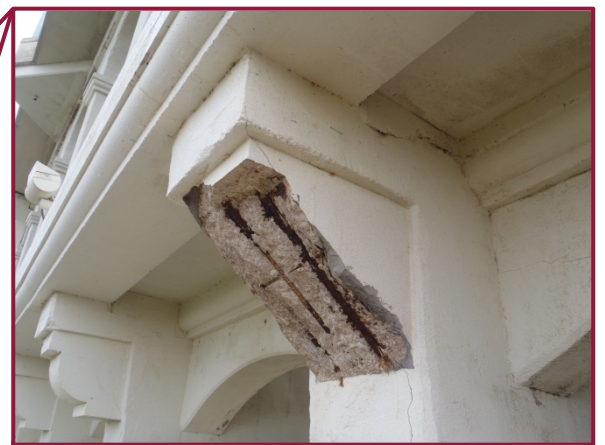
Span 7 Column 10 corbel outside northernmost concrete arch with front face spall and exposed reinforcing.

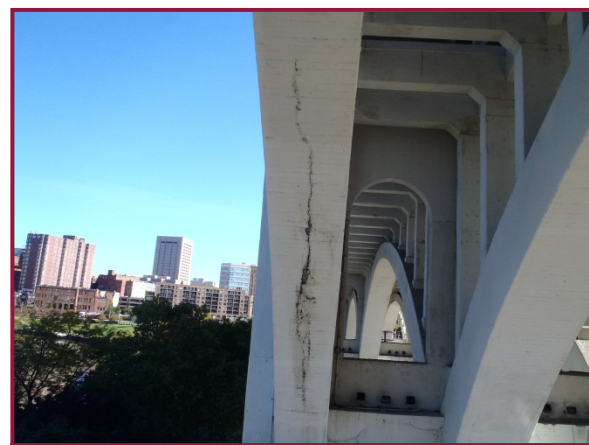
Arch A at the east end of Span 5 exhibits a longitudinal crack approximately 1/4" wide by 40' long on the arch rib underside. This represents the most advanced cracking in the concrete approach spans.

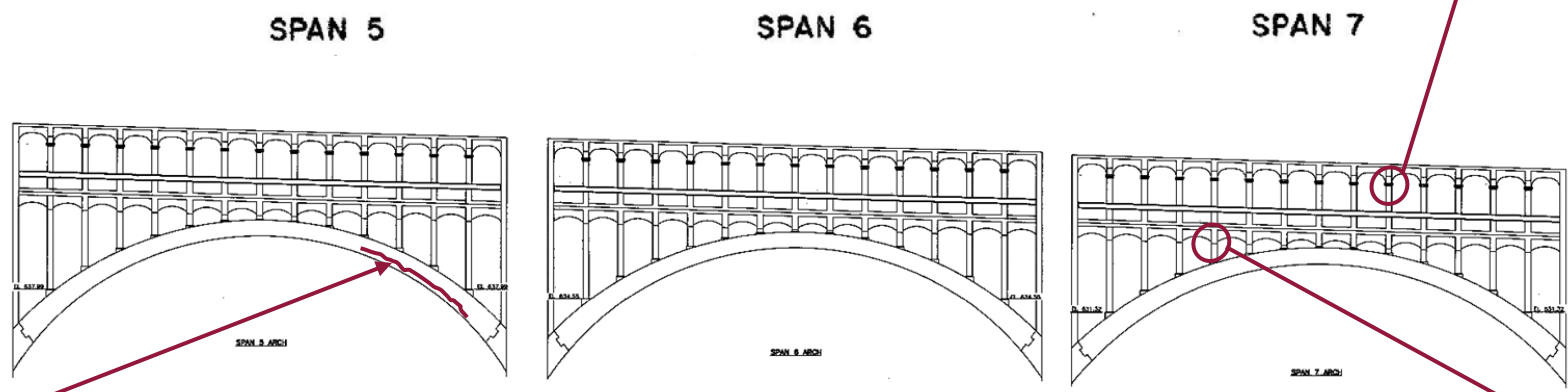
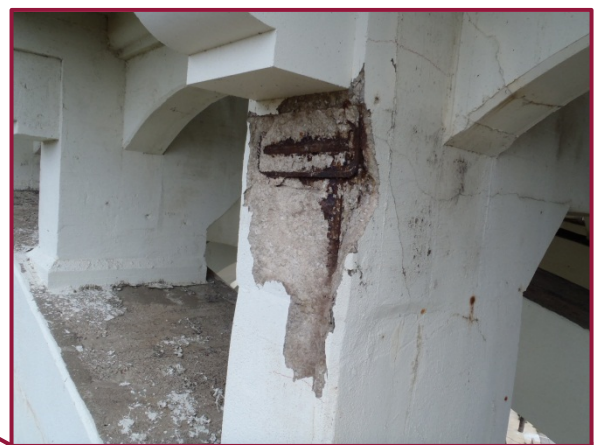
Arch A Column 5 in Span 7 exhibits a spall with exposed reinforcing 39" high x 25" wide x 3" deep below the lower concrete corbel.

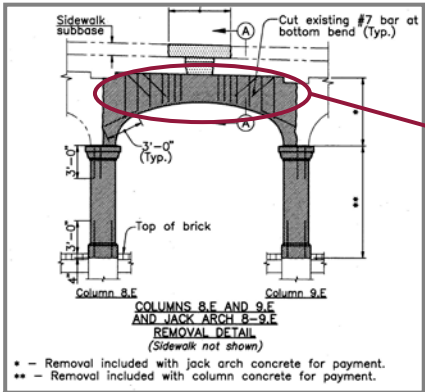
Typical jack arch removal/repair detail per the 1994 rehabilitation plans.

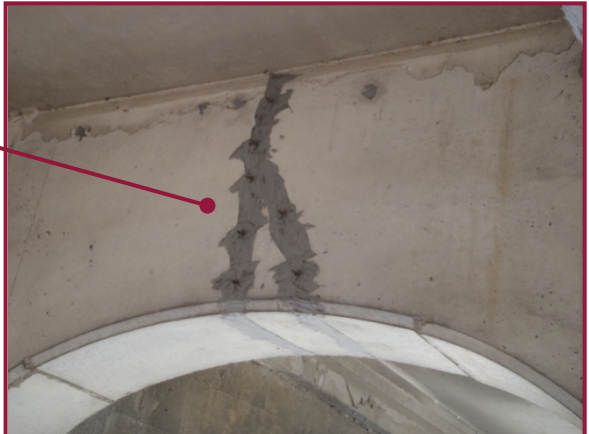
Typical replaced concrete jack arch in Span 9 (Line B between Floorbeams 4 and 5 shown). The jack arch at this location exhibits transverse vertical cracks that have been repaired by epoxy injection.

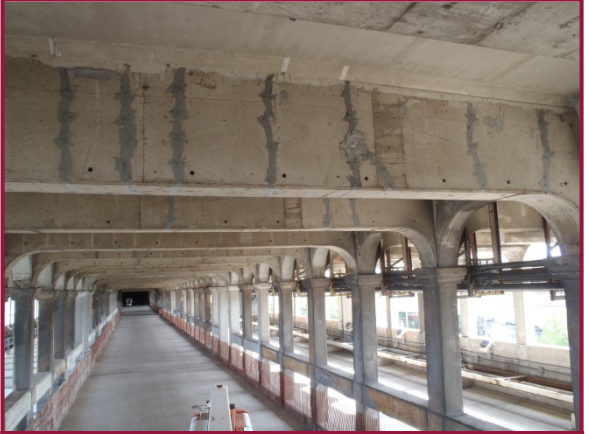
Span 9 Floorbeam 6 with vertical cracks repaired by epoxy injection between Column Lines B and C (west face shown). This repair detail is common throughout the East Approach Spans.

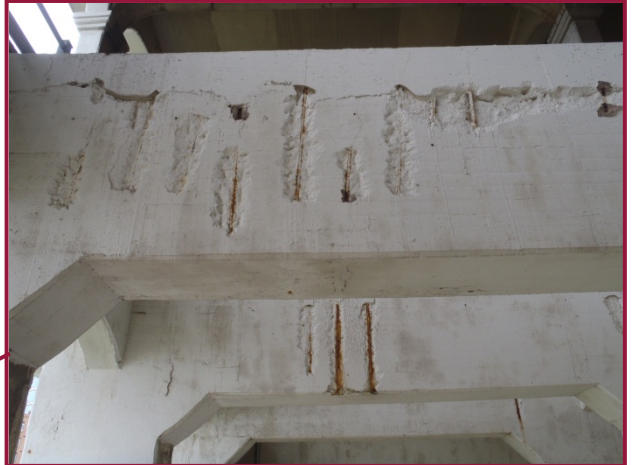
Lower floorbeam 10 in Span 10 exhibits intermittent spalling across the west face between Arches A and B, corresponding to locations of reinforcement. This condition is typical for the north bay in Span 10.

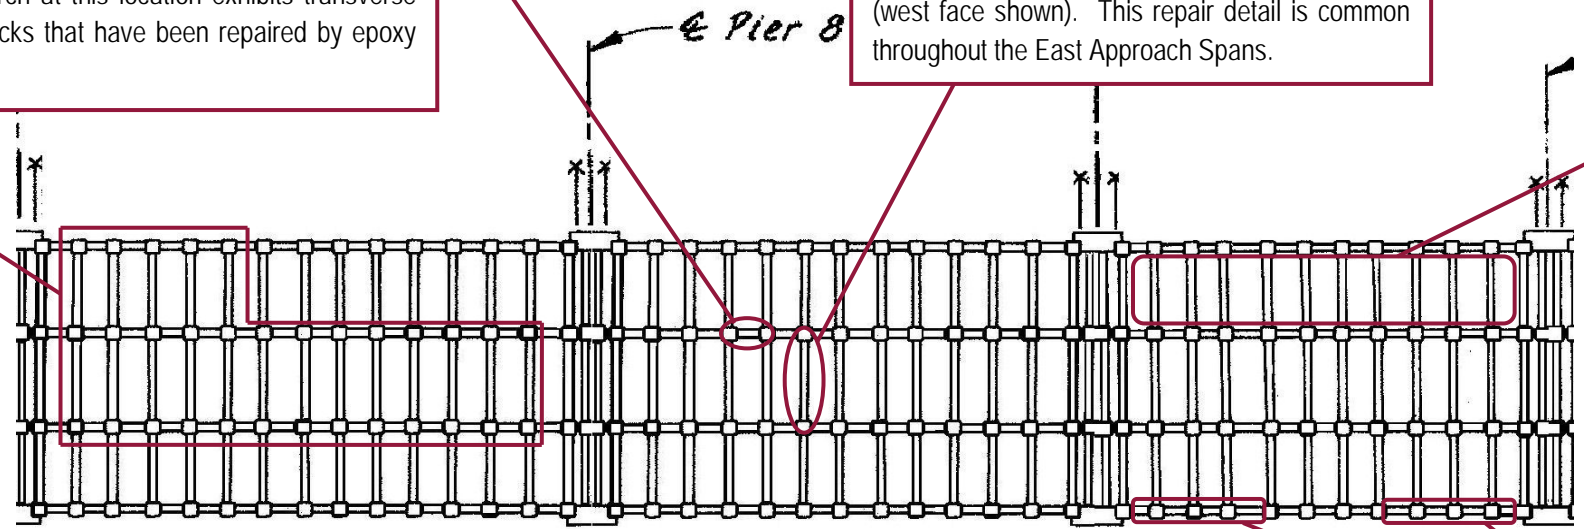
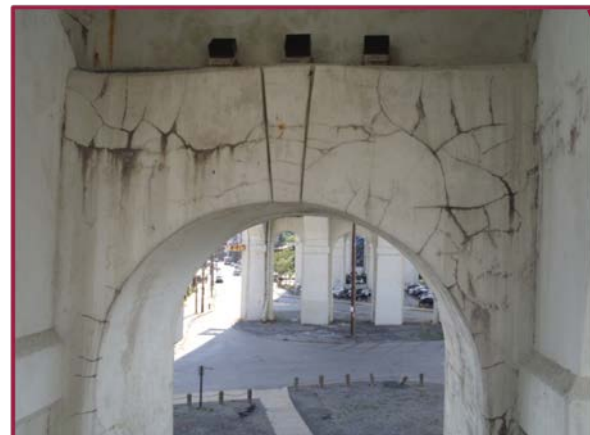
Pier 7 lateral strut between Arches B and C with map cracking throughout. Minor to moderate map cracking is typical at the thrust blocks at each tower base and throughout these adjacent lower struts.

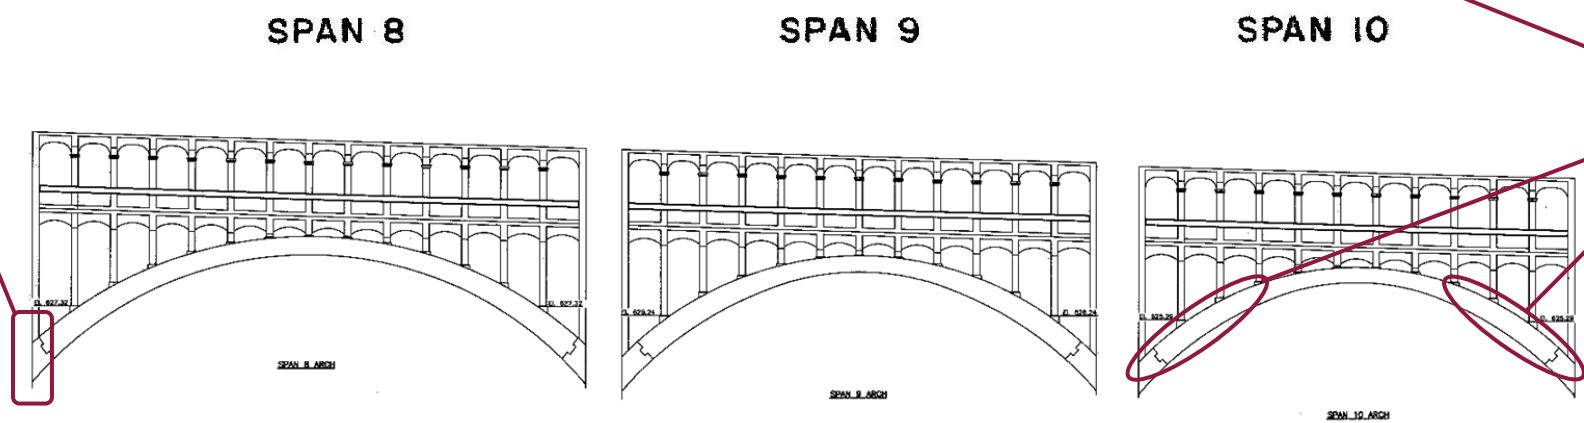
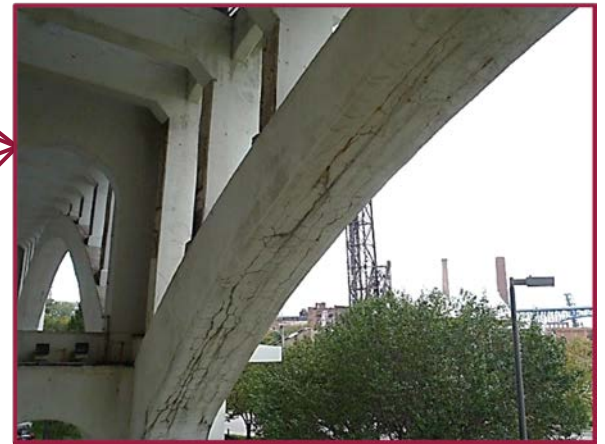
Arch A in Span 10 exhibits widespread map cracking throughout the bottom face of the arch rib, especially in the end 30' to 40' adjacent to the piers (west end at Pier 9 shown, east end similar).
