**PHYSICAL CONDITION REPORT
FOR THE 2012 IN-DEPTH INSPECTION**

VETERAN'S MEMORIAL (DETROIT-SUPERIOR) BRIDGE

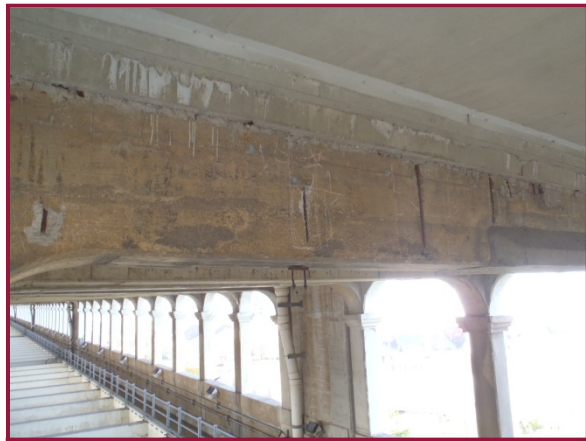
Floorbeam 3 in the north bay of Span 12 exhibits isolated web spalling at vertical reinforcement locations along the east face.

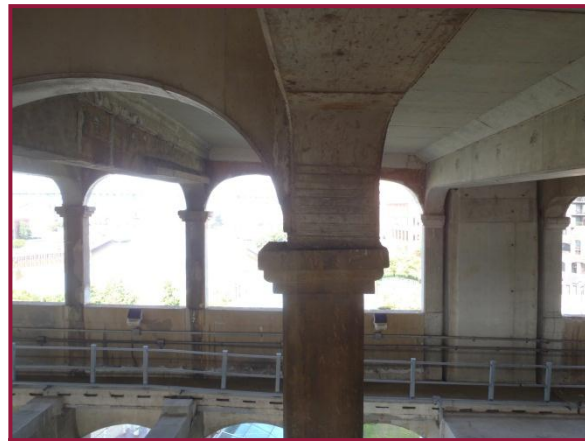
Jack arch to floorbeam connection misaligned horizontally with approximately 4" offset to the east with respect to column B8 below in Span 11.

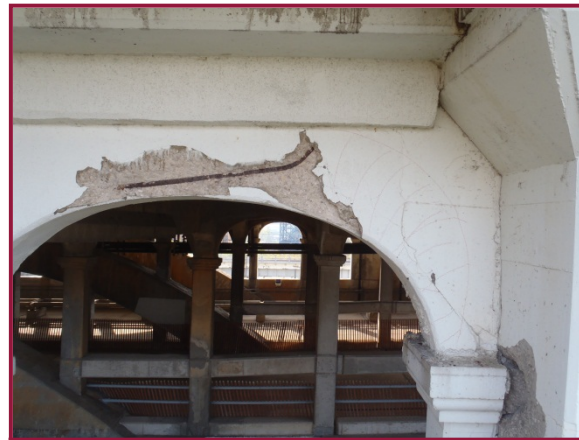
The jack arch between Columns A1 and A2 in Span 12 exhibits a large spalled/delaminated area on the north face, approximately 7 feet wide and up to 2" deep.

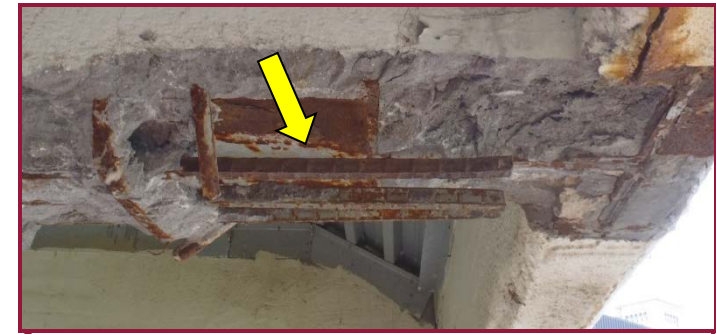
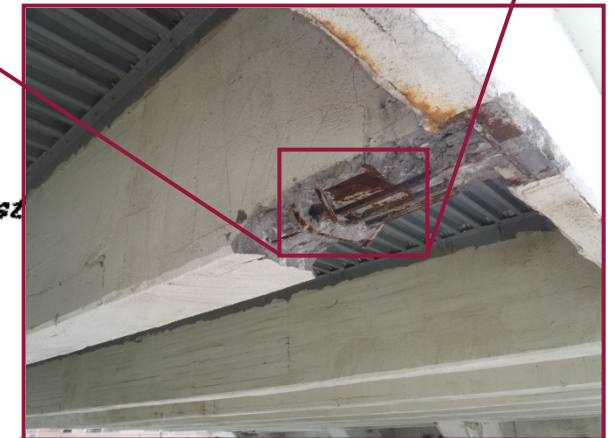
Isolated hangers and floorbeam members in Span 12 consist of concrete-encased steel beams. The underside of Floorbeam 4 is spalled at the connection to the south fascia, exposing a portion of the embedded steel beam and surrounding reinforcing.

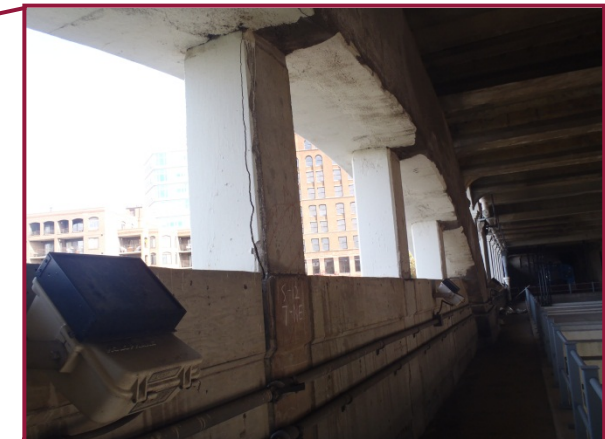
Isolated cracking is common on the concrete arch ribs and hangers in Span 12. The arch ribs typically exhibit moderate map cracking on the undersides as they pass through the lower deck, while large vertical cracks and delaminations are common on the concrete hangers.

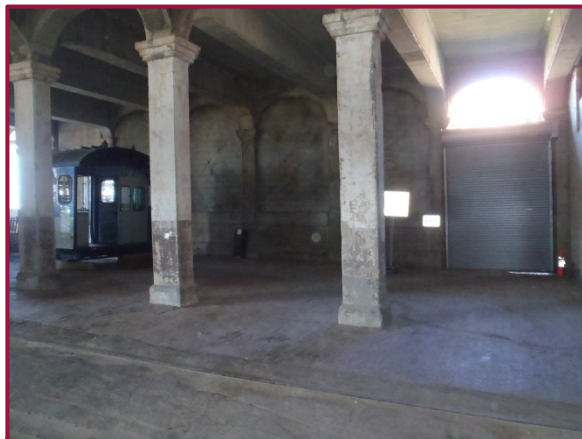
The concrete columns in the East Side Station typically do not exhibit significant deficiencies.

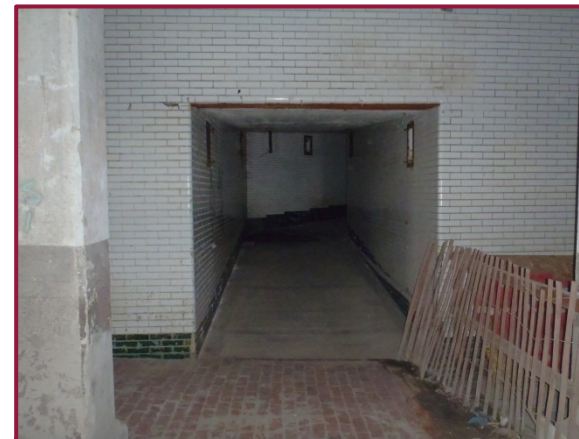
General view in tunnel section within the north wall of the East Side Station.

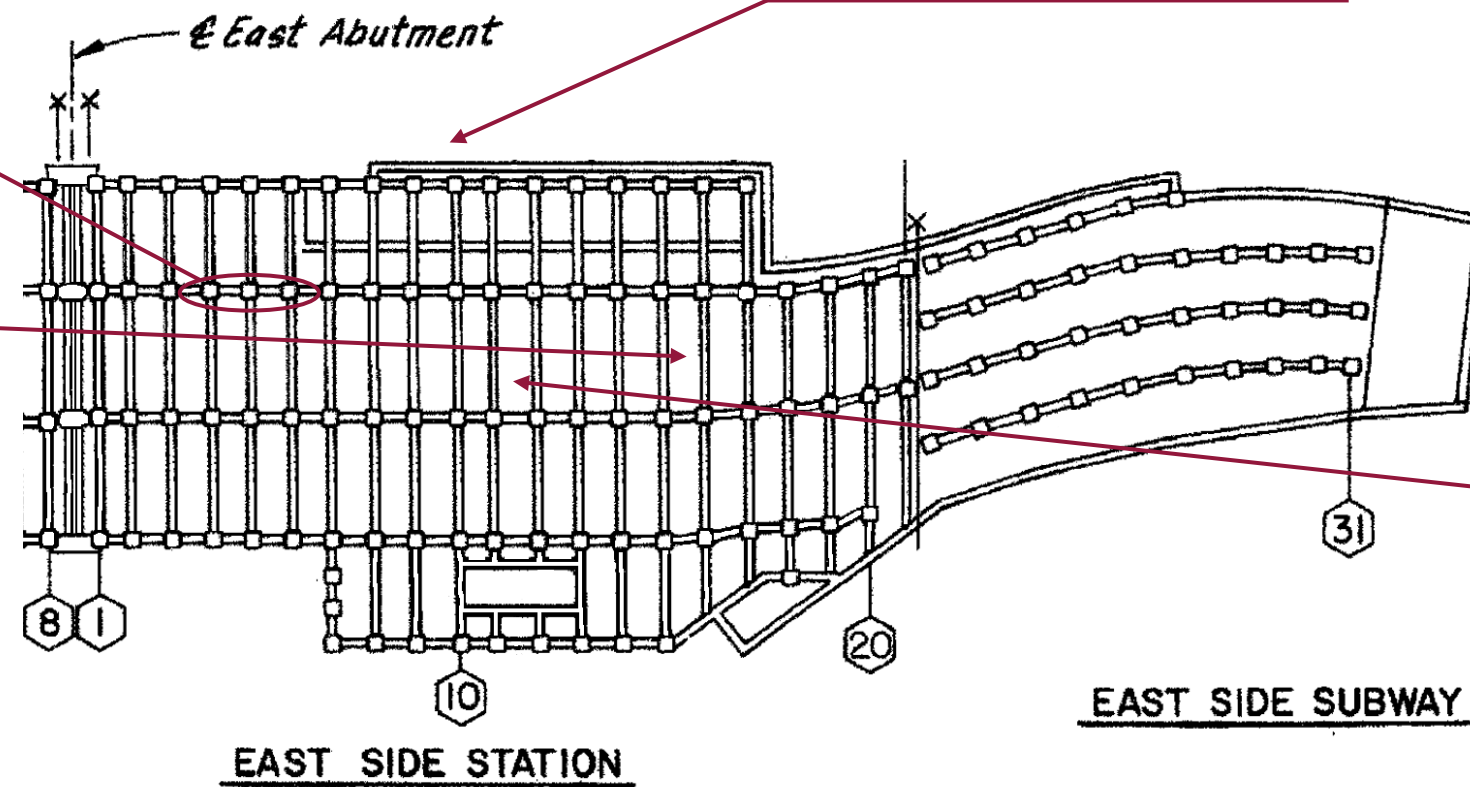
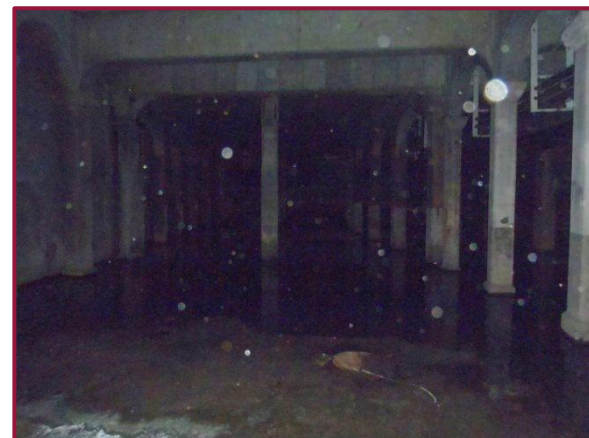
East approach cellular construction with standing water on the lower deck level, looking east. This standing water covers the entire width of the deck, beginning midway through the East Side Station and increasing to a maximum depth of roughly 3' at the east end.
