# Ohio Department of Transportation 2015 Physical Condition Report

## Detroit-Superior Bridge over Cuyahoga River Bridge No. CUY-6-1456

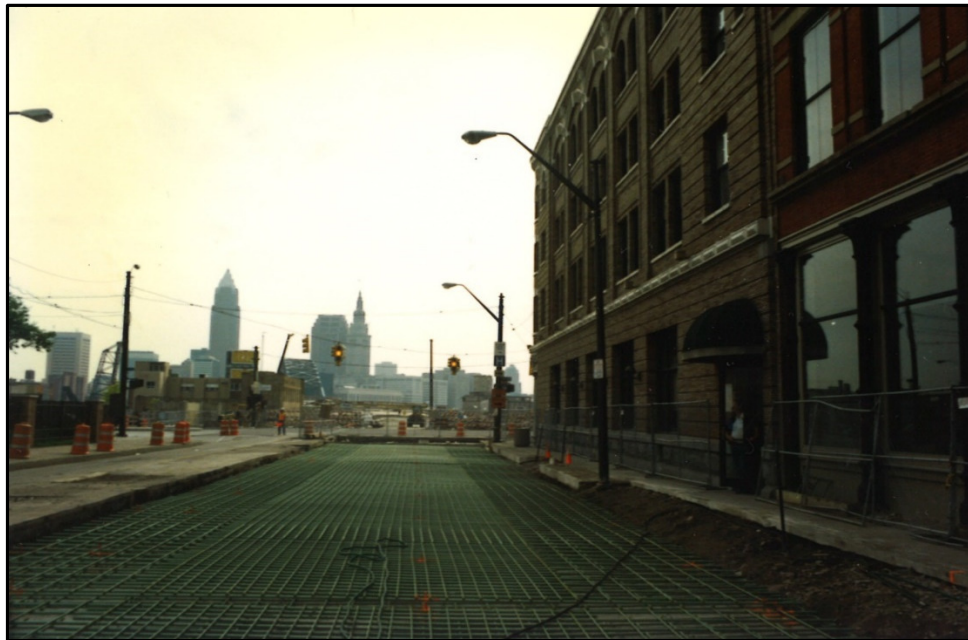
**Photo 4 - Construction of Detroit Avenue Tunnel Supplemental Roof Slab, Looking East, 1996.**

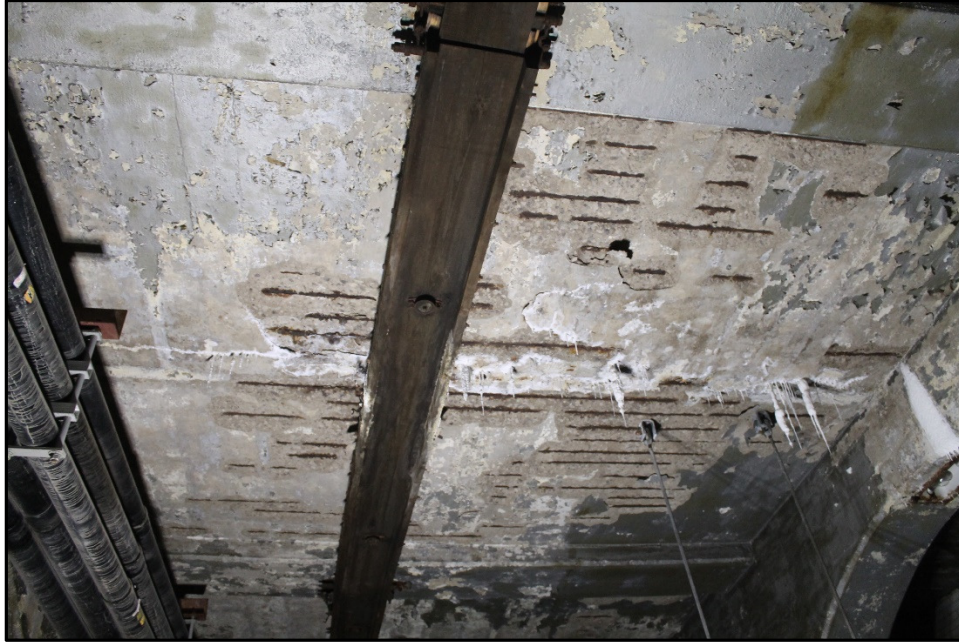
Photo 5 – Active Efflorescence, Water Infiltration & Rebar Corrosion, Panel D12, West Station.

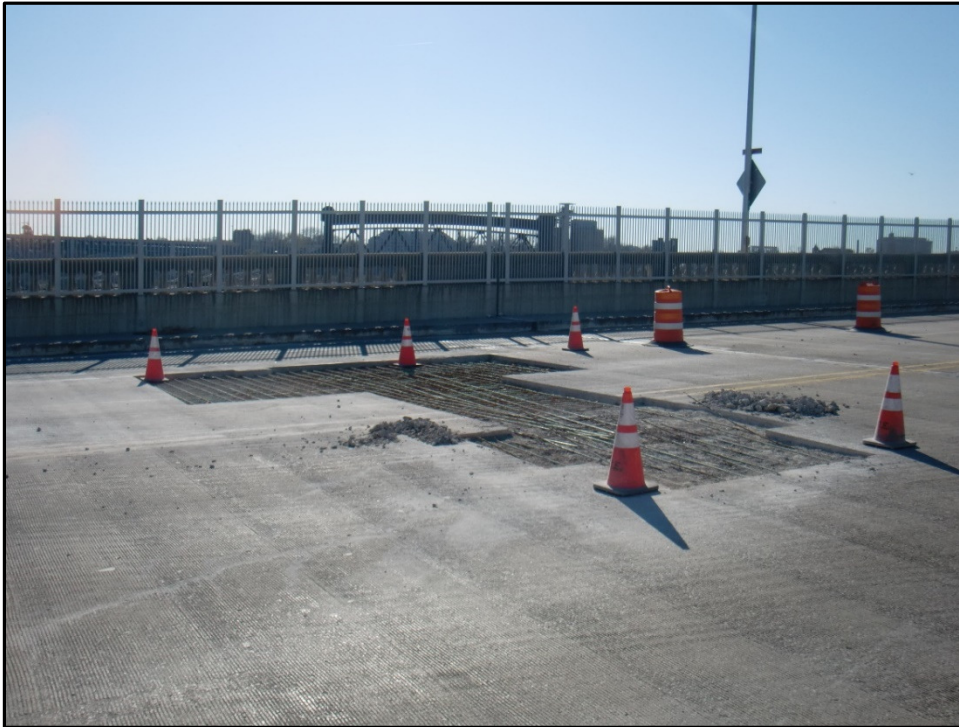
Photo 6 – Recent Wearing Surface Repair, Span 9 (November 2015).

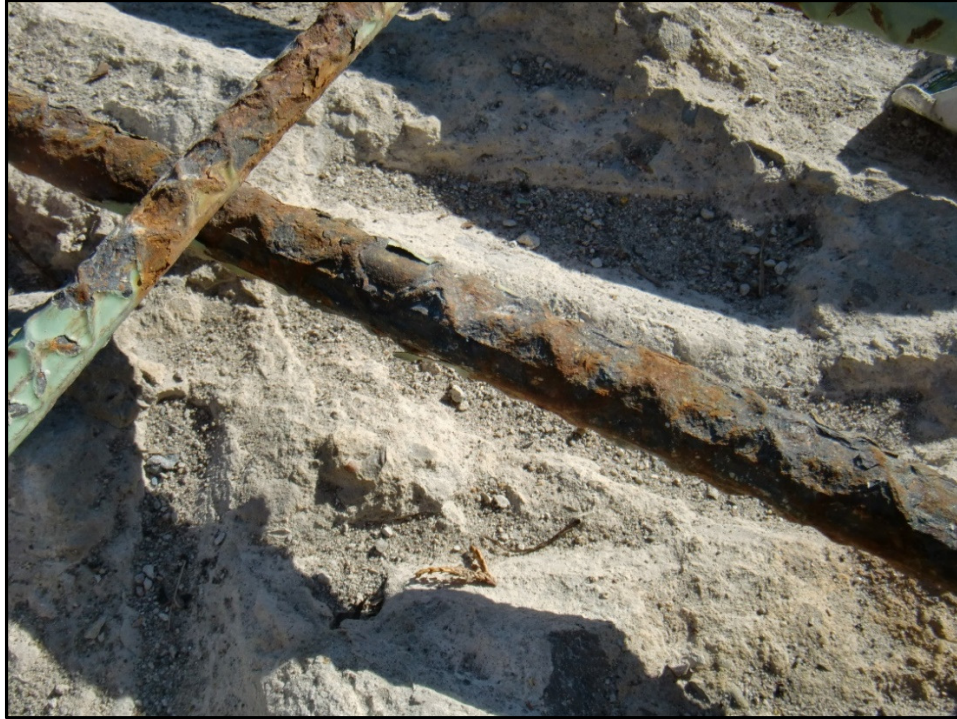
**Photo 7 – 1/8-Inch Deep Section Loss of Epoxy Coated Rebar Following 18 years of Service.**

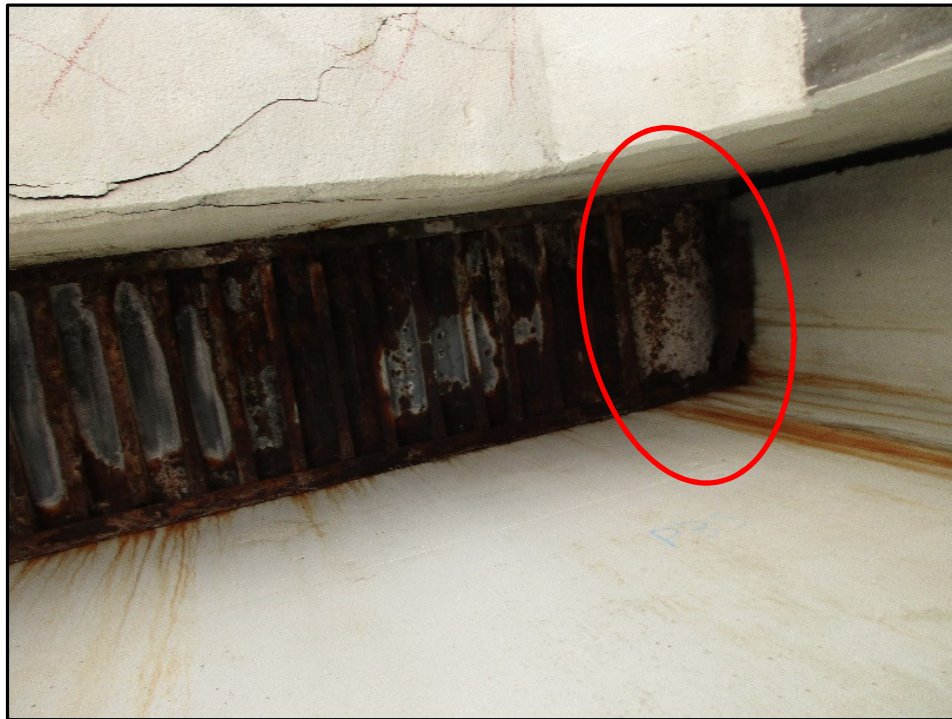
**Photo 9 - Corroded & Missing Stay-in-Place Form (Circled),  
Lower Deck Panel 15 Center, Span 2.**

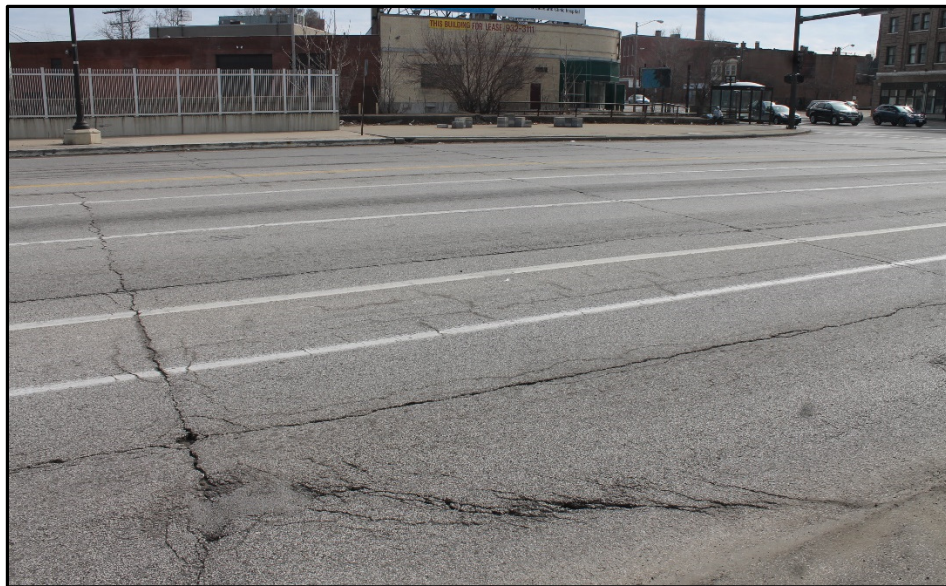
**Photo 10 - Cracked Asphalt Wearing Surface, West Station.**

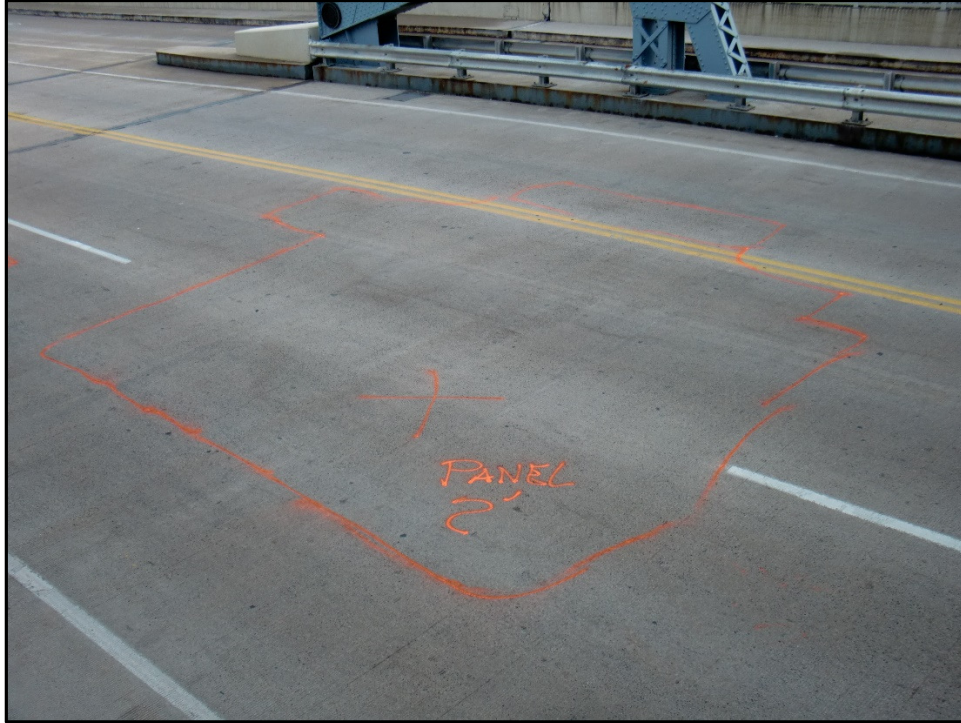
Photo 11 – Large Area of Delaminated Wearing Surface, Panel 2', Span 4.

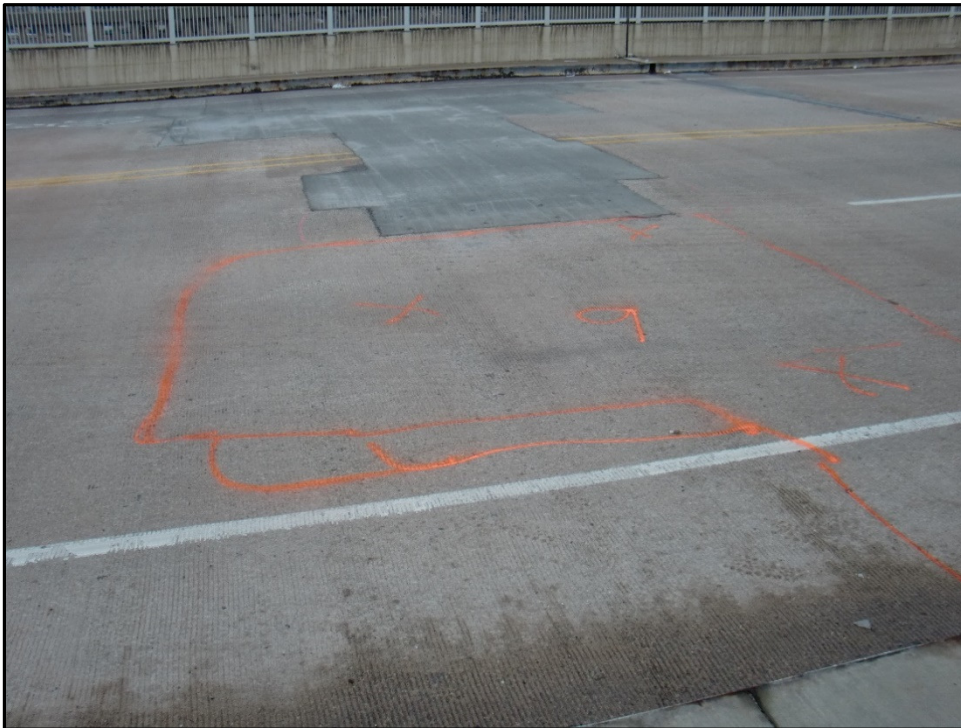
Photo 12 – Delaminated Wearing Surface Adjacent to November 2015 Repair, Span 9.

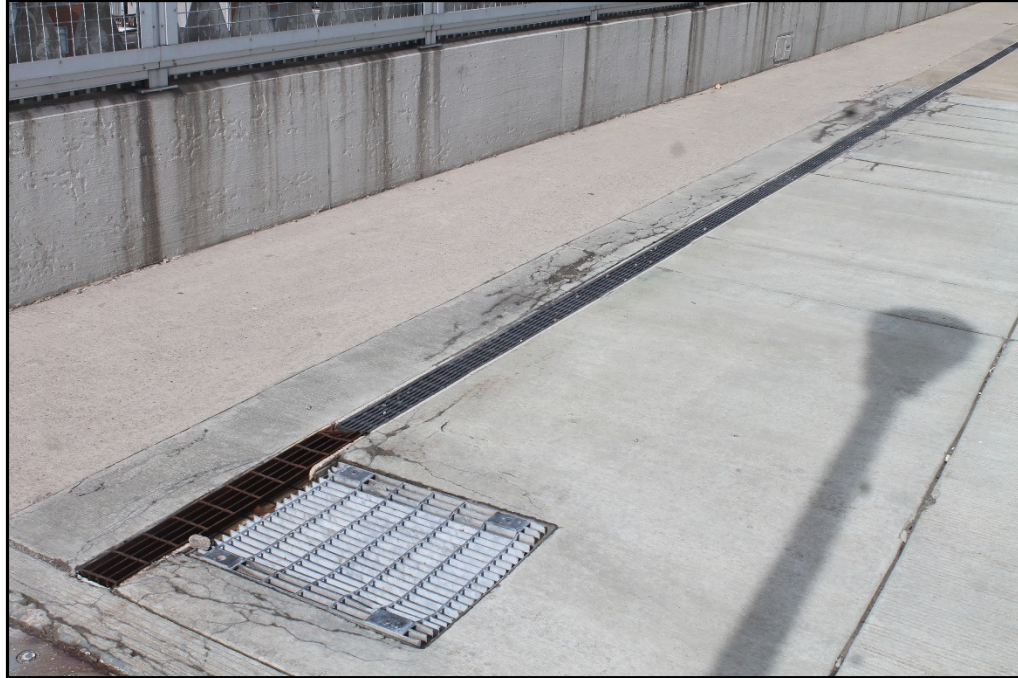
**Photo 13 – Cracked & Delaminated Concrete, 2003 North Sidewalk Extension.**

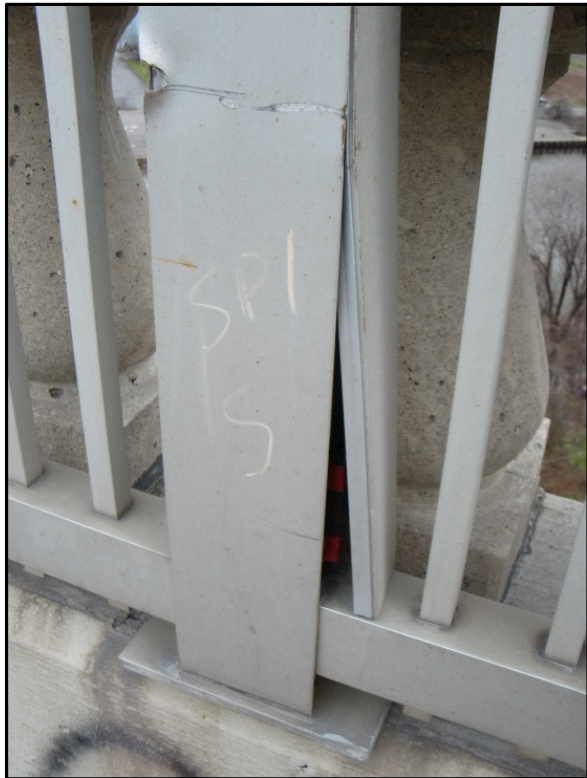
**Photo 14 – Vandalism & Attempted Theft of Aluminum Fence, South Rail.**

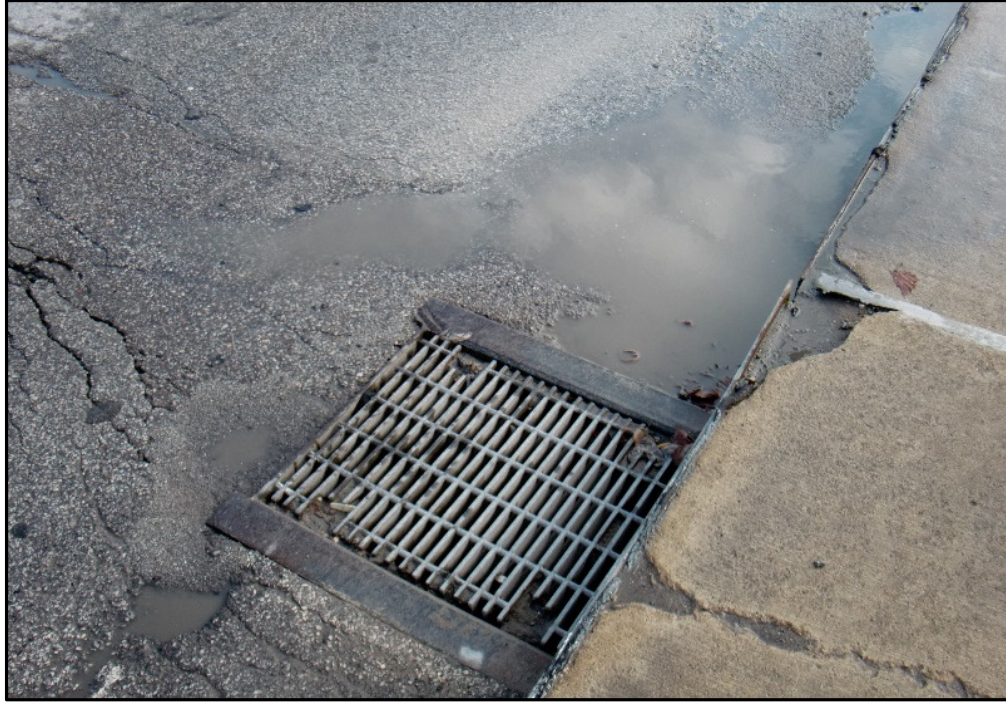
**Photo 16 – Water Ponding Adjacent to Panel D20 Catch Basin, South Curb, West Station.**

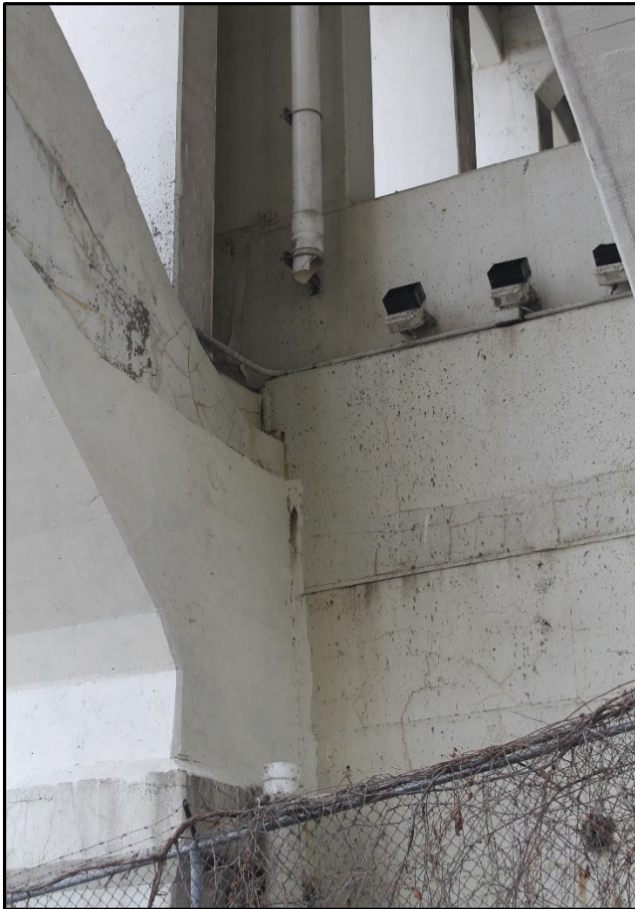
**Photo 17 – Broken PVC Drainpipe, Pier 1.**

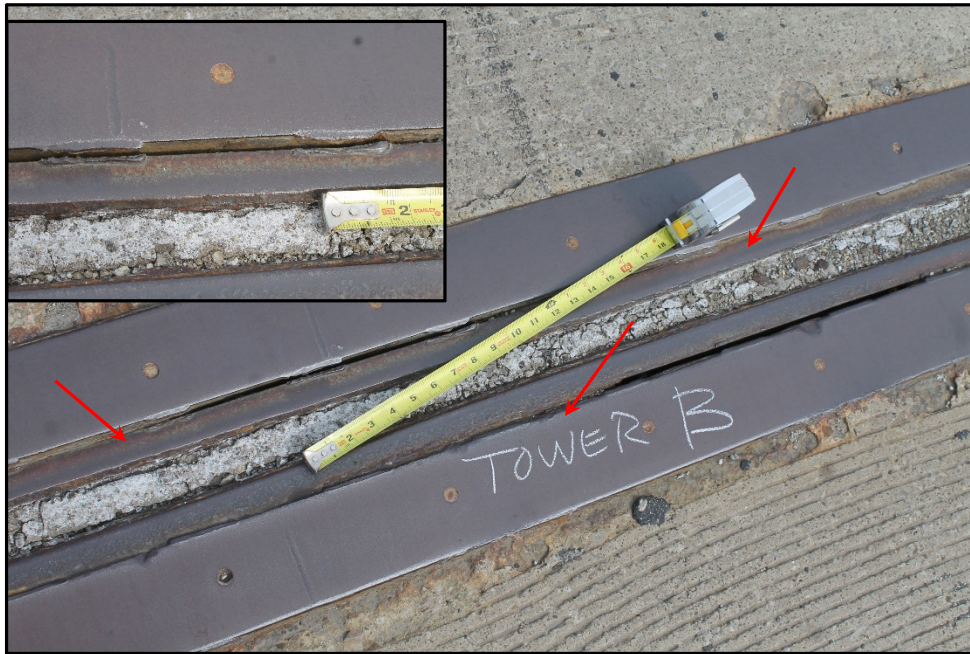
**Photo 18 – Pack Rust (at Arrows) & Broken Fillet Welds (Inset) with Infiltration Points, Tower B Expansion Joint.**

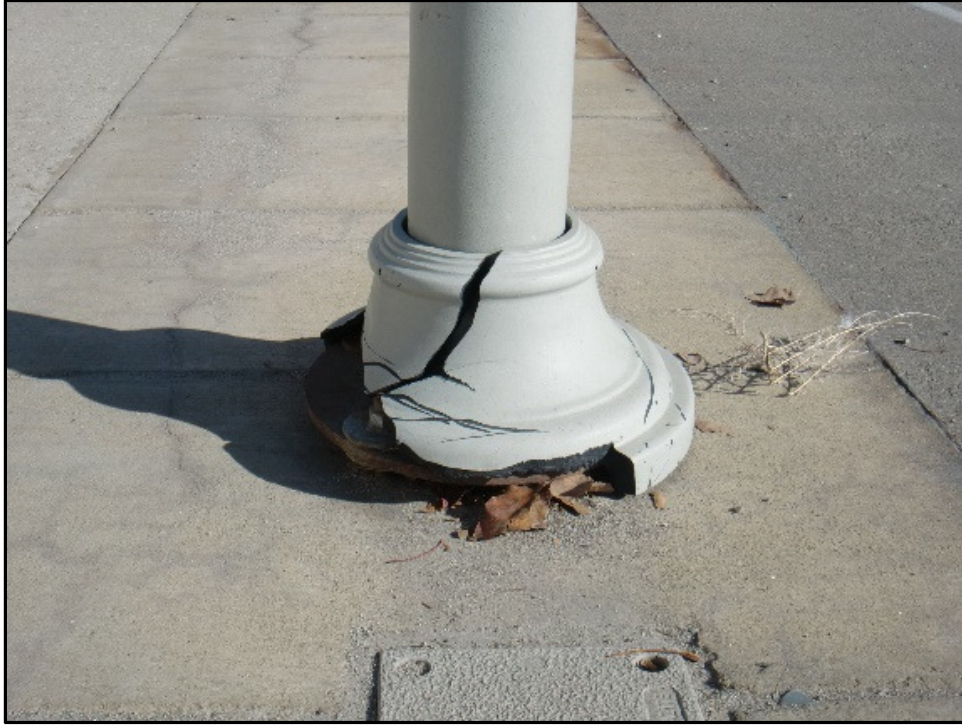
Photo 19 – Fractured Light Base, North Sidewalk.

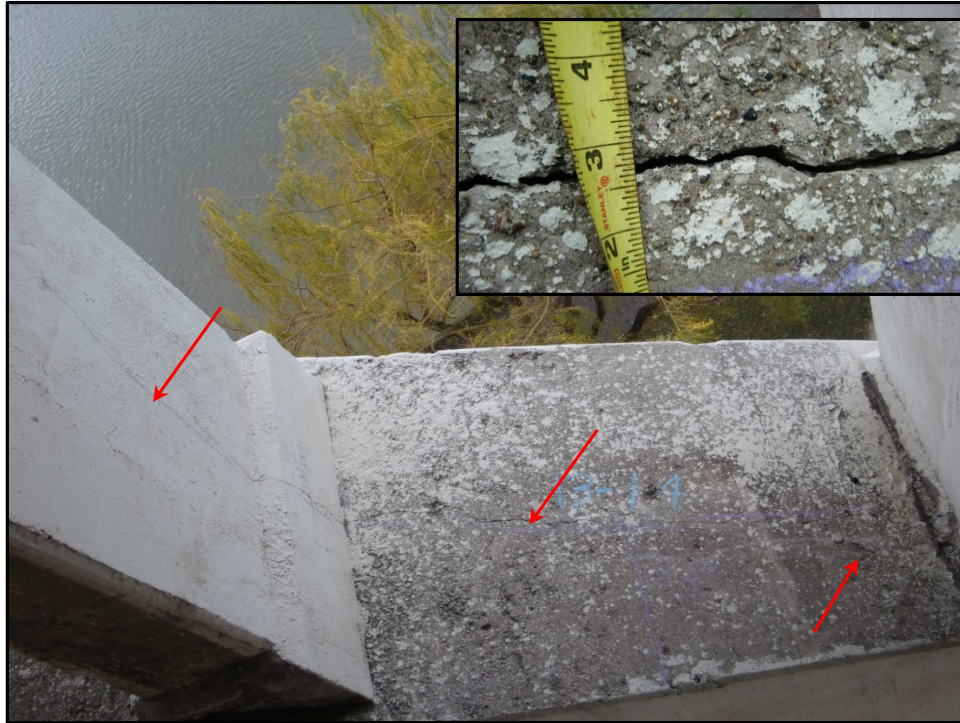
Photo 20 – Open Crack (at Arrows) on NE Arch Rib Extrados, Panel 14, Span 5.

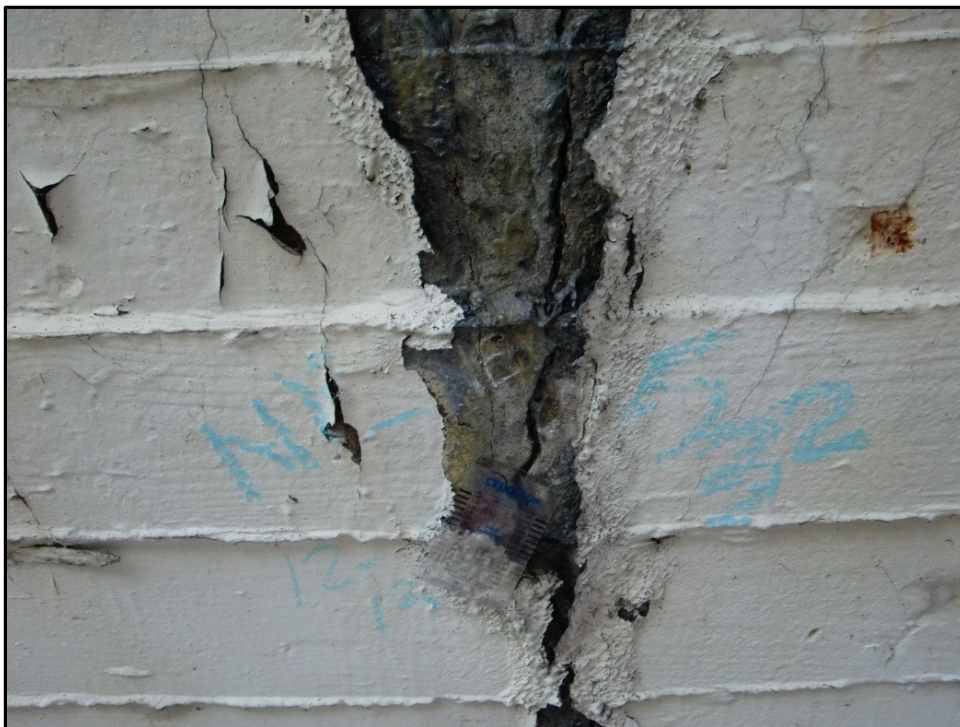
Photo 21 – Close-up of  $\frac{5}{32}$ " Epoxy-Injected Intrados Crack, Panel 13, NE Arch Rib, Span 5.

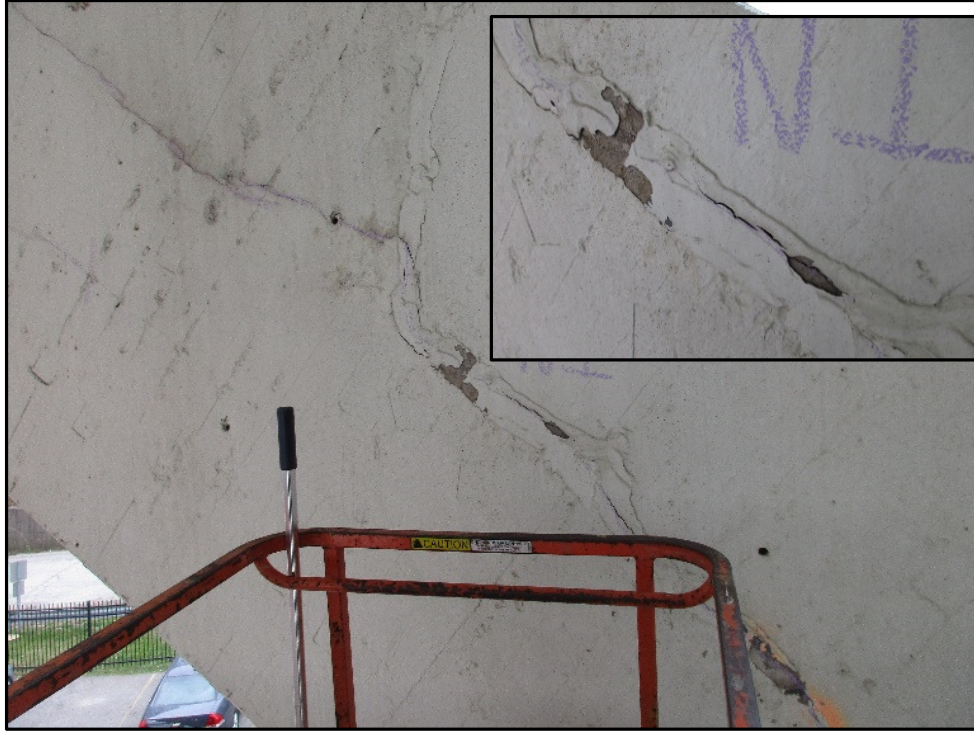
Photo 22 – New Crack at Previous Epoxy Injection Repair, NI Arch Rib, Span 3.

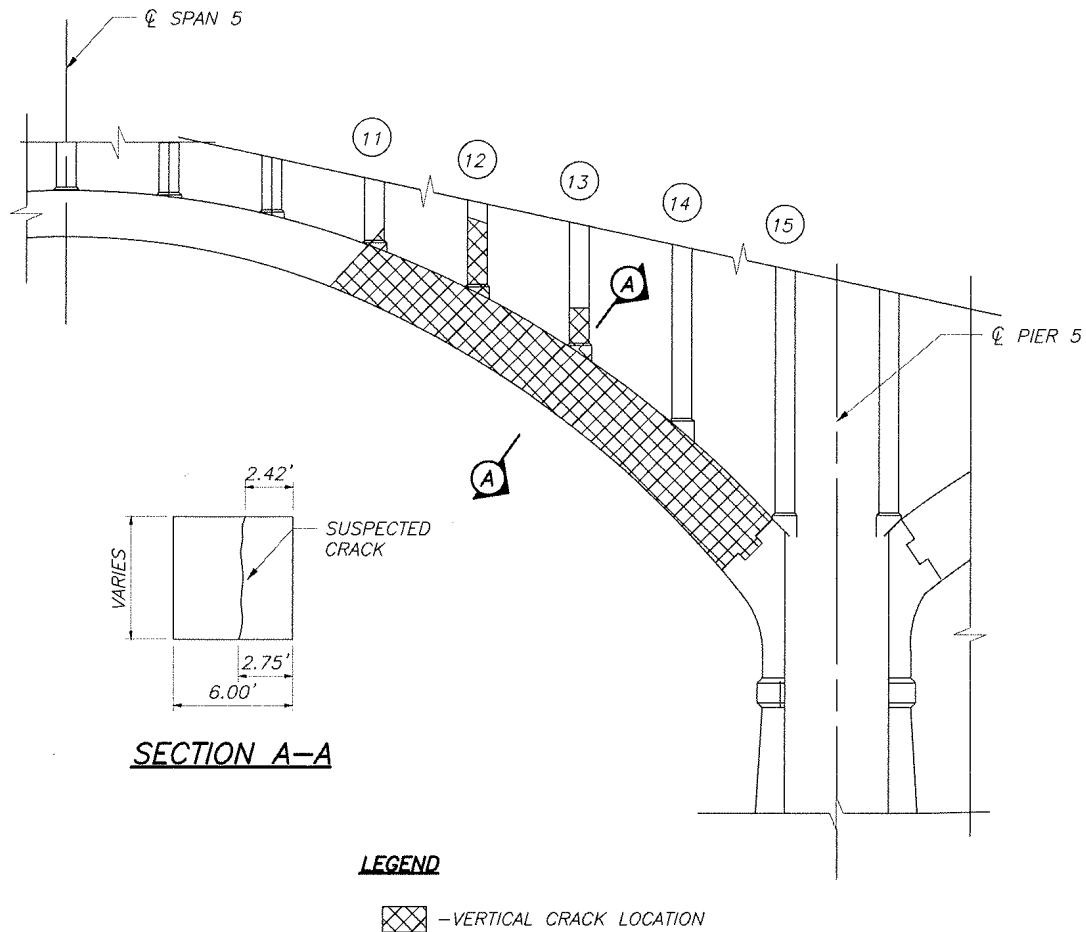
**Figure 5 – Estimated Alignment of Vertical Crack, Span 5 NE Arch & Spandrel Columns.**

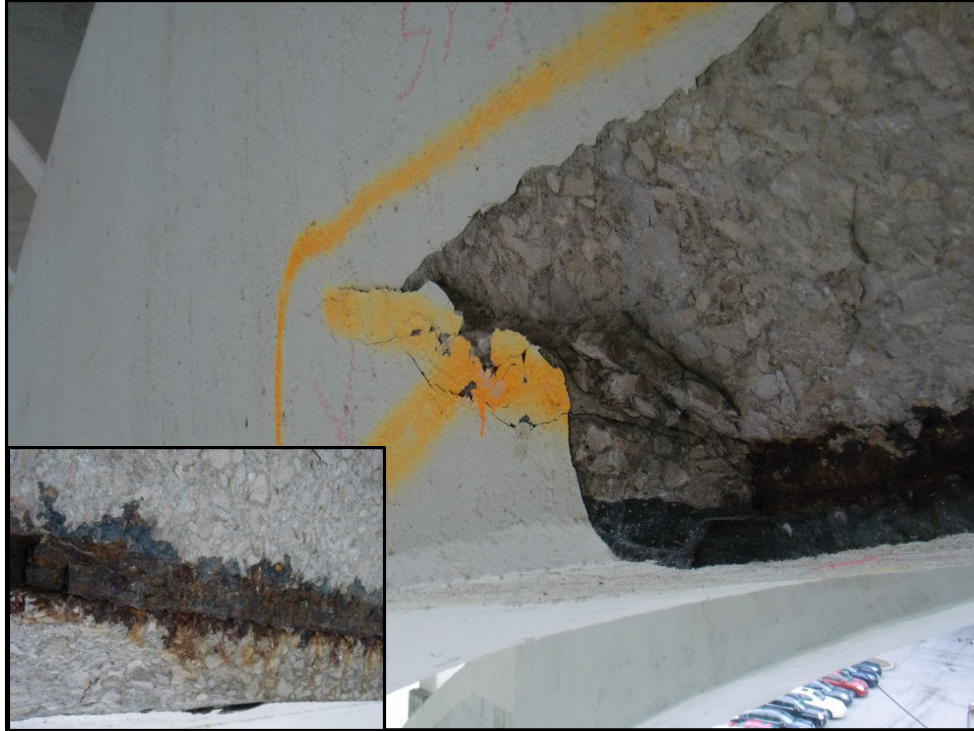
Photo 23 – Outline of Delaminated Arch Rib Corner, SI Arch Rib, Span 7.  
(Inset: Active rebar corrosion present.)

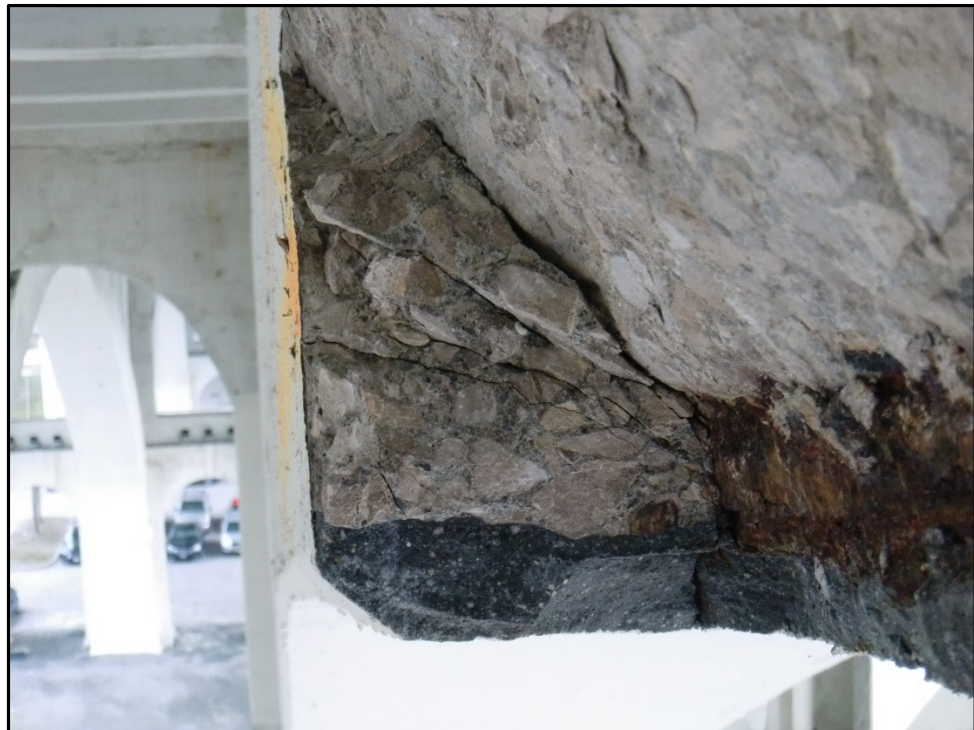
Photo 24 – Sound 1996 Shotcrete Patch & Fractured Original Concrete,  
SI Arch Rib, Span 7.

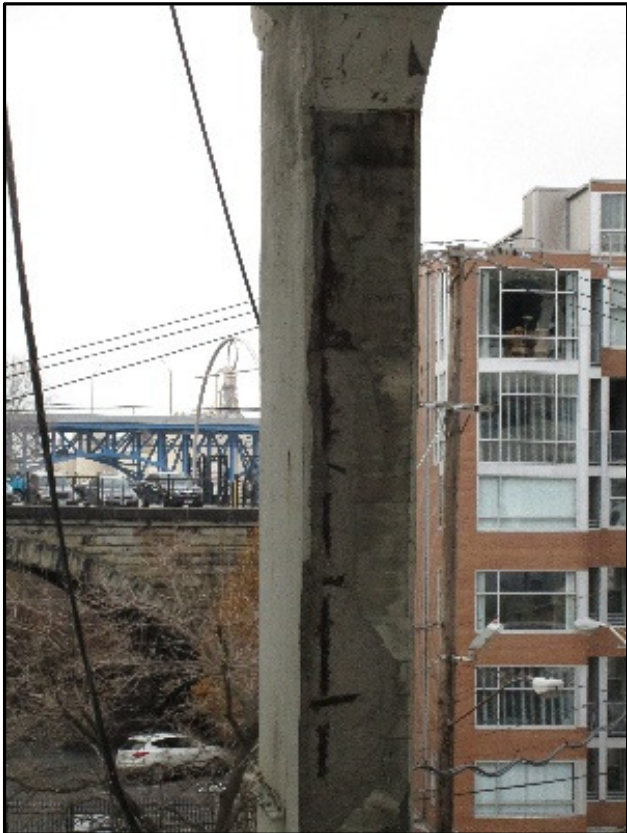
**Photo 25 – Cracked & Spalled Lower Deck Column NE 2, Span 3.**

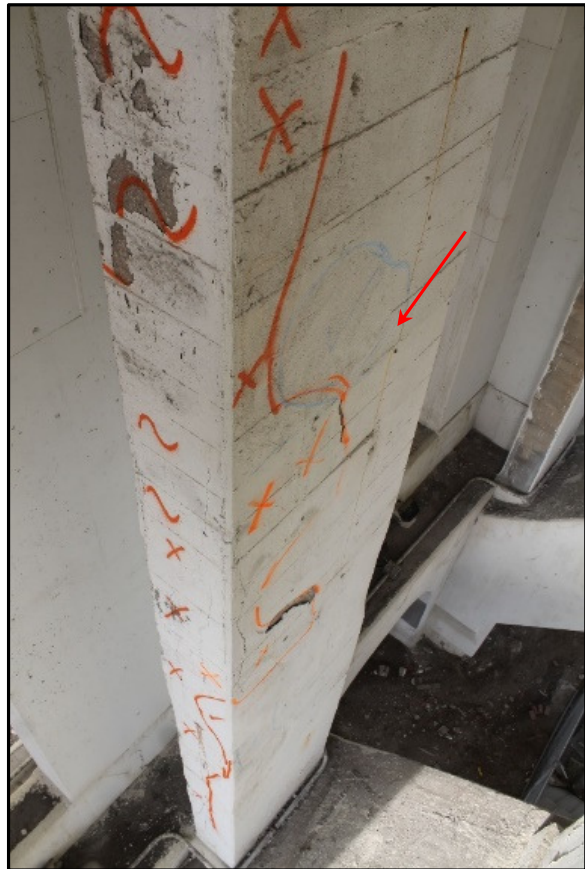
#### **Floorbeams – Concrete (c18)**

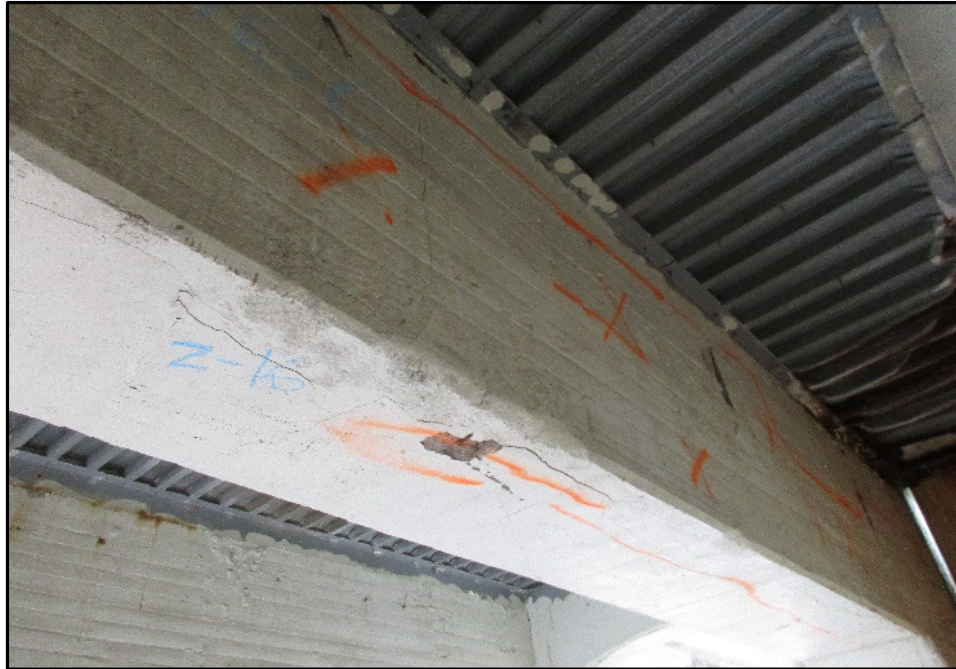
Photo 27 – Delaminated Surfaces of Lower Deck Floorbeam 16, Center Bay, Span 2.

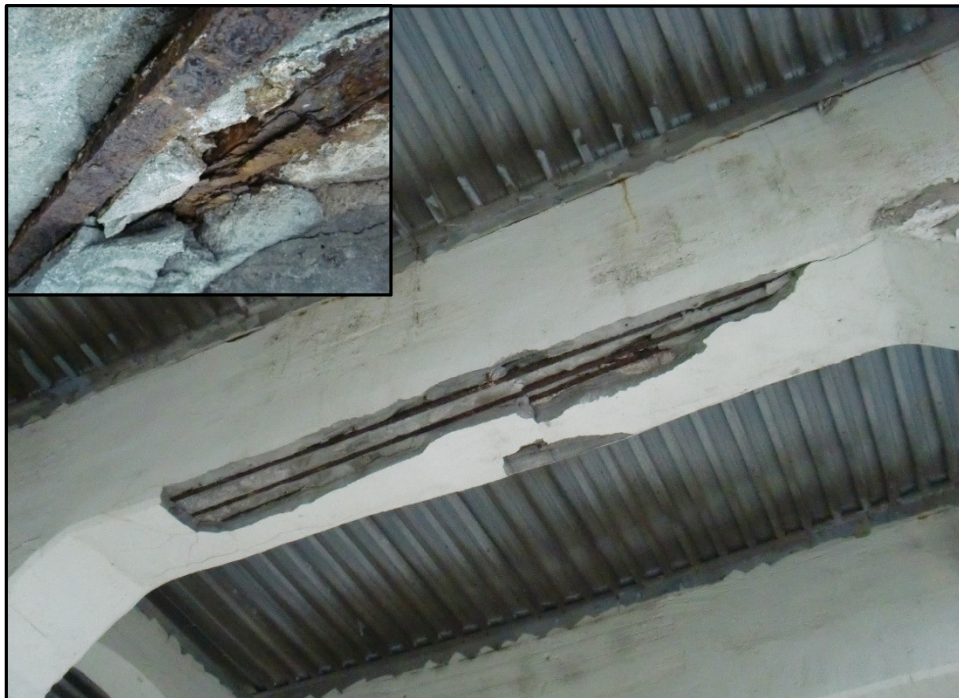
Photo 28 – Spalled 1996 Shotcrete Patch, Lower Deck Floor Beam 14, South Bay, Span 6. (Inset: Continued reinforcement corrosion at shotcrete patch/original concrete interface.)

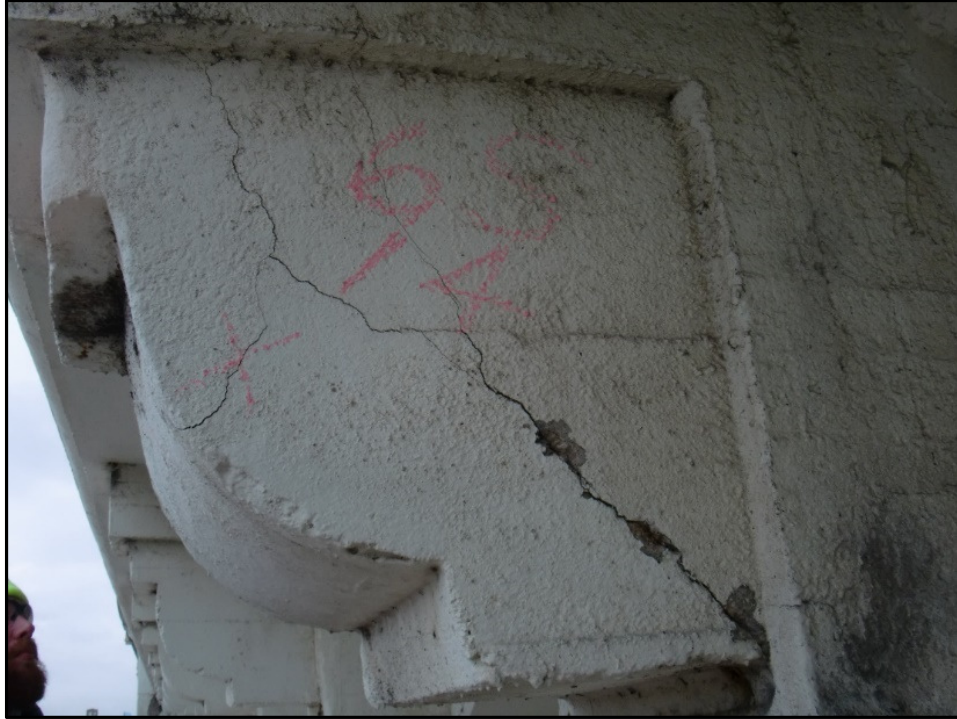
Photo 29 – Common Crack in Line of Primary Reinforcement, Lower Deck Corbel.

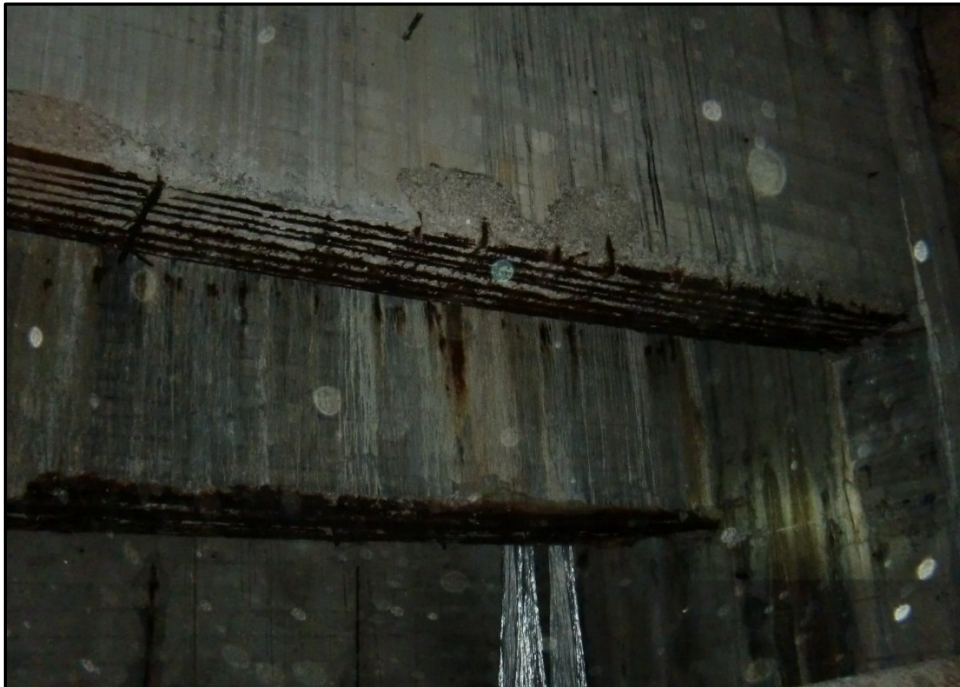
Photo 30 – Exposed Bottom Reinforcement Mat, Lower Deck Floorbeams 1 & 2, North Bay, East Station.

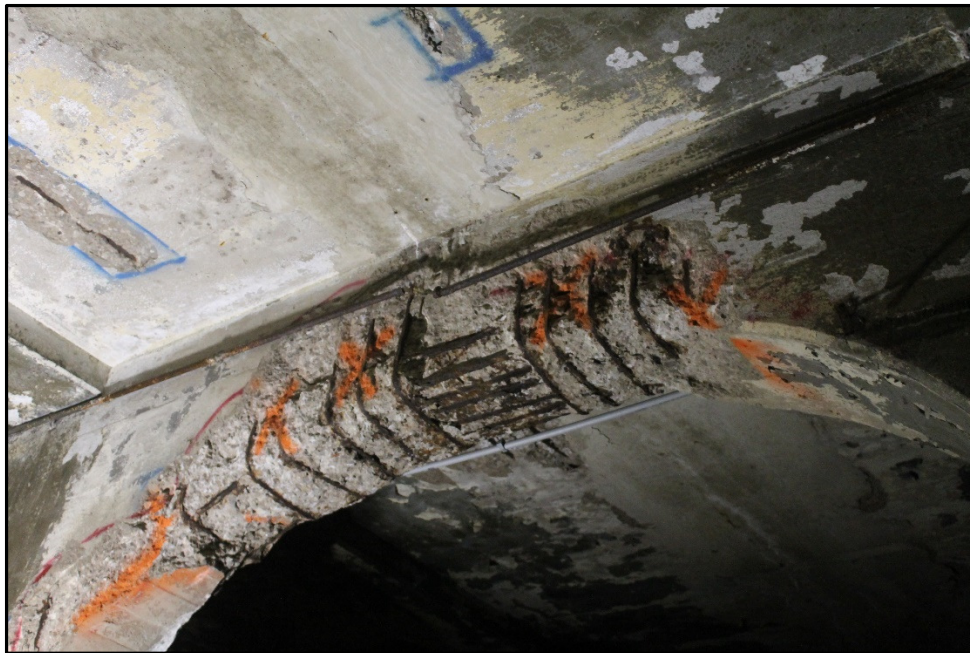
Photo 31 – Spalled Beam D22, West Station.

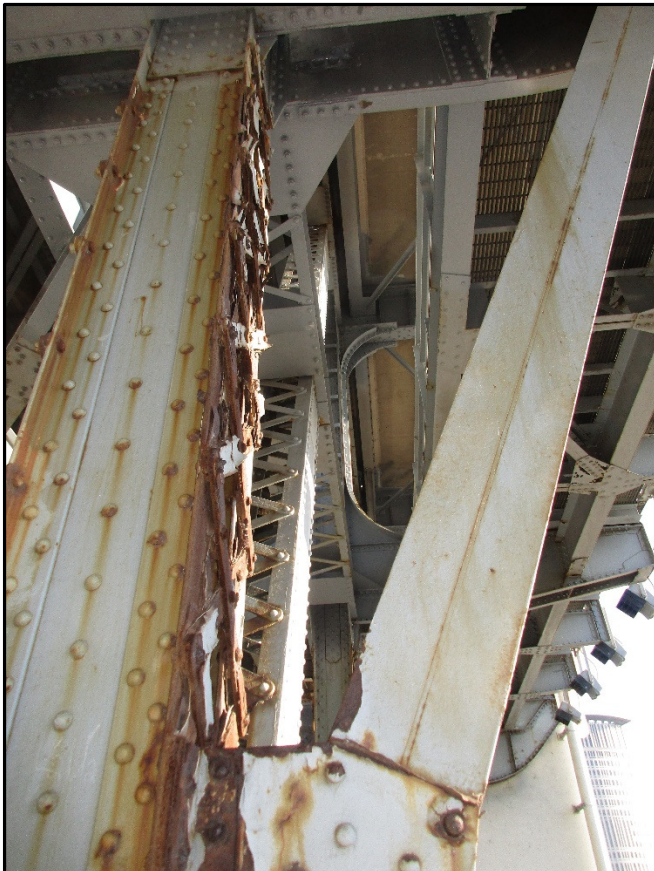
Photo 32 – Typical Minor Corrosion of Vertical Below Lower Deck.

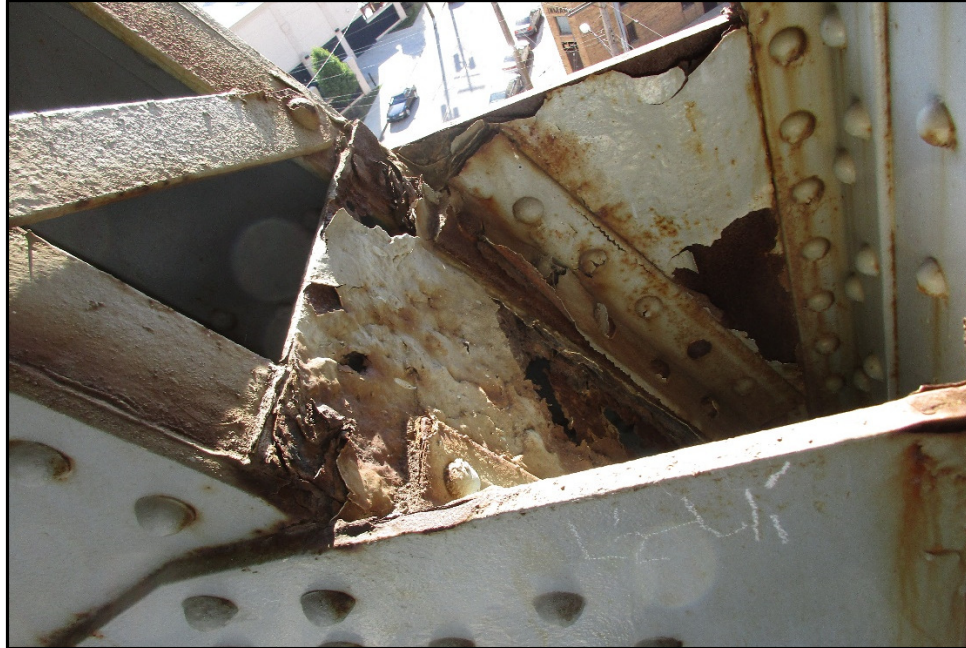
Photo 33 – Minor Pitting Top Stay Plate, U1'-L2' South.

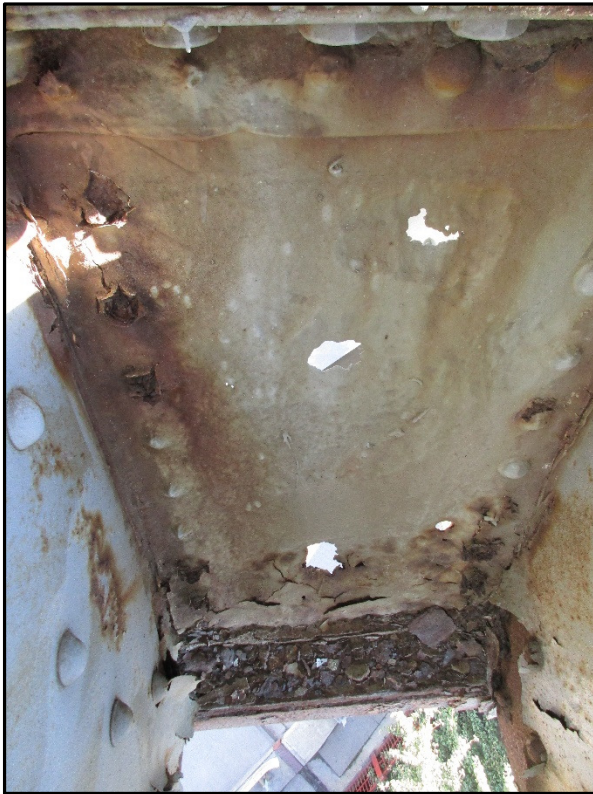
**Photo 34 – Common Perforations of Lower Chord Diaphragm.**

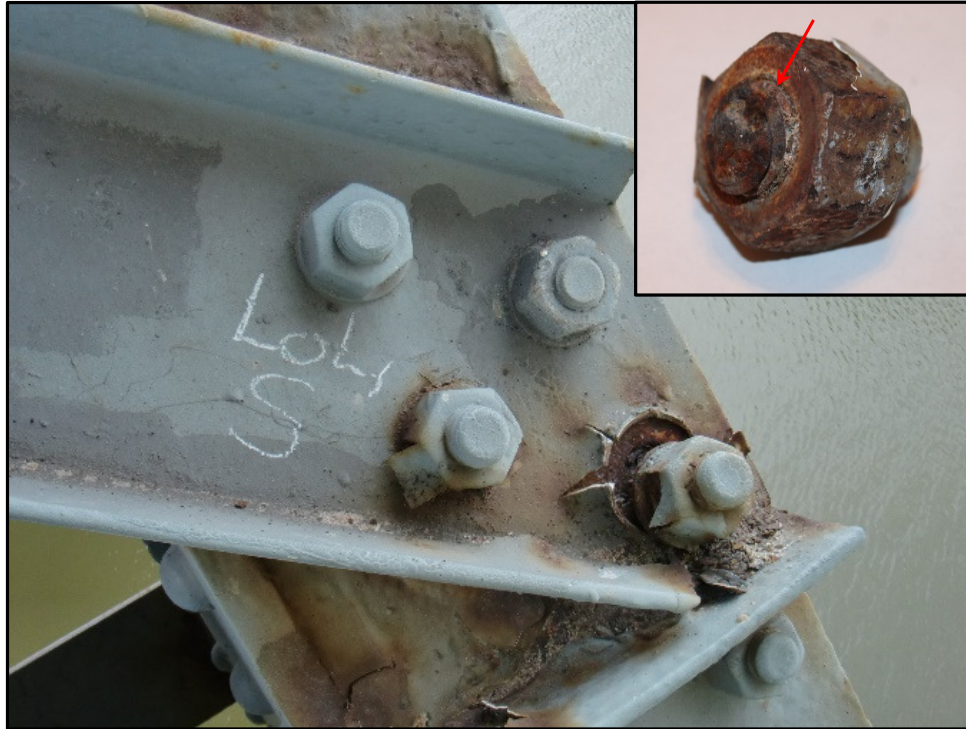
Photo 37 – Fractured Bolt, South L<sub>0</sub>L<sub>1</sub>.  
(Inset: Fracture Origin at Arrow.)

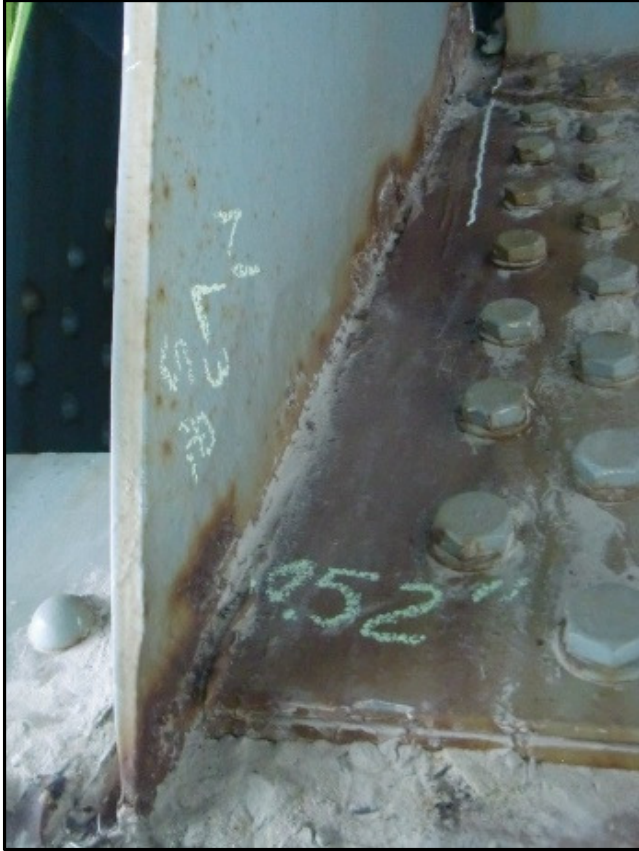
Photo 38 – 0.23" Deep Section Loss x 6" Long at Edge of Gusset Plate, North L<sub>3</sub>.

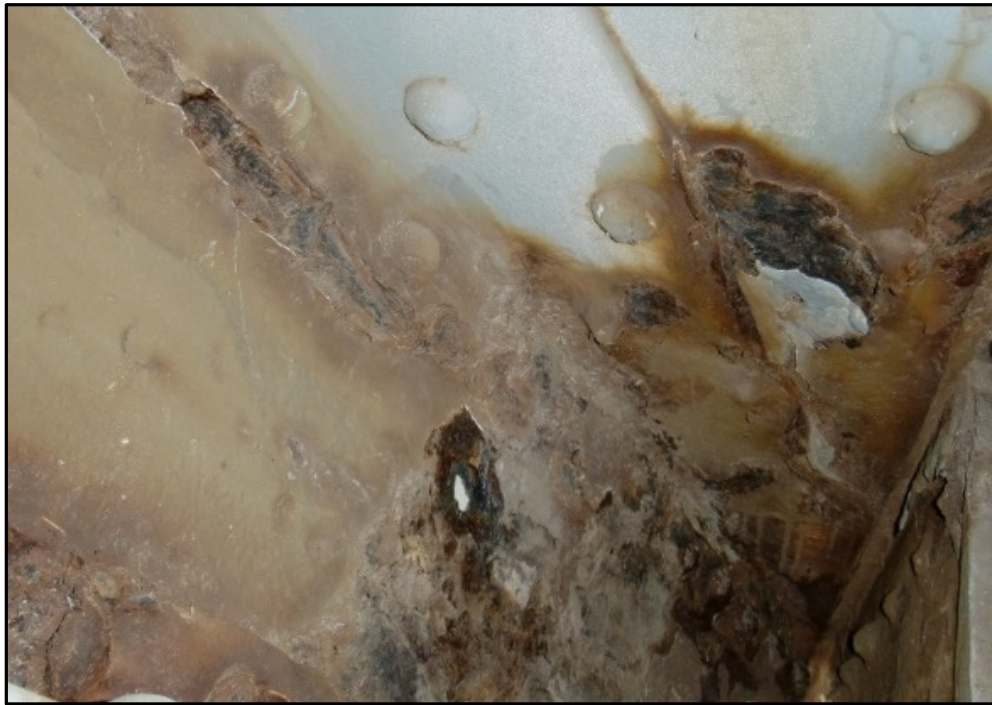
Photo 39 – Typical Rust Nodule (at Arrow) on Interior Gusset Plate Surface.

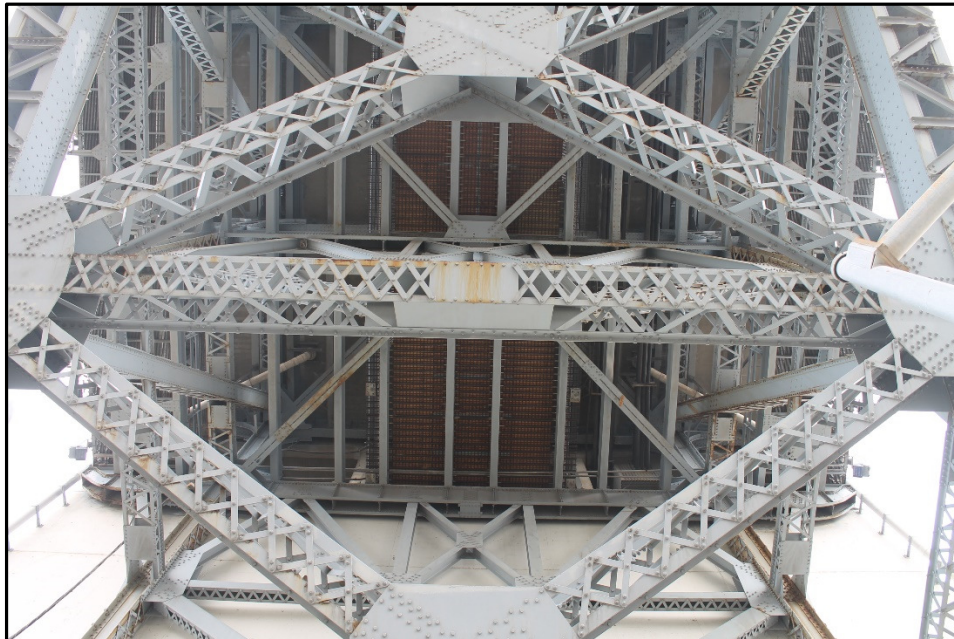
**Photo 40 – Light Corrosion Stains, Lower Lateral Bracing.**
