# Ohio Department of Transportation 2015 Physical Condition Report

## Detroit-Superior Bridge over Cuyahoga River Bridge No. CUY-6-1456

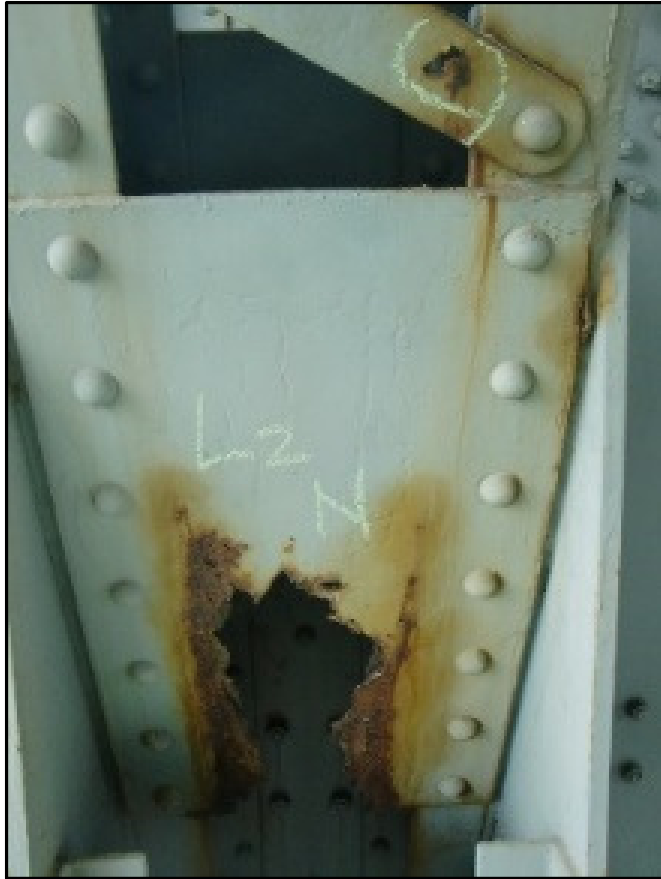
Photo 41 – Perforation of Sway Brace Stay Plate & Lacing Bar, North L<sub>2</sub>.

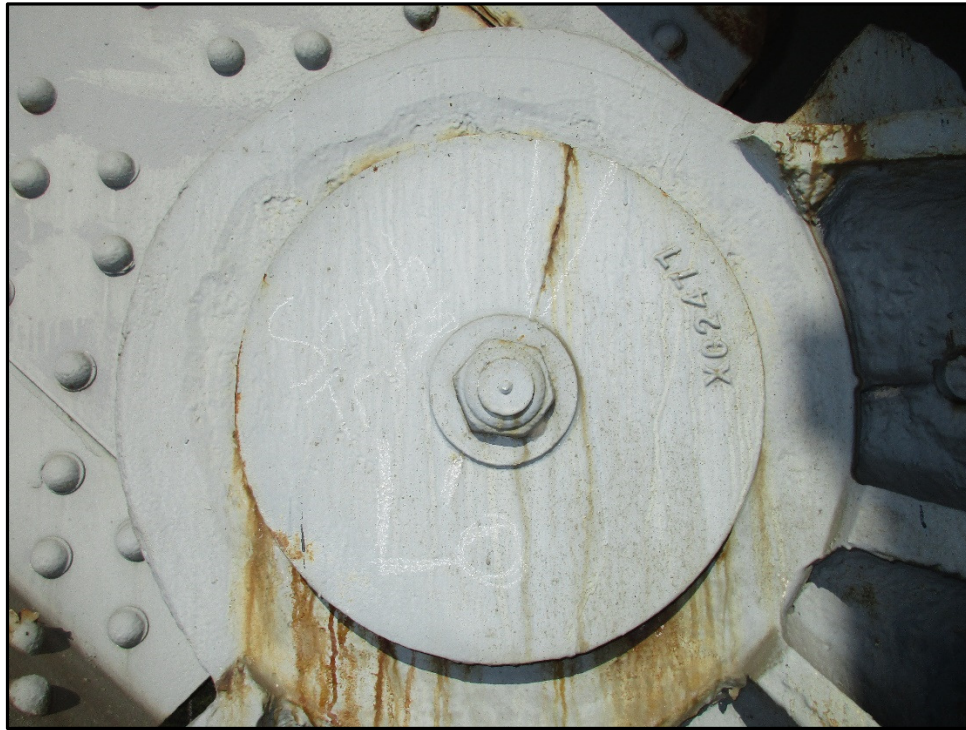
**Photo 42 – Typical Bearing Pin Cover Plate Crack.**

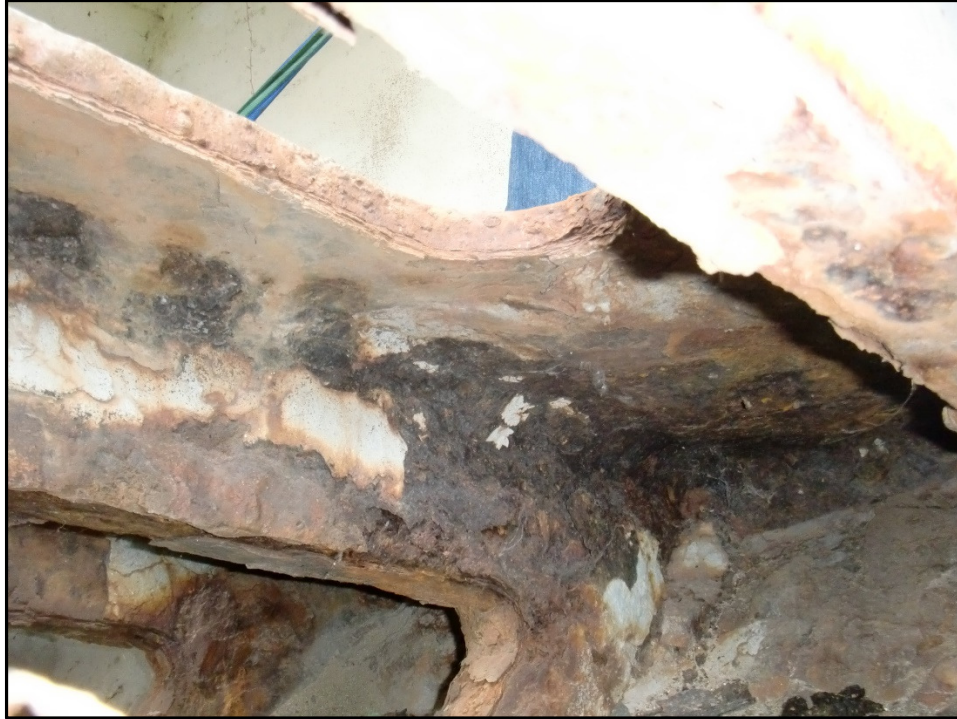
Photo 43 – Typical Corrosion Interior Surface of Bearing Casting.

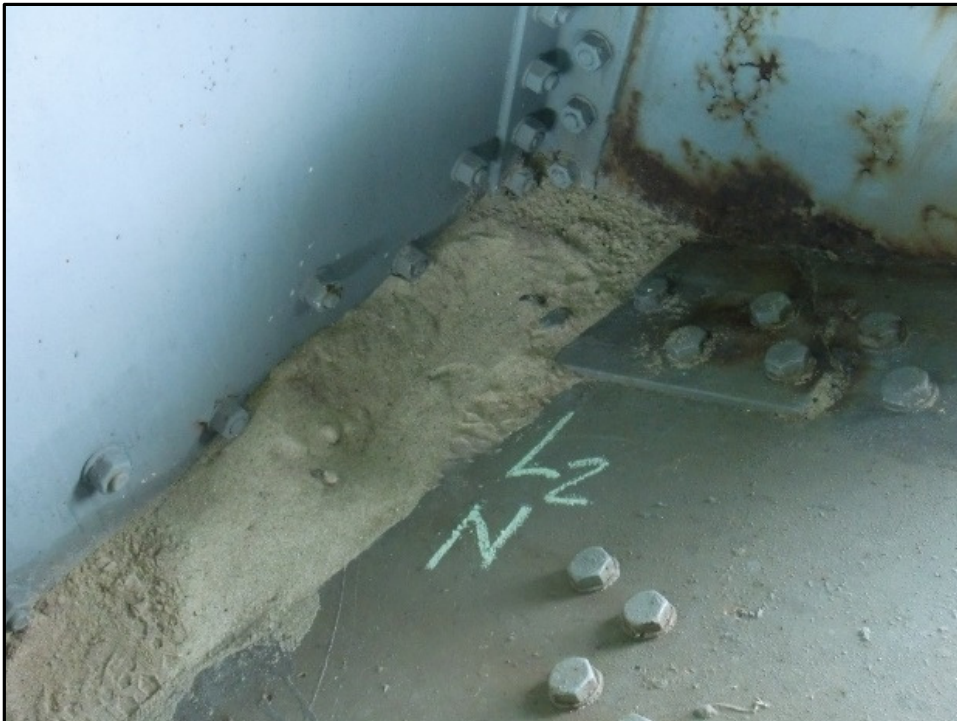
Photo 44 – Blast Material Accumulation, Top of Lower Lateral Bracing Gusset Plate, Panel Point North L2.

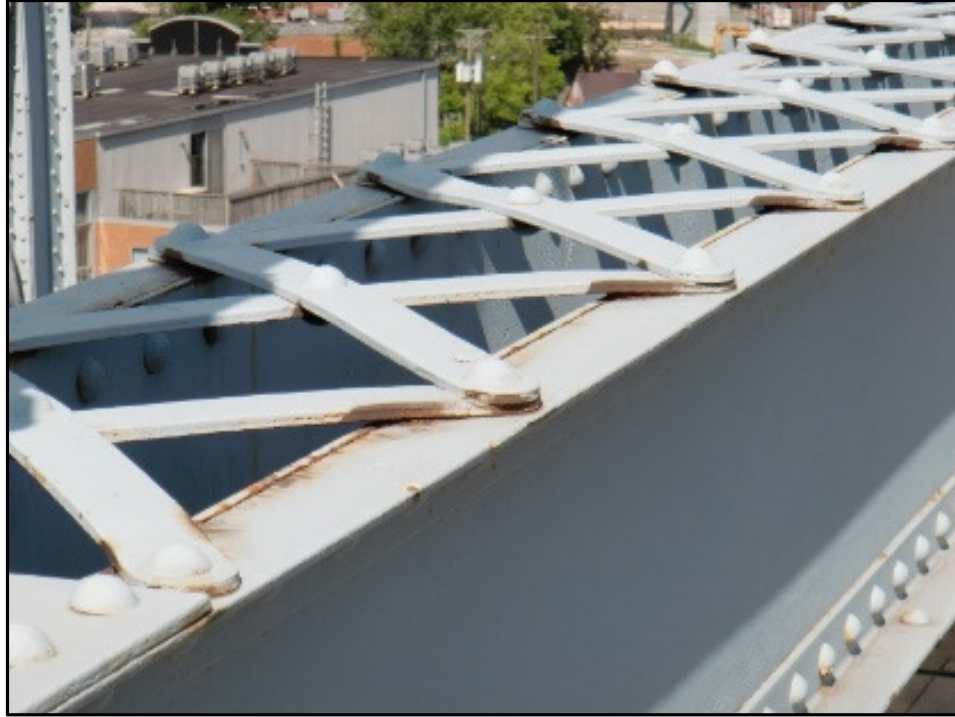
Photo 45 – Oxidized Top Coat & Light Rust Staining Above Upper Deck.

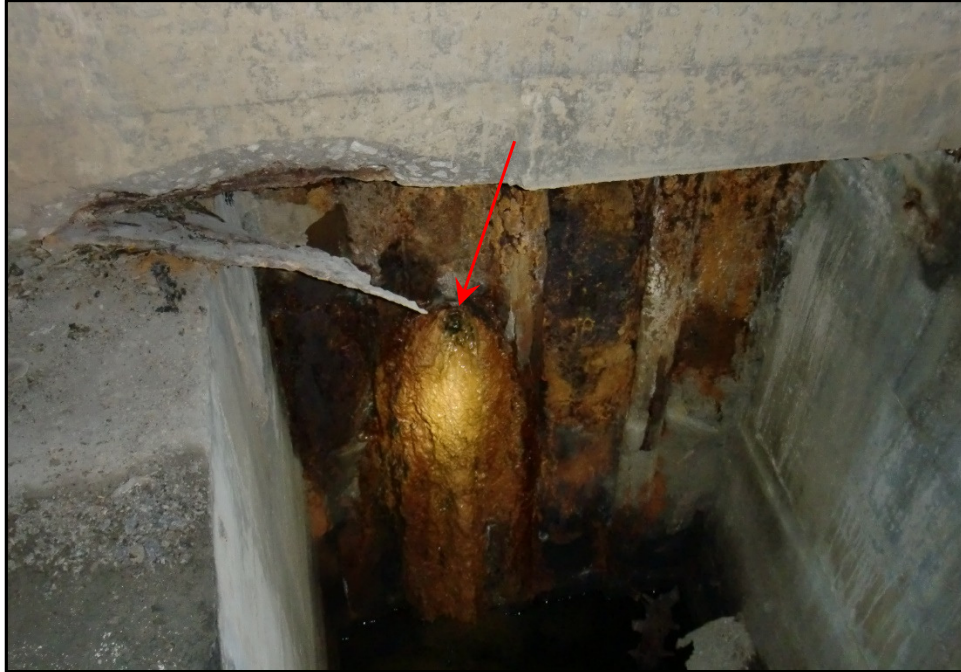
**Photo 45 – Possible Deposit Clogged Pedestrian Tunnel Drain Outlet (at Arrow), East Abutment Cellular Construction.**

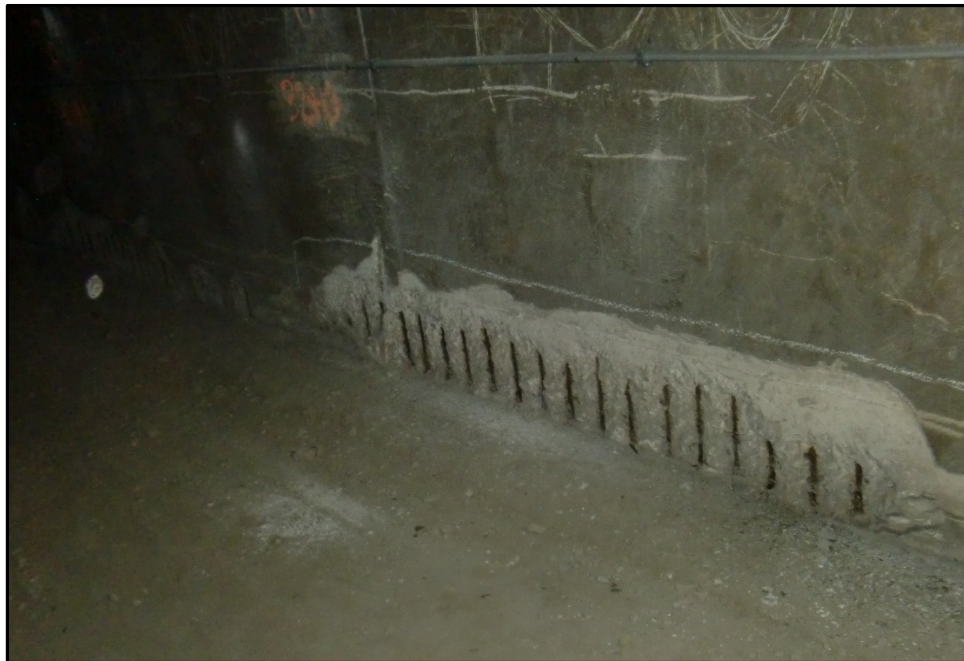
**Photo 46 – Typical Wall Base Spalls, Detroit Ave. & West 25<sup>th</sup> St. Tunnel.**

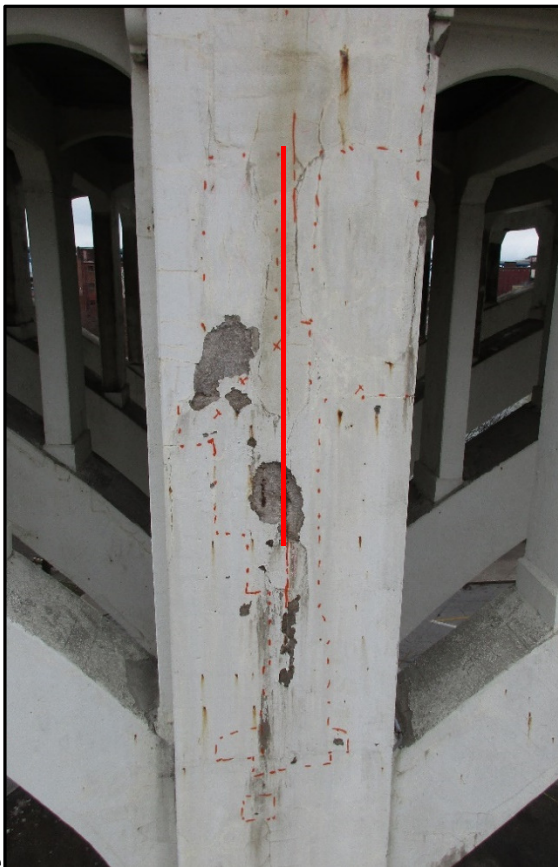
**Photo 47 – Scaled Concrete Core, SE Lower Deck Shaft, Outlined in Dotted Paint. (Note: Original encased drain pipe is located behind red line.)**

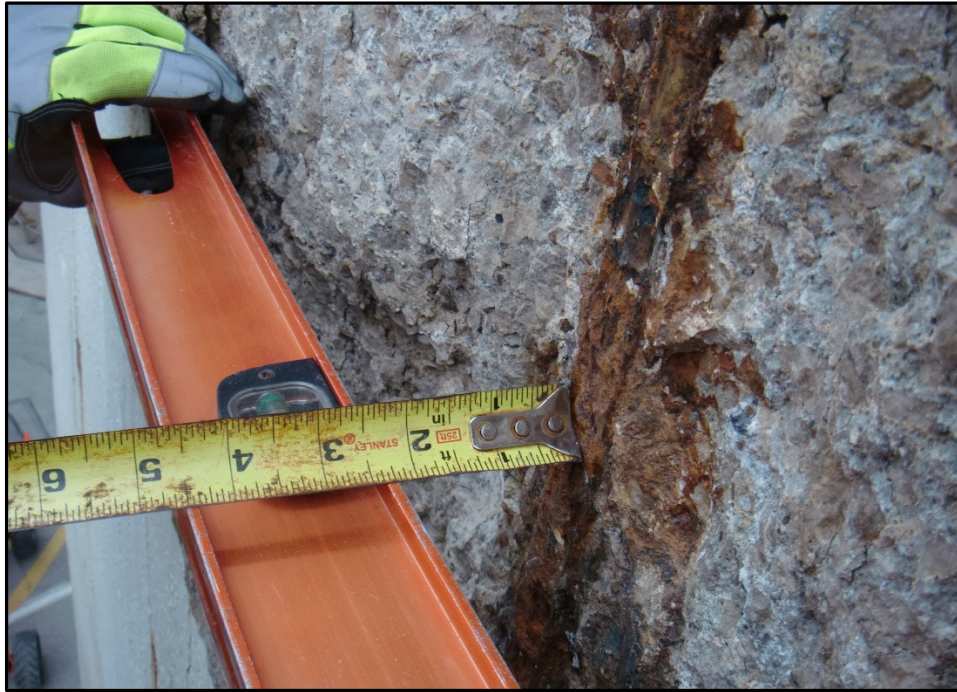
**Photo 48 – Scaled Concrete & Rebar Corrosion, SE Lower Deck Shaft.**

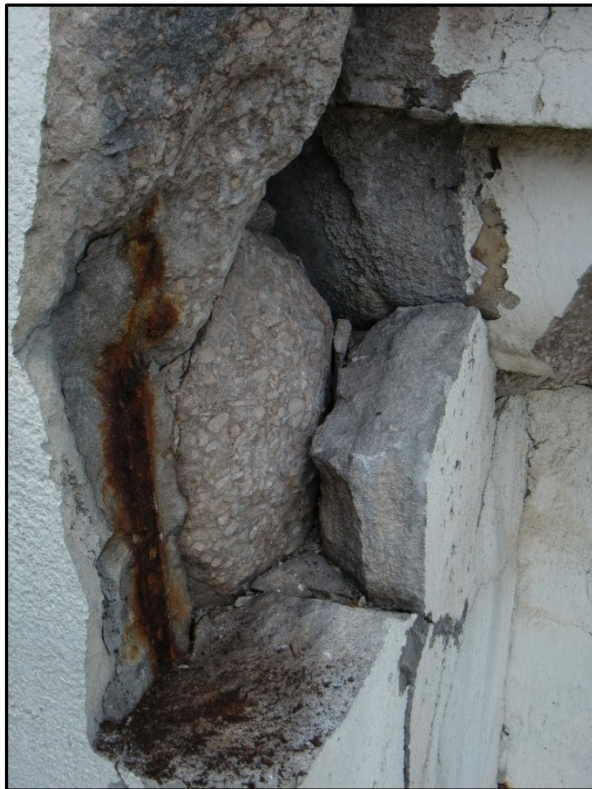
**Photo 49 – Deeply Cracked East Face of South Exterior Lower Deck Shaft, Pier 5 at Lower Deck Corbel.**

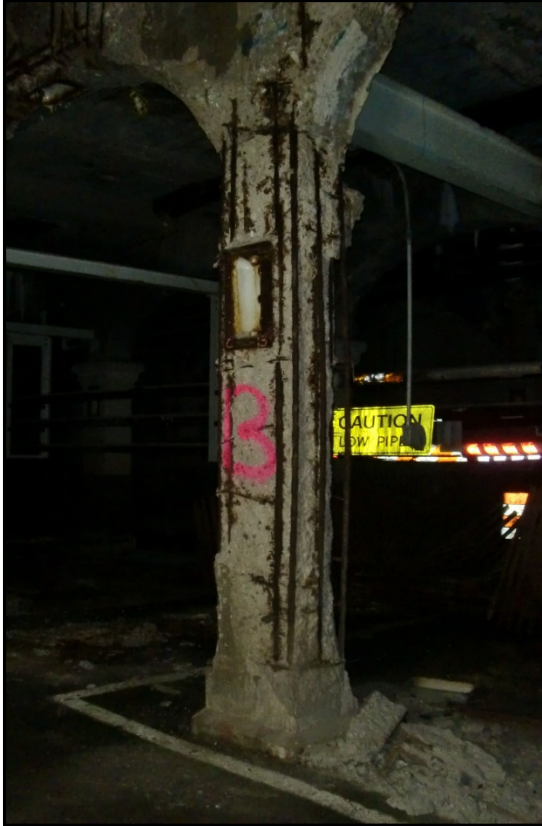
Photo 51 – Advanced Concrete Corrosion, Column C13, West Station.

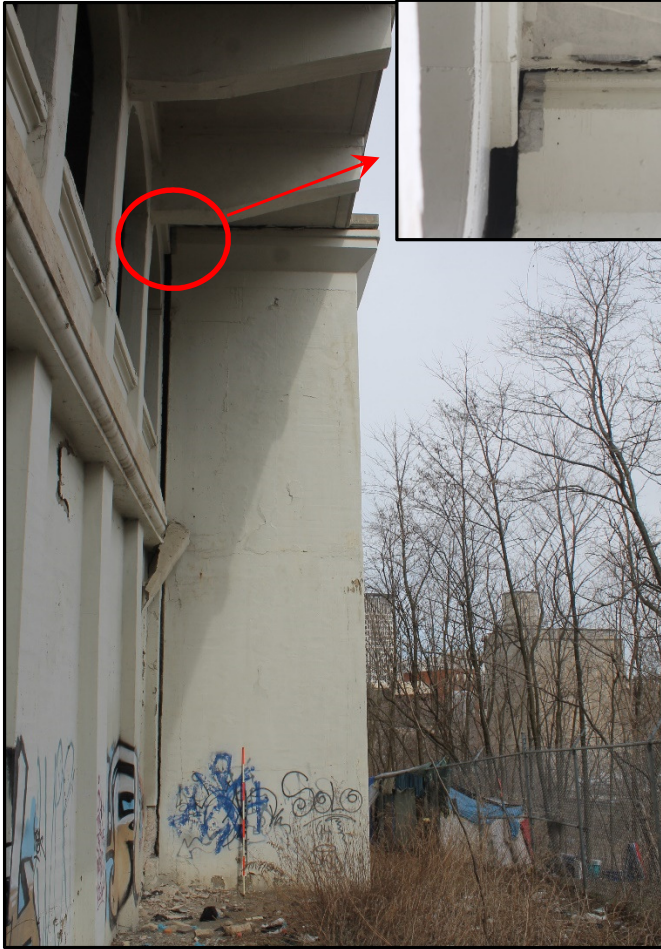
Photo 52 – Rotation of Tower B South  
(Inset: 6" rotation at top NW  
corner.)

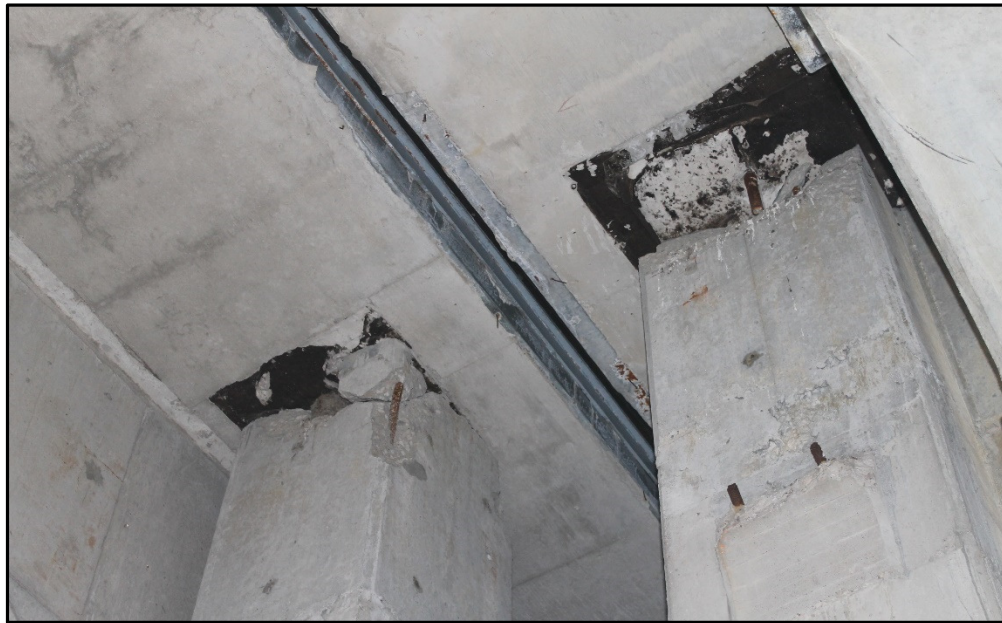
Photo 53 – Fracture of Top Interior Section Against Upper Deck Slab, Tower B South.

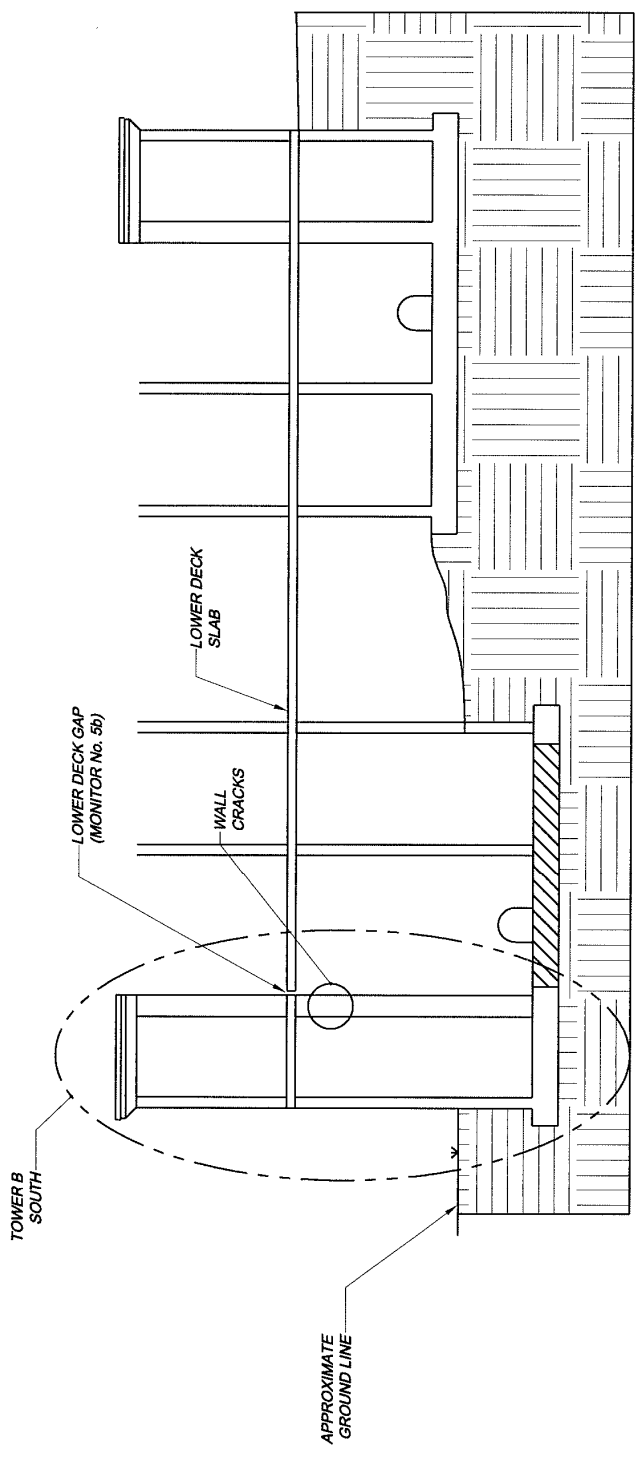
TOWER B CELLULAR CONSTRUCTION

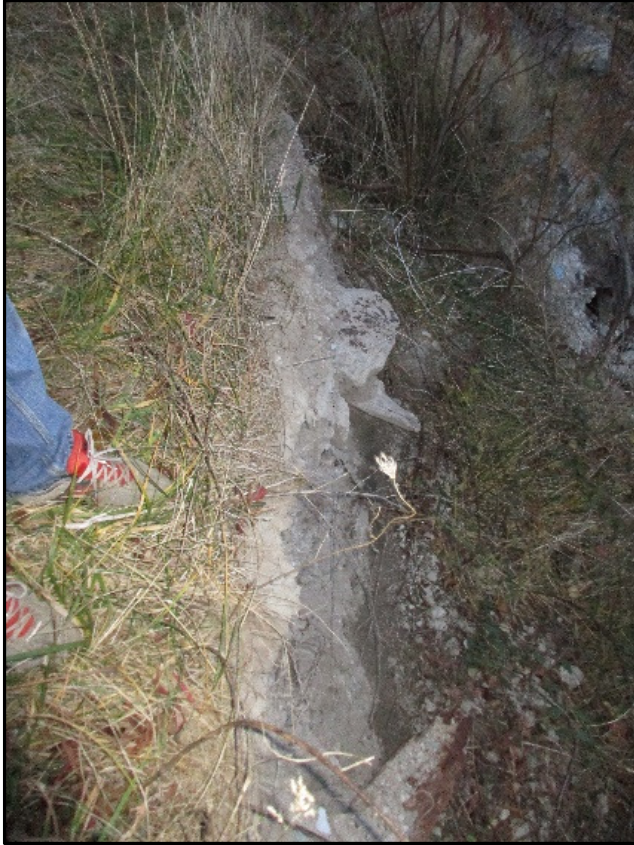
Photo 54 – Slope Settlement, Beneath Span 3.

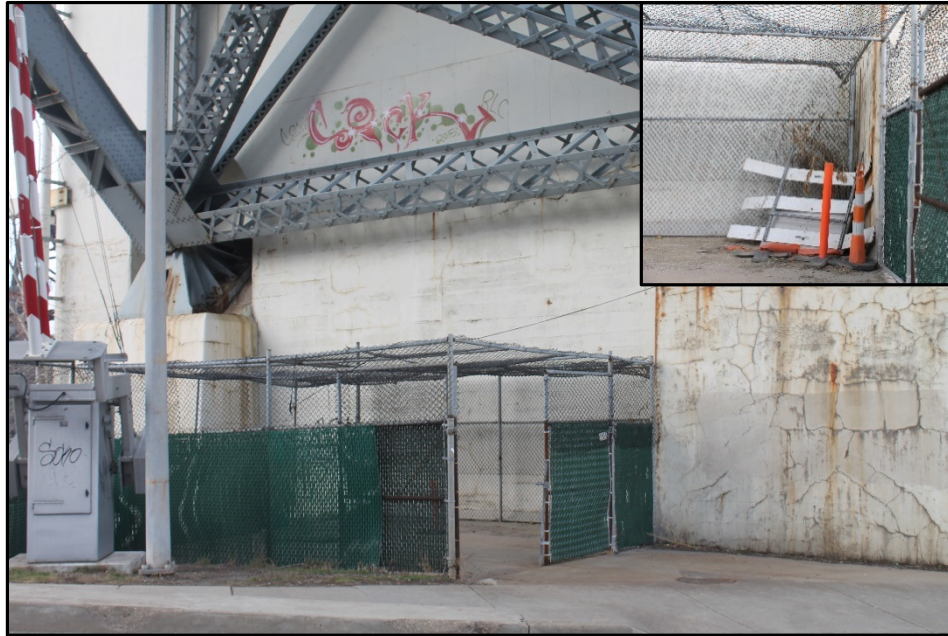
**Photo 57 – Illegal Access onto Steel Superstructure Through Vehicle Enclosure & Graffiti on Pier 4. (Inset: Barricade propped up for access through broken chain-link cover.)**

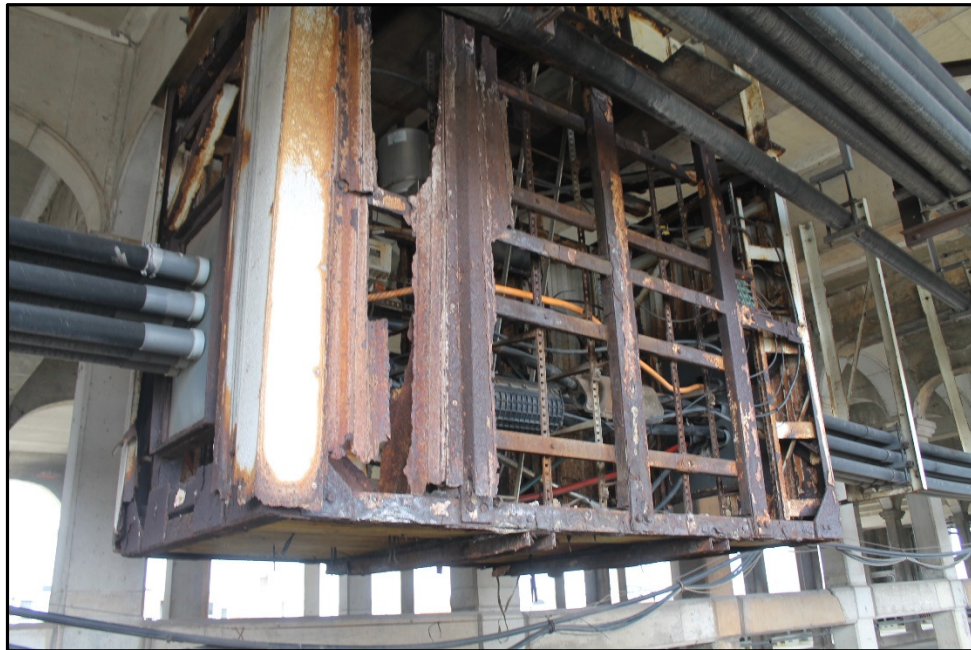
**Photo 59 – Corroded & Unsecure Telephone Junction Chamber, Span 2 Lower Deck.**

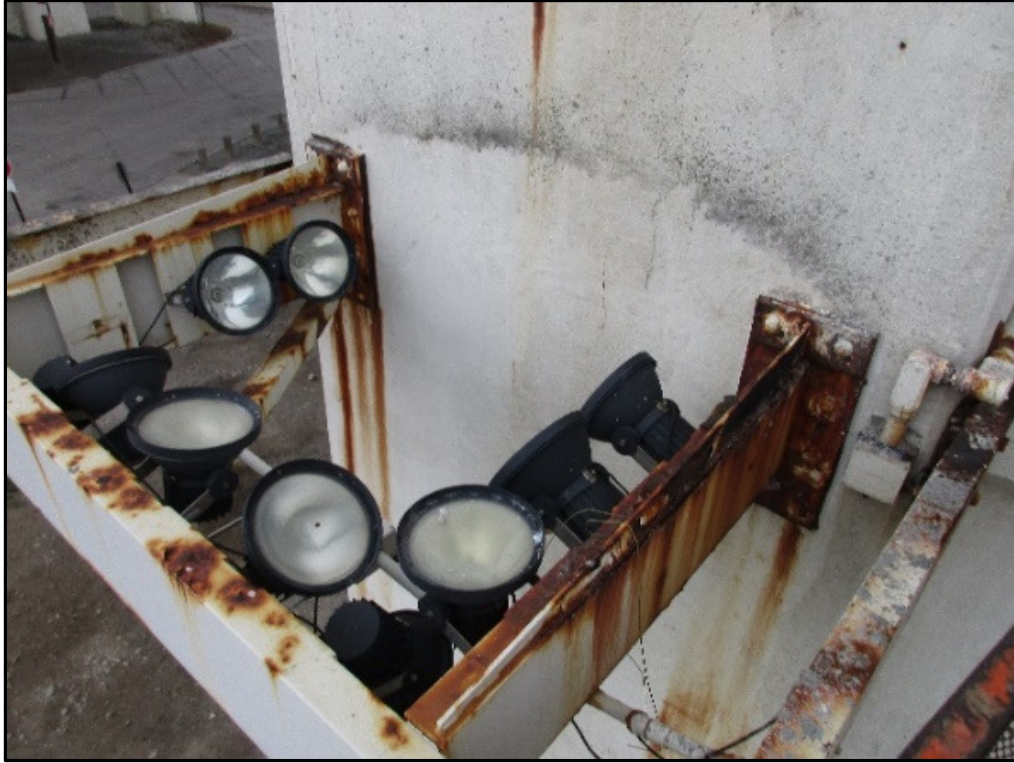
Photo 60 – Typical Paint Failure & Corrosion, Exterior Pier Shaft Lighting Brackets.
