***2015 BRIDGE INSPECTION  
FIELD REPORT***

## BRIDGE INSPECTION FIELD REPORT

Inventory Bridge Number: CUY 00006 14.560 N

USR 6 over (1499)CUY. RIVER & RTA

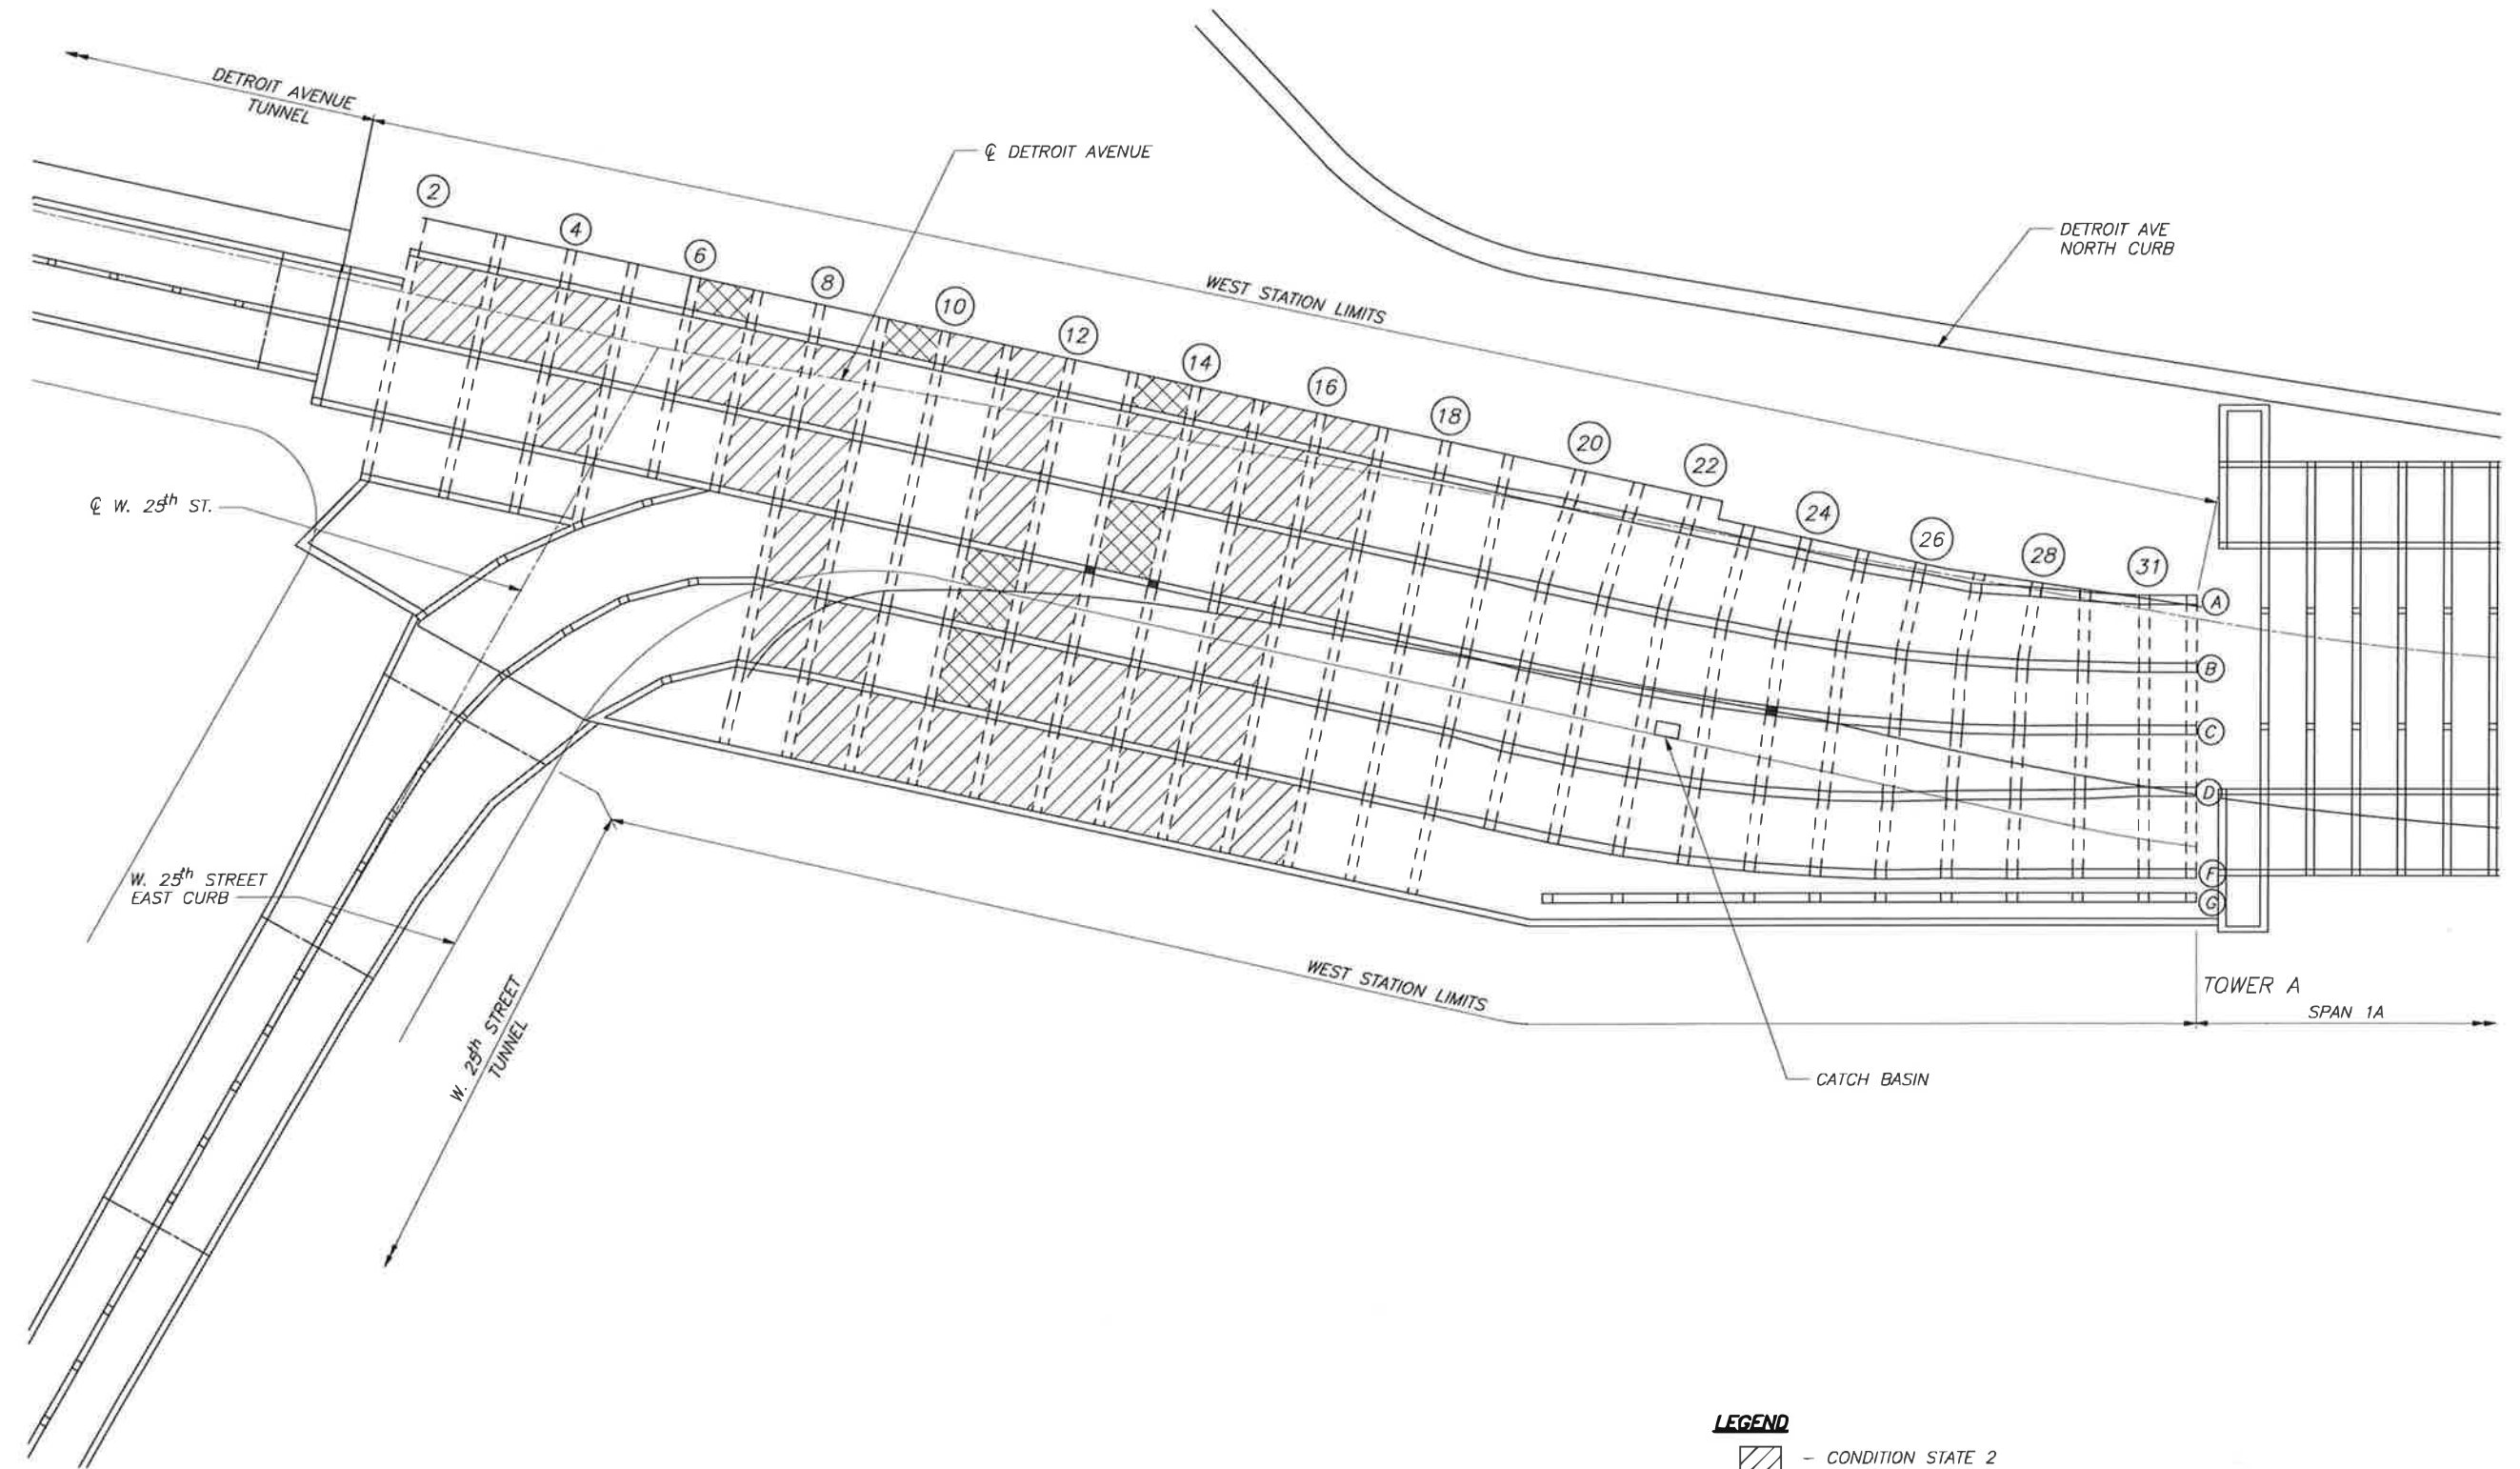
SPANS 1 - 5
	WEST STATION ROOF SLAB
	B-1

The West Station floor slab has areas of CS 2 and CS 3 primarily beneath the south curb line and along deficient floor joints. CS 2 - 7342 SF, CS 3 - 832 SF. Top of West Station slab was extensively patch in Fall 1995. Waterproofing placed in 1995 is not effective. Slab is 16 inches thick in most areas.

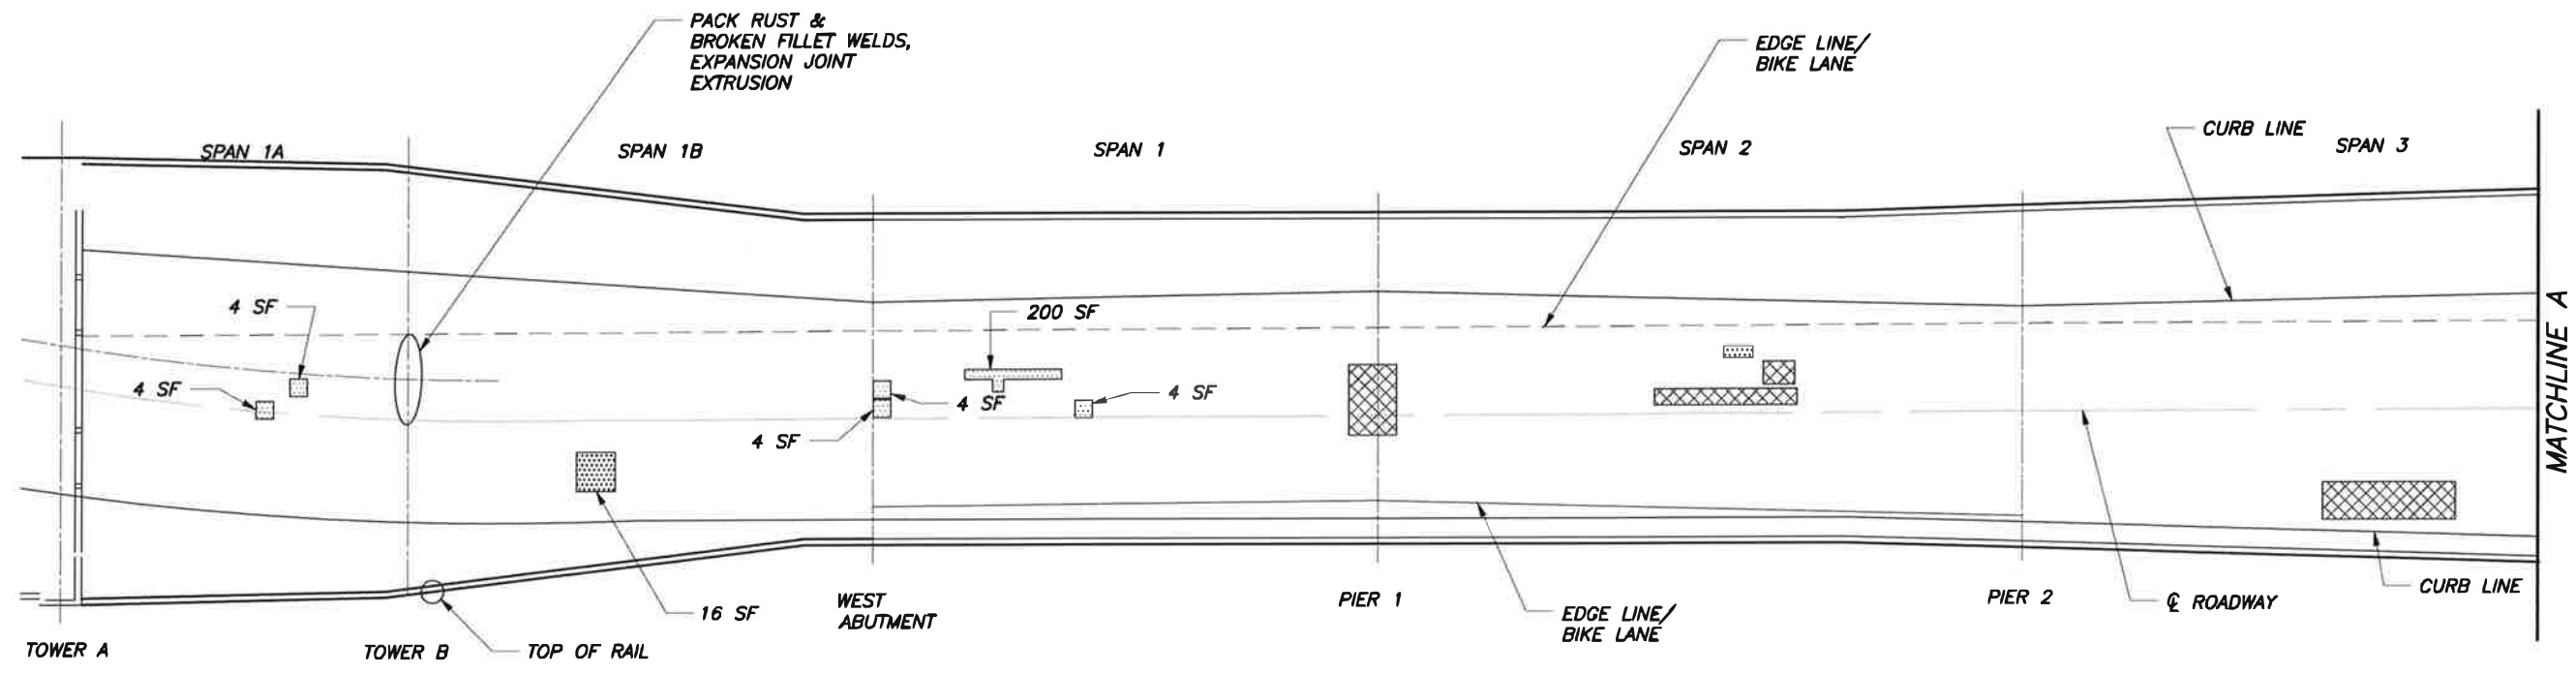
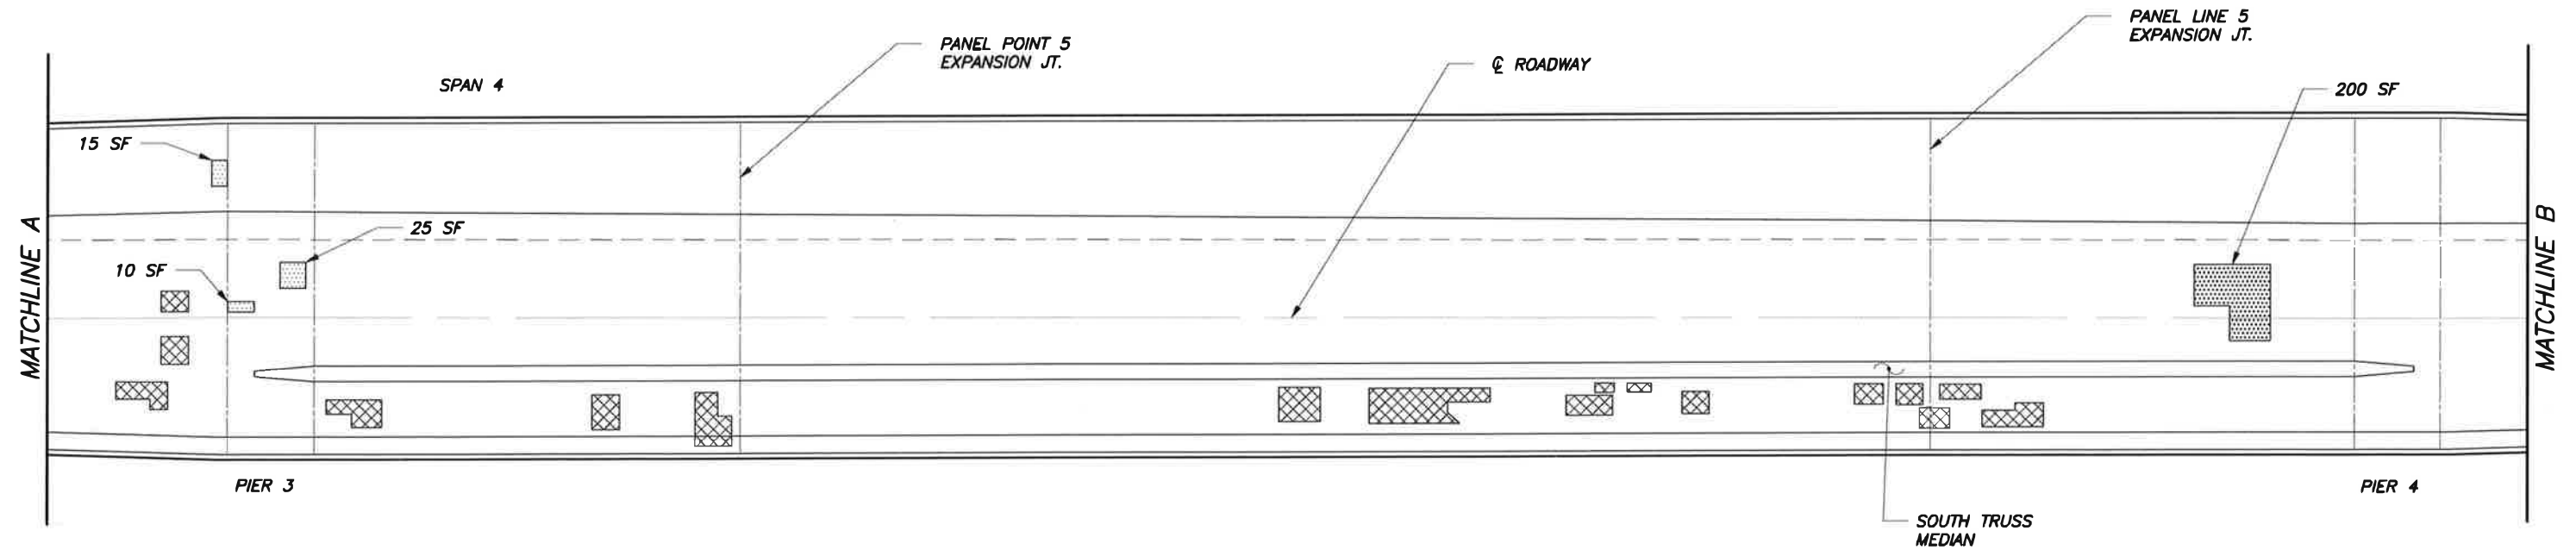
UPPER DECK FINDINGS SPANS 1A- EAST STATION
	B-2

Overall, portions of the the concrete wearing surface were repaired in 2014 and 2015. condition with isolated spalls, patches, and plow damage. Local sounding of the concrete wearing surface revealed 2 to 5% of total WS area unsound. Open longitudinal cracks are also present in the concrete WS. On asphalt patch is present in Span 4, interior WB lane. Contractor also performed one additional large WS patch in Span 9 that revealed significant section loss of top mat rebar.

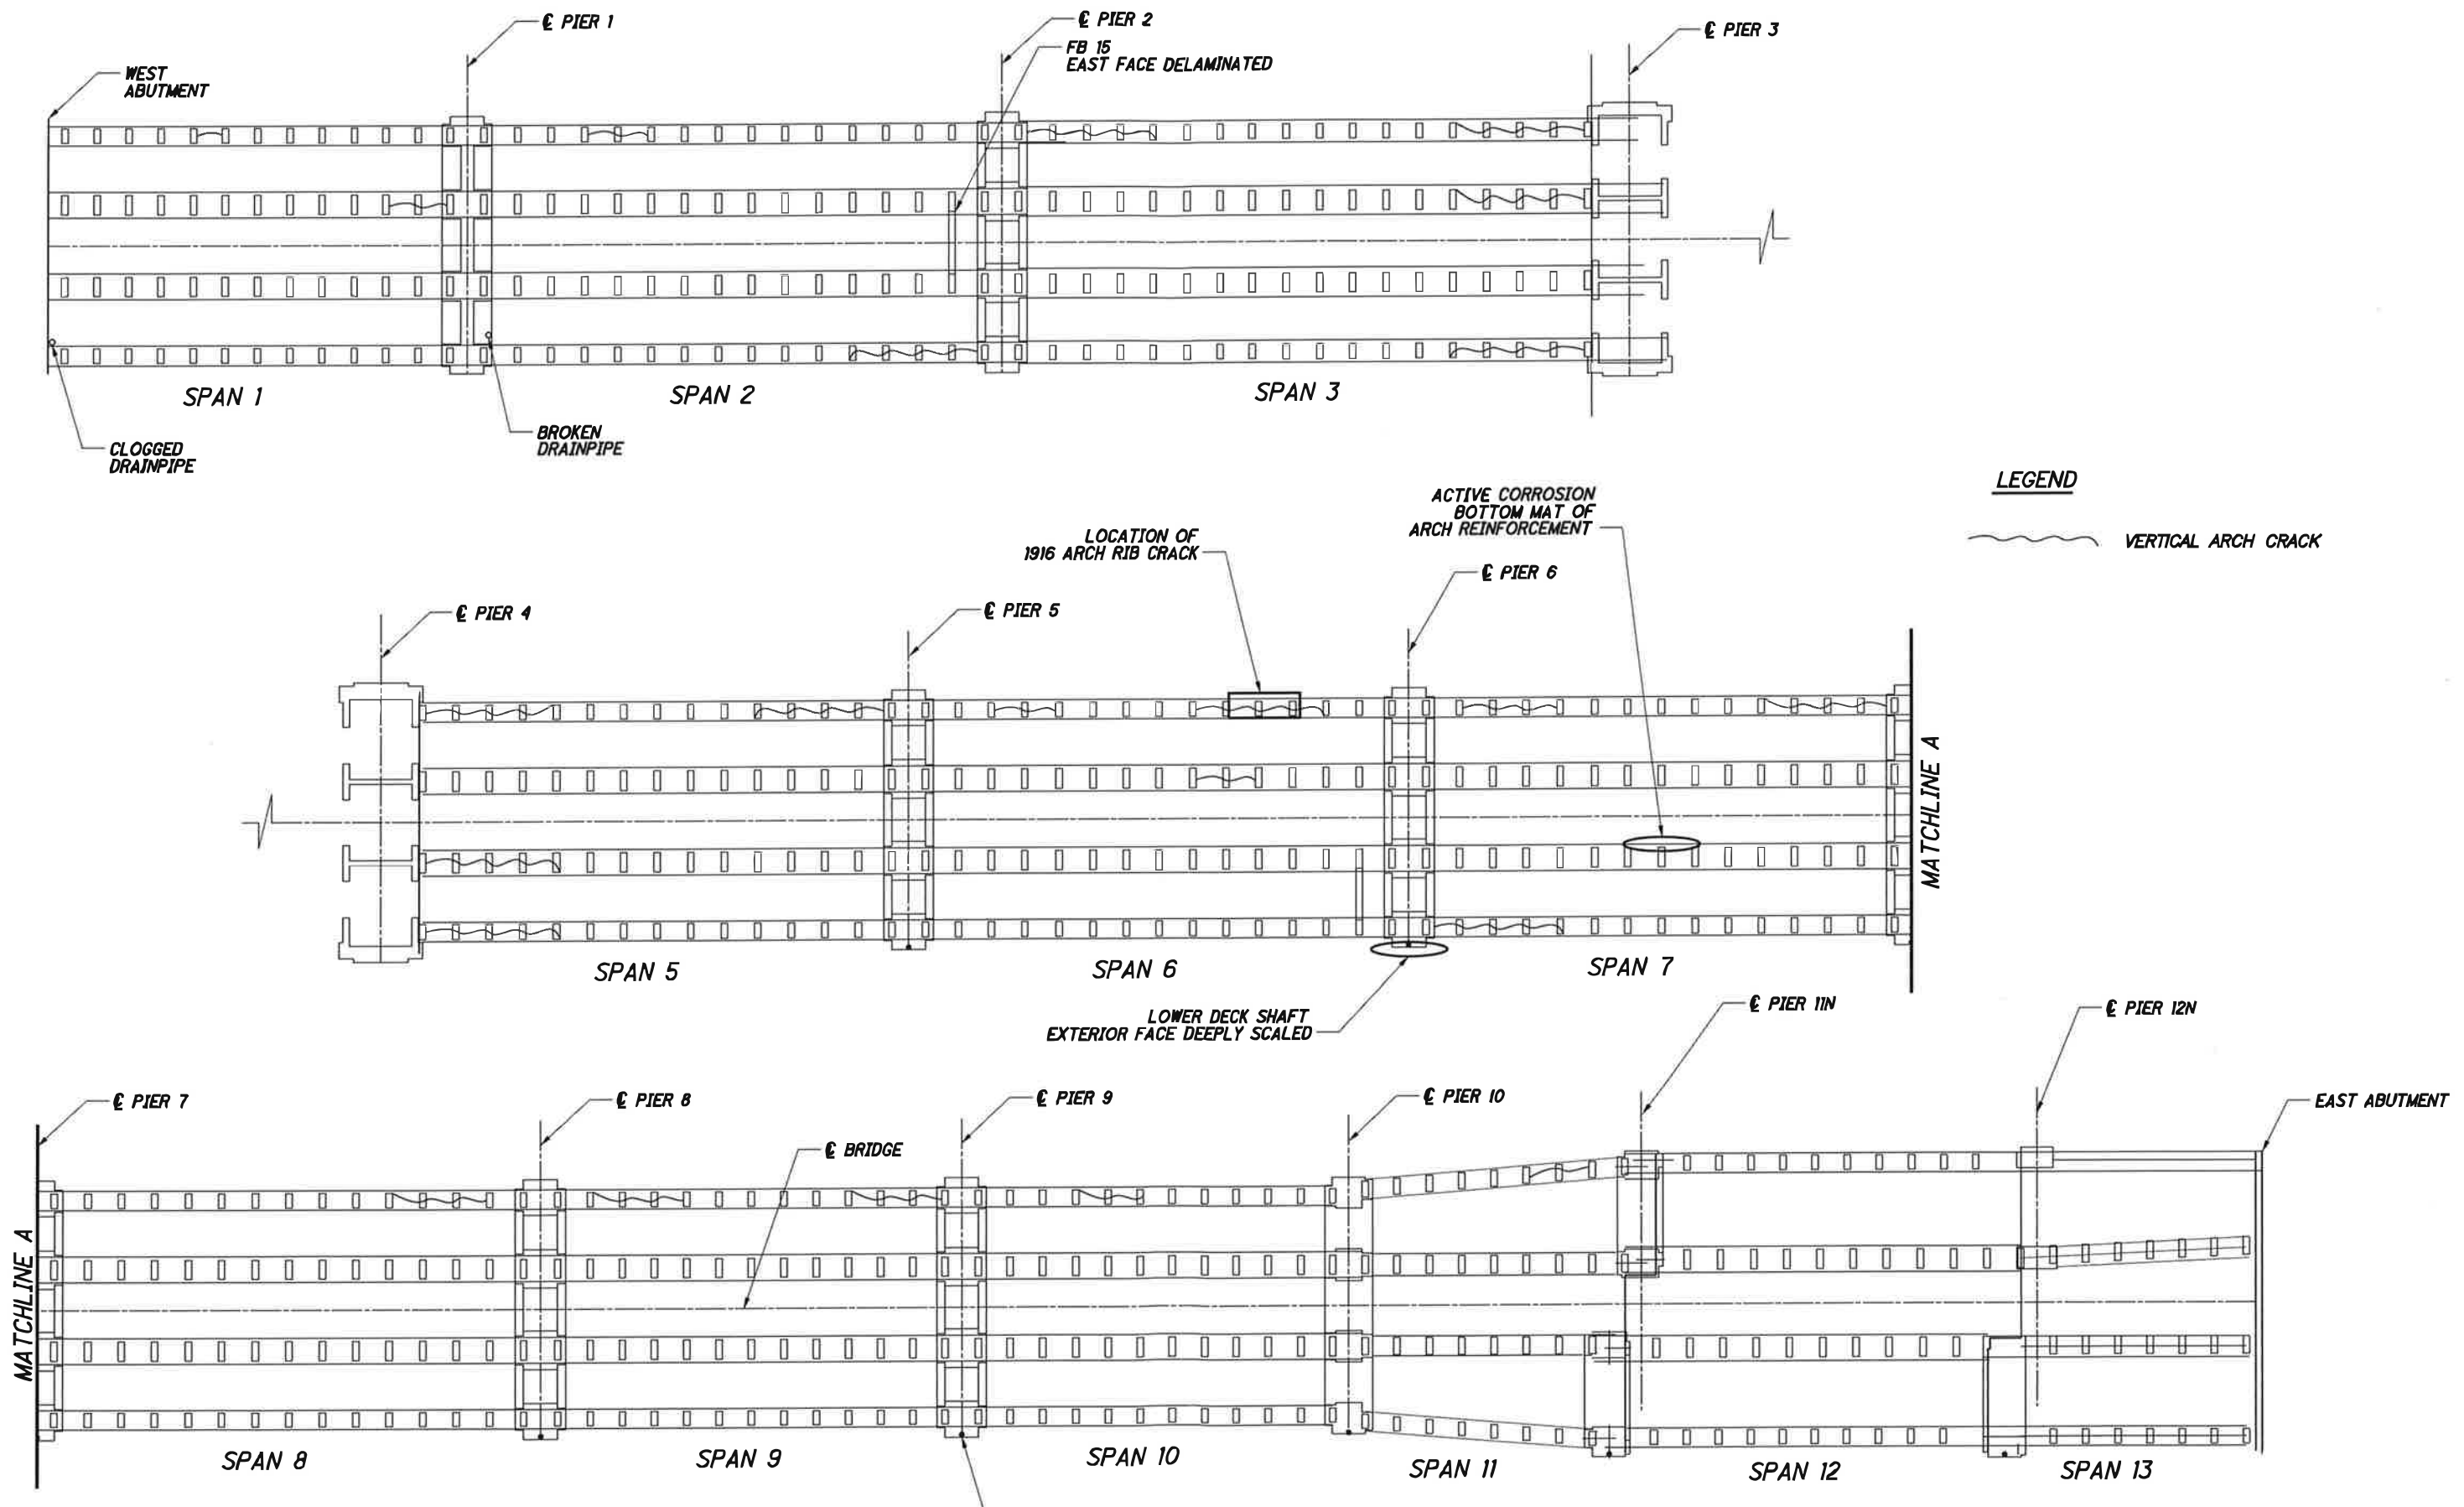
LOWER CONCRETE SUPERSTRUCTURE COMMENTS
	SPANS 1-13
	B-4

Span 3 NE, NI & SE arches, Span 5 NE and SE arches: Evidence present that the arches are cracked vertically through full section centered on the 1/4 point of the arches.

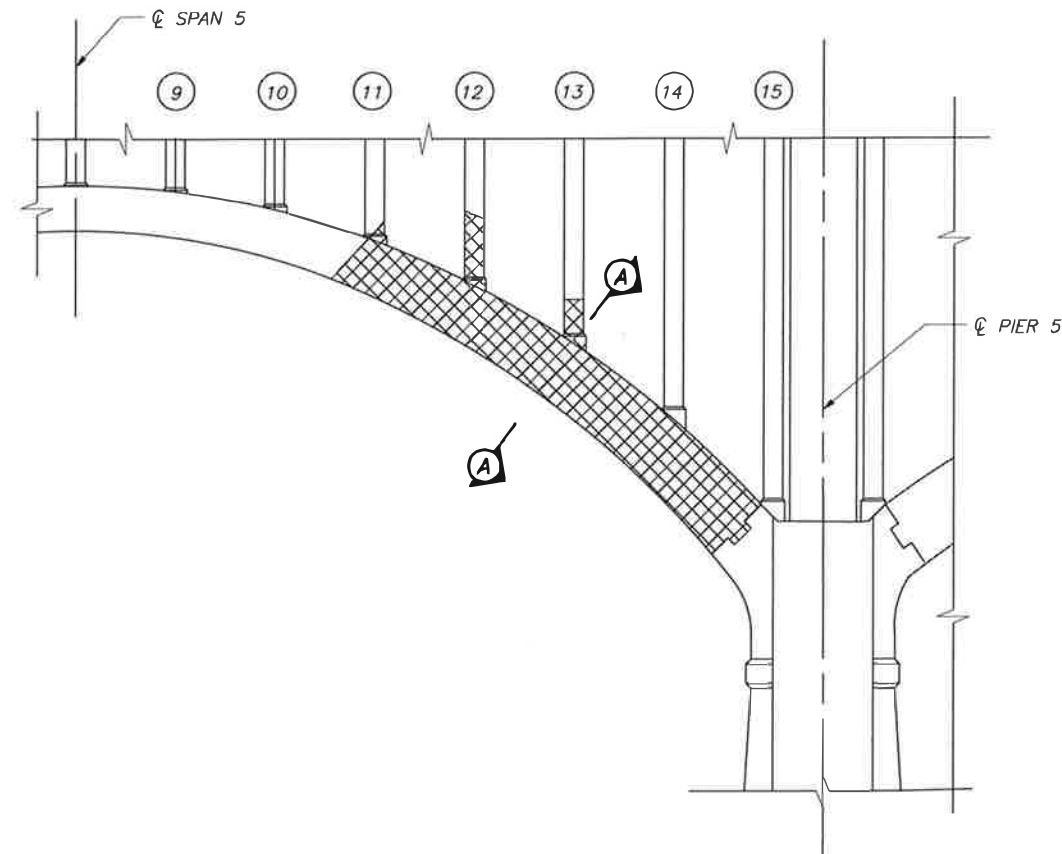
**SPAN 5 NE ARCH PARTIAL ELEVATION**

CRACK MEASUREMENTS				
PANEL	INTRADOS		EXTRADOS	
	MEASURED CRACK WIDTH	DIST. FROM SOUTH FACE	MEASURED CRACK WIDTH	DIST. FROM SOUTH FACE
11-12	0.030"	3.50'	<0.030"	2.58' TO 3.75'
12-13	0.156"	2.75'	$\frac{3}{32}$ " & $\frac{5}{8}$ "	2.42'
13-14	0.035" & 0.020"	2.50' & 3.83'	0.040" TO 0.094"	2.75'
14-15	0.012"-0"	2.00'	0.010" TO 0.020"	2.75'

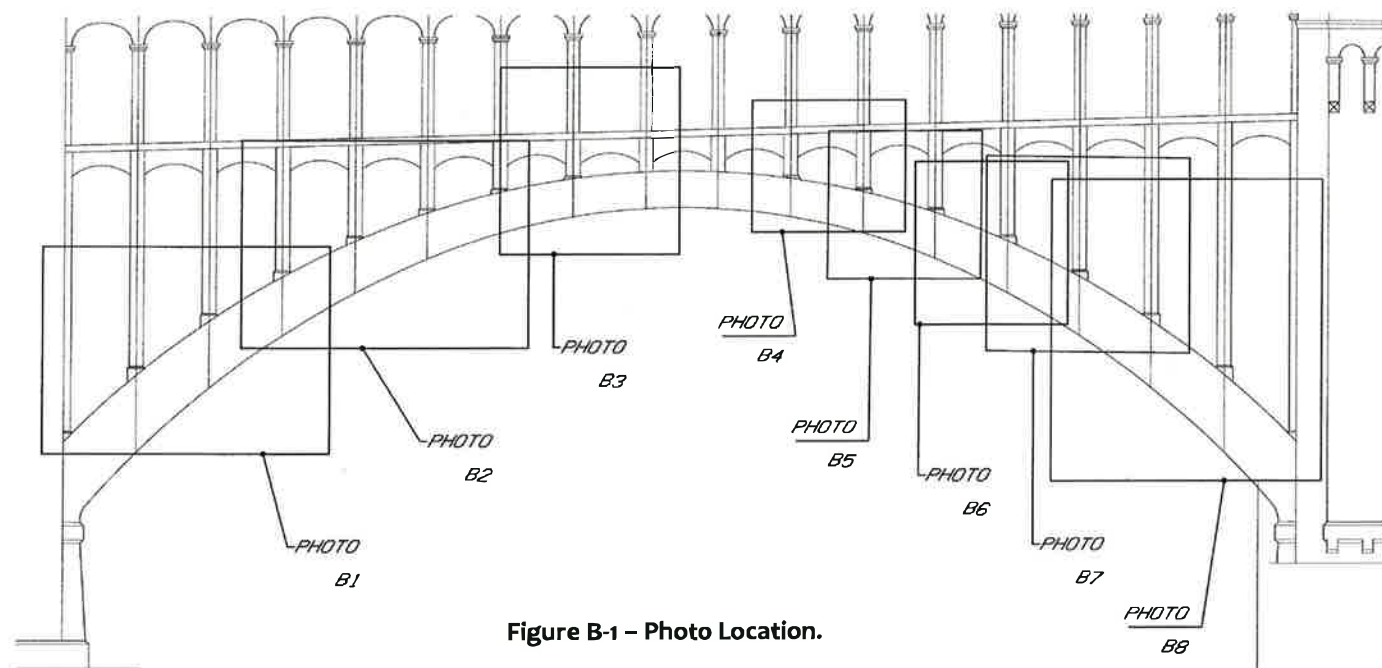
Figure B-1 – Photo Location.

Photos represent the narrow, horizontal crack observed on the south face of the Span 3 NE Arch Rib. In several locations, a similar crack is present on the north face also. Arch segments shown in photos are identified in Figure B-1.

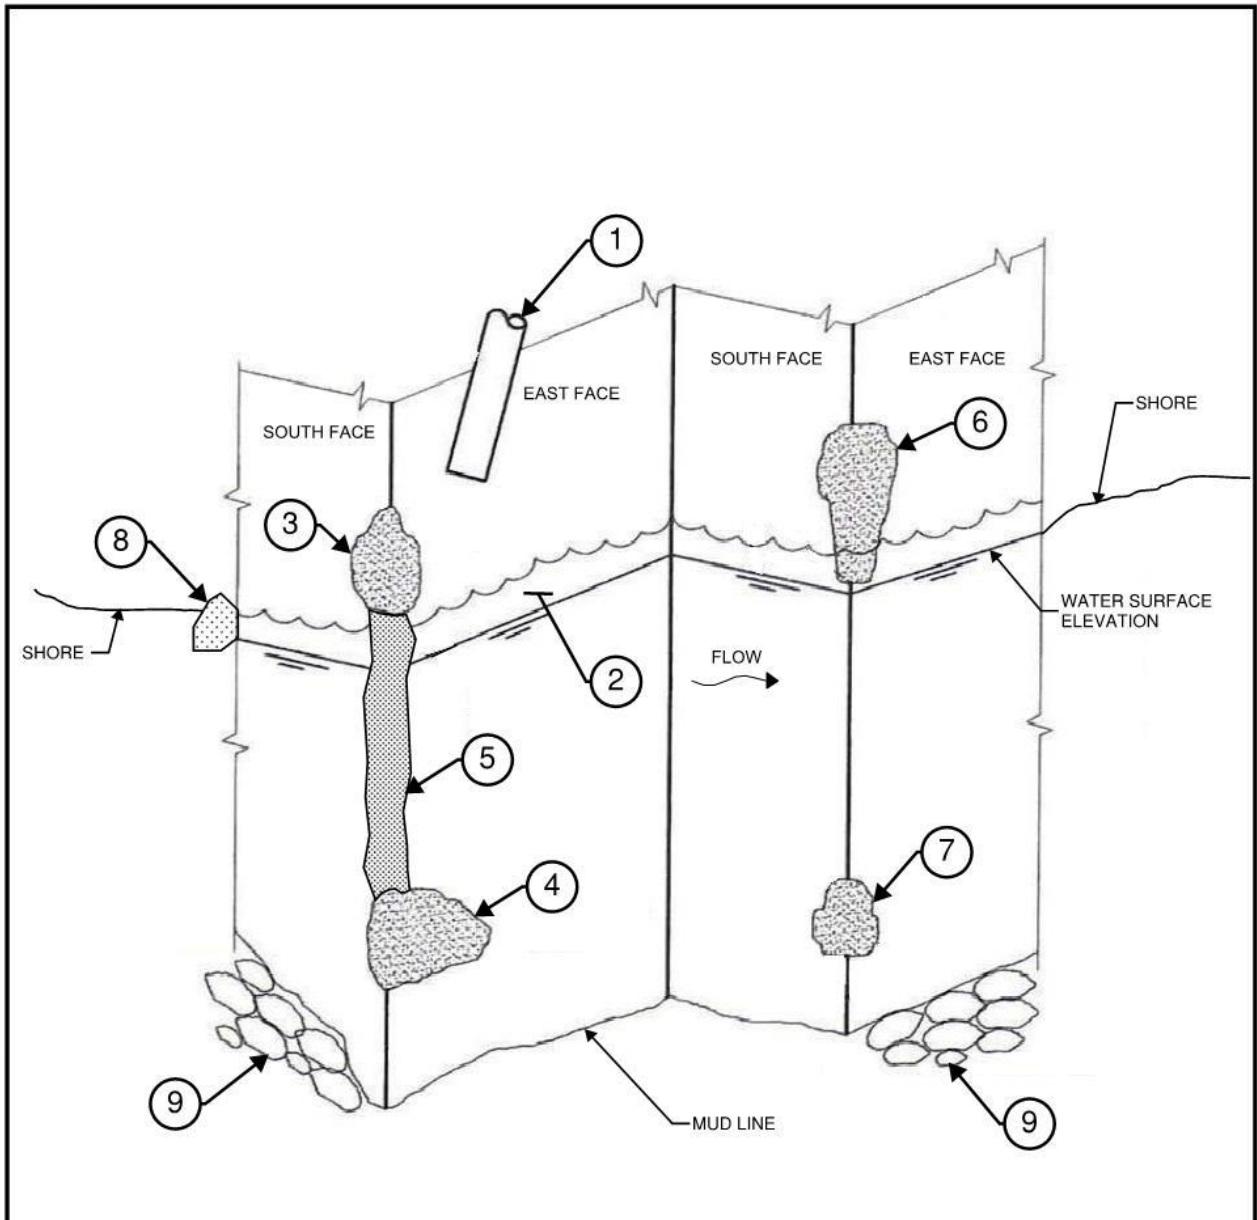
**PIER 3 ELEVATION**  
NTS

- Corner spall 3 feet high x 2 feet wide x 2 feet deep located at south corner of Pier 3 in splash zone was confirmed as documented in underwater inspection done in 2010 and has not advanced in severity. (See photo 7)

- Corner spall 3 feet high x 3 feet wide x 3 inches deep located 6 deep above mudline at south corner of Pier 3 was confirmed as documented in underwater inspection done in 2010 and has not advanced in severity.

- Corner spall starting at splash zone on south corner continuing underwater approximately 10 feet high x 2 feet wide x 3 to 4 inches deep.
- Corner spall 4 feet high x 2 feet wide x 1.5 feet deep located at north corner of Pier 3 in splash zone was confirmed as documented in underwater inspection done in 2010 and has not advanced in severity.

- Corner spall 1.5 feet high x 2 feet wide x 6 inches deep located 3 feet above mudline at north corner of Pier 3 was confirmed as documented in underwater inspection done in 2010 and has not advanced in severity.

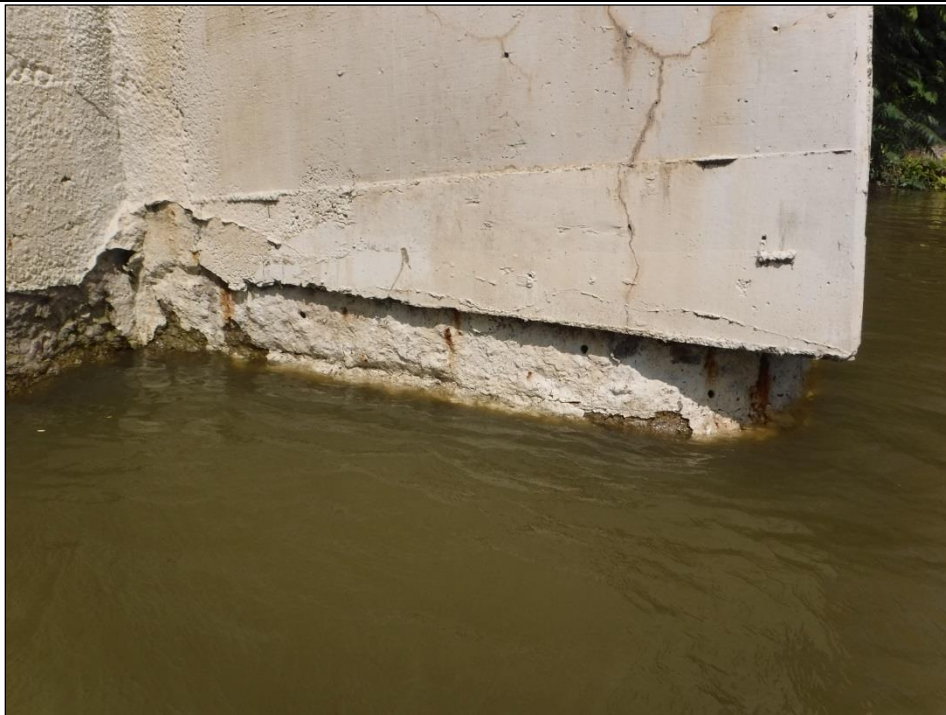
Photograph 6  
View of Pier 3,  
Typical scaling at  
the splash zone.

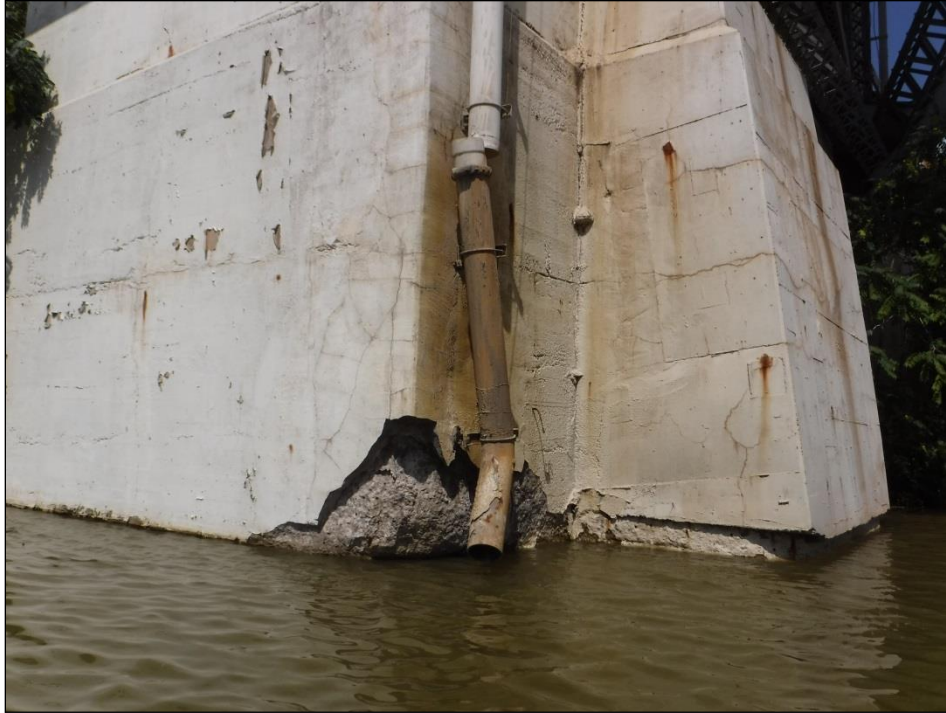
- Scupper drain is disconnected allowing water to leak onto south corner contributing to large spall as documented in underwater inspection done in 2010 and has not advanced in severity. (See photo 7)

Photograph 7  
View of Pier 3  
South corner.  
Spall at waterline  
and  
disconnected  
scupper drain.

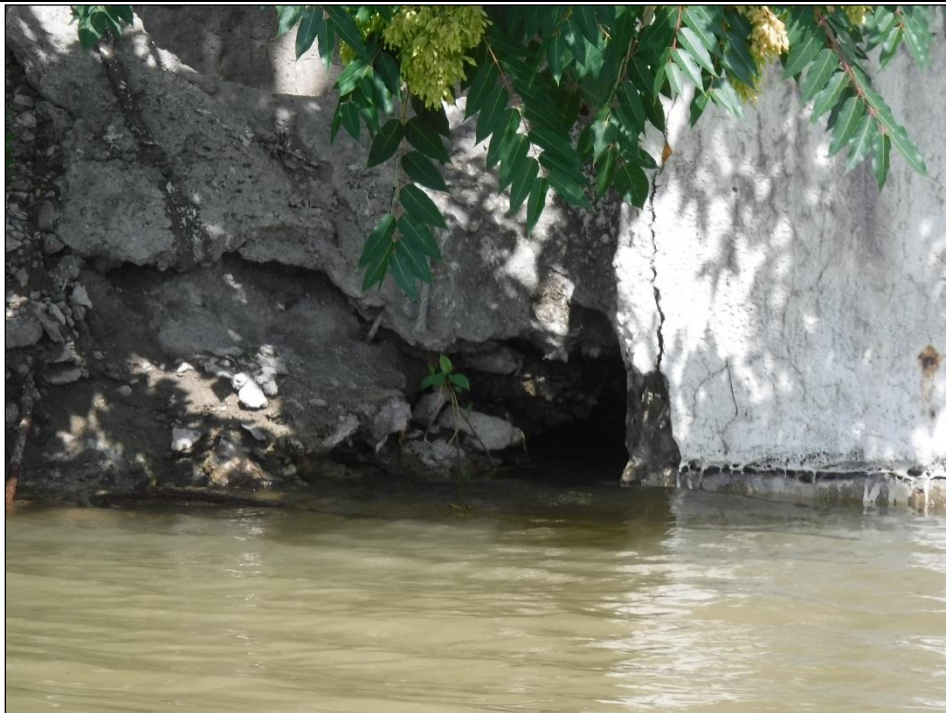
- Minor erosion and sloughing observed on northwest and southwest embankments adjacent to Pier 3.

Photograph 8  
View of void at  
interface of  
Southwest  
embankment  
and Pier 3.

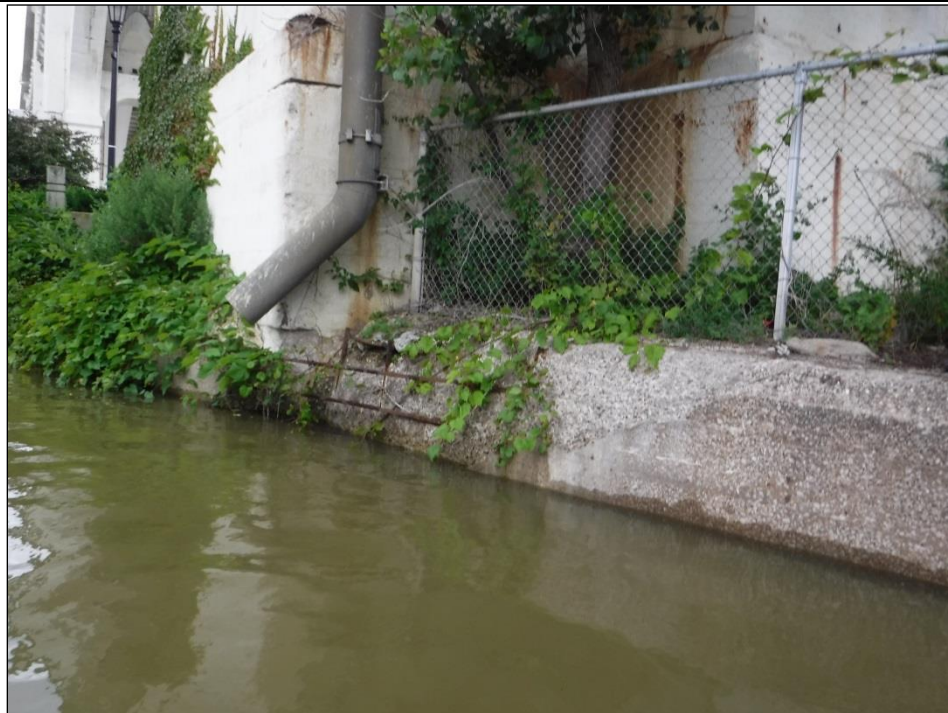
Photograph 10  
View of Pier 4.  
Spall with  
exposed rebar.

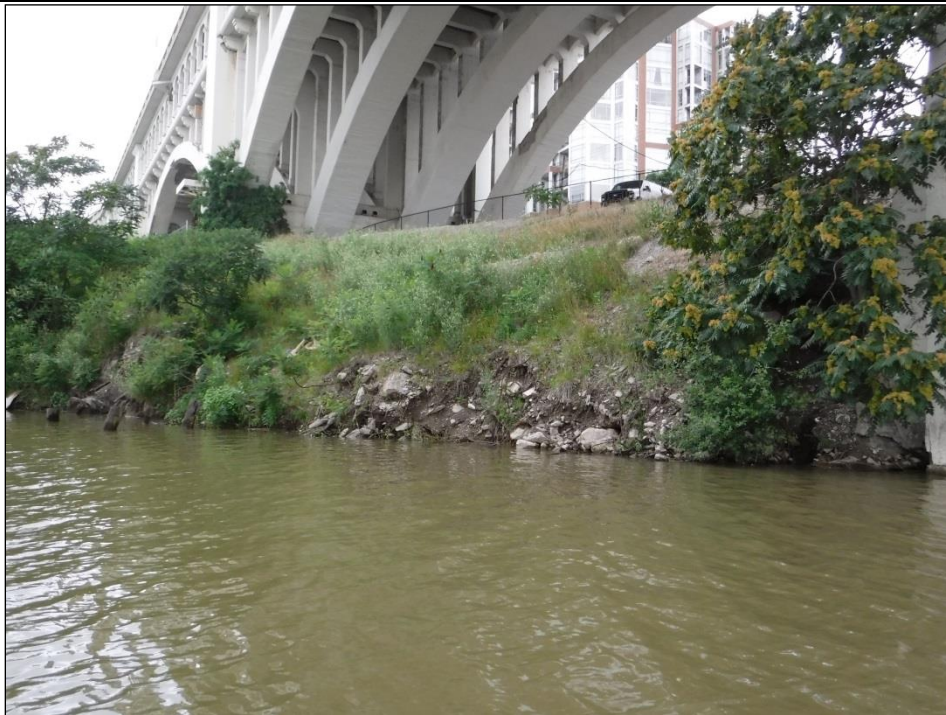
The SW embankment adjacent to the abandoned Riverbed Road is experiencing slope movement and is being monitored. This failure has led to the movement and cracks of the south west approach wingwall between Tower A and Tower B.

Photograph  
14  
View of View of  
Southwest  
Embankment.
