PHOTO SHOWS RUSTED THRU HOLES AND RUSTED SECTION LOSS TO UPPER CORD MEMBERS OF TRUSS #2 (NORTH MIDDLE).

PHOTOS SHOW RUSTED THRU HOLES TO LOWER GUSSET PLATE OF TRUSS #4 (SOUTH).

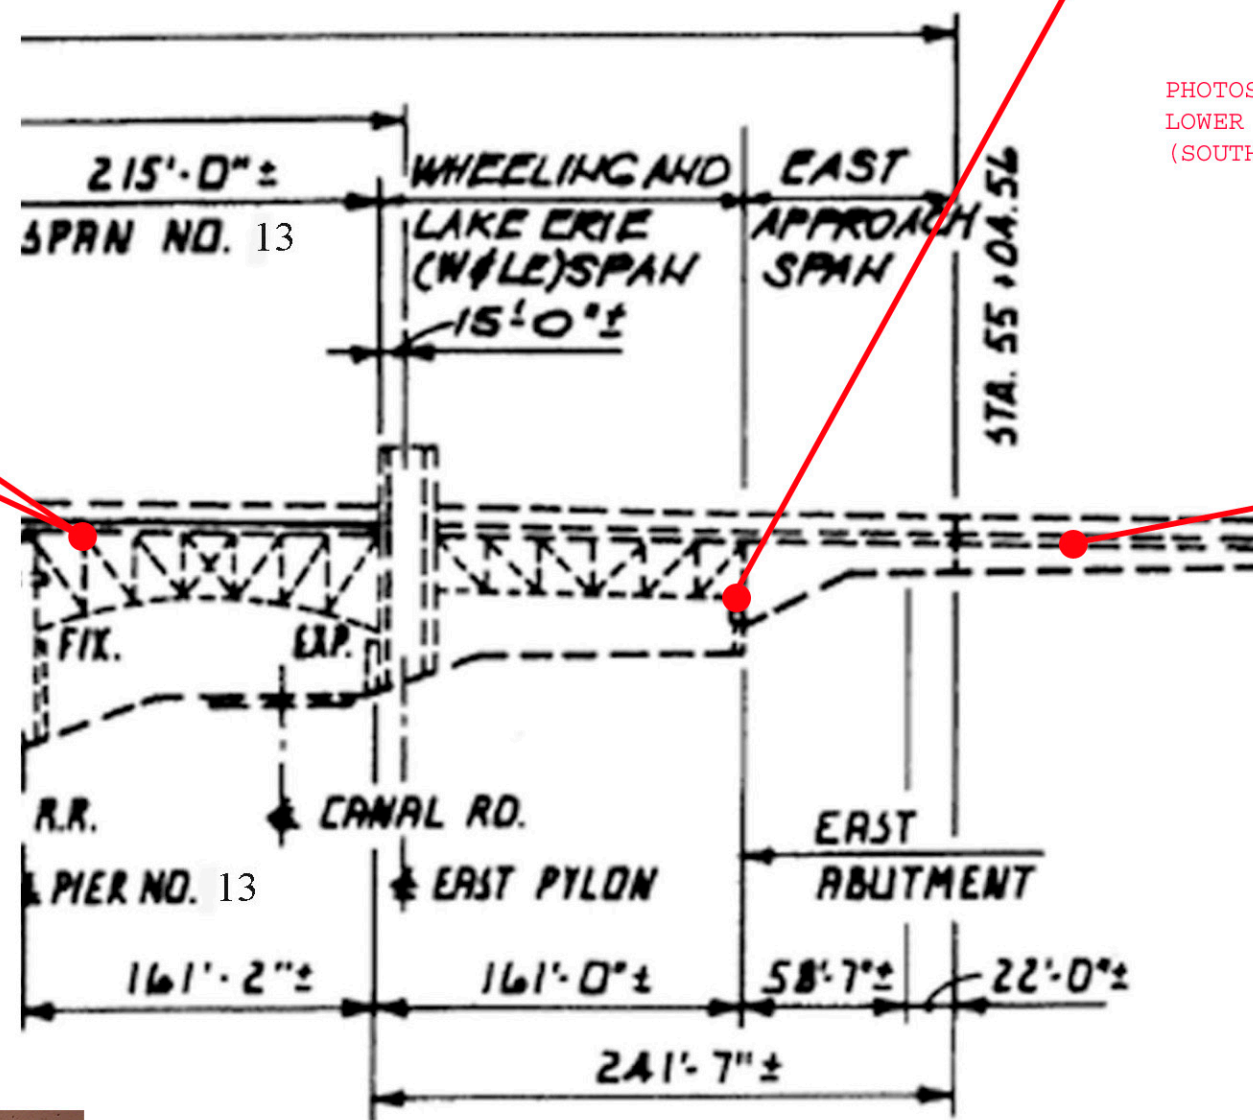
**PIER #13 TO EAST ABUTMENT**

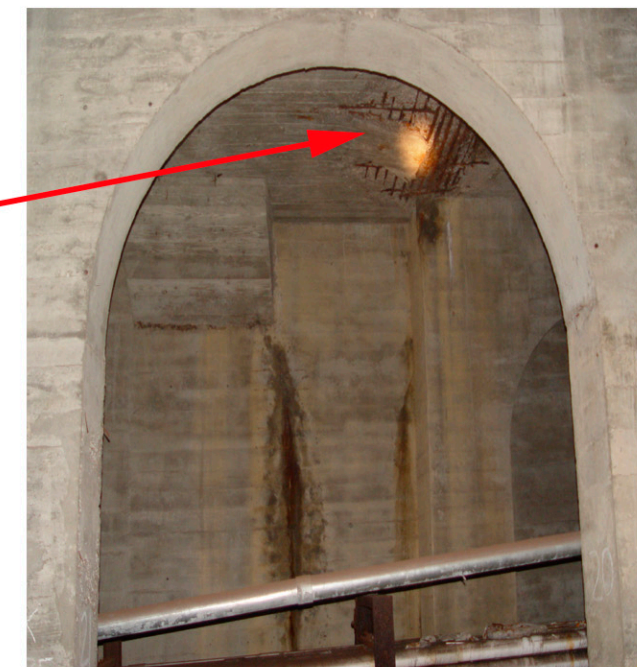
PHOTO SHOWS A SPALL FORMING OVER UTILITY CONDUIT INSIDE FINISH (EAST) ABUTMENT CELLULAR CONSTRUCTION. THIS IS APPROXIMATELY 75' WEST OF EAST CELLULAR ABUTMENT WALL.
