PIER #4 TO PIER #7
 CUY-10-1613
 SFN-1801503

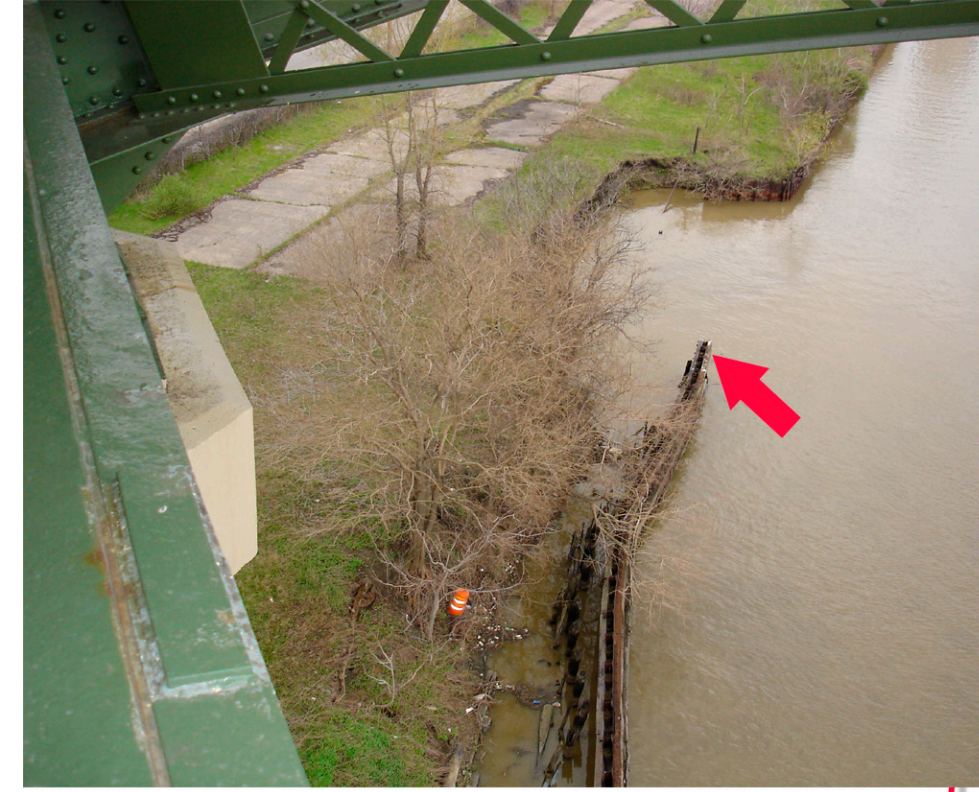
PHOTO SHOWS HOW RIVER FLOWS INTO AND ERODING THE WEST BANK. RED ARROW SHOWS THE END OF DOWN RIVER FENDER.

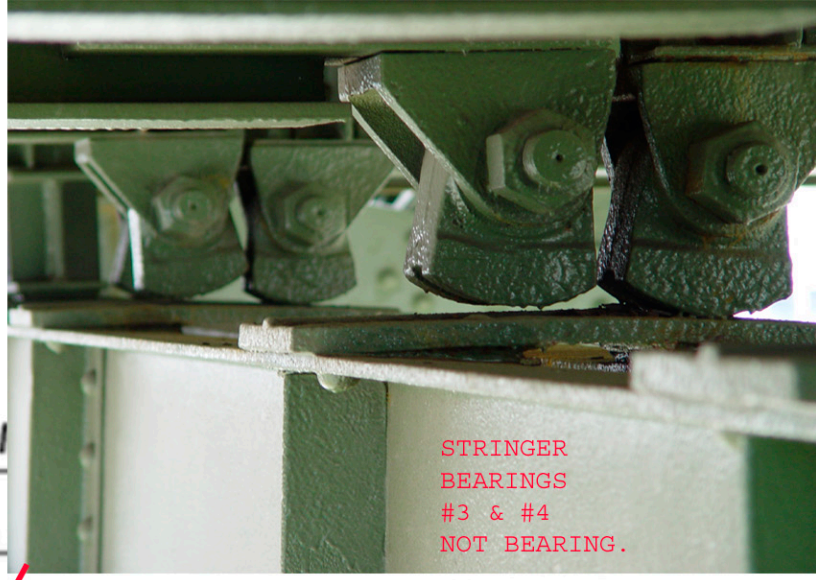
STRINGER BEARINGS #3 & #4 NOT BEARING.

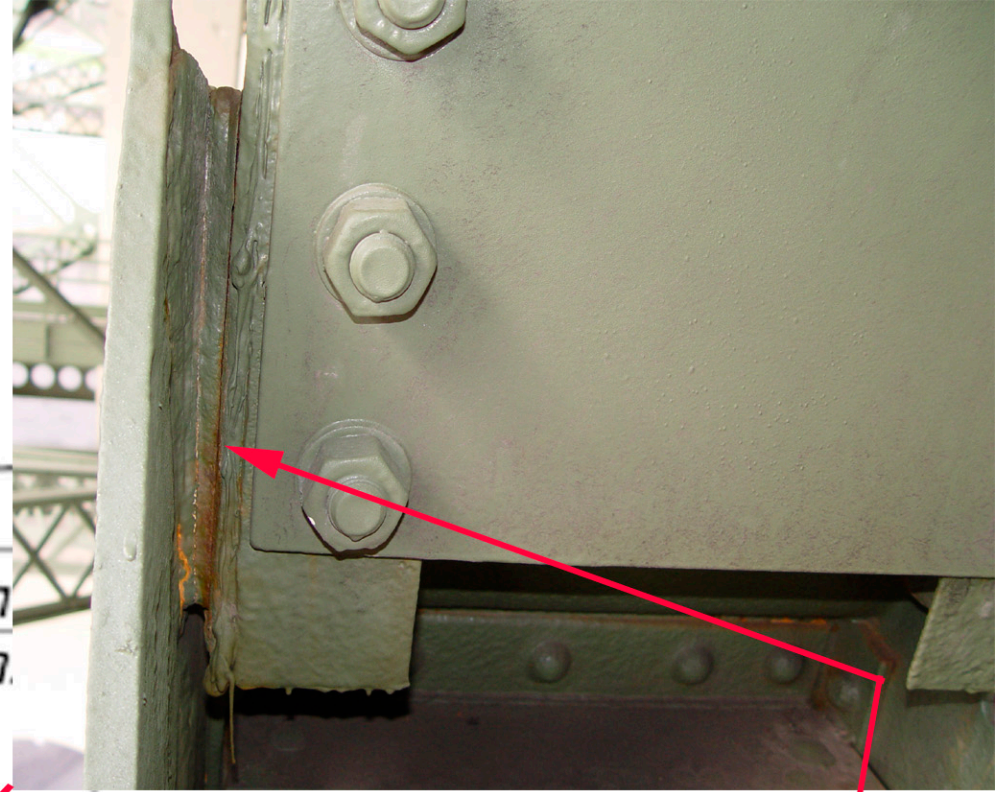
PHOTO SHOWS EVIDENCE OF MOVEMENT AT PIN CONNECTION. THIS IS TRUSS #3 (SOUTH MIDDLE TRUSS).

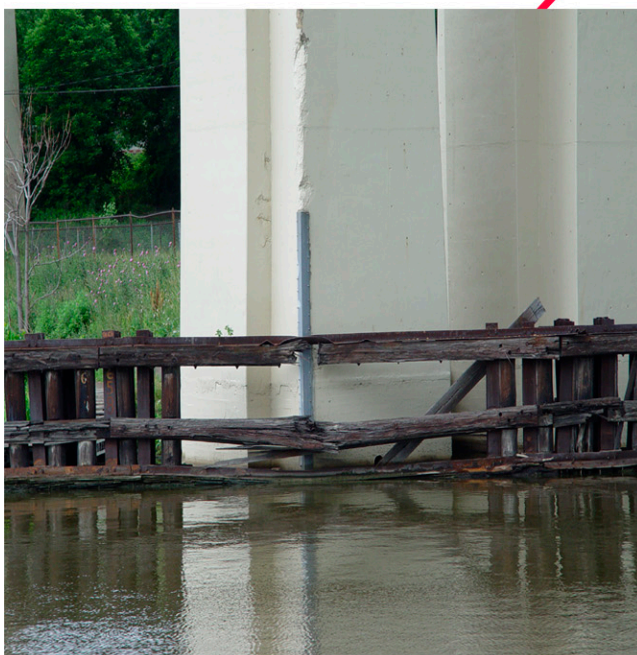
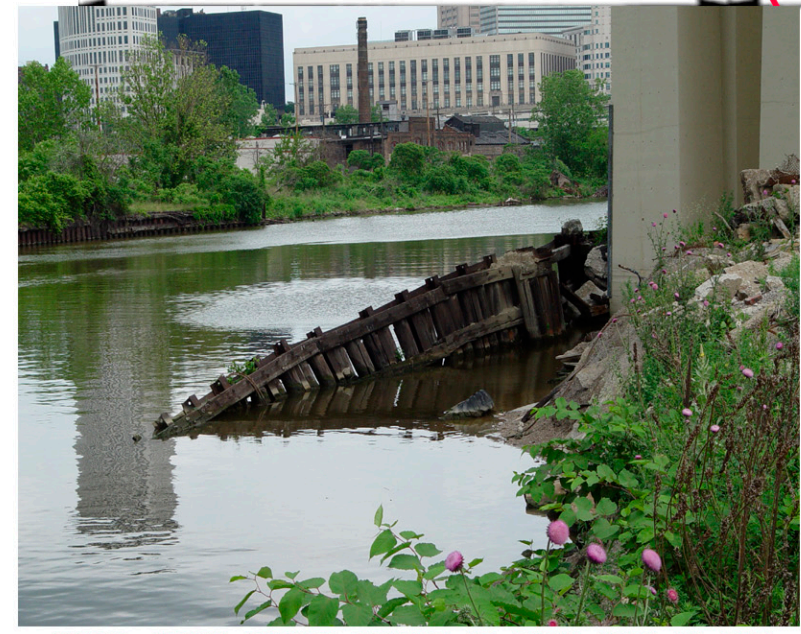
PHOTO SHOWS DAMAGED FENDER TO EAST SIDE OF THE RIVER.

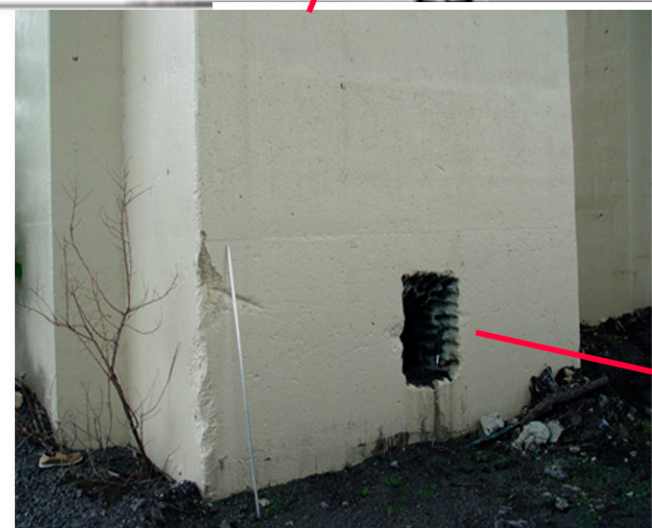
PHOTO SHOWS A DRILLED OUT HOLE AT BASE OF START (WEST) SIDE OF LEFT (NORTH) COLUMN. HOLE IS 19" W BY 22" H.

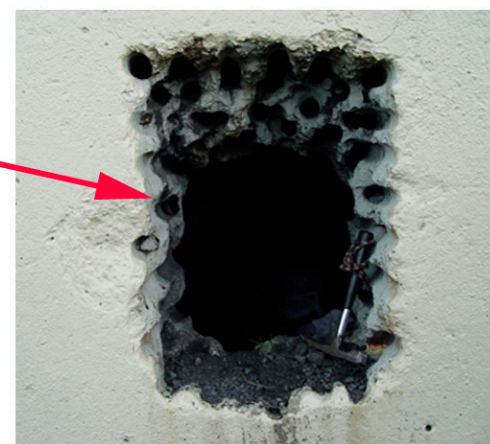
CLOSE UP SHOT.

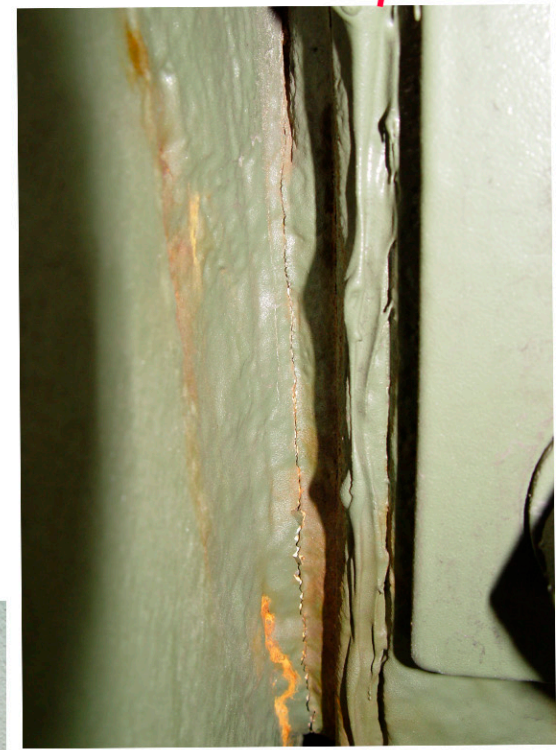
CLOSE UP OF ABOVE PHOTO.
