CUY-10-1613
SFN-1801503

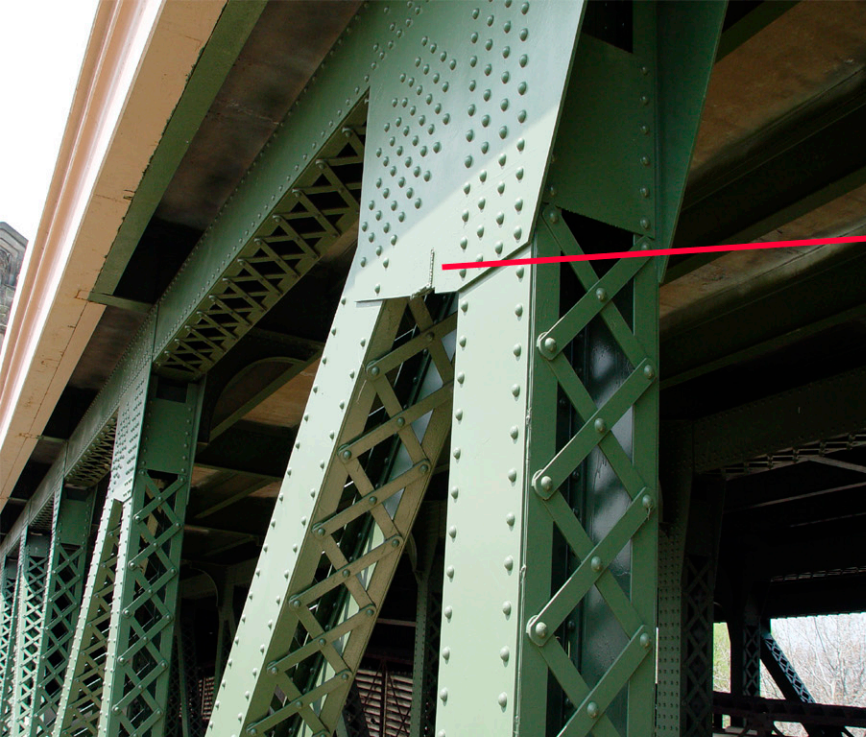
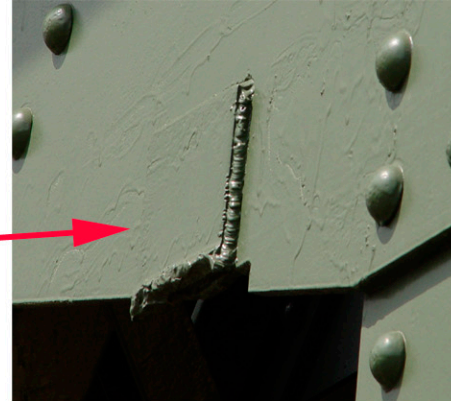
CLOSE UP SHOT.

PHOTO SHOWS A WELDED PLATE TO LEFT (SOUTH) OUTSIDE GUSSET PLATE.
