STATE OF OHIO DEPARTMENT OF TRANSPORTATION  
BRIDGE INSPECTION REPORT

BRIDGE NUMBER **CUY 00010 1613**  
TWP ROUTE UNIT

# 2009 Annual Inspection of the Detroit-Superior Bridge CUY-10-1613 SFN 1801503

## Supplemental Report of 2009 Inspection Results

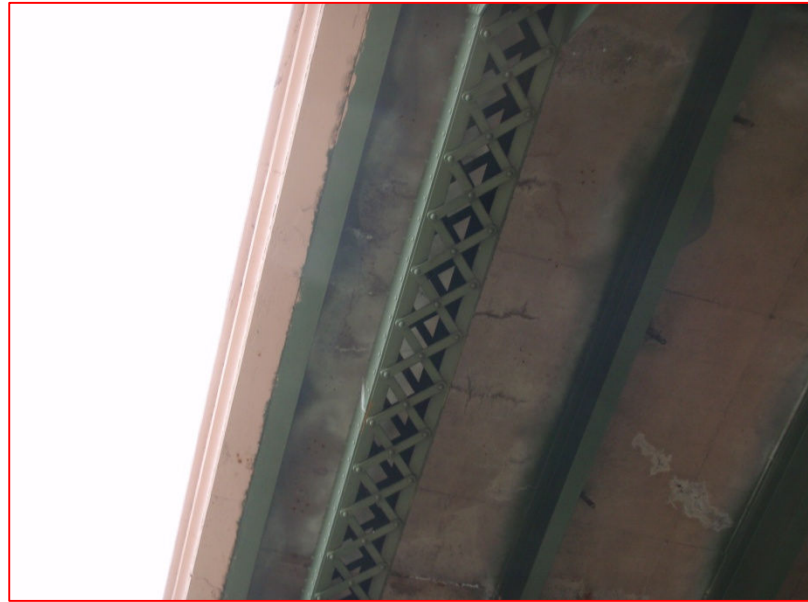
Leakage through deck under south sidewalk (visible in wet spots).

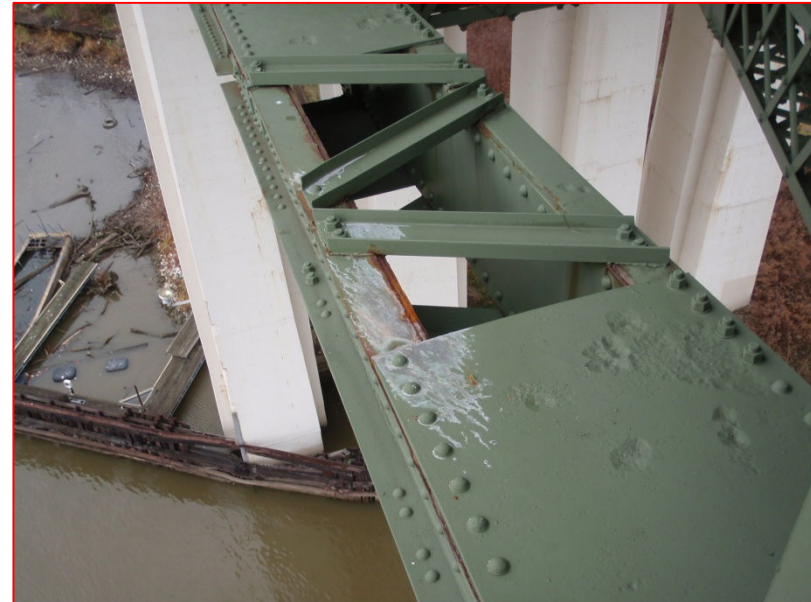
Efflorescence on lower chord and new corrosion (rust staining) directly below leaking areas in the south sidewalk.

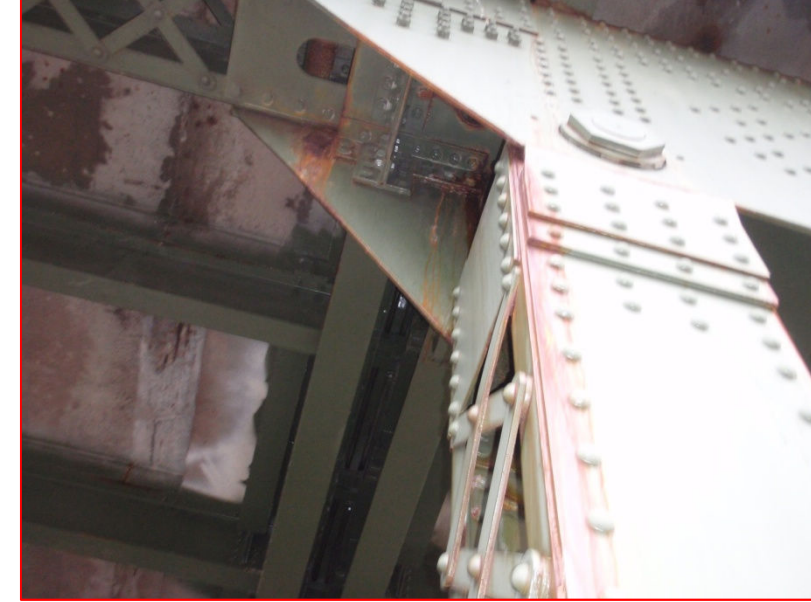
The expansion joint seals have been leaking. At the time of the inspection, icicles could be seen hanging from the undersides of the expansion joints in multiple locations, especially near the outer ends (over the north and south exterior truss lines and under the sidewalks and curbs). This leakage of the roadway drainage, with its chloride content, is causing rust staining on the truss members directly below, and it is beginning to re-activate the pack rust that had been dormant since the recent rehabilitation.

Efflorescence, rust staining on the outside of the new paint in areas below the joints that are leaking (typical at all joints).

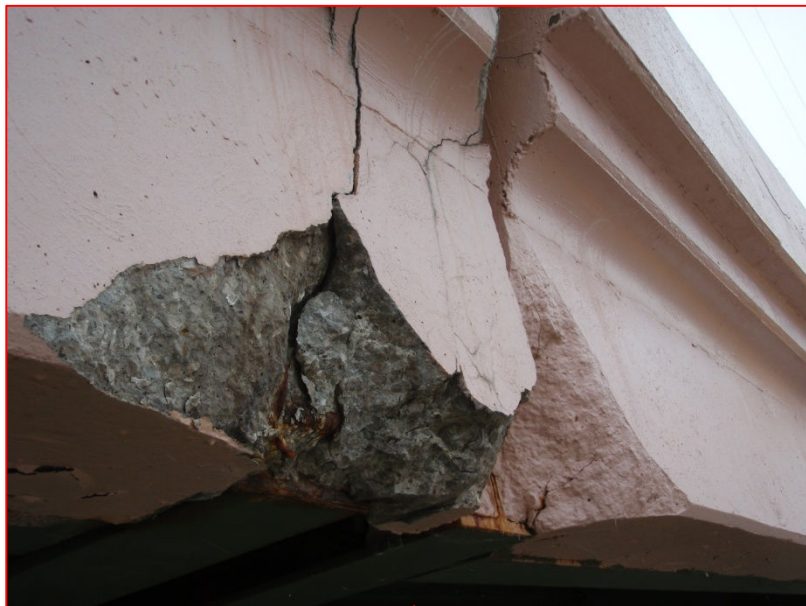
The piers have some cracking and spalling occurring on the upper ends of the outer decorative walls. These are decorative and are not load-bearing portions of the piers. The abutments and piers in general have many patched areas. Per information provided to the consultants by ODOT, sounding has been performed on these patched areas and has indicated that, although they have an appearance of delamination, they are in fact in good condition. No sounding of the substructure was included in the scope of the 2009 routine inspection.

Spalling at top of decorative details over piers, exterior faces.

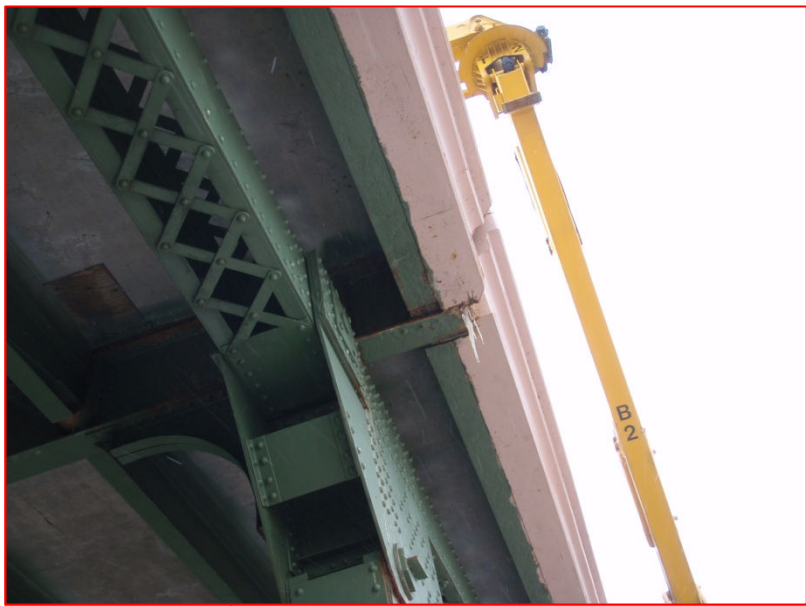
Leakage through joints at the ends, visible here in the form of icicles – typical all expansion joints.

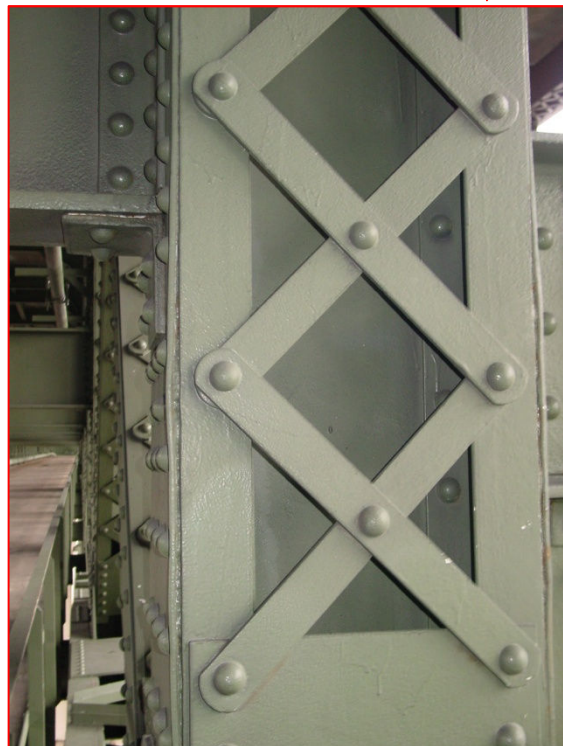
Typical good condition of paint after rehabilitation. Most members, like U8-L8 shown here, have some previous pack rust that has been cleaned and painted over and is not currently active.

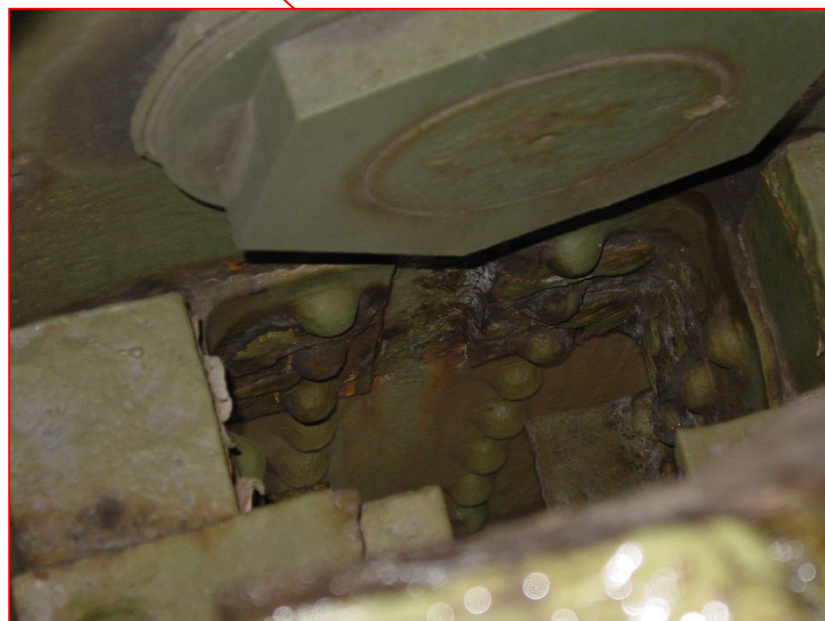
In general the truss verticals are in the same condition as at the completion of the rehabilitation. However, the pinned verticals directly below the expansion joints are experiencing corrosion again already.

Corrosion beginning to re-activate on angles below bottom chord pin. These members are directly below a leaking joint, as are all the members that have re-activation of corrosion.

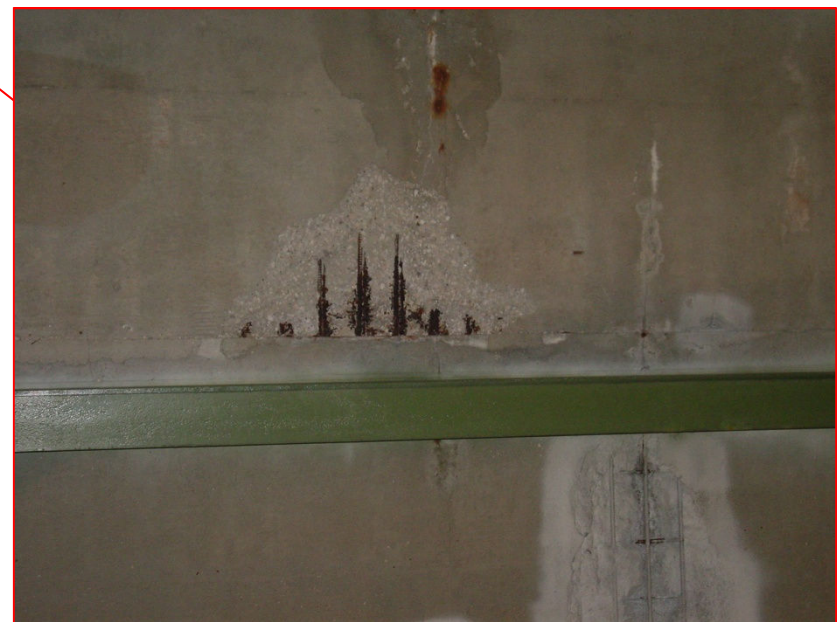
Spall, 6'x3', in underside of deck, span 11 between U7 and U8.
