**Underwater Inspection Report for:**

The Hope Memorial Bridge over the Cuyahoga River in Cleveland, Ohio  
(Thirteen-span, Steel Cantilever Deck Truss Bridge with Concrete Piers)

KCI Associates of Ohio  
388 S. Main Street, Suite 401  
Akron, Ohio 44311  
Phone: (330) 564-9100

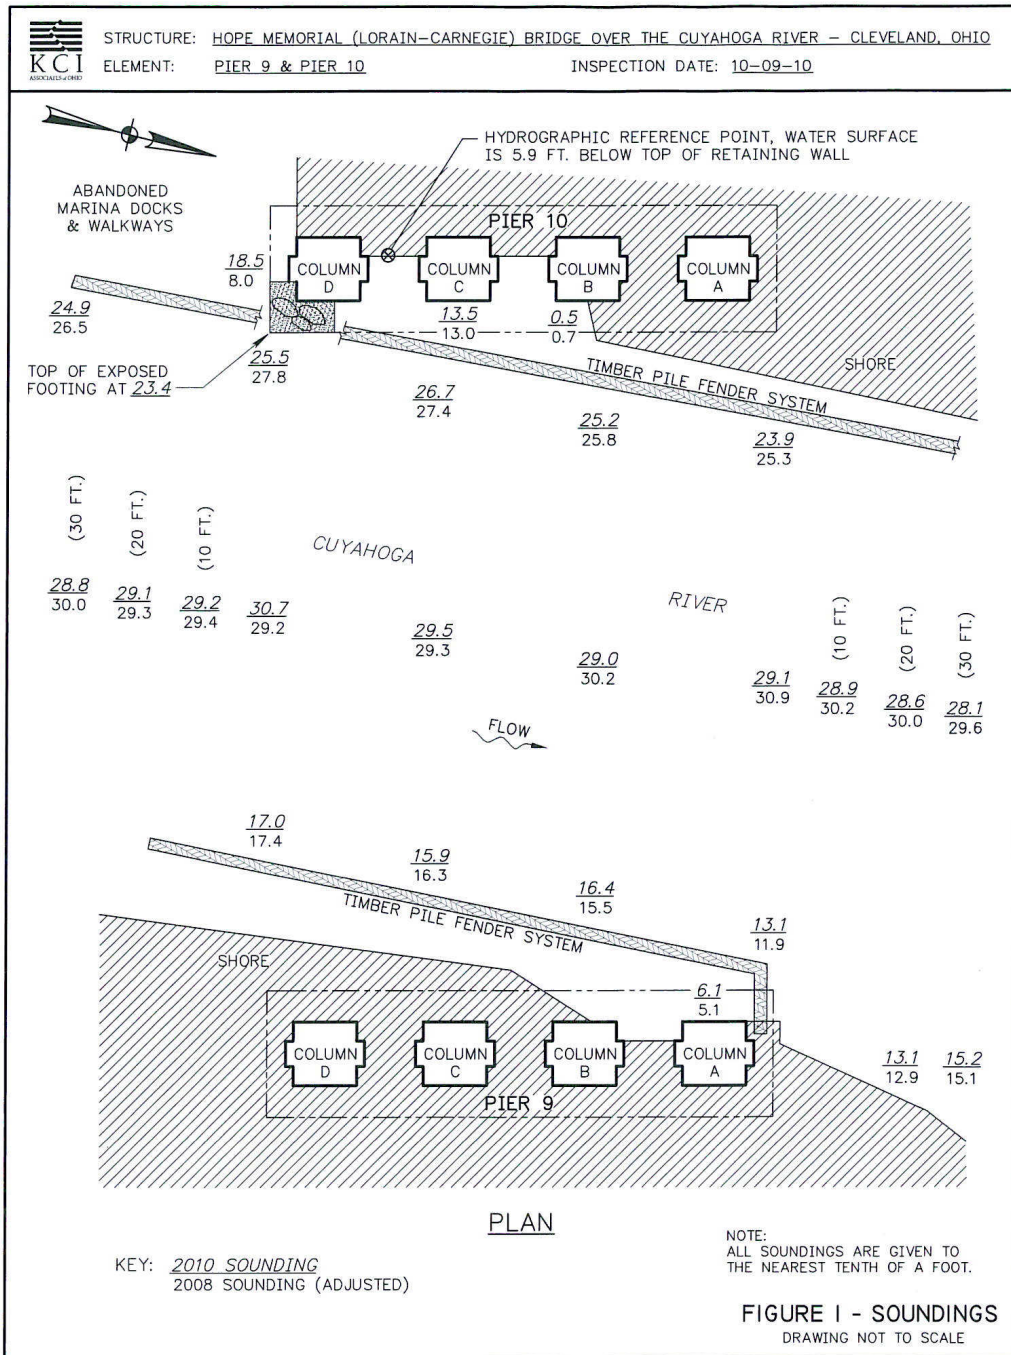
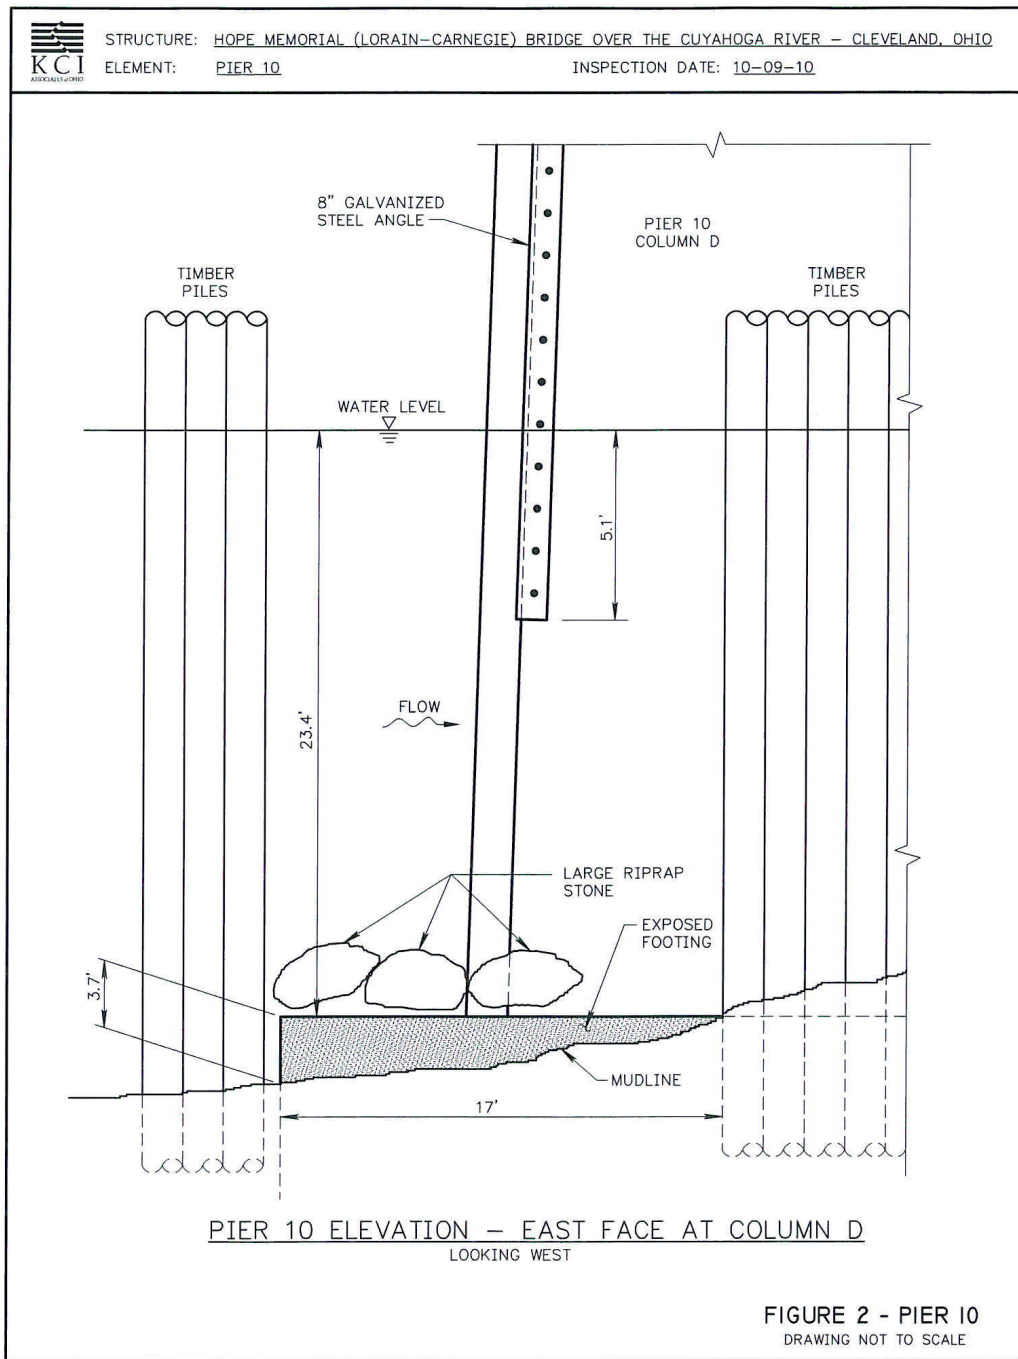
- The southeast corner of the pier footing is exposed along the east face of Column D (Figures 1 and 2). The maximum vertical exposure was measured to be 3.7 feet in 2010 and 3.2 feet during the 2008 inspection. 9.5 horizontal feet of footing are exposed along the south side and 17 horizontal feet are exposed on the east face of the footer. The timber piles are driven into the river bottom tight up against the footing on both the south and east intersection points. This is shown above water in Photo 7. No footing undermining was detected.

- Viewing from above, the footer extends 7.3 feet east of the east face of Column D. Likewise in plan view, the footer extends 7.7 feet south of the south face of Column D. The top of footer was 23.4 feet below the water surface. The flat concrete of the southeast corner top of footer has numerous 2-foot diameter boulders laying on it that were not present during the 2008 inspection. This very large riprap material was stacked to form a nearly vertical wall eleven feet west of the exposed southeast corner during the 2008 inspection. It has since fallen down increasing the sounding midway on the south face of Pier 10, Column D from 8.0 feet in 2008 (adjusted) to 18.5 feet in 2010. This diver had the opportunity to do both the 2008 and 2010 inspections and was surprised to find this much material had fallen towards the center of the channel and was spread out across the top of the footer.

Similar to the 2008 inspection findings, the southeast corner of Pier 10 (West Pier) footing is exposed along the east face of Column D. The maximum vertical exposure was 3.7 feet in 2010 and 3.2 feet during the 2008 inspection. The flat concrete of the southeast corner top of footer has numerous 2-foot diameter boulders laying on it that were not present during the 2008 inspection. This very large riprap material was stacked to form a nearly vertical wall eleven feet west of the exposed southeast corner during the 2008 inspection. It has since fallen down increasing the sounding midway on the south face of Pier 10, Column D from 8.0 feet in 2008 (adjusted) to 18.5 feet in 2010. The large difference in soundings along this south face of Column D is an isolated incident resulting from rotting timber piles holding back a steep, unstable stack of extremely large riprap. This is not a scour issue, nor is it cause for concern. However, future inspections should continue to monitor the exposed footer in this corner.

The material on the steep slopes around both piers continues to slide towards the center of the channel. As long as the timber pile fender system continues to break down, this will remain the case. It may increase in years with high water events and a year that the shipping channel is dredged. Typically, armor matting, grout bags or large riprap stone are used for erosion protection. Unfortunately those fixes would only be temporary and very dependent on the condition of the failing timber pile fender system. The only suggestion at this time would be to continue to monitor the exposed footer with underwater inspections and continue to compare soundings.

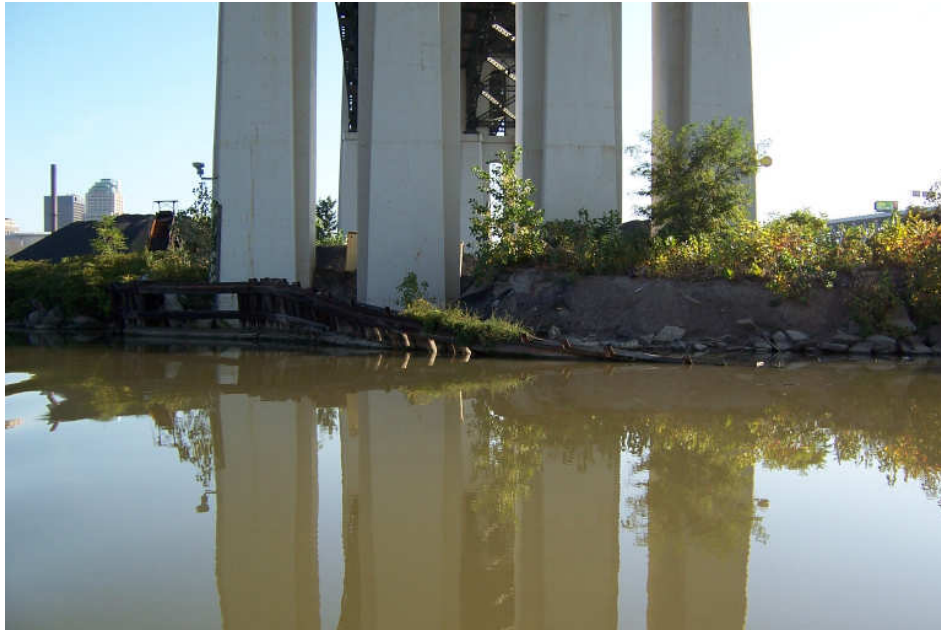
- The concrete surfaces had up to 1 ½-inch deep scaling with exposed aggregate at the waterline. This condition was up to 2 inches deep in the splash zone at the northwest and southwest corners. The northwest corner is protected with an 8-inch wide galvanized steel angle to prevent impact damage. The steel angle stops 2.6 feet above the water line and is in good condition (Photos 5 and 6).

Photo 5 – Facing East. West face of Pier 9.

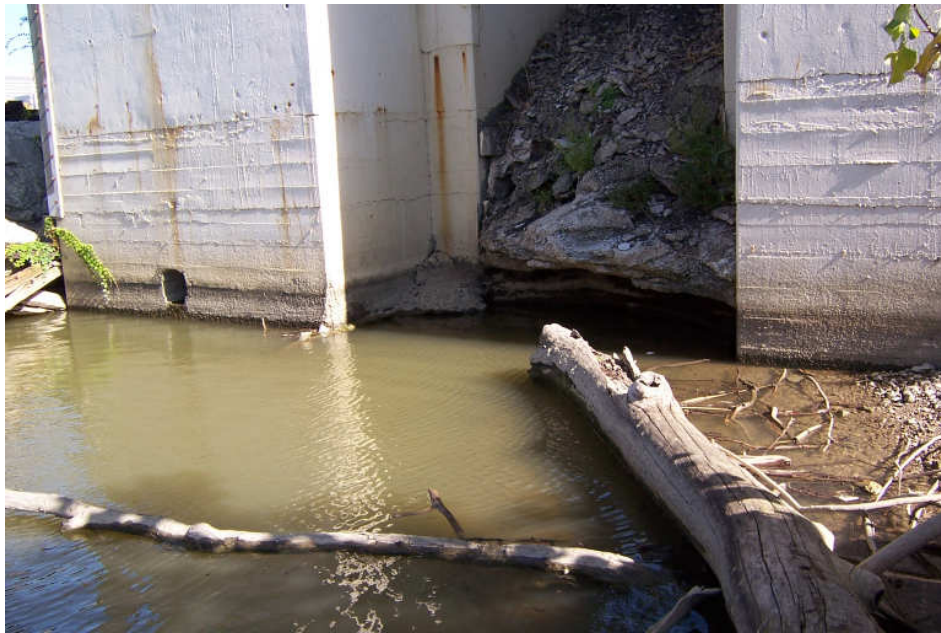
- Just above the waterline on the west face there is a 10-inch diameter hole formed in the concrete. This was the location of a scupper drainpipe outlet. Pier 10 has a steel pipe in this location; however no pipe was present on Pier 9. This is shown in Photo 6.

- Photo 6 also shows the stone and concrete that was dumped between Columns A and B for shore protection. The material between the columns under this concrete has up to 3.7 feet of undermining. The undermining found during the 2008 inspection was only 1.0-

foot. This also supports that material is sliding down the steep slope towards the center of the channel.

- The concrete surfaces had up to 1-inch deep scaling with exposed aggregate at the waterline. Only parts of the north and west sides were exposed to the water (Photo 6). The water at the northwest corner of this column was only 0.2 feet deep.
- The bottom consisted of small stones and timber debris sloping towards the center of the channel. This is shown in Photo 6.
- No exposed footing was present and no other defects were found at the time of inspection.

Photo 6 – Facing Northeast. West face of Pier 9, Columns A and B.

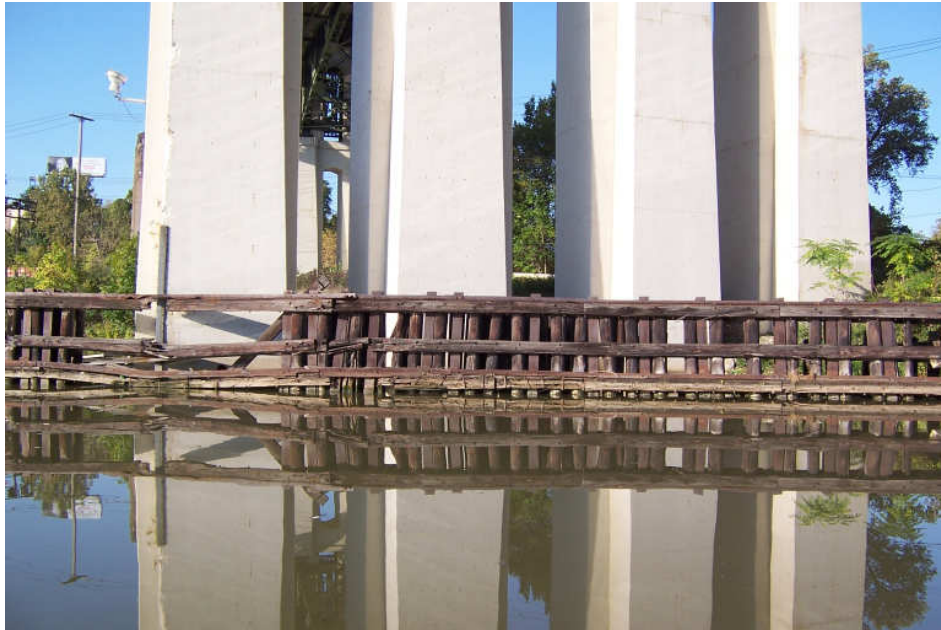
- Photo 7 shows the 10-inch diameter steel scupper pipe exiting the east face of Pier 10, Column D just above the water line. This is similar to the 10-inch scupper hole found on the west face of Pier 9, Column A.

Photo 7 – Facing West. East face of Pier 10.

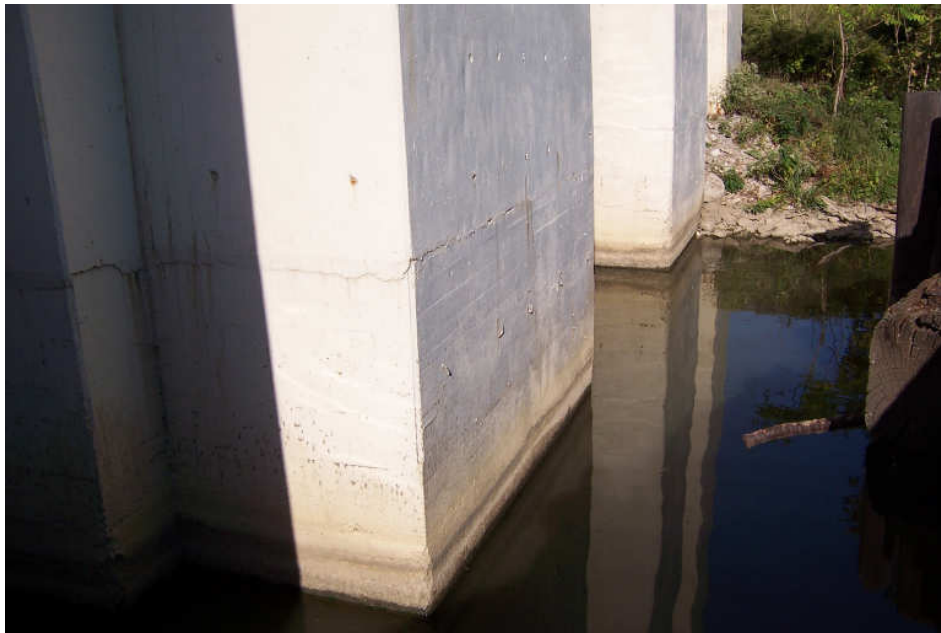
- Only the south and east faces were exposed to water.
- The concrete surfaces had up to 1 ½-inch deep scaling with exposed aggregate at the waterline. This condition was up to 2 inches deep in the splash zone at the southeast corner and is shown in Photo 8.
- Soft mud and timber debris has accumulated on the bottom between Columns B and C. The bottom material on the east face is mud and small stone steeply sloping towards the center of the channel.
- No exposed footing was present and no other defects were found at the time of inspection.

- The concrete surfaces had up to 1 ½-inch deep scaling with exposed aggregate at the waterline. This condition was up to 2 inches deep in the splash zone at the east corners and is also shown in Photo 8.
- Soft mud and timber debris has accumulated on the bottom between Columns C and D. The bottom material on the east face is mud and small stone steeply sloping towards the center of the channel.
- The timber retaining wall between Columns B and C was sounded with a hammer and found to be in good condition.

Photo 8 – Facing Northwest. East face of Pier 10, Columns C, B and A.

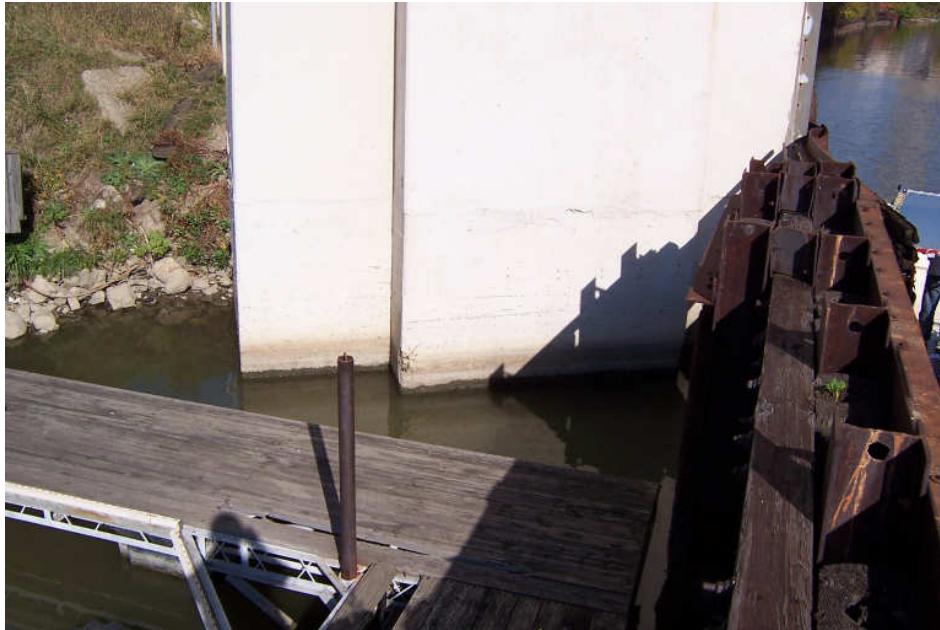
Photo 9 – Facing North. South face of Pier 10, Column D.

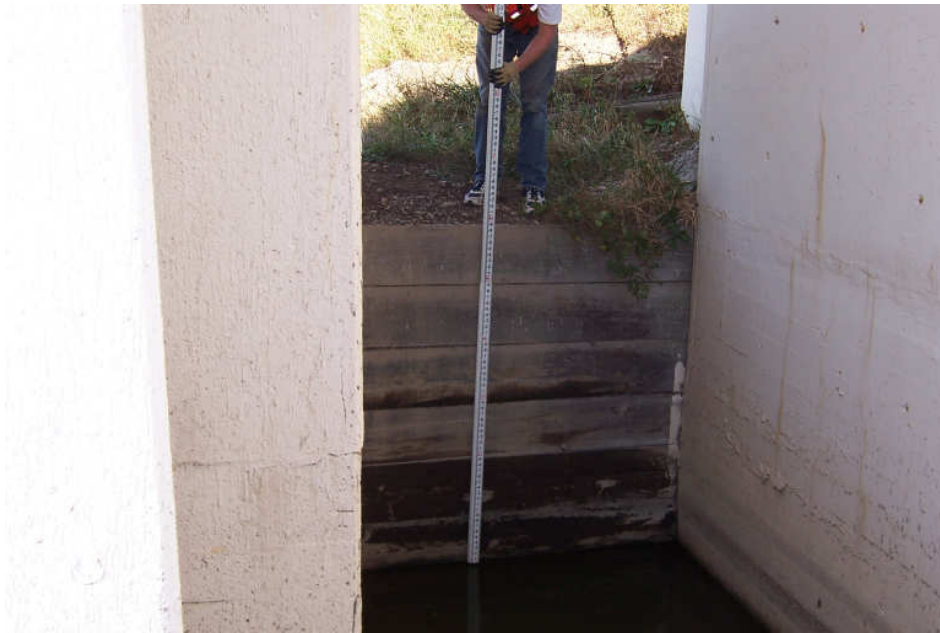
The top surface of the timber retaining wall between Columns C and D on Pier 10 (West Pier) was chosen as the hydrographic reference point. This was the same location used in both the 2005 and 2008 Underwater Inspection Reports. The water surface was measured to be 5.9 feet below this point (see Photo 10).

Photo 10 – Facing West. Hydrographic Reference Point  
Timber Retaining Wall 5.9 feet above water surface.
