## BRIDGE DESCRIPTION

Location Map

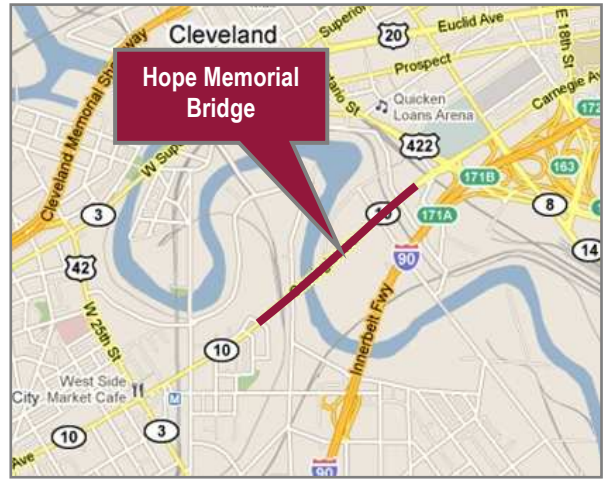
The CUY-10-1613 (Hope Memorial) Bridge carries four lanes of State Route 10 traffic, 3200 feet through downtown Cleveland, over numerous local streets, Norfolk Southern/CSX railroad tracks and the Cuyahoga River. Constructed in 1932, the bridge was originally intended to carry two rapid tracks on a lower deck as well as a utility deck for truck access. The main truss spans include a 13 span cantilevered Pratt deck truss consisting of 4 truss lines and a 3 truss line simply supported Pratt deck truss at the east end of the bridge (See Figures 1 and 2). Approach spans consist of a cellular unit at the east end of the bridge and steel beam simple spans at the west end, supported by both steel bents and concrete piers.

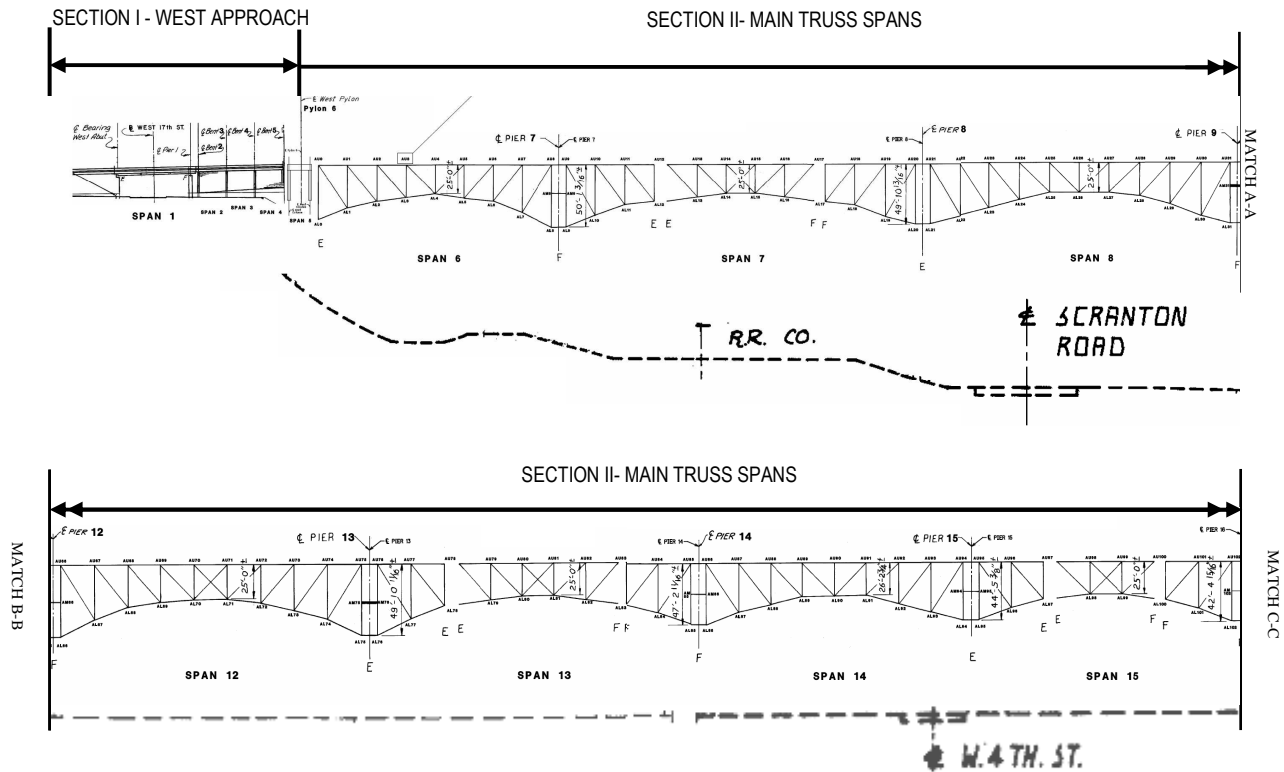
Figure 1 – Partial south elevation of the Lorain-Carnegie Bridge.

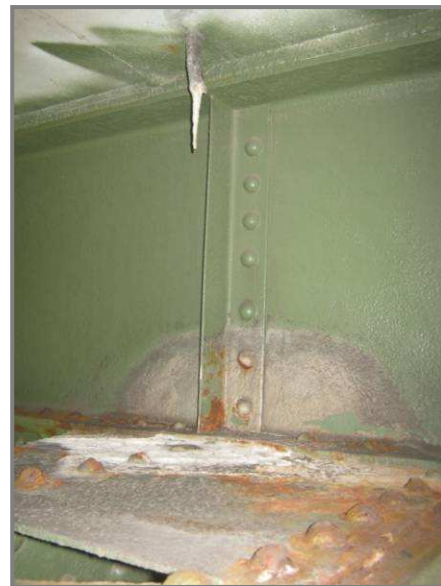
Photo 2 – Isolated location exhibiting a stalactite formation dripping onto Truss D at Panel Point DU47.

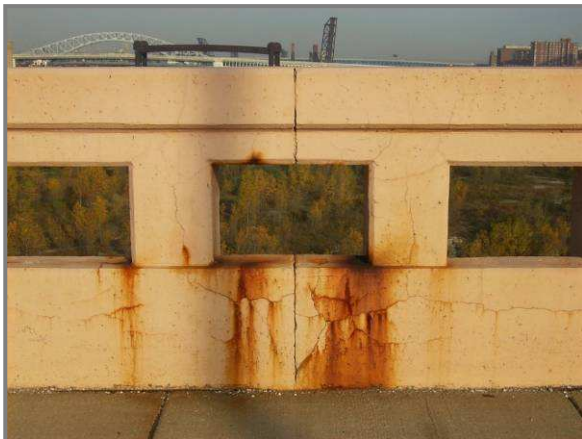
Photo 6 – Typical parapet hairline cracks with rust staining.

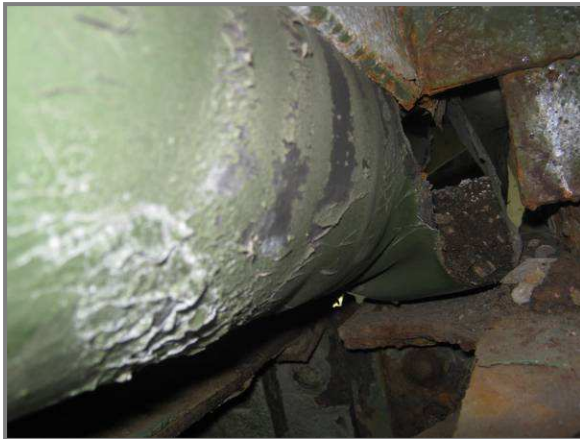
Photo 9 – Isolated torn neoprene trough with debris spilling onto roadway framing members adjacent to Panel Point DU35.

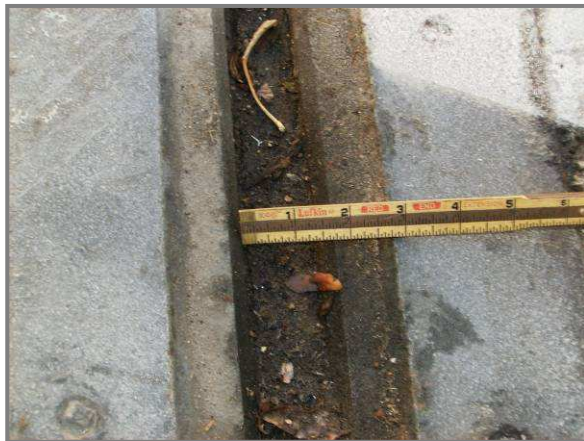
Photo 10 – Typical granular debris buildup in Joint 0 at West Abutment.

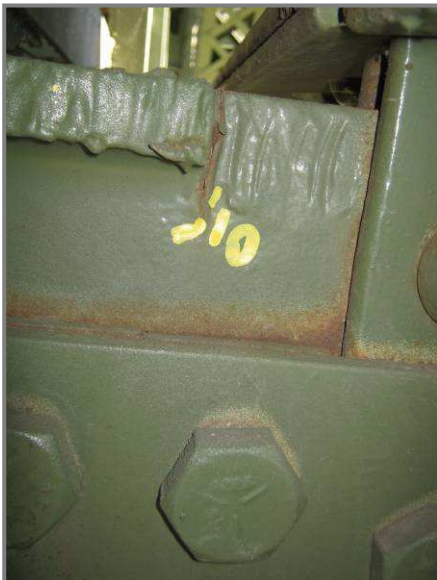
Photo 16– Crack in web of FB37 at CL37.

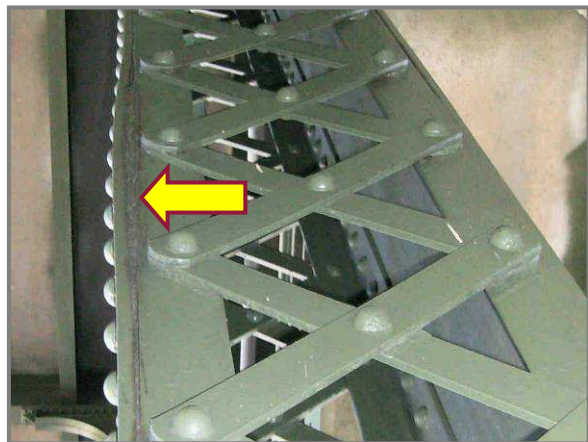
Photo 21 – Impacted rust between the web plate and flange angle of member BL76-BU76 up to 7/8" thick.

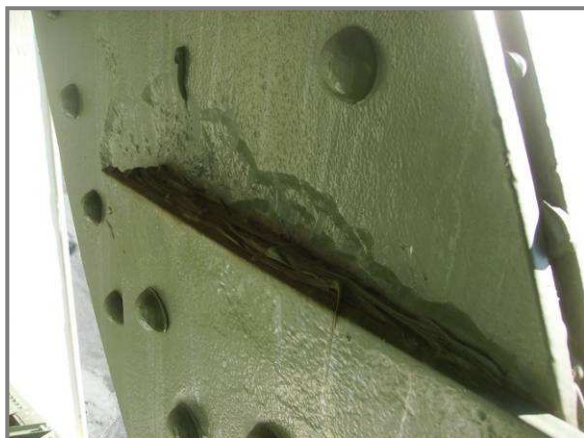
Photo 22 – Pitting up to 1/4" on the north web of member DL43-DU44 at interface with DL43 gusset plate. Note impacted rust present.

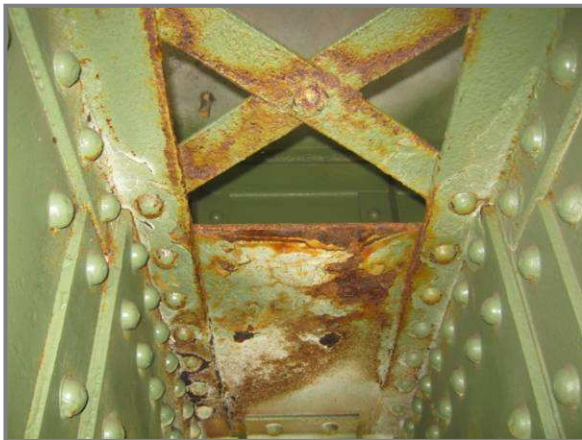
Photo 26 – Active surface corrosion to lacing bars and batten plate beneath area of leaking deck at AU120.

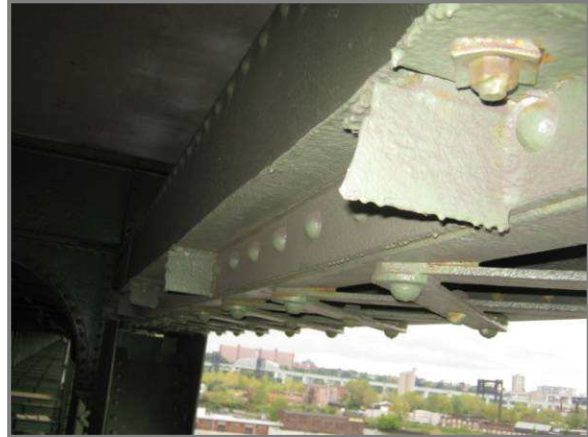
Photo 28 – Abandoned platform connection to the top chord member AU120-AU121 with typical field welds.

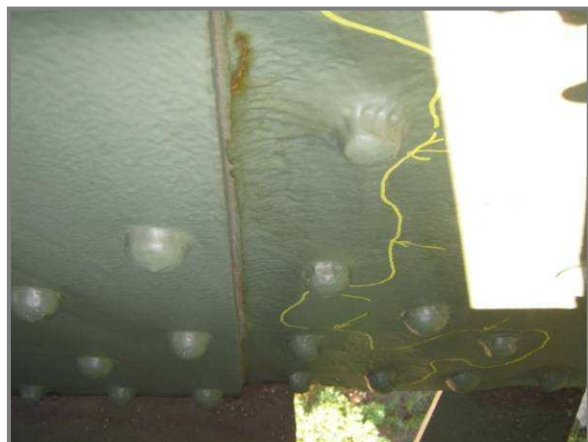
Photo 31 – DL7-DL8 1/4" pitting over full height of south web at DL8.

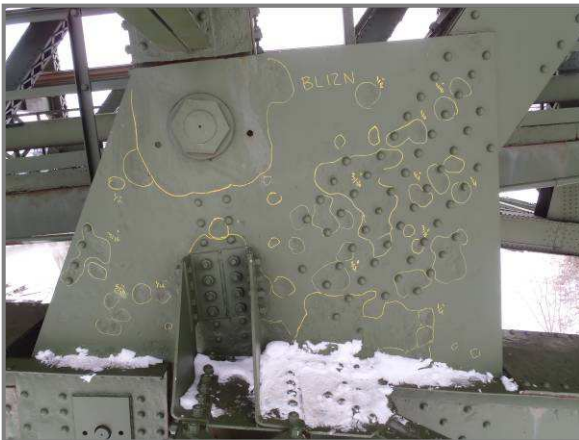
Photo 38 – Up to 1/4" pitting (highlighted in yellow) at gusset plate (BL12N). Note pitting around pin and chord members.

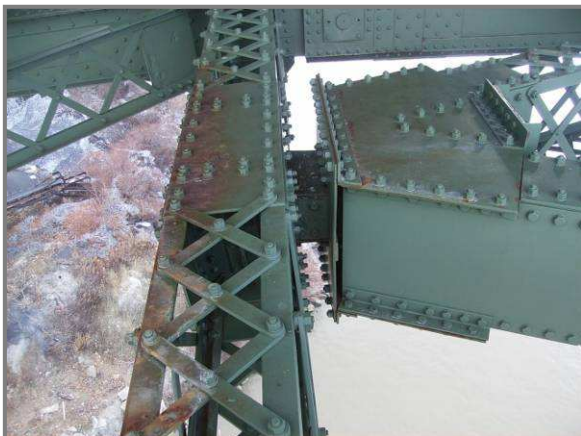
Photo 44– Typical wind lock with minor surface corrosion at strut.

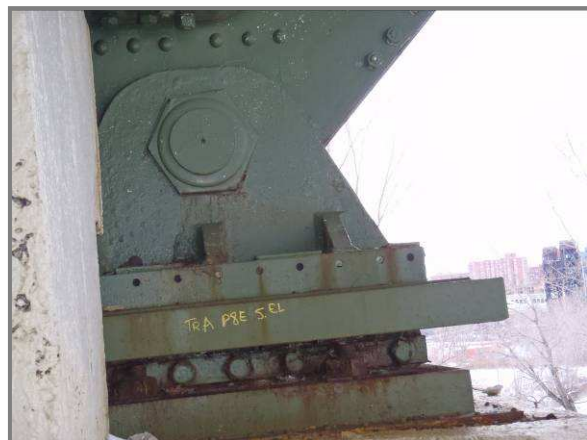
Photo 47– Roller nest assembly at AL21 with active surface corrosion present.

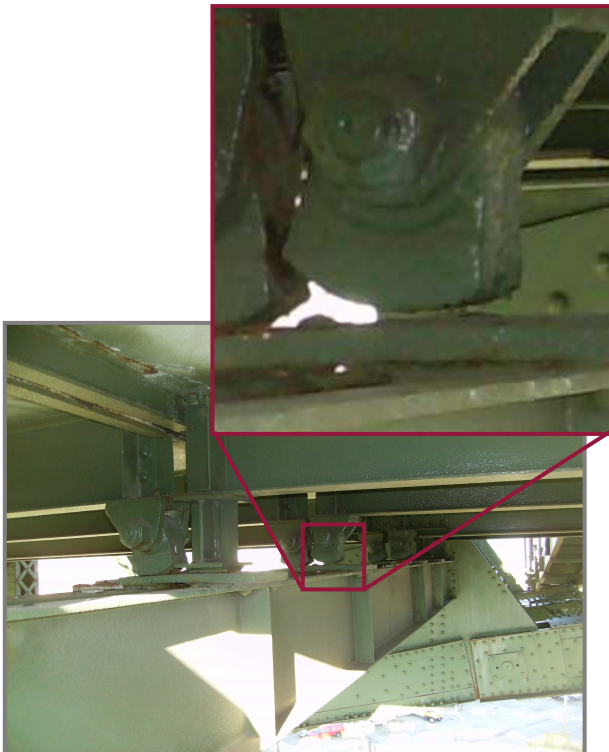
Photo 48 – Gap between Stringer 3 rocker bearing and bearing plate at FB 35.

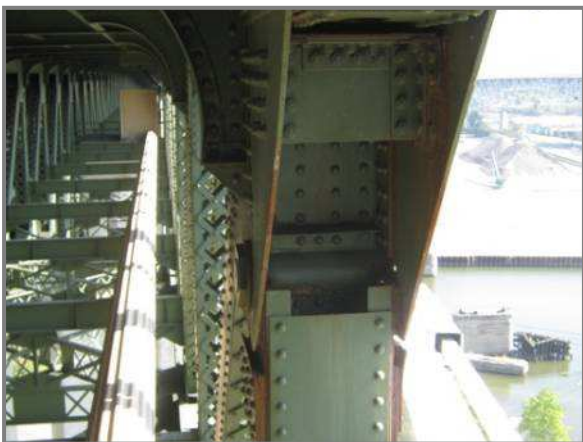
Photo 50– Active minor surface corrosion at DU12.

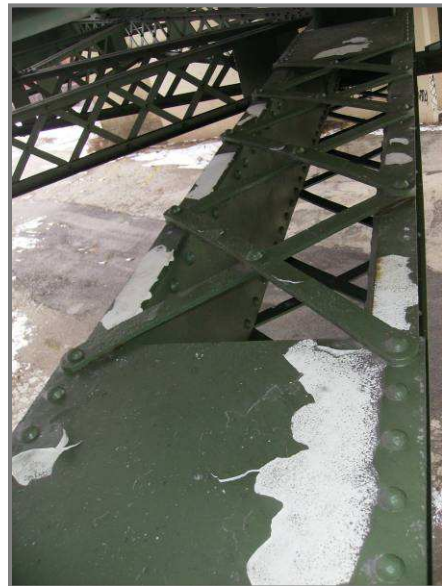
Photo 51– Isolated peeling paint in Span 21.

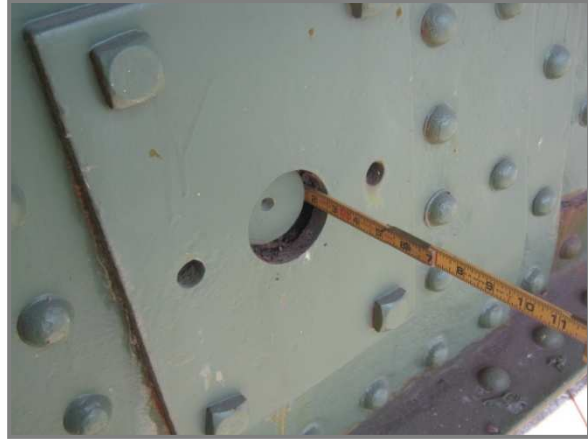
Photo 52 – Sliding pin at CL12S not fully bearing on the outermost pin plate due to impacted rust between the web plate and gusset plate.

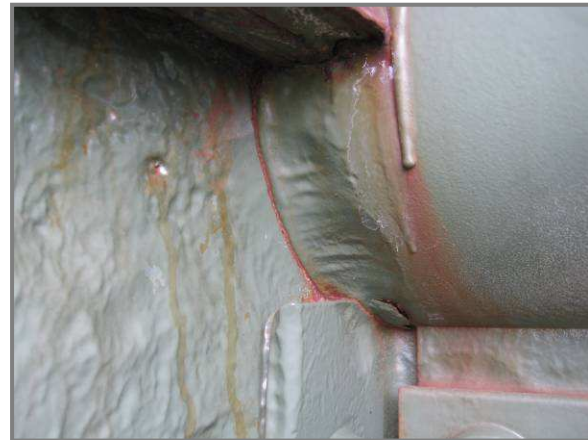
Photo 53– Wear along vertical pin at AL12 up to 5/16" loss over the lower half of the pin circumference.

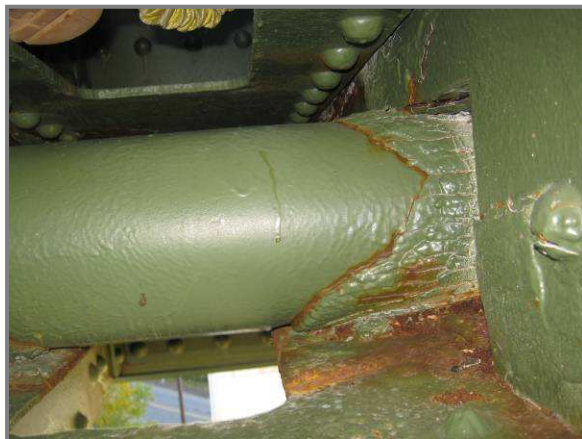
Photo 54– Sliding pin at AL17 seized due to impacted rust which has been painted over.

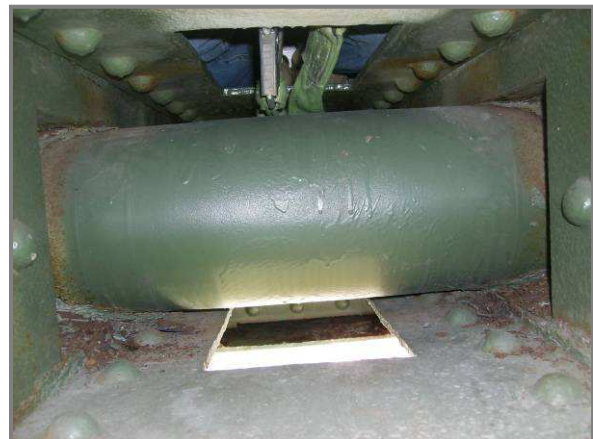
Photo 55– Sliding pin at BL41 seized due to impacted rust.

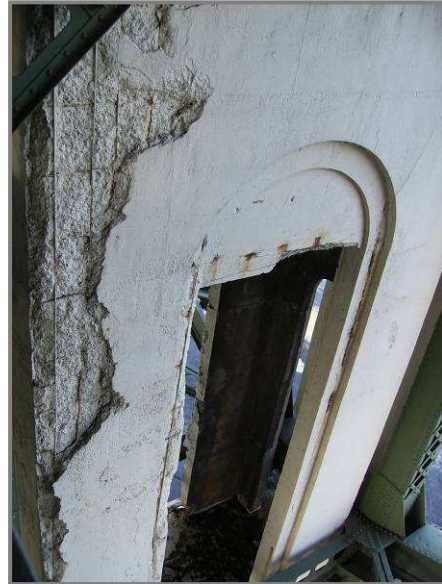
Photo 56– Typical spall with exposed rebar pier tower.

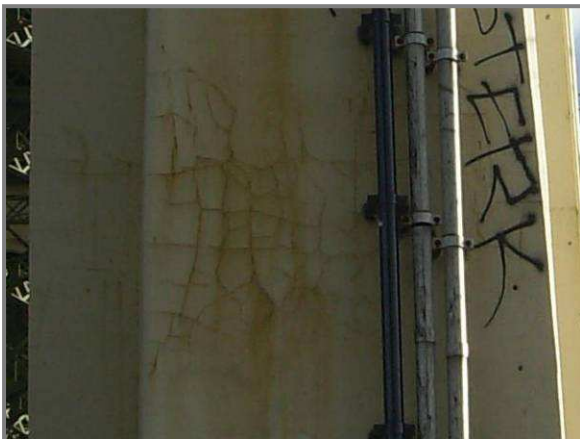
Photo 58– Isolated patch of map cracking on pier wall with rust staining.

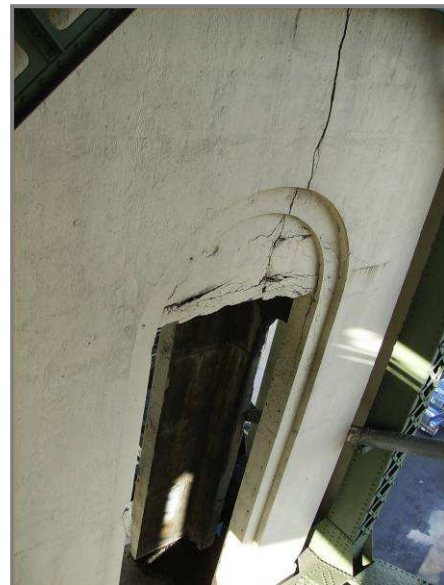
Photo 59– Vertical crack in Pier 13 north tower section.

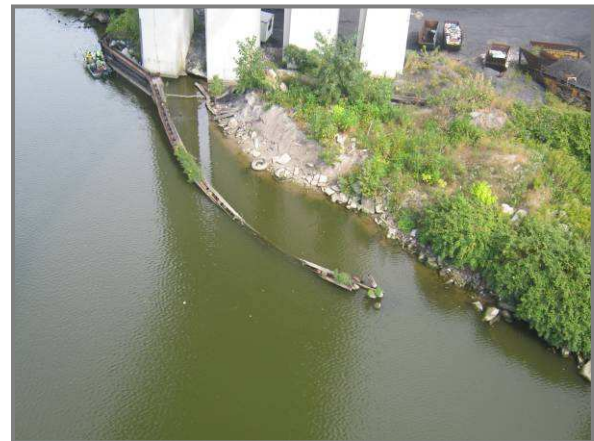
Photo 61– South half of the east bank fender system collapsed towards river centerline.

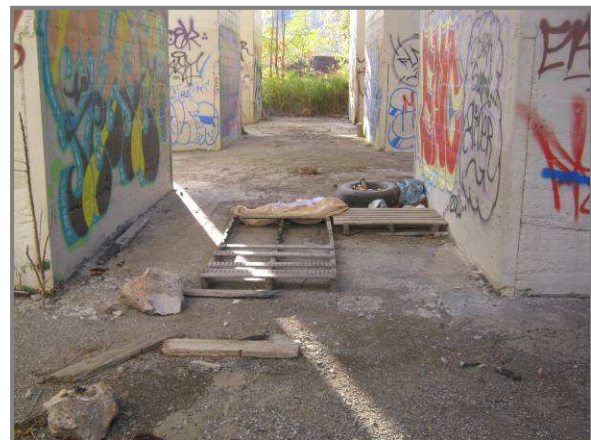
Photo 68– Old mattress and trash piles at Pier 7.

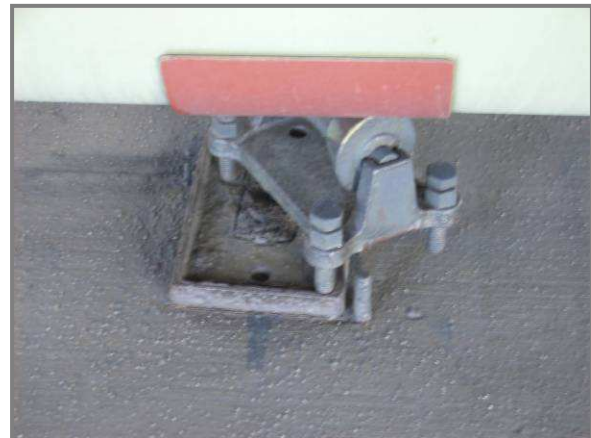
Photo 72– Misaligned support for 40" gas main on utility deck adjacent to Pier 15.
