**SPAN 6
TRUSS A**

Small areas of pitting 1/4" deep pitting are scattered throughout the south face of AL7S, as indicated with field markings.

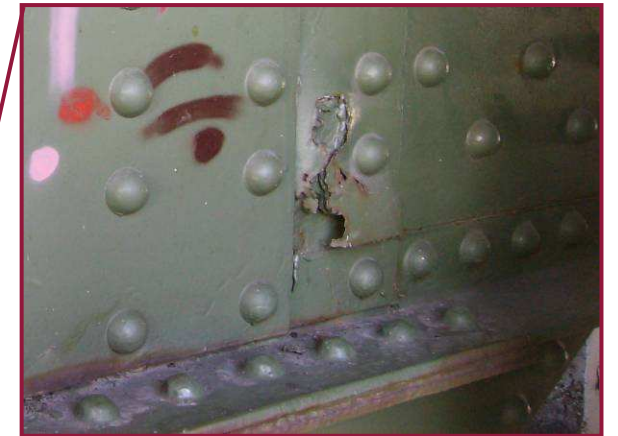
Advanced corrosion at the south web fill plate at BL8 has resulted in a 6" diameter hole.

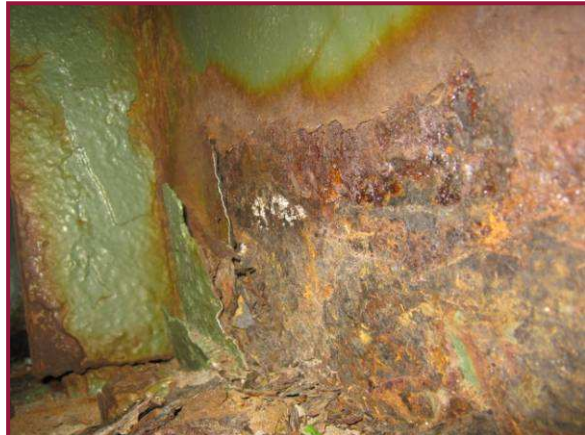
Active heavy corrosion with 1/16" pitting on the bottom flange and lower 1/3 of the web of Floorbeam 0, adjacent to a failed deck joint.

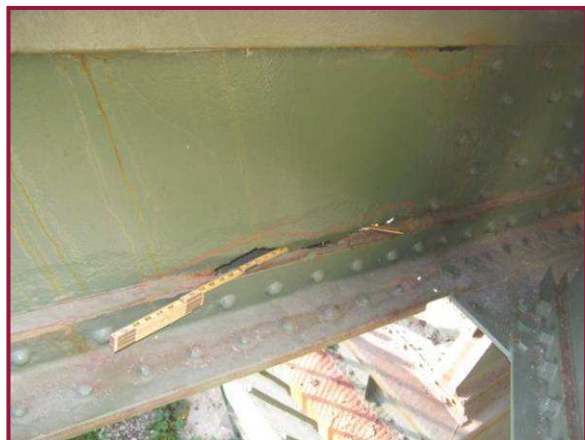
DL0-DL1 exhibits a 2'L x 3"H hole in the north web plate near the bottom flange angle and a 6"L x 2"H hole adjacent to the top flange angle, 5' from DL0.

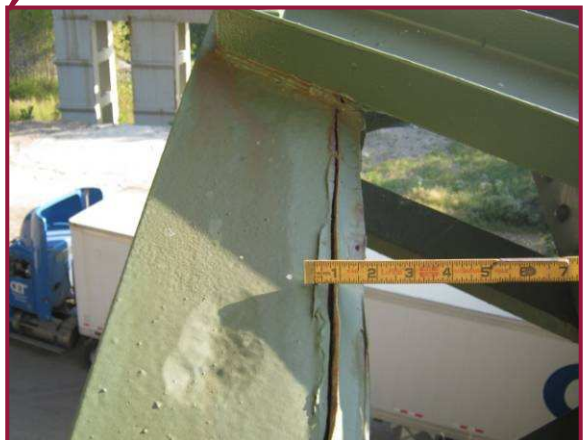
Typical evidence of pack rust reactivating between top flange angle and web plate (DL1-DL2 shown).

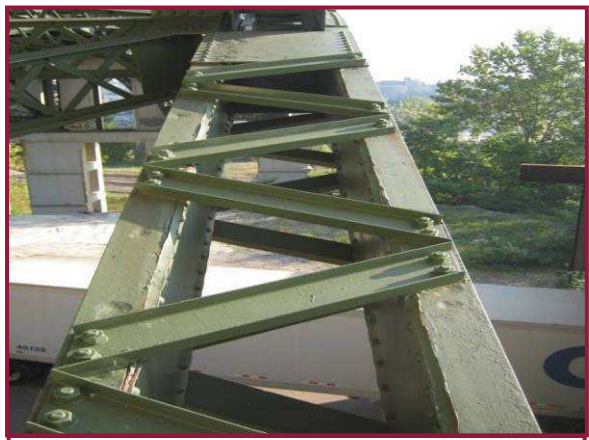
Bottom chord members in Span 6 typically exhibit localized 1/4" pitting (cleaned and painted) on the top flange angles and cover plates (DL1-DL2 shown).

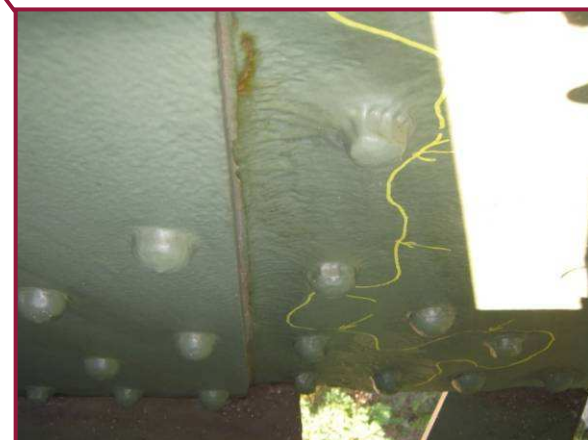
Pitting up to 5/16" deep was noted over the full height of the north web plate of DL7-DL8 adjacent to DL7.

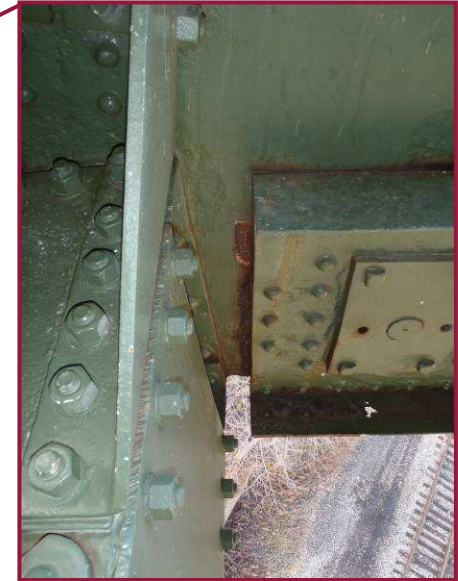
The north gusset plate at AL12 shows wear from abrasion with AL12-AL13.

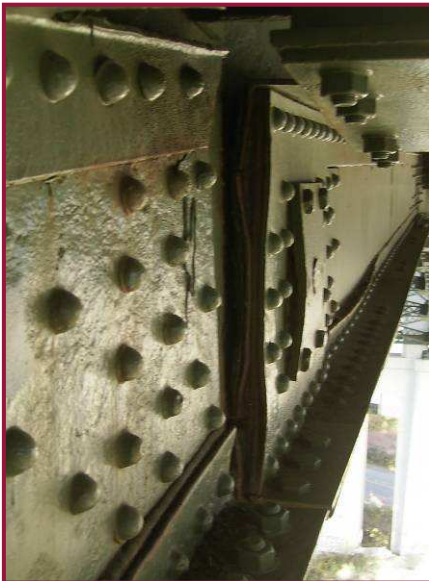
Heavy pack rust between the plates at the lower sliding pin location near BL12 has caused significant distortion of the plates. Heavy pitting is present on the web plate of BL11-BL12 (foreground).

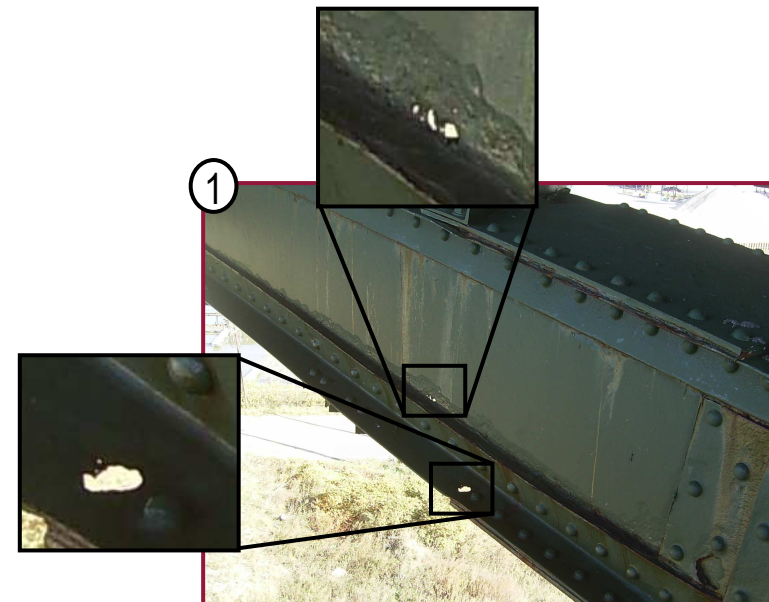
The lower flange angle of BL12-BL13 exhibits a 1" diameter hole. The adjacent web plate exhibits 1/8" pitting and is perforated due to isolated advanced corrosion at one location.

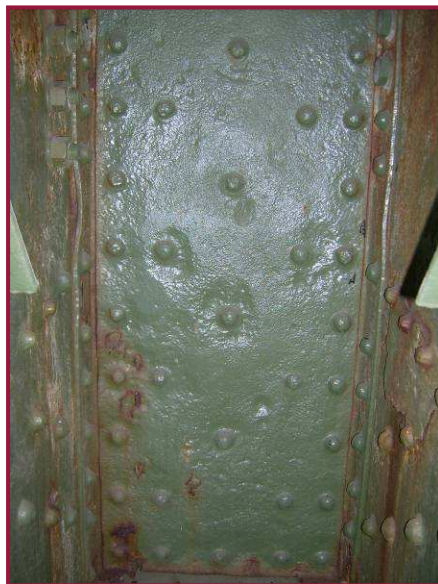
The internal diaphragm plate at CL12 exhibits heavy pitting around the rivet heads and along the edge of the plate at the gusset plate interfaces. Note the active rust throughout.

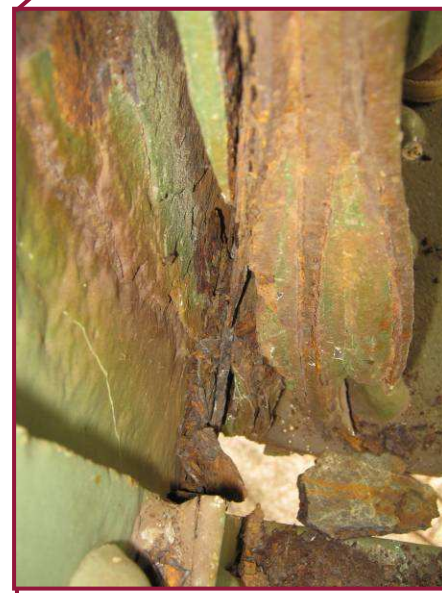
CL12-CL13 exhibits advanced section loss and heavy pack rust at the sliding pin location at CL12. A thin internal fill plate has rusted away at this location, and built up member connections are becoming distressed due to the pack rust and subsequent distortion of the web members, as shown.

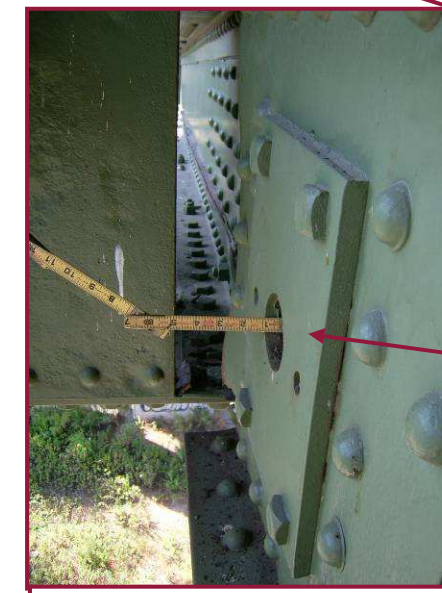
At the lower chord sliding pin at CL12, heavy pack rust has forced the pin plates away from the end of the pin. The end of the pin is approximately 1" from flush with the keeper plate.

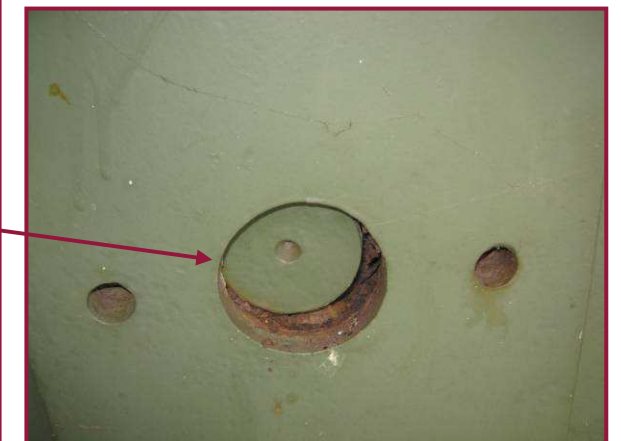
The lower chord sliding pin at CL12 is not bearing on the keeper plate, exhibiting lateral misalignment.

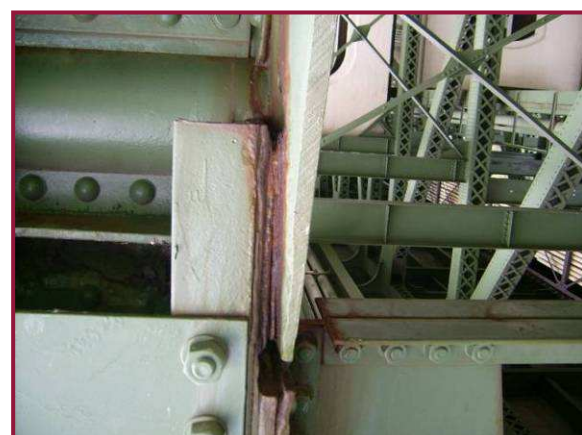
Active pack rust between the north gusset plate and vertical member angle at DL12

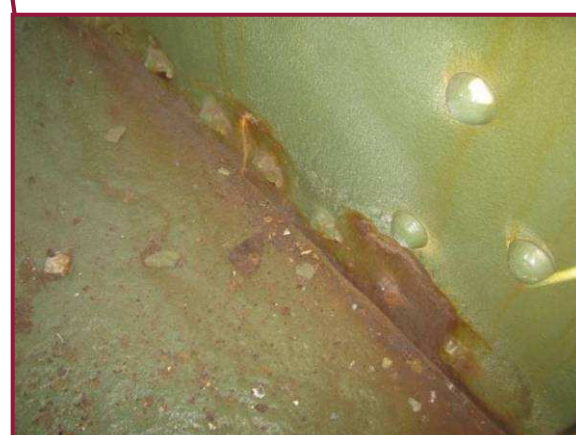
DL12-DL13 exhibits moderate corrosion and pitting up to 1/4" deep over the lower 1/3 of north web plate, with a 2" Ø hole near the bottom cover plate interface.

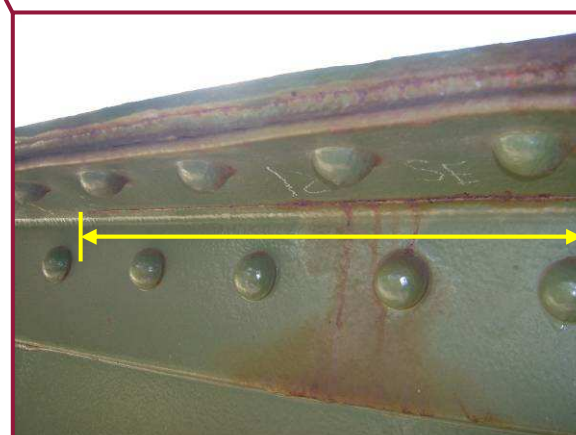
Longitudinal crack is located between legs of the north upper flange angle measuring 24" long at DL15-DL16.

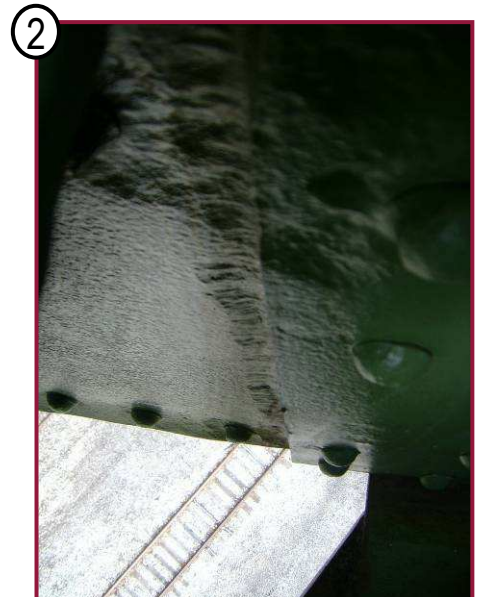
Up to 1/4" pitting (cleaned and painted) extends the full height of the north web of DL14-DL15 adjacent to DL15. This condition is typical for Span 7 lower chord members.

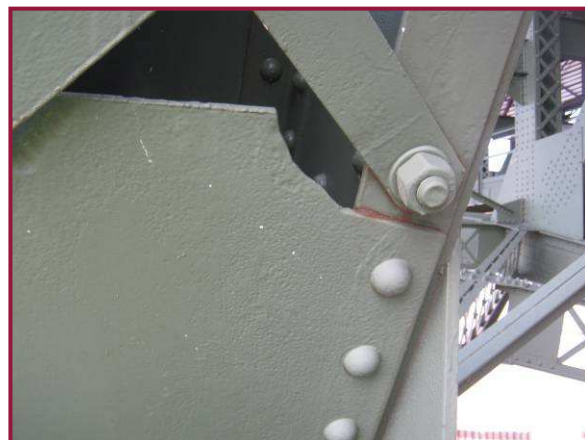
The lower cover batten plate of AL23-AU22 has been flame-cut to accommodate previous repair work done at this location. Note retrofit bolt at the lower lacing connection.

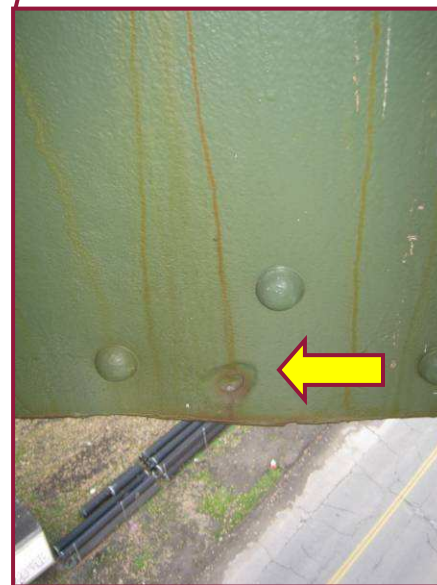
The north web plate of AL26-AL27 exhibits isolated advanced loss of section with a 2" diameter perforation within the bounds of the vertical leg of the bottom flange.

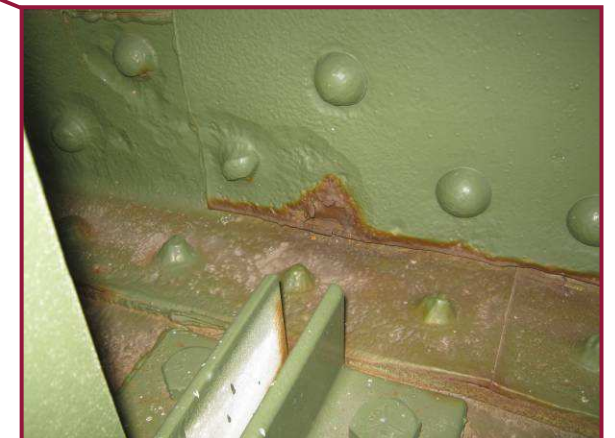
The south web splice plate at AL27 exhibits 1/4" pitting with reactivating rust along the lower flange. Additionally, the adjacent bottom flange exhibits pitting up to 1/4" deep and the rivet heads connecting the lateral bracing connection plate exhibit significant loss of section.

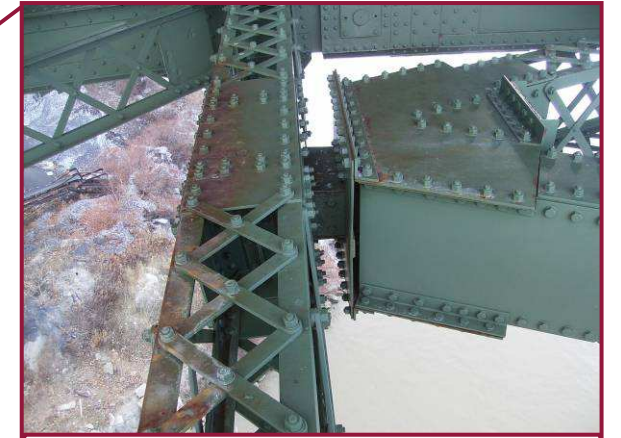
The built up strut at AL41 exhibit active surface corrosion throughout.

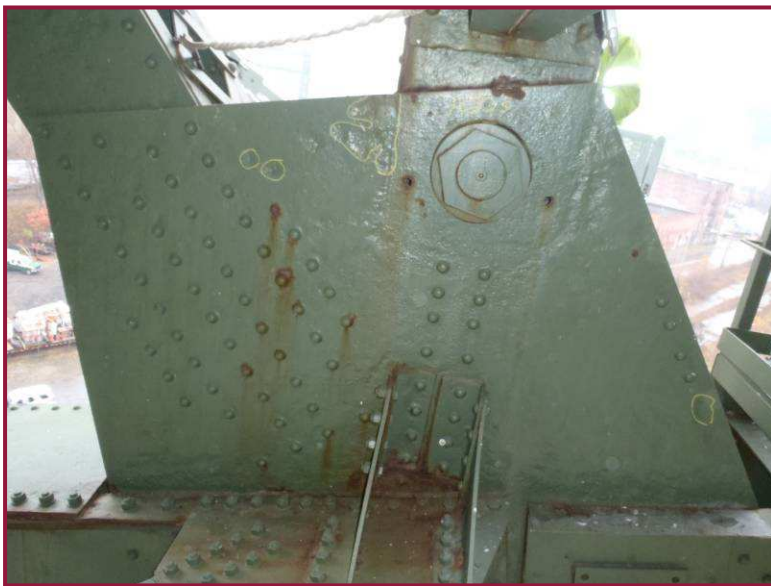
AL35S exhibits heavy pitting throughout the south face of the plate, with 1/4" losses in isolated areas.

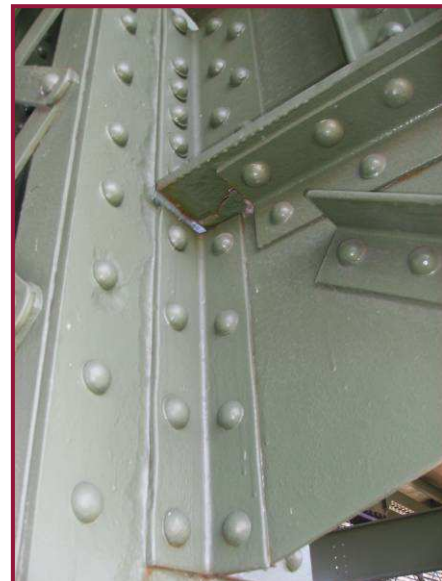
BL40-UL40 exhibits up to 3/16" deep pitting adjacent to the sway strut connection (see Section A-A).

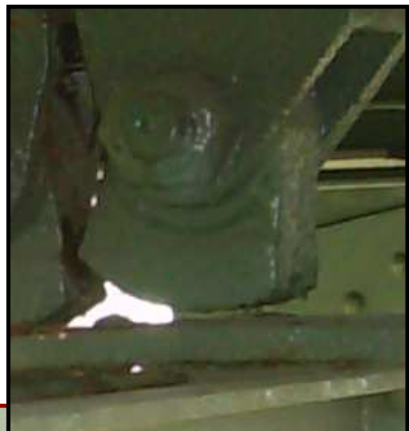
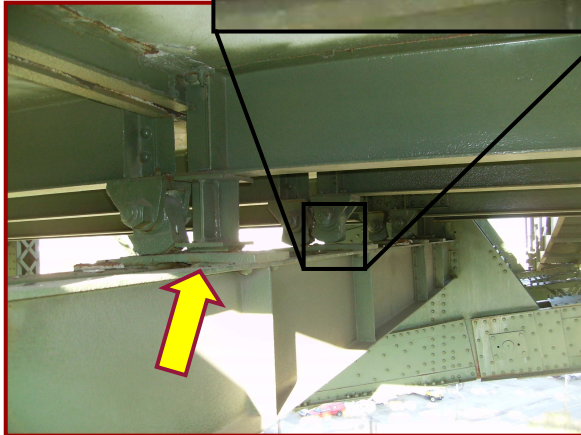
Stringer 3 is not bearing properly at the utility deck Floorbeam 35 bearing plates. Stringers 1 and 4 have retrofitted bearings, consisting of modified beam sections with welded vertical stiffeners. Note that pack rust between the top floorbeam flanges and the bearing plate has caused the plates to bow up.

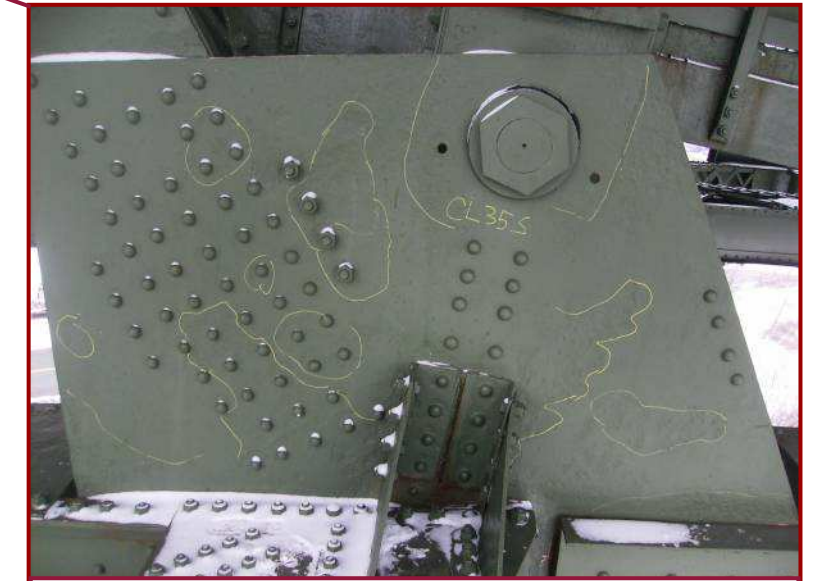
The south gusset plate at CL35 exhibits 1/8" deep pitting throughout areas of the south face, with small areas with up to 1/4" deep pits on the north face of the plate along the lower chord.

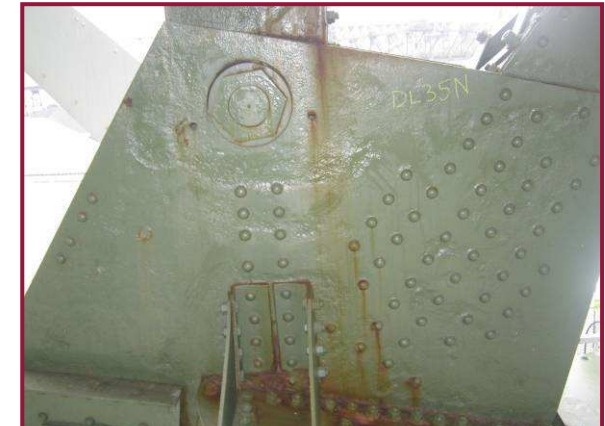
Rust reactivation is typical at the pinned gusset plates due to joint failures above (DL35N shown).

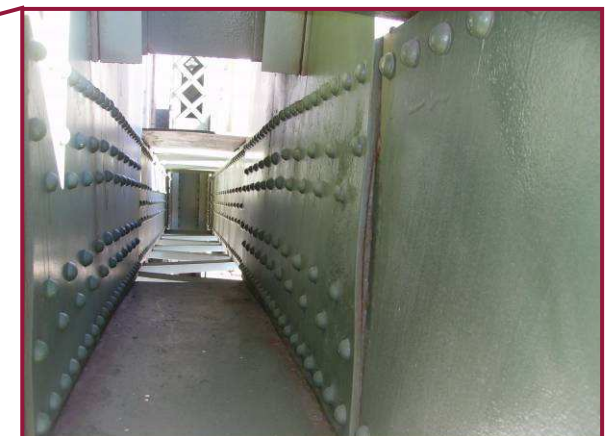
3/4" thick pack rust has formed between the DL43 south gusset and the lower chord web plate resulting in localized minor distortion. This condition was also noted at DL37 in Span 9.

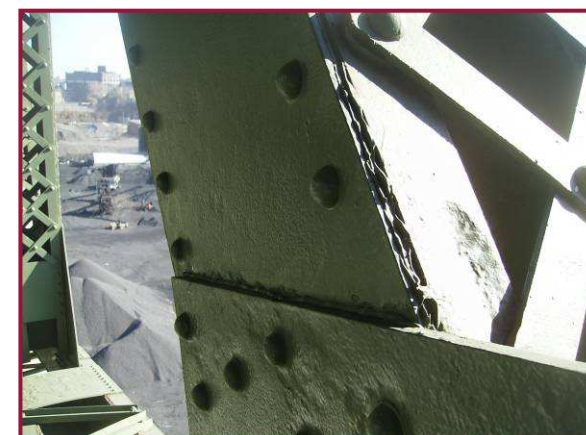
At the seam between the interior lower gusset plate and the diagonal web plate, 1/4"-5/16" deep pitting was noted on member DL42-DU43. Note also the 1/4" deep pitting of the northwest flange angle.

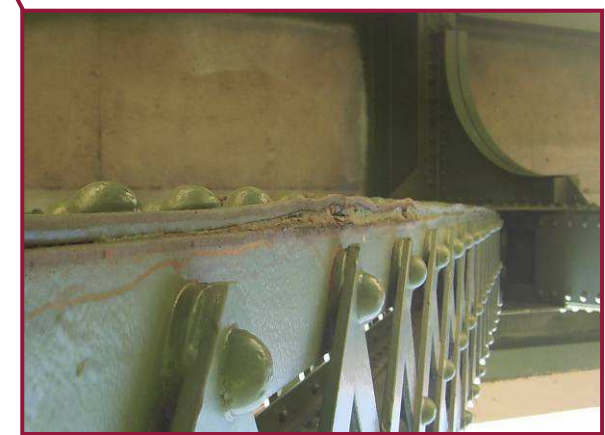
Pack rust between the bottom flange angle and web plate of diagonal members is common throughout the structure. Minor distortion can be seen as a result of the 1/2" thick pack rust at DL42-DU43.
