AL49S exhibits heavy pitting up to 1/4" deep along the lower chord interface, as outlined on the plate.

**SPAN 10
TRUSS A**

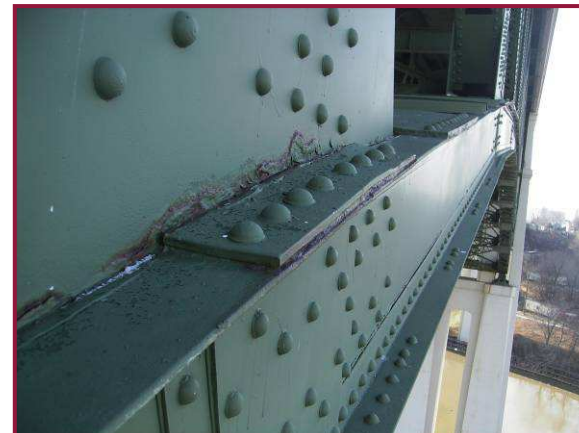
The top flange splice at AL53 exhibits minor distortion due to pack rust forming. Note the adjacent active rust on the gusset plate.

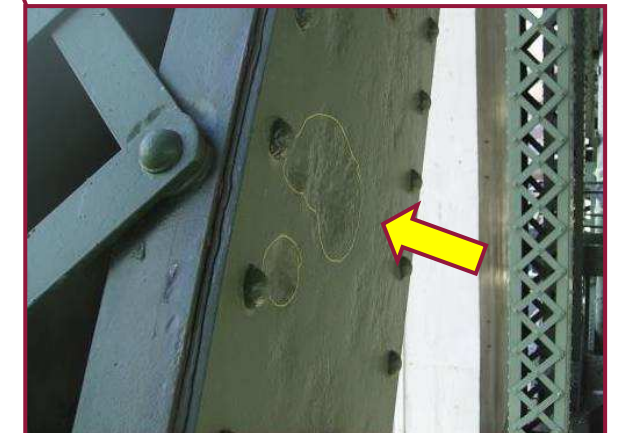
The south web plate of AL54-AU55 exhibits isolated areas with up to 3/8" deep. The largest area measures 6"Ø and is shown above.

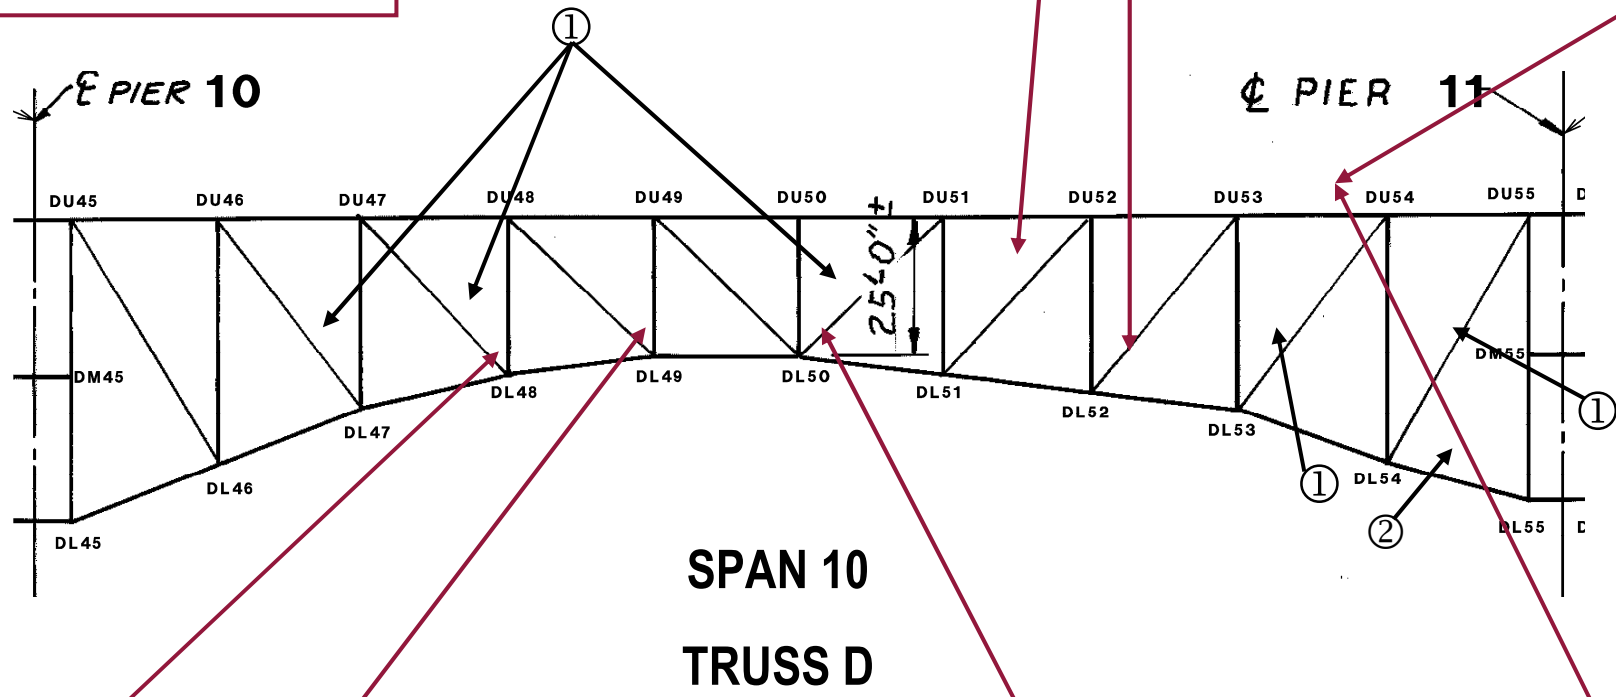
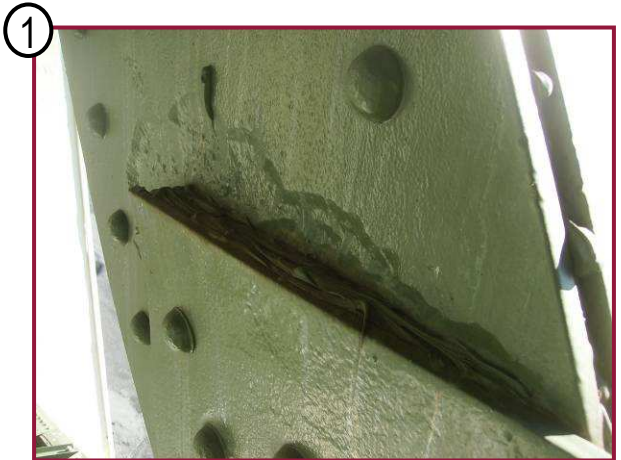
Member DL50-DU51 exhibits pitting of the north web plate at the interface with the lower gusset plate. Pitting at this location averages between 1/8" to 1/4" deep for the width of the plate.

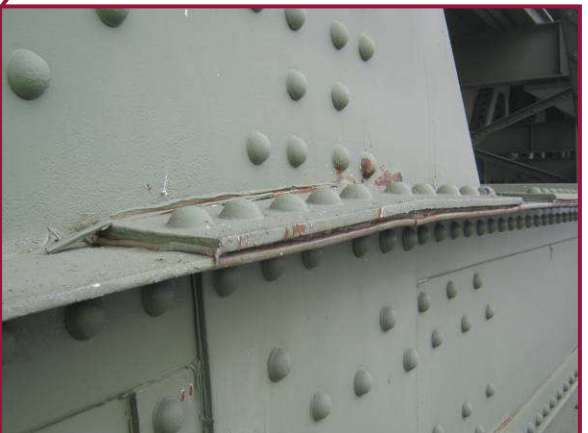
At the flange splice plate at panel DL49, 1/2" thick pack rust has developed and is deforming the flange angles. Reactivating pack rust at this detail is typical of lower chord splices throughout Span 10.

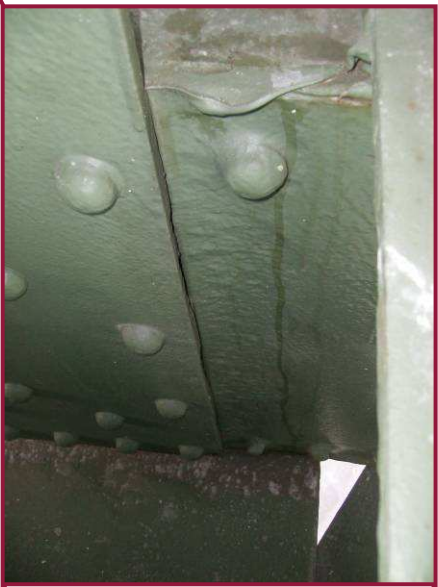
DL50-DL51 exhibits up to 1/4" deep pitting over the full height of the north web at DL50. 1/8" pitting is typically found at similar locations throughout the lower panels in Span 10.

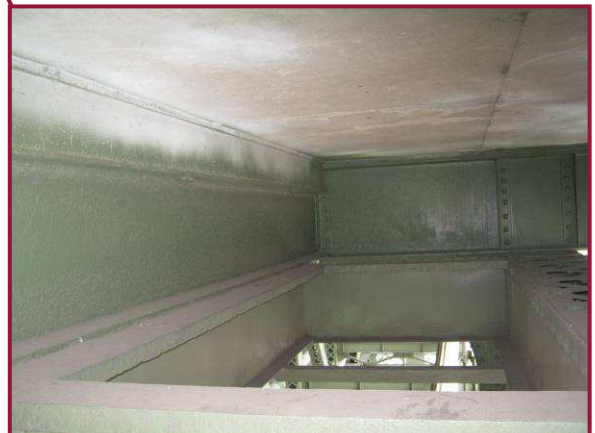
Between Floorbeams 53 and 54 an appurtenance (platform) is stitch welded to Stringer 1 and the interior face of the upper chord of Truss D.

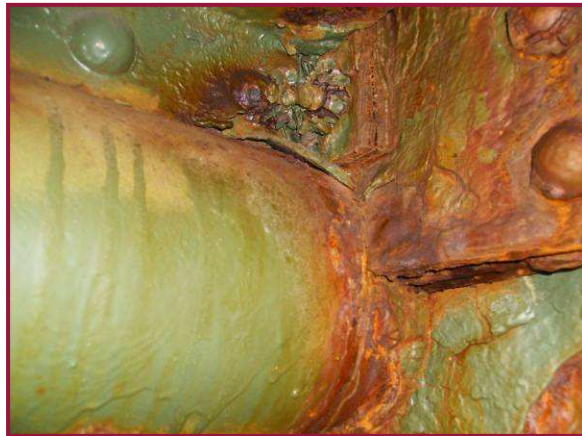
Heavy corrosion is present throughout the interior of AL58-AU58 at the lower panel bearing pin.

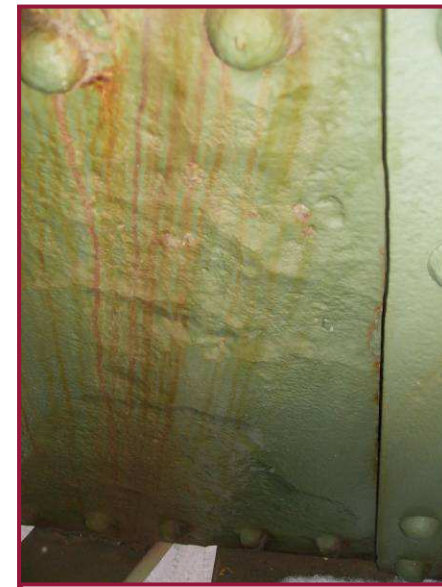
The south face of the AL63-AL64 south web exhibits 1/4" deep pitting along the full height of the plate at the AL63 gusset plate interface.

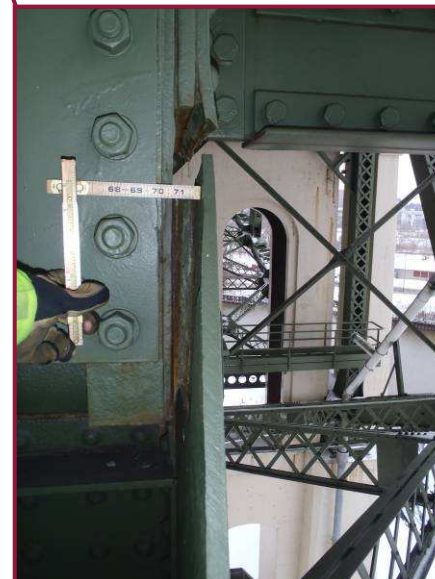
Pack rust up to 1.25" has formed between the north gusset plate and the vertical member near the lower vertical pin at BL58.

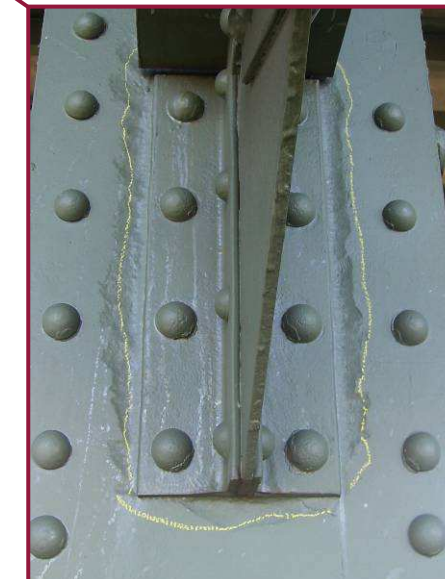
BL59-BU59 exhibits web pitting up to 1/8" surrounding the sway strut knee brace connection.

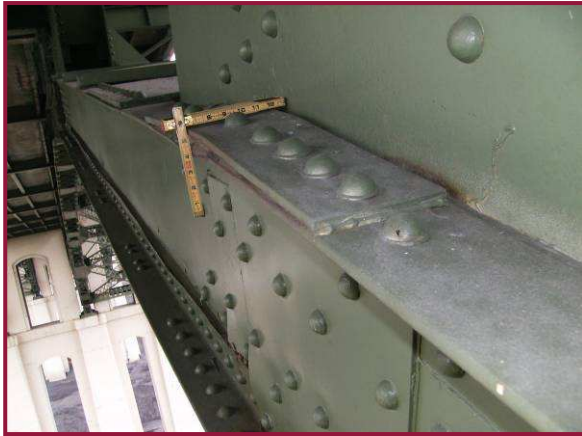
Pack rust at CL57S has caused distortion of the top flange and web splice plates. Approximately 1" thick pack rust is present between the localized areas at each plate.

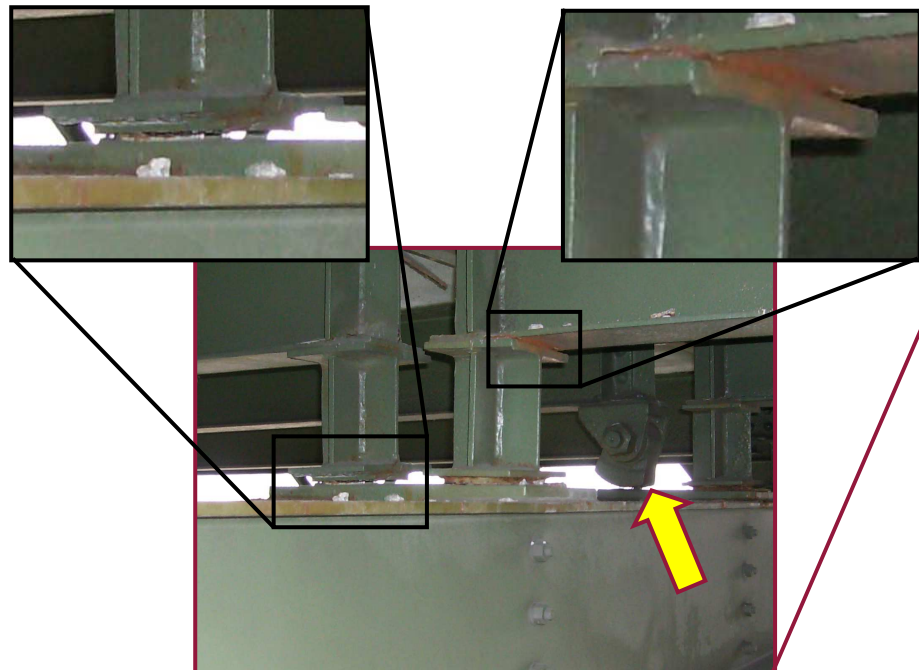
Isolated stringer bearings at utility deck Floorbeam 58 exhibit poor contact with the bearing plates (left). Additionally the retrofitted bearing for Stringer 4 in the near span (between L58 and L59) exhibits a cracked bearing to stringer bottom flange weld and is producing abrasion dust (right). The far span Stringer 3 rocker bearing is not in contact with the bearing plate (arrow).

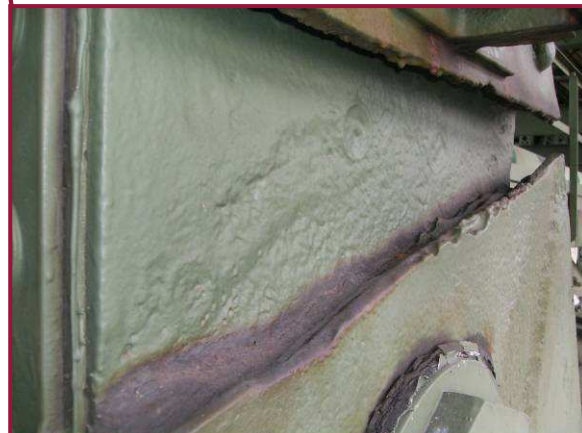
1/8" deep pitting is typical (isolated locations up to 1/4" deep) along the full width of both the north and south web plates of CL58-CU58 above the lower gusset plate interface

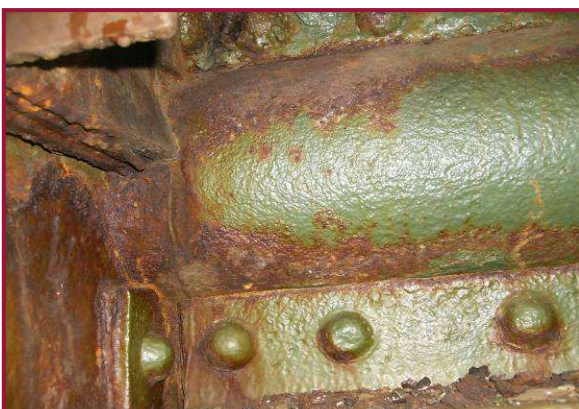
At the main bearing pin at vertical member DL58-UL58, surface rust is typical throughout with light to moderate pitting of adjacent components. Note: this condition is common among the truss pins, especially those below failed deck joints.

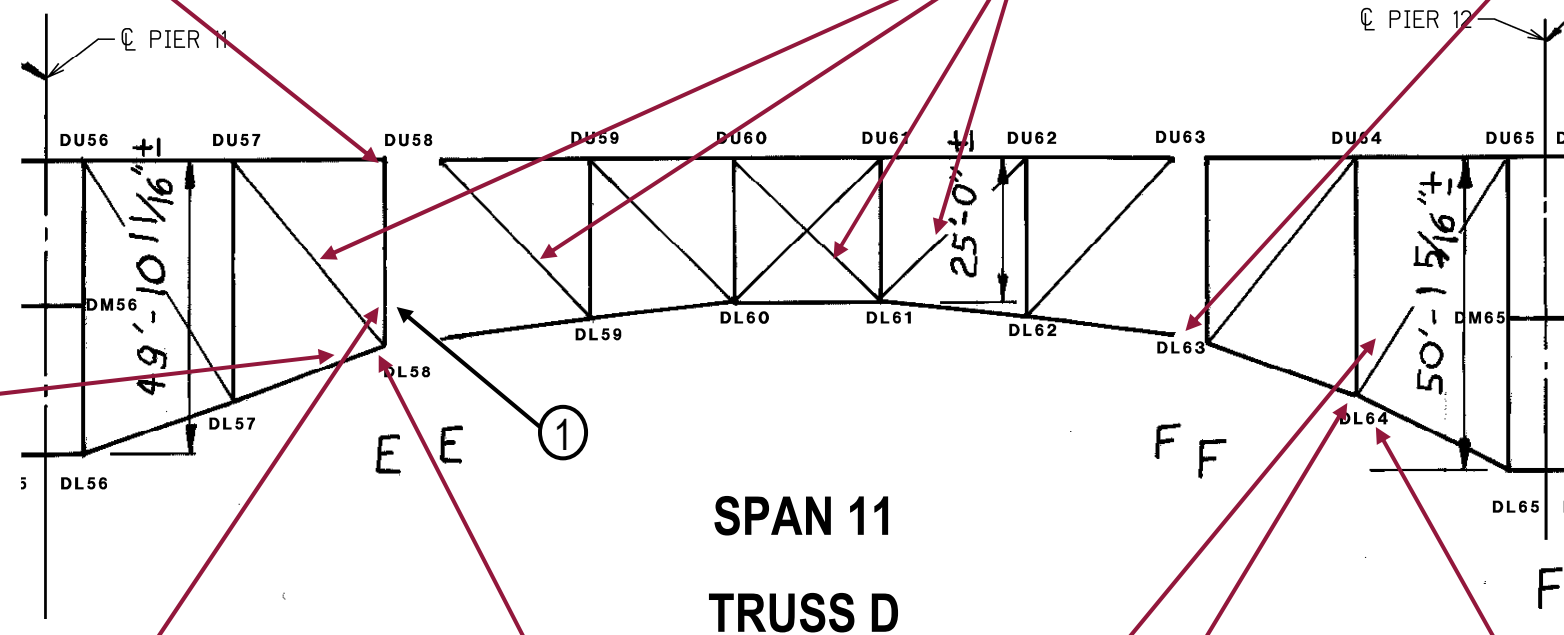
Similar to other spans throughout the structure, the lower chord north web plates exhibit losses along the lower flange angles. Losses in Span 11 are typified by 1/16"-1/8" deep pitting occurring within the lower 2" of the web and most of the length of each bay. The adjacent flange angles exhibit similar pitting.

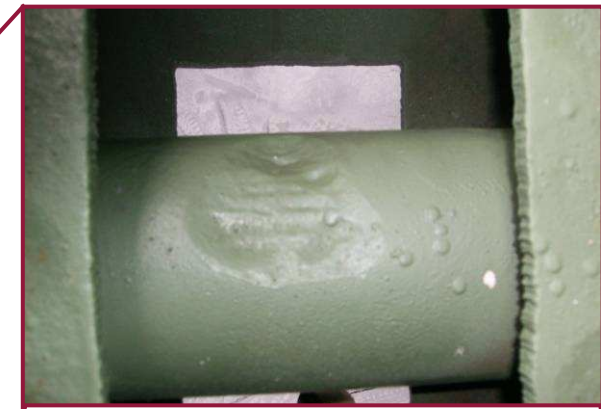
The lower sliding pin at DL63 has a 4" diameter area exhibiting up to 5/16" deep pitting. This location has been cleaned and painted with no active rusting.

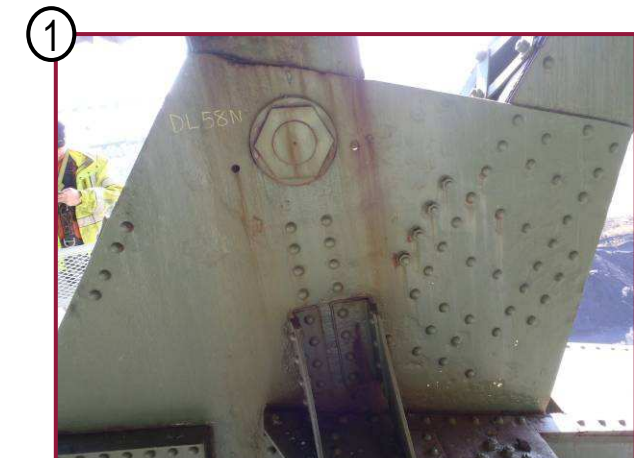
The north gusset plate at DL58 exhibits up to 3/16" pitting, a condition typically found at the expansion locations throughout the structure.

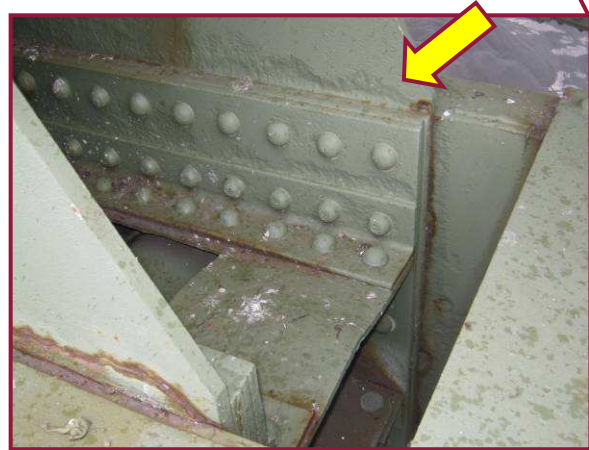
Active rusting is typical along the seams of the built up members at DL58. The south face of the north gusset plate exhibits 1/8" pitting that has been cleaned and painted, while the same location on the south gusset plate exhibits up to 1/4" loss (arrow). Additionally, note that the horizontal stiffener plate between the two gussets is bowed up, measuring approximately 1" from its original plane.

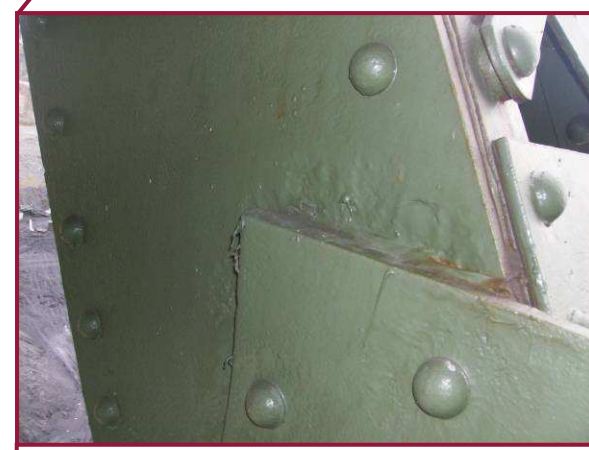
Pitting of the north web plate at the gusset plate interface on diagonal member DL64-UL65 is up to 3/16" deep with light surface corrosion along the seam between the two plates. This condition is typical for Span 11, Truss D for other web members. Only member DL59-UL58 in Span 11 exhibited heavier pitting at this interface, with up to 5/16" loss.

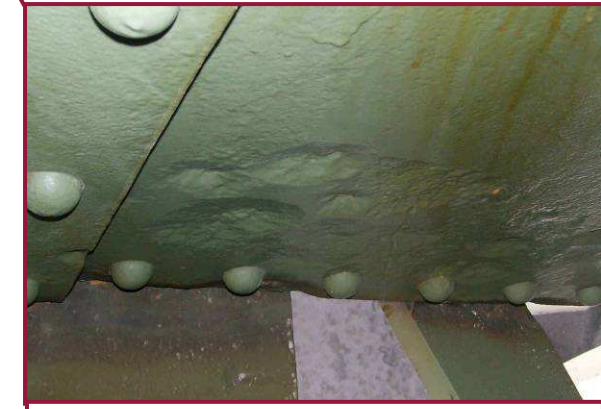
The lower half of the interior face of the DL64-DL65 north web plate exhibits pitting up to 5/16" deep adjacent to the DL64 gusset plate. This condition is typical for Truss D lower chord web plates at the panel interfaces throughout Span 11; however, pitting varies from 1/8" to the 5/16" depth at DL64.

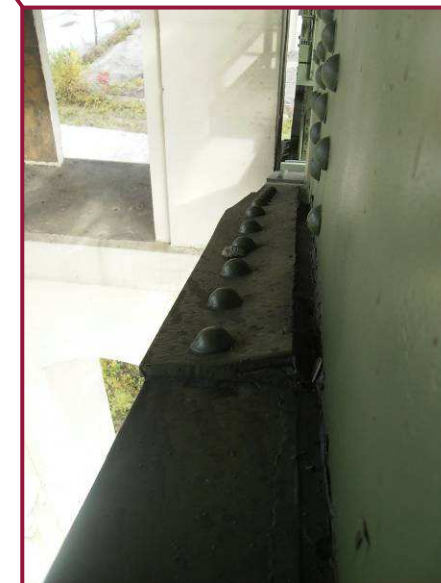
The top flange splice plate at CL74S is distorted due to pack rust.

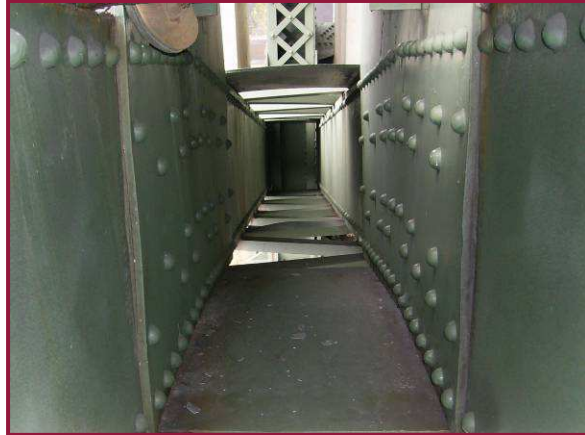
Pack rust between the gusset plates and web plates at DL67 has caused 1/2" bowing of the gusset plates.

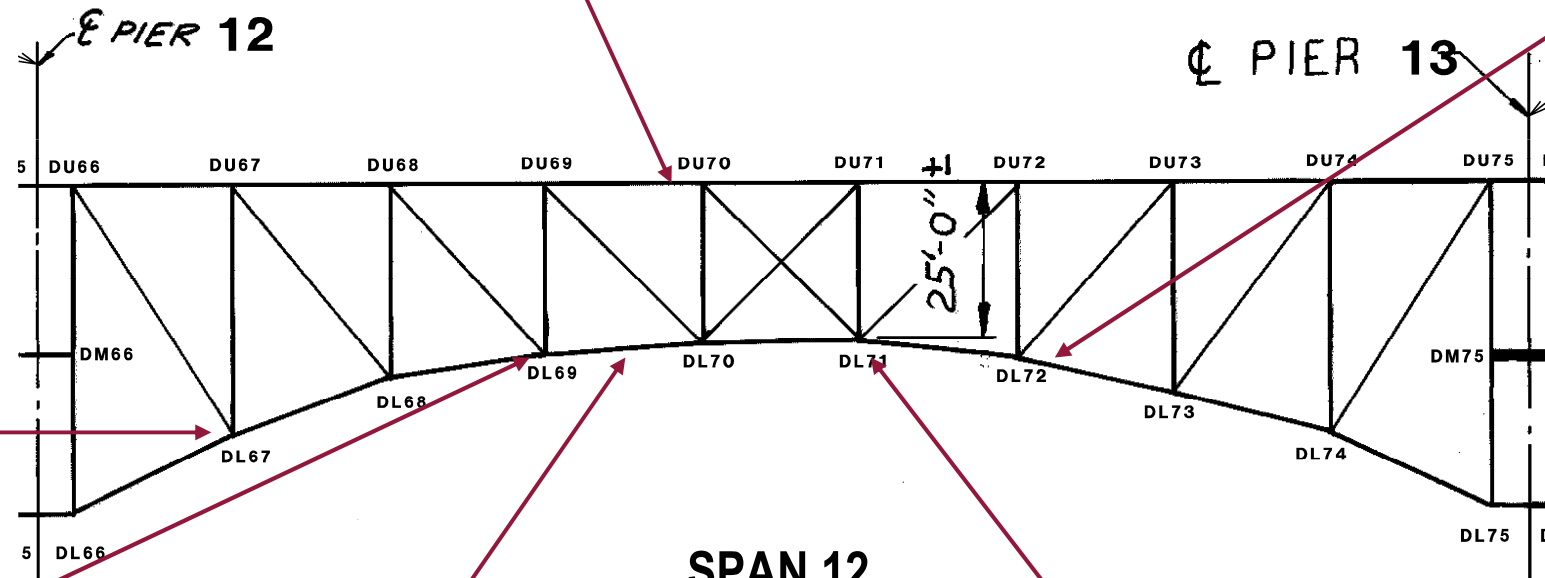
The diagonal members throughout Span 12 typically exhibit 1/16" - 1/8" pitting along the gusset plate interfaces at the north web plates. This condition is typical throughout the structure.

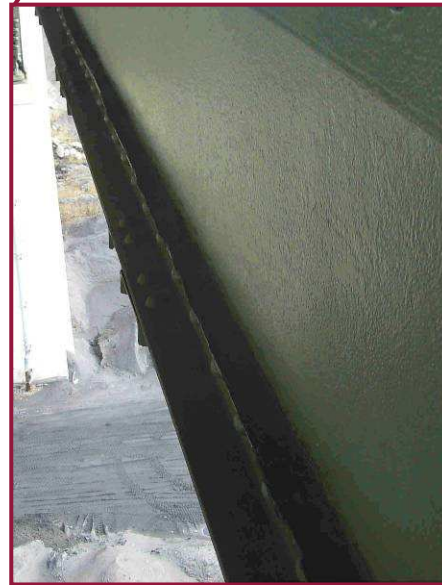
The lower chord member DL69-DL70 exhibits pack rust up to 2" thick between the north web plate and the lower flange angle. Pitting up to 3/16" was noted on the north web plate along the flange angle.

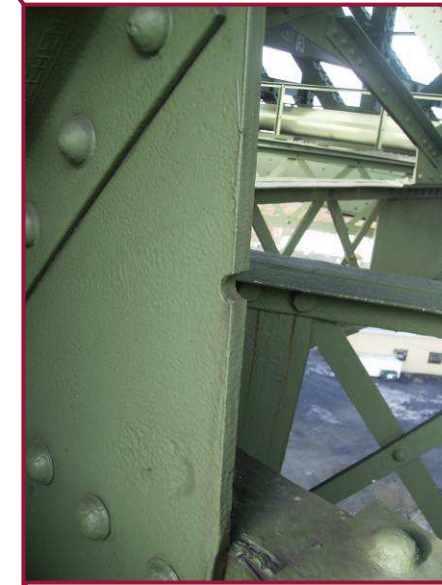
Both gusset plates at DL71 have misplaced drill/punch holes along the east free edge.

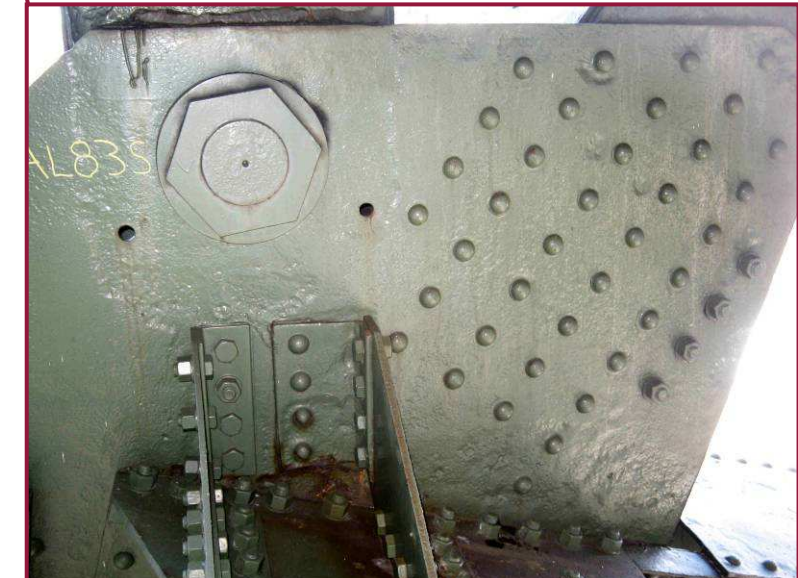
The south gusset plate at AL83 exhibits heavy pitting throughout the south face, with pitting up to 1/4" deep along the lower chord interface. Similar conditions are exhibited by the south plate at AL78.

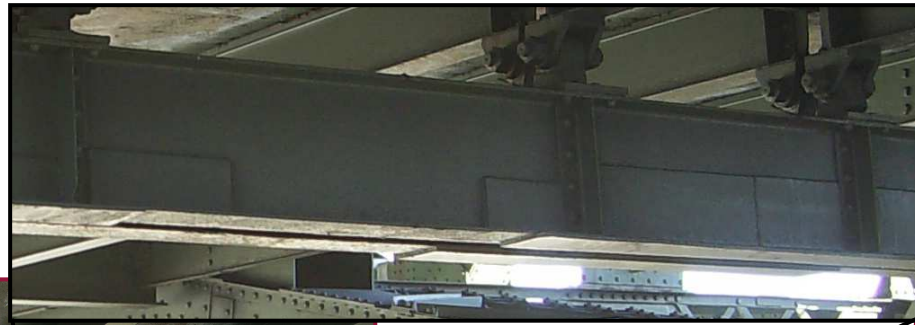
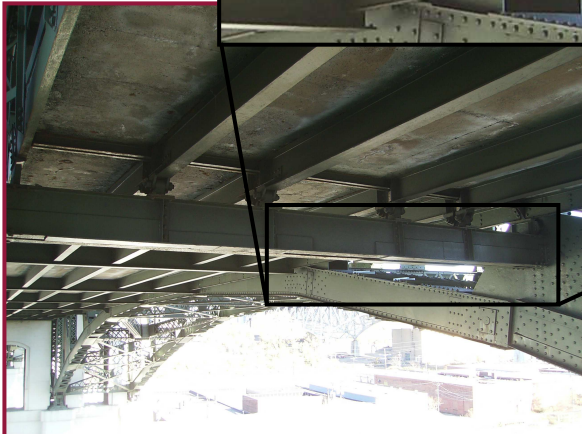
The utility deck Floorbeam 78 has received extensive web retrofits throughout the length of the member.

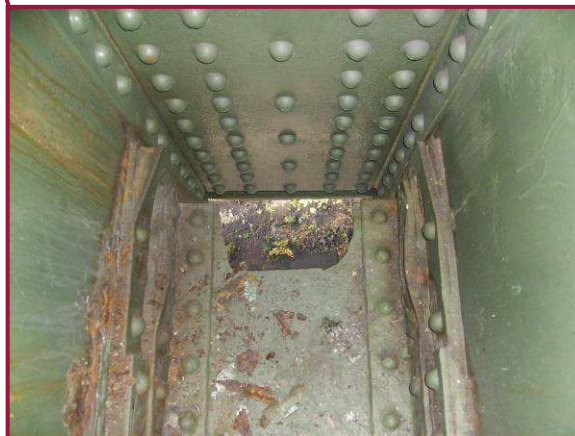
The internal pin plates at BL78 exhibit pack rust up to 1.5" thick at the plate corners with localized distortion.

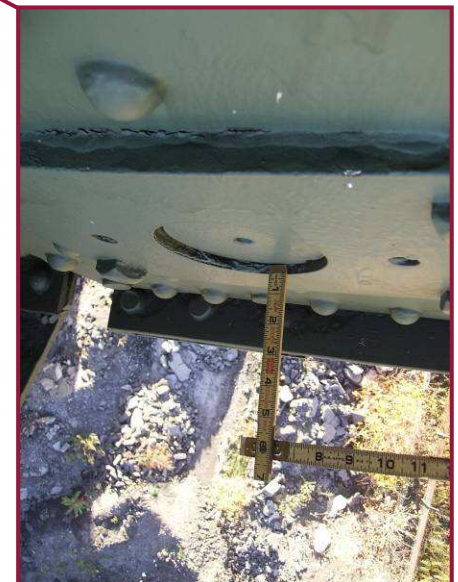
Pack rust at BL83 has pushed the sliding pin plates outward.

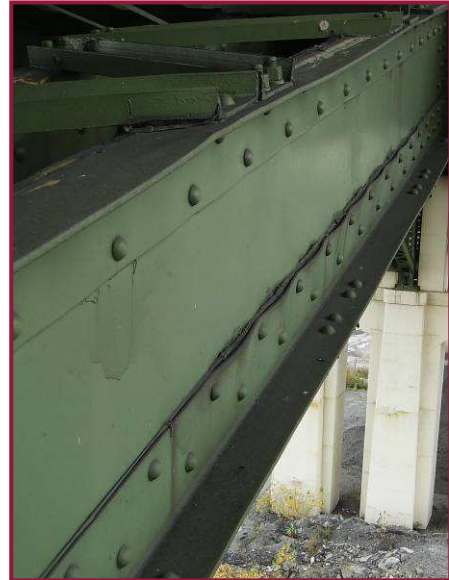
Pack rust between the bottom flange angle and south web of CL77-CL78 has distorted the vertical angle leg. The rust is reactivating, as indicated by rust staining. This condition is common among the lower chord members throughout Truss C.

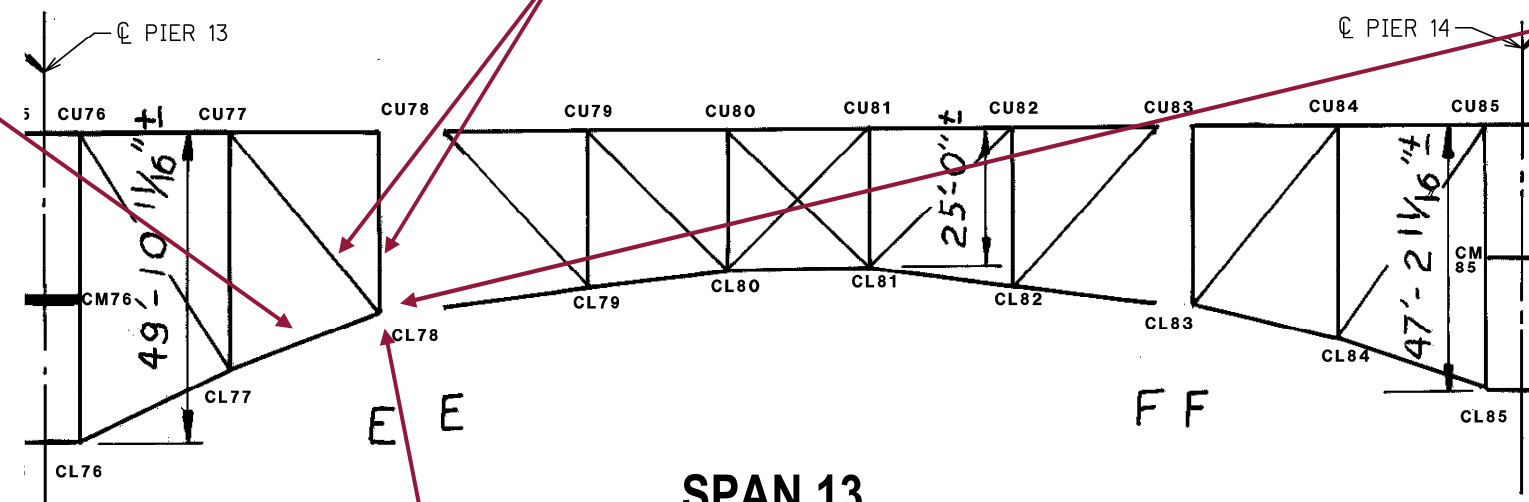
The north web plates exhibit 1/8" deep pitting along the full width of the member at the gusset plate interface.

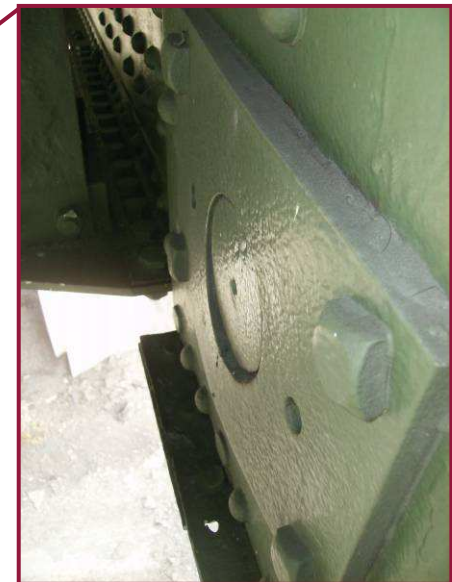
The suspended span sliding pin at DL83 is misaligned with the north keeper plate due to 3/8" pack rust causing localized plate distortion.

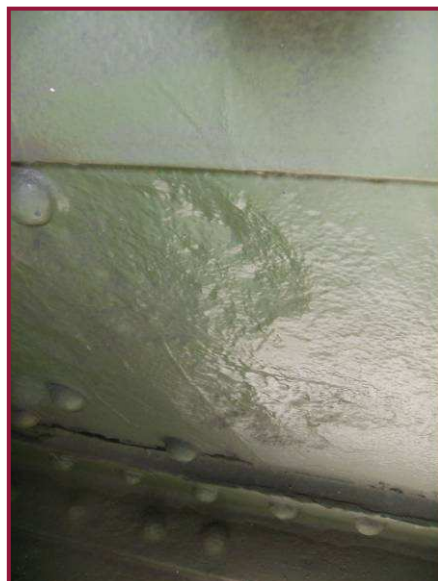
The north web plate of DL77-DL78 exhibits 1/8", full height pitting near DL78. This condition is commonly found throughout Truss D and throughout Span 13; however, losses are typically less, measuring 1/16" on average. The web plate at DL85 exhibits pitting up to 3/16" deep in this area.

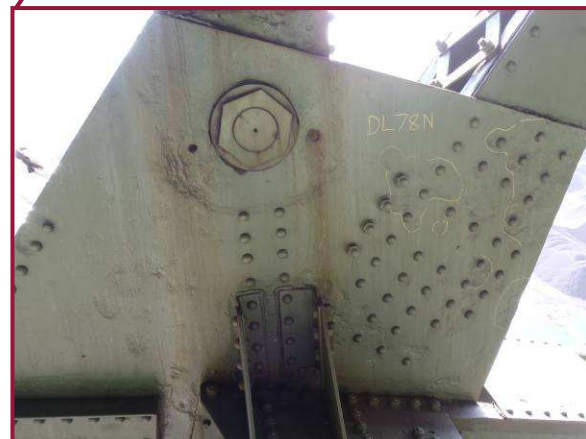
Heavy pitting (greater than or equal to 1/4" deep in isolated locations) of the lower gusset plates at the pin locations is typical with reactivating surface corrosion due to failing deck joints above.

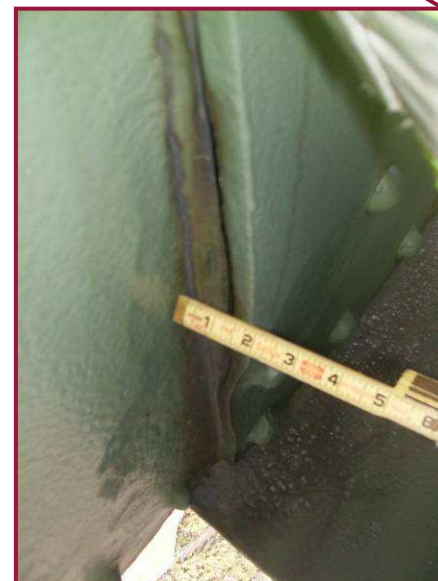
The north gusset plate at DL79 is bowed to the south approximately 1-3/16" along the interface with the lower chord web of DL78-D79 due to heavy pack rust accumulating between the two plates. Also note the 1/16"-1/8" loss of the web plate in this area.

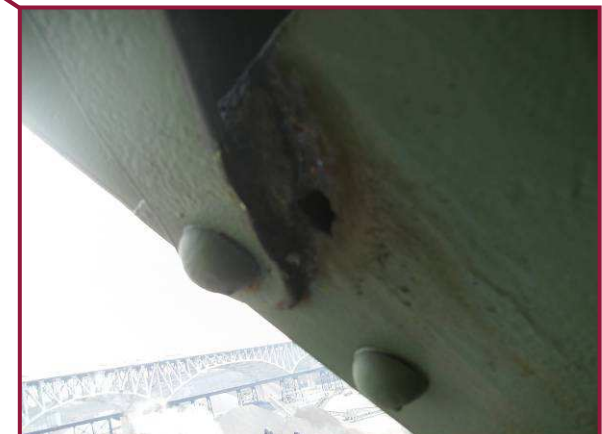
The lower batten plate on the underside of diagonal member DL80-UL81 exhibits advanced corrosion with a 2" hole and adjacent 1/4" pitting near the lacing connection.
