**SPAN 14
TRUSS B**

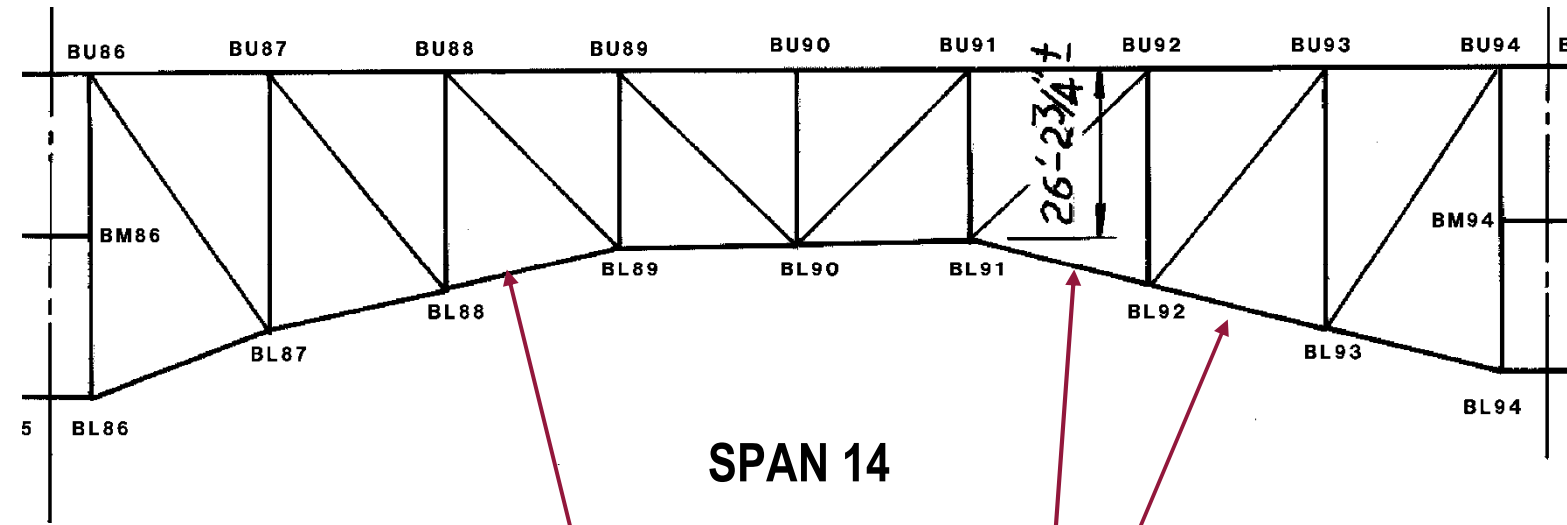
1/8" pitting of the north lower chord web plate along the length of the members at isolated locations

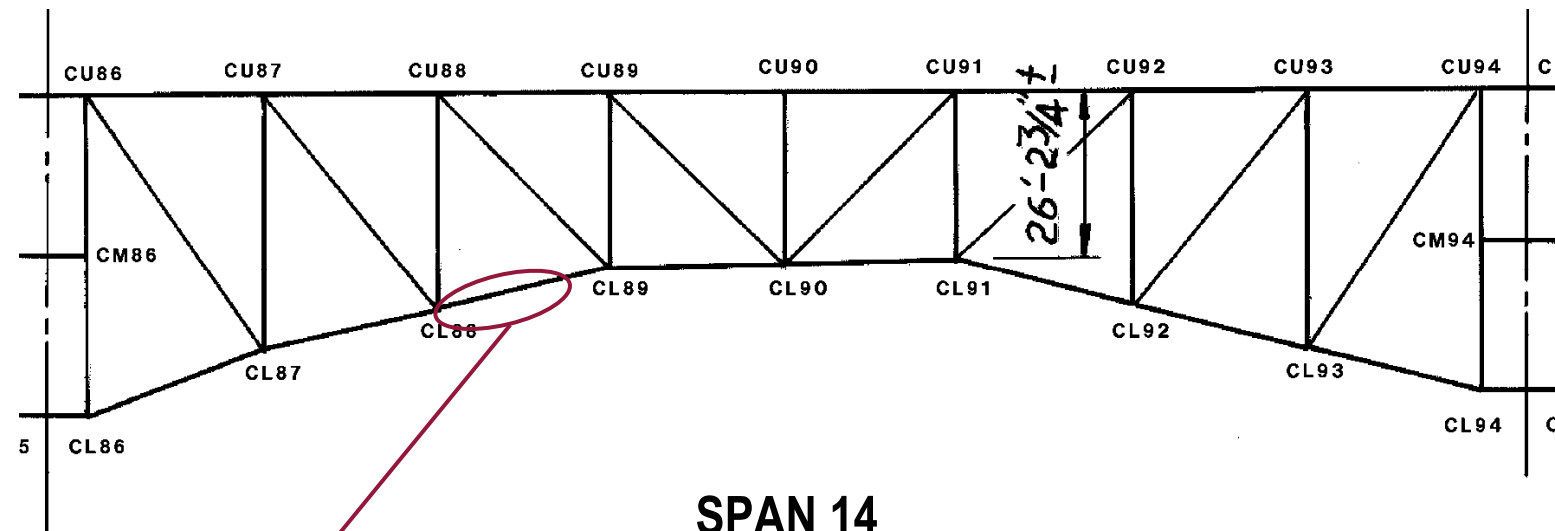
**SPAN 14
TRUSS C**

The lower chord north web plate exhibits pitting up to 3/16" deep pitting along the bottom flange angle in the lower half of the plate. The pitting extends approximately 3/4 of the length of CL88-CL89.

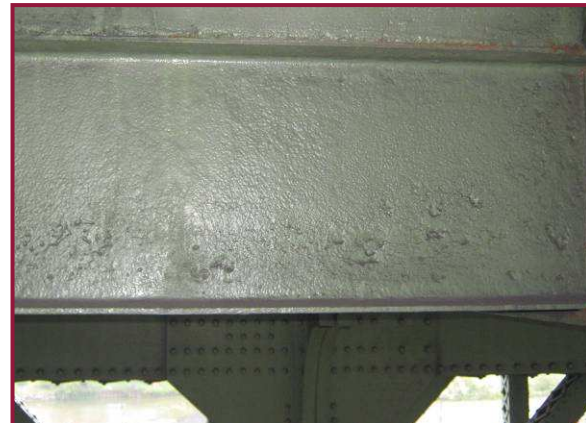
Between Floorbeams 89 and 90, the south face of Stringer 2 exhibits heavy pitting throughout the web. The pitting at this location was measured to be 1/8" deep on average with isolated locations up to 1/4" deep. Similar conditions are present between Floorbeams 92 and 93.

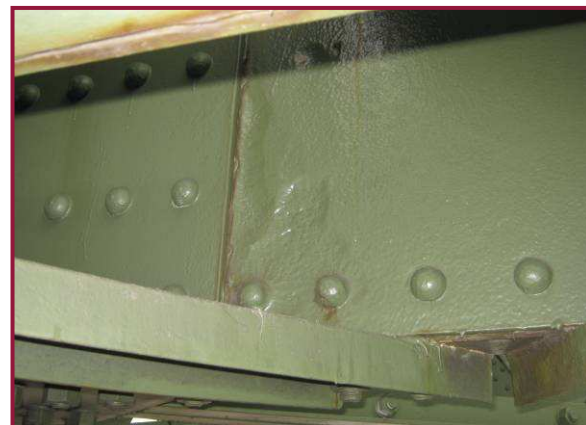
The interior face of the lower chord web near DL90 exhibits 1/4" pitting for the full height of the plate. The lower chord typically exhibits pitting between 1/16"-1/8" deep in this location throughout Span 14.

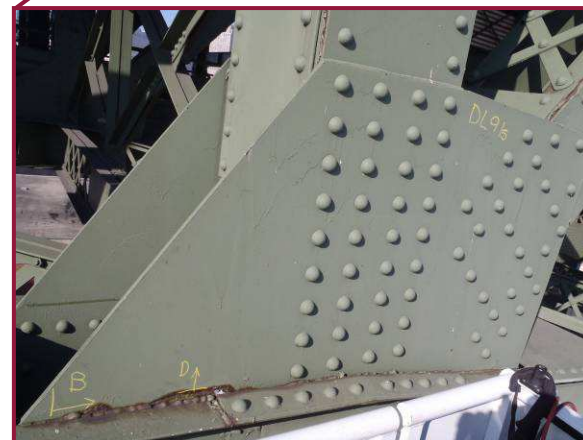
Gusset plate DL91 exhibits conditions typical of the exterior gusset plates throughout Span 14, Truss D, with activating rust along the interface at the lower chord and associated minor pitting.

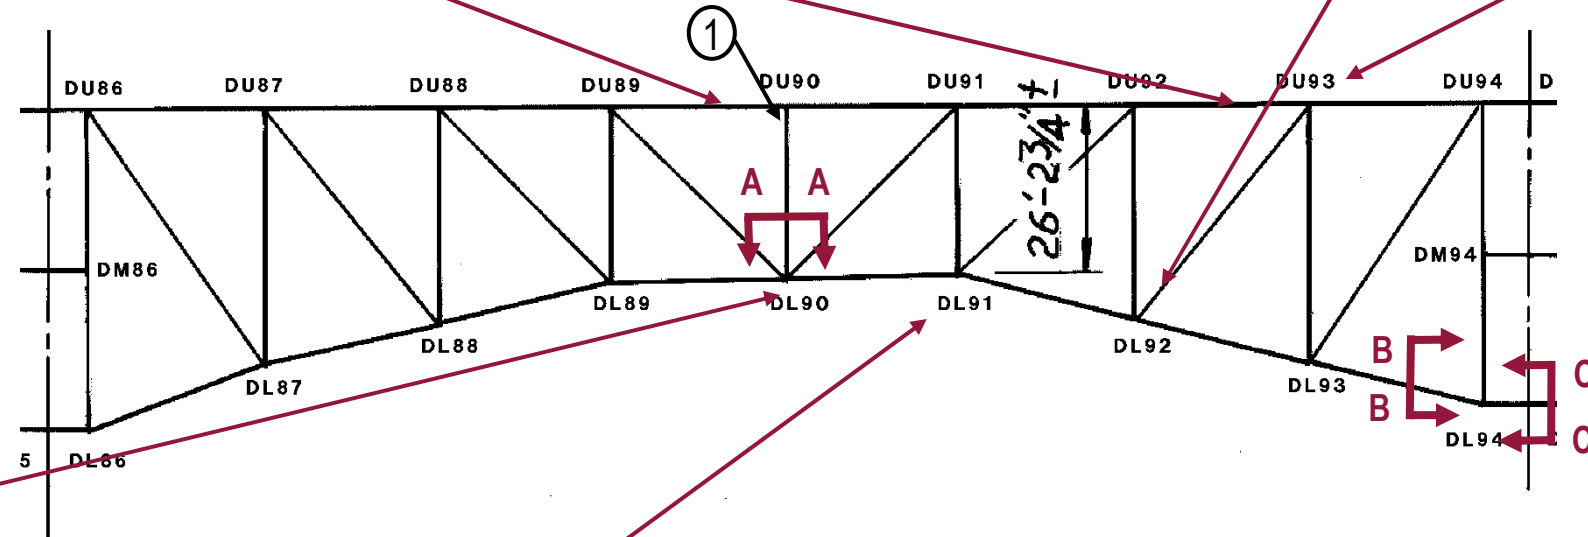
SPAN 14
TRUSS D

The upper batten plate at the base of the diagonal member exhibits 1/4" pitting throughout, with a 2"Ø perforation.

1 Floorbeams 90 and 93 in Span 14 exhibit pitting up to 1/8" deep at isolated locations on the west face of the web between Truss D and Stringer 1.

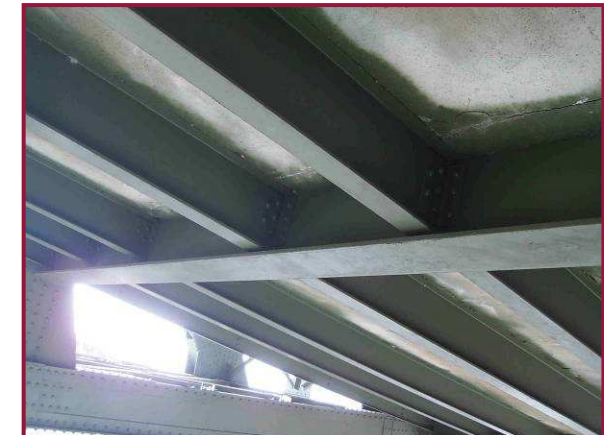
Typical framing between Trusses C and D showing the east face of Floorbeam 92. The interior portions of the floorbeams and the interior stringers are typically in good condition with isolated minor pitting (<1/16" deep) that has been cleaned and painted.

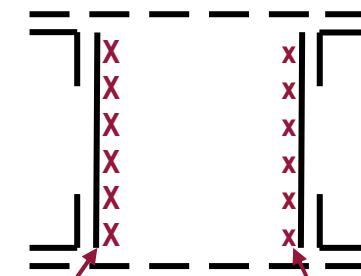
Section B-B

1/8" pitting x full height web plate

1/16" pitting x full height web plate

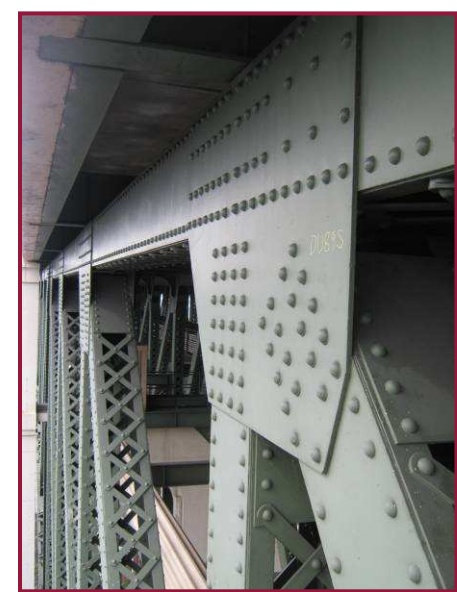
The upper chord of Truss D in Span 14 is in good condition overall with no significant deficiencies noted. Truss D is shown here looking northwest along the upper chord at DU89.

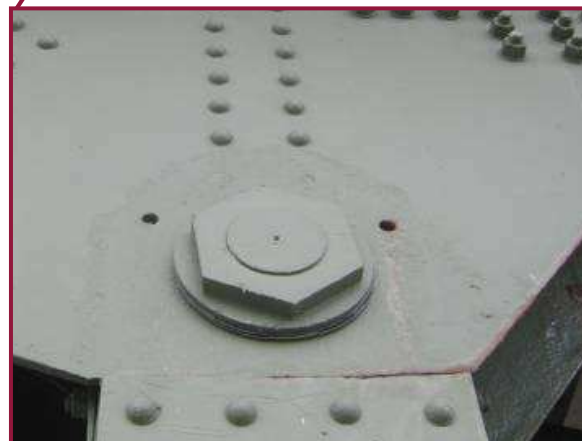
The north gusset plate at AU97 exhibits localized areas with pitting up to 1/4" adjacent to the lower pin and 1/8" pitting along the free edges of the plate.

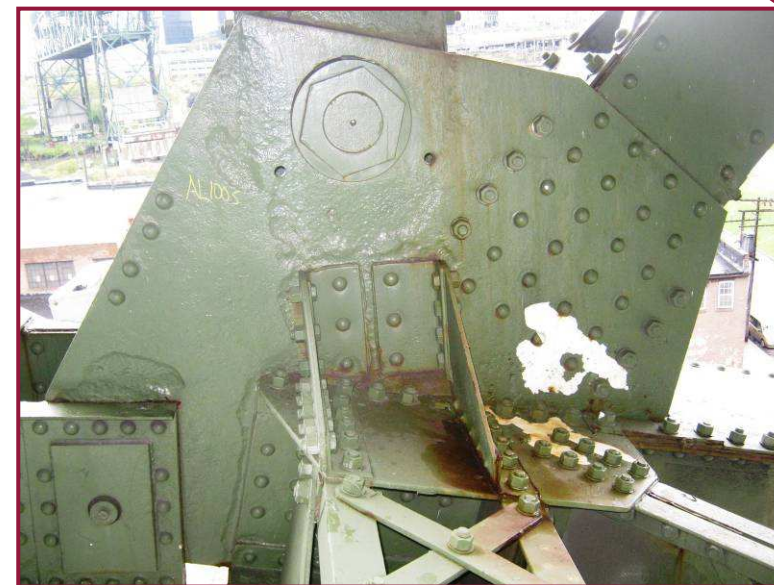
The south gusset plate at AL100 exhibits widespread heavy pitting, with locations up to 1/4" common, especially adjacent to connecting members.

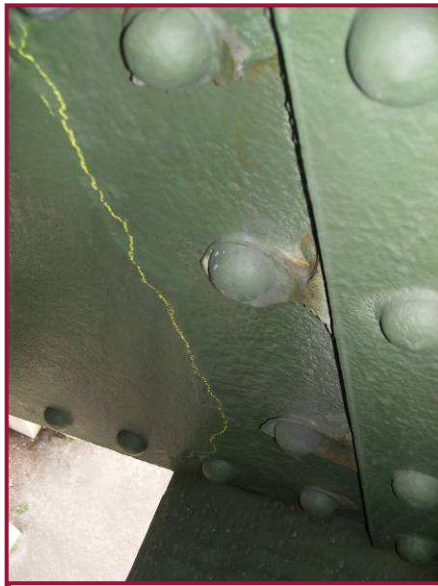
The north web plate of BL95-BL96 (left) exhibits 3/16" deep pitting for the full height of the plate adjacent to the BL96 gusset plate. This location was covered by a thin fill plate which has since completely corroded outside the bounds of the gusset plate.

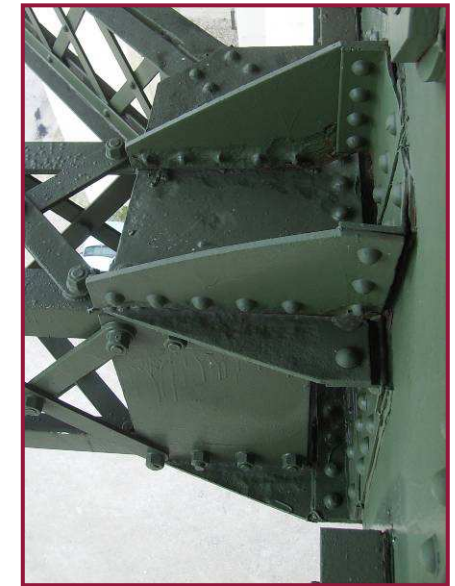
The lateral connection members at BL100 exhibit 1/8" deep pitting throughout the horizontal faces. Pack rust has formed between the knee brace connection and the gusset plate, distorting the connection angles.

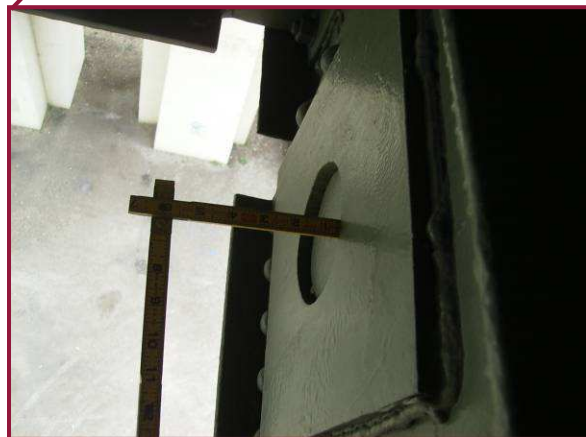
The south outermost pin plate at BL97 has been replaced with the welded plate shown. The end of the pin and the outer edge of the plate are 1/2" out of plane, resulting in less pin bearing area.

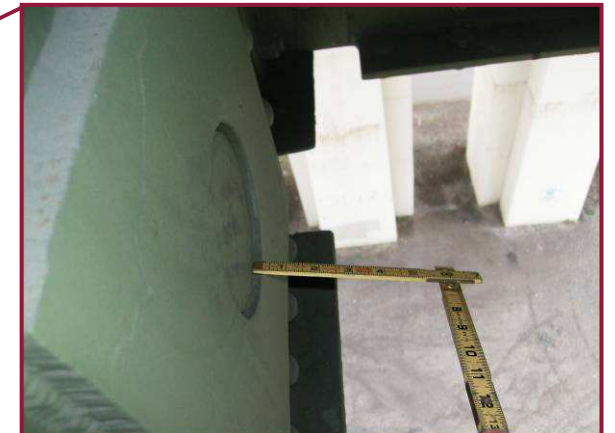
The lower chord sliding pin at CL100 is not bearing fully on the outermost pin plate.

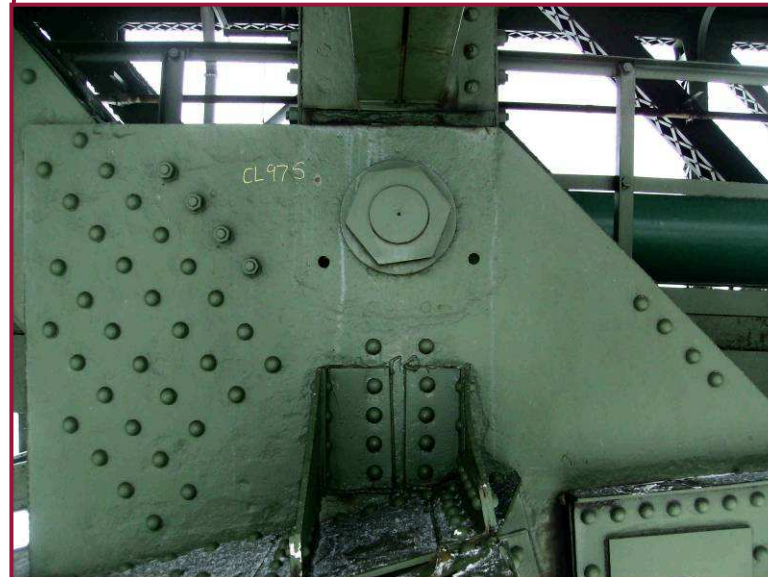
The south gusset plate at CL97 exhibits heavy pitting throughout the south face with up to 1/4" deep areas isolated among the more typical 1/8"-3/16" deep pitting. The deepest pitting is found along the interface of the gusset with the lower chord top flanges and vertically along the lateral knee brace.

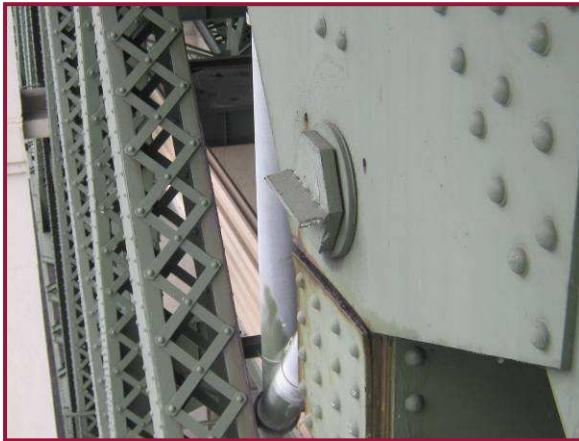
The upper vertical pin at DL97 has been retrofitted with a welded plate on the exterior face of the pin. Note the nut is not fully engaged and a gap is present. Minor pack rust is developing between the exterior web plates of the vertical near the pin.

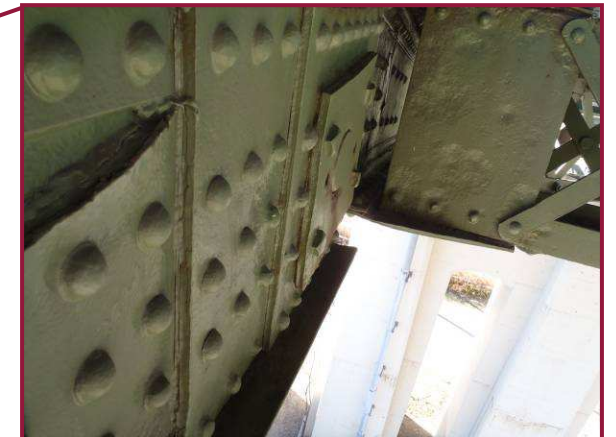
The lower chord at DL97/DL98 exhibits distressed connections due to heavy pack rust, as well as heavy localized pitting up to 5/16" deep.

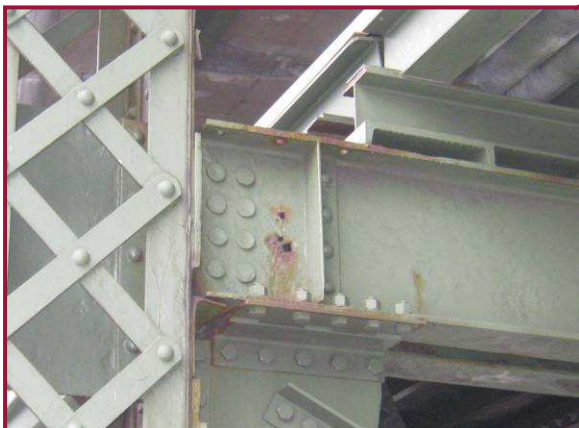
Three 1"Φ holes are present in the web of the sway strut between Truss D and Truss C at Panel 97.

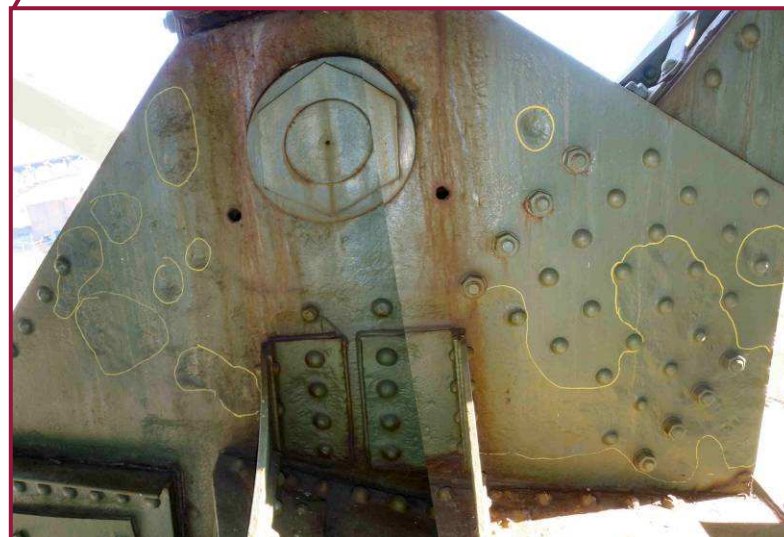
The north gusset plate at DL97 exhibits areas of heavy pitting throughout its north face. Pitting greater than or equal to 1/4" deep is indicated by the field markings, as shown. Rust is activating throughout the upper portion of the plate, as well as along the lower chord top flange interface.

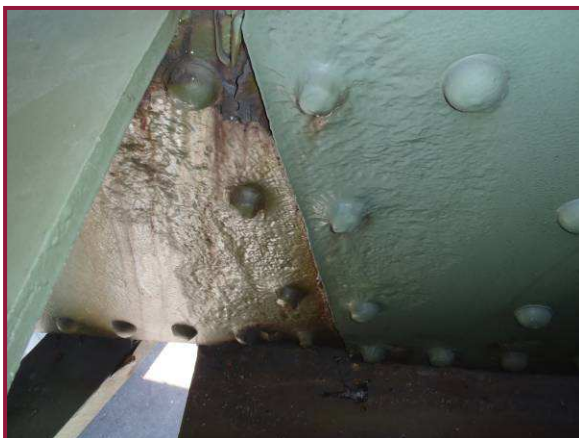
The fill plate between gusset plate DL96 and the north web plate of DL96-DL97 exhibits 100% section loss and the adjacent web plate has 1/4" pitting over the full height. The south web plate exhibits a similar condition with 1/8" pitting.

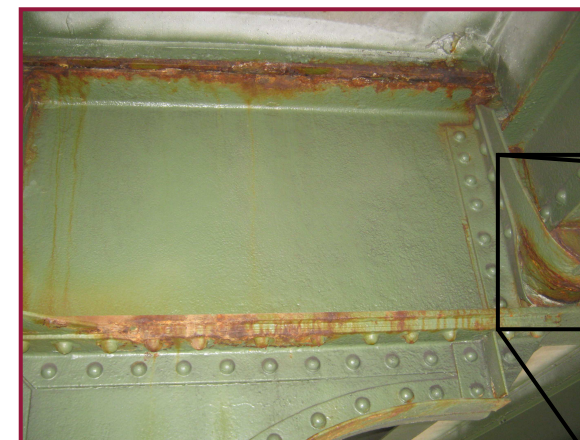
At Floorbeam 100 active rusting of the flanges is typical throughout, with advanced corrosion of the stringer connection angle below the saddle bearing rivets. The connection angle has a 1.5" diameter perforation at this location (right). Additionally, the saddle bearings typically exhibit minor pitting and reactivating rust; however, some locations exhibit pitting with minor loss of section.

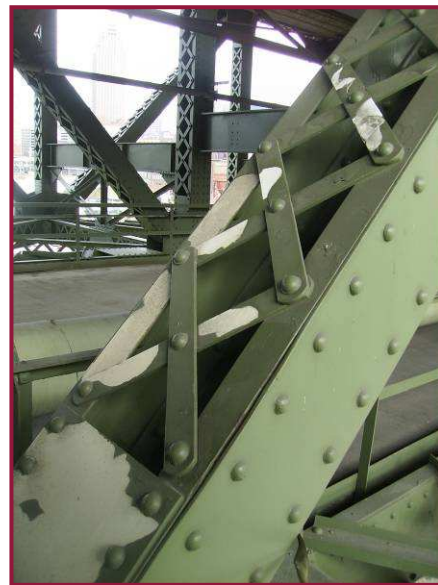
Failures of the paint top coat were found on diagonal members near the lower gusset plate connections at CL105, CL106, and CL107 in Span 16 (CL106-CU107 shown).

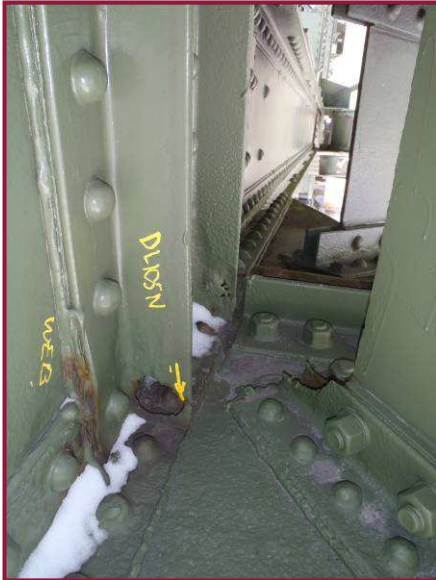
Vertical stiffeners for the lower chord at DL105 exhibit advanced section loss with both outstanding legs having 100% loss in the lower 4". Pack rust has formed between the stiffener angle and the web fill plate at this location, and heavy pitting of the lateral bracing connection plate and the lateral bracing bottom flange angles.

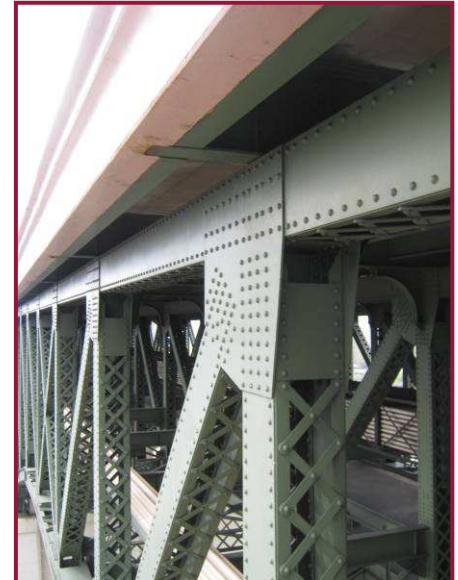
The exterior of the Truss D upper chord is clean with paint intact and no significant deficiencies noted in Span 16. Photo looking west from DL109.

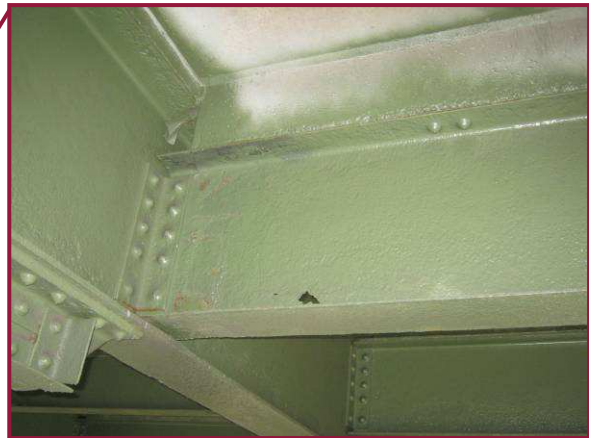
Stringer 2 between AU117 and AU118 exhibits advanced section loss with less than 1/8" section remaining for the full height of the web near AU118. A 4" diameter hole is present in the web at the flange.

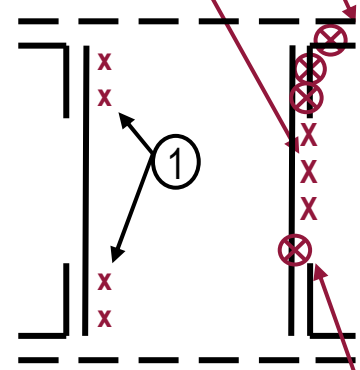
Section A-A

Flange angle with 100% loss of section

3/16" web pitting

Web with 1/2" diameter holes near the bottom flange

① 1/8" web pitting around top and bottom flange rivets, interior face

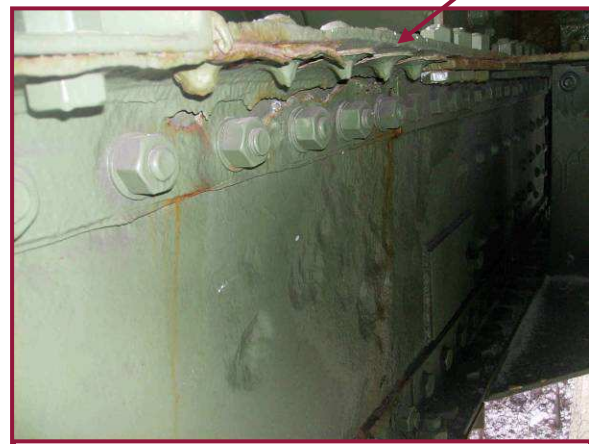
The top and bottom flanges of AL112-AL113 have been flame-cut and removed in isolated areas, and lacing channels have been replaced along the member in some locations.

Lower chord member AL112-AL113 exhibits advanced section loss at several components of the built up member at AL113. These losses are depicted in Section A-A. Note multiple retrofits at this location.

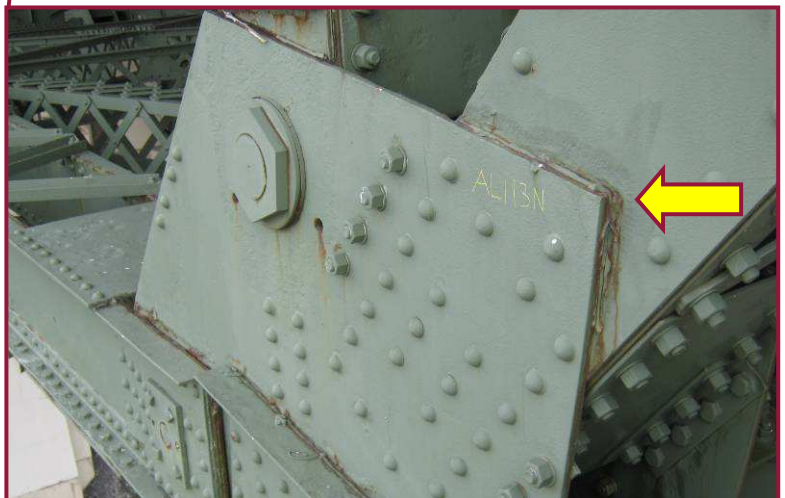
The north gusset plate at AL113 exhibits areas of 1/8" pitting scattered throughout the north face. The north web plate of the diagonal member AU112-AL113 exhibits 1/8" deep pitting along the full height of the web plate.

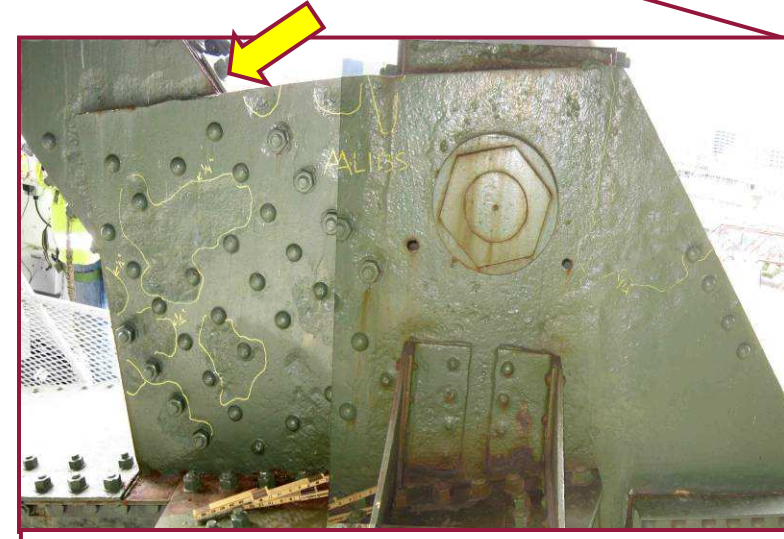
The south face of the south gusset plate at AL113 exhibits widespread heavy losses. The areas highlighted on the plate in yellow exhibit pitting of 1/4" deep or greater. The interior face of the south plate exhibits isolated areas with up to 1/4" loss. Additionally, note the 1/4" deep pitting along the full height of the web of the diagonal member AU112-AL113 near the gusset plate interface.

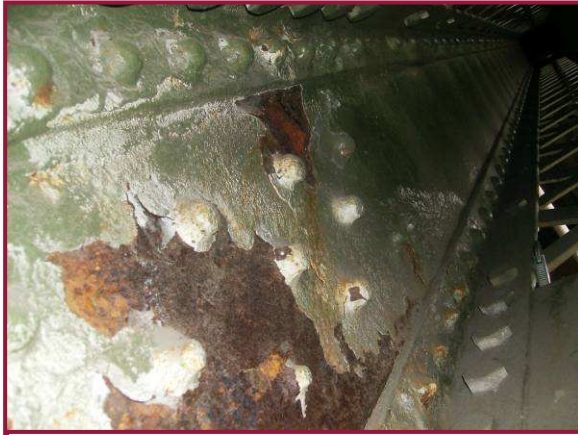
The interior of BU112-BL113 exhibits failing paint throughout with minor active corrosion near BL113. The rivets connecting the diagonal member to the gusset plates are heavily pitted, with an estimated 50% loss of rivet head section.

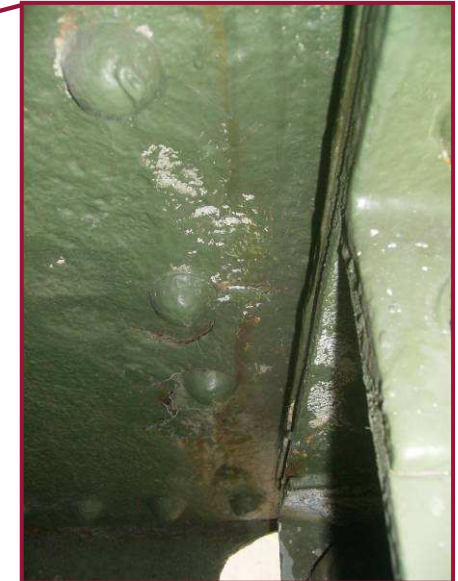
The interior face of the south web plate of BL113-BL114 exhibits full height pitting up to 1/4" deep at the interface with the BL113 gusset plate.

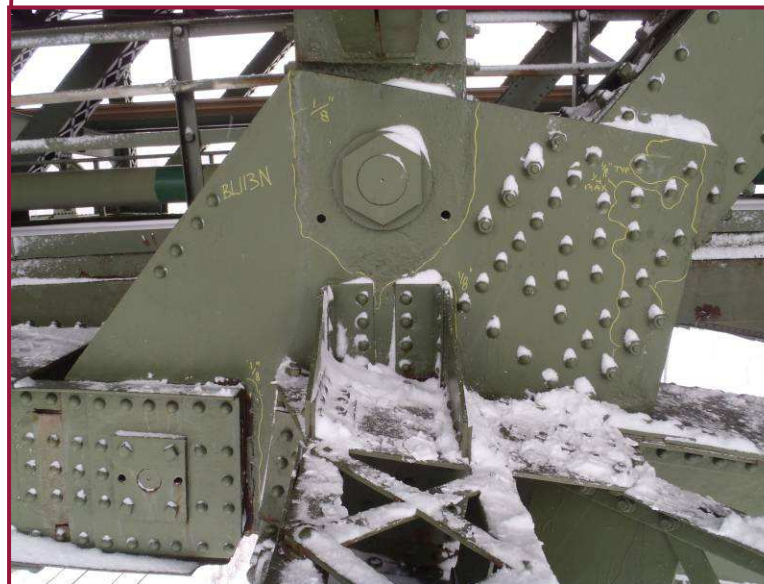
The north gusset plate at BL113 exhibits localized pitting up to 1/4" deep. The areas outlined on the plate are representative of typical losses at pinned gusset plates throughout the structure.

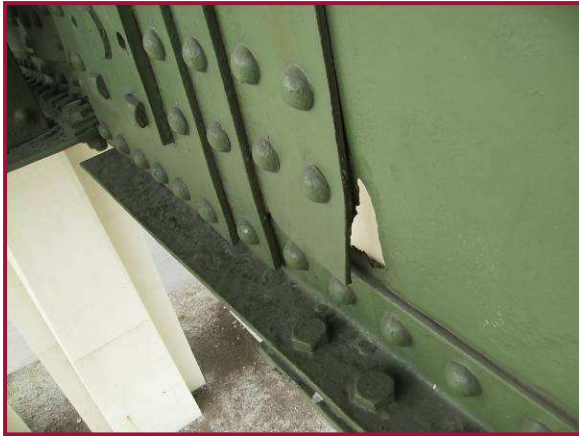
Corrosion has produced a 5"x 4" hole in the south web plate of CL113-CL114 at the bottom corner of the innermost pin plate.

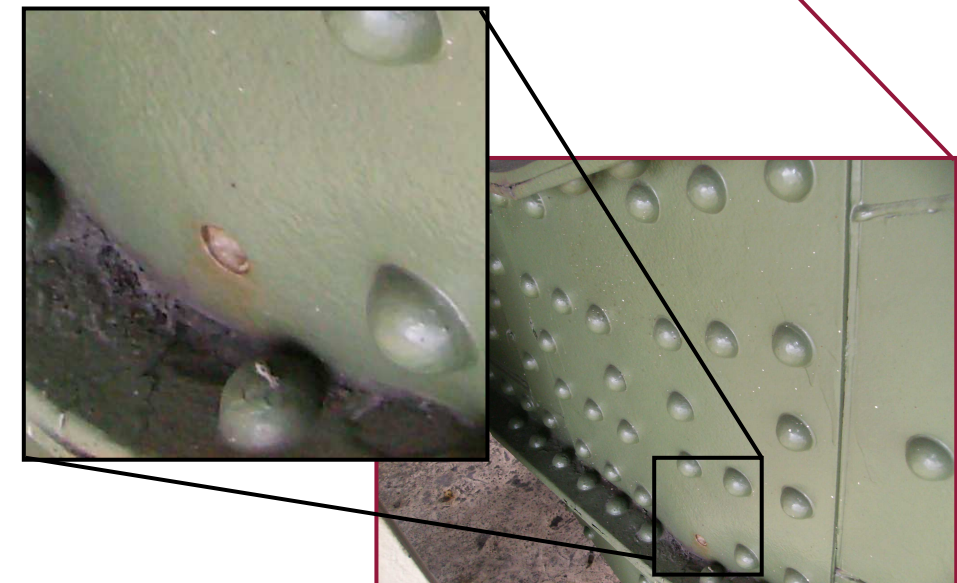
The outermost north web splice plate at CL118 is bowed along the bottom flange angle due to pack rust and a rivet has broken as a result.

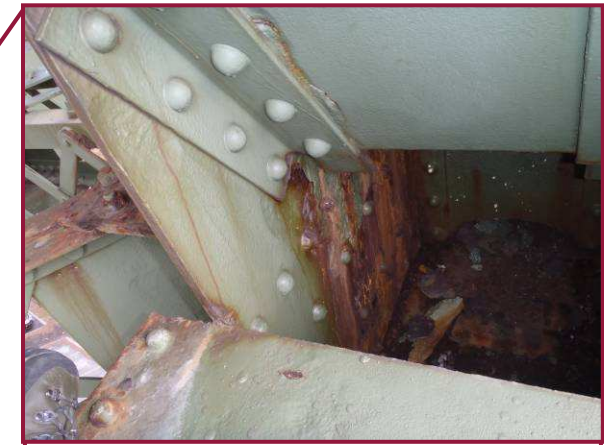
South face of DL113N at west end of plate.

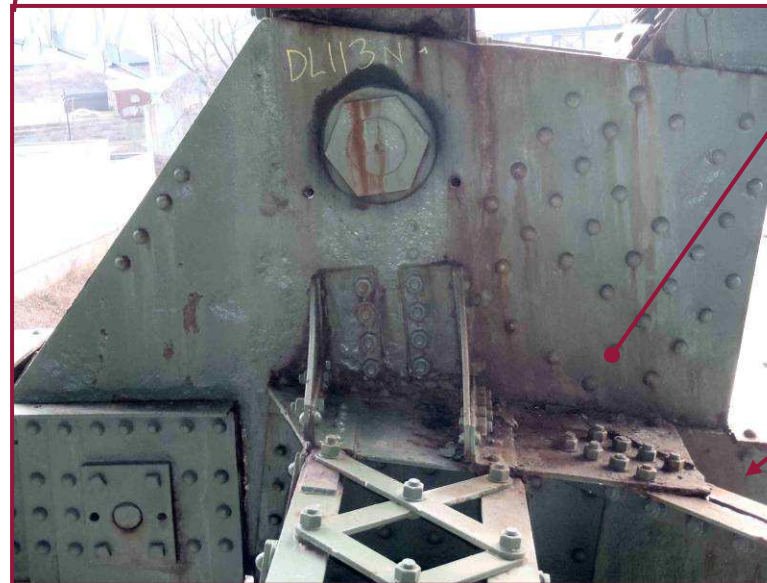
DL113N exhibits heavy pitting throughout both faces of the plate (north face shown). Active corrosion is present due to the leaking deck joint above this location.
