**SPAN 18
TRUSS A**

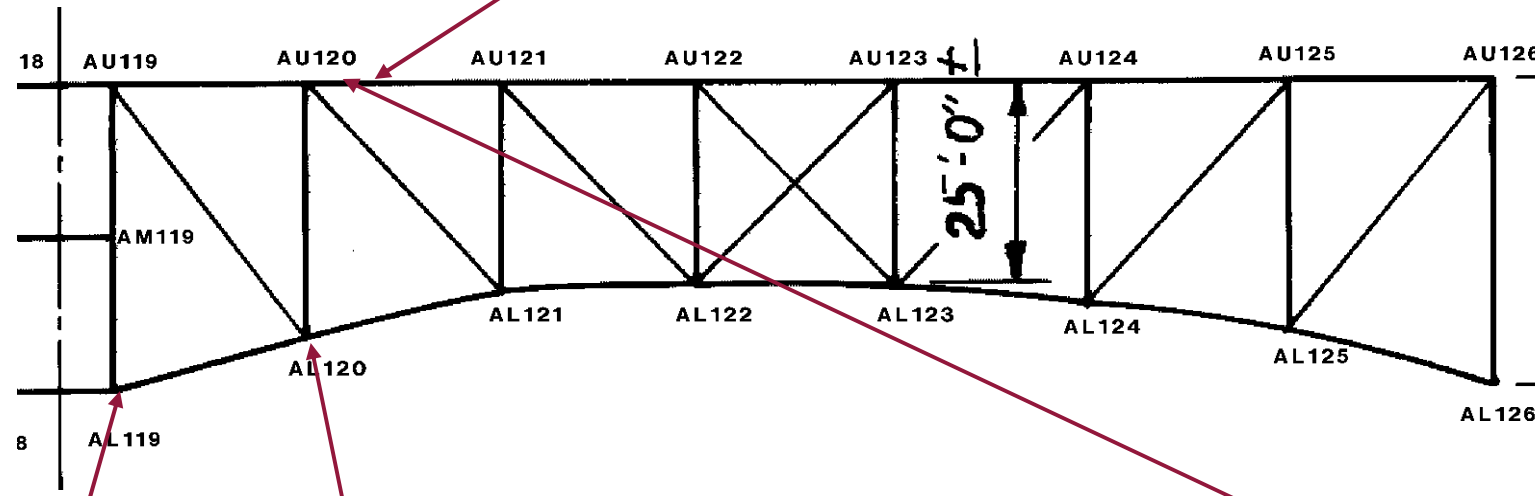
Abandoned welded appurtenances are present at multiple locations along the north web of AU120-AU121, within the tension region of the upper chord, constituting a fatigue prone detail.

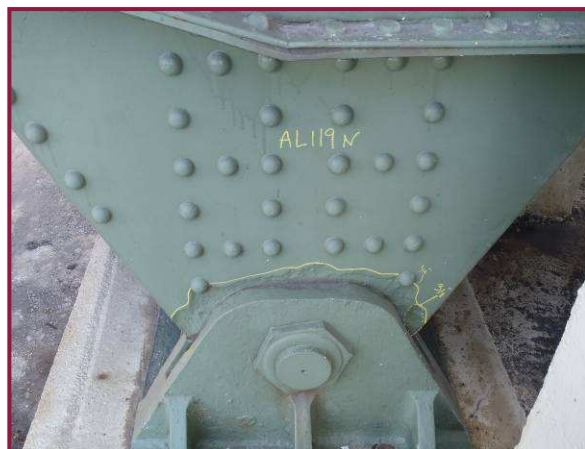
The north gusset plate at AL119 exhibits 1/4" deep around the bearing plate above the pin, with one 3" diameter area with up to 3/8" pitting.

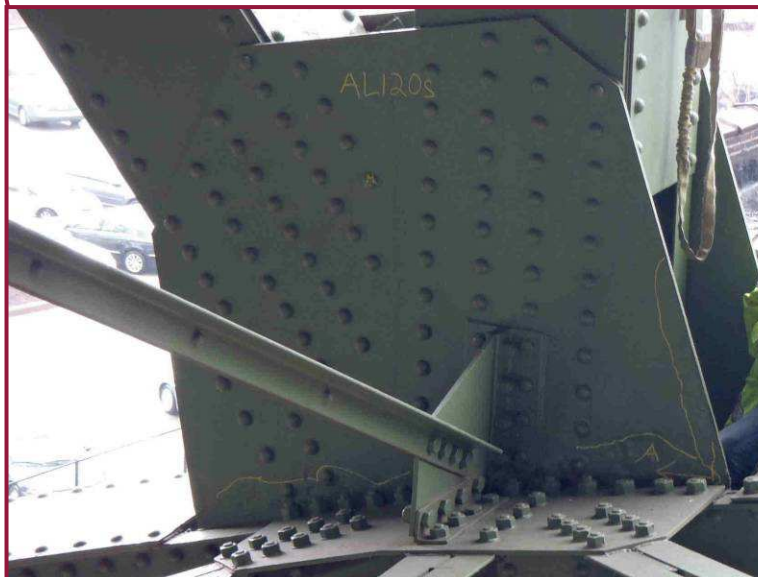
The south gusset plate at AL120 exhibits heavy pitting along the lower chord interface for the entire length of the plate.

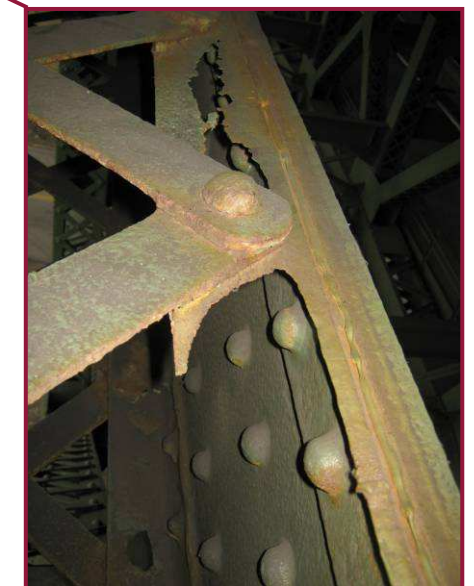
The horizontal leg of the flange angle of AU120-AU121 exhibits advanced section loss with a large area completely corroded. Rust is beginning to reactivate in this area.

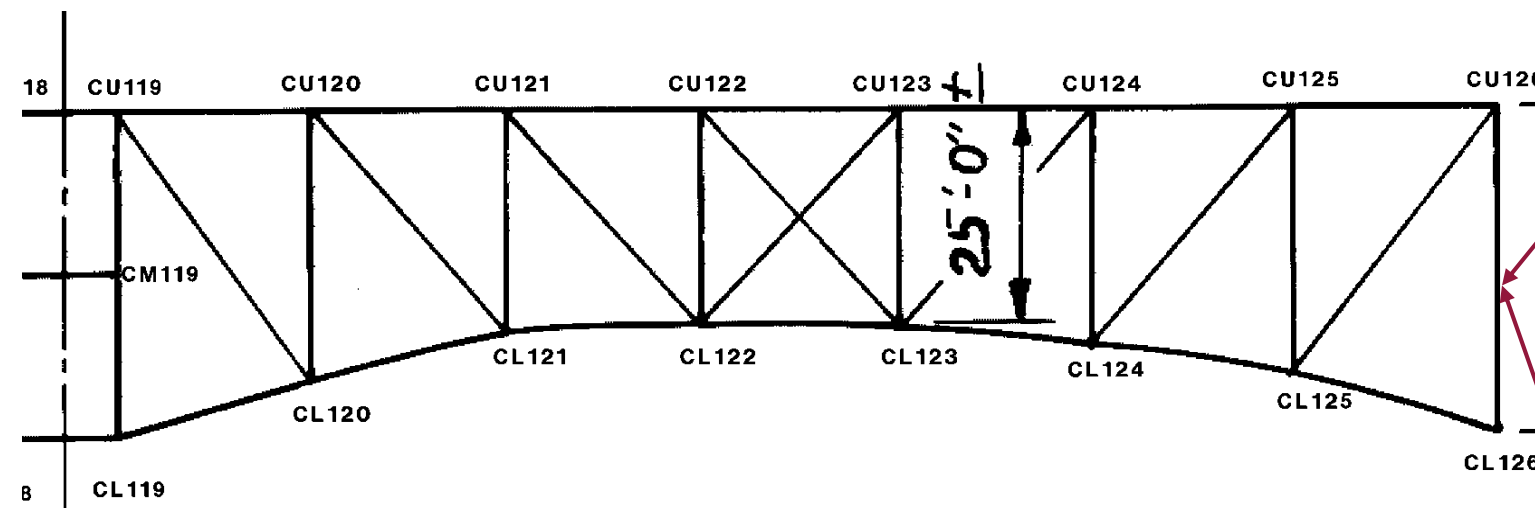
The internal stiffener plate at CL126-CU126 exhibits isolated areas of 1/4" deep pitting.

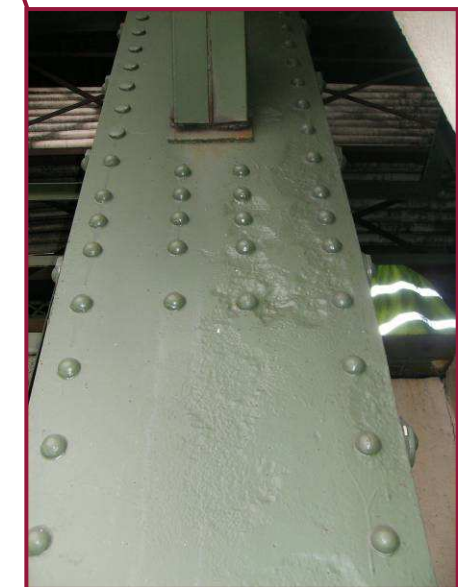
The south web plate of vertical member CL126-CU126 exhibits up to 1/4" pitting below the sway strut connection.

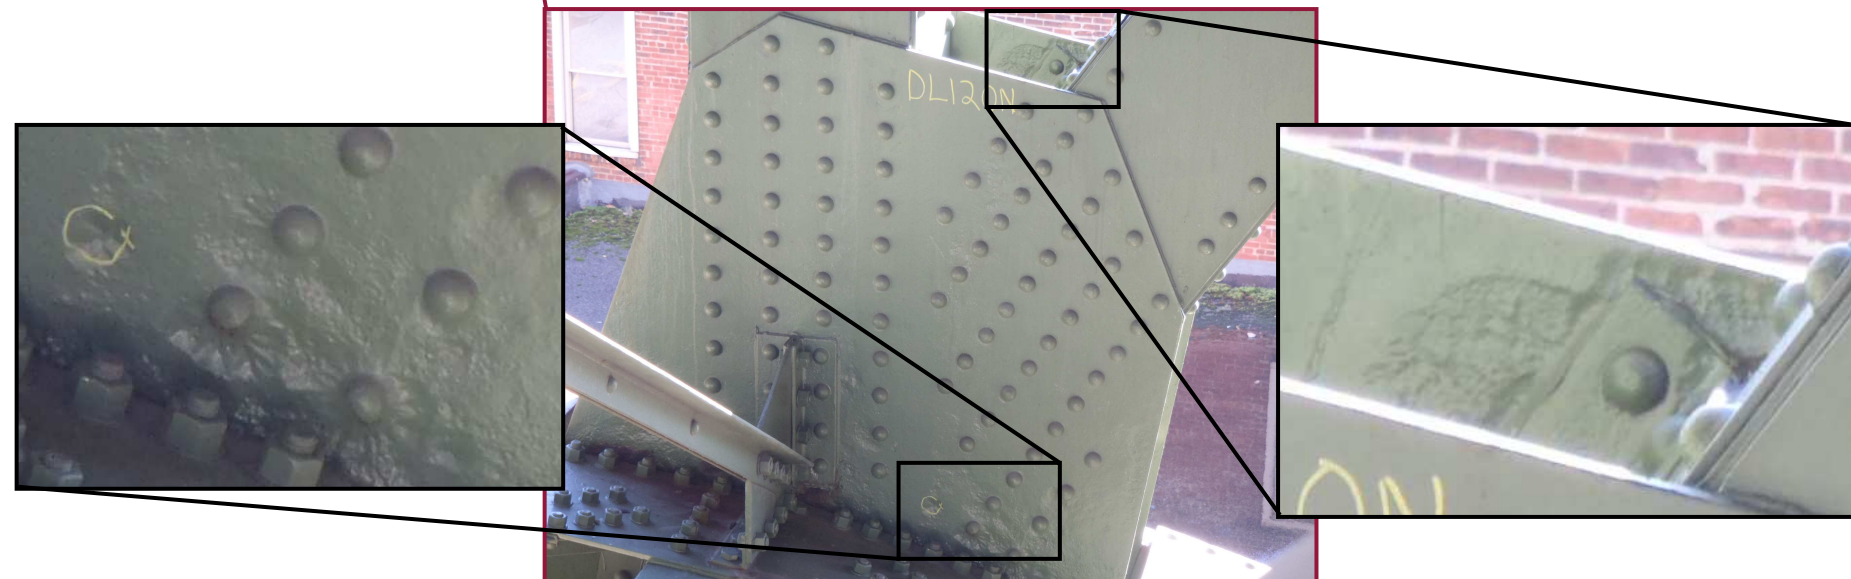
Both the north and south gusset plates at DL120 exhibit isolated heavy pitting that has been cleaned and painted.

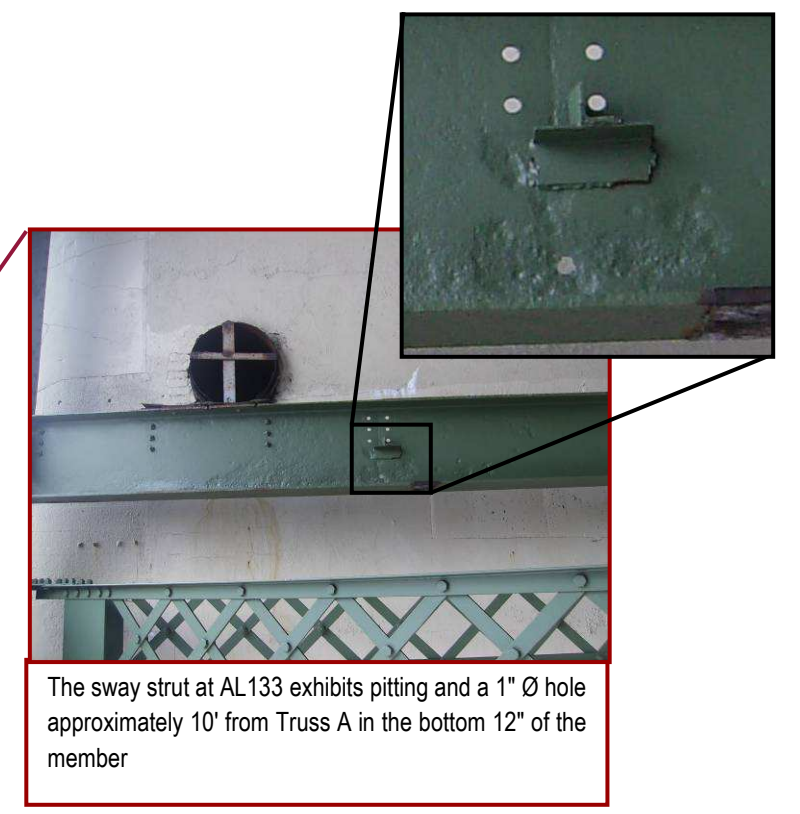
The sway strut at AL133 exhibits pitting and a 1" Ø hole approximately 10' from Truss A in the bottom 12" of the member

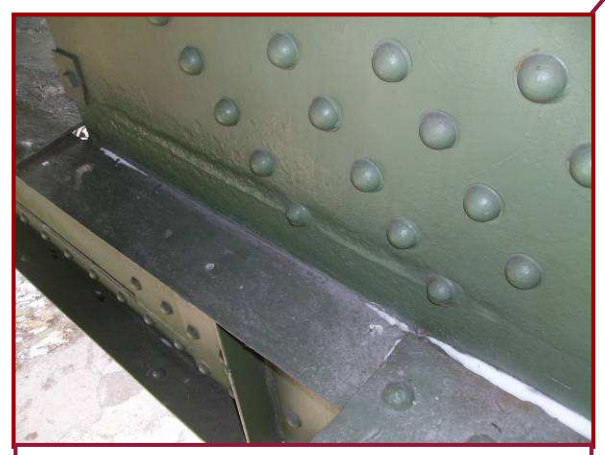
Up to 1/8" pitting is present on the south face of gusset plate AL129S along the bottom row of rivets.

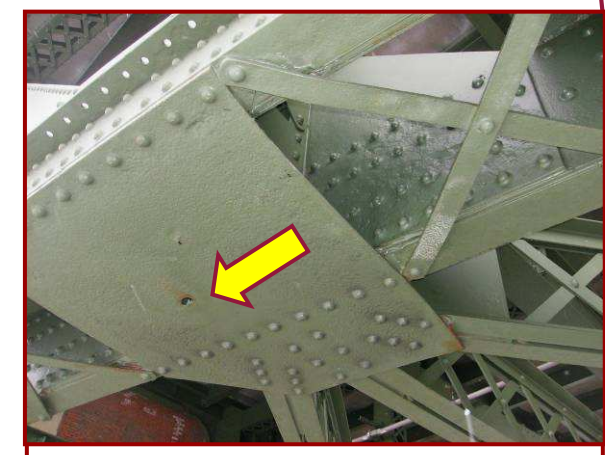
The north face of AL131S exhibits pitting up to 1/4" between the lower chord rivets. The lateral bracing connection plate/bottom cover plate is perforated with a 2" diameter hole.

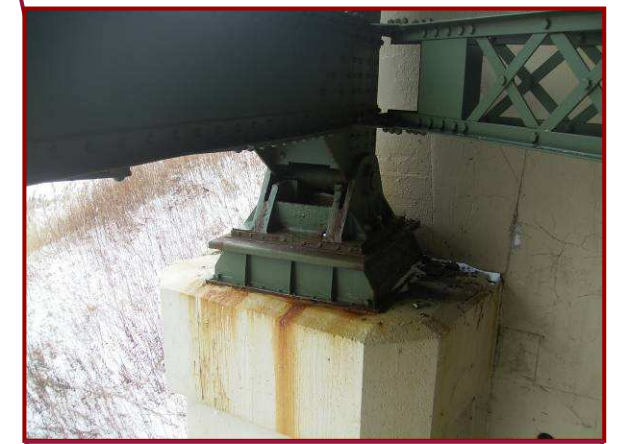
The bearing components at AL131 exhibit 1/8" pitting and activating surface rust throughout.

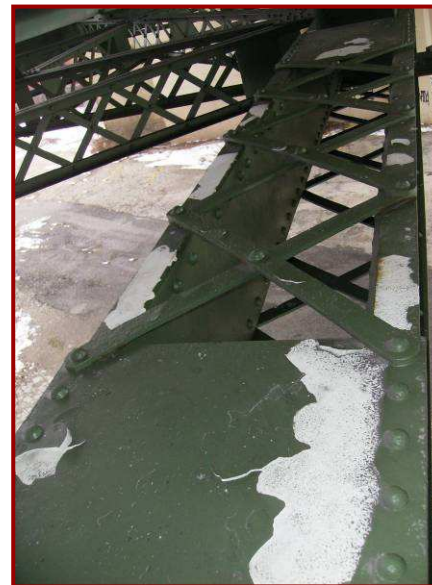
BL130-BL131 exhibits extensive areas of peeling paint.

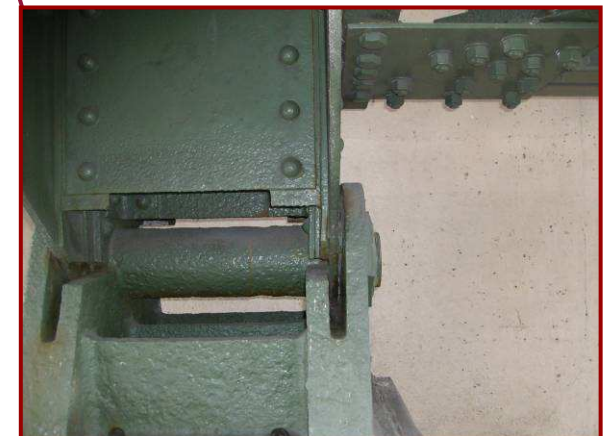
The bearing components at BL133 exhibit 1/8" pitting on all surfaces, with isolated pitting up to 1/4". Additionally, surface rust is reactivating between built up members.

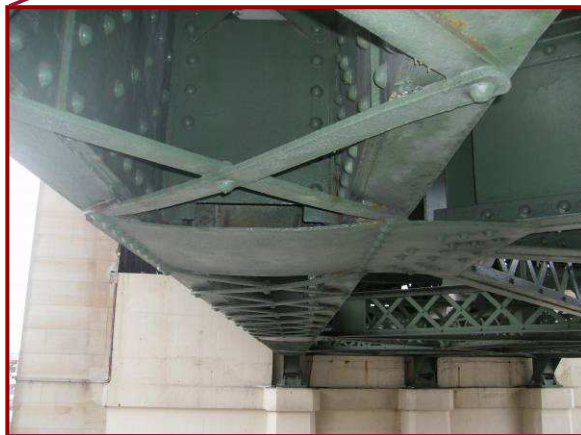
The lateral bracing connection plate/bottom cover plate CL130 is bowed due to active pack rust up to 1" thick.

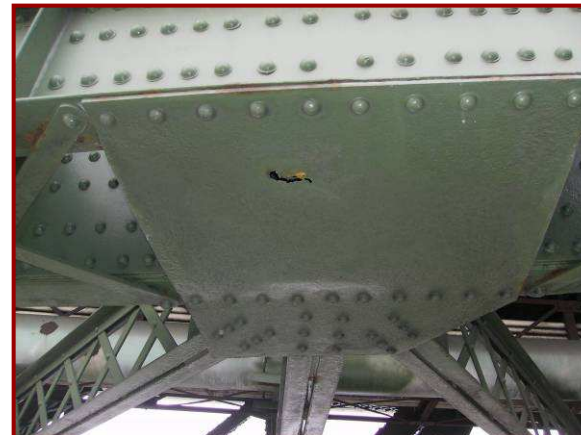
The lateral bracing connection plate/bottom cover plate CL131 is perforated with a 4" diameter hole.

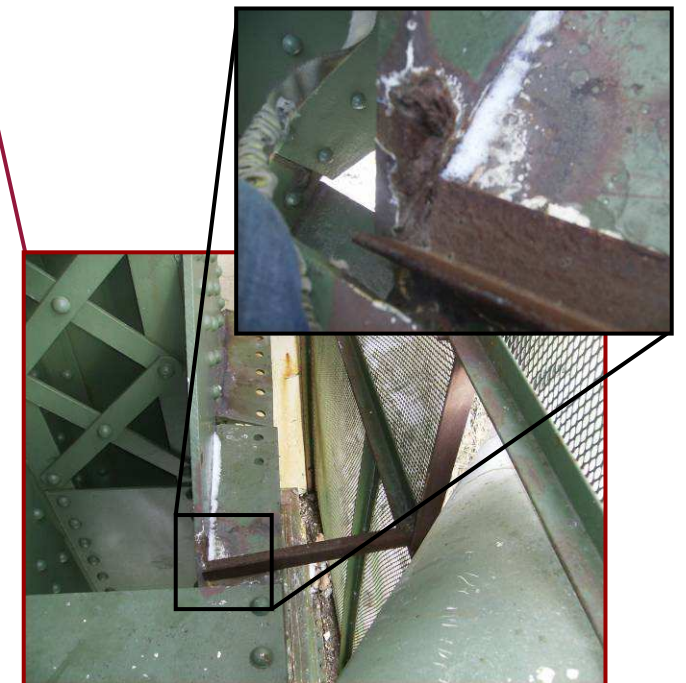
The fence support angle weld to the south gusset plate of CL133 is cracked; however, the crack does not appear to have propagated into the gusset plate base metal.
