**PHYSICAL CONDITION REPORT  
FOR THE 2010 IN-DEPTH INSPECTION**

**LORAIN-CARNEGIE BRIDGE**

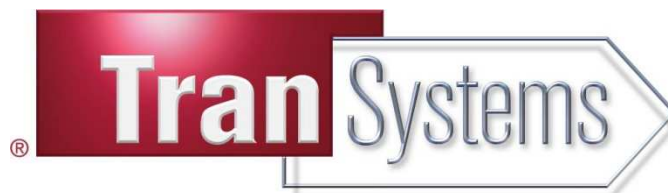
**IN-DEPTH PHYSICAL CONDITION REPORT  
Of The  
LORAIN-CARNEGIE BRIDGE  
S.R. 10**

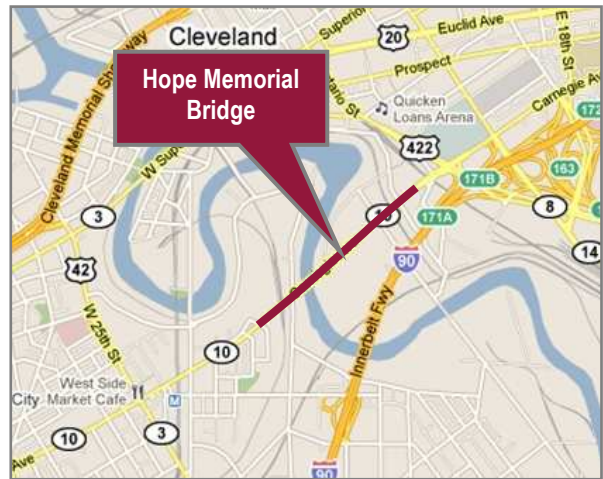
The CUY-10-1613 (Hope Memorial) Bridge carries four lanes of State Route 10 traffic, 3200 feet through downtown Cleveland, over numerous local streets, Norfolk Southern/CSX railroad tracks and the Cuyahoga River. Constructed in 1932, the bridge was originally intended to carry two rapid tracks on a lower deck as well as a utility deck for truck access. The main truss spans include a 13 span cantilevered Pratt deck truss consisting of 4 truss lines and a 3 truss line simply supported Pratt deck truss at the east end of the bridge (See Figures 1 and 2). Approach spans consist of a cellular unit at the east end of the bridge and steel beam simple spans at the west end, supported by both steel bents and concrete piers.

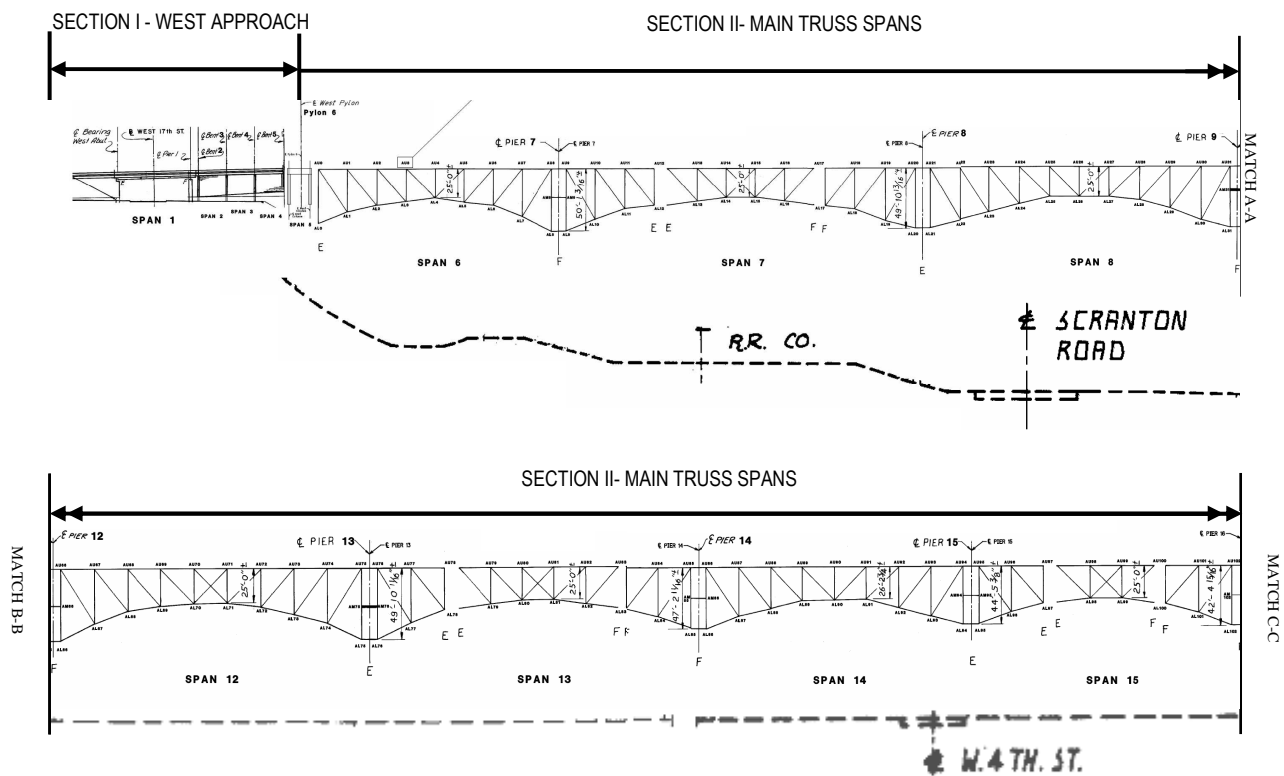
Figure 1 – Partial south elevation of the Lorain-Carnegie Bridge.

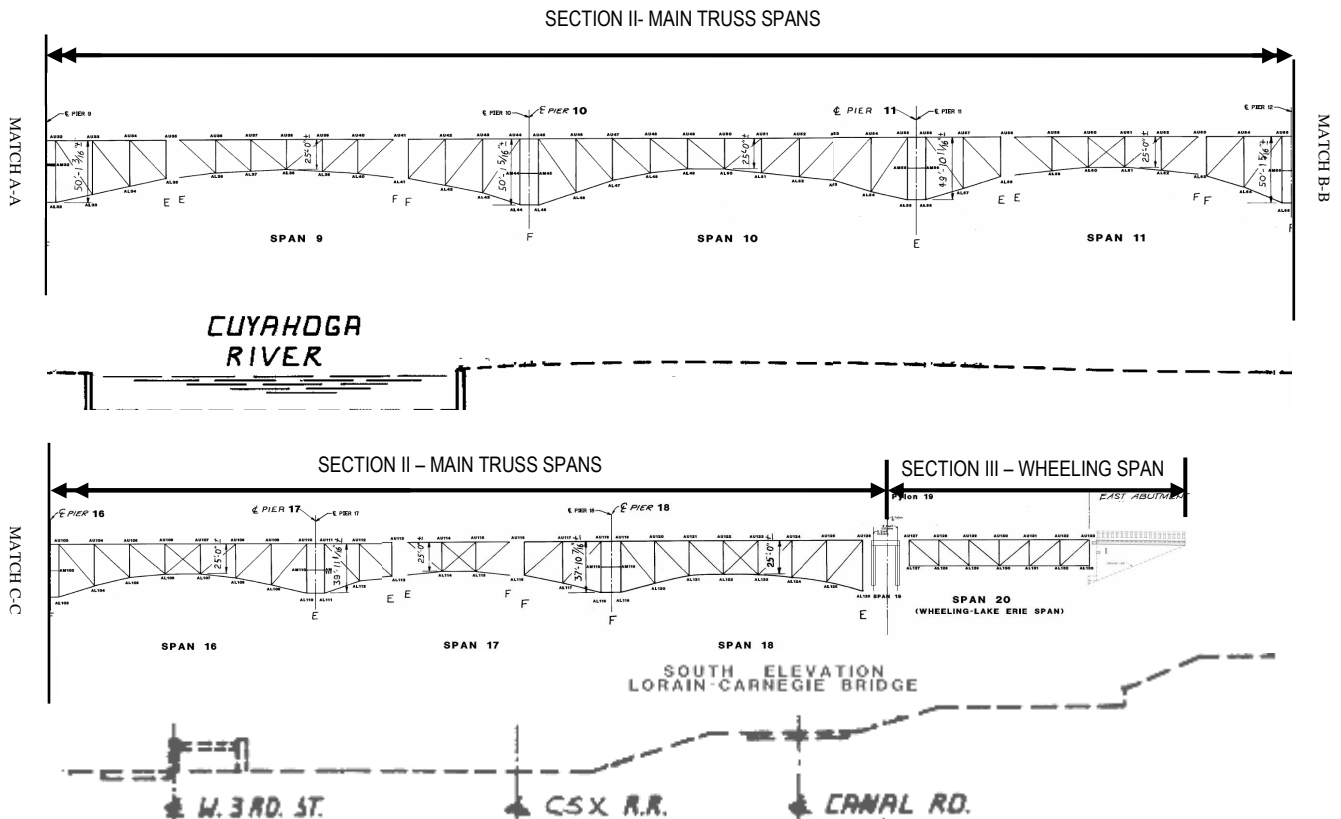
Figure 2 – Partial south elevation of the Lorain-Carnegie Bridge.

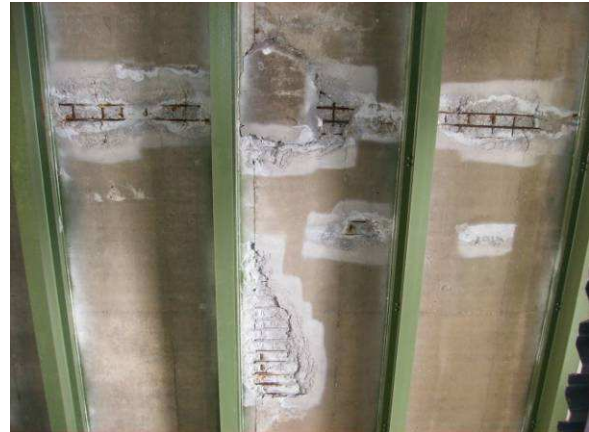
Photo 1 – Span 9 between FB 33 and FB34 roadway deck underside. Note several spalls have been sealed.

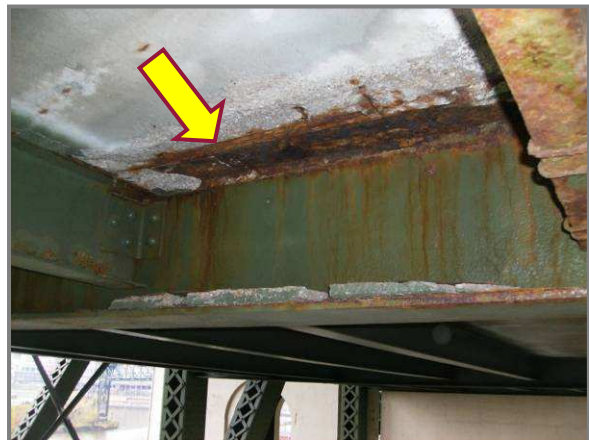
Photo 3 – Typical utility deck haunch spall adjacent to floor beam 53 top flange in Bay 5.

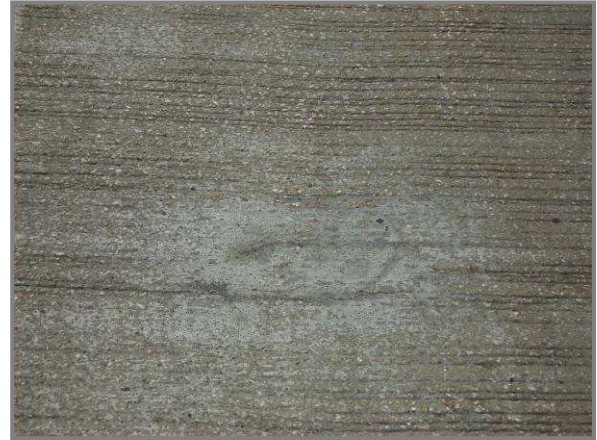
Photo 4 – Isolated area of worn wearing surface in bike lane.

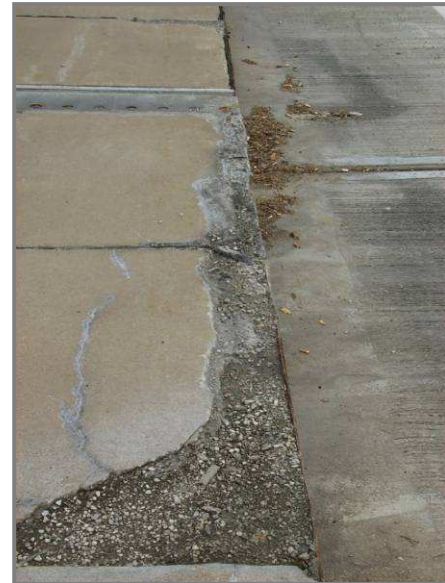
Photo 5 – Isolated sidewalk spall in Span 19 on the north sidewalk.

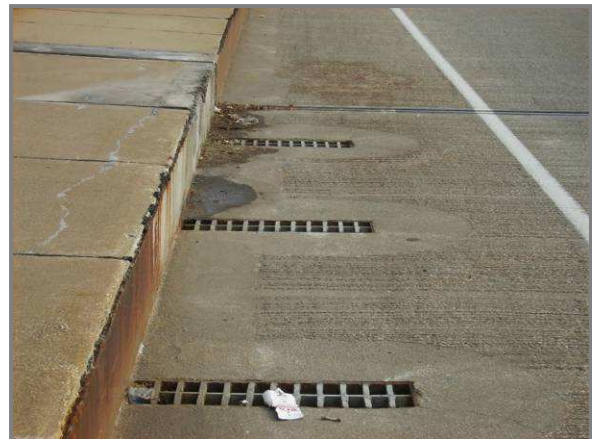
Photo 7 – Typical roadway drain with minor water pooling around drain.

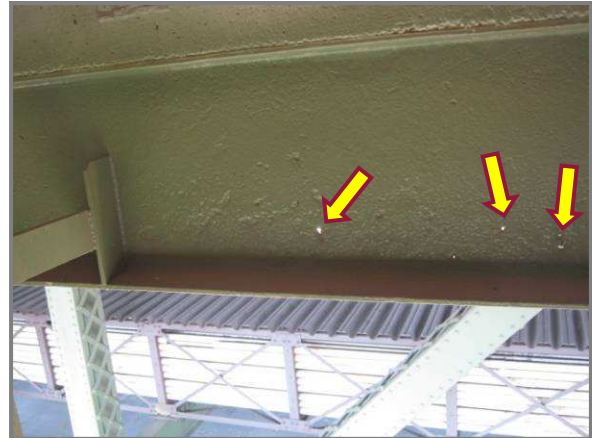
Photo 11 – First interior stringer adjacent to Panel Point DU165 with holed-through sections up to 1" diameter.

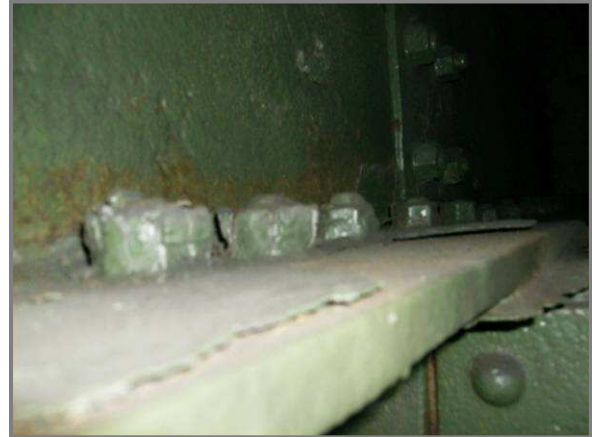
Photo 14 – Isolated 1/4" pitting over the lower fifth of the web of floor beam 78 adjacent to Panel Point CU78.

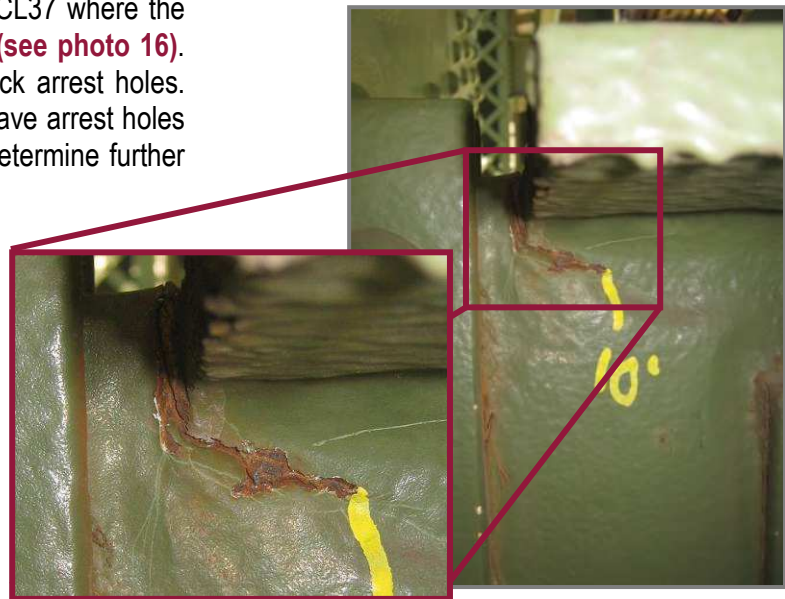
Photo 15 – Crack in utility deck floor beam at gusset plate CL36N connection.

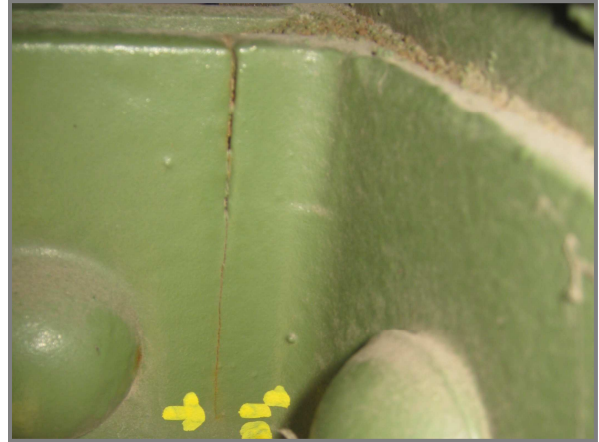
Photo 17 – Utility deck floor beam connection angle to gusset plate BL15S exhibits 3" long rolling flaw.

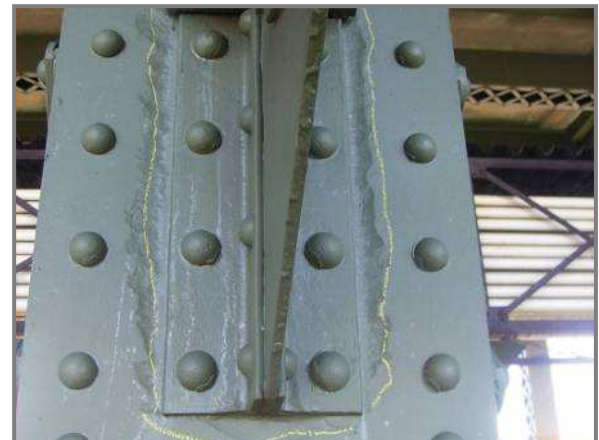
Photo 19 – Pitting up to 1/8" surrounding the sway bracing connection to the north web plate of member BL59-BU59.

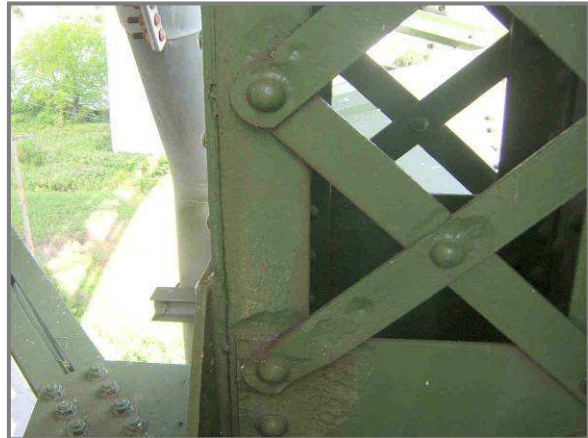
Photo 20 – Isolated pitting up to 1/4" on vertical DL21-DU21 adjacent to lacing bars.

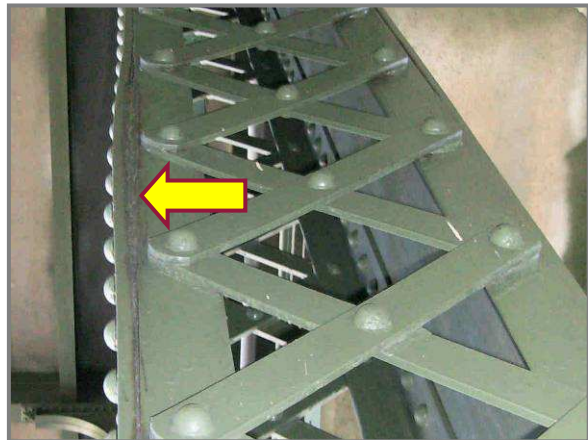
Photo 21 – Impacted rust between the web plate and flange angle of member BL76-BU76 up to 7/8" thick.

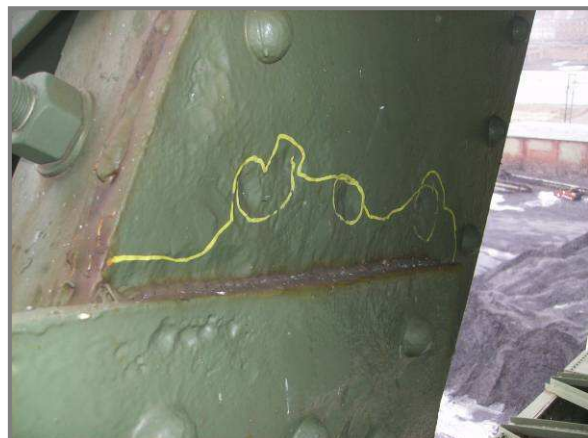
Photo 23 – Typical pitting up to 1/4" (circled in yellow) along interface with gusset plate.

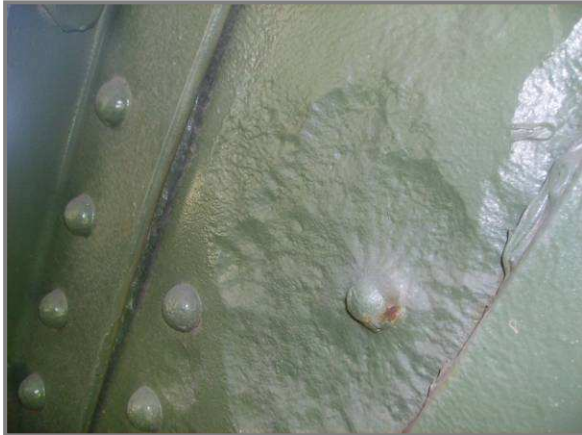
Photo 24 – 3/8" pitting (cleaned and painted) on the interior face of the south web plate near the interface with gusset plate DL36 between flange angles.

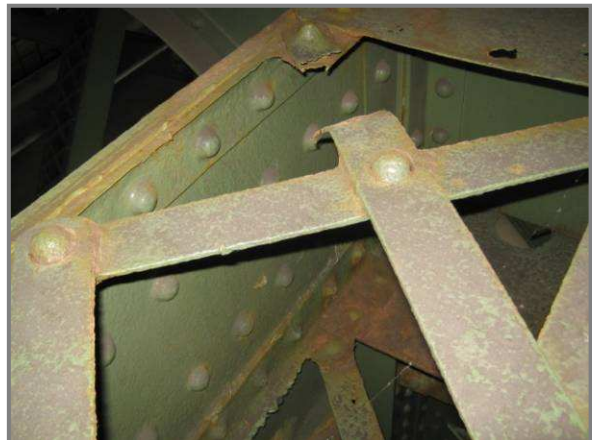
Photo 27 – AU120-AU121 exhibits 100% section loss to lacing bars and horizontal leg of flange angles over a 1' length within the bounds of gusset plate AU120.

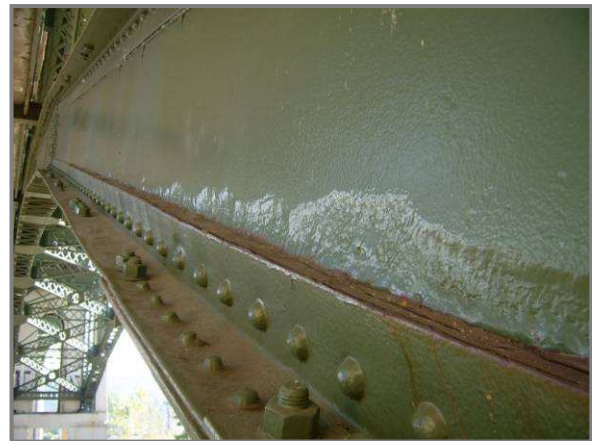
Photo 29 – North web plate of CL0-CL1 with 1/4" pitting up to 3" tall along the interface with the bottom flange angle.

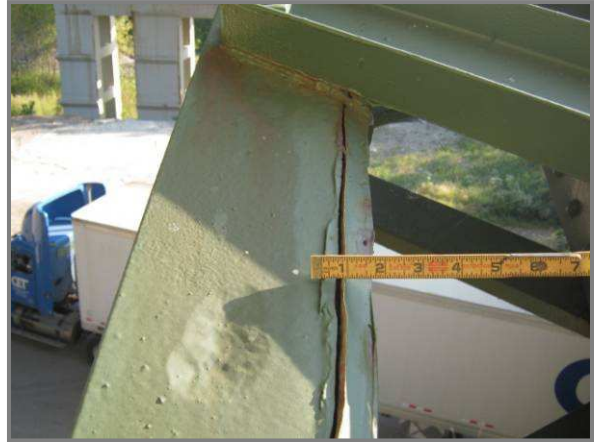
Photo 32 – Typical evidence of sealed impacted rust reactivating.

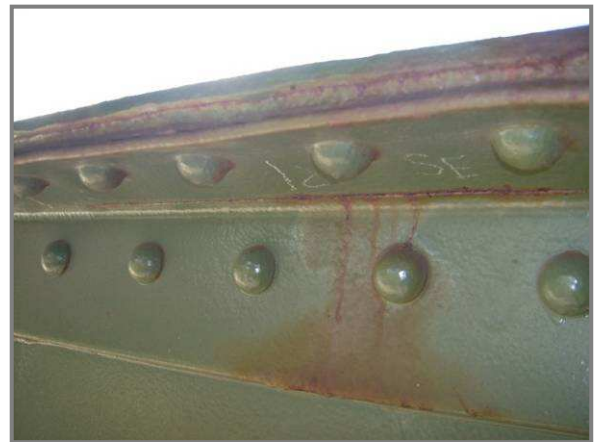
Photo 33 – Crack in top flange angle of DL15-DL16 near DL15 within Bounds of top batten plate.

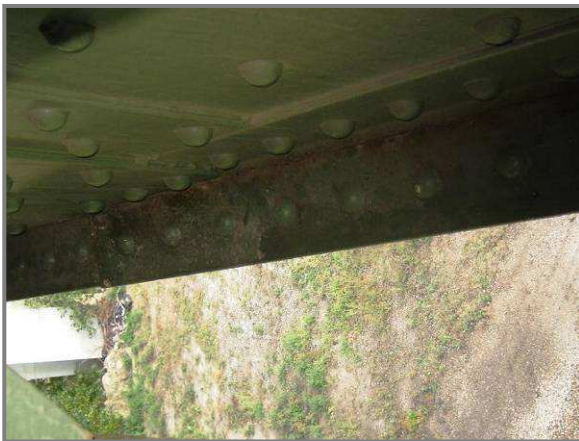
Photo 34 – Crack in bottom flange angle of BL13-BL14 near BL13 within the bounds of the bottom flange batten plate.

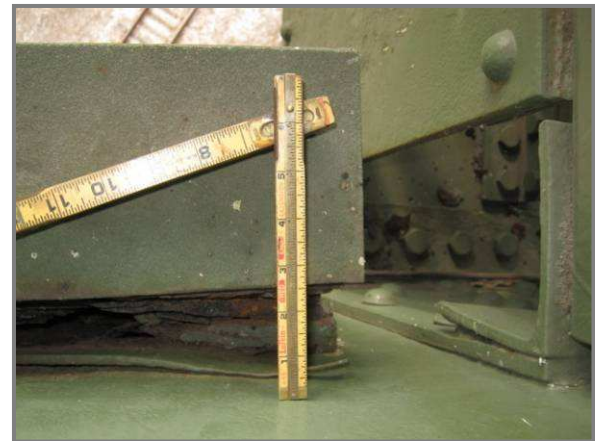
Photo 35 – Impacted rust up to 2 1/2" between the south web plate of CL12-CL13 and gusset plate CL12S.

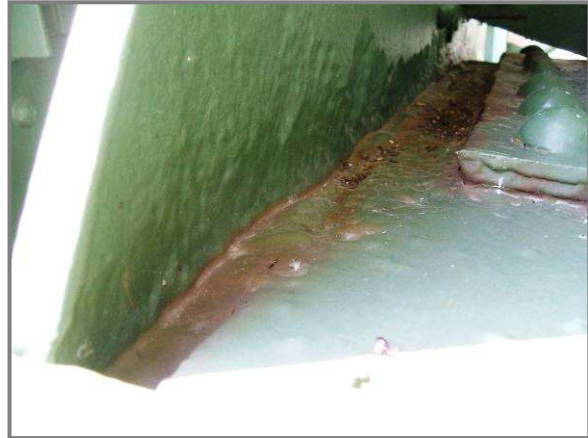
Photo 36 – Typical section loss along the chord member. Exterior of gusset plate DL2N shown.

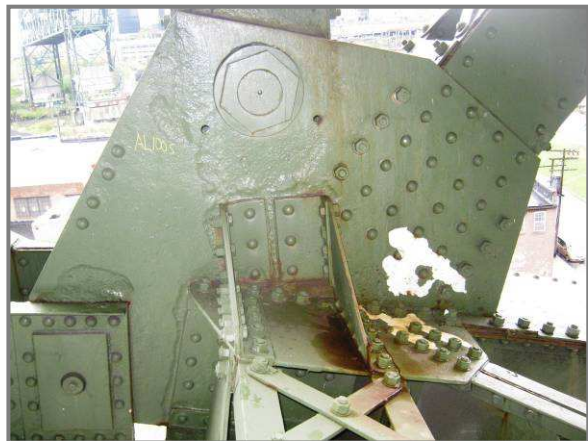
Photo 37 – Typical pitting at a lower pin gusset plate (AL100N). Note pitting around pin and chord members as well as isolated peeling top coat.

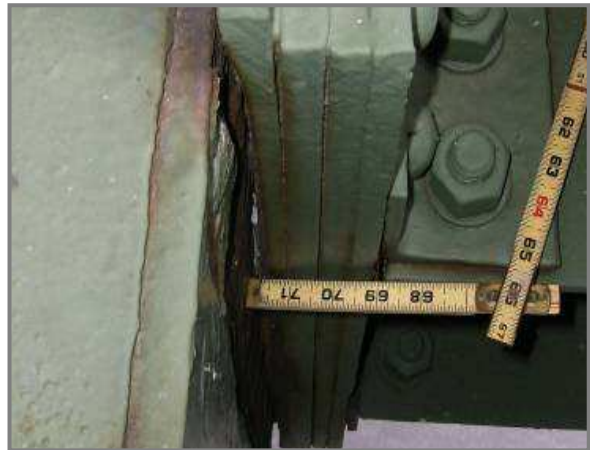
Photo 42 – Typical gusset plate loss measurable along the free edge at sliding pin locations.

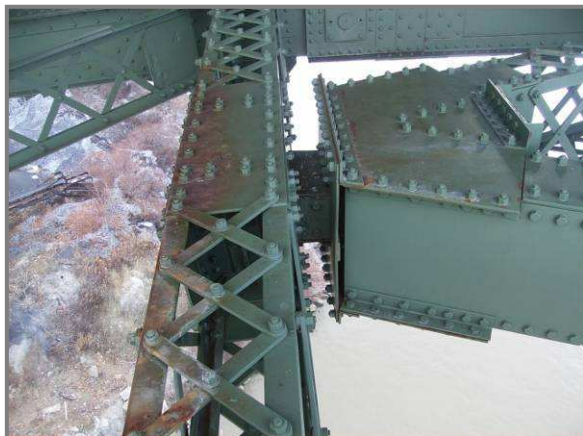
Photo 44– Typical wind lock with minor surface corrosion at strut.

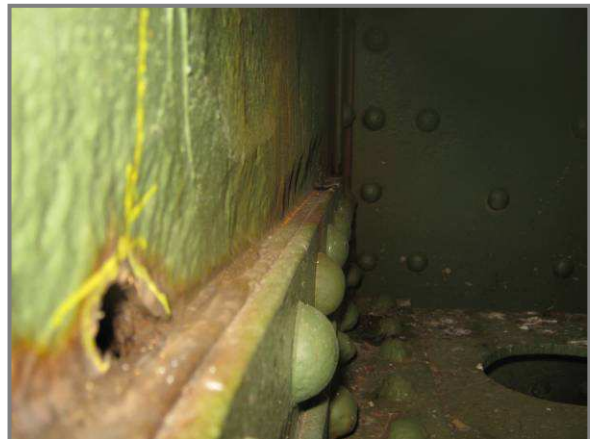
Photo 43 – 1" diameter hole in DL12S along interface with interior diaphragm.

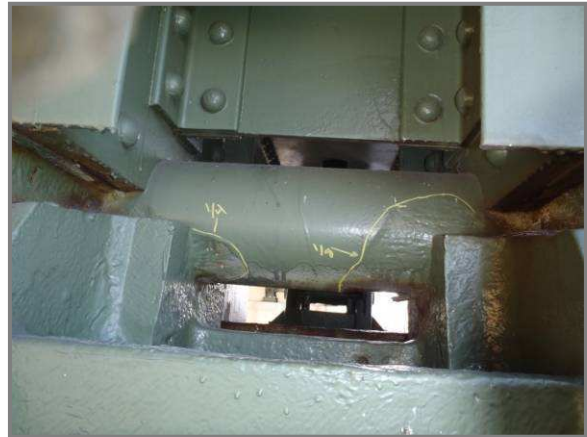
Photo 45– Bearing pin at AL119 with up to 1/4" pitting (cleaned and painted) around the bearing casting.

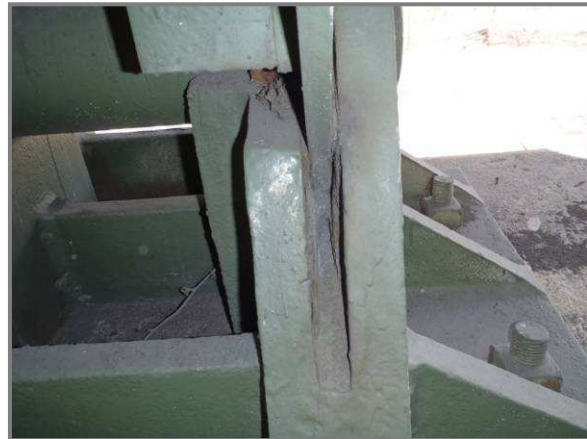
Photo 46– CL119 impacted rust between bearing casting and gusset plate seizing panel point from free rotation.

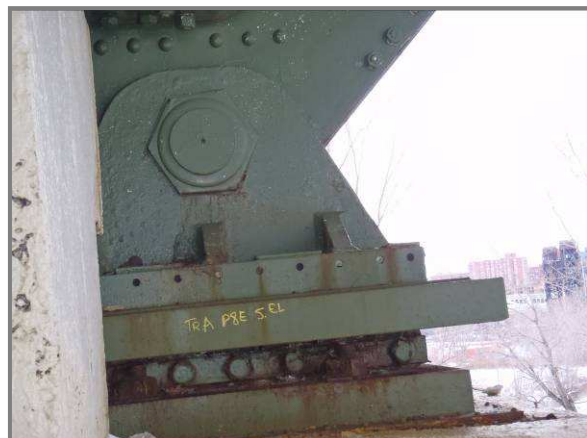
Photo 47– Roller nest assembly at AL21 with active surface corrosion present.

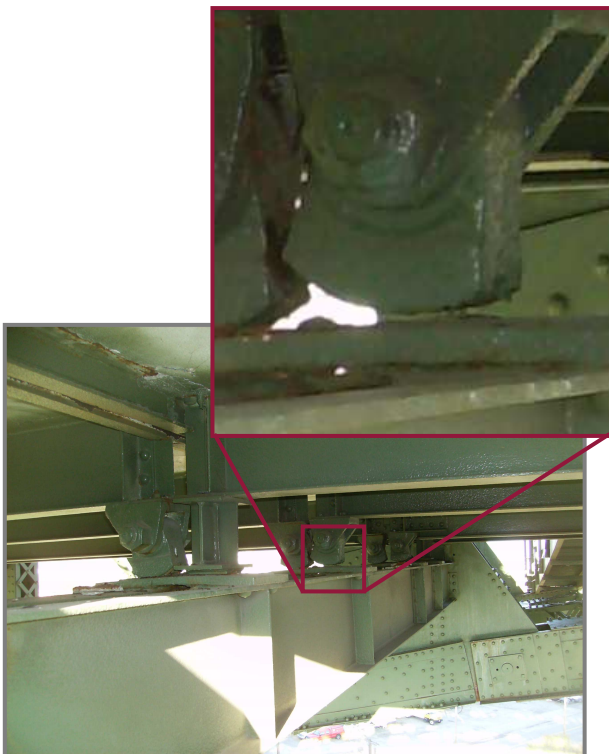
Photo 48 – Gap between Stringer 3 rocker bearing and bearing plate at FB 35.

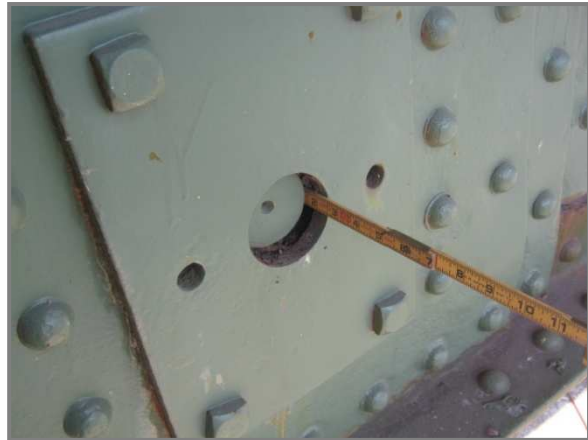
Photo 52 – Sliding pin at CL12S not fully bearing on the outermost pin plate due to impacted rust between the web plate and gusset plate.

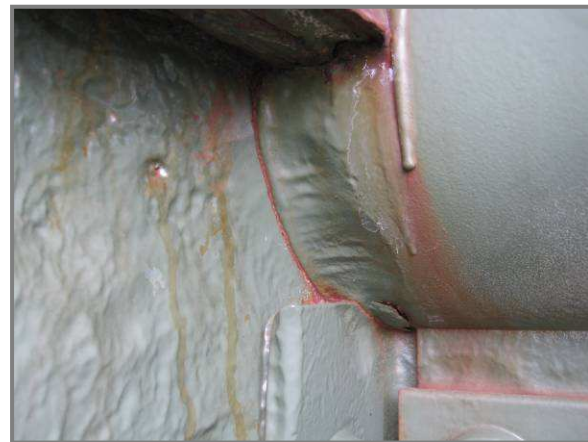
Photo 53– Wear along vertical pin at AL12 up to 5/16" loss over the lower half of the pin circumference.

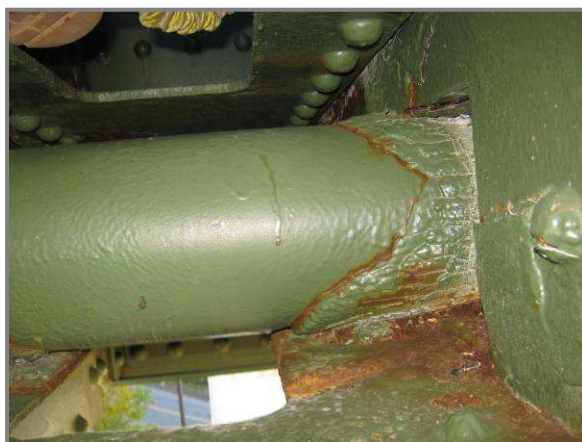
Photo 54– Sliding pin at AL17 seized due to impacted rust which has been painted over.

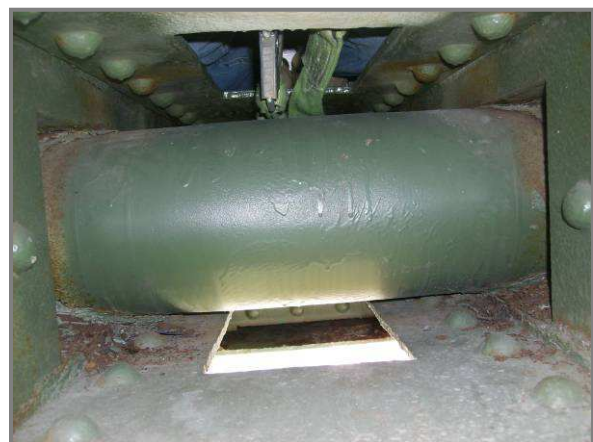
Photo 55– Sliding pin at BL41 seized due to impacted rust.

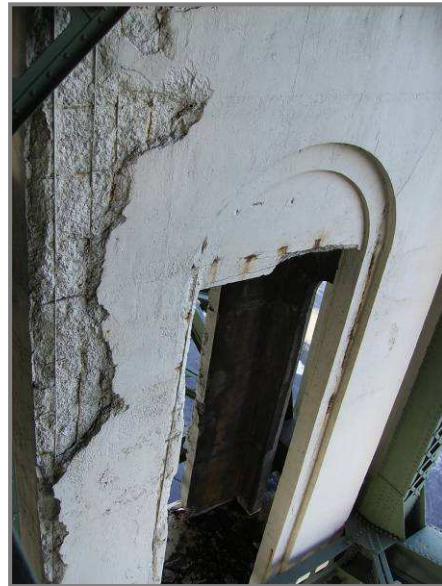
Photo 56– Typical spall with exposed rebar pier tower.

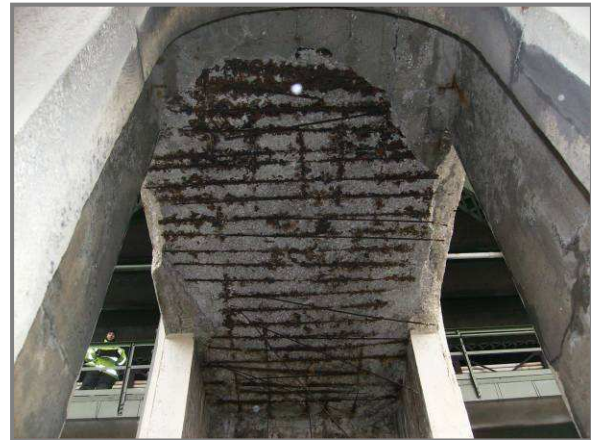
Photo 57– Advanced spall with exposed rebar on roof of Pier 12 tower above bearings. Note hanging exposed rebar.

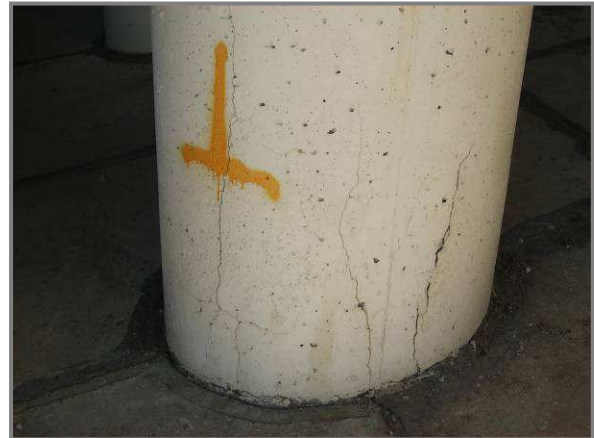
Photo 60– Vertical hairline cracks in Bent 1 columns.

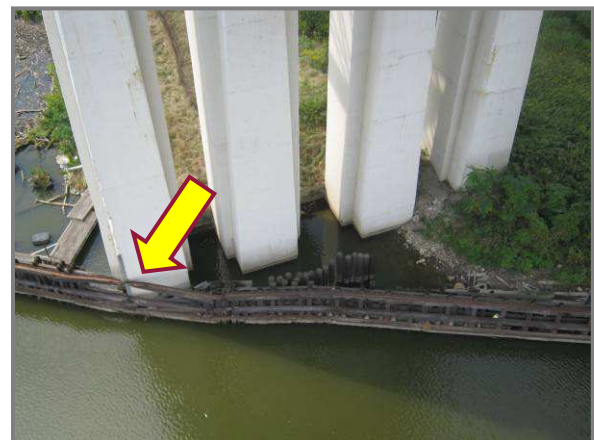
Photo 63– West bank fender system with collision damage at the southernmost pier column.

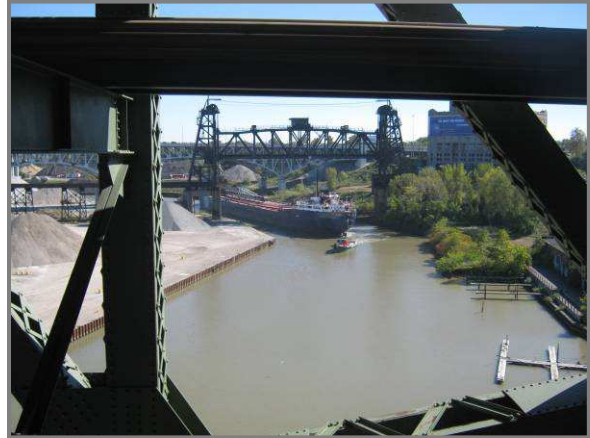
Photo 64– Bend upstream (south) of the bridge crossing.

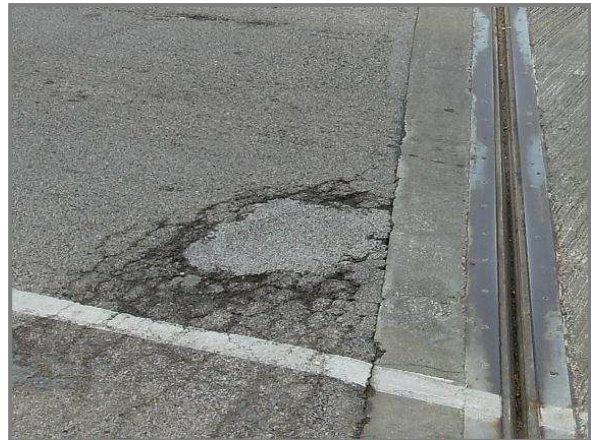
Photo 67– Map cracking around patched pothole in approach pavement.

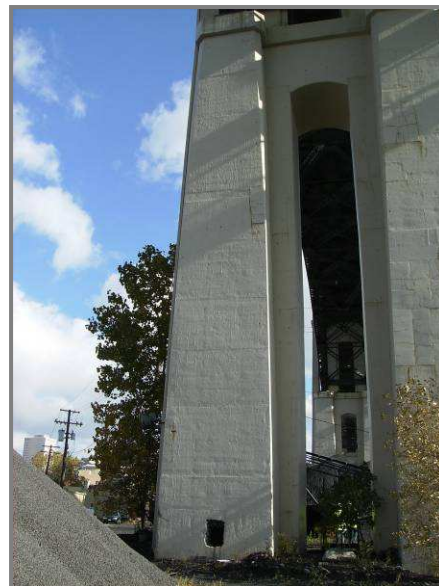
Photo 69 – 2'x2' drilled hole in the west face of the northernmost column at Pier 11.

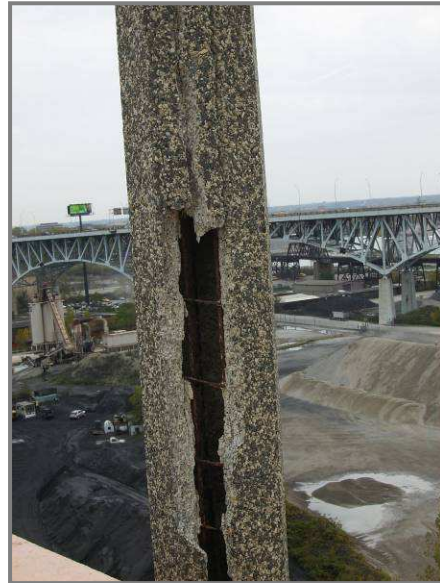
Photo 70– 5'x6" spall in light pole with exposed rebar located along the south sidewalk in Span 10.

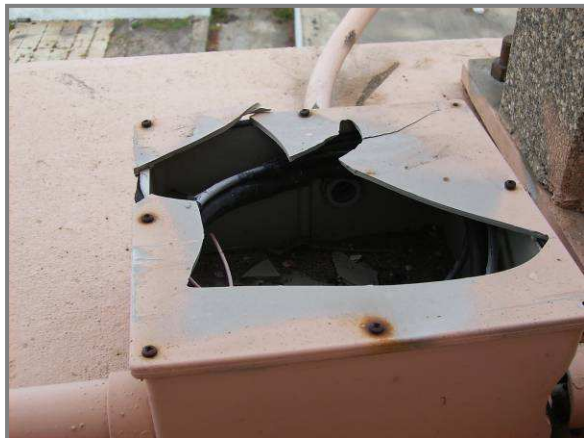
Photo 71– Broken electrical box cover with exposed electrical wires in Span 14 of the north sidewalk overhang.

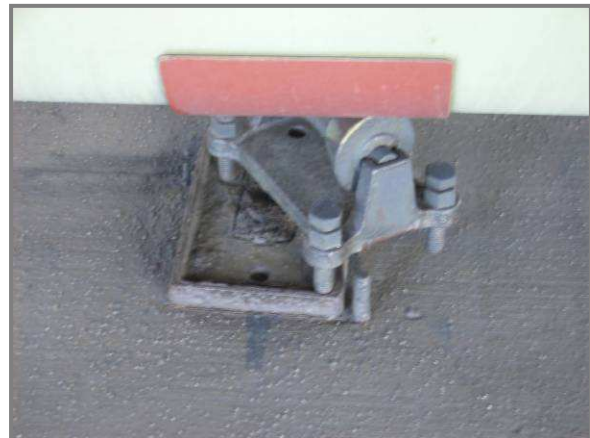
Photo 72– Misaligned support for 40" gas main on utility deck adjacent to Pier 15.

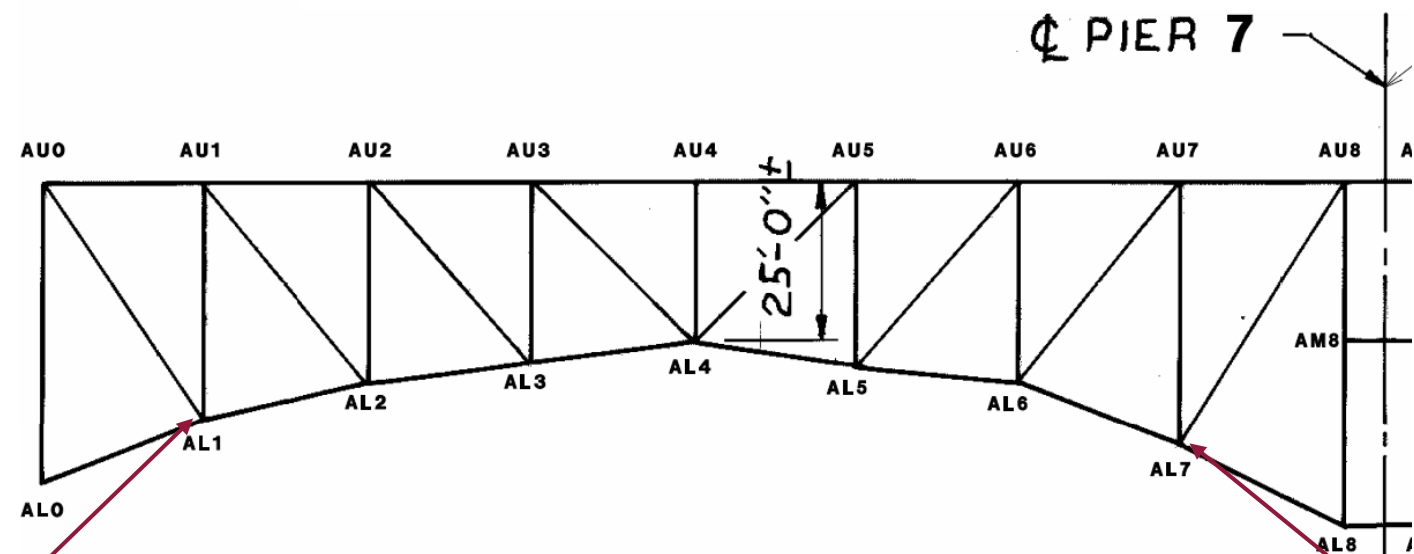
**SPAN 6  
TRUSS A**

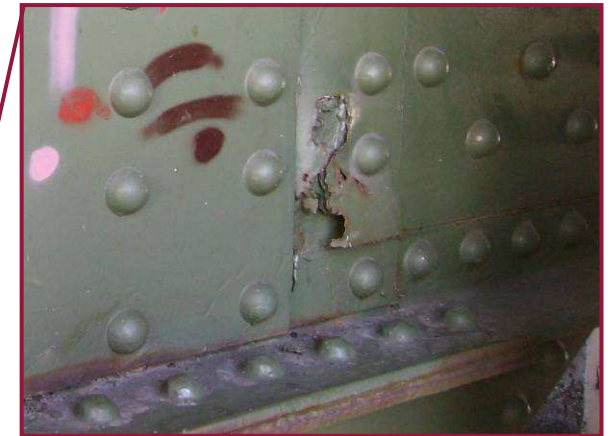
Advanced corrosion at the south web fill plate at BL8 has resulted in a 6" diameter hole.

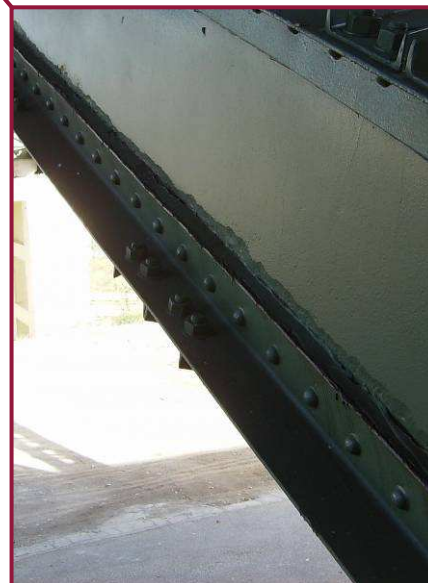
Pitting up to 1/8" deep is present in the bottom 4" of the north web plate along the bottom flange angle at BL0-BL1.

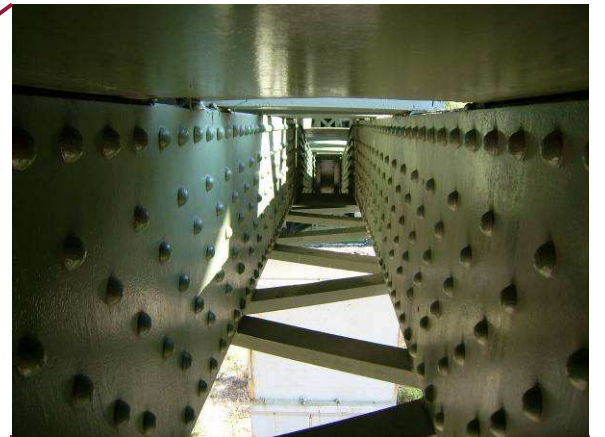
The interior of the lower chord box section is typically cleaned and painted, typically with little or no active rusting (CL6-CL7 shown).

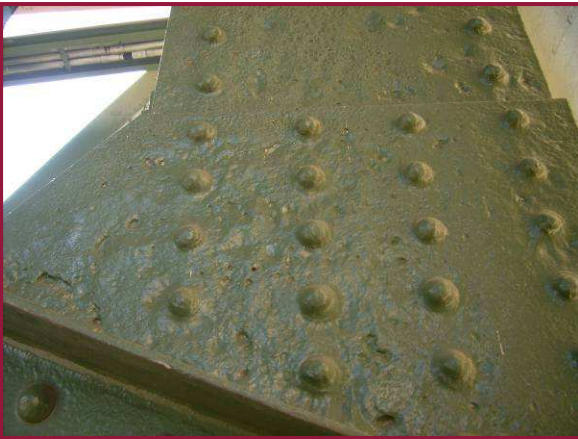
The north gusset plate at CL0 exhibits heavy pitting throughout with areas with pits up to 3/8" deep.

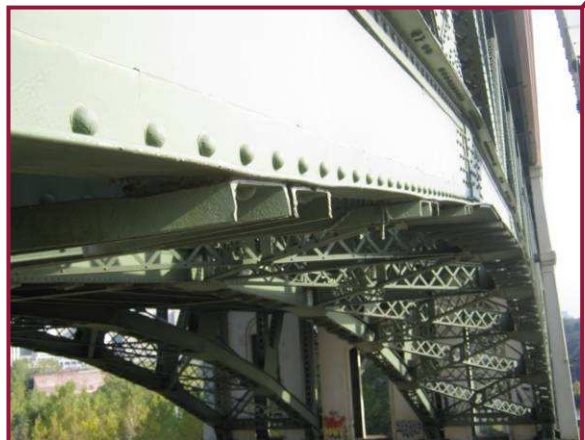
The horizontal legs of bottom flange angles are warped slightly throughout the bridge at isolated lacing connections due to pack rust between the angles and the lacing channels.

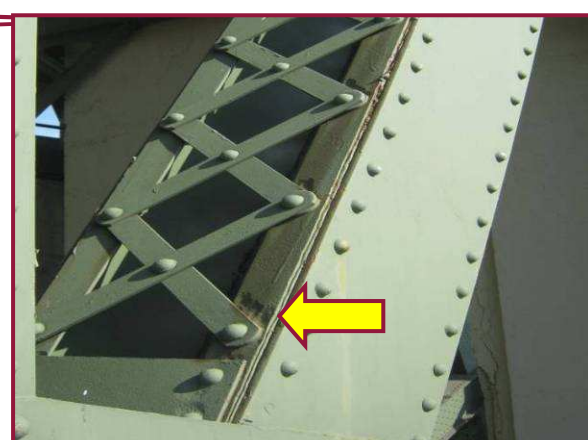
Isolated pitting up to 1/4" deep was noted along the top flange angles at lacing connections (DL7-DU8 shown).

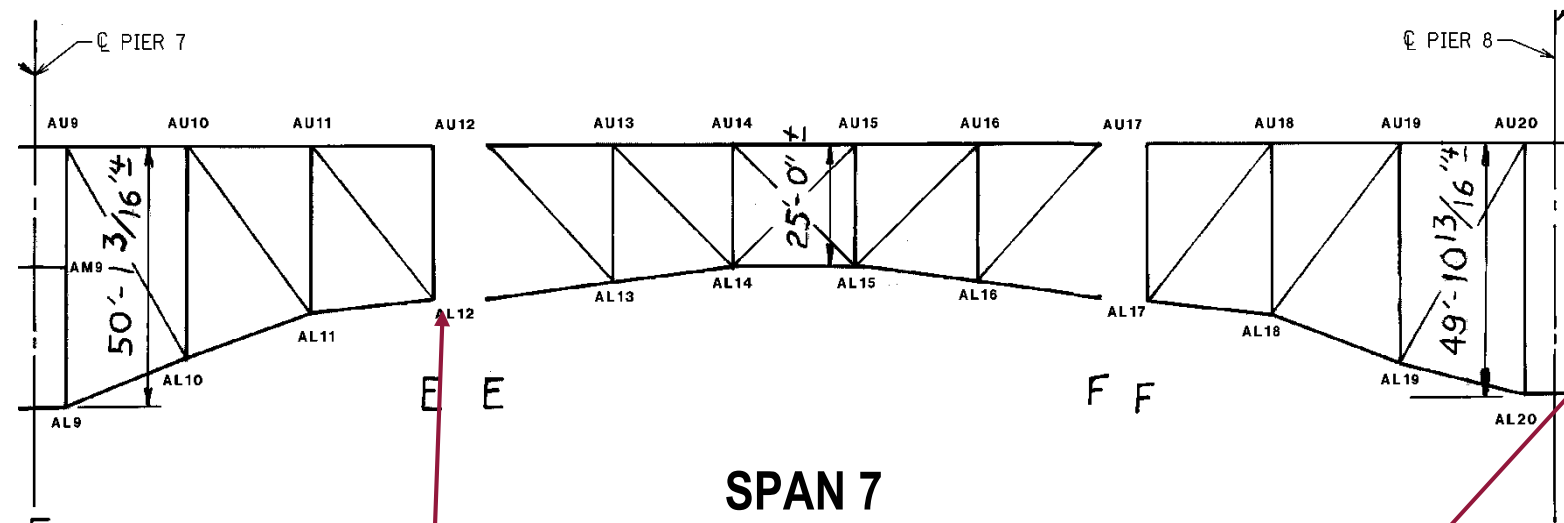
**SPAN 7  
TRUSS A**

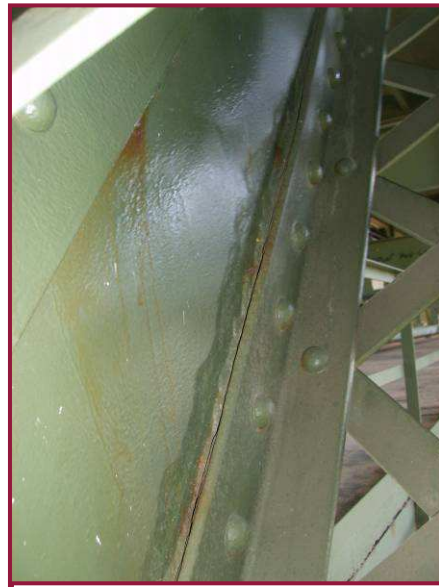
The interior face of the south web plate at BL12-LU11 exhibits 1/8" deep pitting along the lower flange angle.

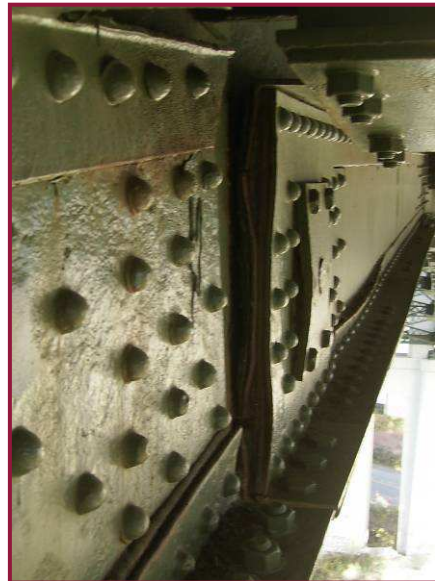
Heavy pack rust between the plates at the lower sliding pin location near BL12 has caused significant distortion of the plates. Heavy pitting is present on the web plate of BL11-BL12 (foreground).

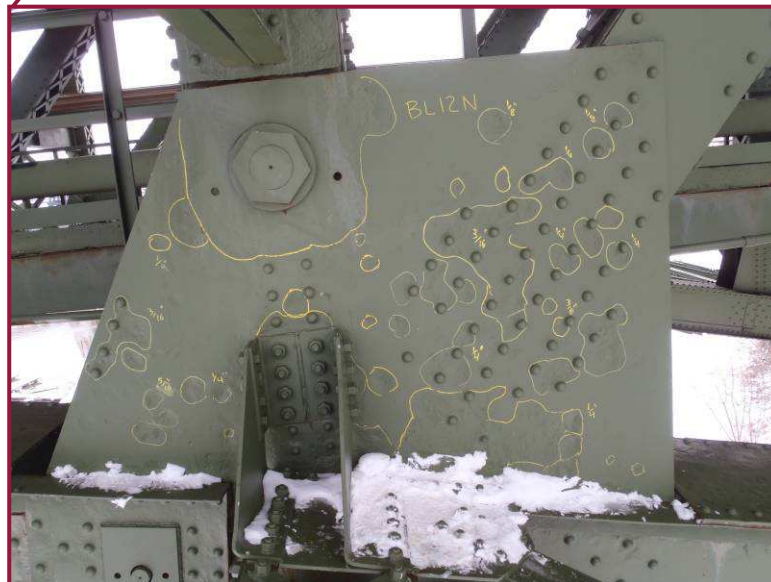
Gusset plate BL12N exhibits small areas of deep pitting up to 5/16" throughout. All locations exhibiting greater than 3/16" deep pitting are highlighted with field markings. The south plate at BL12 exhibits conditions similar to those shown, while losses at BL17 are considerably less severe, typically 1/8" deep.

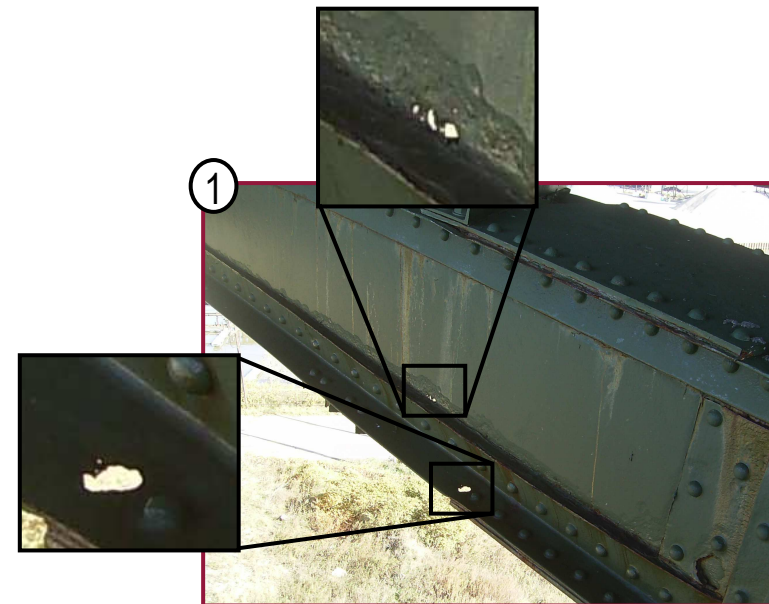
The lower flange angle of BL12-BL13 exhibits a 1" diameter hole. The adjacent web plate exhibits 1/8" pitting and is perforated due to isolated advanced corrosion at one location.

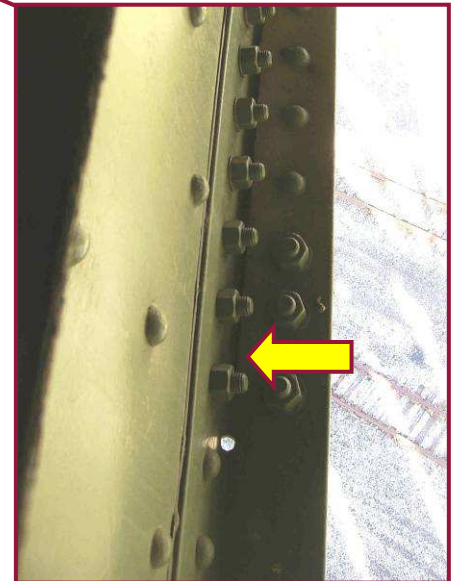
The south bottom flange angle at BL13 exhibits longitudinal cracking due to pack rust between the outstanding leg of the flange and the bottom lateral bracing connection plate. Arrest holes have been drilled and the bottom connection plate has been replaced at this location.

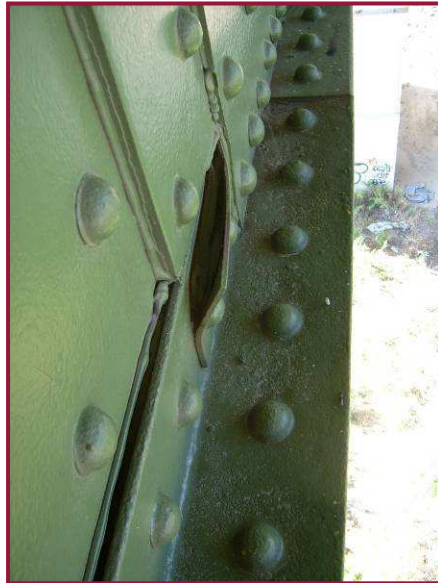
The bottom flange angle splice plate at CL11 is bowed out approximately 1.5" due to heavy pack rust.

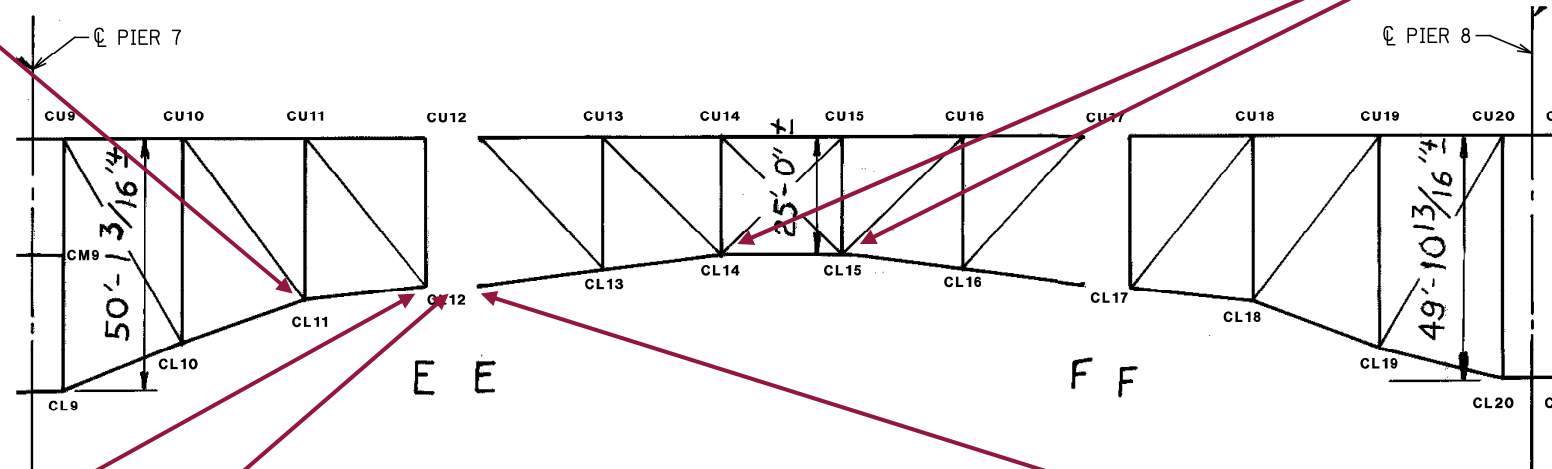
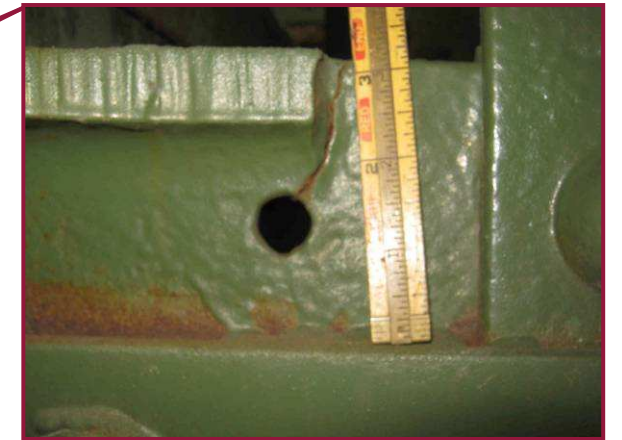
Utility deck Floorbeams 14 and 15 exhibit cracking at the top flange coping near Truss C, extending down into stress relief holes. These cracks are approximately 1.75" long and do not appear to have propagated beyond the stress relief holes

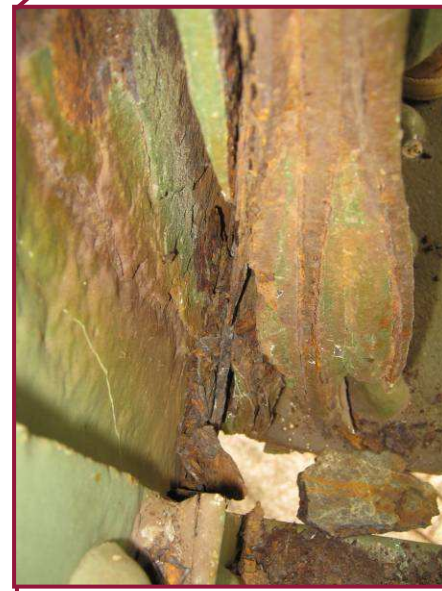
CL12-CL13 exhibits advanced section loss and heavy pack rust at the sliding pin location at CL12. A thin internal fill plate has rusted away at this location, and built up member connections are becoming distressed due to the pack rust and subsequent distortion of the web members, as shown.

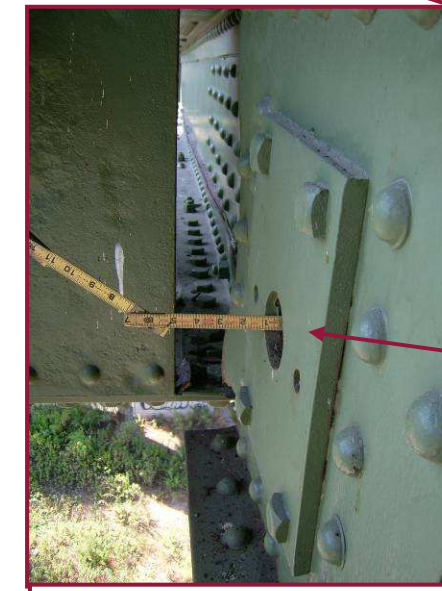
At the lower chord sliding pin at CL12, heavy pack rust has forced the pin plates away from the end of the pin. The end of the pin is approximately 1" from flush with the keeper plate.

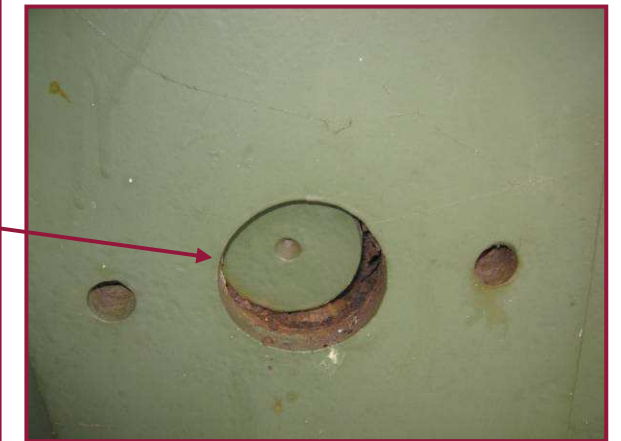
The lower chord sliding pin at CL12 is not bearing on the keeper plate, exhibiting lateral misalignment.
