**PHYSICAL CONDITION REPORT  
FOR THE 2010 IN-DEPTH INSPECTION**

**LORAIN-CARNEGIE BRIDGE**

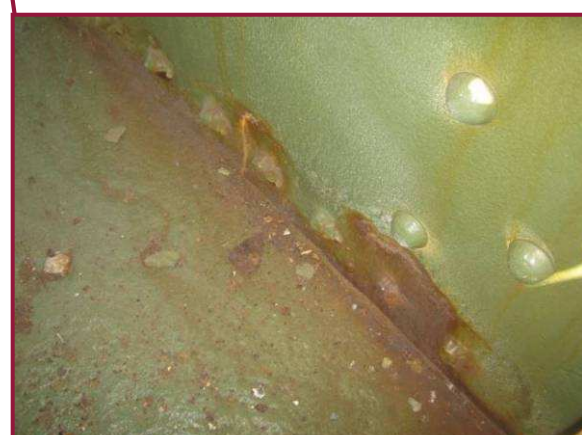
DL12-DL13 exhibits moderate corrosion and pitting up to 1/4" deep over the lower 1/3 of north web plate, with a 2" Ø hole near the bottom cover plate interface.

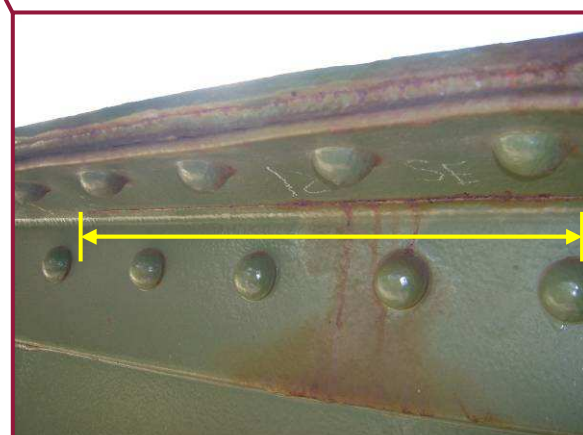
Longitudinal crack is located between legs of the north upper flange angle measuring 24" long at DL15-DL16.

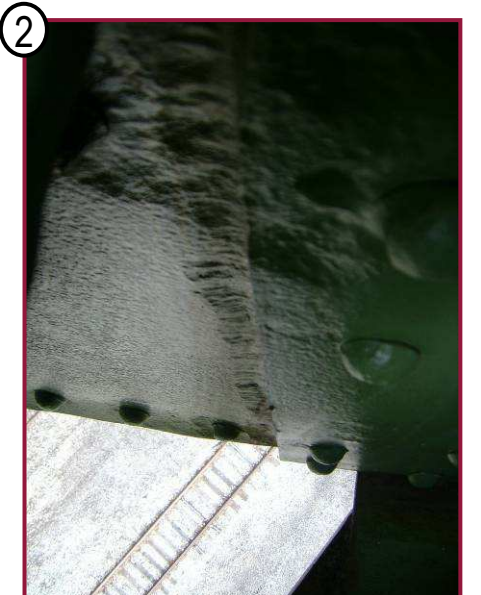
Up to 1/4" pitting (cleaned and painted) extends the full height of the north web of DL14-DL15 adjacent to DL15. This condition is typical for Span 7 lower chord members.

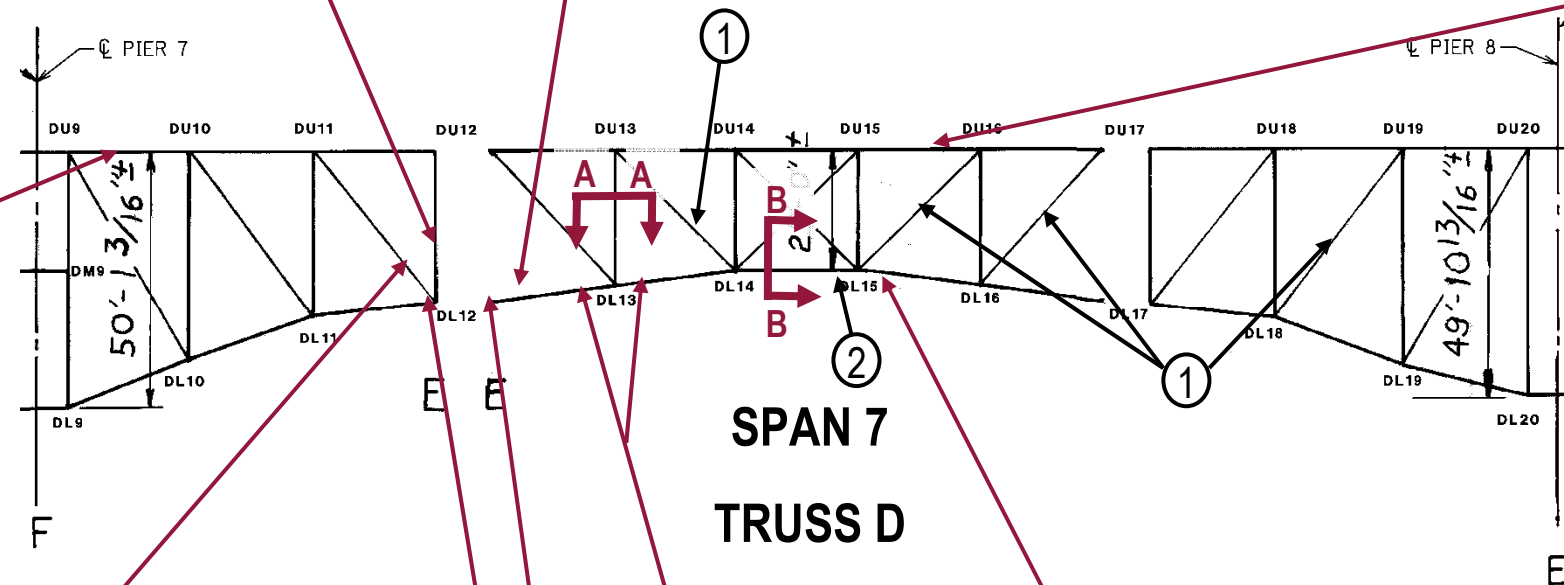
Pack rust is typical between web plates and flange angles and between flange angles and lacing channels. Isolated areas have reactivating rust.

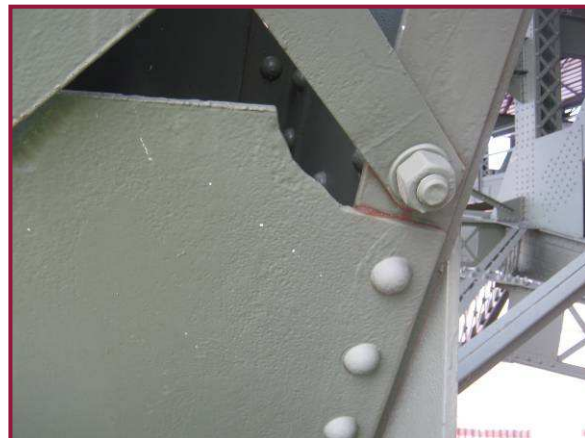
The lower cover batten plate of AL23-AU22 has been flame-cut to accommodate previous repair work done at this location. Note retrofit bolt at the lower lacing connection.

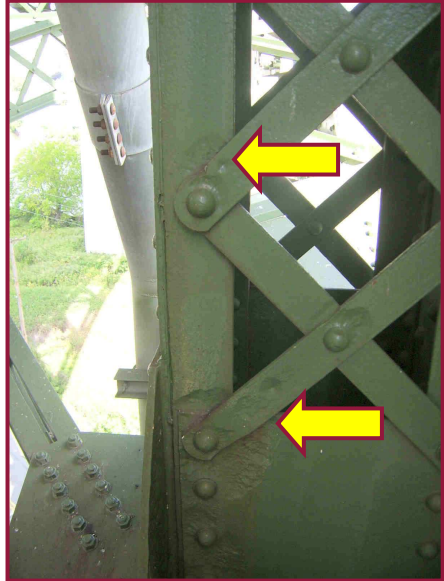
DL21-DU21 exhibits areas of heavy pitting (up to 1/4" deep) adjacent to the lacing connections on the flange angle legs and the lacing bars near the lower panel point.

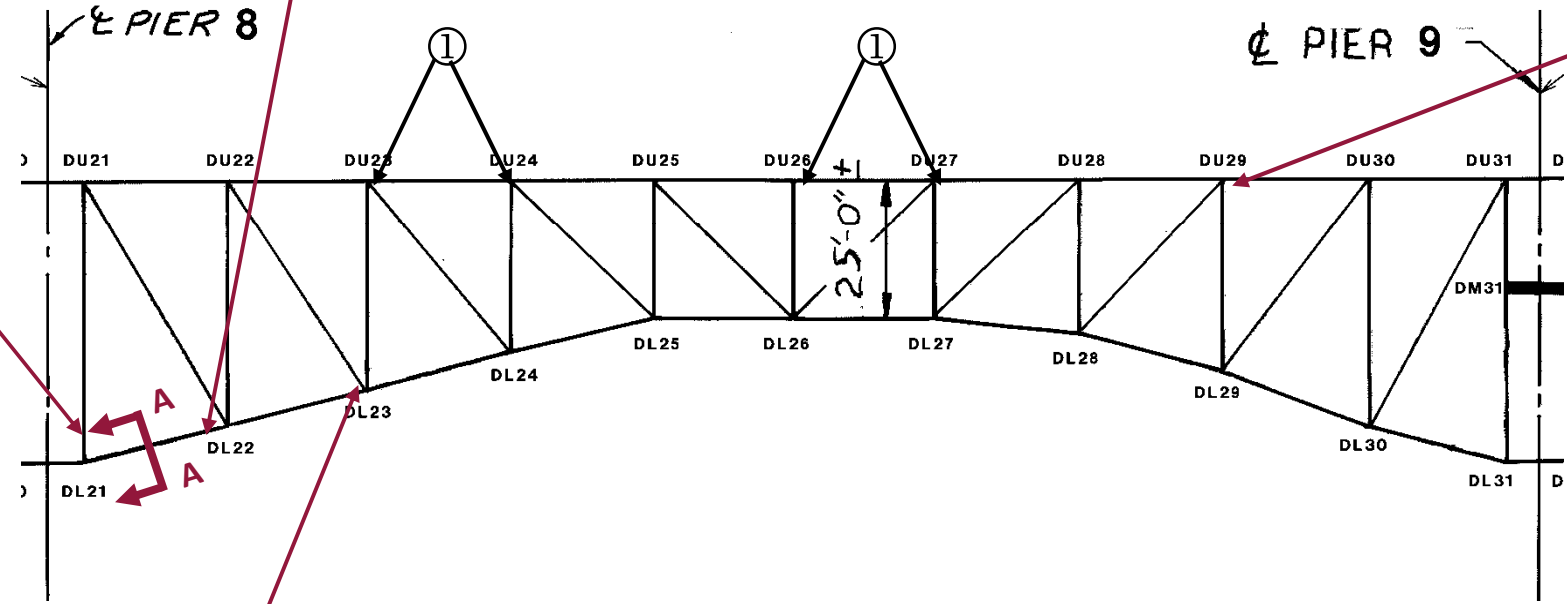
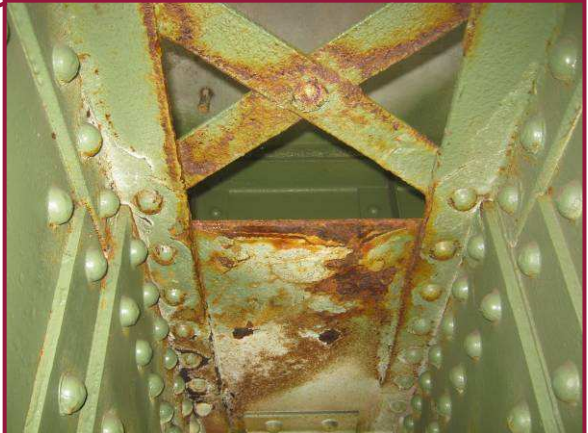
The interior of the upper chord between the gusset plates at DU29 exhibits active rusting with only minor surface pitting.

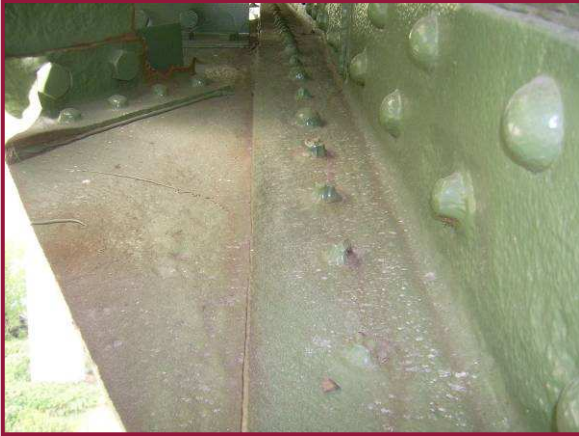
Heavy pitting is typical along the horizontal surfaces of members at DL23, including approximately 50% loss of 9 of the 20 rivet heads connecting the lower lateral gusset plate to the lower chord flange at this location (cleaned and painted).

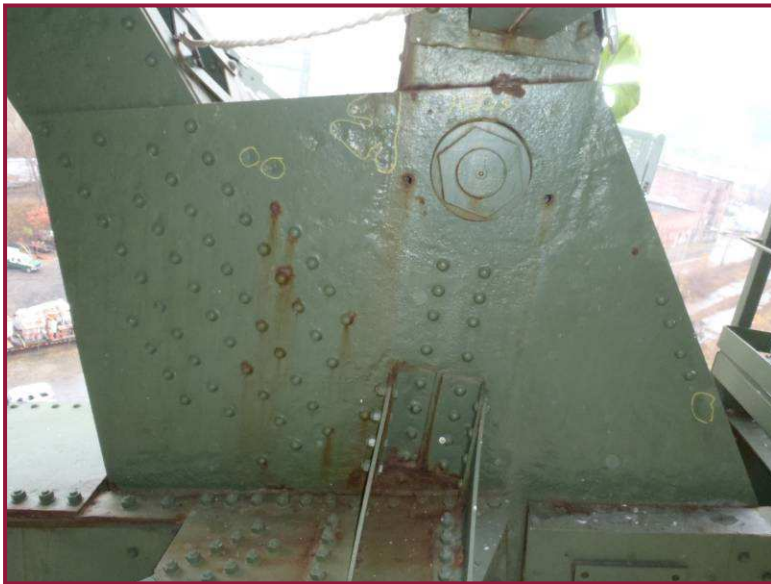
AL35S exhibits heavy pitting throughout the south face of the plate, with 1/4" losses in isolated areas.

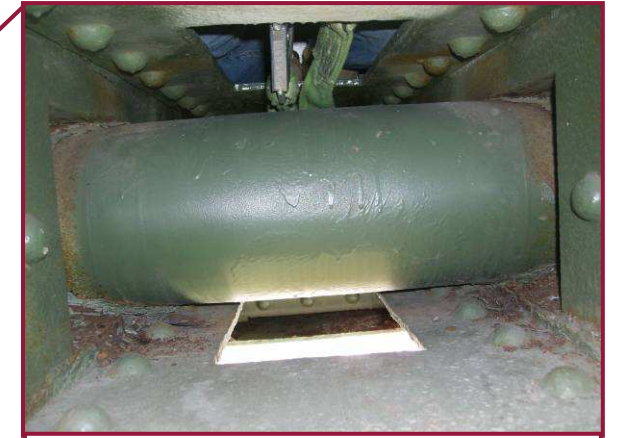
The lower sliding pin at BL41 exhibits losses up to 1/8" adjacent to the pin plates along the pin circumference. The pin at BL35 exhibits similar conditions in addition to minor corrosion throughout the surface of the pin.

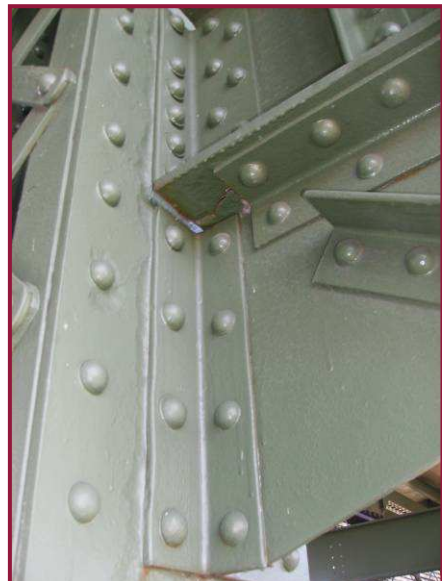
BL40-UL40 exhibits up to 3/16" deep pitting adjacent to the sway strut connection (see Section A-A).

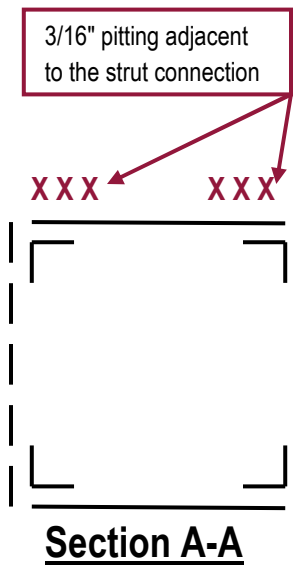
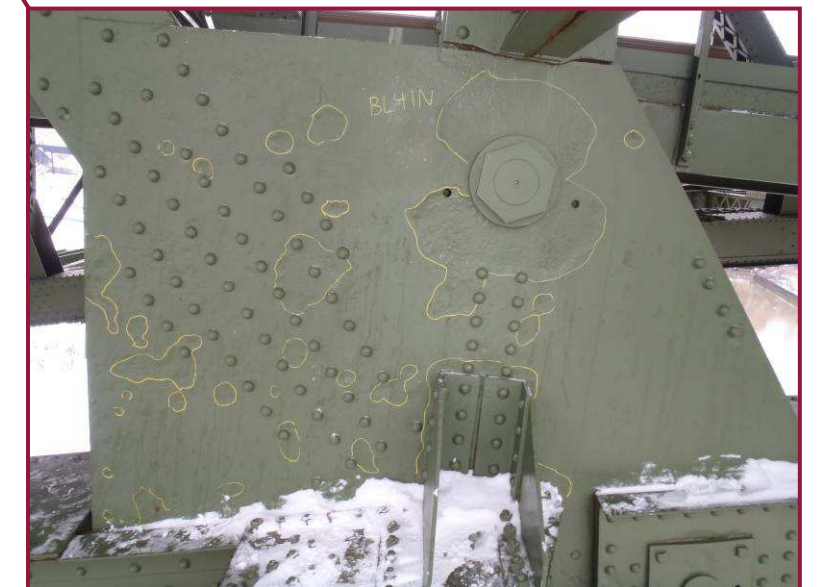
The north gusset plate at BL41 exhibits isolated areas of pitting up to 1/4" with losses between 1/16" and 1/8" common throughout the north face. The north and south gusset plates at BL35 exhibit similar conditions.

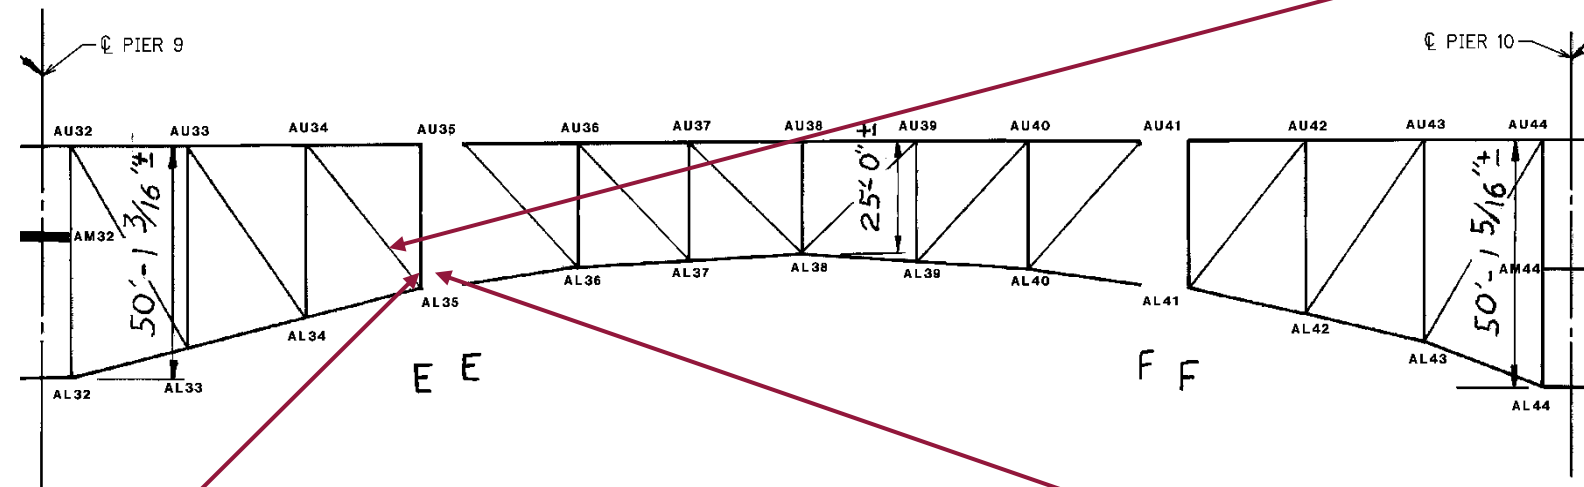
**SPAN 9  
TRUSS C**

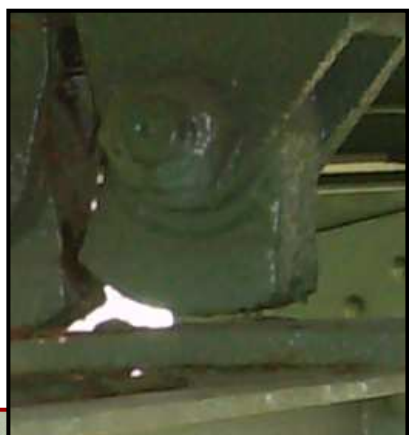
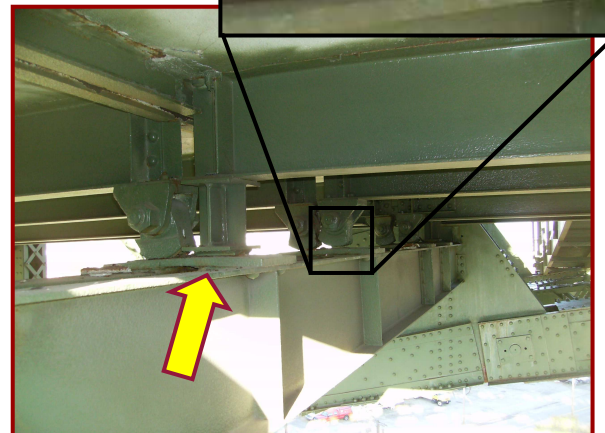
Stringer 3 is not bearing properly at the utility deck Floorbeam 35 bearing plates. Stringers 1 and 4 have retrofitted bearings, consisting of modified beam sections with welded vertical stiffeners. Note that pack rust between the top floorbeam flanges and the bearing plate has caused the plates to bow up.

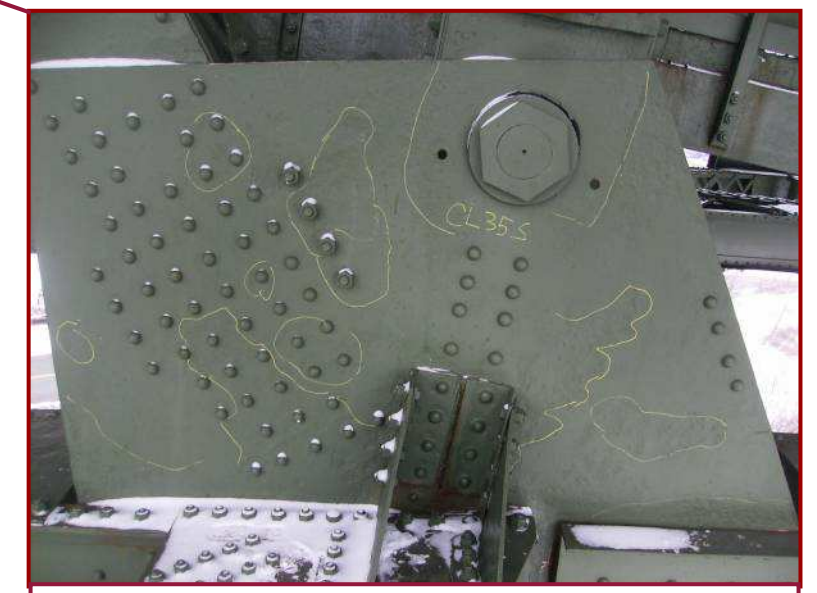
The south gusset plate at CL35 exhibits 1/8" deep pitting throughout areas of the south face, with small areas with up to 1/4" deep pits on the north face of the plate along the lower chord.

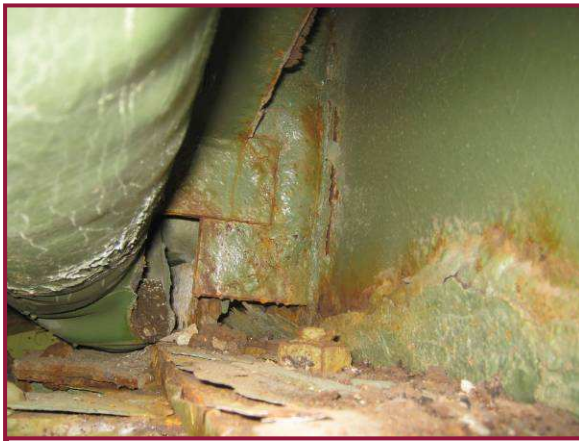
Floorbeam 35 exhibits active corrosion of the bottom flange and the adjacent web and vertical stiffeners with up to 1/16" deep pitting. The joint trough has failed and water and debris are leaking onto the floorbeam.

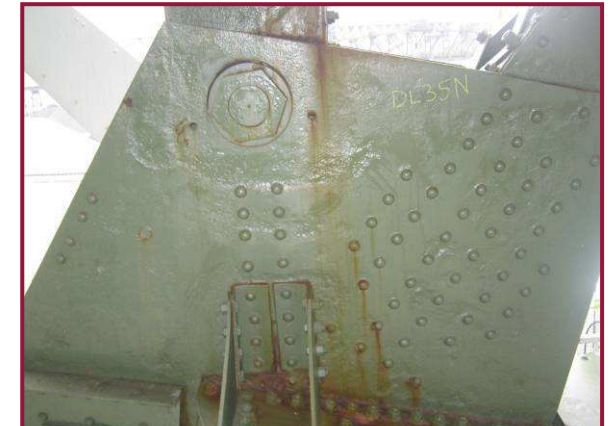
Rust reactivation is typical at the pinned gusset plates due to joint failures above (DL35N shown).

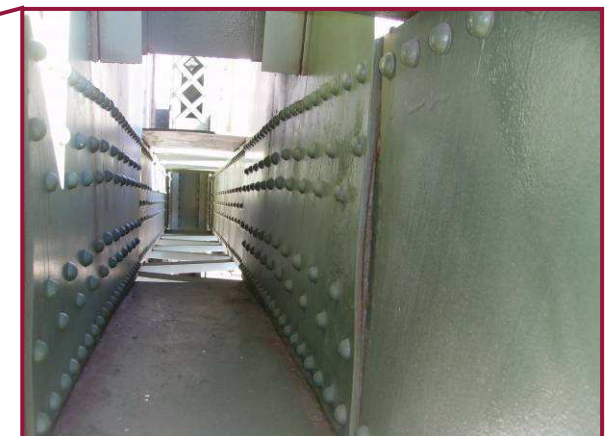
3/4" thick pack rust has formed between the DL43 south gusset and the lower chord web plate resulting in localized minor distortion. This condition was also noted at DL37 in Span 9.

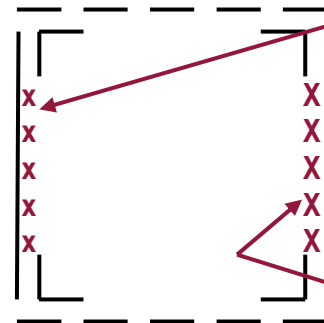
Pitting up to 1/4" deep for half the web width

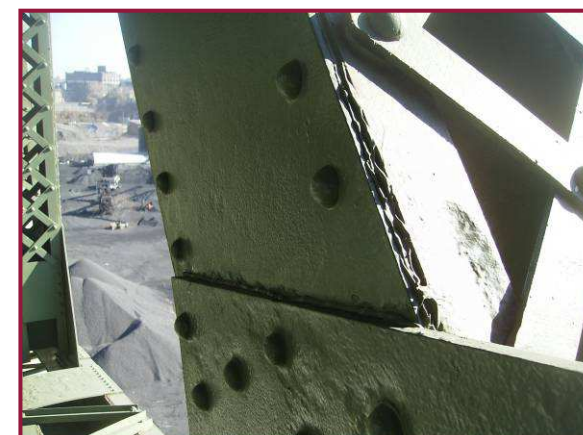
At the seam between the interior lower gusset plate and the diagonal web plate, 1/4"-5/16" deep pitting was noted on member DL42-DU43. Note also the 1/4" deep pitting of the northwest flange angle.

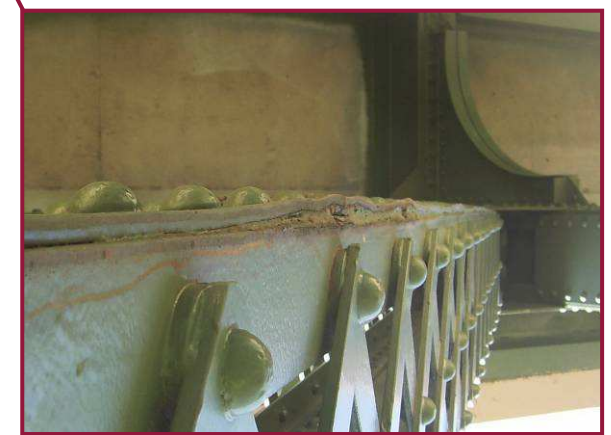
Pack rust between the bottom flange angle and web plate of diagonal members is common throughout the structure. Minor distortion can be seen as a result of the 1/2" thick pack rust at DL42-DU43.

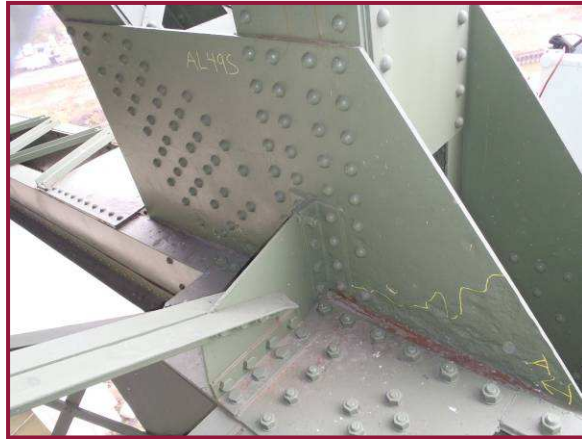
AL49S exhibits heavy pitting up to 1/4" deep along the lower chord interface, as outlined on the plate.

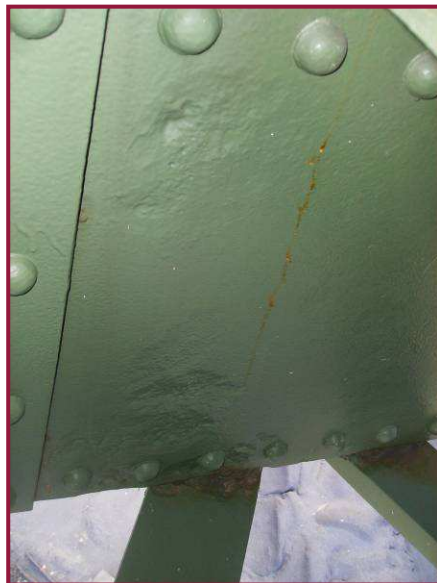
The south web plate of AL48-AL49 has heavy pitting up to 1/4" deep for approximately half the web height near AL49. Similar conditions are found at AL 51.

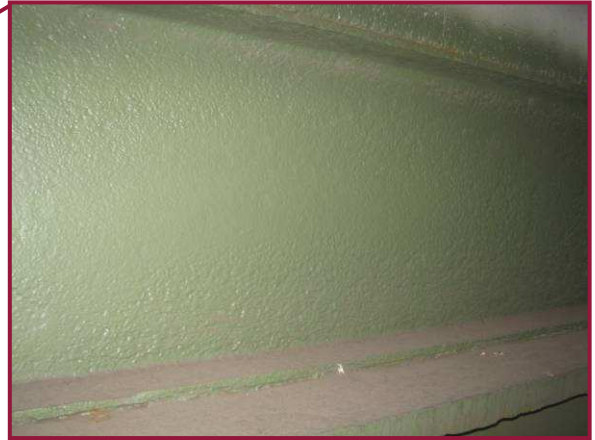
Pitting up to 1/8" deep is freckled throughout the south face of Stringer 2 between Floorbeams 53 and 54. This condition is common for Stringer 2 throughout Span 10.

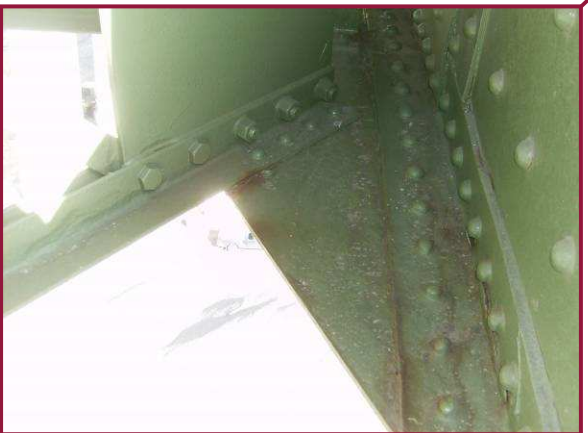
The lower lateral bracing connection plates typically exhibit pitting between 1/16" and 1/8" deep, with localized pitting up to 1/4" deep. The adjacent bottom flange angles exhibit similar pitting. Light surface corrosion is typically forming at these locations.

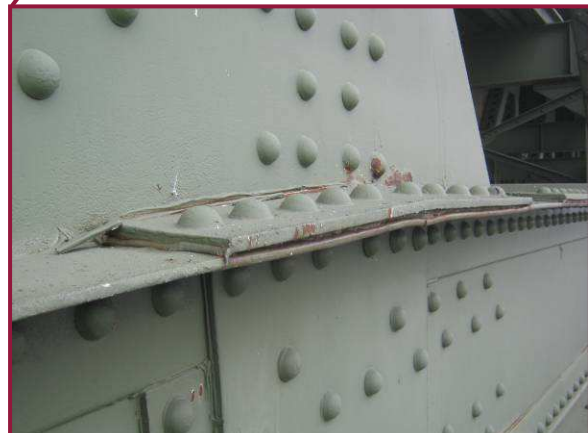
At the flange splice plate at panel DL49, 1/2" thick pack rust has developed and is deforming the flange angles. Reactivating pack rust at this detail is typical of lower chord splices throughout Span 10.

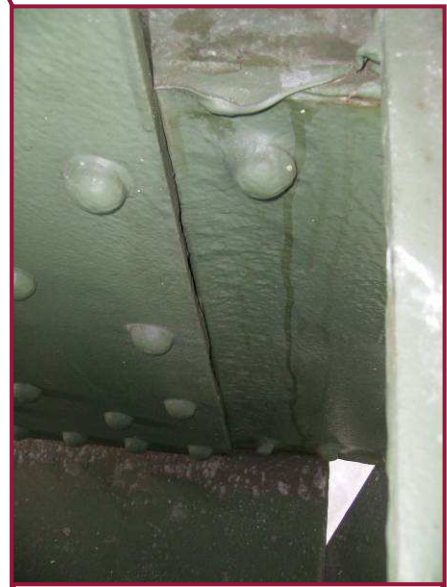
DL50-DL51 exhibits up to 1/4" deep pitting over the full height of the north web at DL50. 1/8" pitting is typically found at similar locations throughout the lower panels in Span 10.

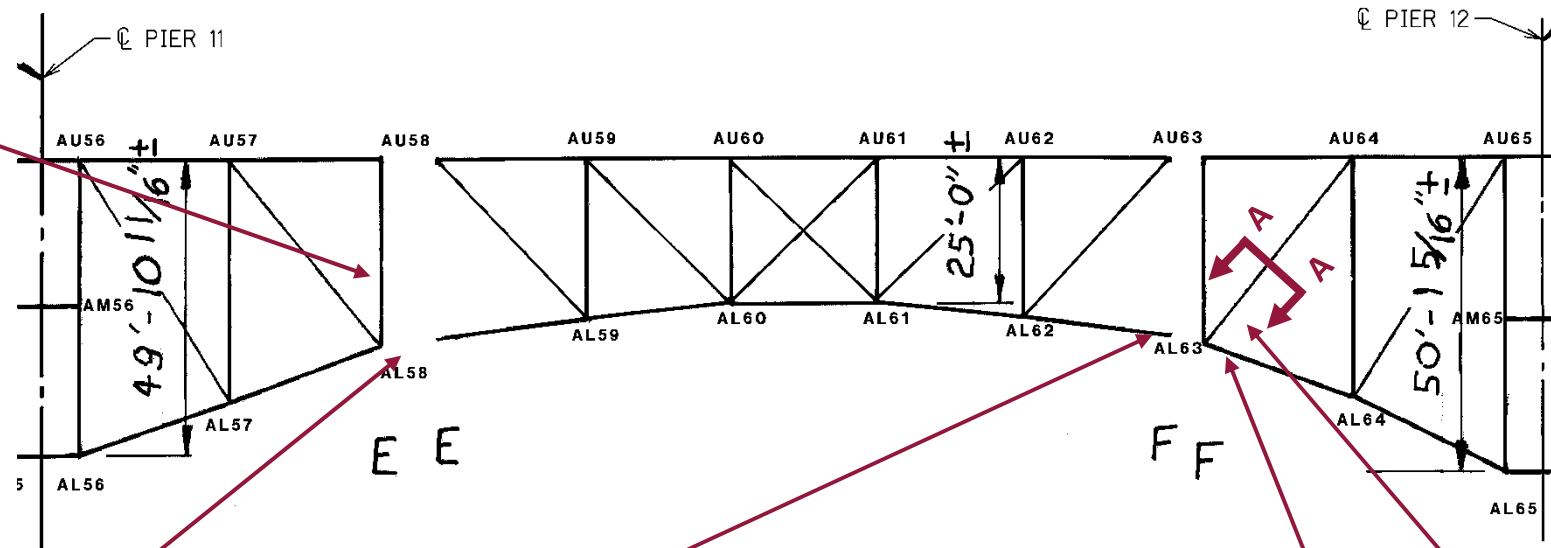
**SPAN 11  
TRUSS A**

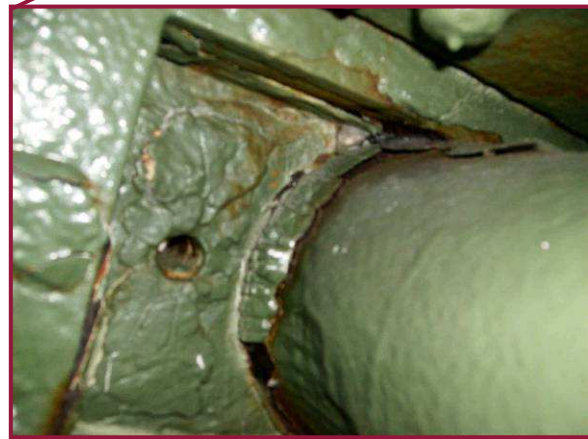
The lower sliding pin at AL63 is heavily corroded with rust scaling at the pin to pin plate interface. Rust is reactivating throughout these components.

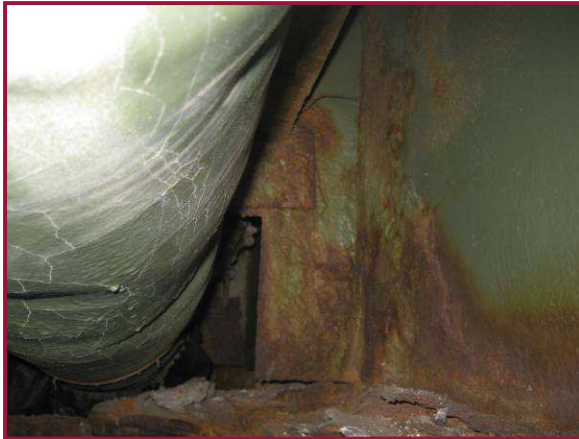
Floorbeam 58 exhibits widespread moderate corrosion with 1/16"-1/8" pitting adjacent to the drainage trough. This condition is typical for floorbeams at expansion joint locations due to joint deficiencies.

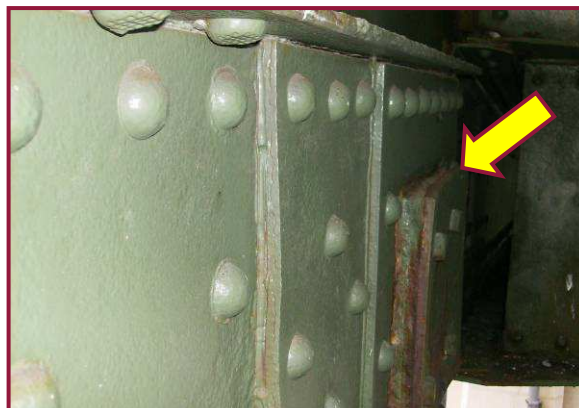
DL58-DL59 exhibits pack rust measuring approximately 1.5" thick between the two outermost pin plates at DL58. Losses surrounding the pack rust are approximately 1/8" on each plate. Similar conditions were noted at DL63 with 1/2" thick pack rust.

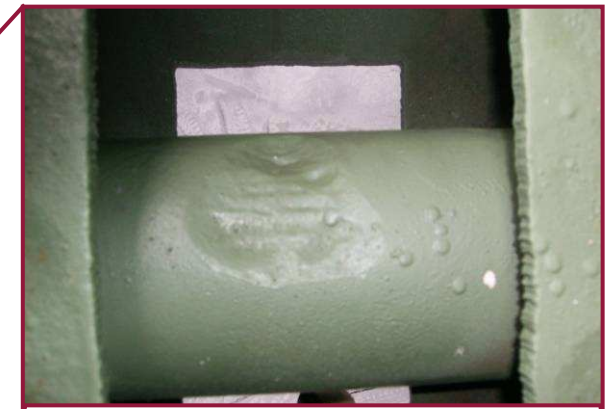
The lower sliding pin at DL63 has a 4" diameter area exhibiting up to 5/16" deep pitting. This location has been cleaned and painted with no active rusting.

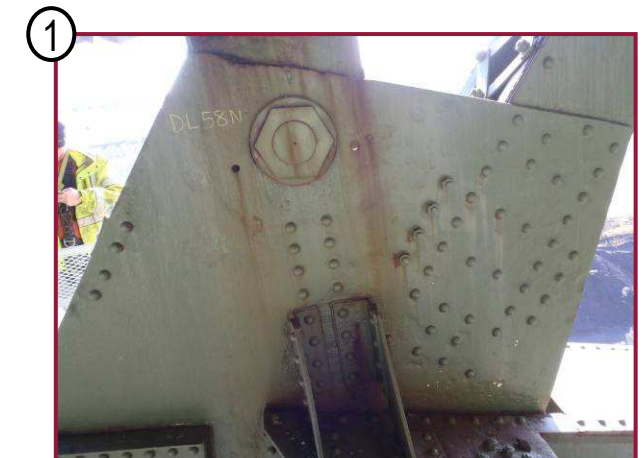
The north gusset plate at DL58 exhibits up to 3/16" pitting, a condition typically found at the expansion locations throughout the structure.

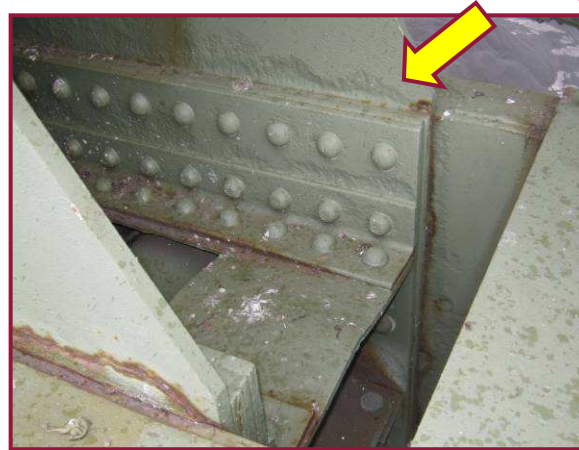
Active rusting is typical along the seams of the built up members at DL58. The south face of the north gusset plate exhibits 1/8" pitting that has been cleaned and painted, while the same location on the south gusset plate exhibits up to 1/4" loss (arrow). Additionally, note that the horizontal stiffener plate between the two gussets is bowed up, measuring approximately 1" from its original plane.

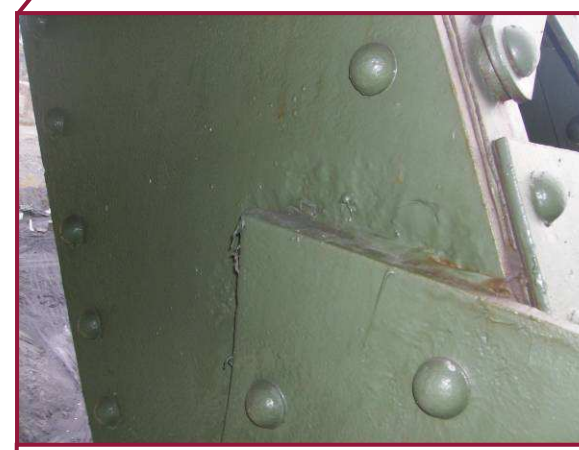
Pitting of the north web plate at the gusset plate interface on diagonal member DL64-UL65 is up to 3/16" deep with light surface corrosion along the seam between the two plates. This condition is typical for Span 11, Truss D for other web members. Only member DL59-UL58 in Span 11 exhibited heavier pitting at this interface, with up to 5/16" loss.

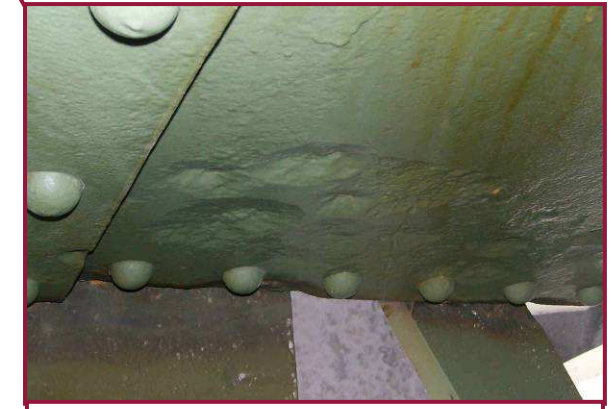
The lower half of the interior face of the DL64-DL65 north web plate exhibits pitting up to 5/16" deep adjacent to the DL64 gusset plate. This condition is typical for Truss D lower chord web plates at the panel interfaces throughout Span 11; however, pitting varies from 1/8" to the 5/16" depth at DL64.

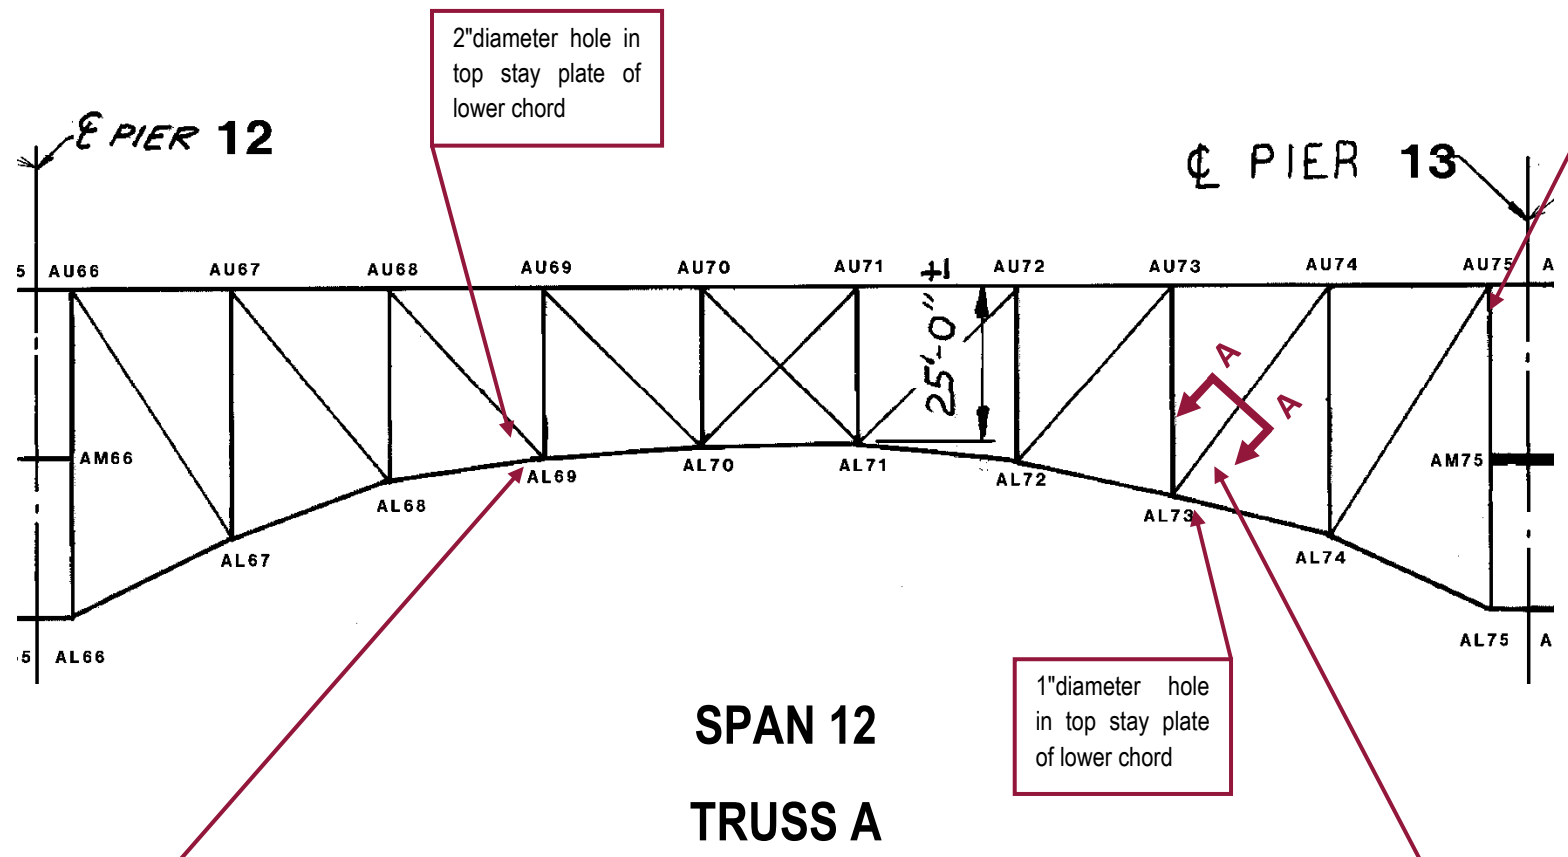
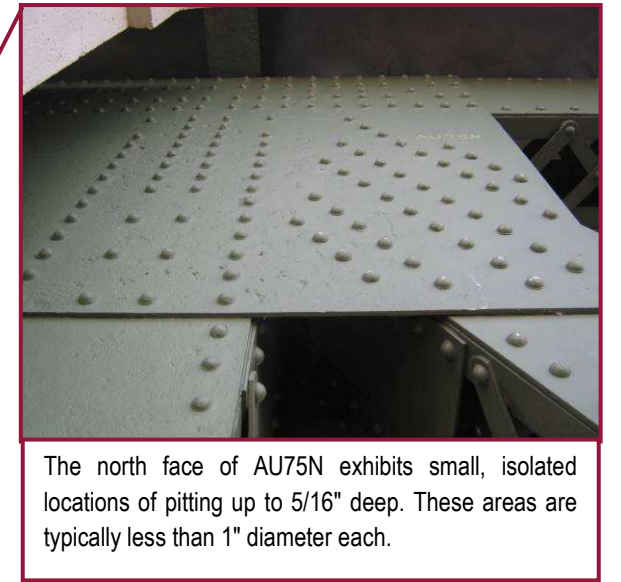
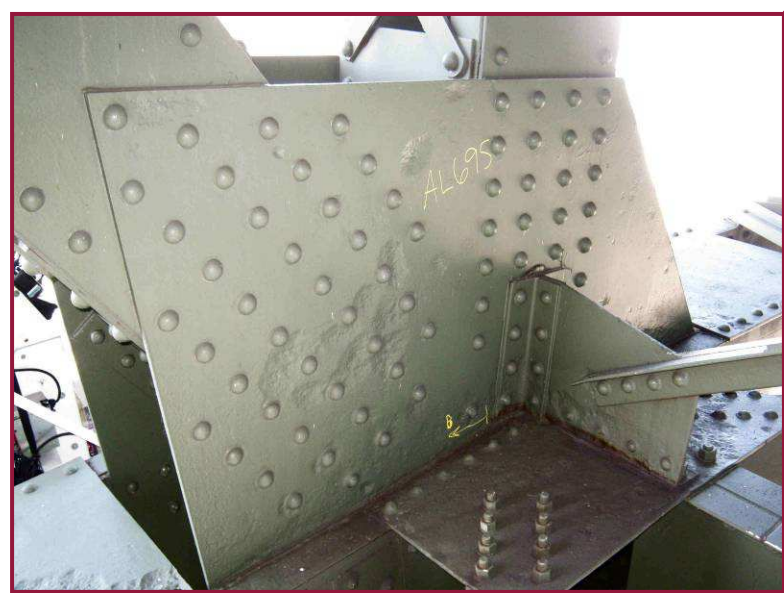
The south face of the south gusset plate at AL69 exhibits heavy pitting along the lower chord interface and adjacent to isolated rivet heads. Note the heavy pitting of the lateral connection plates at this location as well.

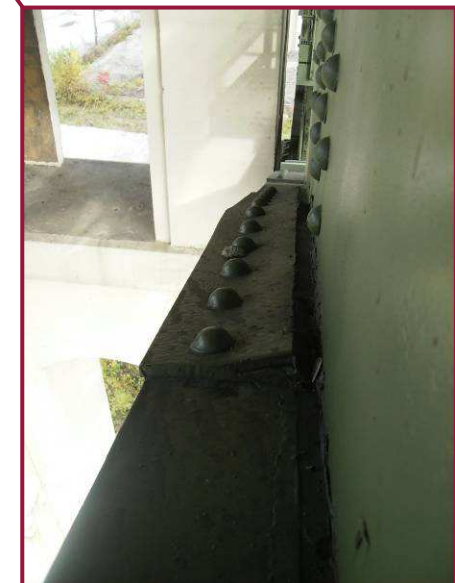
The top flange splice plate at CL74S is distorted due to pack rust.

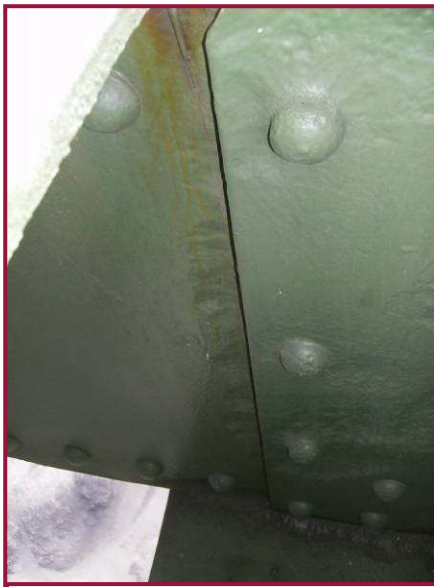
The lower chord, north web plate at DL69 exhibits pitting up to 1/4" deep along the gusset plate interface. This condition is common throughout Span 12; however, losses are typically less, consisting of 1/8" deep across the section. Also note the minor pitting along the interior face of the gusset plate adjacent to the lower chord.

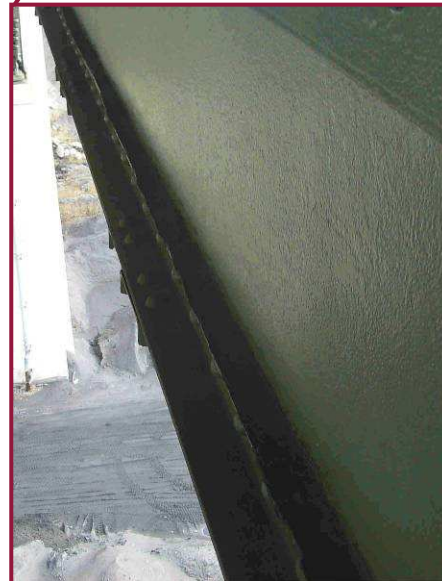
The lower chord member DL69-DL70 exhibits pack rust up to 2" thick between the north web plate and the lower flange angle. Pitting up to 3/16" was noted on the north web plate along the flange angle.

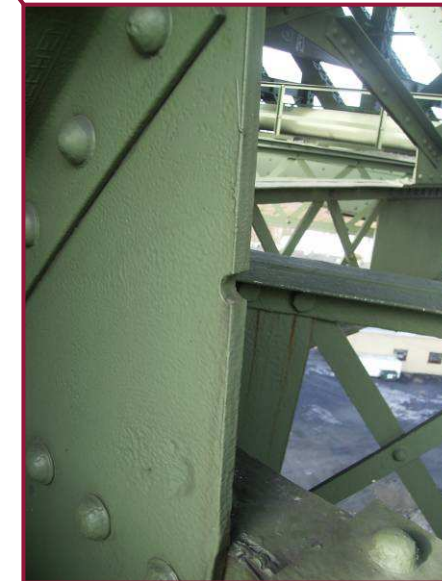
Both gusset plates at DL71 have misplaced drill/punch holes along the east free edge.

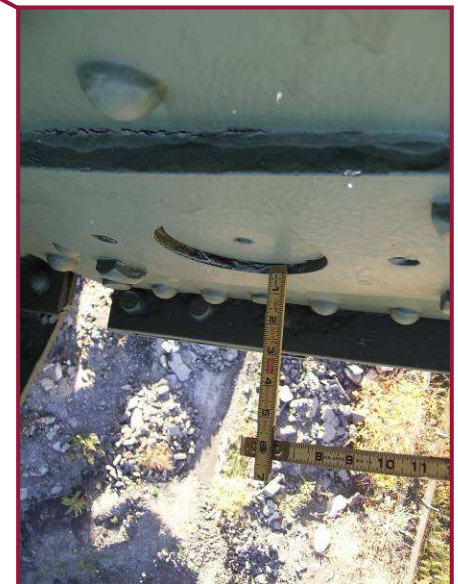
Pack rust at BL83 has pushed the sliding pin plates outward.

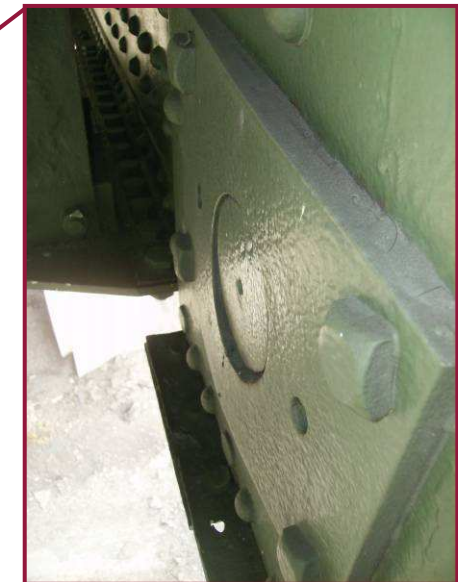
The suspended span sliding pin at DL83 is misaligned with the north keeper plate due to 3/8" pack rust causing localized plate distortion.

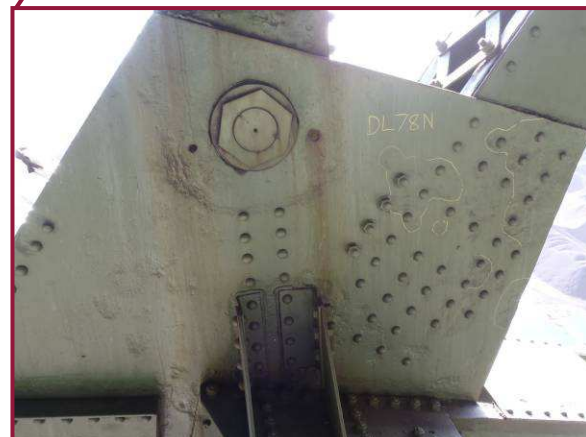
Heavy pitting (greater than or equal to 1/4" deep in isolated locations) of the lower gusset plates at the pin locations is typical with reactivating surface corrosion due to failing deck joints above.

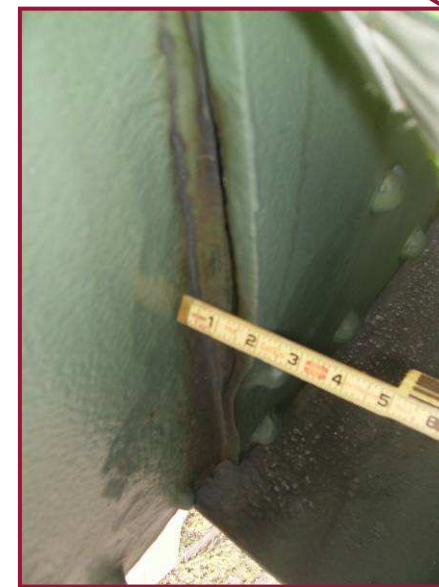
The north gusset plate at DL79 is bowed to the south approximately 1-3/16" along the interface with the lower chord web of DL78-D79 due to heavy pack rust accumulating between the two plates. Also note the 1/16"-1/8" loss of the web plate in this area.

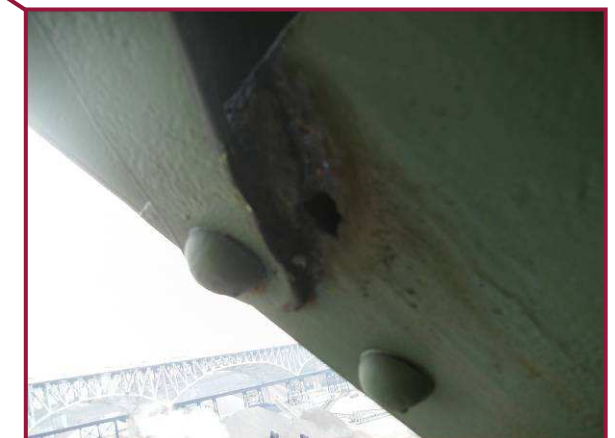
The lower batten plate on the underside of diagonal member DL80-UL81 exhibits advanced corrosion with a 2" hole and adjacent 1/4" pitting near the lacing connection.

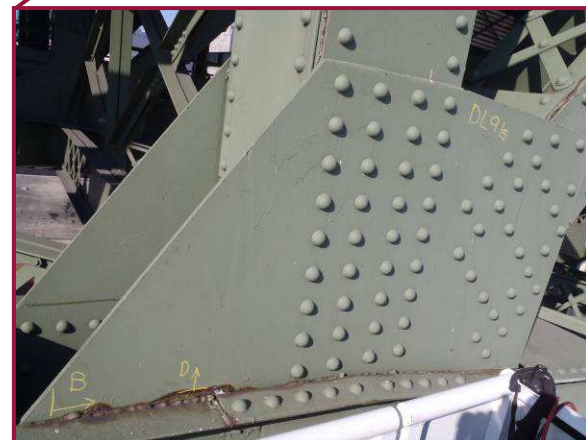
Gusset plate DL91 exhibits conditions typical of the exterior gusset plates throughout Span 14, Truss D, with activating rust along the interface at the lower chord and associated minor pitting.

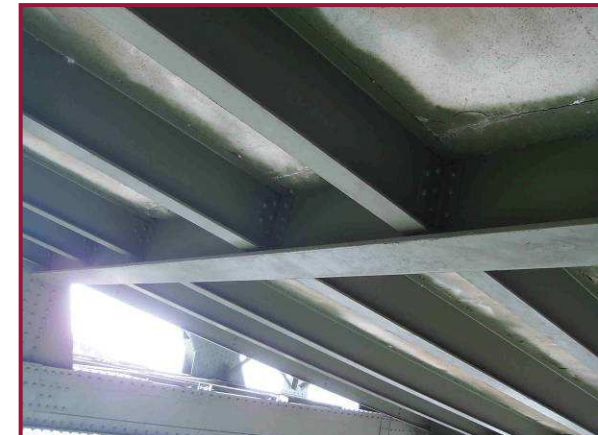
Typical framing between Trusses C and D showing the east face of Floorbeam 92. The interior portions of the floorbeams and the interior stringers are typically in good condition with isolated minor pitting (<1/16" deep) that has been cleaned and painted.

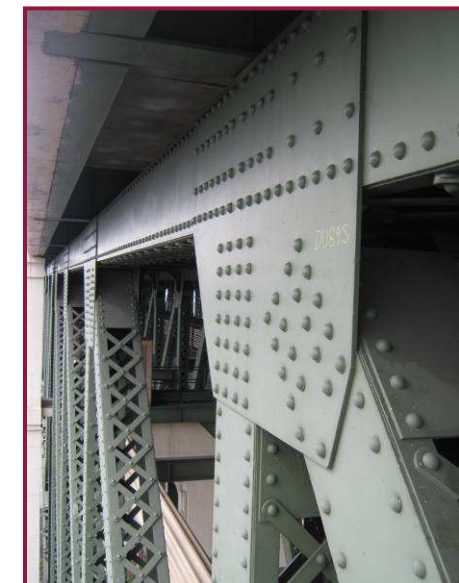
The upper chord of Truss D in Span 14 is in good condition overall with no significant deficiencies noted. Truss D is shown here looking northwest along the upper chord at DU89.

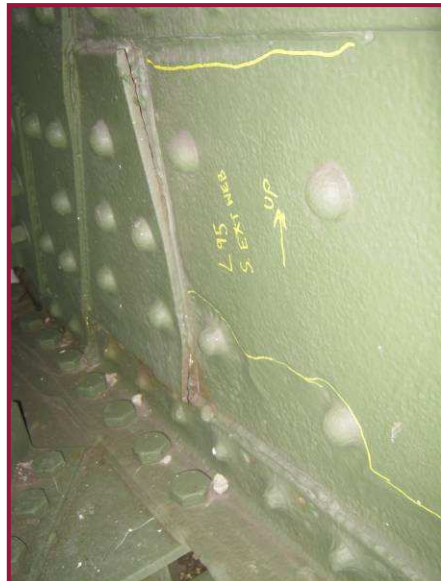
The south web plate of AL95-AL96 at AL95 exhibits 1/8" and 1/4" deep pitting along the top and bottom flanges, respectively. The bottom flange angle has 1/8" deep pitting on the vertical leg, with isolated pinholes measuring approximately 1/4" diameter.

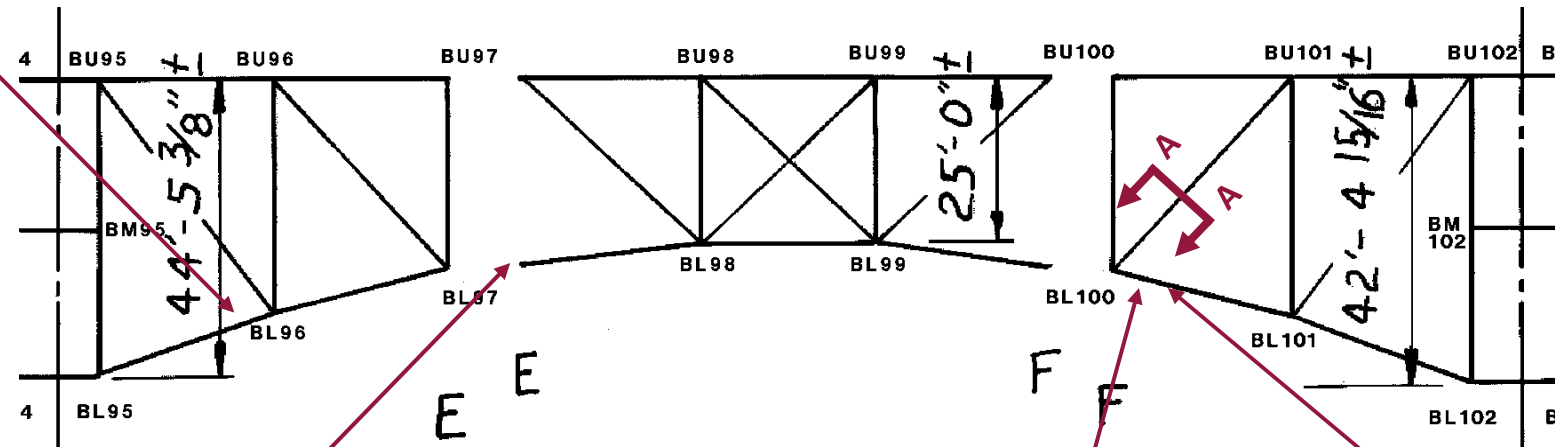
**SPAN 15  
TRUSS B**

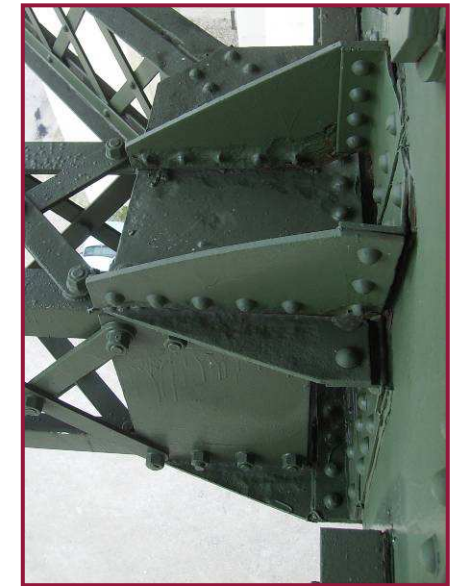
The lateral connection members at BL100 exhibit 1/8" deep pitting throughout the horizontal faces. Pack rust has formed between the knee brace connection and the gusset plate, distorting the connection angles.

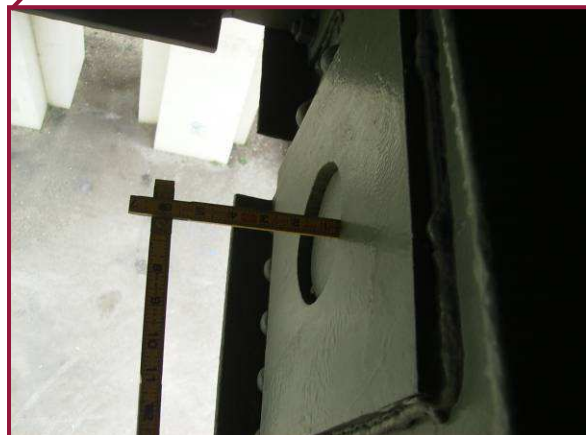
The south outermost pin plate at BL97 has been replaced with the welded plate shown. The end of the pin and the outer edge of the plate are 1/2" out of plane, resulting in less pin bearing area.

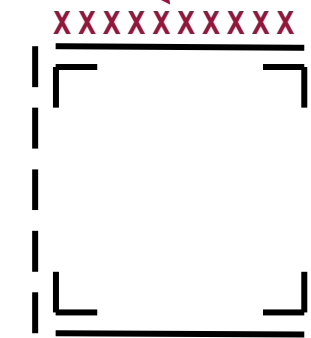
1/4" deep pitting for the full height of the web

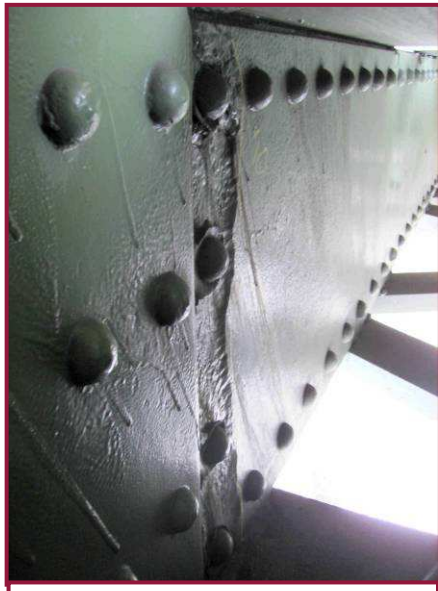
The south web plate of CL95-CL96 exhibits advanced section loss across the full height of the plate at the interface with the south gusset at CL96. Pitting up to 3/8" was noted at this location.
