**PHYSICAL CONDITION REPORT  
FOR THE 2010 IN-DEPTH INSPECTION**

**LORAIN-CARNEGIE BRIDGE**

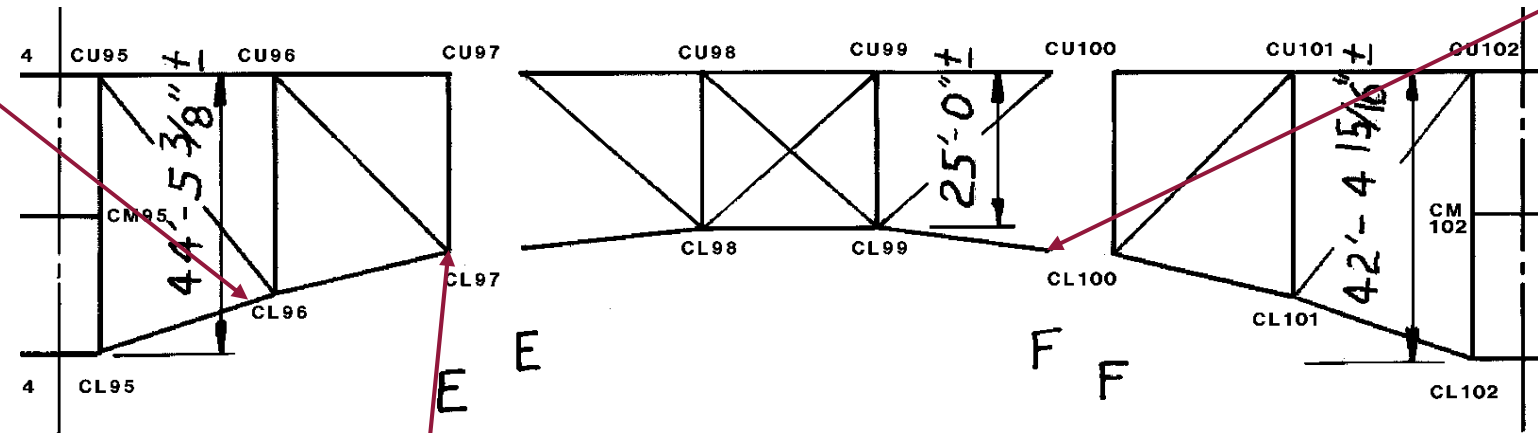
**SPAN 15  
TRUSS C**

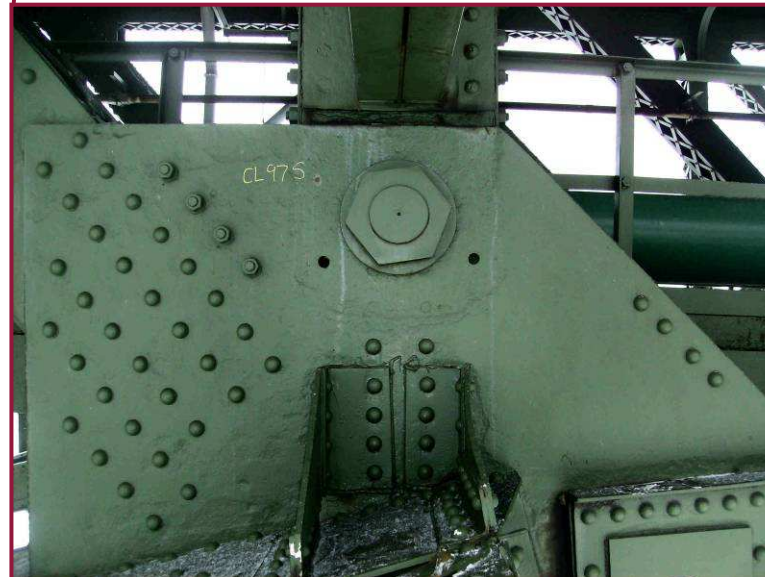
The south gusset plate at CL97 exhibits heavy pitting throughout the south face with up to 1/4" deep areas isolated among the more typical 1/8"-3/16" deep pitting. The deepest pitting is found along the interface of the gusset with the lower chord top flanges and vertically along the lateral knee brace.

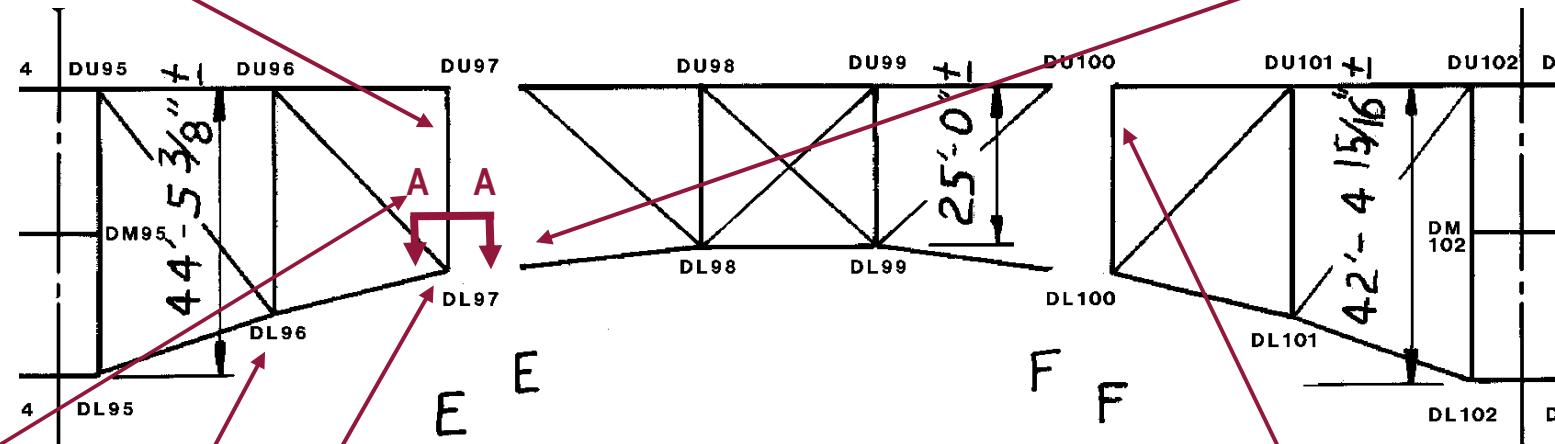
The lower chord at DL97/DL98 exhibits distressed connections due to heavy pack rust, as well as heavy localized pitting up to 5/16" deep.

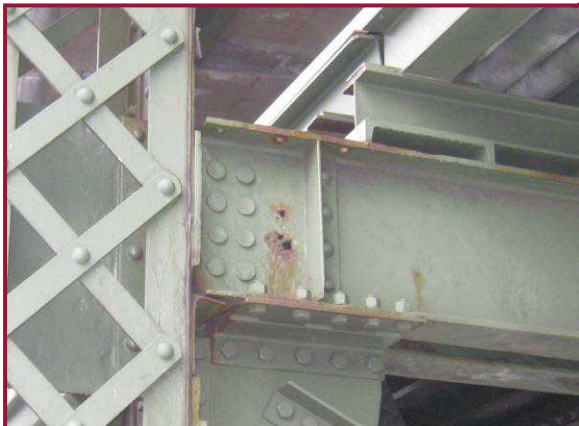
Three 1"Φ holes are present in the web of the sway strut between Truss D and Truss C at Panel 97.

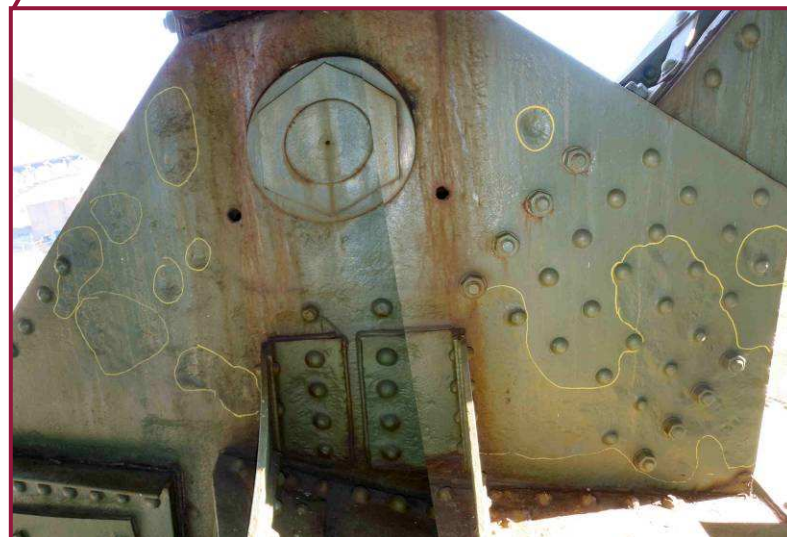
The north gusset plate at DL97 exhibits areas of heavy pitting throughout its north face. Pitting greater than or equal to 1/4" deep is indicated by the field markings, as shown. Rust is activating throughout the upper portion of the plate, as well as along the lower chord top flange interface.

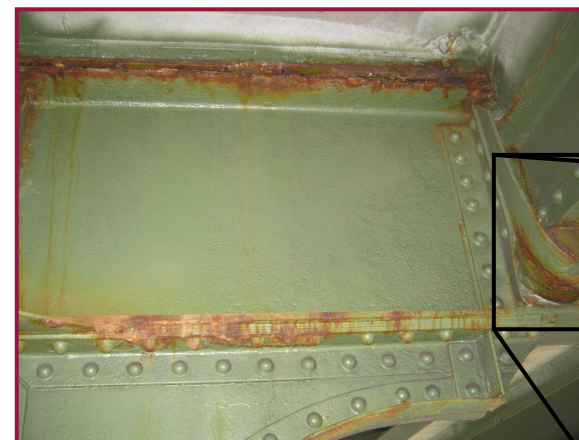
At Floorbeam 100 active rusting of the flanges is typical throughout, with advanced corrosion of the stringer connection angle below the saddle bearing rivets. The connection angle has a 1.5" diameter perforation at this location (right). Additionally, the saddle bearings typically exhibit minor pitting and reactivating rust; however, some locations exhibit pitting with minor loss of section.

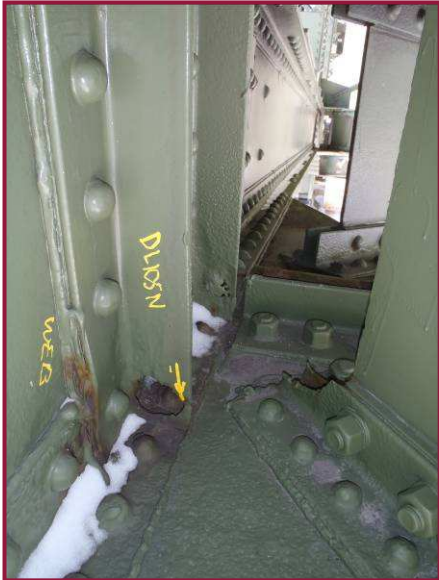
Vertical stiffeners for the lower chord at DL105 exhibit advanced section loss with both outstanding legs having 100% loss in the lower 4". Pack rust has formed between the stiffener angle and the web fill plate at this location, and heavy pitting of the lateral bracing connection plate and the lateral bracing bottom flange angles.

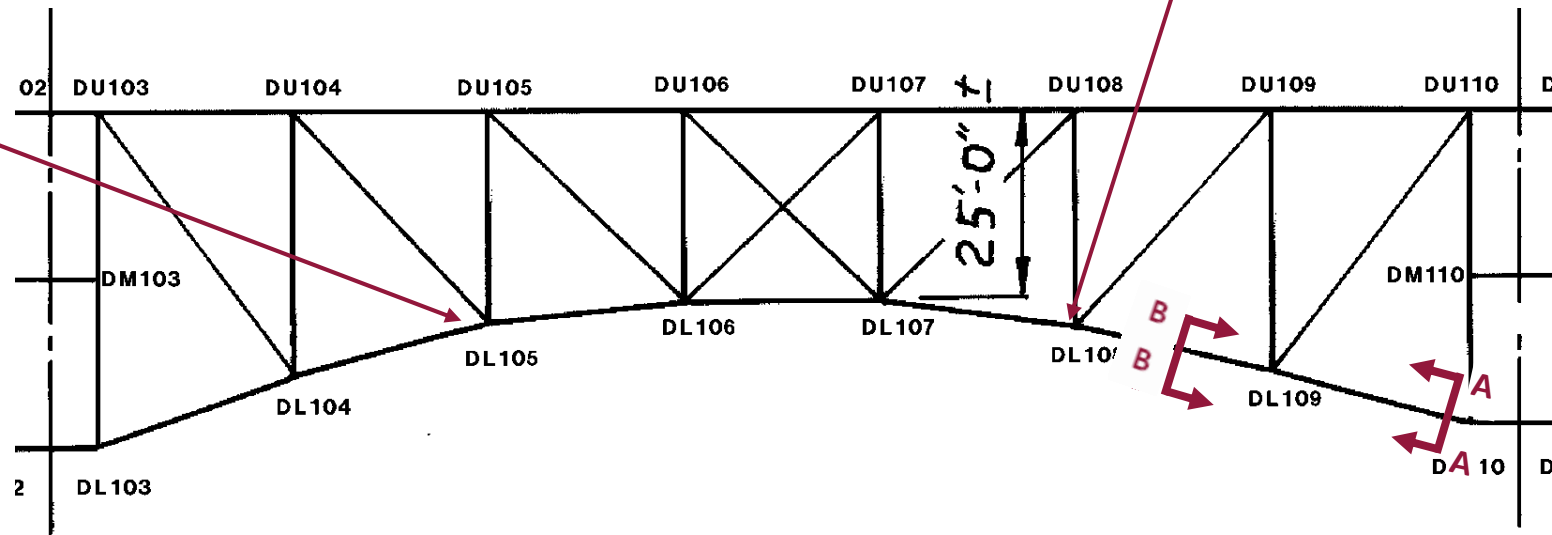
**SPAN 16  
TRUSS D**

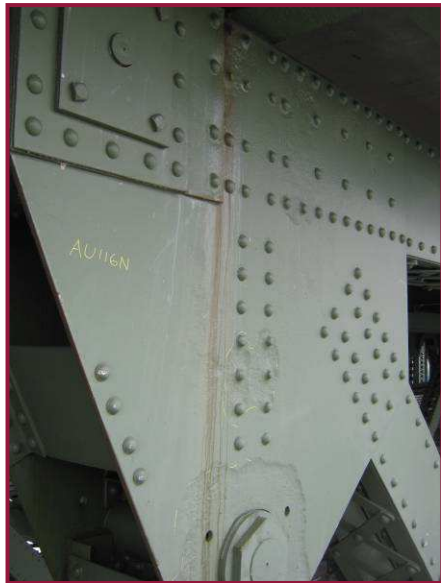
The south gusset plate at AU113 exhibits pitting up to 1/4" deep adjacent to the bearing pin, as well as isolated minor pitting throughout the upper half of the interior face of the plate.

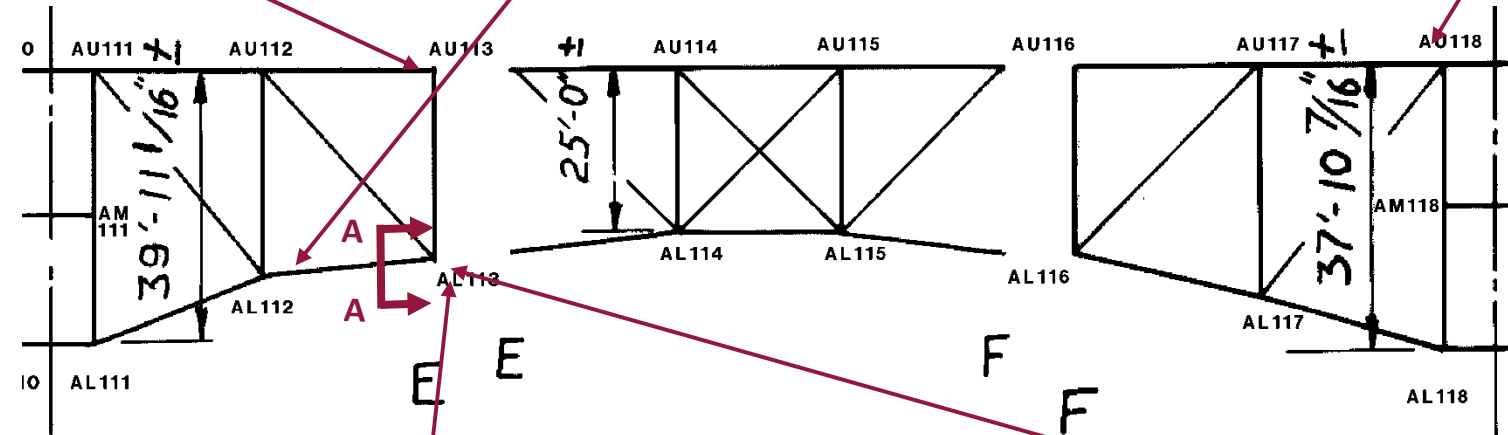
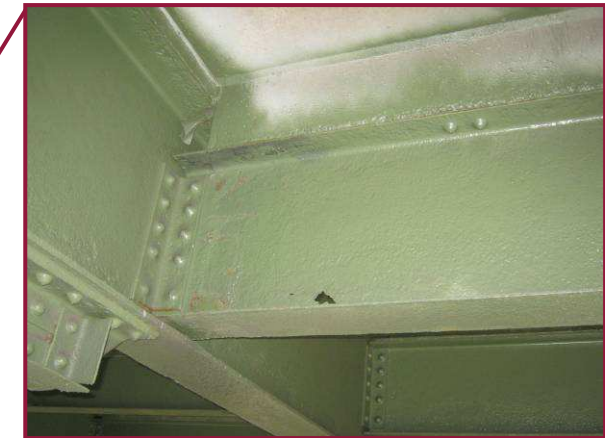
Stringer 2 between AU117 and AU118 exhibits advanced section loss with less than 1/8" section remaining for the full height of the web near AU118. A 4" diameter hole is present in the web at the flange.

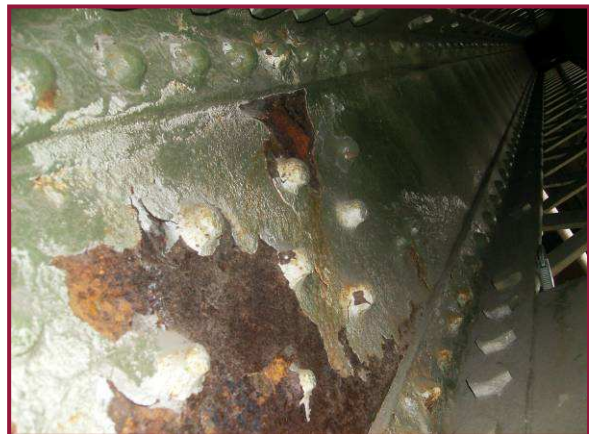
The interior of BU112-BL113 exhibits failing paint throughout with minor active corrosion near BL113. The rivets connecting the diagonal member to the gusset plates are heavily pitted, with an estimated 50% loss of rivet head section.

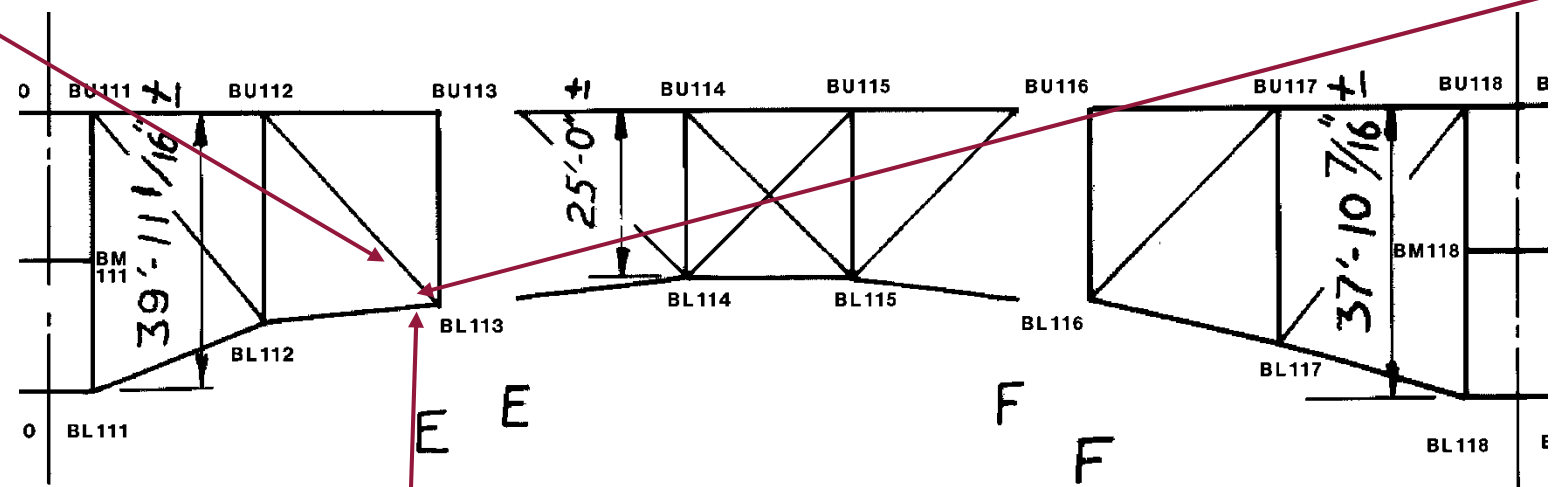
**SPAN 17  
TRUSS B**

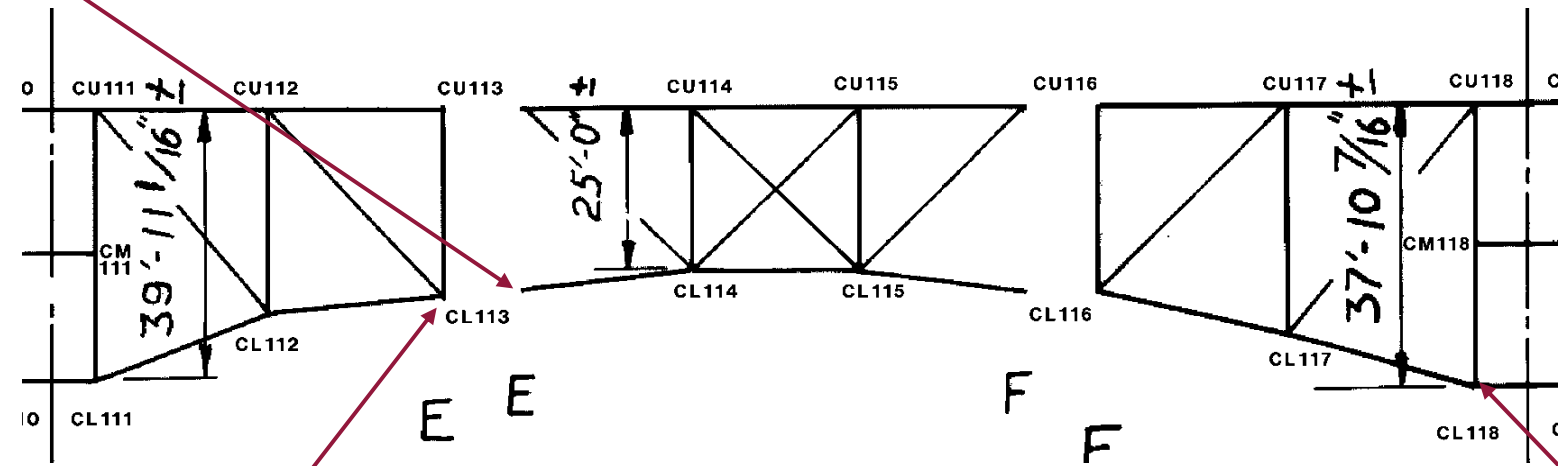
**SPAN 17  
TRUSS C**

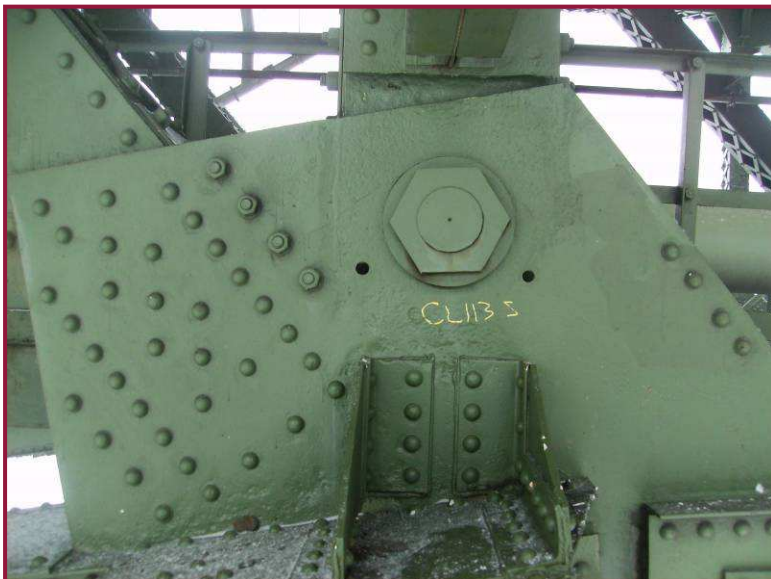
The north gusset plate at CL113 exhibits heavy pitting throughout the north face with up to 1/4" deep areas isolated among the more typical 1/8"-3/16" deep pitting. The deepest pitting is found along the interface of the gusset with the lower chord top flanges and vertically along the lateral knee brace.

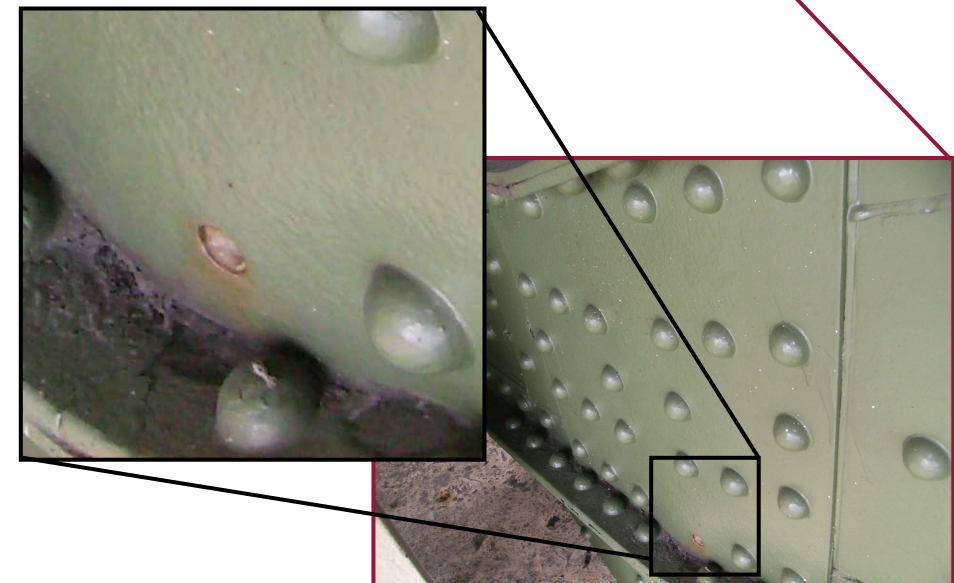
The outermost north web splice plate at CL118 is bowed along the bottom flange angle due to pack rust and a rivet has broken as a result.

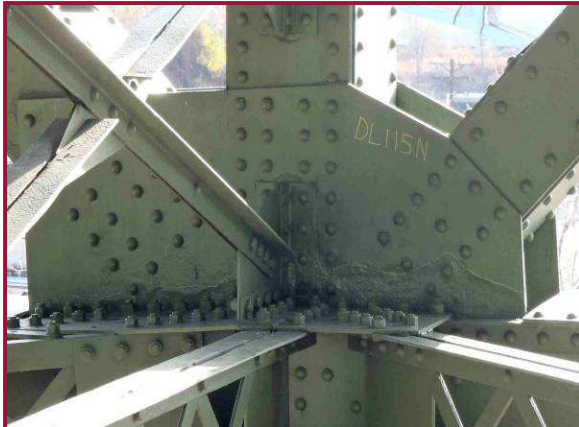
DL115N exhibits heavy pitting along the lower chord interface. The pitting is typically between 6" and 12" tall and extends the length of the plate. DL114N exhibits similar conditions.

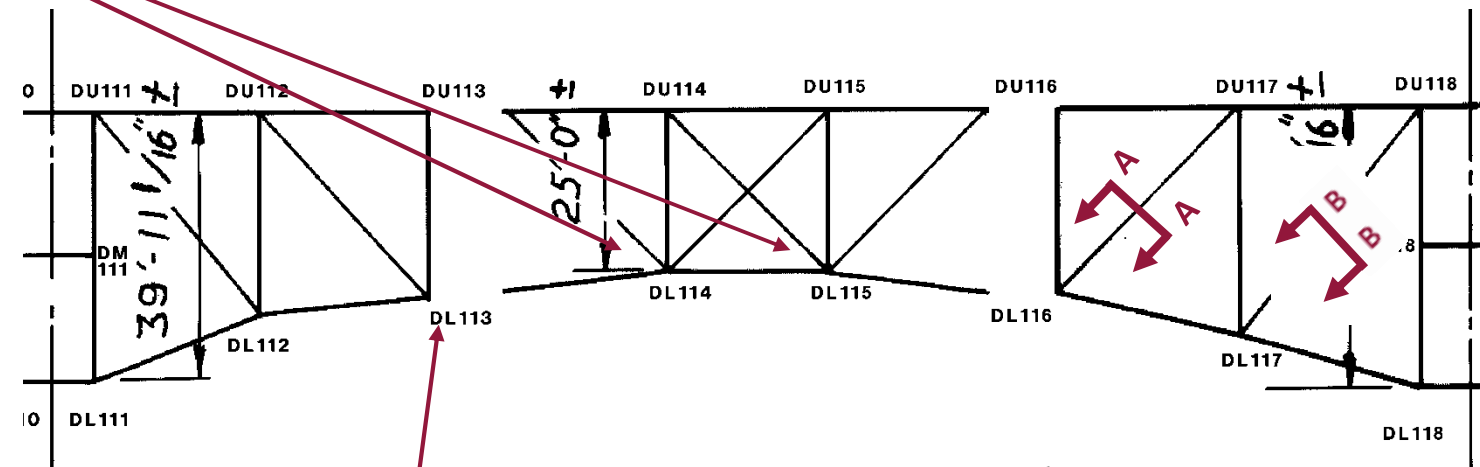
Locations of advanced section loss are isolated throughout Span 17, with isolated flange angles and lacing channels exhibiting small perforations.

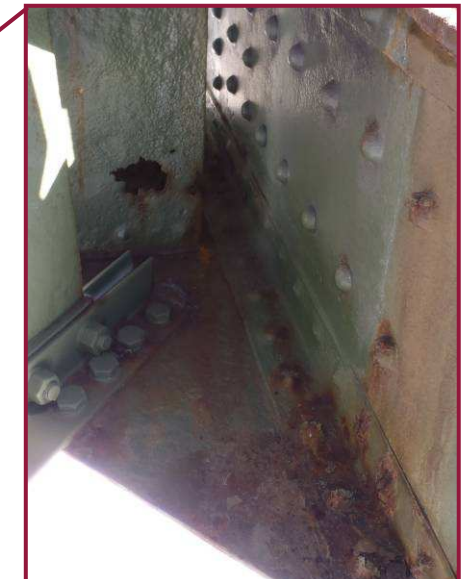
The lower chord below DL113 exhibits heavy pitting of the north web plate and flange angles. The stay plate of the lateral bracing is perforated with a 6"Ø hole.

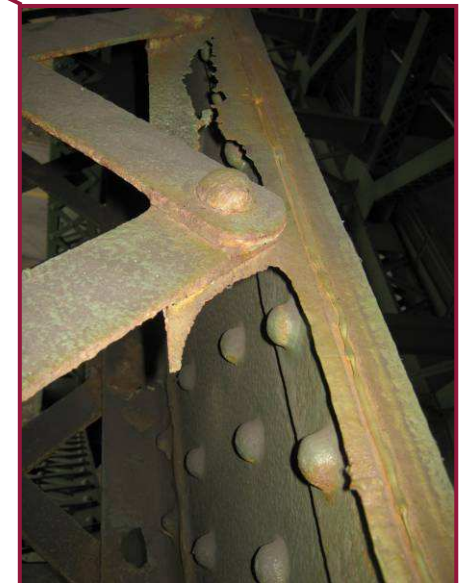
The horizontal leg of the flange angle of AU120-AU121 exhibits advanced section loss with a large area completely corroded. Rust is beginning to reactivate in this area.

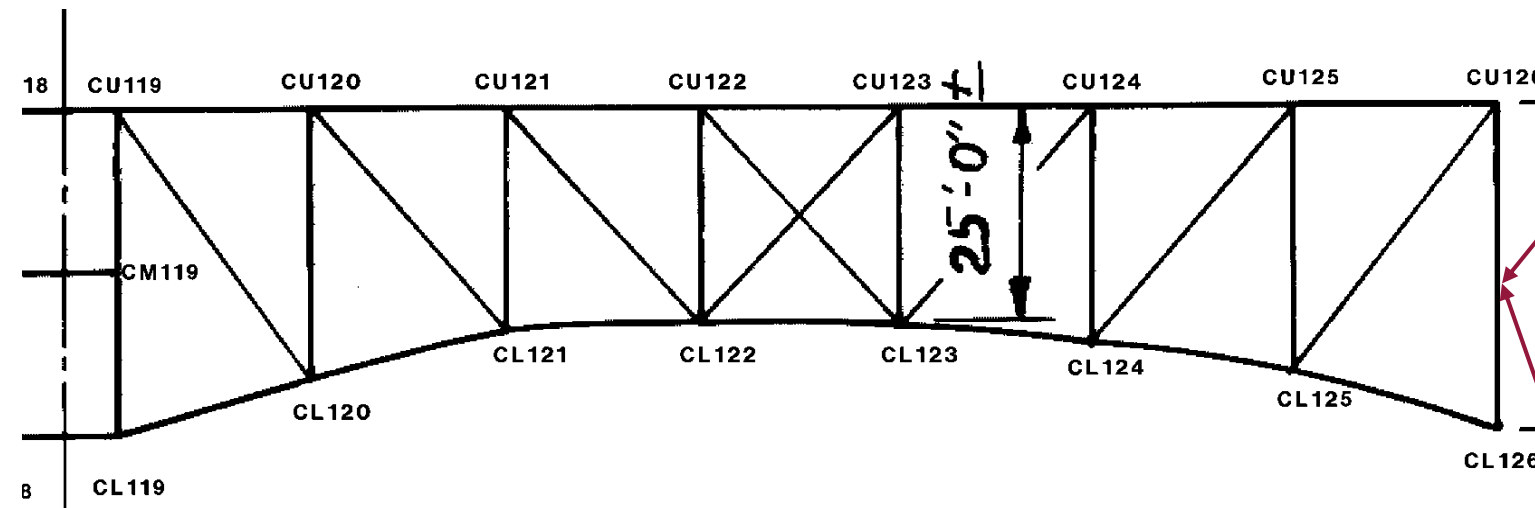
**SPAN 18  
TRUSS C**

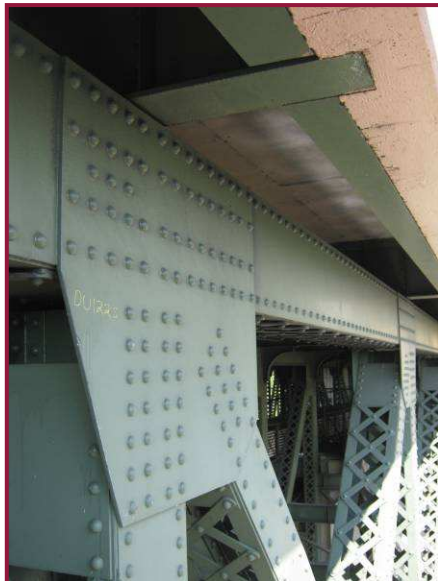
The Truss D upper chord in Span 18 is typically clean with paint intact and no significant deficiencies. DL122 is shown looking east.

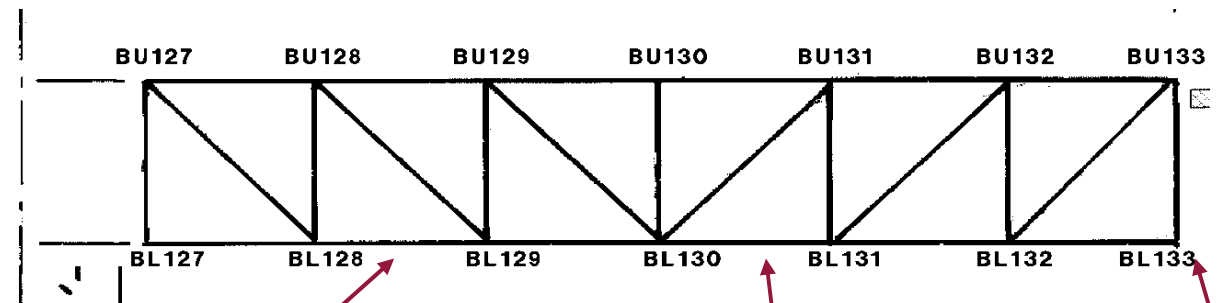
**SPAN 20  
TRUSS B**

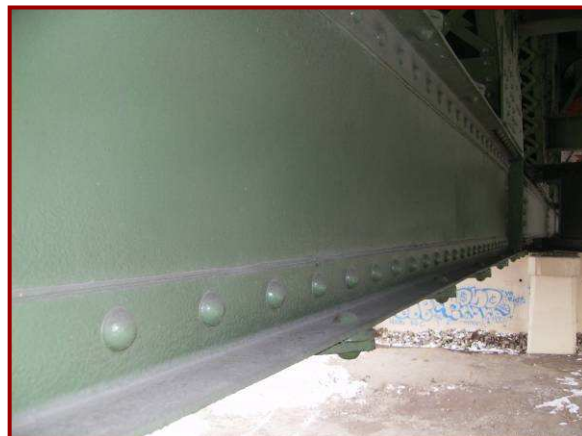
BL128-BL129 exhibits conditions typical for lower chord members throughout Truss B in Span 20.

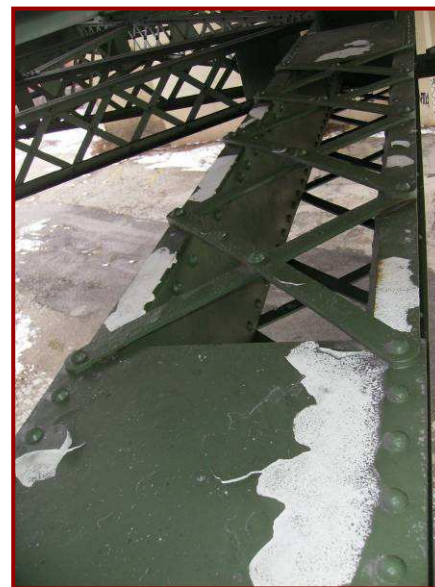
BL130-BL131 exhibits extensive areas of peeling paint.

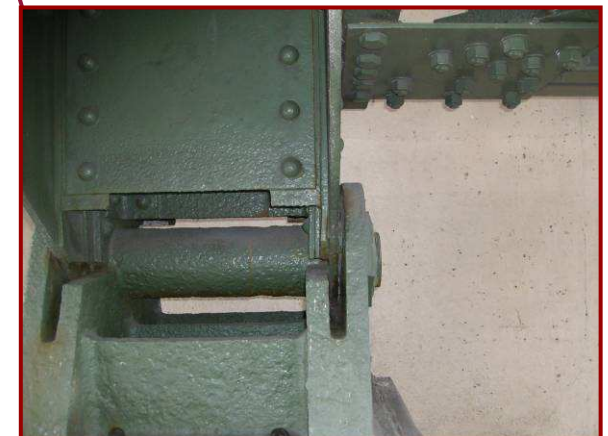
The bearing components at BL133 exhibit 1/8" pitting on all surfaces, with isolated pitting up to 1/4". Additionally, surface rust is reactivating between built up members.

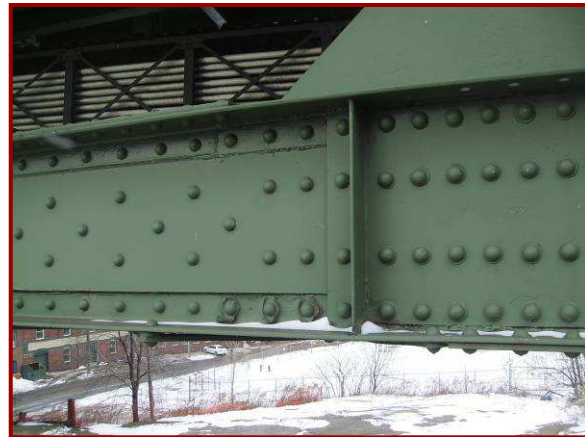
The south web fill plate exhibits 100% section loss below the bounds of the splice plate as well as 1/8" pitting on the bottom angles.
