**PHYSICAL CONDITION REPORT
FOR THE 2011 ROUTINE INSPECTION**

LORAIN-CARNEGIE BRIDGE

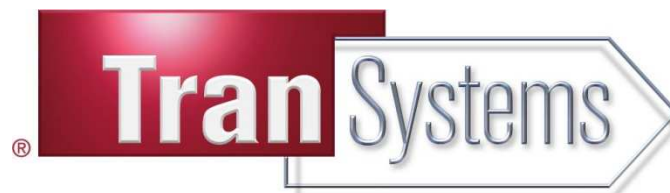
**IN-DEPTH PHYSICAL CONDITION REPORT
Of The
LORAIN-CARNEGIE BRIDGE
S.R. 10**

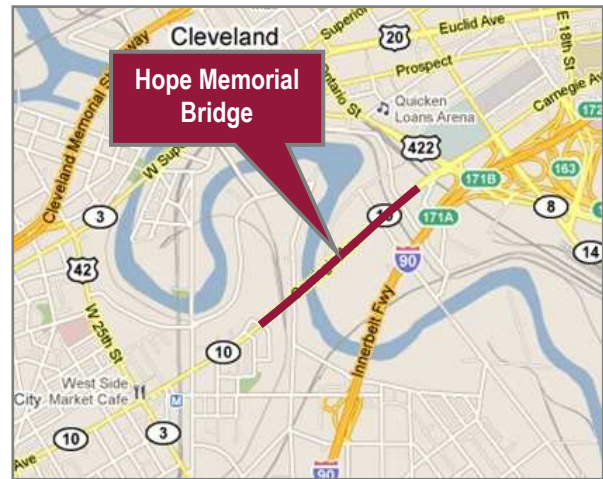
The CUY-10-1613 (Hope Memorial) Bridge carries four lanes of State Route 10 traffic approximately 3,200 feet on the southwest side of Cleveland, Ohio. The bridge passes through downtown Cleveland and over the Cuyahoga River, Norfolk Southern/CSX railroad tracks and numerous local streets. Constructed in 1932, the bridge was originally designed to carry two rapid transit tracks on a lower deck alongside a utility deck for truck access. The main truss spans include a 13-span cantilevered Pratt deck truss consisting of 4 truss lines and an additional simply supported Pratt deck truss with 3 truss lines at the east end of the bridge (see **Figures 1 and 2**). The west approach spans consist of steel beam simple spans, supported by both steel bents and concrete piers, while the each approach is a concrete cellular unit.

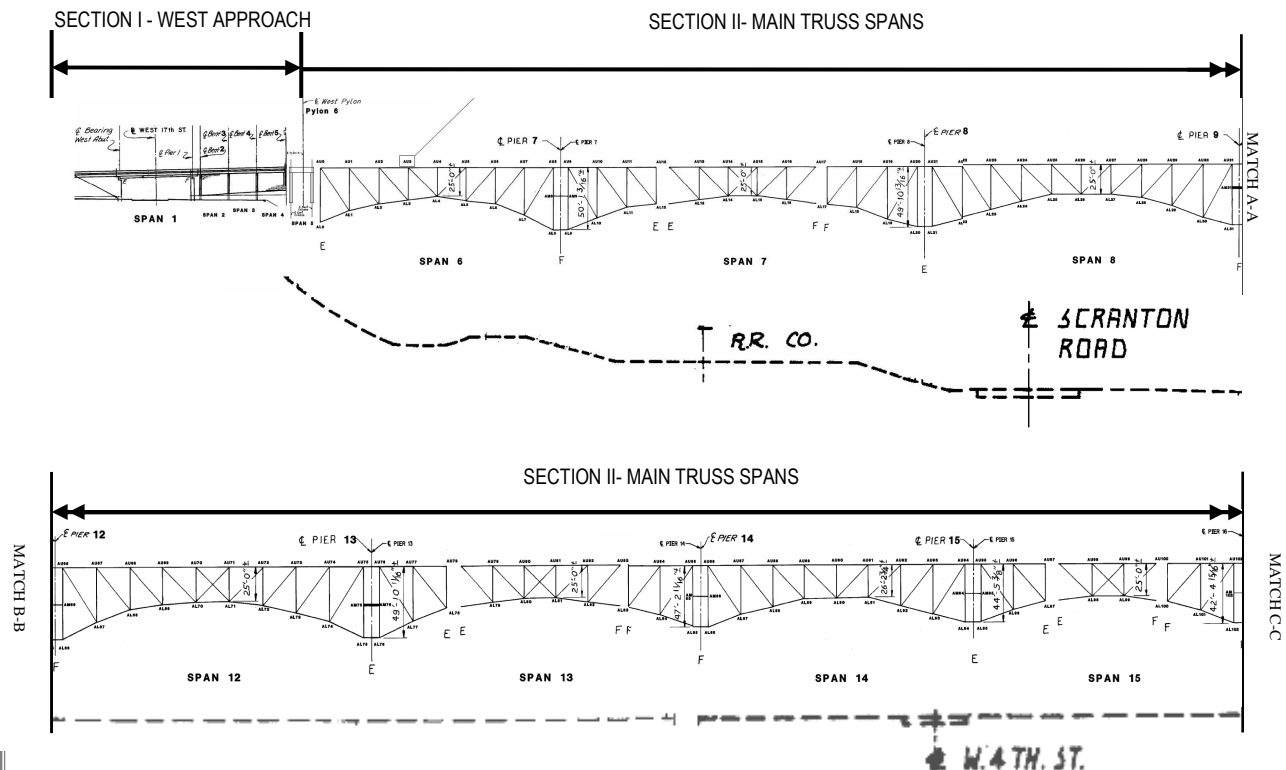
Figure 1 – Partial south elevation of the Lorain-Carnegie Bridge.

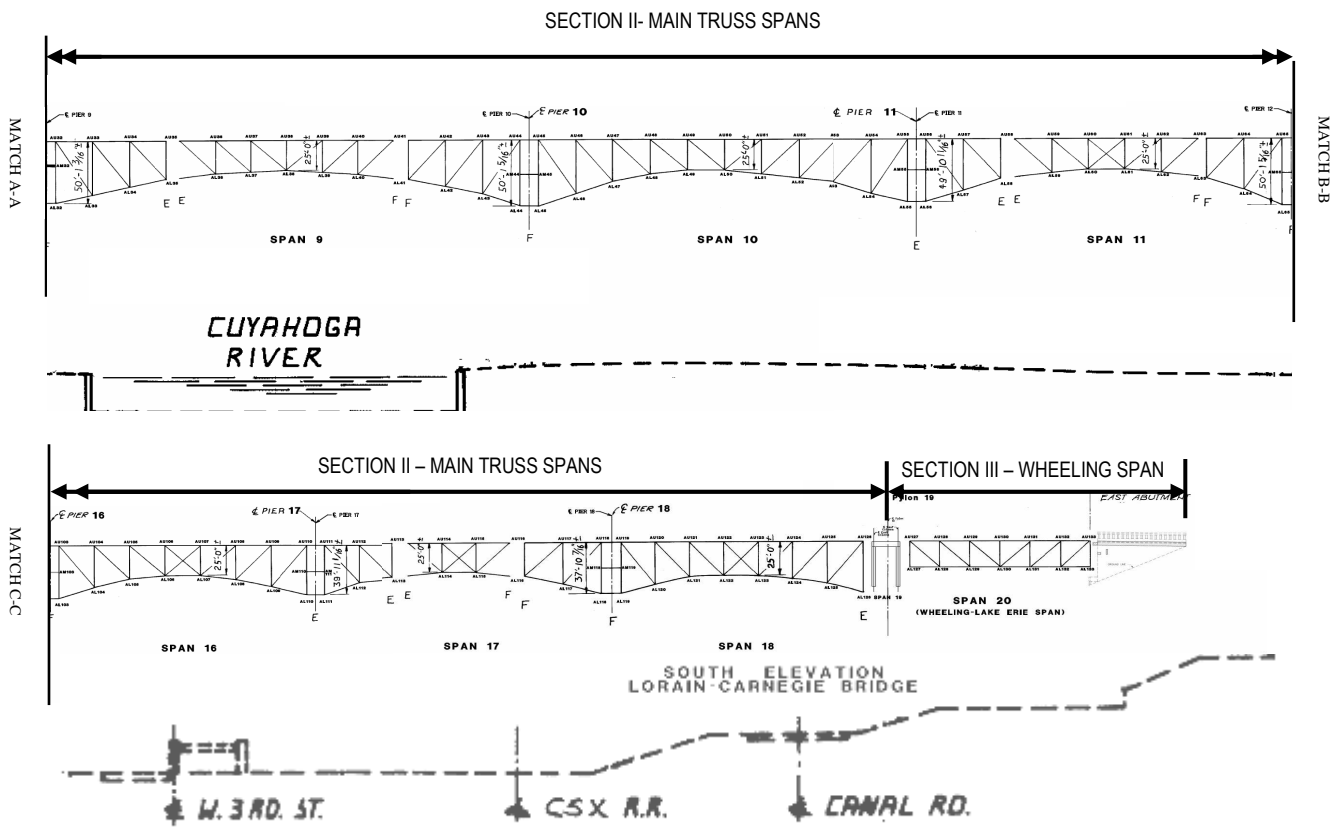
Figure 2 – Partial south elevation of the Lorain-Carnegie Bridge.

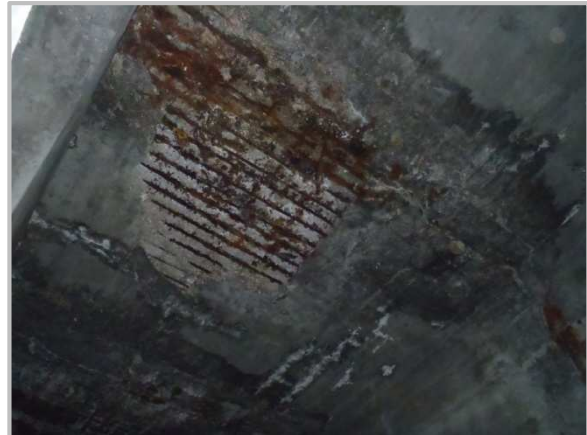
Photo 1 – 10' diameter spall with 100% section loss to 7 consecutive transverse reinforcing bars within the east cellular unit.

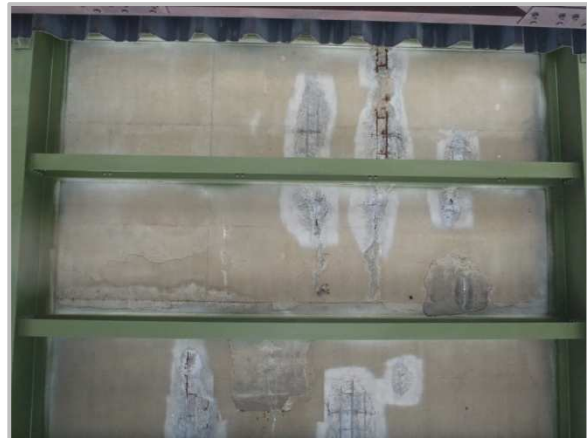
Photo 2 – Roadway deck underside in Span 16 between Floorbeams 107 and 108. Note several spalls have been sealed.

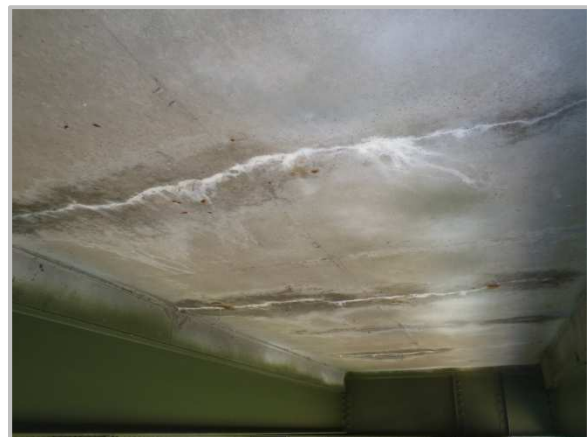
Photo 3 – Transverse cracks with efflorescence and stalactite formations between Floorbeams 28 and 29.

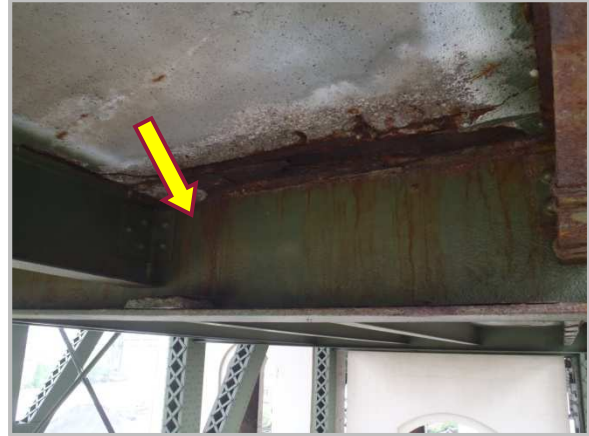
Photo 4 – Typical utility deck haunch spall in Bay 5 adjacent to the top flange of Floorbeam 53.

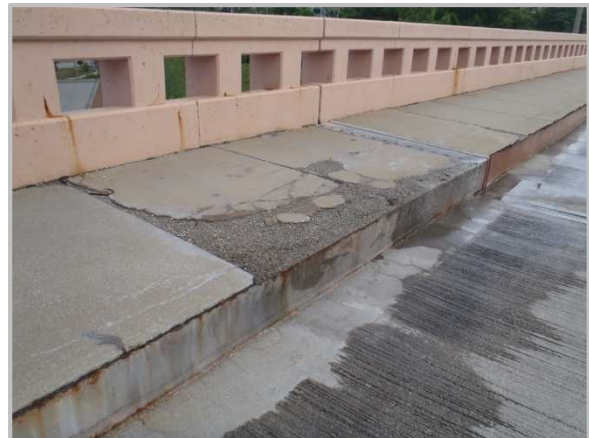
Photo 5 – Shallow spalls in north sidewalk surface adjacent to East Abutment joint.

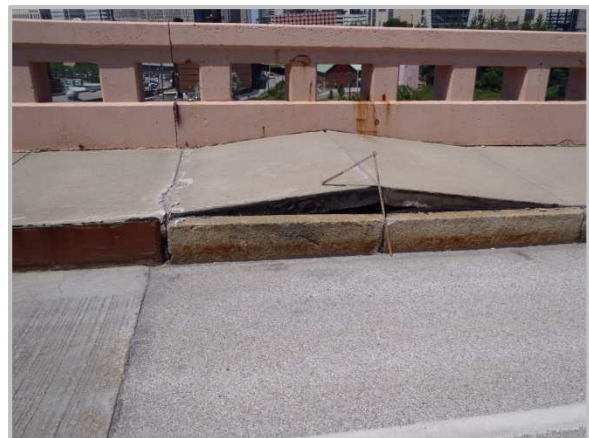
Photo 6 – Buckled section of north sidewalk adjacent to the joint between the east approach slab and east approach roadway.

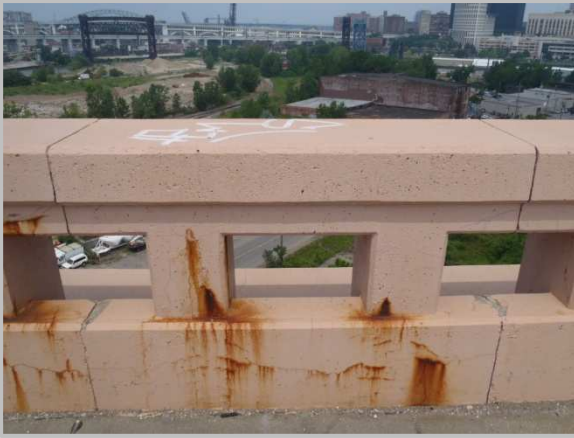
Photo 7 – Typical parapet hairline cracks with rust staining.

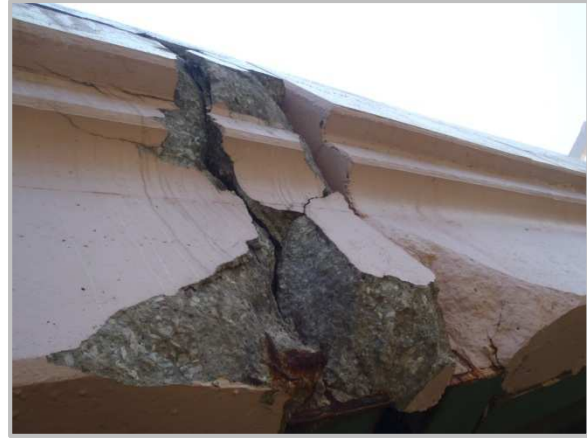
Photo 8 – Spall with exposed reinforcing in fascia soffit over Panel Point AU12.

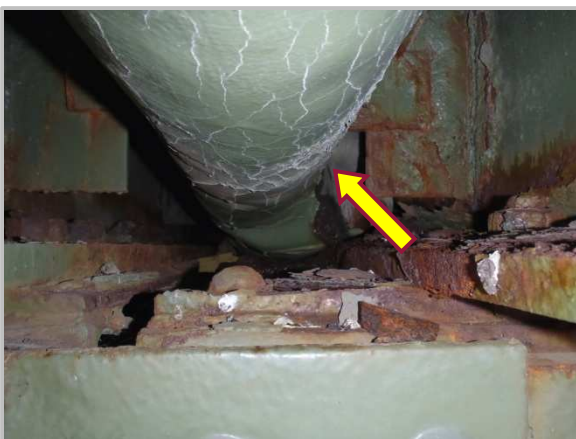
Photo 9 – Isolated torn neoprene trough and active corrosion to framing members adjacent to Panel Point DU35.

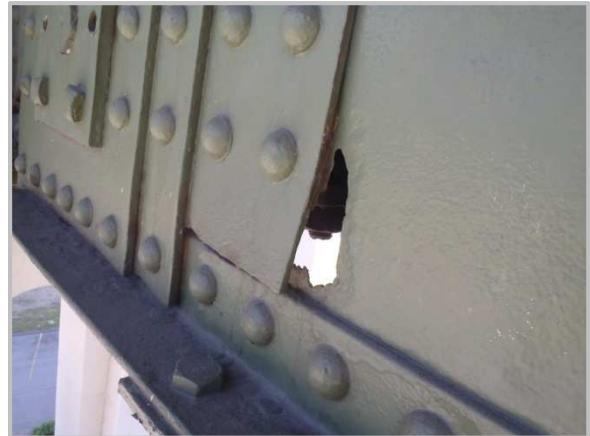
Photo 10 – 4" high by 5" wide holed-through section in south web plate of member CL113-CL114 near CL113 pin location.

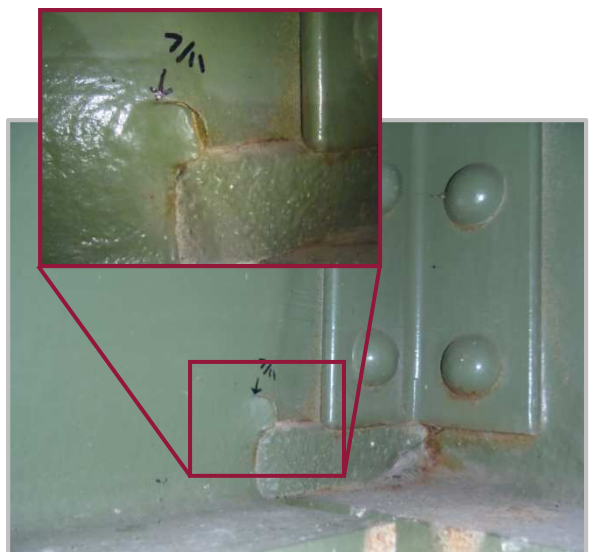
Photo 12 – West end of Stringer 1 at connection to Floorbeam 24 with hooked crack in bottom flange cope. Note bow in stringer web at this location.

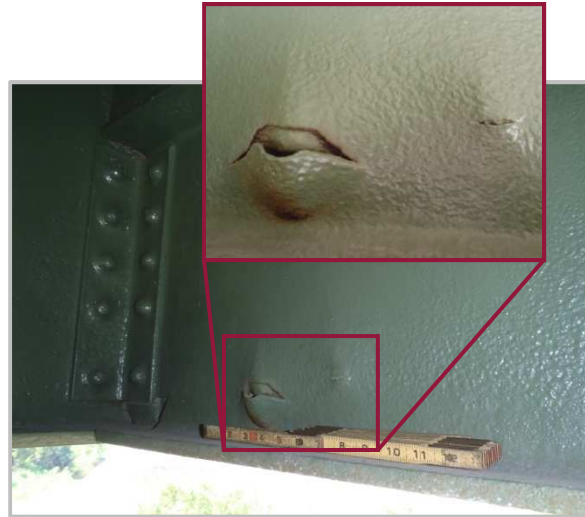
Photo 13 – Tears in web of north fascia stringer just east of Floorbeam 25 with concrete seepage.

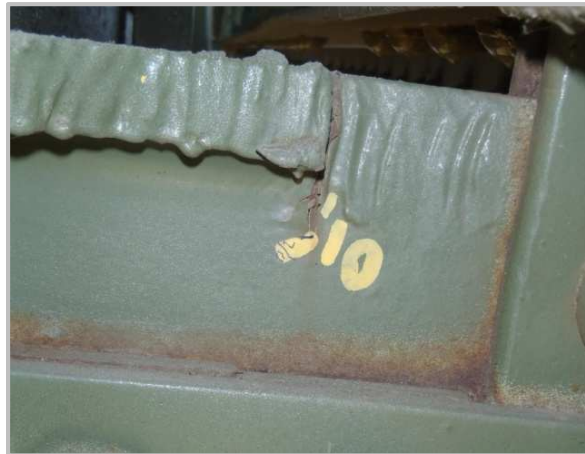
Photo 14 – Crack in utility deck floorbeam at connection to gusset plate CL37S.

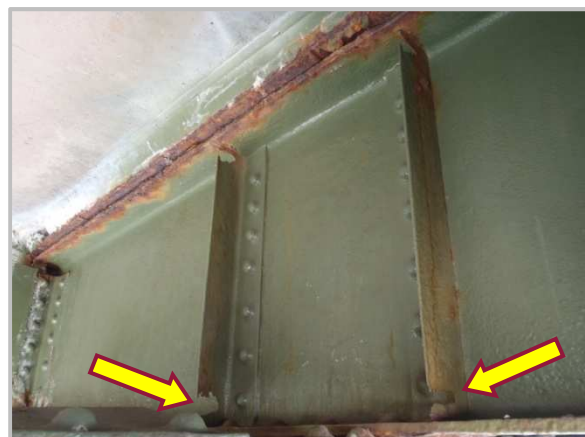
Photo 15 – East face of Floorbeam 100 with 100% section loss to web stiffeners adjacent to Truss A.

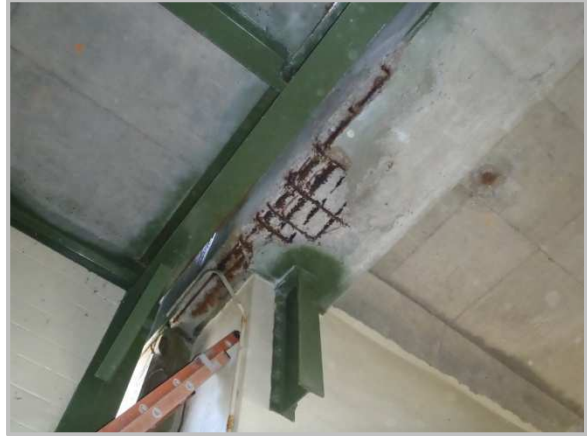
Photo 16 – Spall with exposed reinforcing at north end of west end floorbeam in Pylon Span 5.

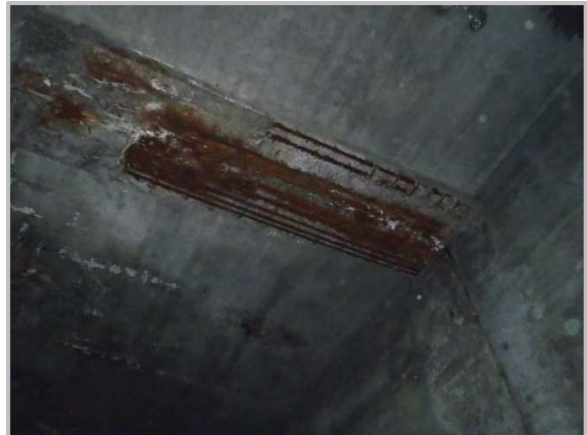
Photo 17 – Spall with exposed, corroded reinforcing bars in Floorbeam 5 underside in the north bay of the east cellular unit.

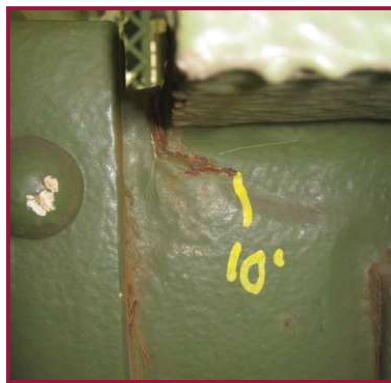
Photo 19 – View of same crack location during 2010 inspection

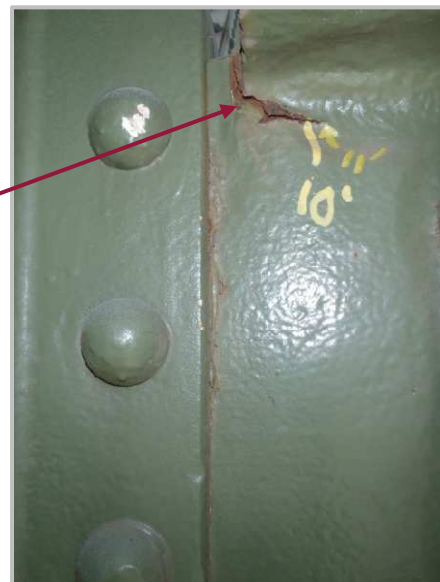
Photo 18 – Crack in utility deck floorbeam at connection to gusset plate CL36N.

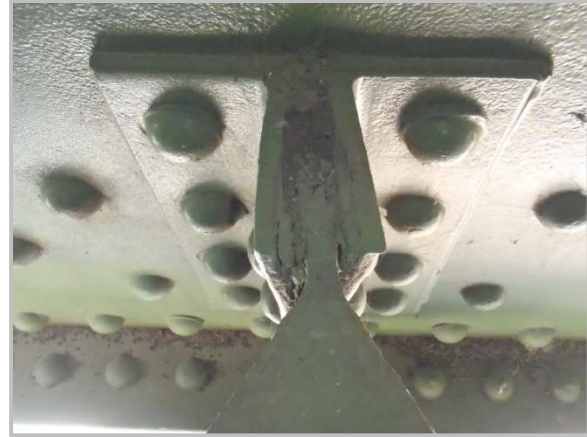
Photo 20 – Pack rust at utility deck floorbeam web and connection angles to gusset plate CL4S.

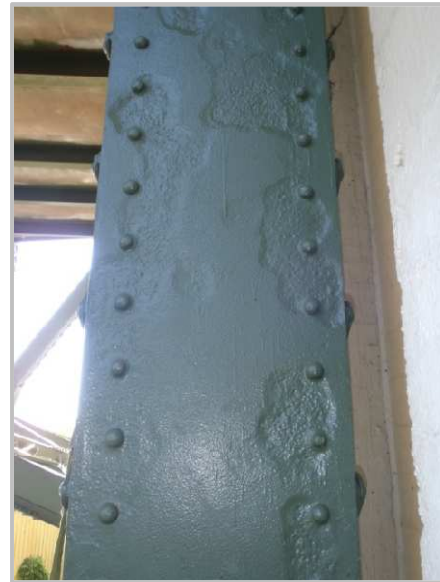
Photo 21 – 1/8" pitting on member BL0-BU0 with isolated 1/4" pitting over the lower half of the north web plate.

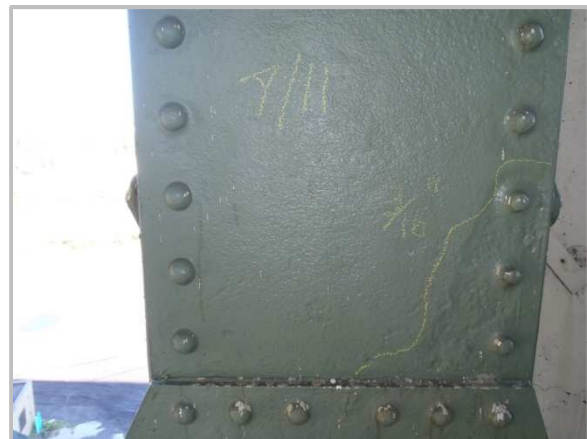
Photo 22 – AL65-AU65 with 3/16" pitting on south web plate along lower chord gusset plate.

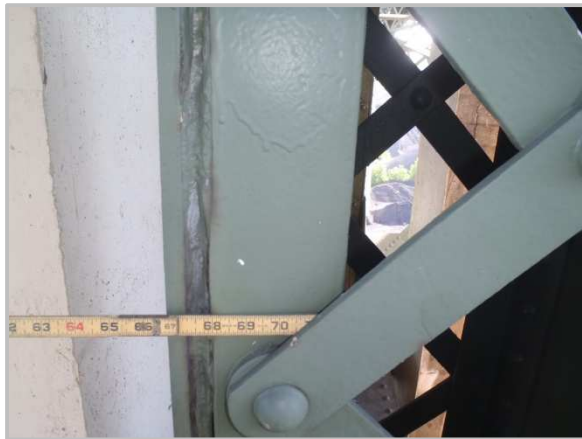
Photo 23 – Pack rust between the north web plate and flange angles of member CL65-CU65 up to 3/4" thick.

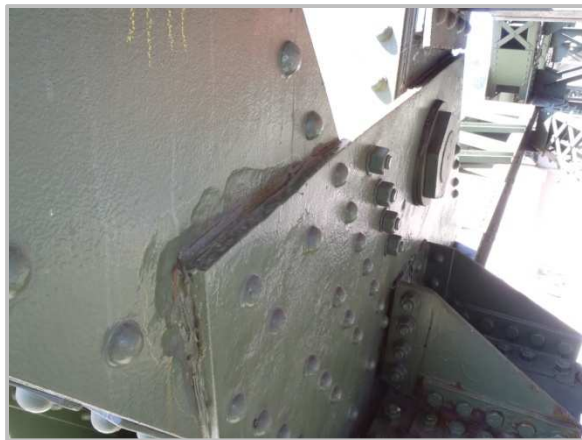
Photo 24 – Member DL116-DU117 with 3/8" pitting on the north web plate along the lower chord gusset plate.

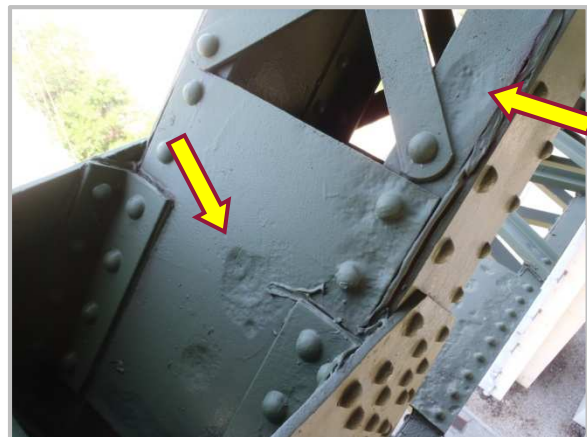
Photo 26 – Pitting up to 1/4" deep on AL108-AU109 batten plate and top flange angle at lacing bar connection adjacent to lower chord gusset plate.

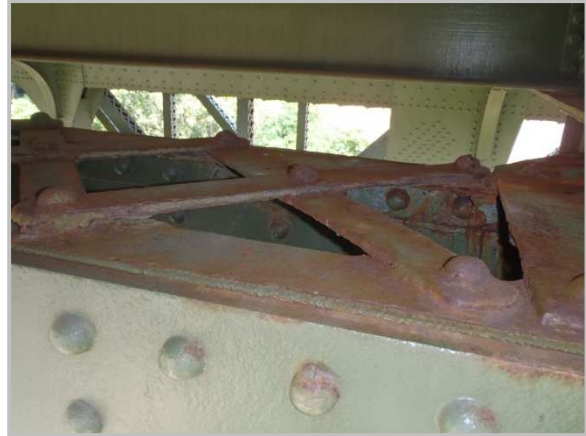
Photo 27 – Active corrosion on DU4-DU5 top flange angles and lacing bars near Panel Point 5.

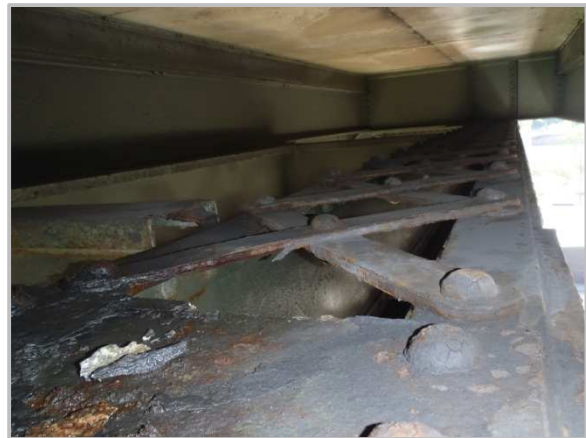
Photo 28 – Pitting up to 1/8" on top flange angles and lacing bars with active corrosion at DU80-DU81 subdrain location.

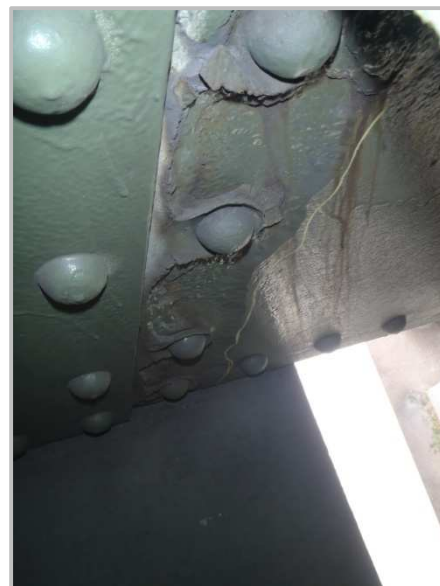
Photo 29 – Advanced section loss up to 3/8" across the hull height of the CL95-CL96 south web plate along gusset plate CL96S.

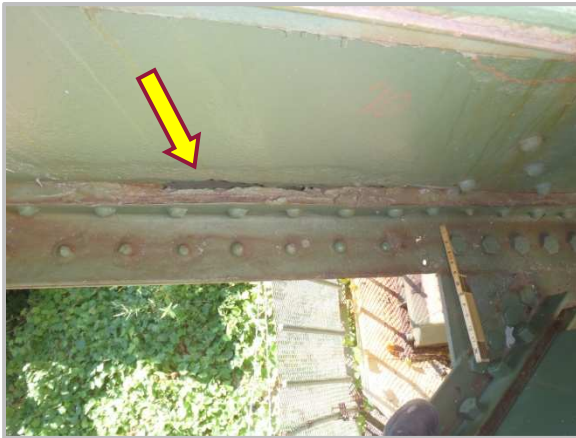
Photo 31 – Holed-through section of DL0-DL1 north web plate 24" long by 2" high adjacent to gusset plate DL0N.

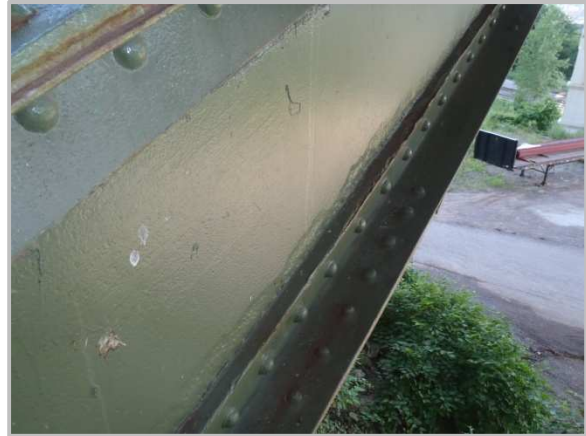
Photo 30 – South web plate of AL0-AL1 with 1/8" pitting along the bottom flange angle.

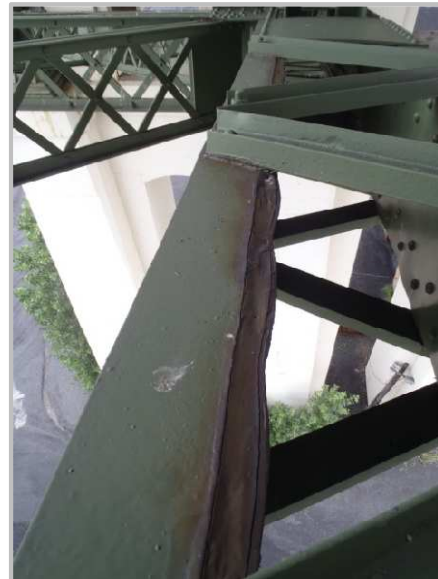
Photo 32 – Previously sealed impacted rust beginning to reactivate between the north web plate and top flange angle of member BL53-BL54.

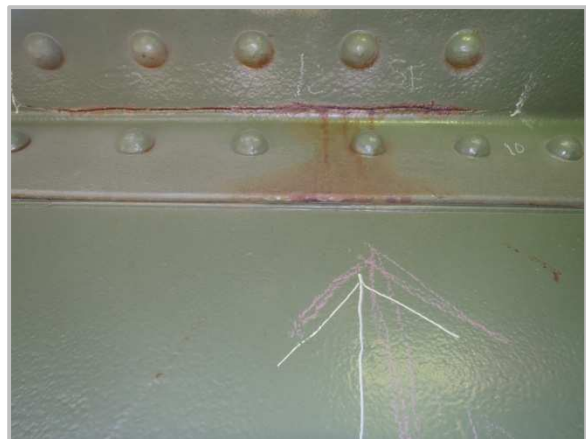
Photo 33 – Crack in top flange angle of DL15-DL16 near DL15 within bounds of top batten plate. This crack has not propagated since the last inspection.

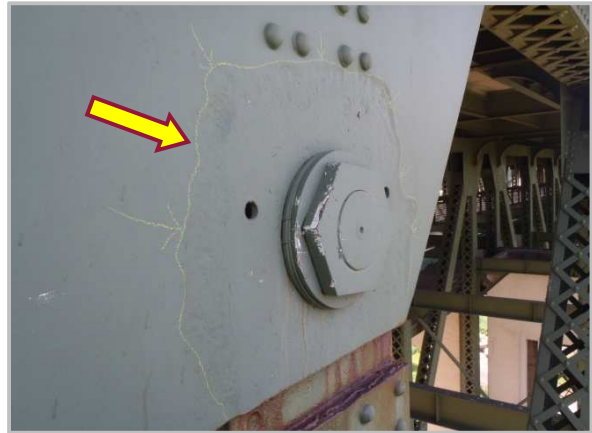
Photo 34 – Typical 1/4" pitting surrounding pin (gusset plate DU113S shown).

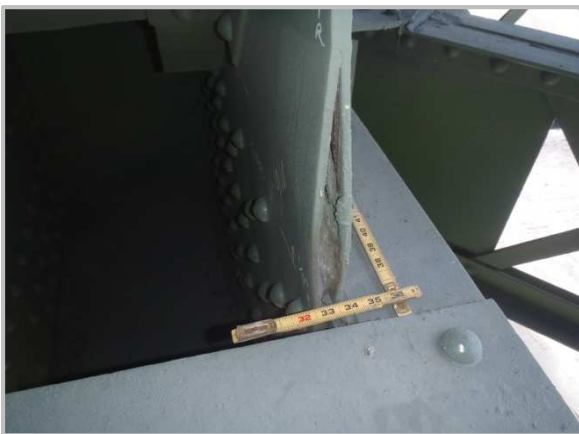
Photo 35 – Lamellar tear along west edge of gusset plate CL70S.

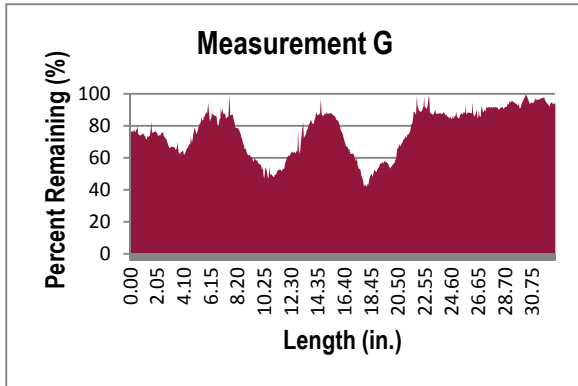
Figure 13 – Advanced section loss under vertical of gusset plate AL10S.

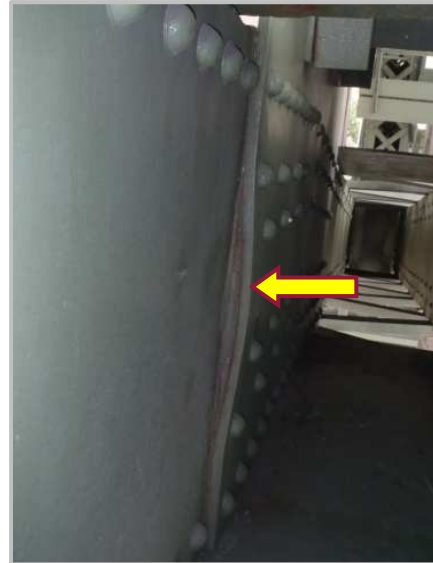
Photo 42 – Pack rust between BL57S free edge and BL57-BL58 south web plate.

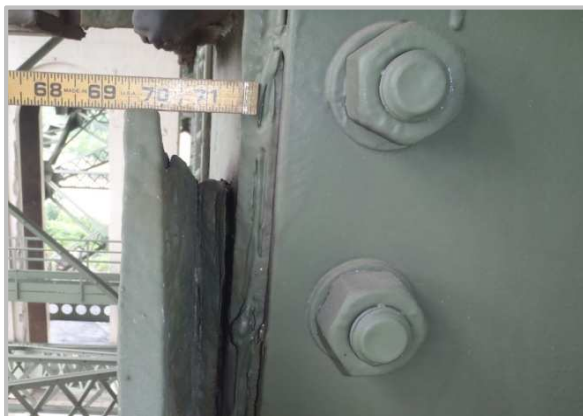
Photo 43 – 1 1/2" pack rust between CL58S free edge and CL58-CU58 south web plate.

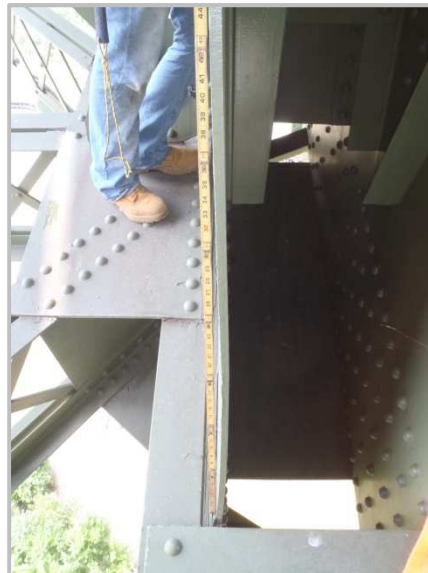
Photo 44 – 1/2" bow on east free edge of CL43S. Note that this plate does not meet the edge stiffness requirements of AASHTO 10.16.11.3

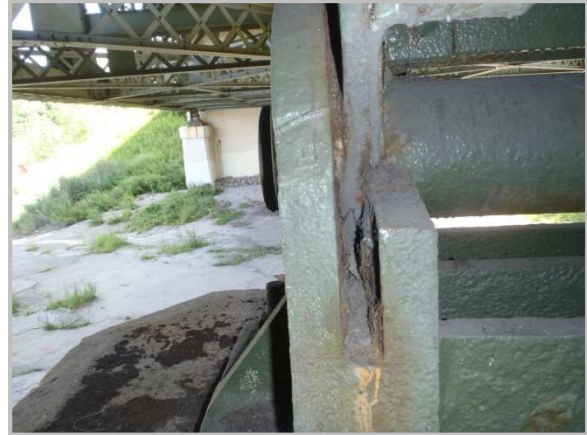
Photo 45 – Pack rust between truss bearing at BL127 and gusset plate BL127N.

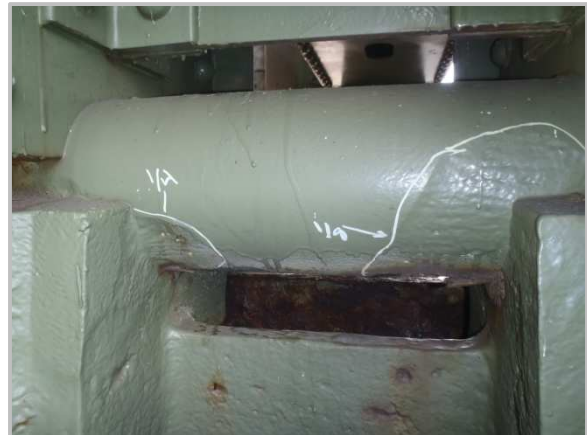
Photo 46 – Section loss up to 1/4" on east face of Pier 18 east bearing at Truss A.

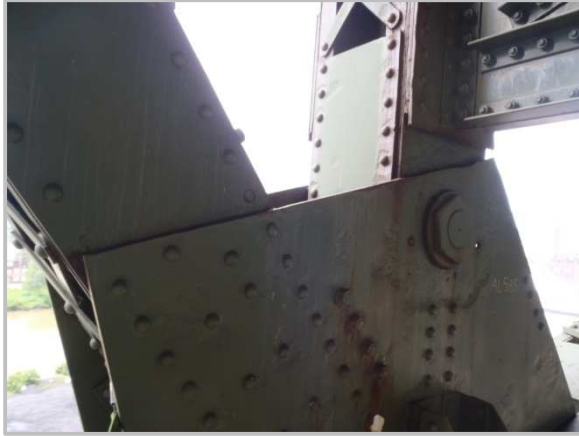
Photo 48 – Active minor surface corrosion at Panel Point AL58.

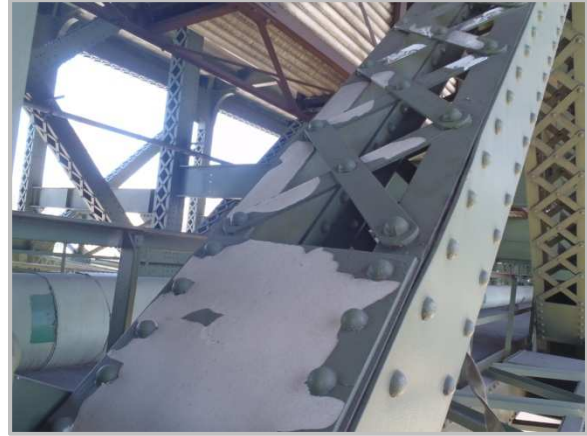
Photo 49 – Isolated paint peeling on diagonal member CL106-CU107 in Span16.

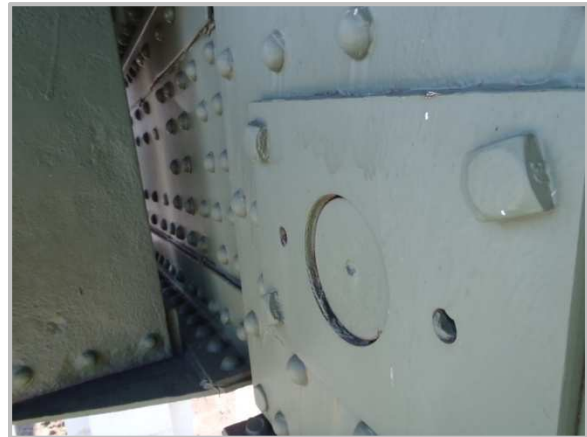
Photo 50 – Sliding pin at BL83 with impacted rust causing 5/16" of pin not to bear on north BL82-BL83 pin plates.

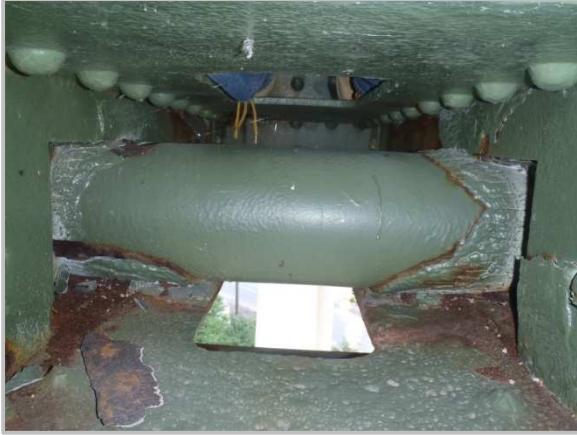
Photo 51 – Sliding pin at AL17 seized due to impacted rust which has been painted over.

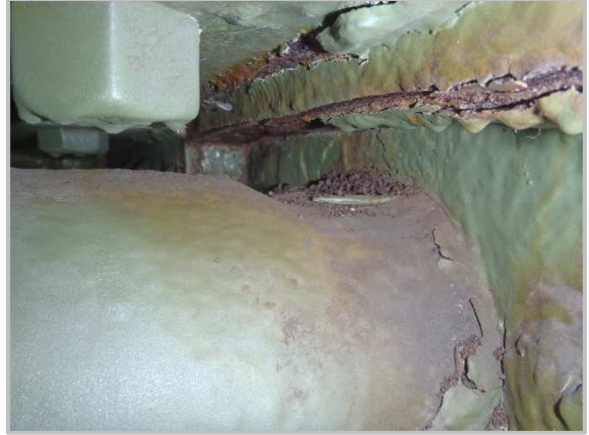
Photo 52 – North side of pin at DL97 with laminate rust and isolated section loss up to 1/2".

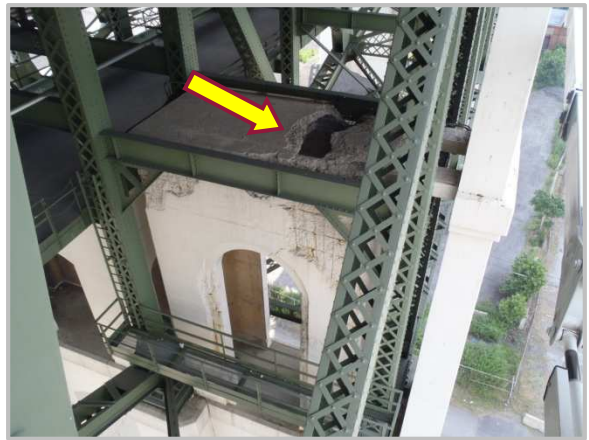
Photo 53 – Pier 15 tower between Truss A and Truss B with 8' by 3' hole in top.

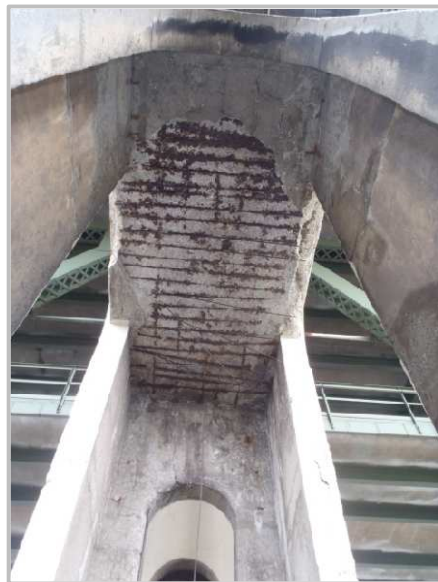
Photo 54 – Pier 12 tower with 20' by 5' spalled area with exposed reinforcing.

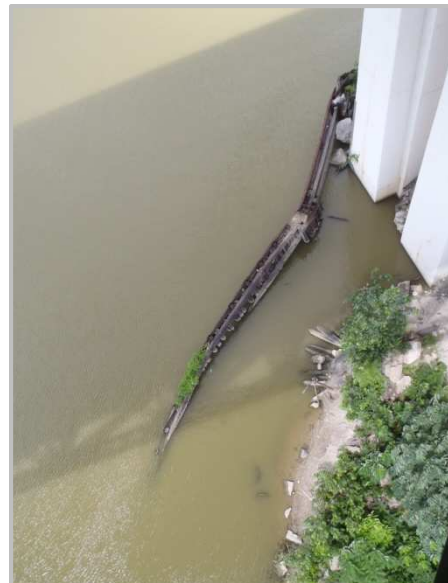
Photo 55 – South half of the east bank fender system collapsed toward river centerline.

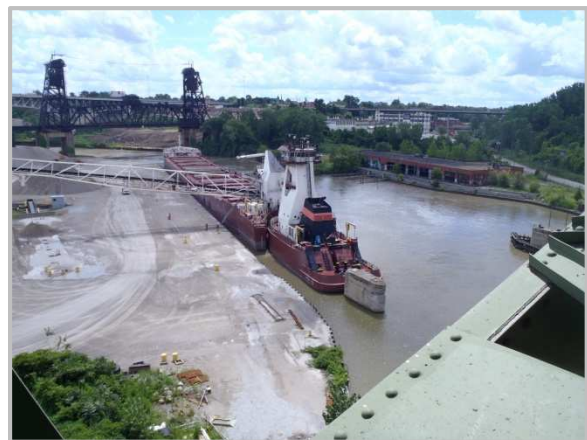
Photo 56 – General view upstream (south) of bridge crossing, showing bend in channel.

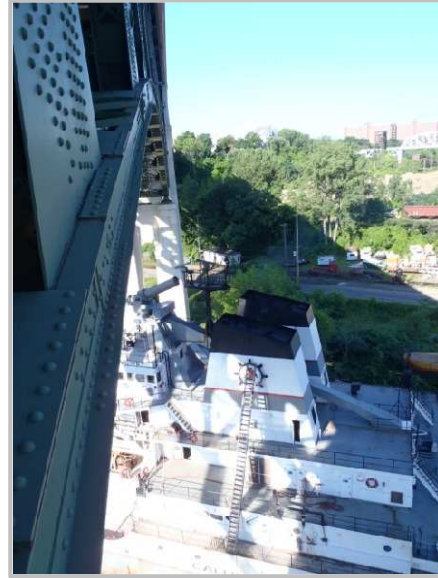
Photo 57 – Vertical clearance between structure and top of vessel under Truss A.

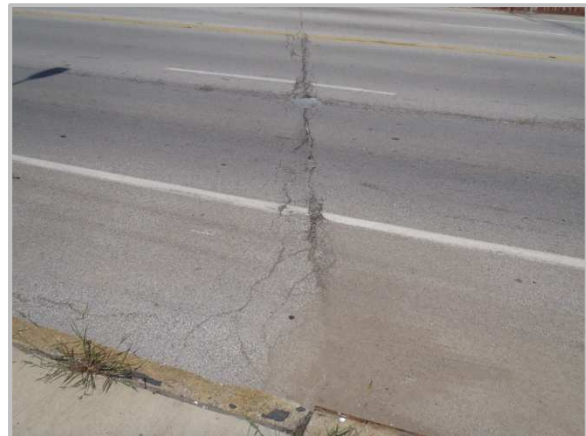
Photo 58 – Transverse crack up to 3/4" wide in west approach pavement.

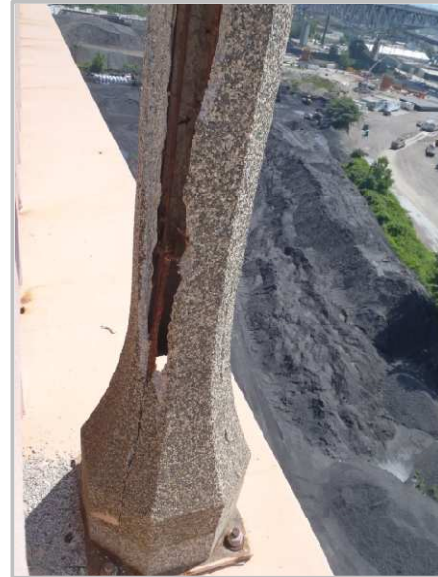
Photo 59 – 8' high by 6" wide spall with exposed rebar and cracking in Span 10 light pole.

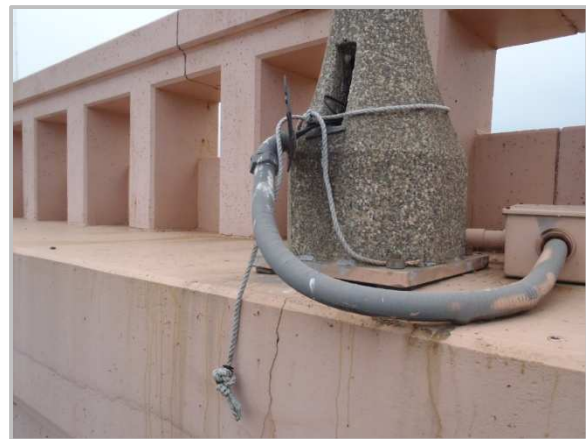
Photo 60 – Light post above AU120 with exposed wires and broken access box cover.

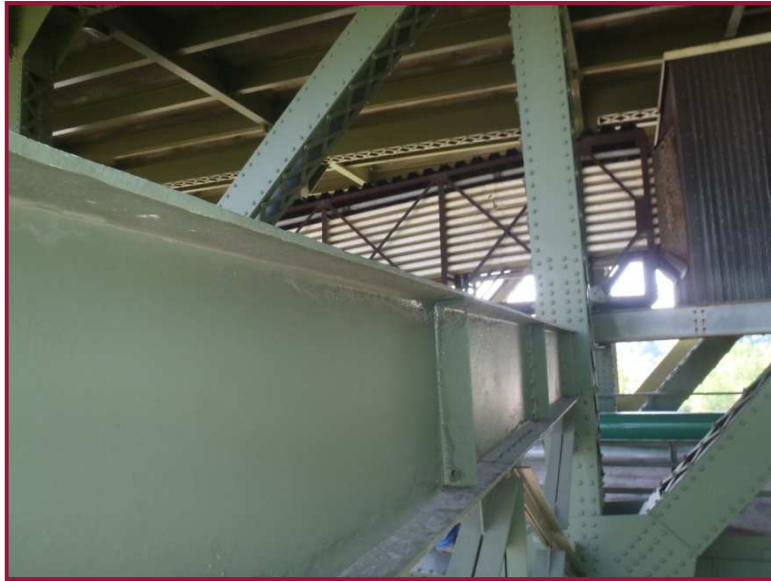
The sway strut between Truss A and Truss B at Panel Point 3 exhibits areas of 100% section loss to the web stiffeners and 1/4" pitting on the web 3" high with isolated holed through sections.

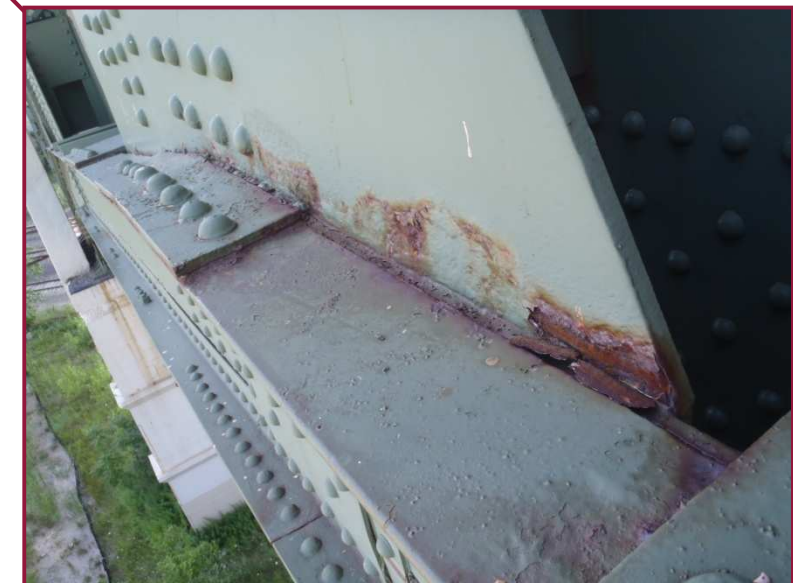
There is active corrosion on gusset plate AL5N along the top flange angle of AL4-AL5 with associated 1/16" pitting.

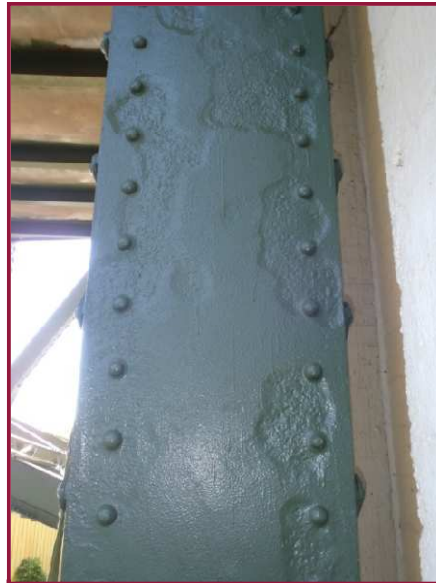
The north and south web plates of BL0-BU0 exhibit 1/8" to 1/4" deep pitting (see Section A-A).

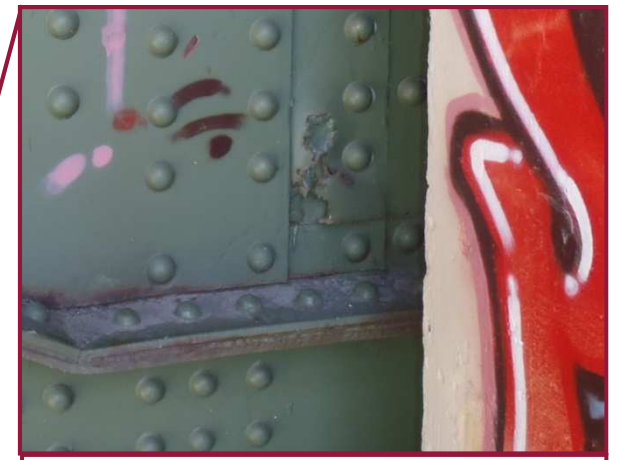
Advanced corrosion at the south web fill plate at BL8 has resulted in a 6" diameter hole.

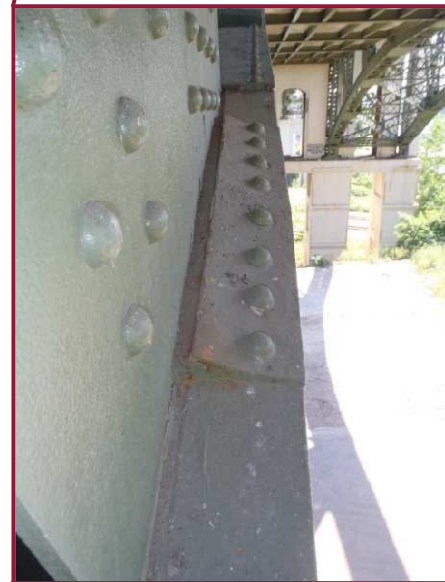
Heavy pack rust up to 1" has formed between the lower chord top flange and flange splice plate at BL1S.

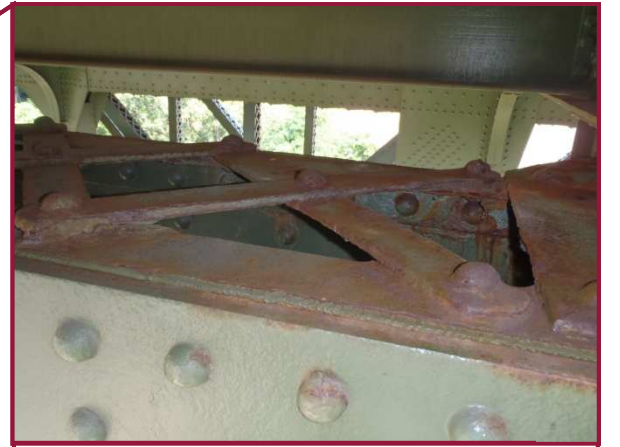
extensive rust and corrosion

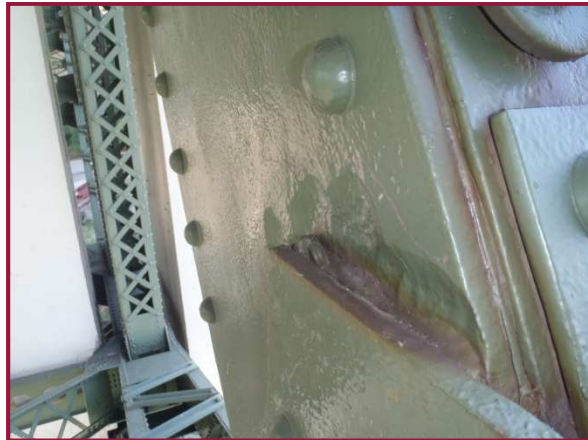
Pack rust up to 1" thick between diagonal member AU9-AL10 and the free edge of gusset plate AL10N, as well as 1/4" pitting on the north web plate of the member at this location.

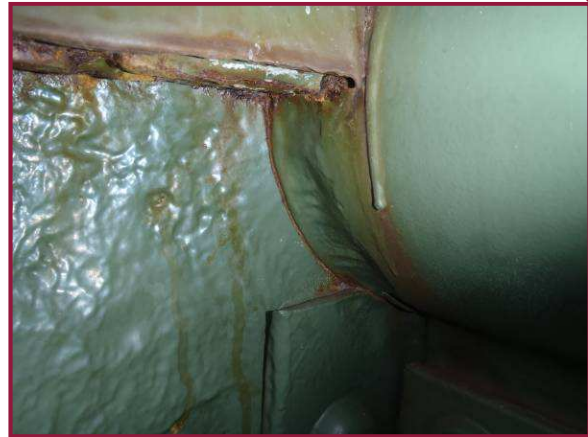
The bearing pin at AL12 exhibits 3/16" deep loss along the circumference adjacent to the pin plates. Additionally, the innermost pin plates exhibit 1/8" deep pitting throughout the interior face adjacent to the pin.

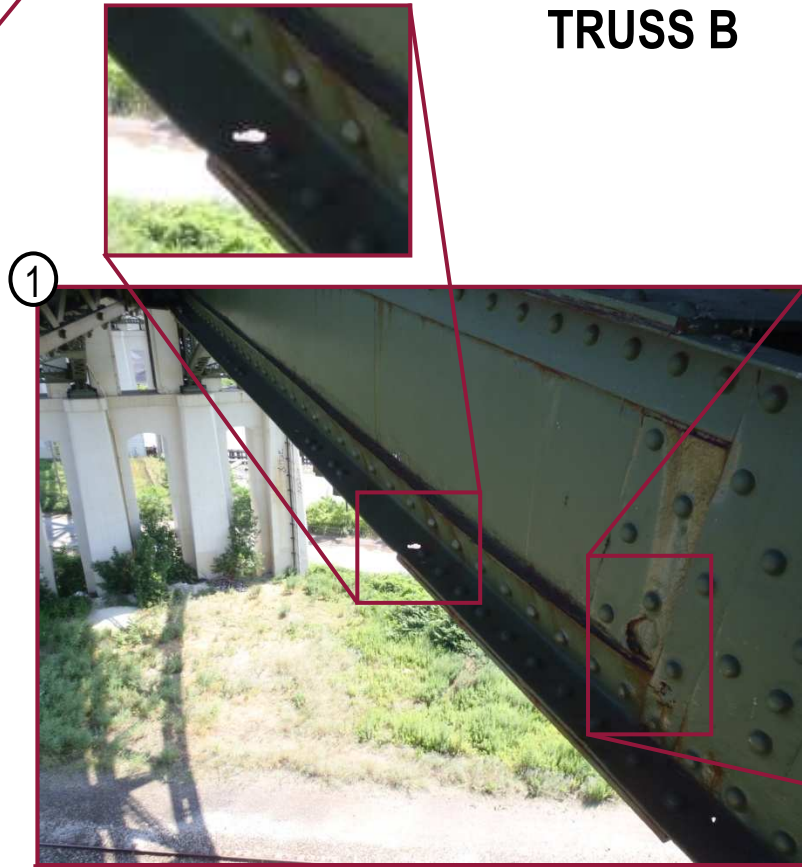
The second pin plate on the north side of lower chord member BL12-BL13 at BL12 has a 3" diameter hole in the bottom corner. Similarly, the third pin plate has a 2" diameter hole in the bottom corner, and the fill plate has a 4" diameter hole at the bottom. 1/8" pitting is typical on the pin plates. A 1-1/2" diameter hole in the north bottom flange is present roughly 5' east of this location.

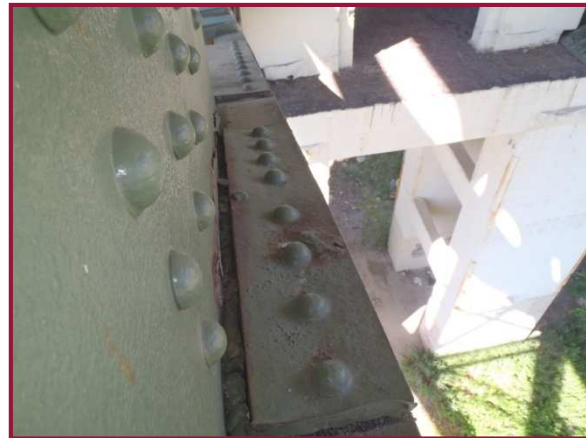
The bottom flange angle splice plate at CL11 is bowed out approximately 1-1/2" due to heavy pack rust.

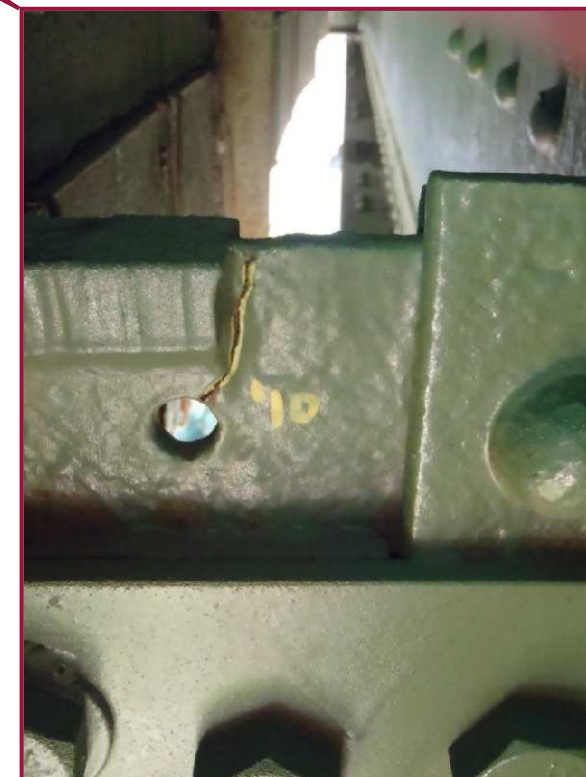
Utility deck Floorbeams 14 and 15 exhibit cracking at the top flange coping near Truss C, extending down into stress relief holes. These cracks are roughly 1-3/4" long and do not appear to have propagated beyond the stress relief holes (Floorbeam 14 shown).

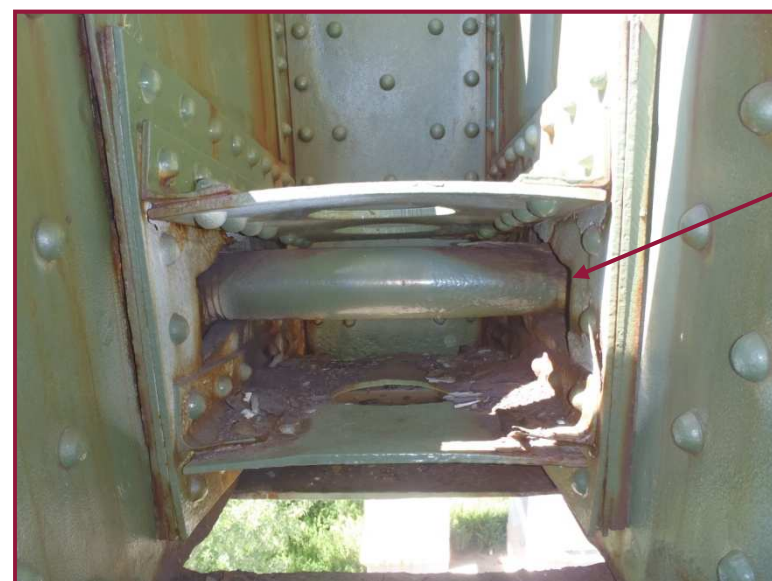
The sliding pins at gusset plate location DL12 are worn. The internal diaphragm between gusset plates above the pin appears to have buckled due to pack rust.

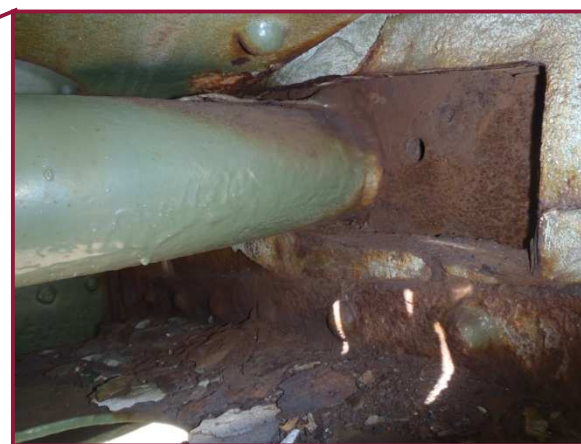
Note active corrosion and wear on north DL12-DL13 lower chord sliding pin at DL12.

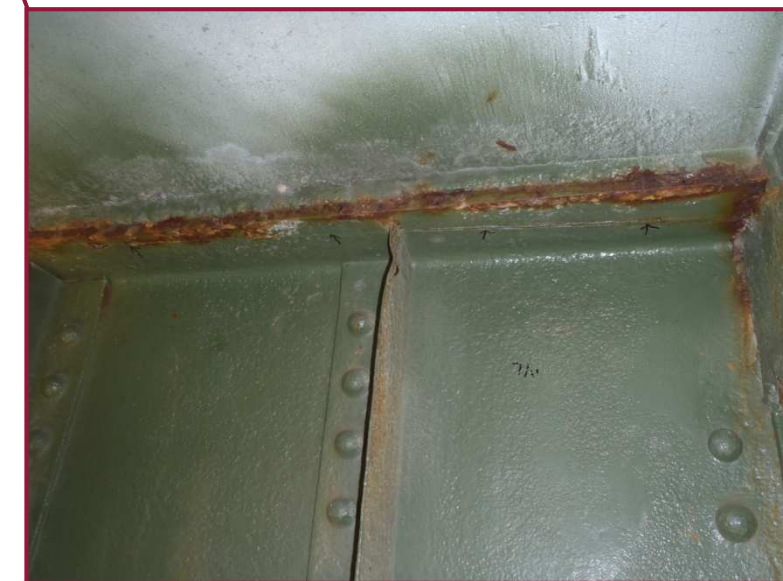
Floorbeam 17 exhibits a lamellar tear approximately five feet long on the bottom of the top flange between Stringer 7 and the interior bearing stiffeners.
