**PHYSICAL CONDITION REPORT
FOR THE 2011 ROUTINE INSPECTION**

LORAIN-CARNEGIE BRIDGE

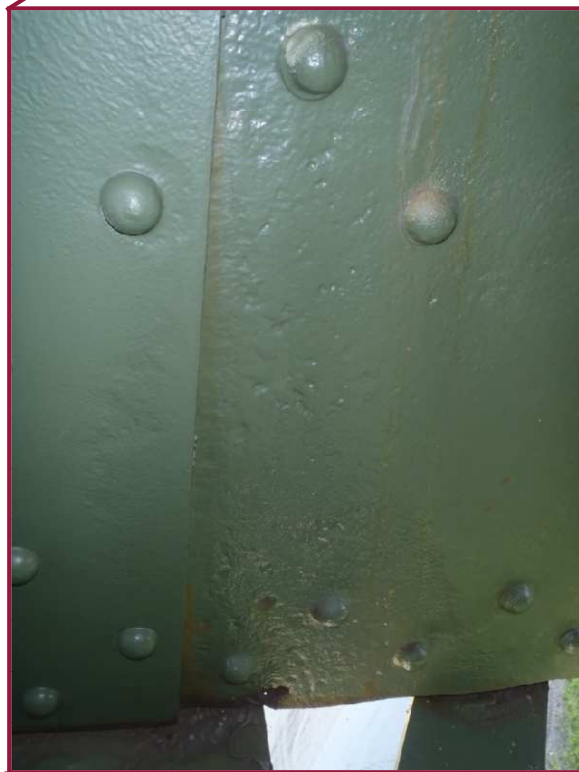
The north and south web plates of chord member AL24-AL25 exhibit 3/16" pitting over the full height of the plate along the interface with Panel Point AL25 gusset plates, with an isolated 1" diameter hole in the south plate (south plate shown).

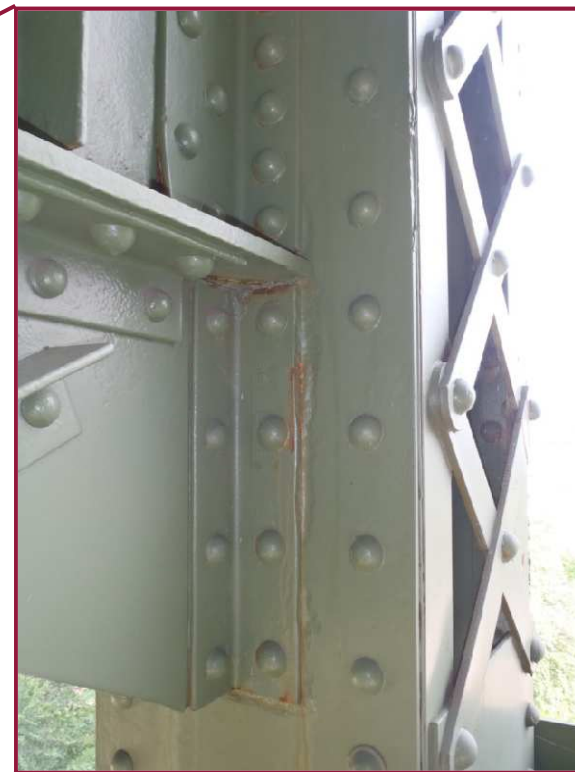
The north web plate of vertical member AL27-AU27 exhibits typical 1/8" pitting around the sway brace connection.

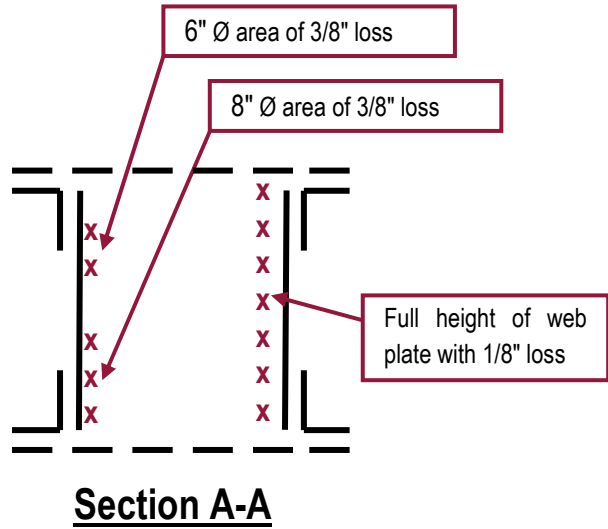
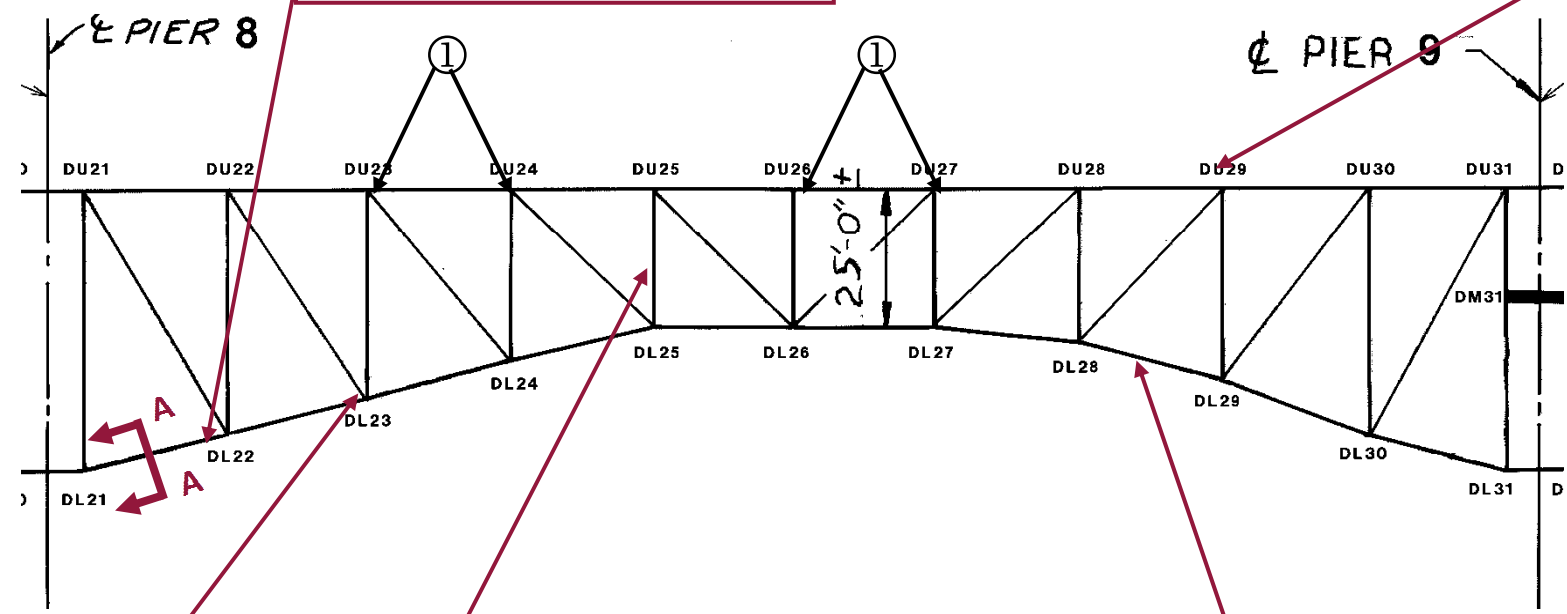
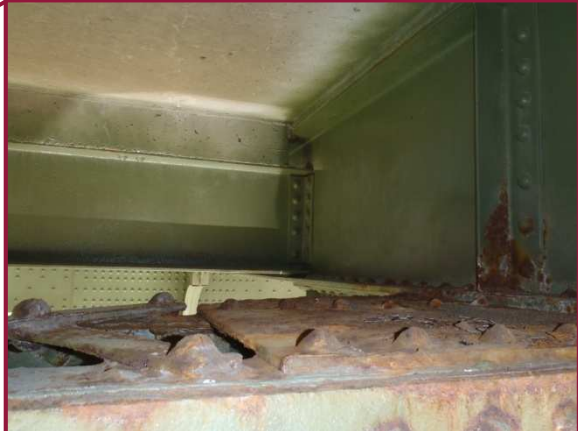
Upper chord member DL28-DL29 exhibits pitting up to 1/8" on the cover plate, lacing bars and top flange angles within the bounds of gusset plates at DL29. This area has active corrosion due to the presence of a deck subdrain.

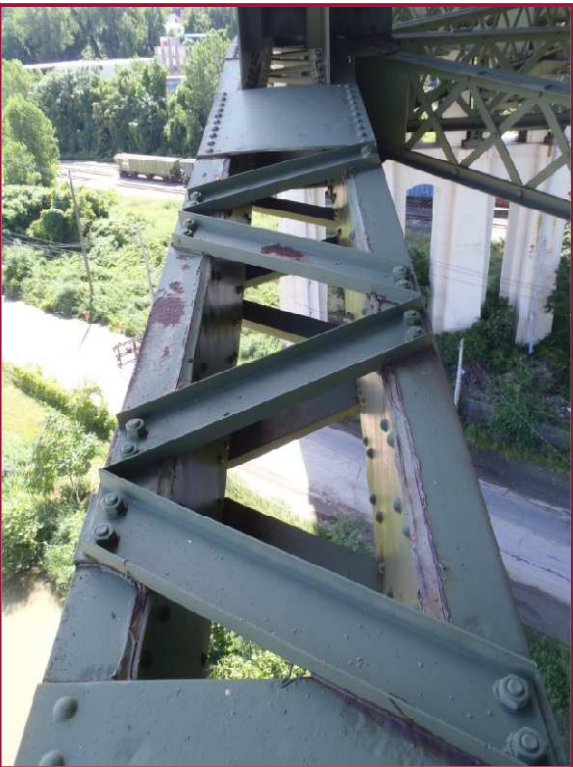
The lower chord members in Span 8 exhibit heavy impacted rust between web plates and flange angles.

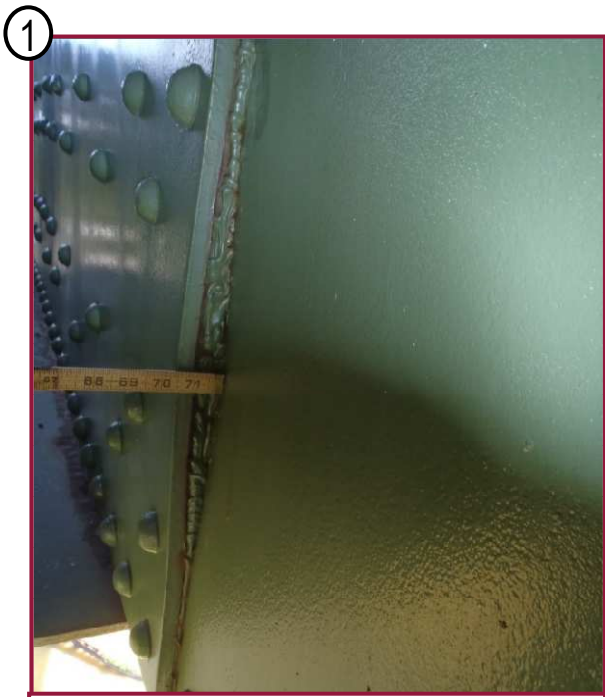
Cleaned and sealed pack rust up to 1" thick is present between lower chord member AL35-AL36 and gusset plate AL36S.

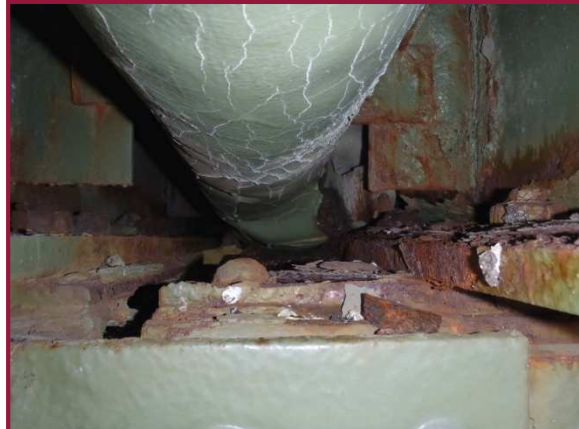
Floorbeam 35 exhibits active corrosion of the bottom flange and adjacent web and vertical stiffener plates with up to 1/16" deep pitting. The joint trough at this location has failed with water and debris leaking onto the superstructure elements.

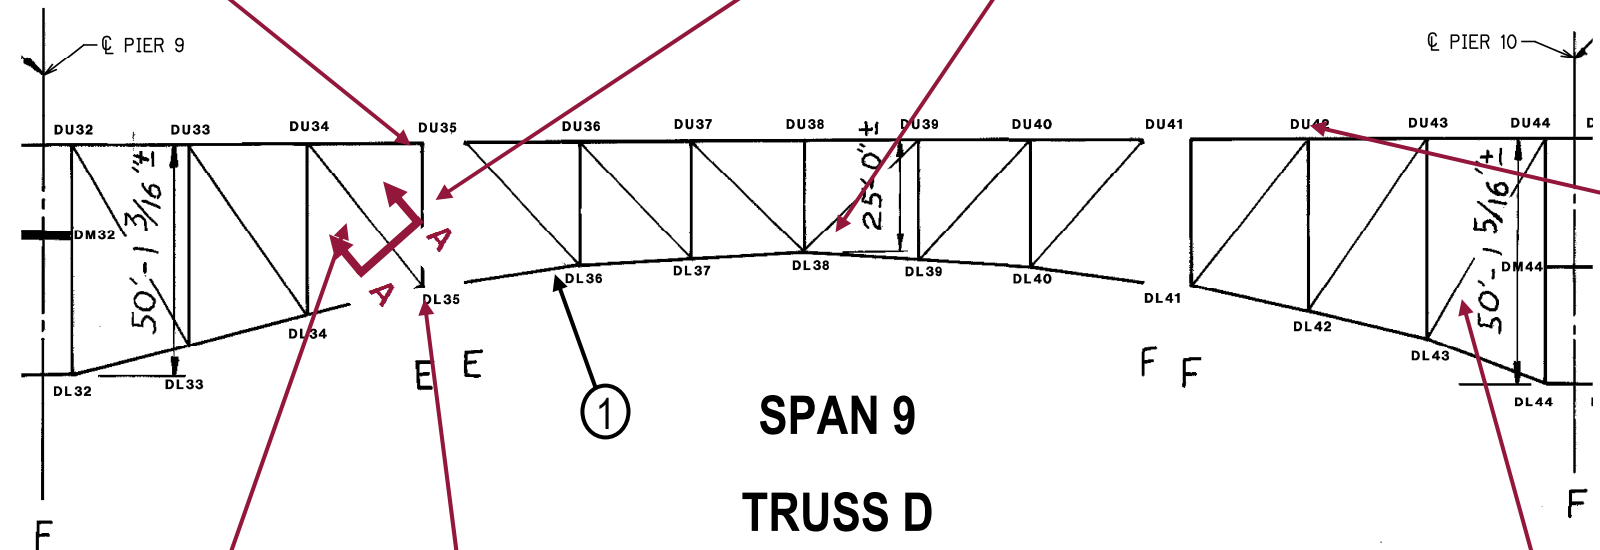
Between Truss D and Stringer 11, Floorbeam 42 exhibits a 1/4" diameter hole in the lower half of the web with 1/16" pitting typical in the surrounding area along the bottom flange.

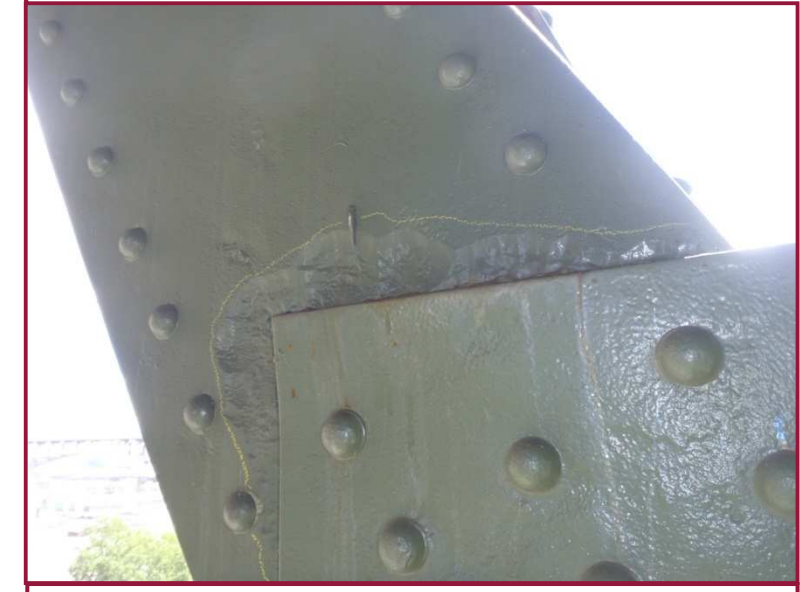
The north web plate of diagonal member DL43-DU44 exhibits 1/4" pitting with isolated 5/16" pitting along gusset plate DL43N for the full height of the section.

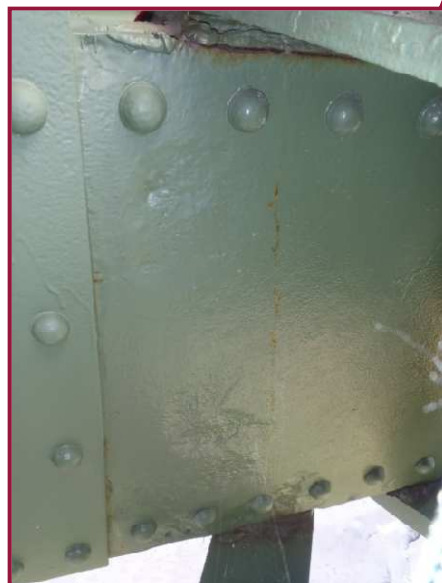
The south web plate of AL48-AL49 has heavy pitting up to 1/4" deep for approximately half the web height near AL49. Similar conditions are found at AL51.

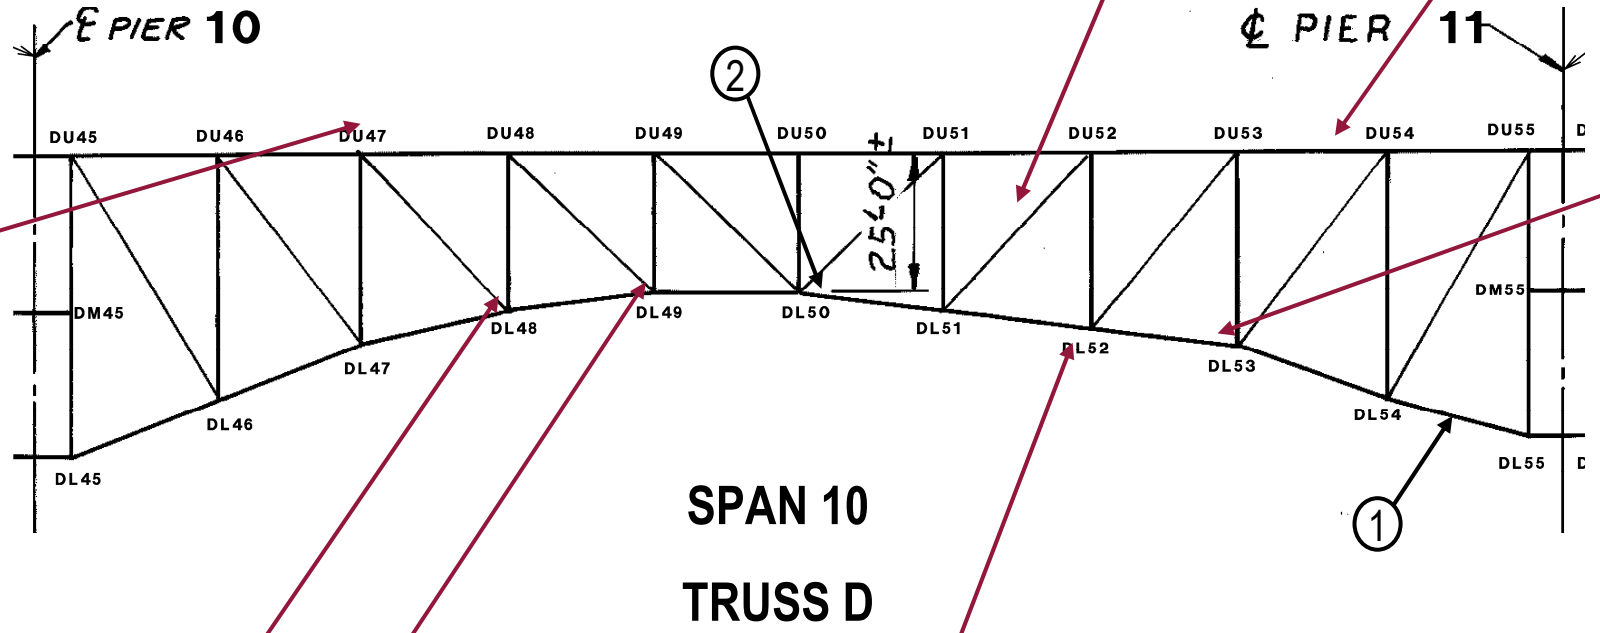
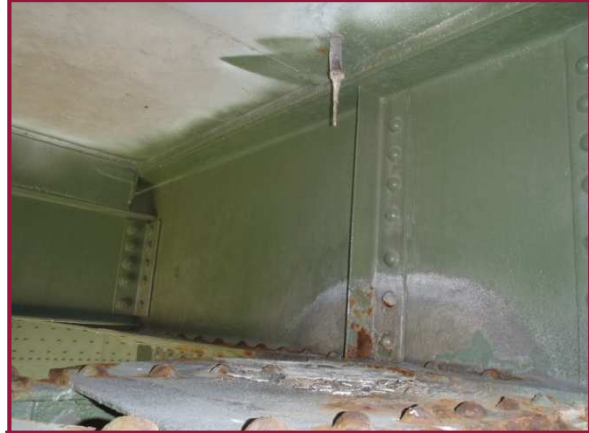
Deck subdrain location on the west side of Floorbeam 47 with 1/16" pitting and active corrosion to the top chord cover plate, lacing bars and flange angles. Note stalactite formation.

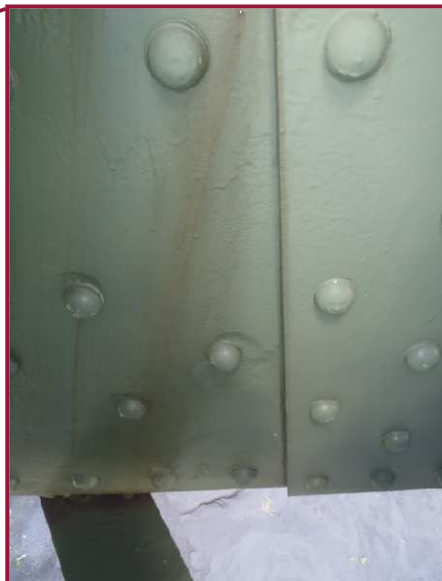
The DL52-DL53 north web plate exhibits an area of 1/4" deep pitting 5" tall (cleaned and painted) along gusset plate DL53N.

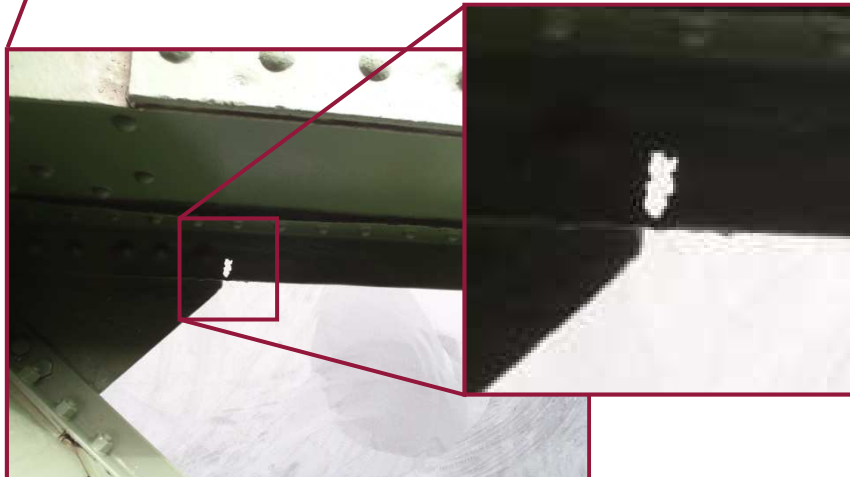
Member DL51-DL52 exhibits a 2" by 1" hole in the north bottom flange outstanding leg with 1/16" pitting on the vertical leg adjacent to Panel Point DL52.

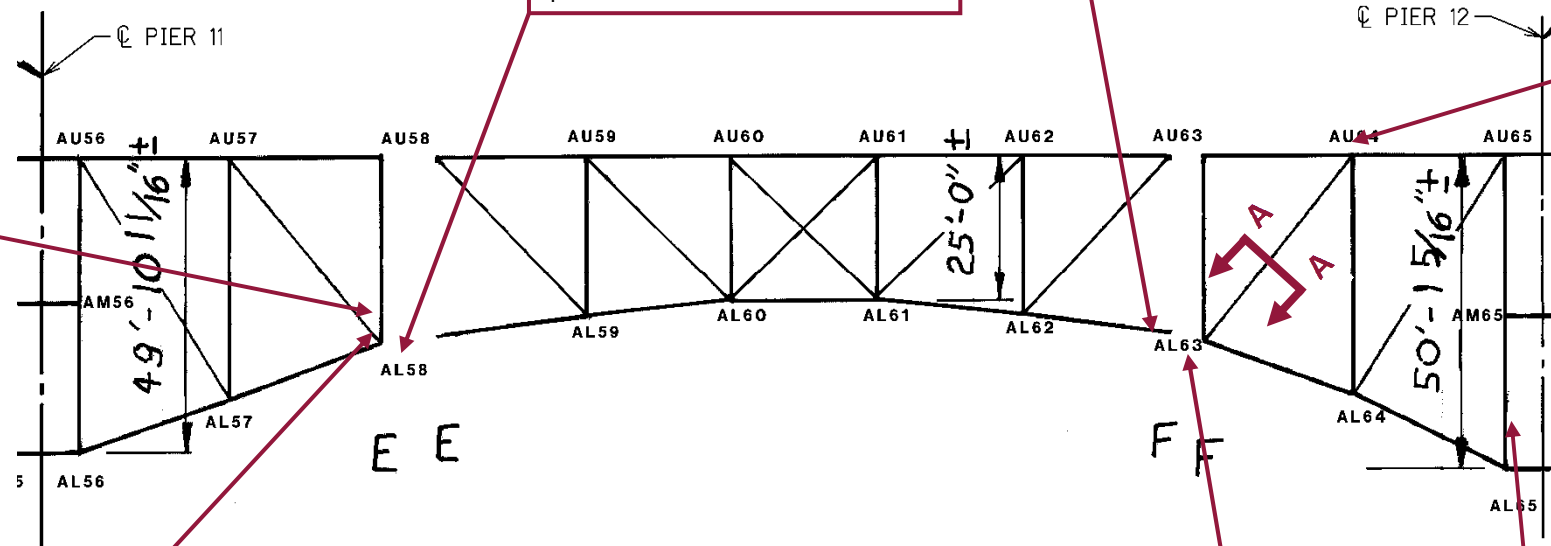
Pitting up to 1/4" deep is present on both members at the interface of the south pin plates and the south web plate of AL58-AL59.

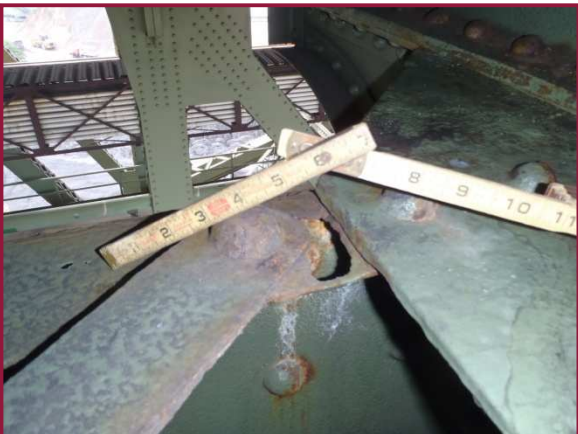
Top chord member AU63-AU64 exhibits 100% section loss to the north top flange angle within the bounds of the gusset plate at AU64.

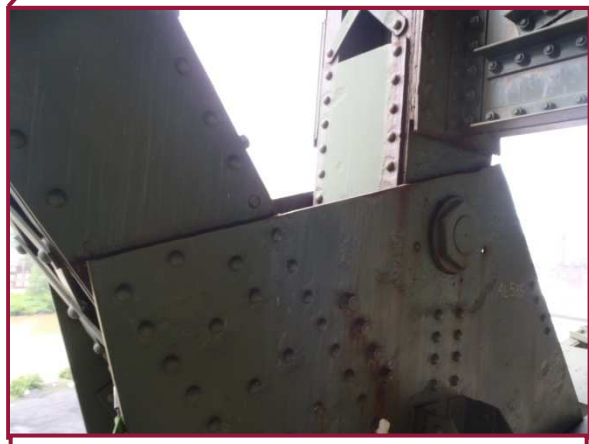
The web members at lower chord Panel Point AL58 exhibit active minor surface corrosion throughout.

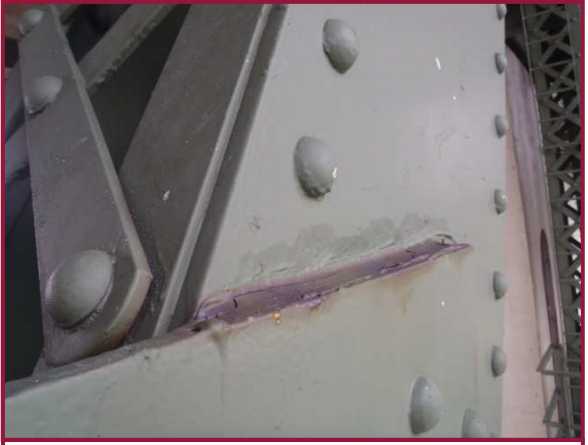
Diagonal member BL57-BU56 exhibits 1/4" section loss on the north web plate with associated pack rust at the lower chord gusset plate BL57N interface.

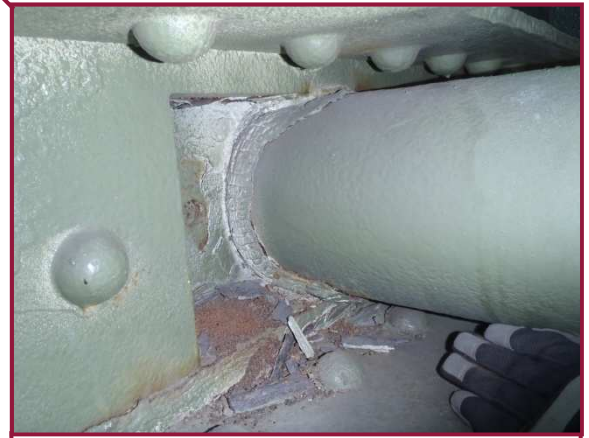
The sliding pin for member BL62-BL63 exhibits typical impacted rust at the north end of the pin at Panel Point BL63.

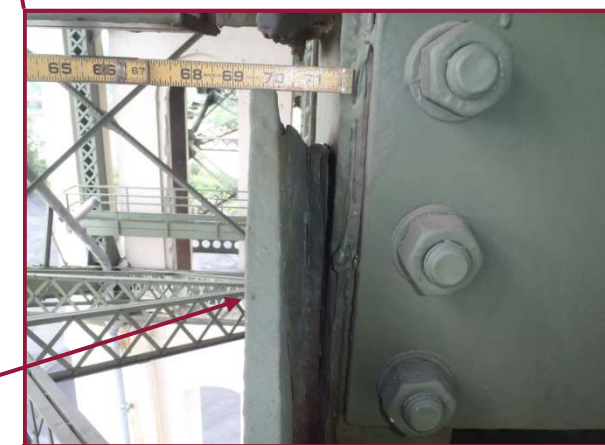
The sliding pin at CL63 exhibits pitting up to 1/4" deep along the pin circumference. The pin plates also exhibit heavy pitting, especially along the pin interface.

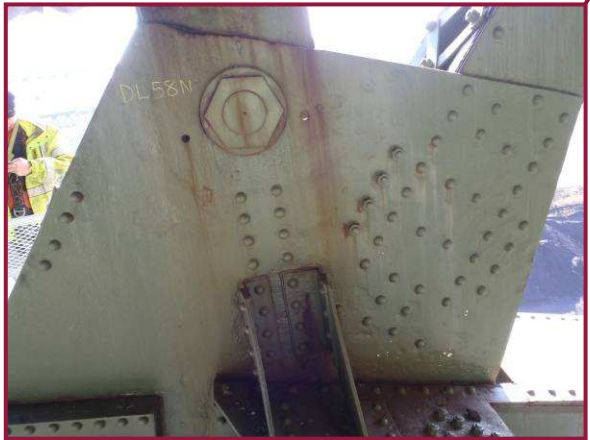
The north gusset plate at DL58 exhibits up to 3/16" pitting, a condition typically found at the expansion locations throughout the structure (Photo taken 2010).

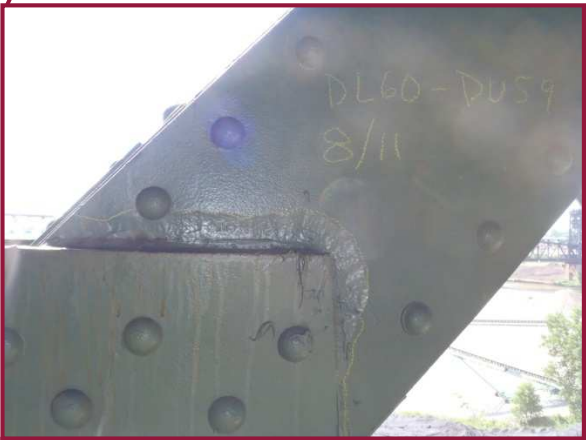
The north web plate of member DL60-DU59 exhibits 1/8" pitting (cleaned and painted) for the full height of the section along the interface with gusset plate DL60N.

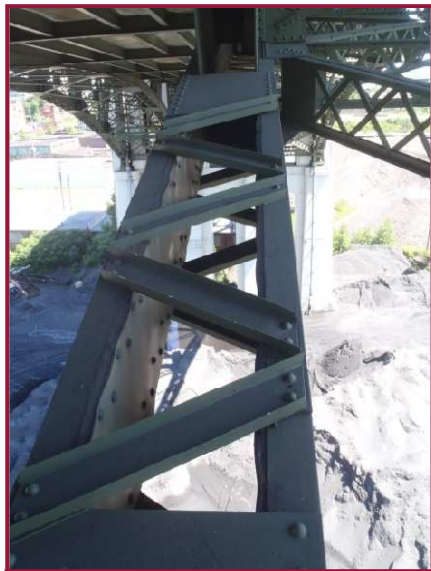
Pack rust is showing signs of reactivation between lower chord web plates and flange angles.

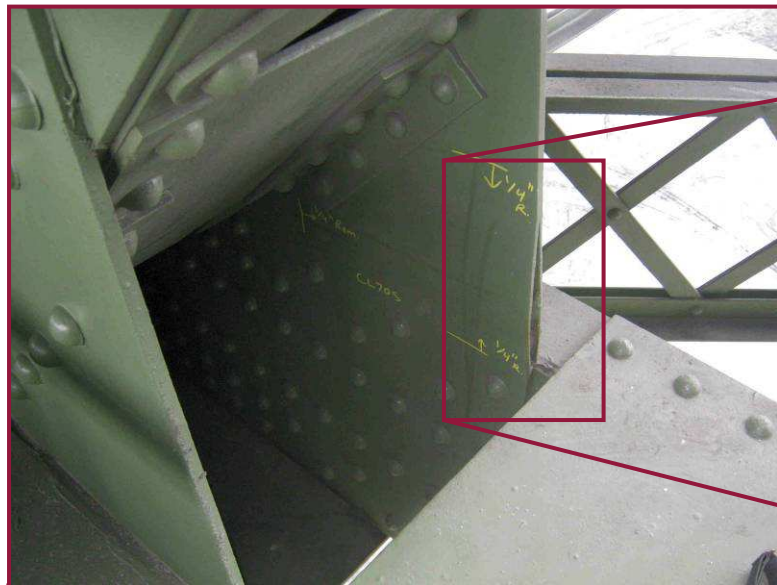
The south gusset plate at CL70 exhibits lamellar separation along the west free edge, with an effective remaining plate thickness of approximately 1/4" (Photo taken 2010). Limits of the separation have no increased since the 2010 inspection.

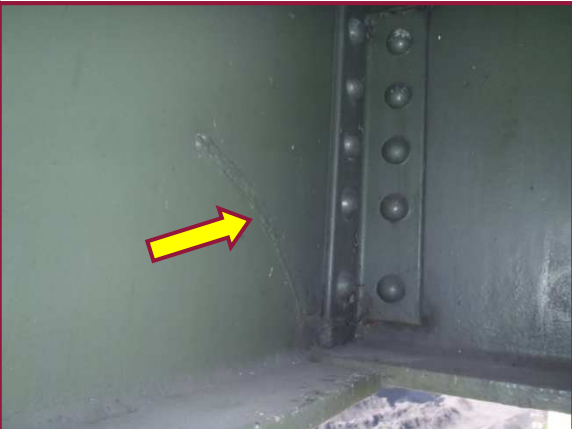
The south fascia stringer just east of Floorbeam 73 has a weld retrofit along the bottom flange cope.

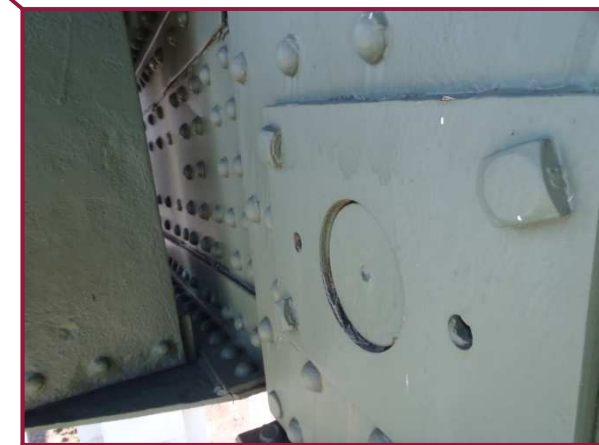
Pack rust at BL83 has pushed the sliding pin plates outward such that 5/16" of the pin is no longer bearing.

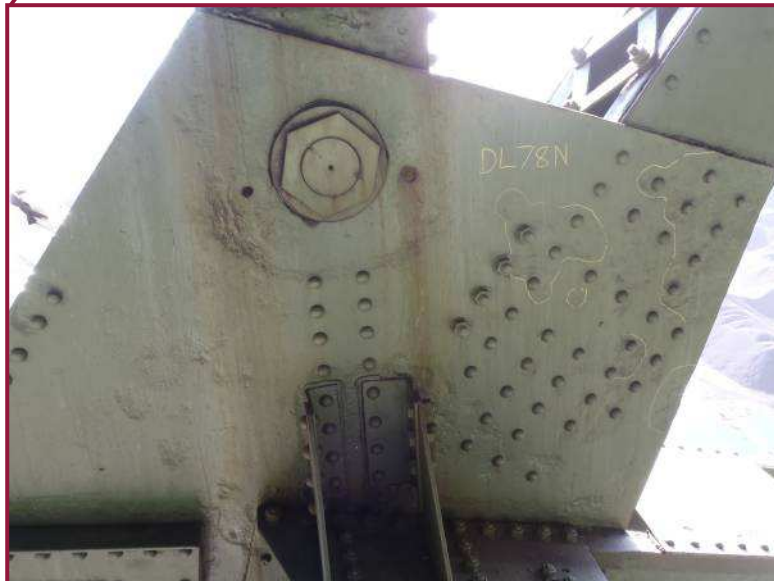
Heavy pitting (greater than or equal to 1/4" deep in isolated locations) of the lower gusset plates at the pin locations is typical with reactivating surface corrosion due to failing deck joints above (Photo taken 2010).

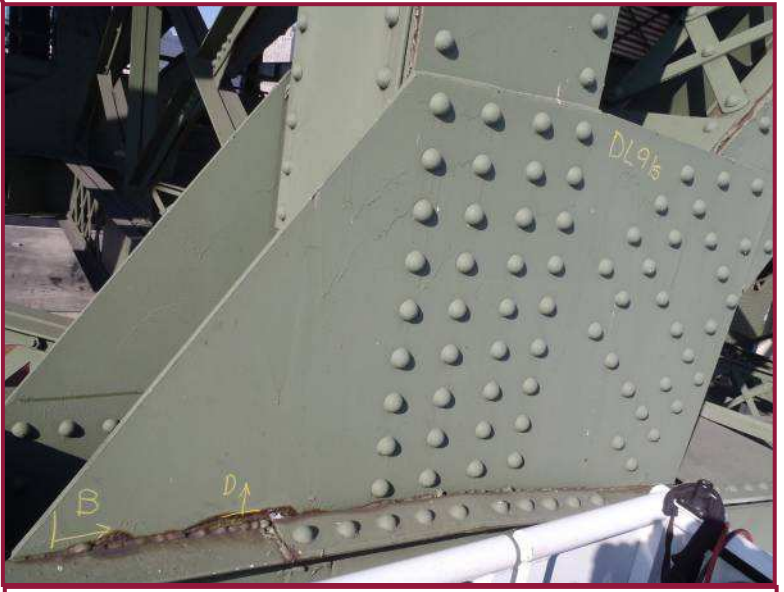
Gusset plate DL91 exhibits conditions typical of the exterior gusset plates throughout Span 14, Truss D, with activating rust along the interface at the lower chord and associated minor pitting (Photo taken 2010).

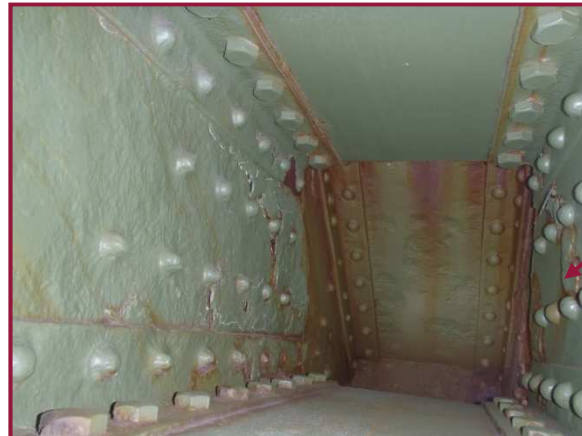
The interior web plates of AU96-AL97 exhibit laminate rust with 1/8" loss on the interior, as well as isolated areas of 3/16" pitting on the interior and exterior faces of this member.

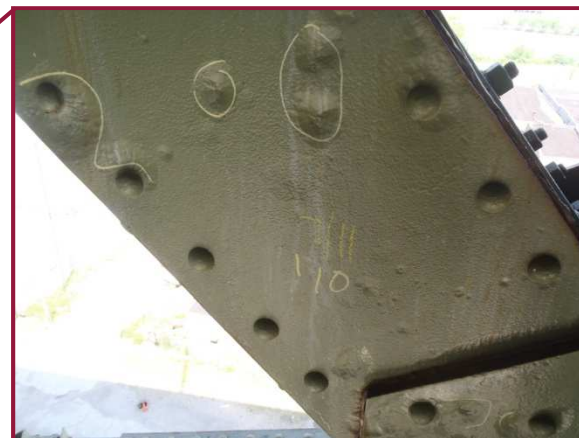
The exterior south web plate of AU96-AL97 exhibits areas of 3/16" pitting (cleaned and painted).

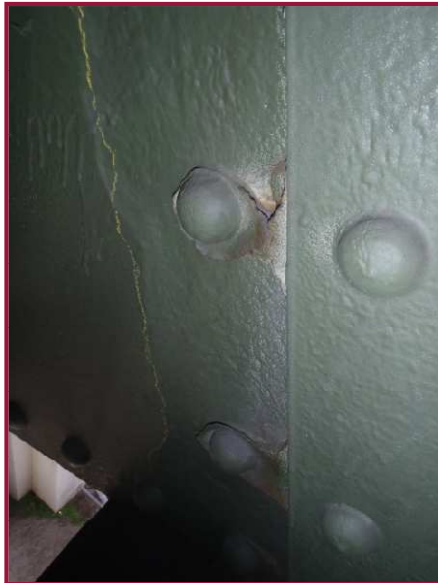
The north web plate of BL95-BL96 exhibits 3/16" deep pitting for the full height of the plate adjacent to BL96N. This location was covered by a thin fill plate which has since completely corroded outside the bounds of the gusset plate.

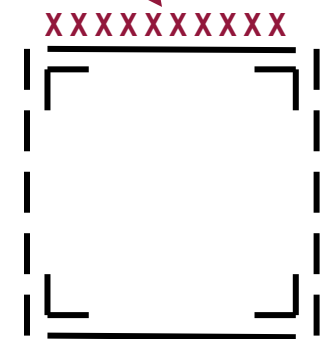
1/4" deep pitting for the full height of the web

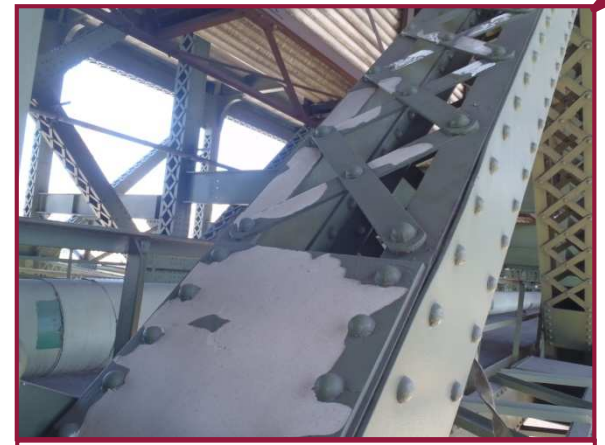
Failures of the paint top coat were found on diagonal members near the lower gusset plate connections at CL105, CL106, and CL107 in Span 16 (CL106-CU107 shown).

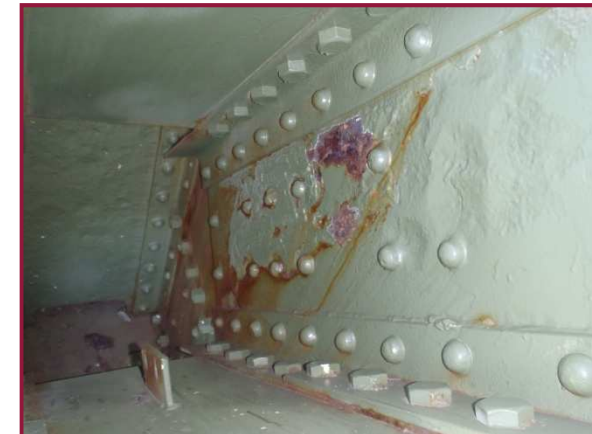
Pitting with active surface rust to the interior south web plate adjacent to gusset plate AL113S

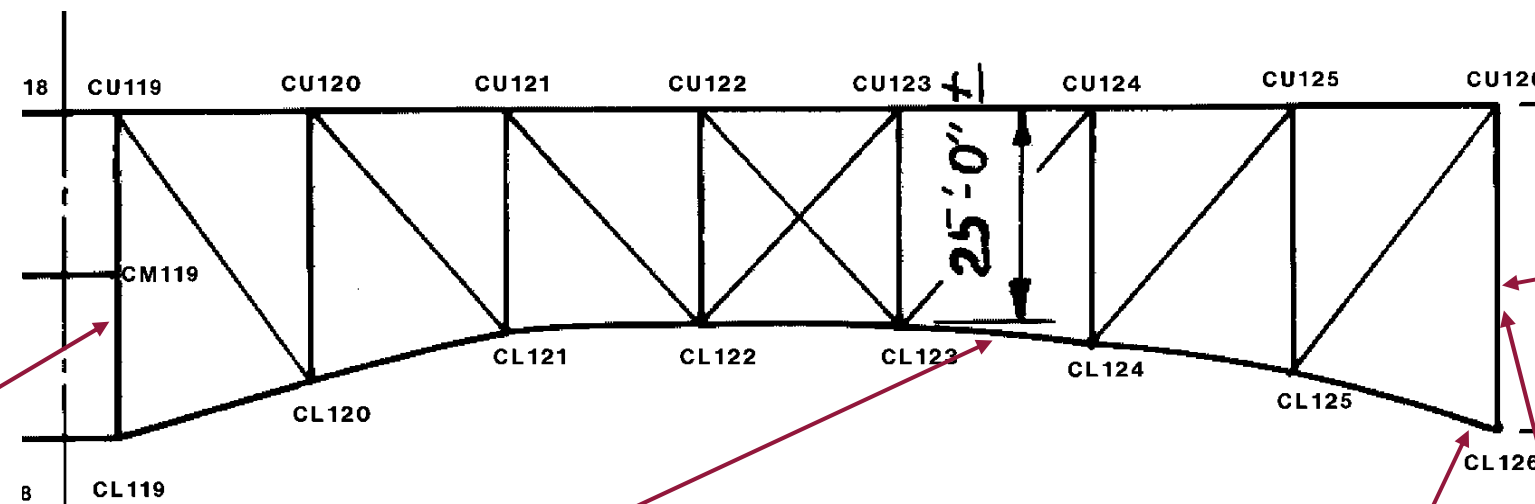
Pack rust up to 1/2" between web plates and flange angles

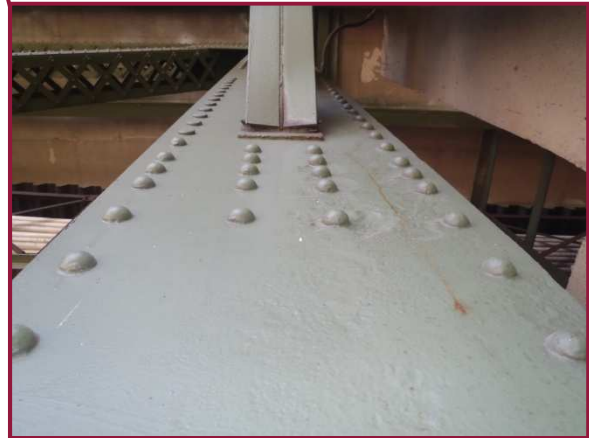
The south web plate of vertical member CL126-CU126 exhibits up to 1/4" pitting below the sway strut connection.

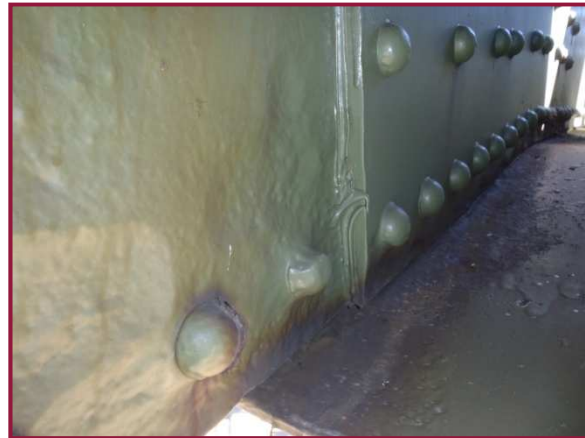
The north web plate of member DL119-DL120 exhibits 1/4" pitting over the bottom 1/4 of the height along the gusset plate interface. Pack rust has built up between this web plate and gusset plate DL120N.

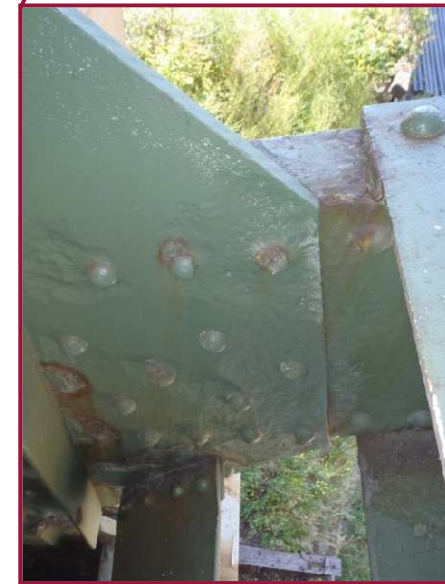
Member DL125-DL126 exhibits 3/16" pitting for the full height of the south web plate along the interface of gusset plate DL126S.

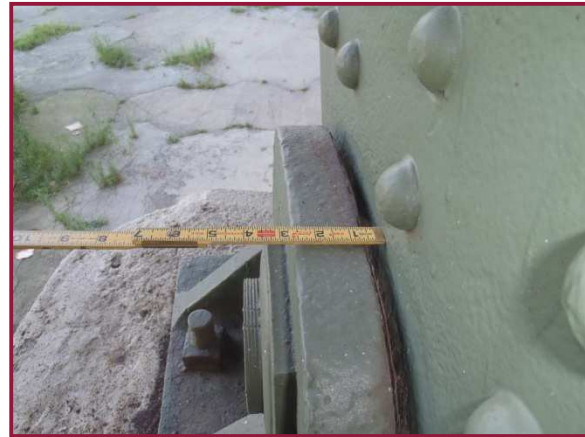
The truss bearing at AL127 exhibits impacted rust up to 5/8" between the gusset plates and bearing casting (north side shown).

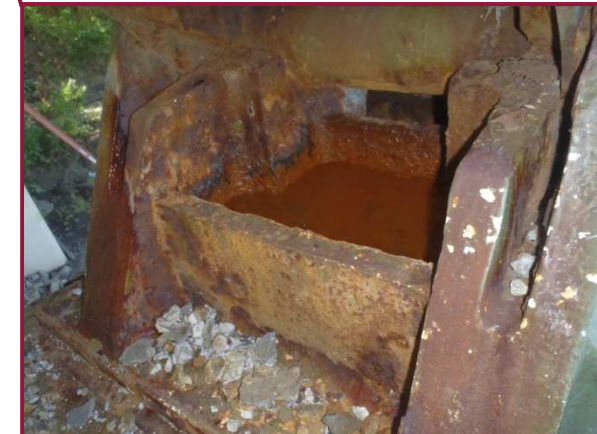
The bearing components at AL131 exhibit 1/8" pitting and activating surface rust throughout. The east side of the bearing contained standing water at the time of the inspection with moderate to heavy rusting in this area.

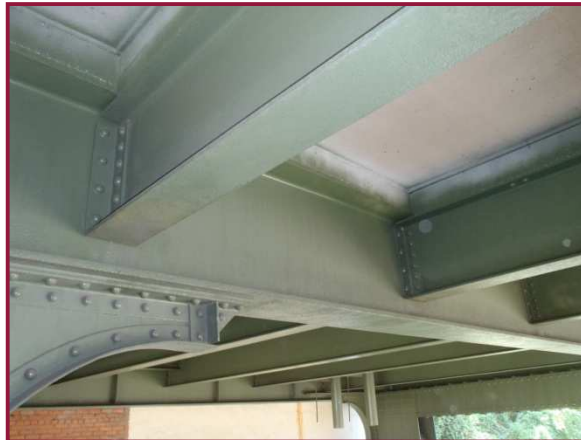
Floorbeam 131 bottom flange exhibits 1/16" pitting (cleaned and painted) for the full width.

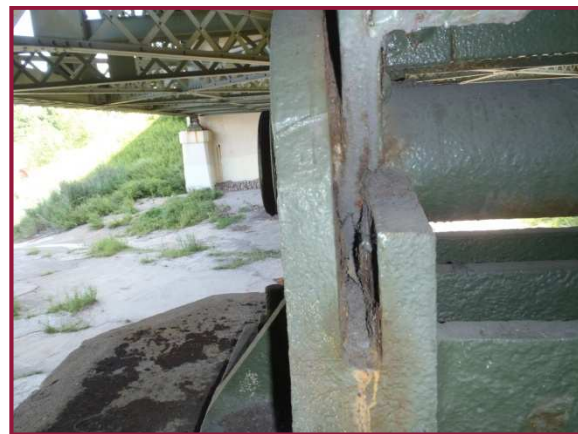
The truss bearing at BL127 exhibits impacted rust between gusset plate BL127N and the bearing casting.

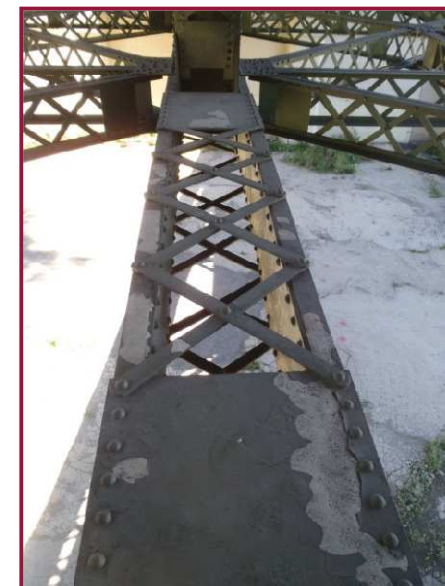
Lower chord BL130-BL131 exhibits extensive areas of peeling paint.

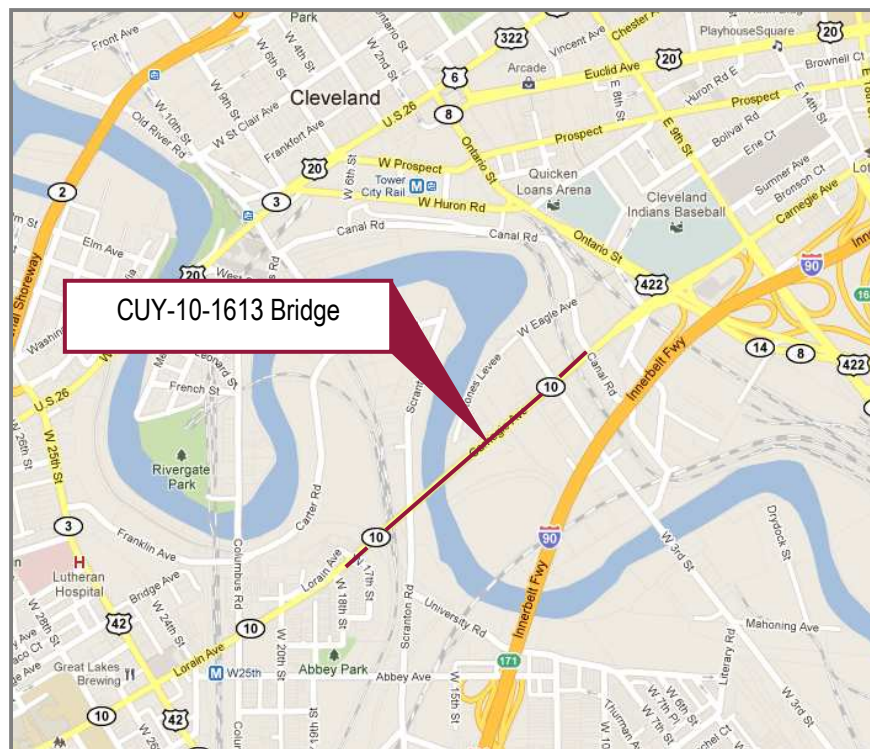
Figure 2 – Location Map

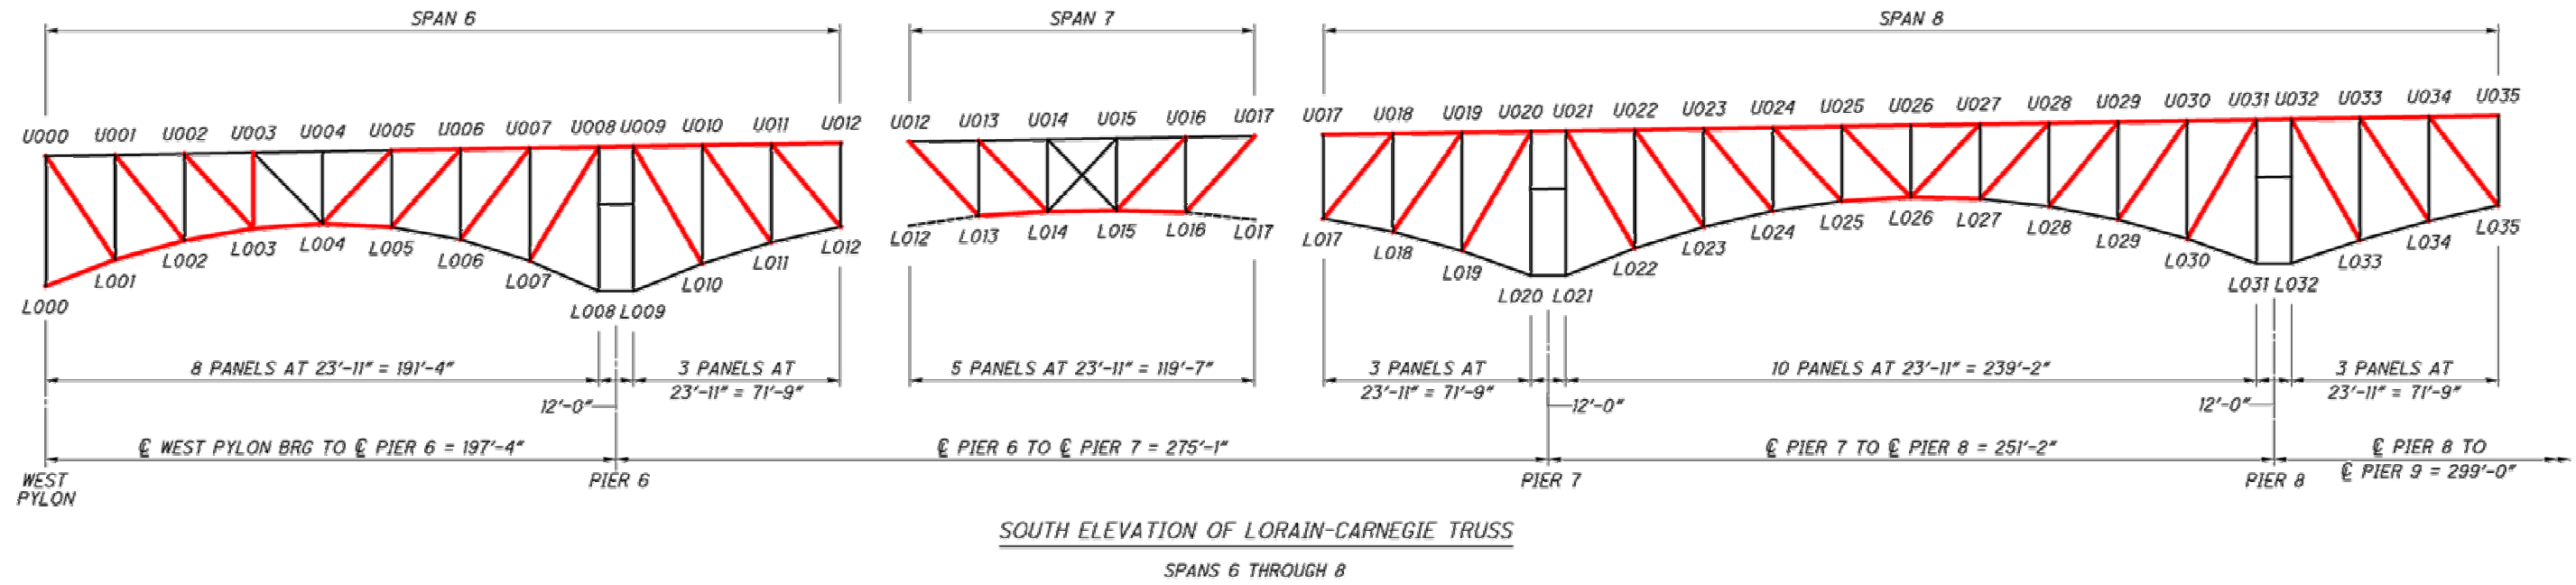
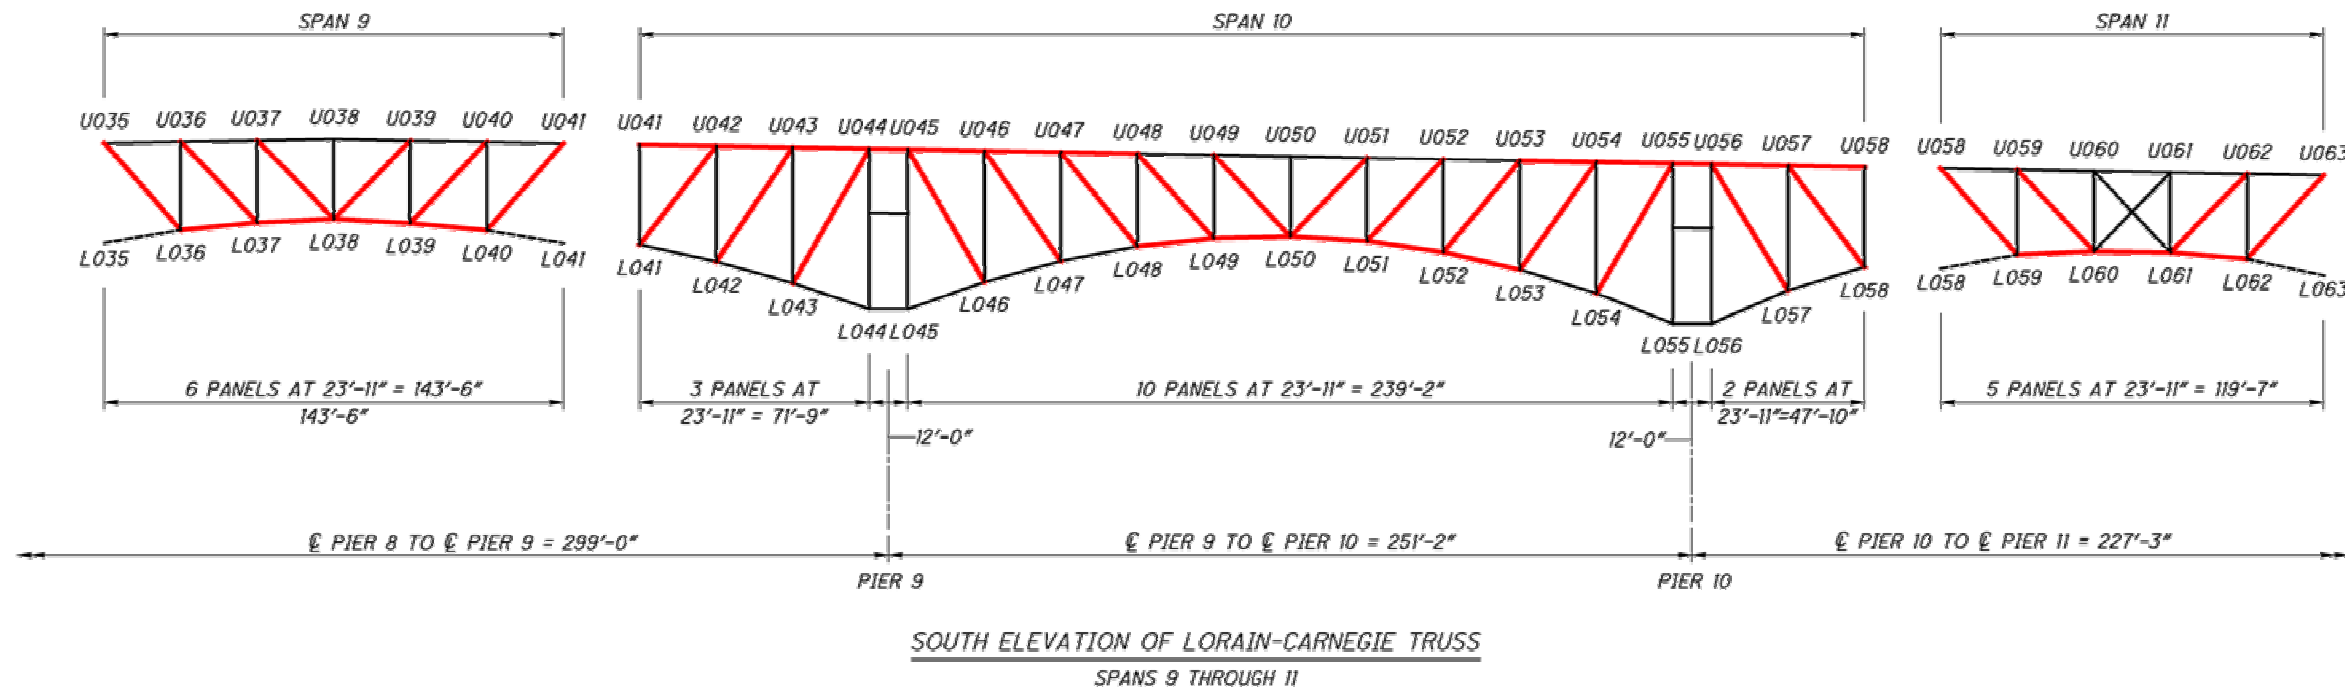
ALL FLOORBEAMS IN THE MAIN TRUSS
SPANS ARE FRACTURE CRITICAL MEMBERS

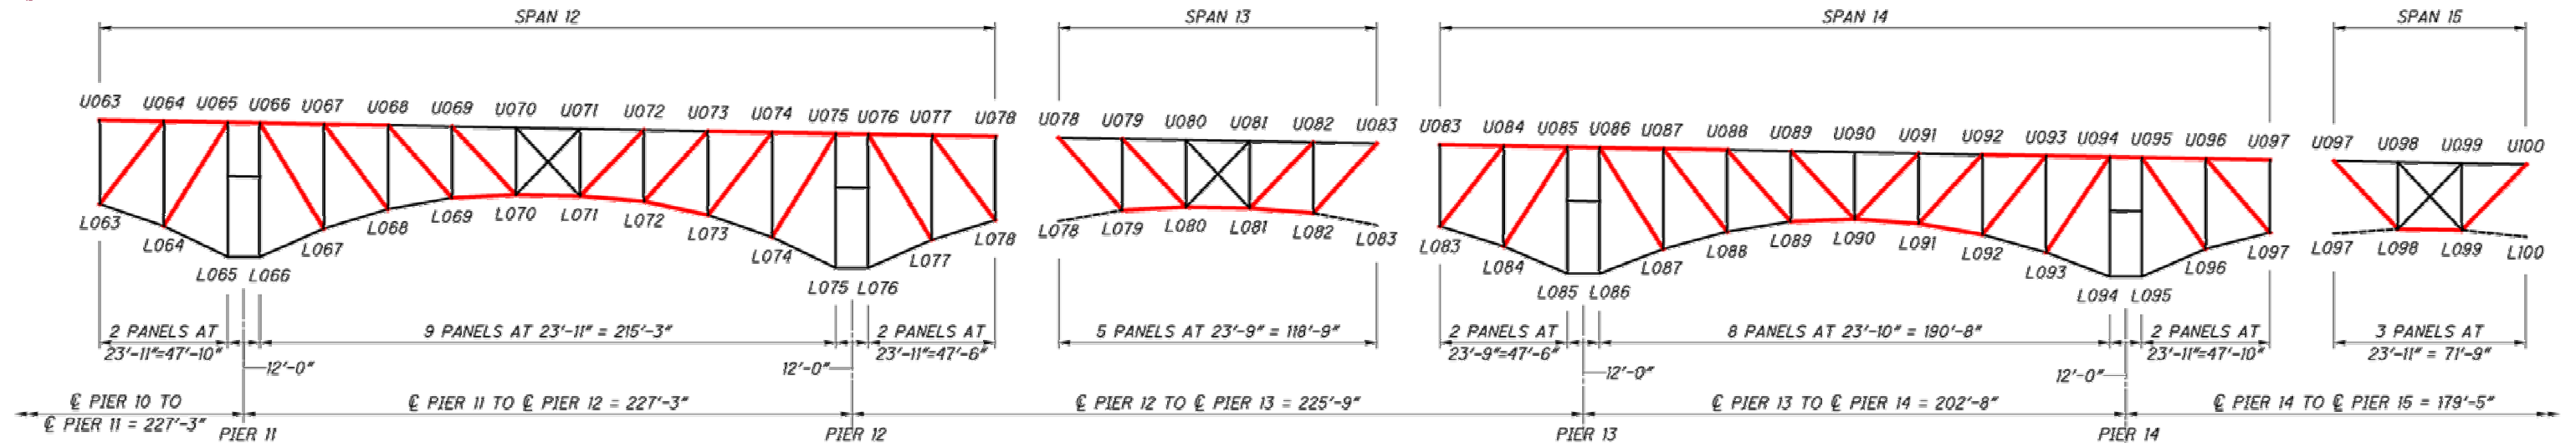
SOUTH ELEVATION OF LORAIN-CARNEGIE TRUSS
SPANS 12 THROUGH 15
