**PHYSICAL CONDITION REPORT
FOR THE 2011 ROUTINE INSPECTION**

LORAIN-CARNEGIE BRIDGE

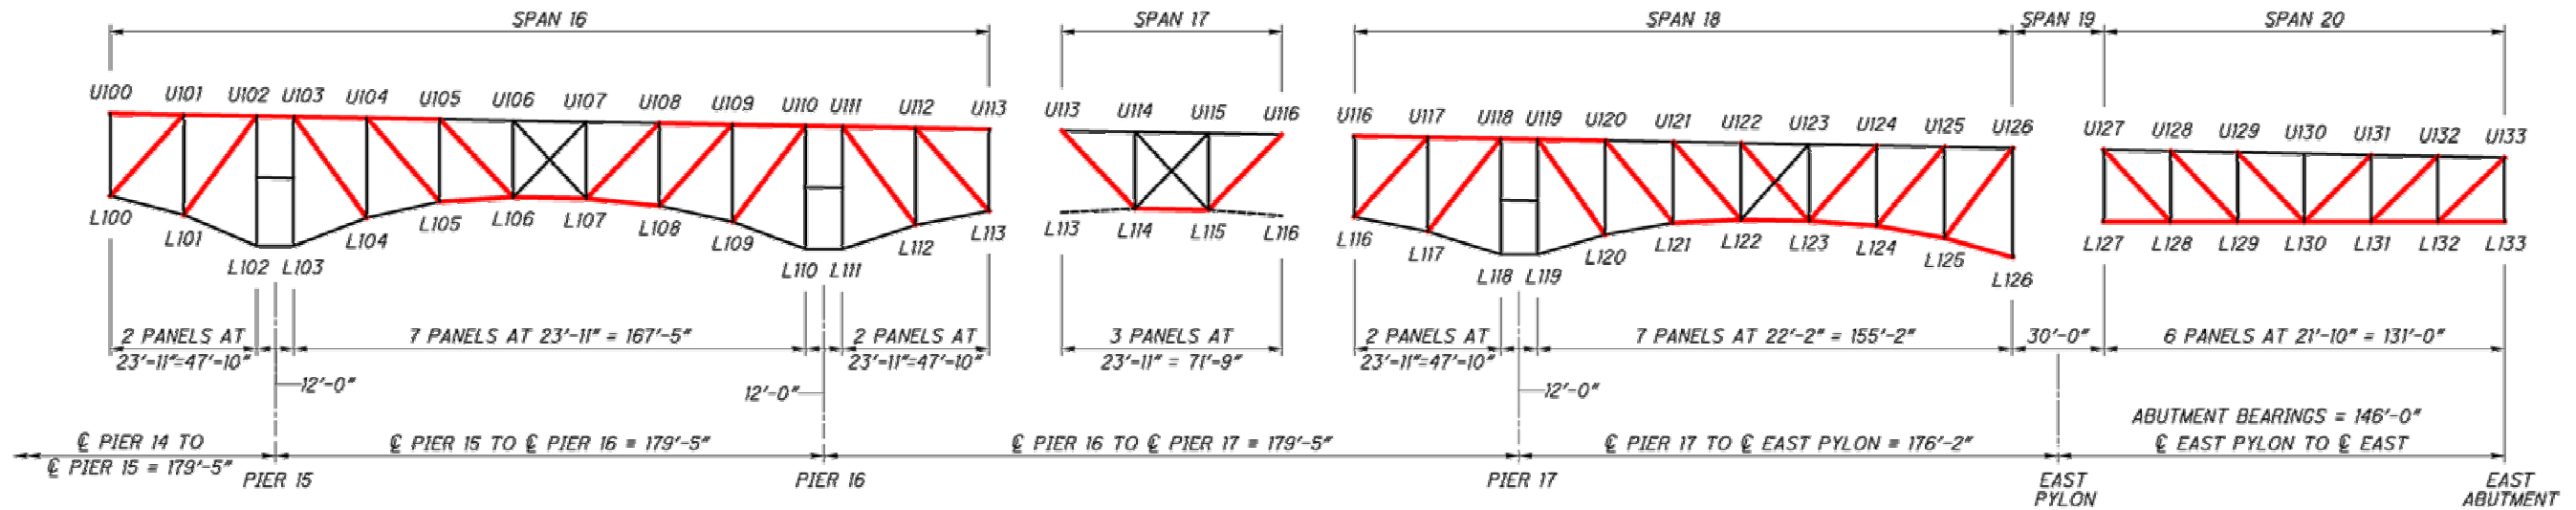
SOUTH ELEVATION OF LORAIN-CARNEGIE TRUSS
SPANS 16 THROUGH 20
