The sway strut between Truss A and Truss B at Panel Point 3 exhibits areas of 100% section loss to the web stiffeners and 1/4" pitting on the web 3" high with isolated holed through sections.

The south web plate of AL7-AU7 exhibits 1/4" pitting for the full width along the interface with gusset plate AL7S.

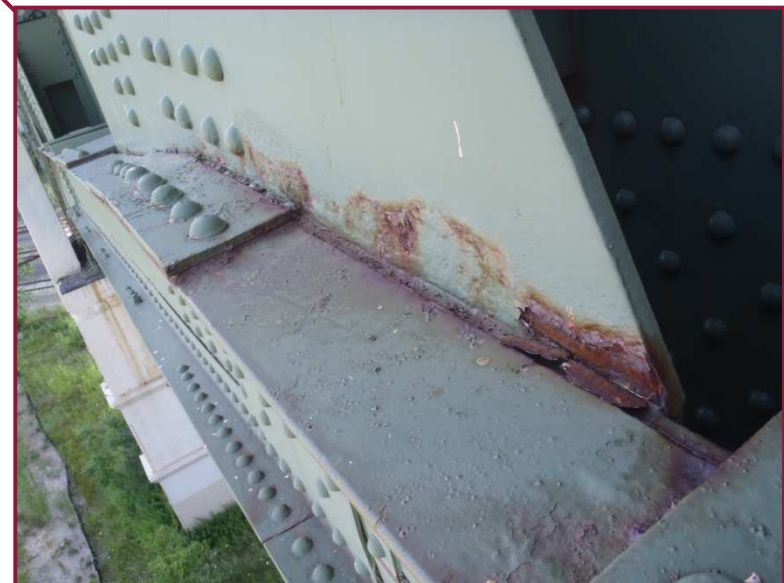
There is active corrosion on gusset plate AL5N along the top flange angle of AL4-AL5 with associated 1/16" pitting.

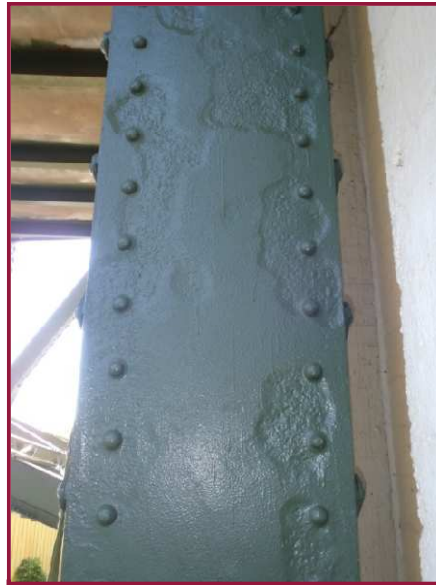
The north and south web plates of BL0-BU0 exhibit 1/8" to 1/4" deep pitting (see Section A-A).

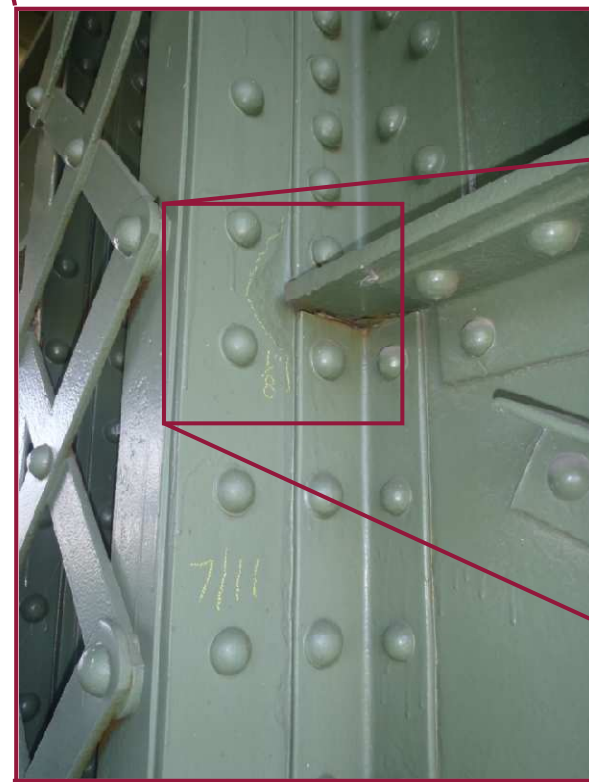
The north web plate of vertical member BL5-BU5 exhibits 1/8" pitting around the sway brace connection.

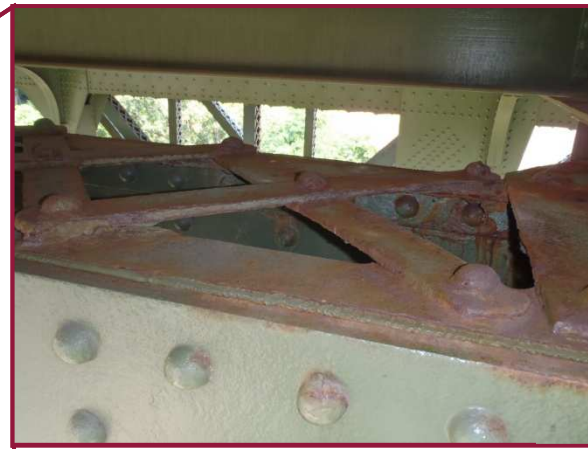
extensive rust and corrosion

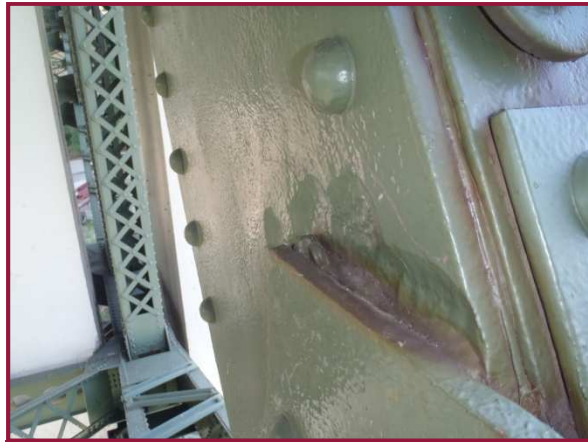
Pack rust up to 1" thick between diagonal member AU9-AL10 and the free edge of gusset plate AL10N, as well as 1/4" pitting on the north web plate of the member at this location.

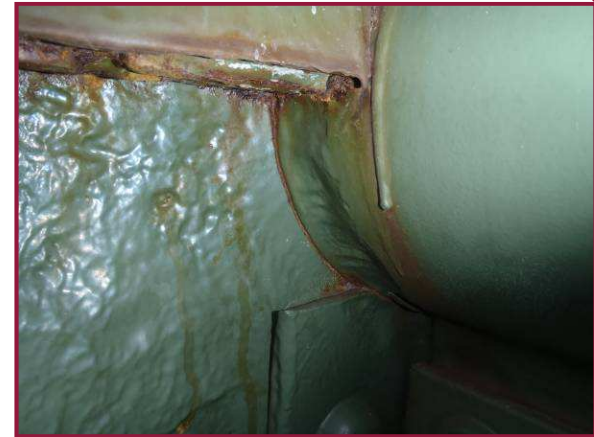
The bearing pin at AL12 exhibits 3/16" deep loss along the circumference adjacent to the pin plates. Additionally, the innermost pin plates exhibit 1/8" deep pitting throughout the interior face adjacent to the pin.

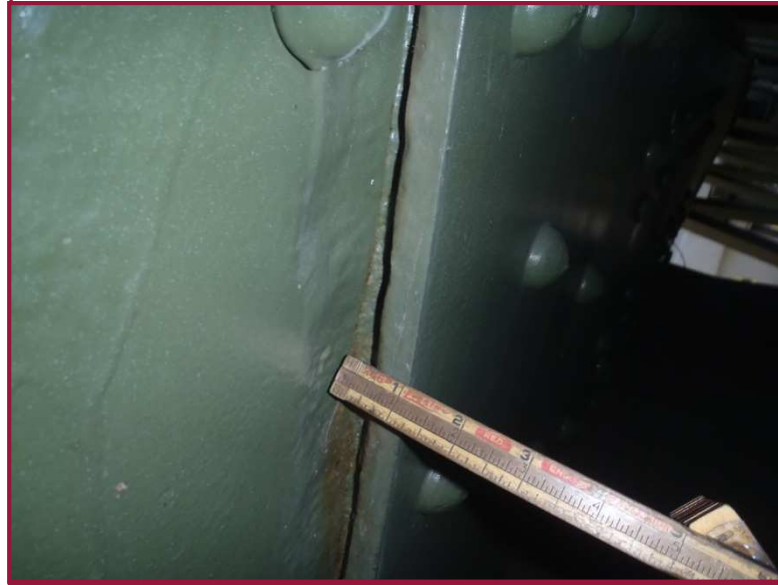
At Panel Point AL14, pack rust is present up to 5/8" thick between the web plates of lower chord member AL13-AL14 and both gusset plates (AL14N shown). Pack rust has not been cleaned and sealed.

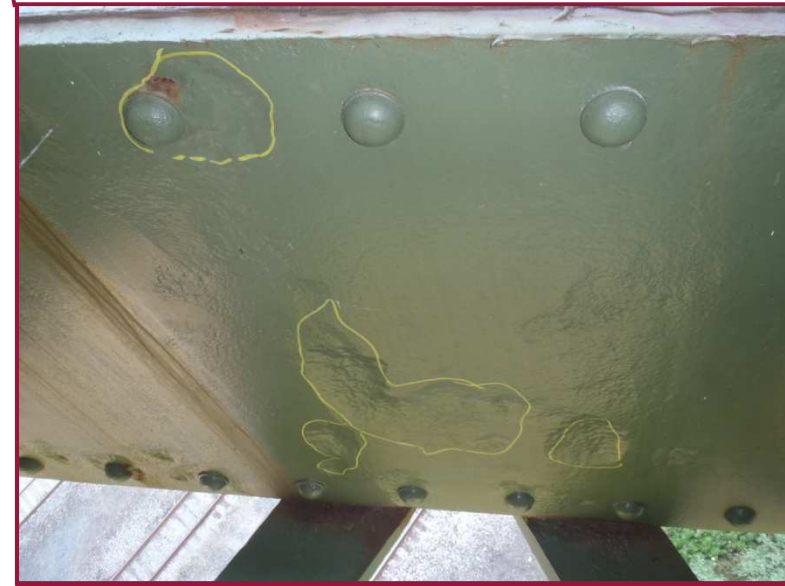
The north web plate of lower chord member AL17-AL18 exhibits 1/4" pitting on the interior face for half the height of the section.

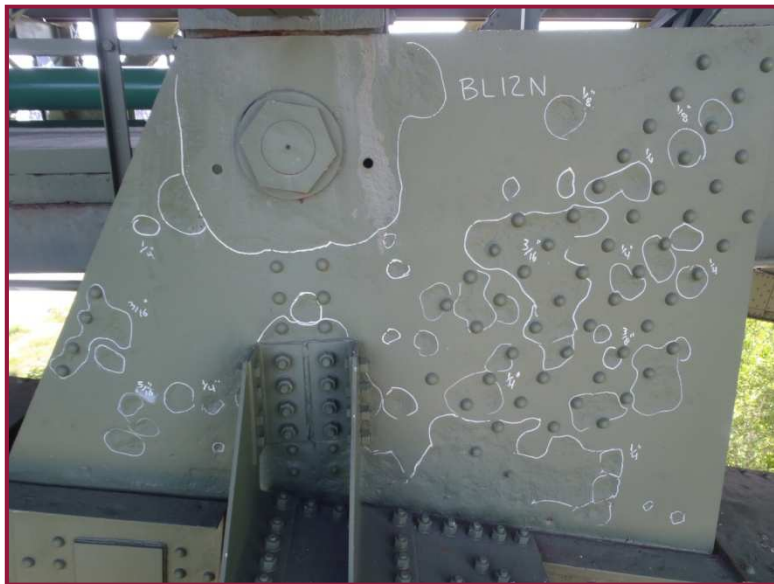
Gusset plate BL12N exhibits small areas of deep pitting up to 5/16" throughout. All locations exhibiting greater than 3/16" deep pitting are highlighted with field markings. The south plate at BL12 exhibits conditions similar to those shown.

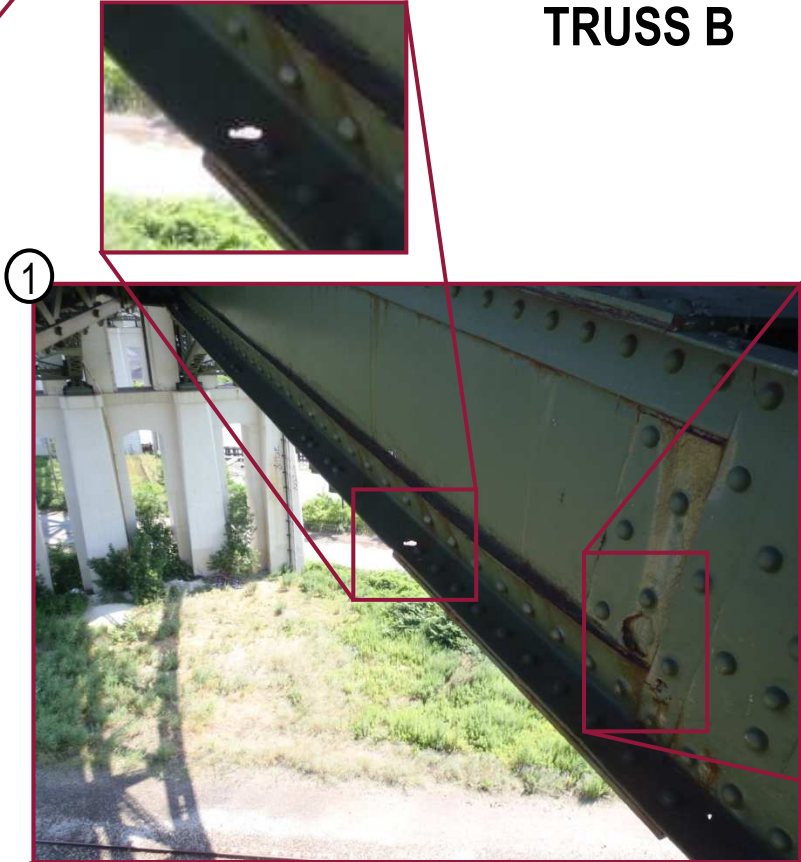
The second pin plate on the north side of lower chord member BL12-BL13 at BL12 has a 3" diameter hole in the bottom corner. Similarly, the third pin plate has a 2" diameter hole in the bottom corner, and the fill plate has a 4" diameter hole at the bottom. 1/8" pitting is typical on the pin plates. A 1-1/2" diameter hole in the north bottom flange is present roughly 5' east of this location.

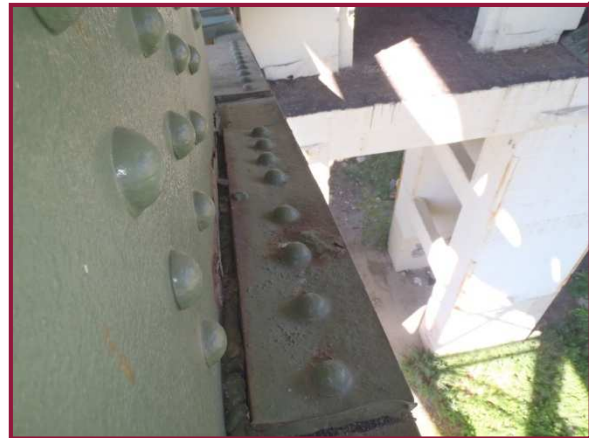
The bottom flange angle splice plate at CL11 is bowed out approximately 1-1/2" due to heavy pack rust.

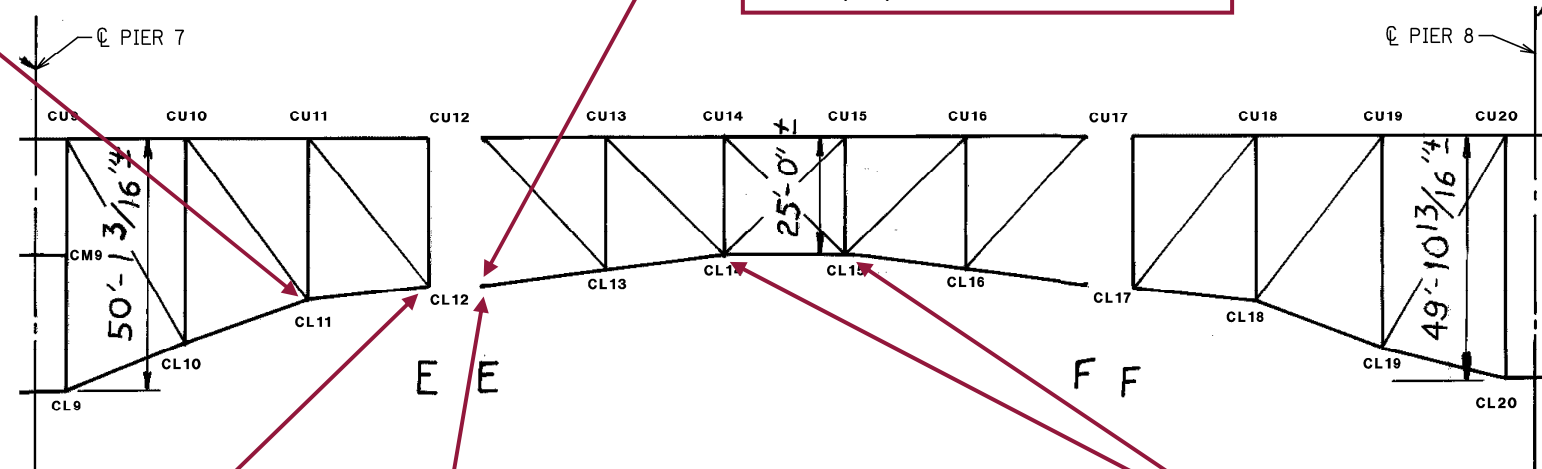
At the lower chord sliding pin at CL12, heavy pack rust has forced the pin plates away from the end of the pin. The end of the pin is approximately 1" from flush with the keeper plate.

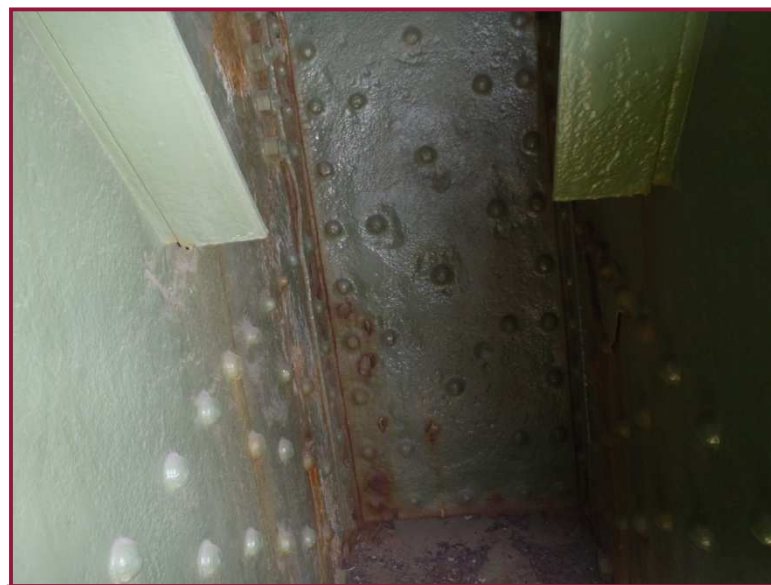
The internal diaphragm plate at CL12 exhibits heavy pitting with active corrosion around the rivet heads and along the edge of the plate at the gusset plate interfaces.

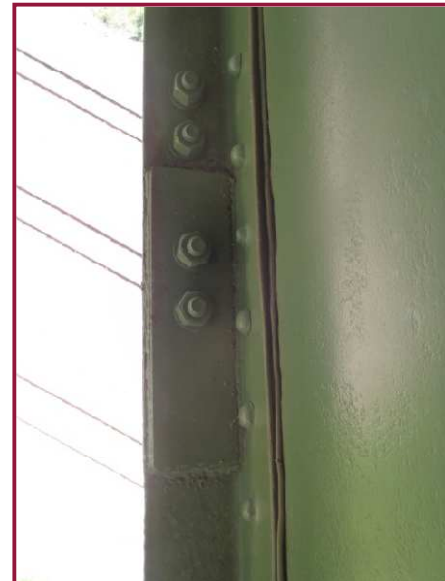
DL11-DL12 has a welded retrofit plate on the outstanding leg of the north bottom flange. A similar plate is located on the south bottom flange at this location.

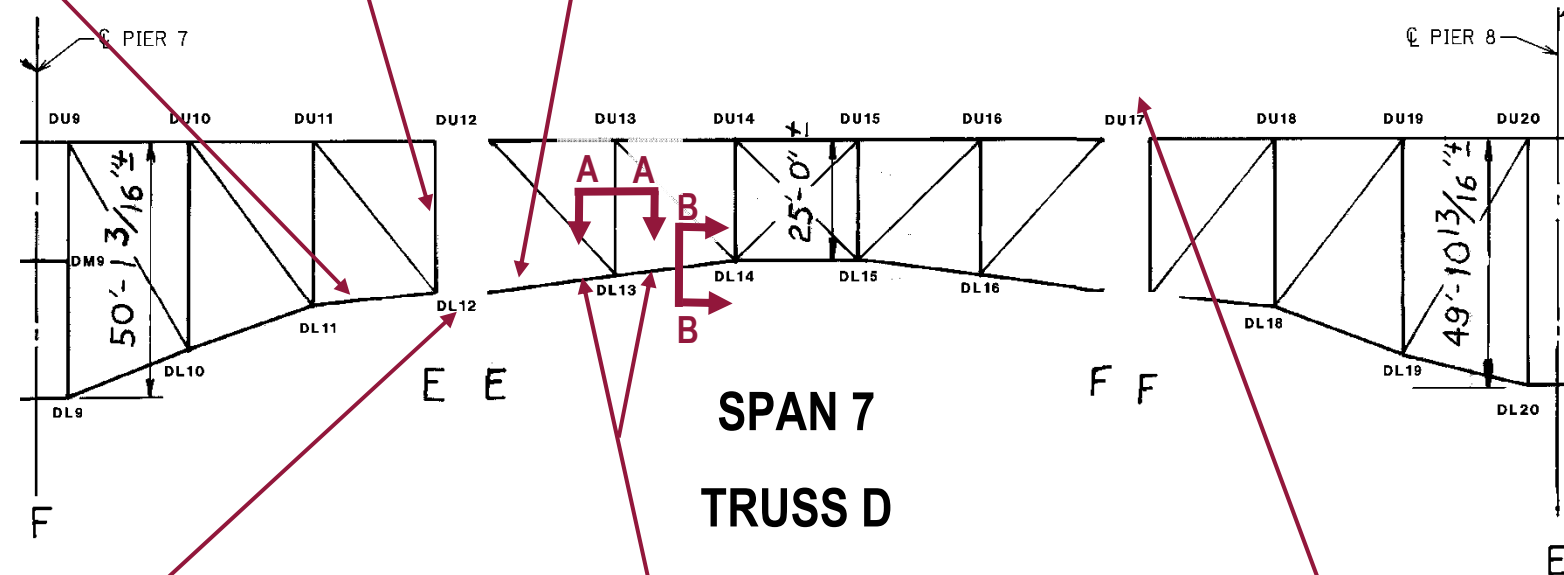
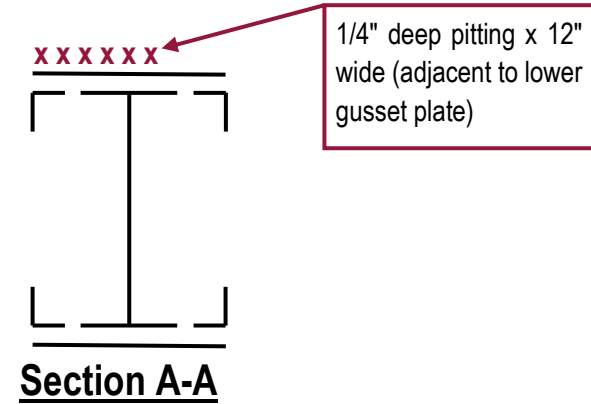
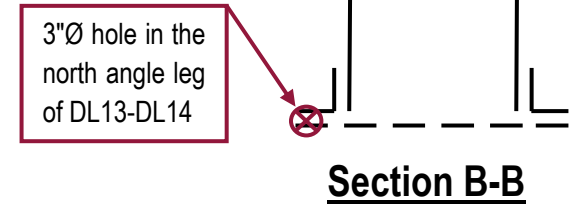
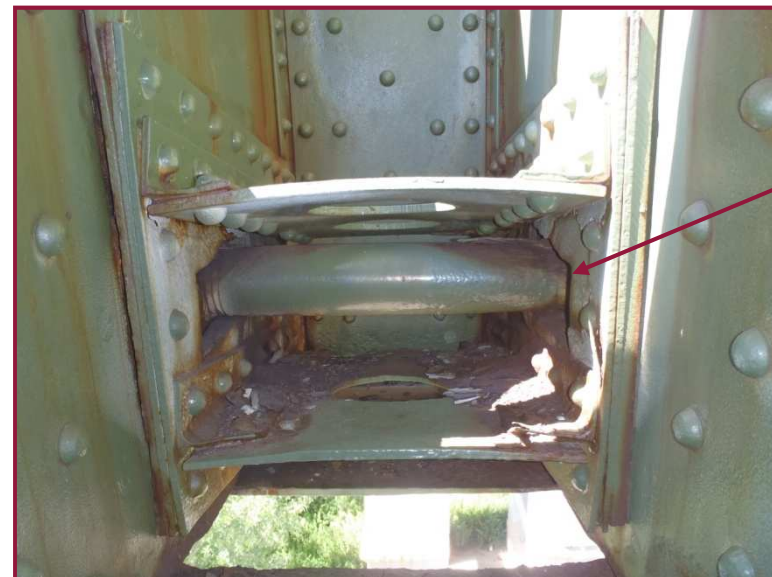
The sliding pins at gusset plate location DL12 are worn. The internal diaphragm between gusset plates above the pin appears to have buckled due to pack rust.

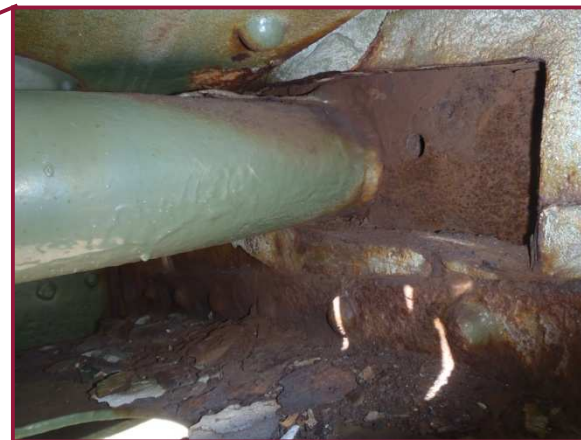
Note active corrosion and wear on north DL12-DL13 lower chord sliding pin at DL12.

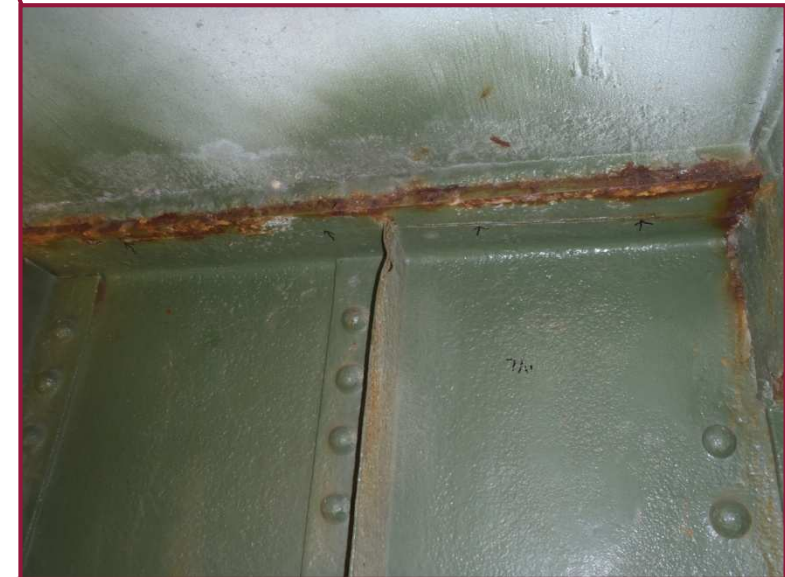
Floorbeam 17 exhibits a lamellar tear approximately five feet long on the bottom of the top flange between Stringer 7 and the interior bearing stiffeners.

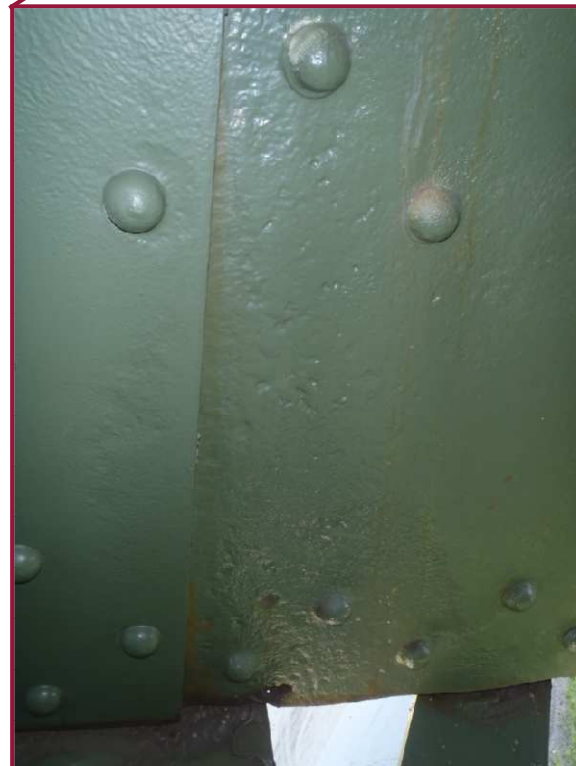
The north and south web plates of chord member AL24-AL25 exhibit 3/16" pitting over the full height of the plate along the interface with Panel Point AL25 gusset plates, with an isolated 1" diameter hole in the south plate (south plate shown).

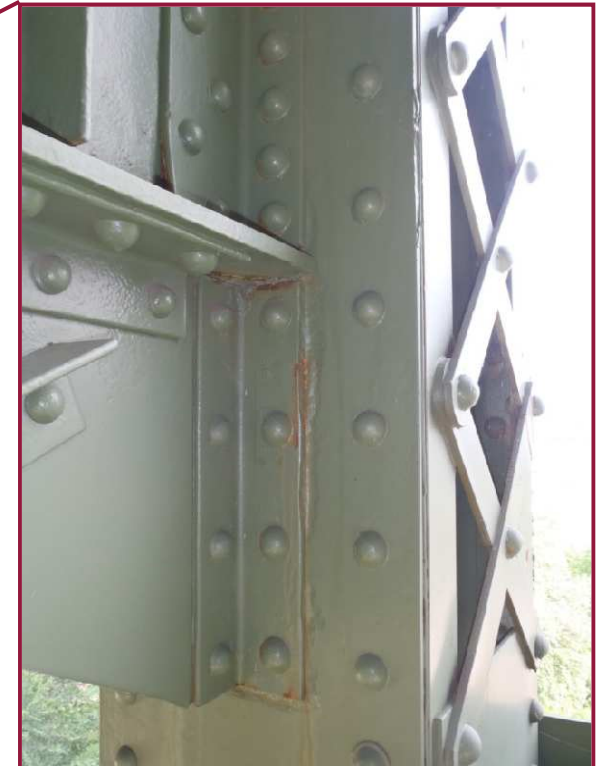
The north web plate of vertical member AL27-AU27 exhibits typical 1/8" pitting around the sway brace connection.

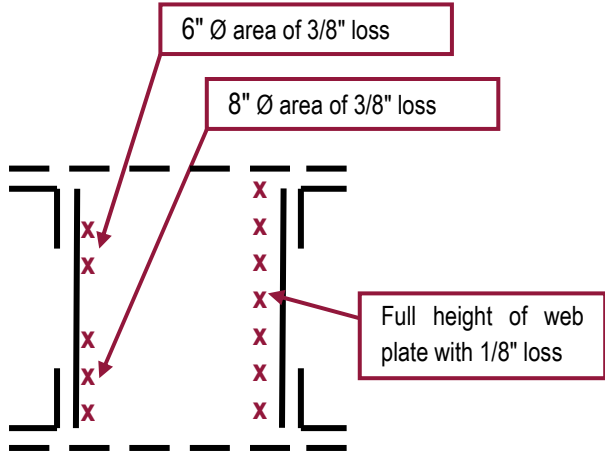
1/16" deep pitting is typical over the full height of the north web plate adjacent to gusset plates throughout Span 8. Pitting at DL22 is up to 1/8" deep at this location.

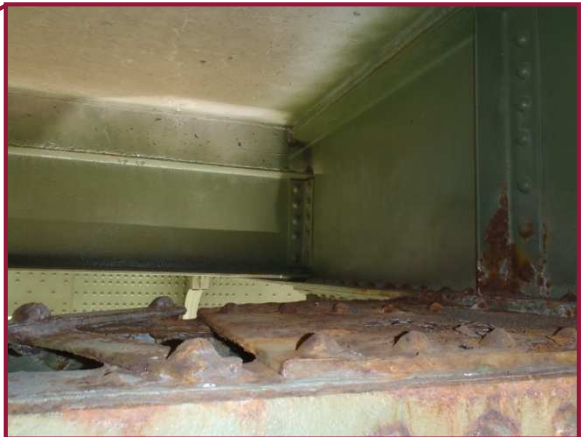
Upper chord member DL28-DL29 exhibits pitting up to 1/8" on the cover plate, lacing bars and top flange angles within the bounds of gusset plates at DL29. This area has active corrosion due to the presence of a deck subdrain.

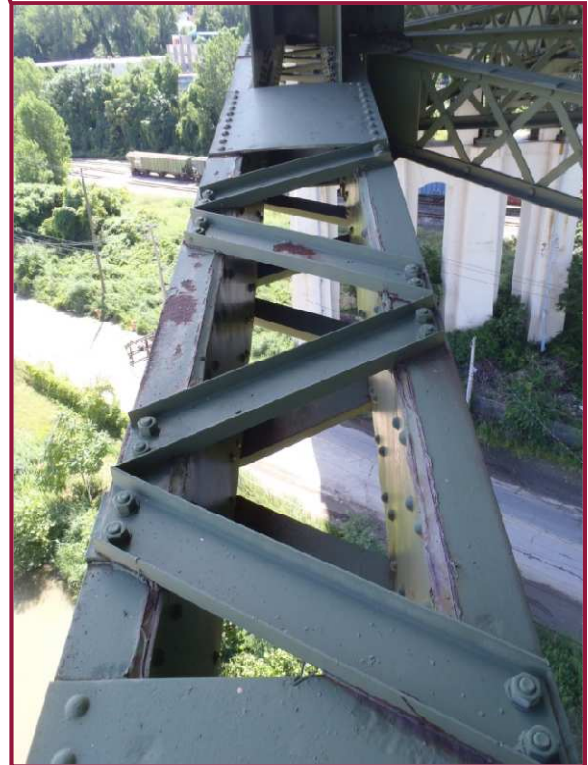
The lower chord members in Span 8 exhibit heavy impacted rust between web plates and flange angles.

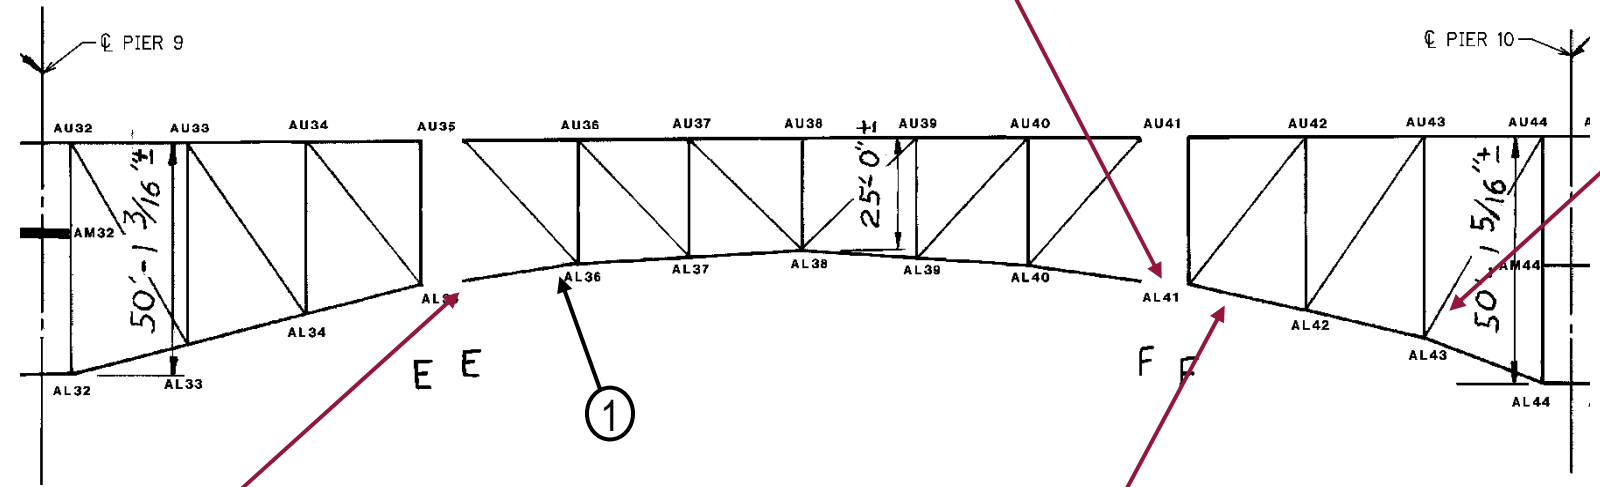
The built-up strut at AL41 exhibits active surface corrosion throughout.

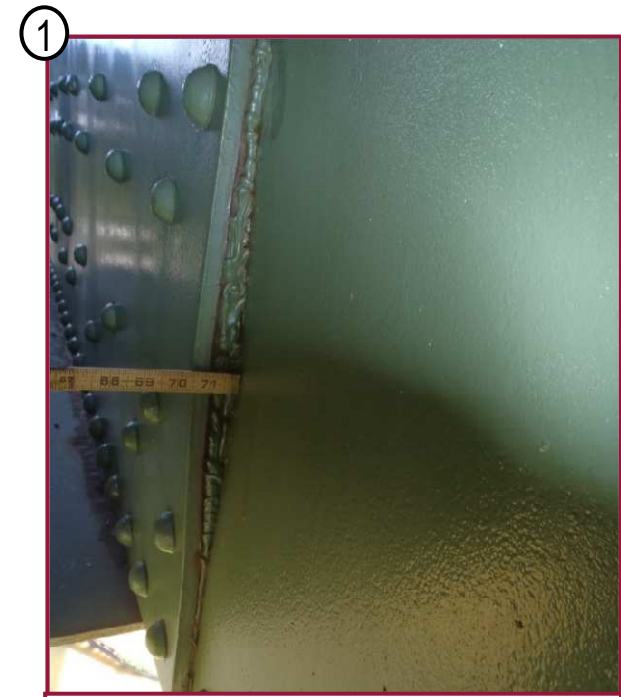
Cleaned and sealed pack rust up to 1" thick is present between lower chord member AL35-AL36 and gusset plate AL36S.

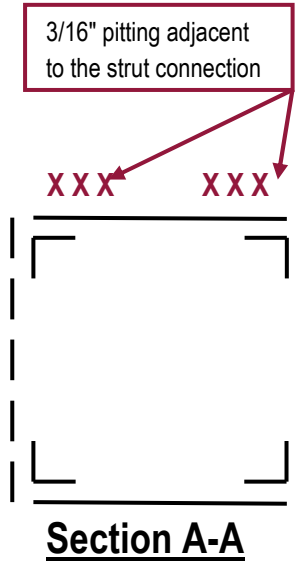
Heavy pitting of the north web plate along the bottom flange angle is typical for the lower half of BL35-BL36. The pitting on this member progressively worsens from west to east, with up to 5/16" deep pitting near BL36.

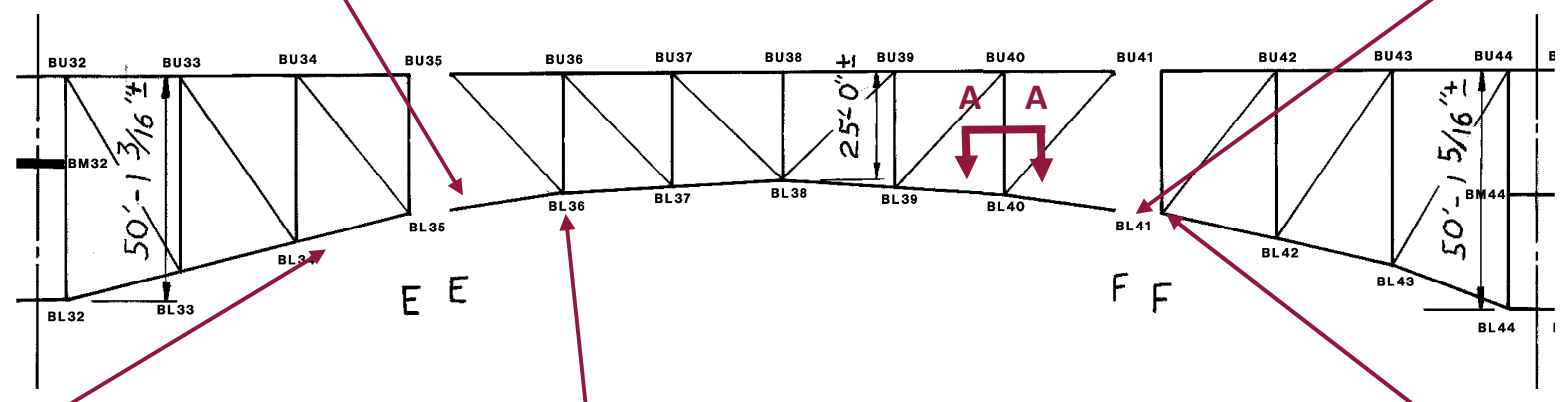
The lower sliding pin at BL41 exhibits loss up to 1/8" adjacent to the pin plates along the pin circumference. The pin at BL35 exhibits similar conditions in addition to minor corrosion throughout the surface of the pin.

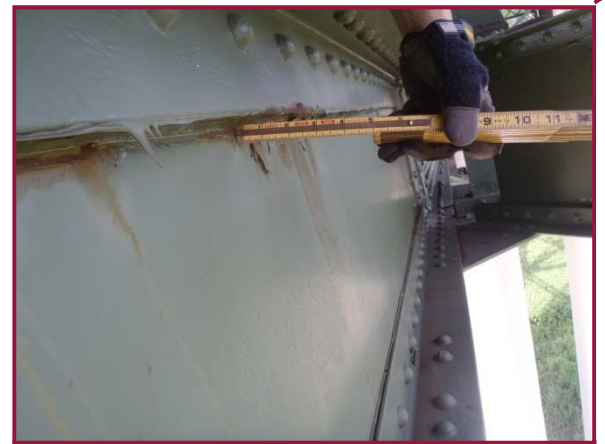
Chord member BL34-BL35 exhibits impacted rust up to 1" thick between the web plates and vertical legs of top flange angles.

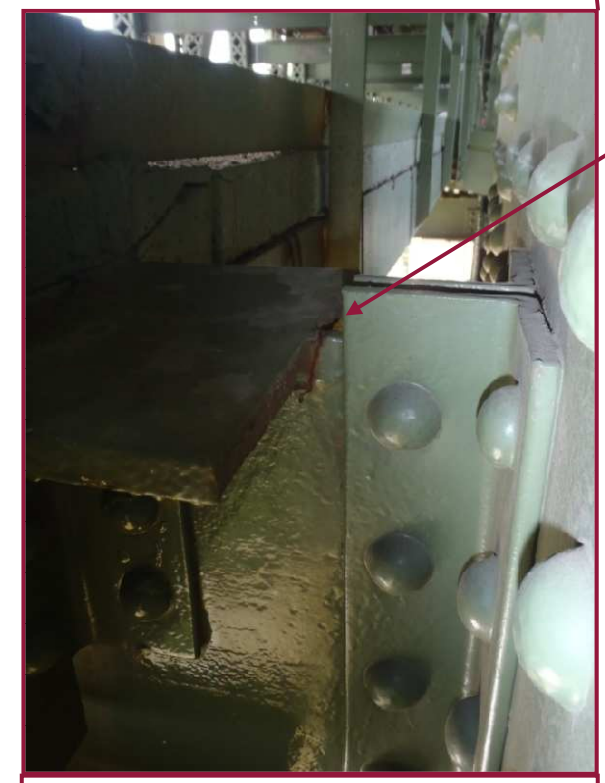
The utility deck floorbeam connection at BL36 exhibits a 1-3/4" long crack at the top cope which has not been arrested.

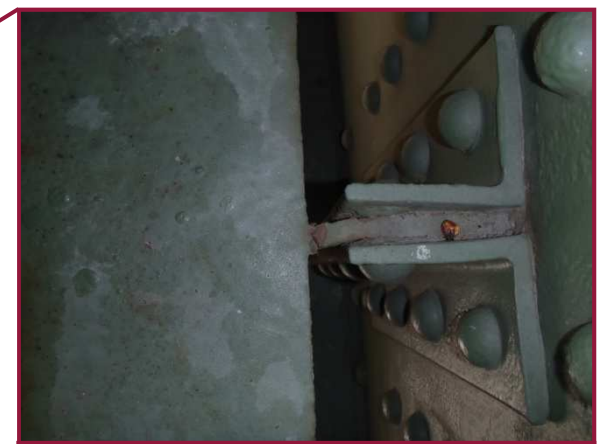
Plan view of utility deck floorbeam, showing out-of-plane deflection in the web at the crack location.

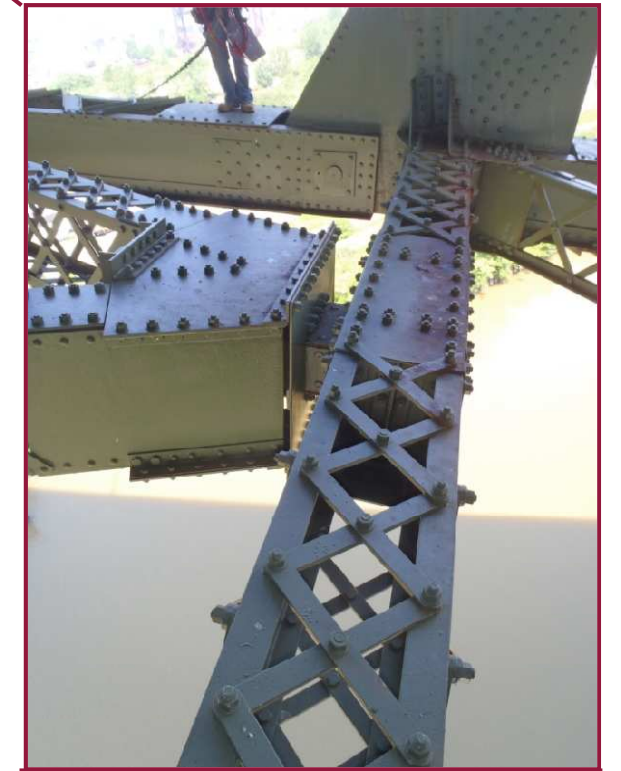
The strut between Truss A and Truss B at Panel Point 41 exhibits active surface rust throughout.

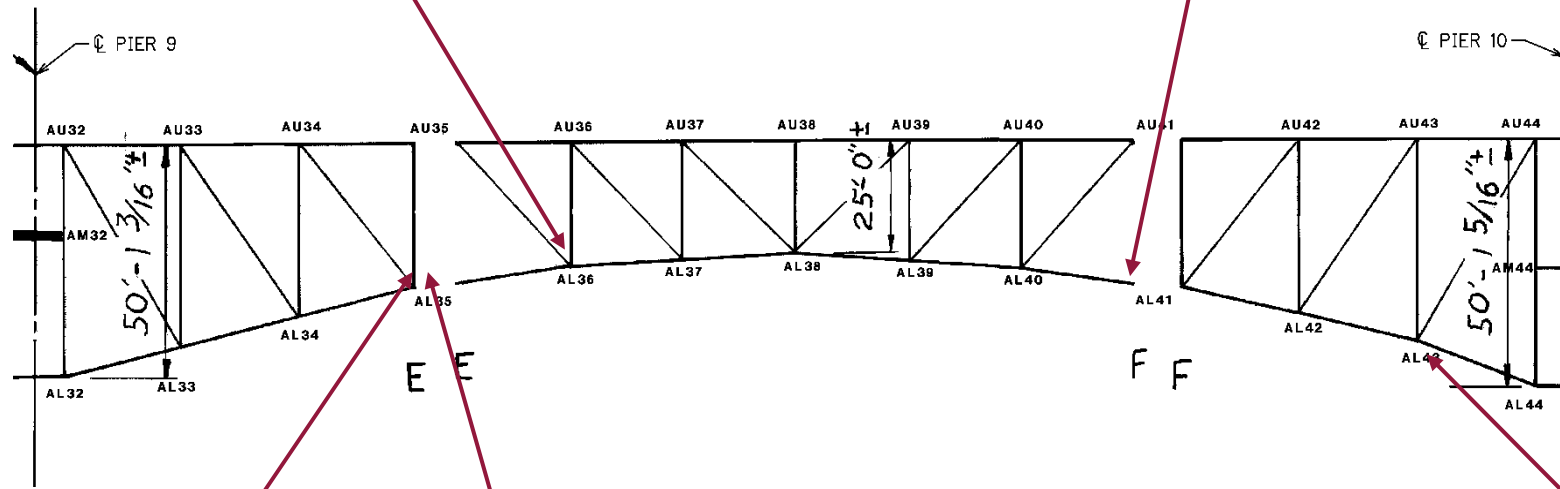
3" diameter hole in the bottom cover plate.

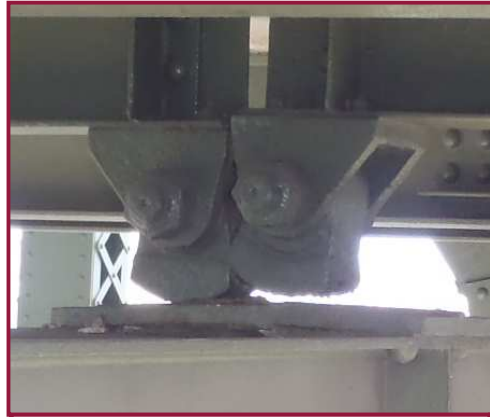
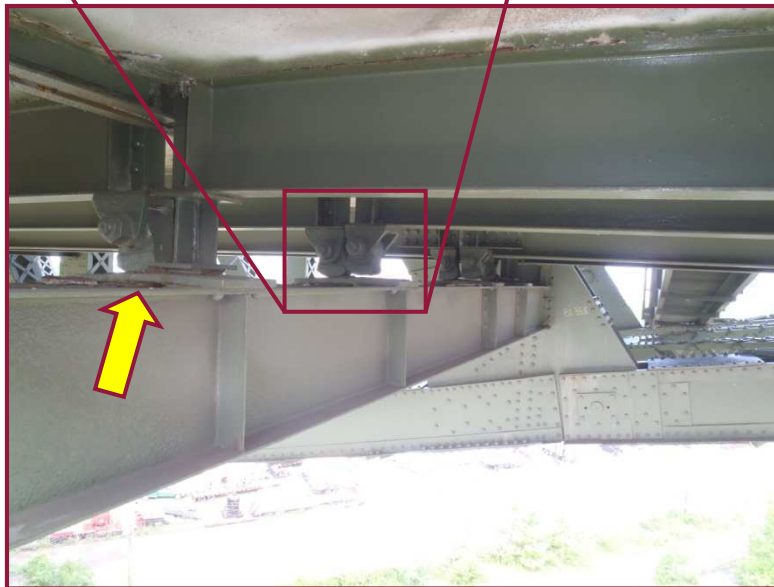
Stringers 2 and 3 are not bearing at the utility deck Floorbeam 35 bearing plates. Stringers 1 and 4 have bearing retrofits, consisting of modified beam sections with welded vertical stiffeners. Note that pack rust between the top floorbeam flanges and the bearing plate has caused the plates to bow up.

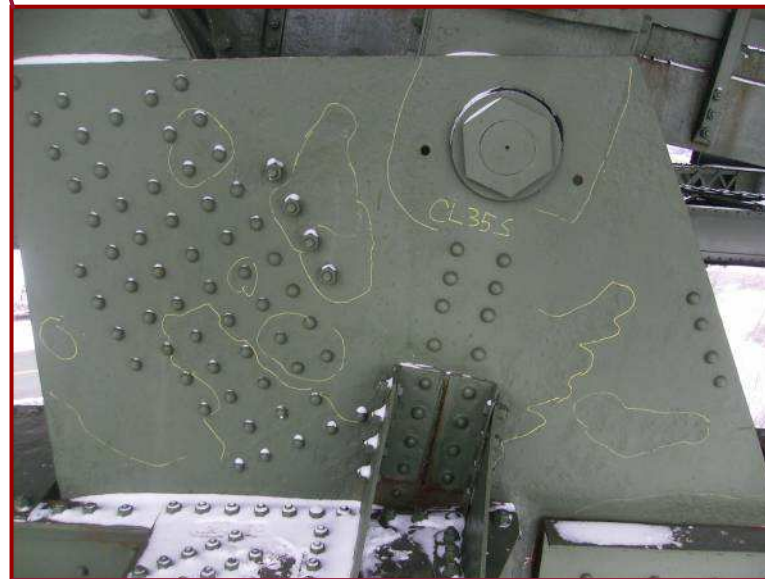
Gusset plate CL35S exhibits 1/8" deep pitting throughout areas of the south face, with small areas with up to 1/4" deep loss on the north face of the plate along the lower chord (Photo taken in 2010).

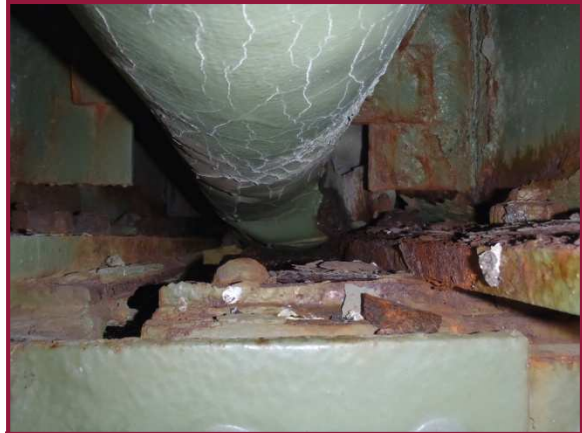
Floorbeam 35 exhibits active corrosion of the bottom flange and adjacent web and vertical stiffener plates with up to 1/16" deep pitting. The joint trough at this location has failed with water and debris leaking onto the superstructure elements.

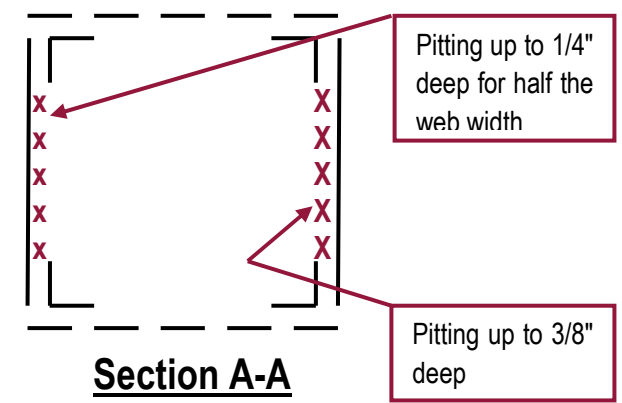
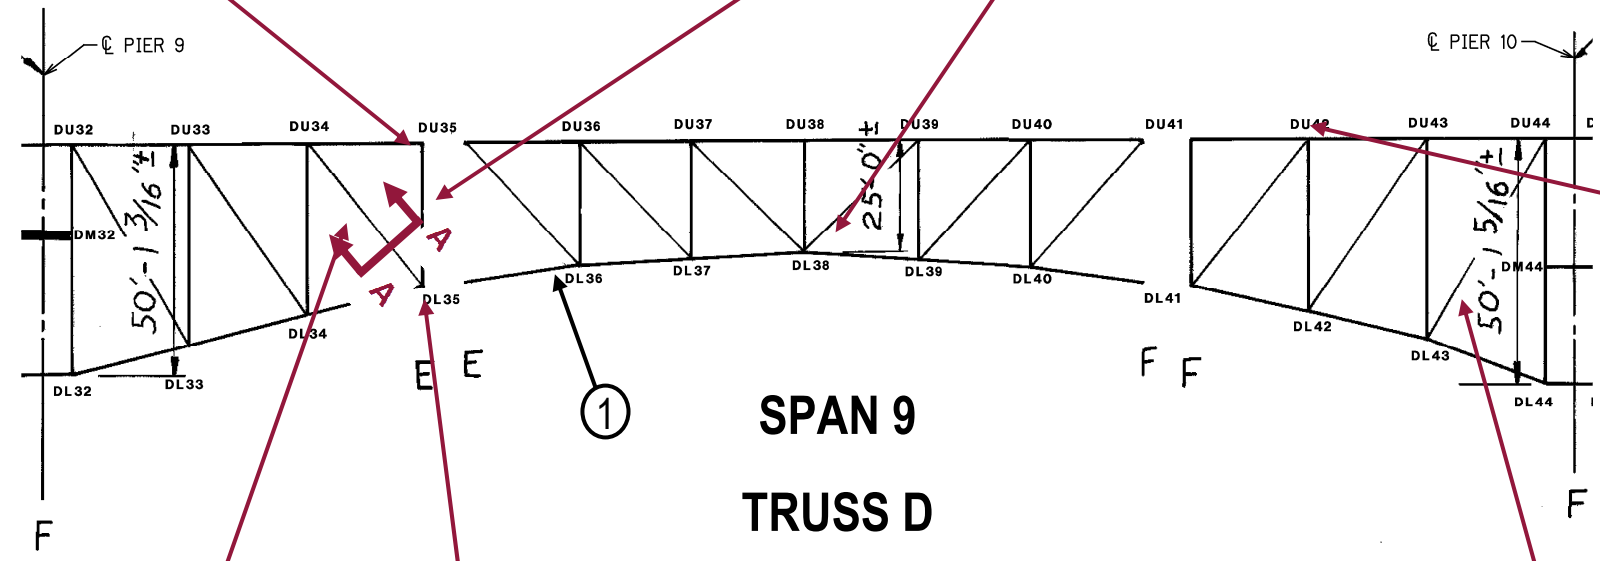
Between Truss D and Stringer 11, Floorbeam 42 exhibits a 1/4" diameter hole in the lower half of the web with 1/16" pitting typical in the surrounding area along the bottom flange.

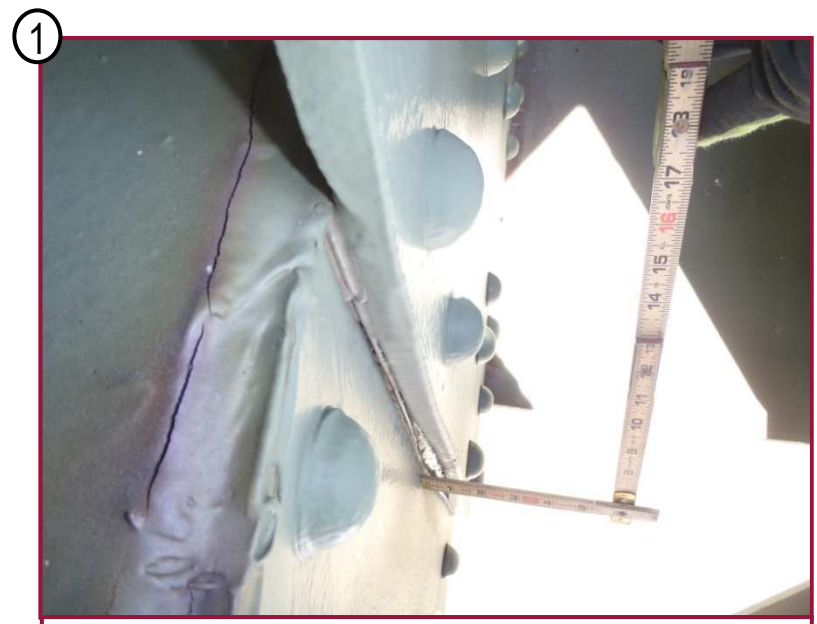
Pack rust up to 3/4" is present between the south web plate of chord member DL35-DL36 and gusset plate DL36S.

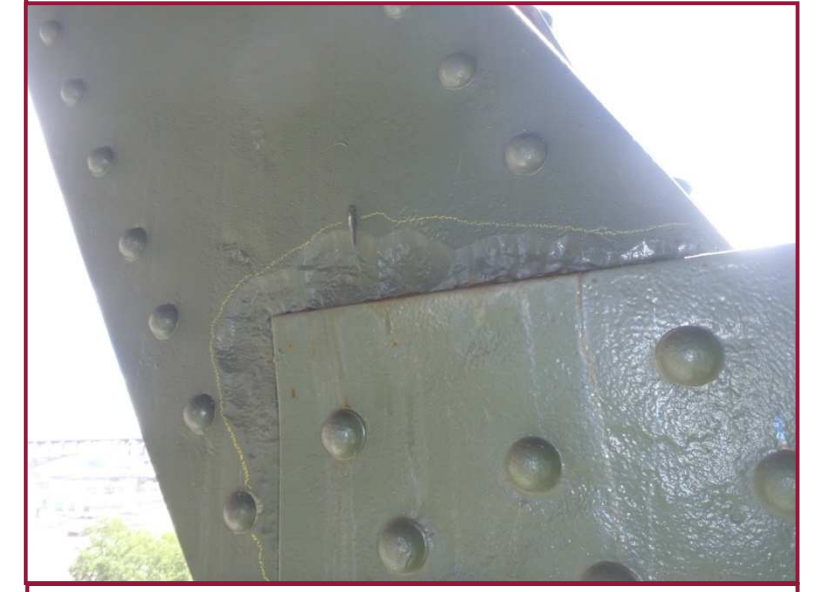
The north web plate of diagonal member DL43-DU44 exhibits 1/4" pitting with isolated 5/16" pitting along gusset plate DL43N for the full height of the section.

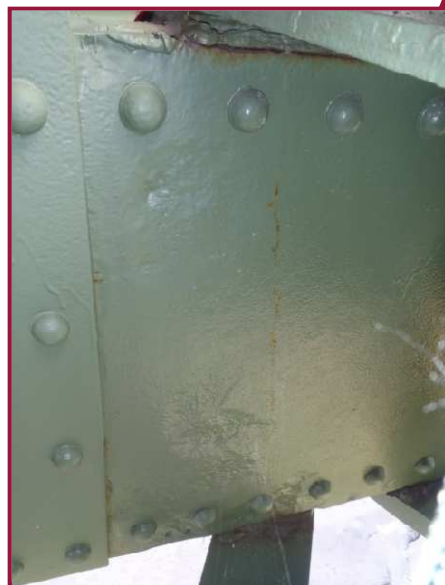
The south web plate of AL48-AL49 has heavy pitting up to 1/4" deep for approximately half the web height near AL49. Similar conditions are found at AL51.

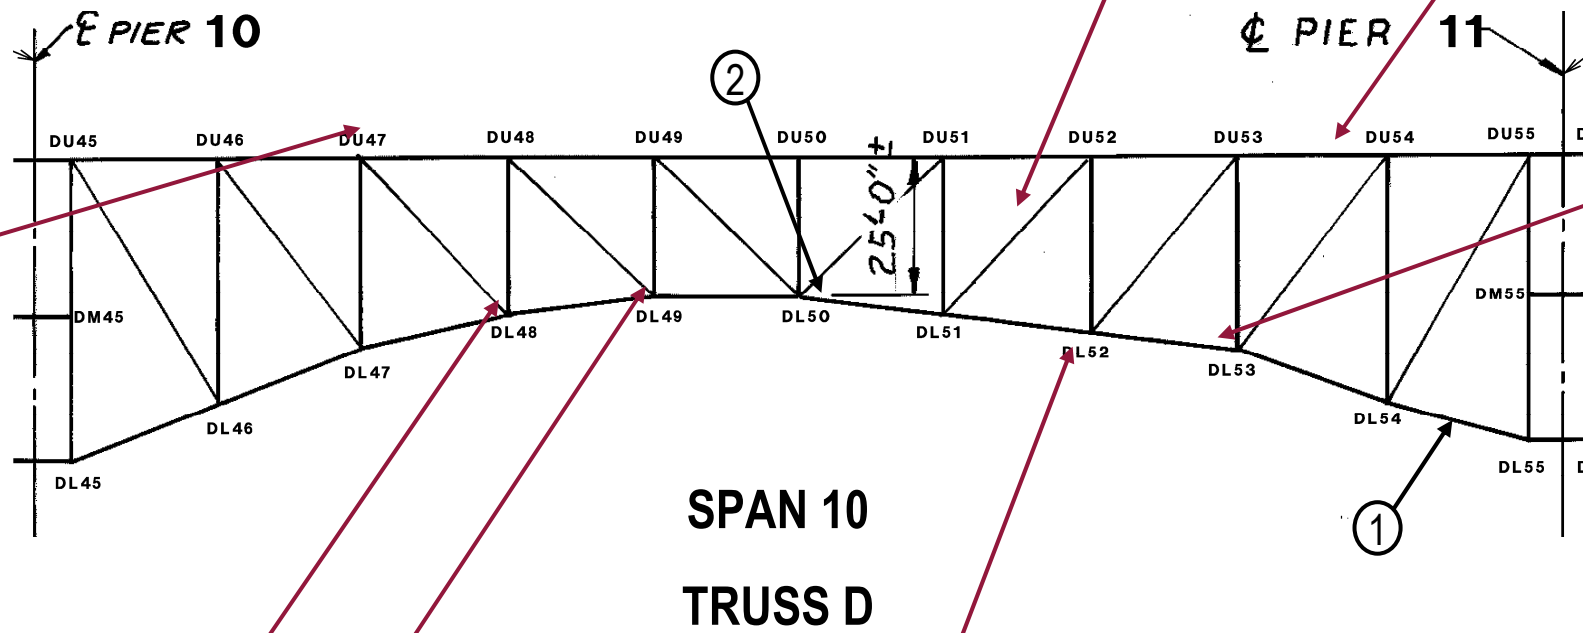
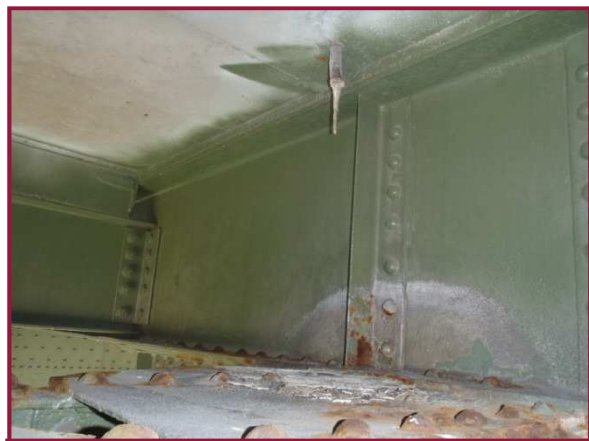
Deck subdrain location on the west side of Floorbeam 47 with 1/16" pitting and active corrosion to the top chord cover plate, lacing bars and flange angles. Note stalactite formation.

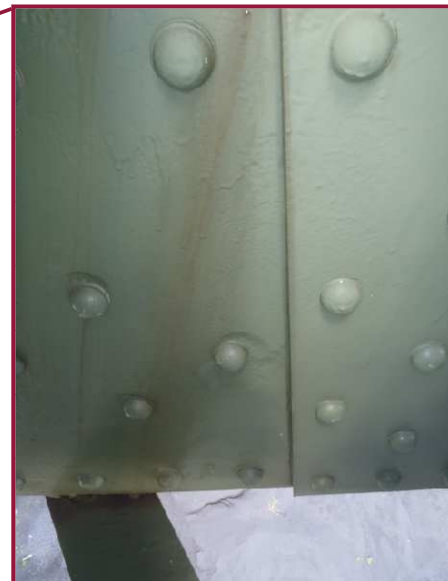
The DL52-DL53 north web plate exhibits an area of 1/4" deep pitting 5" tall (cleaned and painted) along gusset plate DL53N.

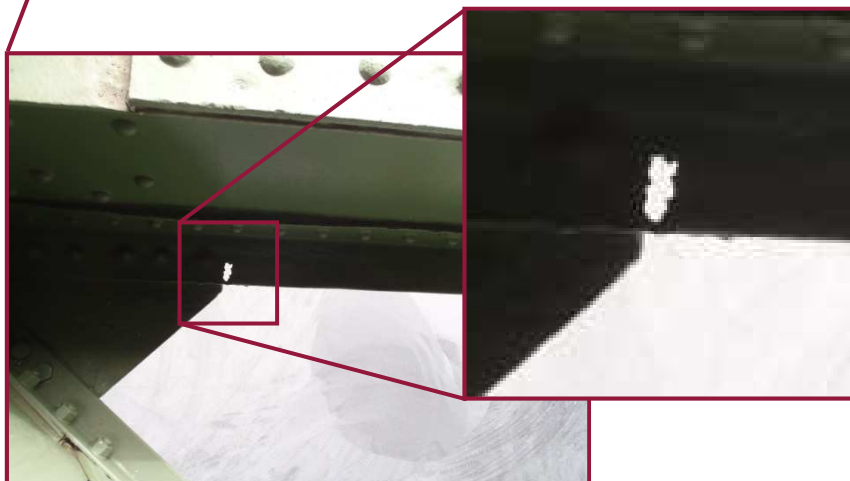
Member DL51-DL52 exhibits a 2" by 1" hole in the north bottom flange outstanding leg with 1/16" pitting on the vertical leg adjacent to Panel Point DL52.

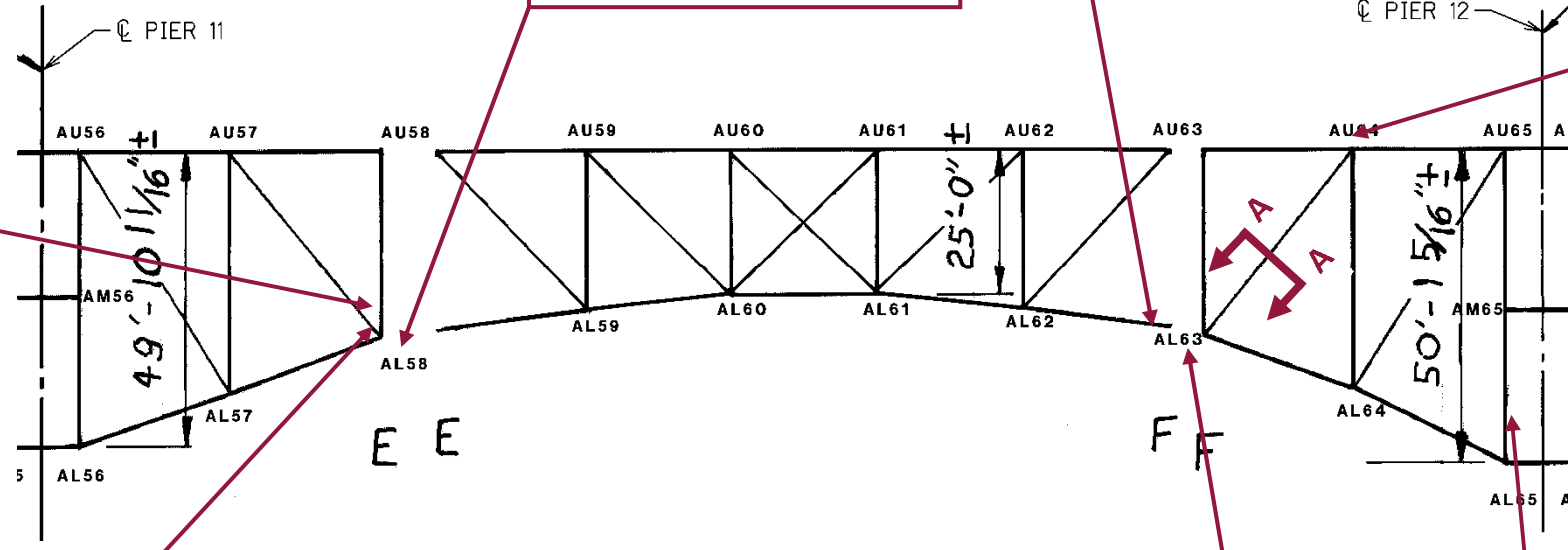
Heavy corrosion is present throughout the interior of AL58-AU58 at the lower panel bearing pin.

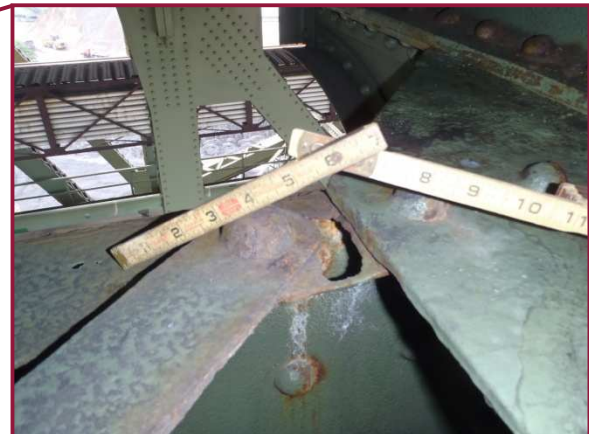
Top chord member AU63-AU64 exhibits 100% section loss to the north top flange angle within the bounds of the gusset plate at AU64.
