The sway strut between Truss A and Truss B at Panel Point 3 exhibits areas of 100% section loss to the web stiffeners and 1/4" pitting on the web 3" high with isolated holed through sections.

The south web plate of AL7-AU7 exhibits 1/4" pitting for the full width along the interface with gusset plate AL7S.

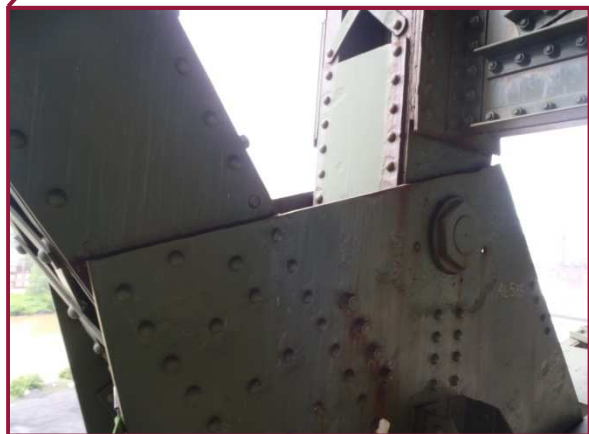
The web members at lower chord Panel Point AL58 exhibit active minor surface corrosion throughout.

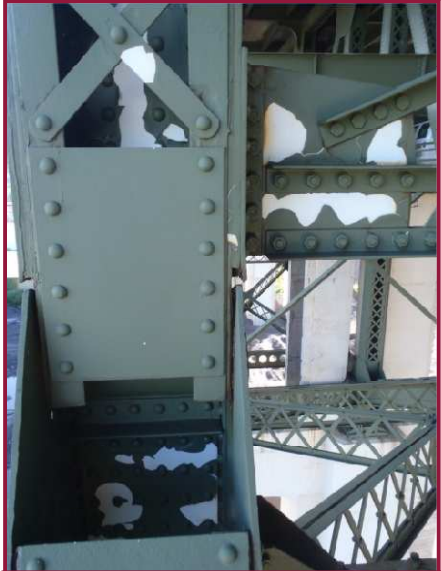
The west face of members at Panel Point AL63 exhibit isolated paint peeling of the top coat, leaving only primer at these locations.

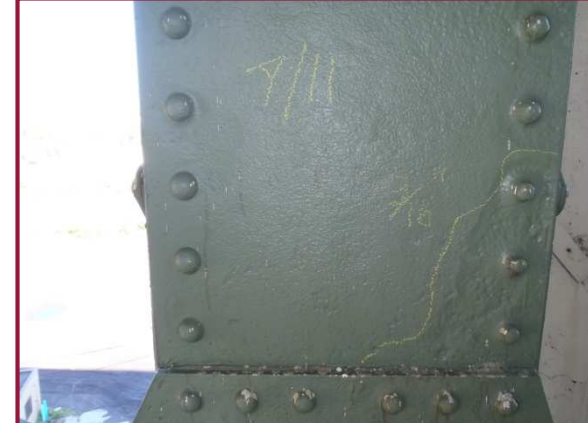
Vertical member AL65-AU65 exhibits pitting up to 3/16" on the south web plate adjacent to the lower chord gusset plate.

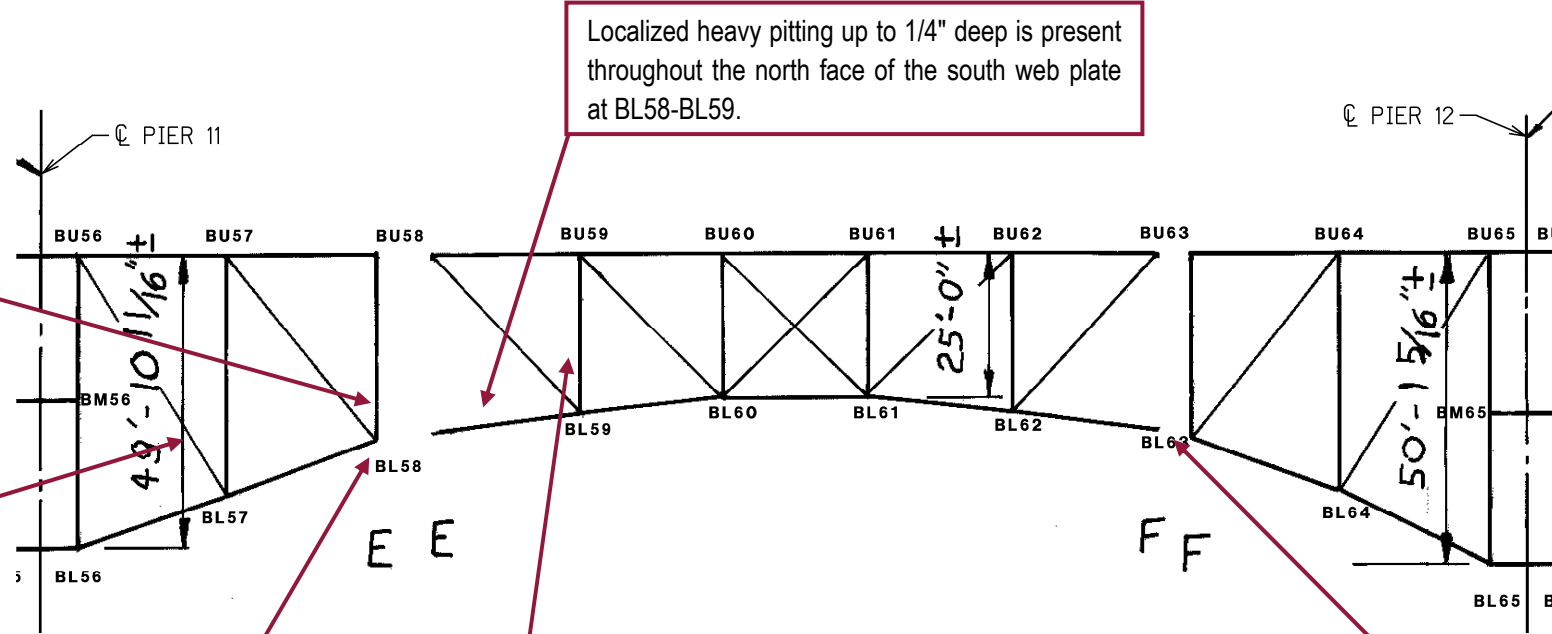
Localized heavy pitting up to 1/4" deep is present throughout the north face of the south web plate at BL58-BL59.

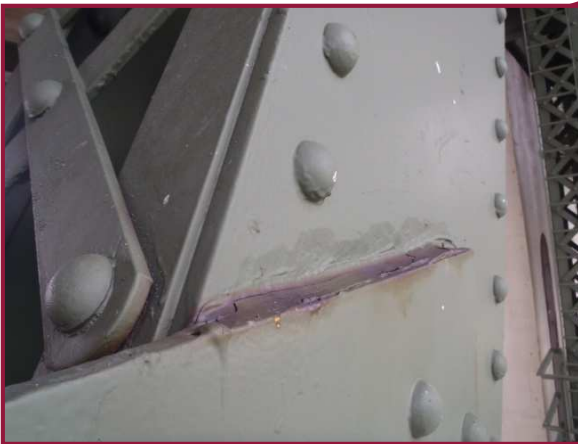
Diagonal member BL57-BU56 exhibits 1/4" section loss on the north web plate with associated pack rust at the lower chord gusset plate BL57N interface.

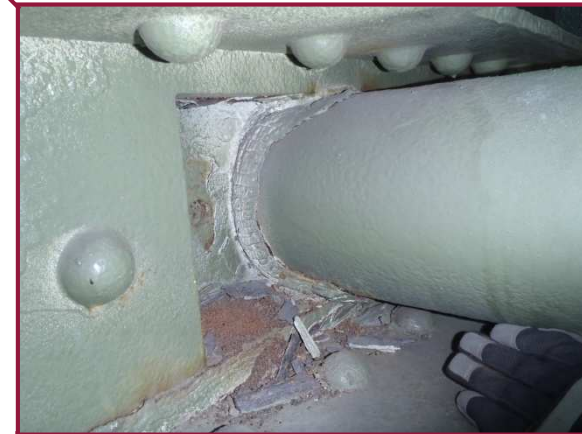
The sliding pin for member BL62-BL63 exhibits typical impacted rust at the north end of the pin at Panel Point BL63.

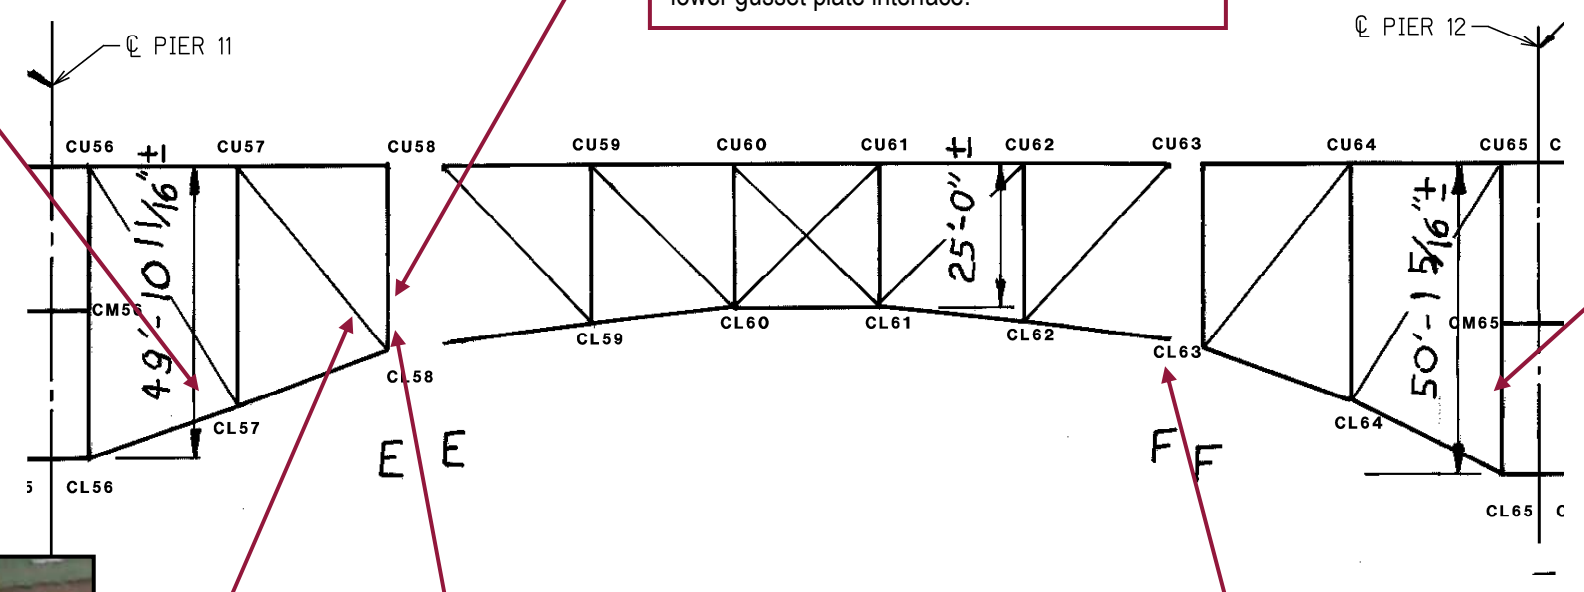
1/8" deep pitting is typical (isolated locations up to 1/4" deep) along the full width of both the north and south web plates of CL58-CU58 above the lower gusset plate interface.

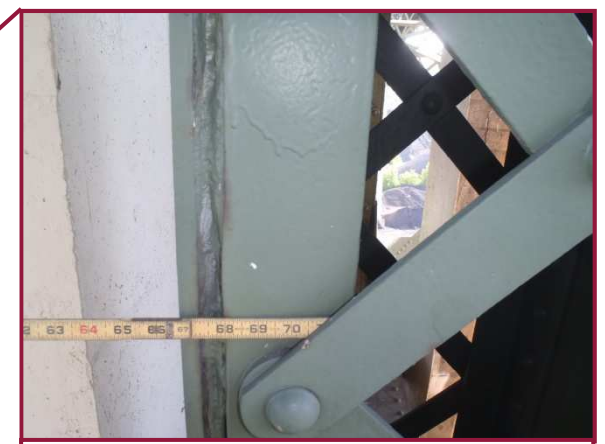
Pack rust up to 3/4" is present between the web plates and flange angles of vertical member CL65-CU65.

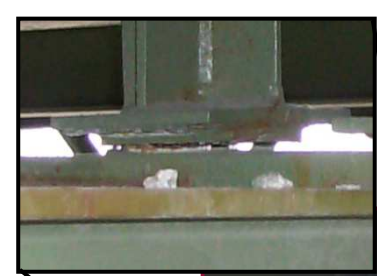
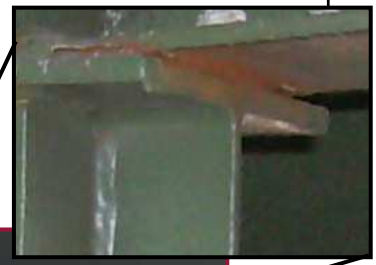
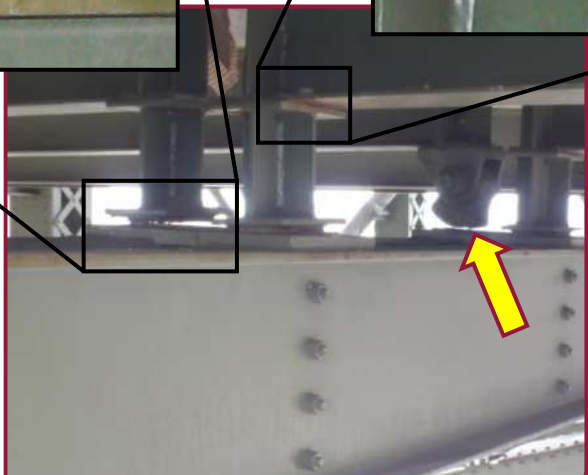
Isolated stringer bearings at utility deck Floorbeam 58 are not in contact with the bearing plates (left). Additionally the retrofitted bearing for Stringer 4 in the near span (between L58 and L59) exhibits a cracked bearing to stringer bottom flange weld and is producing abrasion dust (right).

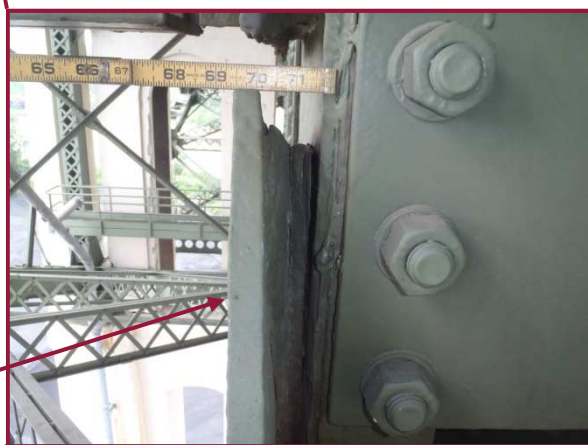
Impacted rust up to 2" thick is present between the vertical web plate and gusset plate CL58S. The pin at this location exhibits a protruding washer.

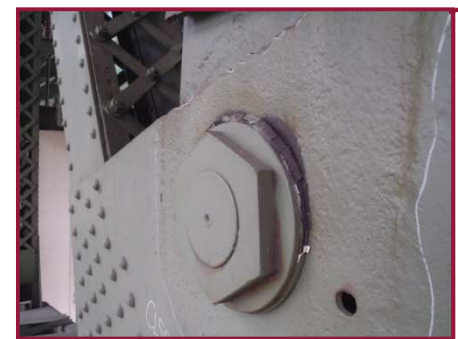
Similar to other spans throughout the structure, the lower chord north web plates exhibit losses along the lower flange angles. Losses in Span 11 are typified by 1/16"-1/8" deep pitting occurring within the lower 2" of the web and most of the length of each bay. The adjacent flange angles exhibit similar pitting.

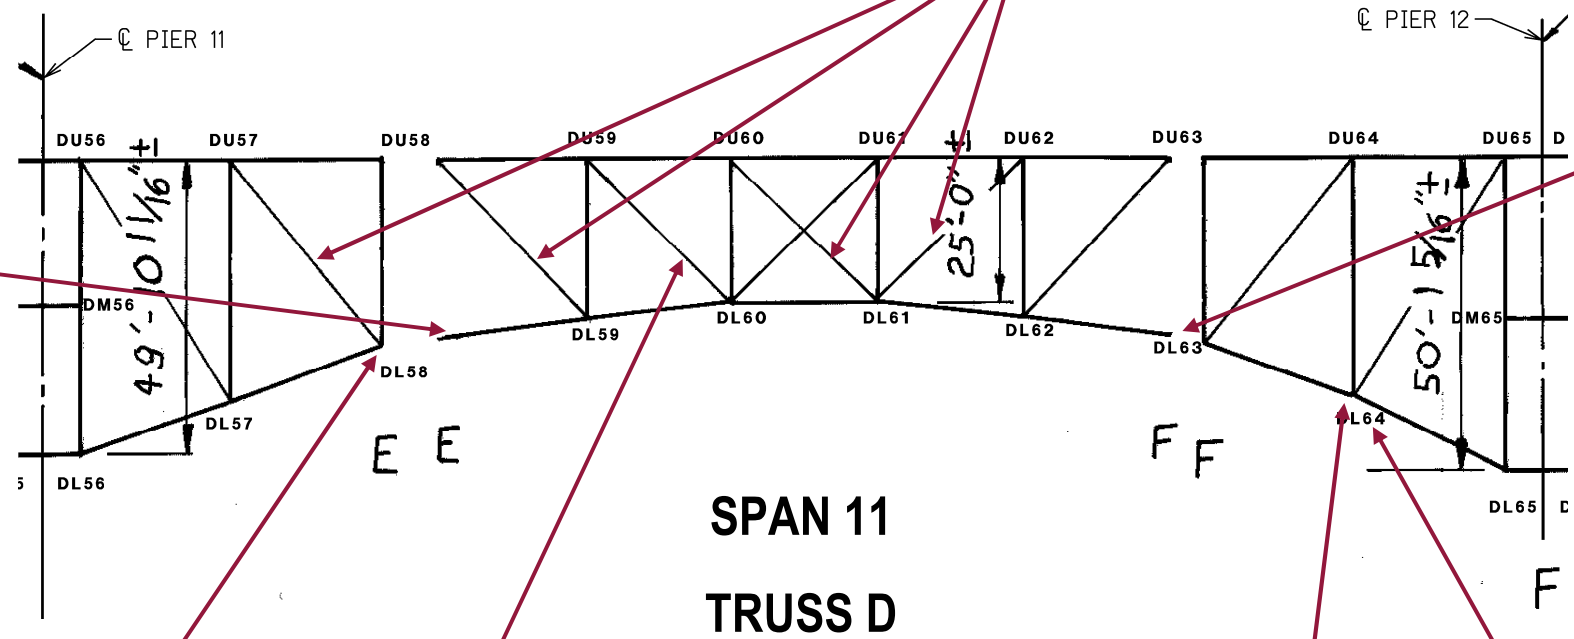
DL58-DL59 exhibits pack rust measuring approximately 1.5" thick between the two outermost pin plates at DL58. Losses surrounding the pack rust are approximately 1/8" on each plate. Similar conditions were noted at DL63 with 1/2" thick pack rust.

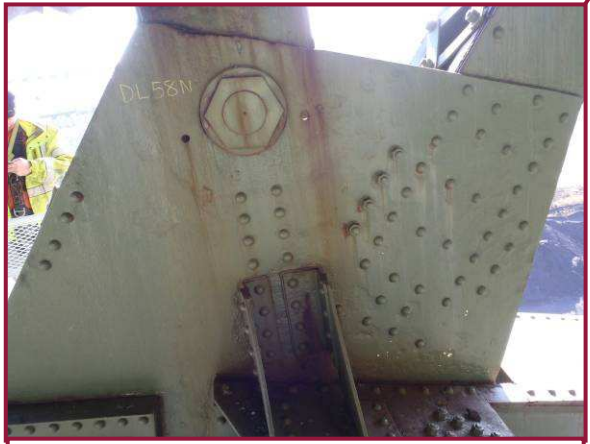
The north gusset plate at DL58 exhibits up to 3/16" pitting, a condition typically found at the expansion locations throughout the structure (Photo taken 2010).

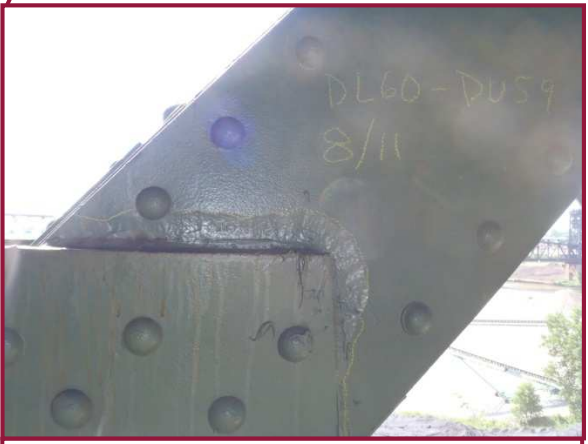
The north web plate of member DL60-DU59 exhibits 1/8" pitting (cleaned and painted) for the full height of the section along the interface with gusset plate DL60N.

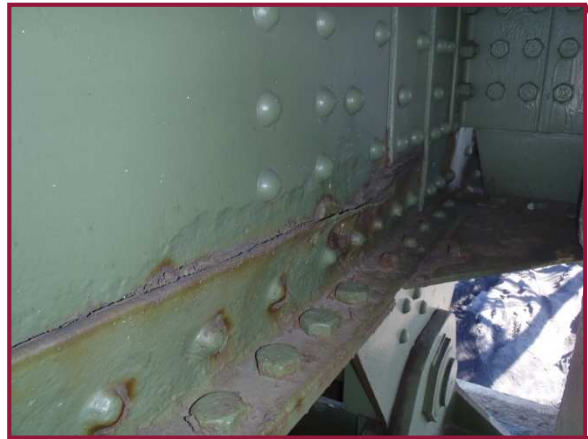
Lower chord member AL65-AL66 exhibits pitting on the flange angles up to 1/8" with a 2" by 1/2" hole and up to 2" of impacted rust between the web and bottom flange angles.

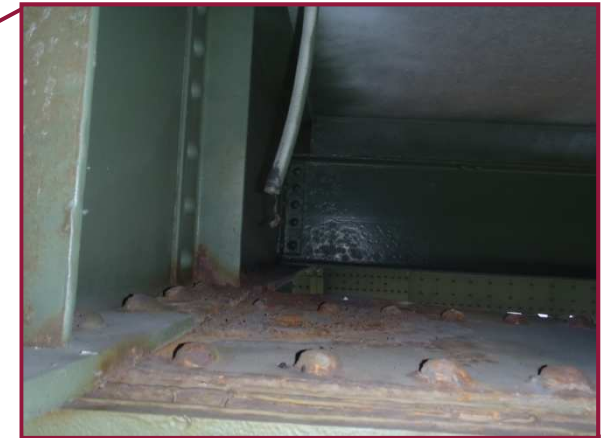
The top chord cover plate just east of Floorbeam 72 exhibits active corrosion due to the presence of a deck subdrain.

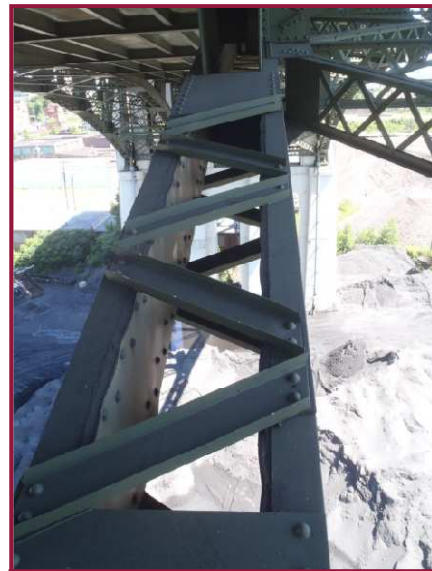
Pack rust is showing signs of reactivation between lower chord web plates and flange angles.

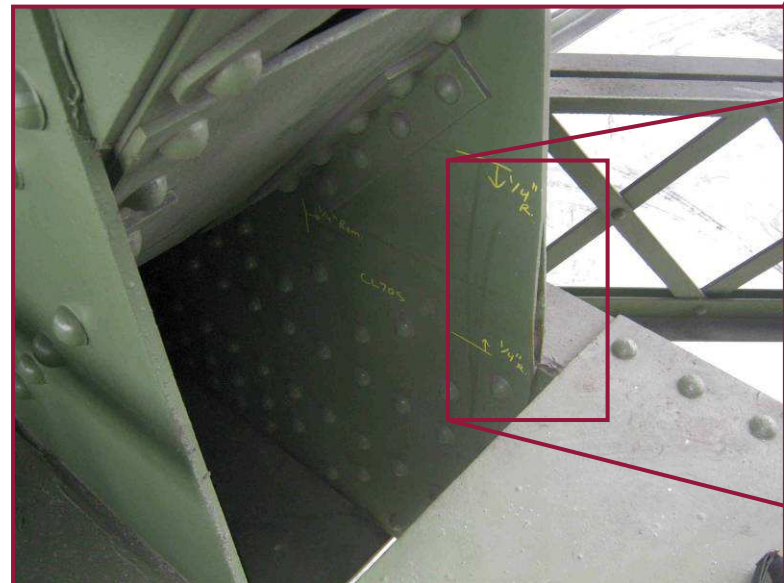
The south gusset plate at CL70 exhibits lamellar separation along the west free edge, with an effective remaining plate thickness of approximately 1/4" (Photo taken 2010). Limits of the separation have no increased since the 2010 inspection.

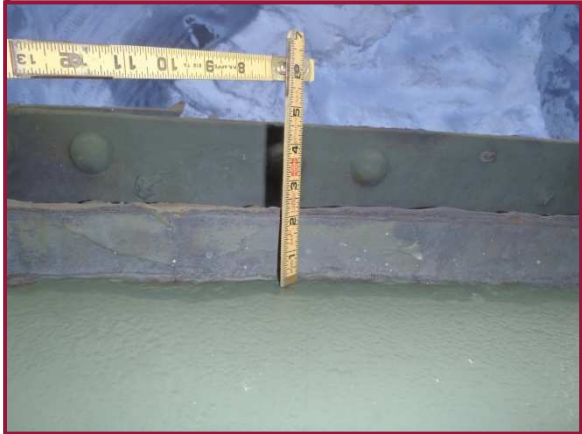
The lower chord member DL69-DL70 exhibits pack rust up to 2" thick between the north web plate and the lower flange angle. Pitting up to 3/16" was noted on the north web plate along the flange angle.

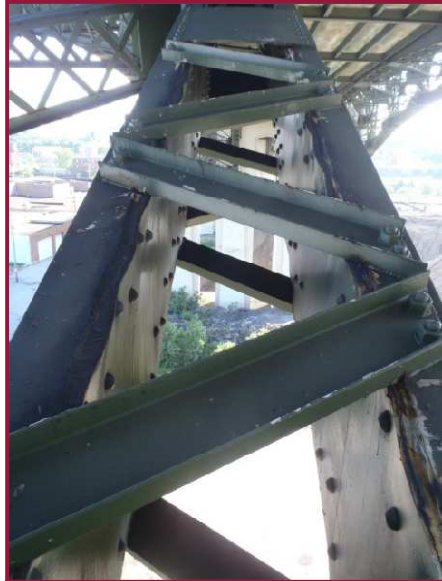
Pack rust between the web plates and top flange angles exhibits signs of reactivation.

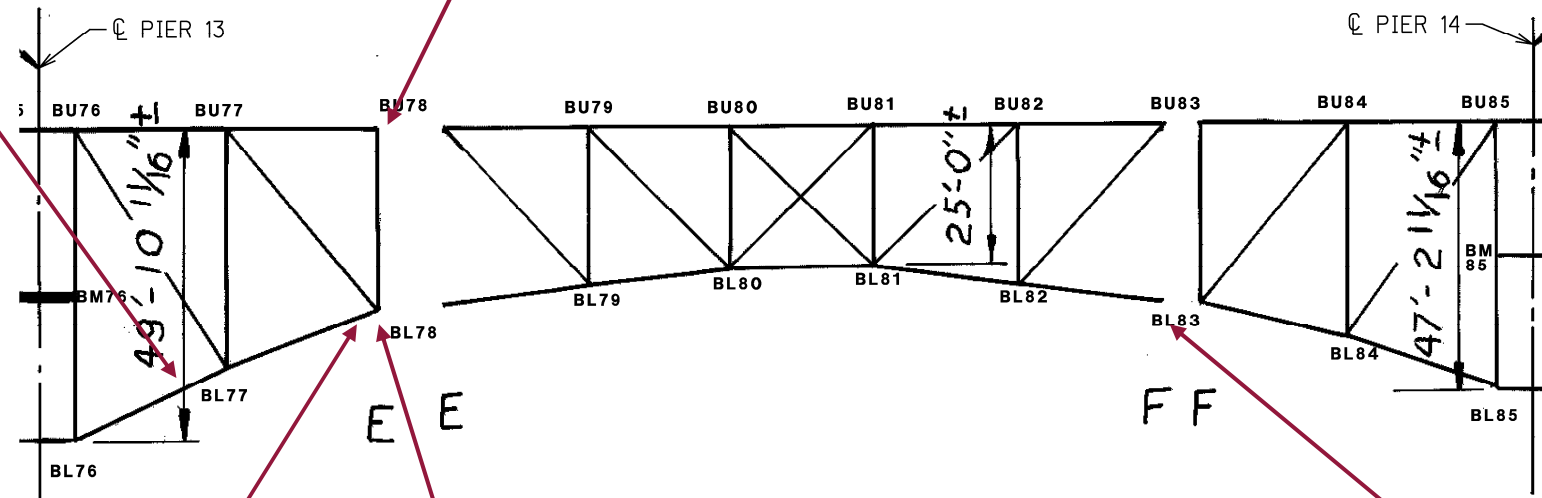
The utility deck Floorbeam 78 has received extensive web retrofits throughout the length of the member.

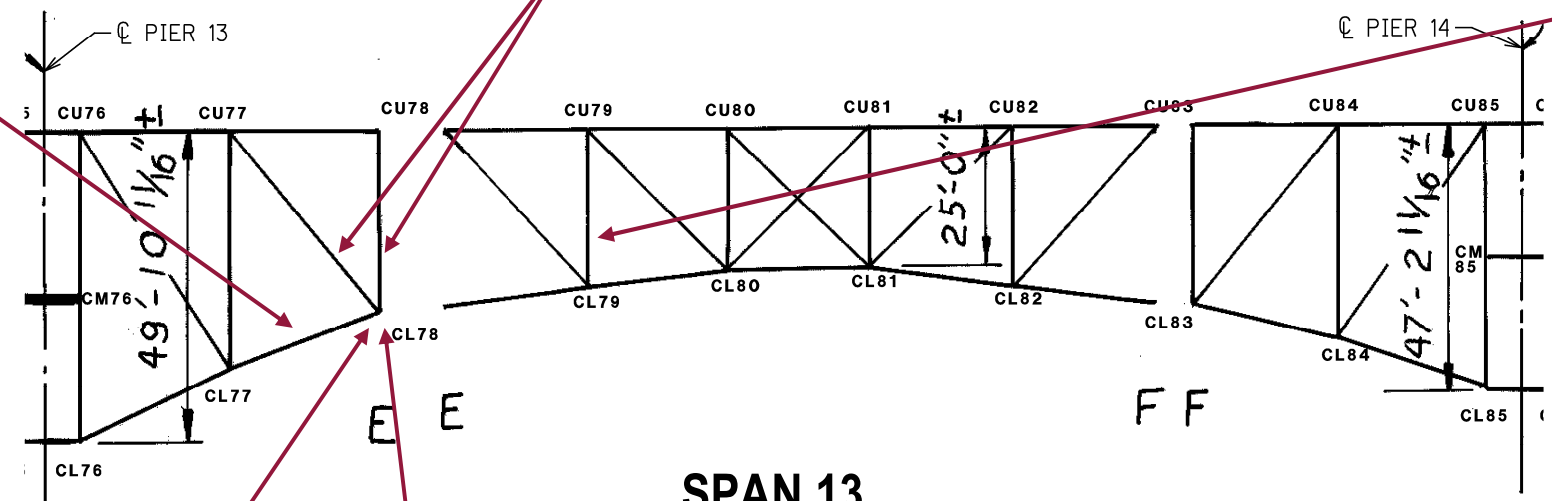
The north web plates exhibit 1/8" deep pitting along the full width of the member at the gusset plate interface.

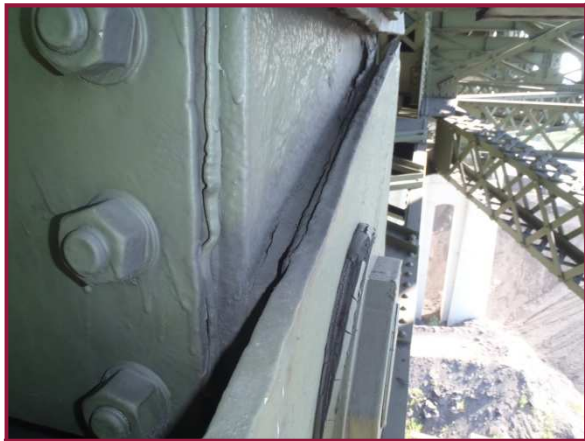
Impacted rust has accumulated between gusset plate CL78S and the vertical member web plate. The rubber washer around the pin is protruding at this location.

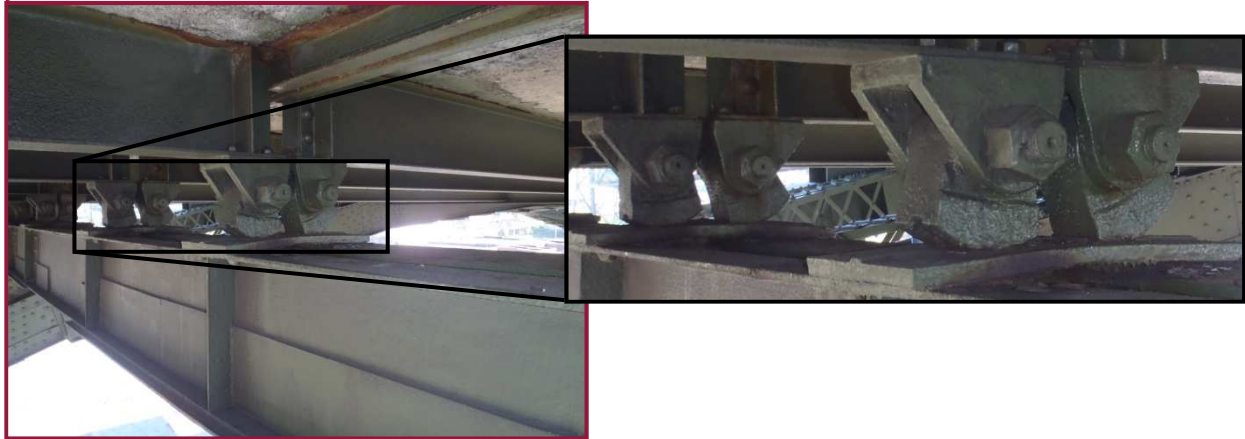
Several utility deck stringer bearings exhibit excessive rotation at Panel Point 78. Note the extensive retrofitting of the web and bottom flange of utility deck Floorbeam 78.

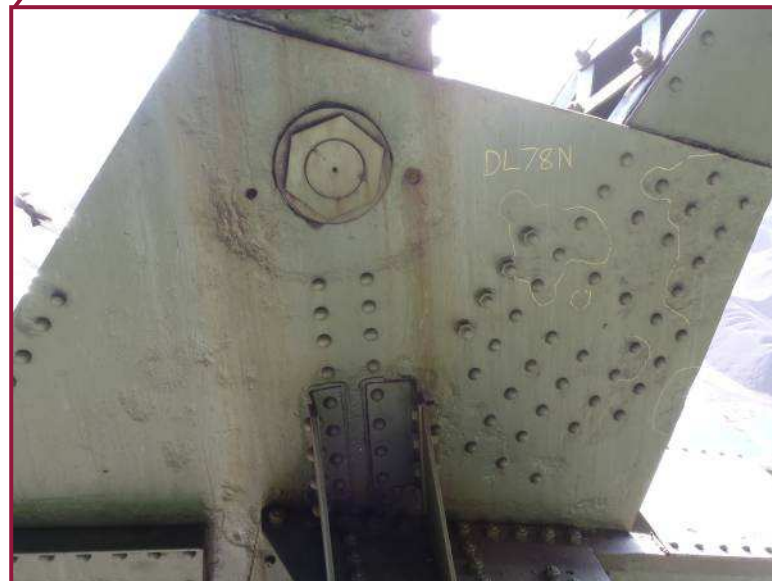
Heavy pitting (greater than or equal to 1/4" deep in isolated locations) of the lower gusset plates at the pin locations is typical with reactivating surface corrosion due to failing deck joints above (Photo taken 2010).

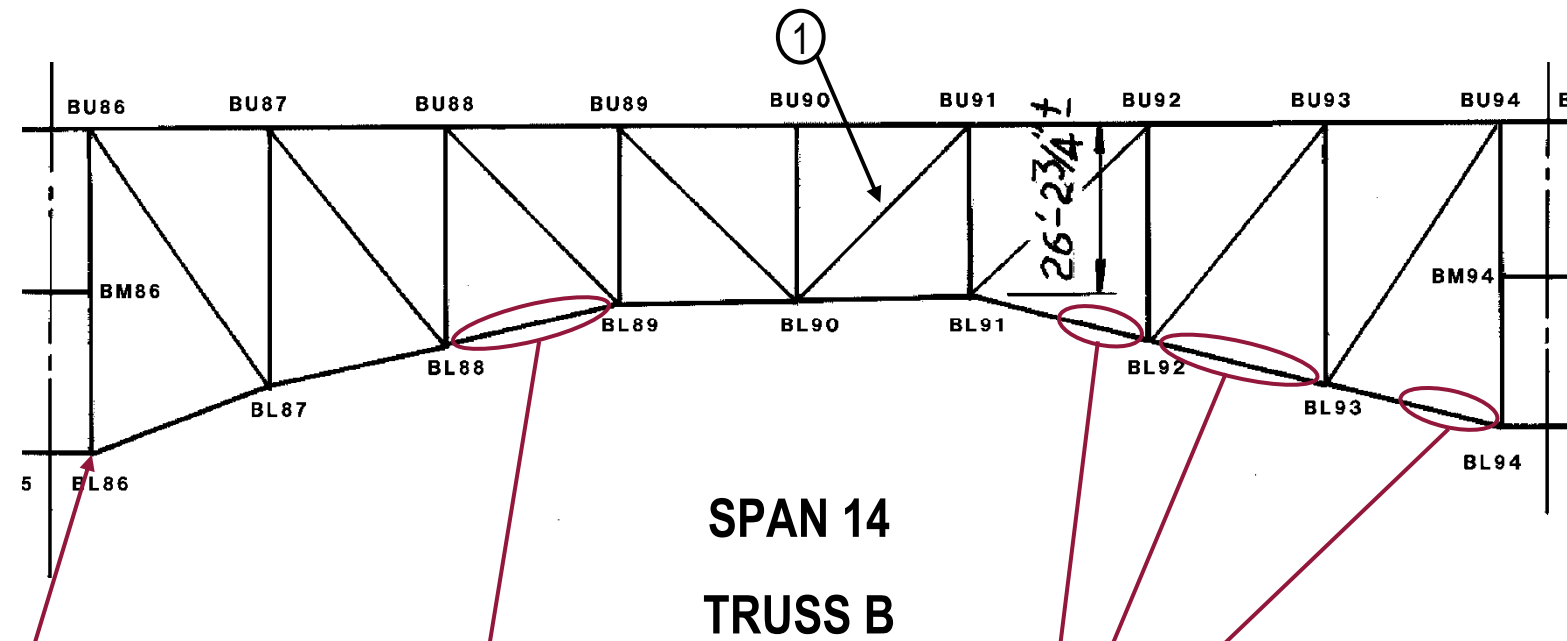
The south exterior lower chord splice plate is pushed out approximately 1" due to pack rust.

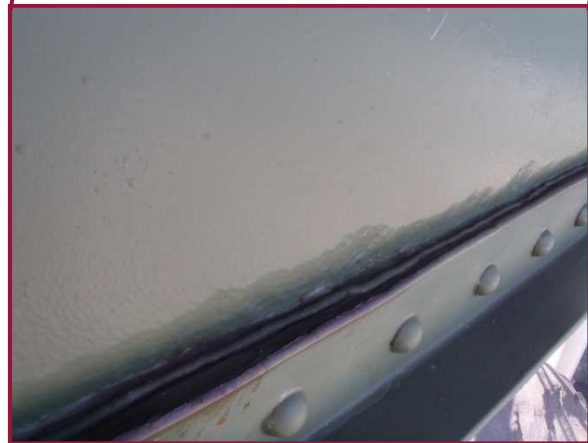
1/8" pitting of the north lower chord web plate along the length of the members at isolated locations (BL91-BL92 shown).

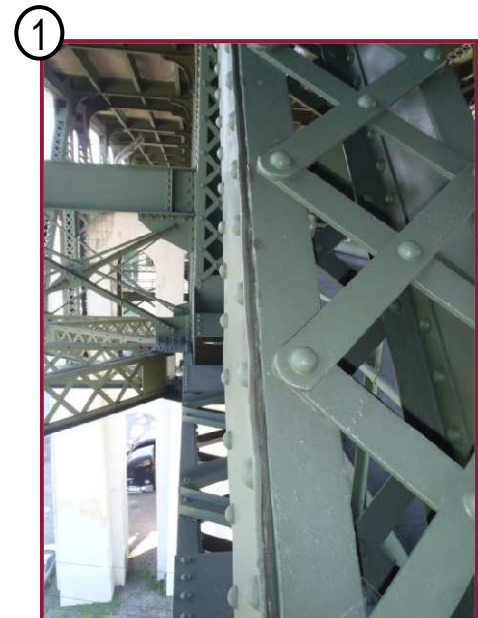
Member BL90-BU91 exhibits pack rust up to 1/2" thick between web plates and flange angles.

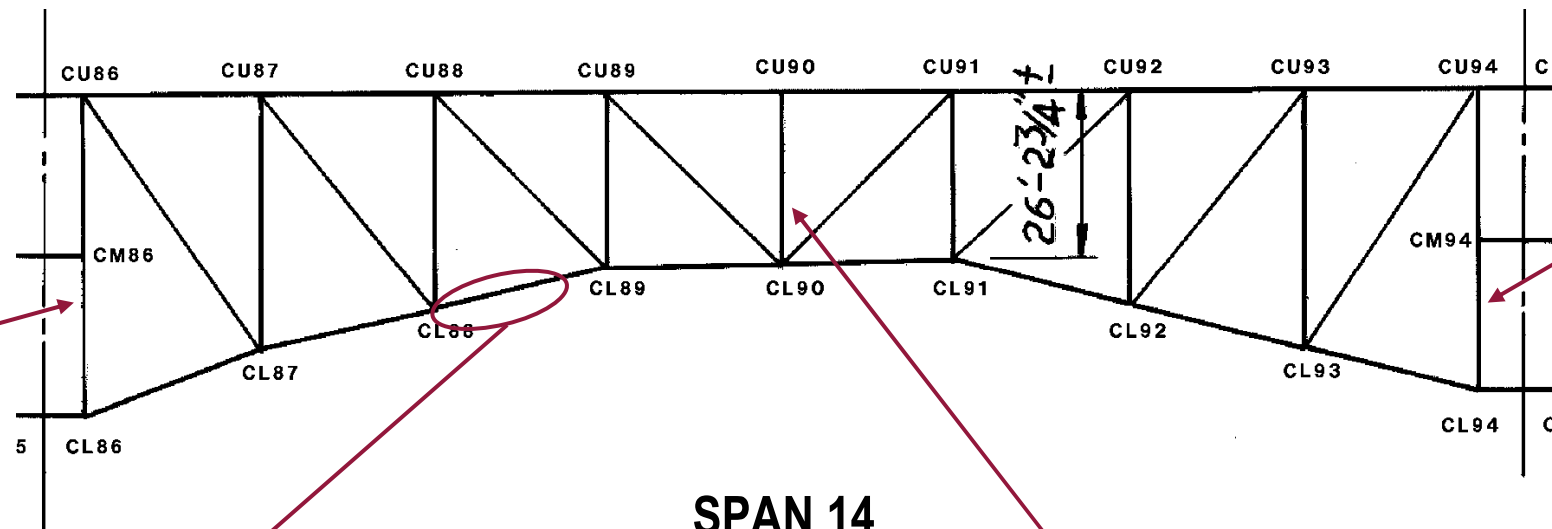
Vertical member CL86-CU86 exhibits pack rust up to 3/8" between the web plates and flange angles.

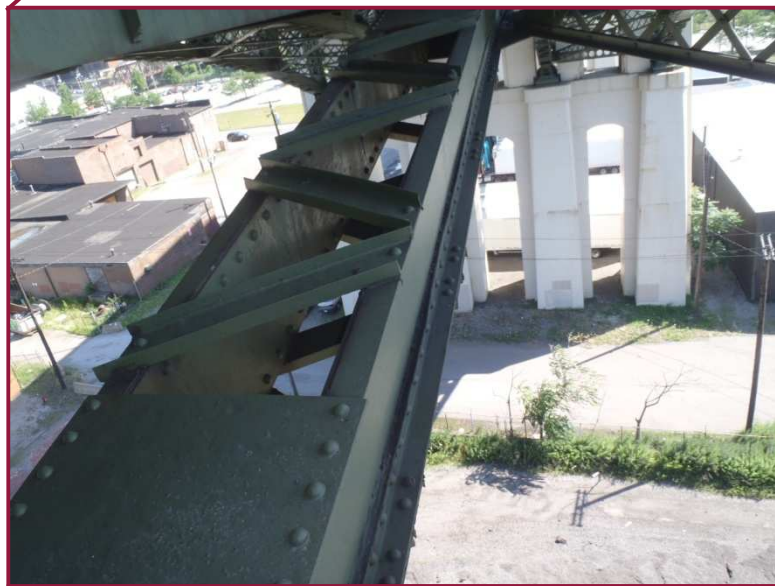
The lower chord south web plate exhibits pitting up to 3/16" deep pitting along the bottom flange angle in the lower half of the plate. The pitting extends approximately 3/4 of the length of CL88-CL89.

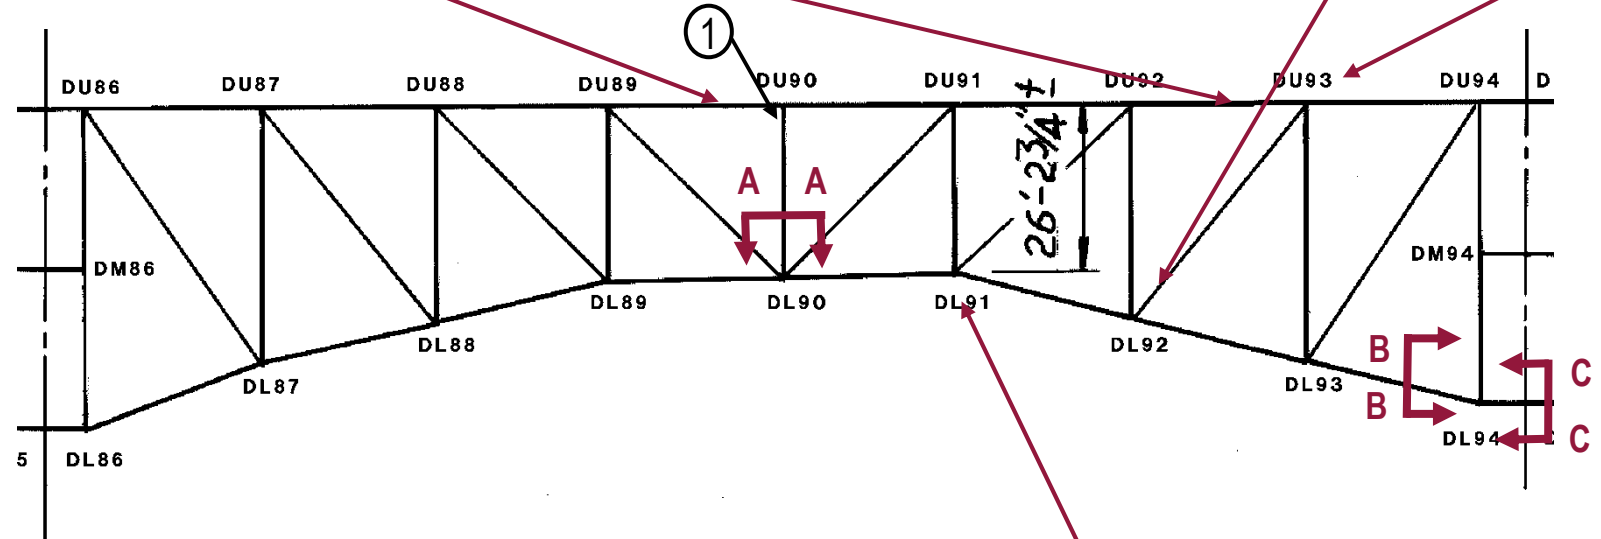
The upper chord of Truss D in Span 14 is in good condition overall with no significant deficiencies noted.

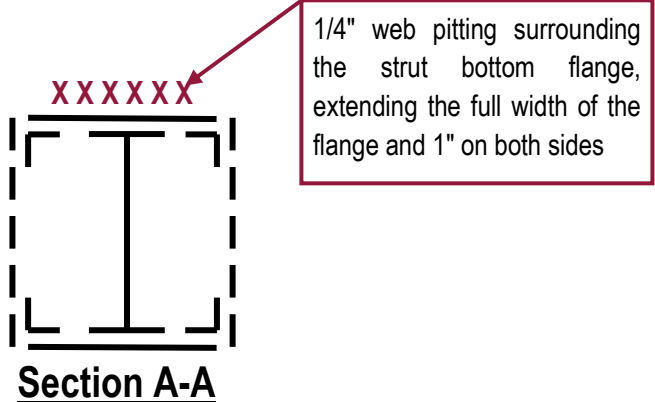
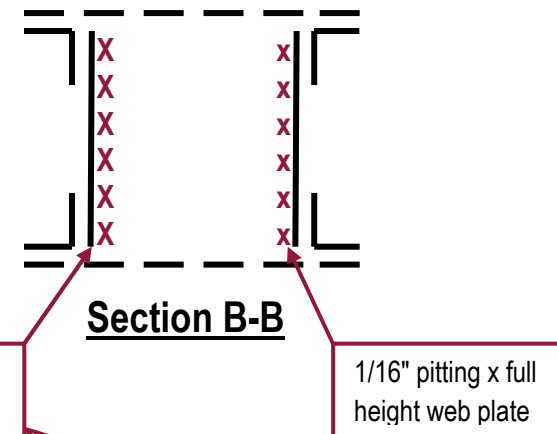
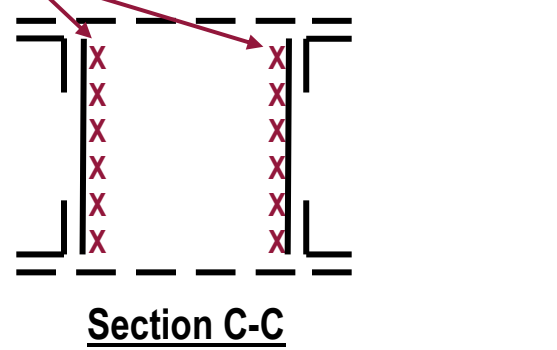
Gusset plate DL91 exhibits conditions typical of the exterior gusset plates throughout Span 14, Truss D, with activating rust along the interface at the lower chord and associated minor pitting (Photo taken 2010).

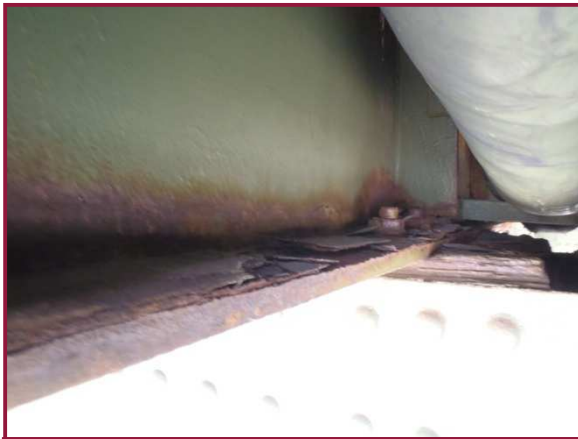
The west bottom flange of Floorbeam 97' at AU97 exhibits active laminate rust with 1/16" section loss.

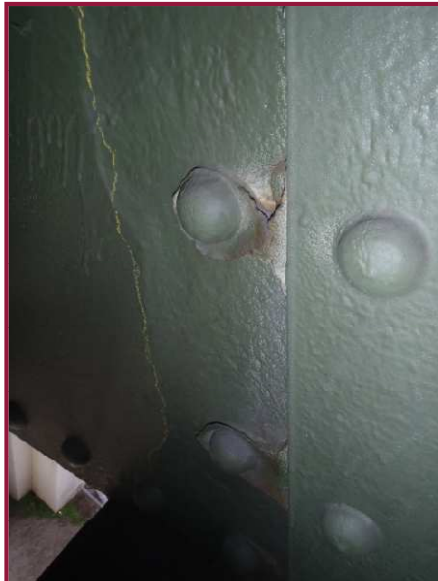
The north web plate of BL95-BL96 exhibits 3/16" deep pitting for the full height of the plate adjacent to BL96N. This location was covered by a thin fill plate which has since completely corroded outside the bounds of the gusset plate.

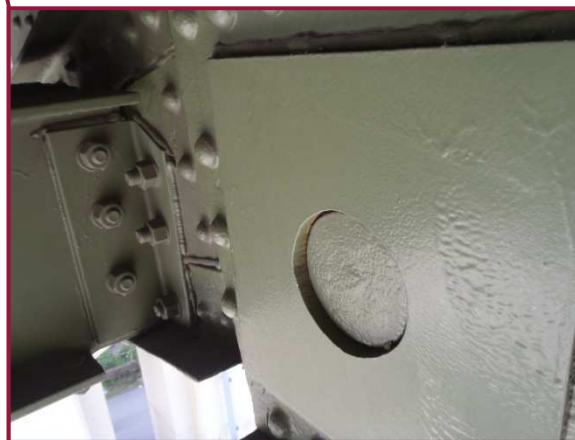
The south outermost pin plate at BL97 has been replaced with the welded plate shown. The end of the pin and the outer edge of the plate are 1/2" out of plane, resulting in a reduced pin bearing area.

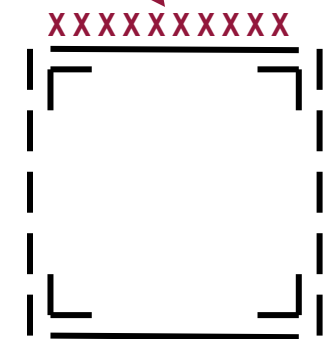
1/4" deep pitting for the full height of the web

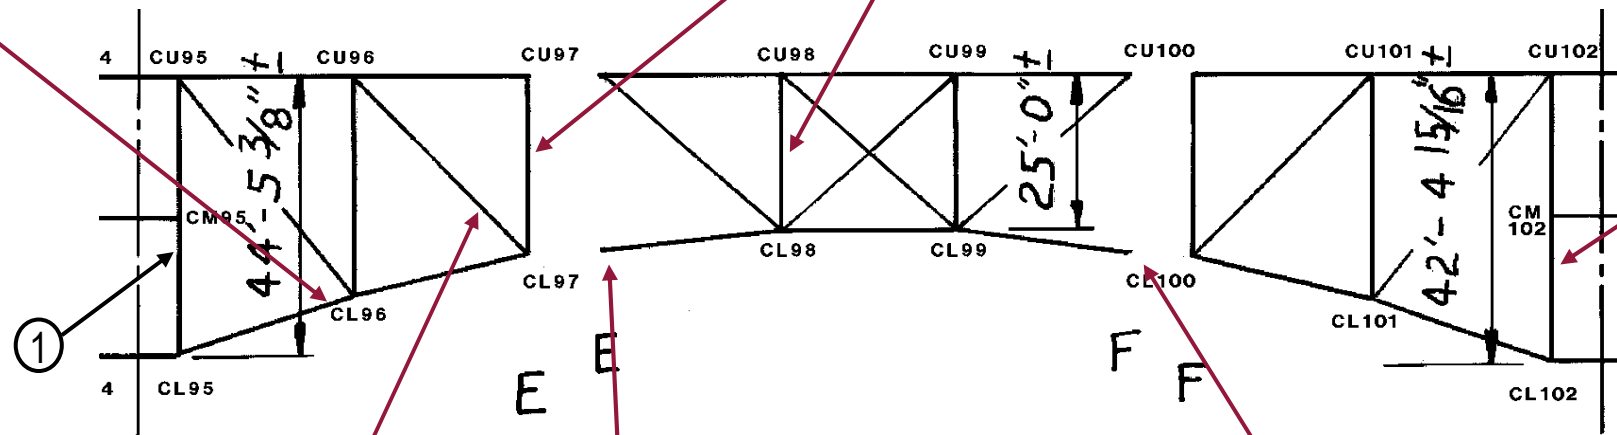
Surface pitting of lacing bars up to 1/16" throughout vertical member

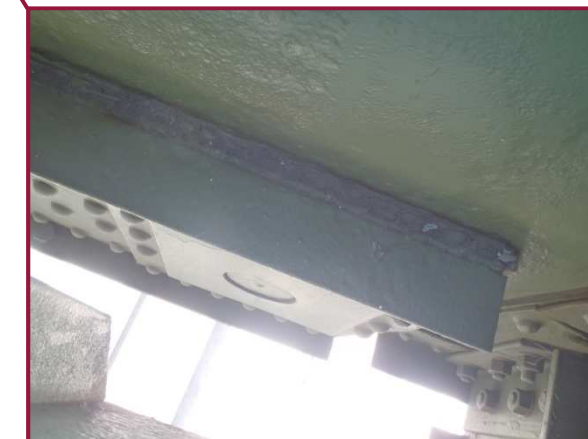
The lower chord sliding pin at CL100 is not bearing fully on the outermost pin plate due to impacted rust between the lower chord and gusset plate. The end of the pin and outer edge of the pin plate are misaligned by 1/4".

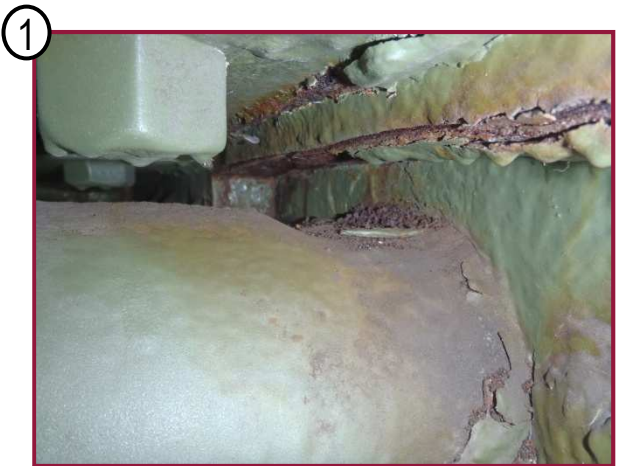
The lower chord pin and Panel Point DL97 exhibits laminate rust with section loss up to 1/2" at the north end along the top.

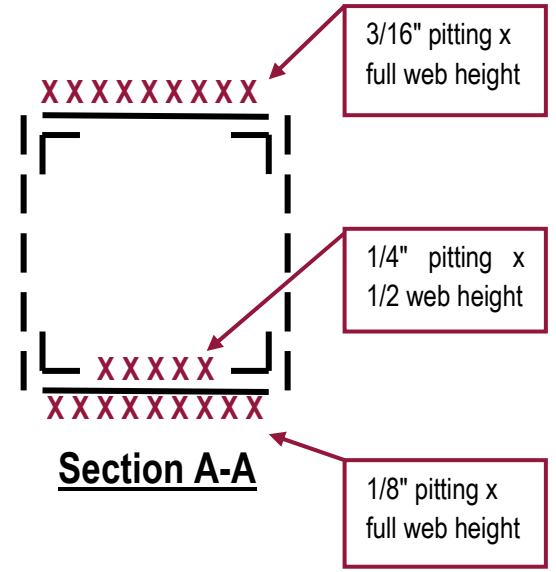
The fill plate between gusset plate DL96 and the north web plate of DL96-DL97 exhibits 100% section loss and the adjacent web plate has 1/4" pitting over the full height. The south web plate exhibits a similar condition with 1/8" pitting.

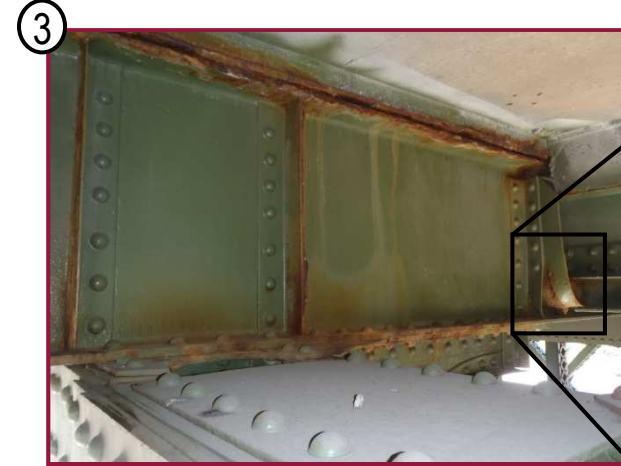
At Floorbeam 100 active rusting of the flanges is typical throughout, with advanced corrosion of the stringer connection angle below the saddle bearing rivets. The connection angle has a 1.5" diameter perforation at this location (right). Additionally, the saddle bearings typically exhibit minor pitting and reactivating rust; however, some locations exhibit pitting with minor loss of section.

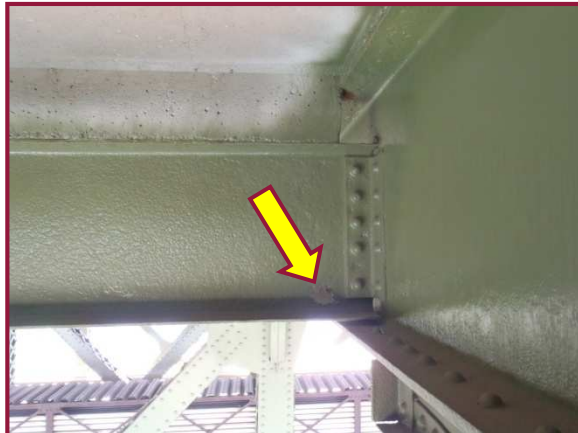
Stringer 2 web exhibits a 4" diameter hole approximately 3" from the floorbeam connection with 1/16" pitting for the height of the web at this location.

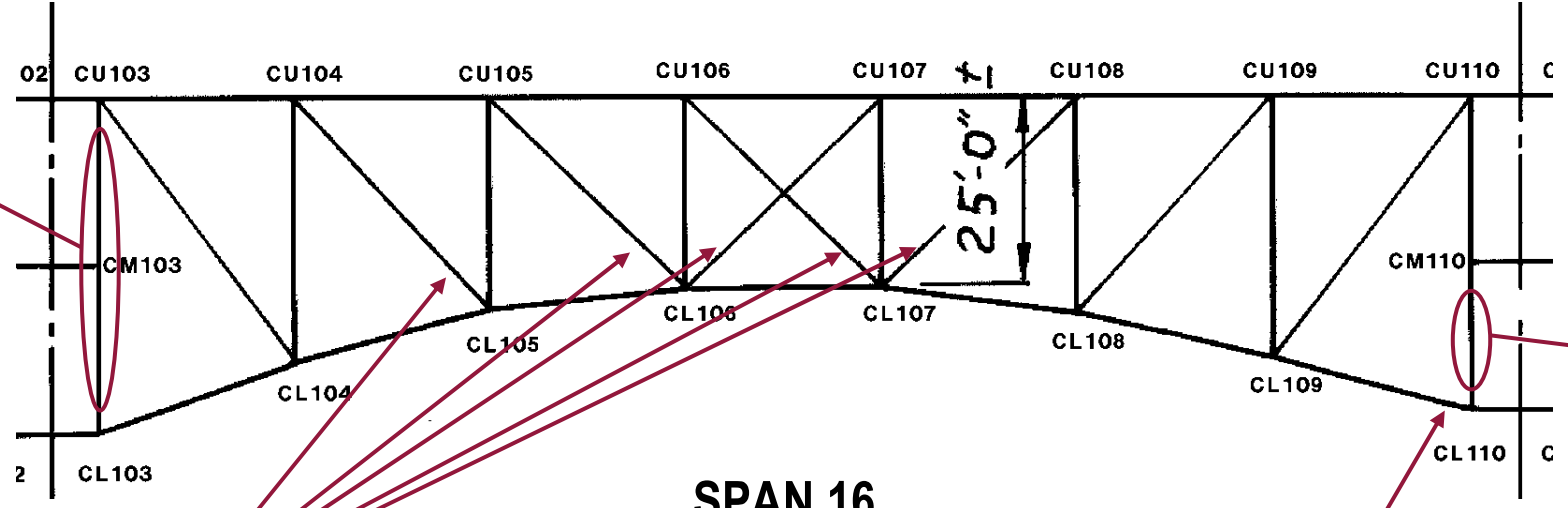
Pack rust up to 3/8" between web plates and flange angles

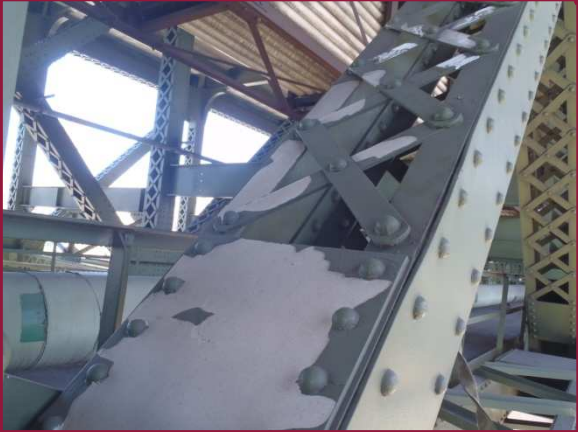
Failures of the paint top coat were found on diagonal members near the lower gusset plate connections at CL105, CL106, and CL107 in Span 16 (CL106-CU107 shown).

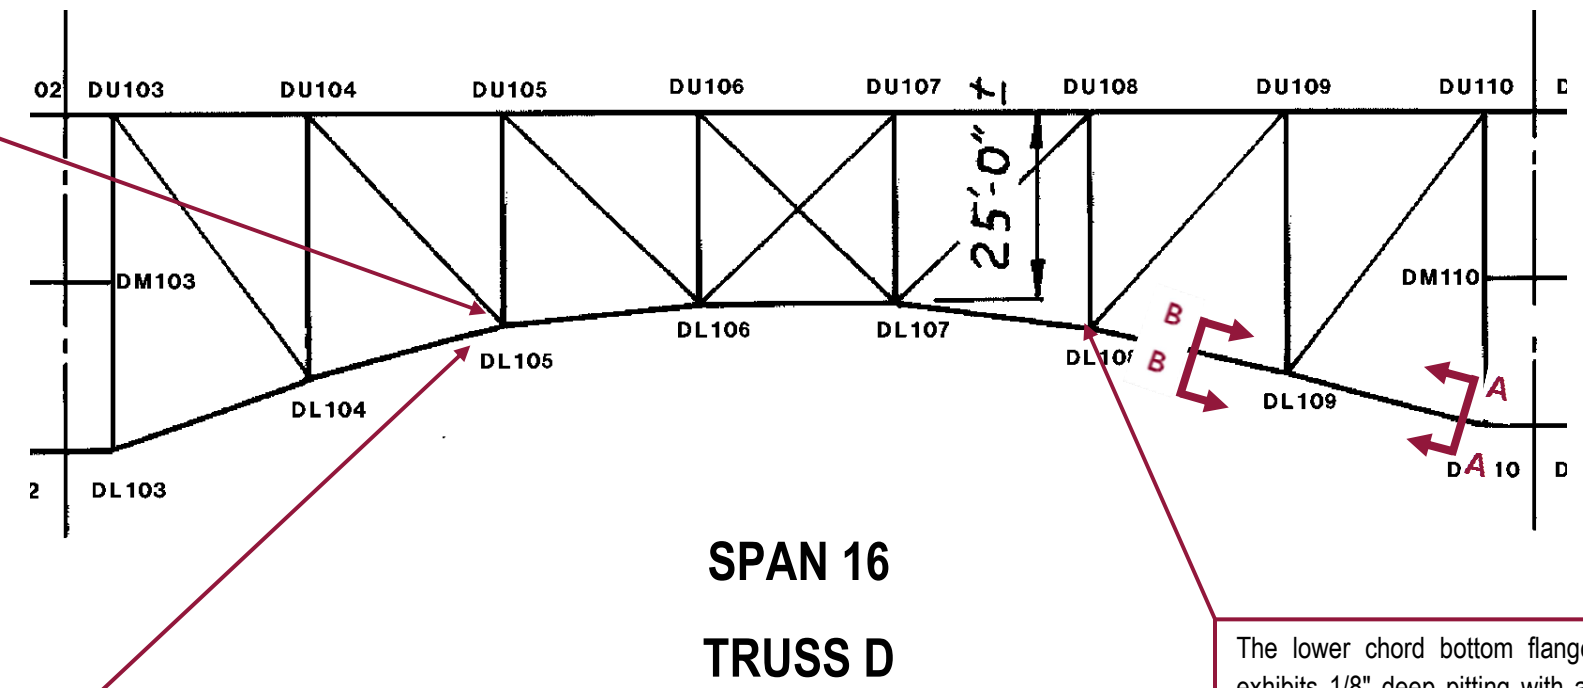
The lower chord bottom flange at Panel Point DL108 exhibits 1/8" deep pitting with an estimated 25% loss of rivet heads at the lateral bracing gusset plate connection.

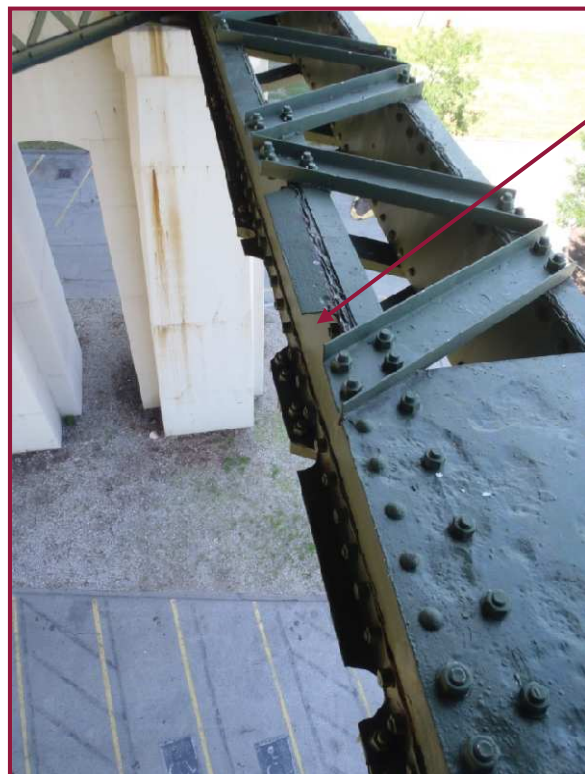
Lower chord member AL112-AL113 exhibits advanced section loss at several components of the built-up member at AL113. These losses are depicted in Section A-A. Note multiple retrofits at this location.

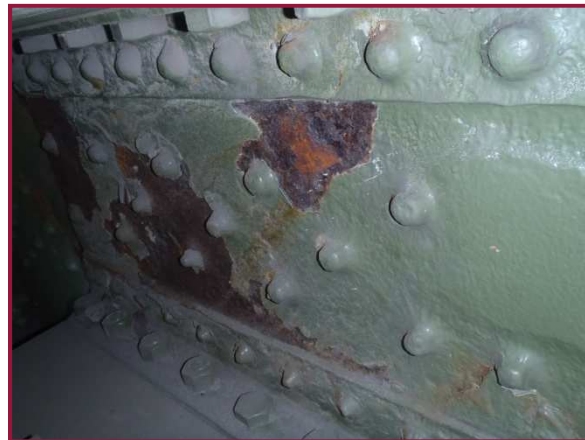
The interior of BU112-BL113 exhibits failing paint throughout with minor active corrosion near BL113. The rivets connecting the diagonal member to the gusset plates are heavily pitted, with an estimated 50% loss of rivet head section.
