The sway strut between Truss A and Truss B at Panel Point 3 exhibits areas of 100% section loss to the web stiffeners and 1/4" pitting on the web 3" high with isolated holed through sections.

The south web plate of AL7-AU7 exhibits 1/4" pitting for the full width along the interface with gusset plate AL7S.

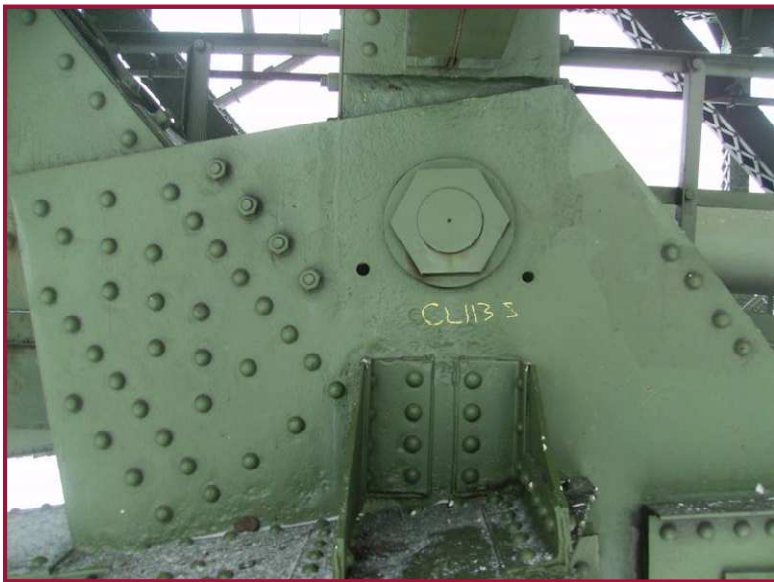
hibits heavy pitting throughout
areas isolated among the more
deepest pitting is found along
lower chord top flanges and
(Photo taken 2010).

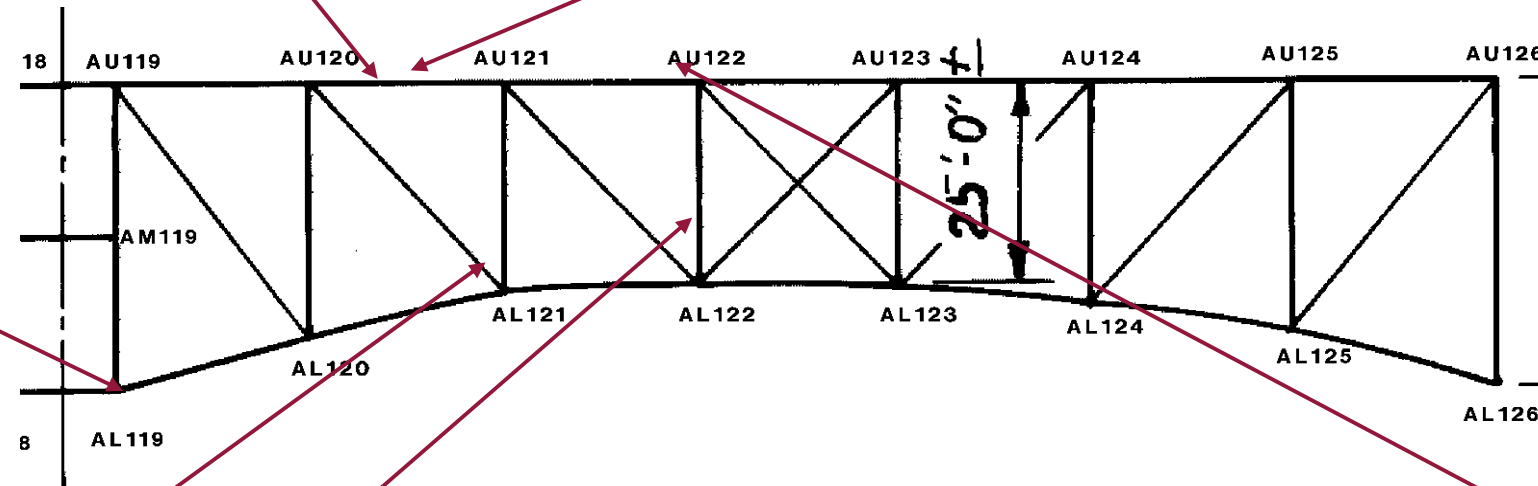
The north gusset plate at AL119 exhibits 1/4" deep pitting around the bearing plate above the pin, with one 3" diameter area with up to 3/8" pitting.

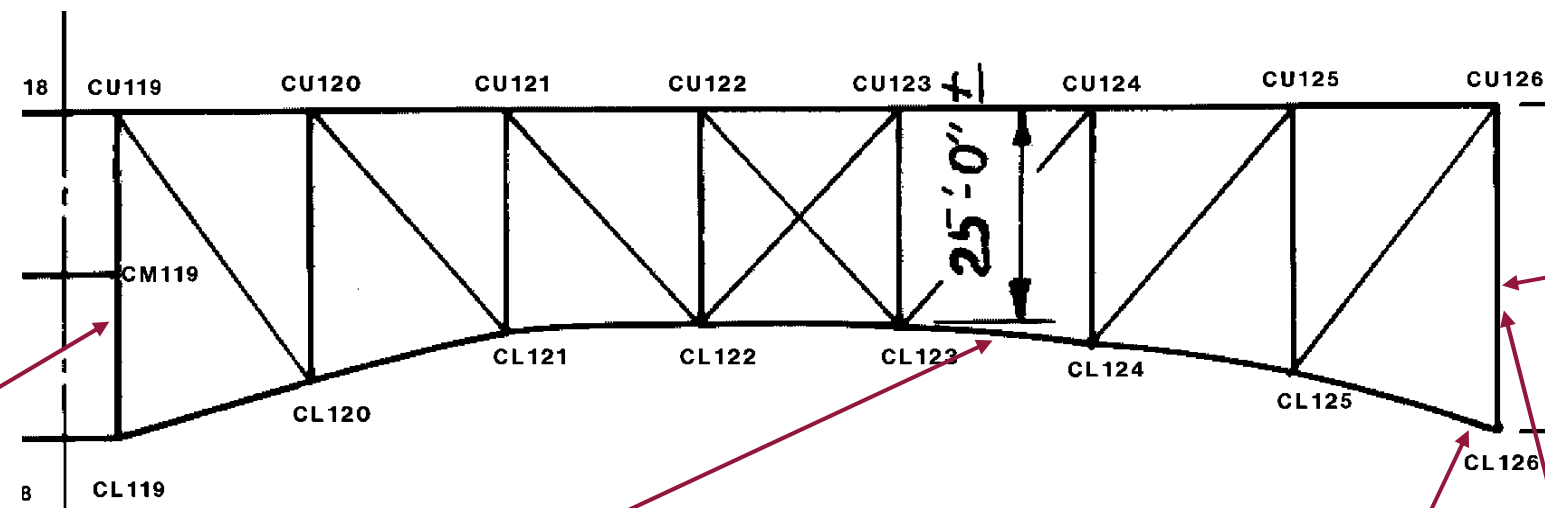
Pack rust up to 1/2" between web plates and flange angles

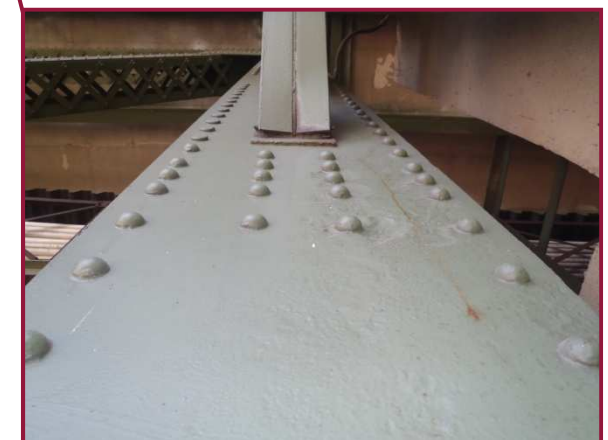
The south web plate of vertical member CL126-CU126 exhibits up to 1/4" pitting below the sway strut connection.

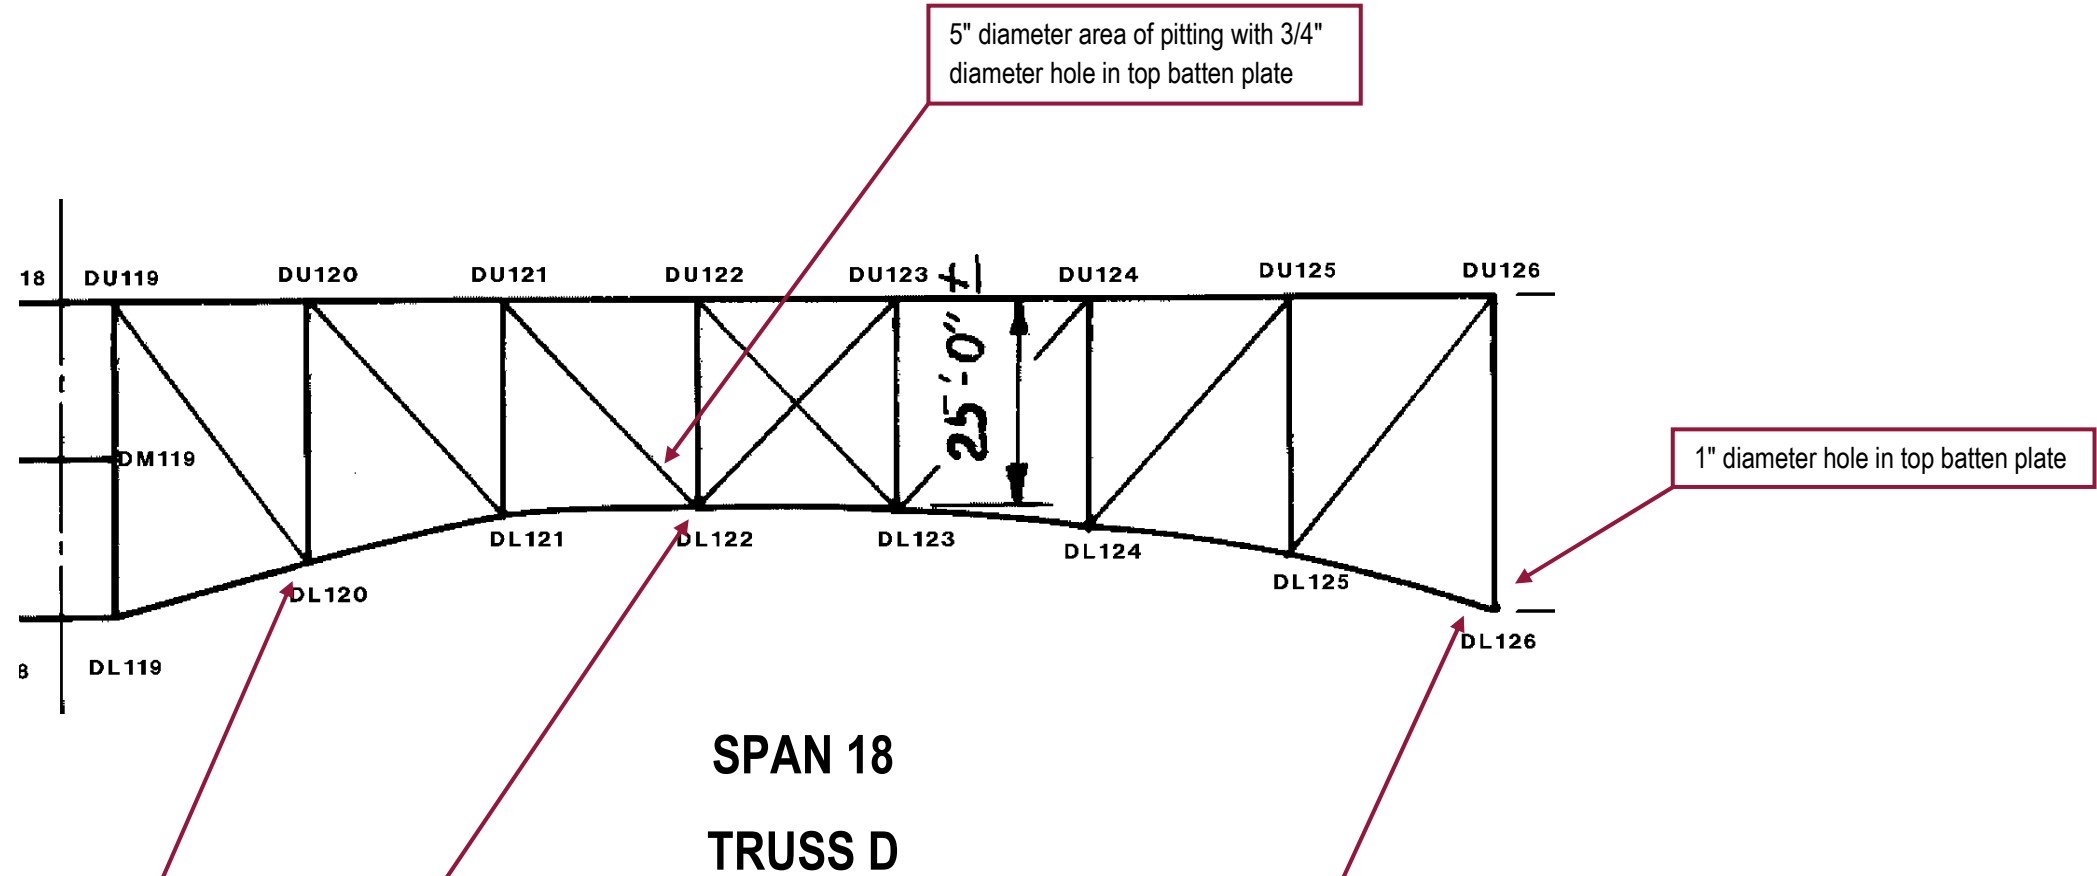
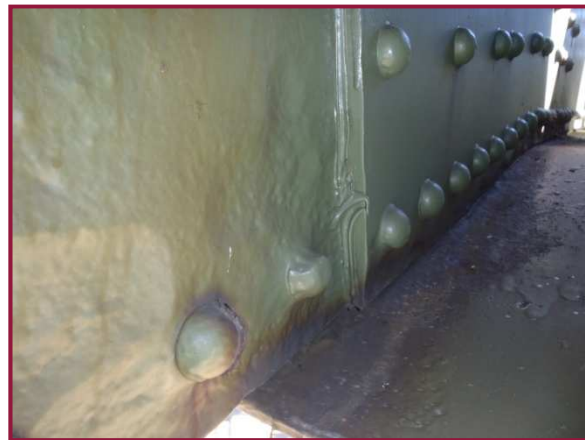
The north web plate of member DL119-DL120 exhibits 1/4" pitting over the bottom 1/4 of the height along the gusset plate interface. Pack rust has built up between this web plate and gusset plate DL120N.

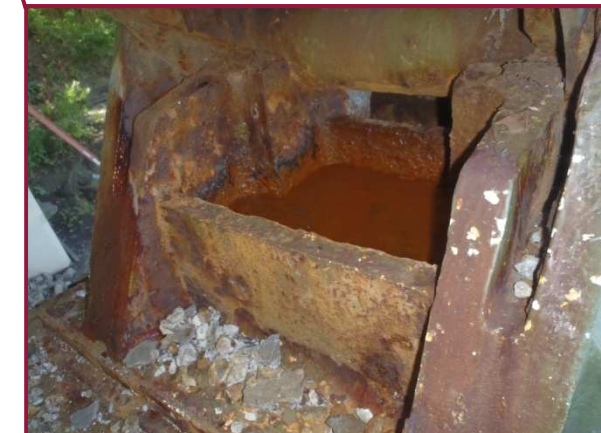
The bearing components at AL131 exhibit 1/8" pitting and activating surface rust throughout. The east side of the bearing contained standing water at the time of the inspection with moderate to heavy rusting in this area.

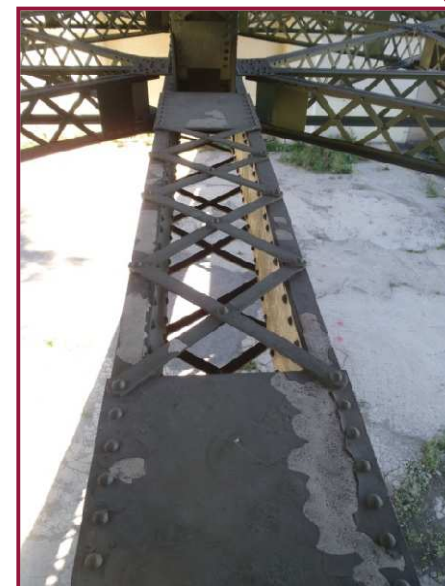
Lower chord BL130-BL131 exhibits extensive areas of peeling paint.

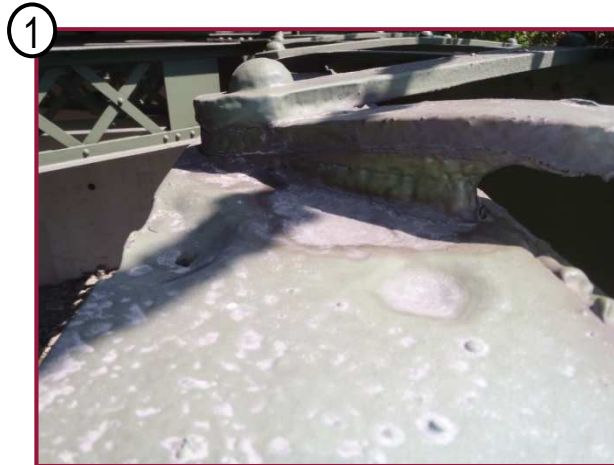
The north top flange angle of CL131-CL132 exhibits a 3" diameter area of section loss up to 100%, including one 3" diameter hole, in the outstanding leg. Also note the heavy pack rust between the flange angle and lacing bar.

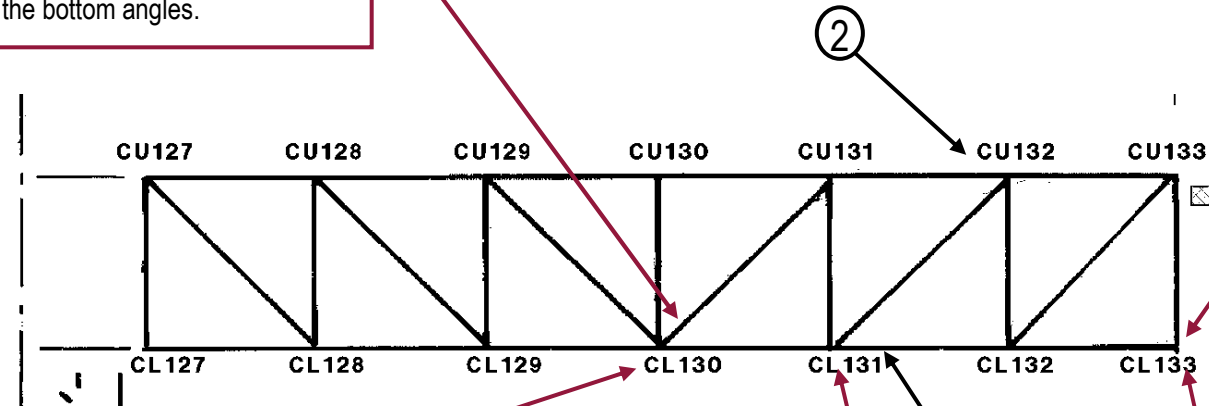
The south web fill plate exhibits 100% section loss below the bounds of the splice plate as well as 1/8" pitting on the bottom angles.

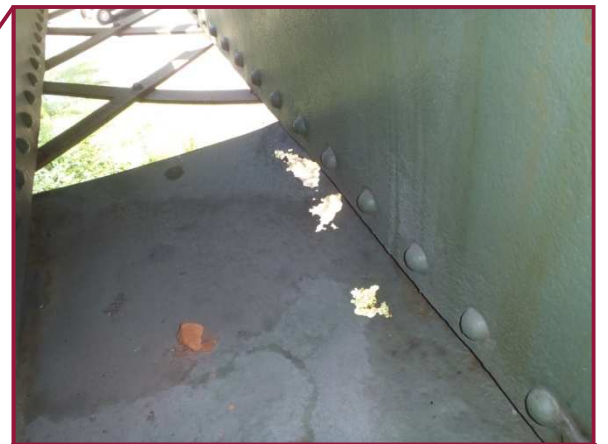
The bottom cover plate at CL133 exhibits a 12" long by 3" wide area with up to 100% section loss.

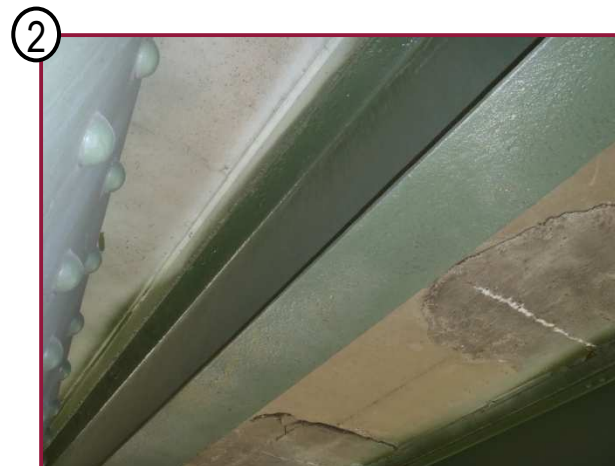
The Stringer 11 bottom flange exhibits pitting up to 1/8" between Panel Points CU131 and CU132.
