**OHIO DEPARTMENT OF TRANSPORTATION  
2014 PHYSICAL CONDITION REPORT**

**LORAIN-CARNEGIE BRIDGE OVER CUYAHOGA RIVER  
BRIDGE NO. CUY-10-1613**

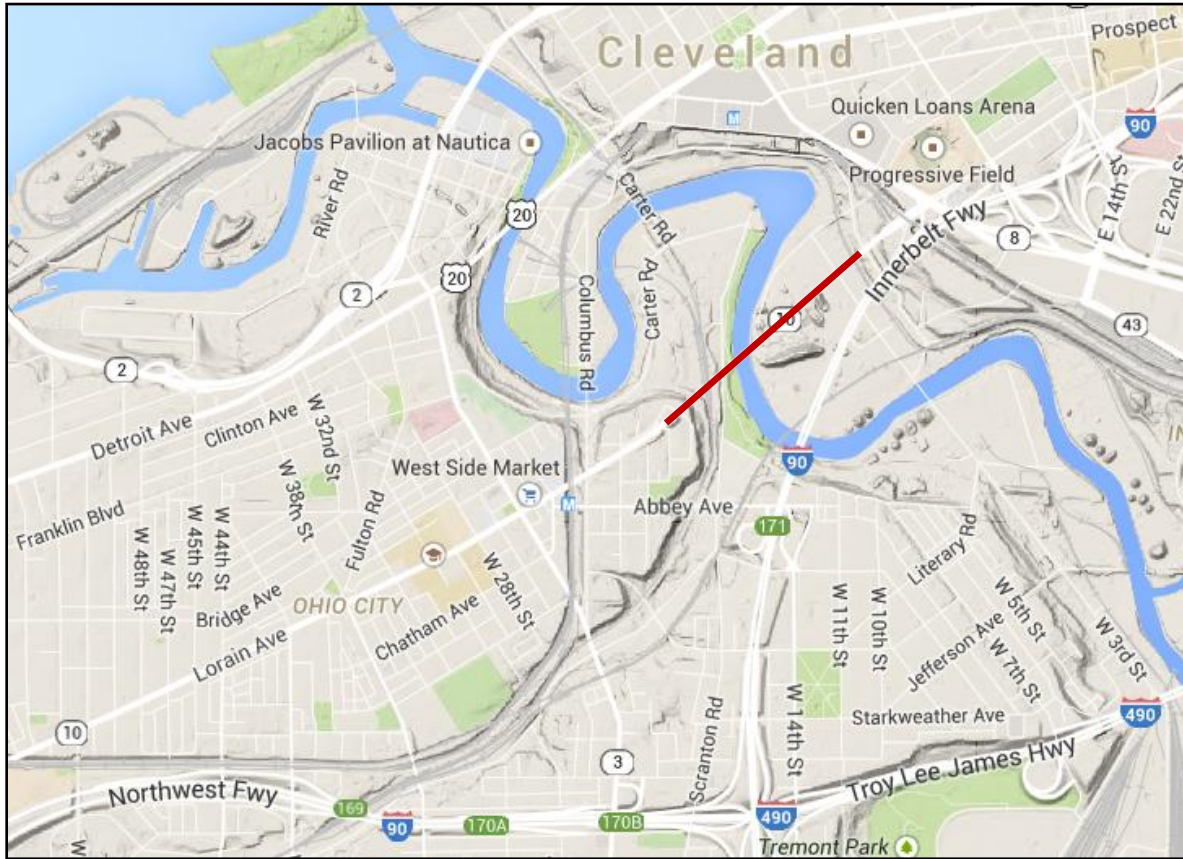
Figure 1 – Lorain-Carnegie Bridge Location Map.

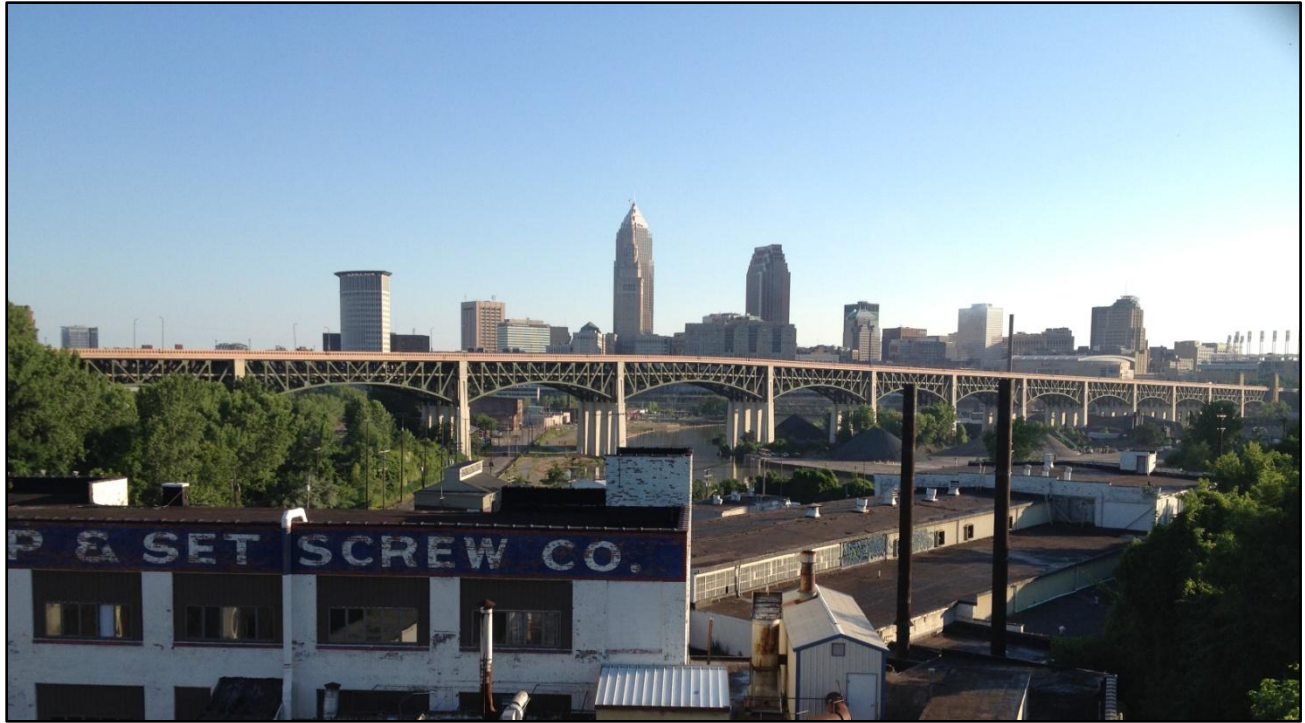
**Photo 1– South Elevation, Lorain-Carnegie Bridge.**

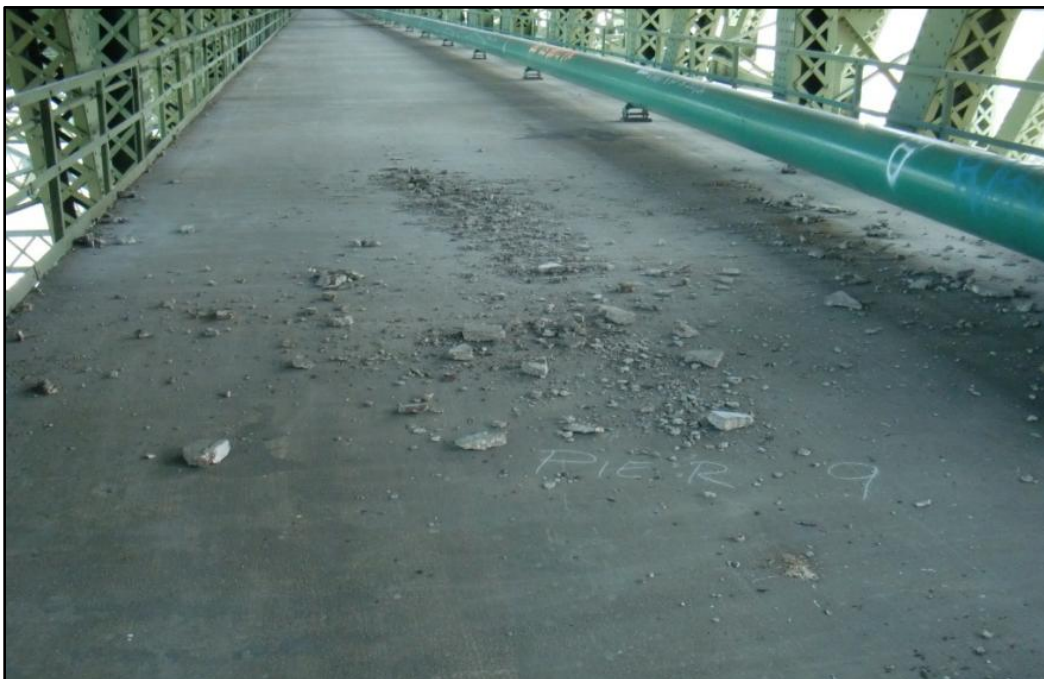
Photo 3 – New Fallen Concrete from Upper Deck, Span 9.

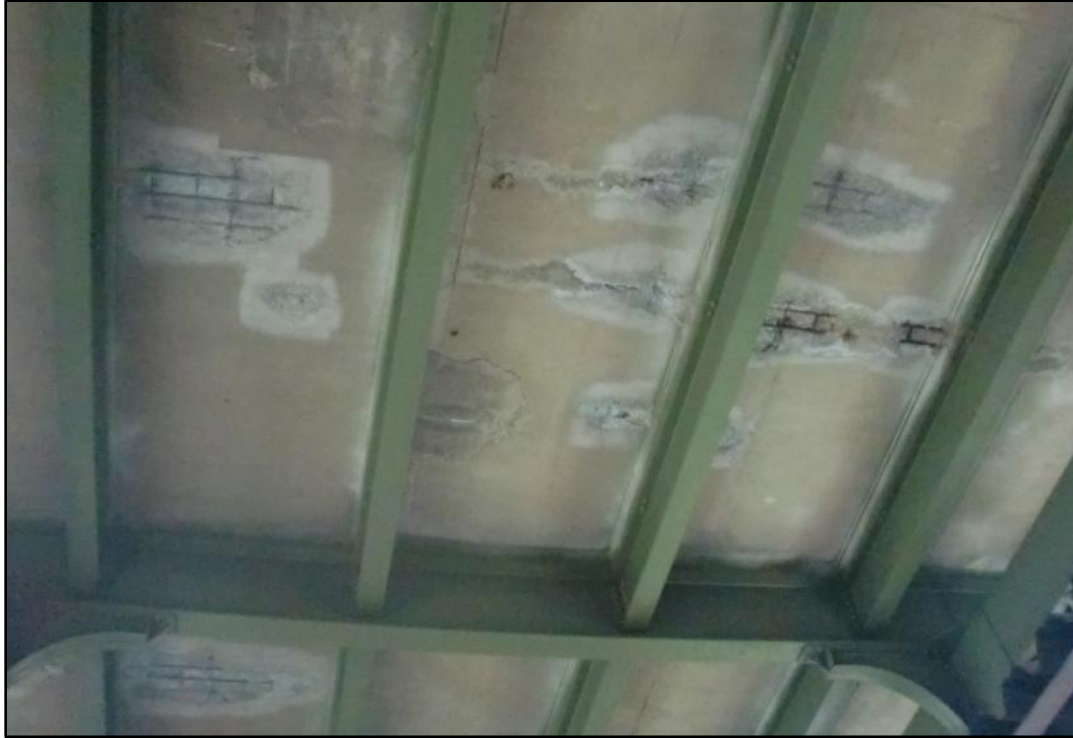
**Photo 4 – Corrosion on Steel Reinforcement with Missing Sprayed-On Cathodic Protection.**

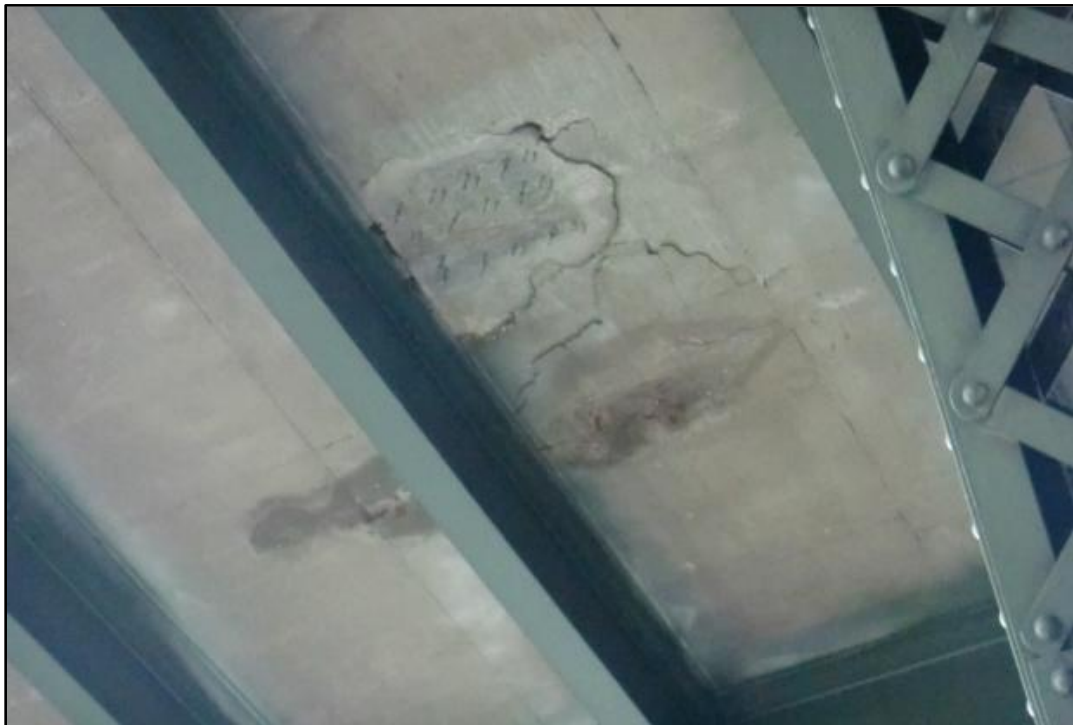
**Photo 5 – Deck Delamination Adjacent to 2001 Full-Depth Patch.**

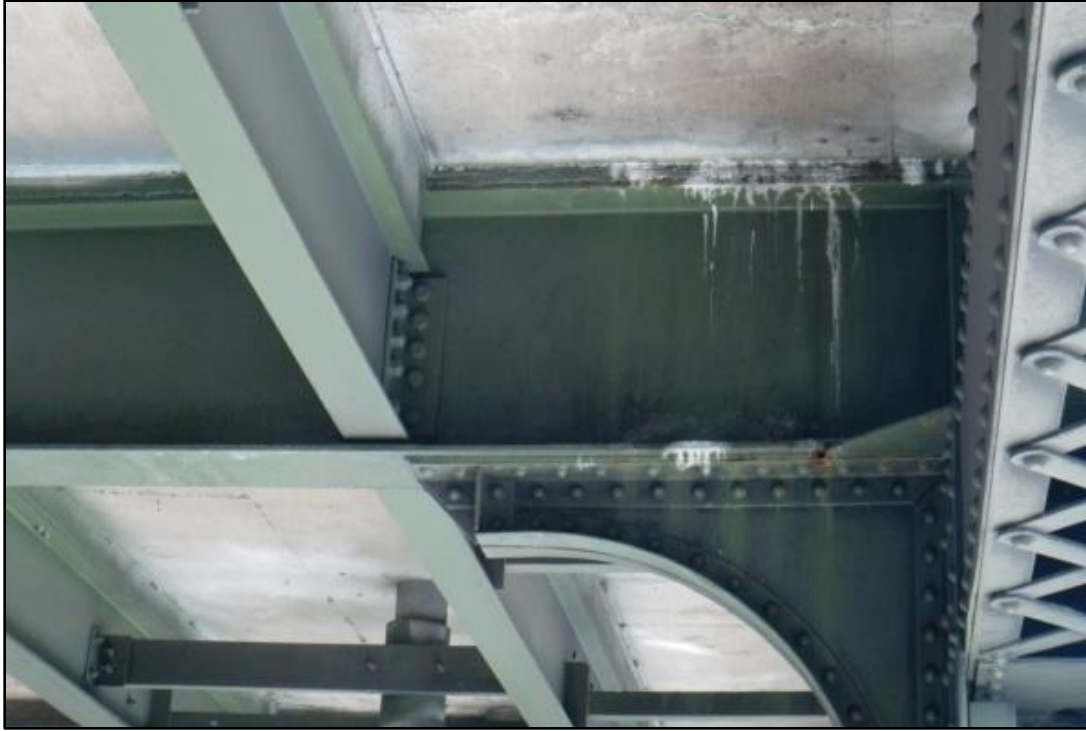
**Photo 6 - Upper Deck Water Infiltration & Efflorescence, Floor Beam 13, Span 5**

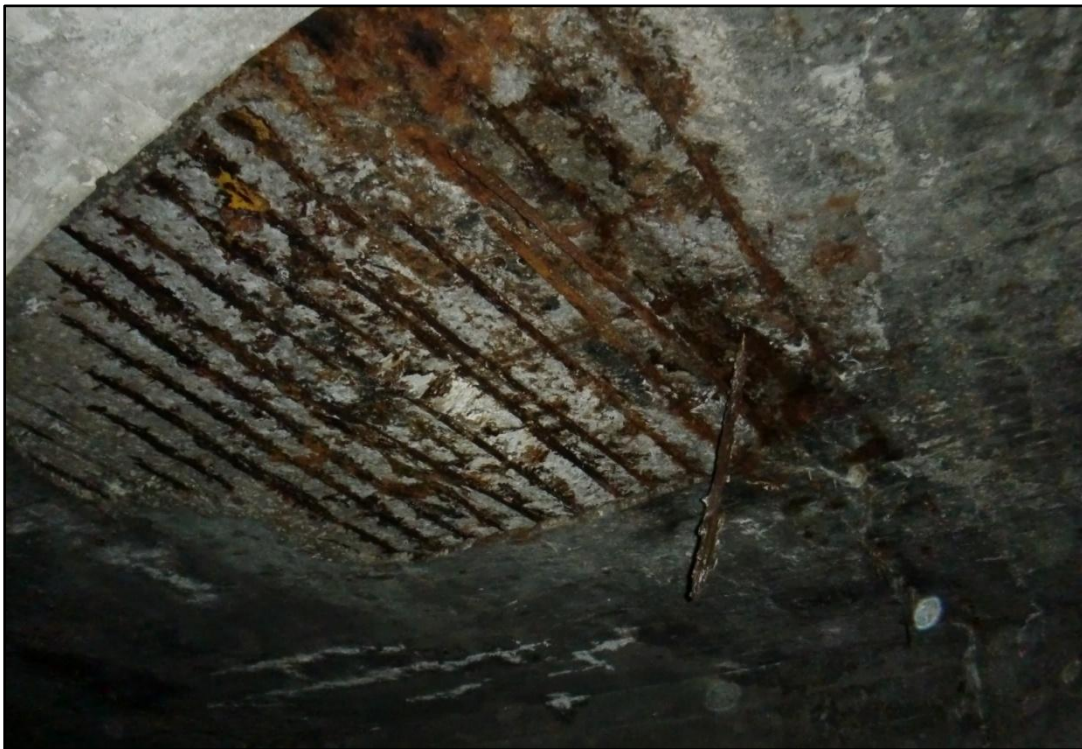
**Photo 7 - Spall with Broken Reinforcement, East Subway.**

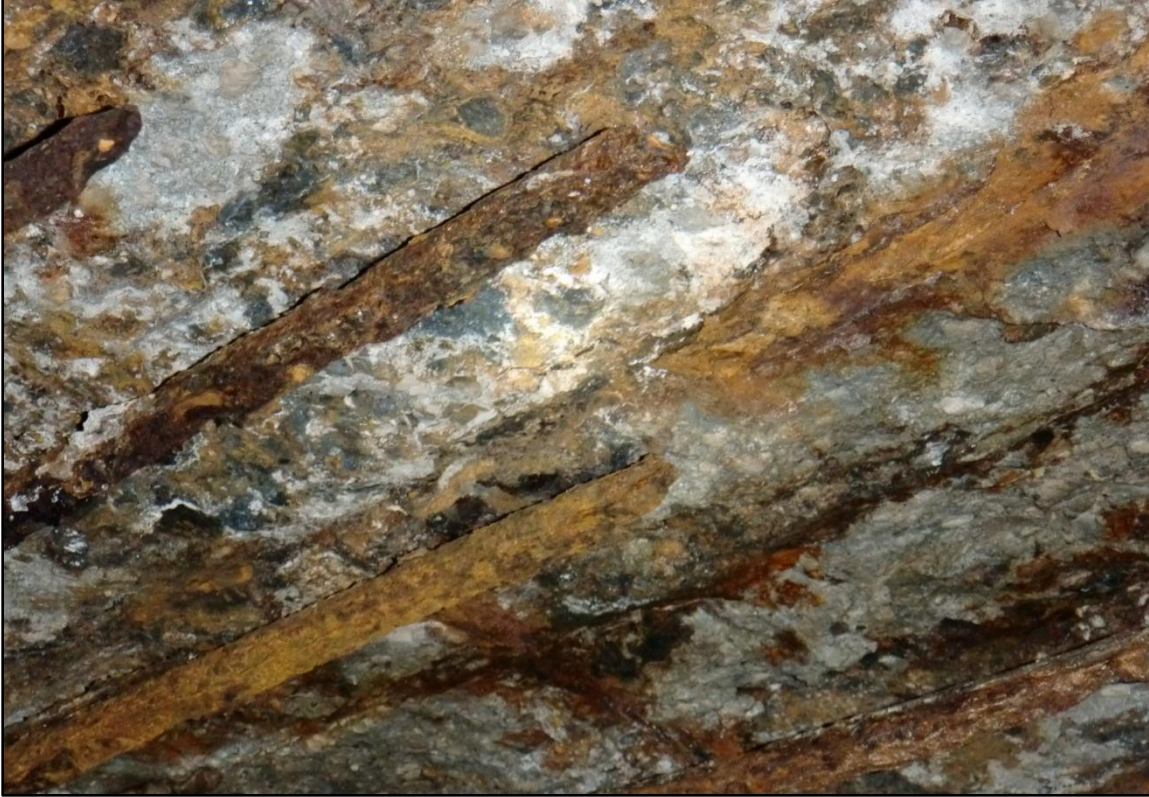
**Photo 8 – Close-up of Severed Broken Reinforcement, Panel 3 South, East Subway.**

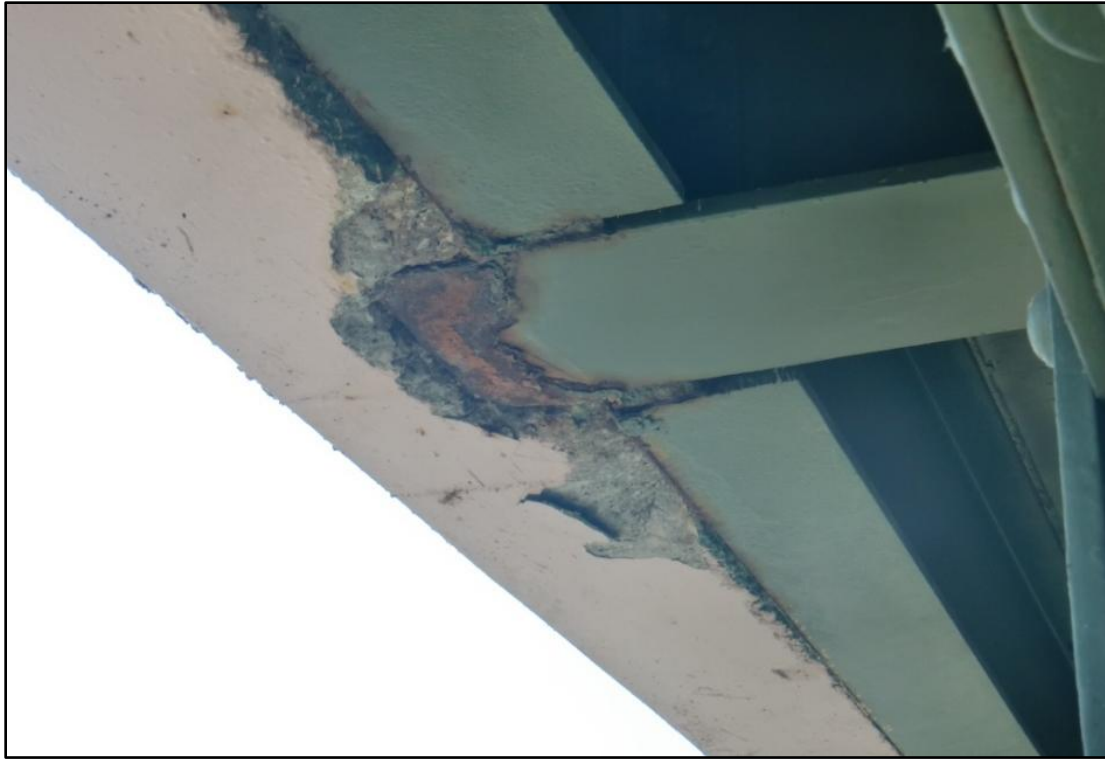
**Photo 9 – Fascia Spall at Upper Deck Floor Beam, Span 11, Occurring Since 2002 Sealing.**

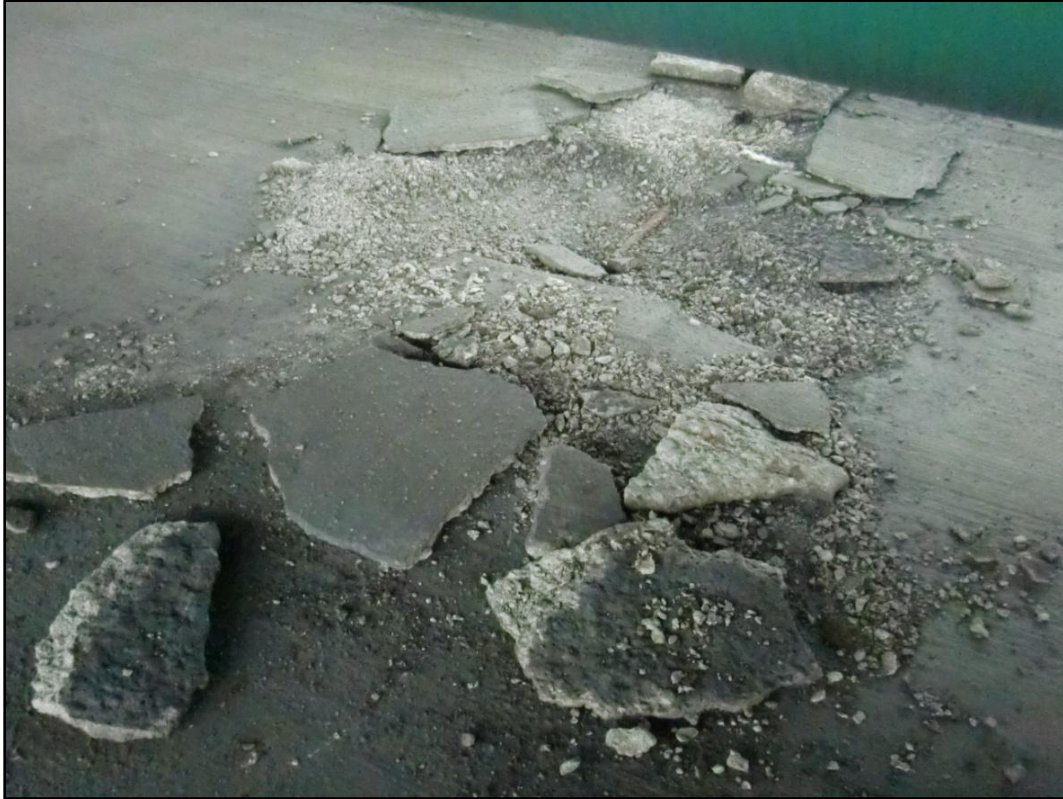
**Photo 10 – Typical Local Deteriorated Concrete, Maintenance Deck.**

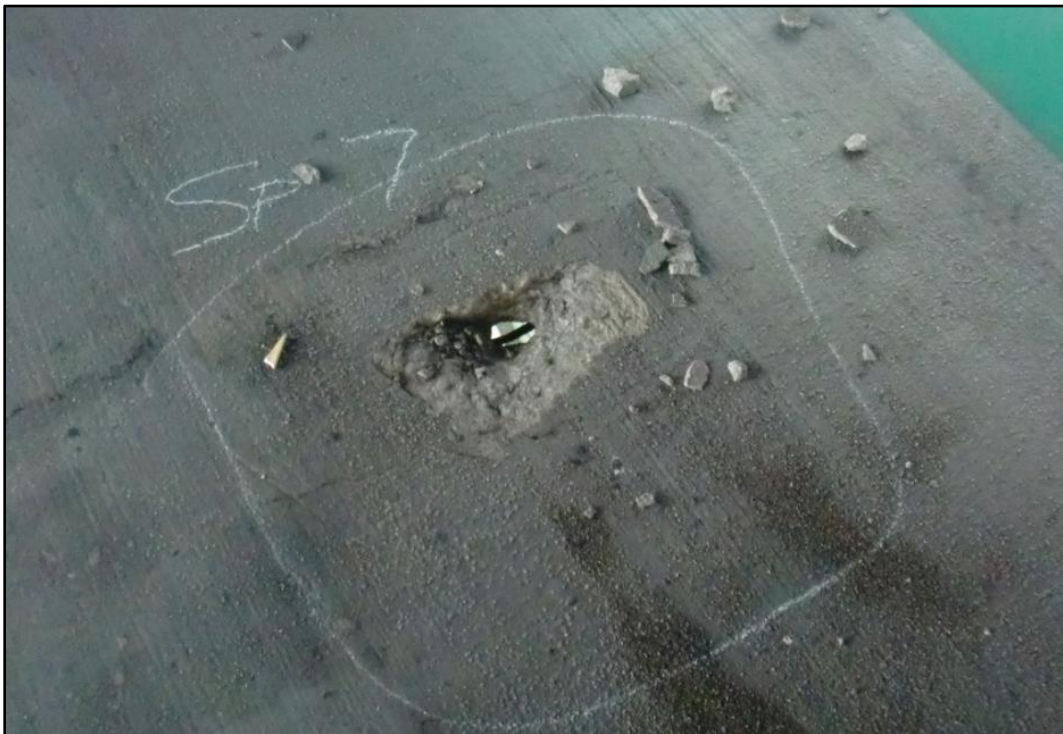
**Photo 11 – Recent Popout & Full Depth Spall, Maintenance Deck near Pier 7.**

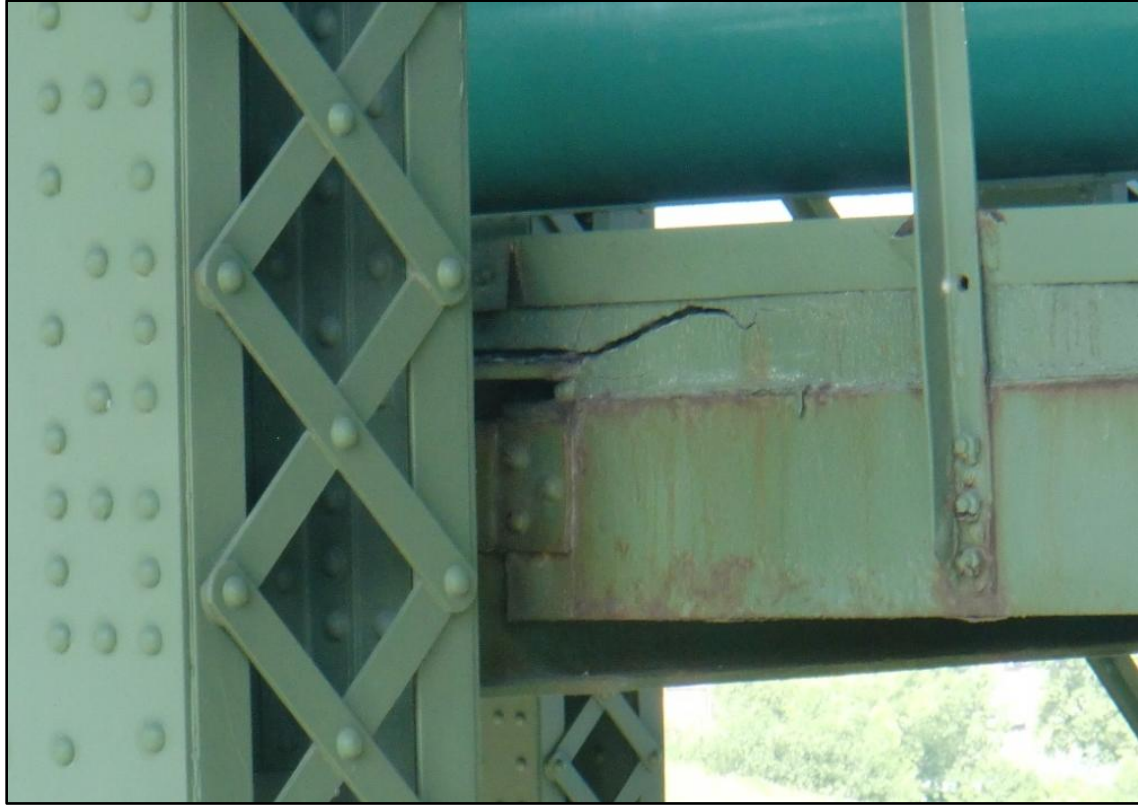
**Photo 12 - Maintenance Deck at Floor Beam 17, Span 11.**

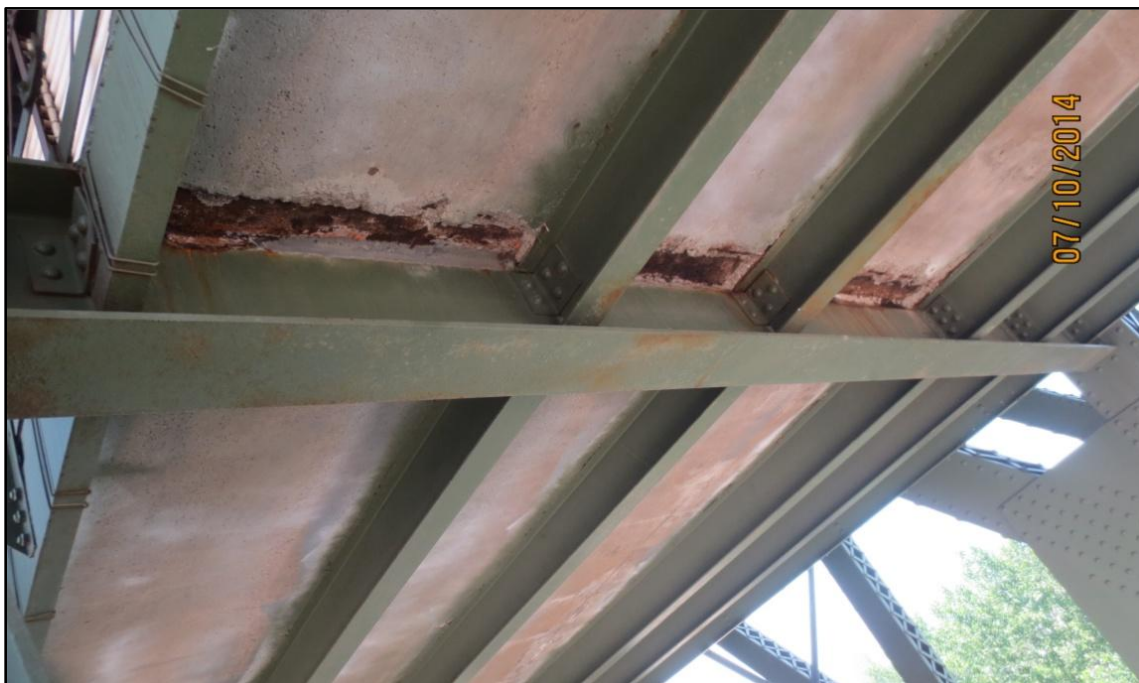
**Photo 13 – Water Infiltration through Maintenance Deck & Corrosion of Maintenance Deck Floor Beam Top Flange.**

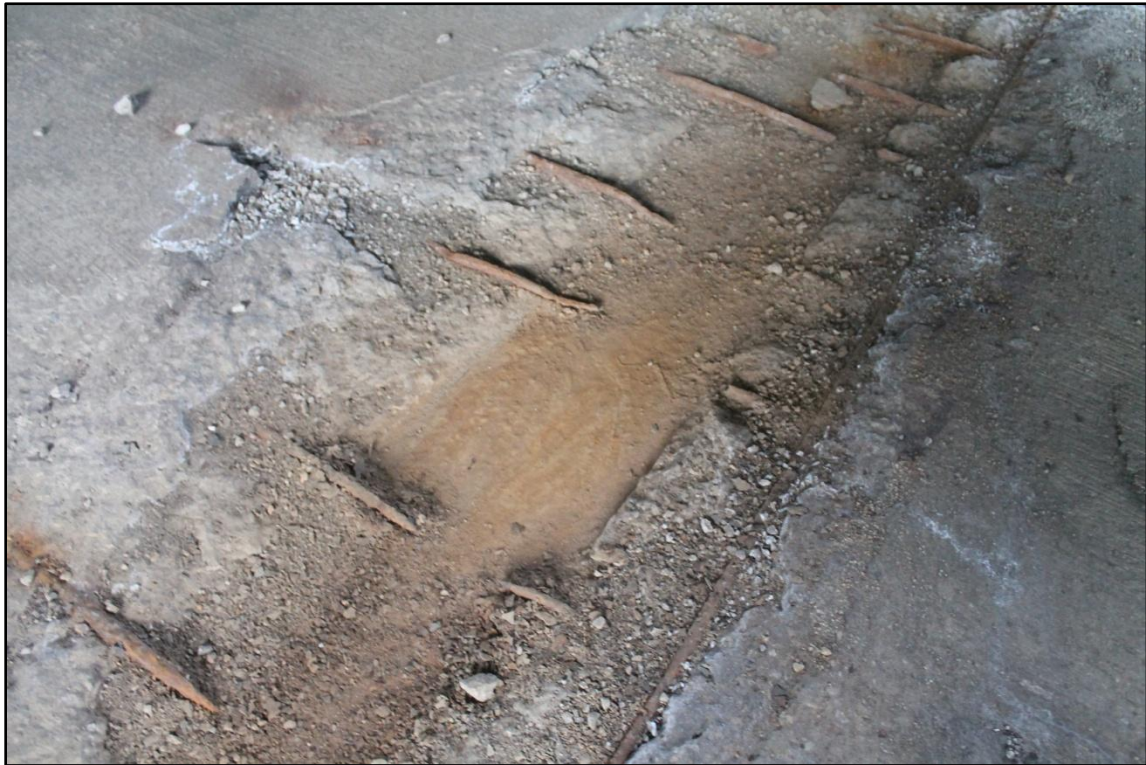
**Photo 14 – Complete Fracture & Removal of Maintenance Deck above Floor Beam 3, Span 11  
(Note: Exposed top flange visible).**

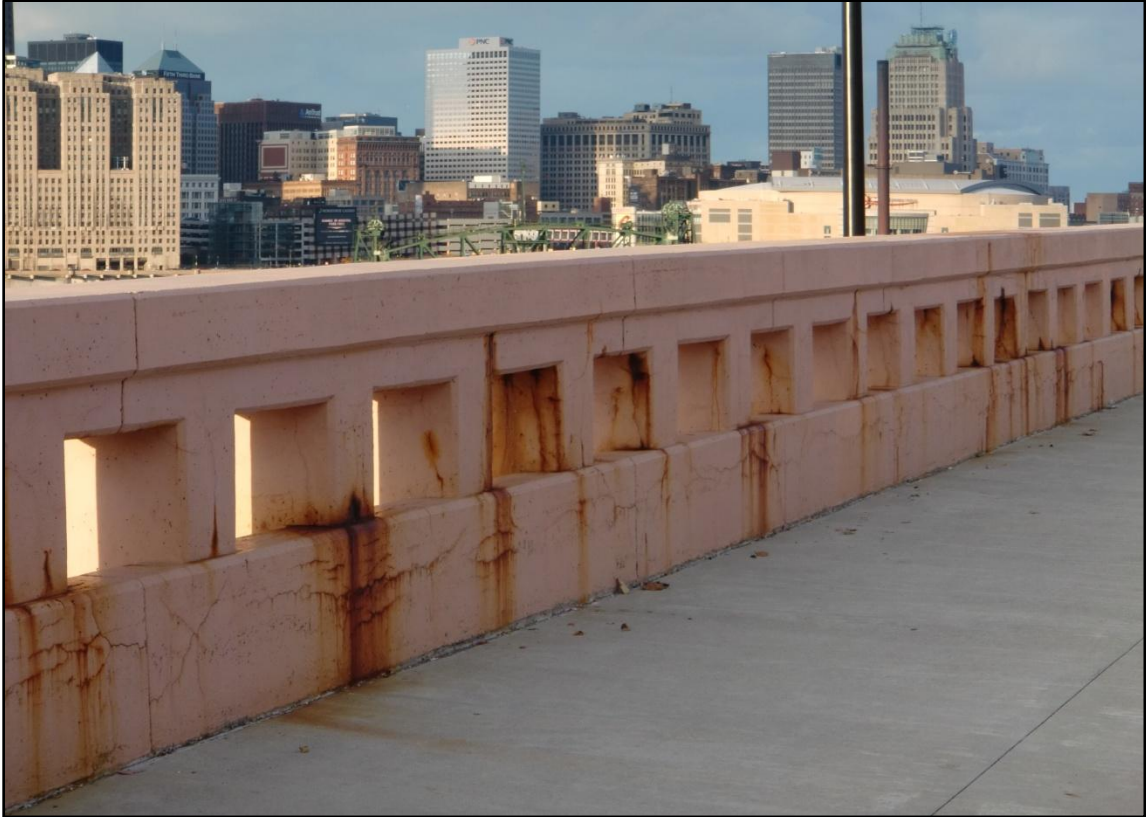
**Photo 15 – Cracked North Railing with Active Corrosion, Span 11.**

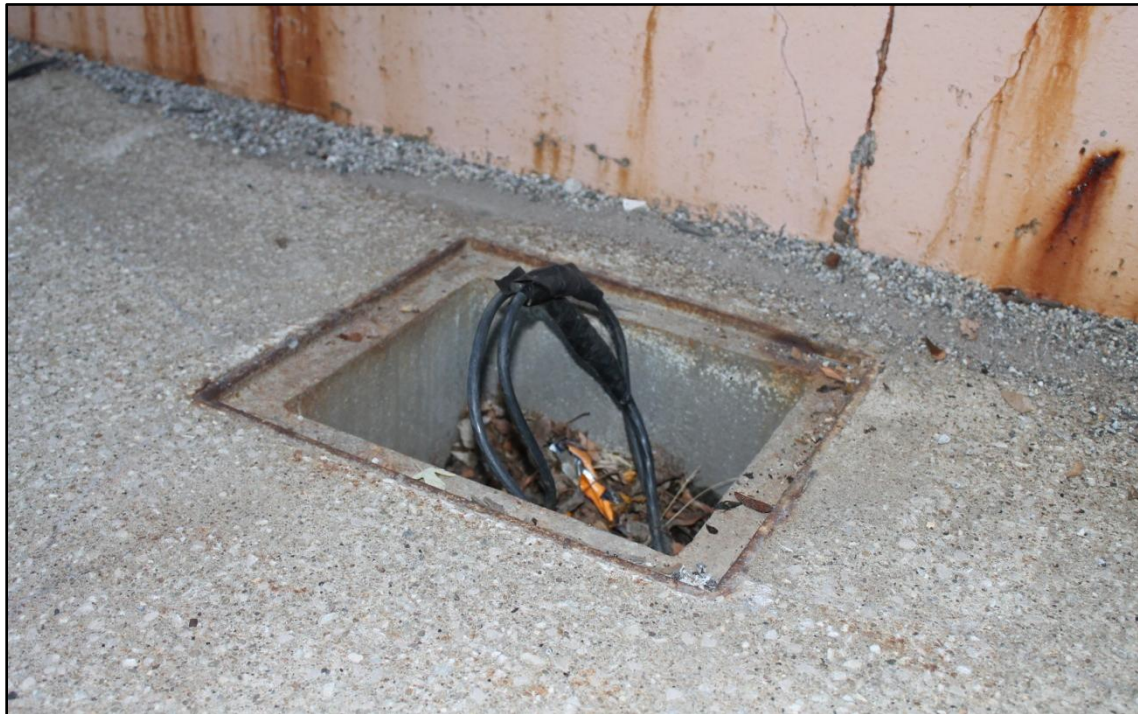
**Photo 16 – Open Pull Box, South Sidewalk, Span 13.**

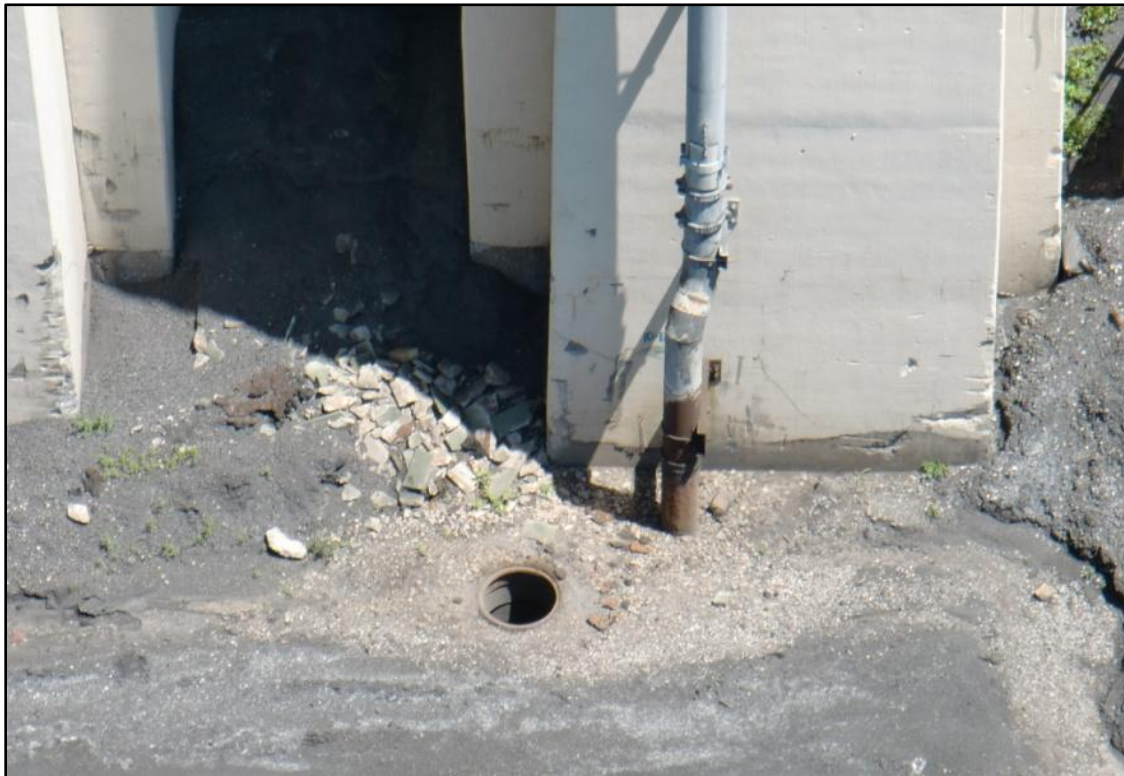
**Photo 17 – Missing Manhole Cover, Pier 6 SE Column.**

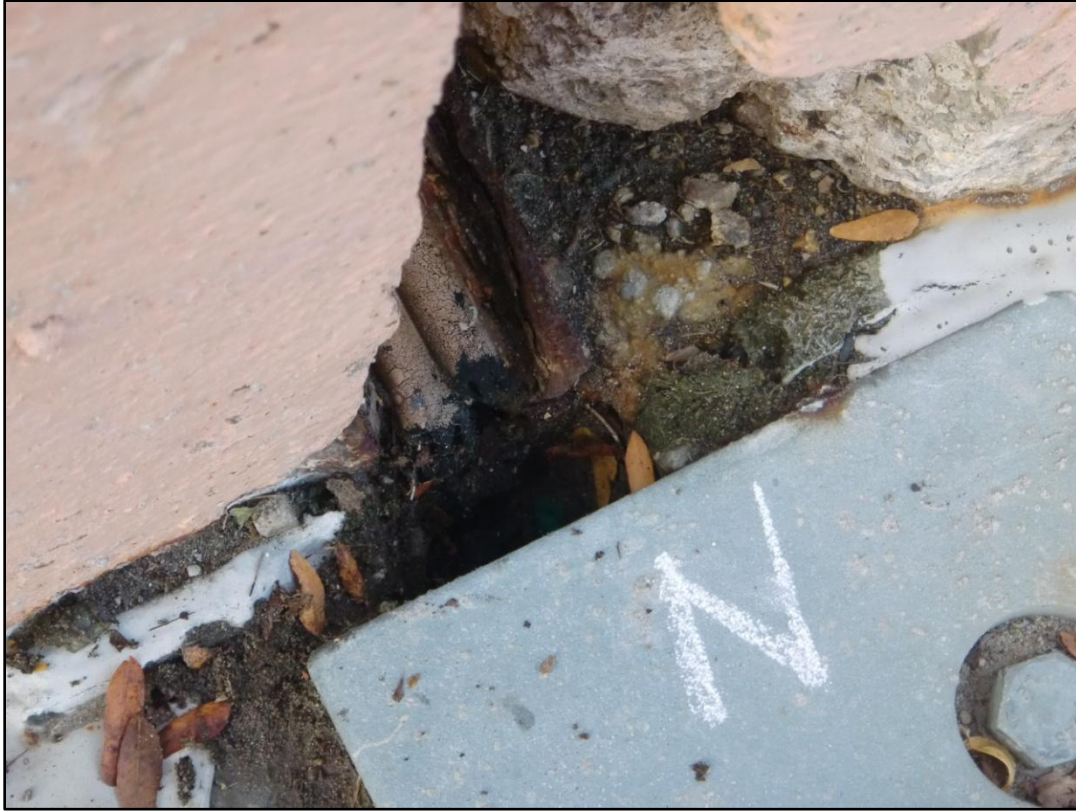
**Photo 18 – Cut Expansion Joint Membrane & Open Drainage, North Sidewalk Retrofit.**

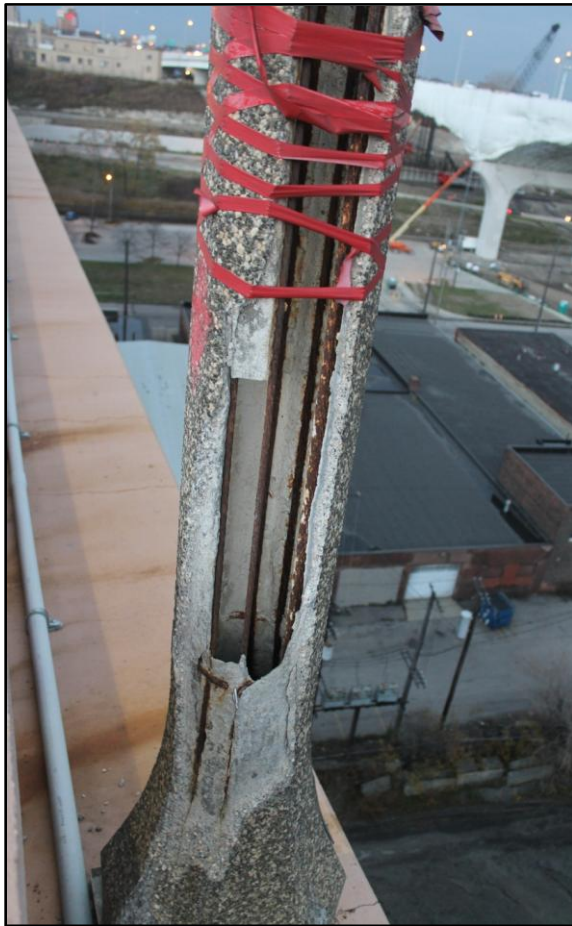
**Photo 19 – Critical Deterioration of Light Pole, Span 5, South Fascia (Light Standard No. 11S).**

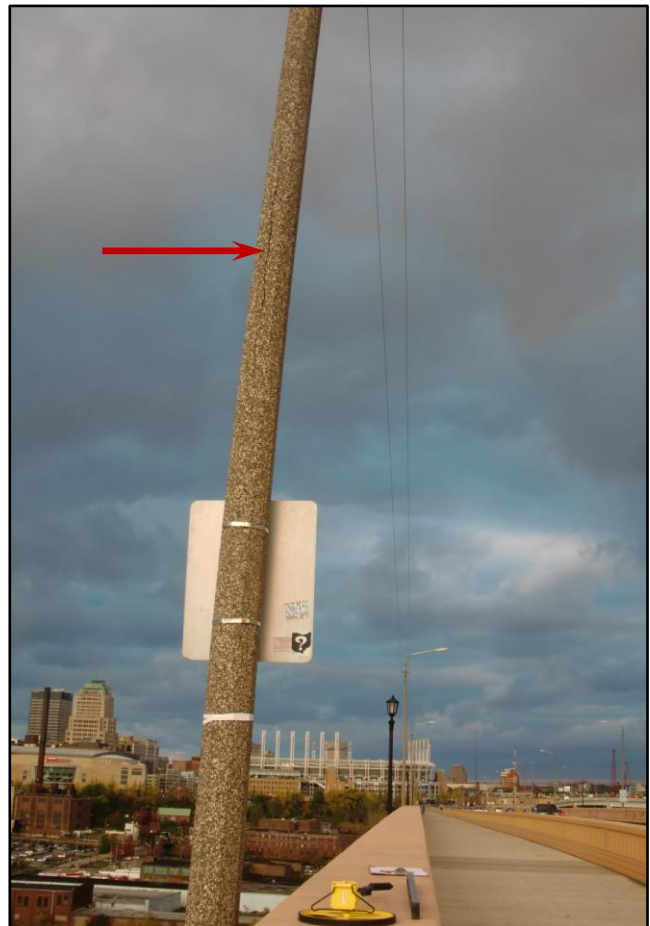
**Photo 20 – Leaning Concrete Light Pole with Open Vertical Crack (at Red Arrow), Span 8, North Fascia (Light Standard No. 5N).**

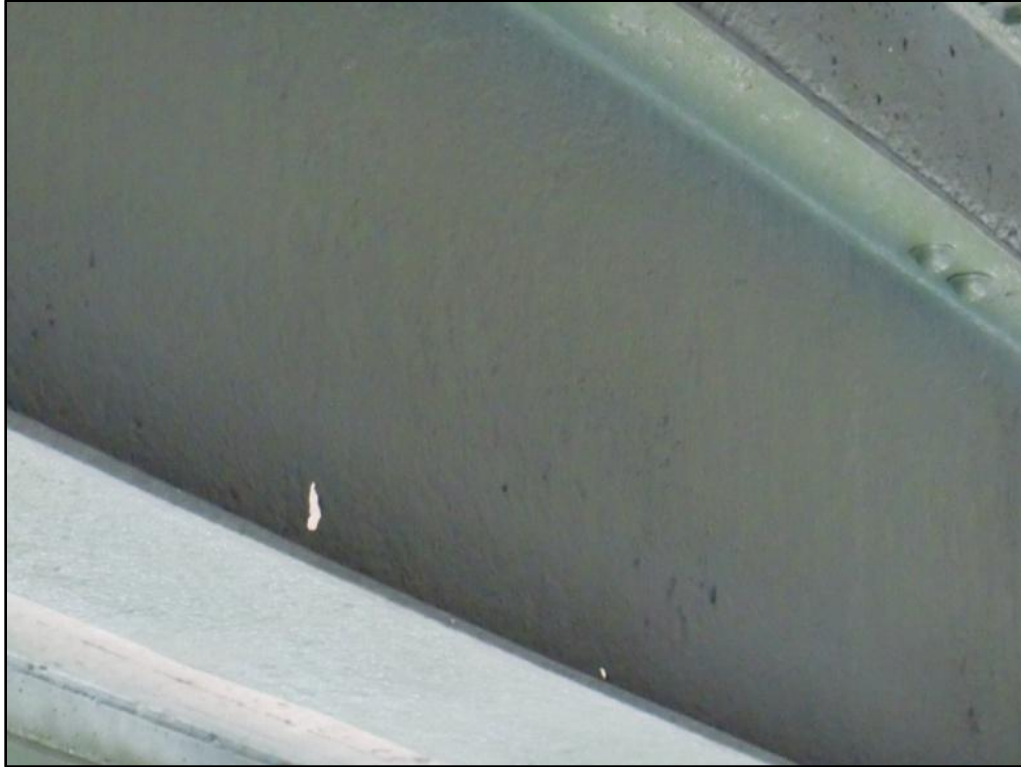
**Photo 21 – 2-inch High Web Perforation, Stringer 11, Panel 4, Span 7.**

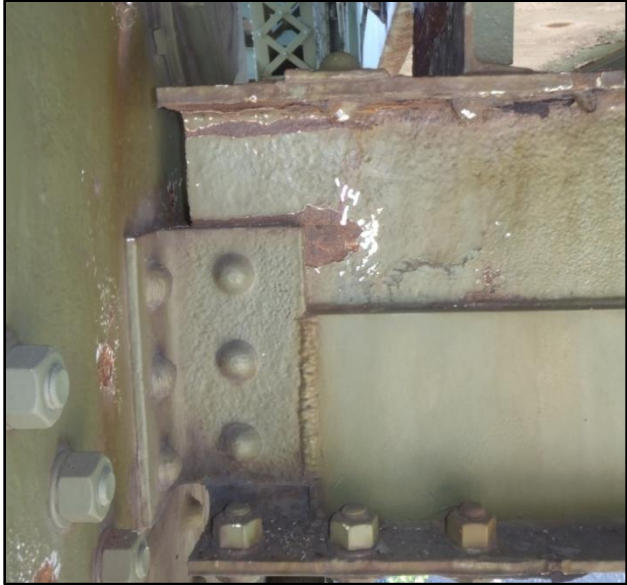
**Photo 22A – Crack Propagation. North Interior End of West Face, Maintenance Deck Floor Beam 15, Span 7.**

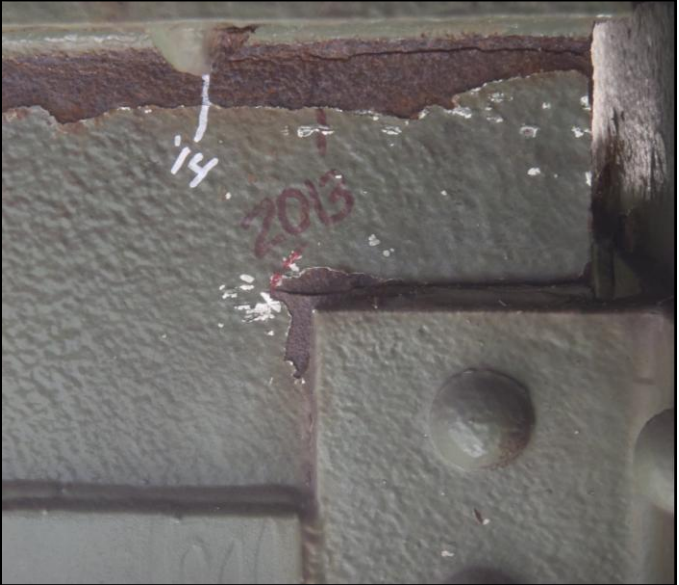
**Photo 22B – Crack Propagation. North Interior End of East Beam, Maintenance Deck Floor Beam 15, Span 7.**

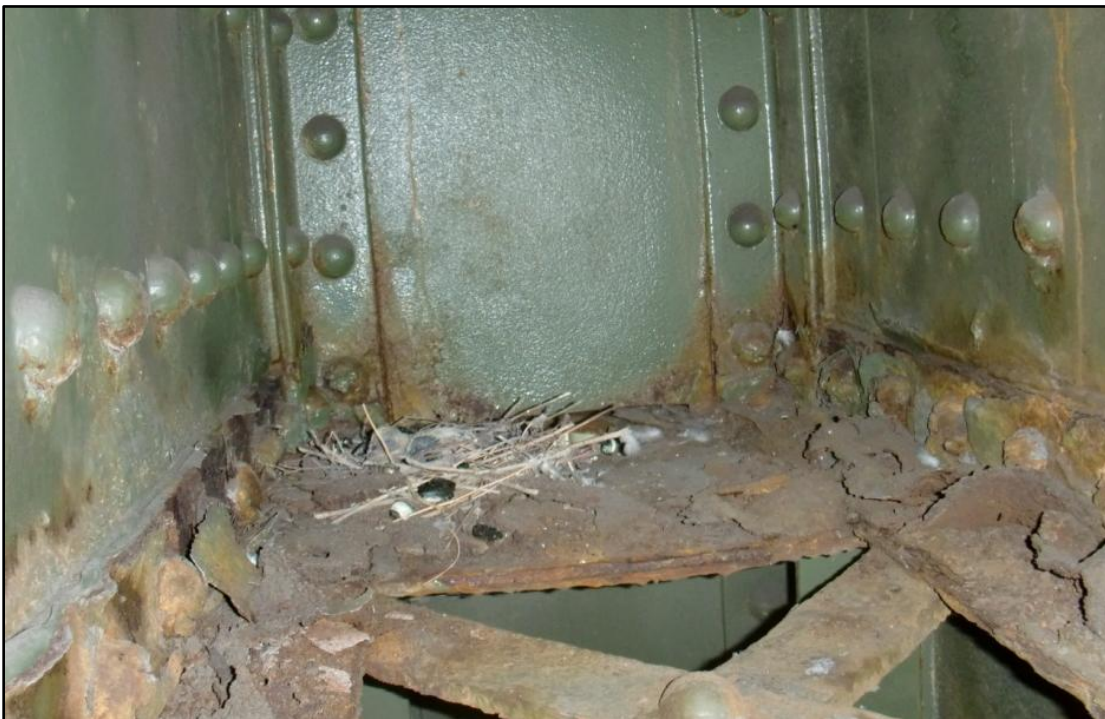
**Photo 24 – Isolated Corrosion Beneath Abandoned Pull Box Drain.**

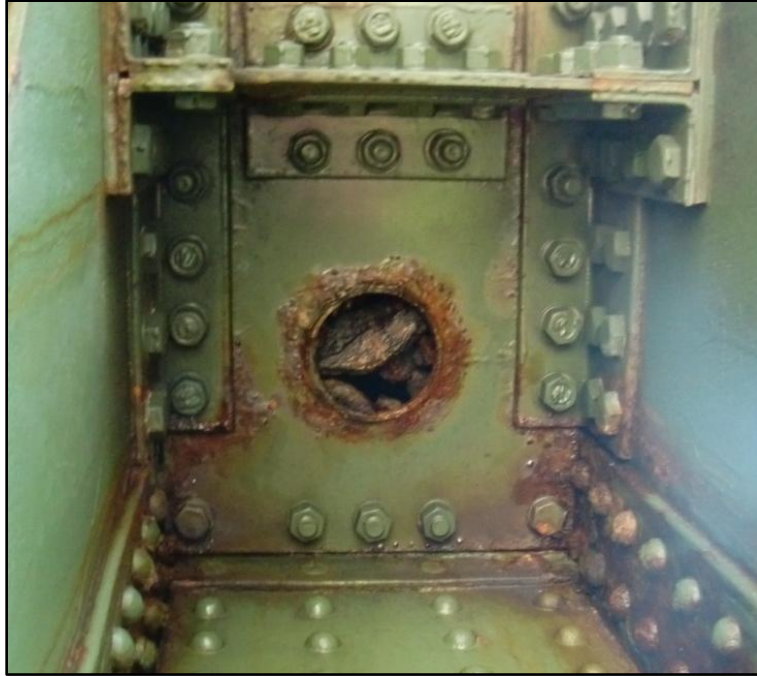
**Photo 25 – Demolition Debris & Expansion Joint Water Infiltration within Upper Chord, SE U13, Span 5.**

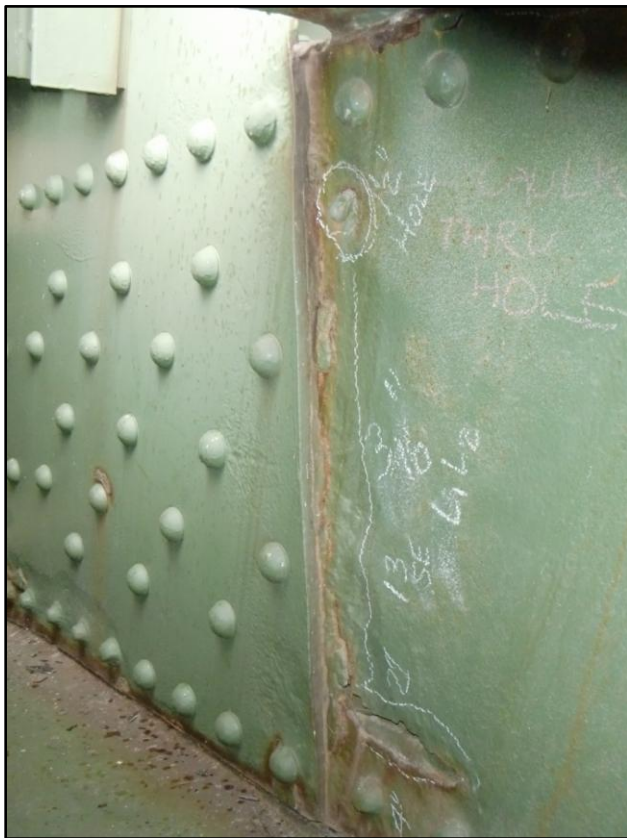
**Photo 26 – Two Perforation & 3/16" Section Loss on North Web Plate, SE L<sub>1</sub>L<sub>2</sub>, Span 13.**

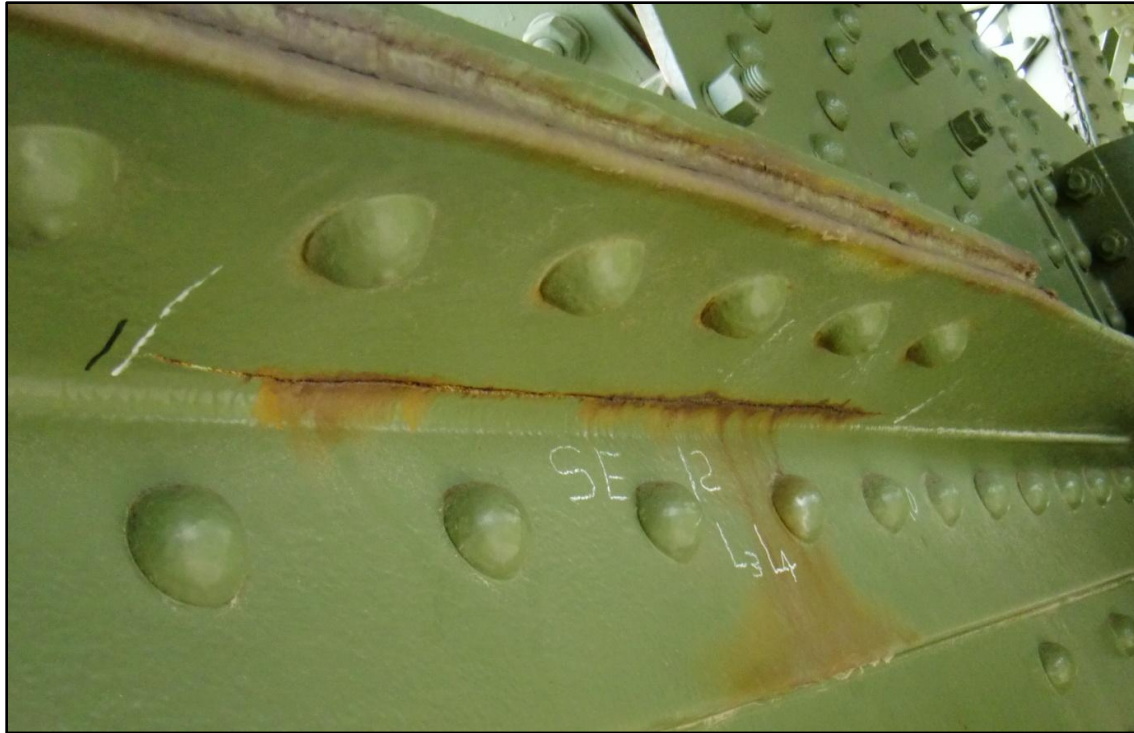
Photo 27 – Stress Corrosion Crack, Top North Flange Angle, SE L<sub>3</sub>L<sub>4</sub>, Span 12.

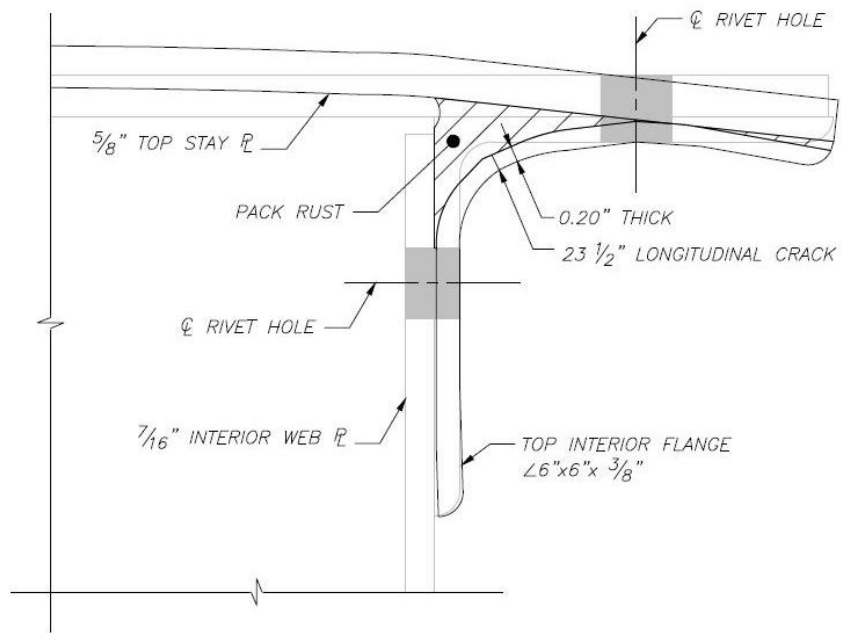
Figure 5 – Top Interior Flange Angle Deformation & Longitudinal Crack Location, L<sub>3</sub>L<sub>4</sub>, Span 12, SE Truss.

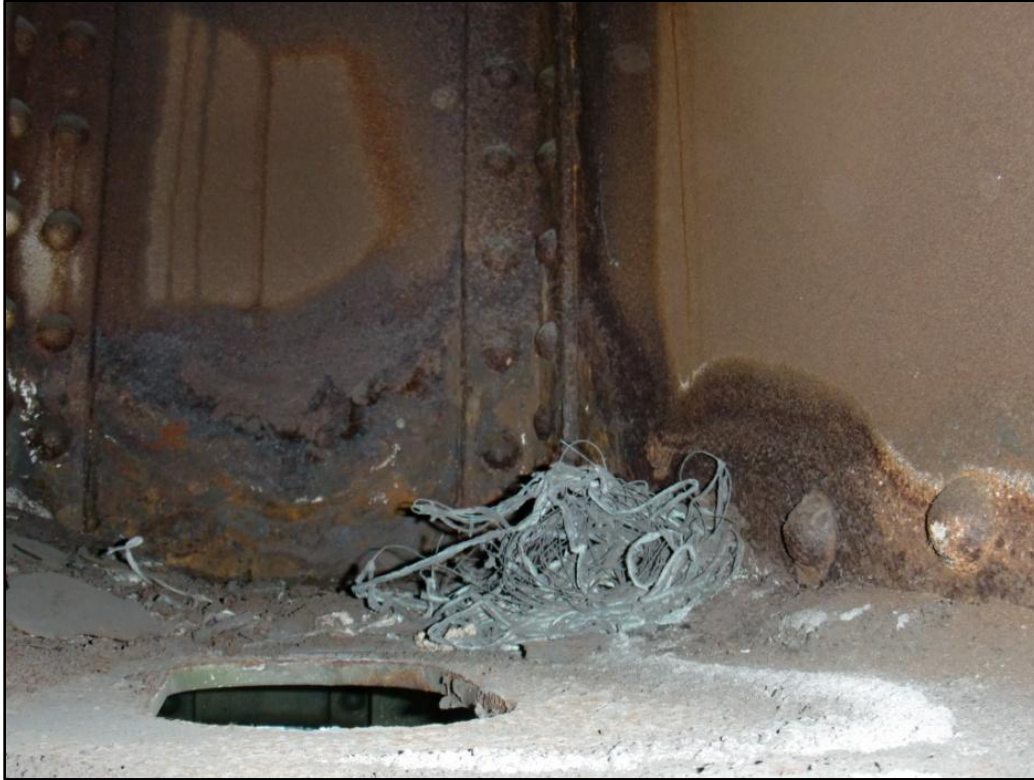
**Photo 28 – Typical Corrosion & Debris Inside Lower Chord Between Pier Bearings (Interior of SE L<sub>12</sub>L<sub>13</sub>, Span 7 Shown).**
