**OHIO DEPARTMENT OF TRANSPORTATION  
2014 PHYSICAL CONDITION REPORT**

**LORAIN-CARNEGIE BRIDGE OVER CUYAHOGA RIVER  
BRIDGE NO. CUY-10-1613**

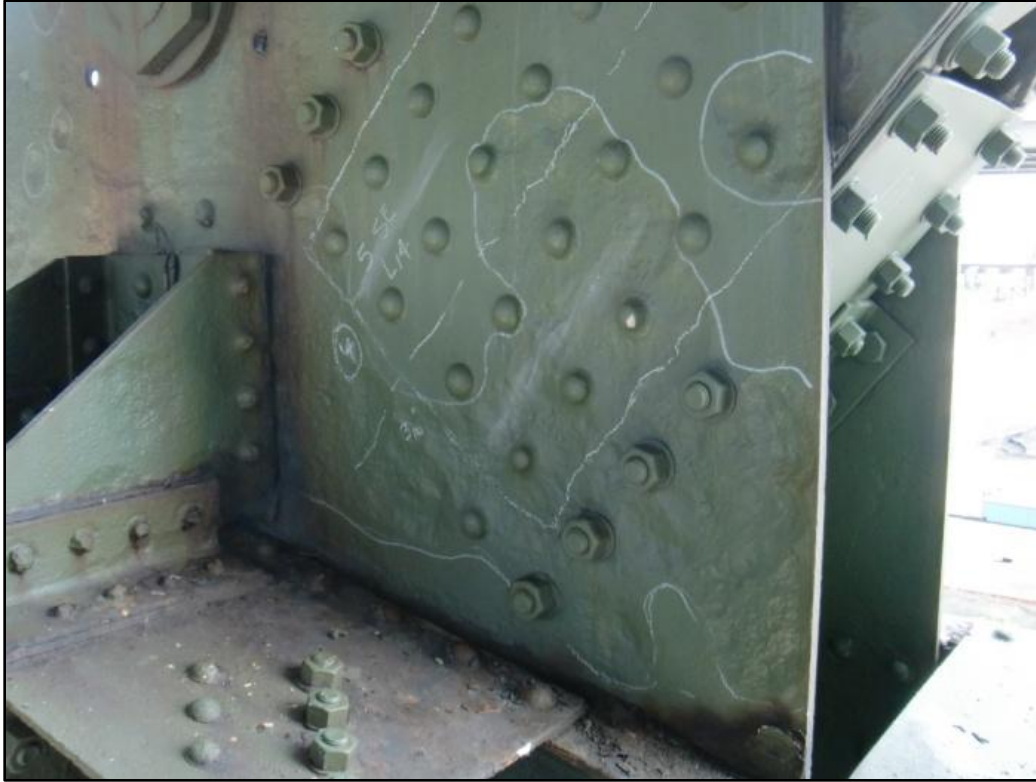
**Photo 29 –  $\frac{3}{16}$ " Deep General Pitting, Exterior Face, North Gusset Plate, SE L14, Span 5  
(Note: Outline of diagonal member sketched on plate.)**

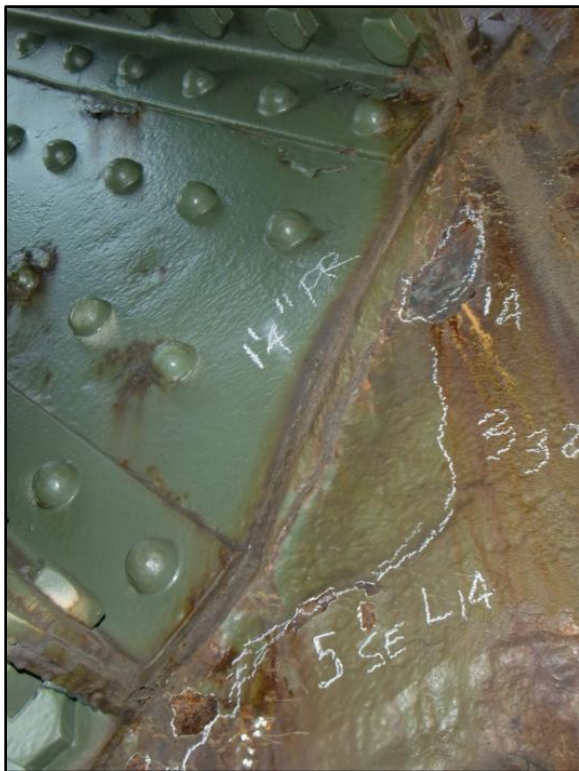
**Photo 30 –  $\frac{3}{32}$ " to  $\frac{1}{4}$ " Section Loss at End of Diagonal Connection with  $1\frac{1}{4}$ " Pack Rust, North Gusset Plate SE L<sub>14</sub>, Span 5 (Note: Shown is the interior face of gusset plate in Photo 29).**

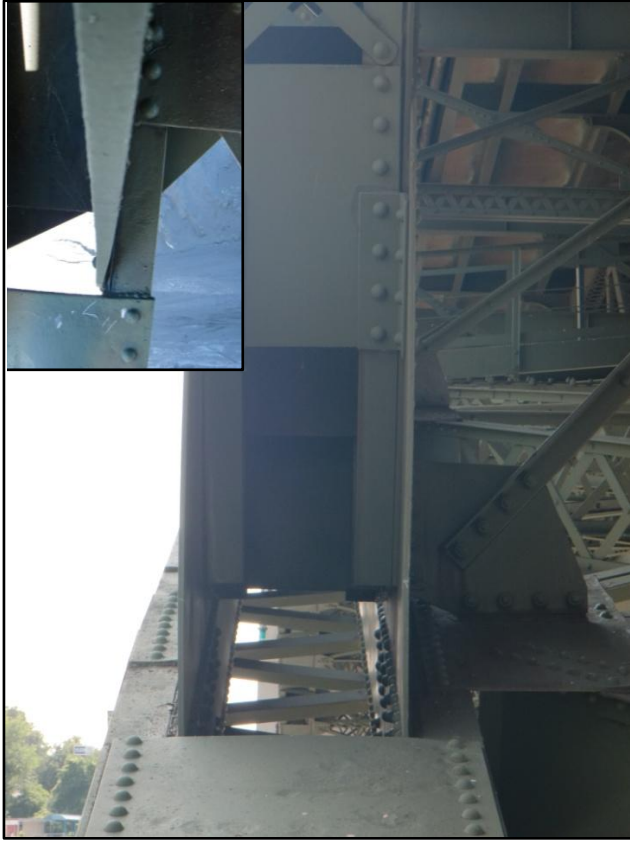
**Photo 31 – Slight Bow to North Gusset Plate East Pylon at SE Truss.**

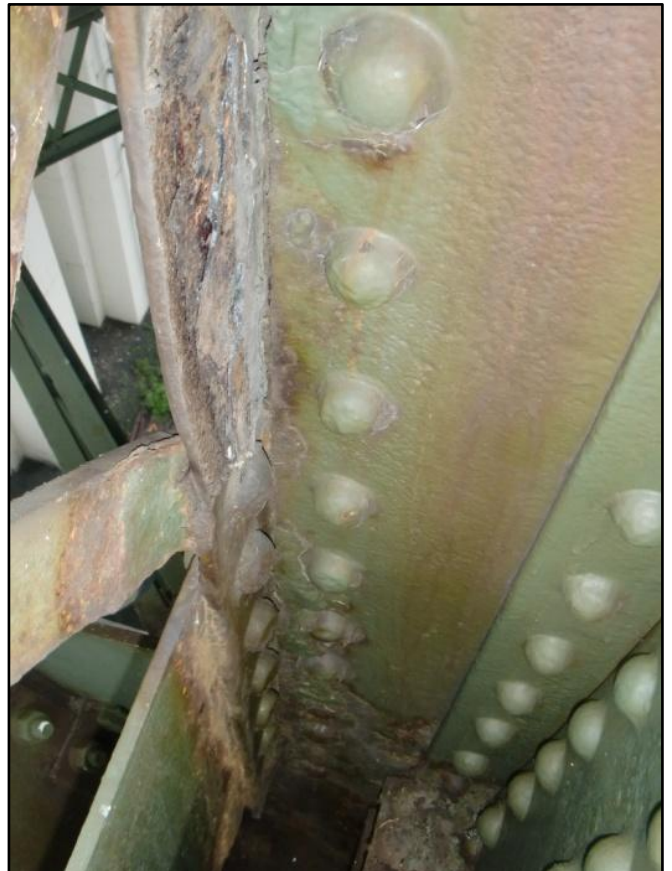
### *Lower Lateral Bracing*

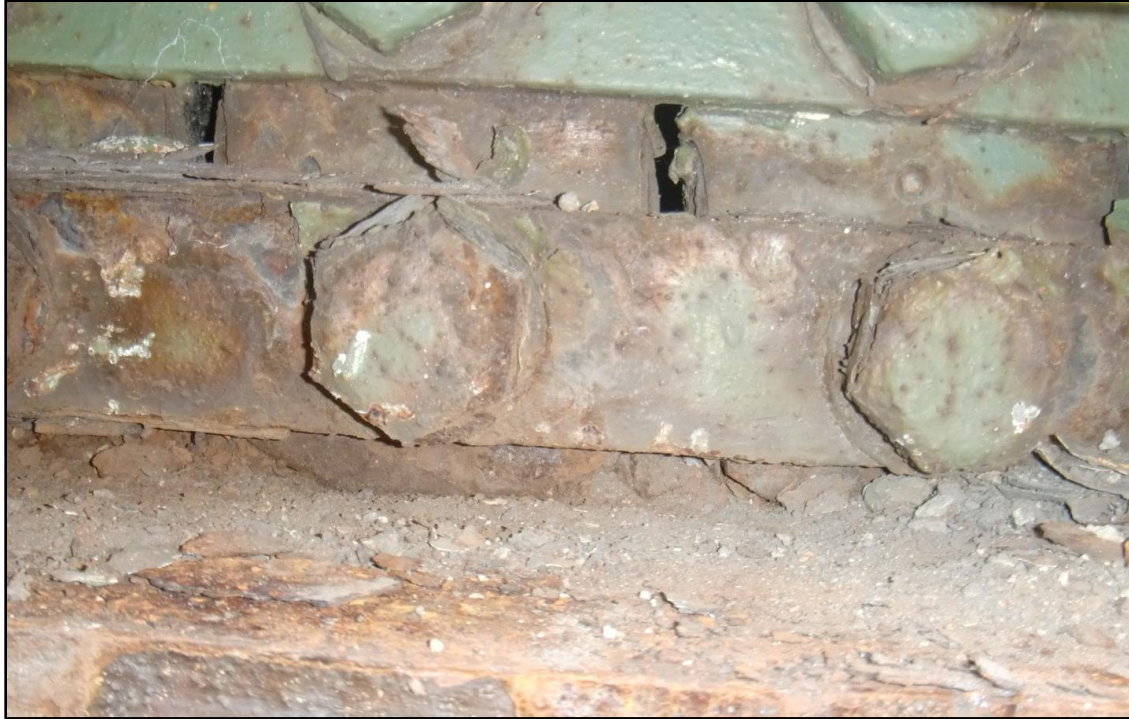
**Photo 33 – Typical Debris within Expansion Rollers.**

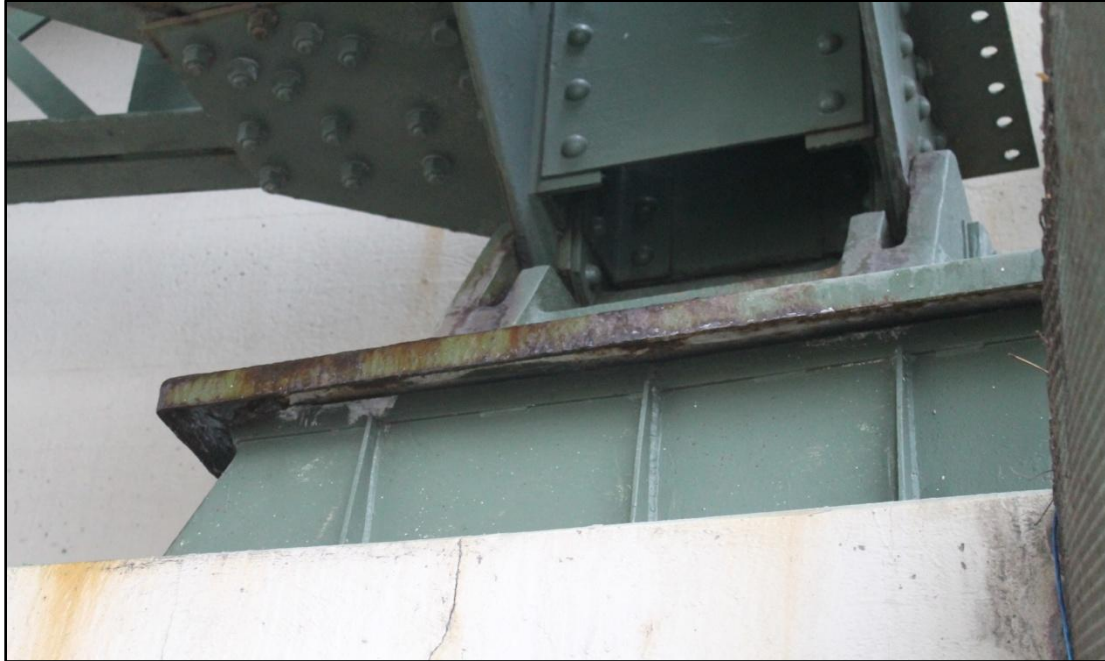
**Photo 35 – Active Corrosion on Grease Box Cover, Bearing South L6, Wheeling & Lake Erie Span.**

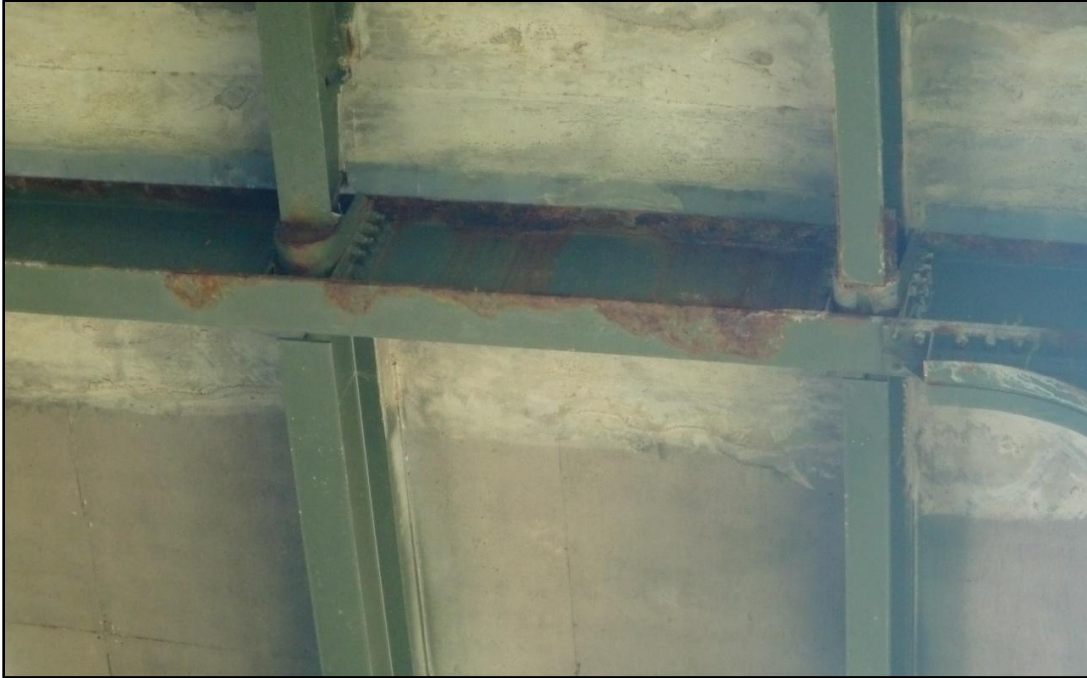
**Photo 34 – Protective Coating System Failure below Upper Deck Joint F3, Spans 5 & 6.**

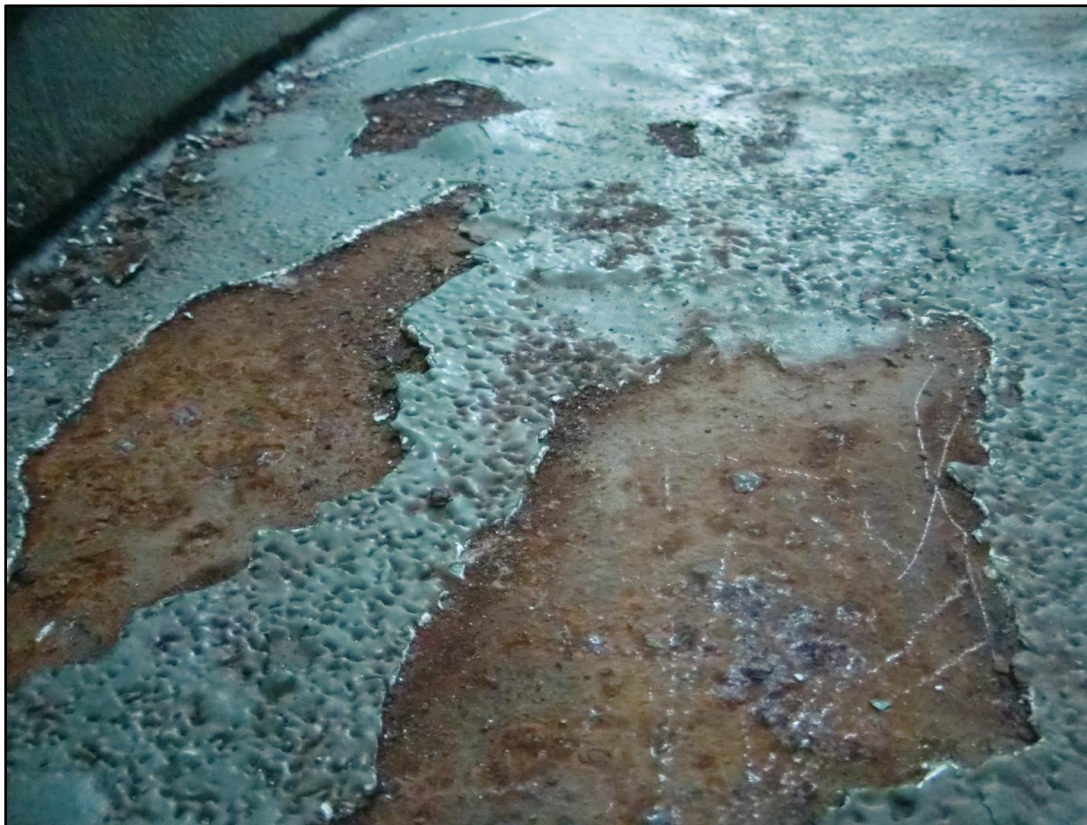
**Photo 35 – Poorly Prepped Steel & Locally Failed Protective Coating System.**

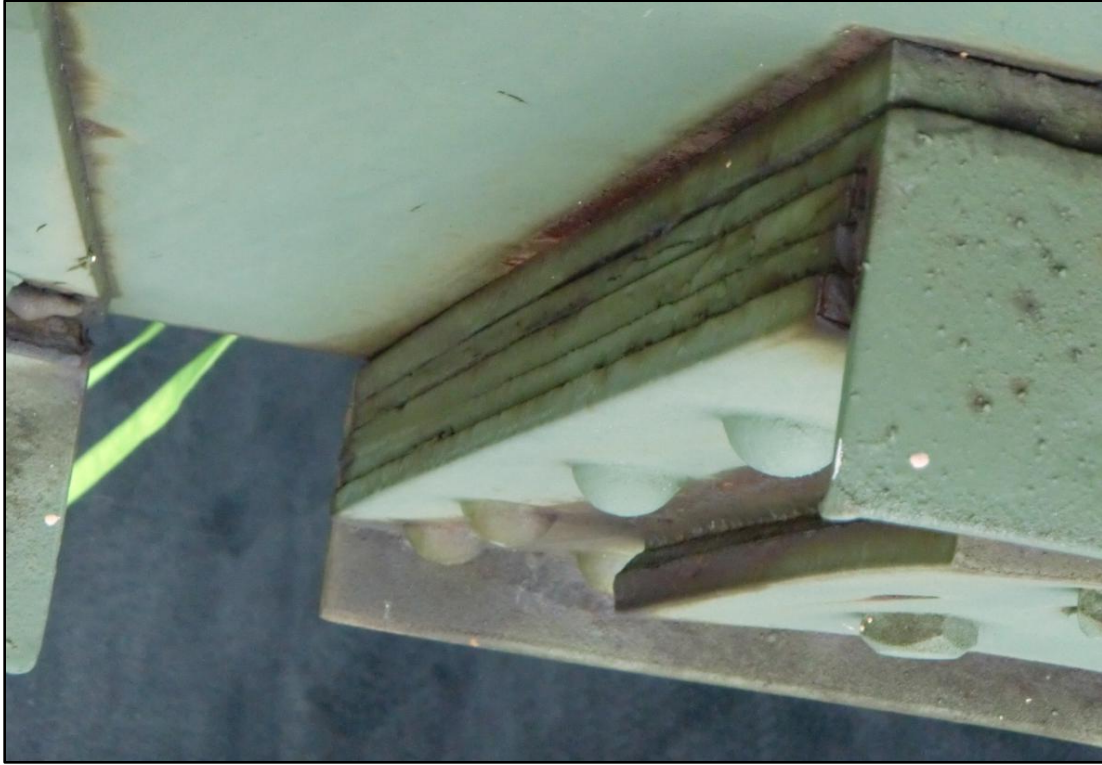
**Photo 36 – Wear to Paint Indicating Hinge Movement, SE L<sub>13</sub>, Span 3.**

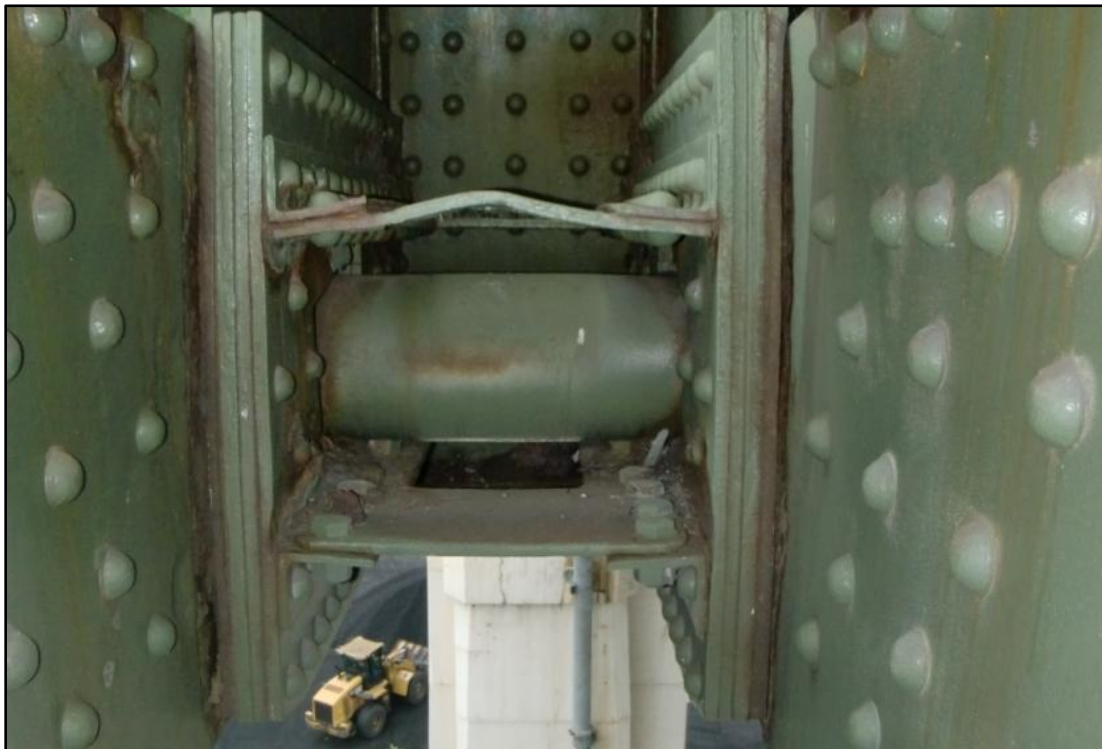
**Photo 37 – Frozen Hinge Due to Pack Rust with Buckled Diaphragm, SE L<sub>15</sub>, Span 7.**

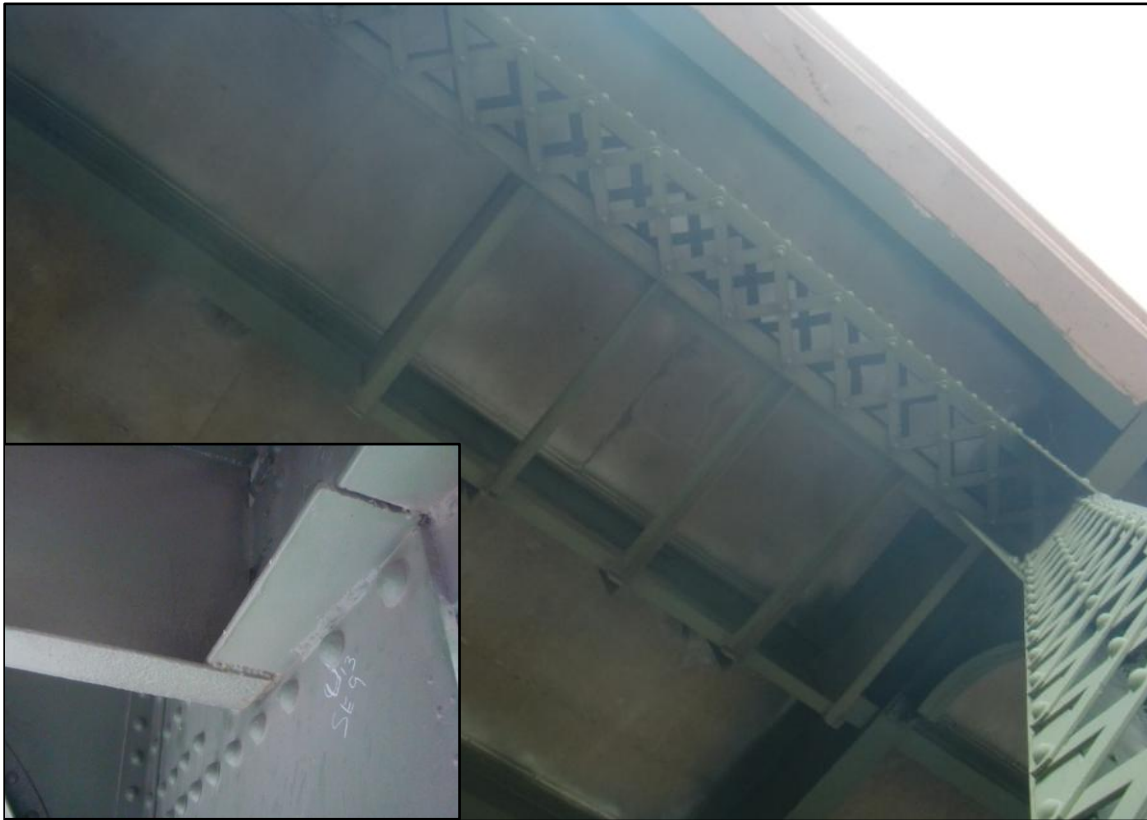
**Photo 38 – Occasional Welded Frame to Upper Chord & Gusset Plate.**

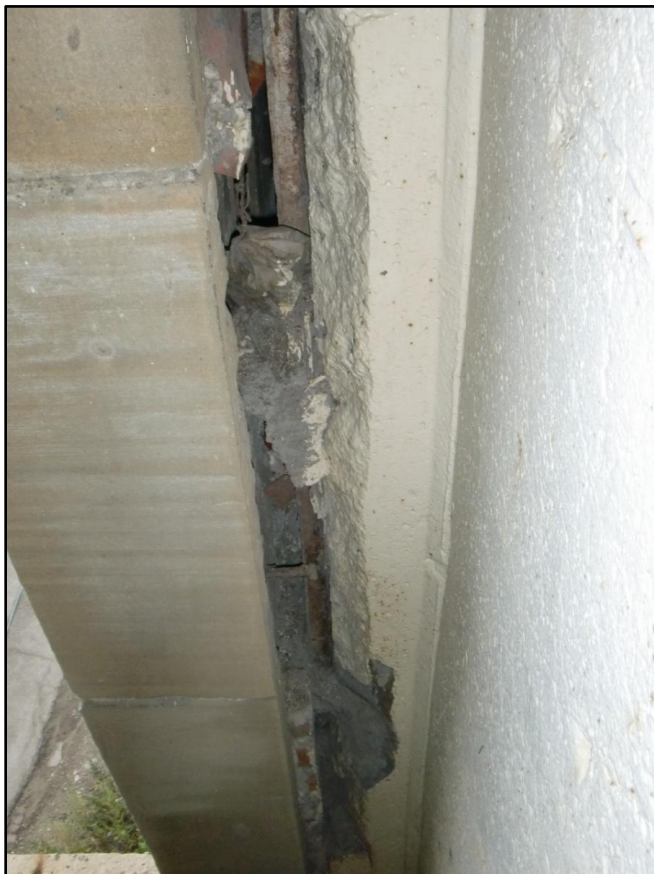
**Photo 39 – Backwall Loss & Missing Anchorage for East Pylon Sandstone Facing.**

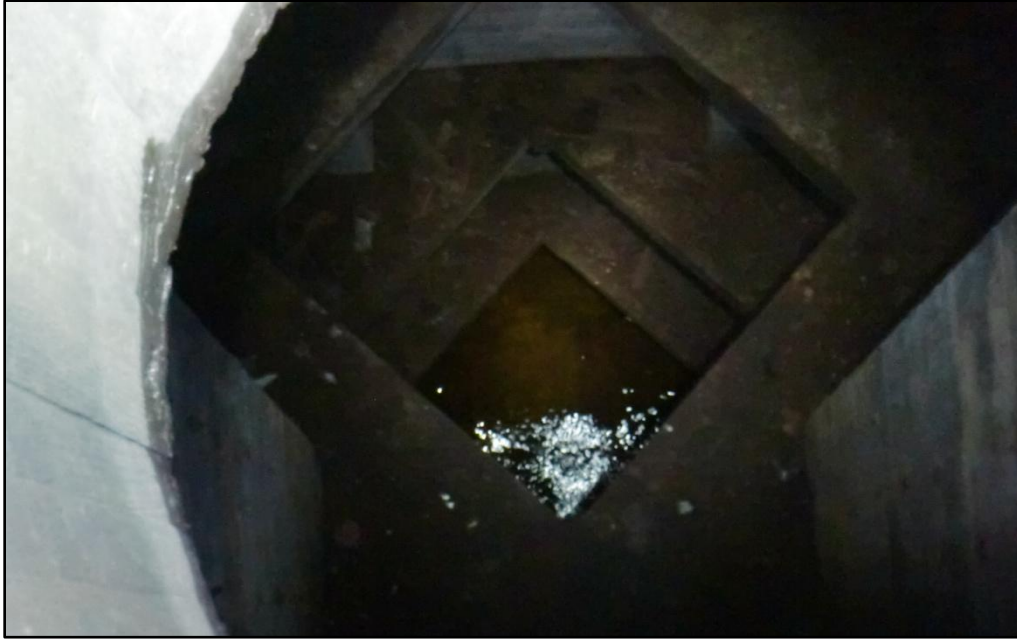
**Photo 41 – Standing Water Below Ground Line Inside  
North Exterior Pier Column, Pier 5.**

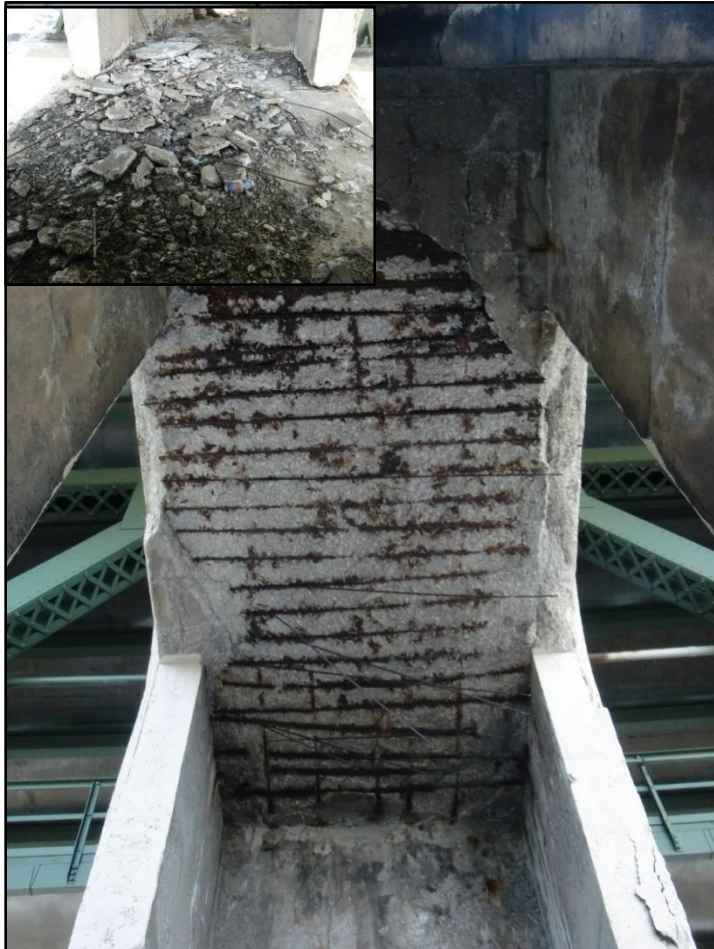
**Photo 42 – Deteriorating Floor & Accumulated  
Fallen Concrete Since 2002,  
North Pier Tower, Pier 7.**

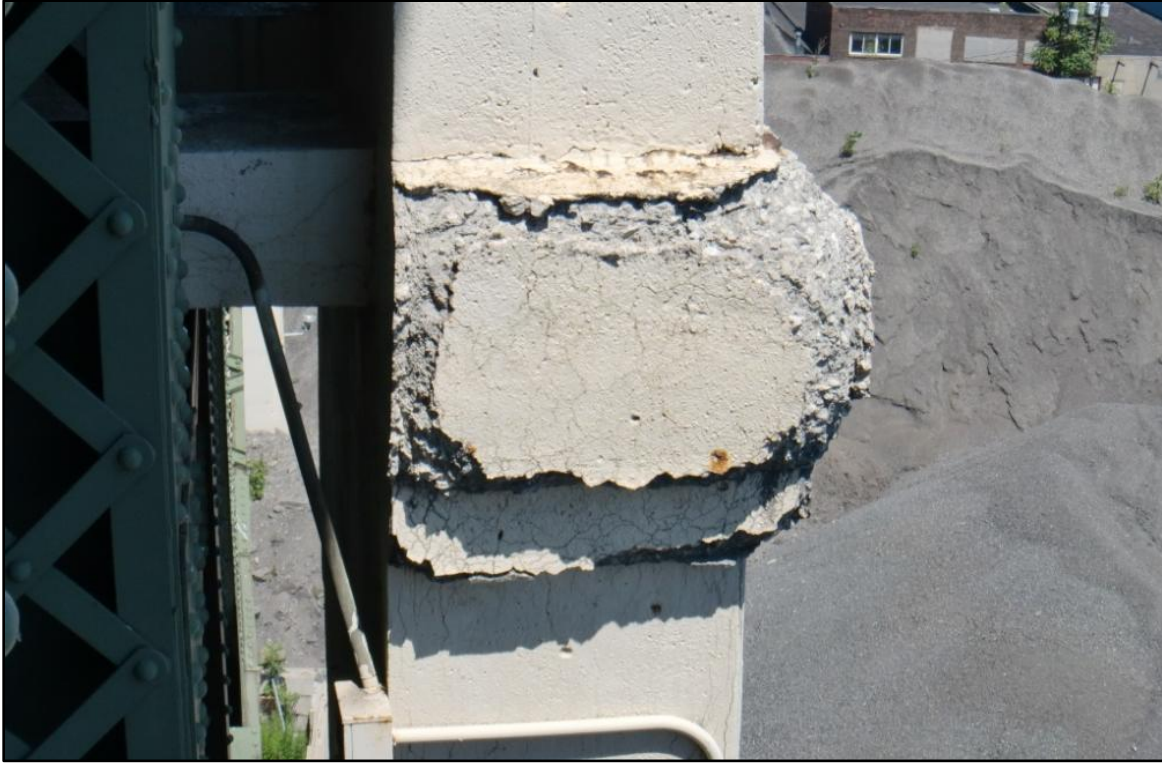
**Photo 42 – Scaled Architectural Band, South Pilaster, Pier 8.**

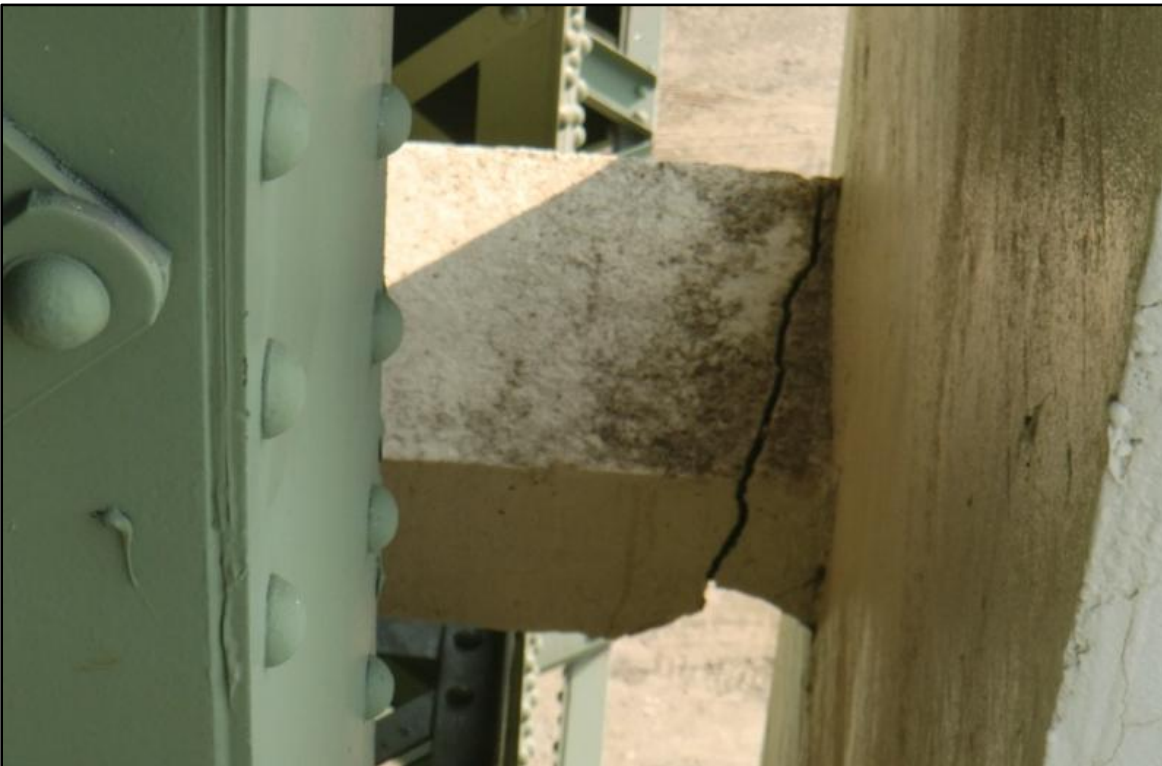
**Photo 43 – Full Depth Crack, East Bracket, Pier 1 South Pilaster.**

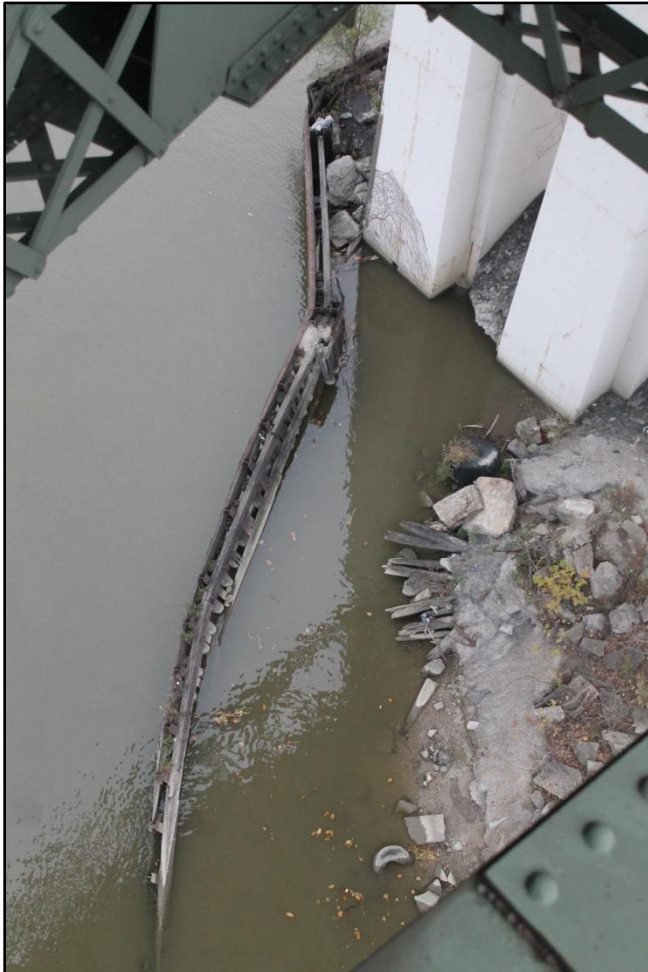
**Photo 44 – Failing Bulkhead along Pier 9  
& East River Bank.**

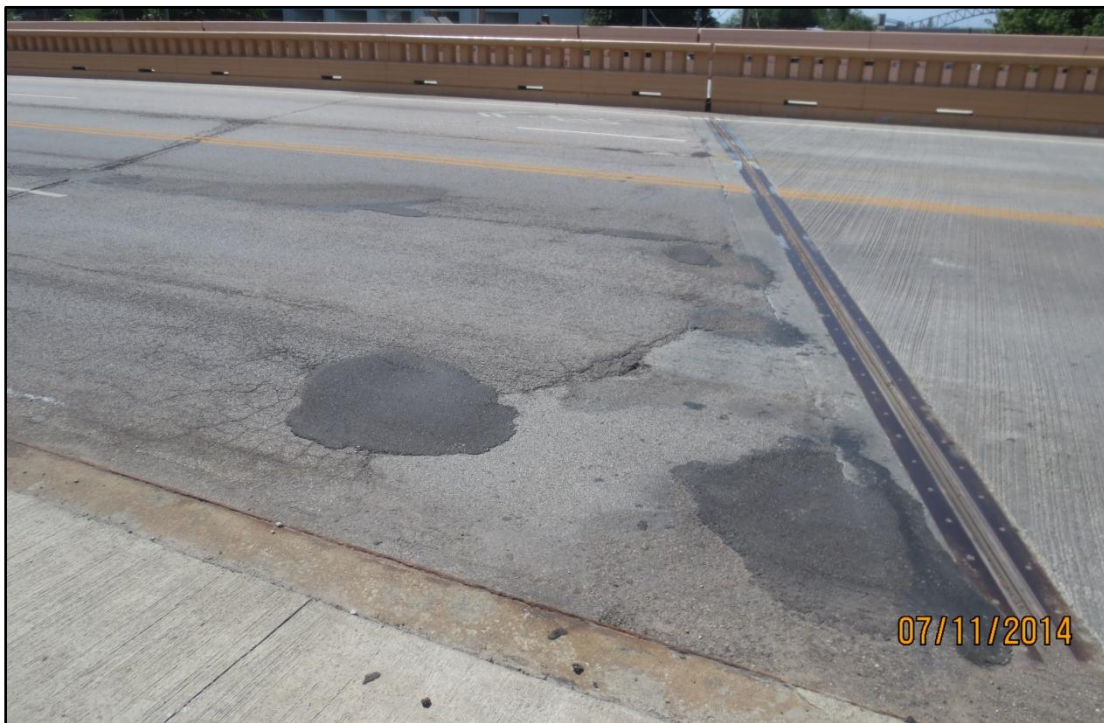
**Photo 45 – Moderate Rutting with Patches, West Approach Pavement.**

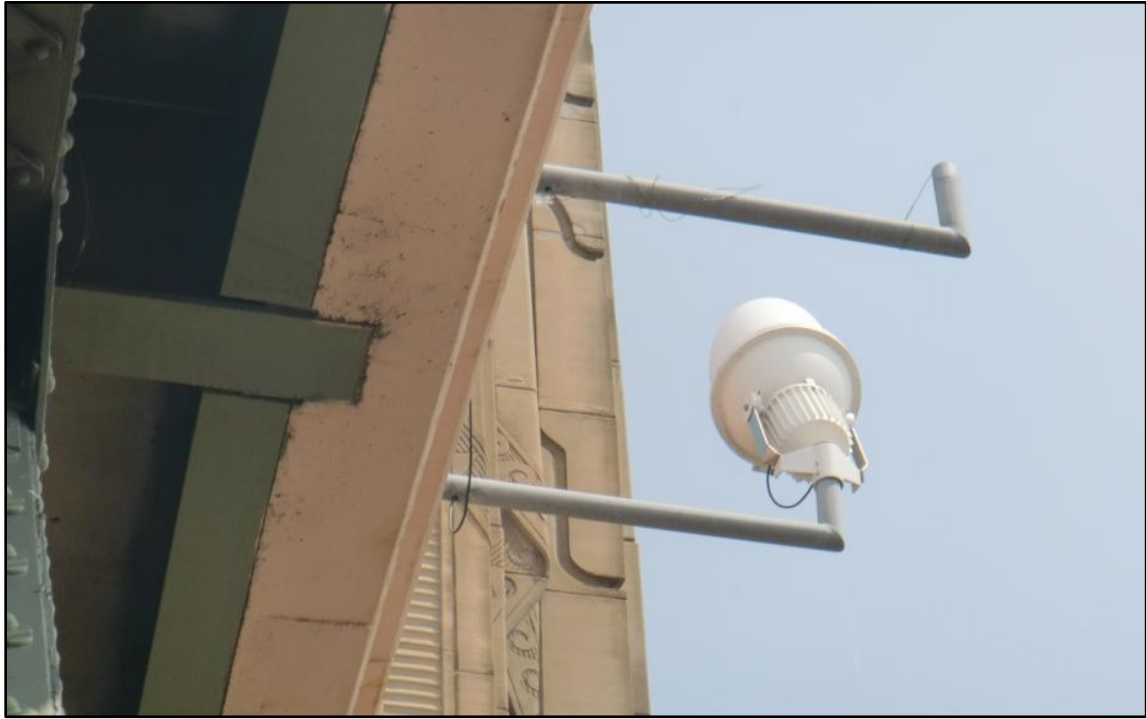
**Photo 51 – Missing Architectural Spot Light, West Face, South East Pylon.**

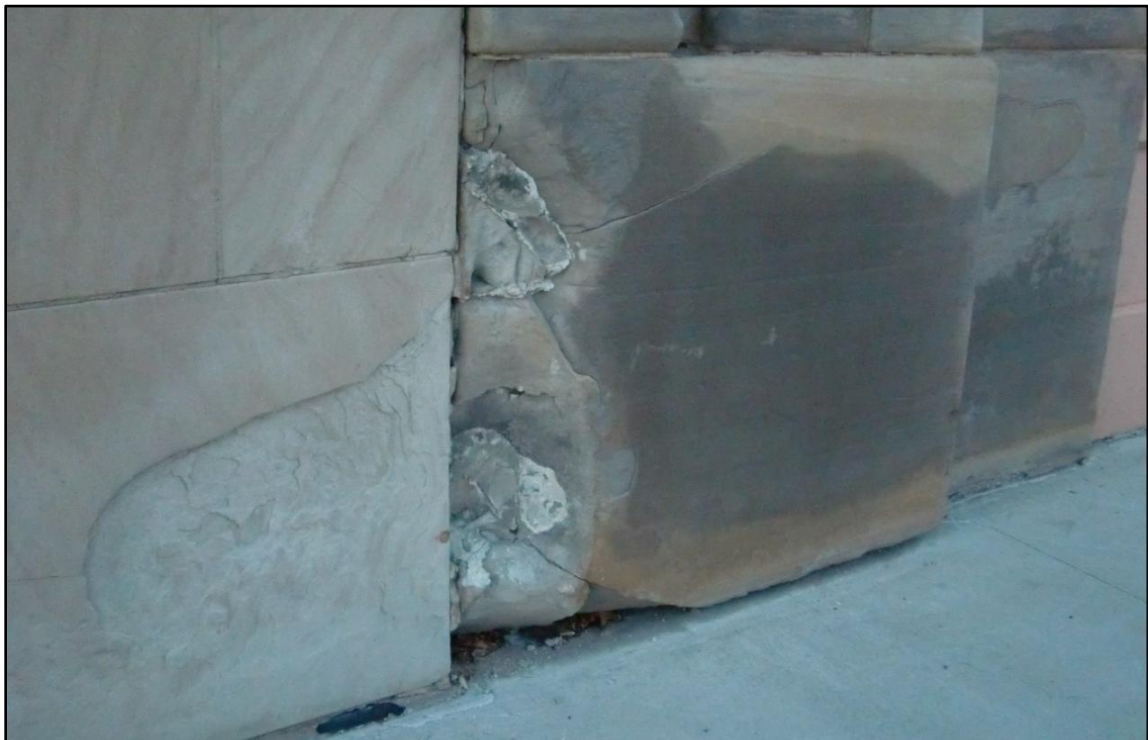
**Photo 52 – Spalled Sandstone at Sidewalk, Northeast Pylon.**
