***2014 BRIDGE INSPECTION
FIELD REPORT***

Inventory Bridge Number: CUY 00010 16.130 N

SR 10 over CUY RIVER VALLEY & FI RR

**2014 SUPERSTRUCTURE
INSPECTION FINDINGS**

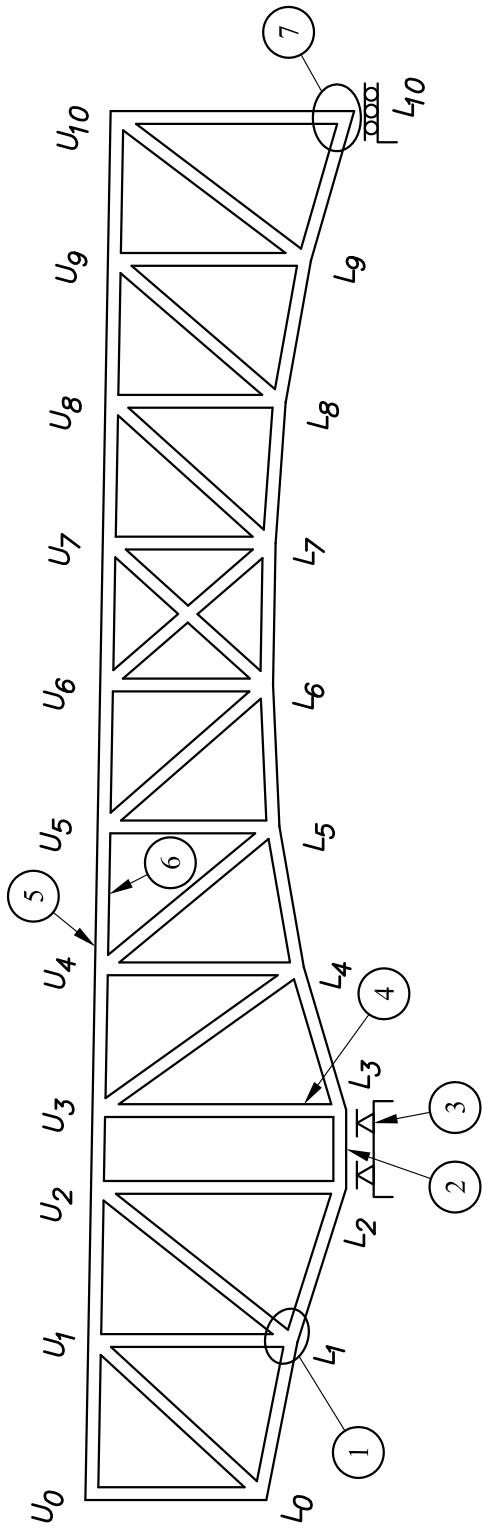
No.	Findings
1	Local paint failure.
2	Hole in bottom stay plate.
3	Bearing drain holes clogged with steel shot.
4	Ivy on top of pier and growing up truss verticals.
5	Water from junction box drain causing corrosion. Top and bottom tie plates holed through with $\pm 1/8$ " section loss to outstanding legs of flange angles.
6	Member has angles welded to south web plate.
7	Water leaking on joint long after rain event. Debris falling is causing local paint failure at bearing. Large rust flakes on gusset plate along Member L ₉ -L ₁₀ by joint.

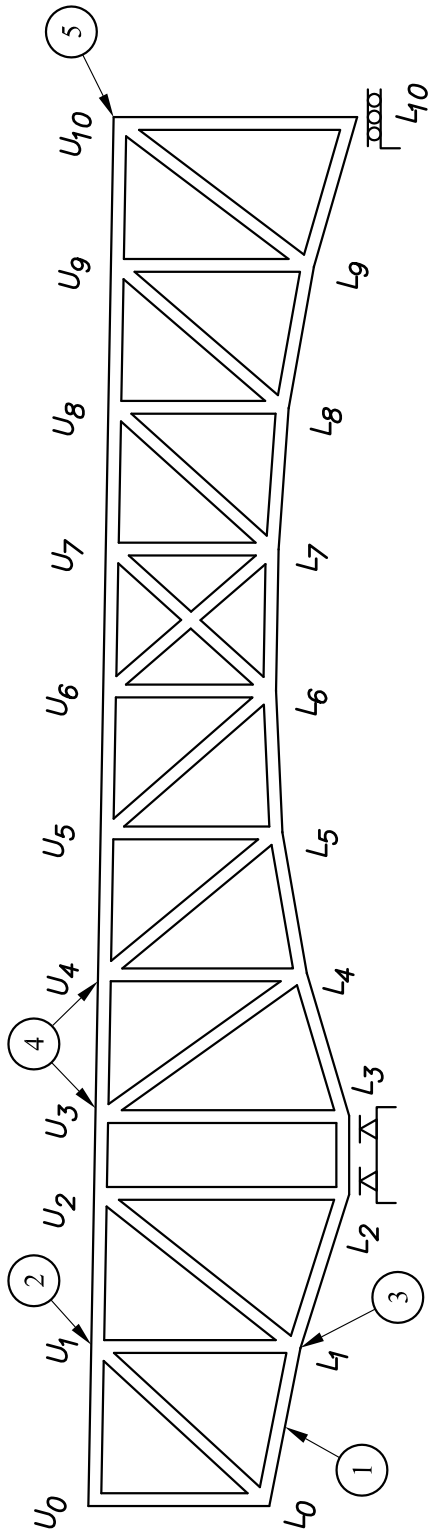
No.	Findings
1	Peeling top coat at the inside face of south web plate along a 2' section.
2	Active corrosion at Joint U ₁ .
3	Peeling top coat at bottom gusset plate.
4	Minor corrosion and pitting throughout joint.
5	Joint U ₁₀ has pitting with section loss on interior plates.

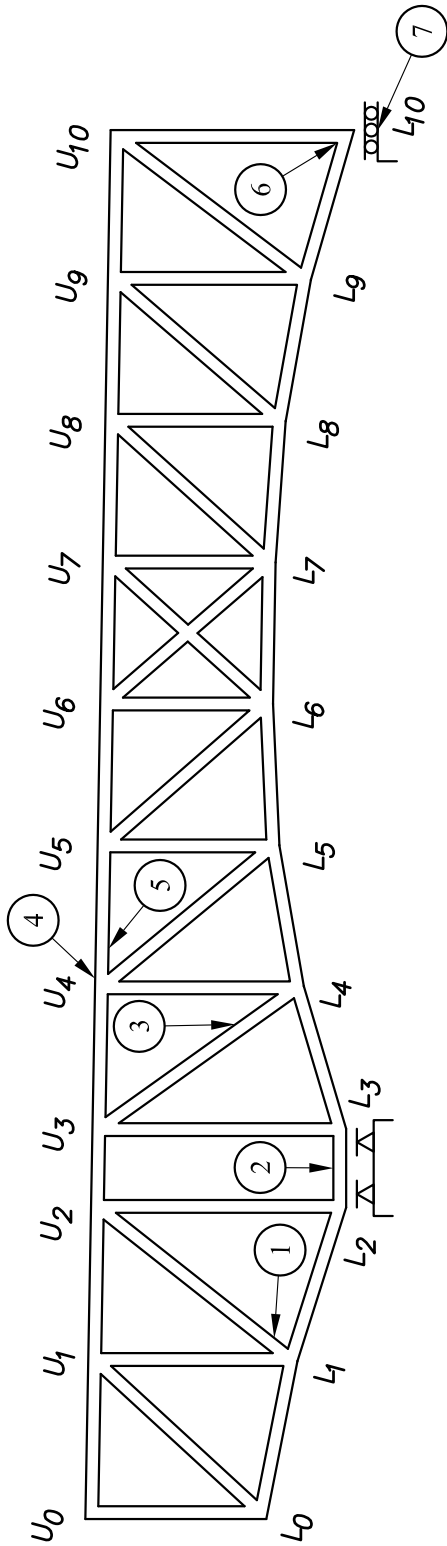
No.	Findings
1	1/4" x 3" wide section loss to the outstanding legs of all four angles.
2	Bottom stay plate has two holes. Top plate replaced in 2000 rehab instead of bottom stay plate.
3	3/16" to 1/4" Ø section loss to outstanding leg of top angle at lacing.
4	Leaking utility drain causing corrosion to upper chord and floorbeam connection plate.
5	Steel frame welded to fracture critical gusset plate.
6	South gusset plate pitted with up to 5/16" section loss around rivets on interior face.
7	Debris lodged behind the east side of roller. Rollers are 1/2" contracted.

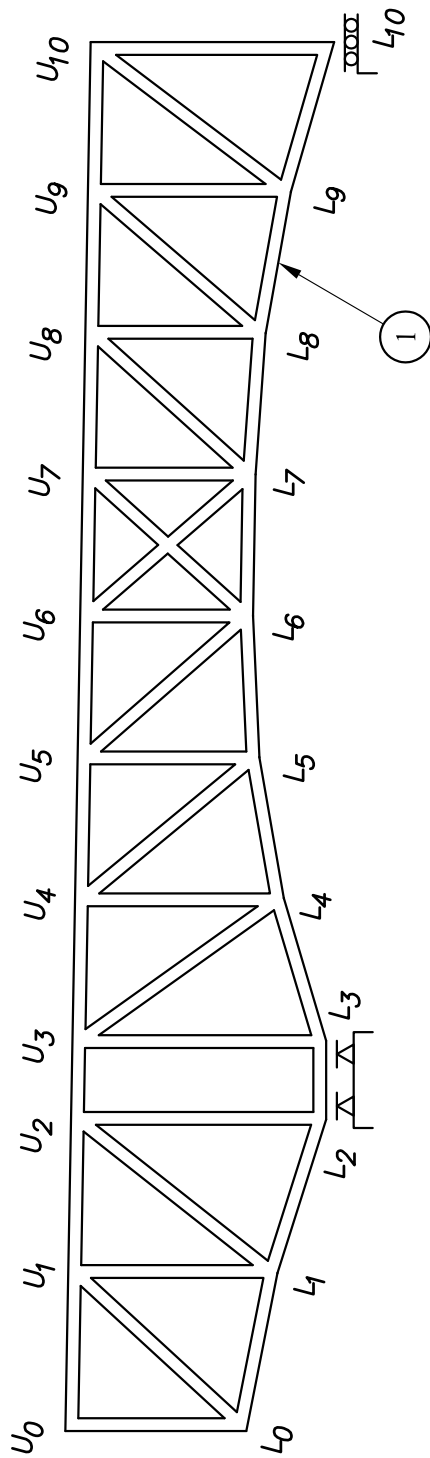
No.	Findings
1	Active corrosion to top surfaces caused by water infiltrating through utility shed above maintenance deck.

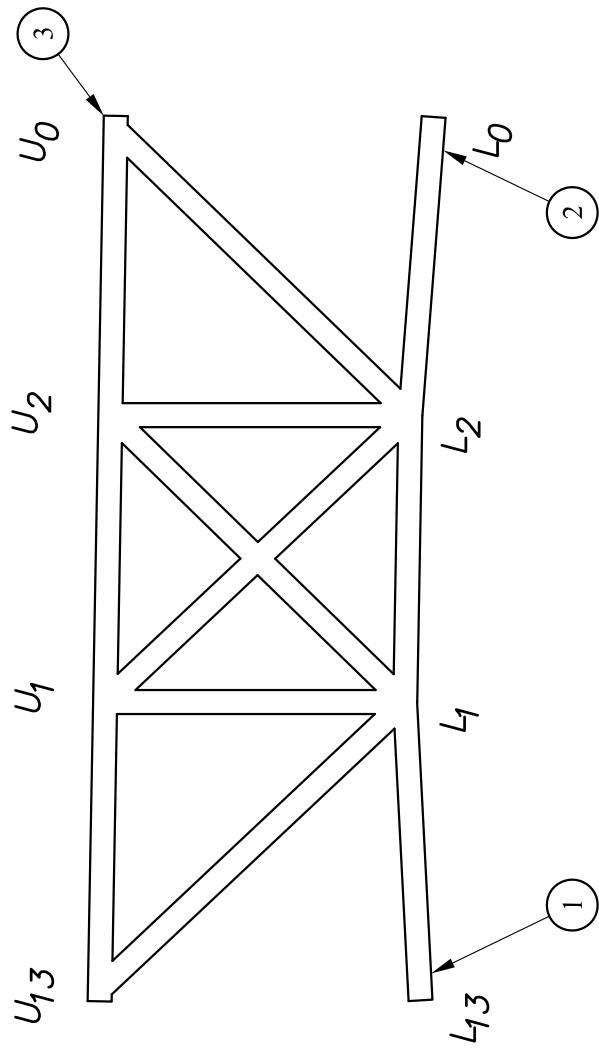
No.	Findings
1	$5/8$ " movement in fixed hinge.
2	Hinge appears frozen.
3	$1/16$ " section loss to top flange of floorbeam near joint.

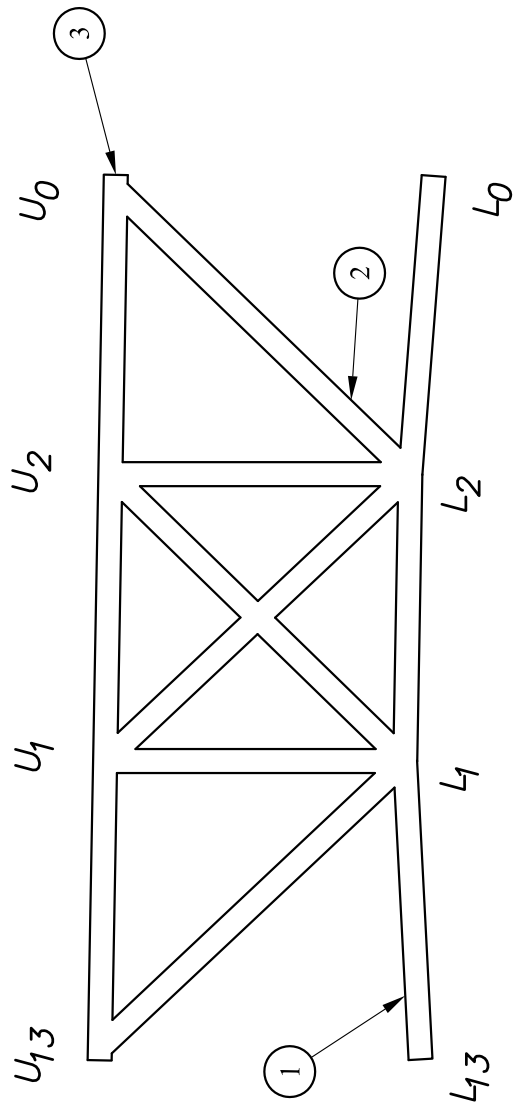
No.	Findings
1	Hole in exterior face web plate, first lacing channel, and flange plate. Member has large amount of pack rust between sliding surfaces. Hinge likely frozen.
2	3/4" pack rust along a 3' section of the north web plate.
3	Active corrosion and minor pitting throughout Joint U0.

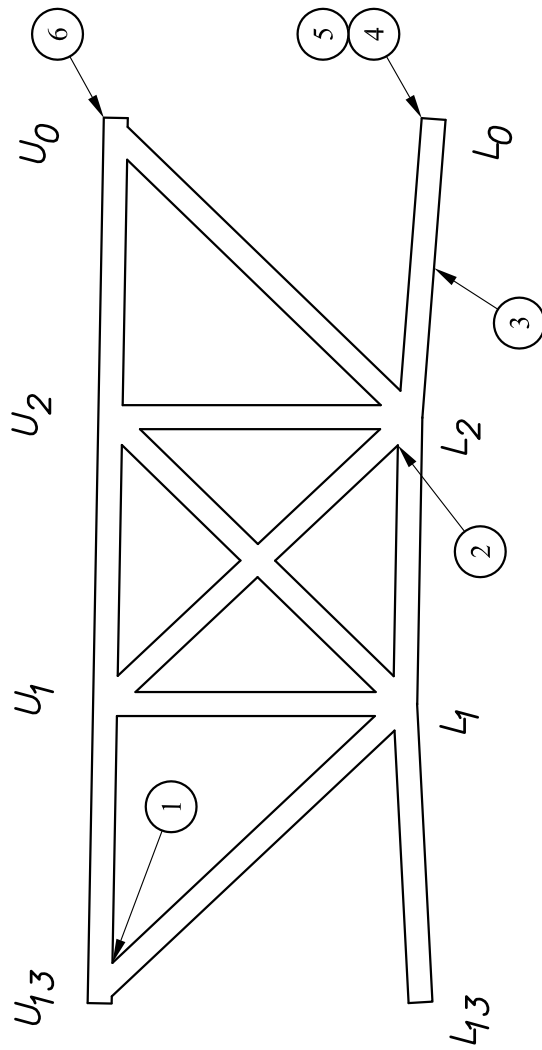
No.	Findings
1	Active corrosion at upper chord.
2	1/4" x 4" high section loss to the north gusset plate above the lower chord.
3	1 - 1 1/2" wide/high hole to both legs of the bottom north angle.
4	1/8" gap between pin and top expansion slot. Bottom horizontal rivets are mostly corroded.
5	3/8" movement at fixed pin hinge.
6	Heavy corrosion to top flange of Floor Beam 0. Deck delamination at corner of Stringer 11.

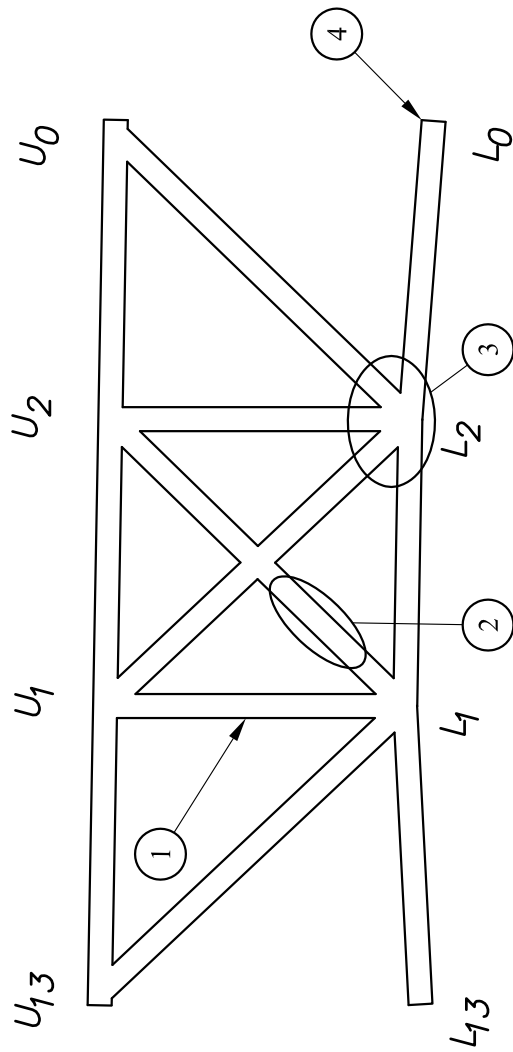
No.	Findings
1	Pack rust on vertical northwest corner angle.
2	Local paint failure.
3	Minor pack rust between truss members and gusset plates. Local paint failure.
4	Free movement in hinge.

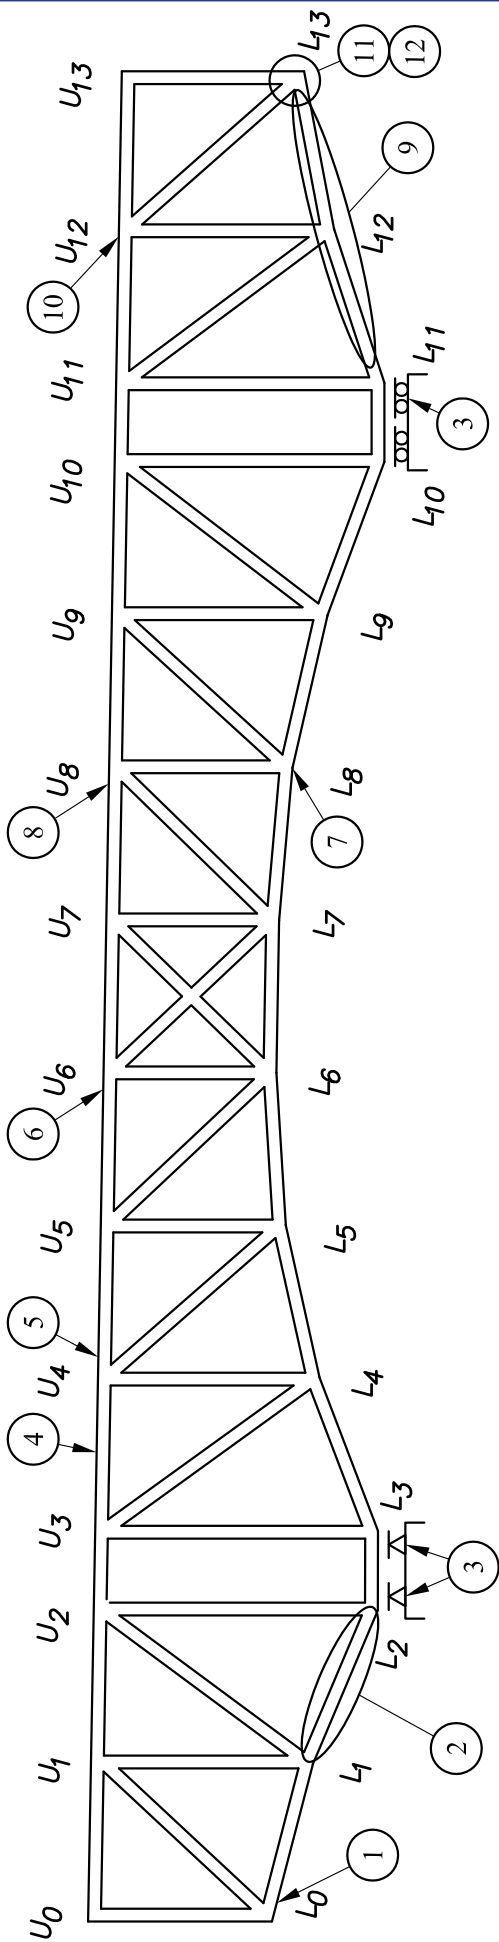
No.	Findings
1	0.10" section loss to both gusset plates at lower chord.
2	Local paint failure.
3	Bearing drain holes clogged by steel shot?
4	Welded rods from Stringer 1 to top north angle present.
5	Water from junction box drain causing active corrosion.
6	Stringer 2 has web hole 3" Ø near the bottom at Panel Point 6.
7	Advanced section loss to lower lateral bracing gusset plate present.
8	Old pitting and new rust on top horizontal plate.
9	Active corrosion along flange angles.
10	Leaking drain causing active corrosion to upper chord.
11	1/6" to 1/8" deep section loss to both gusset plates along U12 and L13.
12	Local paint failure.

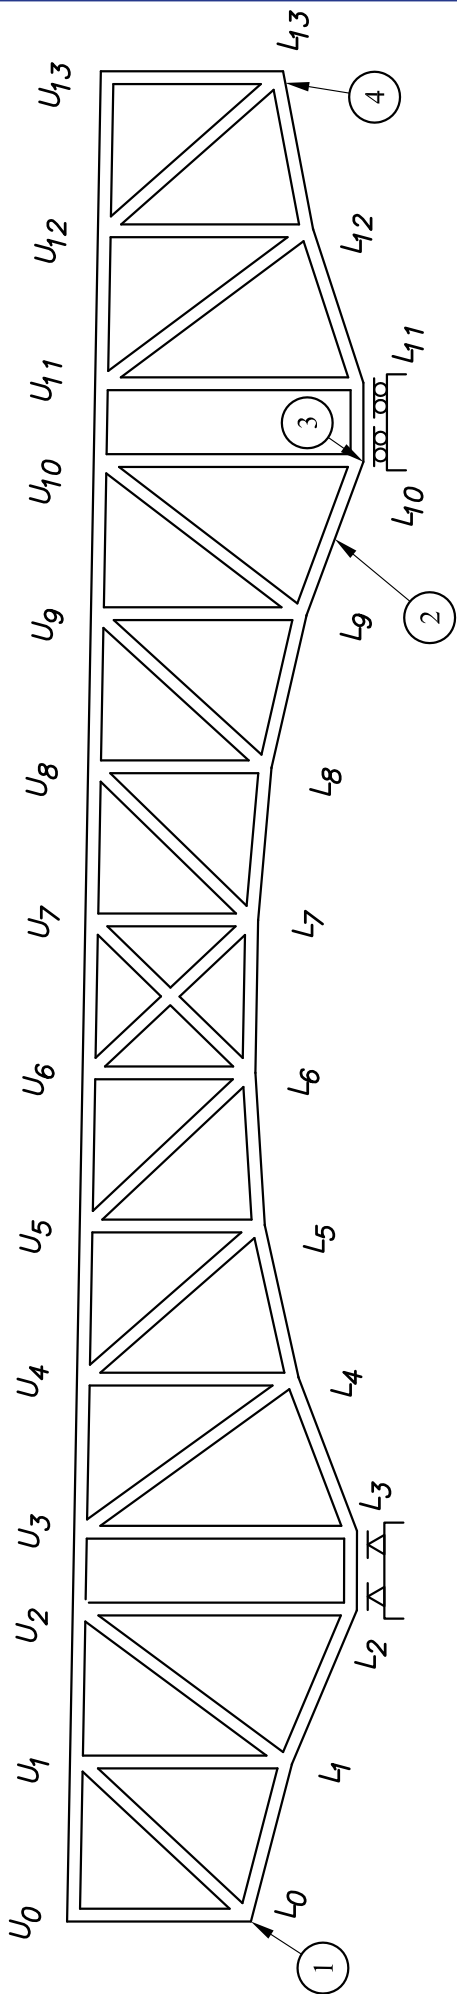
No.	Findings
1	Advanced paint failure and section loss on plates at expansion joint.
2	Pack rust causing interior web plate to bulge out by up to 1/2" along a 1' long section.
3	Web plates at L ₁₀ bulging due to pack rust. Exterior web plate has 1" Ø perforation.
4	Active corrosion present at L ₁₃ .

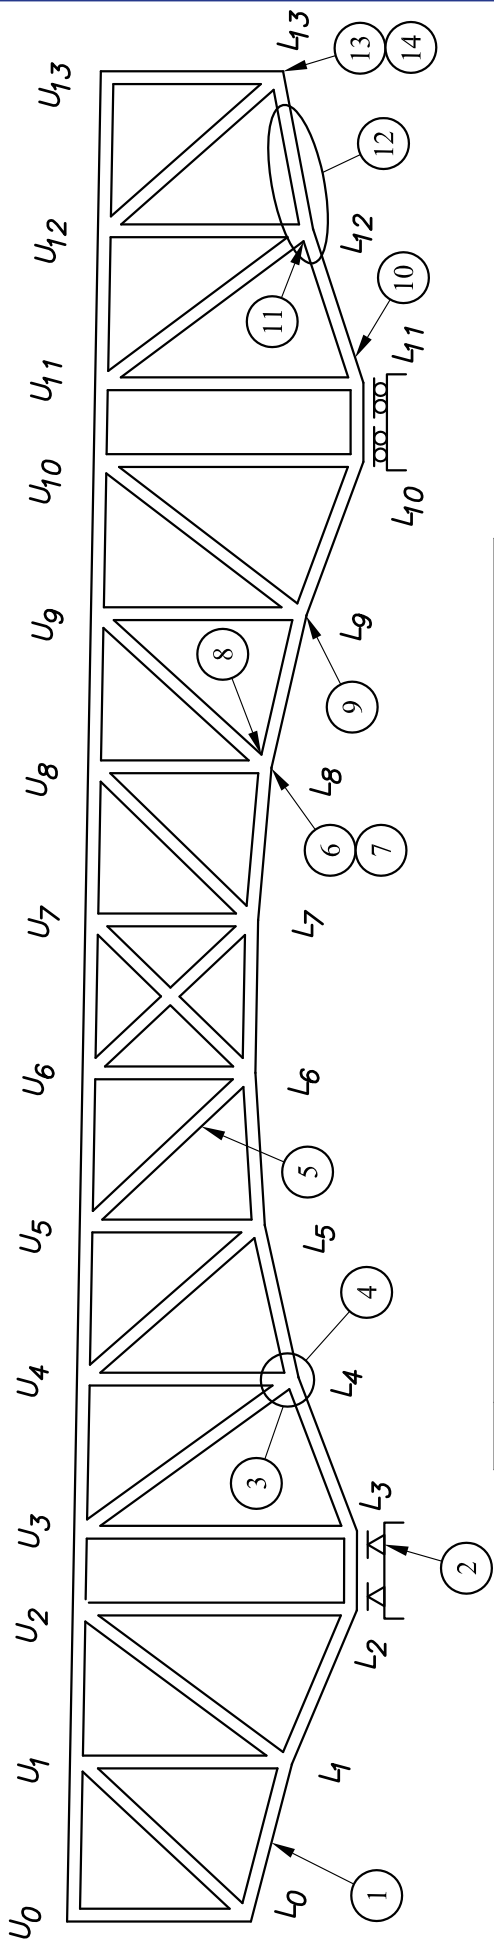
No.	Findings
1	Hole to vertical leg of bottom north angle with $\frac{3}{4}$ " pack rust.
2	1" to 1 $\frac{1}{2}$ " steel shot in bearing.
3	$\frac{3}{16}$ " to $\frac{1}{4}$ " section loss above angle channel to west gusset plate.
4	Rust flakes painted.
5	Two holes (1 $\frac{1}{16}$ " \emptyset) to south web plate.
6	Two holes (1 $\frac{1}{16}$ " \emptyset) to south web plate.
7	Section loss to top of both web plates.
8	$\frac{3}{16}$ " x 3" high section loss and painted over rust flakes at the north gusset plate.
9	$\frac{3}{8}$ " aggregate section loss ($\frac{1}{16}$ " int., $\frac{1}{16}$ " ext.) to the north gusset plate above lower chord.
10	$\frac{1}{8}$ " x 4" high section loss to interior of south web plate.
11	Top and bottom lower lateral gusset plates have painted over rust and paint failure.
12	Poor paint throughout.
13	Outstanding leg of the top north angle is completely corroded through top lateral gusset plate and stay plate.

14	$\frac{1}{2}$ " \emptyset hole to outstanding leg, bottom south angle.

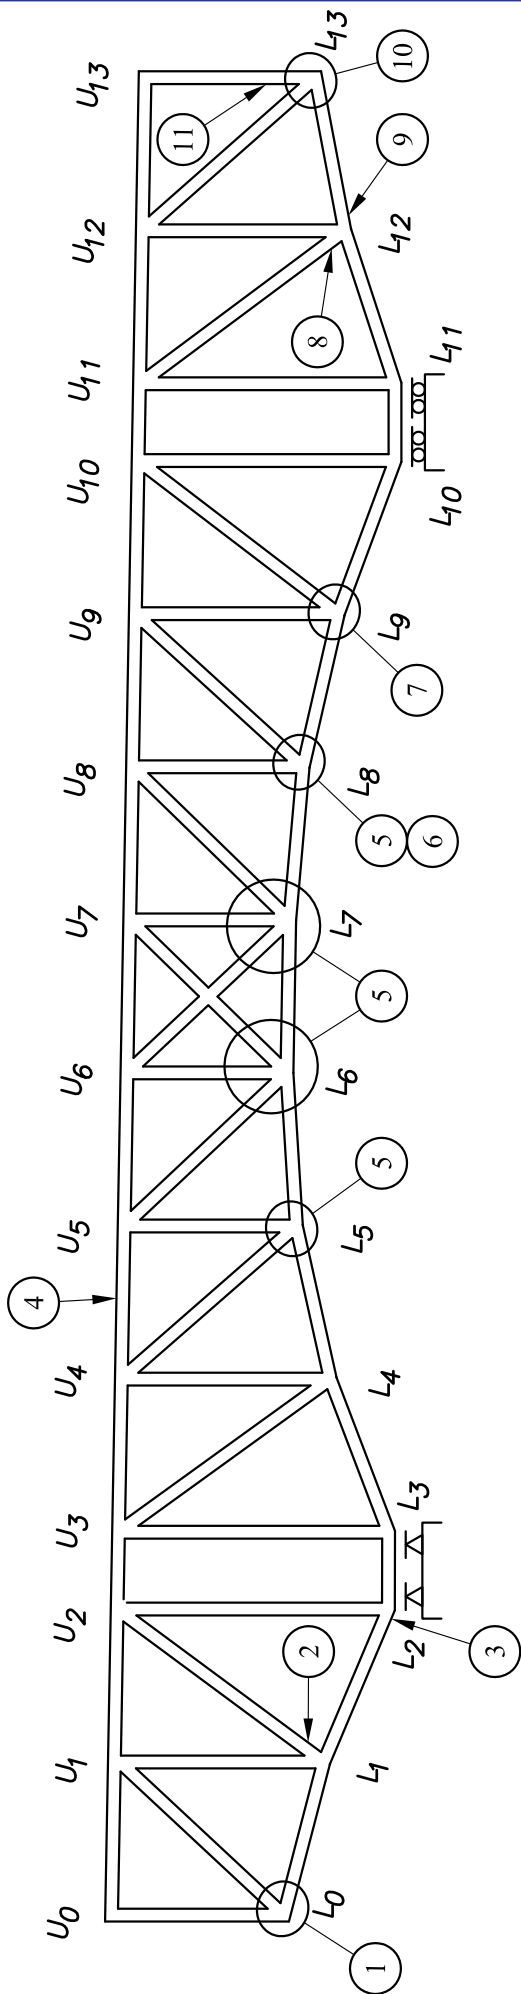
No.	Findings
1	Pack rust at north top angle near pin. Flange is rotated out and down about $\frac{1}{8}$ ". Inside plates at pin are bowed inwards. Tops of gusset plates have slight bowing ($\frac{3}{16}$ ") due to pack rust.
2	Pack rust between L_1U_2 bottom angle and gusset plate.
3	Pack rust along north bottom angle.
4	Minor section loss to top flange of Stringer 8 due to leakage from deck.
5	Local paint failure.
6	Pack rust between floor beam and connection angles.
7	Local paint failure at floor beam.
8	$\frac{1}{4}$ " pack rust on outside diagonal web and gusset. Section loss on inside of north gusset plate.
9	Pack rust at bottom of interior gusset plate. Gusset plate bowed in $\frac{1}{8}$ " to $\frac{1}{4}$ " along edge.
10	Section loss on inside of north and south gusset plates. Pack rust on outside face of north gusset plate. Pack rust on both sides between gussets and vertical above pins.

11	Maintenance deck channel has section loss and support channel has pack rust (1 " angle thickness).

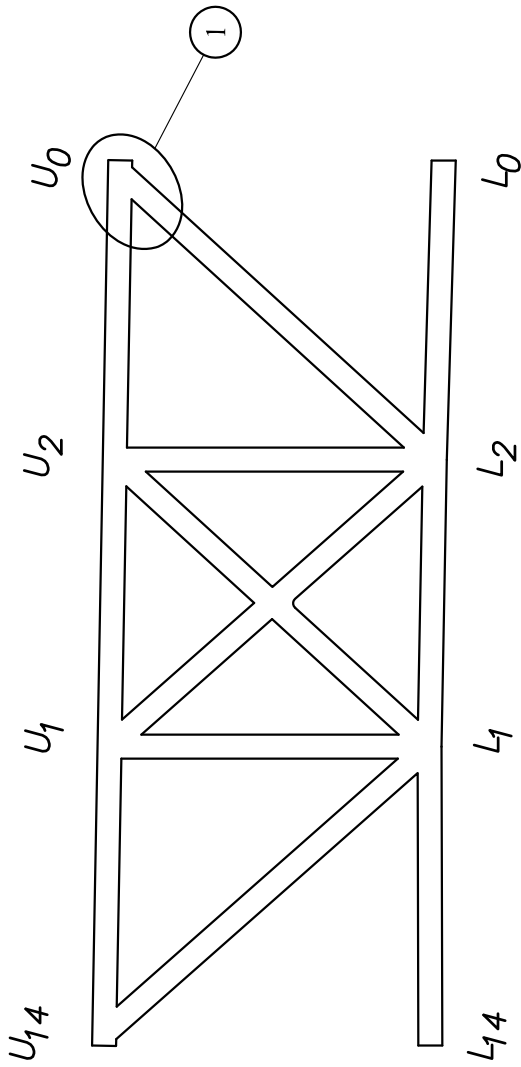
No.	Findings
1	Active corrosion and paint failure.

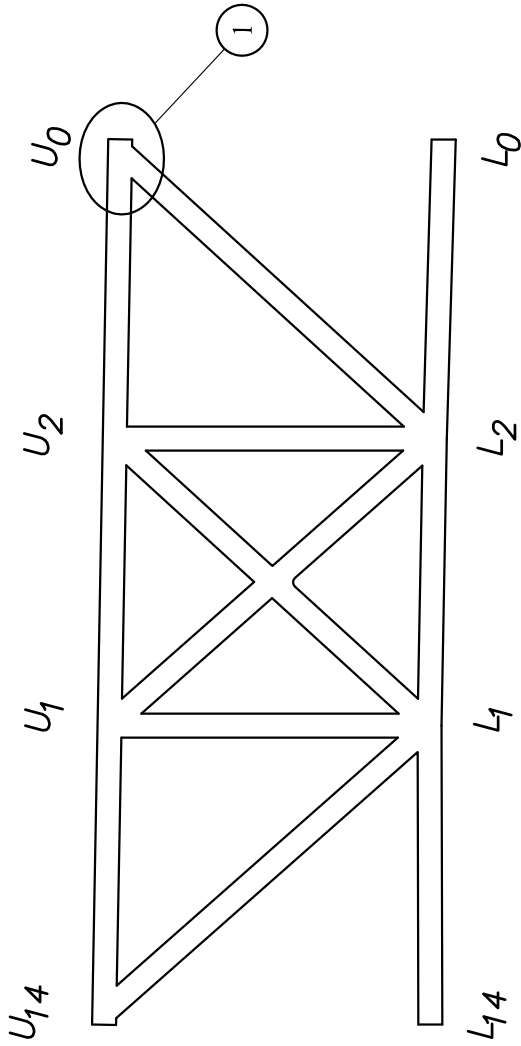
No.	Findings
1	Moderate active corrosion and paint failure.

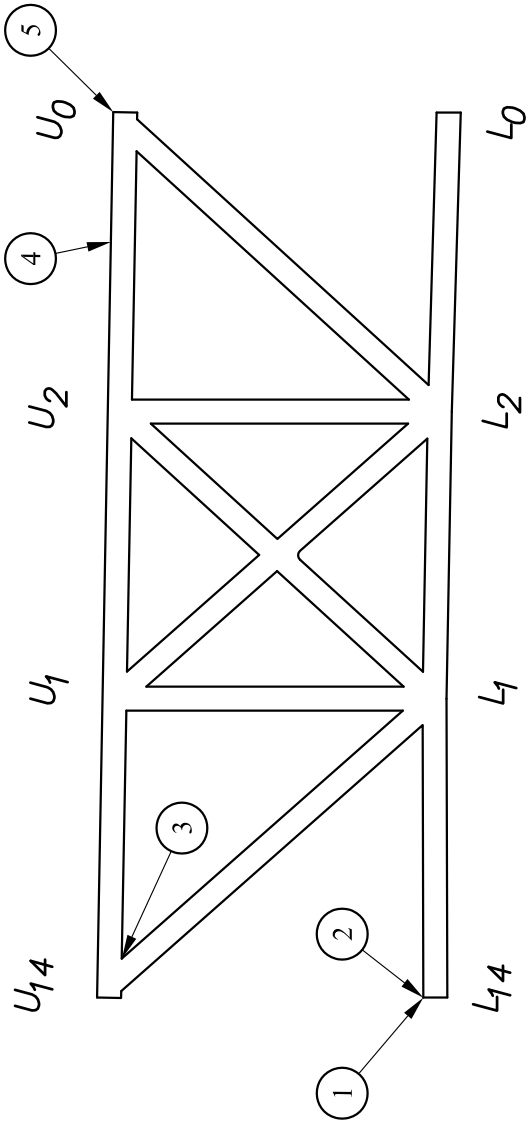
No.	Findings
1	1/4" section loss at a 4" long x 2" wide area on the north interior plate. 1/4" pack rust present.
2	Hinge is frozen tight.
3	Debris in connection. Rust stains to top flange, floor beam, and stay plates.
4	Subdrain closest to Floor Beam 0 is leaking.
5	Corrugation to top flange and bracket of Floor Beam 0.

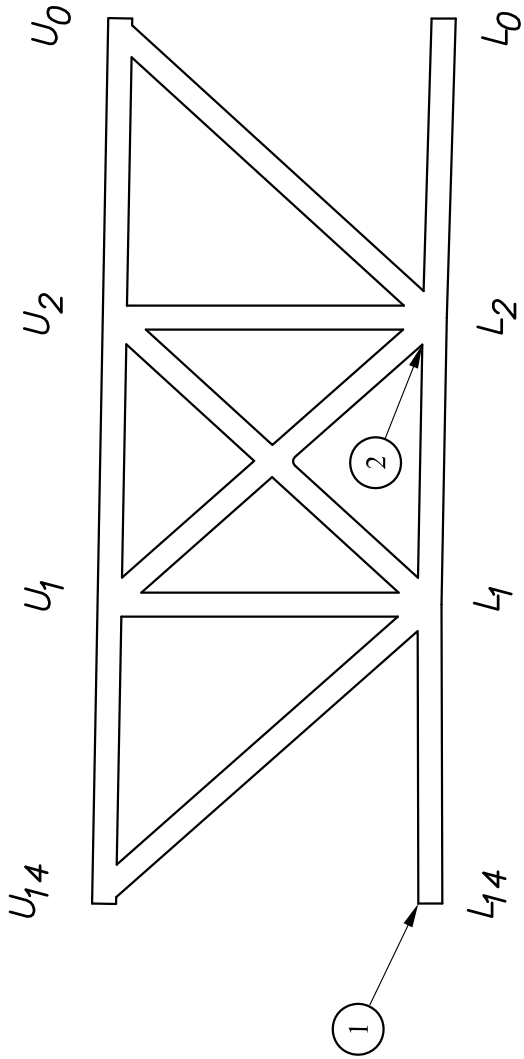
No.	Findings
1	Pack rust present between both gussets and member L ₁ L ₁ exterior chord webs.
2	Pack rust along entire length of inside top plate.

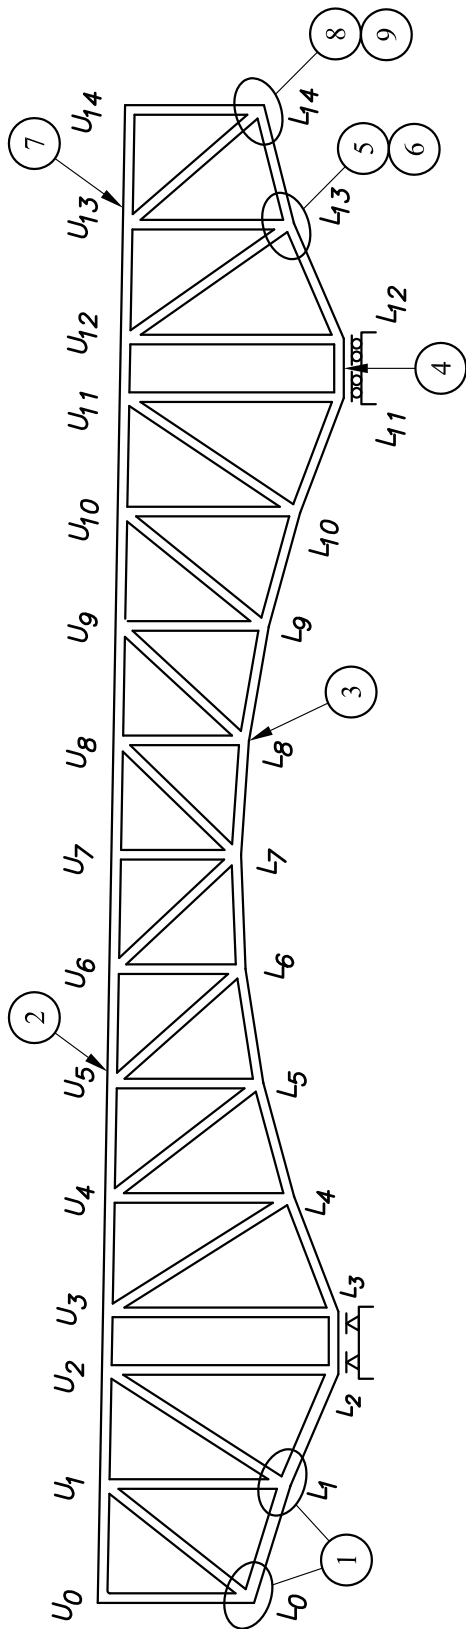
No.	Findings
1	Local paint failure present.
2	Top tie plate is rusted all the way through. Rust staining on top chord web and bottom plate.
3	Steel shot painted over on top exterior angle of the bottom chord.
4	Advanced pack rust between pin plate and interior web plate. Dirt and debris also present.
5	Pack rust between north web plate and gusset plate at U ₁₃ .
6	Local paint failure.
7	Subdrain above U ₁₃ causing surface corrosion on surrounding members. Several holes (4"Ø max) in both upper and lower ties plates at joint.
8	Lower portion of connection has new pack rust between web plates and gusset plates. Top of pin at ends has new section loss.
9	Local paint failure and surface corrosion around joint.

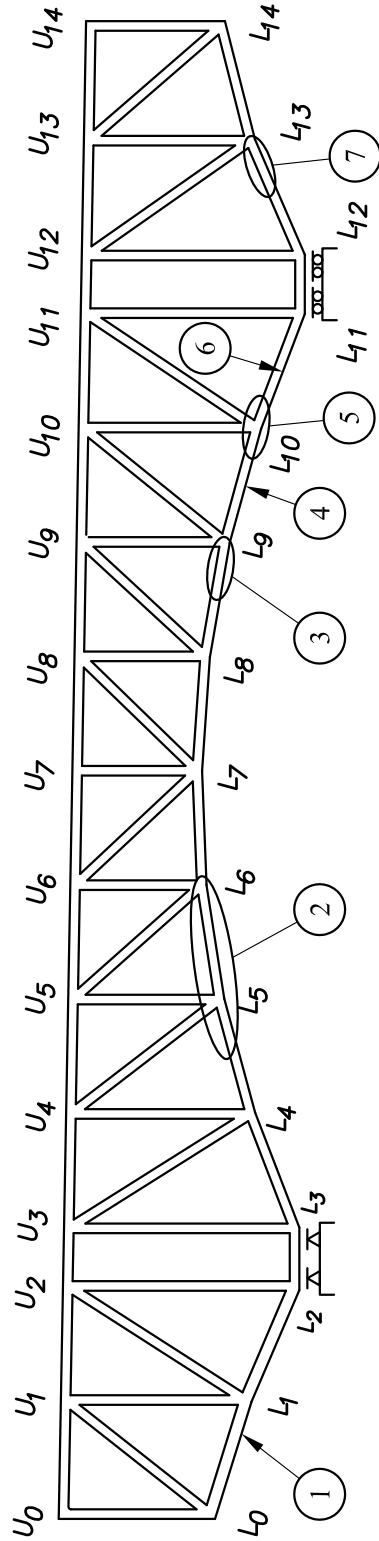
No.	Findings
1	Up to 1 1/4" pack rust along 10' at north web plate and lower angle.
2	Pack rust between north angle and web plate along L ₅ L ₆ (6' section on L ₄ L ₅).
3	1 3/4" pack rust along top of bottom exterior angle.
4	1" pack rust along top of bottom exterior angle.
5	Local paint failure present.
6	3/4" pack rust along top of bottom exterior angle.
7	3/4" pack rust along top of bottom angles.

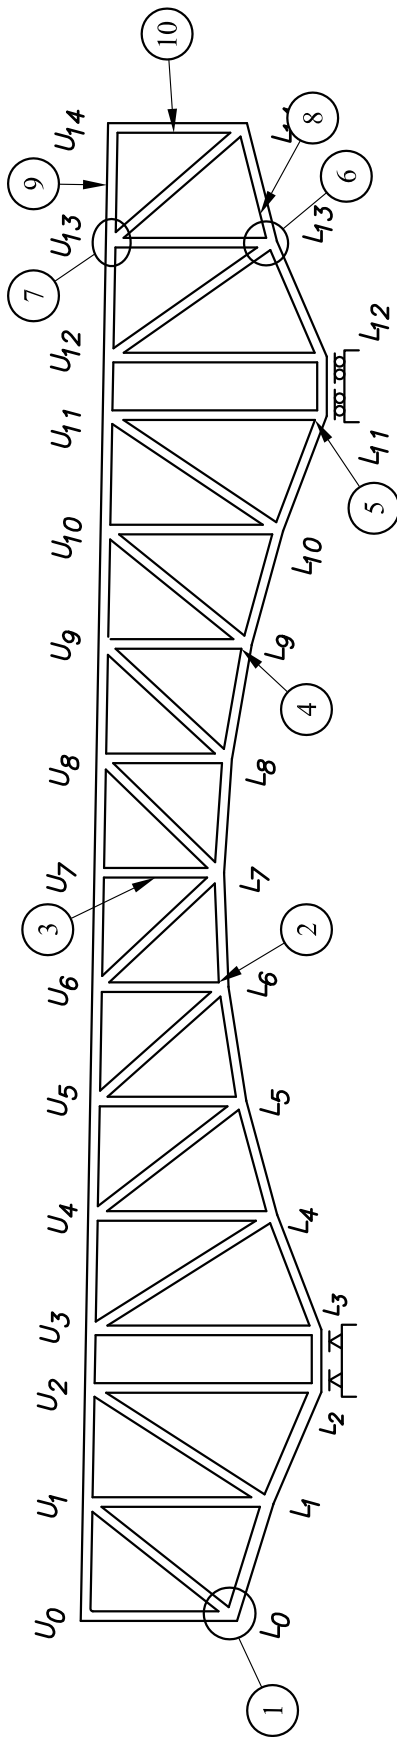
No.	Findings
1	$\frac{1}{8}$ " deep corrosion to both pin and pin plate. Bottom longitudinal pin plate bent downward.
2	$\frac{3}{16}$ " x $1\frac{3}{4}$ " high section loss to the north gusset plate above the top lower lateral gusset plate.
3	$\frac{5}{8}$ " pack rust and section loss to web plate.
4	$\frac{1}{8}$ " section loss along the outside of L ₉ U ₁₀ rivets on the gusset plate with some corrosion to pin holes.
5	West half of Gusset Plates: General pitting ($\frac{1}{8}$ " at most) of interior surfaces of south plate. North plate has a $\frac{1}{8}$ " section loss on 50% of surface.
6	$\frac{3}{16}$ " section loss to both sides of web plate at L ₁₃ - $\frac{3}{16}$ " section loss to north gusset plate by L ₁₂ -L ₁₃ connection. Active corrosion, failing paint, and rust flakes are still present.
7	Efflorescence leaking through floor.
8	Paint failure and rust flakes to top stay plate.
9	Deck is leaking efflorescence.

10	$\frac{1}{6}$ " aggregate section loss to both sides of web plate.

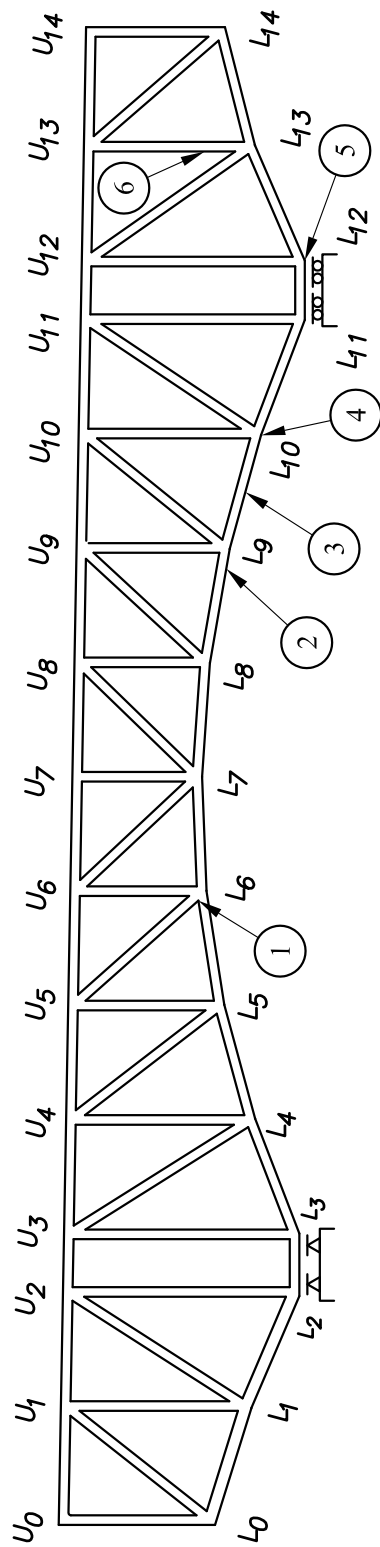
No.	Findings
1	$\frac{1}{8}$ " to $\frac{3}{16}$ " section loss at south gusset plate along and at end of diagonal U ₅ L ₆ .
2	$\frac{1}{2}$ " pack rust at top of bottom south flange angle.
3	$\frac{3}{4}$ " pack rust at top of bottom north flange angle.
4	Active pack rust between north gusset plate and lower chord. East inside gusset plate is bowed out approximately 1" at top corner.
5	Outside gusset plates are bowed out at the bottom.
6	Crack in maintenance floor beam west connection angle to truss vertical.

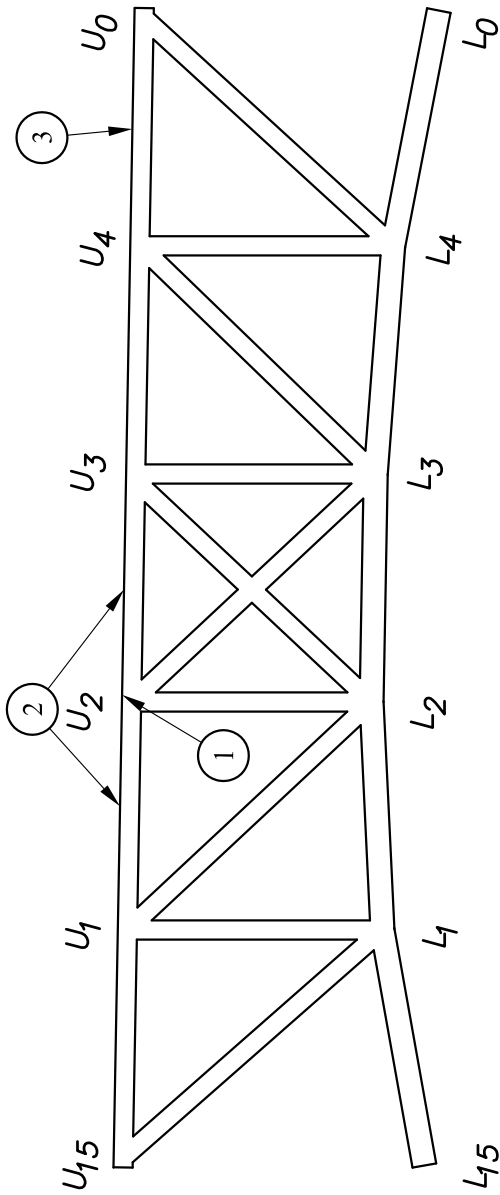
No.	Findings
1	Water from junction job drain above U ₂ is causing surface corrosion to top floor beam and upper chord lacing.
2	Pigeon nests present inside upper chord.
3	Stringer 2 at Panel Point 0 has section loss and hole at bottom of web at web angle connection.

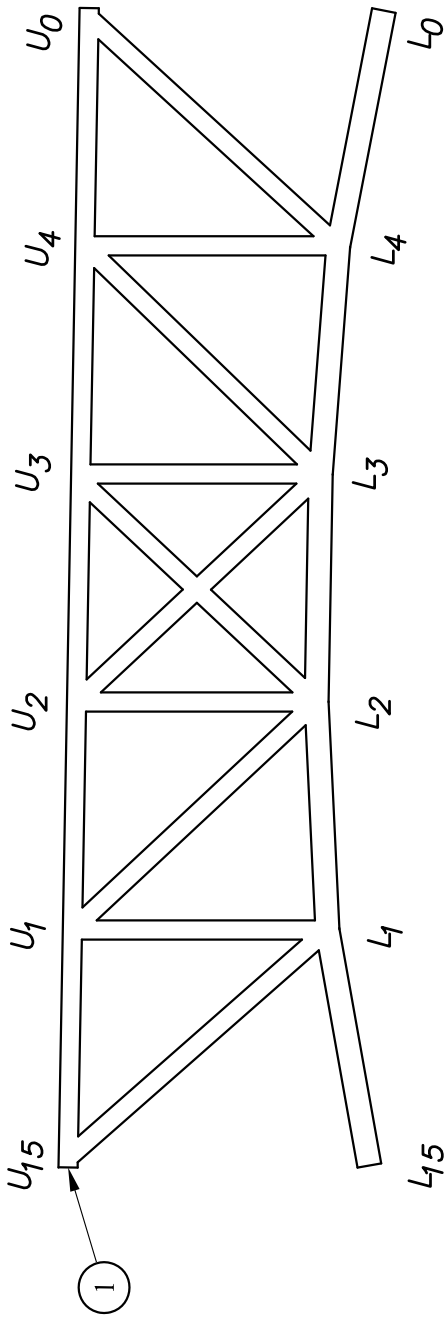
No.	Findings
1	Maintenance deck floor beam crack present $6 \frac{3}{16}$ " long.

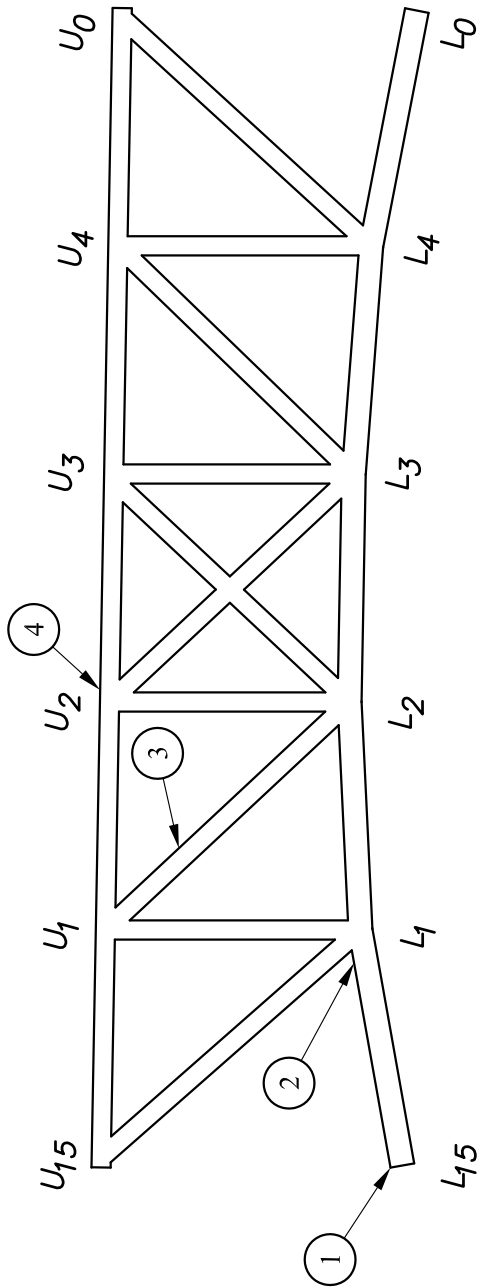
No.	Findings
1	Debris inside L ₁₅ .
2	1 1/4" pack rust along north web plate.
3	1/2" pack rust pushing out web plate by 3/8" on all sides of the member.
4	Leaking utility drain causing corrosion to surrounding members.

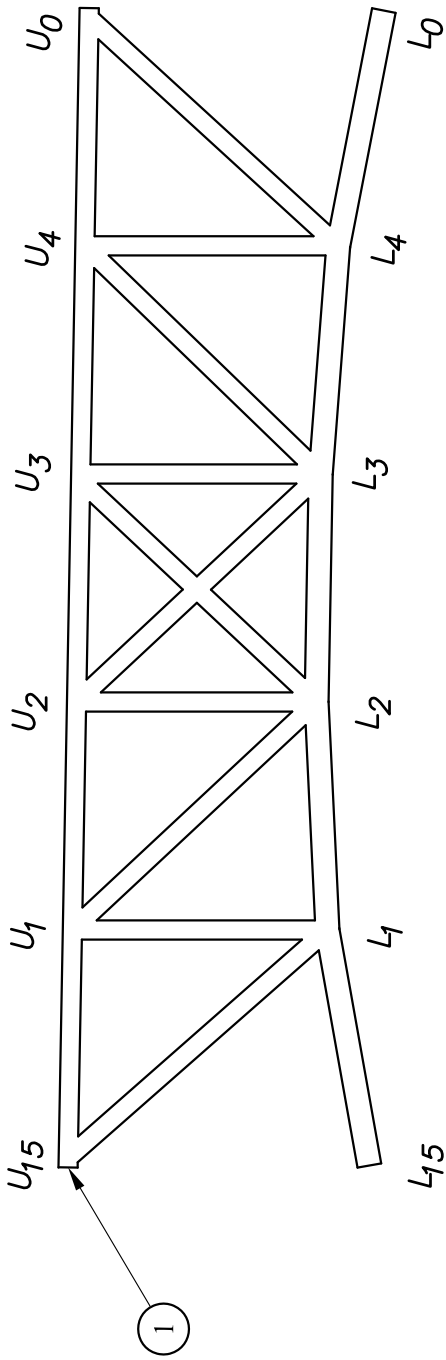
No.	Findings
1	Water leaking through torn joint gland.

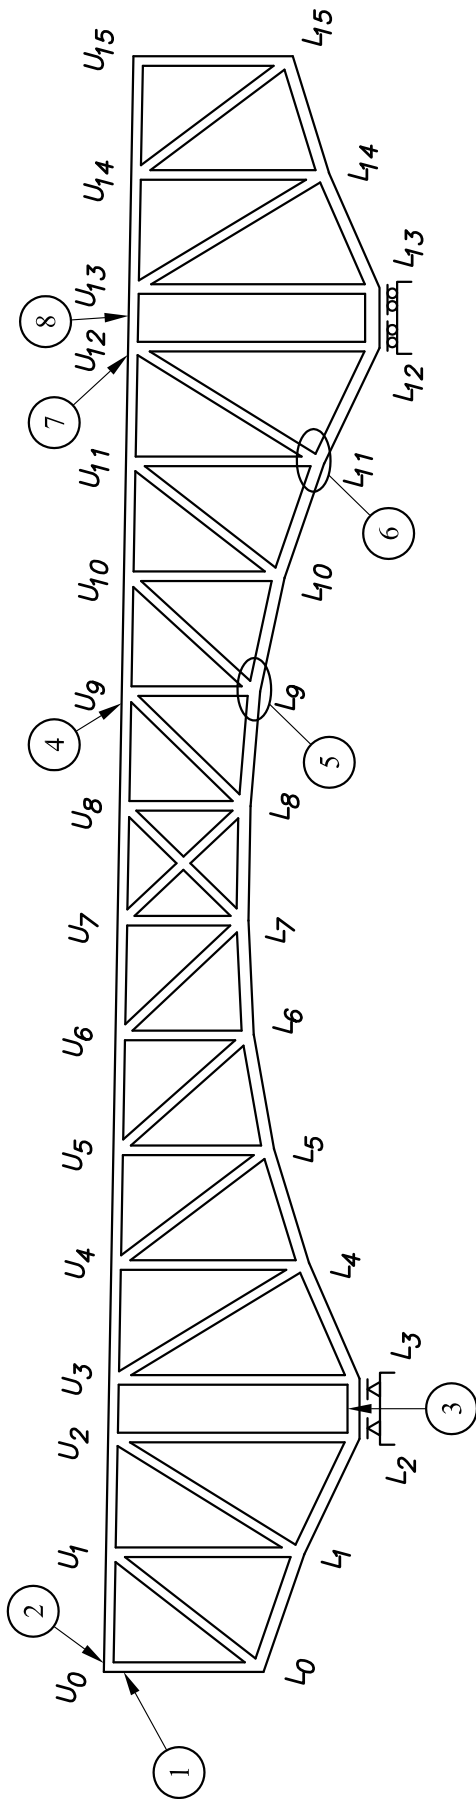
No.	Findings
1	Advanced pack rust expanding gusset plates of L ₀ U ₀ .
2	Floor Beam 0 near the north exterior truss has surface corrosion.
3	2' long section of advanced pack rust (2" wide) between web plate and bottom angle.
4	Water from junction box drain causing surface corrosion to the top of floor beam and horizontal knee brace gusset plate.
5	L ₉ has local paint failure and surface corrosion on top of top plate at lower lateral bracing gusset plate.
6	Local paint failure present.
7	Heavy pitting all around U ₁₂ .
8	Interior face of north pilaster cracked.

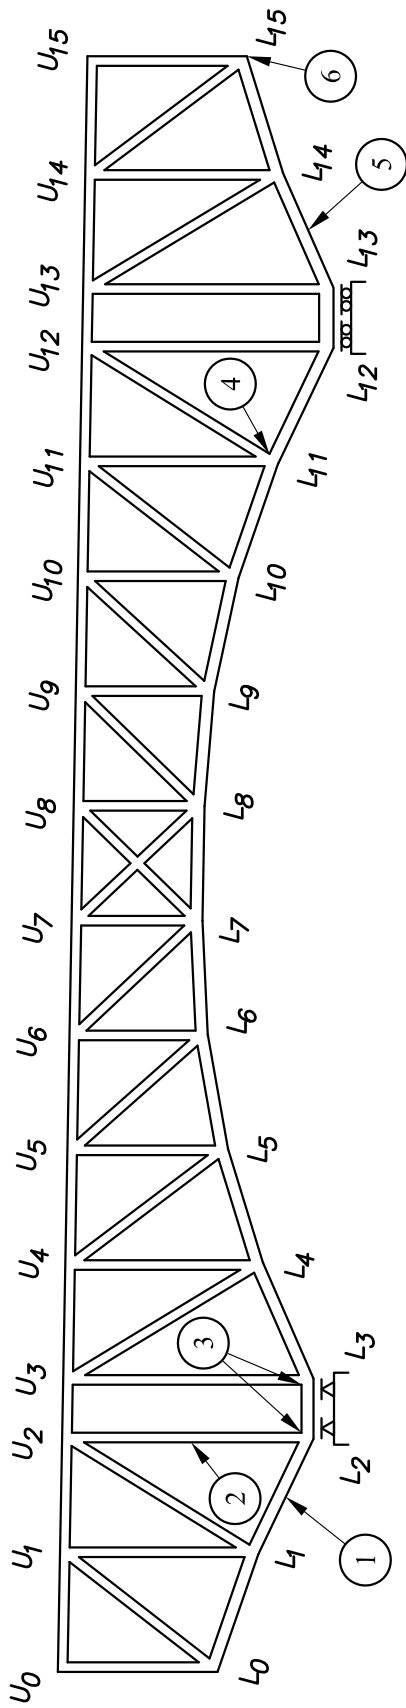
No.	Findings
1	Pack rust at top and bottom angles and north and south web plates.
2	Pack rust at angles and north and south web plates.
3	Pack rust at north and south gusset plates at both joints.
4	Pack rust at north gusset plate of diagonal connection.
5	Outstanding legs of top angles wavy due to built up pack rust causing separation between angles and web plates.
6	Pack rust and corrosion to north and south gusset plates and top angles above the pin at joint.

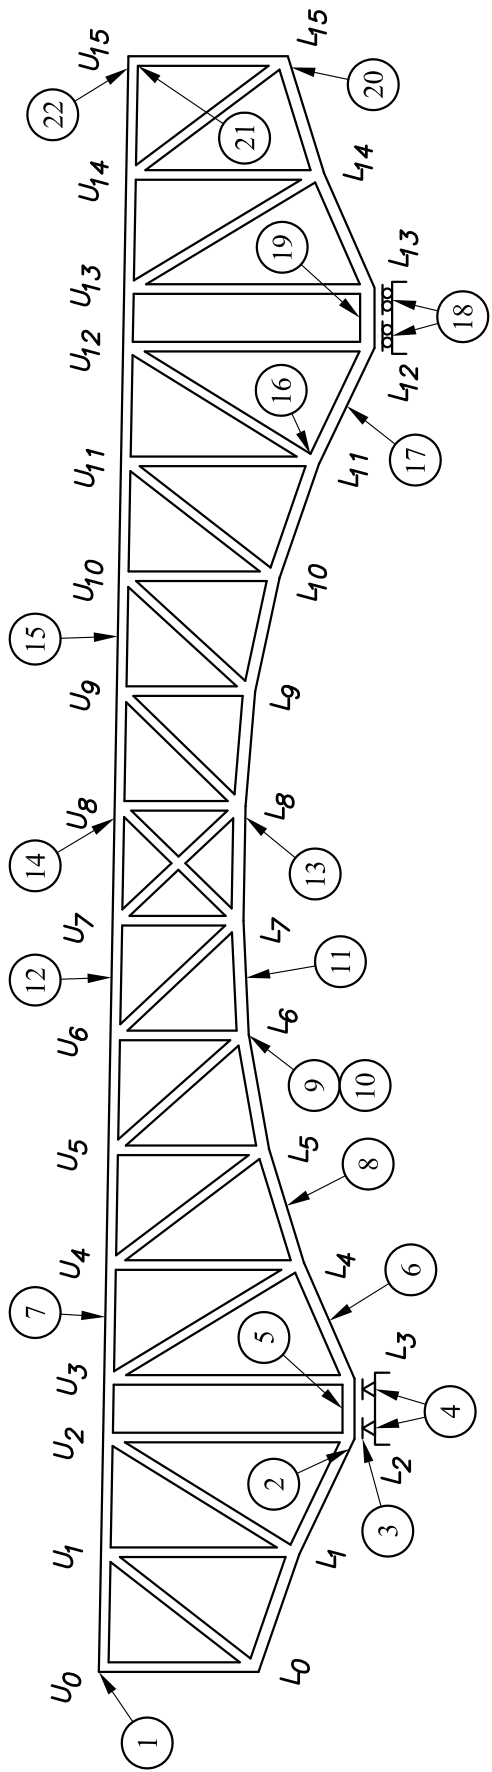
No.	Findings	No.	Findings
1	Active corrosion on the Floor Beam 0 top flange across 2 stringer bays.	12	Stringer 10: Active corrosion to top flange.
2	Holes found on the bracing of the gusset plate.	13	Pack rust at the south web gusset plate near L ₈ .
3	1/4" deep x 1/4" high pitting on the south gusset plate above the bearing casting.	14	Floor Beam 8: Corrosion to top flange present.
4	Drain holes clogged in bearing chamber.	15	Stringer 9 & 10: Rust stains and corrosion to top flange along entire length.
5	Active corrosion inside the box.	16	Gusset plates kinked inward due to pack rust.
6	1" of pack rust along the bottom north angle	17	1" pack rust along the vertical leg of the top north angle.
7	Stringer 11: 4" high hole at the web. 1/4" to 3/8" section loss along the entire bottom flange.	18	Debris collected at expansion bearing at L ₁₂ .
8	1 1/2" pack rust along the vertical leg of the bottom north angle.	19	Poor paint on south exterior web plate. Active pack rust on along the vertical leg of the bottom north angle.

9	5/16" section loss to the north gusset plate. The average depth over an area of 12"x6" is 1/4" at the east end.	20	Debris on top of lower lateral gusset plate at L ₁₅ .
10	1/4" to 1/8" section loss on both sides of the web plate at L ₆ .	21	3/4" to 1" pack rust along bottom of of gusset plates connection.
11	1 1/2" pack rust along the vertical leg of the bottom north angle. The web plate is 3/8" thick and bowed inward.	22	Debris inside bearing assembly. Leaking onto north side of bottom flange. Wind shear strut has flaked paint and light corrosion.

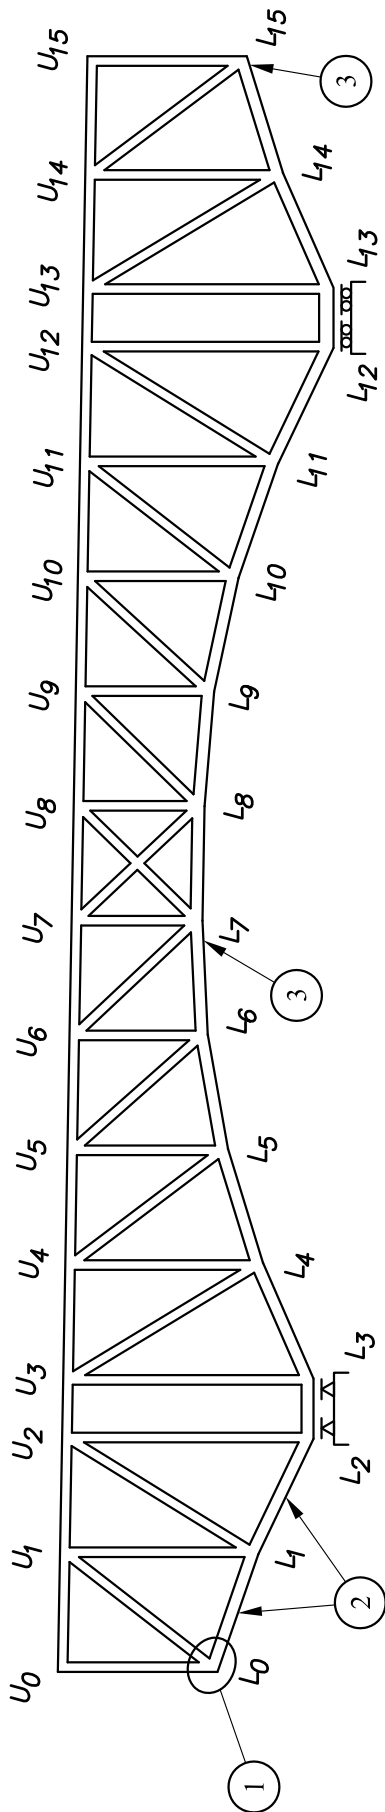
No.	Findings
1	Local paint failure with active corrosion.
2	Pack rust caulked with active corrosion between web plates and angles.
3	Split laminar tear in south gusset (11" x 16") at south plate. No growth present.
4	Pack rust with active corrosion and section loss (approximately 1/16") between inside of gusset plates and web plate of vertical and diagonal. Top gusset plate slightly bowed out.
