***2014 BRIDGE INSPECTION
FIELD REPORT***

Inventory Bridge Number: CUY 00010 16.130 N

SR 10 over CUY RIVER VALLEY & FI RR

**2014 SUPERSTRUCTURE
INSPECTION FINDINGS**

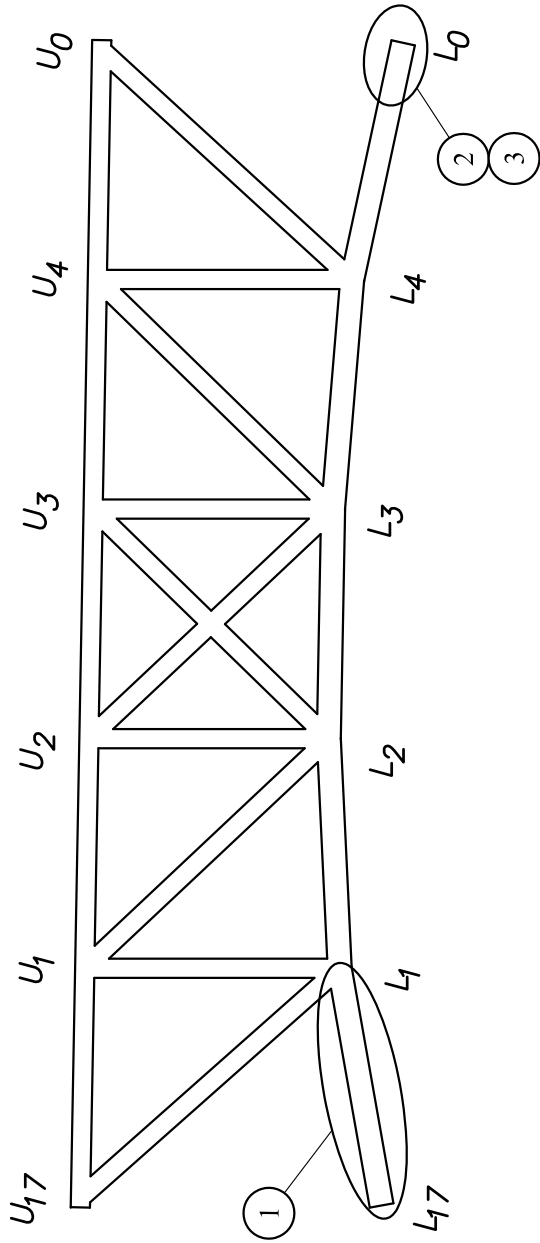
No.	Findings
1	Local paint failure.
2	Top horizontal diaphragm buckled above pin due to pack rust.
3	Local paint failure.

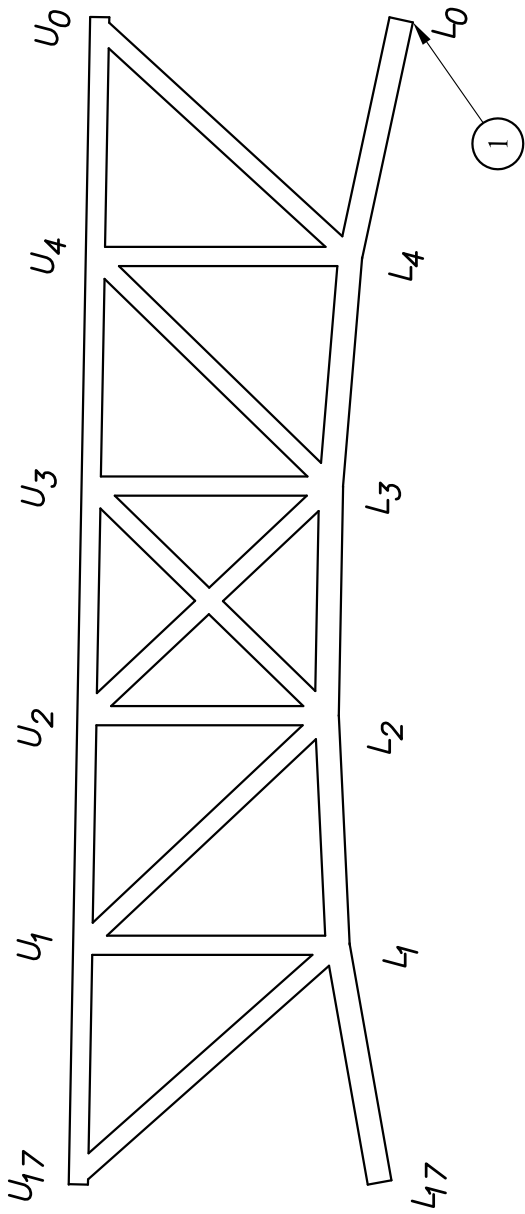
No.	Findings
1	North and south gusset plates have section loss at connection to L ₄ L ₀ .

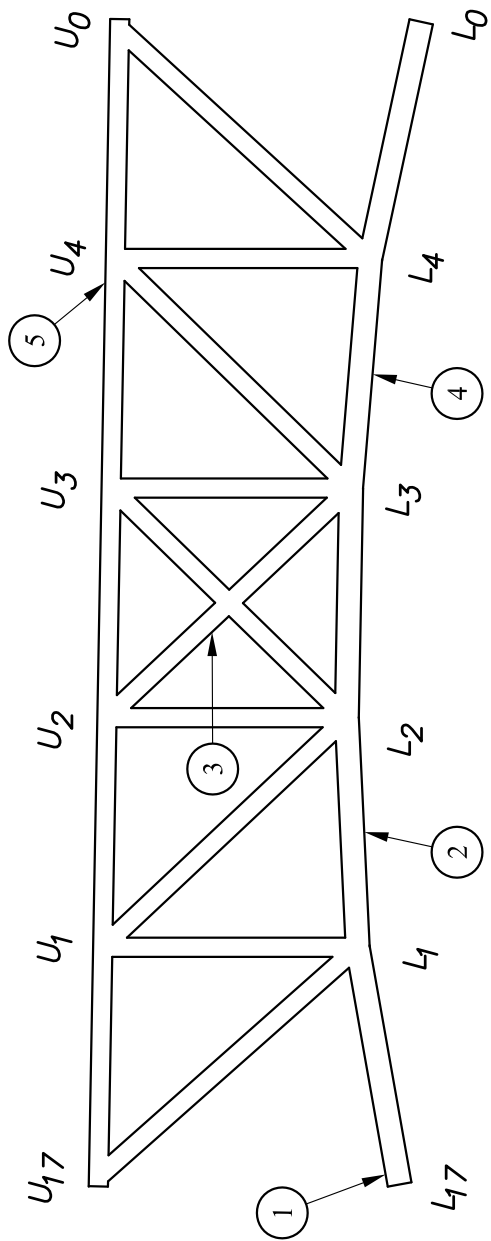
No.	Findings
1	Top plate buckled up $7/16$ " over a length of 5". L ₁₇ appears frozen.
2	$3/8$ " of pack rust along both sides of the top portion of the chord.
3	Pack rust found along the underside of the member
4	1" of pack rust along the vertical leg of the bottom north angle.
5	Pigeon manure found inside U ₄ enclosure.

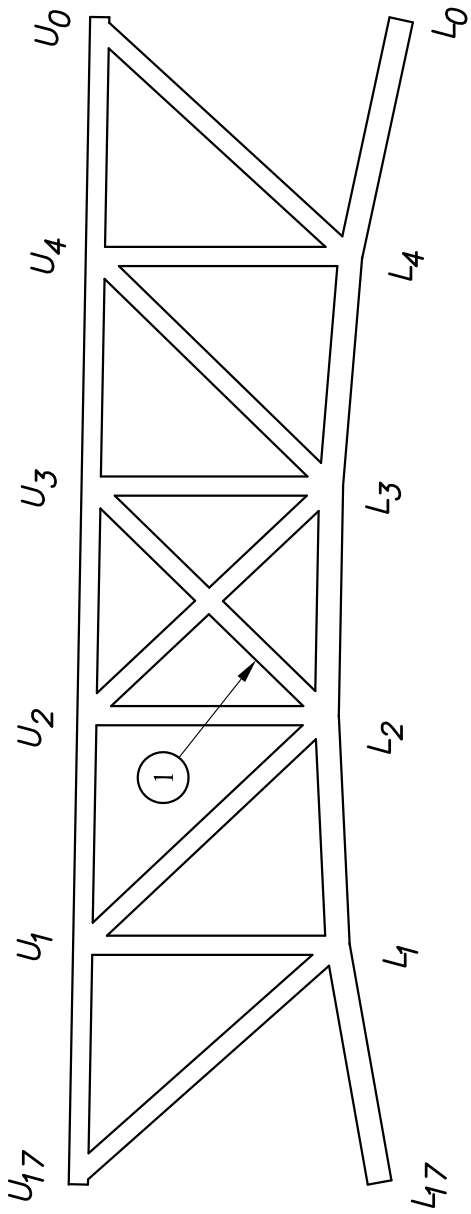
No.	Findings
1	Active pack rust along north web plate, active corrosion on top angles.

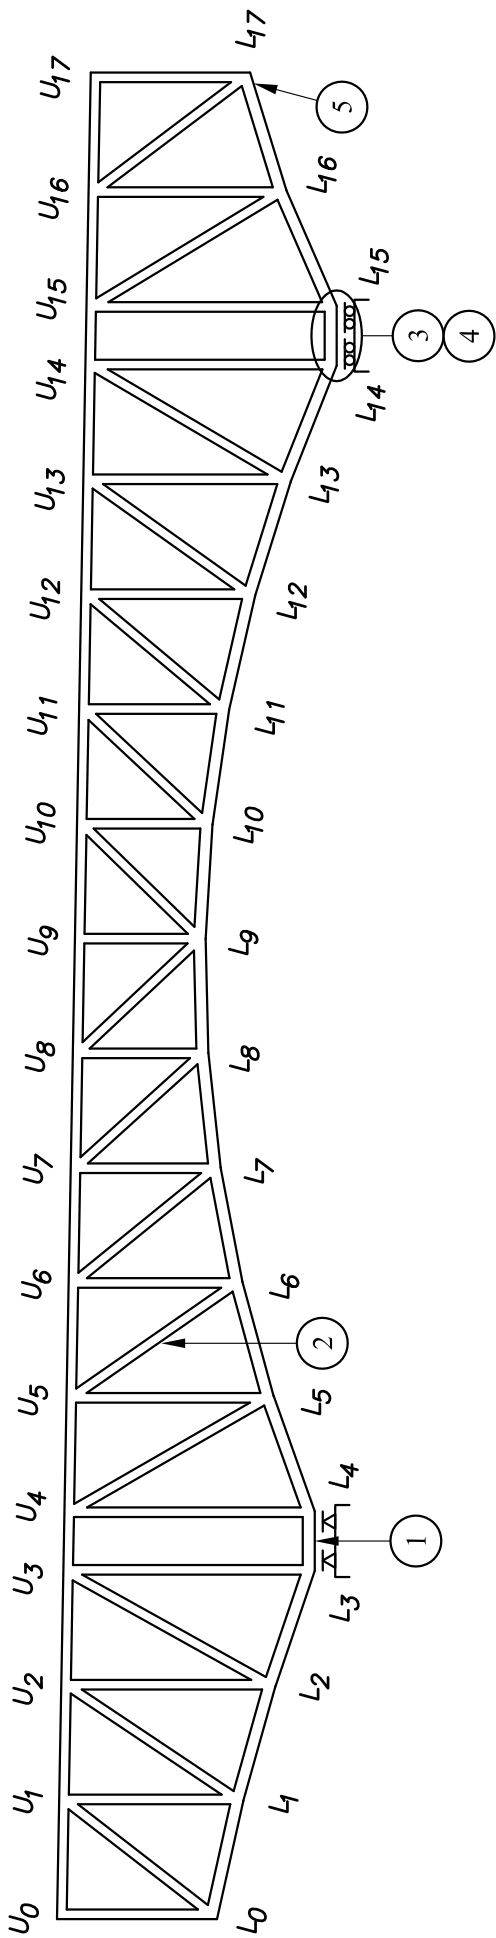
No.	Findings
1	1" pack rust between bottom angle and web plate.
2	Fin in web plate in material midway up U ₅ L ₆ on top interior angle.
3	Water in both pots of L ₁₄ . Bearing L ₁₅ is dry.
4	Local paint failure present.
5	Section loss on both pins of L ₁₇ .

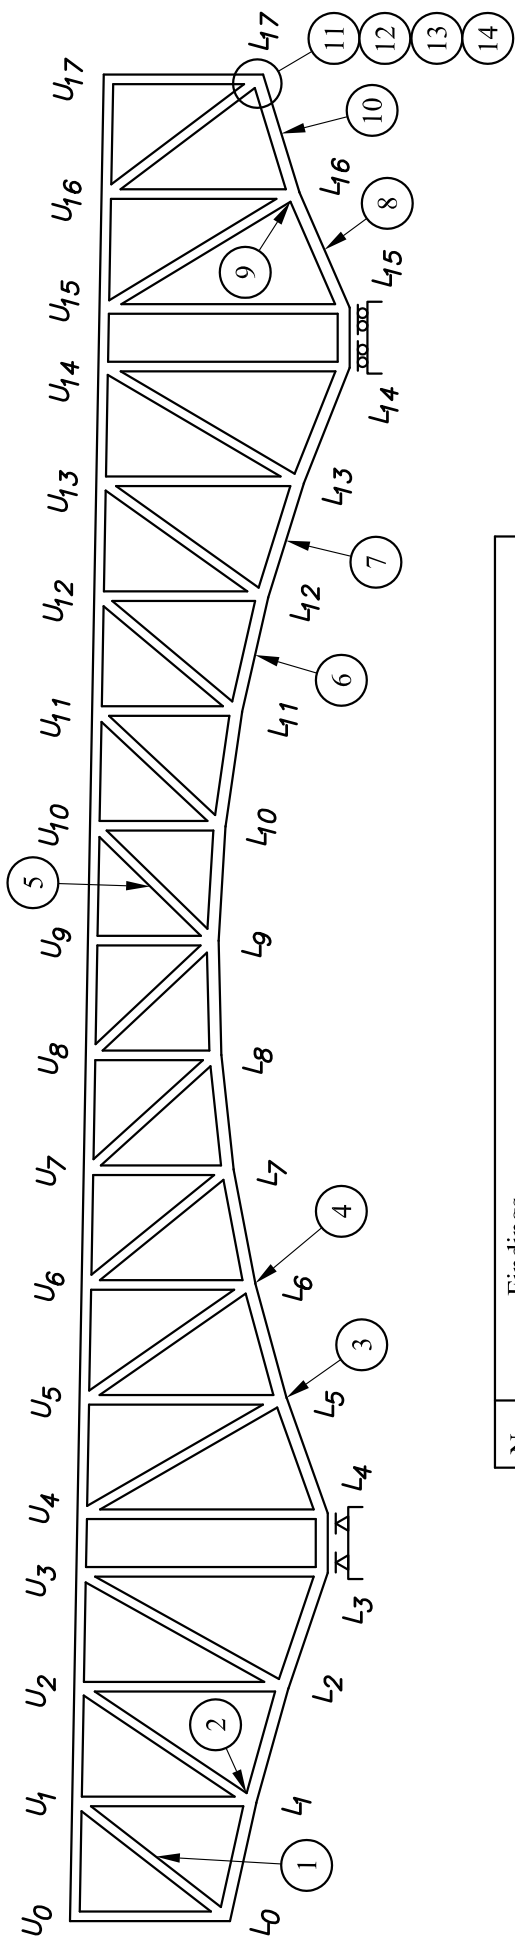
No.	Findings
1	South web plate has pack rust up to 1". North web plate has pack rust up to $\frac{3}{4}$ ".
2	Gusset plates slightly kinked inward.
3	Section loss to south gusset plate at vertical and diagonal connections.
4	Gusset plates kinked slightly outward.
5	Up to $\frac{3}{4}$ " pack rust at north web and top angle.
6	Top angles are warping between channel lacings.
7	Pack rust found along the entire length of the member.
8	Top angles have pack rust along the member and are warped between channel lacing.
9	Section loss to the north face of diagonal connection gusset plate.
10	Hole in south lower angle flange.
11	North and south gusset plates moderate section loss and pack rust.
12	Pack rust at lower angles of gusset plate connection to diagonal.
13	Corrosion at north lower lateral brace gusset plate.
14	Local paint failure present.

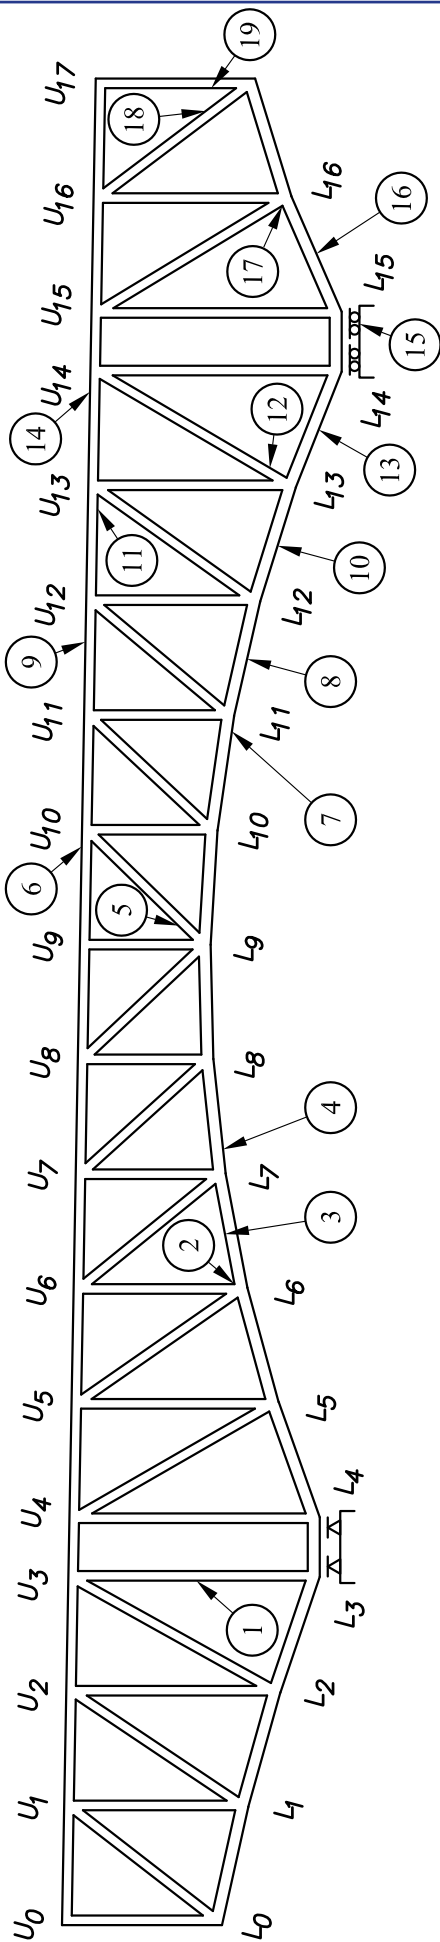
No.	Findings	No.	Findings
1	Separation between web plate and angle at lateral diagonal connection???	11	Metal plate welded to Joint U ₁₃ gusset plate and U ₁₂ U ₁₃ .
2	South gusset plate kinked below gusset plate brace.	12	18" long x 3/16" deep section loss to the north web plate.
3	5/16" separation between the north top angle and web plate caused by peculiarly rooted pack rust.	13	1/4" to 3/8" separation between top angles and web plate due to pack rust.
4	1/2" hole to the outstanding leg of the bottom north flange angle.	14	Utility drain leaking on top chord at Joint U ₁₄ .
5	3/16" x 3" loss to the outstanding leg of the top north angle.	15	Dirt accumulation along the bottom of the east roller nest.
6	Pigeon nest present in upper chord.	16	1" pack rust along the vertical leg of the bottom angle.
7	3" wide hole in the outstanding leg of the bottom north angle.	17	1/4" of section loss to the north web plate at gusset plate interface?

8	1/4" pack rust along the vertical leg of the bottom north angle.	18	1/8" x 3" section loss along the outstanding leg of the top angle around Joint L ₁₇ .
9	Corrosion to the top flange of Stringer 10, Panel 12.	19	2 3/8" of pack rust between the interior web plate and gusset plate.
10	1 3/8" pack rust found at two spots on the bottom north angle.

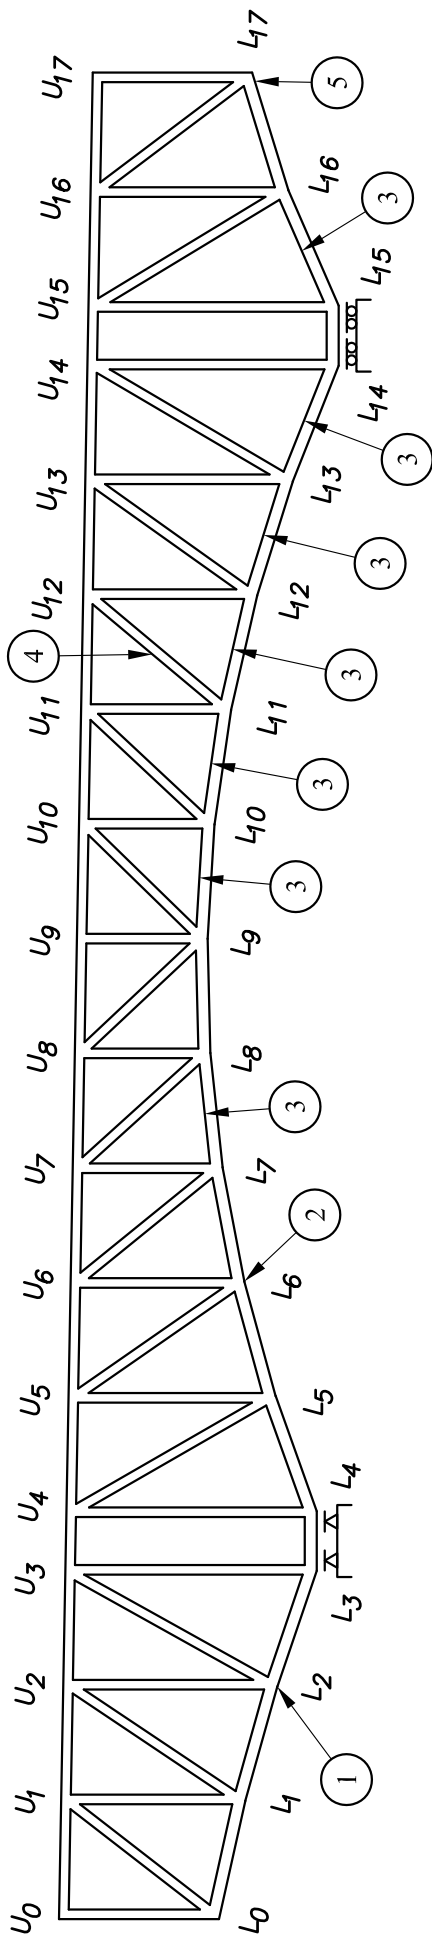
No.	Findings
1	Gusset plates appear slightly bowed inward along east unbraced length.
2	Active corrosion with section loss at top of lower chord angle by north gusset plate.
3	Active corrosion at sealed pack rust along top flange angles.
4	Active corrosion with minor section loss to north face of north web plate. Manhole through top deck leaks onto utility shed.
5	Pack rust between angles and active corrosion inside gusset plates.

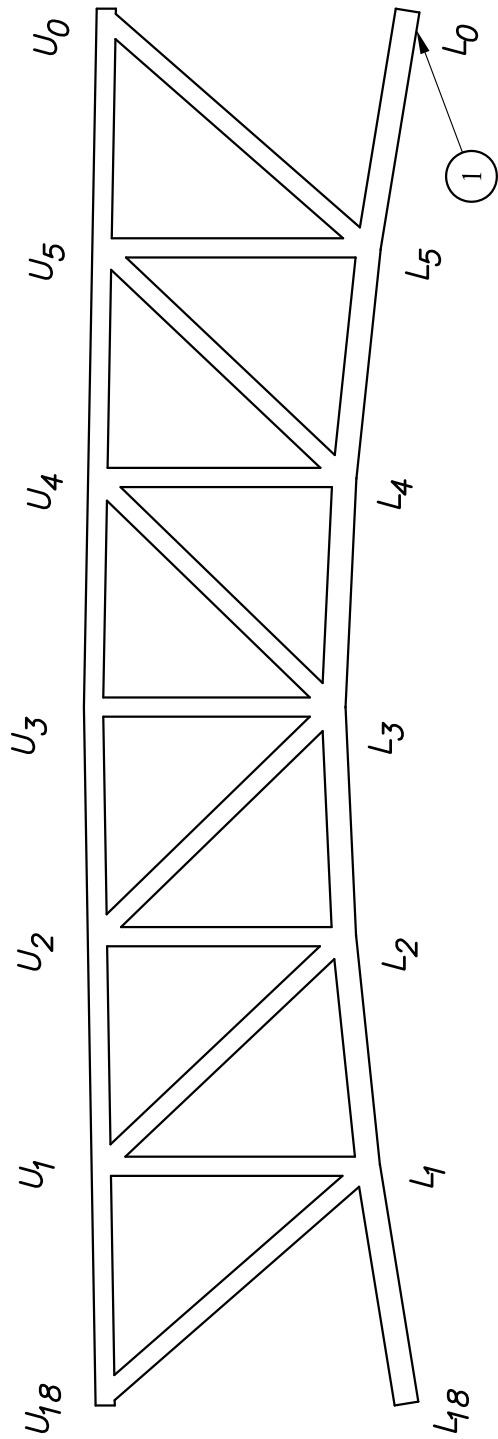
No.	Findings
1	Paint flaking on top of bottom tie plate.

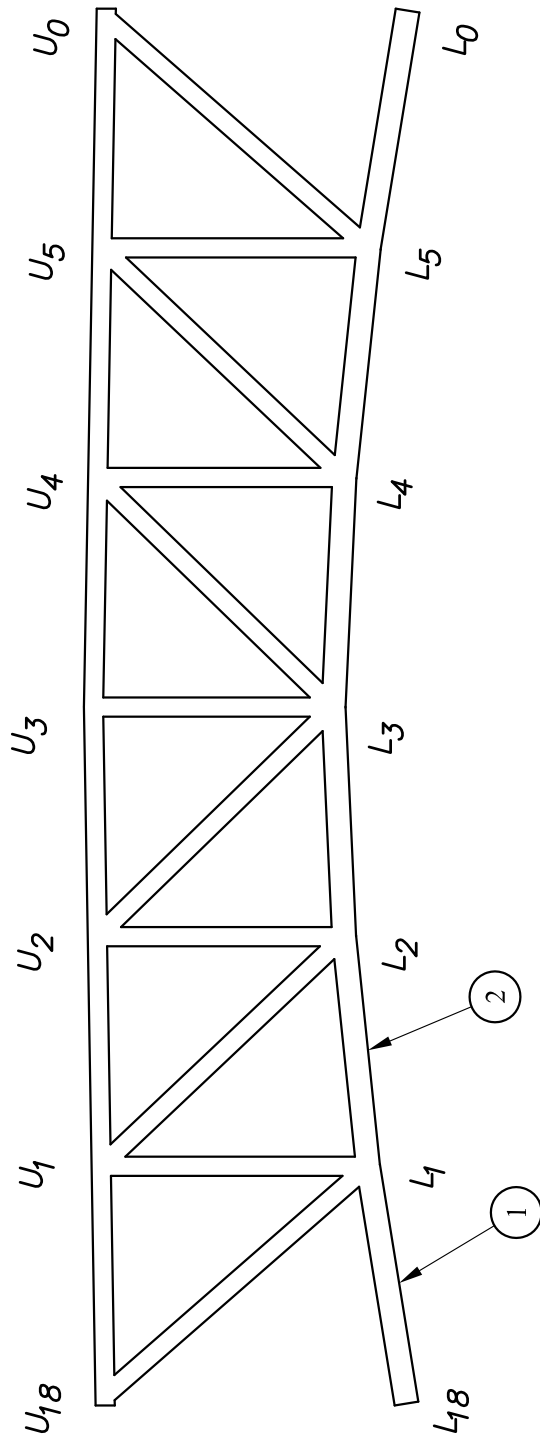
No.	Findings
1	1" pack rust along top south flange angle and 1 3/4" pack rust along top north flange angle.
2	1 1/2" pack rust along top north flange angle.

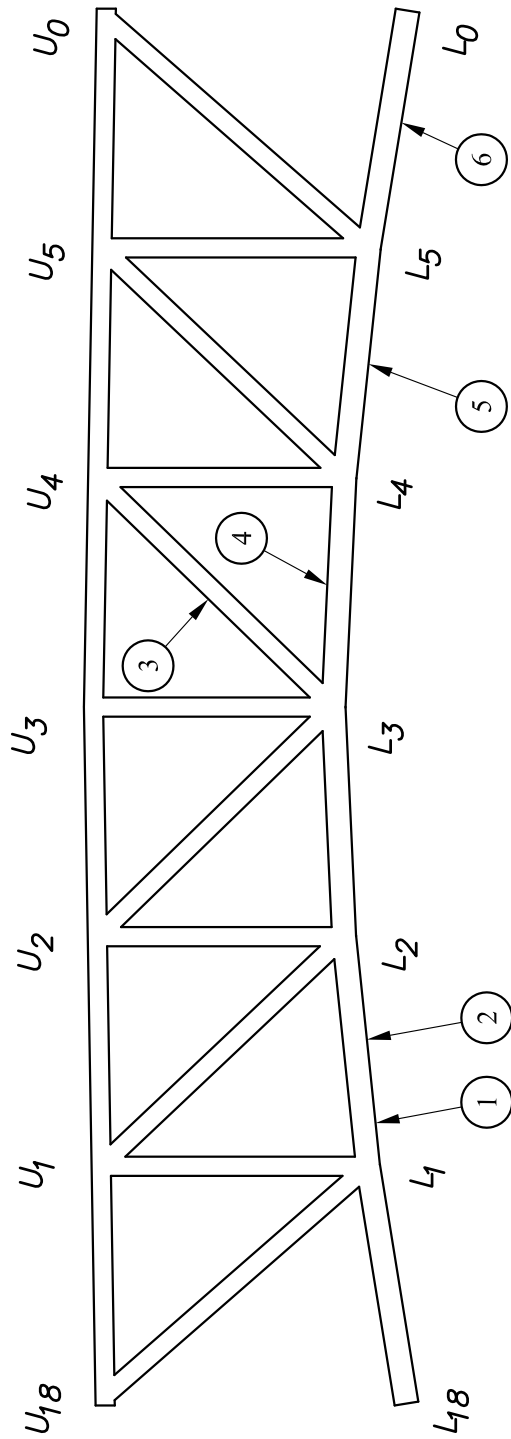
No.	Findings
1	Pin hole to bottom north angle outstanding leg.
2	1 1/2" to 1 5/8" pack rust along the vertical leg of the bottom north angle; remaining angle leg thickness 3/16" - 1/4".
3	Pack rust along top flange angles.
4	Top outstanding leg of angle has a 1/2" downward buckle; 1 1/2" of pack rust along bottom north angle; active corrosion at pack rust caulk.
5	Heavy pack rust at top flange angles.
6	Downward bowing in the outstanding leg of the top south flange.

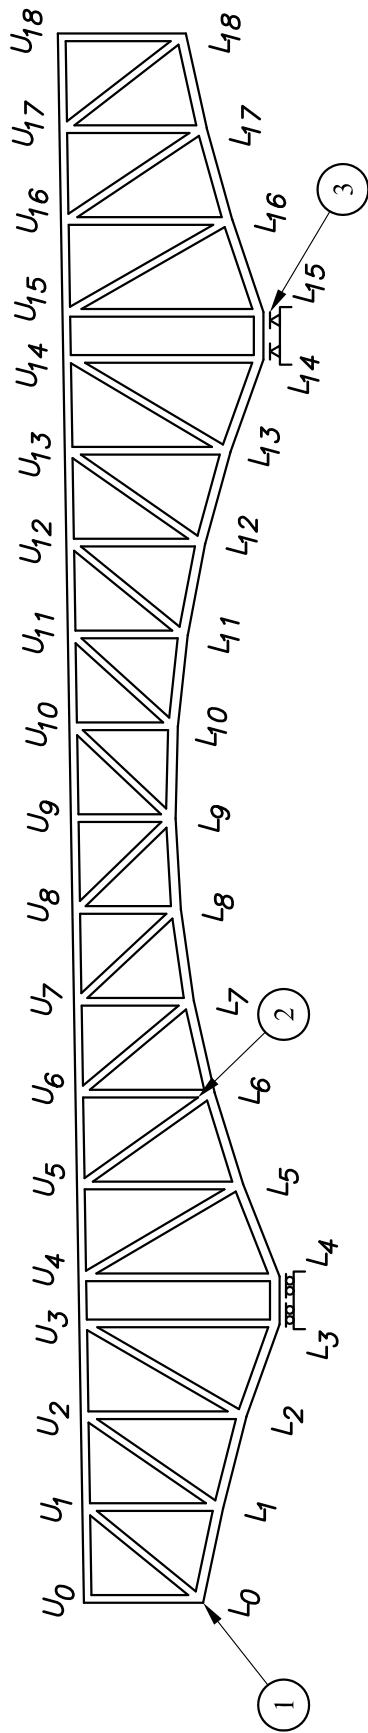
No.	Findings
1	Active corrosion at pack rust locations.
2	1/8" deep pitting on bottom stay plate.
3	Minor pack rust between gusset plate and bearing plates.

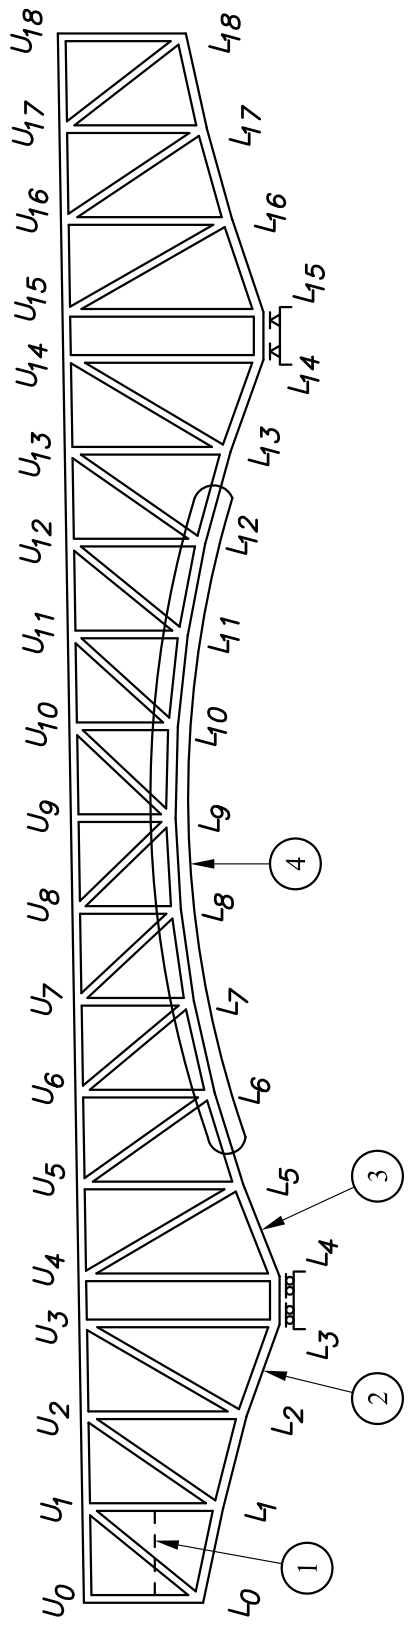
No.	Findings
1	North web plate top corner bowed with pack rust.
2	Maintenance Deck, Stringer 1: multiple holes in web at L ₀ floor beam connection.
3	North and south web plates bowed at top, no pack rust evident.
4	North and south web plates bowed $\frac{1}{4}$ " to $\frac{1}{2}$ " top and bottom along interior.

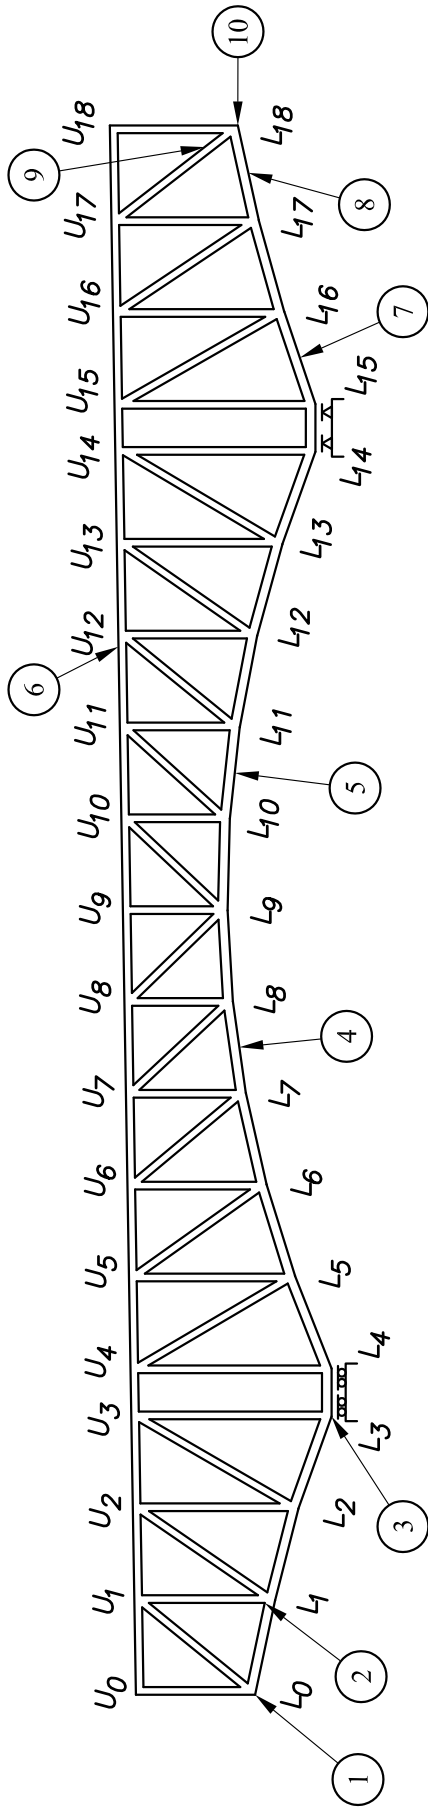
No.	Findings
1	Missing rivet to north and south gusset plate connections.
2	Slight bow to south gusset plate.
3	Old flake rust painted over.
4	1 1/2" pack rust at top of north flange and 3/4" pack rust at top of south flange.
5	4" high x 9" long section loss to bottom of north web plate.
6	Utility drain leaking onto diagonal.
7	Both web plates bowed out 9/16" to 1" with little corrosion observed.
8	2" diameter circular area with 1/2" section loss.
9	1/8" section loss to the outstanding legs of the top two angles.
10	Corrosion to bottom lateral and vertical gusset plates. Rust was not successfully removed during painting in 2002 rehab.

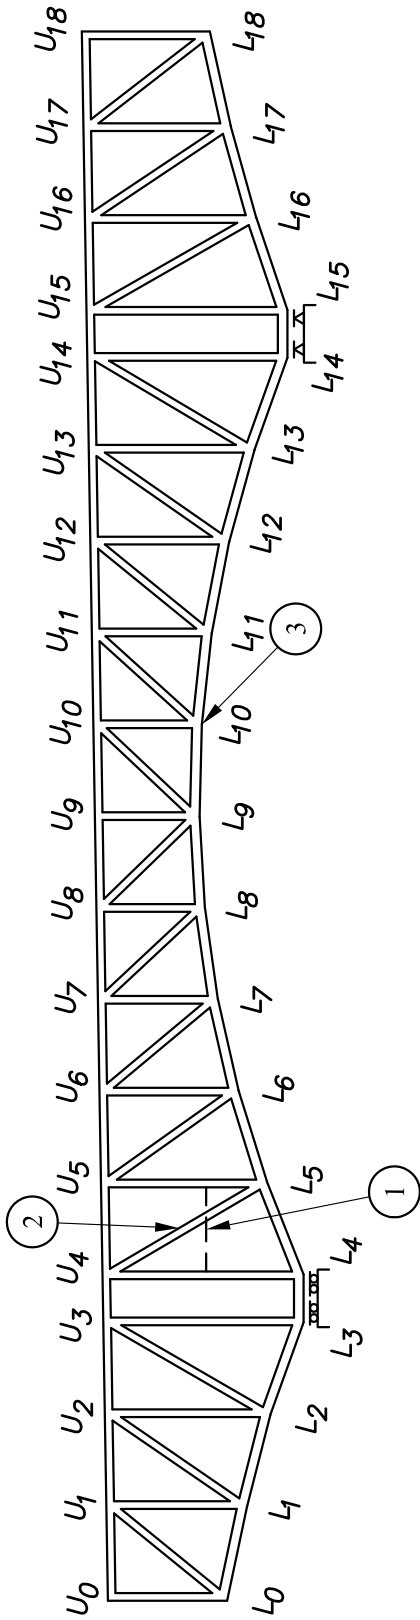
No.	Findings
1	Infiltration through maintenance deck.
2	Active corrosion along full length of top flange angles due to pack rust.
3	1/4" deep pitting throughout top of lower lateral bracing gusset plate.

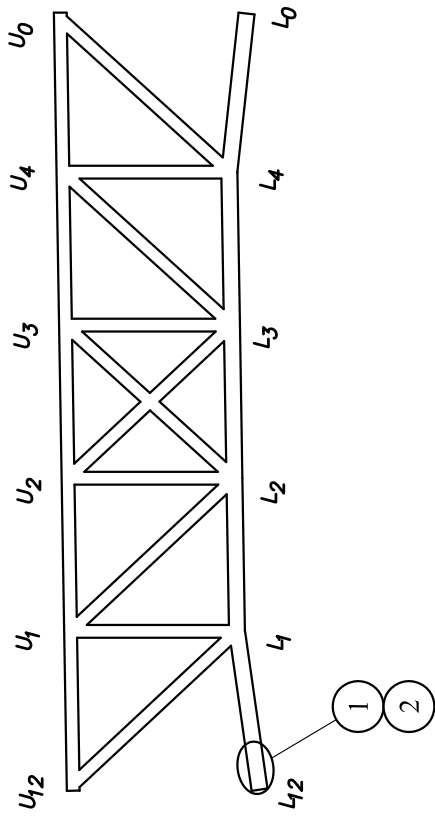
No.	Findings
1	1/4" deep loss to pin at plate interface.
2	Local paint failure.

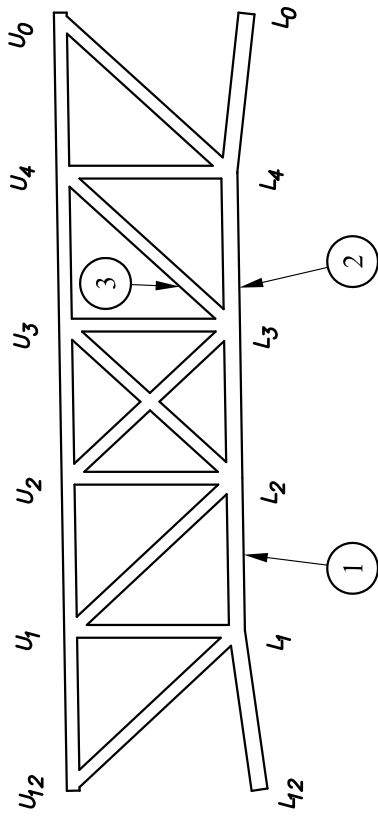
No.	Findings
1	3 holes (up to 2" Ø) to the outstanding leg of the bottom north angle.
2	23 1/2" long crack on outstanding leg of top north angle under the top stay plate has grown about 1/2" since 2012.
3	3" long x 1/4" deep section loss to both top horizontal angle legs.

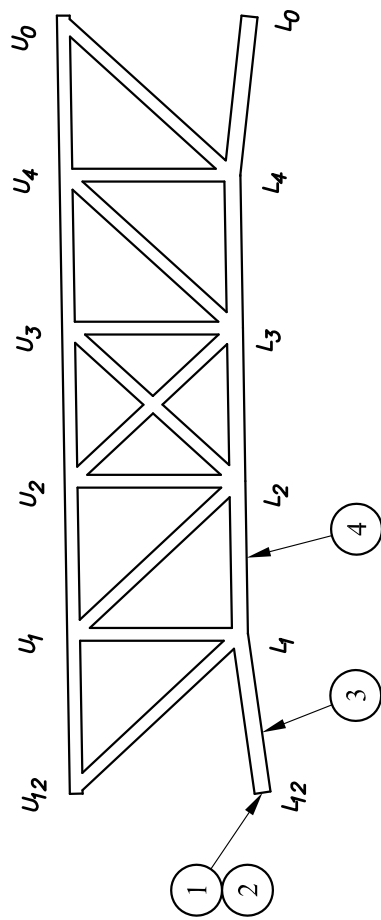
No.	Findings
1	Section loss to pin hinge at web interface.
2	Little or no movement at expansion hinge. Hinge appears frozen due to pack rust.
3	Pin holes to flange angles with pack rust up to 1" wide.
4	1 1/2" Ø hole to south web plate with 1 1/2" pack rust above bottom flange angle.

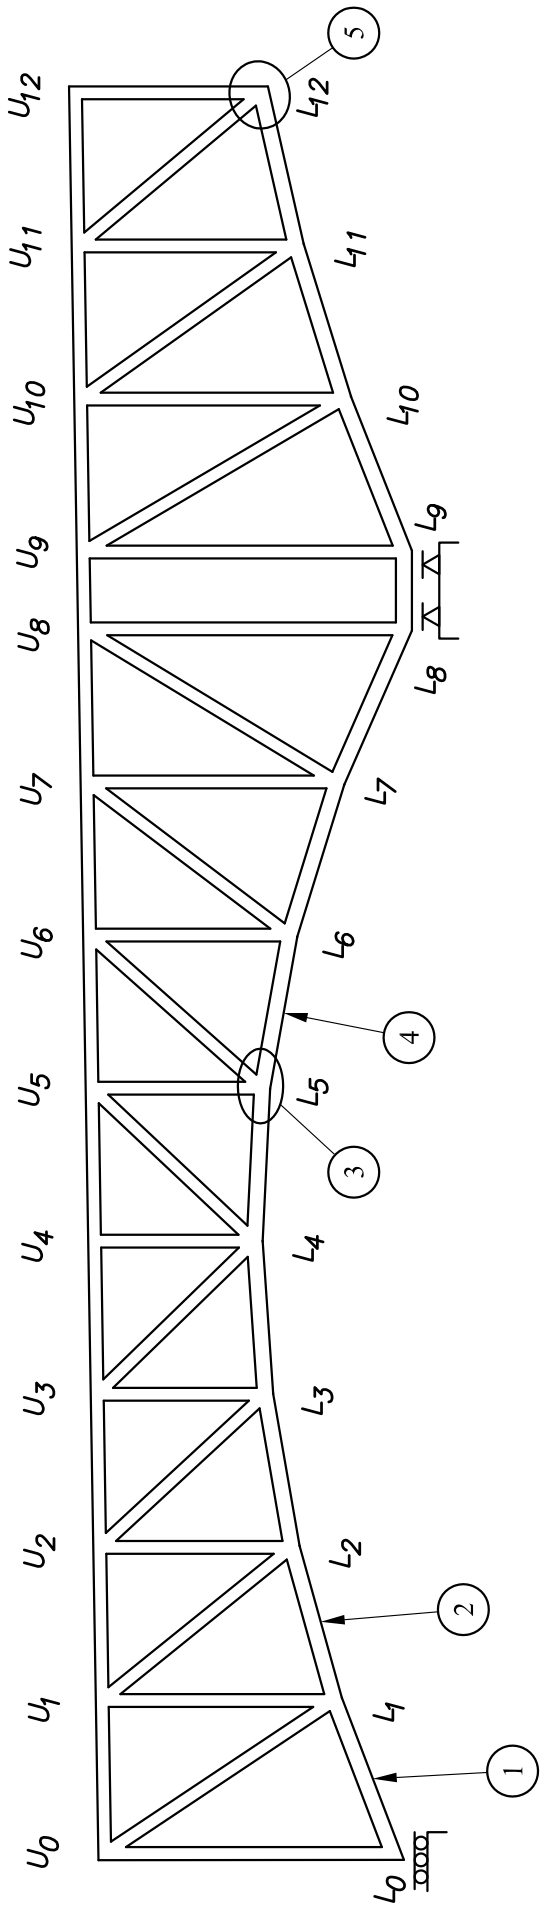
No.	Findings
1	Zero Load Member: Advanced pack rust with 3" high web perforations present.
2	Two-inch pack rust along bottom south flange angles.
3	Failed paint on bottom lateral bracing gusset plate.
4	Flange angles bowed due to pack rust.
5	Local paint failure.

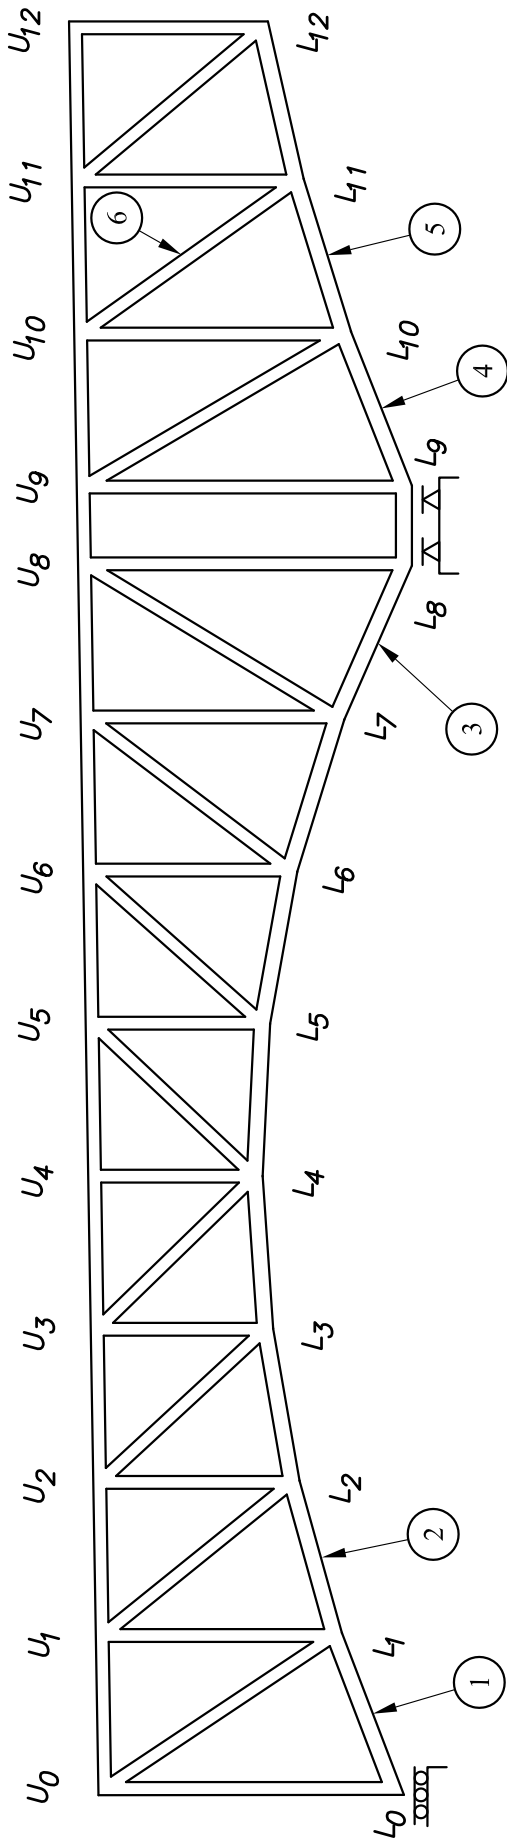
No.	Findings
1	Zero Load Member: Advanced pack rust present.
2	Advanced section loss present.
3	South web plate bowed out $\frac{3}{8}$ ", no signs of pack rust present.
4	Web plate bowed out $\frac{3}{8}$ ", no pack rust present
5	$\frac{3}{4}$ " pack rust at bottom flange angles.
6	Bent lacing bar.

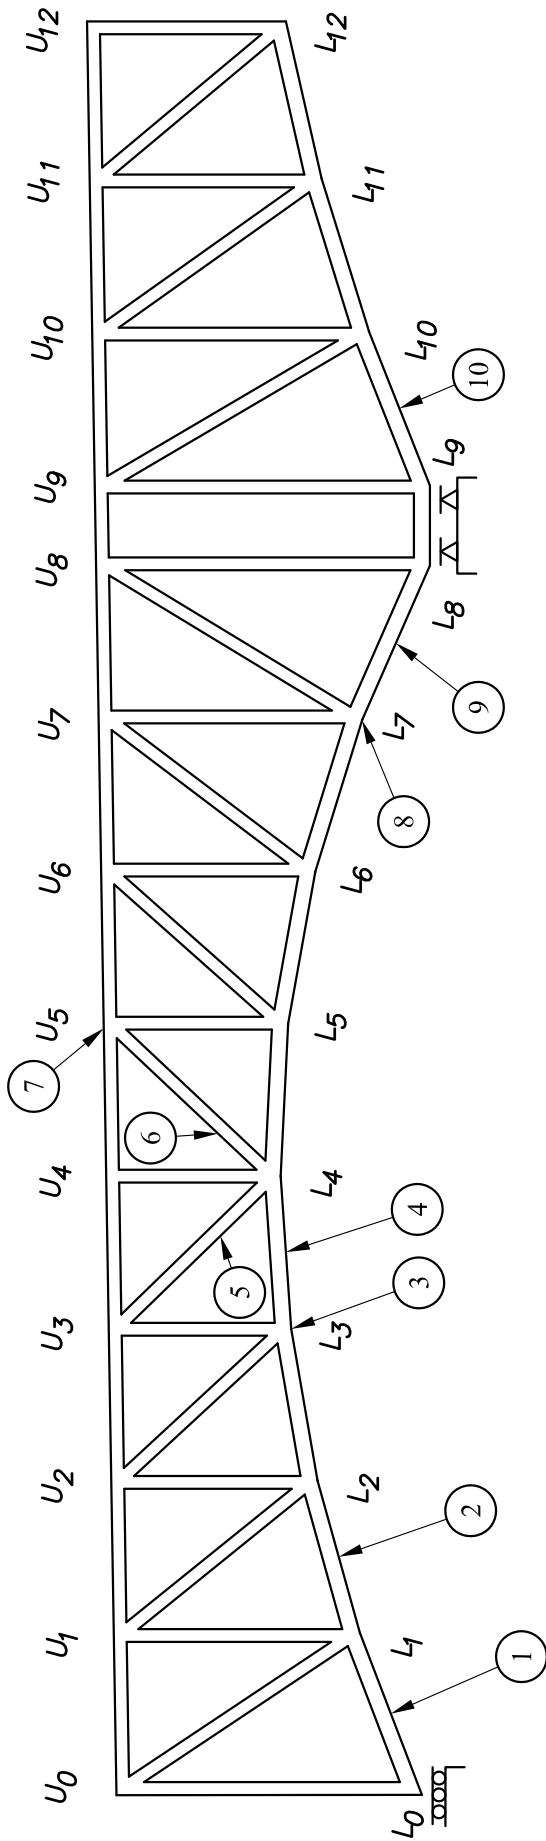
No.	Findings
1	Zero Load Member: Advanced pack rust present.
2	Perforation on north web plate, measured 20% section loss in primary sections.
3	Hole in bottom lateral gusset plate.
4	Bottom north angle: 3 - 1" Ø holes pack rust $\frac{1}{2}$ " to 1" throughout all 4 flange angles.
5	100% section loss to outstanding leg of top south angle.
6	$\frac{1}{4}$ " deep section loss to outstanding leg of top south angle.
7	Leaking pull box drain from deck.
8	12 of 16 bolt rivets (south plate) and 4 of 16 bottom rivets (north plate) missing interior head and have no theoretical clamping force.
9	$\frac{1}{2}$ " to $\frac{3}{4}$ " bowing to top and bottom edges of south supporting web plate. $\frac{3}{4}$ " to 1" bowing to top and bottom edges of north supporting web plate.
10	Pack rust $\frac{1}{2}$ " to 1" wide on all 4 flange angles.

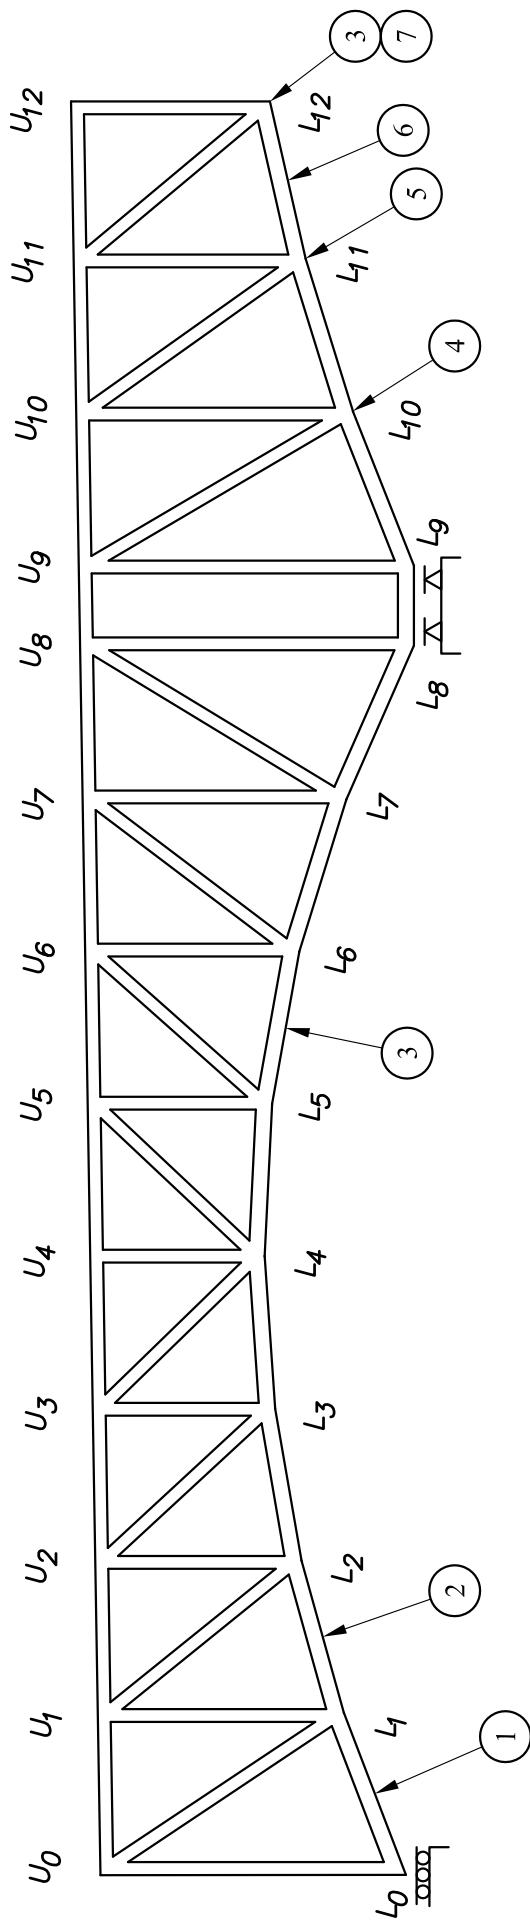
No.	Findings
1	Zero Load Member: Advanced pack rust present.
2	2" thick pack rust along bottom flange angles.
3	$\frac{3}{4}$ " pack rust between vertical interface of north panel point fill plate and north web plate.
4	$\frac{1}{8}$ " total section loss above lower chord with active corrosion on north gusset plate exterior.
5	End of bottom south fill plate bowed out 2".
6	$\frac{1}{2}$ " to $1\frac{1}{2}$ " pack rust at bottom south flange angle.
7	Active corrosion inside panel point connection.
