CUY-0010-1613

SFN 1801503

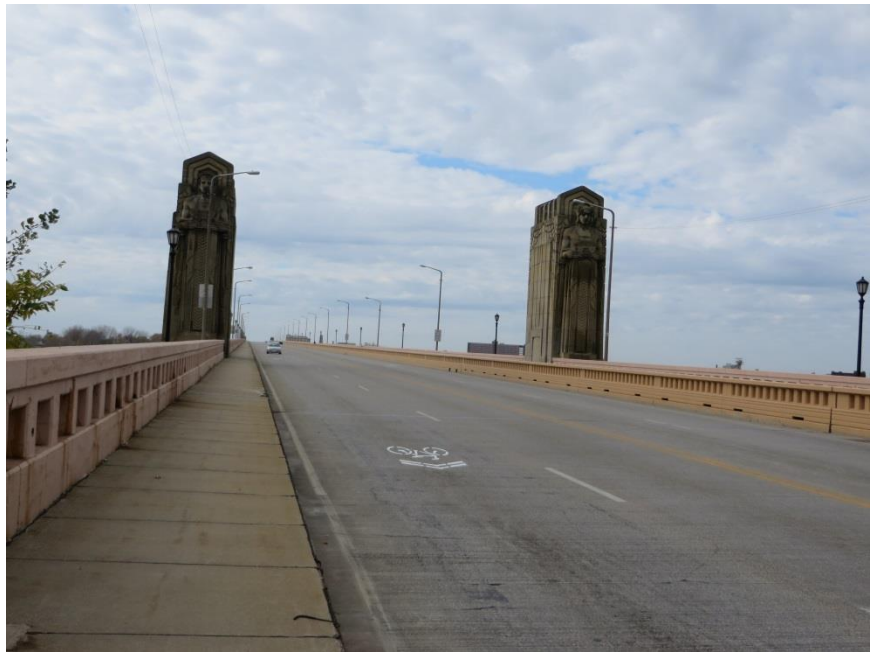
East approach guardrail

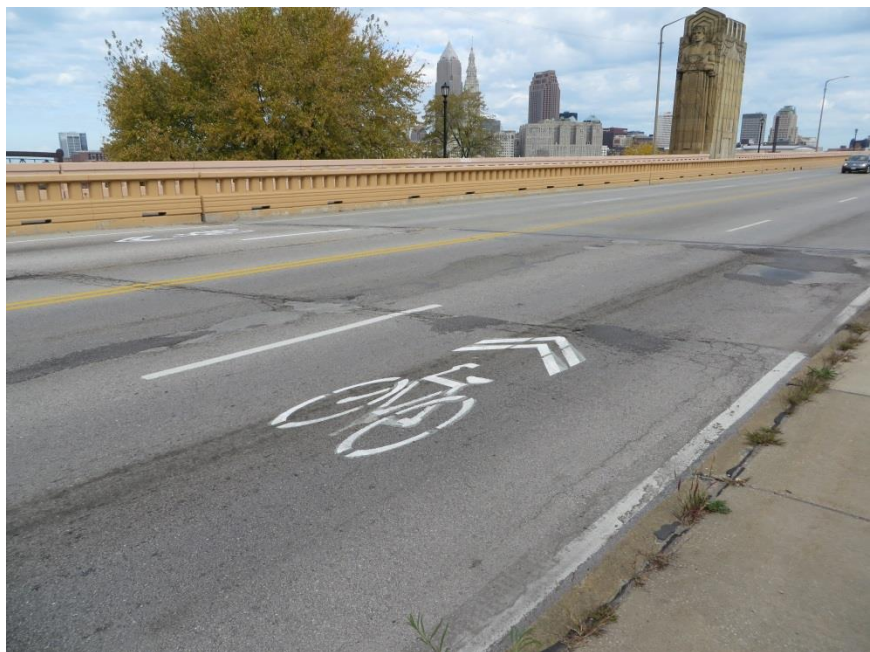
Cracks and patches in west approach wearing surface

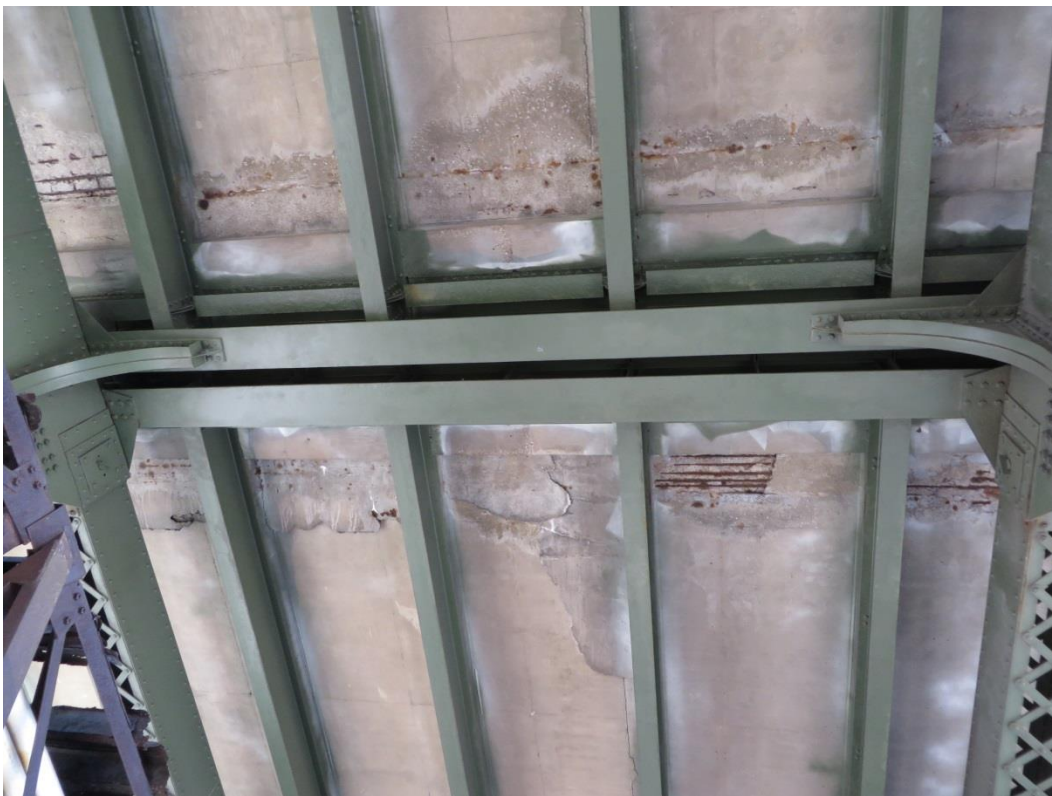
Typical slab condition adjacent to expansion joints

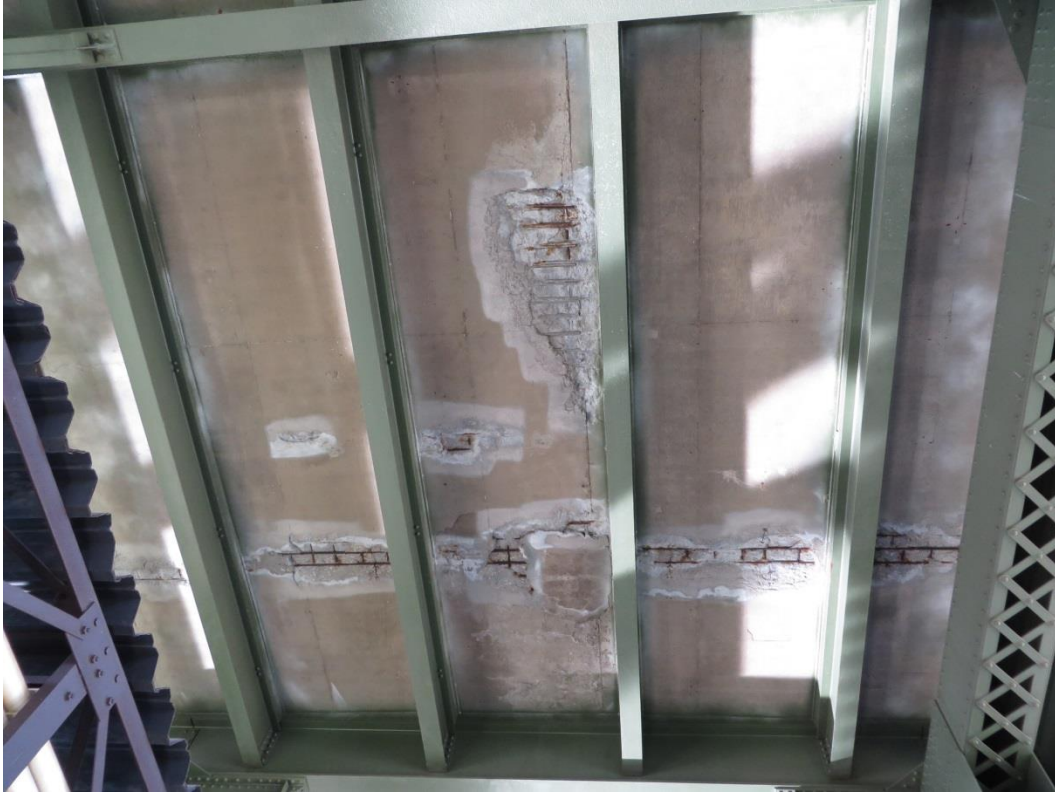
Spalled areas with rust inhibitor and fresh spalls without, common throughout entire deck underside

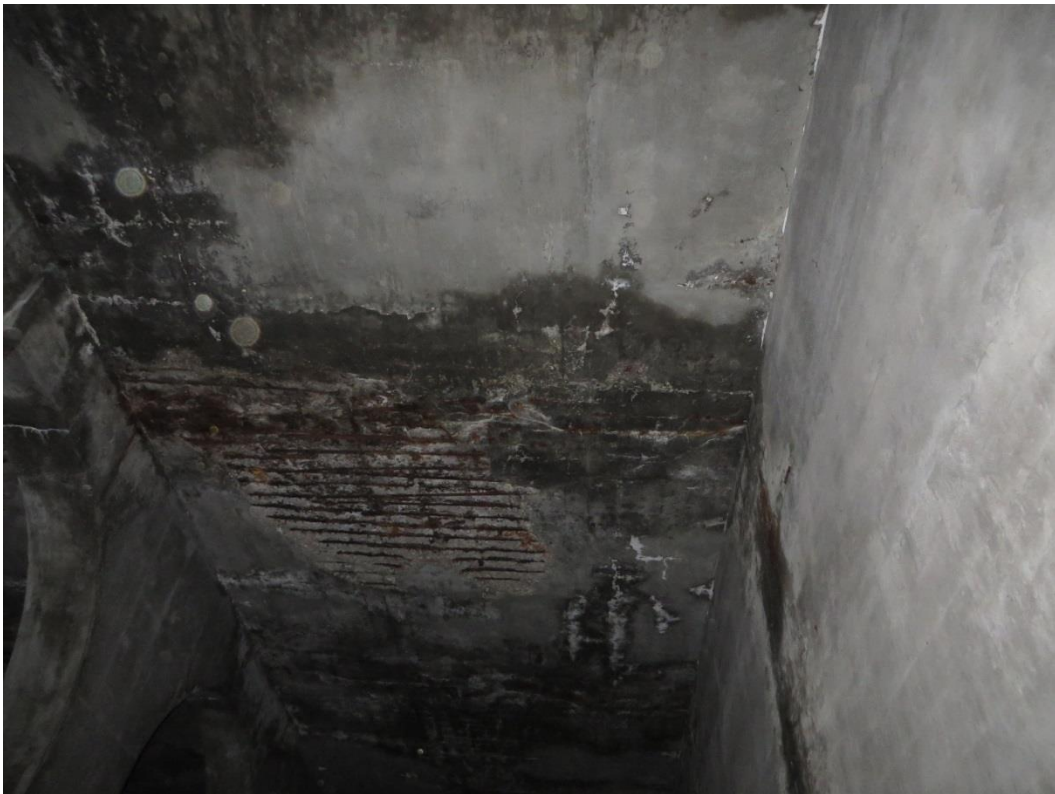
Large saturated and spalled areas with exposed and broken bars in east tunnel

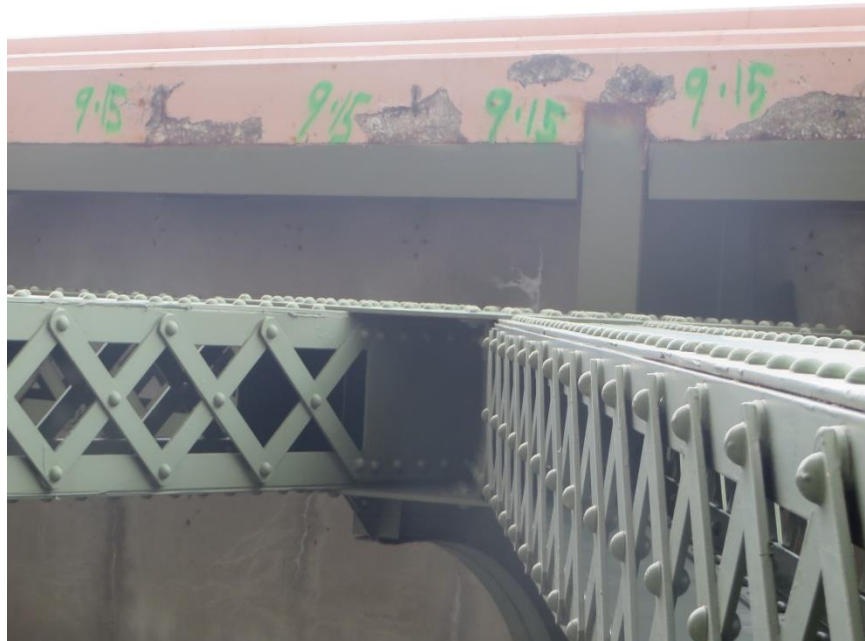
Previously removed spalls on north deck edge

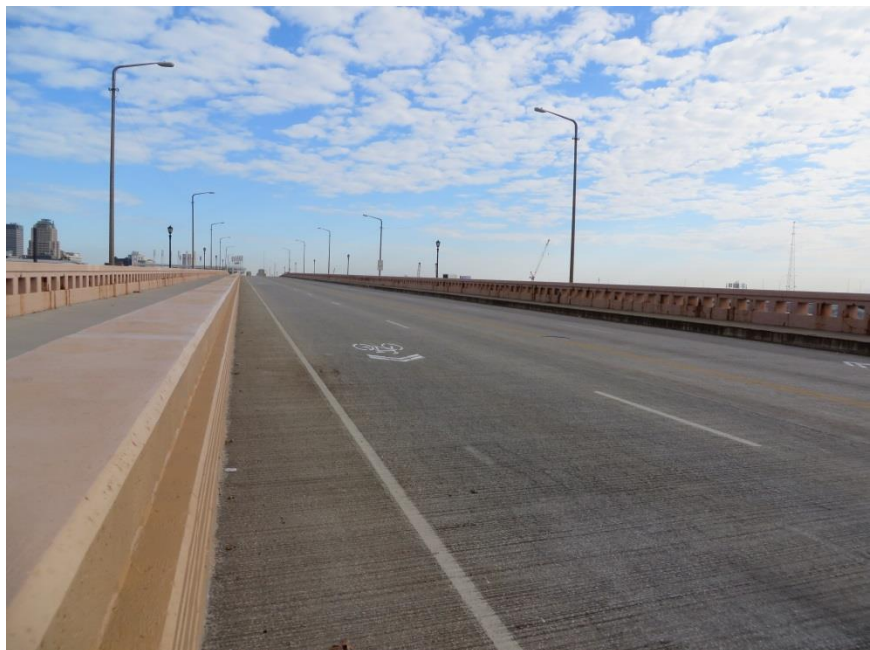
Wearing surface looking east

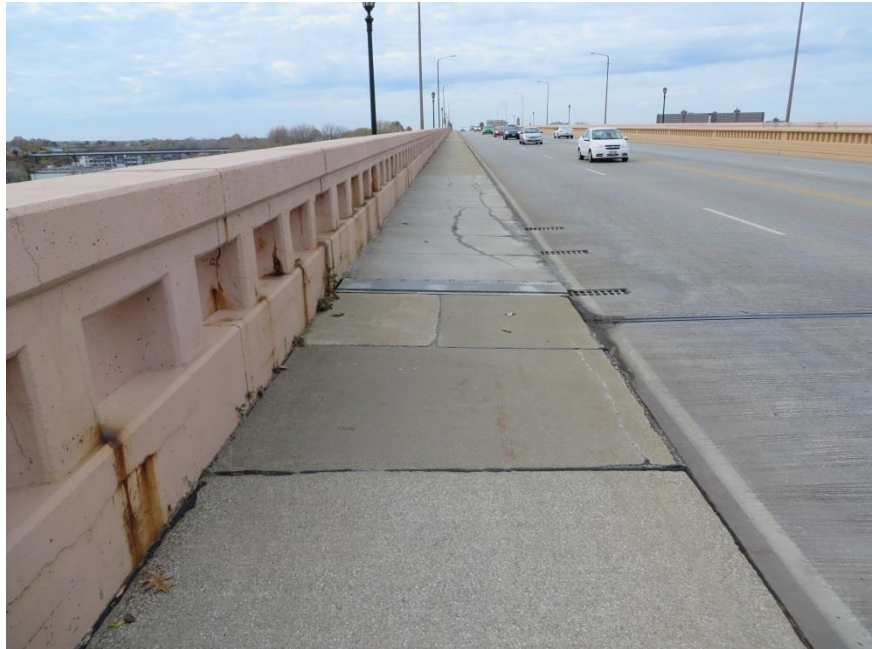
Cracks in previously repaired walk sections

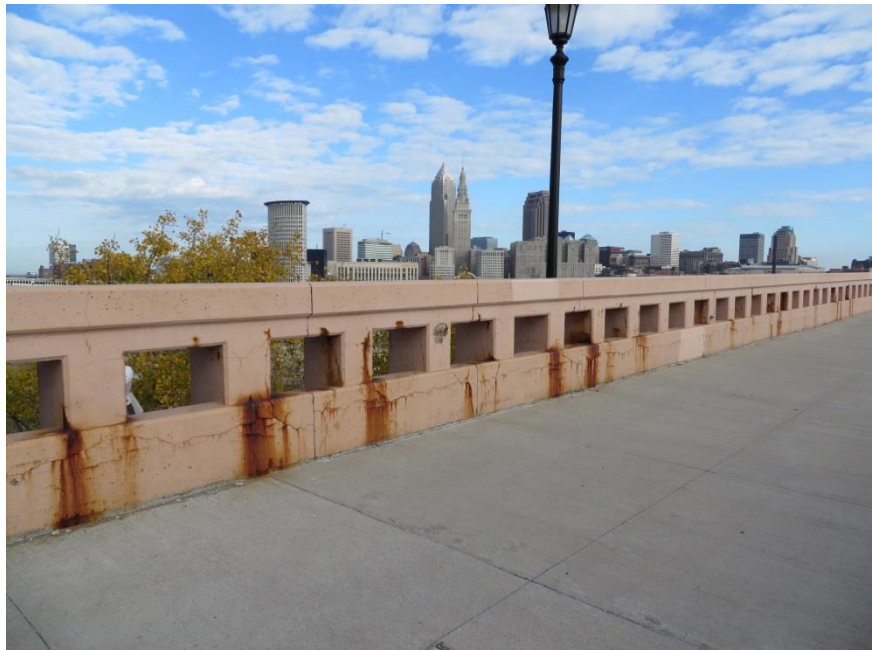
Typical railing cracking and staining pattern

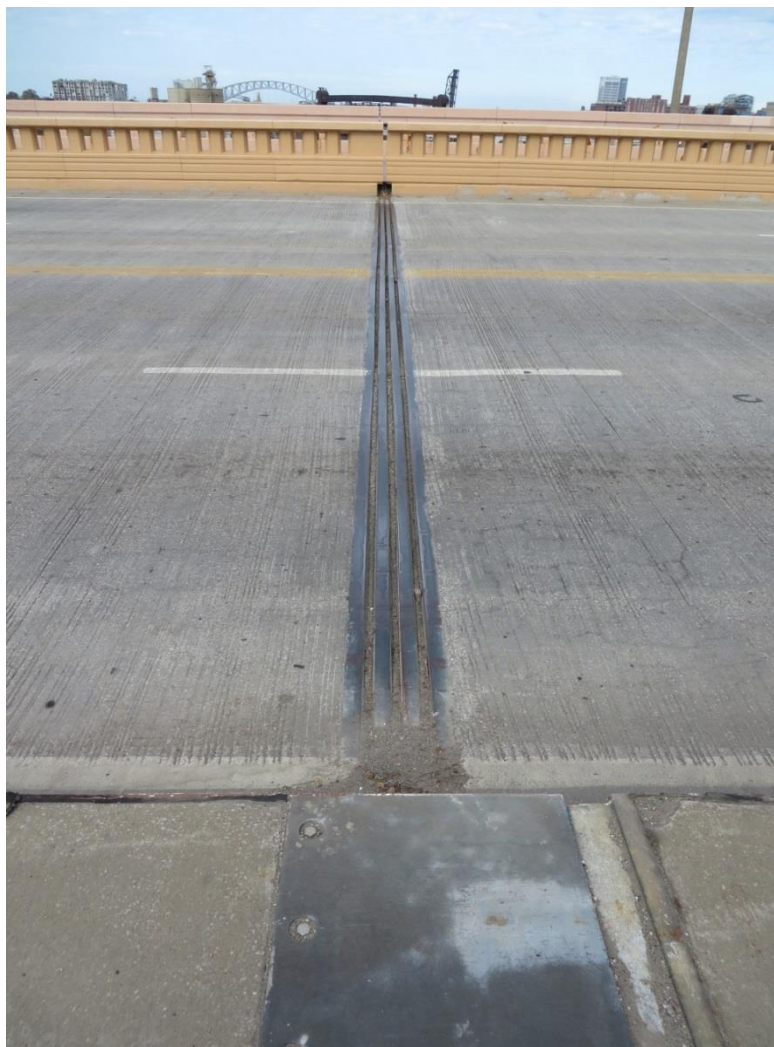
Debris and leakage common in deck joints

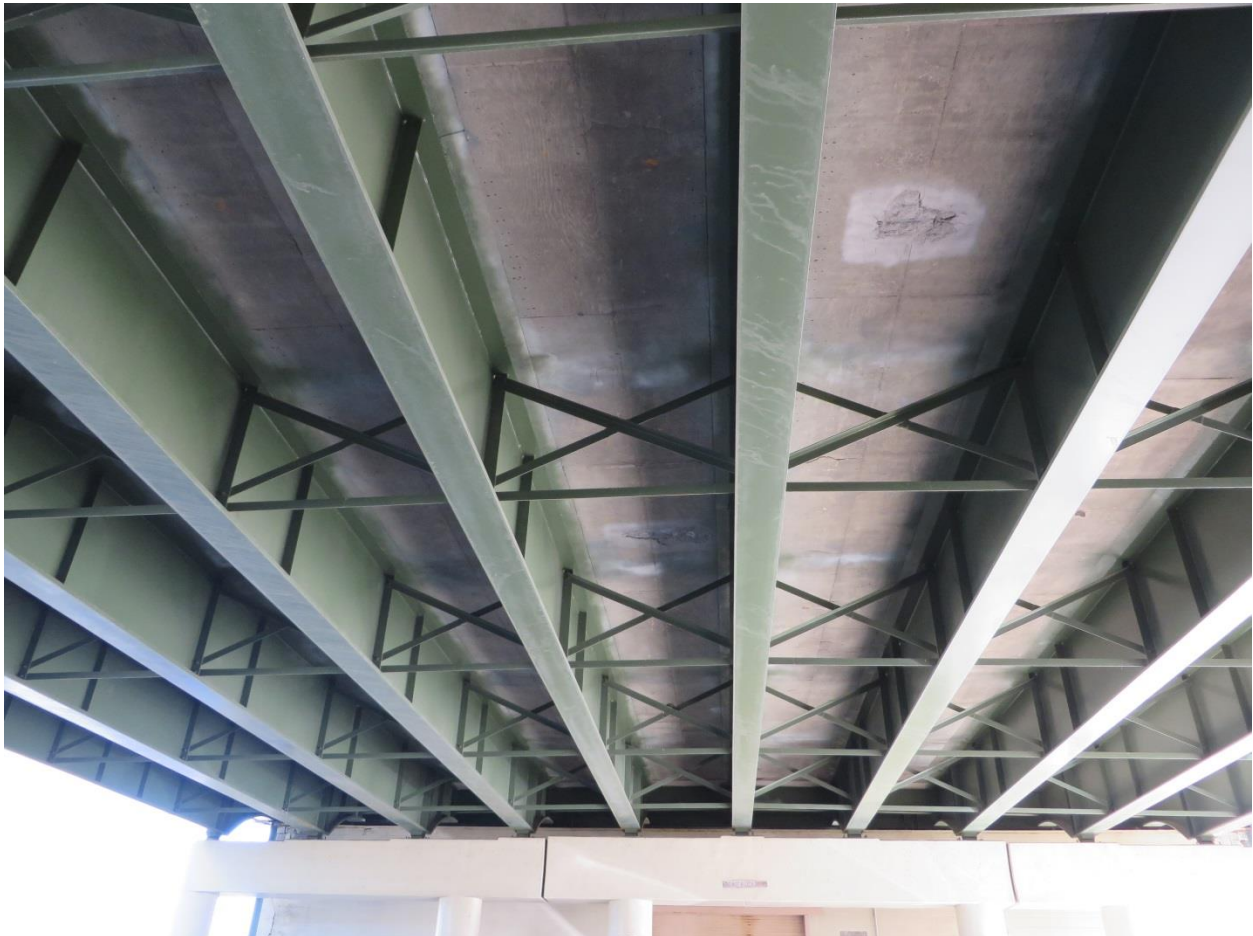
Beams and cross frames in the west approach

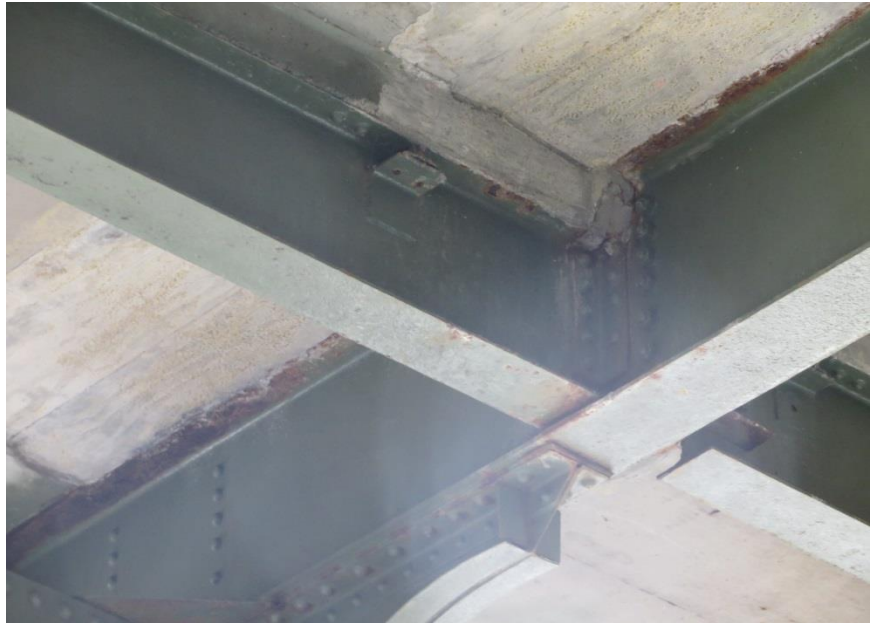
Section loss in stringer floorbeam connection adjacent to expansion joint

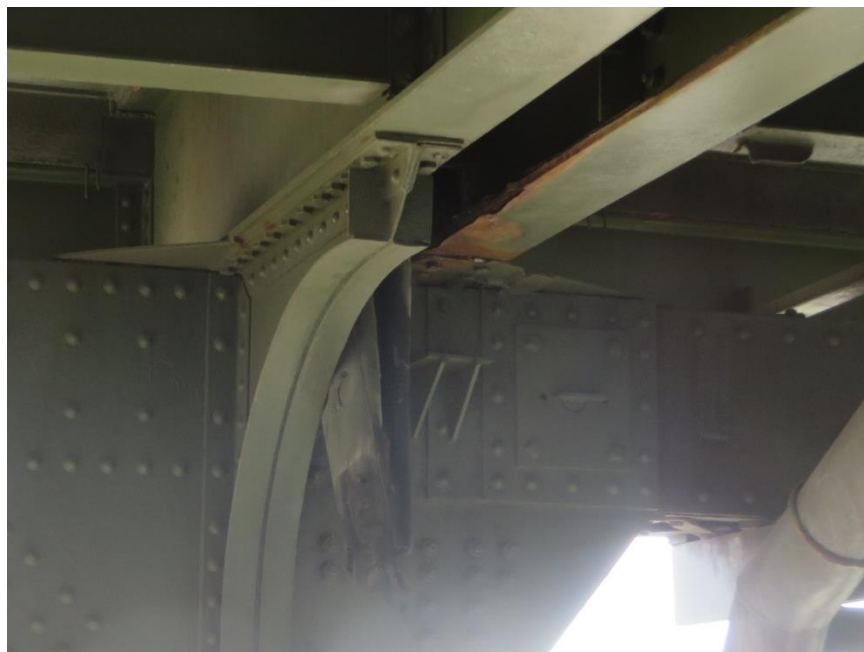
Corrosion in lower flange of D-S03-UC-13 floorbeam

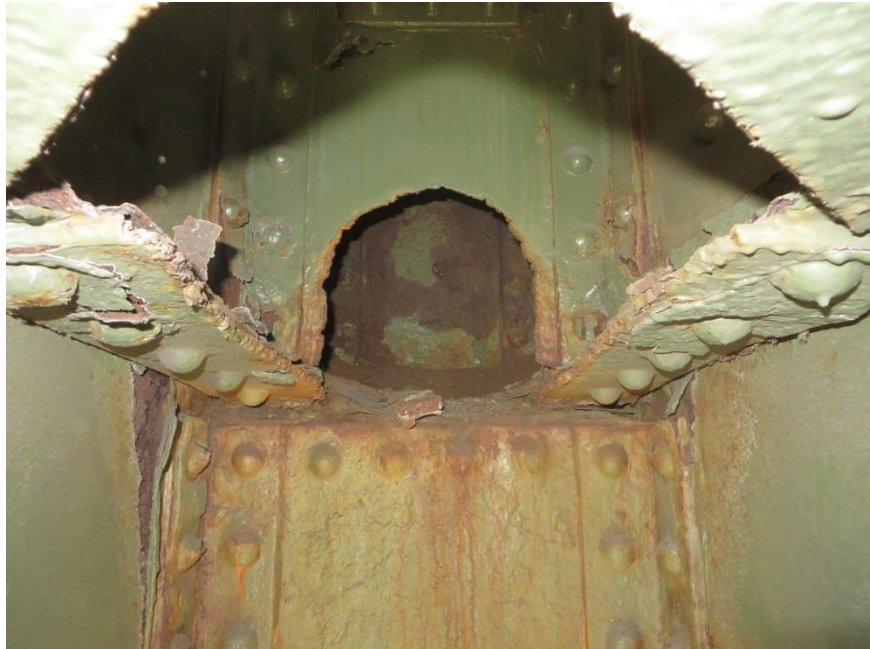
Corrosion inside D-S03-UC-13

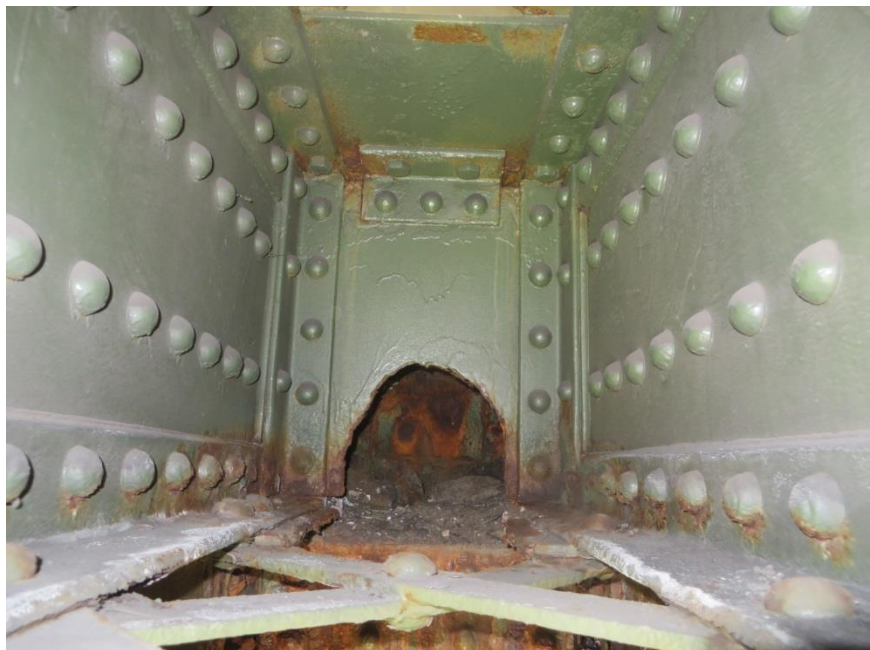
Corrosion inside D-S07-UC-15

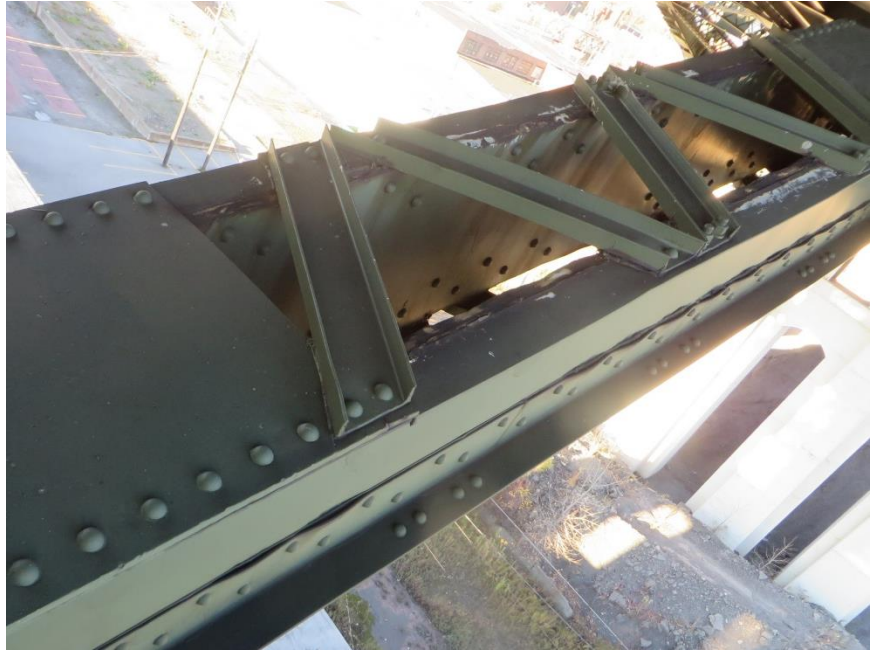
Pack rust in the angles and web plates of C-S07-LC-14

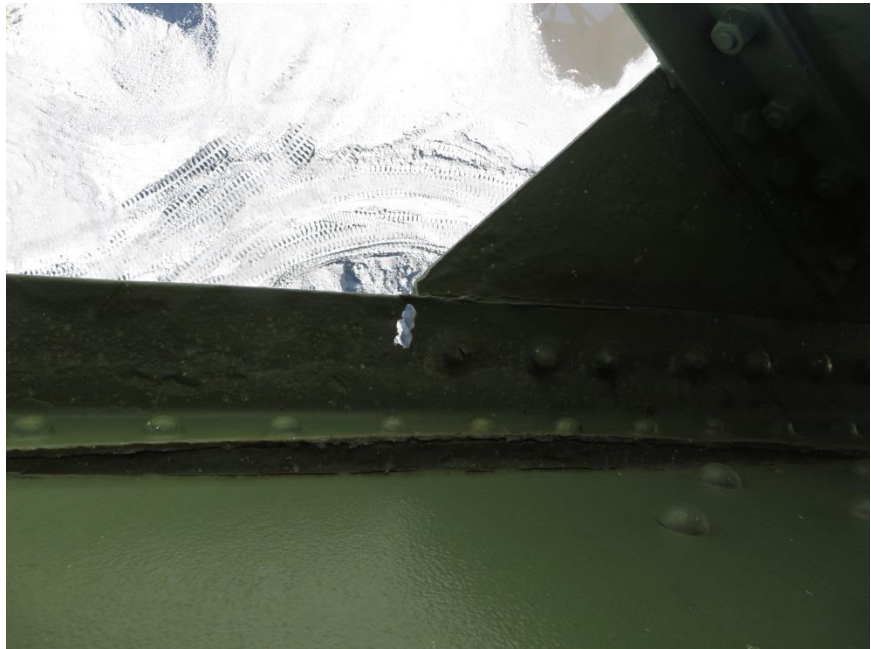
Through hole in lower angle of D-S09-LC-11

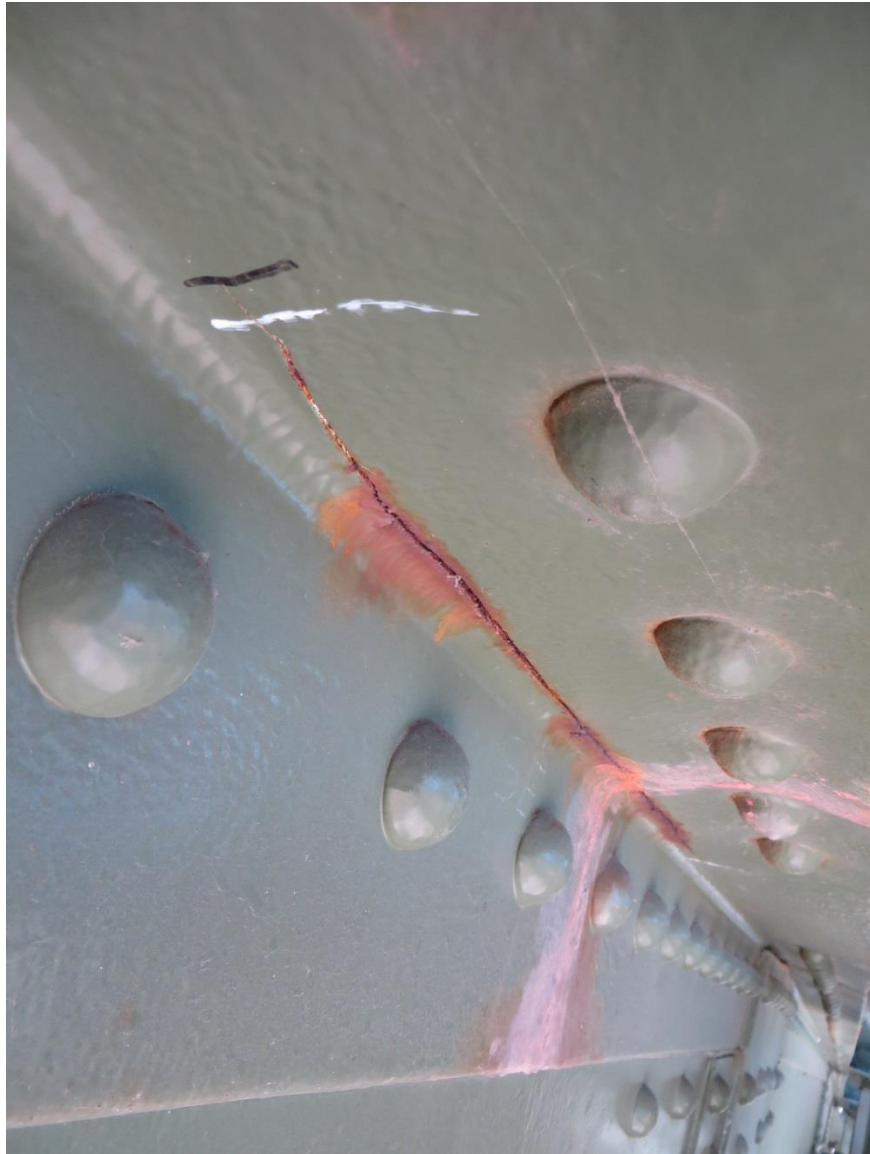
Crack in lower chord D in Span 12 between PP 03 and 04

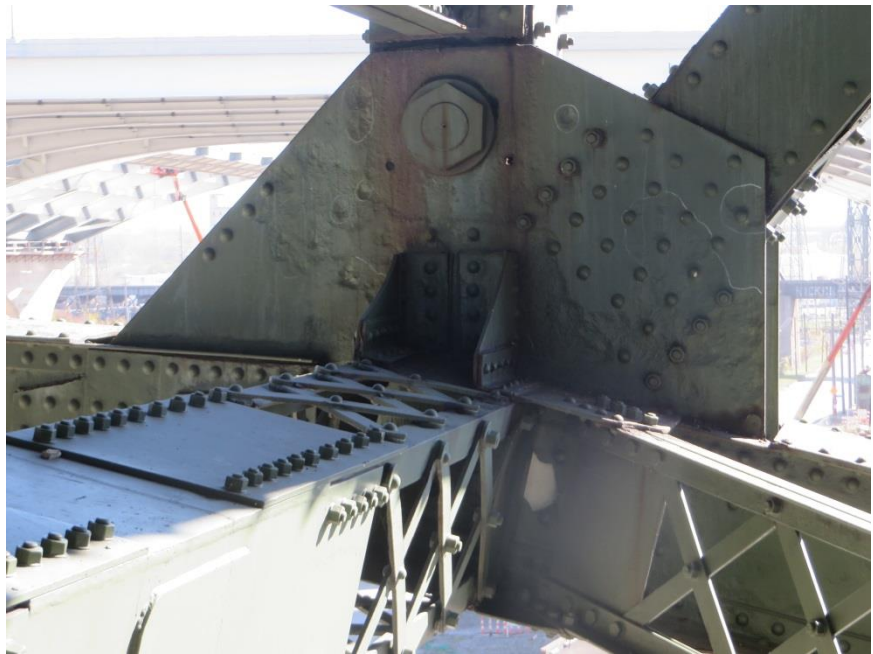
Section loss in D-S05-LC-14

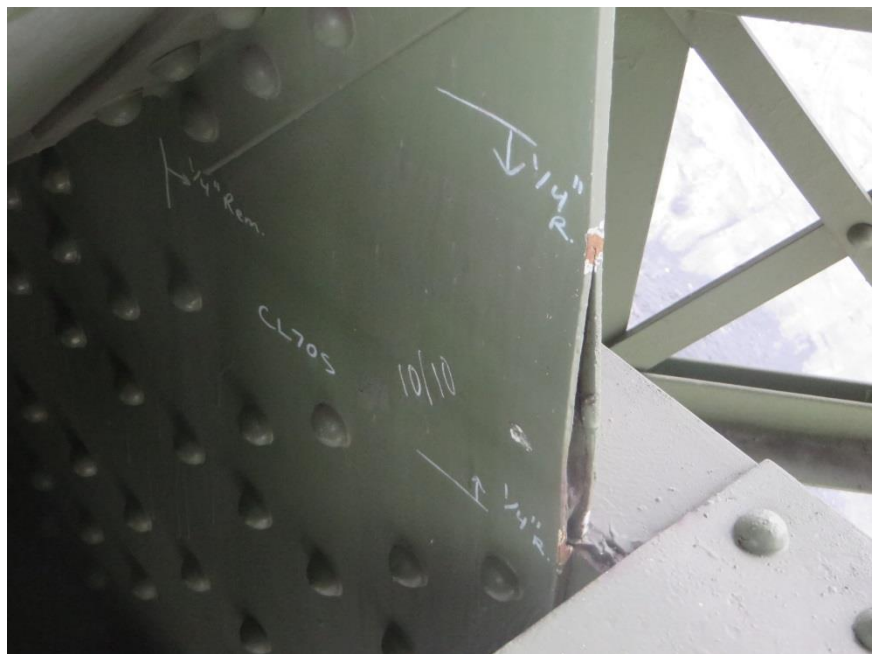
Laminar tear in C-S07-LC-07 gusset

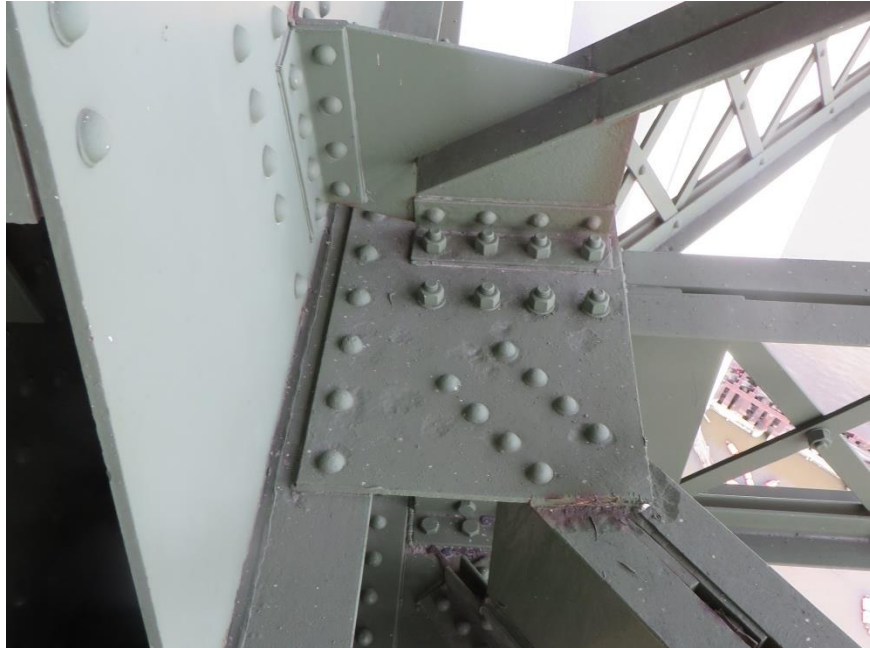
Pitting and corner lifting common in many lateral bracing gussets (C-S11-LC-12 shown)

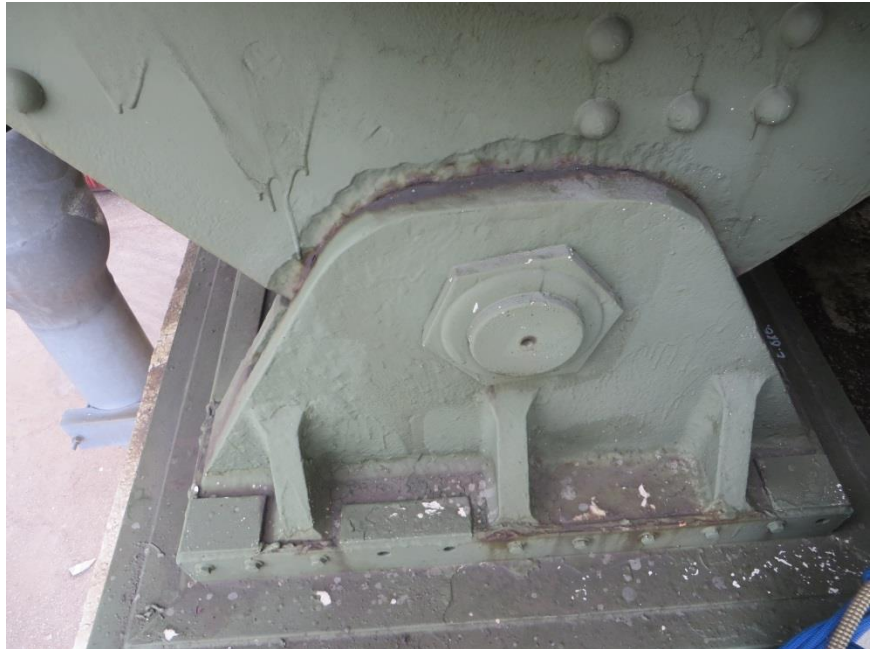
Section loss at A-S05-LC-11 Bearing

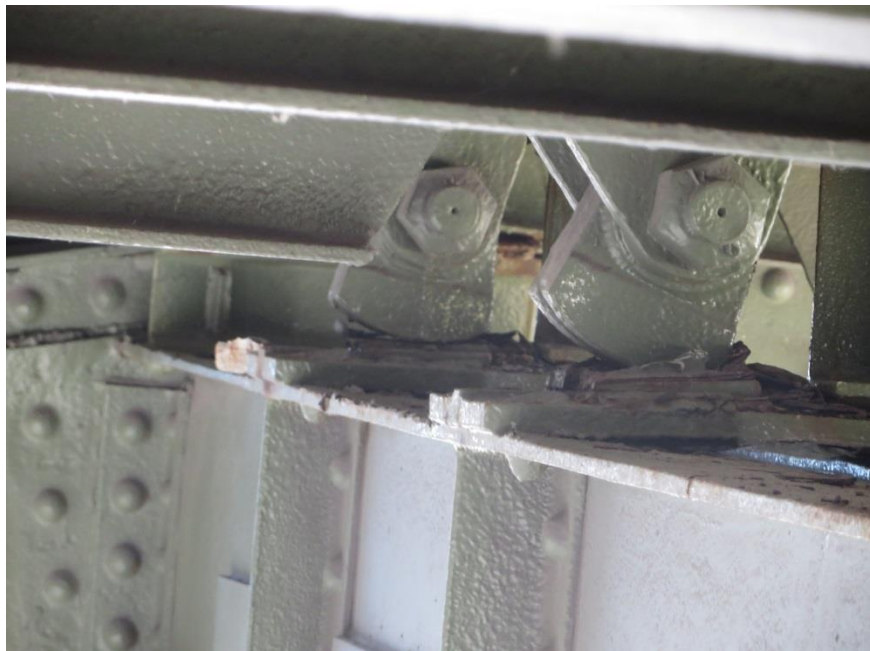
Utility deck bearing condition from C-S03-LC-13

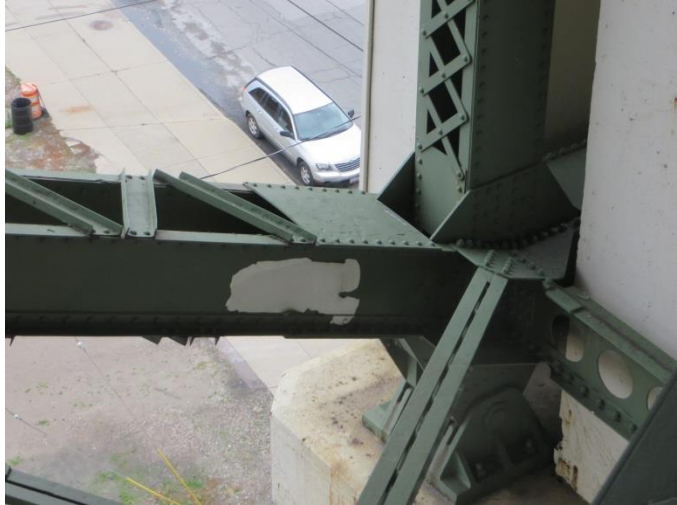
Large PCS failure in lower chord A

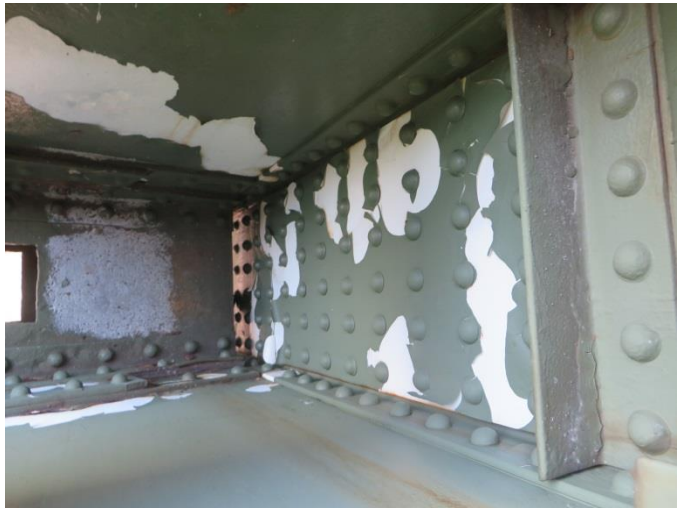
PCS flaking in A-S08-LC-05

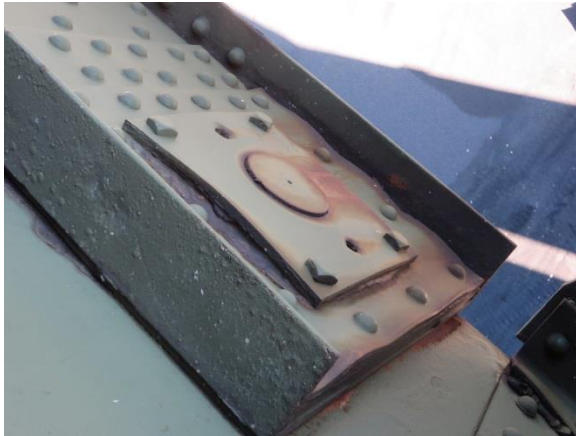
Pack rust in C-S09-LC-17 pin

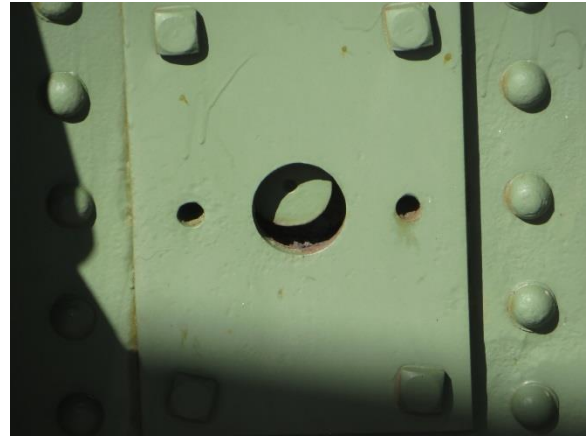
Free pin at C-S13-LC-12

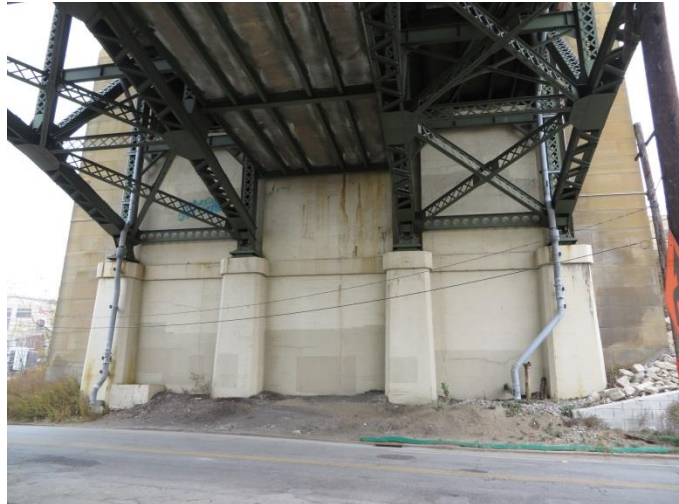
There is minimal staining and hairline cracks in the abutment faces. A quantity of 20 linear feet of the total 171 linear feet of abutment walls was downrated from Good to **Fair** to reflect these deficiencies. **151 feet are rated 1, Good Condition, and 20 feet are rated 2, Fair Condition.**

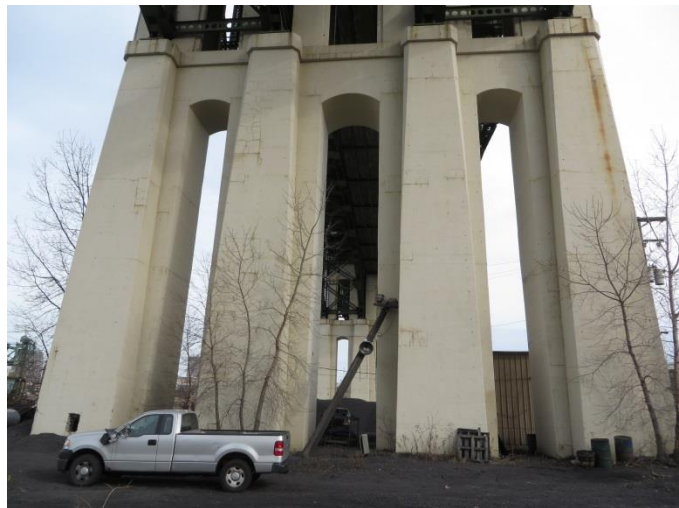
Pier 8 west face showing patches, cracks, and hole in left tower

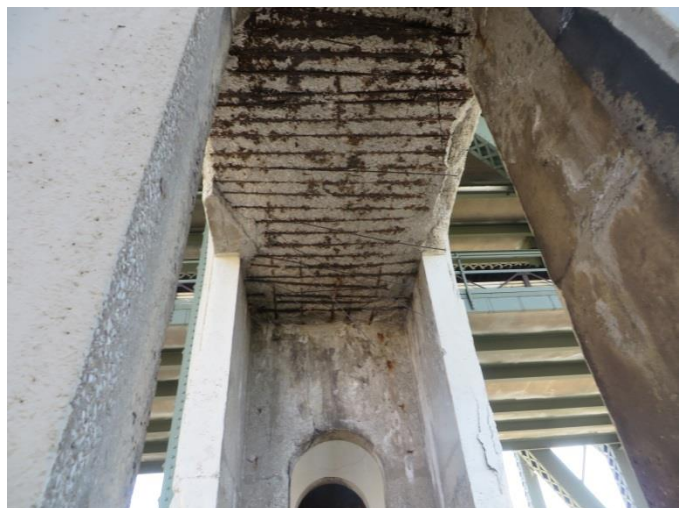
Degrading pier tower roof

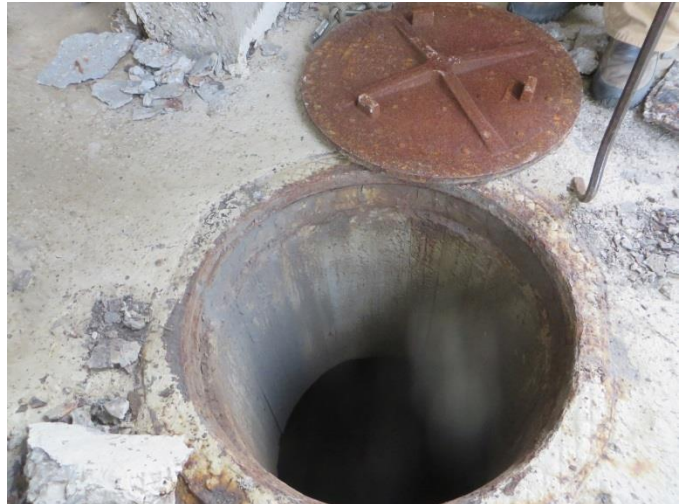
Deteriorated manhole casting in Pier 9

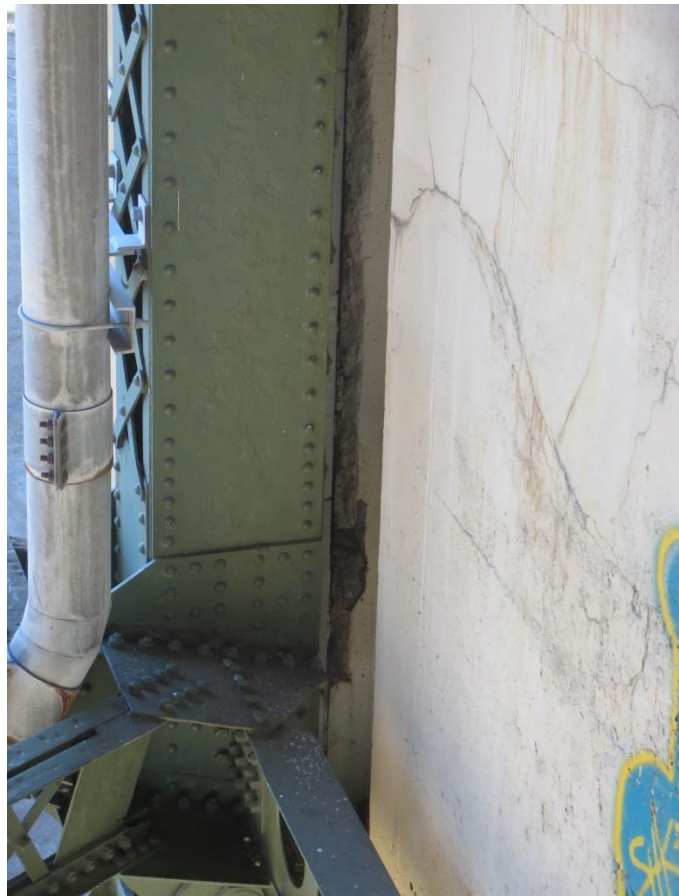
Crack in east pylon backwall

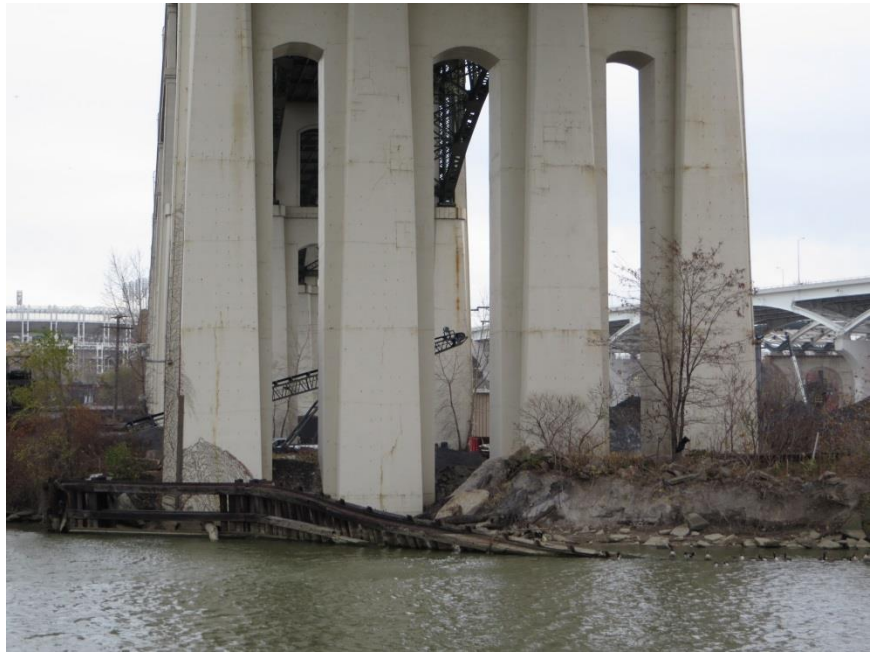
C52. Protection (LF) ded

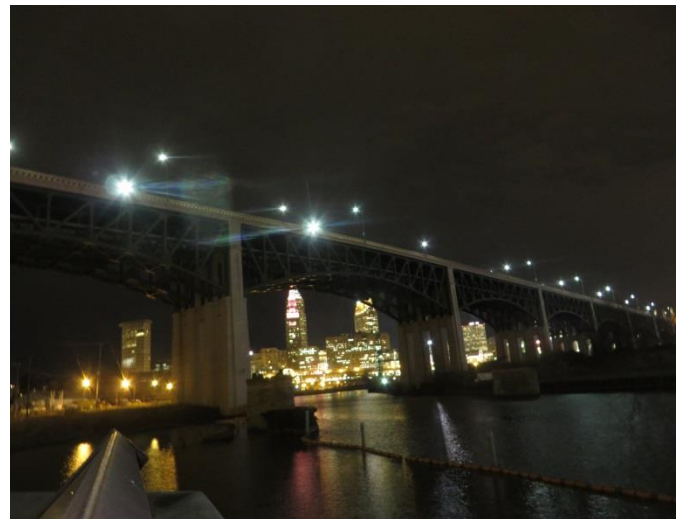
Navigation Lights not working

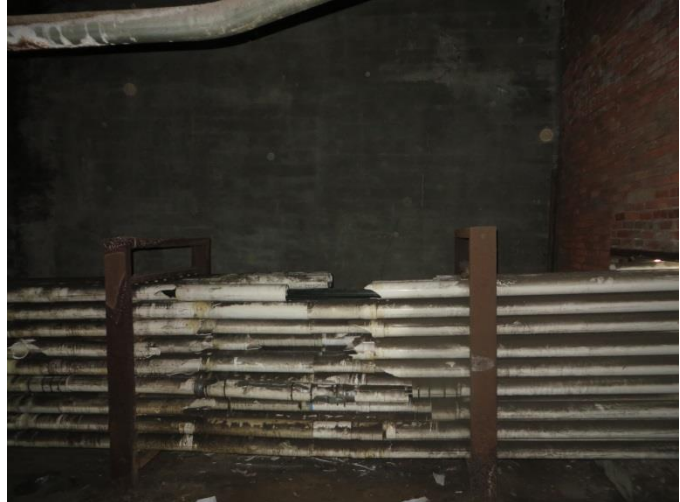
Damaged conduit in east tunnel

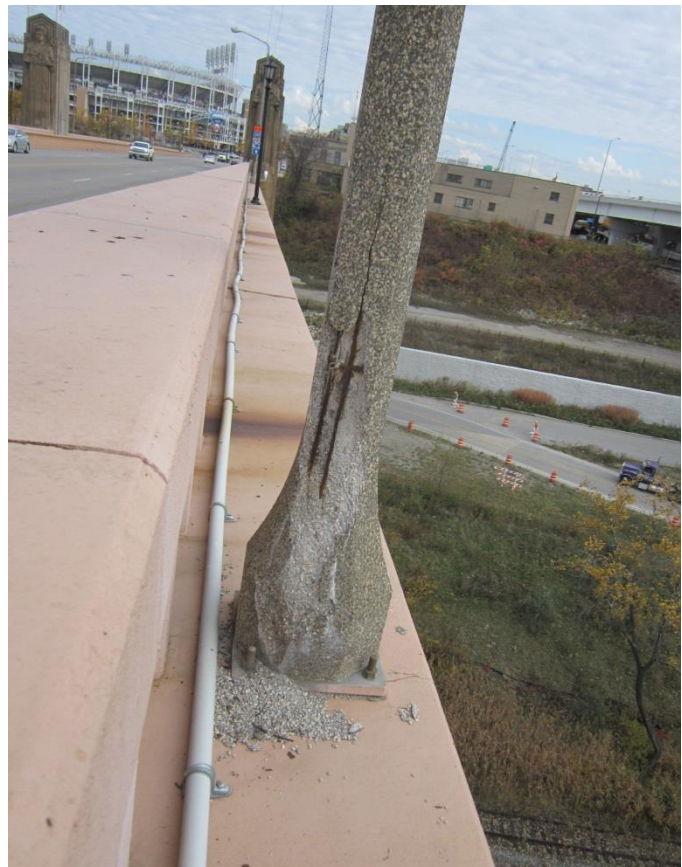
Spalled light post on south railing

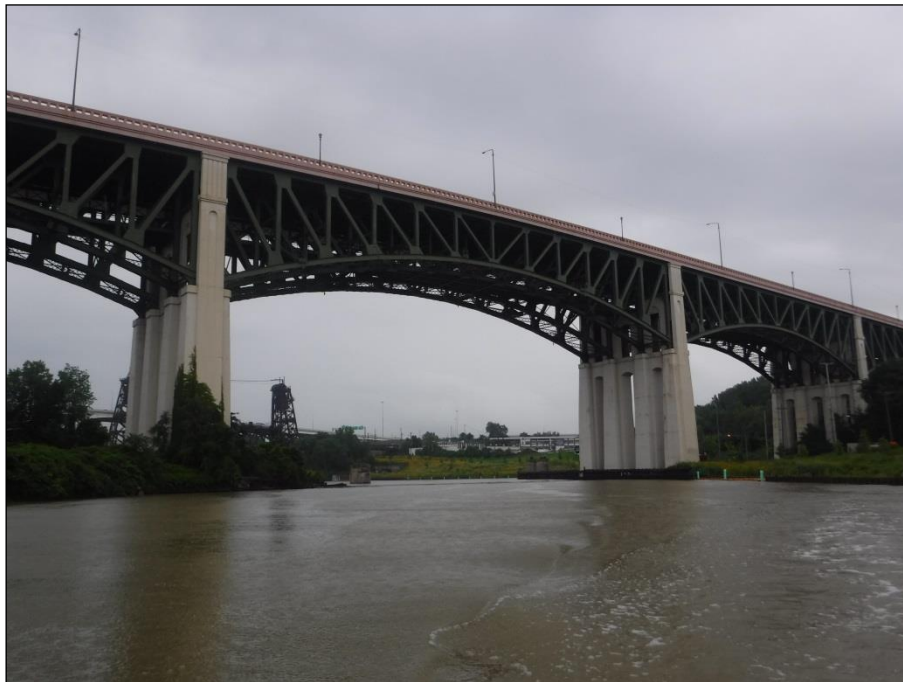
(North Elevation of Bridge)

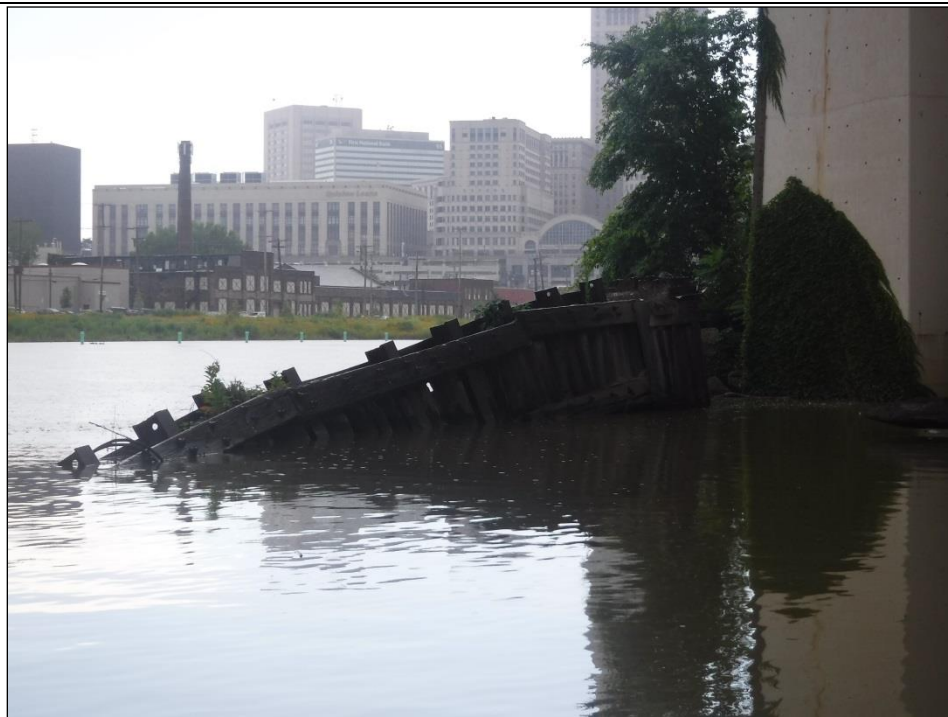
Photograph
10
View of failed
East Fendering
System, Looking
North.

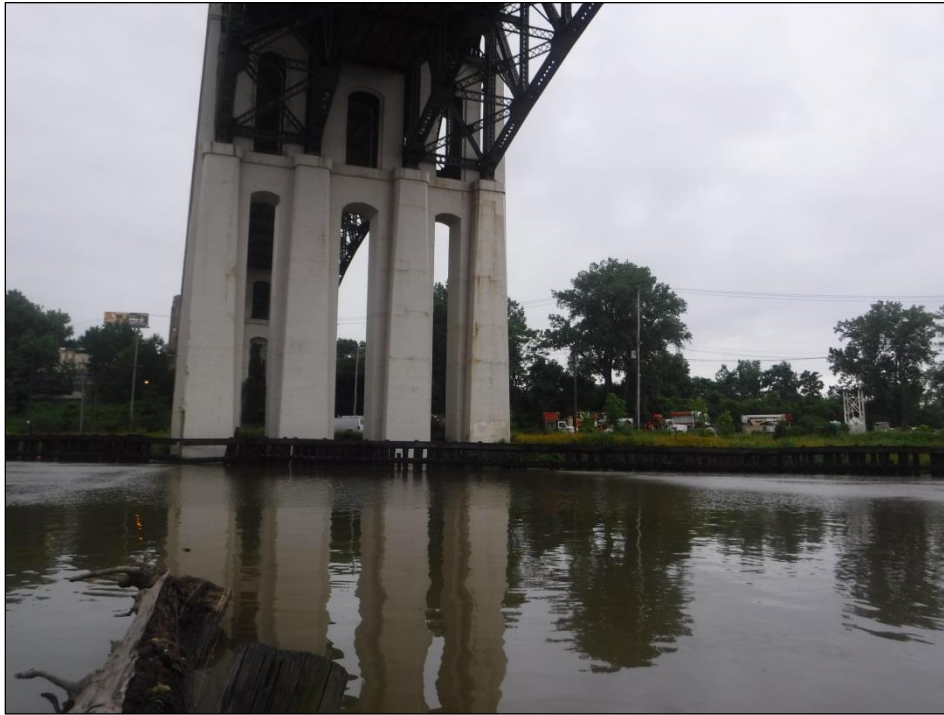
Photograph
11
View of Pier 10,
East Face.
Looking West.

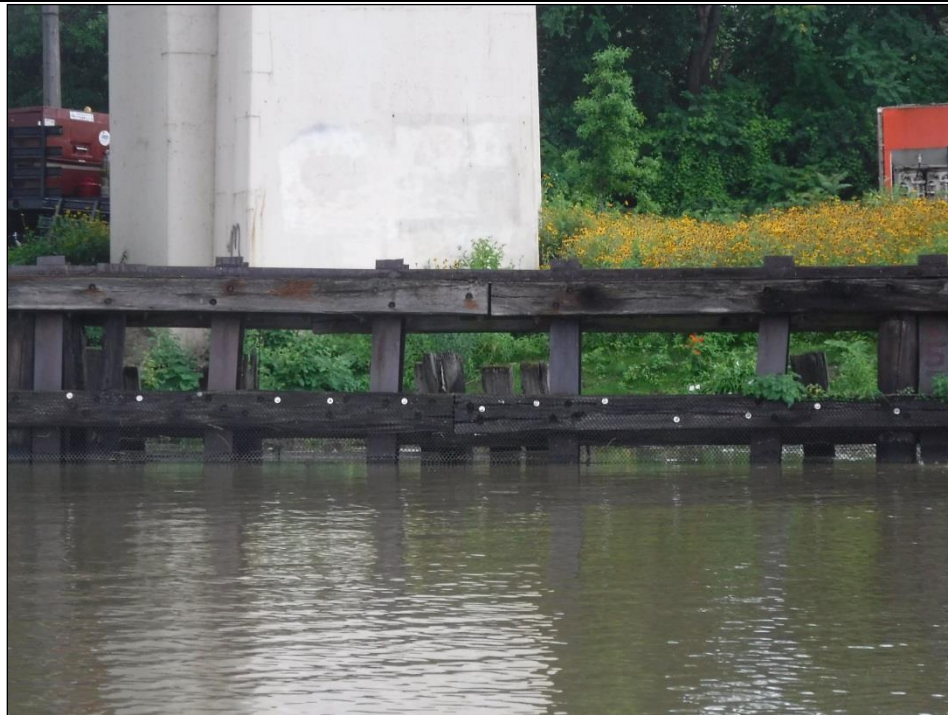
Photograph 14
View of typical condition of West fendering system, Looking West.
