CUY-0010-1613

SFN 1801503

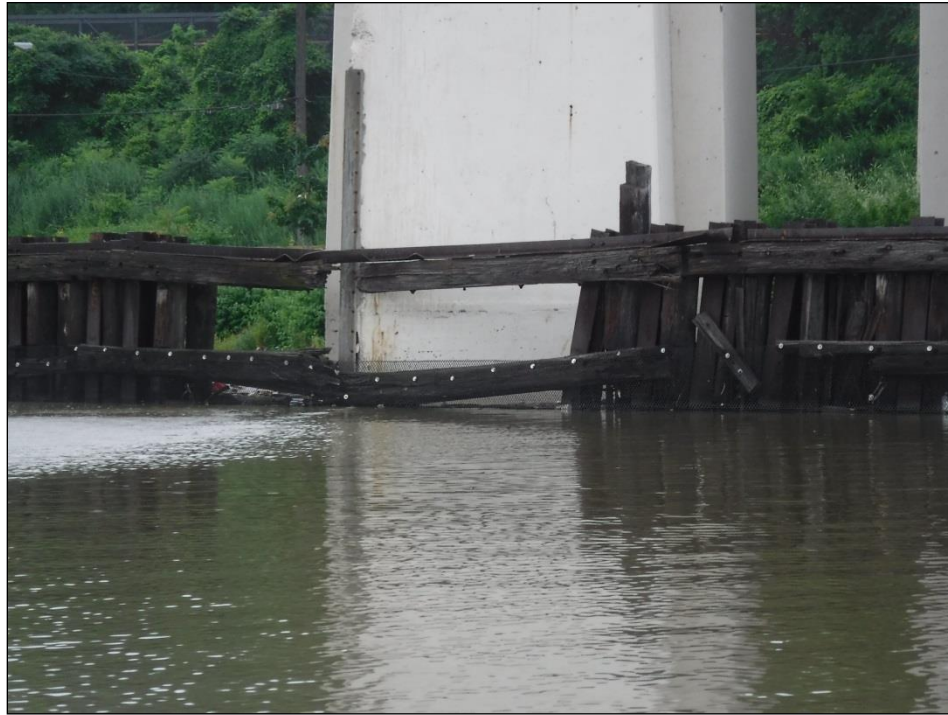
Photograph
15
View of damage
to West
fendering system
near Column D
of Pier, Looking
Southwest.

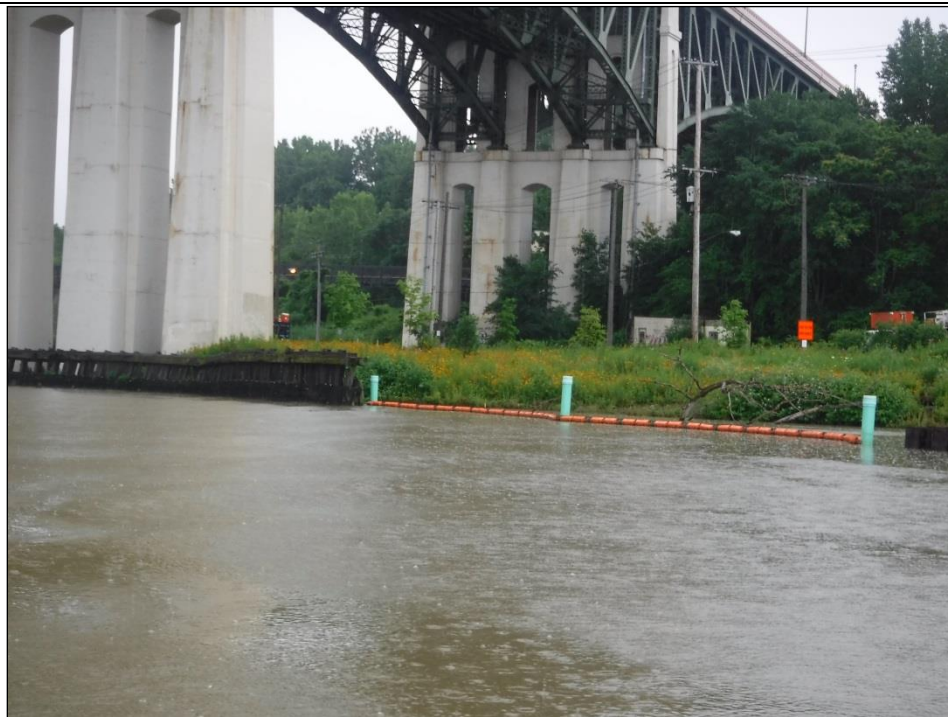
Photograph
16
View of
Northwest
Embankment.
