BRIDGE INSPECTION REPORT

1802771
Structure File Number

BRIDGE NUMBER CUY 00020 2295

DIST 12 Bridge Type 595 TYPE SERVICE 5 5 W BRANCH DUGWAY BROOK

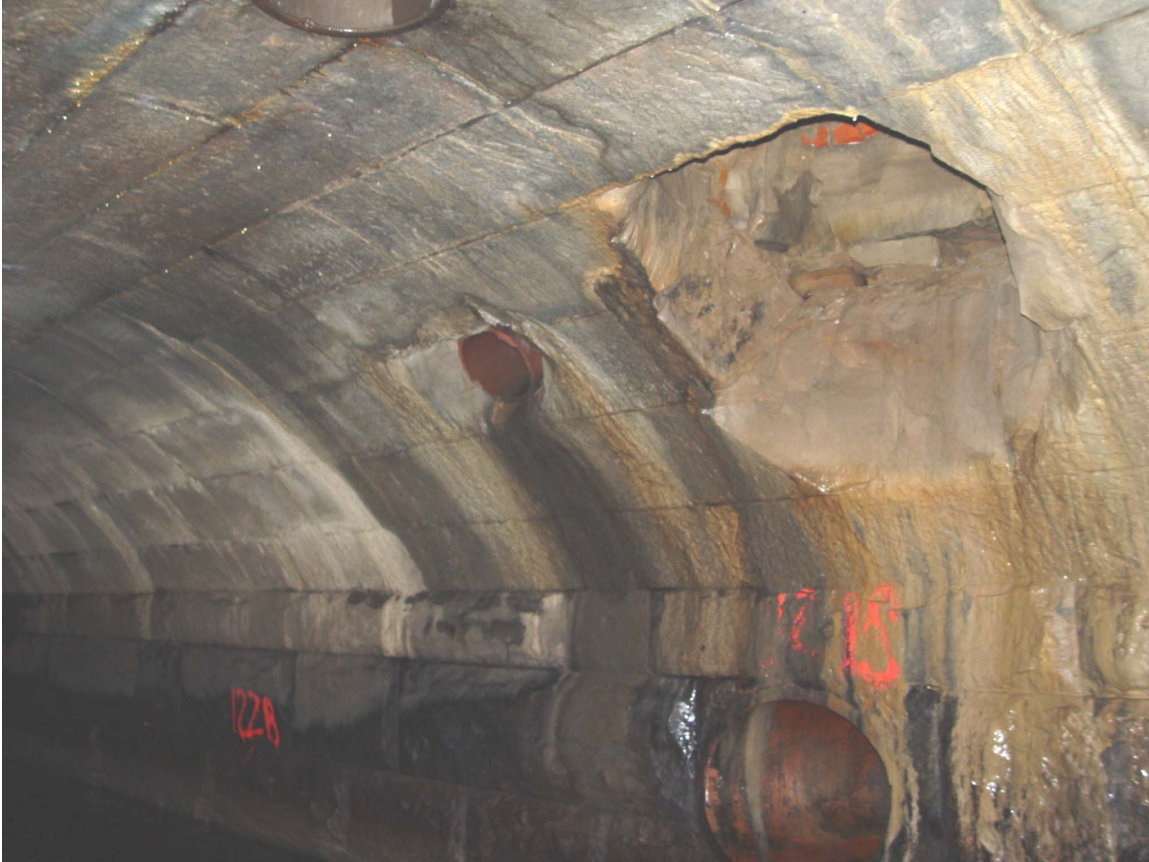
CUY-20-2295 SFN 1802771
West Branch of Dugway Brook
Photo taken on 10/21/04

GENERAL: SPALLS. MORTAR CRACKS AND MORTAR MISSING IN SOME AREAS (PROBE AS DEEP AS 13" TO MISSING MORTAR VOIDS). MISSING STONE AT INLET; SEE ATTACHED PHOTO #1 DATED 10/21/04.

Photo 1. Stones have been removed from arch to a connect catch basin.
