BRIDGE INSPECTION REPORT

BRIDGE NUMBER CUY 00020 2295

Inspection Report for:

West Branch of Dugway Brook under U.S. Route 20 below Lake View Cemetery in Cleveland, Ohio (Stone Arch and Reinforced Concrete Culvert)

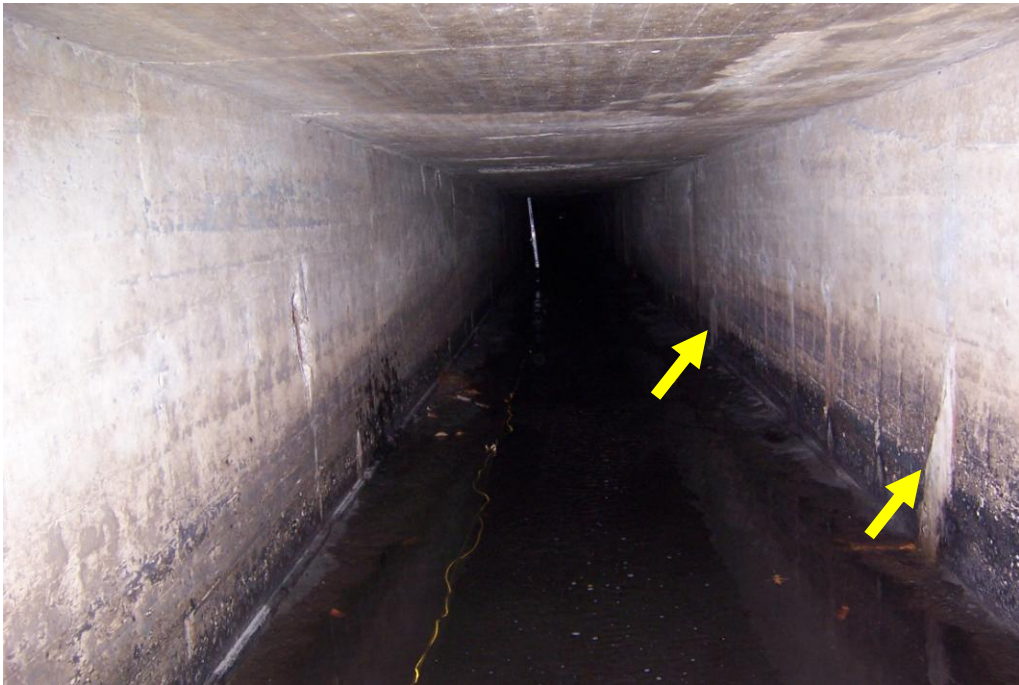
- The walls and the top slab of the reinforced concrete box culvert have several wrap-around hairline cracks with efflorescence (see Photo 3).
- The bottom slab of the reinforced concrete box culvert is undermined at the south end of the stone arch culvert. The area of undermining is 1.2' high x 2.7' deep along the full width of the culvert (see Photo 22).

Photo 3 – Facing South. Concrete Box Culvert. Also showing typical hairline wrap-around cracks.

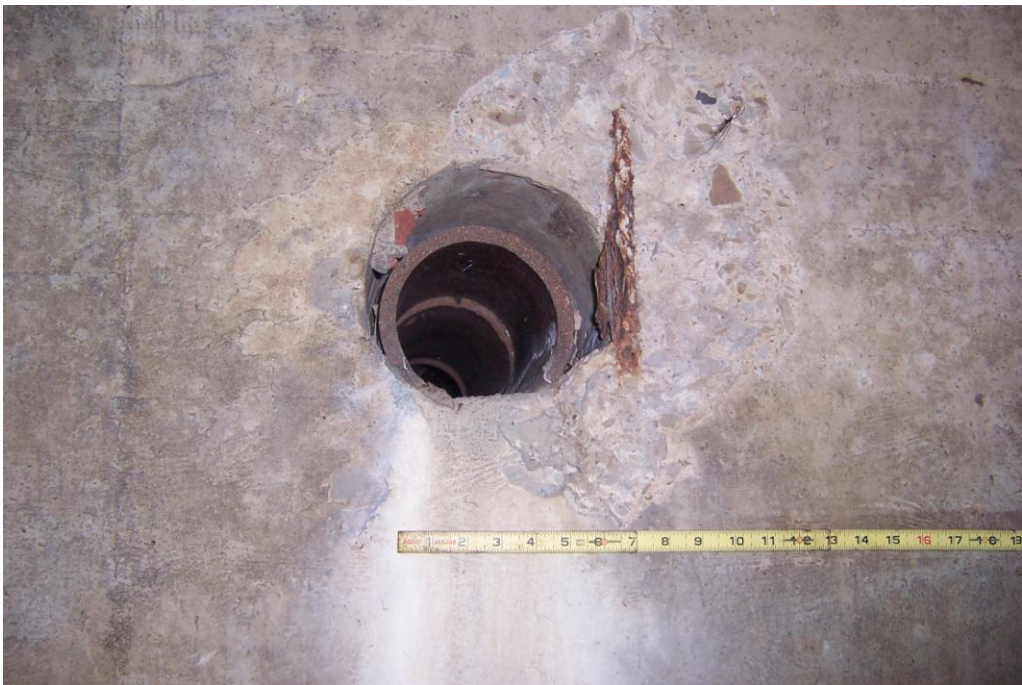
*Photo 8 – Facing West. 20’ north of the cemetery entry manhole.
6” diameter inlet pipe with an adjacent 8” wide x 16” high x 1” deep spall with exposed
corroded reinforcing steel.*

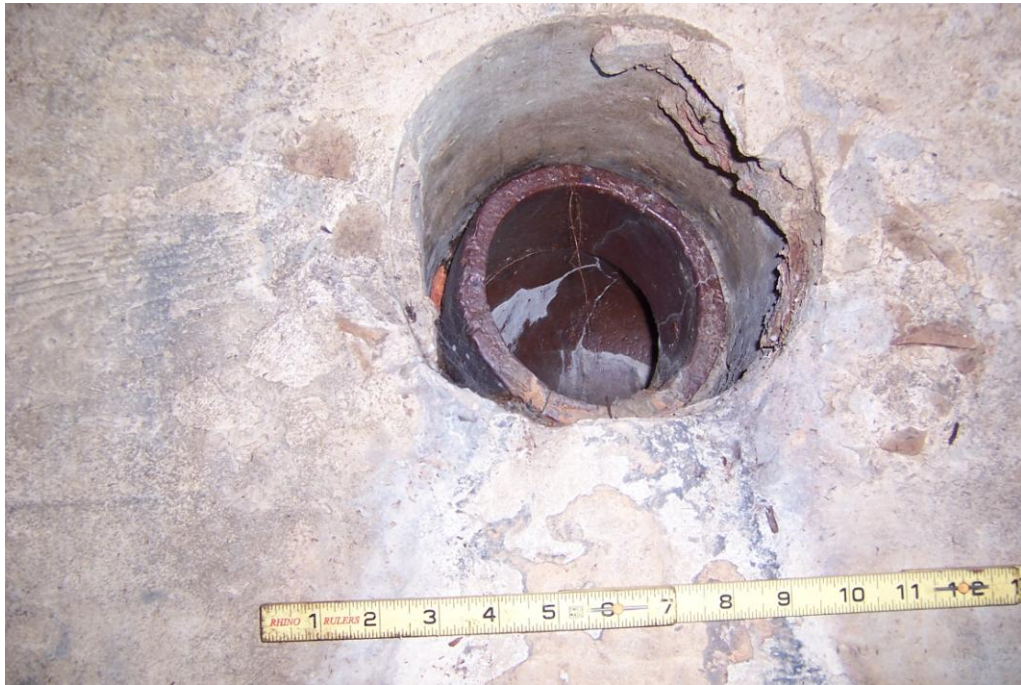
*Photo 9 – Facing East. 20’ north of the cemetery entry manhole.
6” diameter inlet pipe with edge spalling.*

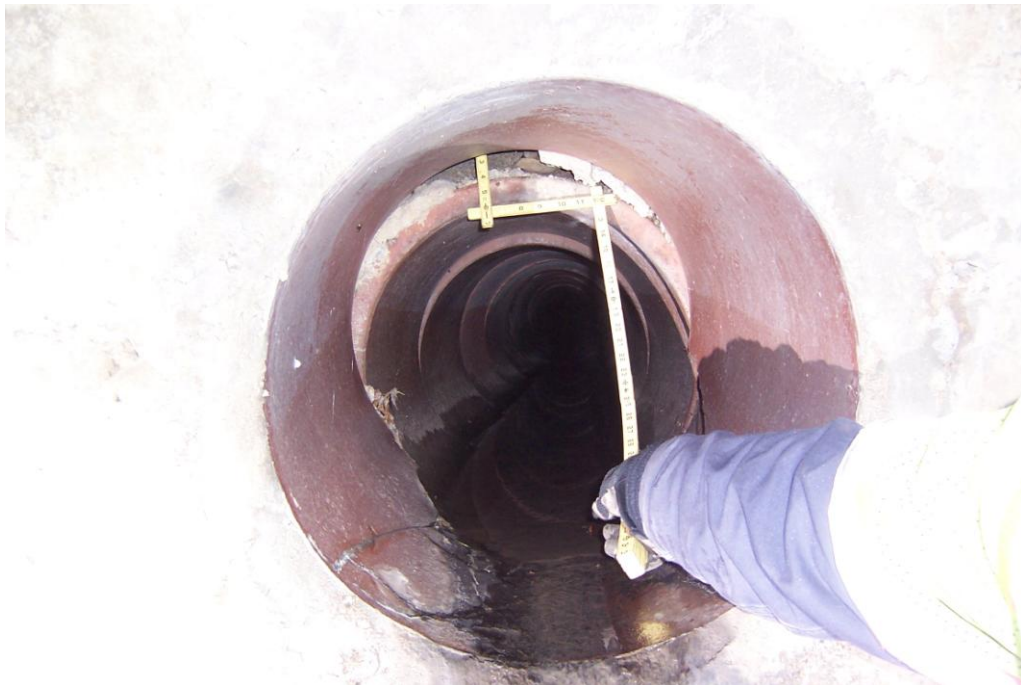
*Photo 10 – Facing West. 20’ north of the cemetery entry manhole.
18” diameter inlet pipe with an offset section and exposed fill.*

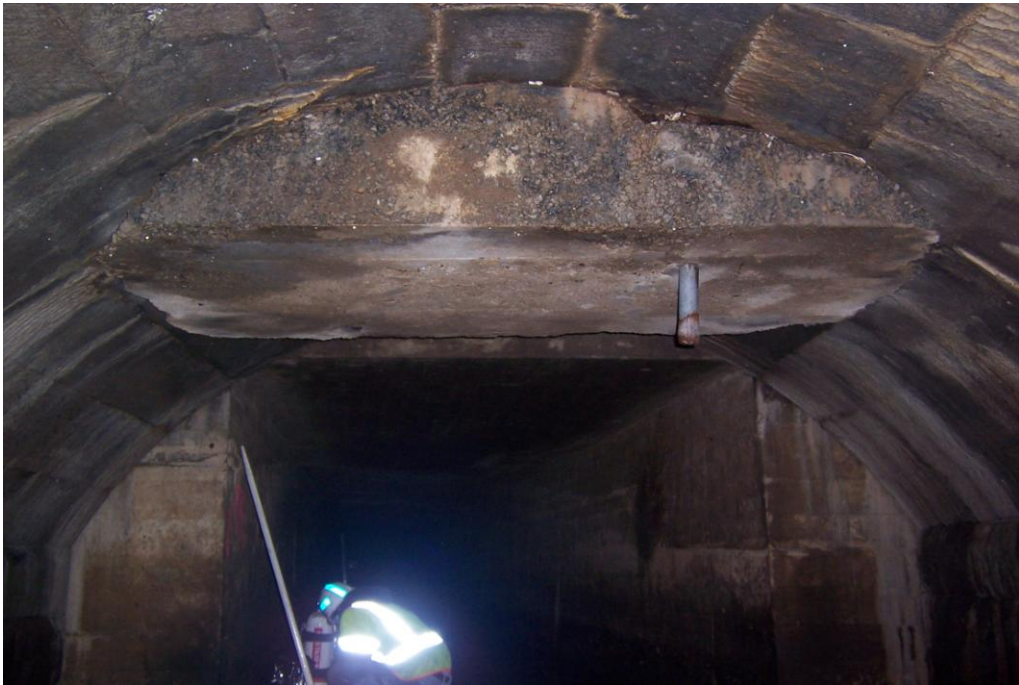
- The stone arch culvert has a roughly formed rectangular concrete pour in the crown near the south end with a 3" diameter steel drain pipe (see Photo 19). The concrete pour has scaling and spalling along the edges up to 1" deep. Although the exact purpose of the concrete is unknown, its location (running adjacent to Route 20) suggests that it may be enclosing sewer, water or utility lines.

Photo 19 – Facing South. 110’ north of the cemetery entry manhole.
Concrete pour at the south end of the stone arch culvert.

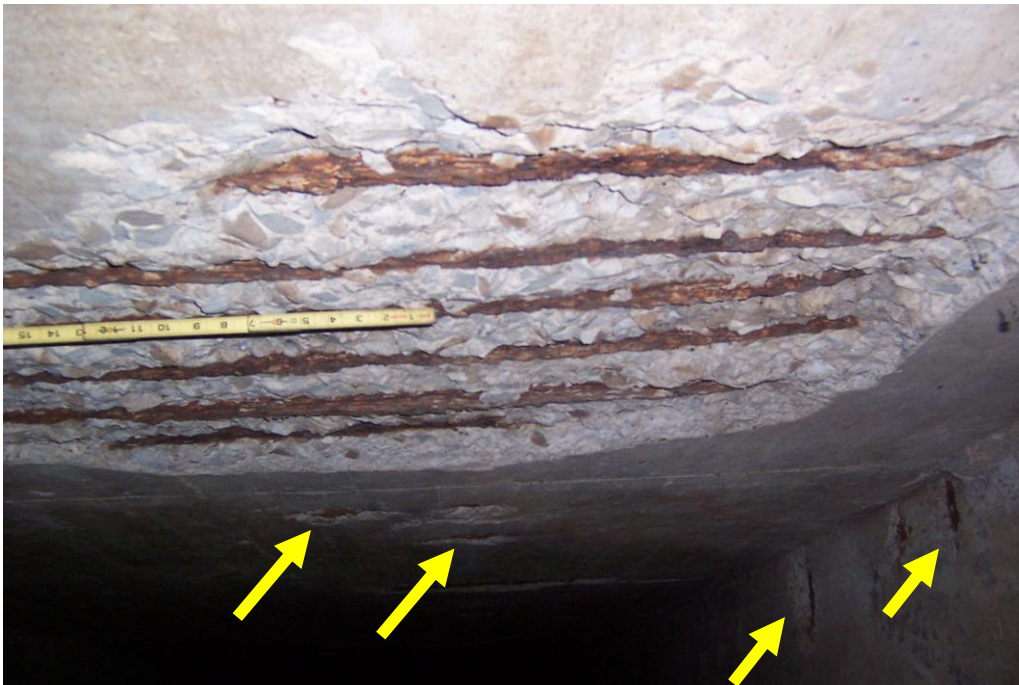
- All the ladder rungs at the cemetery entry manhole are corroded and have 100% section loss.
- The reinforced concrete box culvert has several spalls up to 2' diameter x 2" deep throughout with exposed rusted reinforcing steel. Photo 20 shows a few of these spalls along the top slab and the west wall.

- There is a 3' diameter x 4" deep spall with exposed corroded reinforcing steel in the top slab of the reinforced concrete box culvert 75' from the cemetery entry manhole (see Photo 20).

Photo 20 – Facing South. 75’ north of the cemetery entry manhole. 3’ diameter x 4” deep spall with exposed reinforcing steel in the top slab of the box culvert. Also showing typical spalls along the top slab and west wall.

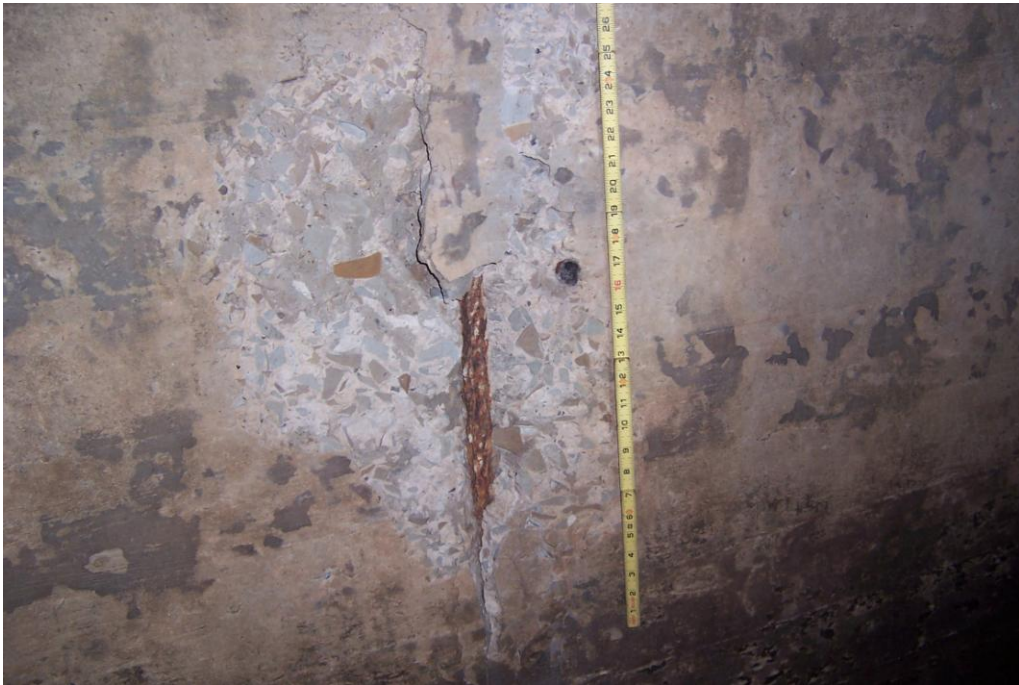
- There is a 30" high x 18" wide x 3" deep spall with exposed reinforcing steel in the east wall of the reinforced concrete box culvert, 85' from the cemetery entry manhole (see Photo 21).

Photo 21 – Facing East. 85' north of the cemetery entry manhole.
30" high x 18" wide x 3" deep spall with exposed reinforcing steel.

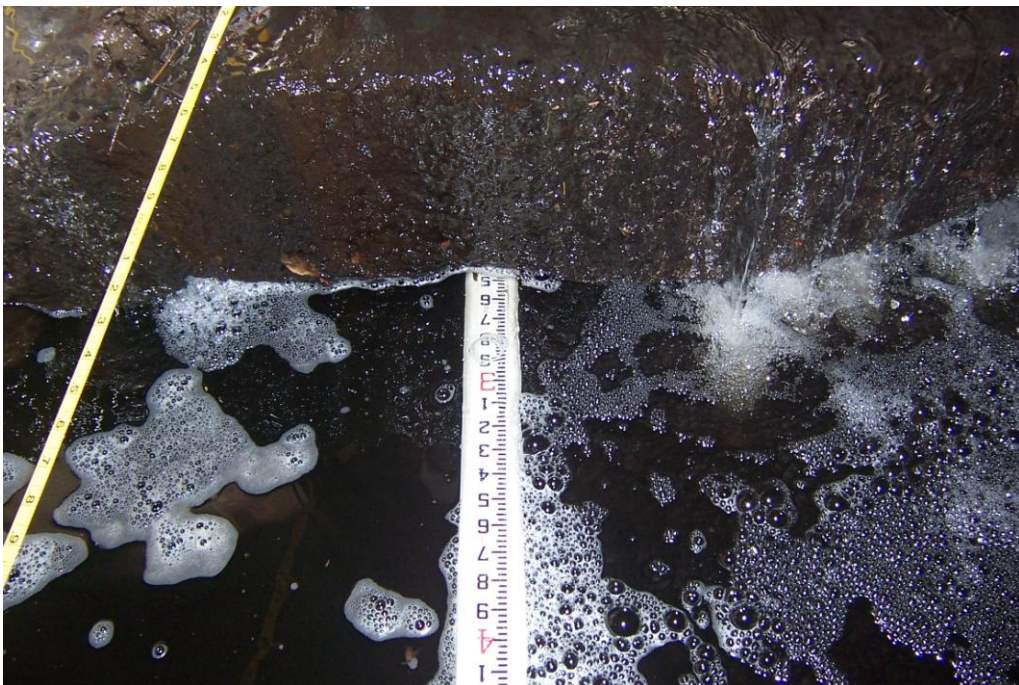
SCOUR: AT UPSTREAM INTERSECTION OF THE TWO CULVERT TYPES, THE REINFORCED CONCRETE BOX CULVERT HAS AN UNDERMINED AREA, UP TO 1.2'X 2.7'X THE WIDTH OF THE CULVERT. SEE ATTACHED DIVER REPORT DATED 11/1/10.

The underwater inspection found the cut stone culvert to have a smooth rock bottom with no signs of scour. At the upstream intersection of the two culvert types, the reinforced concrete box culvert has up to 1.2' high x 2.7' deep x full width undermining of the discharge concrete slab. Although this concrete undermining is not significant enough to jeopardize the structural integrity of the culvert system, it should be monitored and measured with routine inspections.

The culvert's condition has changed very little since the previous inspection. The undermining at the south end of the stone arch culvert has increased by 0.3'. Two large stones with unknown origin were found along the bottom of the stone arch culvert. There are several wrap-around cracks with efflorescence in the reinforced concrete box culvert. Soundings were taken along the walls and centerline of the stone arch culvert to serve as a benchmark for future inspections to track any changes to the floor of the culvert.

Photo 22 – Facing South. 106' north of the cemetery entry manhole.
Undermining of the bottom slab of the concrete box culvert at the south end of the stone arch culvert (1.2' high x 2.7' deep x full width)

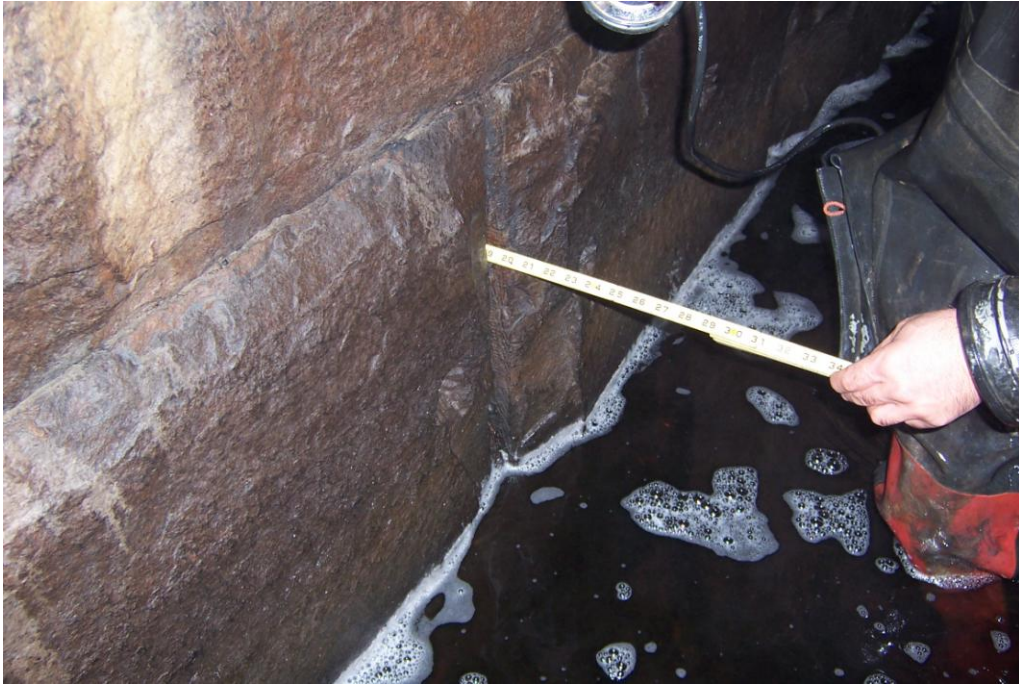
HEADWALLS: MORTAR CRACKS AND MORTAR MISSING.

- The stone arch culvert has missing mortar along the waterline and minor efflorescence along the joints (see Photo 23).
- Two 3' diameter stones are present on the floor of the stone arch culvert, one at the southwest corner and one near mid-length.

Photo 23 – Facing West. Typical missing mortar along the waterline of the stone arch culvert.
