BRIDGE INSPECTION REPORT

BRIDGE NUMBER CUY 00020 2295

**Inspection Report for:**

West Branch of Dugway Brook under U.S. Route 20 below Lake View Cemetery in Cleveland, Ohio (Stone Arch and Reinforced Concrete Culvert)

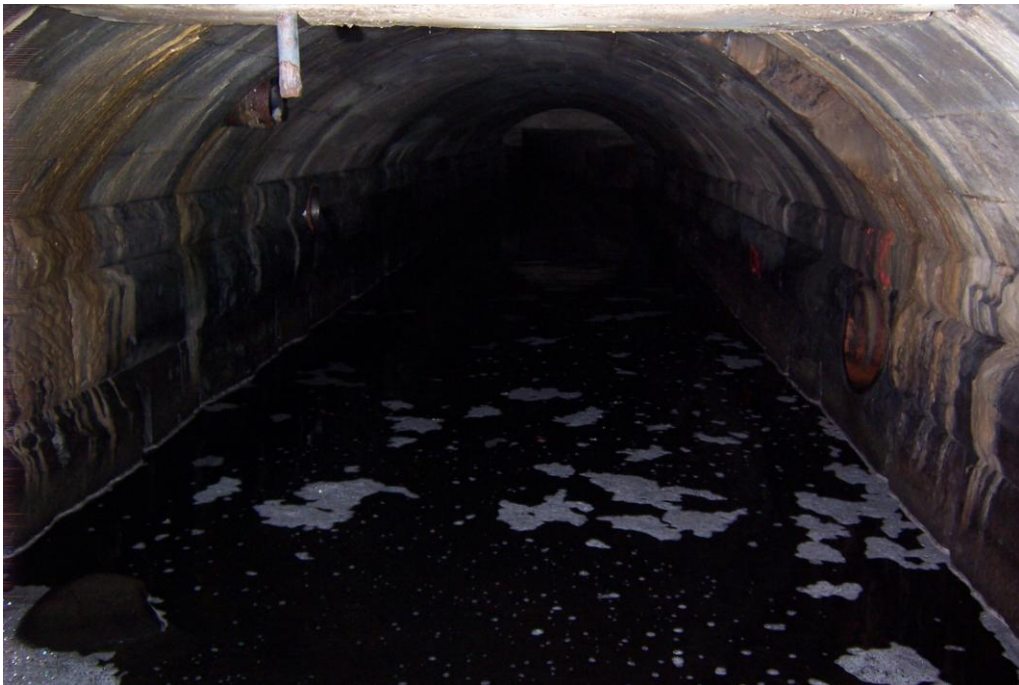
- The arch culvert consists of large stacked cut stones with a smooth stone floor (see Photo 4). There are two large (3' diameter) stones on the floor.

Photo 4 – Facing North. Stone Arch Culvert.

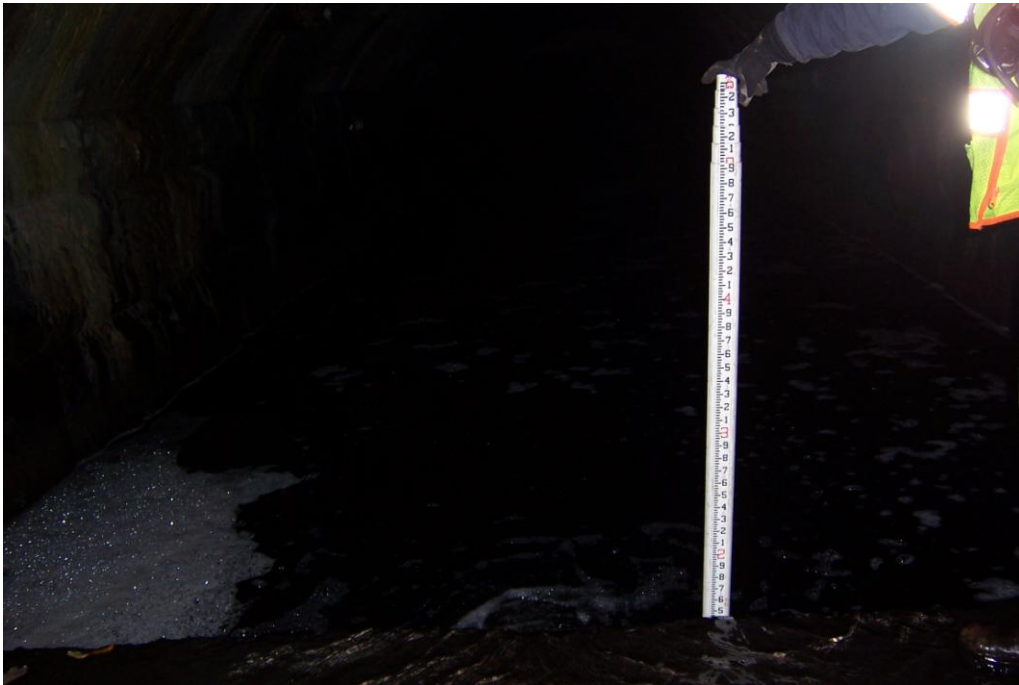
- The stone arch culvert has water depths ranging from 0.5' to 4.3' and flows north into another reinforced concrete box culvert. This is shown in Photo 5 and the Soundings Page. There are two weir walls along the bottom of the box culvert approximately 20' north of the stone arch culvert (see Photo 6).

Photo 5 – Facing North. Water depth at the south end of the stone arch culvert.

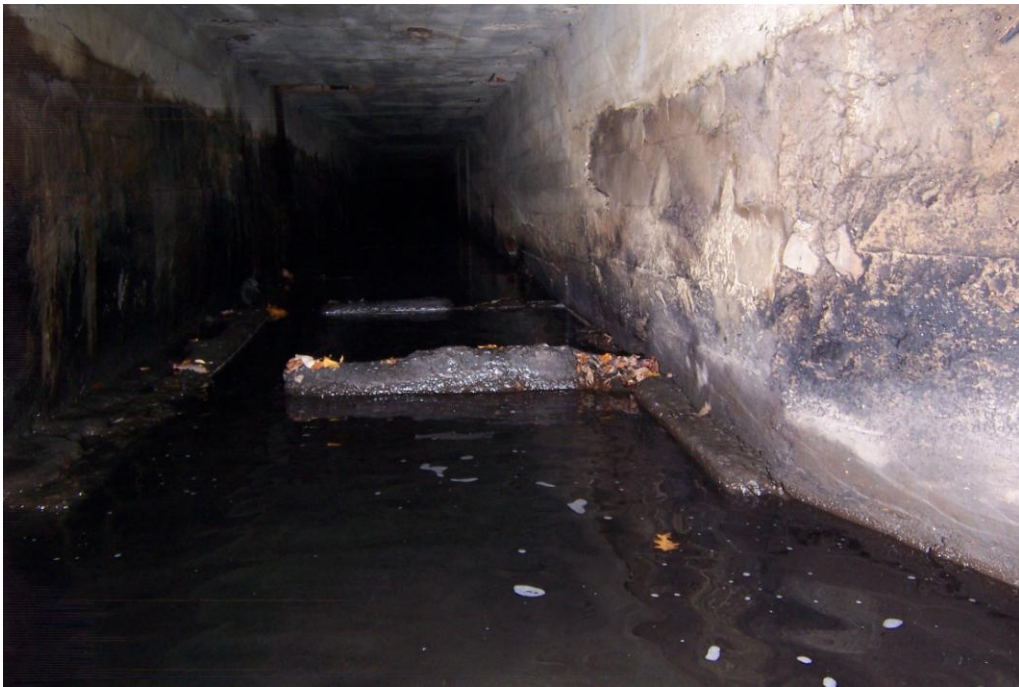
Photo 6 – Facing North. Weir walls along the bottom of the concrete box culvert at the north end of the stone arch culvert.

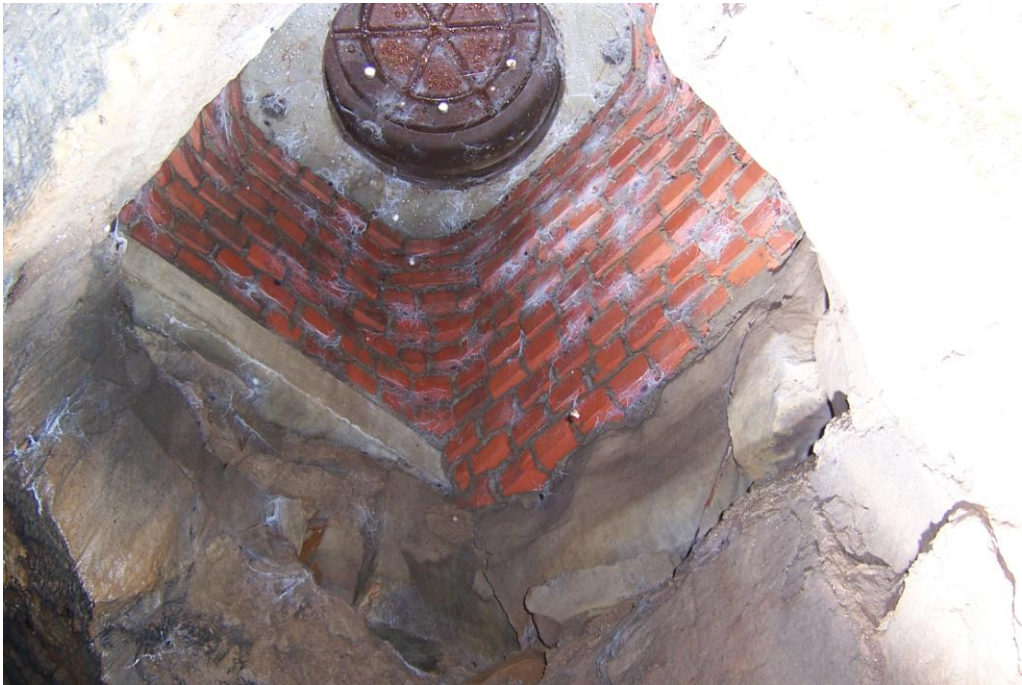
*Photo 7 – Facing Northeast at 122’ north of the cemetery entry manhole.  
Manhole entrance into the stone arch culvert.*

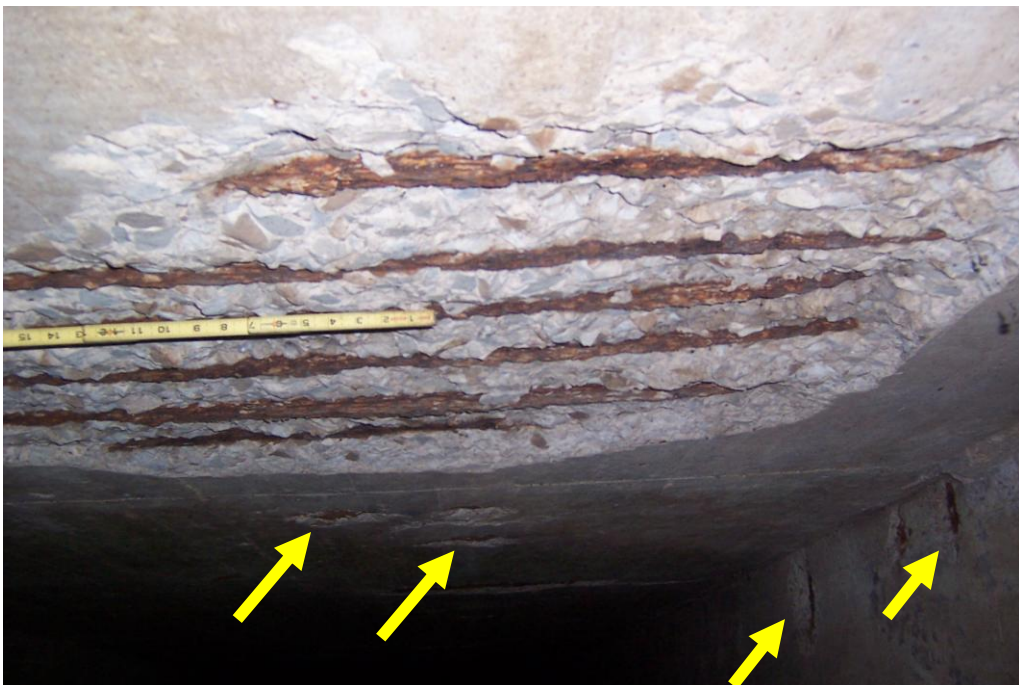
- All the ladder rungs at the cemetery entry manhole are corroded and have 100% section loss.
- The reinforced concrete box culvert has several spalls up to 2' diameter x 2" deep throughout with exposed rusted reinforcing steel. Photo 20 shows a few of these spalls along the top slab and the west wall.

- There is a 3' diameter x 4" deep spall with exposed corroded reinforcing steel in the top slab of the reinforced concrete box culvert 75' from the cemetery entry manhole (see Photo 20).

*Photo 20 – Facing South. 75’ north of the cemetery entry manhole. 3’ diameter x 4”  
deep spall with exposed reinforcing steel in the top slab of the box culvert. Also showing  
typical spalls along the top slab and west wall.*

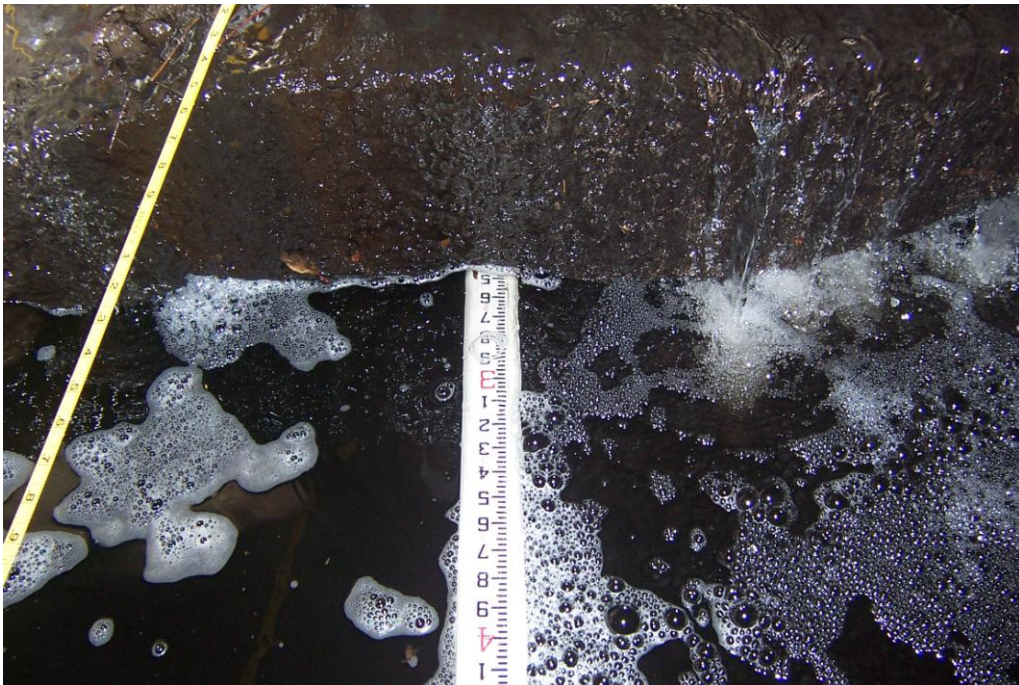
SCOUR: AT UPSTREAM INTERSECTION OF THE TWO CULVERT TYPES, THE REINFORCED CONCRETE BOX CULVERT HAS AN UNDERMINED AREA, UP TO 1.2'X 2.7'X THE WIDTH OF THE CULVERT. SEE ATTACHED DIVER REPORT DATED 11/1/10.

- The walls and the top slab of the reinforced concrete box culvert have several wrap-around hairline cracks with efflorescence (see Photo 3).
- The bottom slab of the reinforced concrete box culvert is undermined at the south end of the stone arch culvert. The area of undermining is 1.2' high x 2.7' deep along the full width of the culvert (see Photo 22).

The underwater inspection found the cut stone culvert to have a smooth rock bottom with no signs of scour. At the upstream intersection of the two culvert types, the reinforced concrete box culvert has up to 1.2' high x 2.7' deep x full width undermining of the discharge concrete slab. Although this concrete undermining is not significant enough to jeopardize the structural integrity of the culvert system, it should be monitored and measured with routine inspections.

Photo 22 – Facing South. 106' north of the cemetery entry manhole.  
Undermining of the bottom slab of the concrete box culvert at the south end of the stone arch culvert (1.2' high x 2.7' deep x full width)
