## BRIDGE INSPECTION REPORT

BRIDGE NUMBER CUY 00071 1791 R

CUY-71-1791 R      SFN 1805371

I-71 over SR 176

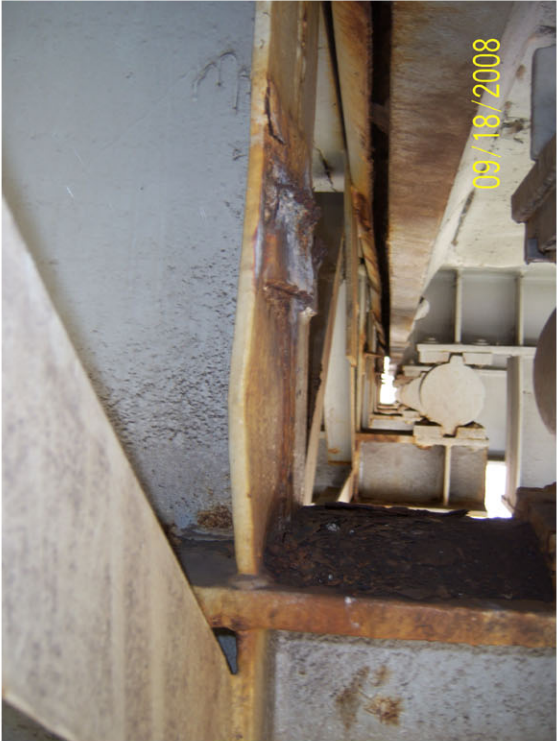
HINGES: RUST SECTION LOSS. A FEW BENT STIFFENERS. SEE  
ATTACHED PHOTO DATED 09/18/08.

Under Joint 1A bent stiffener of Beam 3.JPG
