BRIDGE INSPECTION REPORT

1805371
Structure File Number

BRIDGE NUMBER CUY 00071 1791 R

I-71 over SR 176

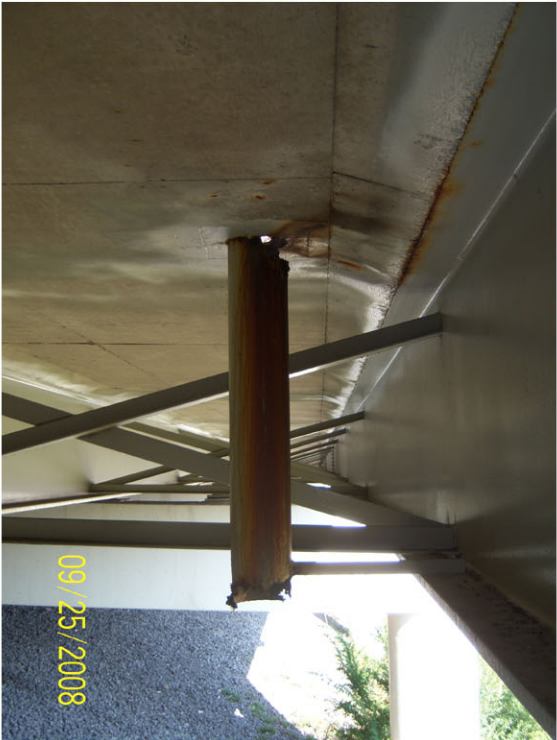
DRAINAGE: HOLES IN DOWNSPOUTS NEAR BOTH MAINLINE ABUTMENTS.
SEE ATTACHED PHOTO DATED 09/25/08. DOWNSPOUT AT
EAST END OF PIER 18 AE IS PLUGGED WITH CONCRETE
AT OUTLET. LOOSE DRAINAGE TROUGH AT JOINT 2A HAS
BEEN REMOVED. DOWNSPOUT PLUGGED @ FINISH ABUT AE.

Holes top and bottom at downspout 1R near star...
