BRIDGE INSPECTION REPORT

BRIDGE NUMBER CUY 00071 1791 R

CUY-71-1791 R; SFN 1805371

I-71 over SR 176

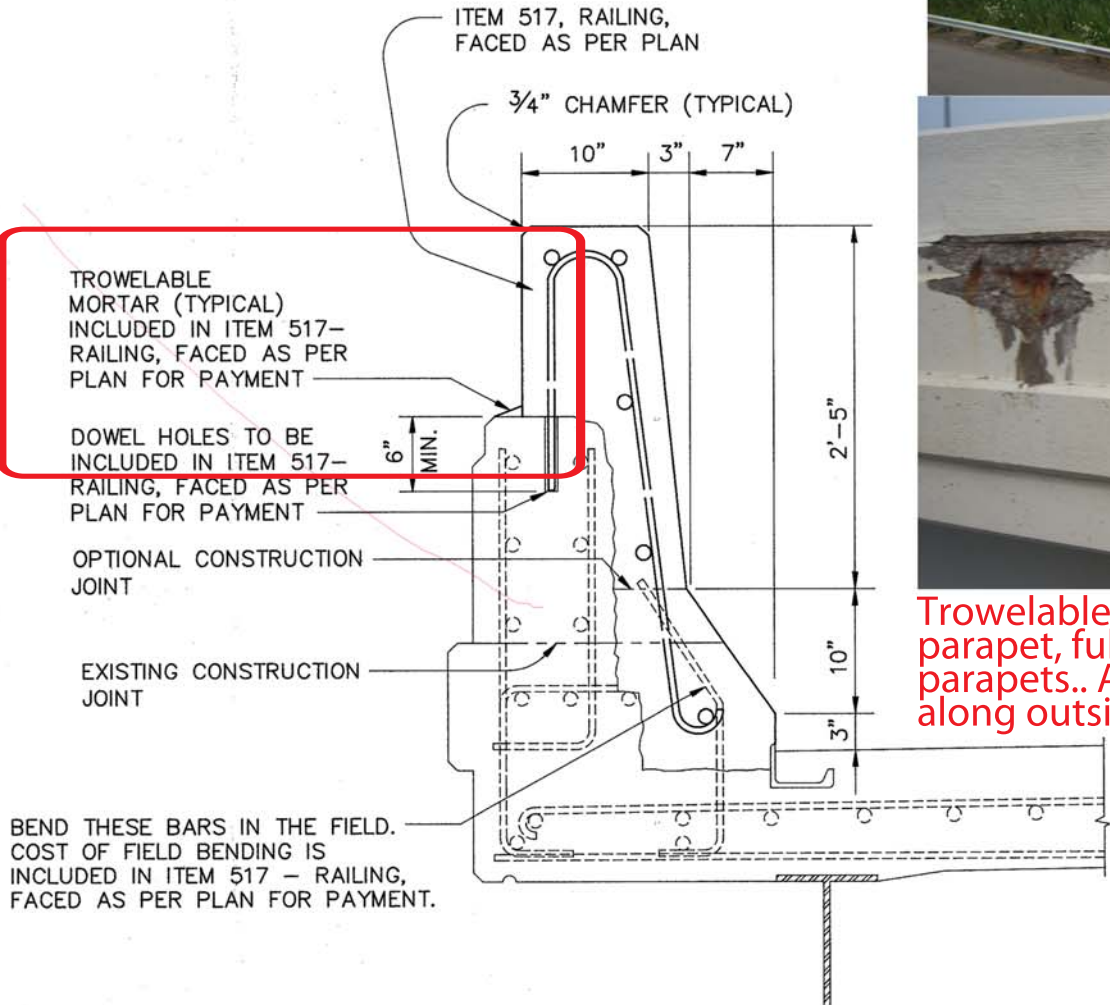
RAILING: SPALLS & DELAMINATED AREAS. 6' LONG DETERIORATED AREA IN RIGHT RAIL OF RAMP TO WEST 14TH/WB 90 (UNIT 4AE). TROWLEABLE MORTAR WEDGE DELAMINATING FROM PARPET RETROFIT (1990) FORMING POSSIBLE SPALLS OVER TRAFFIC. IMPACT ATTENUATOR DAMAGED @ GORE RAMP AE.

Trowelable Mortar delaminating from
parapet, full length, all retrofitted
parapets.. Additional Spalls forming
along outside parapet .

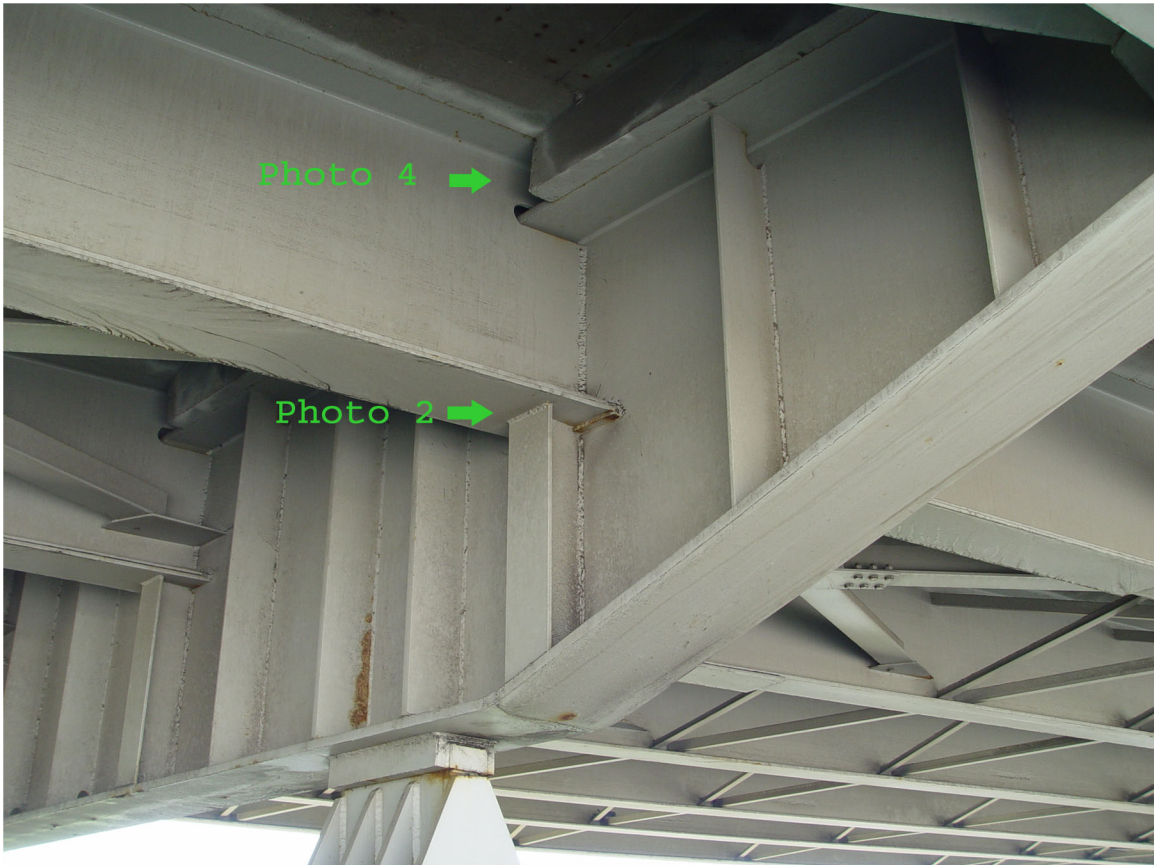
STEEL PIER CAPS HAVE MANY POOR WELDING DETAILS. SEE ATTACHED PHOTOS DATED 07/22/05.

Photo 1. Facing south looking at beam 6 framing into steel pier cap 22AE.

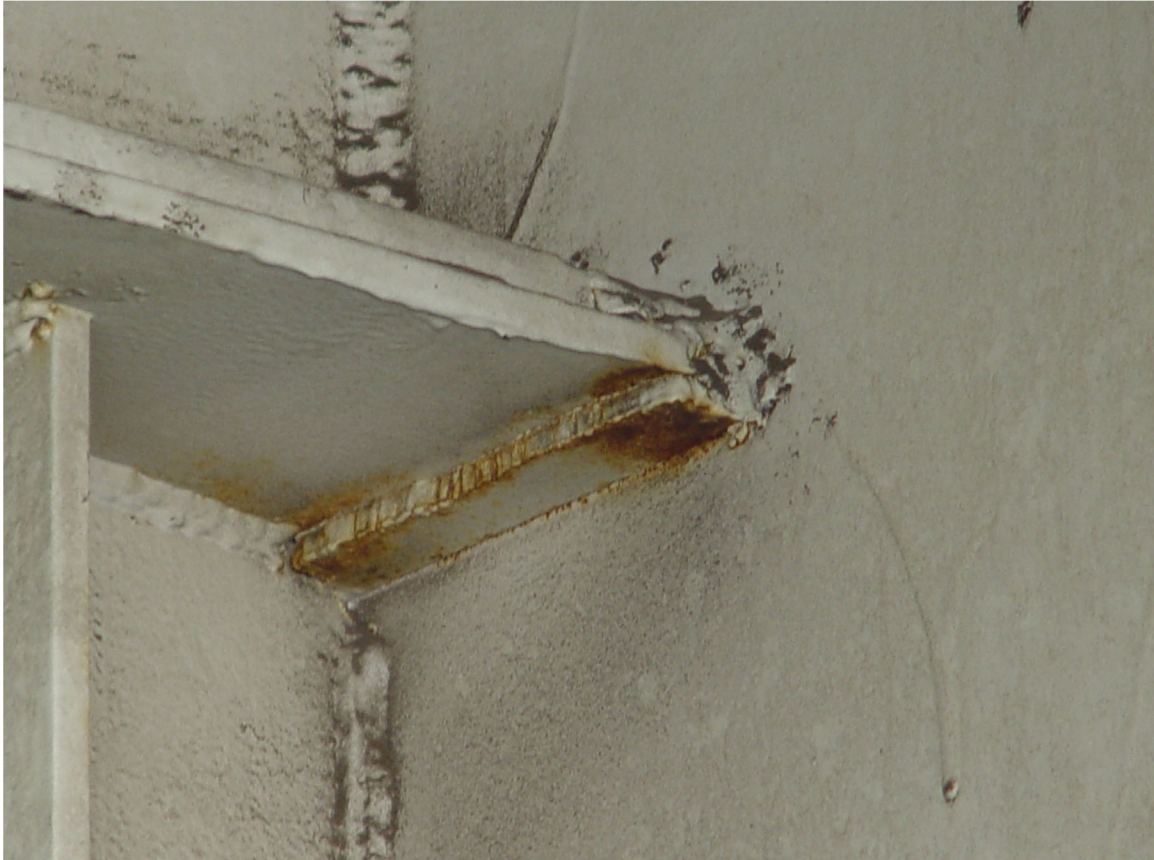
Photo 2. Close up of Photo 1, showing a backer bar used to weld the lower flange of beam 6 into the web of the pier cap.

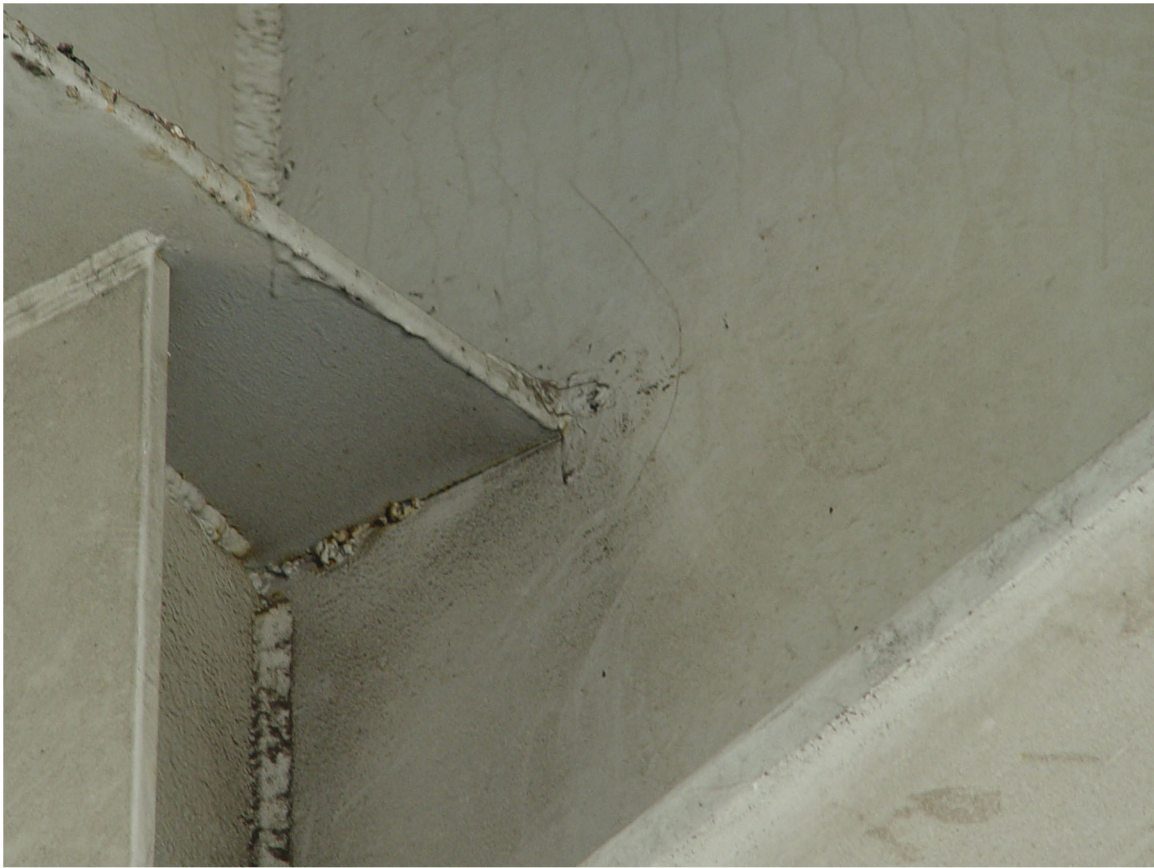
Photo 3. In several locations where a backer bar was not used the weld lacks full penetration between the flange and web plates.

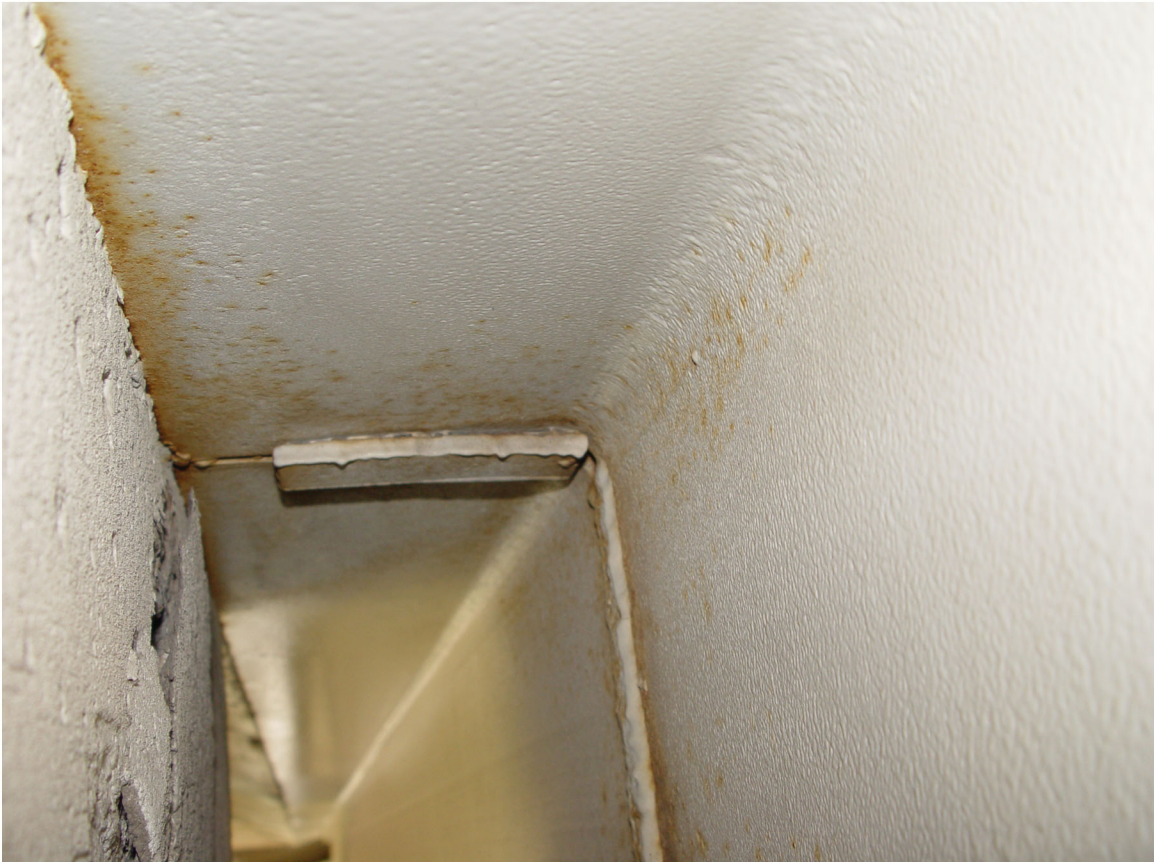
Photo 4. Backer bar and lack of penetration where top flanges were welded together above the steel pier caps.

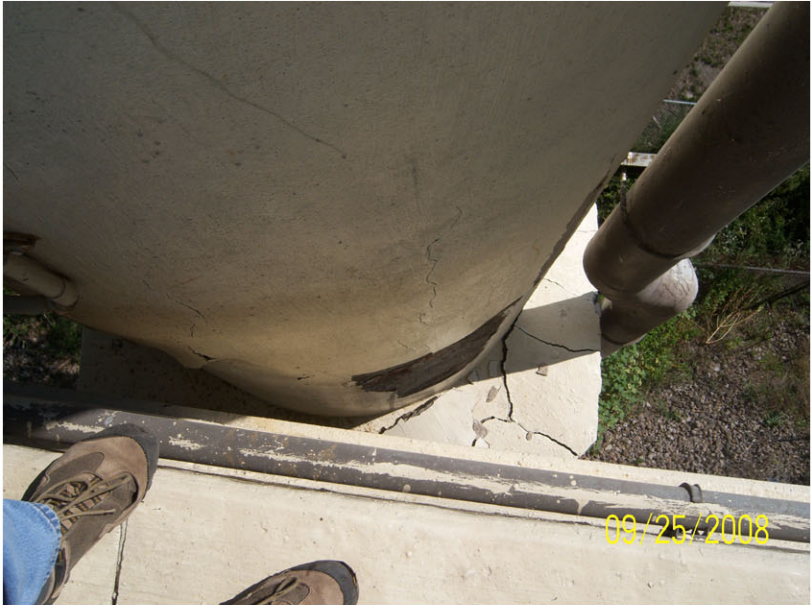
PIERS: DELAMINATIONS AND SPALLS TO COLUMNS BEHIND PARAPETS OF LOWER BRIDGE. SEE ATTACHED PHOTO DATED 09/25/08.

Spalls and delams of right column of Pier14 .JPG

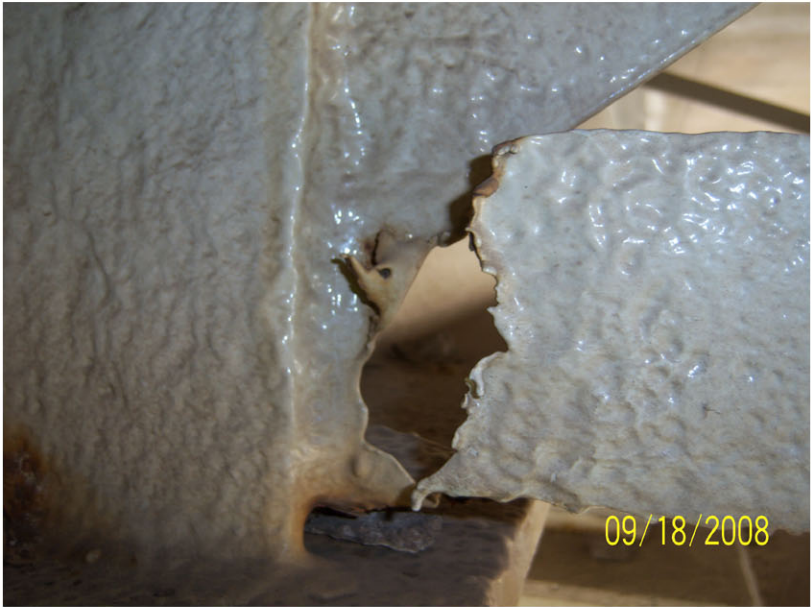
XFRAMES: RUST THRU HOLES, RUST SEVERED ANGLES AND CRACKED WELDS OF XFRAMES UNDER SEATED HINGES. SEE ATTACHED PHOTO DATED 09/18/08.

Under Joint 2A rust severed xframe angle in Bay...
