## **2012 In-Depth Inspection Report**

### **I-71/SR 176 Double Decker Bridge – (I-71 Upper Deck)**

**CUY-00071-1791  
(SFN 1805371)**

**Inspection Dates: 07/30/2012 to 08/10/2012**

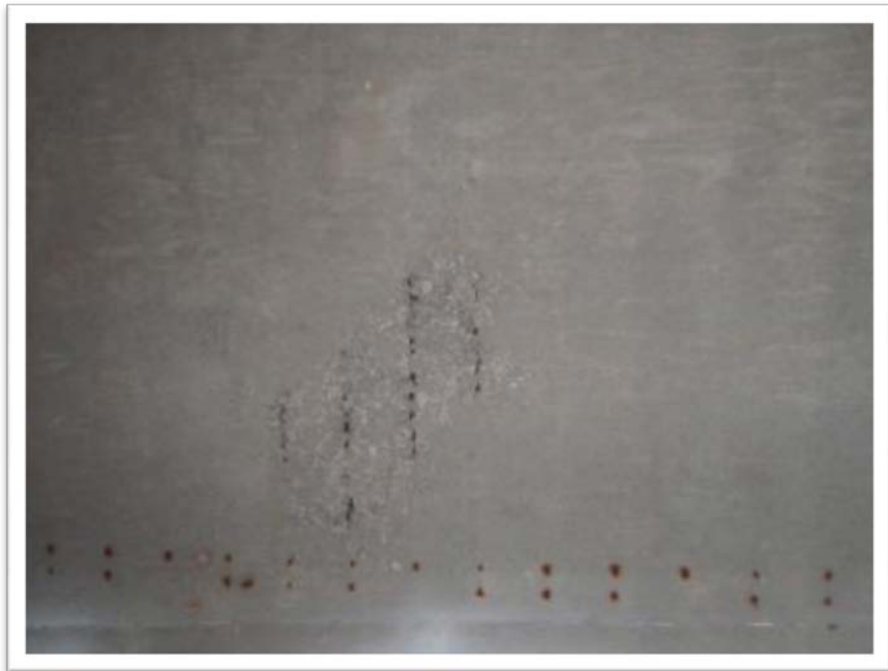
- There is hairline to narrow transverse cracking throughout. Efflorescence is typical.
- Nine areas have honeycombing. The largest area is 2 ½' x 1'.

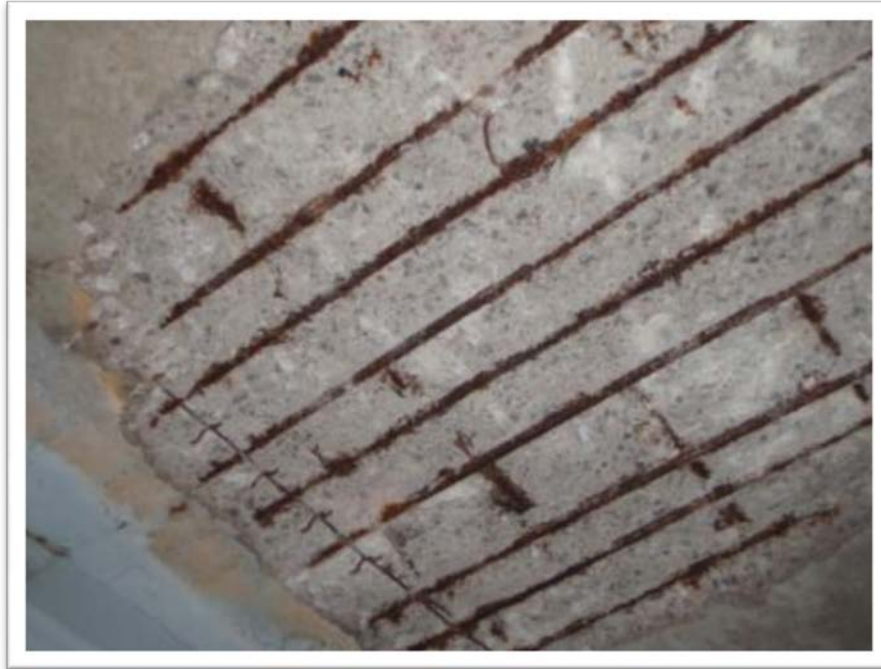
- Map cracking exists in Spans 1, 4, 5, 6, 7, 8, 9, 10, 13, 15, 17, 20AW, 22AW, 18AE, 19AE, 20AE, and 21AE.
- Spalling exists in Spans 2, 3, 5, 7, 8, 9, 10, 11, 16, 17, 20AW, 22AW, 18AE, and 19AE.

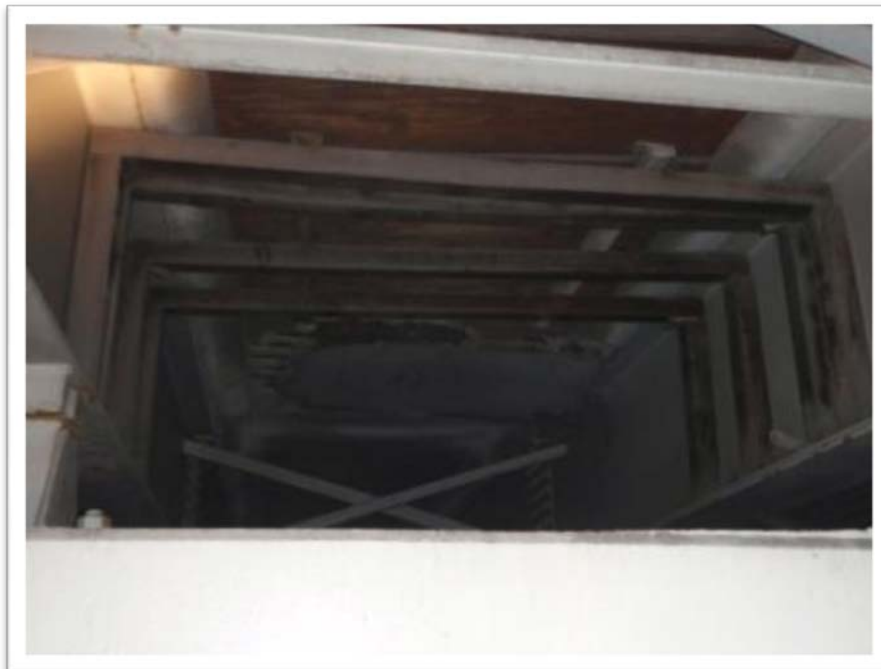
- Delaminations exist in Spans 2, 9, and 20AE.
- Formwork was left in place in Span 20AW.

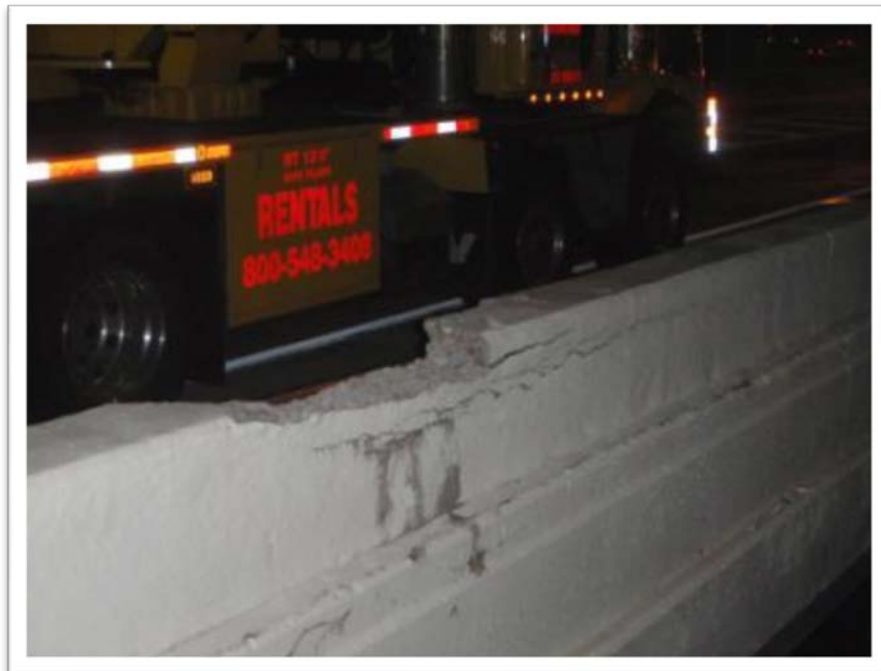
- Spalls and deteriorations exist along the large portions of the toe of the barrier, especially on the low side of the structure.
- There are a few vertical cracks throughout.
- One large spall with exposed rebar was noted between Pier 22AE and the North Abutment AE.

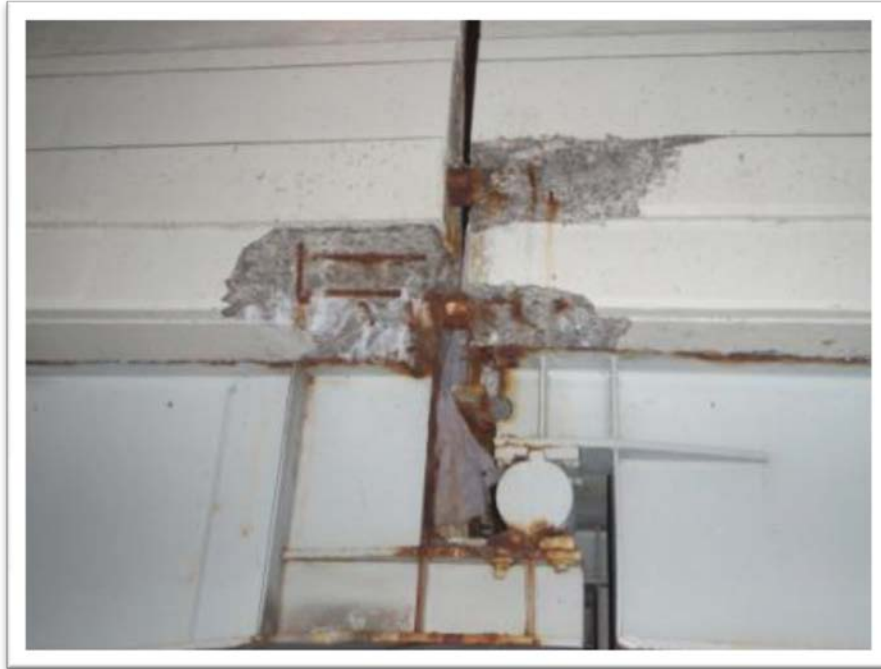
- Multiple spalls (2' x 1' x 3", 2' x 1' x 1", 3" x 1') in the rail's exterior face near the seated hinge in Span 7.

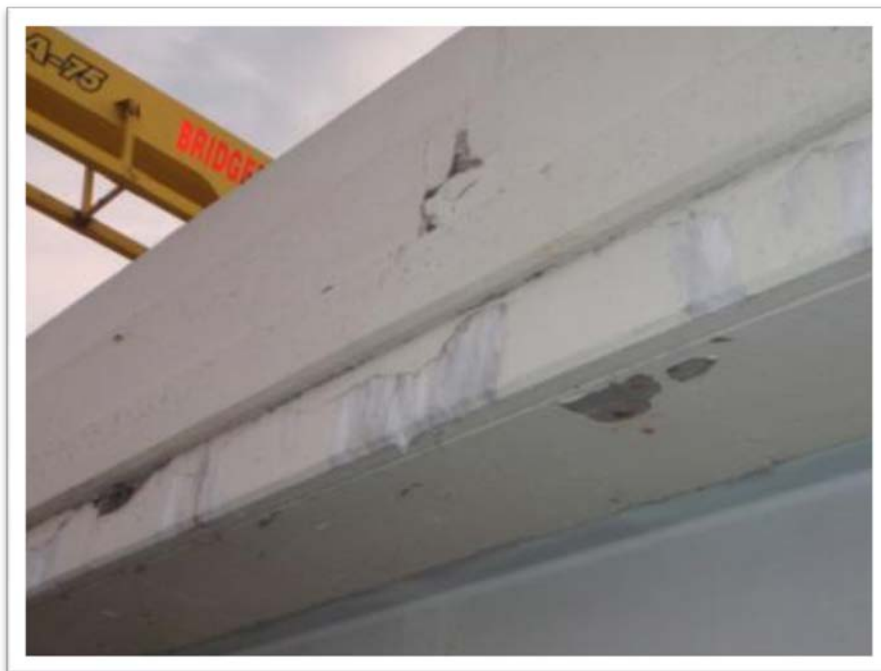
- Longitudinal cracking with efflorescence is typical in the rail's exterior face.

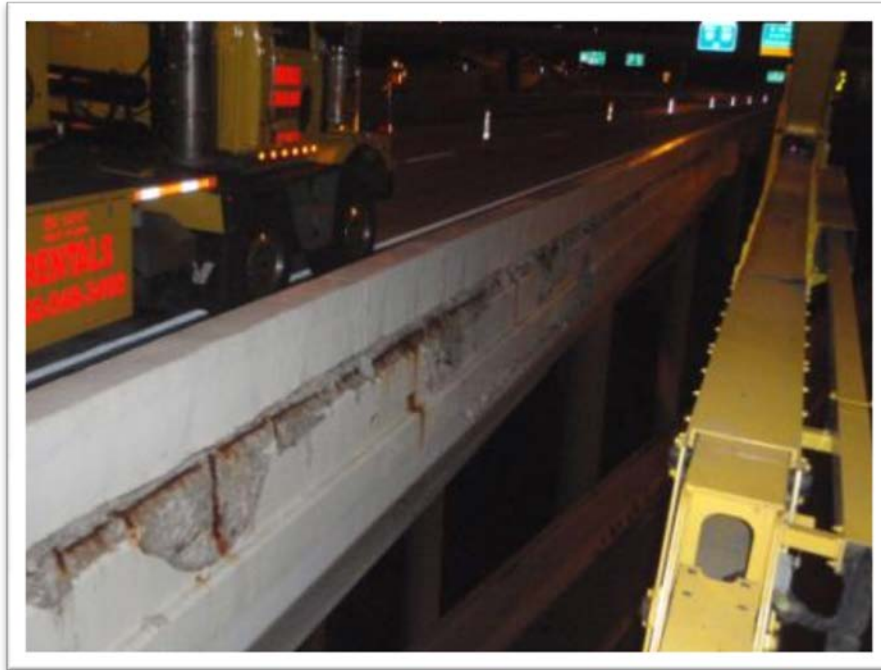
- There is spalling with exposed rebar on the exterior face of the rail in Span 18AE.

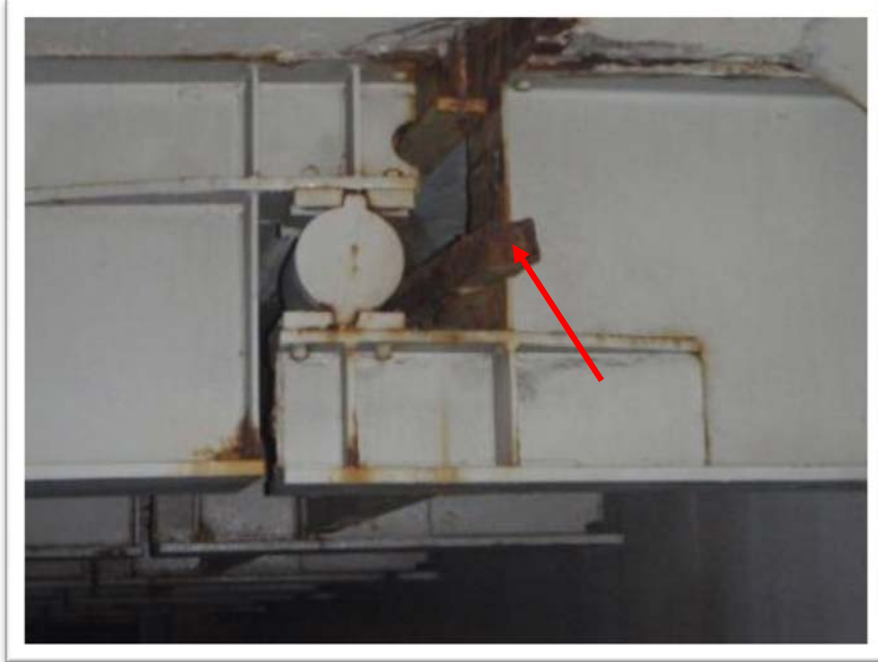
- There are clogged drains on the east side near Pier 11 and the North Abutment AE. See Appendix C for details.
- The downspout has surface corrosion in Span 23AE near the North Abutment AE.
- The drain is clogged near Pier 6 in Span 7.
- Part of the drain has fallen onto the girder cope next to the seated hinge at the following locations.
  - ♦ Span 12

- ◆ Span 17

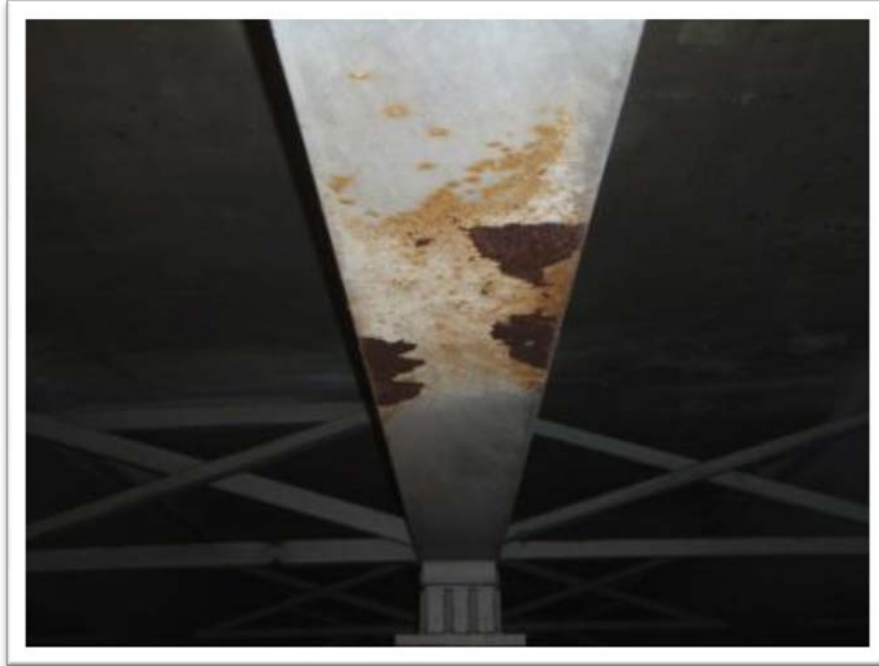
- Light surface corrosion with isolated locations of moderate corrosion on the web, stiffeners, and flanges, specifically the bottom flange.

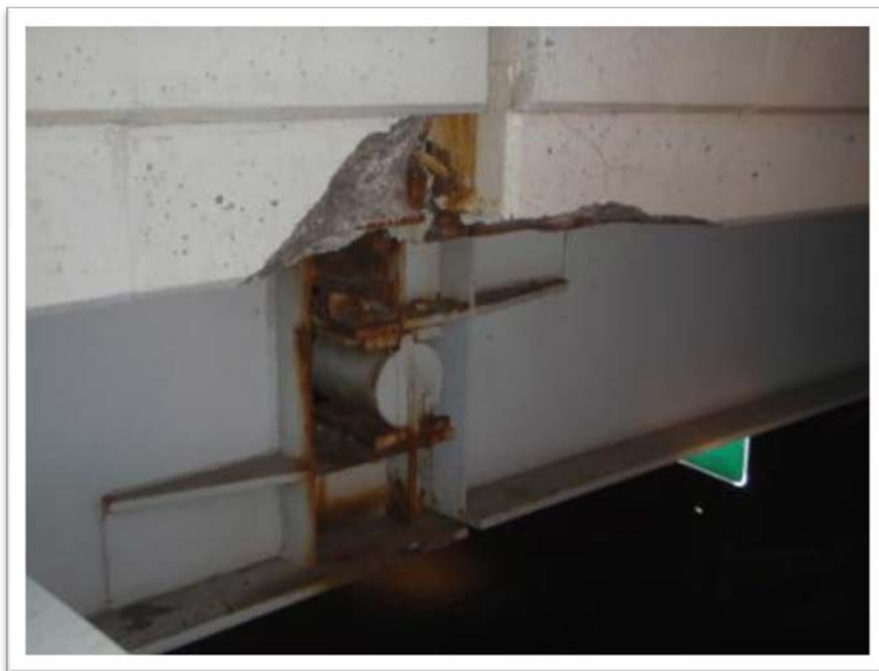
- Surface corrosion at the seated hinges with up to 1/16" section loss.

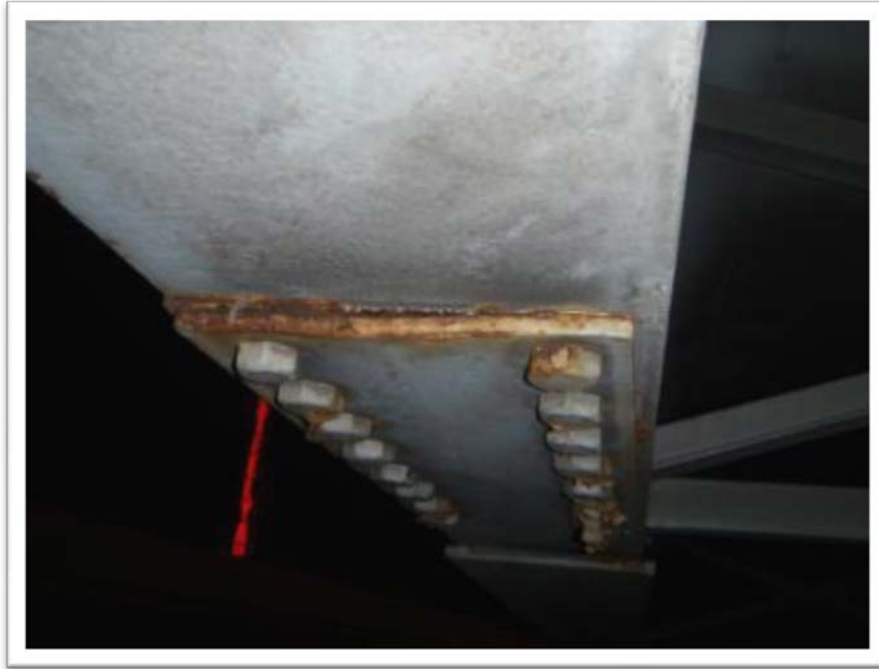
- 1/2" pack rust has bowed the bottom cover plate of Beam F in Span 20AW.

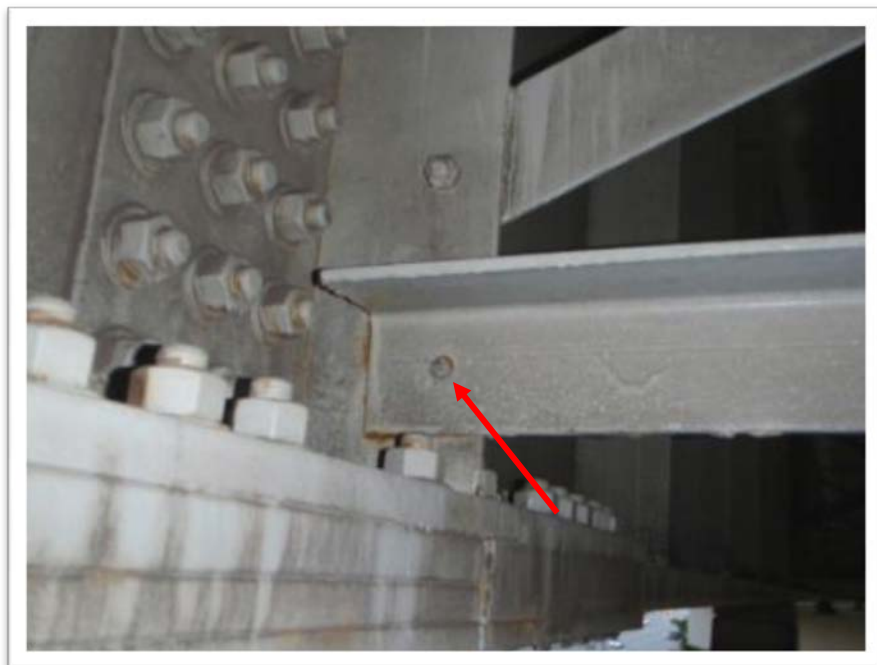
- There is a missing bolt at Girder F in Span 2.
- There is a missing bolt between Girders C and D in Span 4.

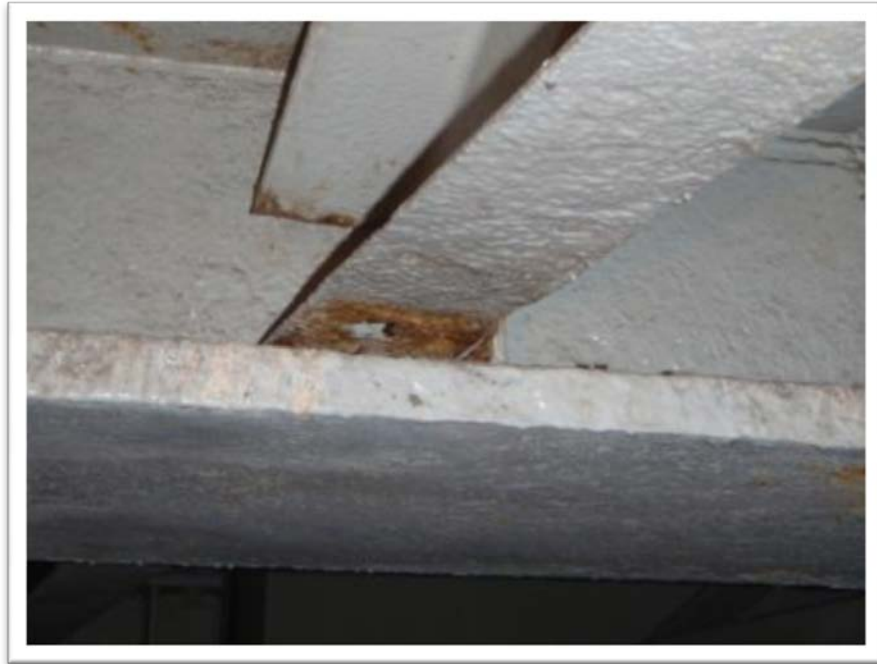
- A 1 ½” corrosion hole exists near Beam K between Beams K and L in Span 18AE.

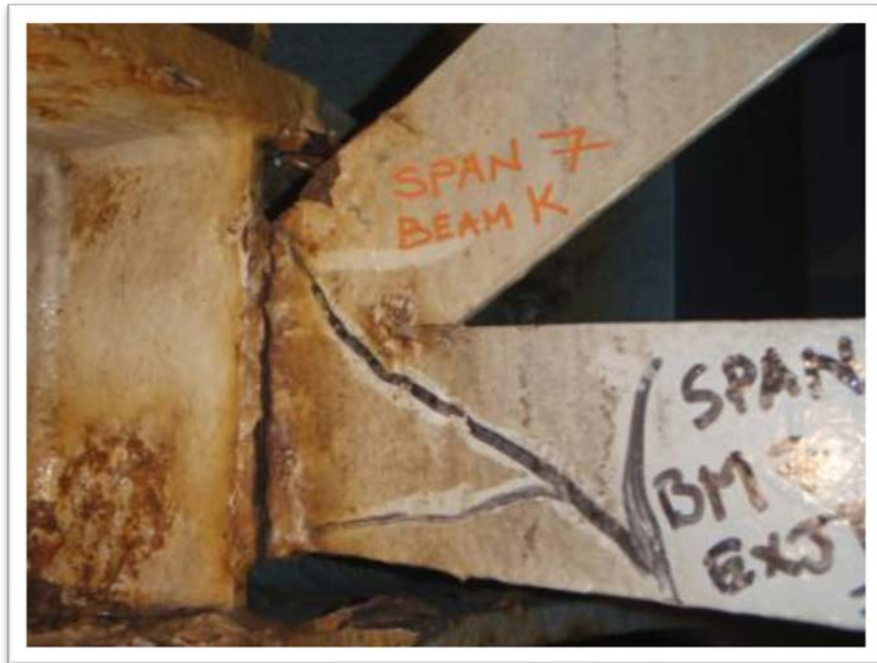
- The following locations have tears or are beginning to tear.
  - ♦ The crossbracing is severed at Beam K between Beams K & F in Span 7.

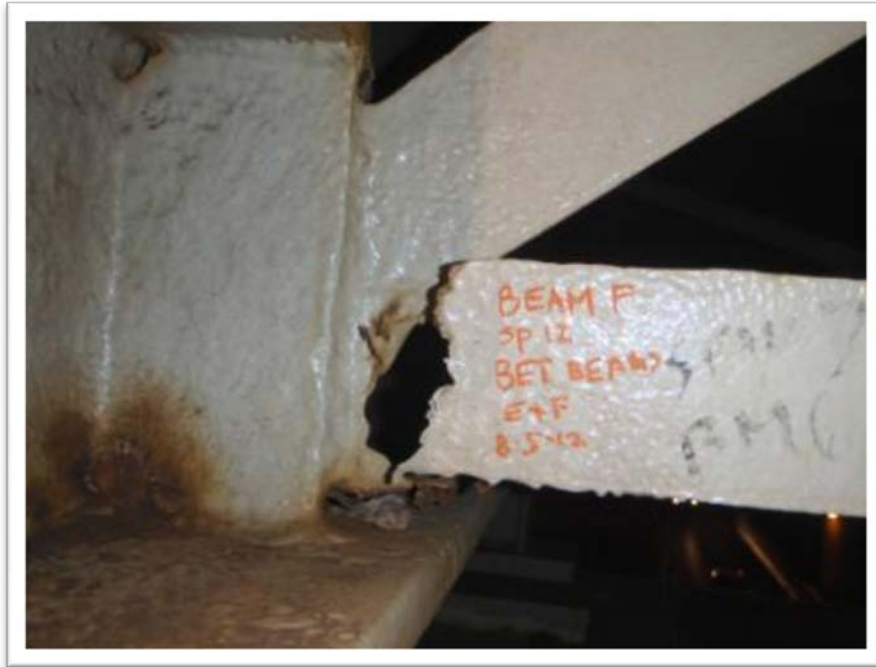
- ♦ Surface corrosion exists at various locations.
- ♦ Pack rust is beginning to tear at Beam F between Beams K & F in Span 7.

- ♦ There is a 1 ¼” tear at Beam K between Beams K & L in Span 18AE.
- ♦ There is a 2 ½” tear at Beam L between Beams K & L in Span 12.
- ♦ There is a 3” tear at Beam K between Beams F & K in Span 12.
- ♦ A full tear exists in Beam F between Beams E & F in Span 12.

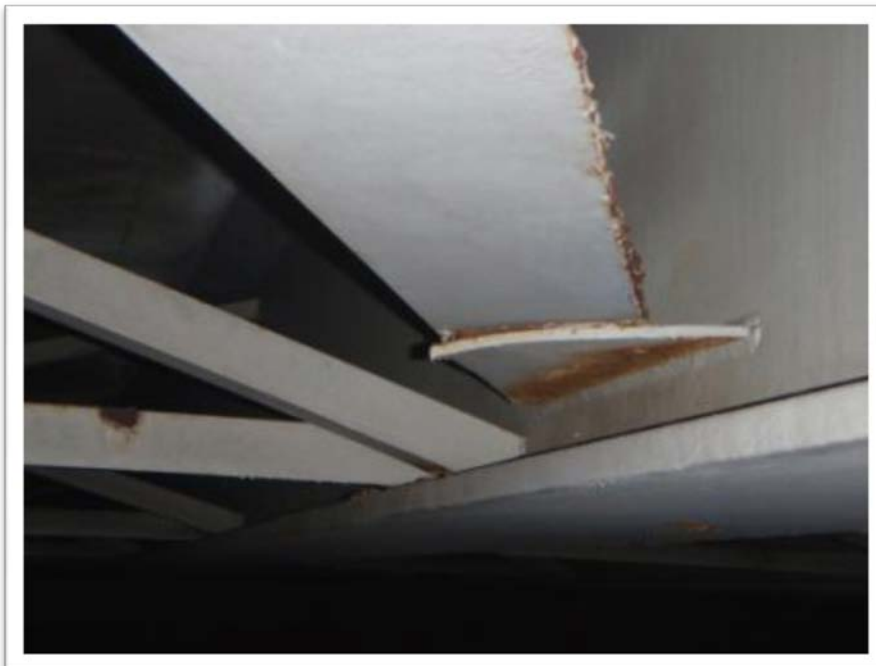
- ¾” pack rust is bowing the gusset plate in Span 18AE at Beam K.

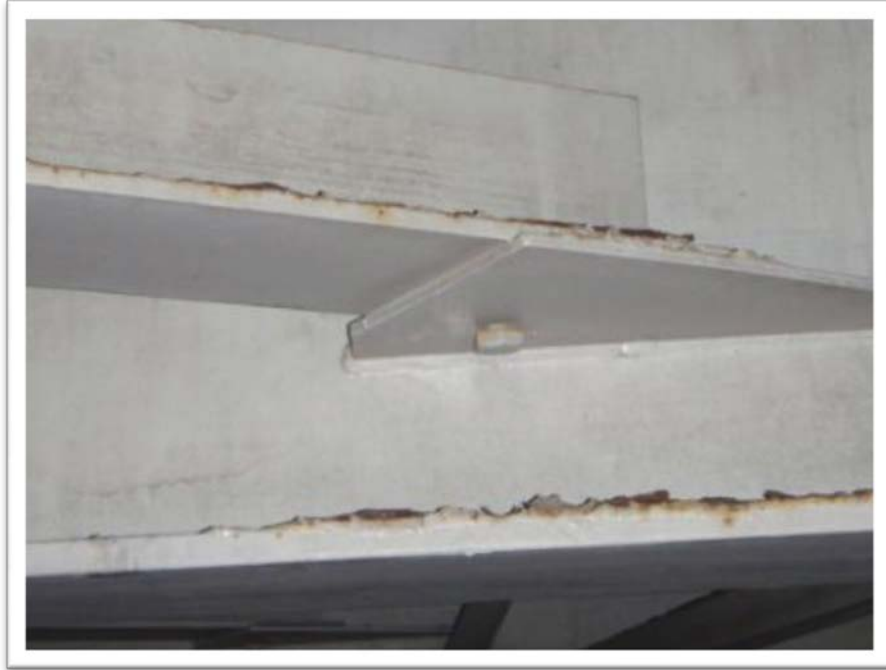
- ½” pack rust and a bent gusset plate in Span 19AE at Beam J.
- There is a loose bolt at the gusset plate in Span 21AE at Beam K.

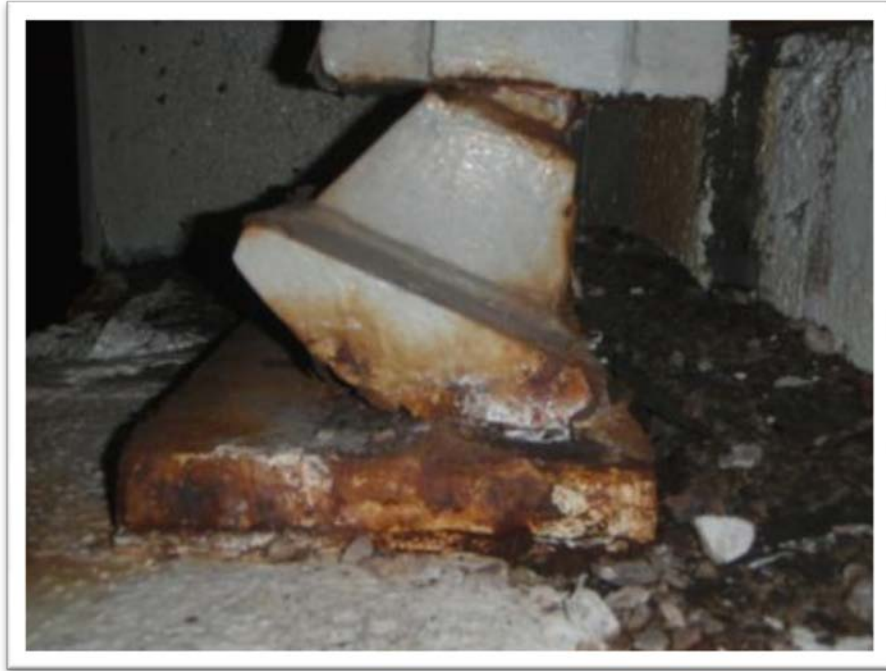
- One bearing is rocked beyond recall (Horizontal Distance >  $\frac{1}{3}$  H).
  - ♦ North Abut AW      23°N      Bearing G

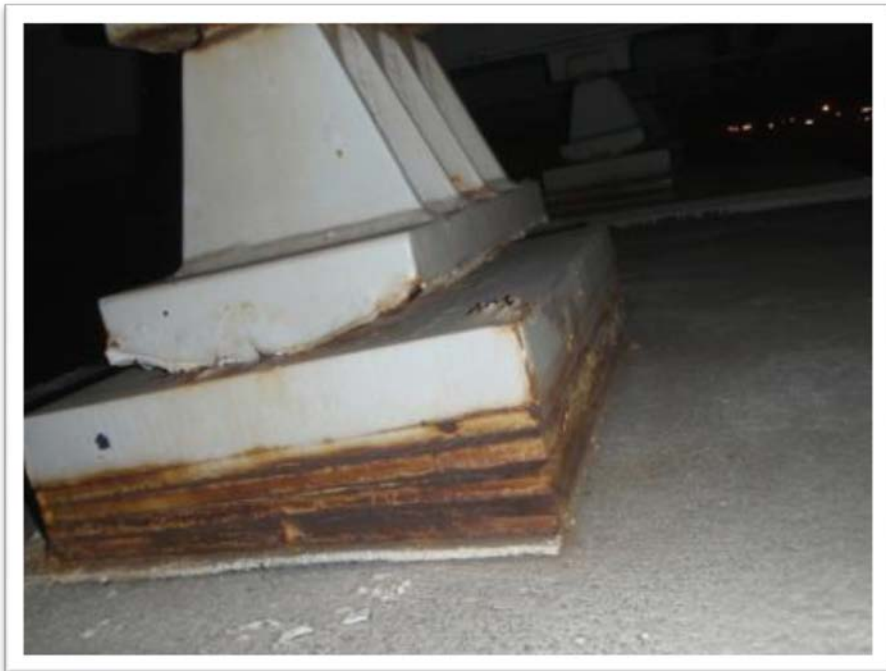
- The bearings at Pier 21AW have pack rust between the shims causing the masonry plate to be rotated.

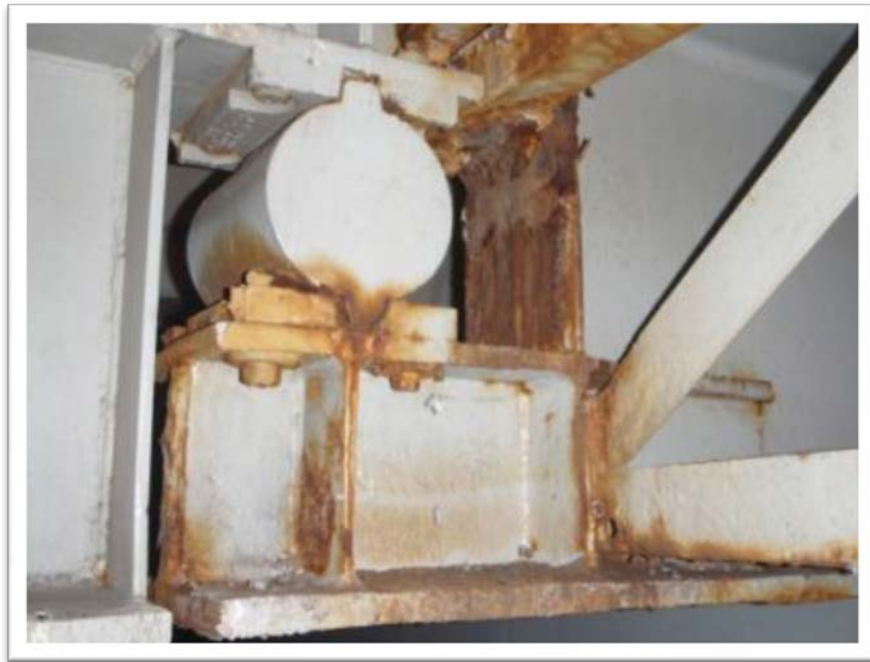
- Surface corrosion. Heavier corrosion at the groove.

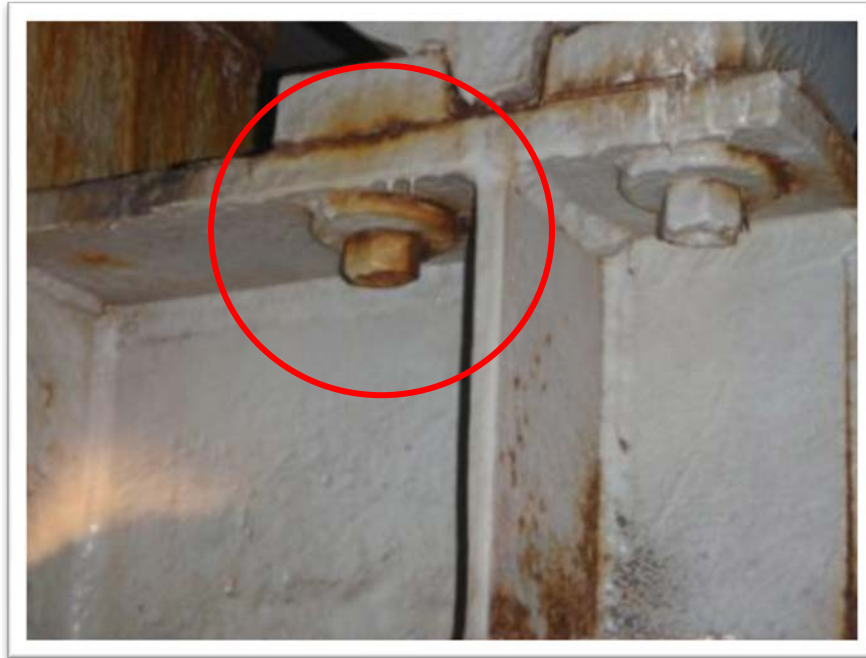
- Loose bolt in Span 18AW on Beam E.

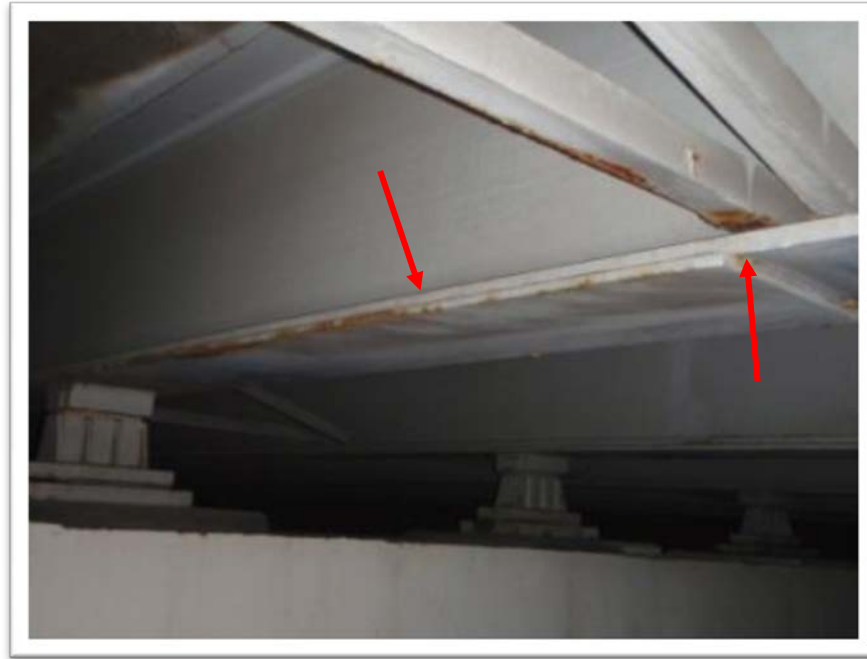
- Surface corrosion on the intersecting welds under the seated hinge.
- Surface corrosion on the welds along the bottom cover plate and at the ends.

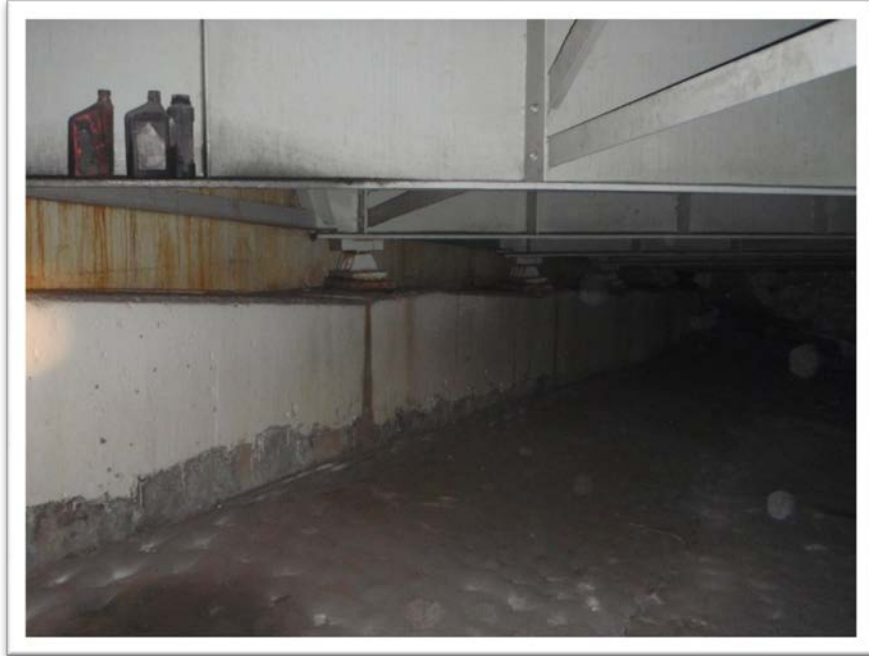
- South Abutment A – There is light cracking.

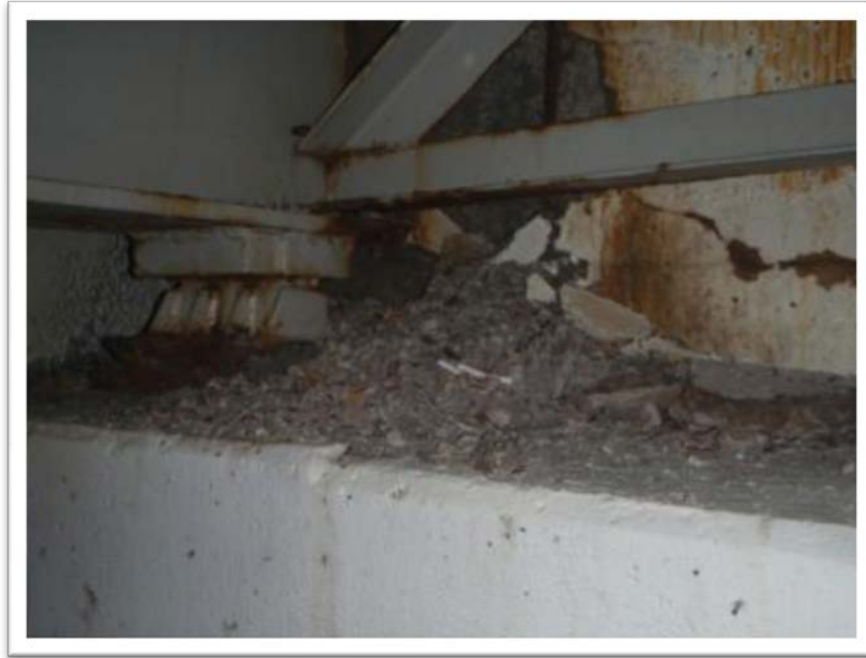
- North Abutment AW – There is debris around Bearing A and F.

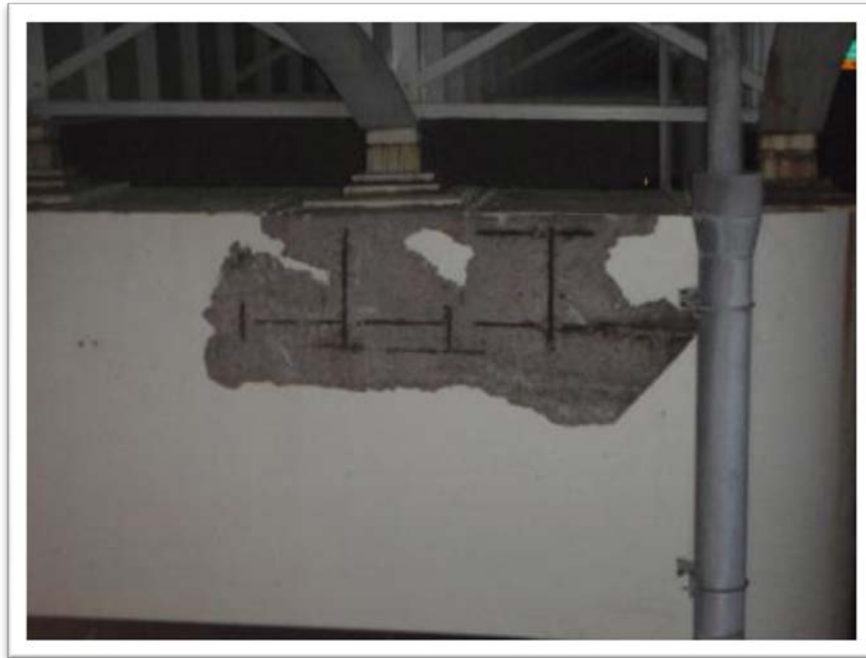
- Pier 6 – The pier cap has multiple cracks. The bottom edge of the south side has a 6' x 4" spall with exposed rebar. The bottom edge of the north side has a 5' x 2' spall with exposed rebar. The north face of the pier cap has an 8' x 4' spall with exposed rebar on the west side.

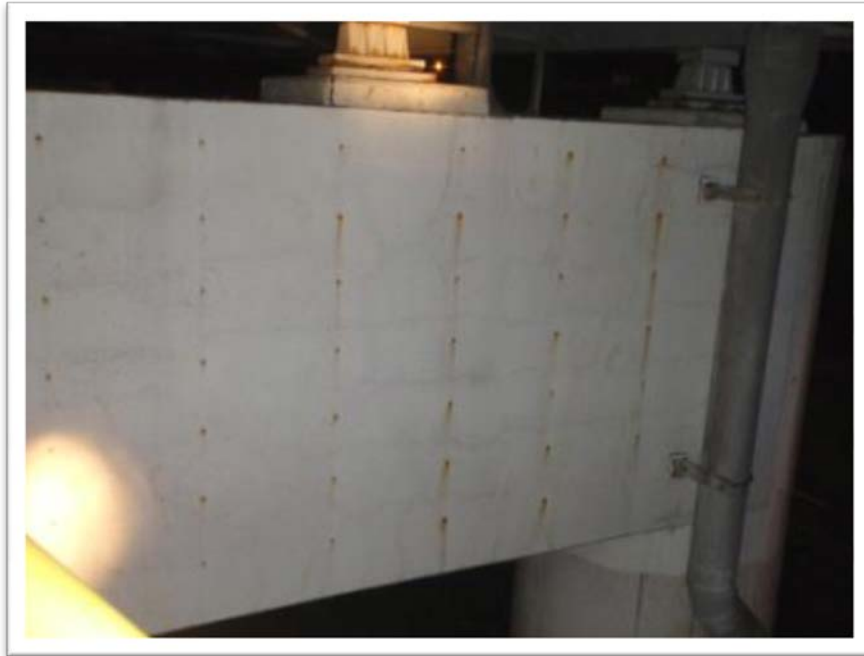
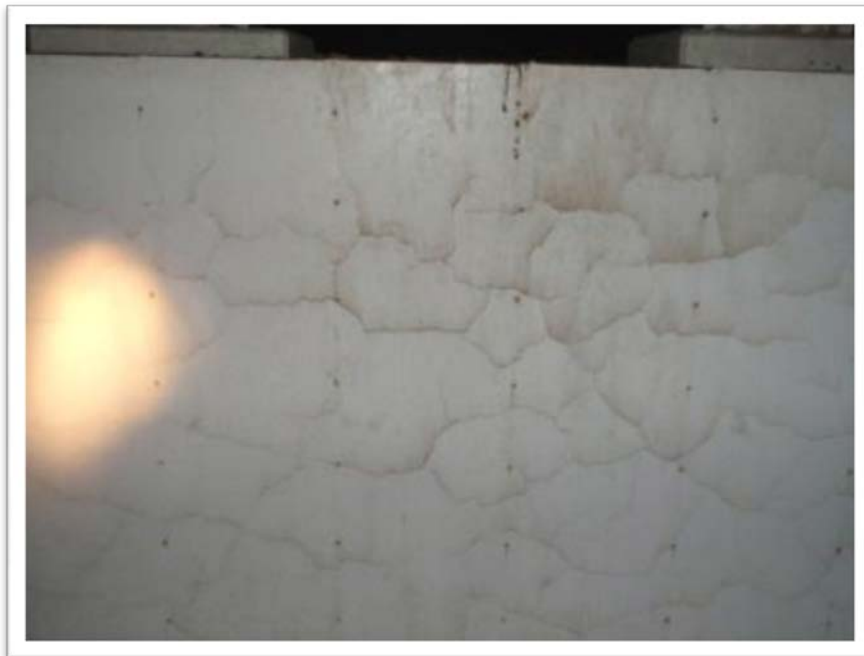
- Pier 11 – The pier cap has multiple cracks. The north face has map cracking that mirrors the rebar pattern and alligator cracking. The north face also has several spalls, some with exposed rebar.

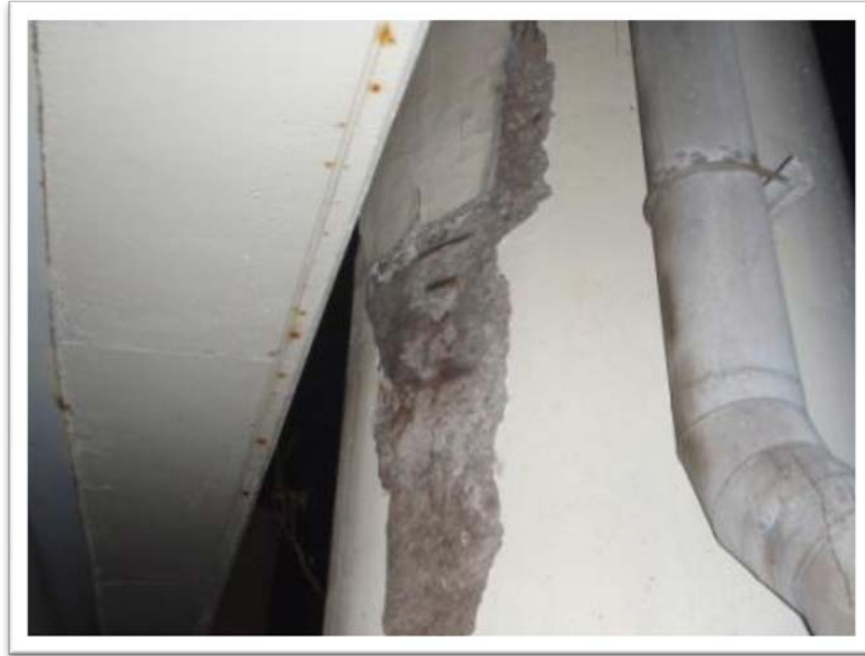
- Pier 14 – The pier cap has multiple cracks. The east column has a 3' x 9' spall with delaminations and exposed rebar. There is also a 3 ½' x 2' spall with exposed rebar.

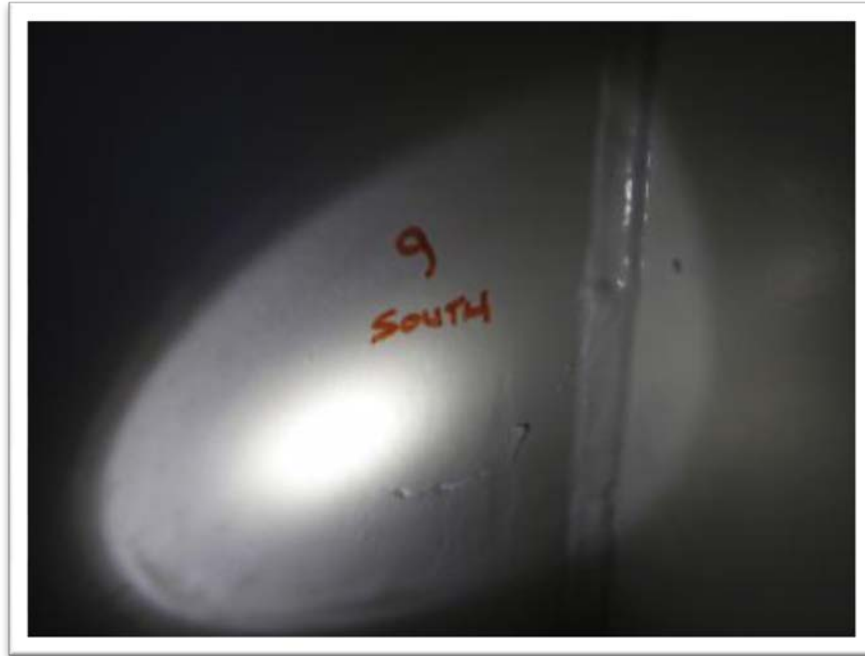
- ♦ At Section 9S, there is a steel inclusion in the web.

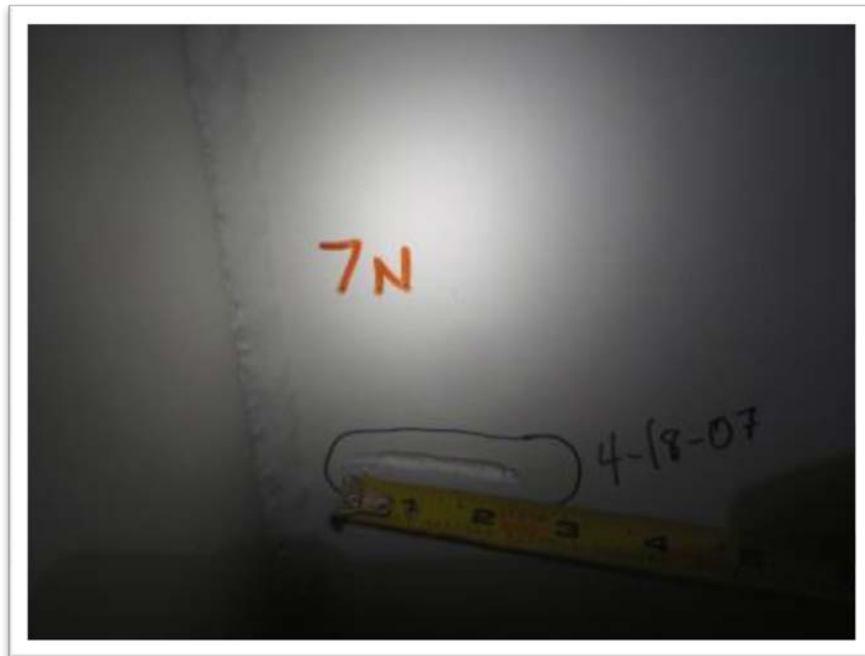
- ♦ At Section 7N, there is a steel inclusion in the web and a 2 1/8" x 1/8" deep gouge.

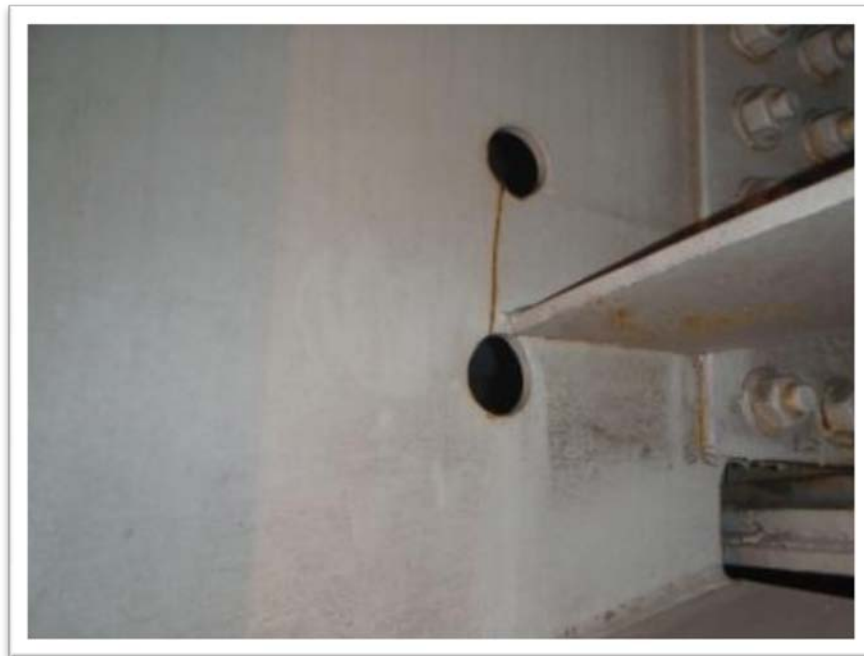
- ♦ Beam G – 4 1/8” crack

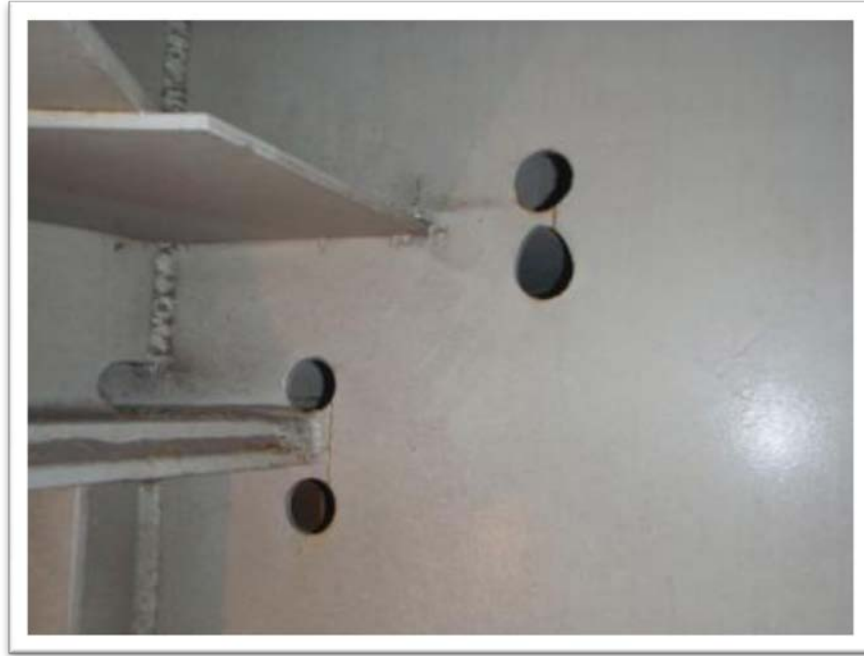
- ♦ Beam H – 3/4" crack
- ♦ Beam J – 1 3/8" and 1" cracks
- ♦ Beam K – 3/4" and 1" cracks
- ♦ Beam L – 3/4", 2 7/8", and 5/8" cracks

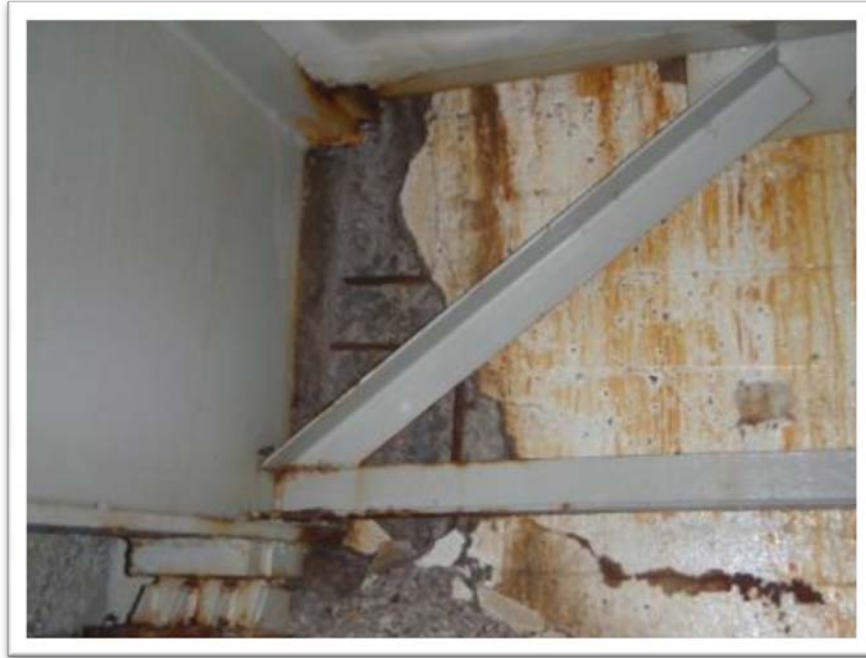
- North Abutment AW – The backwall is failing at the northwest corner (5' x 2 ½' x 3"). This area has exposed rebar.

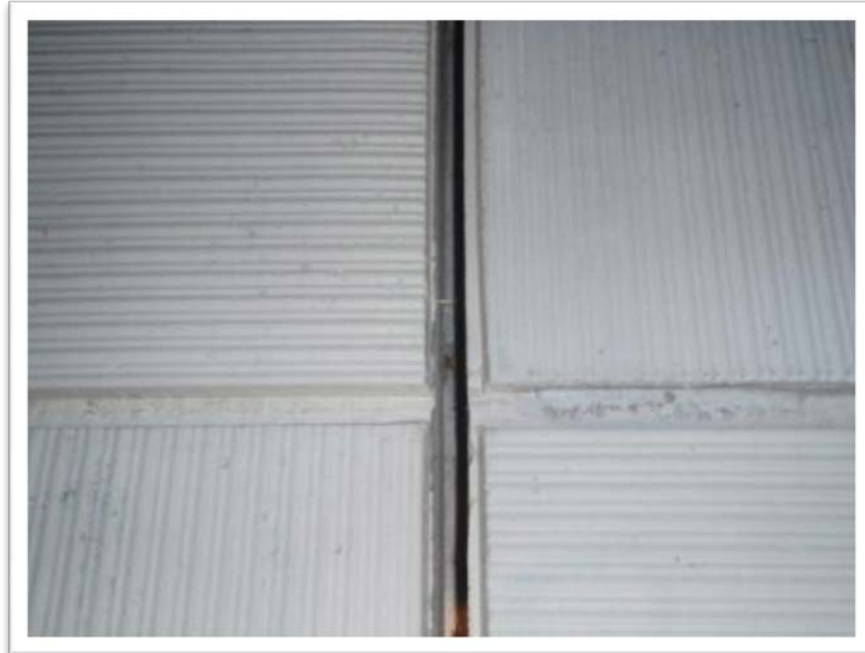
- North Abutment AW – The east wingwall has missing joint material.

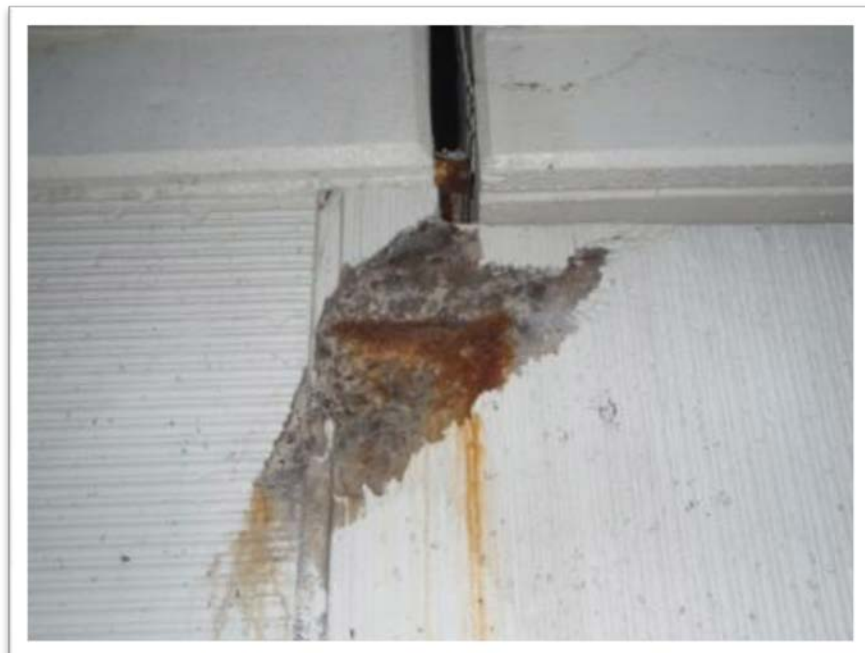
- North Abutment AW – The west wingwall has a 1 ½' x 1 ½' spall with exposed rebar.

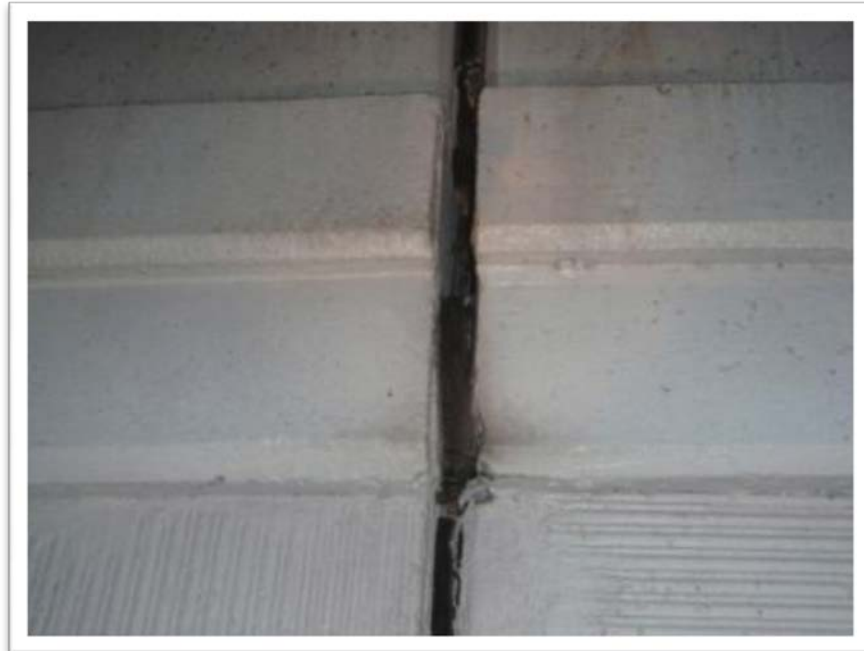
- North Abutment AW – The west wingwall has joint material falling out at the lower rail level.

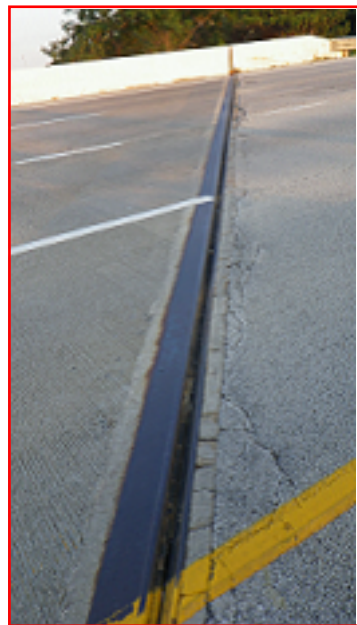
Typical map cracking along expansion joint.

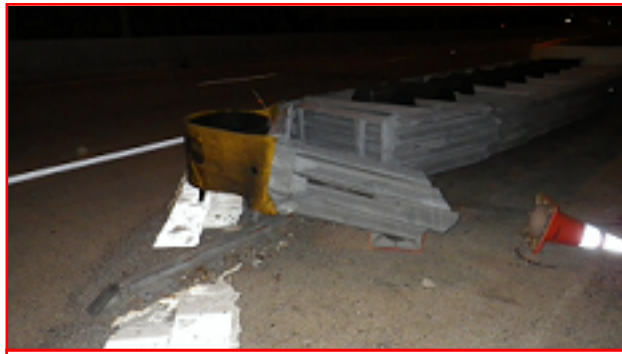
Impact attenuator has been hit by vehicle.

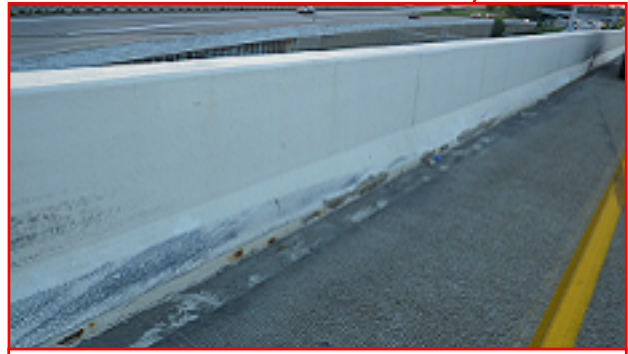
Typical spall at toe of barrier.

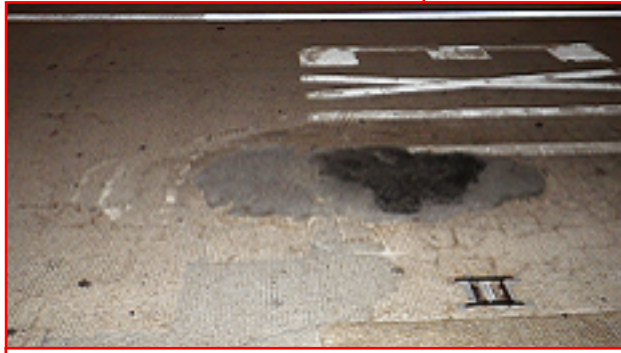
Typical failing asphalt patch.
