## **2012 In-Depth Inspection Report**

### **I-71/SR 176 Double Decker Bridge – (I-71 Upper Deck)**

**CUY-00071-1791  
(SFN 1805371)**

**Inspection Dates: 07/30/2012 to 08/10/2012**

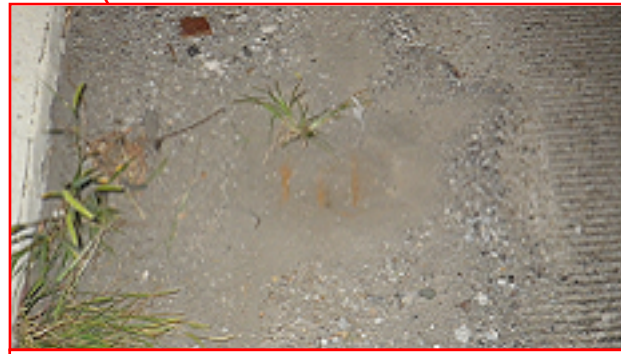
Typical clogged drain.

No major issues were found on the deck surface during the bridge inspection. It is recommended to repair the damaged barrier railing section noted above, and to clear the clogged scuppers noted above.

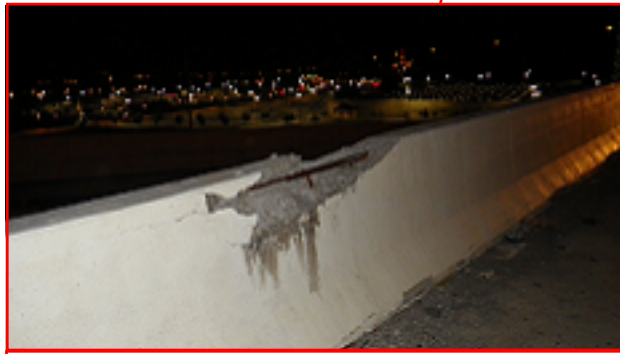
Spall with exposed reinforcing steel at barrier.
